**MATERIAL ANALYSIS OF HURMAN CASTLE AND  
RECOMMENDATIONS FOR RENOVATION**

**İNŞAAT MÜHENDİSLİĞİ BÖLÜMÜ  
YÜKSEK LİSANS TEZİ**

**GÖKHAN GÜMÜŞBURUN**

**OCAK - 2019**

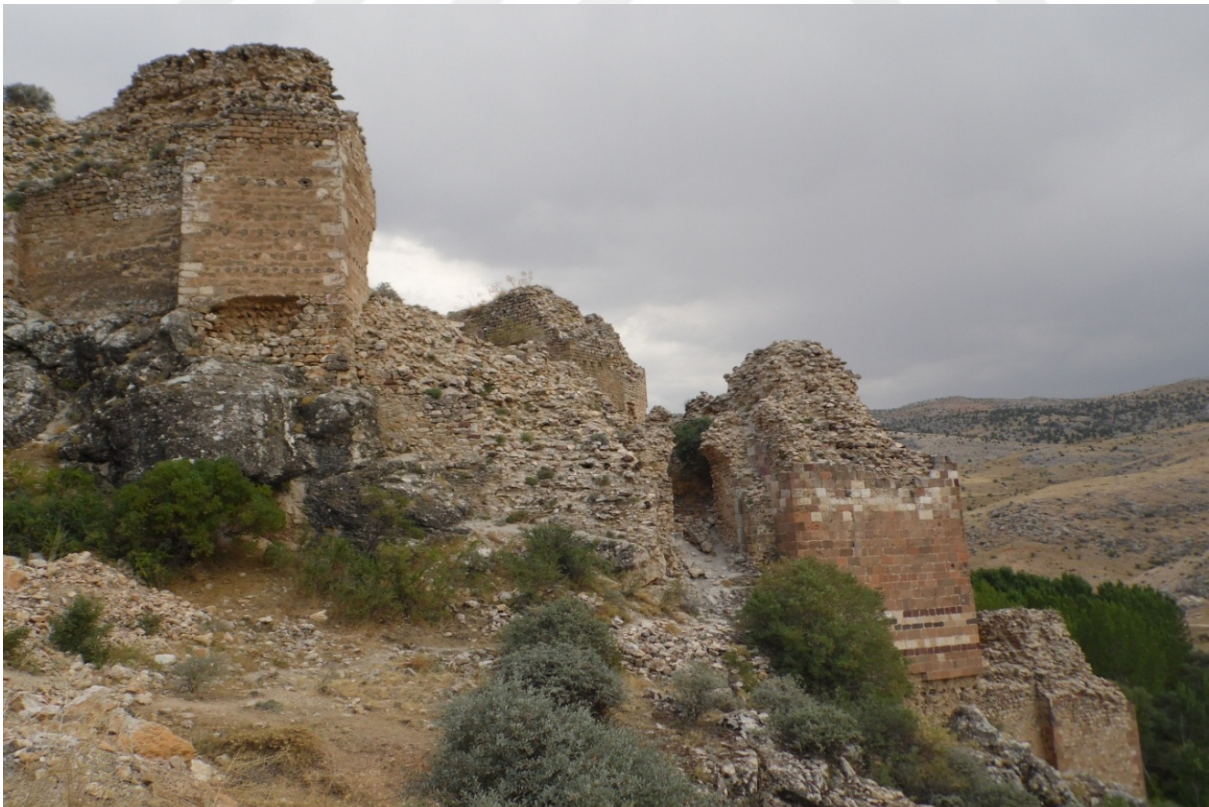
**Photo 100 .** Wall of KD 9-11

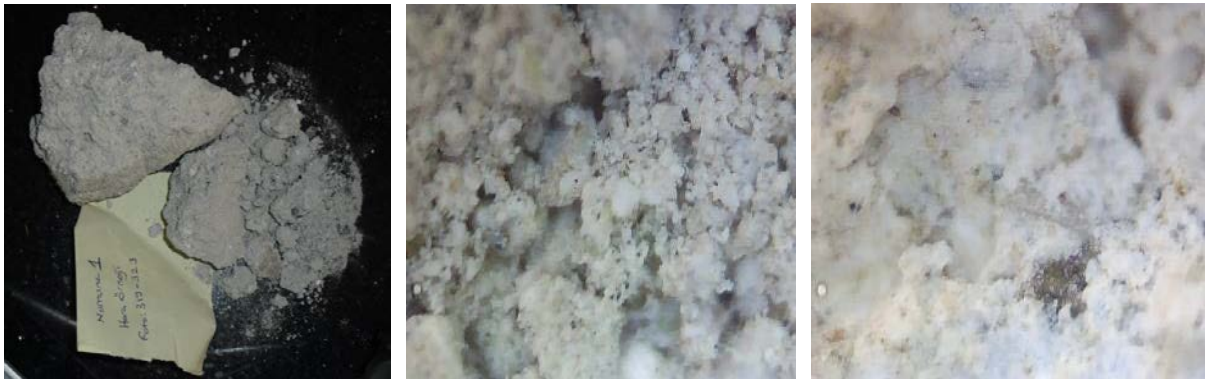
**Photo 115 .** Image with 100 times and 250 times the magnification of the sample number 1

**Sample No. 1:** Sample contains lime and coarse-grained aggregate aggregate . No substance was found as puzolon.

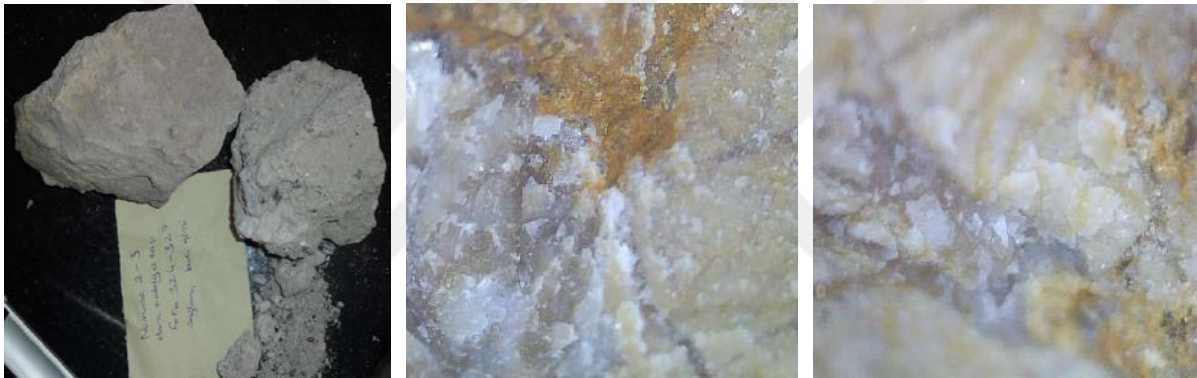
**Photo 116 .** Image with 100 times and 250 times the magnification of the sample number 2 and 3

**Sample 2 and 3:** The information we can get from the stone part of the sample above is that it is a sedimentary carbonate rock with crystal features. Renlekme is due to differences in mineral structure. Hardness degree is high but shows rigid properties. Due to the formation of the metamorphism on the rock and due to the properties of the interconnectors caused a vascular structure.

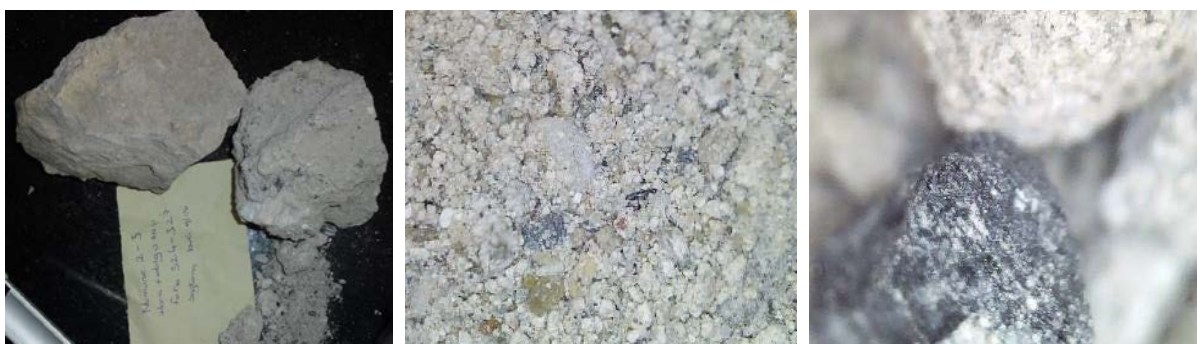
**Photo 117.** Image with 100 times and 250 times the magnification of the sample number 2 and 3

The part of the building mortar consists of mixing the stream aggregate with a poor granulometry with lime. In addition, wood ash was used as puzolon. This structure is intensely seen in Anatolia before the Seljuk mortar mortars. Later, instead of baked clay powder was used. Although the strength of the clay is low, the clays which were cooked at high temperatures were used. This type of material gives strength to the mortar and added to the stiffness.

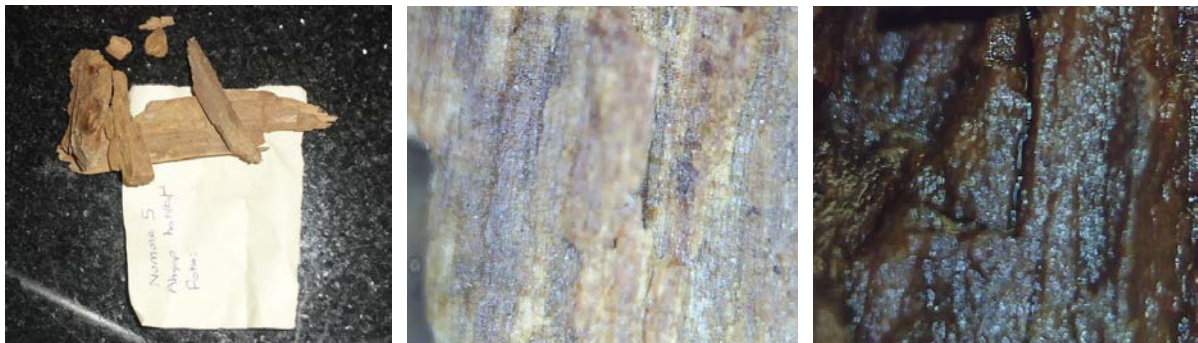
**Photo 119 .** Image with 100 Times and 250 Times Enlarged Cases of Wood Material

**Sample Number 5 (Wood):** It was observed that wood material was resinous and deformed over time according to fiber structure. It has been found that it is under the effect of shear force according to deformation shape.

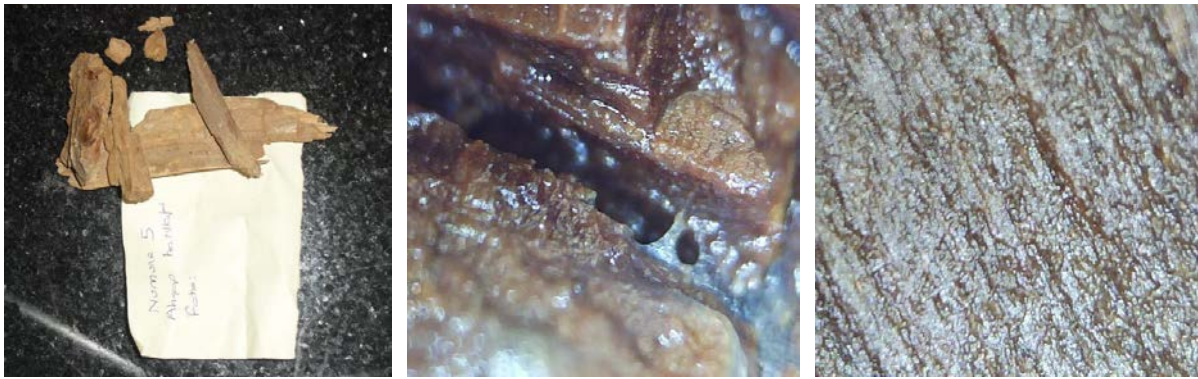
**Photo 120 .** Image with 100 Times and 250 Times Enlarged Cases of Wood Material

This situation can be said to be parallel to the acceleration of gravitational forces where wood material is located . On the contrary, if there had been a situation in the wood material, force formation would be observed to shift the fibers . This would tell us about the moment. The moment state in the masonry structures is considered to be an undesirable situation. It is avoided as much as possible.

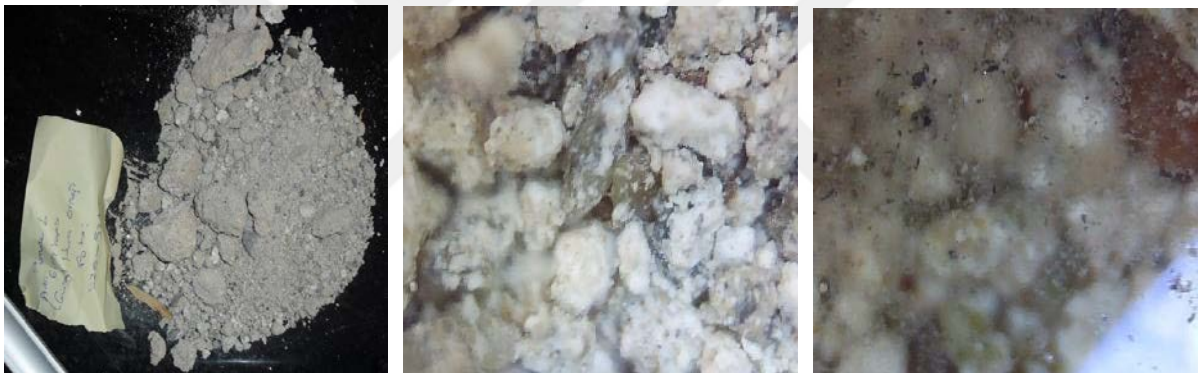
**Photo 121 .** Image with 100 times and 250 times the magnification of the sample number 6

**Sample No. 6:** The sample contains lime and wood ash together with fine-grained stream aggregate. As wood ash is used without good sieving, it is seen as relatively coarse pieces.

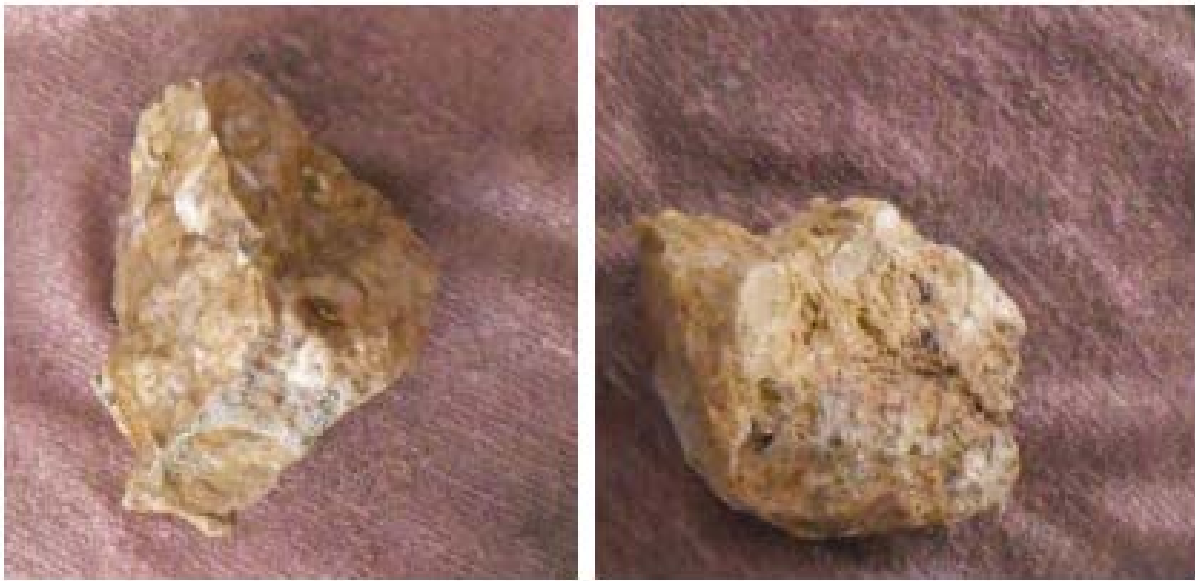
**Photo 129 .** Stone Specimens

Stone specimens consist of limestone and a small amount of crystallized limestone. For this reason, the water absorption rate of the material was observed to be low. In addition, the point load strength of the stone material is higher than the amorphous limestone material, but it is observed to be lower than the totally crystallized limestone (marble, etc.).
