**REORGANISATION OF TRADITIONAL DWELLINGS
IN BARTIN ASMA STREET
ACCORDING TO THE USER CHARACTERISTICS**

**A THESIS SUBMITTED TO
THE GRADUATE SCHOOL OF NATURAL AND APPLIED SCIENCES
OF
THE MIDDLE EAST TECHNICAL UNIVERSITY**

ÇİLER BUKET TOSUN

MARCH 2001

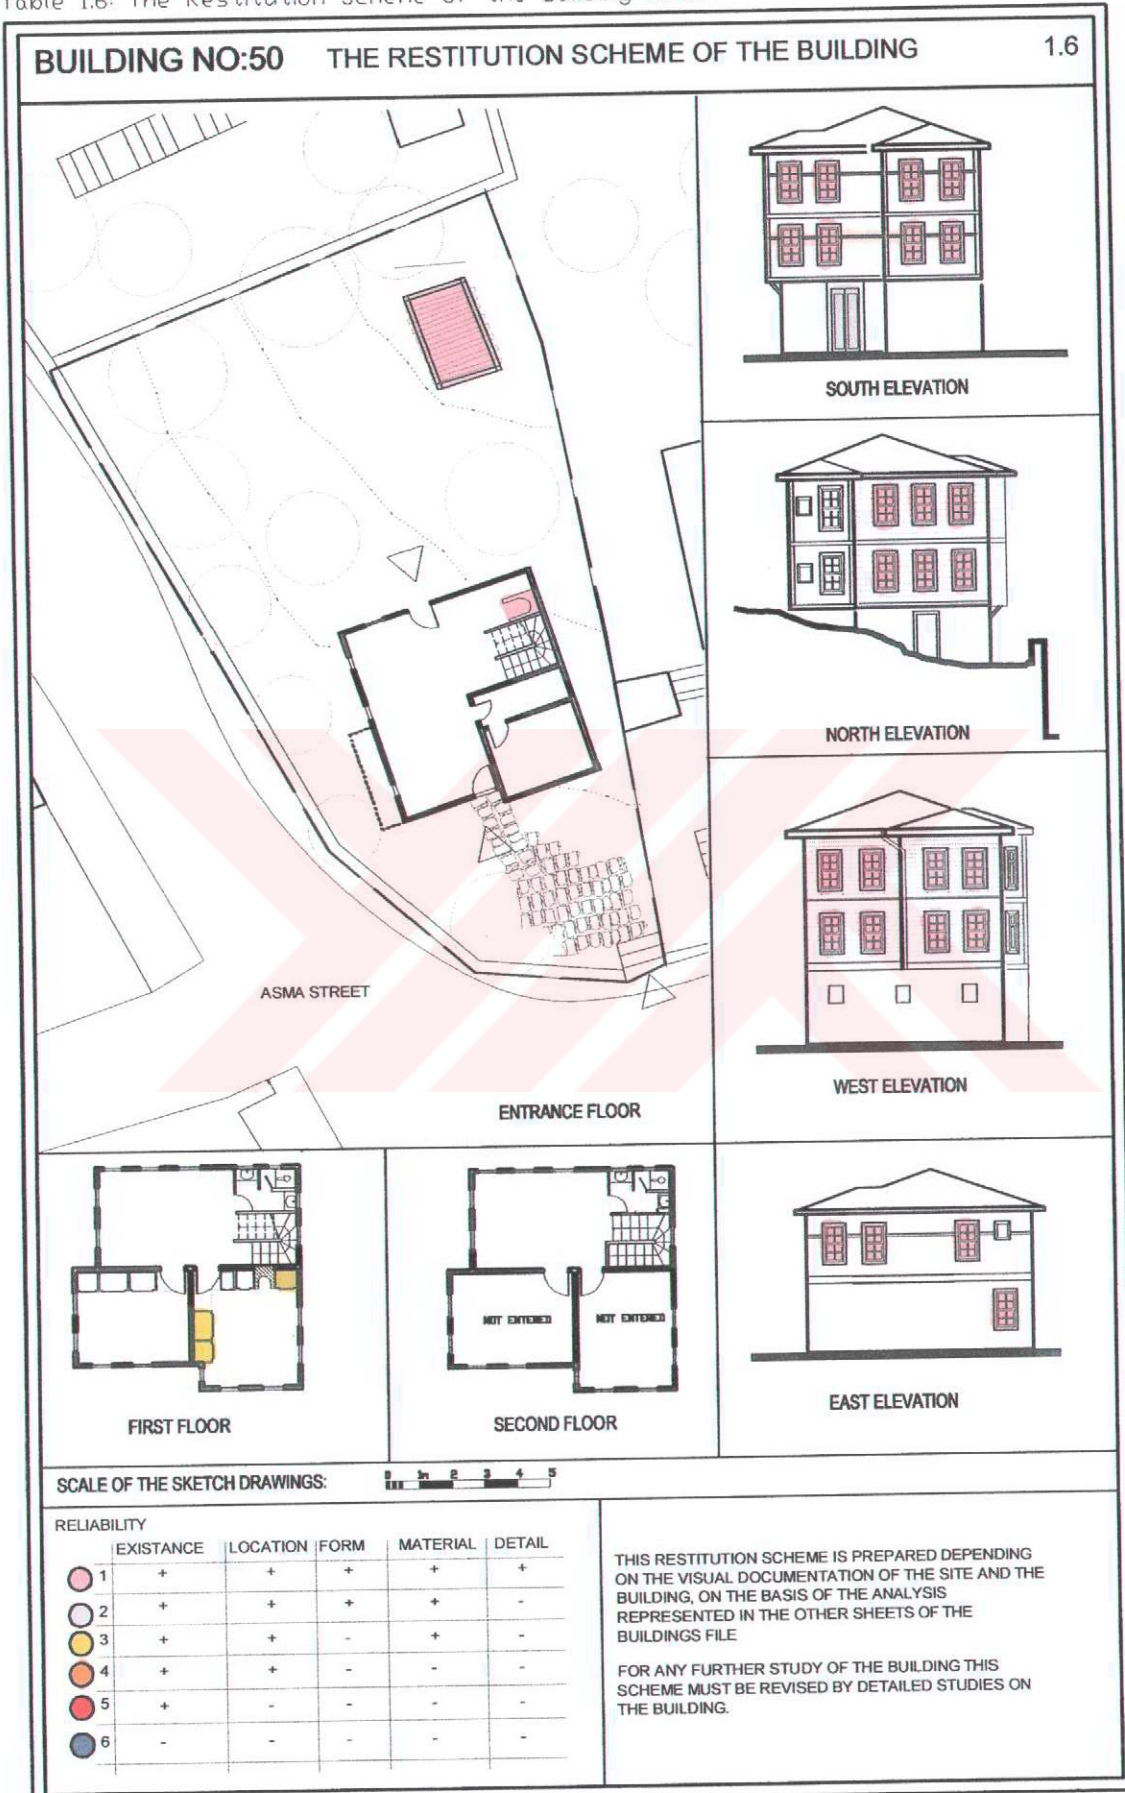
Table 1.7: The Evaluations of the Values and the Problems of the Building No:50

BUILDING NO:50	EVALUATION OF THE BUILDING	1.7
VALUES OF THE BUILDING		
<p>THE BUILDING IS LOCATED AT A VERY IMPORTANT JUNCTION OF THE ASMA STREET. IT IS PLACED IN A GARDEN WITH COURTYARD AT THE ENTRANCE .IT IS A TYPICAL EXAMPLE OF THE TRADITIONAL BARTIN HOUSE WITH ITS ARCHITECTURAL AND PHYSICAL CHARACTERISTICS. A THREE STOREY TIMBER FRAME CONSTRUCTED ON THE STONE MASONRY BASE BUILDING HAS WOOD INFILL IN THE FIRST FLOOR AND 'BAGDADI' TECHNIQUE AT THE SECOND FLOOR, WHICH IS A RARITY VALUE IN THE STUDY AREA.</p> <p>BEING A TRADITIONAL DWELLING IT HAS DOCUMENTARY, HISTORICAL AND CULTURAL VALUES. IT HAS PRESERVED MOST OF ITS ARCHITECTURAL VALUES. MOREOVER, AS IT HAS NOT DIVIDED AND PRESERVED MOST OF ITS PLAN AND FACADE CHARACTERISTICS AND ELEMENTS, (IT CAN BE SEEN IN TABLE II.8 AND FROM THE DRAWING SET OF C1,C2 AND C3: IT HAS PLAN VALUE OF 7 OUT OF 8; FACADE VALUE OF 4 OUT OF 7.) IT IS ONE OF THE TRADITIONAL DWELLING IN THE STUDY AREA WHICH PRESERVED MOST OF ITS VALUES. WHAT IS MORE IT HAS A RARITY PLAN SCHEME VALUE FOR BARTIN WITH NO BASEMENT FLOOR BUT A GROUND FLOOR, WHERE AN ENTRANCE TO THE GARDEN AND A FIREPLACE IS LOCATED.</p> <p>IT HAS ALSO PRESERVED ITS BUILDING LOT CHARACTERISTICS AND TRADITIONAL SERVICE SPACE 'AMBAR' IN THE GARDEN WHICH IS ALSO A RARITY VALUE IN BARTIN. IT IS THE ONLY TRADITIONAL DWELLING IN THE SITE WHICH COULD HAVE PRESERVED ITS COURTYARD STONE COVERING IN THE SITE.</p> <p>AS THE ALL SPACES OF THE DWELLING COULD NOT BE ENTERED, THE EVALUATIONS COULD NOT BE COMPLETED. IN THE ANALYSIS ONLY TWO ROOMS OF THE DWELLING COULD BE ENTERED. IT IS SEEN THAT IT HAD LOST SOME OF ITS ARCHITECTURAL ELEMENTS (CUPBOARDS AND 'GUSULHANE') IN ROOM 6 ; BUT IN WET SPACES ORIGINAL CUPBOARDS AND SHELVES ARE SEEN AT THE SECOND FLOOR MOSTLY. THE COMMON SPACE AT THE SECOND FLOOR IS SEEN TO HAVE DIVIDED BY AN ADDITIONAL TIMBER WALL WHICH CAN EASILY BE TAKEN OUT ; BUT IN ROOM 6 THE ADDITIONAL WET SPACE OF BATHROOM ANNEX TO THE BUILDING CHANGES THE SPACE QUALITY OF ROOM 6.</p>

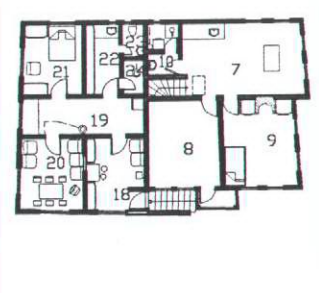
Table 2.5: Physical Problems of the Building No:67

BUILDING NO:67 THE PHYSICAL PROBLEMS OF THE BUILDING		2.5	
	STRUCTURAL DEFORMATIONS	MATERIAL DETERIORATIONS	
STRUCTURAL ELEMENTS	PARTIALLY COLLAPSED THE UPPER STRUCTURE SETTLEMENT PROBLEM: THE FLOORS OF THE UPPER AND DAMPNESS FLOOR STAIRCASE THE WC OF THE SECOND FLOOR	TIMBER SERIOUS INSECT ATTACK PROBLEM	
	CRACKS : AT THE WALLS OF SPACE 7	STONE RISING DAMP DETACHMENT	
		TILES AND MATERIAL LOSS GUTTER	
ARCHITECTURAL ELEMENTS	PARTIALLY COLLAPSED AND : THE STAIRCASE MATERIAL LOSS	TIMBER SERIOUS INSECT ATTACK PROBLEM	
EVALUATION OF THE DEFORMATION AND DETERIORATIONS	THE MAIN PHYSICAL PROBLEM OF THE BUILDING IS THE DEFORMATIONS AND DETERIORATIONS AT THE UPPER FLOOR AND THE UPPER STRUCTURE. THERE ARE ALSO A VERY SERIOUS SCALE INSECT ATTACK PROBLEM ON THE TIMBER ELEMENTS AND RISING DAMP PROBLEM AT THE STONE MASONRY.		
CHANGES	SCALE OF THE SKETCH DRAWINGS.		
<ul style="list-style-type: none"> <input type="radio"/> DIVISION <input type="radio"/> VERTICALLY <input type="radio"/> HORIZONTALLY <input type="radio"/> PARTIALLY COLLAPSED <input type="radio"/> REMOVED <input type="radio"/> REPLACED <input type="radio"/> ADDITION <input type="radio"/> NOT USED

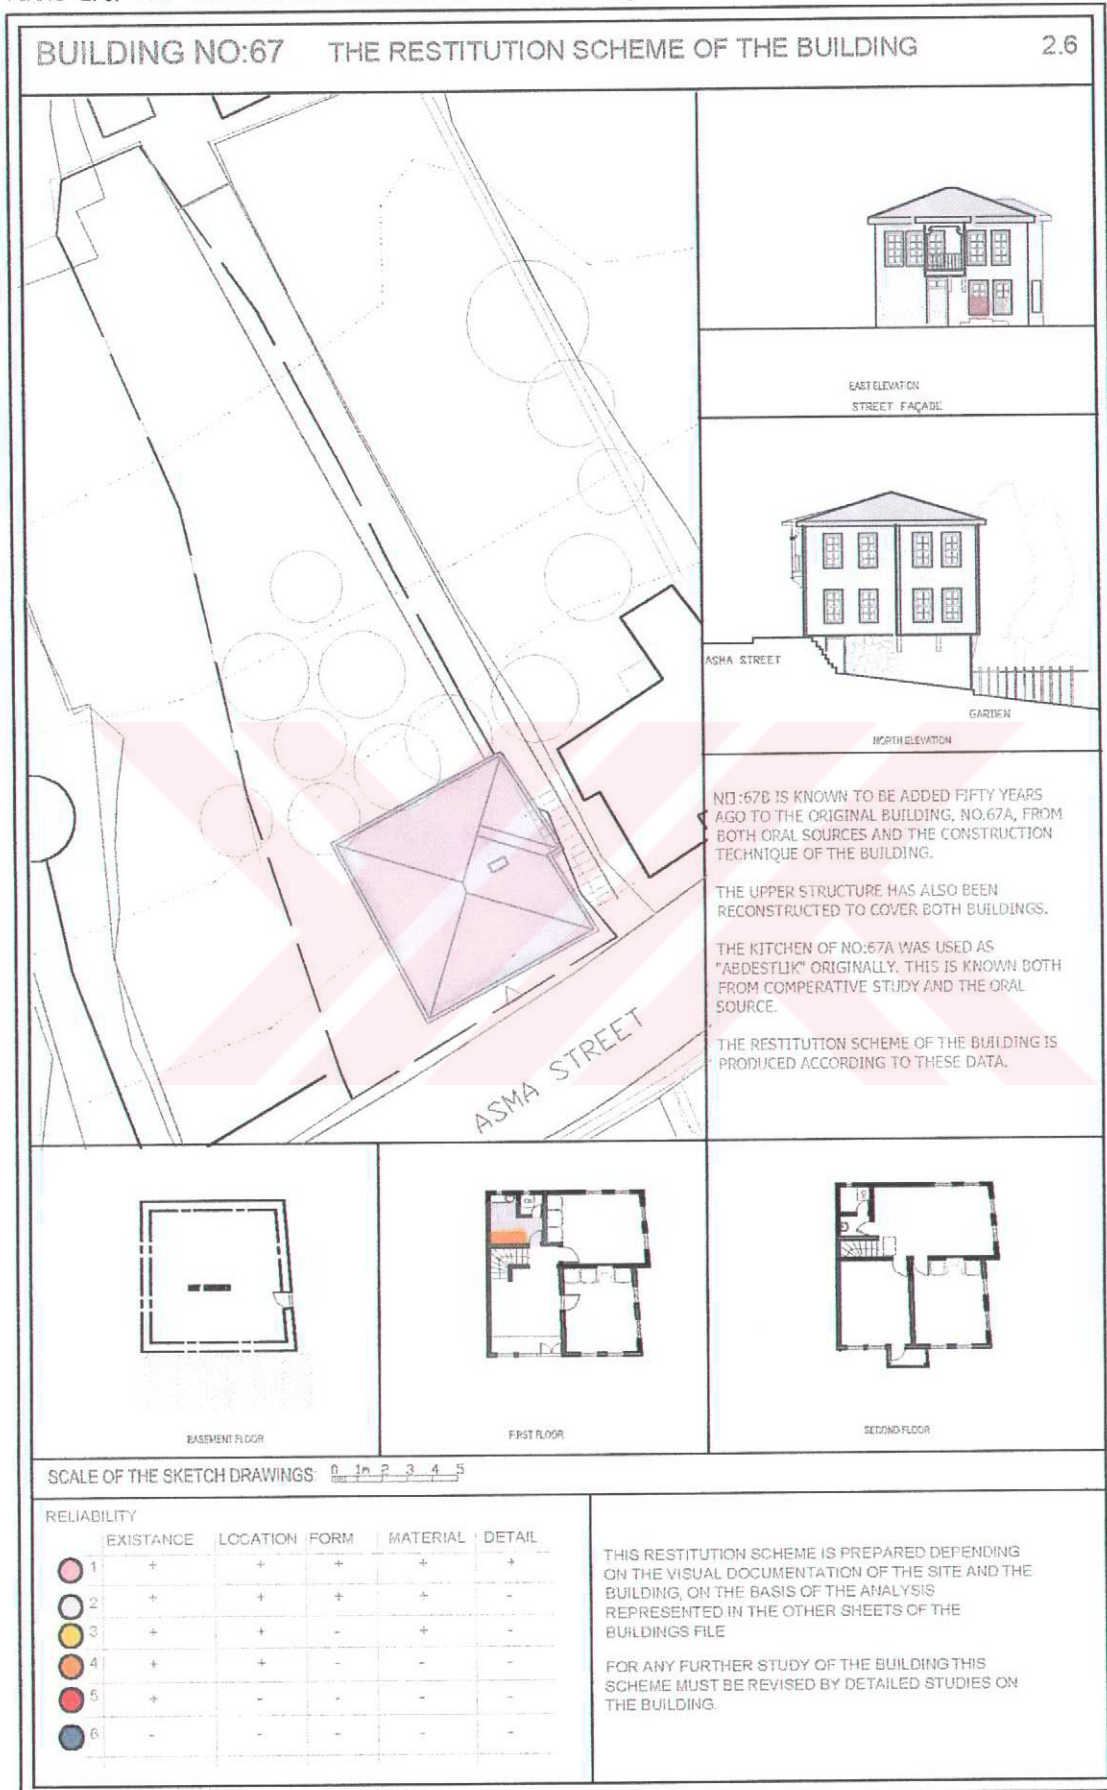
Table 2.7: The Evaluations of the Values and the Problems of the Building No:67A

BUILDING NO:67A EVALUATION OF THE BUILDING	2.7
VALUES OF THE BUILDING	
<p>THE BUILDING IS LOCATED AT ONE END OF THE ASMA STREET, IN A LARGE BUILDING LOT, WHERE THE GARDEN IS SITUATED AT THE BACK OF THE HOUSE. IT HAS TIMBER SKELETON TWO STORIES CONSTRUCTED UPON A STONE MASONRY BASEMENT FLOOR. THE BASEMENT FLOOR IS UNDER THE STREET LEVEL. IT IS A TYPICAL EXAMPLE OF THE TRADITIONAL BARTIN HOUSE, HAVING A SQUARE SHAPED COMMON SPACE AND TWO ROOMS. IT HAS NOT BEEN DIVIDED NOR CHANGED.</p> <p>IT IS THE MOST PRESERVED BUILDING ON SITE. (FAÇADE VALUE 777, PLAN VALUE 777). THE ONLY WOODEN LATTICE ELEMENT IN THE SITE IS IN THIS BUILDING. AND IT IS ONE OF THE MOST IMPORTANT EXAMPLES, WHERE WITH THE FAÇADE ELEMENTS AND ITS BALCONY IT HAS LATE 19TH CENTURY INFLUENCE WHILE WITH ITS SPACE CHARACTERISTICS IT HAS TRADITIONAL ANATOLIAN VALUES.</p>	
PROBLEMS OF THE BUILDING	
<p>BECAUSE OF THE OWNERSHIP PROBLEM, AN ANNEX BUILDING HAS BEEN ADDED ADJACENT TO THE BUILDING, WITH COMMON UPPER STRUCTURE BUILT. THIS CAUSES STRUCTURAL PROBLEMS, ESPECIALLY AT THE UPPER FLOOR. THERE ARE SOME SETTLEMENTS OBSERVED IN THIS FLOOR. MOREOVER, BECAUSE OF THE JOINTING OF THESE TWO BUILDINGS, NO.67 IS NOT REGISTERED IN SPITE OF ITS VALUES. THERE IS ALSO A SEVERE INSECT ATTACK PROBLEM OBSERVED IN THE BUILDING.</p> <p>BEING AT THE RIVER SIDE, IT HAD BEEN SERIOUSLY AFFECTED BY THE RECENT FLOOD, IN 1997. THE BASEMENT FLOOR IS UNUSABLE DUE TO RESIDUE COLLECTION ON THE FLOOR TILL HIGH LEVELS.</p>

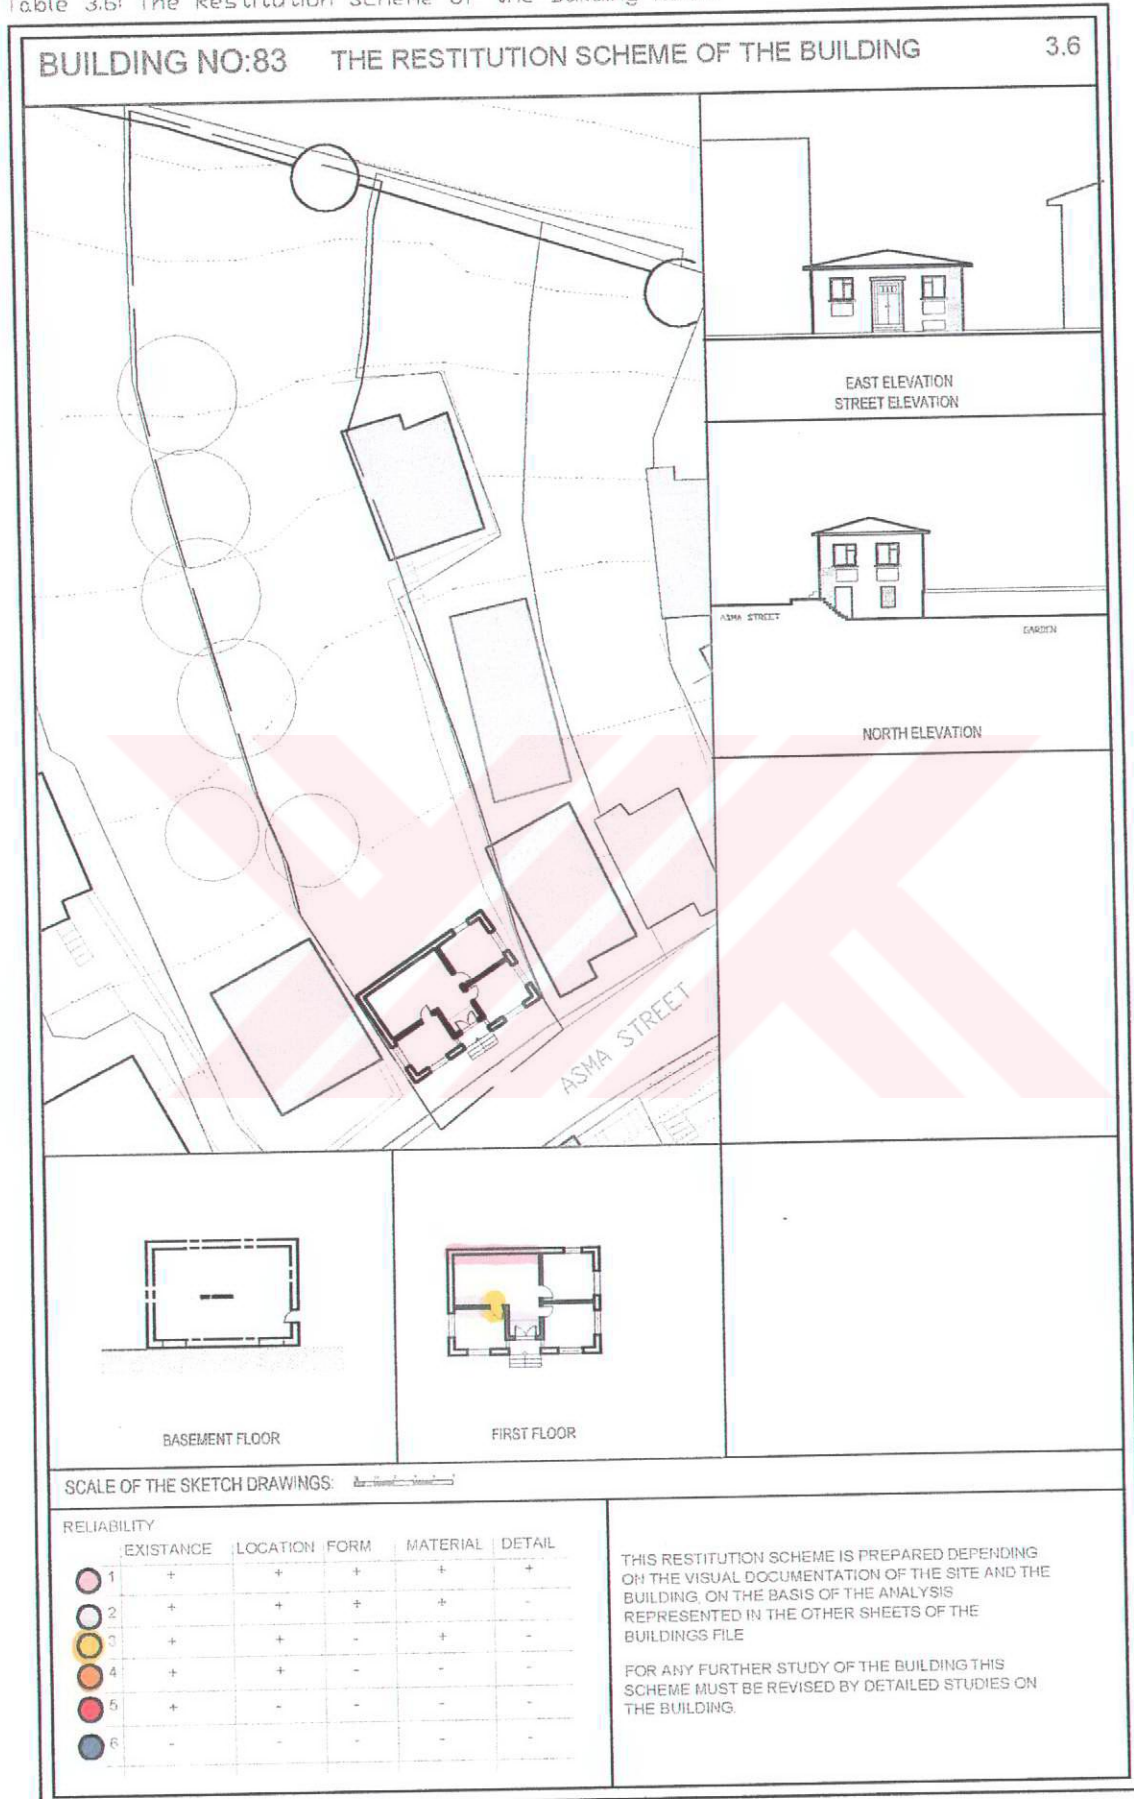
Table 3.7: The Evaluations of the Values and the Problems of the Building No:83

BUILDING NO:50	EVALUATION OF THE BUILDING	1.7
VALUES OF THE BUILDING		
<p>THE BUILDING IS LOCATED AT THE RIVER SIDE OF THE ASMA STREET. IT HAS A SIDE TO THE ROAD WITH A GARDEN AT THE BACK. THE TWO STOREY BRICK MASONRY ON STONE MASONRY BASEMENT FLOOR HAS NO PLAN SCHEME (1/7) OR FAÇADE SCHEME (1/6) VALUES. IT HAS NO TRADITIONAL, HISTORICAL, ARCHITECTURAL, DOCUMENT VALUES</p>		
USAGE AND USER CHARACTERISTICS OF THE BUILDING		
<p>A FAMILY OF THREE MEMBERS FROM BARTIN ARE LIVING IN THIS DWELLING FOR 35 YEARS. THE BUILDING HAS AN ANNEX ALONG THE BACK FAÇADE. IT IS USED AS KITCHEN, WC AND BATHROOM. BESIDES, THE COMMON SPACE HAS BEEN ENLARGED BY INCLUDING ONE OF THE ROOMS IN IT, BY REMOVING THEIR COMMON WALL. ONE OF THE OTHER ROOMS IS USED AS A SALOON, AND THE OTHER AS A BEROOM. INSPITE OF THE ADDITIONS, THE BUILDING STILL IS INSUFFICIENT FOR A FAMILY TO LIVE IN. AND ITS SPACE CHARACTERISTICS ARE QUITE LOW.</p>

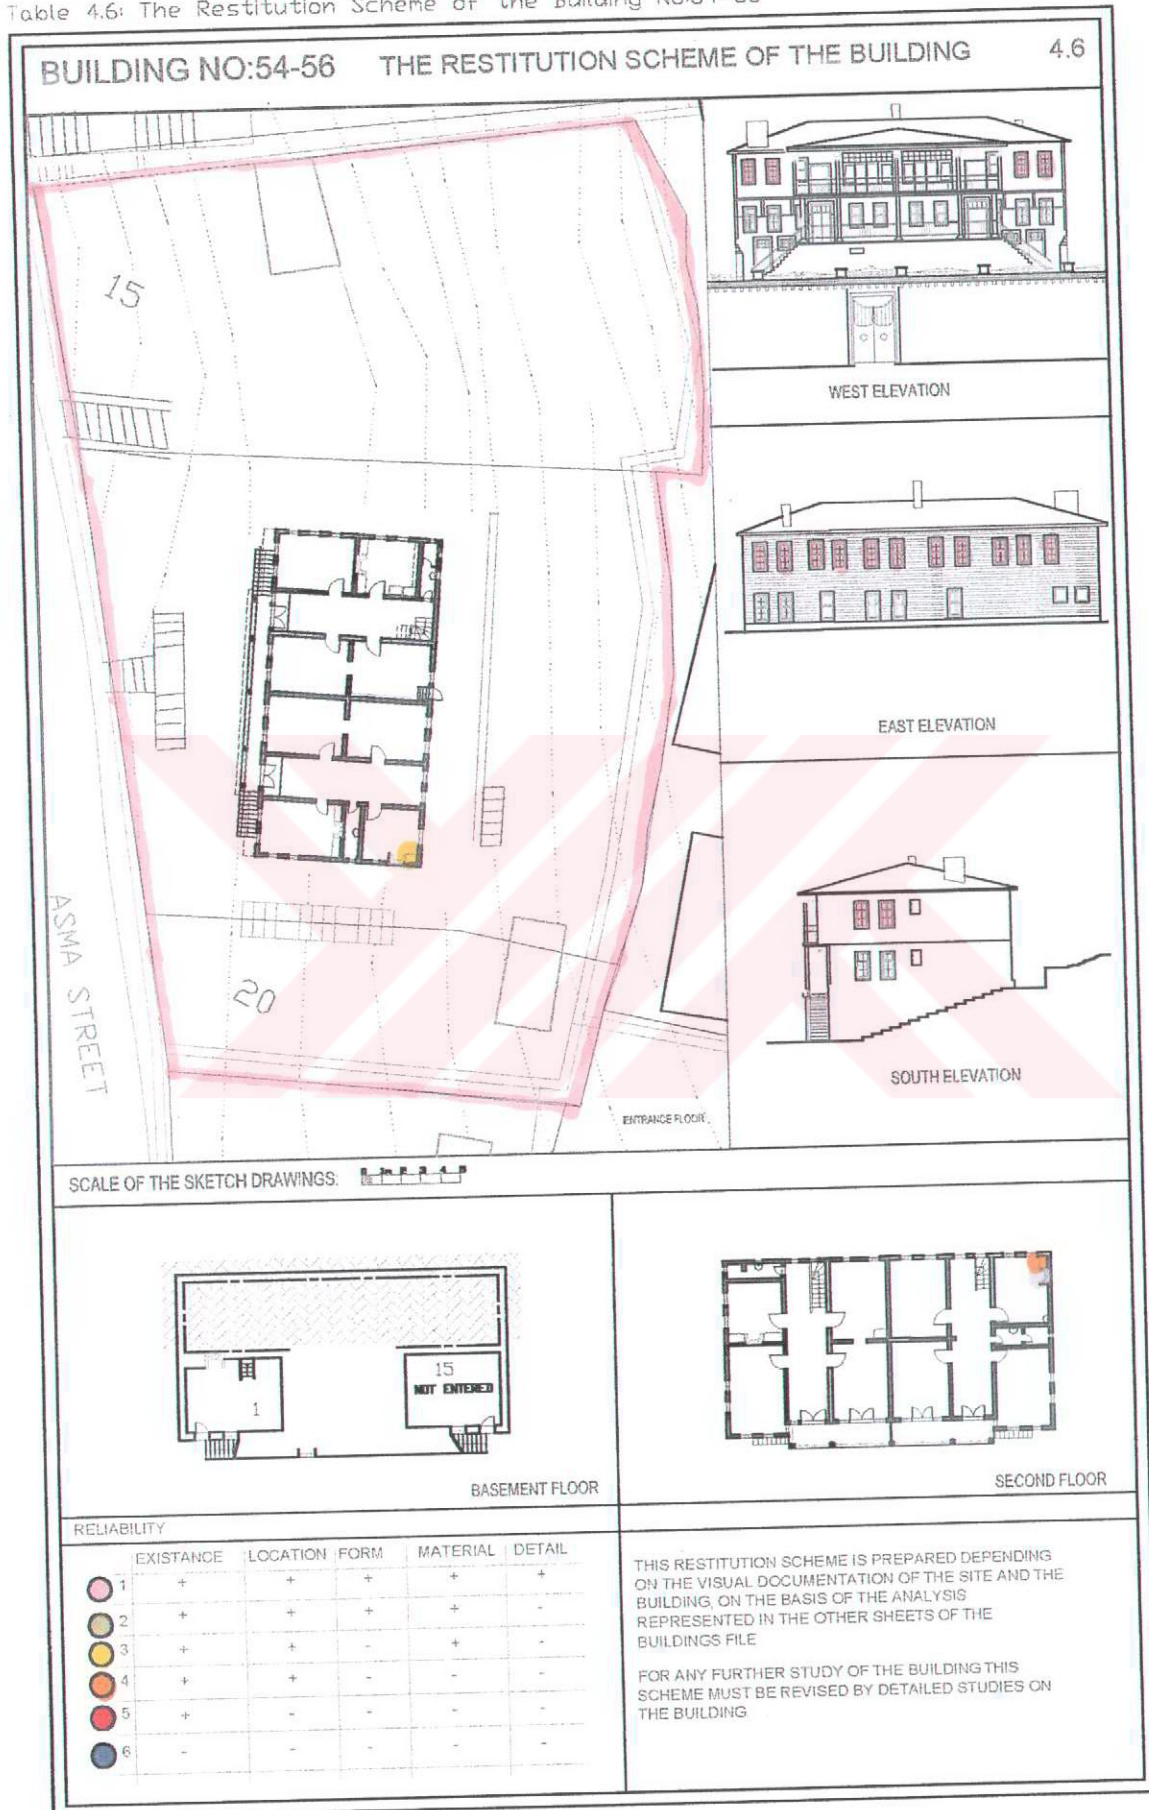
Table 4.7: The Evaluations of the Values and the Problems of the Building No:54-56

BUILDING NO:54-56	EVALUATION OF THE BUILDING	4.7
VALUES OF THE BUILDING		
<p>THE BUILDING HAS BEEN LOCATED THREE METRE ABOVE THE STREET LEVEL. IT HAS A COURTYARD IN THE FRONT AND A GARDEN AT THE BACK AND ON BOTH SIDES. THE BUILDING IS A TWIN HOUSE.</p>		
<p>THE BUILDING HAS TWO STORIES ABOVE THE BASEMENT FLOOR. APART FROM ITS BEING A TWIN HOUSE, IT HAS VERY SPECIAL ARCHITECTURAL FEATURES. IT HAS DECORATIVE ELEMENTS ON THE COURTYARD WALL. IT HAS A DECORATIVE COURTYARD ENTRANCE AND DOOR. THERE IS ONE CISTERN FOR EACH BUILDING, WHERE THE RAINWATER IS COLLECTED. THERE IS A WALL PAINTING IN ONE OF THE ROOMS. THIS FEATURE IS UNIQUE WHEN COMPARED TO OTHER BARTIN HOUSES. APART FROM THESE, ALTHOUGH THE BUILDING HAS BEEN DIVIDED, IT HAS PRESERVED MOST OF ITS PLAN VALUES (6/8) AND FAÇADE VALUES (7/8).</p>		
<p>IT HAS HIGH ARCHITECTURAL, CULTURAL, HISTORICAL AND DOCUMENT VALUES. AS WELL AS THESE, IT HAS PRESERVED MOST OF ITS ARCHITECTURAL ELEMENTS, ESPECIALLY THE FAÇADE ELEMENTS.</p>

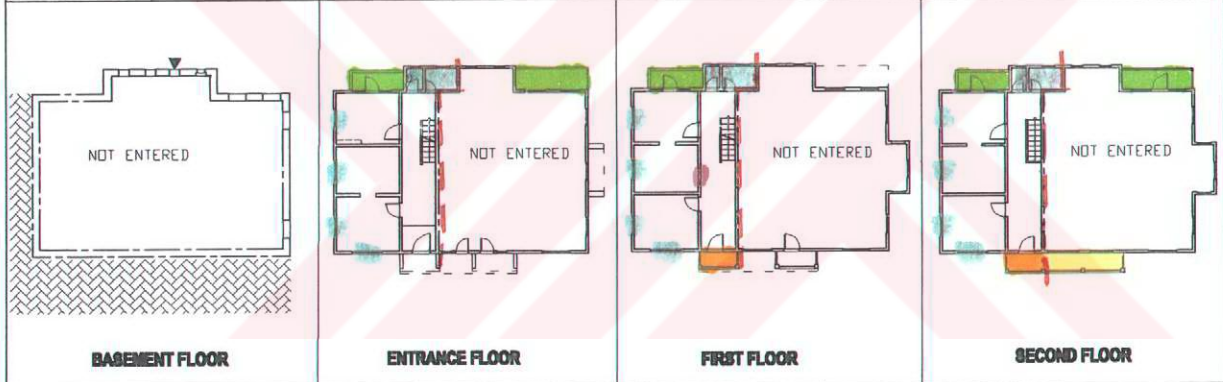
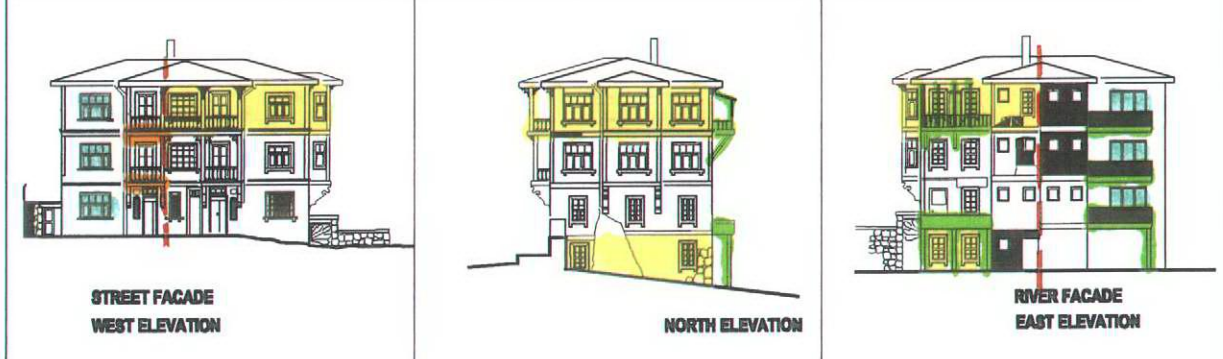
ALTERATIONS AT THE FLOOR AND CEILING COVERINGS		ALL THE CEILING COVERINGS EXCEPT THE ONES AT THE ENTRANCE FLOOR ARE CHIPBOARD IN THE NO-95A THE FLOORS OF THE ROOMS ARE COVERED WITH OILCLOTH, THE WC AND BATHROOMS ARE CERAMICS AS COVERINGS.

EVALUATION OF THE ALTERATIONS		THE BUILDING IS CHANGED A LOT IN ITS PLAN ARRANGEMENT BY THE DIVISIONS, SO THE ORIGINAL PLAN CAN NOT BE READ, AND IT LOST MOST OF ITS PLAN ELEMENTS BY THE CHANGES. ON THE OTHER HAND THE FACADE PRESERVED MOST OF ITS VALUES AND ORIGINAL SCHEME. FACADE HAS UNIQUE ELEMENTS THAT HAS BOTH HISTORICAL AND ARCHITECTURAL VALUES. SO IT MUST BE PRESERVED. ALTHOUGH THE TIMBER ELEMENTS IN THE BUILDING IS CHANGED THEY HAVE A SERIOUS DETERIORATION PROBLEM ESPECIALLY INSECT ATTACK.

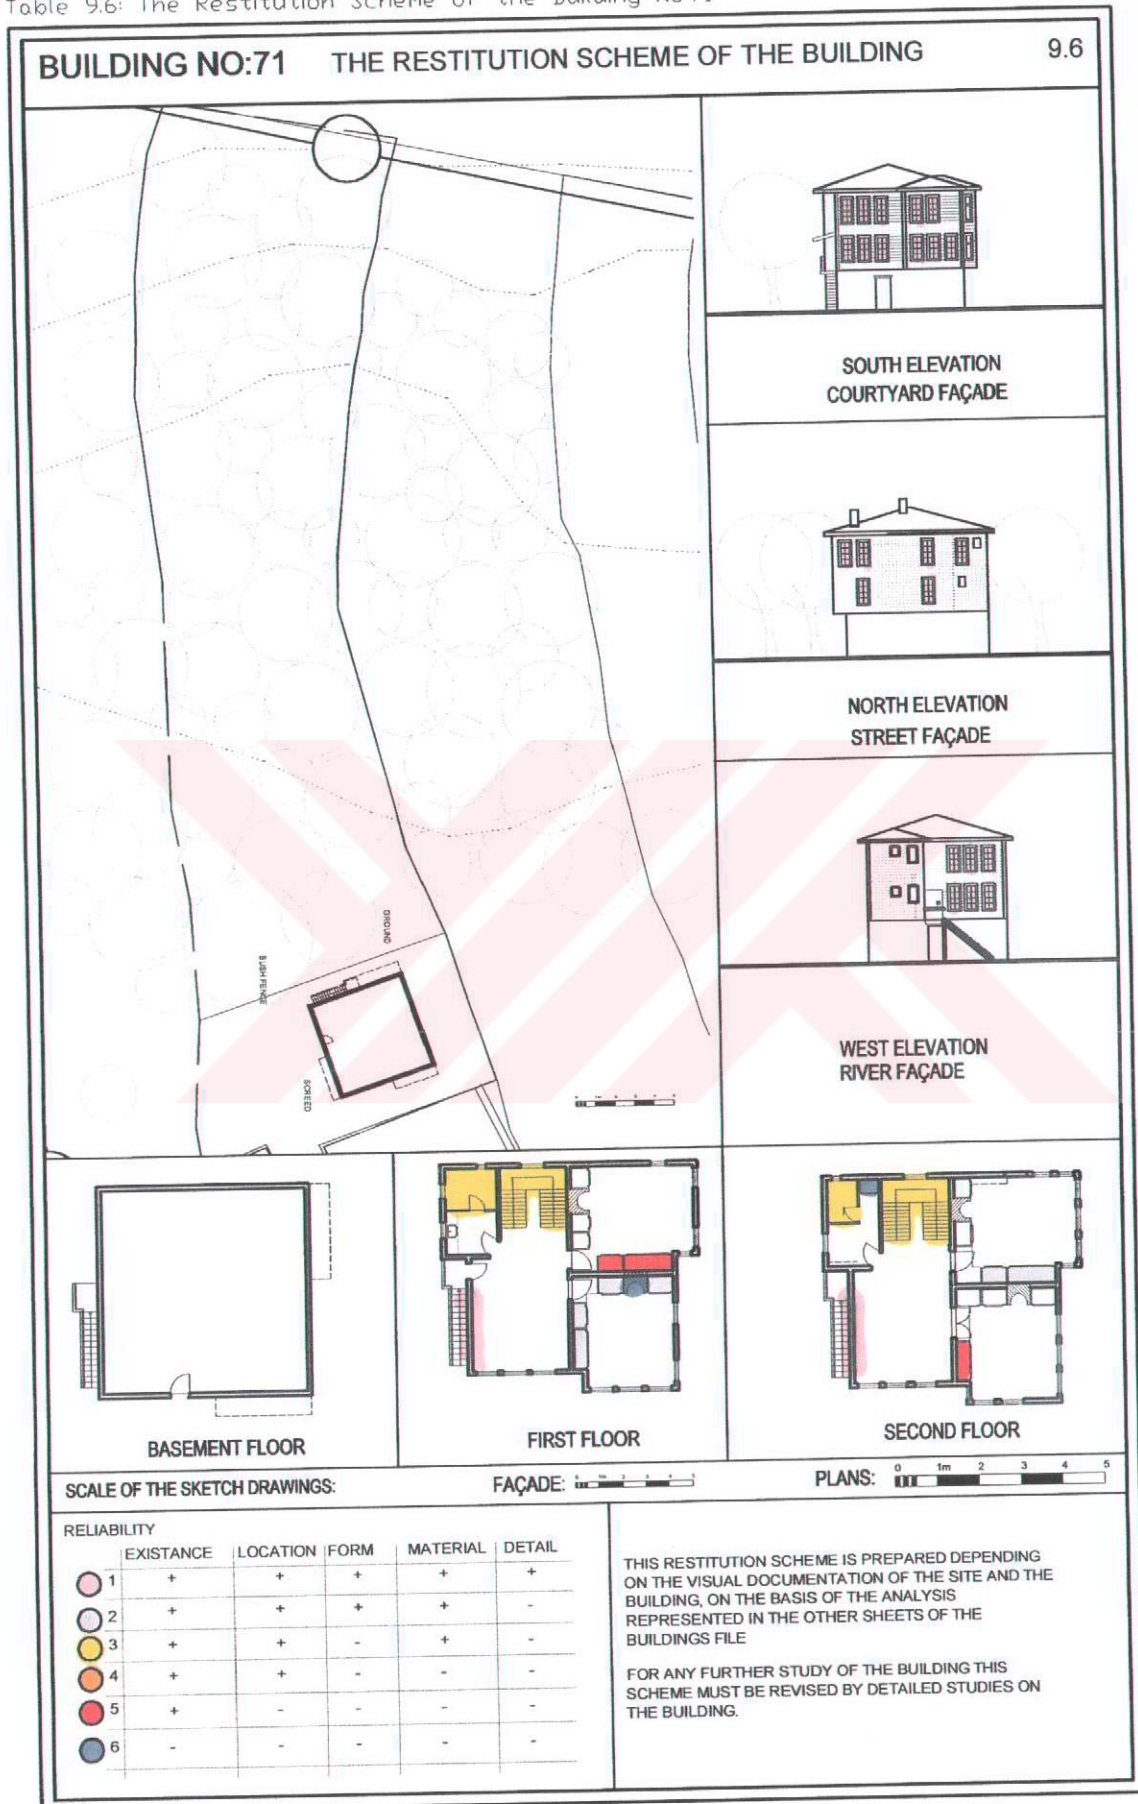
Table 9.7 The Evaluations of the Values and the Problems of the Building No:71

BUILDING NO:71	EVALUATION OF THE BUILDING	9.7
VALUES OF THE BUILDING		
<p>THE BUILDING IS LOCATED AT THE RIVER SIDE OF THE ASMA STREET NEARER TO THE RIVER WHERE IT IS REACHED BY A PATHWAY FROM A COURTYARD. IT HAS GARDEN AT THE BACK.IT IS A TYPICAL EXAMPLE OF THE TRADITIONAL BARTIN HOUSE WITH ITS ARCHITECTURAL AND PHYSICAL CHARACTERISTICS BEING A THREE STOREY TIMBER FRAME CONSTRUCTED ON THE STONE MASONRY BASE BUILDING.</p> <p>BEING A TRADITIONAL DWELLING IT HAS DOCUMENTARY, HISTORICAL AND CULTURAL VALUES. ALTHOUGH IT IS DIVIDED INTO THREE INTO STORIES IT HAS PRESERVED MOST OF ITS ARCHITECTURAL VALUES. MOREOVER, IT HAD PRESERVED MOST OF ITS PLAN AND FACADE CHARACTERISTICS AND ELEMENTS. IT HAS ALSO PRESERVED ITS BUILDING LOT CHARACTERISTICS BUT HAD AN ADDITIONAL SERVICE SPACE IN THE COURTYARD.</p> <p>IT IS SEEN THAT IT HAD LOST SOME OF ITS ARCHITECTURAL ELEMENTS AND HAS ADDITIONALS BECAUSE OF THE DIVISION. THE IMPORTANT CHANGE IS IN THE BASEMENT FLOOR. AS IT IS DESIGNED FOR USAGE OF A DWELLING UNIT, WALLS FOR ROOMS AND A WET SPACE ARE INTRODUCED INSIDE. MOREOVER, THE ORIGINAL STAIRCASE IS REMOVED AND THE SPACES ARE USED AS KITCHEN AT THE FIRST FLOOR AND BEDROOM AT THE SECOND FLOOR. AN ADDITIONAL STAIRCASE IS DESIGNED FOR THE ENTRANCE OF THE FLOORS TO THE DWELLING UNITS. THIS ADDITIONAL ENTRANCE STAIRCASE HAS CHANGED THE BACK FACADE A LOT IN A WAY WHERE THE FACADE CHARACTERISTIC OF THE BUILDING IS DAMAGED WITH THE MATERIAL THAT COVERS ALL THE FACADE EVEN THE WINDOWS. ALSO THE ENTRANCE IS DESIGNED FROM THE ORIGINAL ABDESTLIK SPACE WHICH IS NOT ADEQUATE FOR THE SPACE USAGE.</p>
