**CONSERVATION PROBLEMS OF SEMİZ ALI
PAŞA MADRASA AND DISCUSSION OF ITS
CURRENT STATE**

Master Thesis

MOUHANAD ABOUDAN

İSTANBUL, 2016

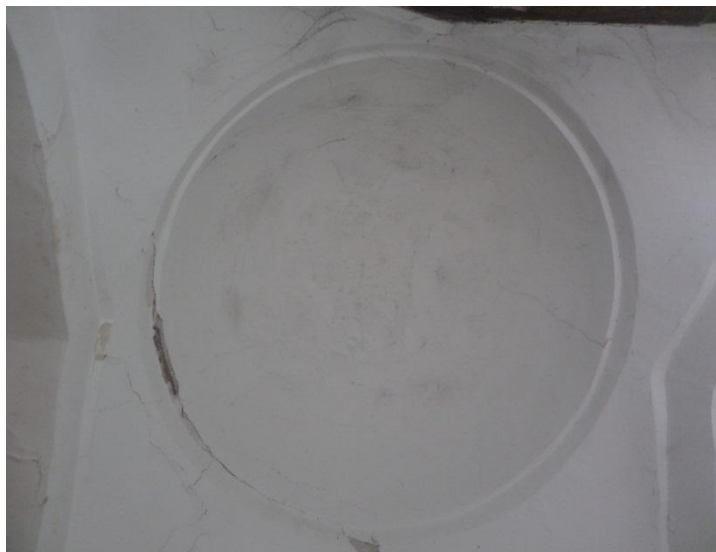
Figure 5.2: Damage of dome (A6A7B6B7)

The central dome of the northern arcade (A6A7B6B7) have some cracks especially on the edges and flakes where they spread widely (Figure 5.2)

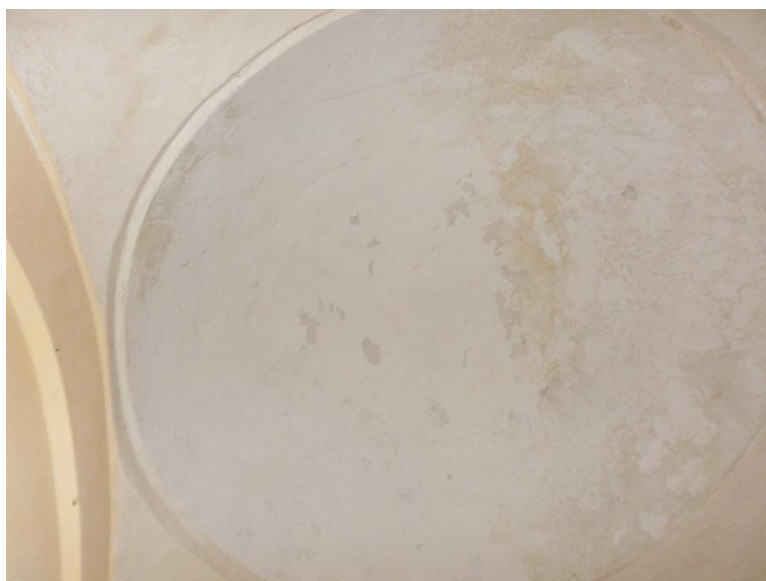
Figure 5.4: Damage of Dome (E1E2G1G2)

The dome Z12 (E1E2 G1G2) suffer from many damage on the inner surface such as flake, salt and staining caused by humidity (Figure 5.4).

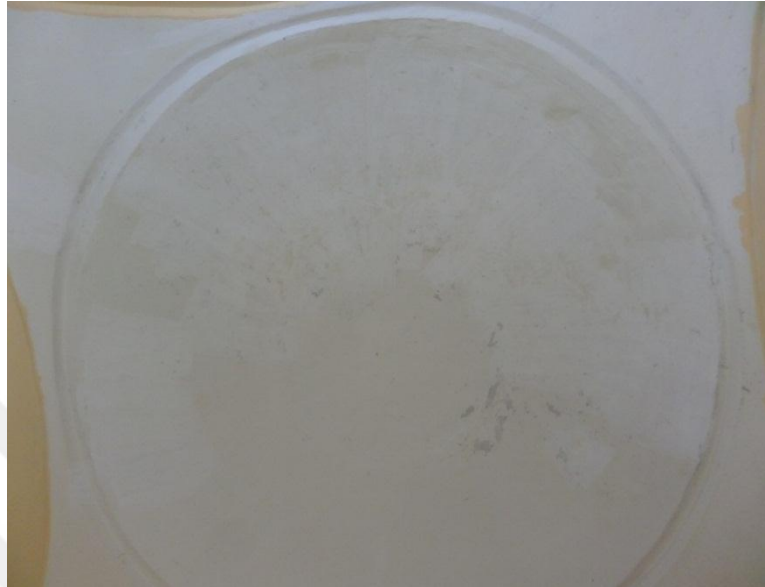
Figure 5.5: Damage of Dome (G1G2H1H2)

The dome Z13 (G1G2H1H2) suffer from staining and flake on the inner surface which is usually caused by salt and humidity (Figure 5.5).

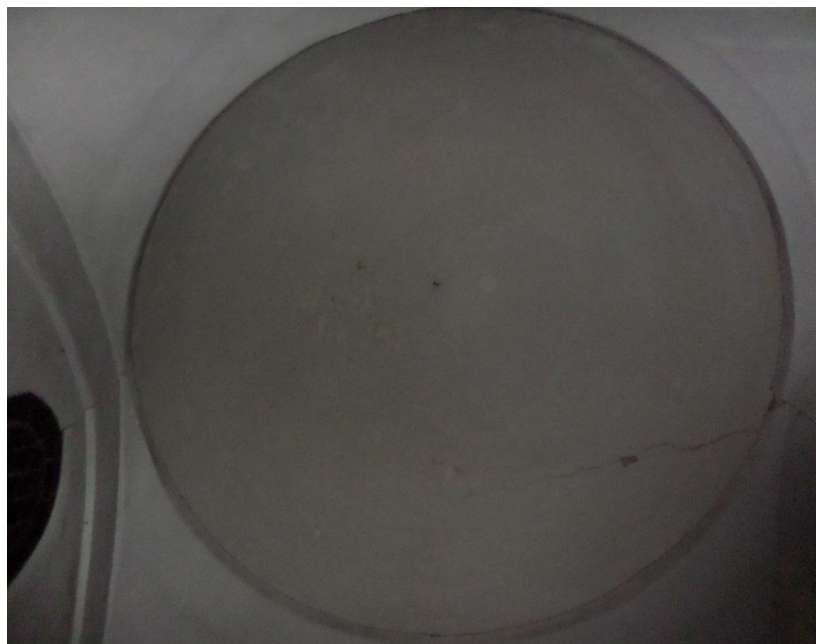
Figure 5.6: Damage of Classroom Dome (I5I7F5F7)

The dome Z16 (I5I7F5F7) is the biggest dome in this madrasa (classroom dome) Suffer from staining, cracks and flake on the inner surface which is usually caused by humidity (Figure 5.6).
