# TYPES AND DISTRIBUTION OF LANDSLIDES IN THE EASTERN PARTS OF BUYUKCEKMECE LAKE, USING GIS

Ali Demirci

Fatih University

July 2001

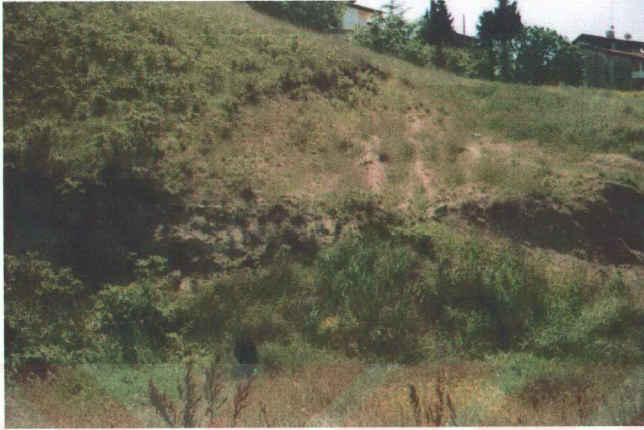
**Figure 22:** Small size rotational slide in the western part of Gürpınar.

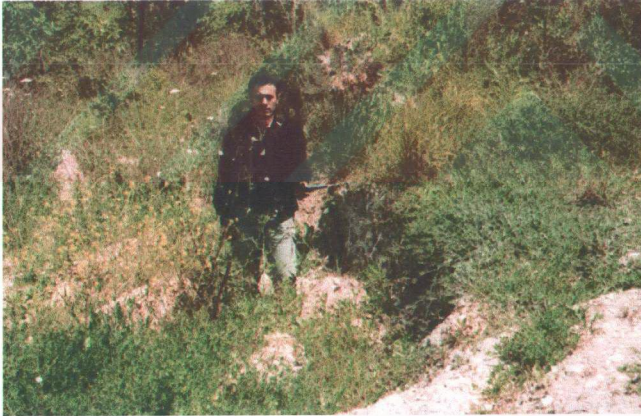
**Figure 23:** Concave scarp of a rotational slide in the southern part of Gürpınar.

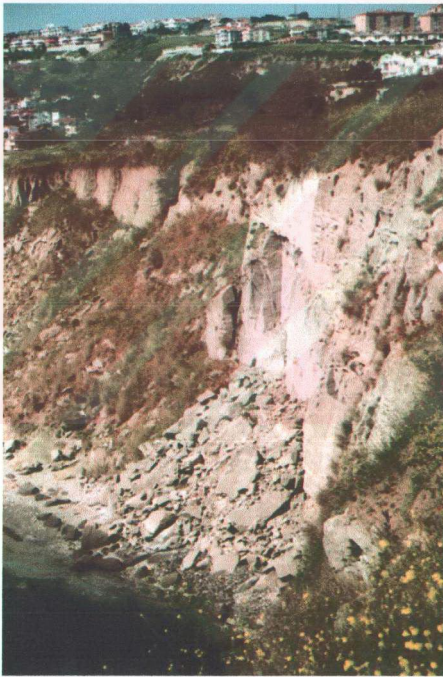
**Figure 24:** Current rock fall on the northeast coast of the Cape Mandabaşı.

Cape Mandabaşı is the only place that current rock falls can be seen on both its west and northwest facing slopes (Figure 24). In that part of the area there are no obstacles to prevent the sea waves from reaching the foot of cliffs. That is why the slopes composed of sandstone erode back daily.

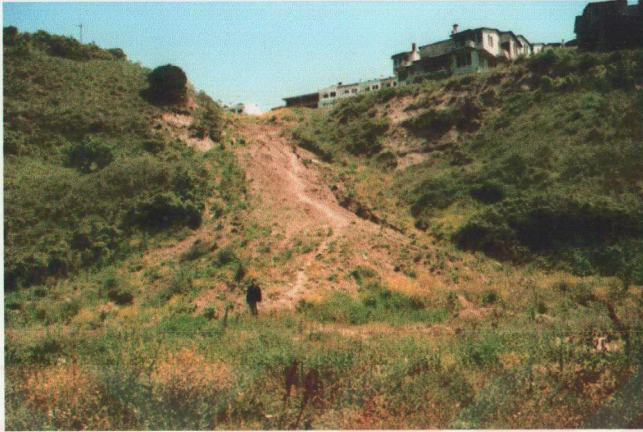
**Figure 27:** Soil flow in the western part of Gürpınar.

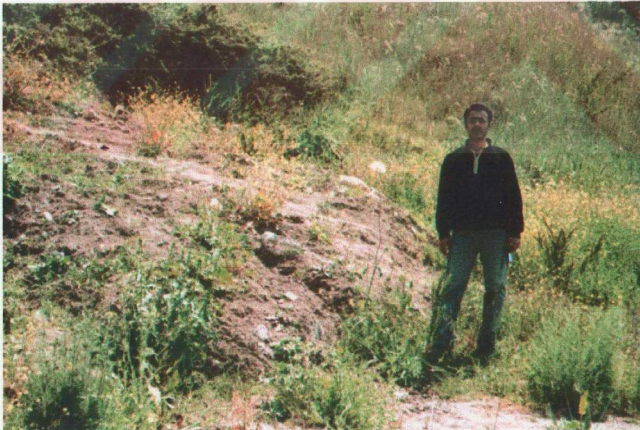
**Figure 28:** The toe part of the soil flow in the western part of Gürpınar.

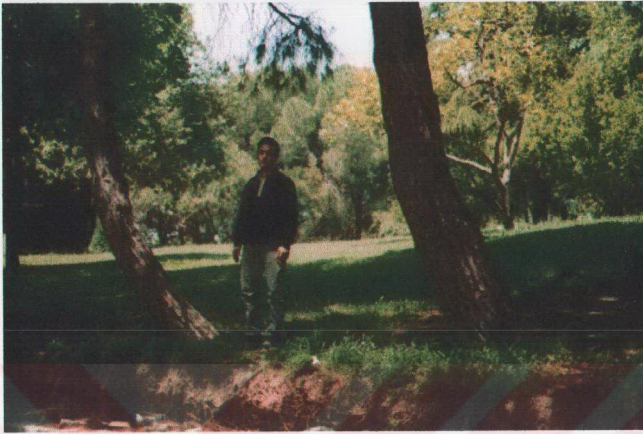
**Figure 29:** Curved trees due to creep in the western coast of Gürpınar.

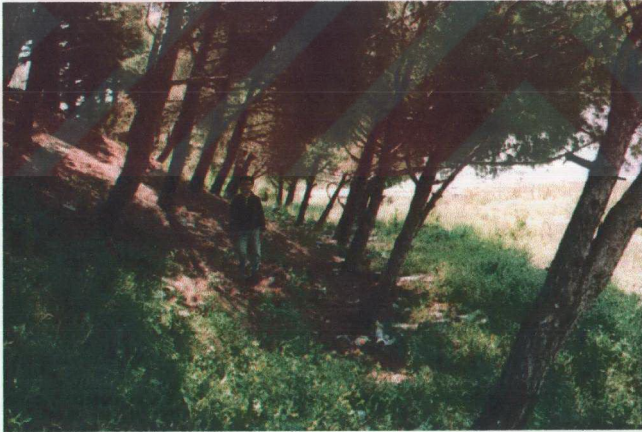
**Figure 30:** Tilted trees due to creep in the western coast of Gürpınar

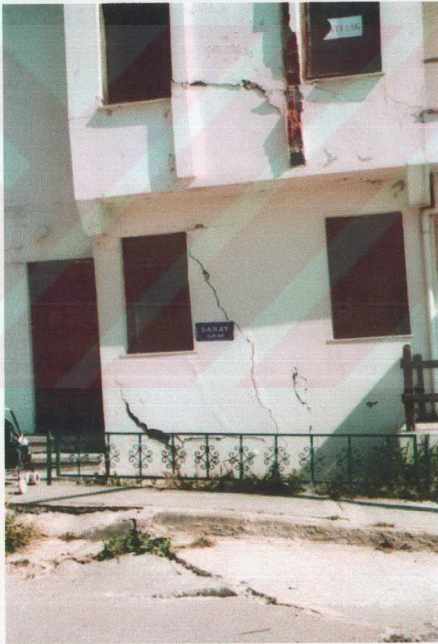
**Figure 31:** Abandoned and damaged building due to expansion and contraction of the clayey soil in the southern part of Gürpınar.

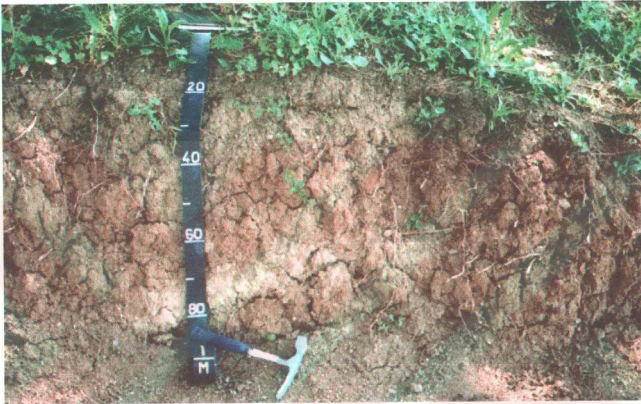
**Figure 32:** The clayey soil causes creep in the western part of Gürpınar.

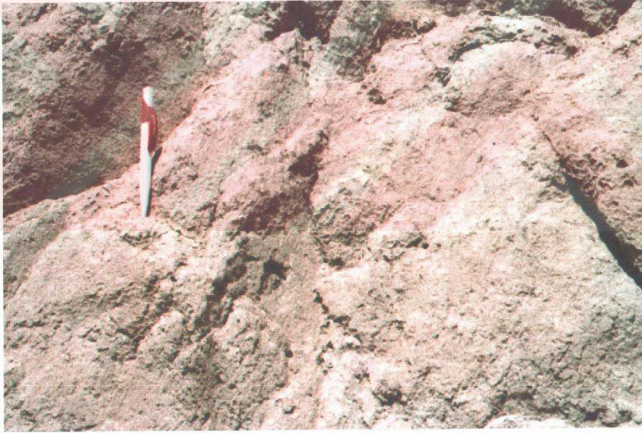
**Figure 33:** Unconsolidated sand unit of the Çukurçeşme formation is susceptible to weathering process.

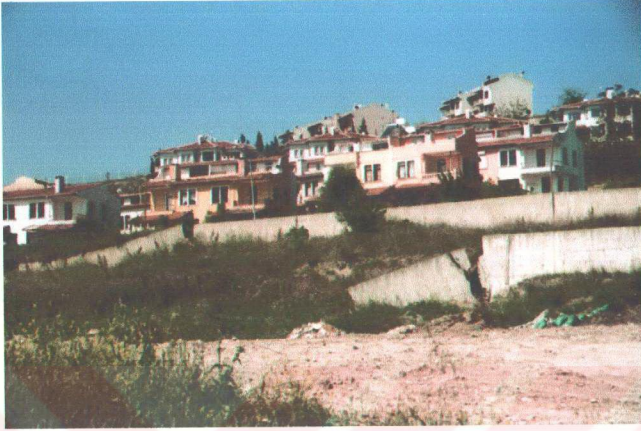
**Figure 34:** Damaged retaining walls in the western part of Gürpınar.

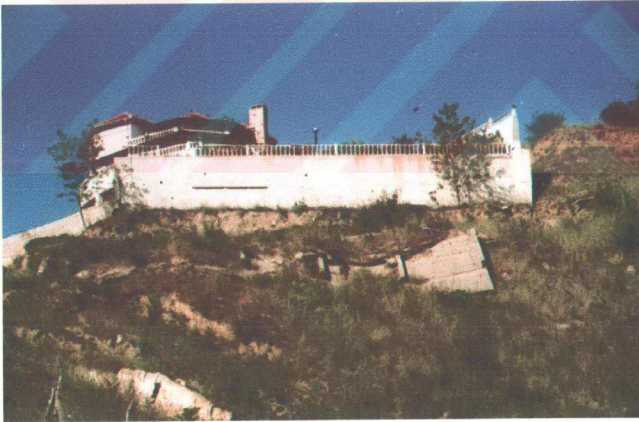
**Figure 35:** Building on the landslide area in the southern part of Gürpınar.

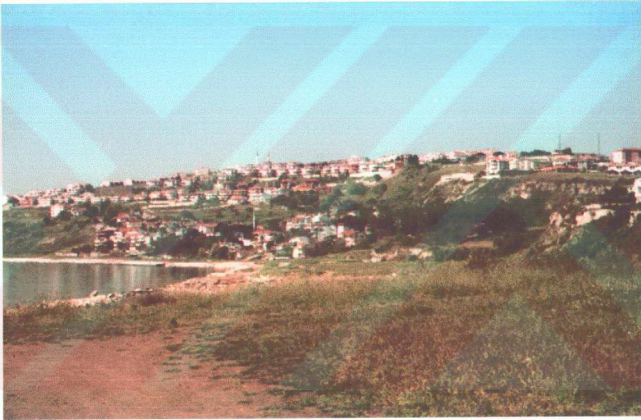
**Figure 37:** Damaged buildings on the collapsed parts of the landslide in the western coast of the study area.

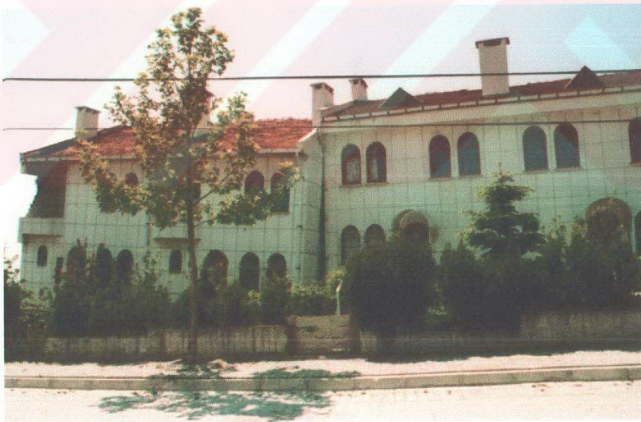
**Figure 38:** Tilted buildings in the southern part of Gürpınar.

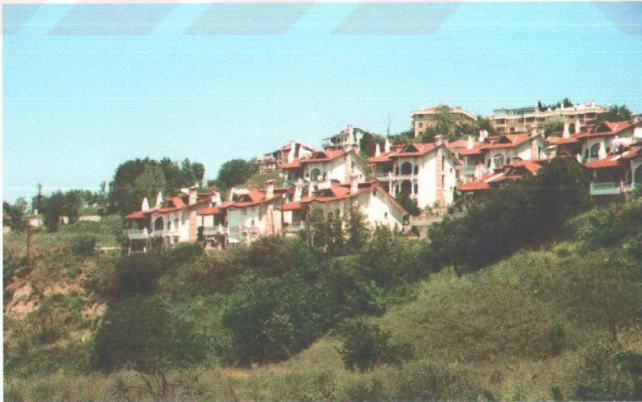
**Figure 39:** New villas have been building on the susceptible slopes in the southern part of the study area.

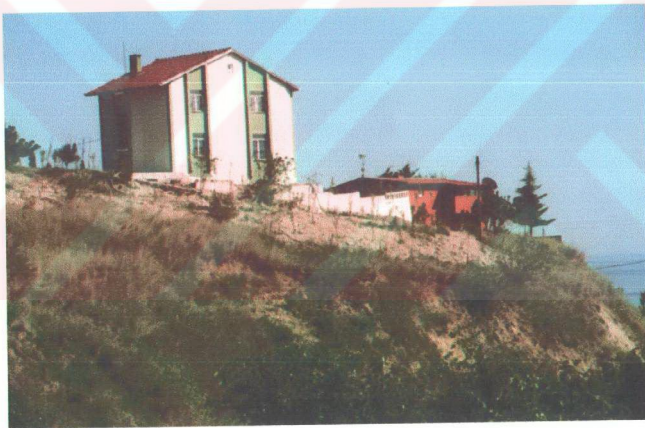
**Figure 41:** Watering tree may increases the landslide risk of the slope.

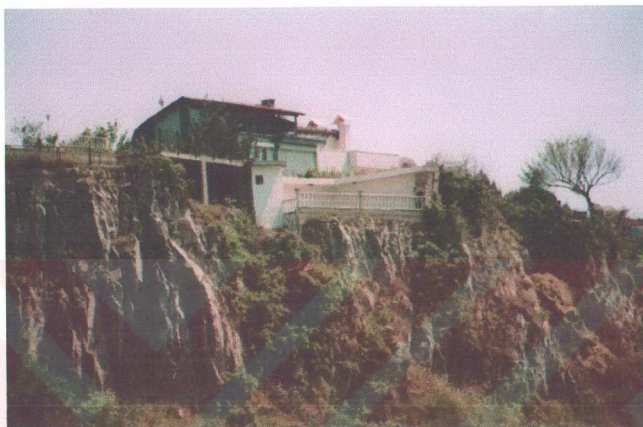
**Figure 42:** Building was built on the high hazardous area.

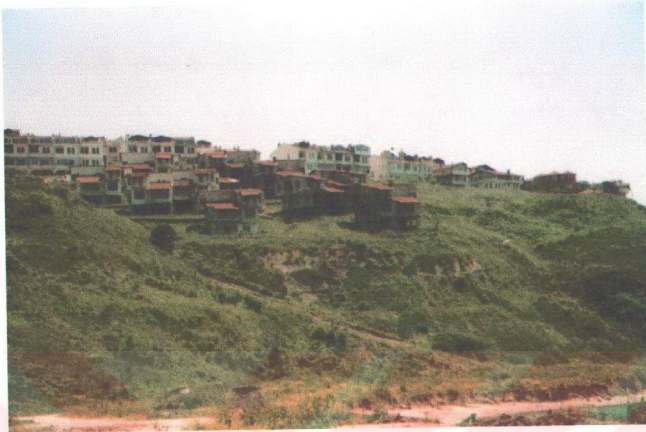
**Figure 44:** New villas have been constructed on the susceptible slopes in the western coast of Gürpınar.

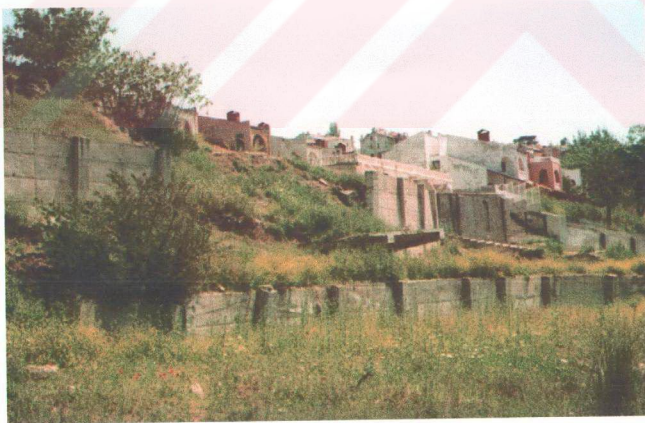
**Figure 45:** Retaining walls were built incorrectly
