**CONSERVATION PROJECT OF LATİFE HANIM
HOUSE IN KARŞIYAKA, İZMİR**

**A Thesis Submitted to
the Graduate School of Engineering and Sciences of
İzmir Institute of Technology
in Partial Fulfillment of the Requirements for the Degree of**

in Architectural Restoration

**by
Esra DİPBURUN**

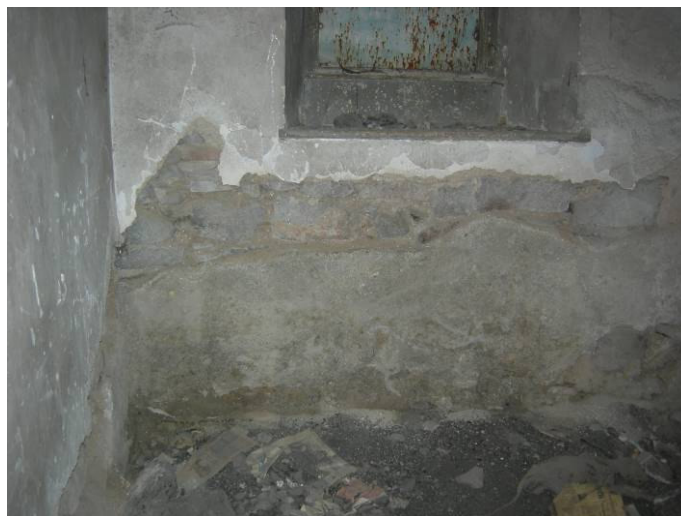
Figure 2.16. The loss of plaster observed on the bottom parts of the walls at the basement.

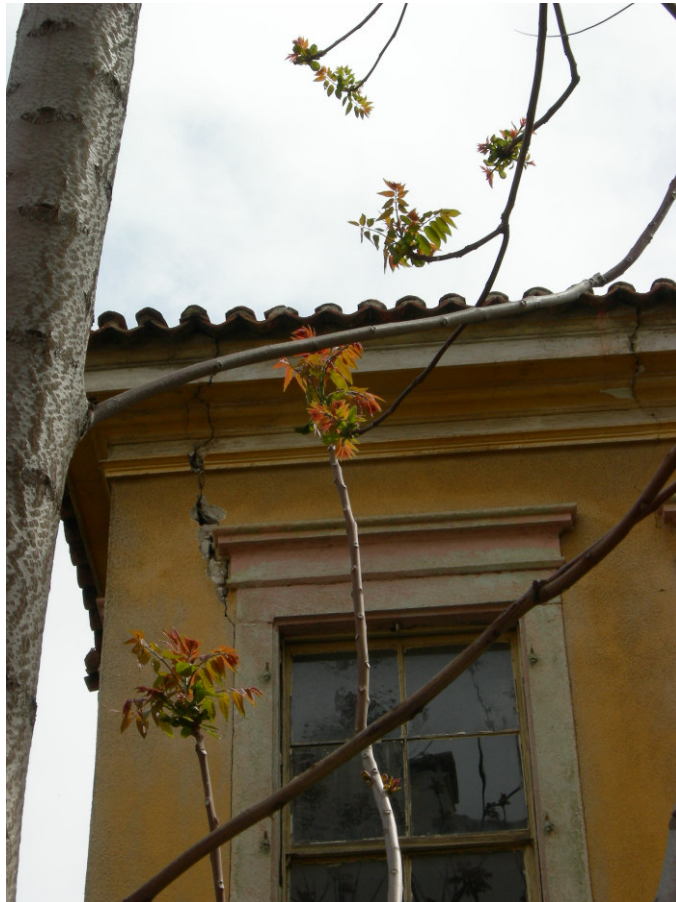
Figure 2.117. The major crack above the window level at the northern corner of western facade.

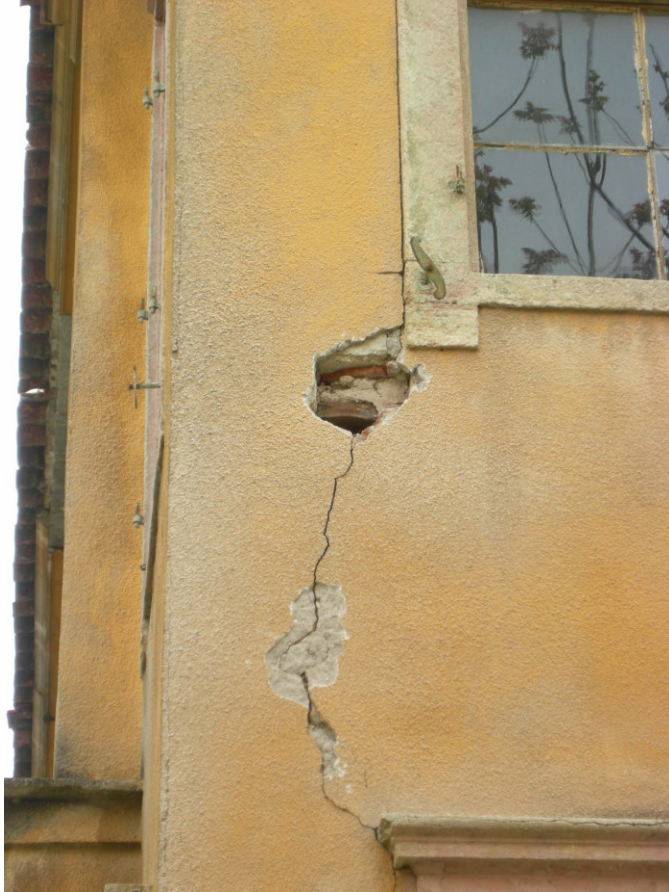
Figure 2.118. The major crack at the bottom level of the window at the northern corner of the western facade.

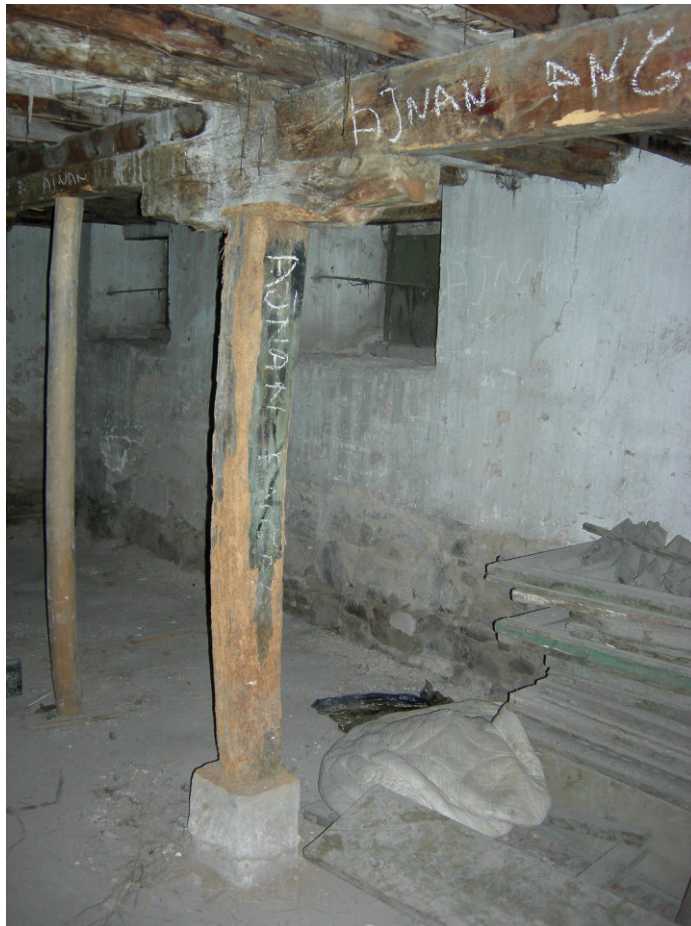
Figure 2.121. The timber beam at the basement which has deflection towards the middle.

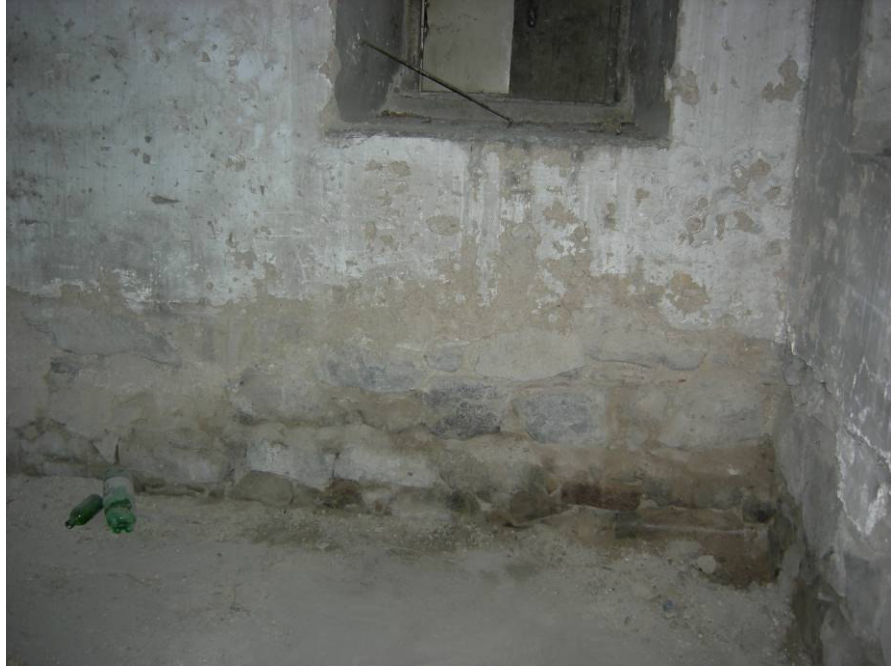
Figure 2.122. Loss of plaster on the interior walls of the basement.

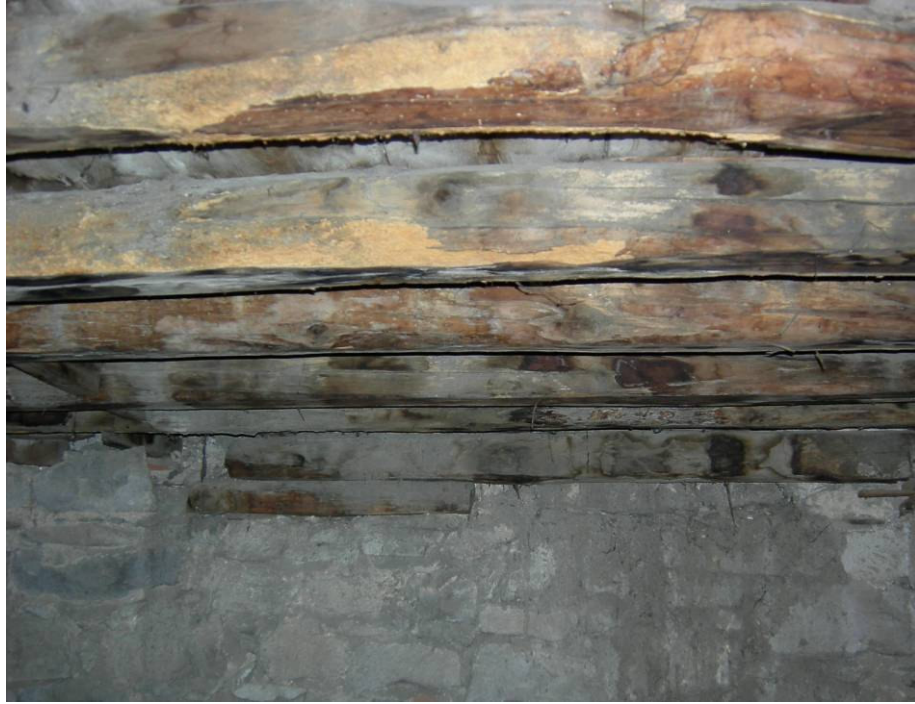
Figure 2.124. The deteriorated timber beams.

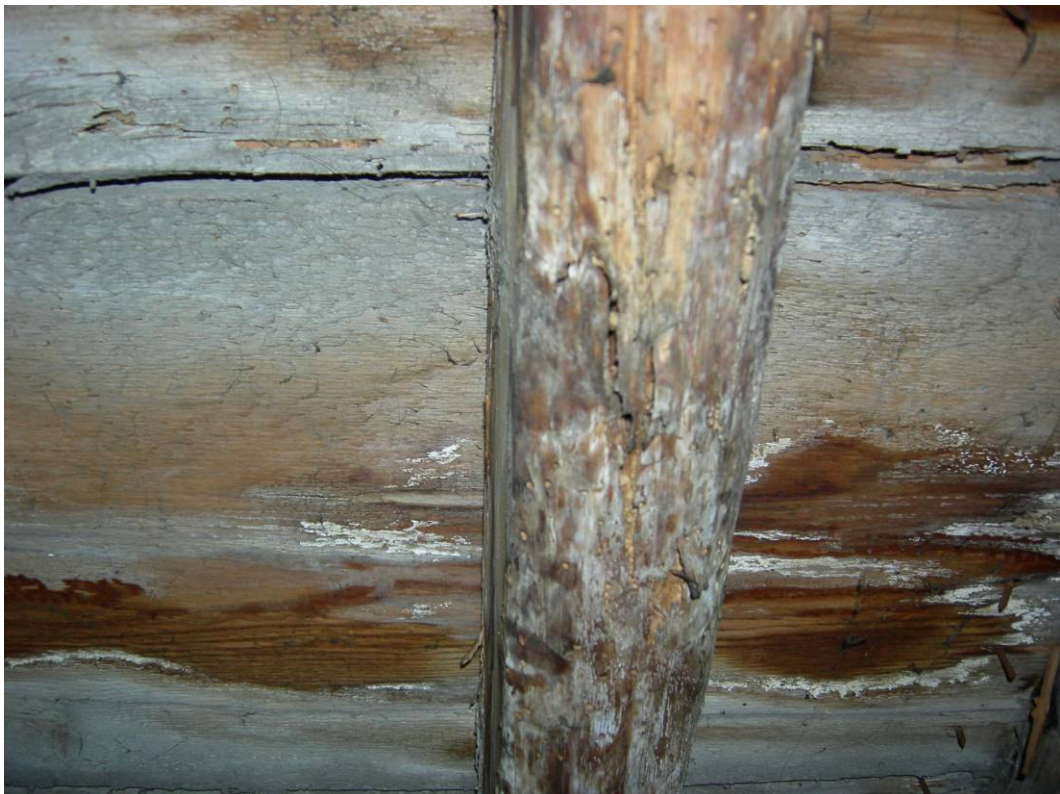
Figure 2.125. Holes in the timber beam, white stains in the timber covering at the basement.

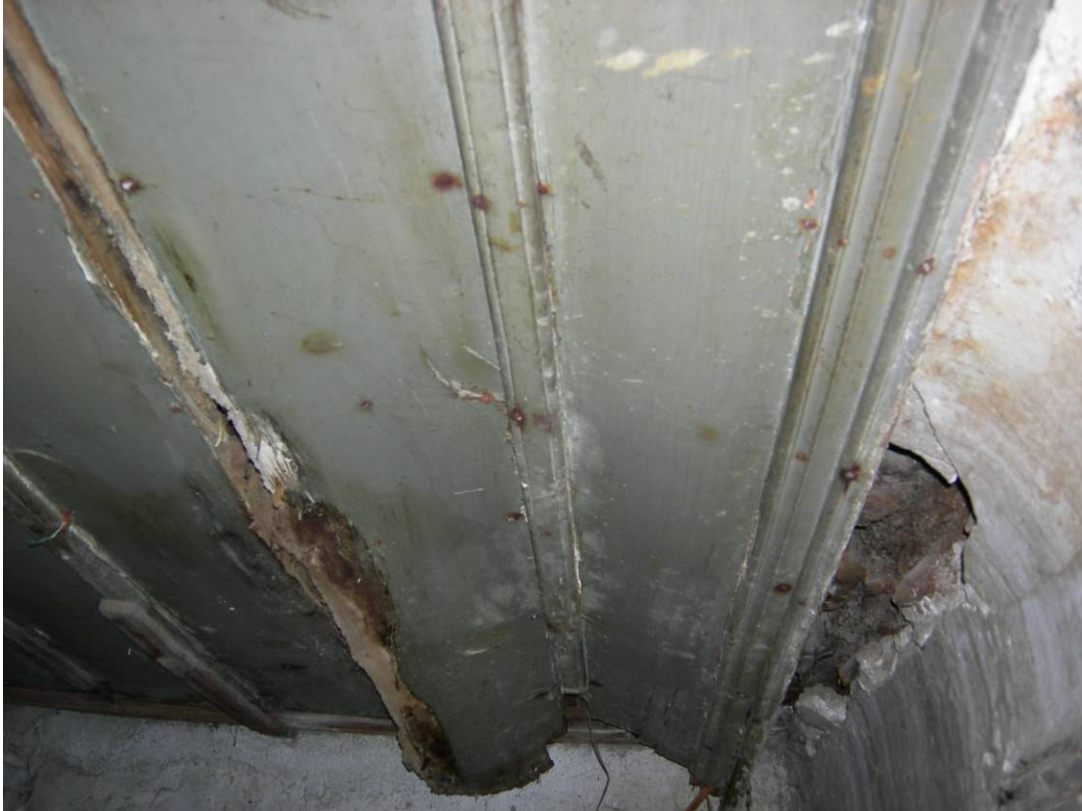
Figure 2.126. The deteriorated gypsum moldings and timber coverings at the basement.

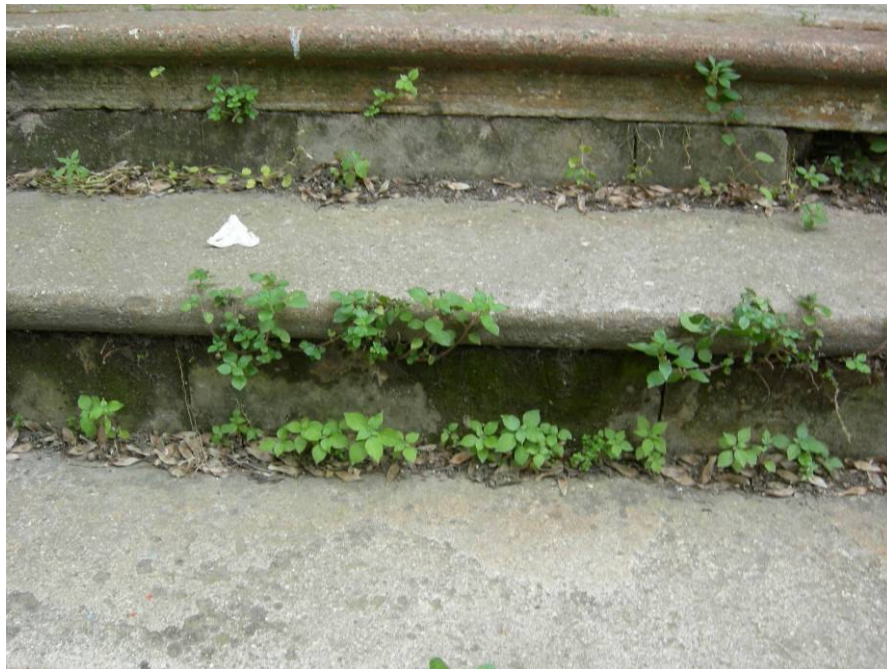
Figure 2.127. Plant formation at the stairs of the terrace.

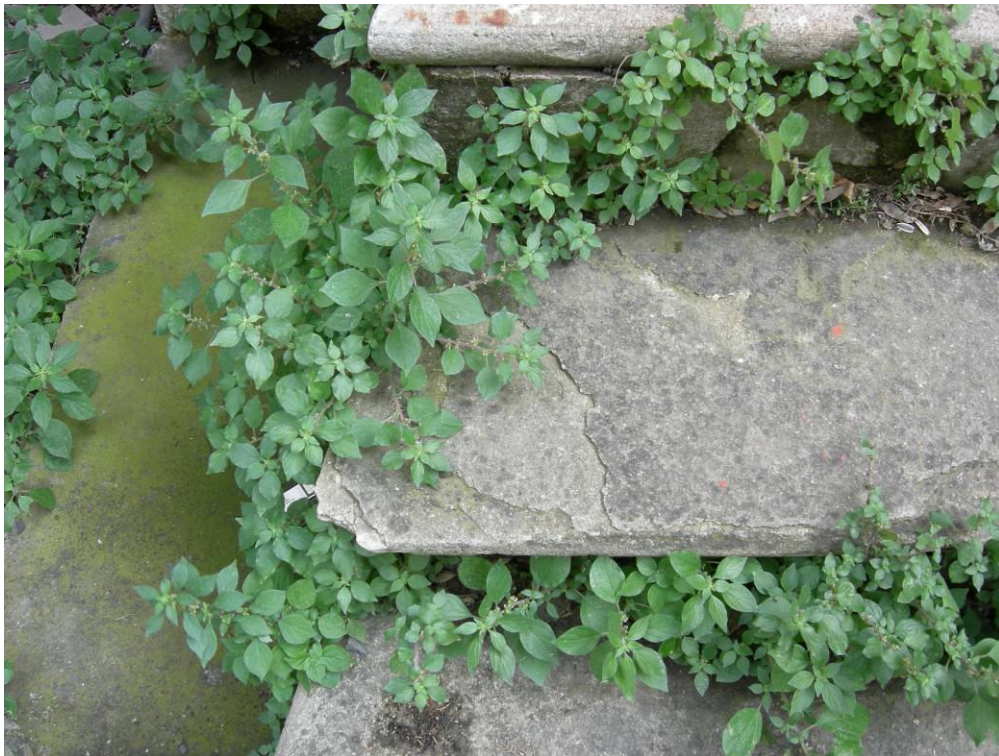
Figure 2.129. Flaking of stone observed on some of the coverings of the terrace.

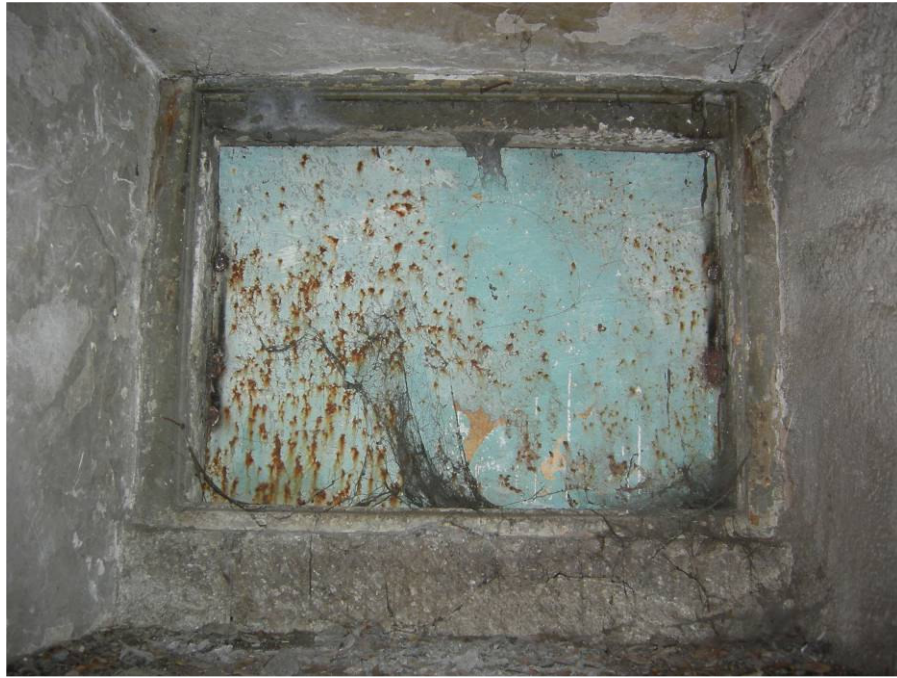
Figure 2.130. The heavily damaged iron shutters at the basement.

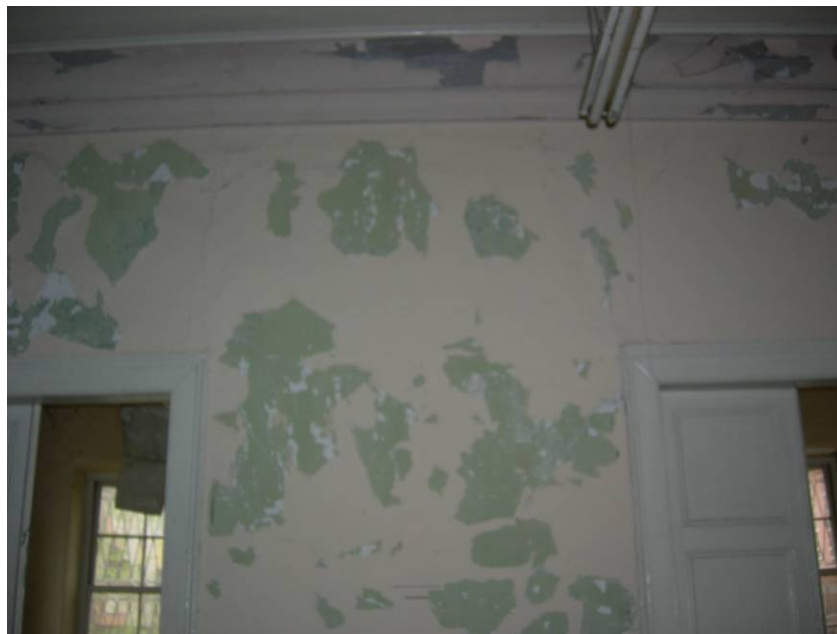
Figure 2.131. The loss of top layer paint on the walls of the hall at the ground floor.

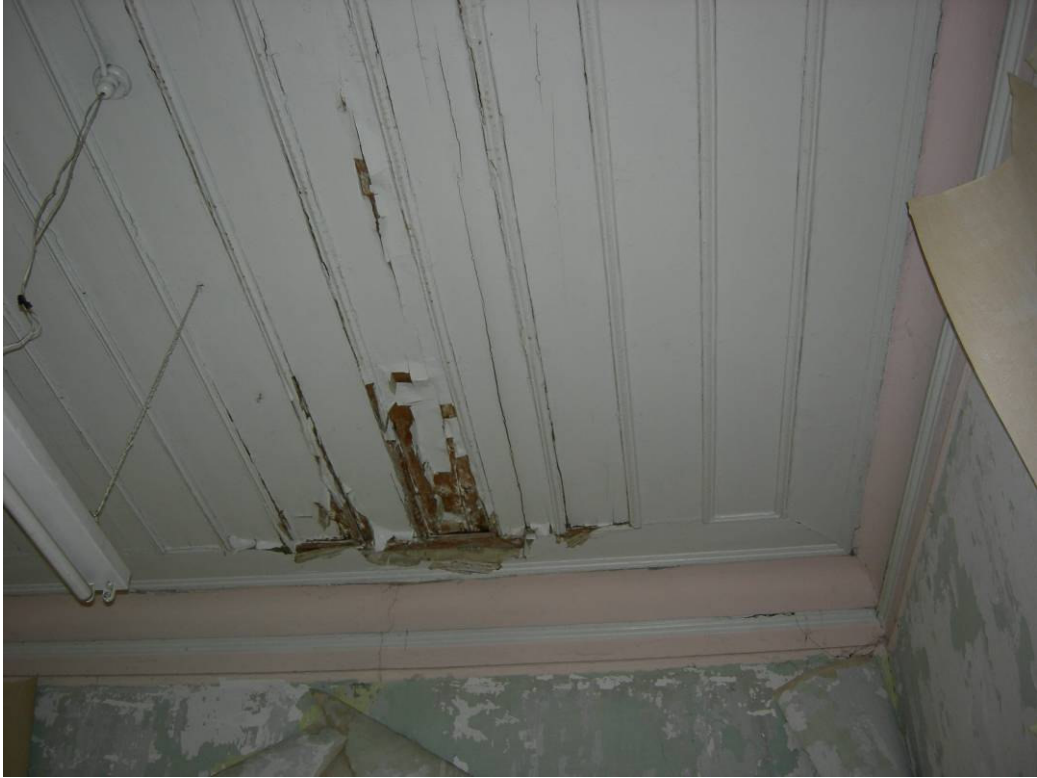
Figure 2.132. Loss of paint and timber decay on the ceiling coverings of room 1 at the ground floor.

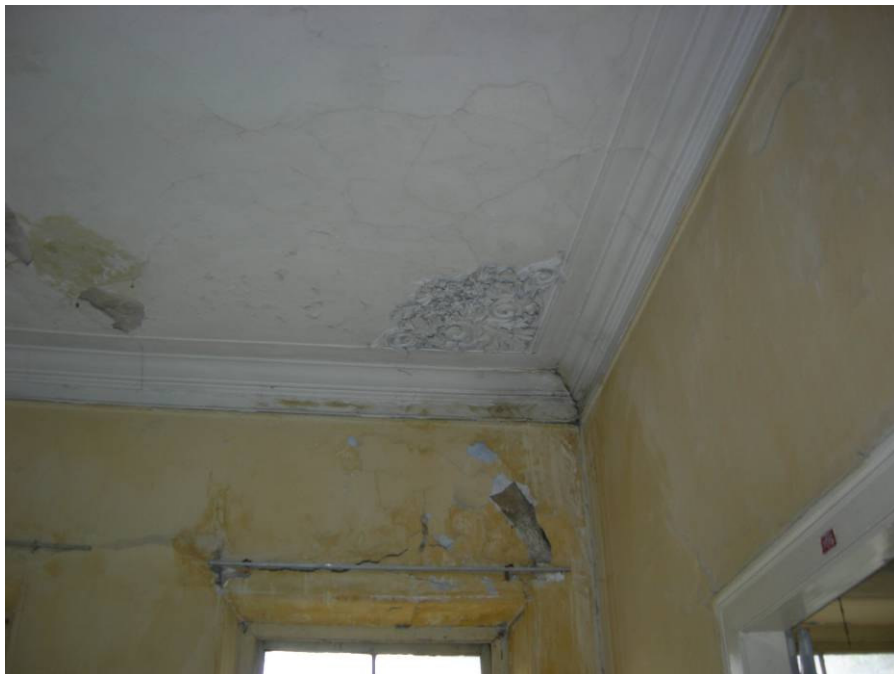
Figure 2.133. The deteriorated walls and ceiling of the hall at the first floor.

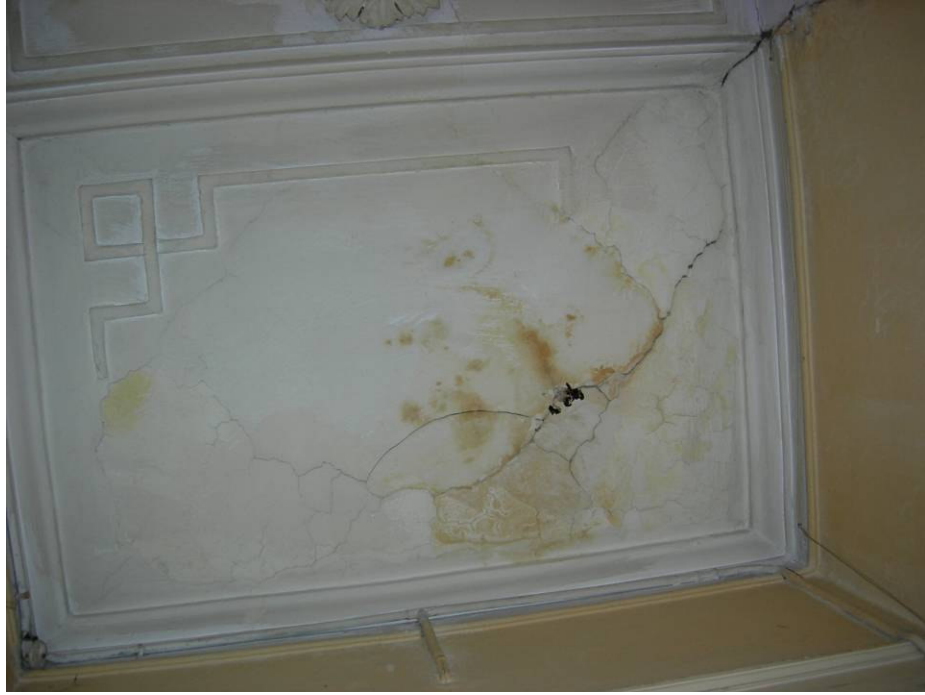
Figure 2.134. Cracks and discoloration in plaster of the ceiling of the stair hall at the first floor level.

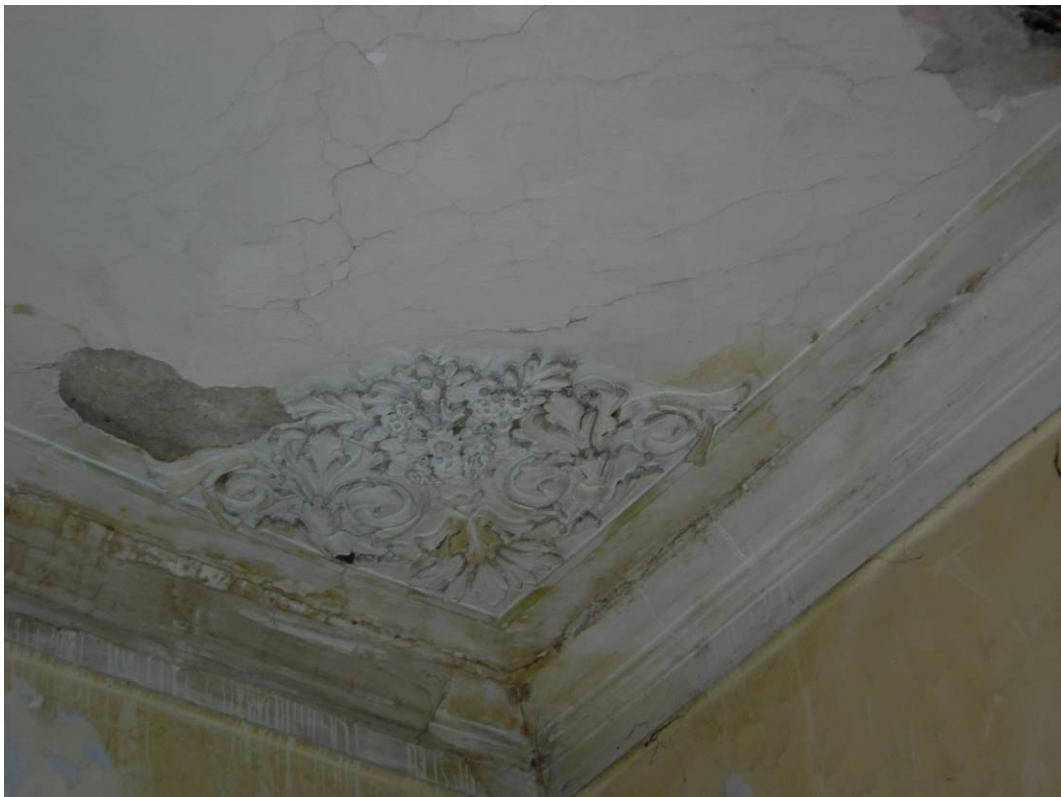
Figure 2.135. The partially detached ornaments on the ceiling of the hall at the first floor.

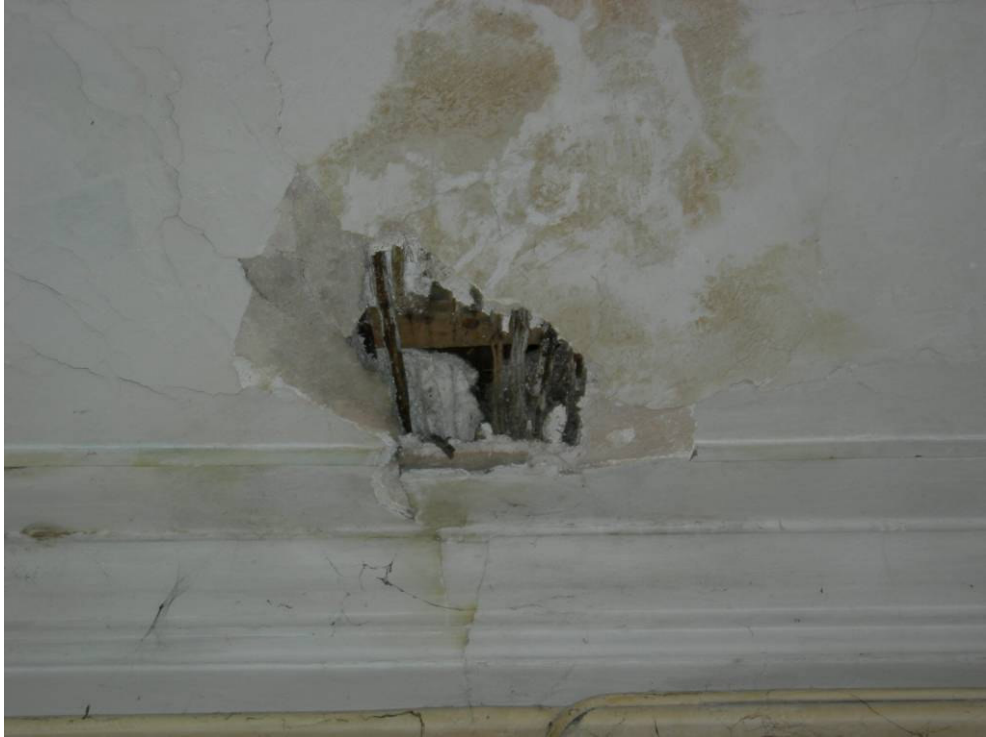
Figure 2.136. The deteriorated plaster and wood laths of the ceiling of the hall at the first floor.

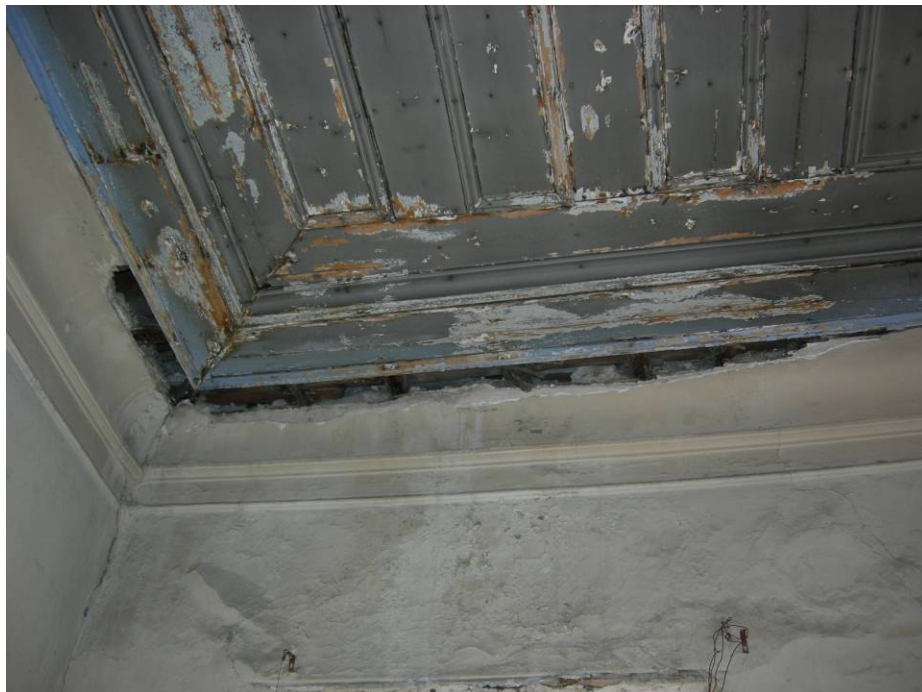
Figure 2.137. The deteriorated gypsum molding and the timber coverings of the ceiling of room 6.
