**EVALUATION OF INTERVENTIONS
IN WESTERN STOA OF AGORA
IN İZMİR**

**A Thesis Submitted to
the Graduate School of Engineering and Sciences of
İzmir Institute of Technology
in Partial Fullfilment of the Requirements for the Degree of**

in Architectural Restoration

**by
Necmiye Funda YAKA**

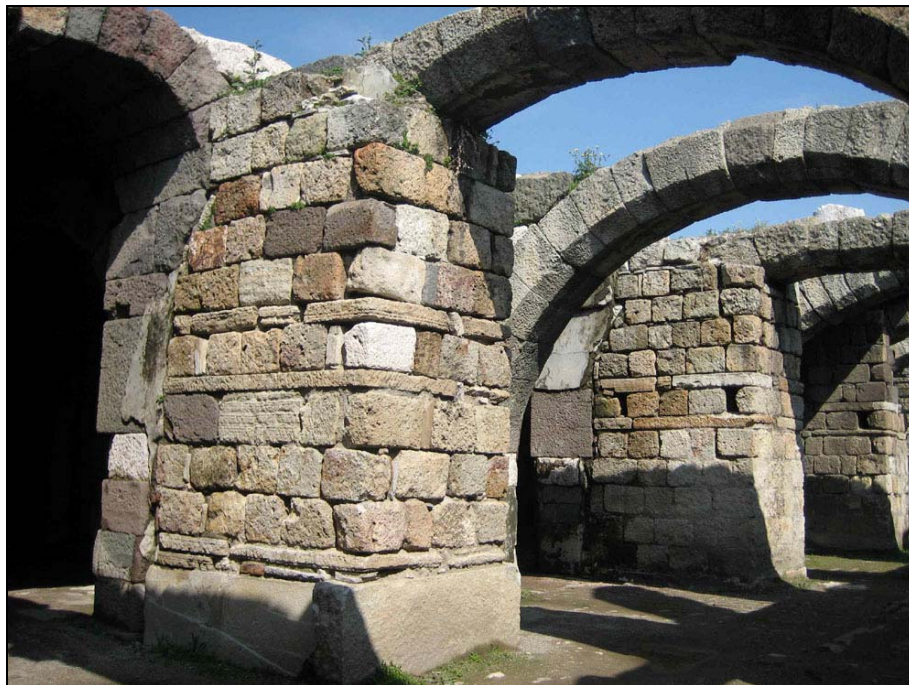
Figure 3.18. Abutments of arches which were strengthened subsequently.

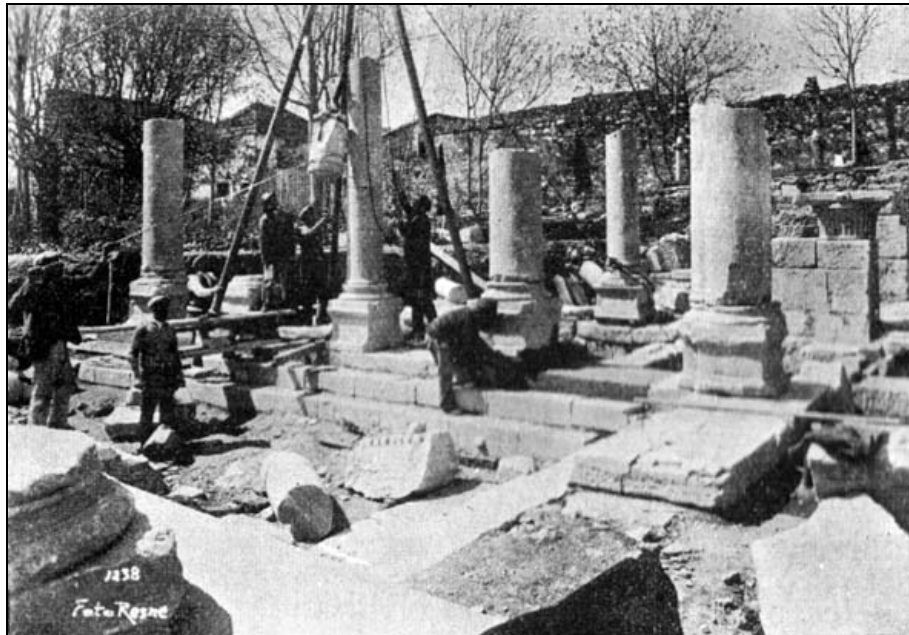
Figure 3.44. The completion of the missing parts by concrete.
(Source: Archives of the Agora excavations)

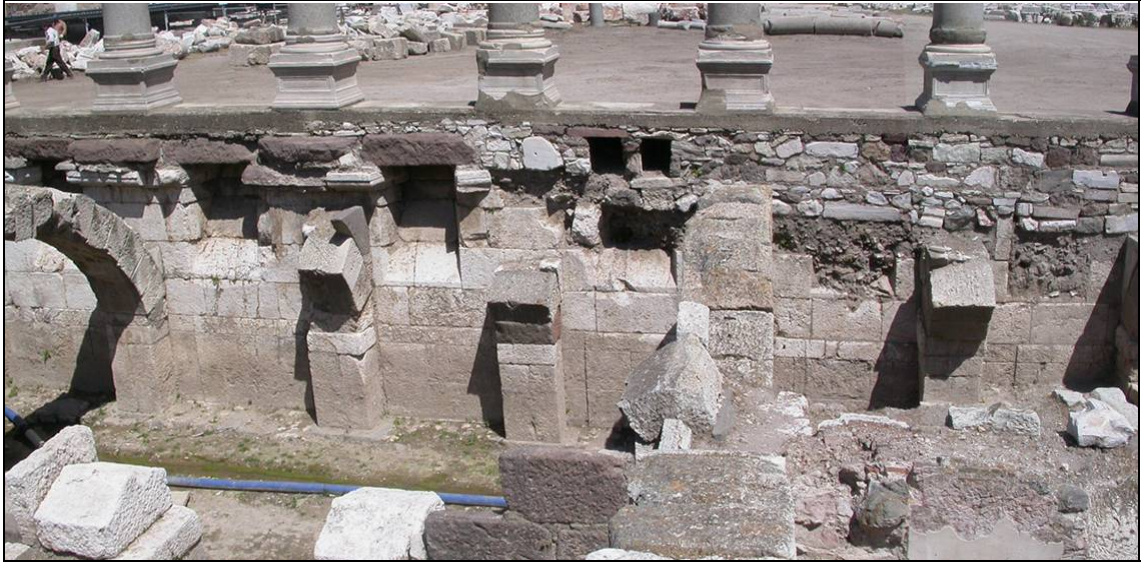
Figure 3.51. The east wall of the West Stoa completed with rubble and concrete.

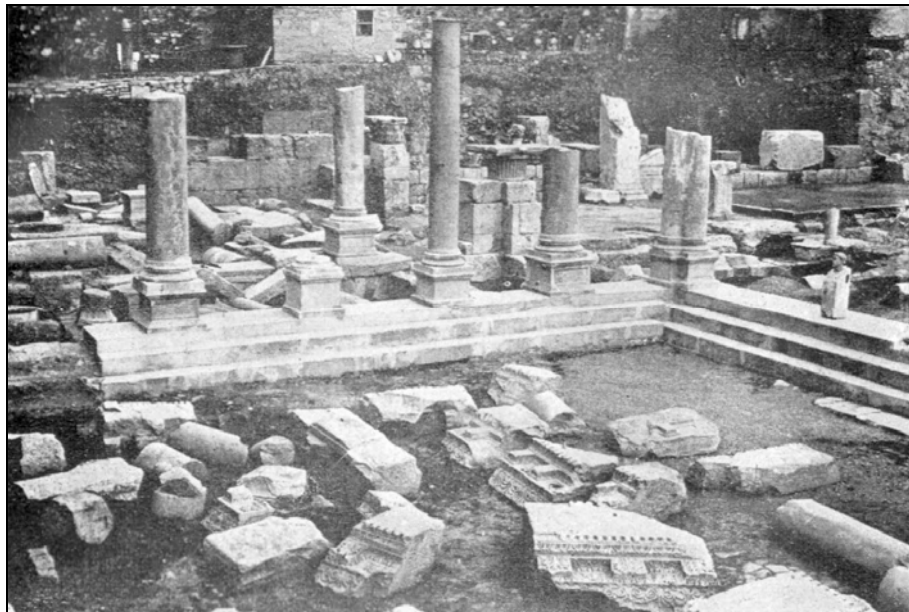
Figure 3.55. The missing parts were completed with concrete.
(Source: İzmir Muhipleri Cemiyeti 1934)

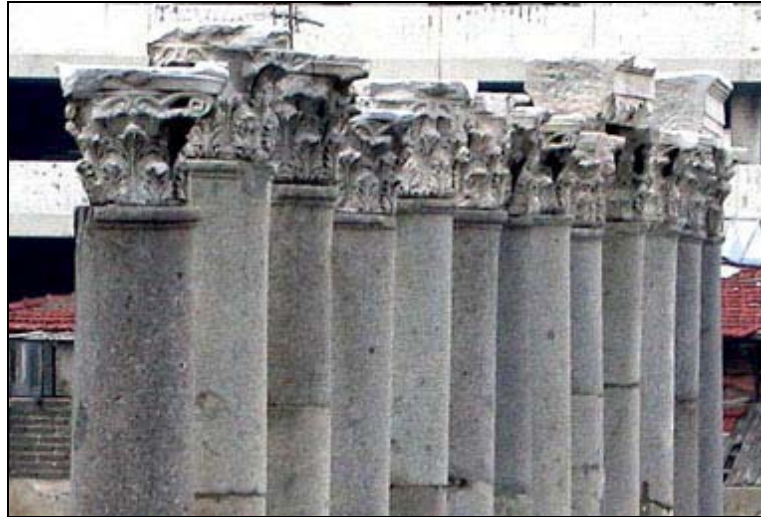
Figure 3.58. The columns stand with different height.
(Source: The archives of the Agora excavation, 2005)

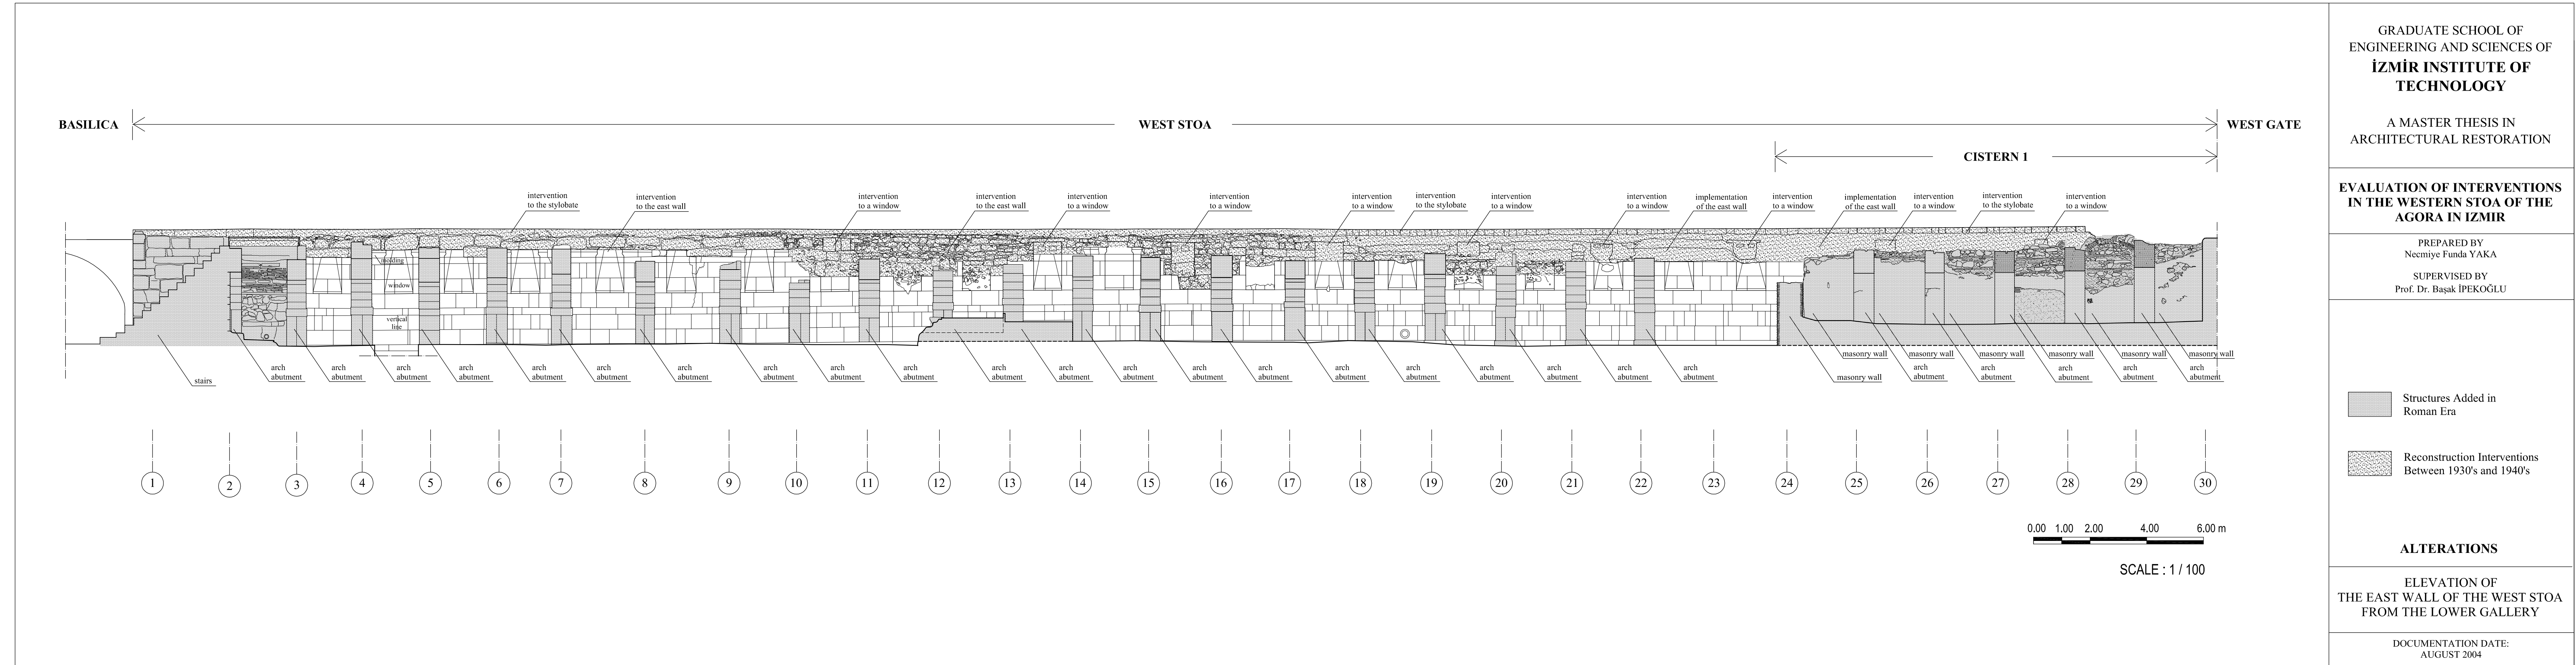
Figure 4.16. Different periods of interventions on the Hellenistic wall.

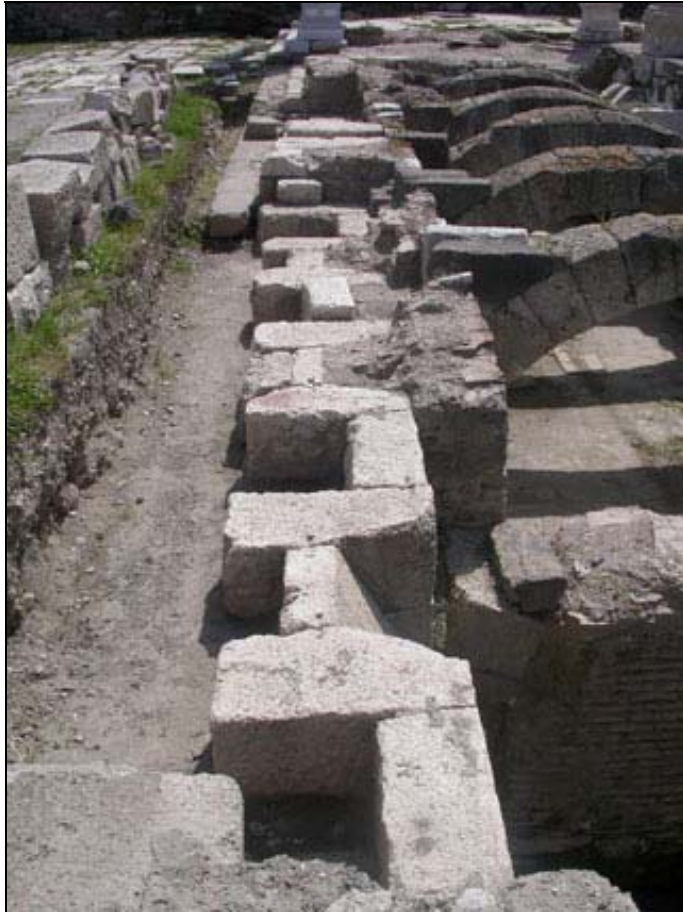
Figure 4.24. The construction style of the wall revealed after the removal of the concrete stylobate implementation.

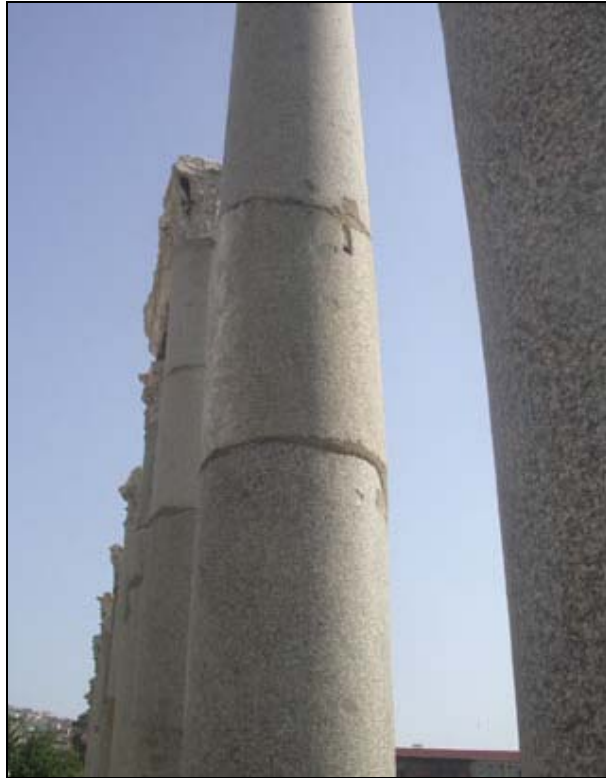
Figure 4.45. The clamp sign leads to an ancient repair.
(Source: Archives of the Agora excavations, 2005)
