**MODELLING OF THE OIL SPILL IN M/V LADY TUNA ACCIDENT
AND THE EVALUATION OF THE RESPONSE OPERATION
IN SIMULATED CONDITION WITH PISCES-II**

M.Sc. THESIS

2019

PİRİ REİS UNIVERSITY

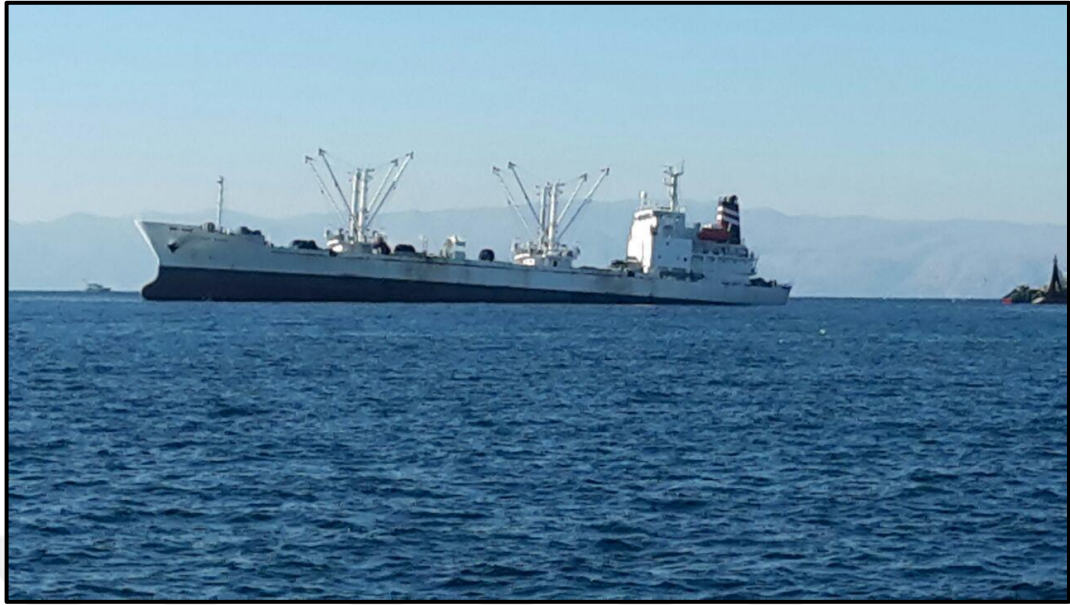
First, the Master of the ship ordered to stop the engine, followed by a slow astern order in order to refloat and move the vessel from the position where she grounded. Upon seeing that the ship was not moving, he ordered to stop the engines and finished with the maneuvers. The view of the vessel after she grounded on the shoal is shown in Figure 7.3. (The Accident Investigation Report, 2017)

Figure 7.3. The View of the Vessel After She Grounded on the Shoal
(The Accident Investigation Report, 2017).

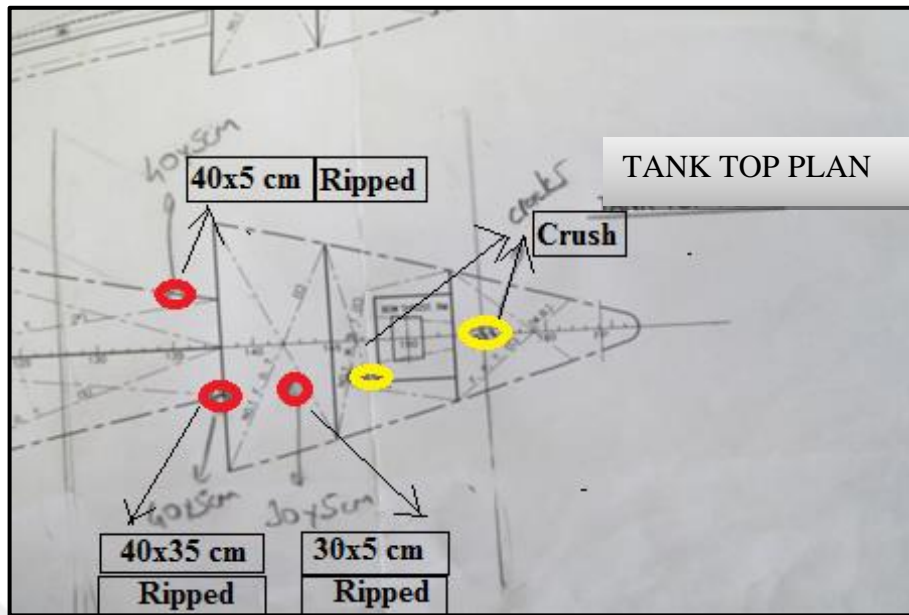
Figure 7.4. Damaged Parts of the Ship as Shown on the Transverse Plan (The Accident Investigation Report, 2017).

Fore Peak Tank	Crush
No:1 Center Ballast Tank	Crush
No:1 Center Fuel Oil Tank	30 cm x 5 cm Ripped
No:2 Port Side Fuel Oil Tank	40 cm x 5 cm Ripped
No: 2 Starboard Side Fuel Oil Tank	40 cm x 5 cm Ripped

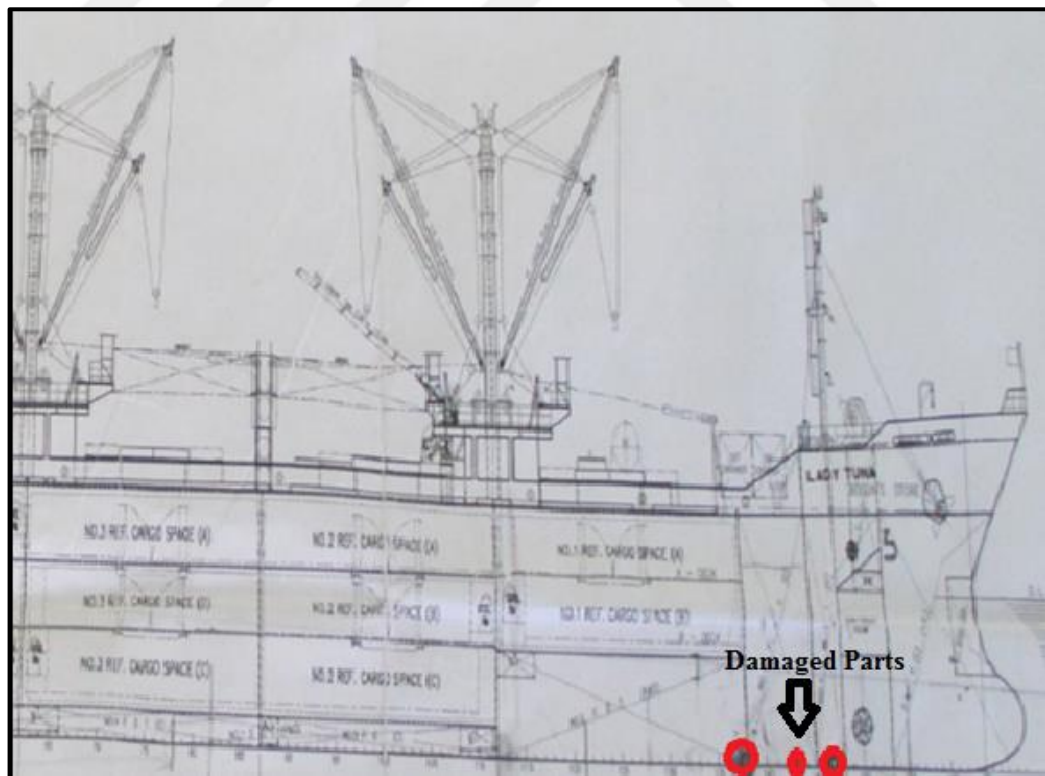
Figure 7.5. The Damaged Parts of the Ship as Shown on the Longitudinal Plan (The Accident Investigation Report, 2017).

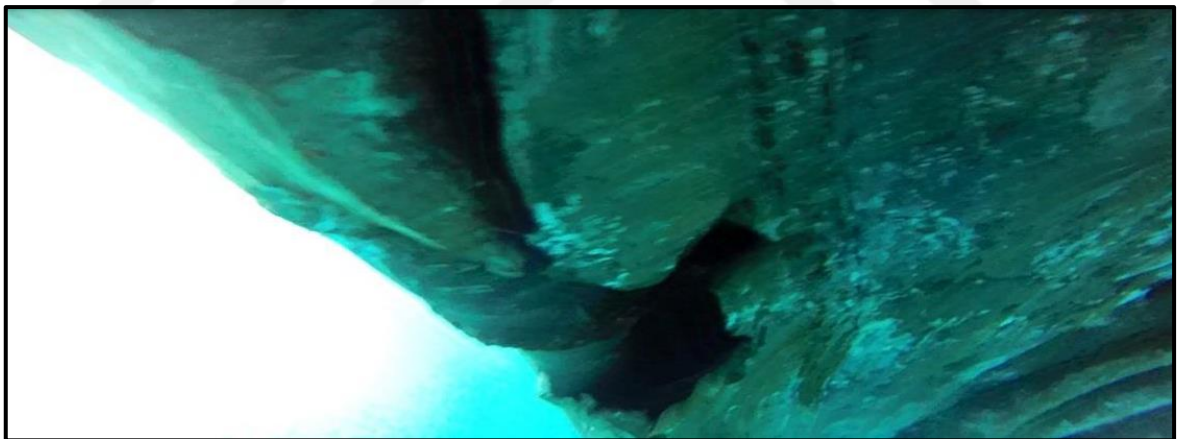
Figure 7.6. Damaged Parts as Recorded by the Diver's Camera (The Accident Investigation Report, 2017).

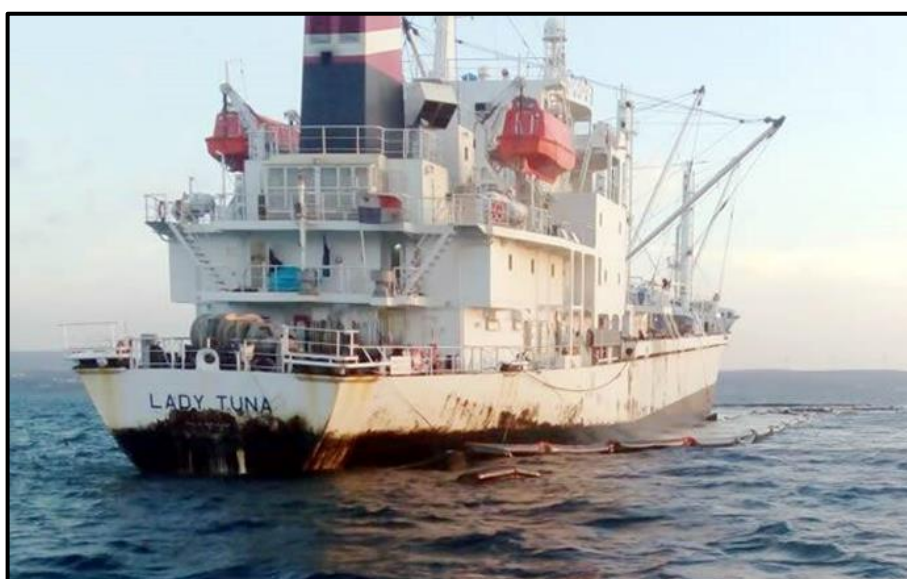
At 15.00 LT (1,5 hours later after the accident), ship's agent asked the pollution response company Most Maritime and Environmental Services which is based at Ulusoy Port, in the administrative responsibility area of Çeşme Port Authority, to make the necessary preparations. Çeşme Port Authority ordered the ship's agent to start necessary pollution response activities at 17:30 LT (4 hours later after the accident). Most Shipping started to encircle the fish farms with barriers at 20:30 LT and they completed to encircle the ship to the containment of pollution with barriers with two skimmers at 22:30 LT (Figure 7.7) (9 hours after the fuel oil leakage from the ship). (The Accident Investigation Report, 2017)

Figure 7.7. Containment of the Leaking Fuel by the Barriers (URL-4).

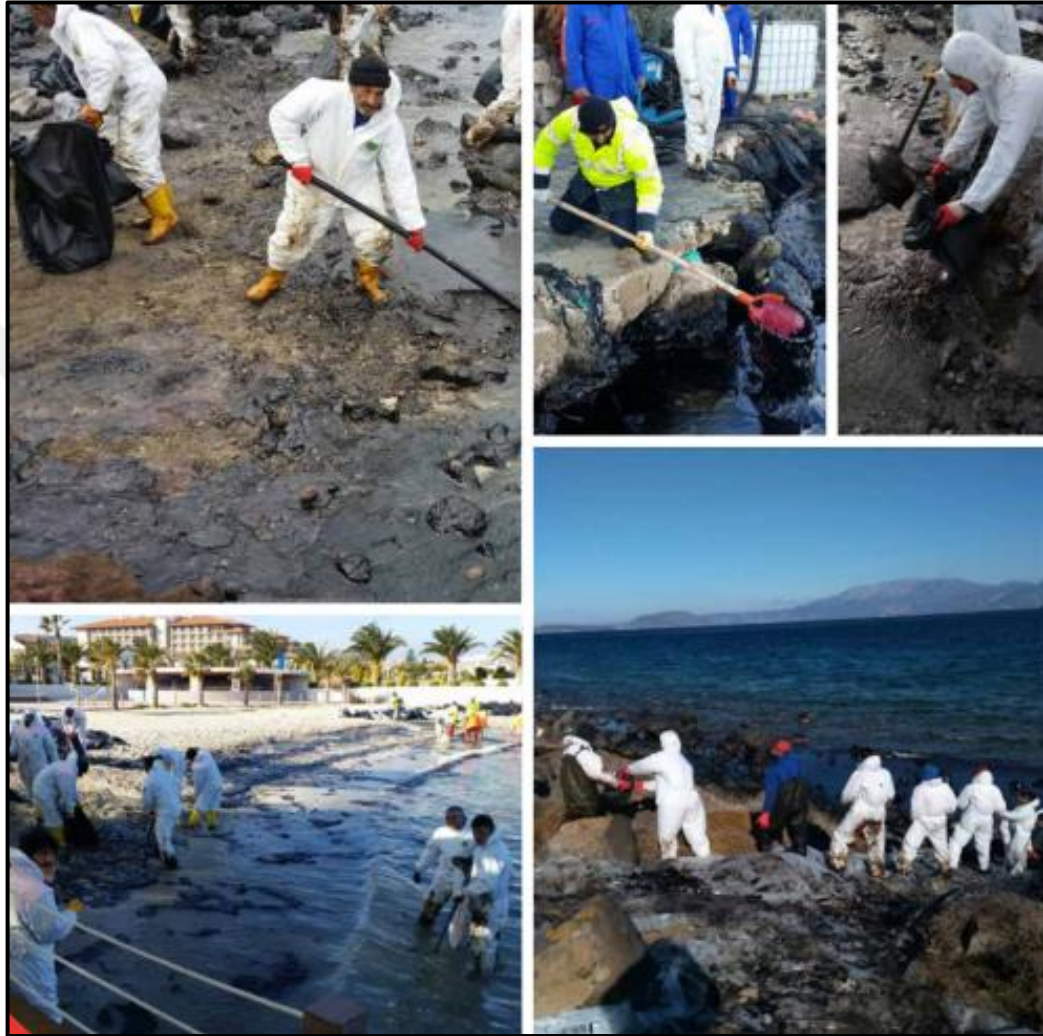
In the following days, both of the authorized companies continued their pollution fighting efforts both at sea (inside the bay) and at shore-line (Figure 7.9) where the pollution had stranded (The Accident Investigation Report, 2017).

Figure 7.9. Pollution on Shore Caused by Fuel Leakage and Pollution Fighting Activities (Mare Marine Cleaning Services INC. Publication, 2017).

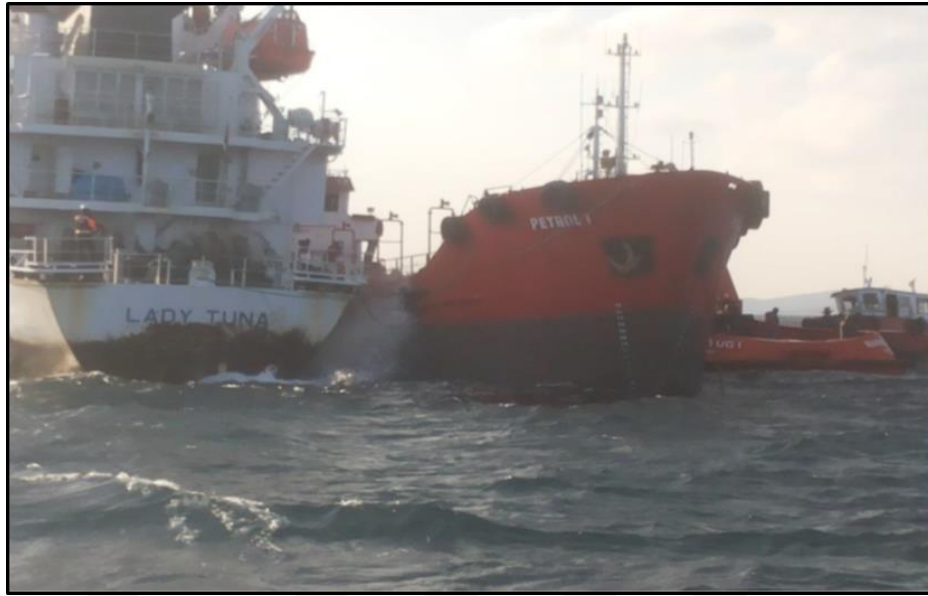
On 24th December 2016 (6 days after the accident), tanker ship PETROL-1 (Figure 7.10) came alongside M/V Lady Tuna in order to discharge the fuel in her damaged parts and discharging operation was completed on 26th December 2016 (8 days after the accident) (The Accident Investigation Report, 2017).

Figure 7.10. The Transfer Operation of the Fuel Oil to the PETROL-1 Tanker Vessel (The Accident Investigation Report, 2017).

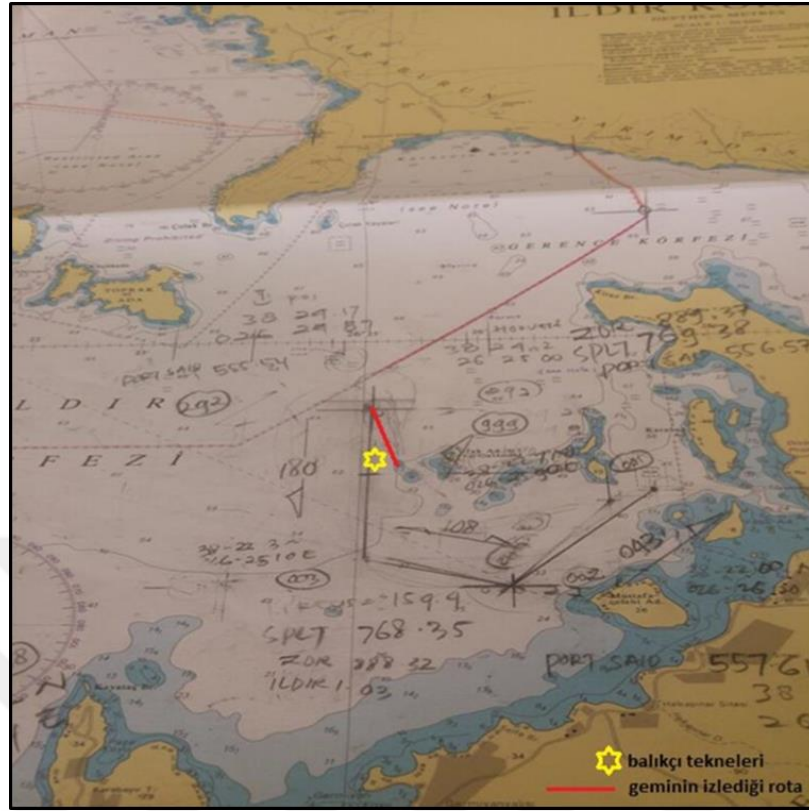
It is seen that the section of the course determined in the related voyage plan was determined without leaving a safe distance to the relevant shoals in any probable collision avoiding situations (Figure 7.12). It can be assessed that the reason for this can be, when preparing the voyage plan, navigational hazards and shoals were not given enough consideration. (The Accident Investigation Report, 2017)

Figure 7.12. The Planned Route According to the Voyage Plan (The Accident Investigation Report, 2017).
