DEVELOPMENT OF TWO-PHASE BIOLOGICAL SELF-
HEALING AGENTS FOR CEMENT-BASED MORTAR

A Thesis

Department of Civil Engineering

Özyeğin University

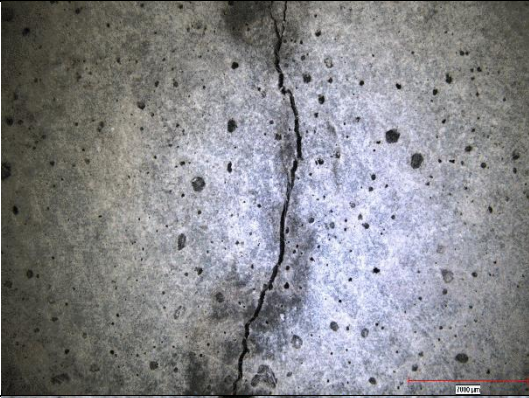
28 Day	Initial Crack	28 th Day of Curing
Water Cured Sample 6.7X

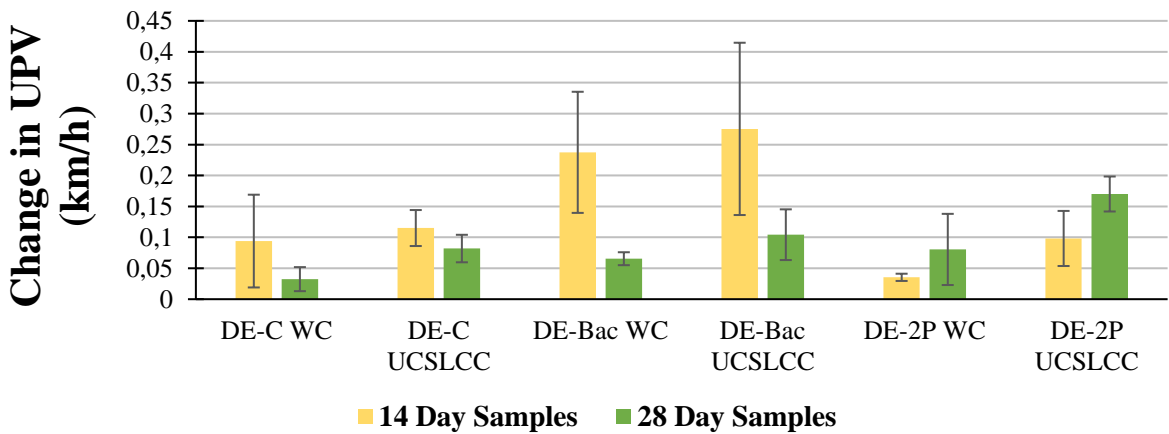
Figure 4. 2 UPV change of the DE containing samples at the end of curing stage. DE: Diatomaceous earth; C: Control samples without any bacteria; Bac: Samples containing bacteria without nutrients; 2P: Samples containing bacterial cells with nutrients -. WC: Water cured; UCSLCC: Nutrient Medium curing. Error Bars represent the standard deviation obtained from triplicates of samples and columns represent the average of 3 samples.

Another point that should be mentioned is the UPV values obtained in samples. Even though the absolute change in DE-2P samples were lower compared to DE-C and DE-Bac samples, particularly for samples cracked at 14 days after mixing, the UPV readings obtained in these samples were relatively higher compared to rest of the samples. Throughout the literature, generally it is agreed that very high velocities (> 4570 m/s) indicates very good concrete quality, while very low velocity ranges (< 3050 m/s) are indicative of poor concrete quality [74]. In addition, period changes in velocity might indicates the possible change in the quality of the concrete [74]. Thus, the increase in velocity is also an indicator of an improvement in quality of the material. Even though the relative change obtained through 28 days was lower, the velocity recorded in DE-2P was already high which is an indicative of a high quality.

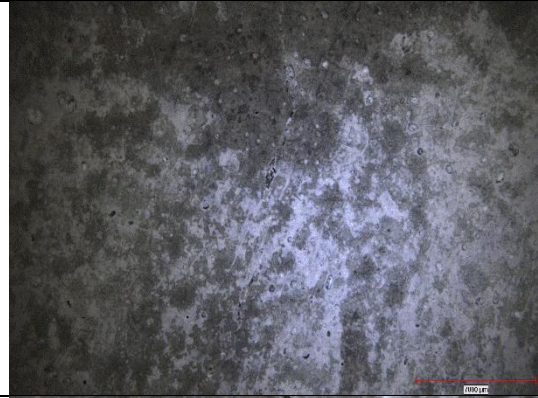
Table 4. 8 BT-2P beams cracked at 28 days.

28 Day	Initial Crack	21 st Day of Curing
Water Cured Sample 6.7X

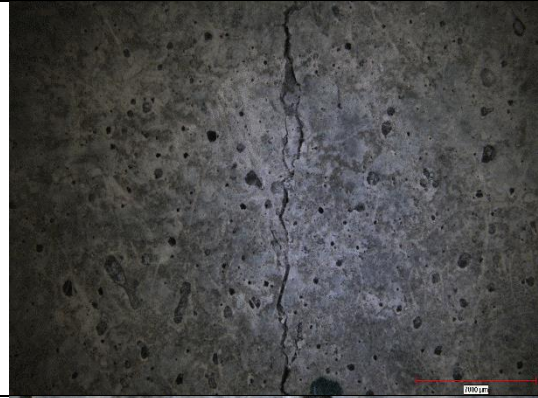
Table 4. 14 Pum-Bac samples cracked at 28 days.

28 Day	Initial Crack	28 th Day of Curing
Water Cured Sample 6.7X

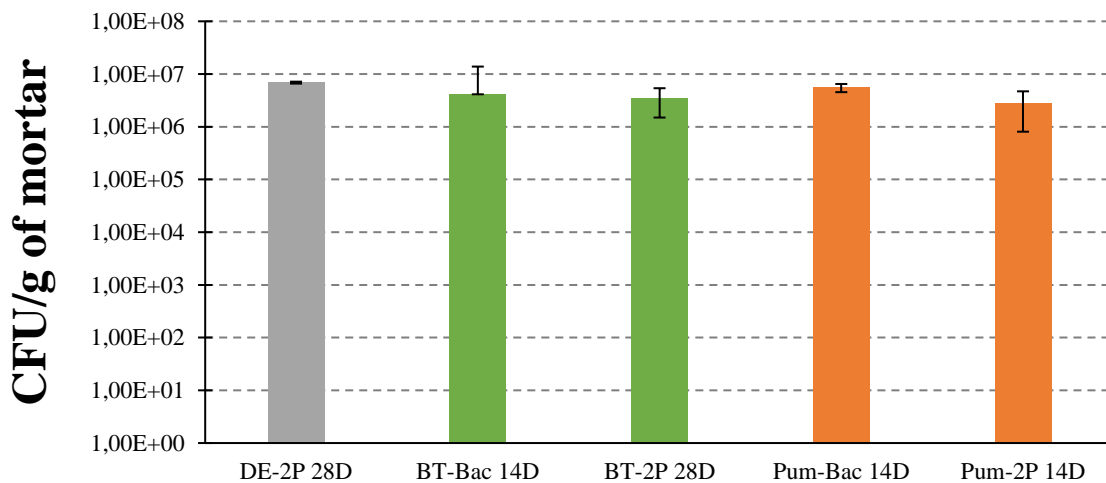
Figure 4. 20 Bacterial viability evaluation of the water cured samples where the crack closure was observed. DE: Diatomaceous earth, BE: Bentonite PUM: Pumice.
