**STRUCTURAL EVALUATION OF THE HURMAN CASTLE AND
RECOMMENDATIONS FOR STRENGTHENING**

**İNŞAAT MÜHENDİSLİĞİ ANABİLİM DALI
YÜKSEK LİSANS TEZİ**

HALİL AYDIN

OCAK - 2019

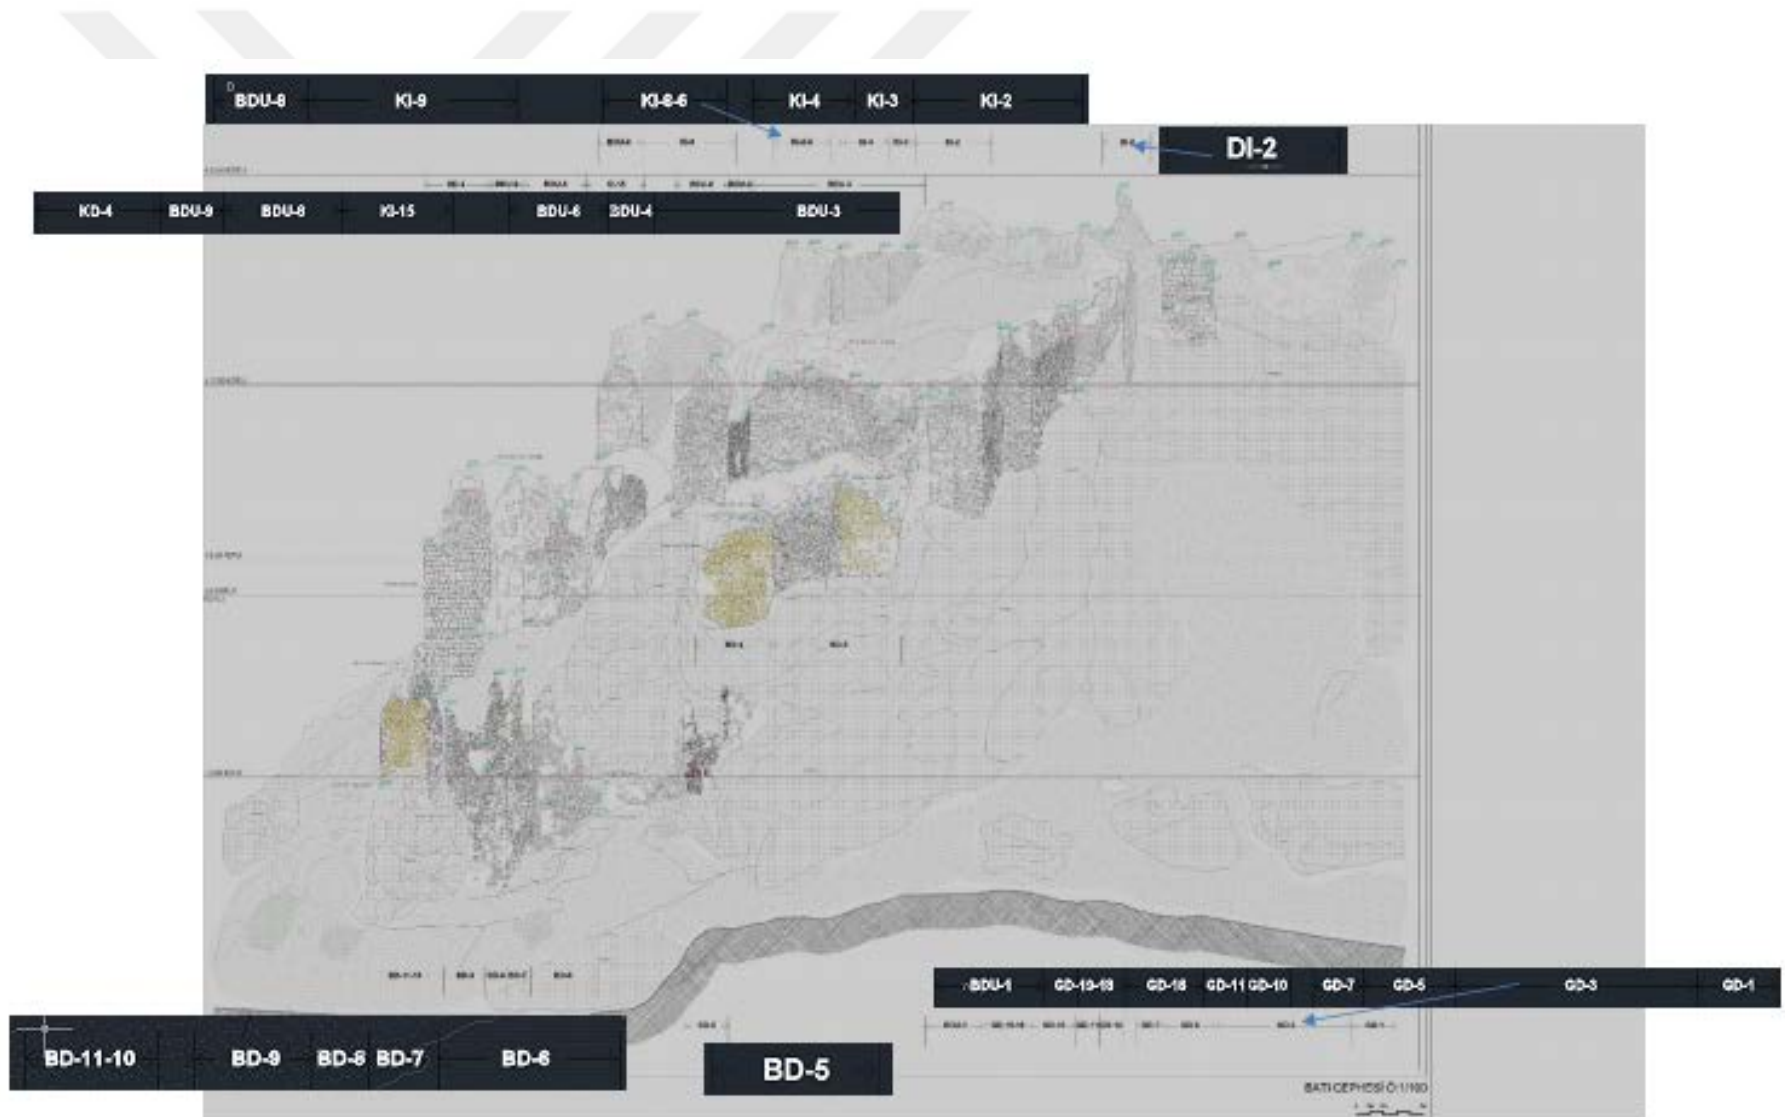
Figure 5. The Western Front of Hurman Castle, Relief Drawing

The fortress structure is located on a hill that will have four façades in the direction observed today. The eastern part is the average in the east, as it appears from the surveys at the highest elevation; +22.0 m The fortress structure resting on the hill showing a slope with a difference of -4.0 m in the west; hence, it has a structure that stretches from west to east. Hence, the entrances of the building are provided from the southern and northern façades where a larger horizontal slope form is present. The structure of the castle, whose inner structure is covered by the rubble ruins of the walls that will be explained later, consists of two main sections, which are divided into three main parts which are surrounded by the outer walls of the outer walls that divide this main area into two parts. The elevation difference between these two steps forming the whole interior area is $14.0 - 6.75 \text{ m} = \sim 7\text{-}8 \text{ m}$. The outer walls of the structure are approximately 60-70 m on the north and south façades and this is $\sim 40 \text{ m}$ on the eastern and western façades. However, especially in the western facade of the protruding bush structures and the steep slope of the plan formed due to the form of the uneven form due to the length of the wall in this short façade wall façade is approximately 2 times the follow-up.

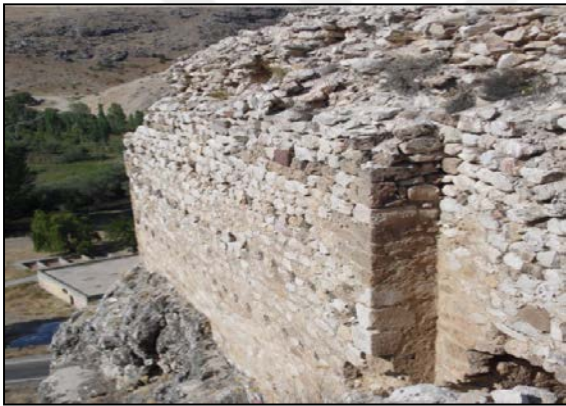
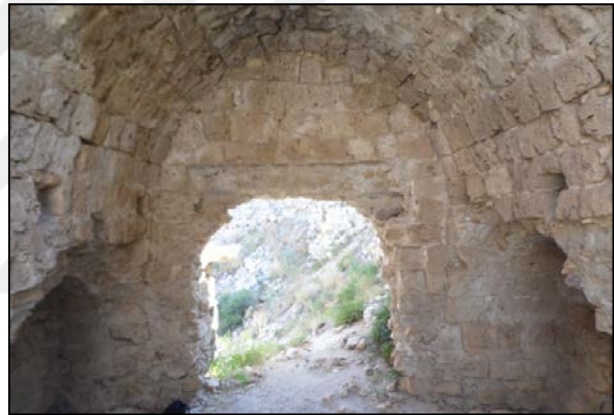
Photo 2. Hurman Castle a) Exterior wall structure in the outer wall structure, wooden vertical chain systems and internal rubble filling upper elevations of the observation. b) In the interior vault stone lattice, deterioration is observed with the eye eye condition. Travertine type stone material is a common type of decay.

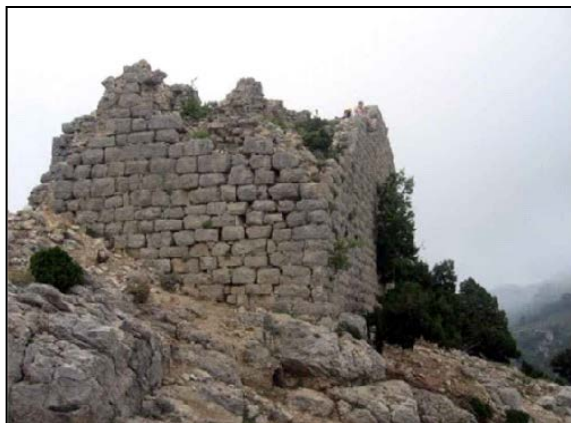
Photo 3. Adana Andil Castle and Adana Bucak Castle Examples

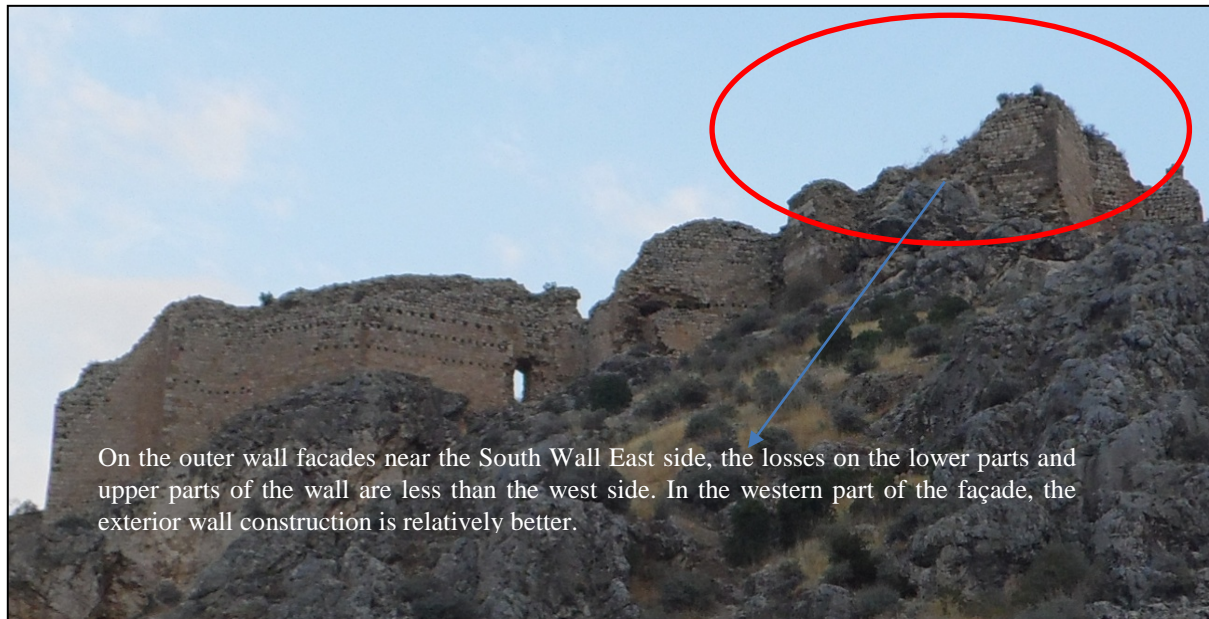
Figure 6. General representation of structural problems of southern wall

The southern façade of the fortress contains all of the above mentioned problems. However, from the upper elevations to the lower elevations, structural problems are described; It is seen that the outer covering of the walls disappear at approximately similar elevations along the line at the upper elevations and the internal debris is exposed to serious wear by the loss of the outer covering to the lower elevations on the GD-1 wall.

The eastern wall of the southern wall line is more problematic than the western walls. In these parts, the outer wall covering of the walls and the internal debris also have discharges at the lower elevations. In other words, the lower part of the walls left the emptied middle segments as console running parts. It is inevitable that these parts will be destroyed by progressive decomposition. The most serious losses can be detected on the GD-8 wall located to the east of the door entrance. The outer wall was destroyed to the lower elevations. On the other hand, the outer wall loss from the GD-8 wall to the DD-16 wall is detected in a horizontal line along the order of the wooden chain near the base level. It is interesting to note that this loss horizontal line is followed by the timber chain. It can be said that the loss in the fronts (burning break or vandalism) triggered the loss of this line. Periodic repair and intervention traces on the southern walls can be detected by different external walling techniques. This reveals the possibilities and traces of vandalism or repair interventions.

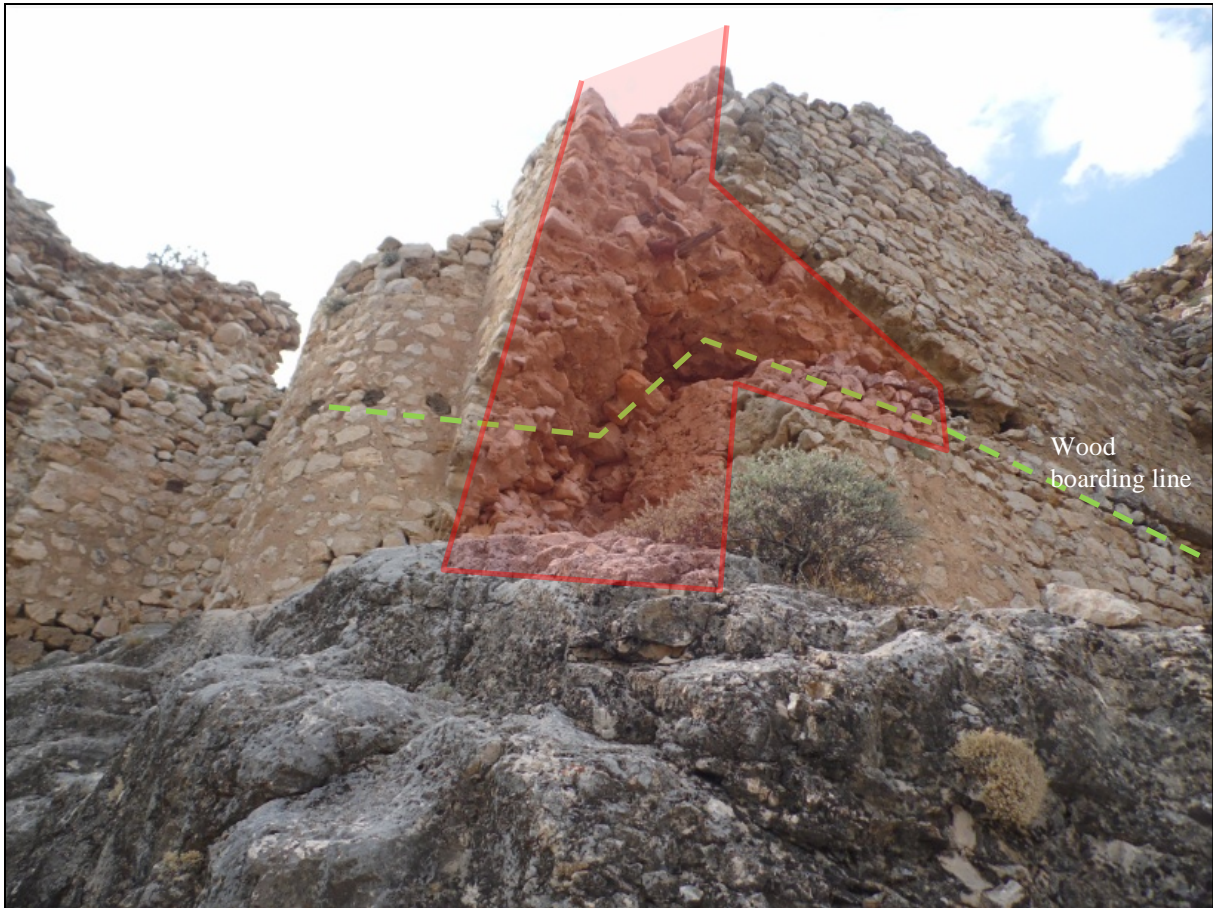
Figure 7. Bottom Wall Discharge at Southern Wall Wall GD-8

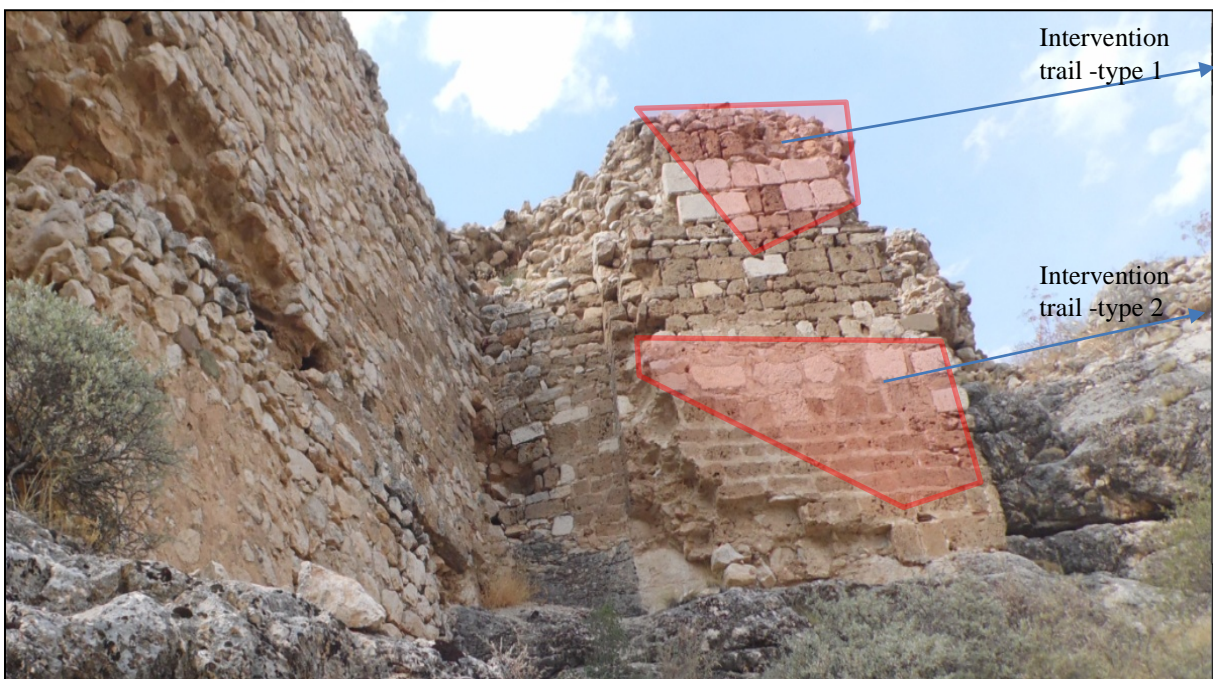
Figure 8. Sampling of Periodic Weave Differences or Repairs Detected on Southern Exterior Walls

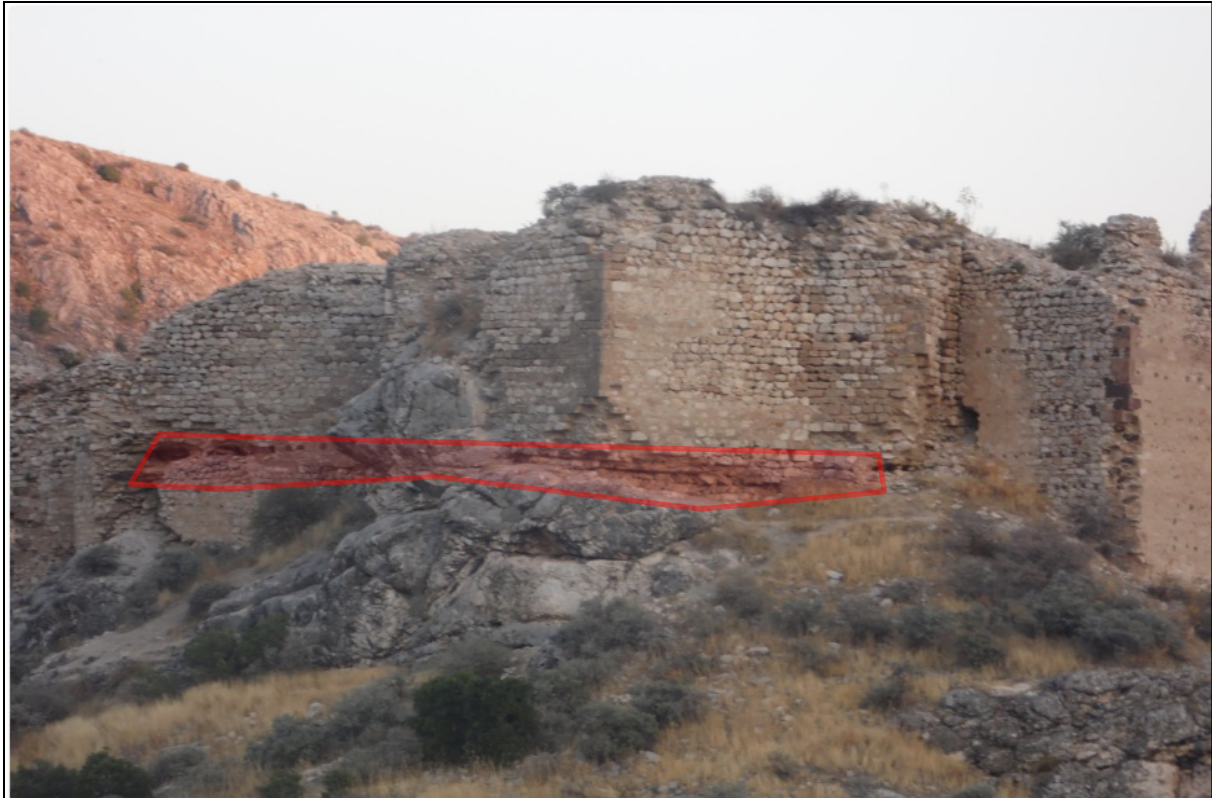
Figure 9. The Downward Trench Level External Wall Loss from the GD-8 Wall to the DD-16 (Eastern Corner Wall) on the Southern Exterior Wall

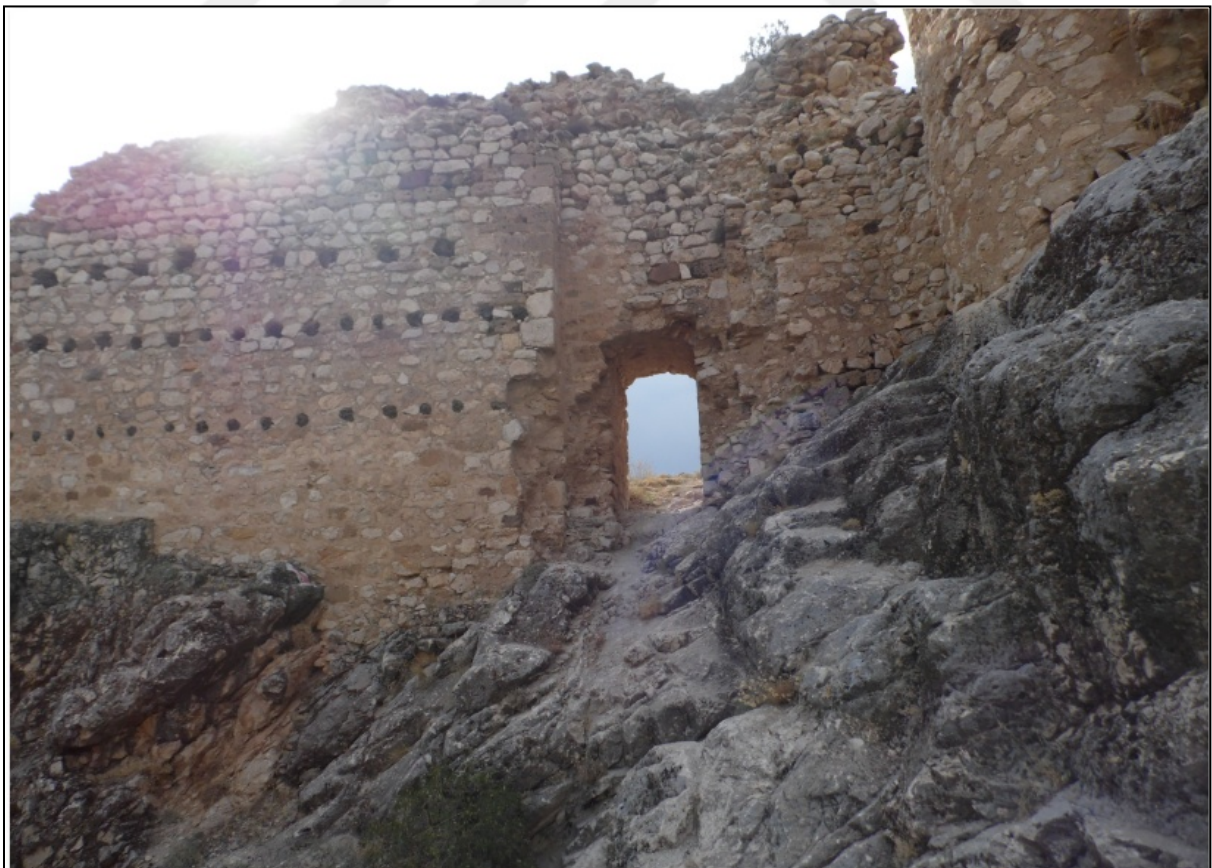
Photo 4. Knitting Stone Loss Around the Entrance Wall of the South Wall

The entrance gate arch structure in the South Wall is still intact and appears to be carrying out the load transfer task. However, the loss of intrados stones in the outer wall segment proves that the stresses in the section of the arch are elevated relative to the original state. Therefore, the belt structure is likely to undergo an ongoing structural demolition process.

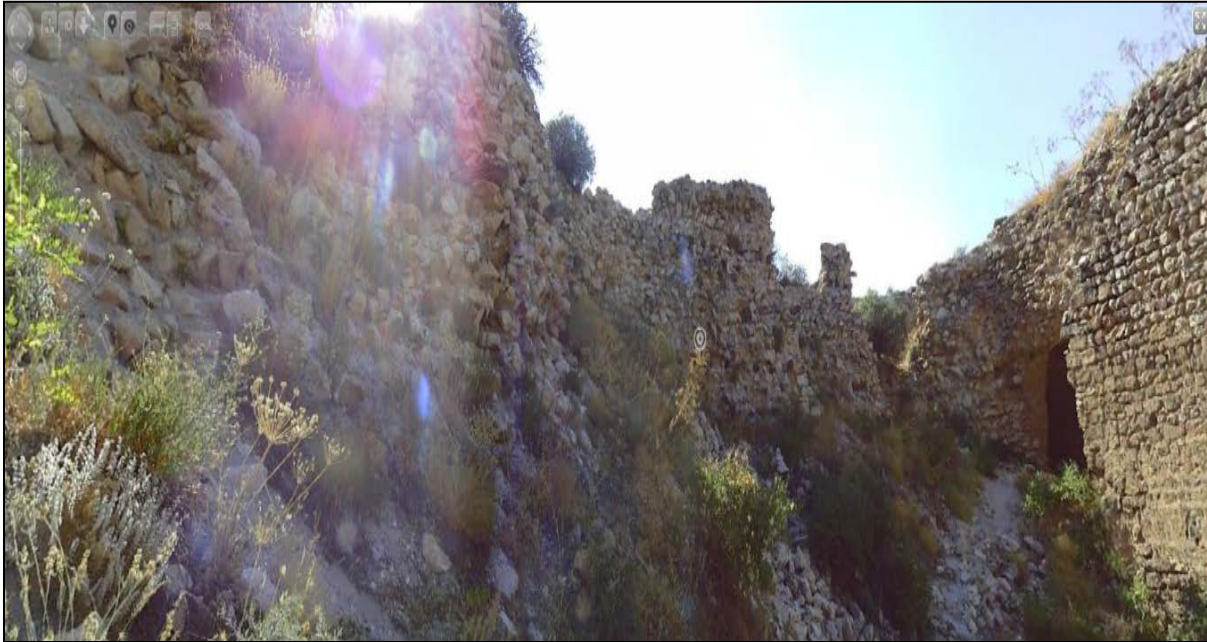
Photo 5. View of South Wall Interior Wall Problems

It can be stated that the main problem is observed when the inner walls of the South Walls are observed. The inner surface wall of the wall line has been completely destroyed and there is a serious loss in the thickness of the rubble. While the inner mortar structure of this rubble continues to crumble while the losses continue, the melting of the wall is an obvious ongoing process. On the other hand, as stated in the above section, the outer hull in the inner and outer wall segments forms the hollow form in the interior debris wall cut (as a result of abrasion). As the loss of the fragments in the inner debris of the wall continues with the part wear, the wall tries to reach the natural slope form. As of today, it is possible to say that the internal debris in the South wall survives an average of 60° along the line. However, it can be said that this angle is so steep that the crushed stone that forms the inner debris is not normal for the agglomeration, so when the mortars lose their binding, the form turns into shallow angles.

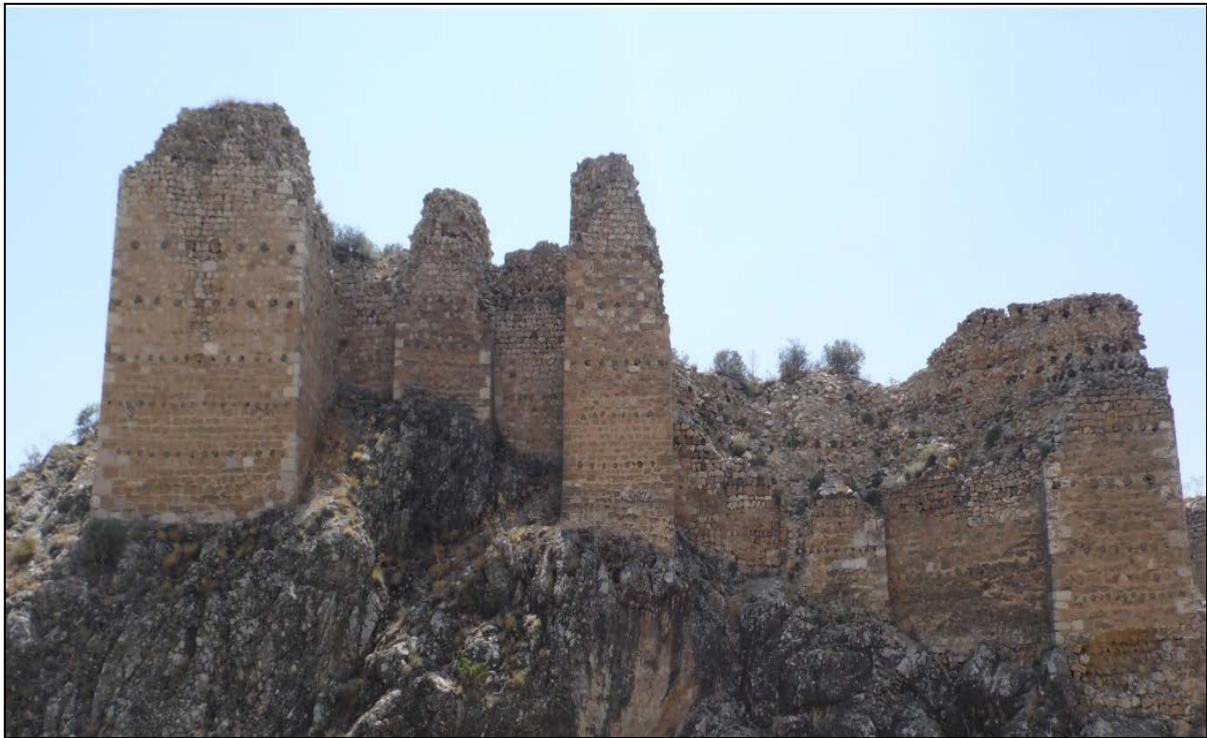
Photo 6. North Wall Exterior View

When the North Wall was examined from the outside, there were no problems other than the southern wall at the lower elevations of the wall. It was also determined that the joints were completed with periodic repairs. The problem of the main structural threat along the length of the wall is the disappearance of the outer wall of the upper elevations and the inner filling. While this problem is present in the entire wall line, it is more effective in the western half of the wall line. Here, the outer walls have been lost to about 4-5 m below the highest elevation of the internal debris. It is assumed that the debris remains standing at a certain cross-section, although relatively narrow at the top level of the authentic wall at this point. The most obvious structural problem of this type of decay is that the inner seal is standing at an angle of almost 80-90 °. In time, these slope angles will be reduced and external debris will be lost.

This means that the angles approach the natural façade means that they will not be subject to breaks as a result of the effects of wind or earthquake. The trend of destroying the rubble is to reach this enthalpy. To ensure inaction.

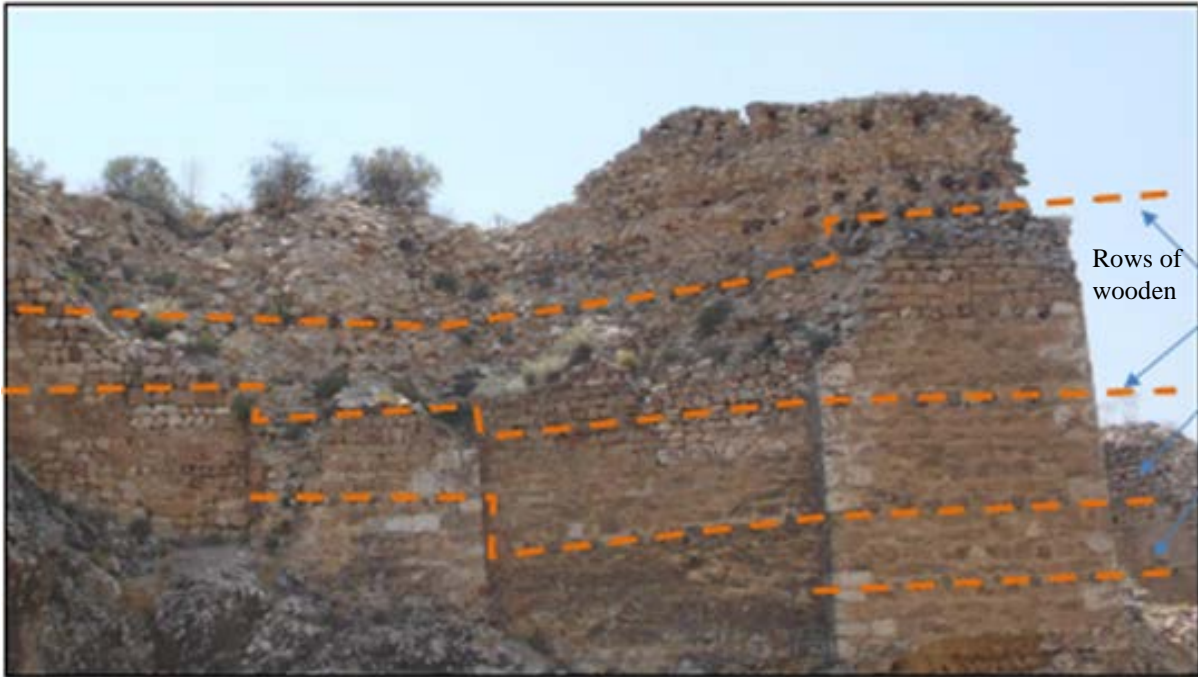
Figure 10. Close view of the walls between the North Wall and the KD11-KD17

It is observed that the Outline of the Northern Front extends from the lower elevation of the bushes and the walls of the interior walls to the lower elevation when it proceeds in the western part towards the slope. In these chapters, it can be said that different period weaves are interventions to close similar losses.

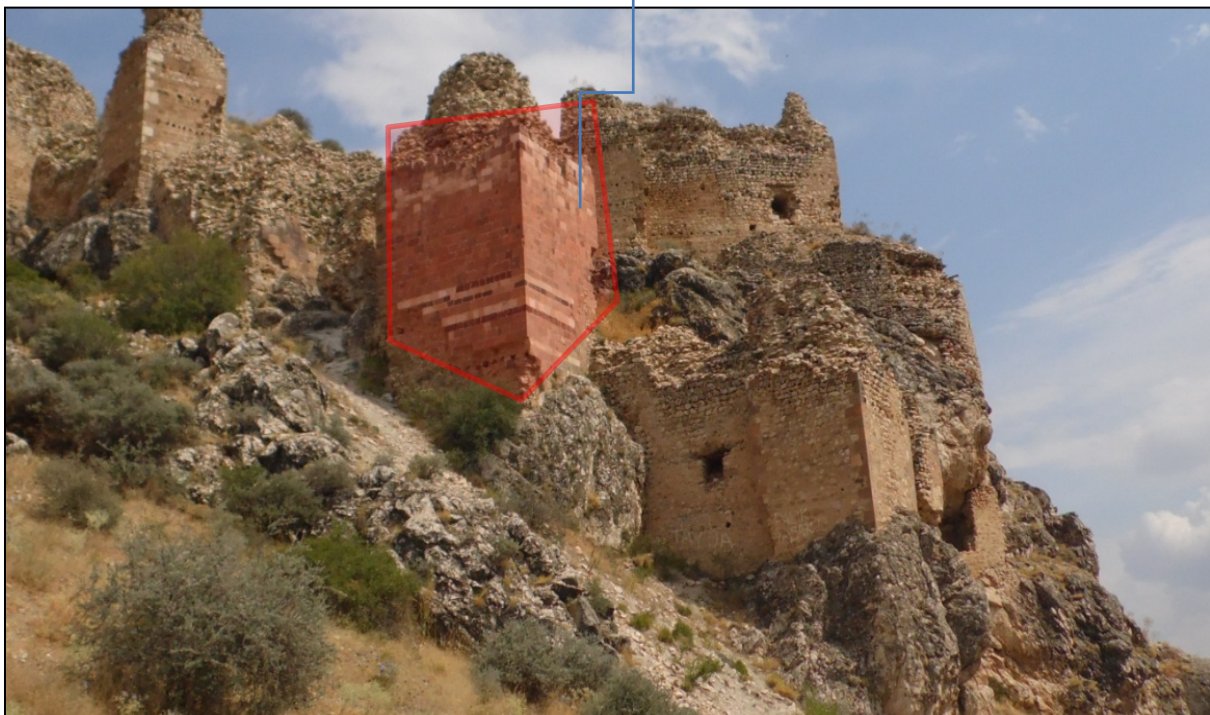
Figure 11. North Wall Exterior, West Slope Segment View

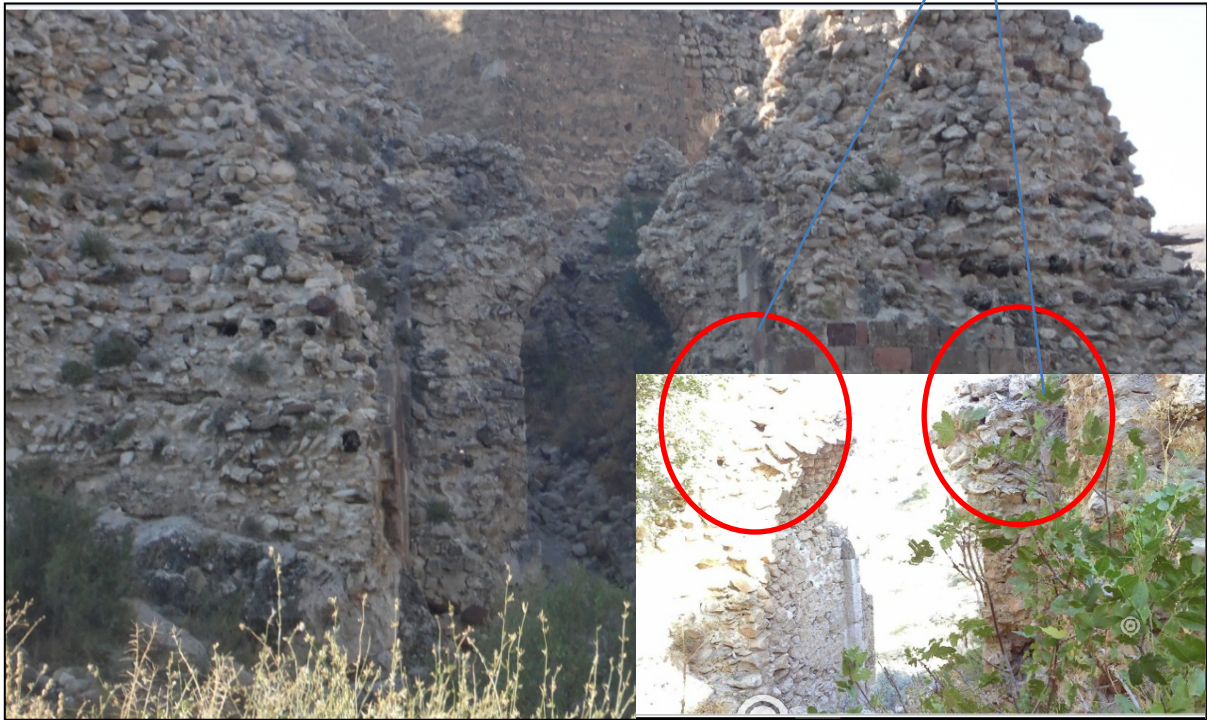
Figure 12. North Wall, Main Entrance Door Exterior Wall Completely Lost and Belt Destroyed

In this case, it is inevitable for the Belt Structure to collapse the cantilever parts and even gradually lose the wearer's rubble. Vertical effects or slight seismic movements will suffice.

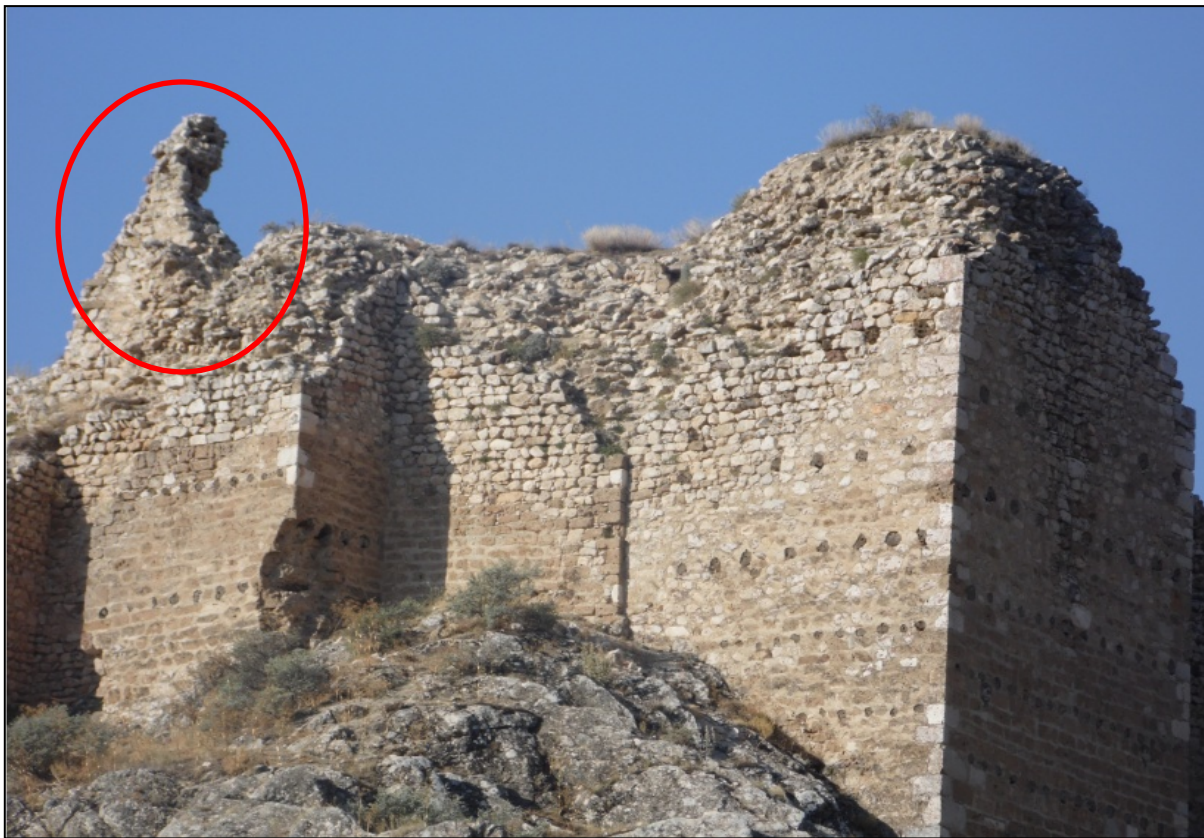
As a result of the internal debris being exposed to both lateral loading effects and climatic negative effects, it is highly dominant on this front.

Figure 13. DD-7 (Interesting) Debris Residue which can be followed on the Eastern Outskirts

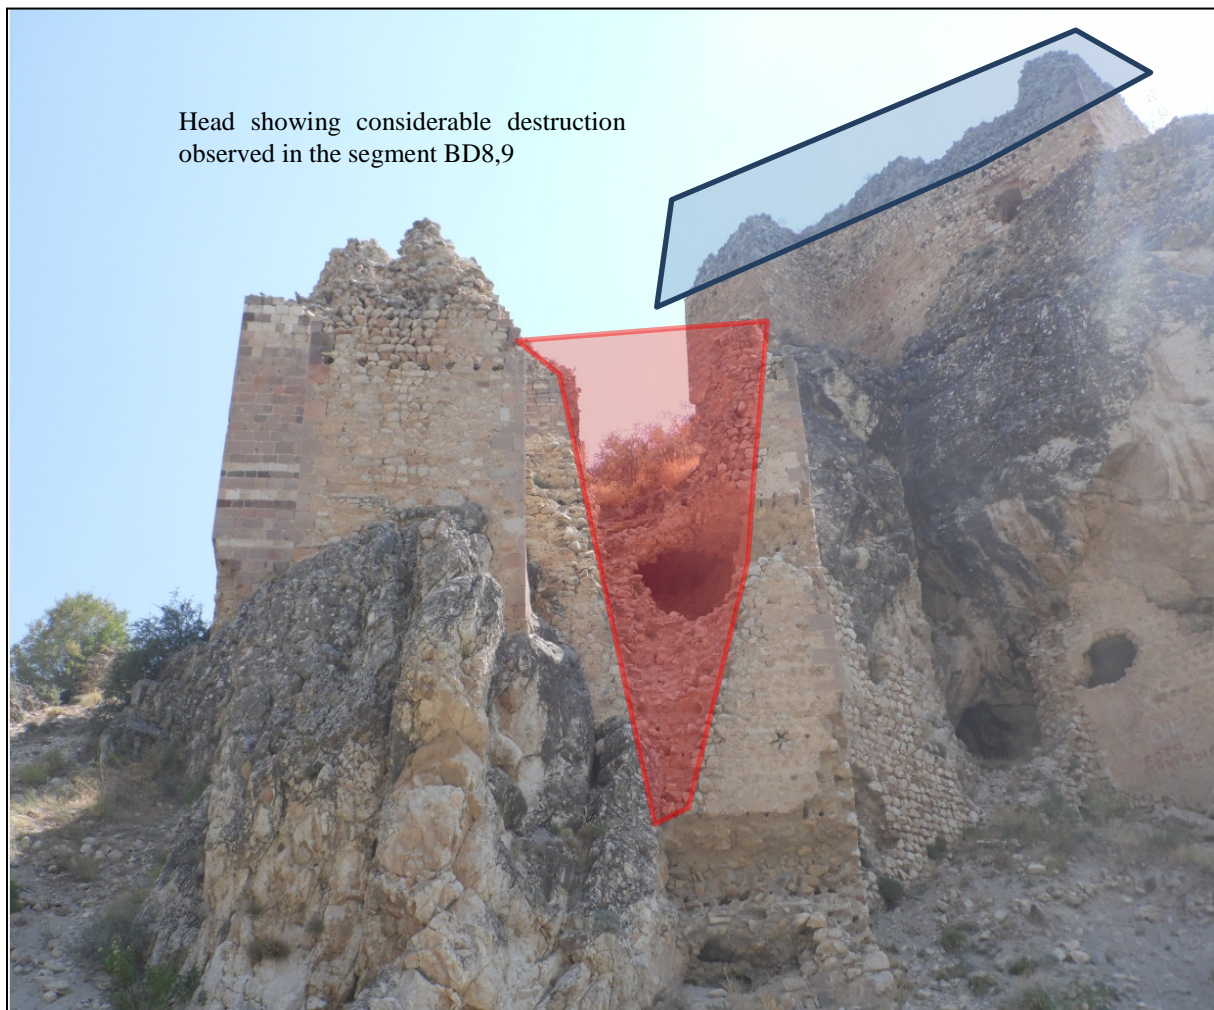
Figure 14. Irregular Demolition in Western Front, BD-8, 9

Regional extinction on the walls, as mentioned above, is present in this concept. It can be assumed that the wall openings on the walls of BD 8, 9 or BD 6 are relatively out-of-plane due to the fact that the walls are relatively high due to the slope and the walls are weakened by the seismic effects due to the fact that the openings such as the crenelate or the window play a debilitating role. It is also a logical assumption that the material degradation of the wall makes an effective contribution. In the present state, these walls are similar threat because of the vertical walls of the walls or wall extensions which are perpendicular to the walls. If the original forum is caught and the walls are supporting each other, this will be an approach to consolidate the problem.

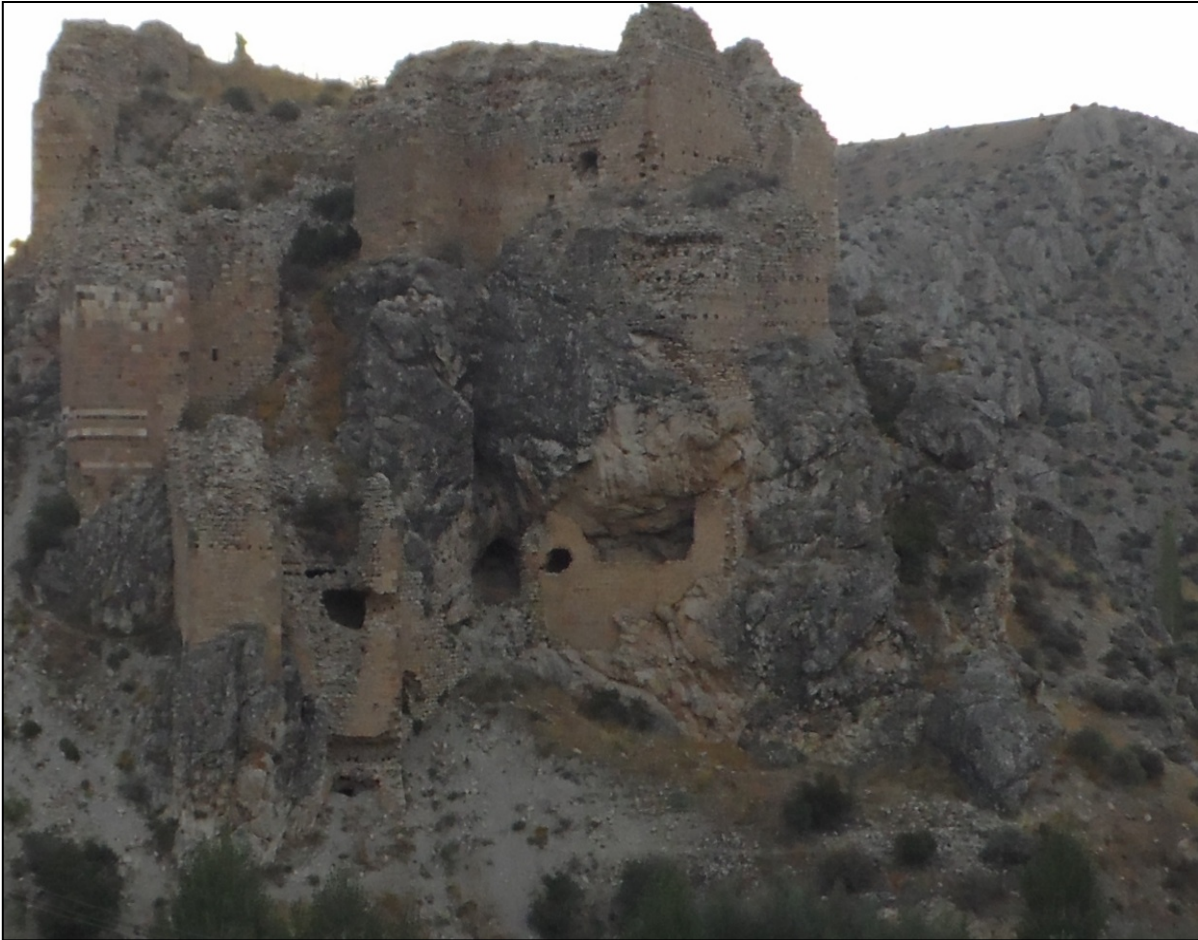
Figure 15. Non-Plane Demolition of Long Span Wall Segment in the Western Front and BD-6 Wall

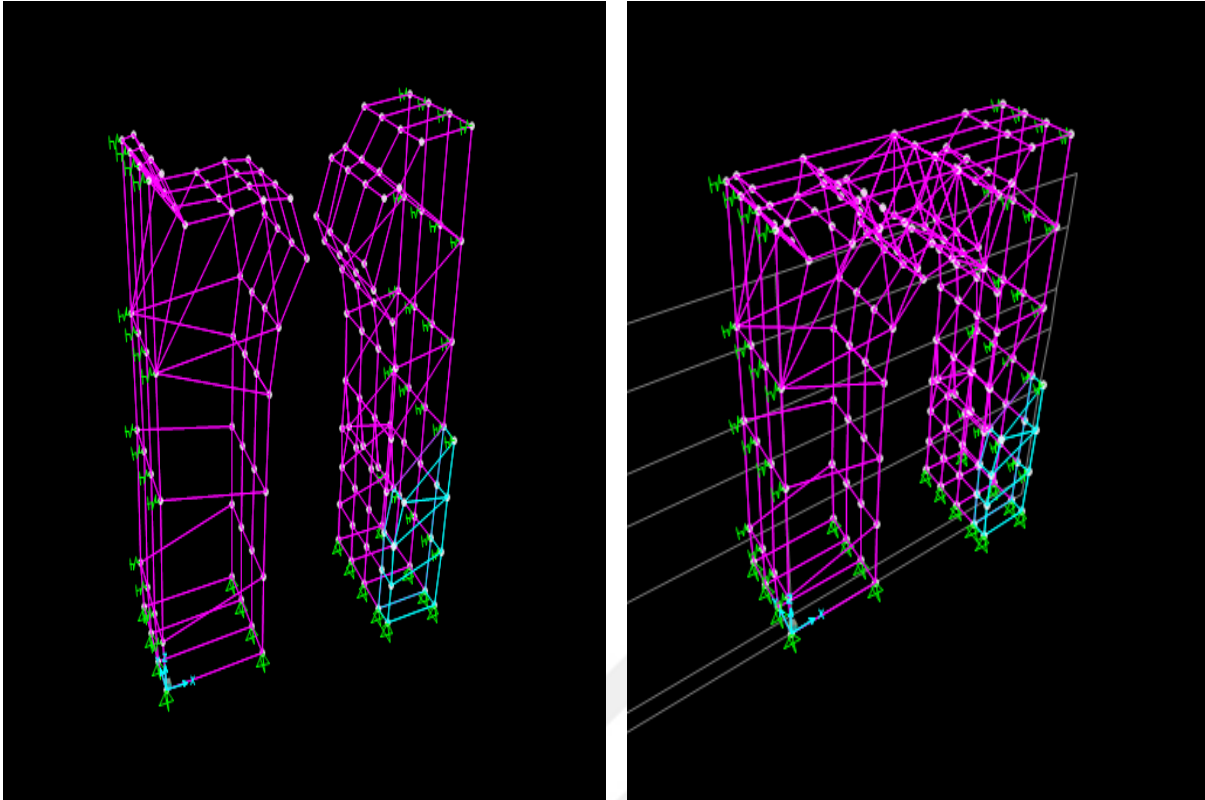
Figure 17. North Front Entrance door segment a) modern geometry model b) part completion proposal model

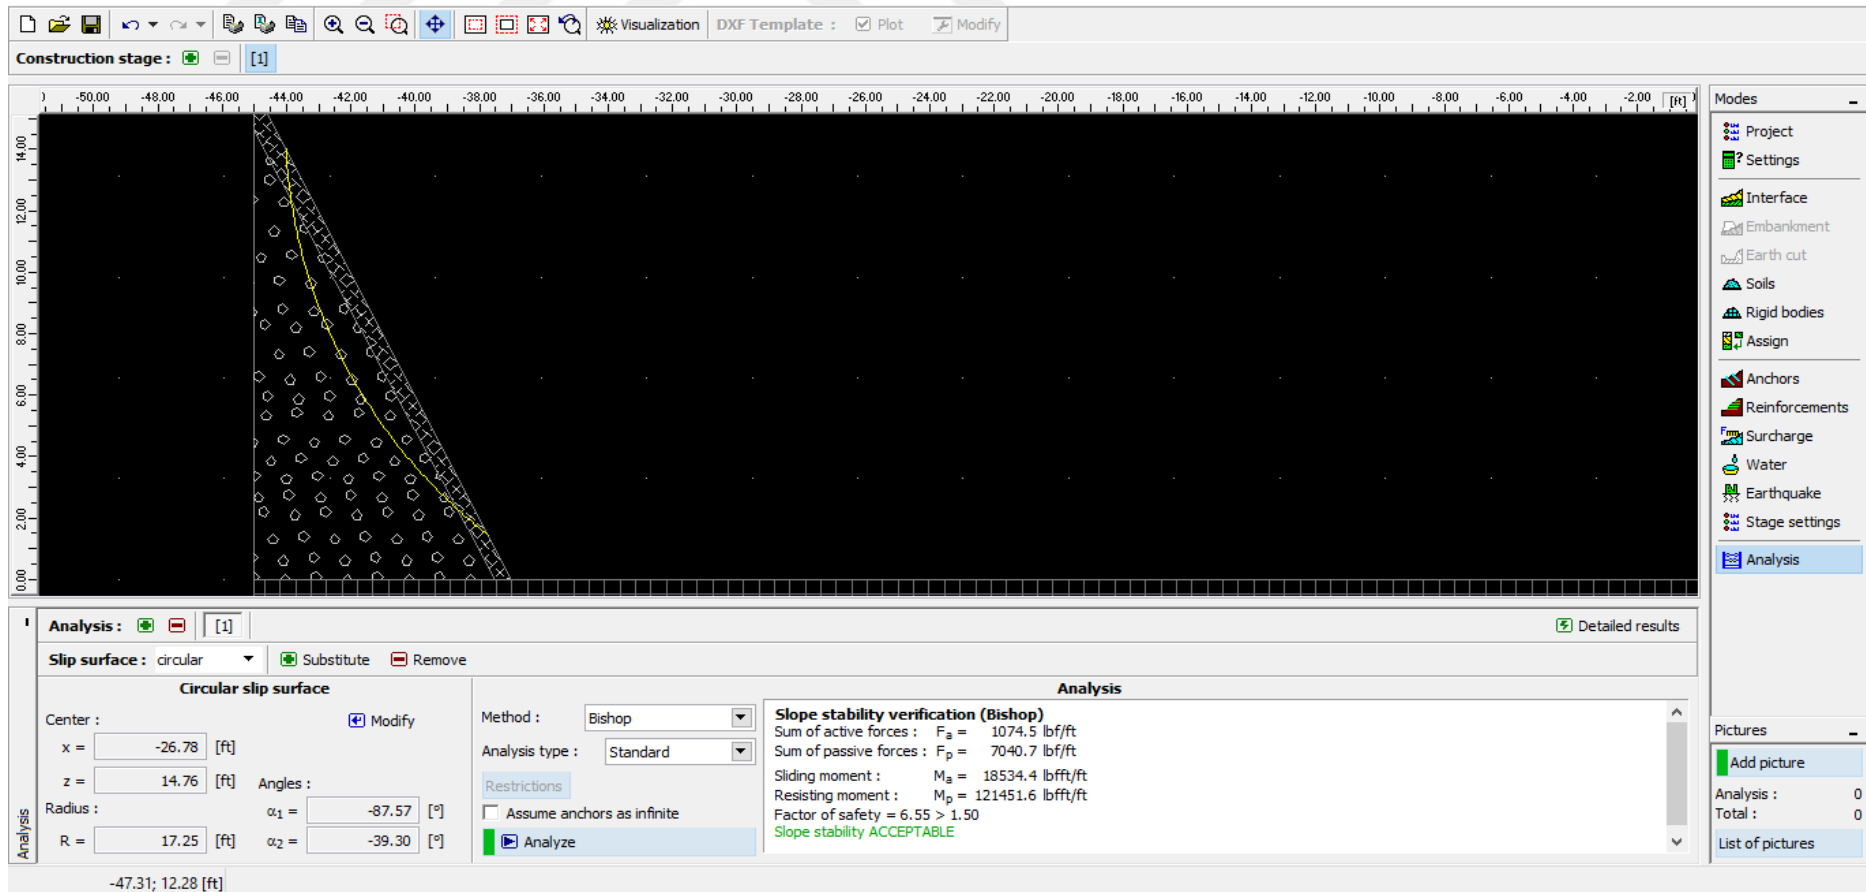
On the western facade KD-4 Wall, a sample slope slip analysis was performed on the narrow and high debris. Bentley GEO5 slope stability module was used for analysis. Width of the rubble (for half a diameter) 2.5 m; The height of the rubble peak is ~ 5.5 m. In the case of a 30 cm deep injection of the superficial rubble, the safety coefficient was found to be 6.5 for a critical slope.

Figure 27. Slope slip analysis of the West Facade KD-4 Wall-1

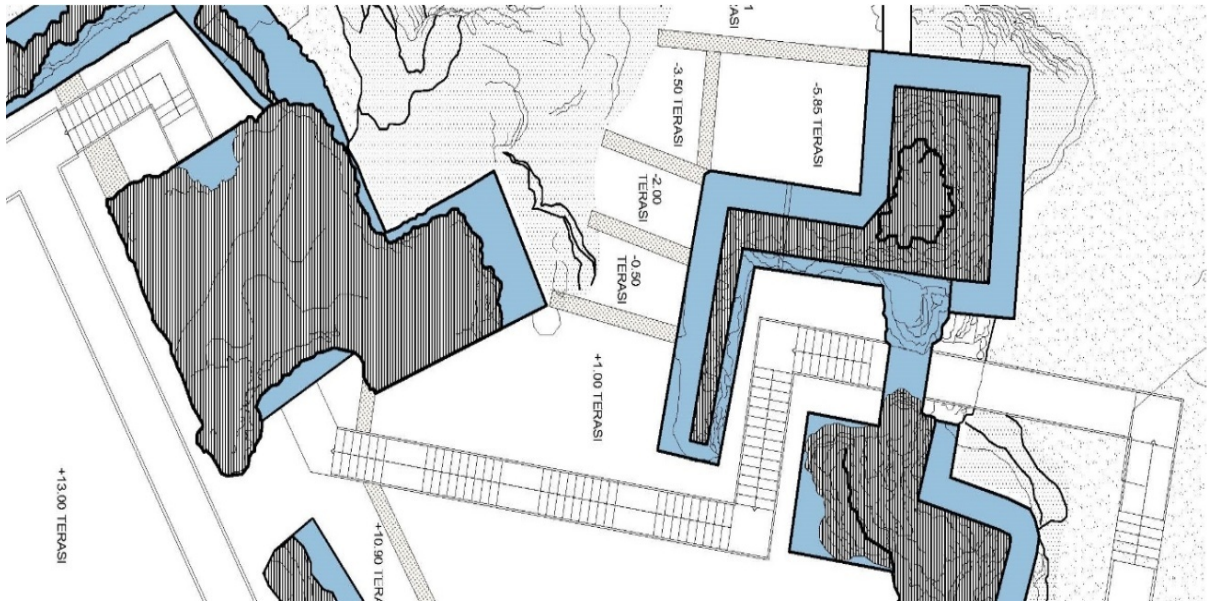
Figure 31. Platform Layout Plan

This report contains the static project accounts of the pedestrian platform structure planned for the Hurman Fortress located within the boundaries of Afsin Municipality of Kahramanmaraş. The platform structure is steel construction and is solved by SAP2000 program.

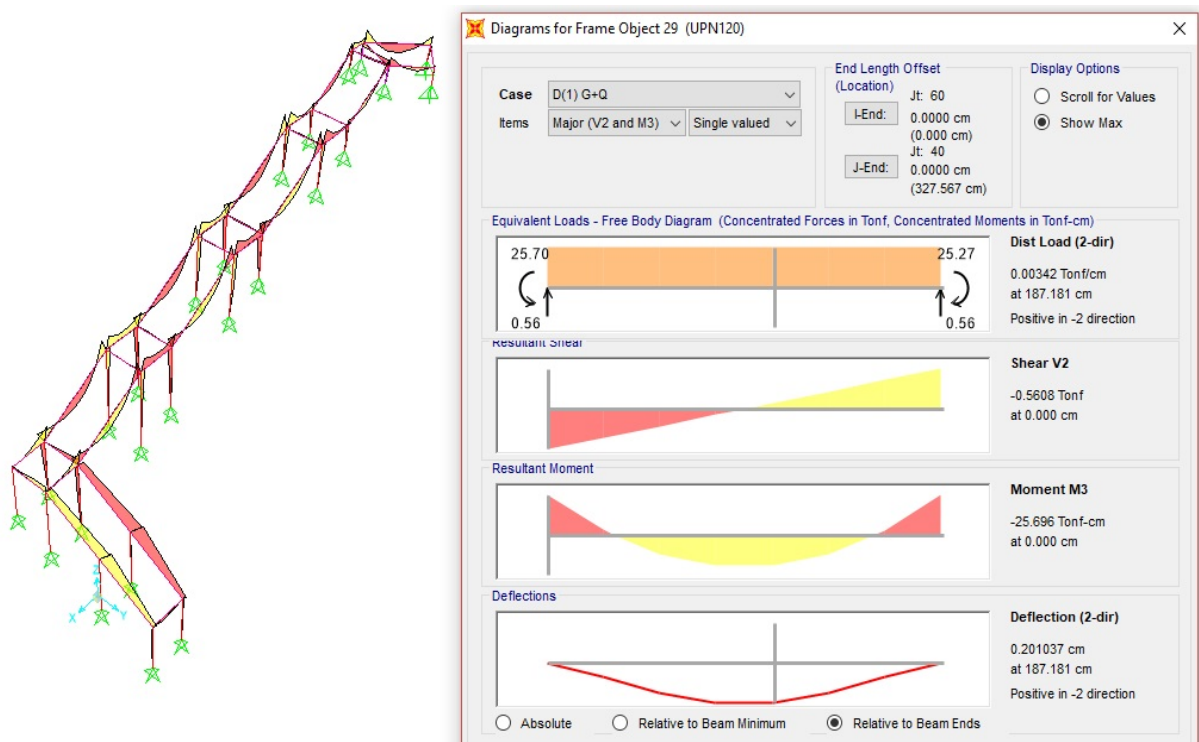
Figure 51. PORTION -2- Vertical Displacement (G + Q) 0.201 cm <1.09 cm (327/300)
