**EARTHQUAKE RISK ASSESSMENT FOR ISTANBUL
METROPOLITAN AREA BY DETERMINISTIC APPROACH**

Submitted to the Kandilli Observatory and
Earthquake Research Institute in partial fulfillment of
the requirements for the degree of
Master of Science
in
Earthquake Engineering

Boğaziçi University

2001

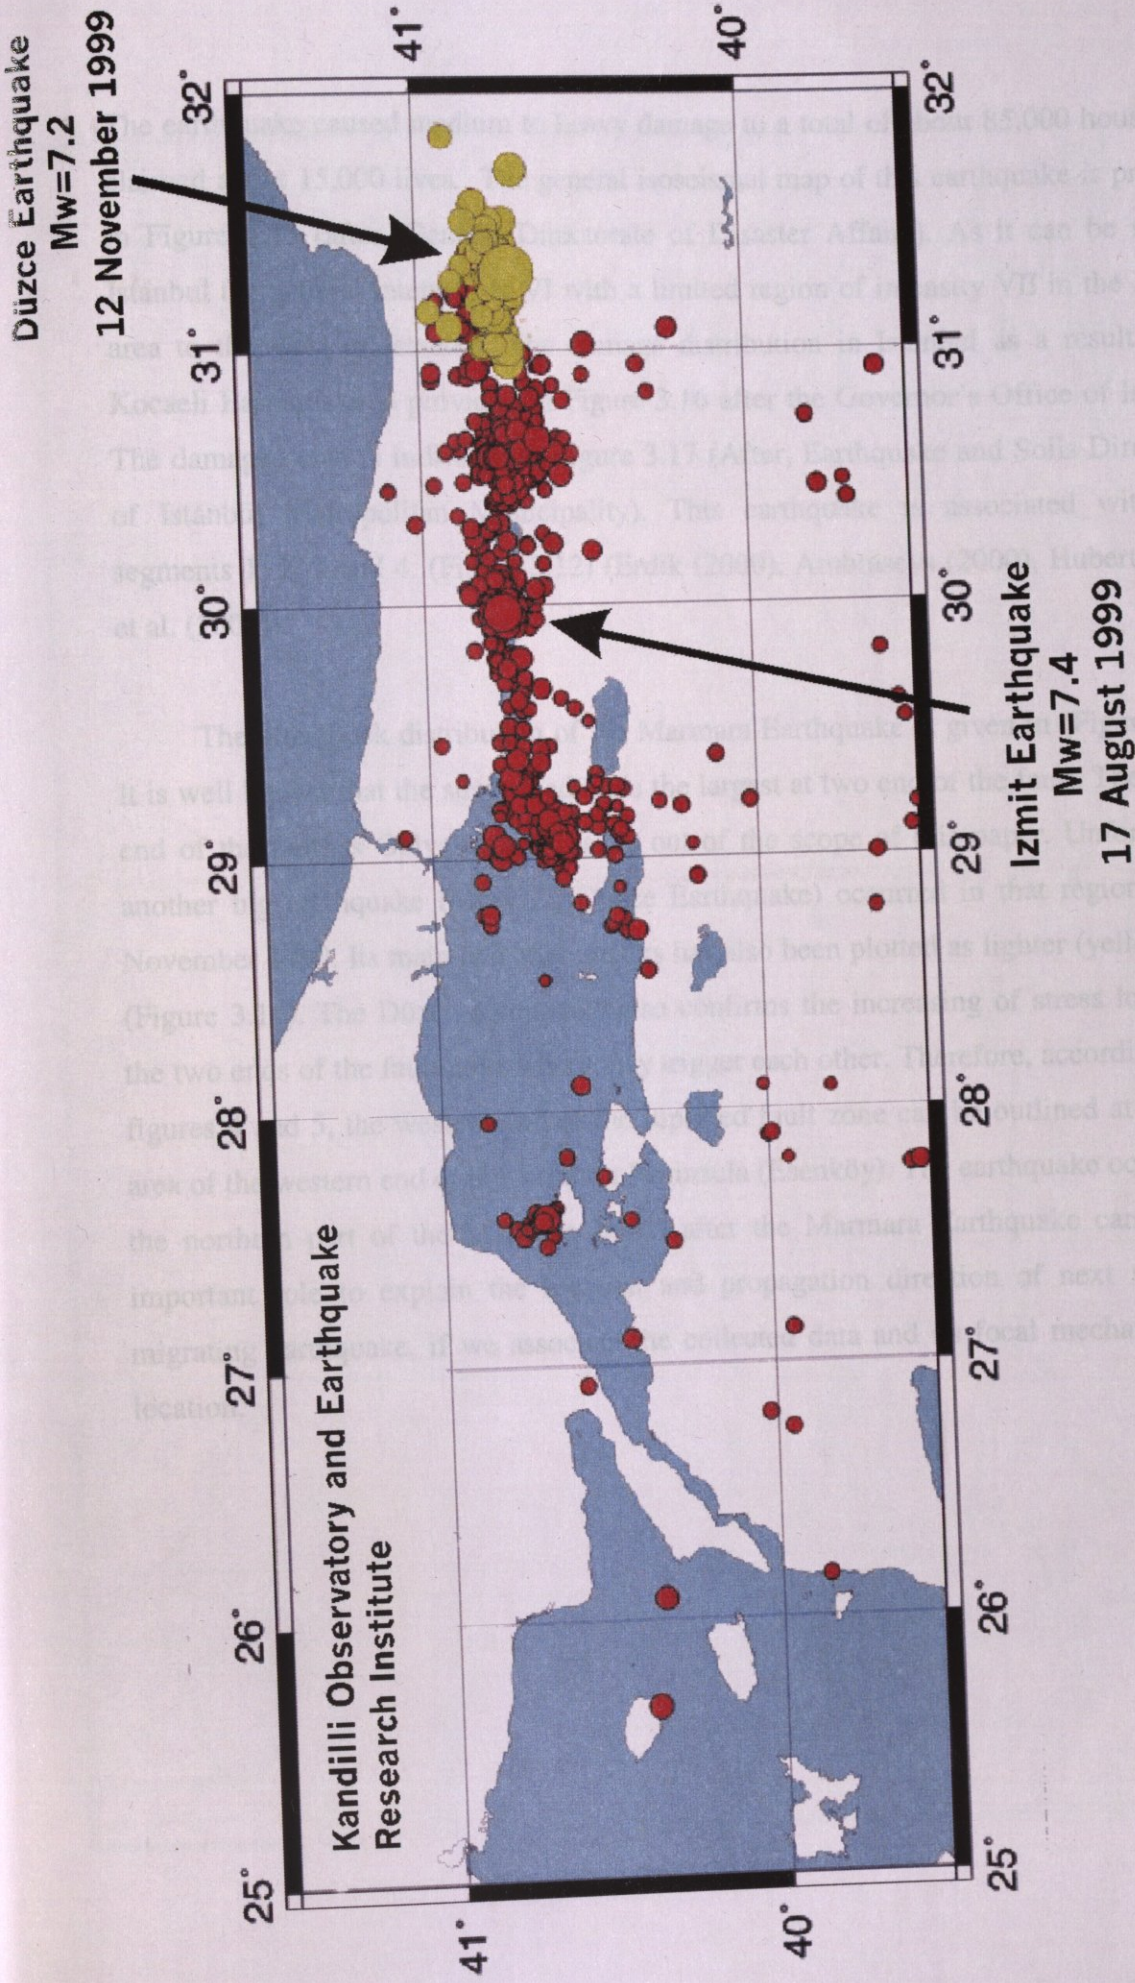
FIGURE 3.14 Locations of İzmit and Duzce Earthquakes, the location of aftershocks

The aftershock distribution of the Marmara Earthquake is given in (Figure 3.14). It is well known that the stress loading is the largest at two end of the fault. The eastern end of the fault is Gölyaka, and that is out of the scope of this paper. Unfortunately another big earthquake ($M_w=7.2$, Düzce Earthquake) occurred in that region in 12th November 1999. Its main and after shocks has also been plotted as lighter (yellow) dots (Figure 3.14). The Düzce earthquake also confirms the increasing of stress loading at the two ends of the fault zone where may trigger each other. Therefore, according to the figures 4 and 5, the western end of the ruptured fault zone can be outlined at offshore area of the western end of the Armutlu Peninsula (Esenköy). The earthquake occurred at the northern part of the Marmara Island after the Marmara Earthquake can play an important role to explain the location and propagation direction of next westward migrating earthquake, if we associate the collected data and its focal mechanism and location.

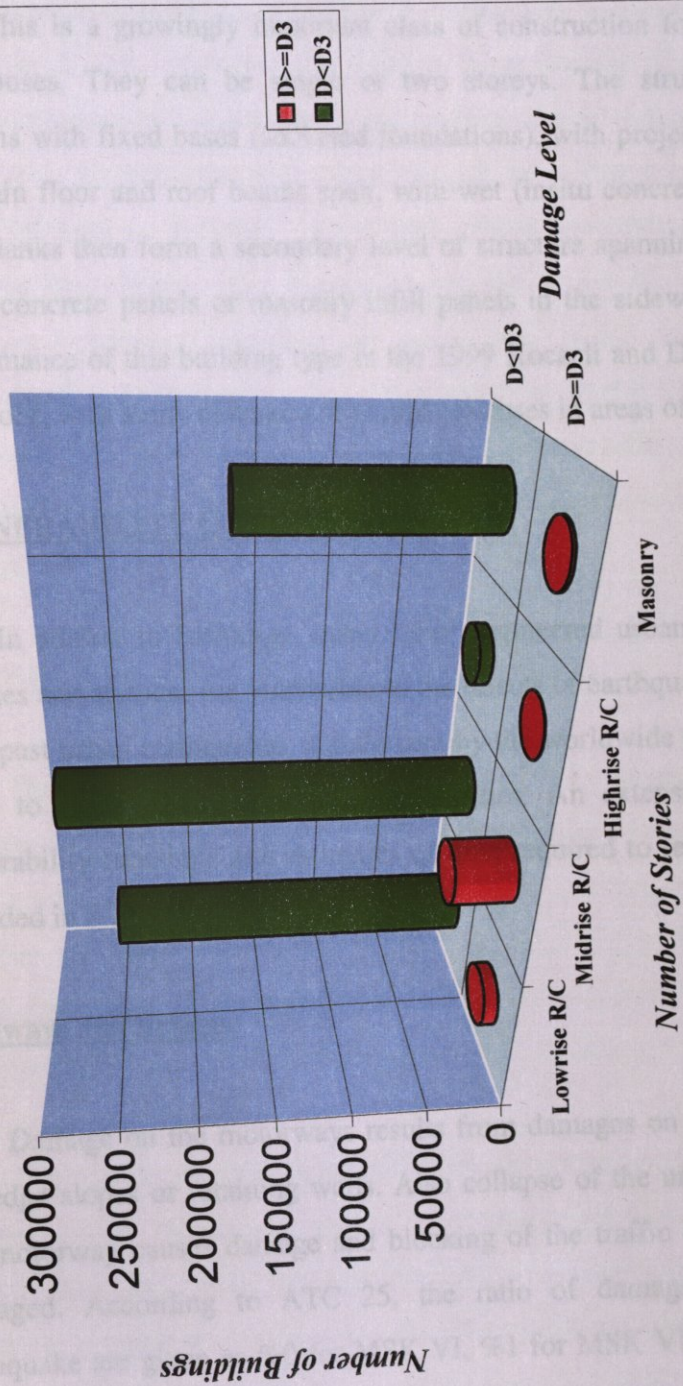
FIGURE 7.23 Variation of damage R/C and masonry buildings in İstanbul with the number of stories
