REINTEGRATION OF A FRAGMENTED HISTORIC URBAN CORE:  
SUNGUR BEY MOSQUE MARKET AREA, NIĞDE

A THESIS SUBMITTED TO  
THE GRADUATE SCHOOL OF NATURAL AND APPLIED SCIENCES  
OF  
MIDDLE EAST TECHNICAL UNIVERSITY

IN PARTIAL FULFILLMENT OF THE REQUIREMENTS  
FOR  
THE DEGREE OF MASTER OF ARCHITECTURE  
IN  
CONSERVATION OF CULTURAL HERITAGE IN ARCHITECTURE

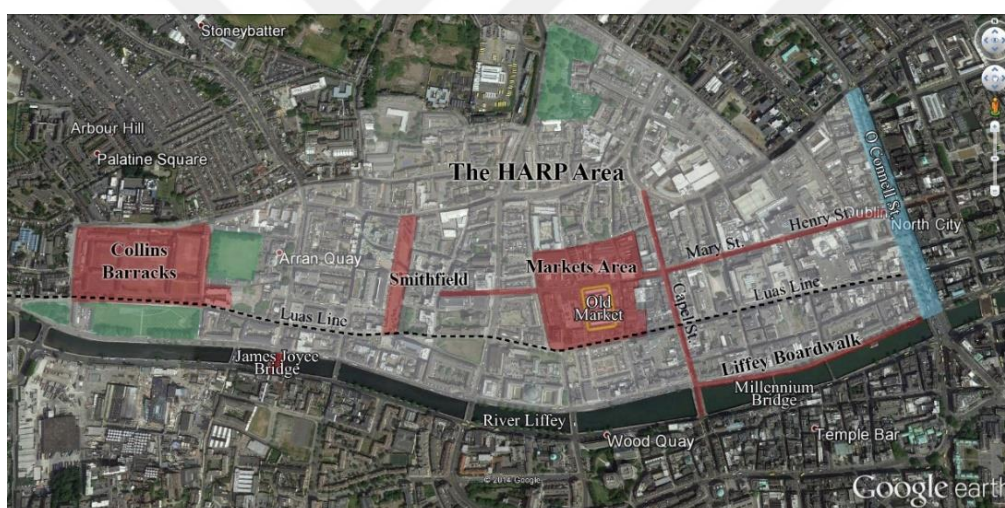
Figure 1.2. The HARP Area (adapted from Google Earth, last visited on May 2016)

The special attention is focused on **the HARP Area**, since it has been used as a major market and trading site on the ‘royal road’ of Ireland for centuries. Located on the north side of the River Liffey, it is also distinguished from the rest of the city by the presence of the Collins Barracks. The HARP Area has been abandoned and left to decay, after losing its military presence. Moreover, it has been greatly suffered from the widespread economic and industrial decline and turned into a forbidding area with an unemployed population and poor standards of social housing and public domain.<sup>6</sup>

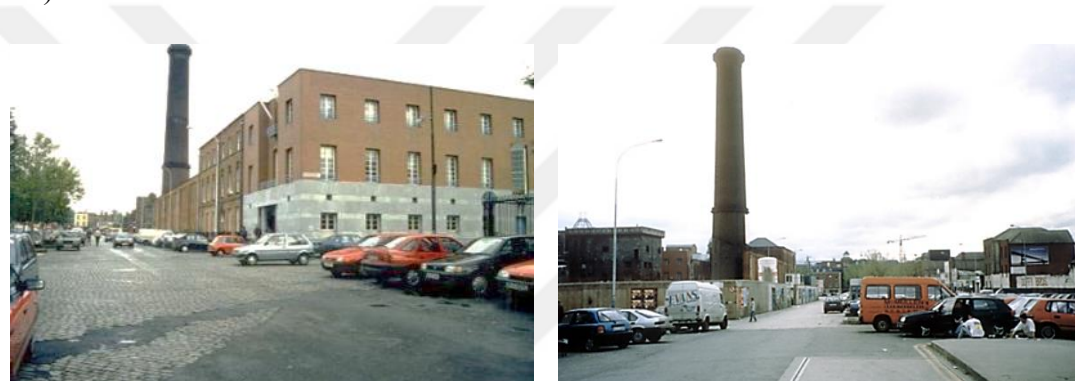
Figure 1.3. The HARP Area (adapted from Google Earth, last visited on May 2016)

**The Smithfield**, established as a cattle market in the 17<sup>th</sup> century, is the largest open space in Dublin. It has been neglected and misused as a surface car park for years (Figure 1.3). Through an architectural design competition, to convert the area into a destination for public events is proposed in 1997. By means of the winning project, the distinctive rectilinear form of the marketplace and its cobbled paving are conserved. The recycled cobbles and granite slabs which allow the pedestrian access across the site are laid diagonally to enhance the sense of width. Furthermore, 26 m high lighting columns having gas braziers and indirect lighting systems are installed to create a symbolic feature for the area (Jackson, 2007: 49, 52).<sup>7</sup>

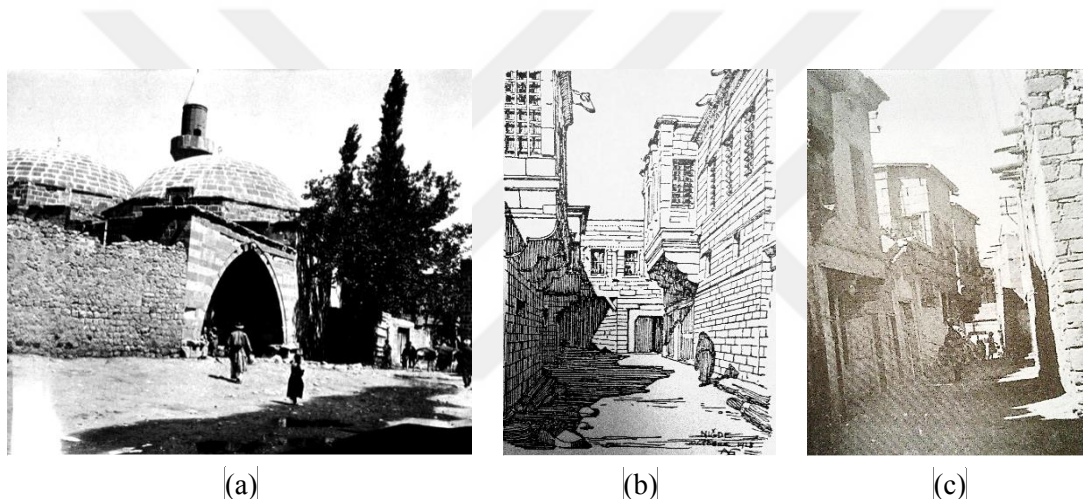
Figure 2.12. (a) Paşa Mosque (Gertrude Bell Archive. O-180, 1909.) (b) Sketch of the traditional buildings in Niğde by Albert Gabriel, 1928. (c) Cullaz Street (Selamoğlu, 2011.)

After the revolts, development of the city continued with the construction of *Çarşı* Hamam on *Külhan* Street and Murat Paşa Complex on *Paşa Kapı* Road. At present, Murat Paşa Complex is composed of a mosque, a mausoleum and a fountain in the west side of the road and a han, a hamam in the east side (Figure 2.12-a). However, it

The majority of the population inhabited in the vicinity of Alaaddin Hill. Kible Maşjid built in the 16<sup>th</sup> century, Torbalı Maşjid (1753) from which, only the minaret is still intact, and Cullaz Maşjid (1762) with its fountain point to the fact that there were neighbourhoods close to the castle area (Figure 2.12-b/c).

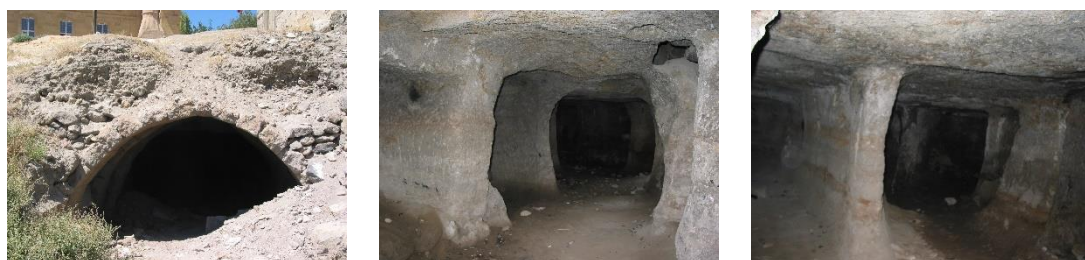
Figure 2.13. The cells and passages reached from the vaulted space which is situated close to Rahmaniye Mosque (Personal Archive)

down and the large stone doors closing the passages. Moreover, it is rumoured that some of the traditional buildings within and around the castle area have connections to the passages that are blocked at present (Figure 2.13).

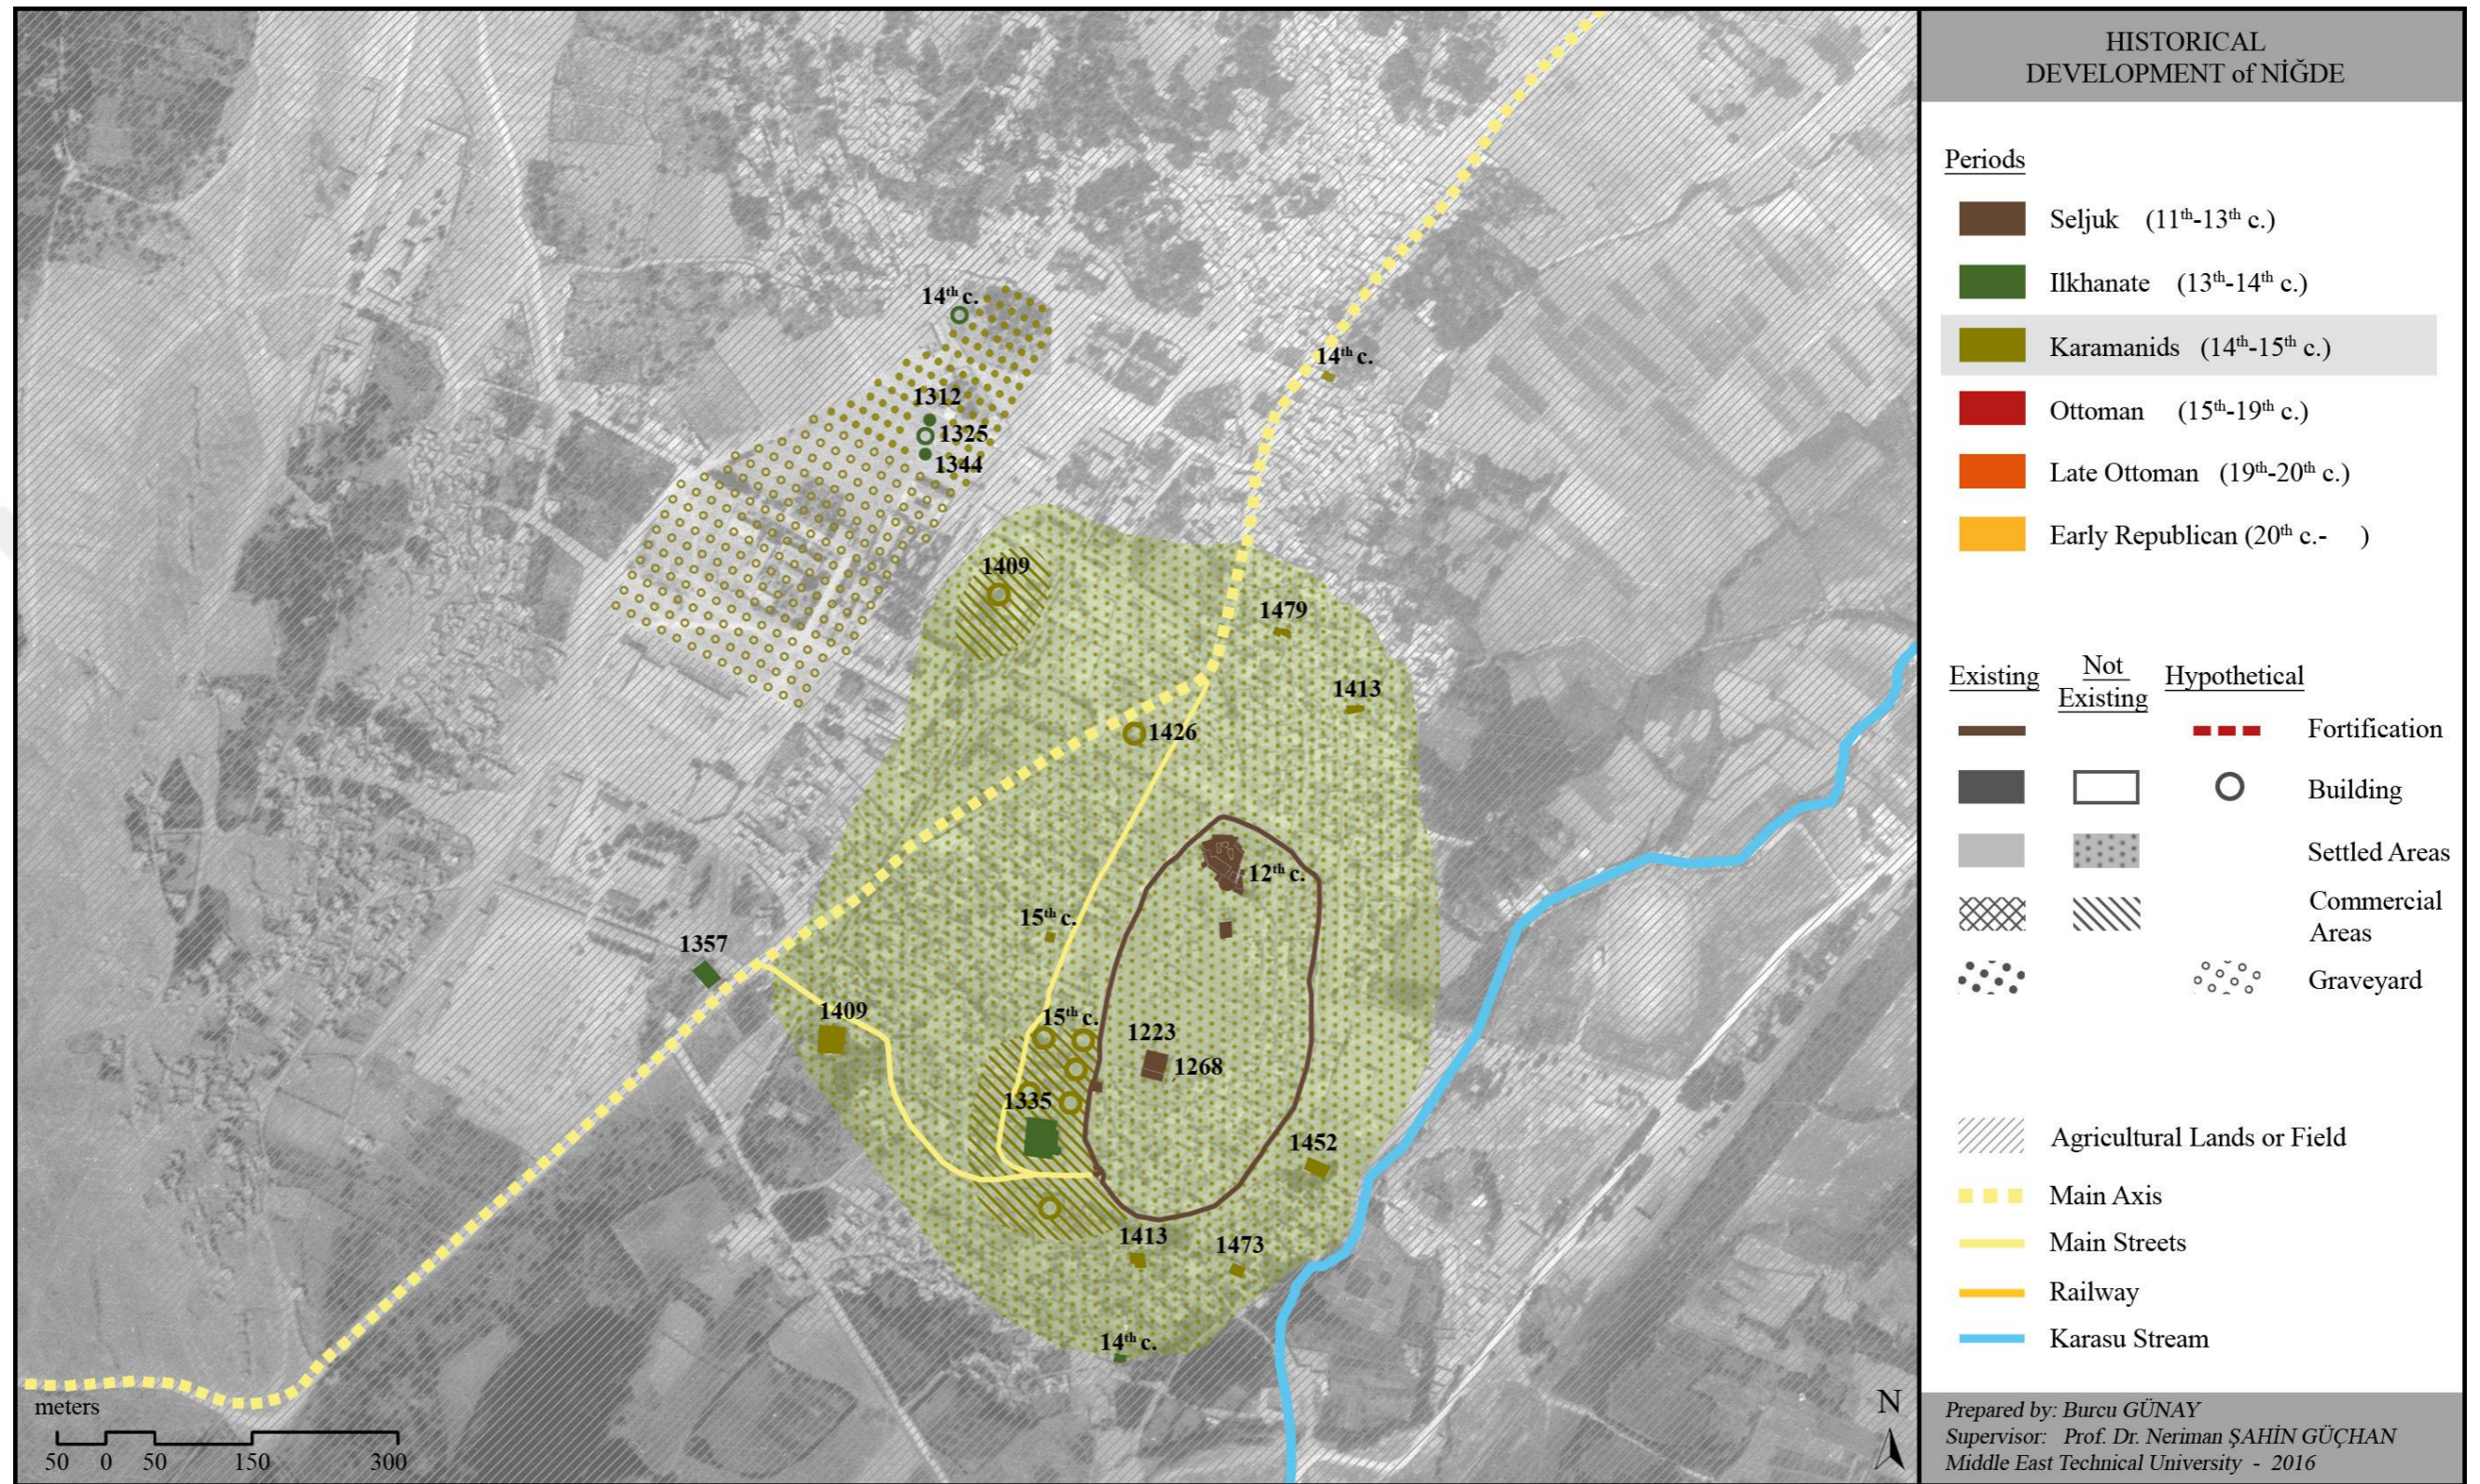
Figure 2.15. Niğde in Karamanids Period (The aerial photograph of Niğde in 1956, taken from GCM, used as base map)

expanded towards the east and the Karasu River became its natural boundary.<sup>17</sup> Şah Süleyman Mausoleum, which is located outside the city, is one of the intact buildings from this period (See the map of Karamanids Period, Figure 2.14 - Figure 2.15).

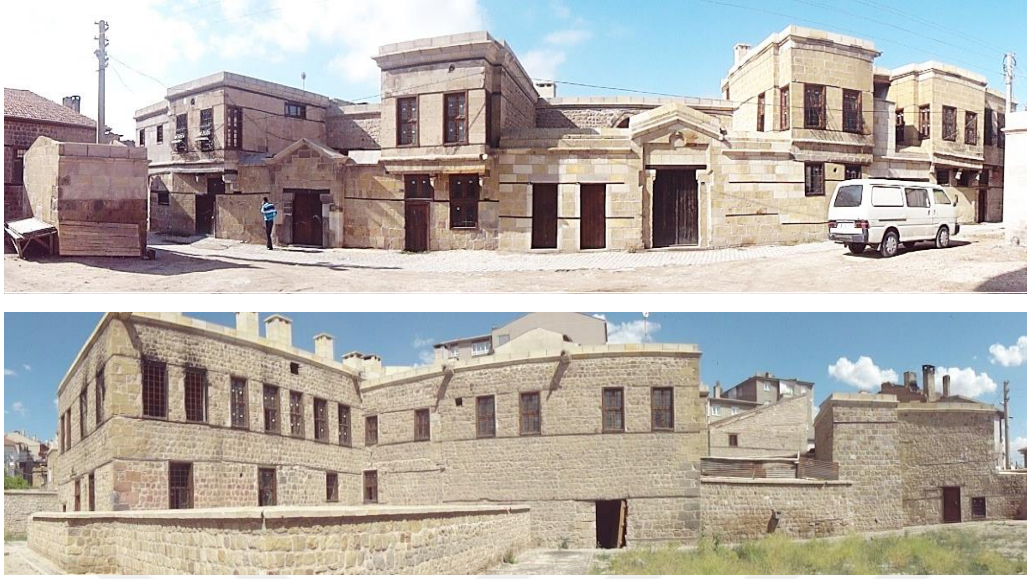
Figure 2.30. Traditional residential buildings that are repaired within the scope of the CSRP (Personal Archive)

The project is almost implemented by 2011; however, the restored buildings are left empty for a long time. Especially, the abandoned buildings, which are undertaken only to façade repair, become frequented by drug addicts and homeless people. This situation affected the residential character of the district in a negative way, it reduced the liveability of the area (Figure 2.30).

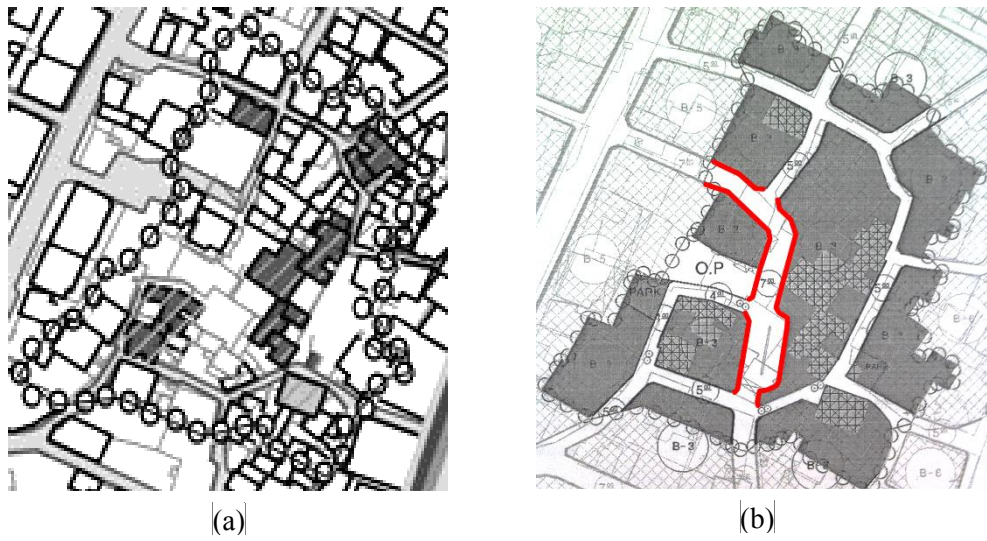
Figure 2.31. (a) Current situation (b) Partially revised development plan (Özkan, 2011.)

Although the development plan for the project area is revised and accepted by NRC in 2011, the revised plan that disregards the historical tissue and organic street pattern is not implemented (Figure 2.31). The development plan of Sıralı District that covers the surroundings of Esen Bey Mausoleum is also revised at the same time. While it does not make any recommendation about the street pattern, it gains importance for restricting the building heights to two and three stories and designing surface car parks around the registered buildings.<sup>41</sup>

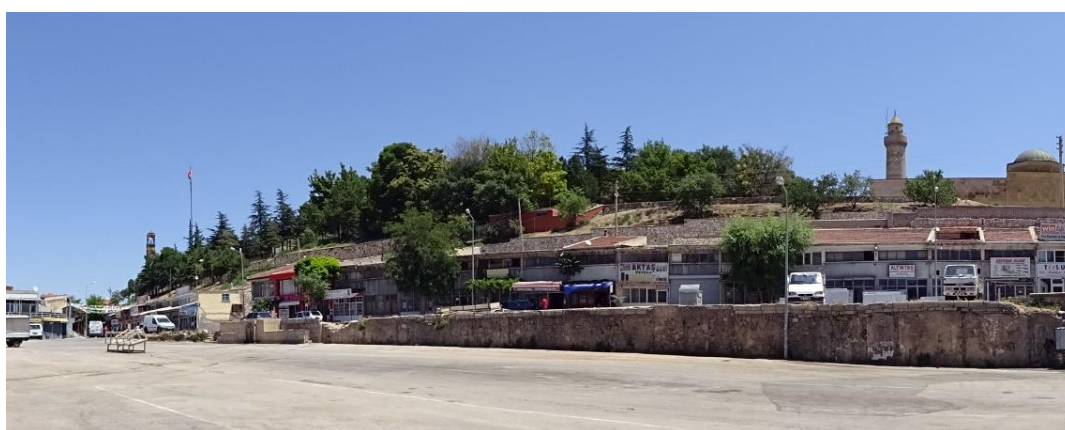
The western boundary of Alaaddin Hill is formed by a line of small shops; and towards the south, it is defined by the remaining fortification walls and the castle entrance. This side of the hill also have a steep slope that is terraced by stone retaining walls. A high-slope street, and stairs between the shops provide access to the hill (Figure 3.1).

*Figure 3.1. Panoramic view of Alaaddin Hill from market area (Personal Archive)*

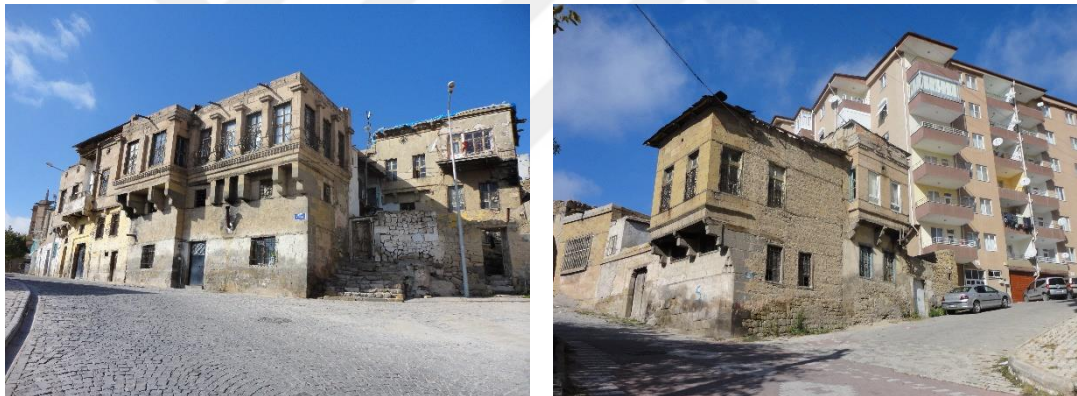
Another distinctive part of the city, Kayabaşı is located at the west of the city center. While the traditional residential tissue surrounding Aşağı Kayabaşı Mosque is accumulated in the upper parts of the hill, newer settlements are extended to the lower parts with medium slopes. The natural form of the hill is subject to threats arising from new constructions (Figure 3.2).

*Figure 3.2.* Traditional residential tissue in Kayabaşı districts (Personal Archive)

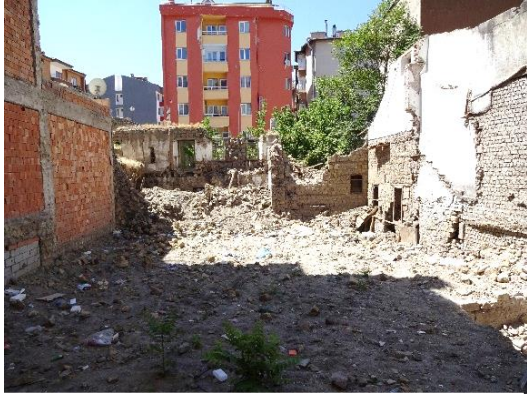
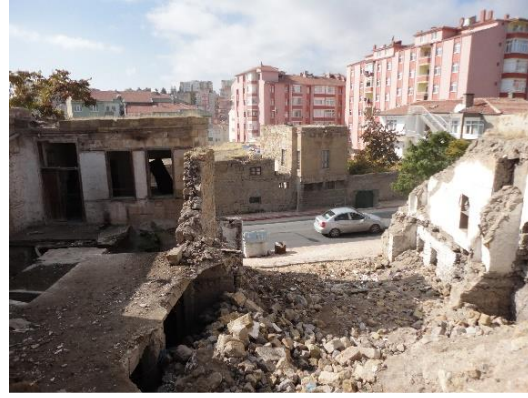
The integrity of traditional urban fabric is interrupted by empty lots. The empty lots, which are under protection within the scope of the 3<sup>rd</sup> degree archaeological site at the Alaaddin Hill, are occupied with foundations and remains of old buildings. The vacant traditional houses contribute dissolution of the fabric in this area and the number of unused private spaces increases. The traditional houses in the urban site are being demolished for security reasons and their sites are being converted to car parking areas. Traditional houses in the areas, which are not covered by any protection decision, are demolished in order to obtain empty lots. Adjacent building lots, which have remained empty for a certain period, are joined together and in these new plots high rise buildings are constructed. By this way, especially in Tepeviran region, a new settlement area, which comprises five or six storied buildings is currently in formation (Figure 3.11).

*Figure 3.11. Vacant areas and remains of traditional houses which are threatened by new constructions (a) near Şadırvan Park (b) in Yenice District (Personal Archive)*

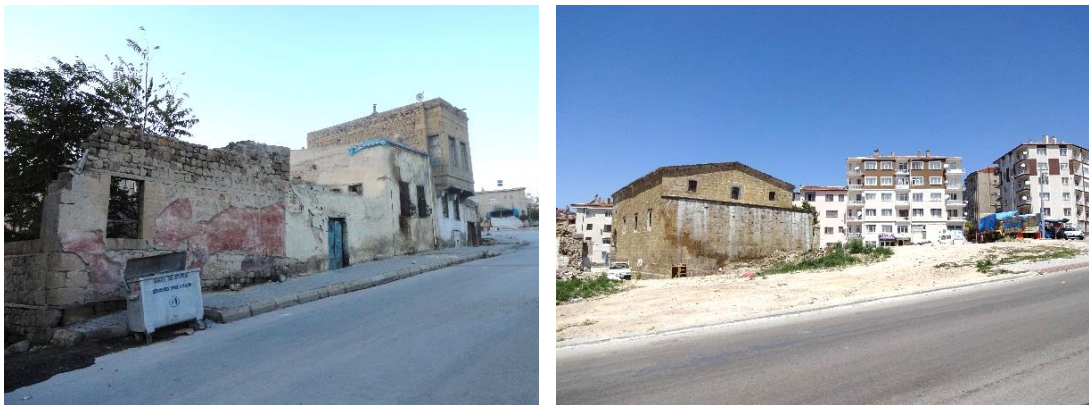
*Figure 3.14.* Demolition of the traditional fabric around H. Stephanos Church (before and after photographs taken at the same location in 2010s, Personal Archive)

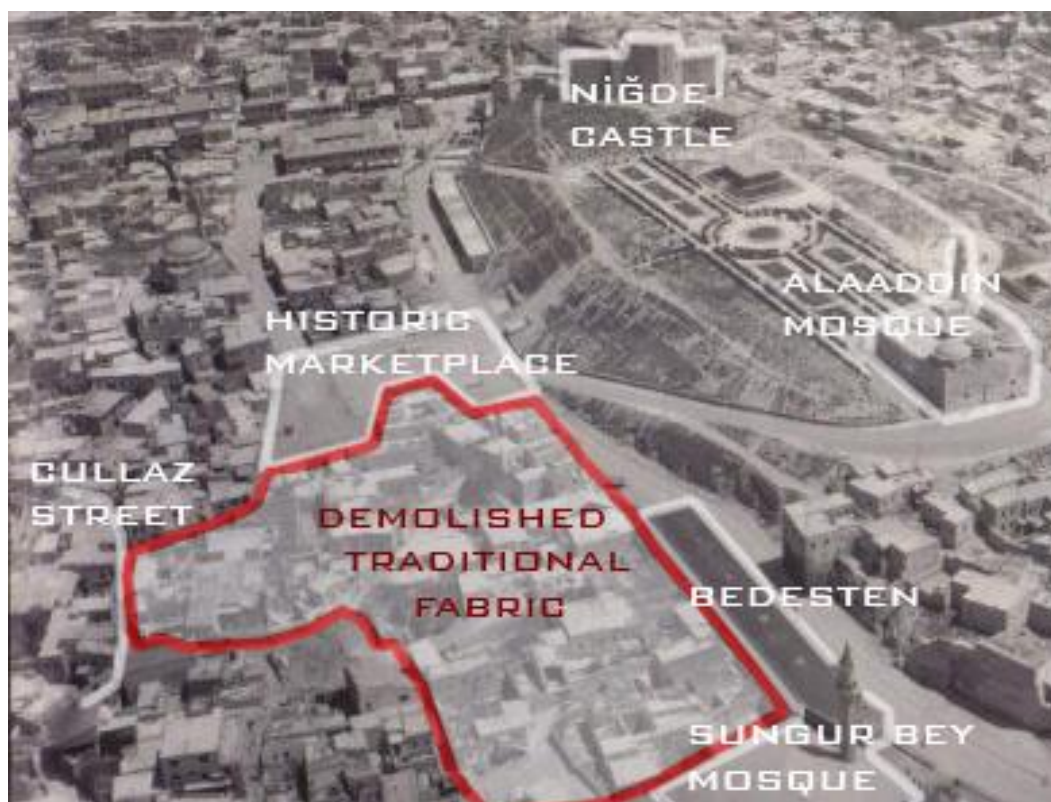
*Figure 3.15.* Demolition of the traditional fabric near the Bedesten and Sungur Bey Mosque in 1960s (adapted from Emin Selamoğlu Archive)

As it is defined in Chapter 2.3. before, the continuous course of inhabitation in Niğde was suddenly interrupted by demolition of the traditional fabric near the Bedesten and Sungur Bey Mosque in 1960s (Figure 3.15). Development of the administrative and commercial centre of the city around the main artery caused land speculation in this region and this in turn lead to losses in the historic fabric. The course of modern development of the city has started after 1970s and this course was accelerated with the Development Plan of 1977, which gave permission to demolition of traditional buildings in areas nearby the new city centre and construction of high-rise buildings in their places. As instructed in the Nairobi Recommendation<sup>46</sup>, modern urbanization,

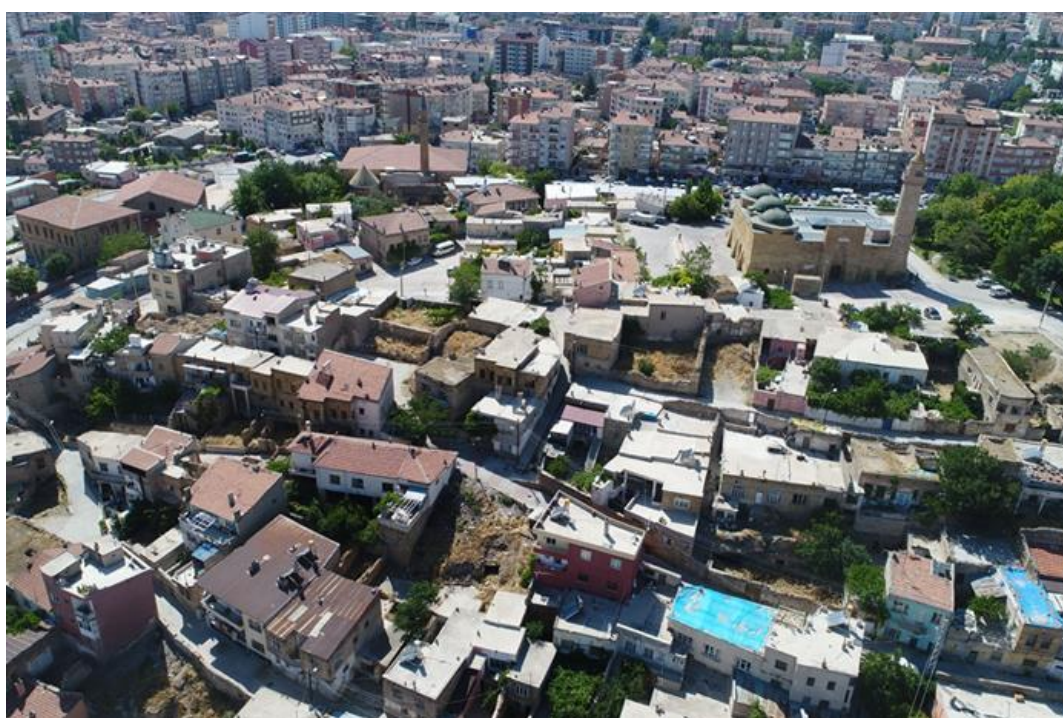
The 3<sup>rd</sup> Degree Archaeological Site in Alaaddin Hill, which is the first inhabited area in the city, contributes to the cultural significance of the hill with the organic urban fabric that is composed of partially protected building lots, human scale streets, stairways and public squares (Figure 3.19). The facades of traditional buildings with the stonewalls of courtyards and gardens, and the balance of open and built-up areas, which is created with the tradition of courtyard and garden construction, are the significant components for the authenticity of the area and these are threatened by empty lots and new buildings. In addition to inadequate public infrastructure in the

Figure 3.19. Traditional residential fabric in Alaaddin Hill (<http://nigde.bel.tr>)

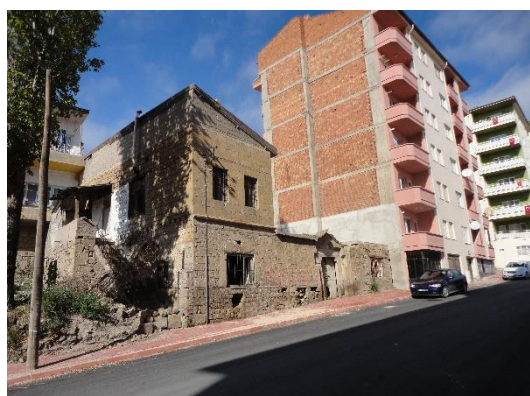
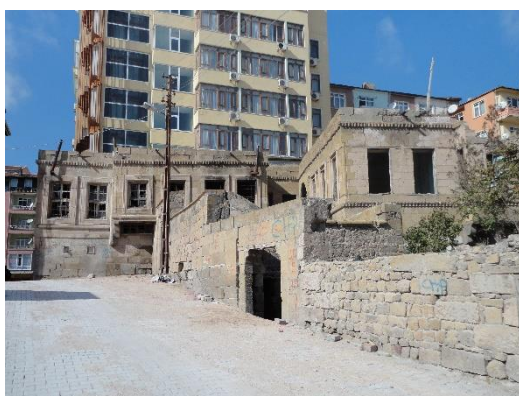
*Figure 3.21.* New developments that create physical, social and economic pressure on the traditional fabric (a) Kayabaşı District (b) Sıralı District (Personal Archive)

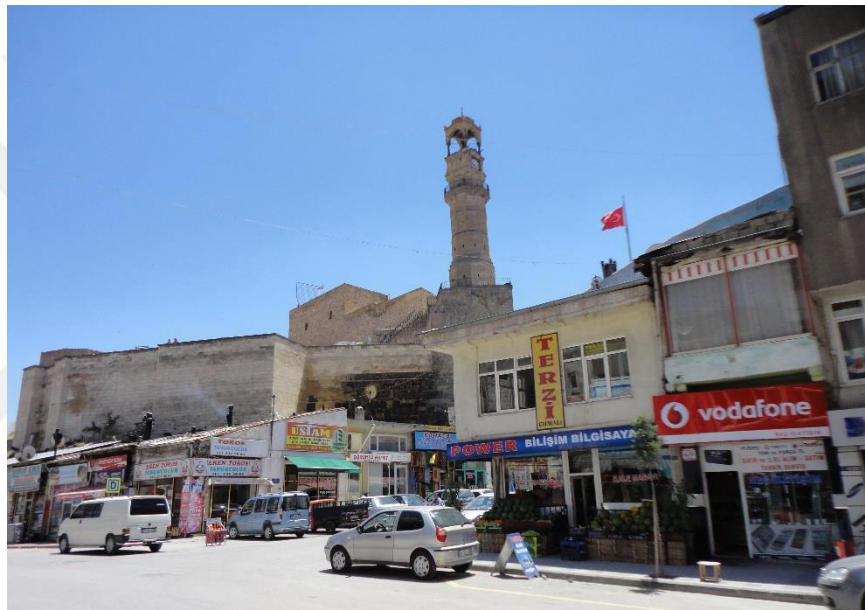
*Figure 3.24. Niğde Castle and fortifications (Personal Archive)*

Because of its conservation status as an archaeological site, its topographical and morphological structure, and its accessibility and relationships with the city centre, **Alaaddin Hill**, which is defined with the Niğde Castle and fortifications, differs considerably from its surrounding environment. The preserved traditional fabric composed of narrow streets and stairways is the integral part of the hill. Being continuously inhabited since early ages, this area has a unique historical value. Alaaddin Mosque located on the top of the hill increases the historical and cultural significance of the area. Alaaddin Hill is also characterised by a green open space that

provides recreational and social values. Steep topography of the hill enables panoramic views and vistas, while it forms a natural boundary for the character area and creates difficulties with regard to the integration of the area with other parts of the city (Figure 3.24).

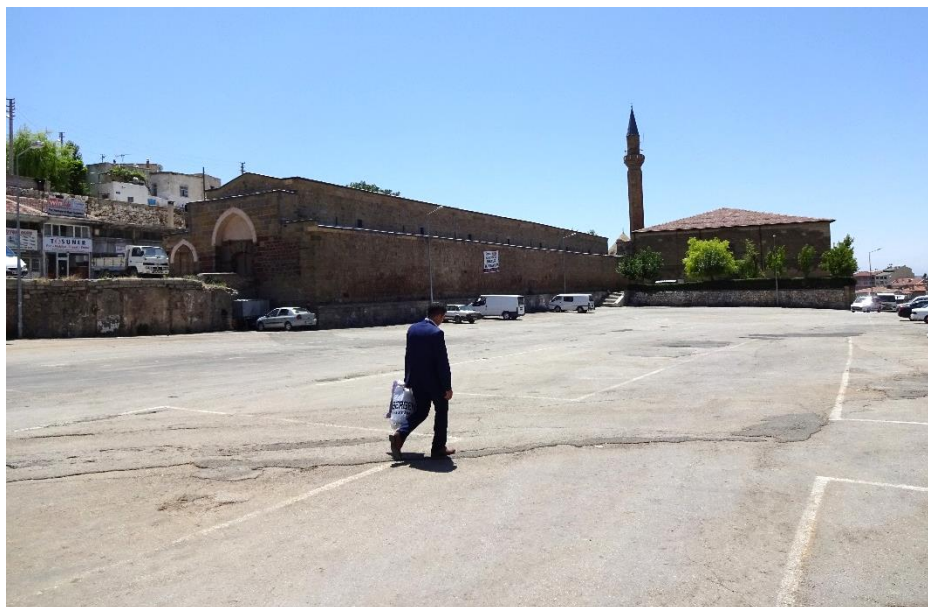
*Figure 3.25. Sungur Bey Mosque, Bedesten and the marketplace (Personal Archive)*

**Sungur Bey Mosque Market Area** is identified as another character area that covers the traditional fabric in the urban site outside the Alaaddin Hill, Cullaz Street area and Ak Madrasa Conservation Area. It includes many monumental buildings with high architectural value and comprises the historic marketplace, which turn into an undefined open space. The relation between the marketplace, Bedesten and Sungur Bey Mosque contributes to historical and cultural identity of the city. Furthermore, the coexistence of Sungur Bey Mosque, H. Prodromos Church of Karamanlides and H. Stephanos Church of the Armenians represents the multi-religious identity of the place and gives a unique spiritual value to the character area. With its residential, commercial, cultural, and social functions and different types of building groups, this character area exhibits a great variety in terms of the values, potentials and problems it possesses (Figure 3.25).

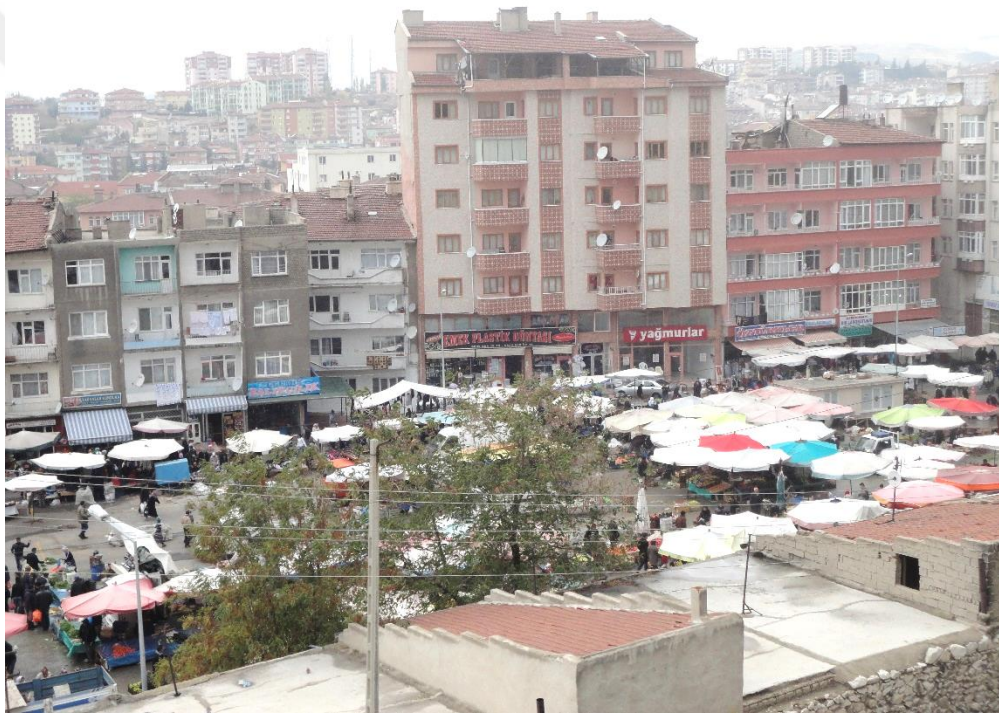
*Figure 3.34. New buildings surrounding the historic marketplace (Personal Archive)*

New buildings built before 2000s with fewer than 4 storeys are generally in harmony with the traditional texture compared to those built after this date. It can be seen from the plan prepared within the scope of 1994 NUDP that until that period, the historical tissue in the area has been better preserved and the spatial layout of the area has been taken into consideration when the new structures were built. (Figure 3.33).

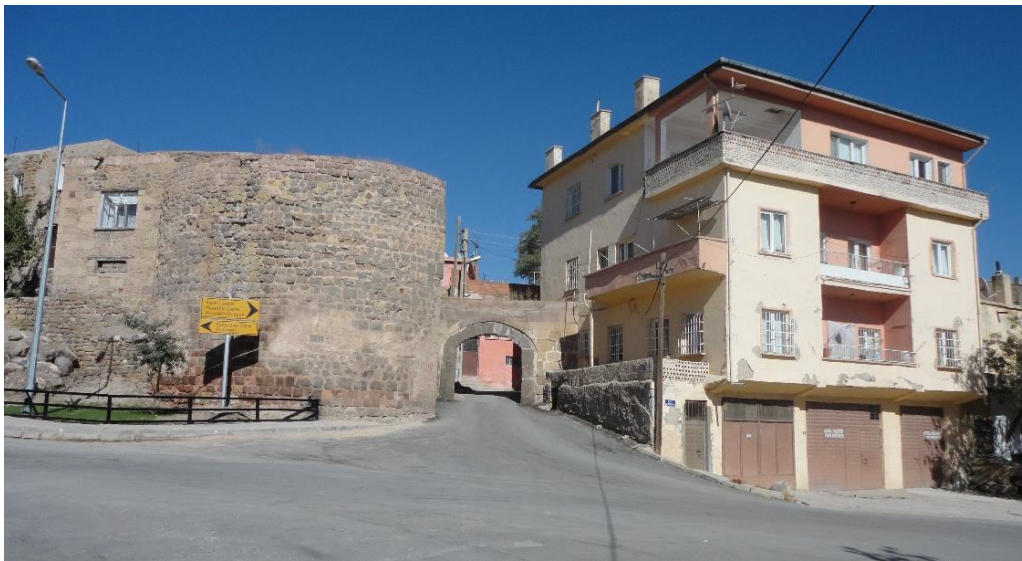
*Figure 3.35. The historic castle entrance (Personal Archive)*

The linearity, created by these small-scale new buildings continues with fortification walls and fort bastion. The fact that a bastion defining the historic castle entrance was demolished and replaced with a new structure damages the historical and aesthetic value of the area (Figure 3.35).

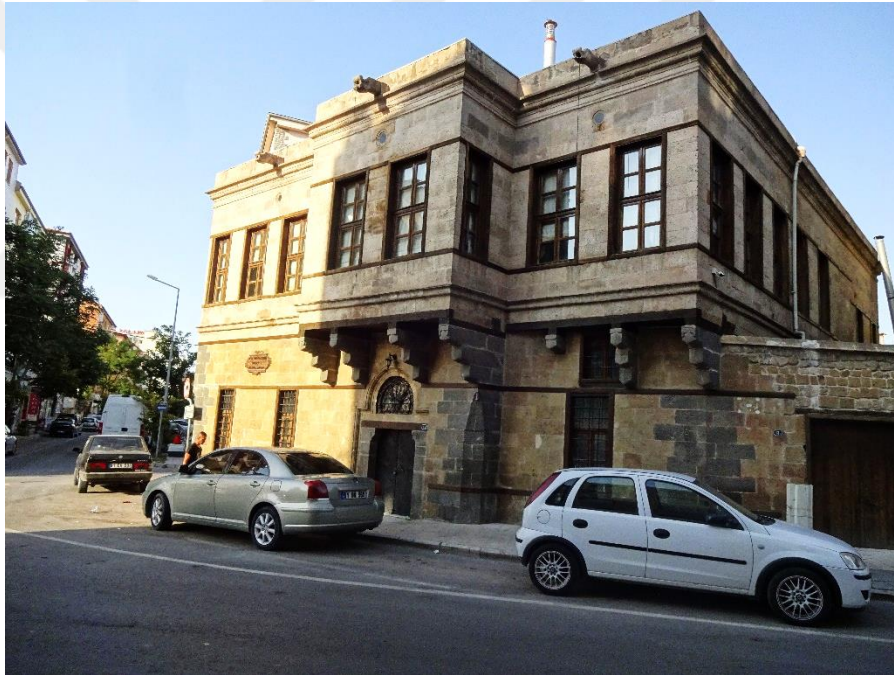
*Figure 3.41.* The traditional house of Resul Özkul (Personal Archive)

The ground floors of the street facades of two storey traditional houses are generally formed with rubble stone, while the second floors are built with cut stone. It is noted that the traditional house of Resul Özkul, some quality houses nearby the churches are only built with cut stone masonry. The tint of cut stones provides colour variety while emphasising the facades (Figure 3.41).

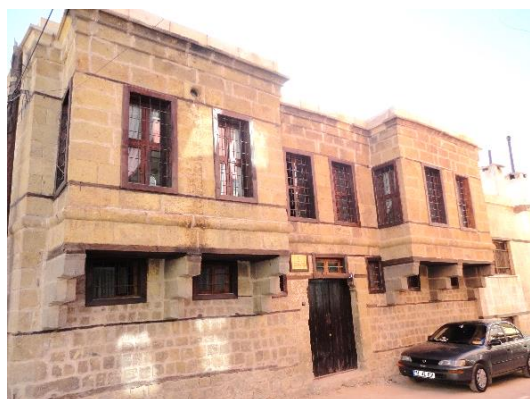
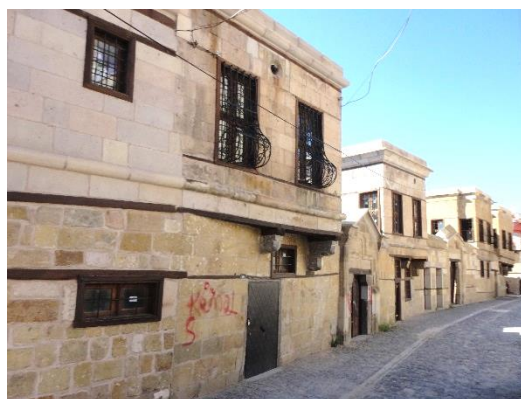
*Figure 3.42.* Projections (a) the traditional house used by Chamber of Architects (b) Inclined projections in Cullaz Street (Personal Archive)

The massive structure of Niğde's traditional houses is enriched visually with the projections supported by stone cantilevers. The surfaces of facade facing towards the streets are enlarged because of sofa or the rooms in its both sides projecting out the facade. The projection facades are square-like and include two windows. There are also windows on the lateral sides of projections. In the Niğde houses, there are examples of inclined projections, which obtain rectangular spaces in the upper floors by adjusting the angle of the lower wall that follows the street level, horizontally. There are two windows in these projections (Figure 3.42).

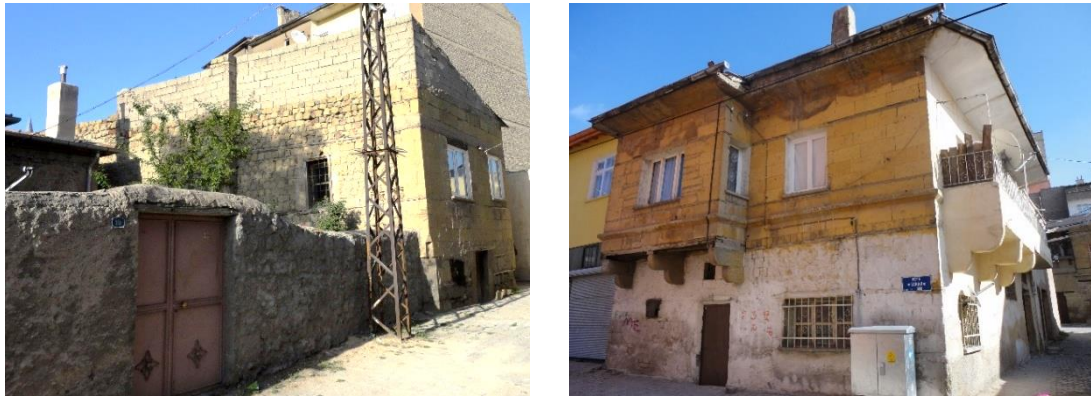
Figure 3.43. Changes in traditional houses (Personal Archive)

The houses are covered with flat earthen roofs. The roof is surrounded with a parapet and projecting stone cornices on the facades. Below the cornices, gargoyles are used for draining rain water. Use of pitched roof and roof tiles are seen only in the big scale traditional buildings. However, it can be seen today that pitched roofs covered with tiles are added to flat roofed houses (Figure 3.43).

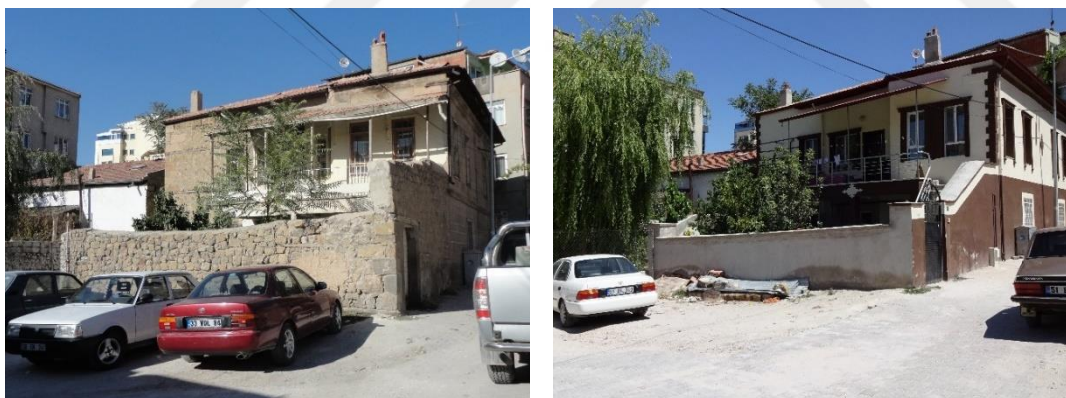
*Figure 3.44.* Before and after photographs of an unregistered traditional house nearby Cullaz Street (Personal Archive)

Facades of traditional houses are originally not plastered. However some of the traditional houses in the study area are cement plastered at present and for this reason, although their stone masonry structural systems are identifiable, the differences in the material uses are not observable. In addition to that, because of the financial and socio-cultural statuses of the householders, and requirements of modern life, today, the houses are divided vertically and horizontally. It is observed that in some traditional houses concrete frame upper floors are constructed on masonry ground floors. Some buildings are added with service spaces and the windows of buildings, usually the ones in the ground floors, are extended. Wooden doors and windows are replaced with iron or plastic based materials (Figure 3.44).

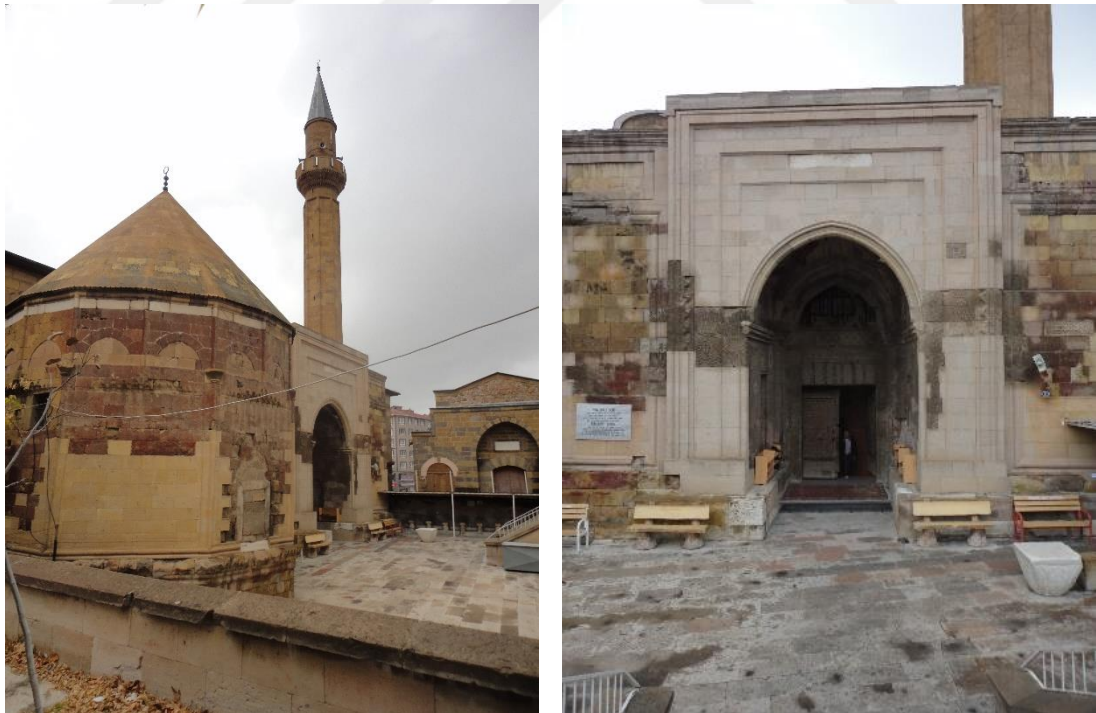
*Figure 3.45. The main entrance of Sungur Bey Mosque (Personal Archive)*

Sungur Bey Mosque, with its elaborated stone craftsmanship and decorations, is a unique monument of its period. The building is constructed with yellow trachyte cut stone. However, in the eastern door opening and in the jambs and lintels of some windows, marble is used. There are portals in the eastern and northern facades of the building. Of these portals, the one projecting from the eastern facade in the form of a pointed arched iwan, which originally had minarets in both sides, is the main entrance (Figure 3.45). There is a tomb attached to the building in the south of this portal. The original minarets of the building have not survived, but one of the minarets was reconstructed in the 19<sup>th</sup> century (Özkarıcı, 2001: 52-53).

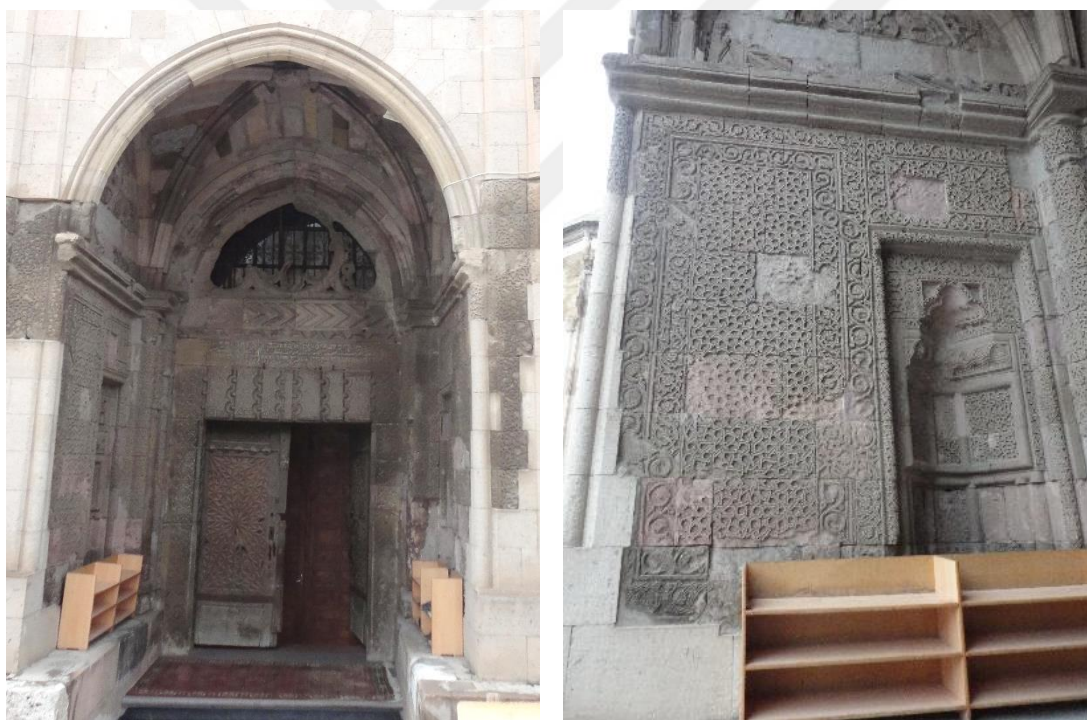
*Figure 3.46. The eastern portal of Sungur Bey Mosque (Personal Archive)*

Originally, the facade of the portal was covered with geometric decorations. However, during the past repairs, great part of the facade has been renovated with cut stone without decorations (Figure 3.46). The iwan is covered with a ribbed cross vault, which is an element of the Gothic architecture. In addition to the well preserved floral and geometric decorations, the stylized figures of animals such as dragon, lion, elephant, horse, monkey, fish and birds on the lateral surfaces of the portal are attention grabbing. The lintel of the door opening, which is made with fitting technique with seven marble pieces, and marble jambs are enlivened with palmette and rumi patterns. Moreover, there is a heavily damaged pointed arched tympanum, which reminds the rose windows of the Gothic architecture.<sup>53</sup>

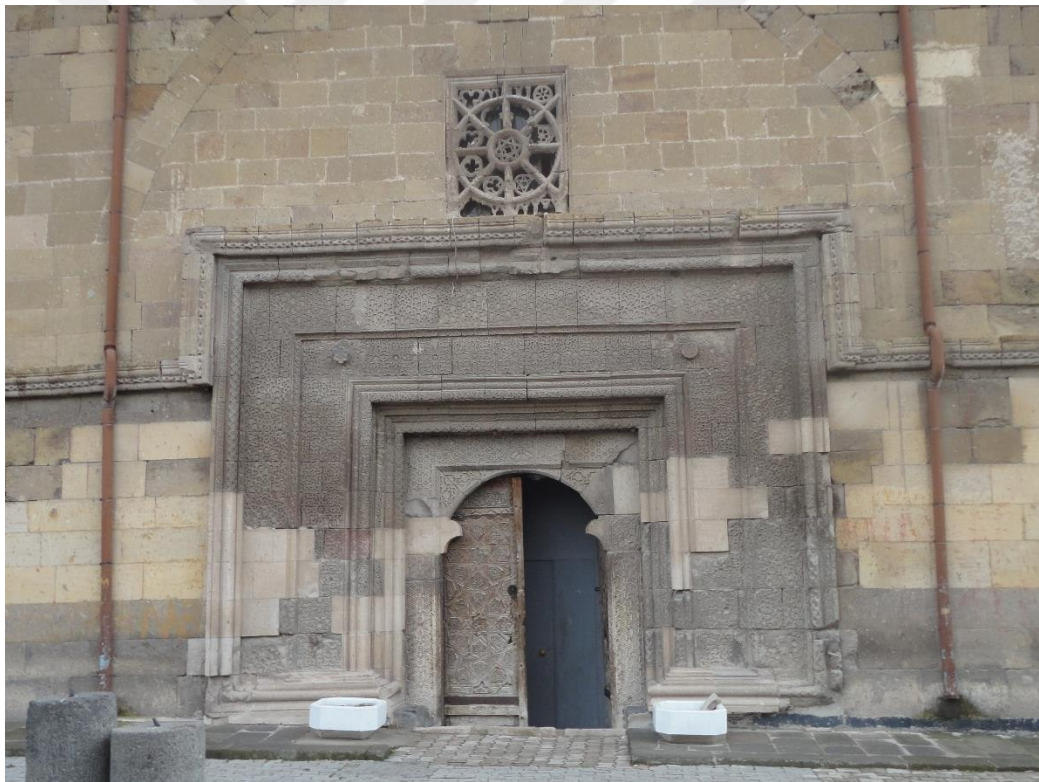
*Figure 3.47. The northern portal of Sungur Bey Mosque (Personal Archive)*

Except for the western facade, the facades of the building are divided with a cornice, which is composed of profiled mouldings that are decorated with various ornamentations. The cornice on the facade frames the upper part of the northern portal. The stone craftsmanship of the portal is as flamboyant as the one in the eastern facade. The stone mouldings and frames of the portal as well as the marble door jambs, which form the depressed arch of the door opening, are decorated with geometric and vegetal ornamentations. In addition to that, there is a double-headed eagle figure on the keystone of the depressed arch. There is a rectangular window with stone tracery resembling rose windows, which is decorated with geometric motifs made with fretwork technique (Figure 3. 47).

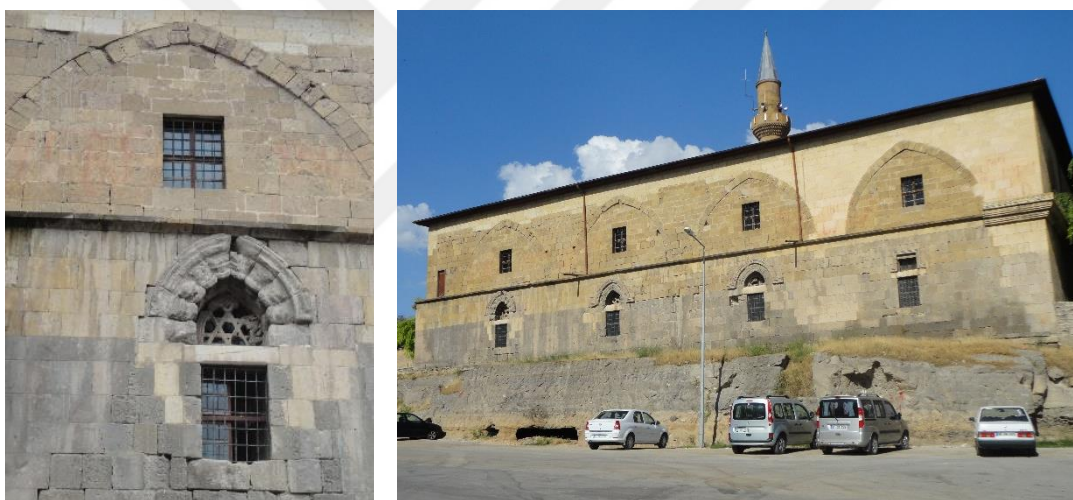
Figure 3.48. The western facade of Sungur Bey Mosque (Personal Archive)

The attention paid to the facade composition of the building is not only restricted to the portals. There are four windows on the lower part of the western facade, each of which has a recessed arch fashioned in a different manner. On the tympanums of these windows, which display foreign influences on Sungur Bey Mosque, there are different geometric motifs made with fretwork technique.<sup>54</sup> In addition to that, the upper parts of the walls above the cornice surrounding the facades are enlivened with blind arches; plain rectangular windows are installed in the centres of these blind arches in the western and southern facades (Figure 3.48). The wooden doors of the building, which are decorated with different techniques such as *kundekari* and plain and bevel carving, are other elements enriching the facades (Özkarıcı, 2001: 63-65).
