REINTEGRATION OF A FRAGMENTED HISTORIC URBAN CORE:  
SUNGUR BEY MOSQUE MARKET AREA, NIĞDE

A THESIS SUBMITTED TO  
THE GRADUATE SCHOOL OF NATURAL AND APPLIED SCIENCES  
OF  
MIDDLE EAST TECHNICAL UNIVERSITY

IN PARTIAL FULFILLMENT OF THE REQUIREMENTS  
FOR  
THE DEGREE OF MASTER OF ARCHITECTURE  
IN  
CONSERVATION OF CULTURAL HERITAGE IN ARCHITECTURE

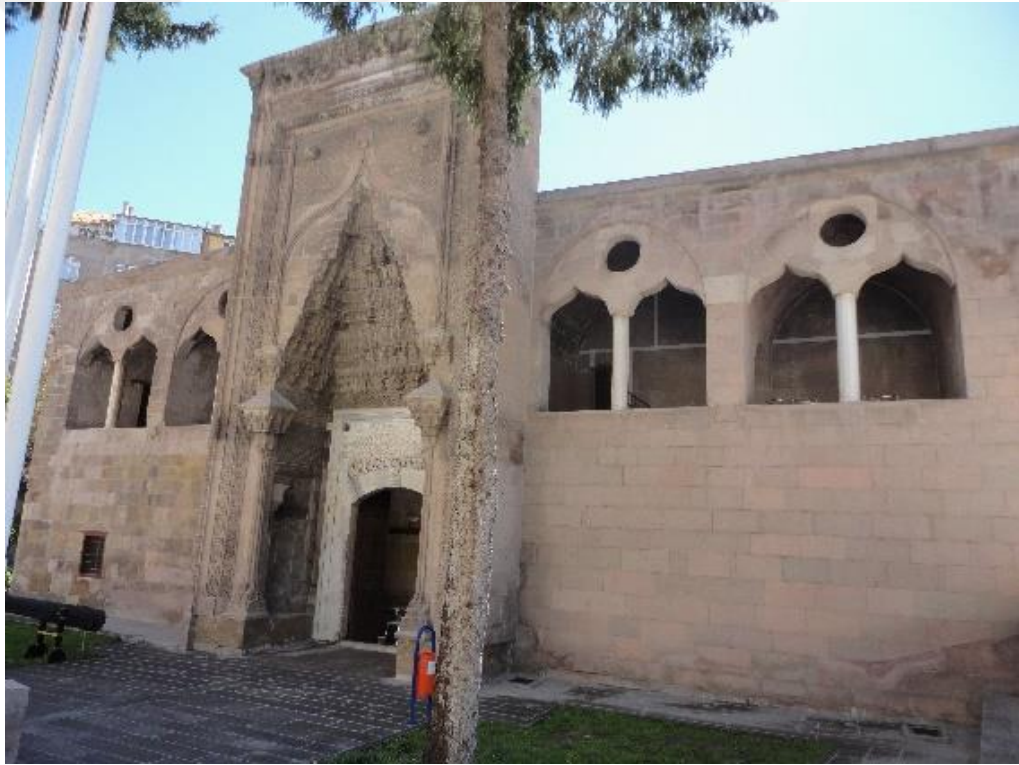
*Figure 3.49.* The northern facade of Ak Madrasa (Personal Archive)

Another building, which draws attention with its elaborate stone craftsmanship, is Ak Madrasa, which is built with cut trachite stone. The madrasa is two storied and have an open courtyard. Its entrance is on its northern facade. There is a projecting portal with muqarnas intrados on this facade. This portal raises one floor above the roof level of the madrasa. The portal, although it is long and narrow, is made outstanding by using white marble in its depressed arched entrance door and the inscription plate above it (Figure 3. 49).

The portal is bordered with segmented pilasters that are topped with capitals, outer parts of which are slightly cylindrical and inner parts are decorated with muqarnas. The four rows of the muqarnas of the intrados form a projection on the facade and this

projection supports the ogee blind arch above. Besides, this projection causes the inner pilasters to seem having double capitals. These elements of the portal are interpreted as the reflections of the Gothic architecture.<sup>55</sup>

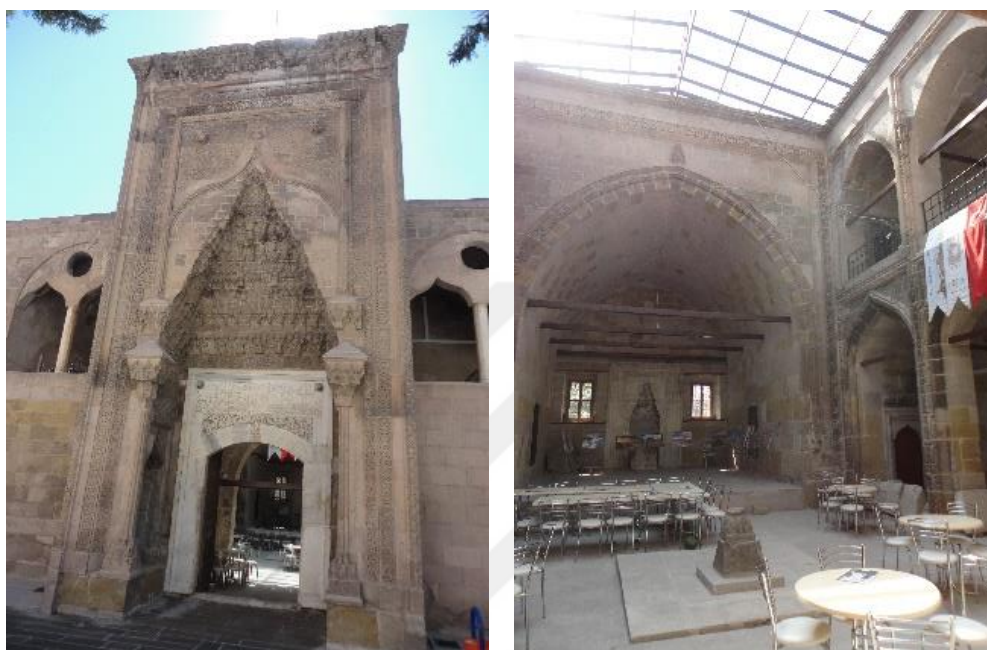
*Figure 3.50. The portal and courtyard of Ak Madrasa (Personal Archive)*

The massive appearance of the other facades of the Madrasa is tried to be eliminated with small window openings. Facade walls are finished with cut stone cornice. Ak Madrasa is covered with a flat roof and rainwater was plumbed from the roof via stone gargoyles. At present day, a transparent covering on the open courtyard of the building is added to its flat roof (Figure 3. 50).

Ak Madrasa is another monumental building annexed to the Municipality of Niğde. It is currently used as a cultural centre. Every room of the madrasa were appointed to different non-governmental organization. Together with the iwans, the courtyard of the madrasa, which is currently covered, serves as a multifunctional hall. Being as a teahouse, it usually provides a gathering place for local community while housing exhibitions and conventions in certain times.

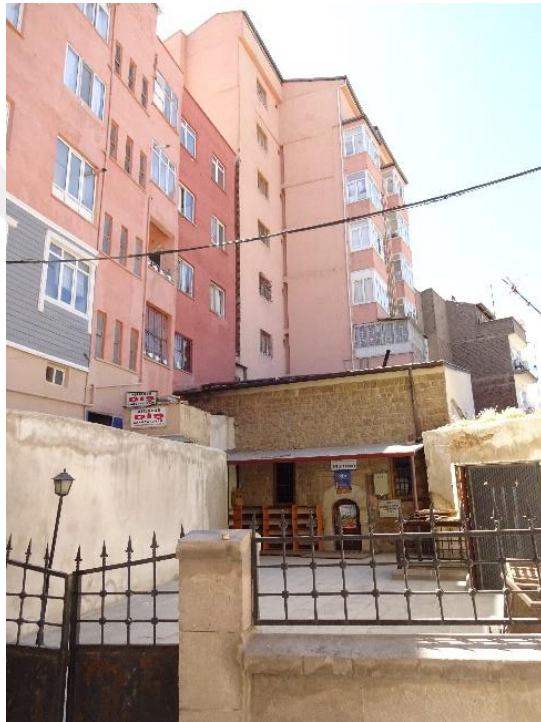
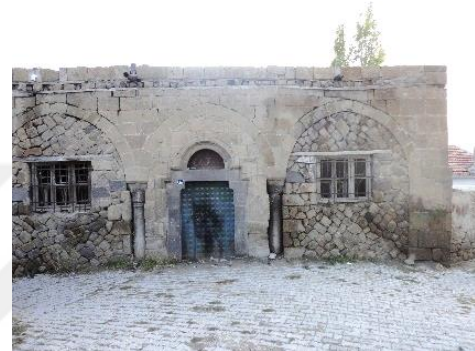
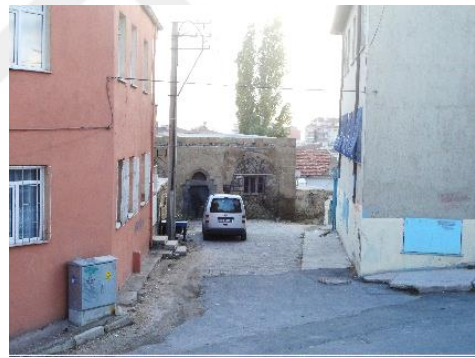
Figure 3.51. (a) Darülzikir Masjid (b) Eskiciler Masjid (Personal Archive)

External facades of the masjids are plain. They were enlivened only by simple rectangular windows. Different from the others, there is a narthex in the northern part of Eskiçiler Masjid. The narthex has pointed arches built with cut stone. In a later period, the gaps of arches were filled with stone. Today, the building is entered through the door installed in the middle arch. The northern facade of the building draws attention with spolia marble columns topped with Corinthian capitals, which support the arches. These masjids, which do not have minarets, are surrounded with multi-storey buildings, which interrupt their visibility (Figure 3. 51).

with its flat earthen roof and timber columns, which are topped with capitals decorated with wood carved muqarnases, supporting this roof. In addition to that, hand carved ornamentations on the wooden columns and ceiling are partially protected.<sup>56</sup>

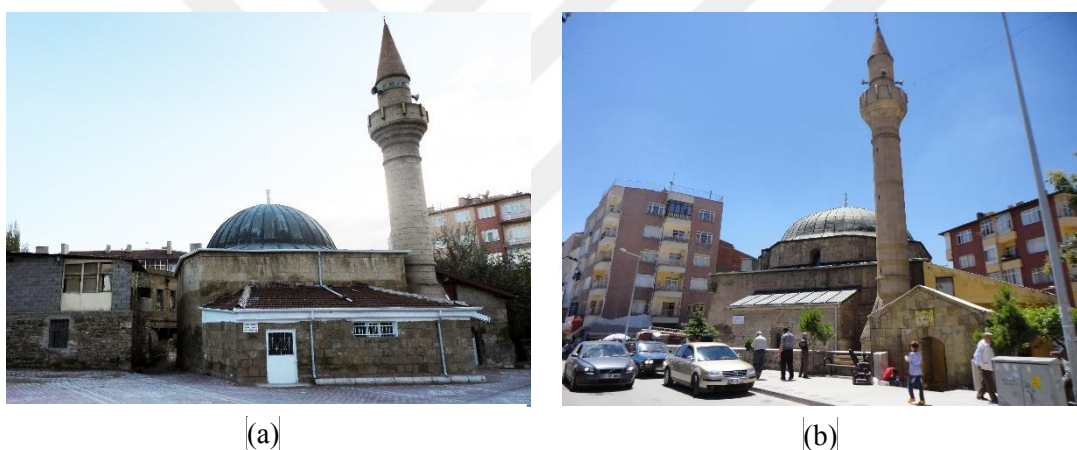
Figure 3.52. (a) Kible Masjid (b) Kığılı (Pazar) Mosque (Personal Archive)

Kible Masjid and Kığılı Mosque are square planned and single domed. They are built with yellowish trachite cut stone. The domes of the buildings are covered with lead. Both buildings have one minaret with single balcony. The minaret of Kible Masjid has been built in a later period. Moreover, a section with tiled pitched roof has been added to the northern part of Kible Masjid as narthex in a later period. Marble was used in

the main gates of the buildings and in some of the window jambs and lintels of Kığılı Mosque. The window jambs and lintels of Kığılı Mosque were decorated with *sulus* inscription panels and geometric motifs. The facades were enlivened with pointed arched pediments above the windows. In addition to that, Kığılı Mosque draws attention with the birdhouse in the eastern façade<sup>57</sup> (Figure 3.52).

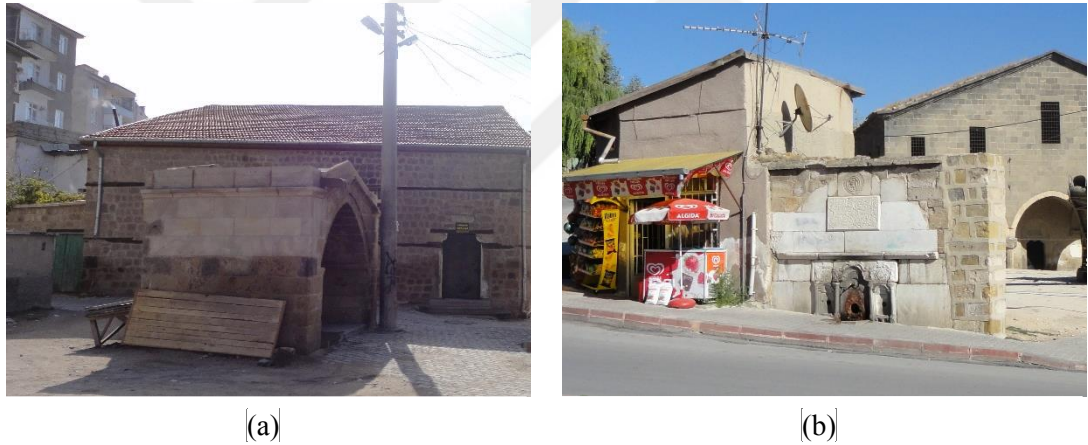
There is a fountain installed in a pointed arch niche at the southern facade of Kible Masjid. While this fountain is out of use, Cullaz Fountain and Nalbantlar Fountain, which were built independently in the study area, are still in use. The water depots and reserves behind the fountains have not survived to present day. Cullaz Fountain, which has a pointed arched niche, was built with yellow trachite cut stone. The main niche of Nalbantlar Fountain has been demolished. It is built with marble. Its front facade, where the taps are installed, displays influences of Baroque architecture (Figure 3.53).

Figure 3.53. (a) Cullaz Masjid and Fountain (b) Nalbantlar Fountain (Personal Archive)

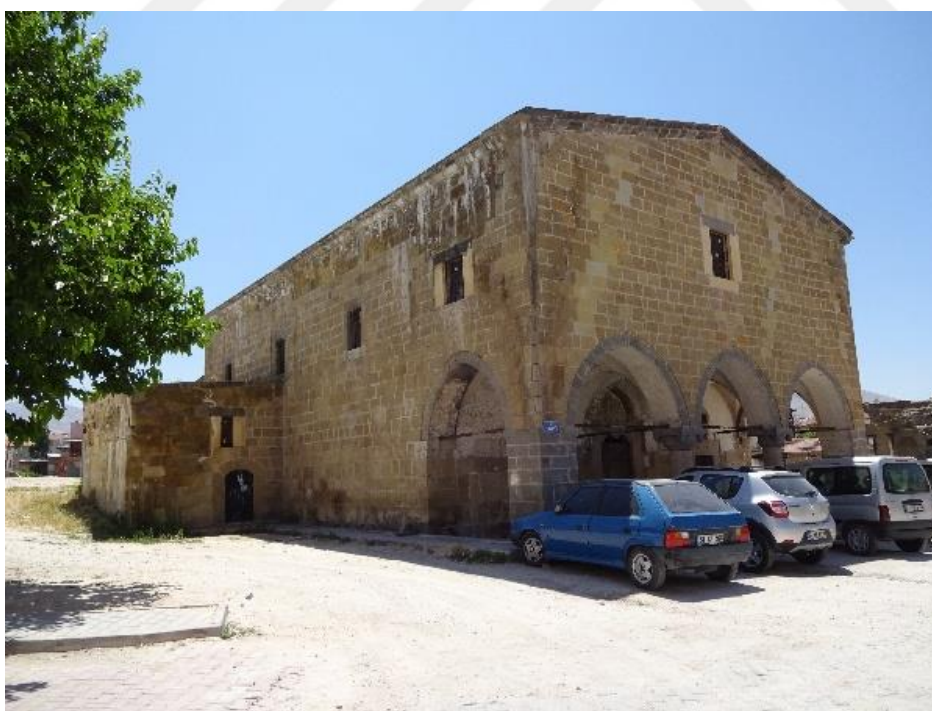
H. Stephanos Church, which is built with yellow cut stones, is smaller and has a plain facade organization. There is the narthex, which is divided into three sections with pointed arches and columns, at the western facade of the building. Use of grey stone in arches at the western facade of the building, in the masonry piers at the two corners of the narthex and lintels of doors and windows enlivens the facades of the church (Figure 3. 54).

*Figure 3.54. H. Stephanos Church (Personal Archive)*

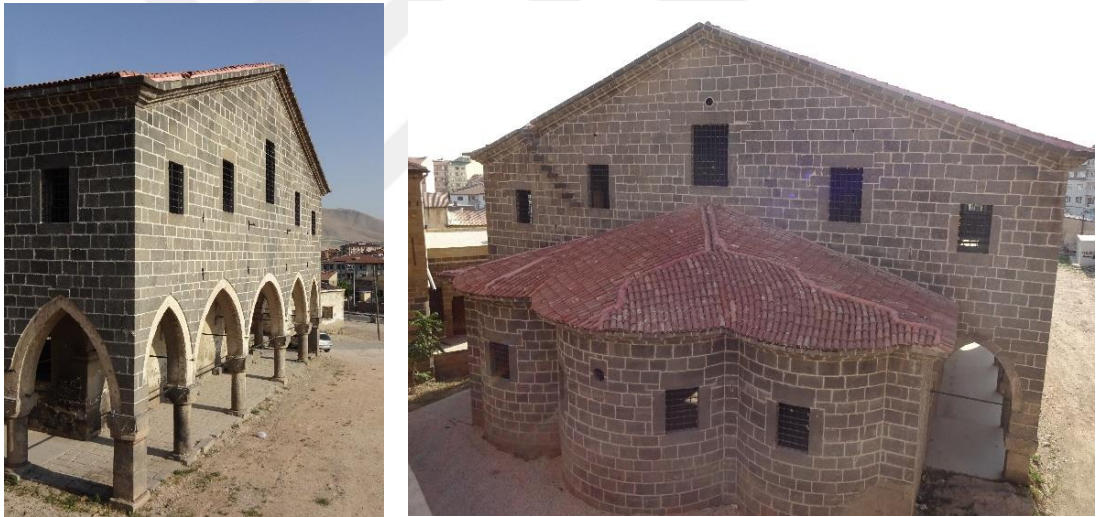
The masonry of the walls of H. Prodomos Church is composed of grey cut stones laid together with lime mortar joint. The fitting system that keeps the masonry together is used as a decoration element on the facades. The dragon figures on the fittings are remarking. Besides, the doors, window railings, tension bars, candelabra rings, and chains are iron elements of the building. The narthex in the western part of the building stretches to the apses in the northern and southern parts. There is the gallery framing the naos in three sides above the narthex, which is covered with cross vault. The capitals of the columns supporting the gallery are ornamented with volutes and fluted pendants. In order to enliven the western facade, the windows, which provide light to the gallery, were set in levels. There are a lot of windows in the other facades of the building (Figure 3. 55).

*Figure 3.55. H. Prodomos Church (Personal Archive)*

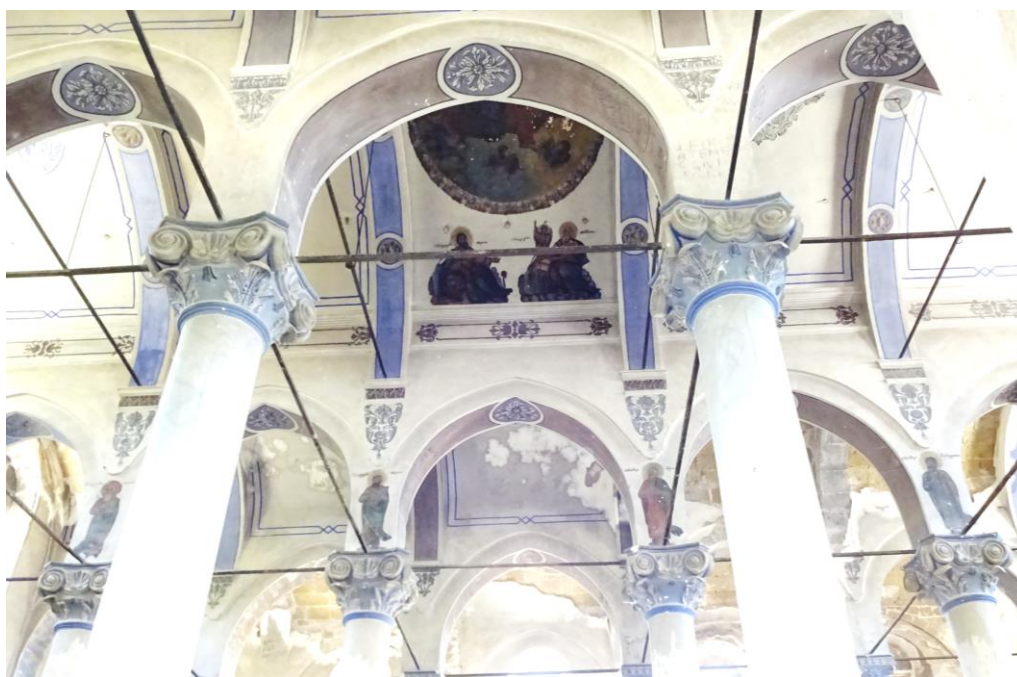
There are frescoes in the H. Prodomos Church. The Ascension of Christ and four gospel writers were depicted on the vault of the middle nave. A fresco of the Annunciation of Holy Virgin is located on the eastern wall of the naos, on both sides of the window opening to the middle nave. Saints and illustrious persons were

depicted on the arches facing towards the middle nave over the capitals supporting the superstructure.<sup>58</sup> The plastering of the building is in its original state and majority of depictions have survived intact (Figure 3. 56).

*Figure 3.56. Frescos in the H. Prodromos Church (Personal Archive)*

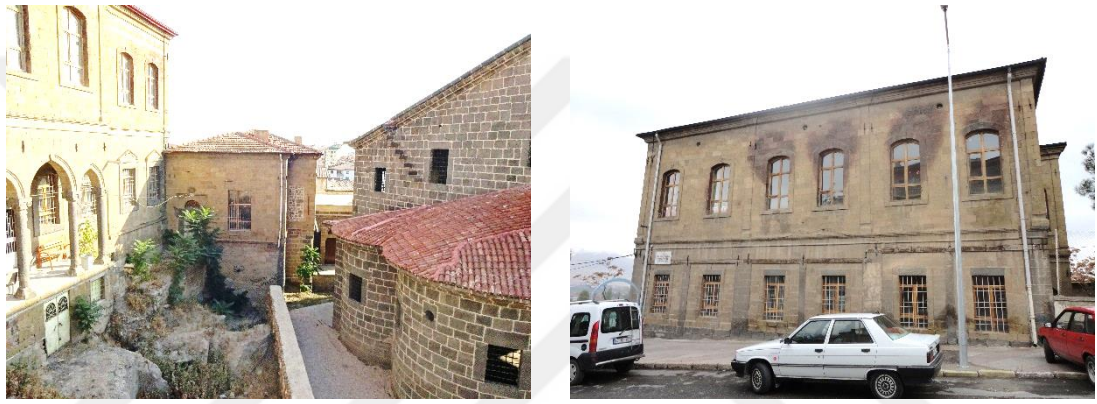
organization of windows in different floors.<sup>59</sup> The building is accessed from the courtyard of the school through the stairs at its south-eastern facade. There is a round arched entrance door on this facade. There are traces of fire on the windows in the second floor of the building (Figure 3.57). The cut stone masonry building, which was used as the library of the monastery, is presently used as the canteen of the school. One of the windows of the single floored building was converted to a door and some of its windows were covered.<sup>60</sup>

Figure 3.57. Dumlupınar Primary School (Personal Archive)

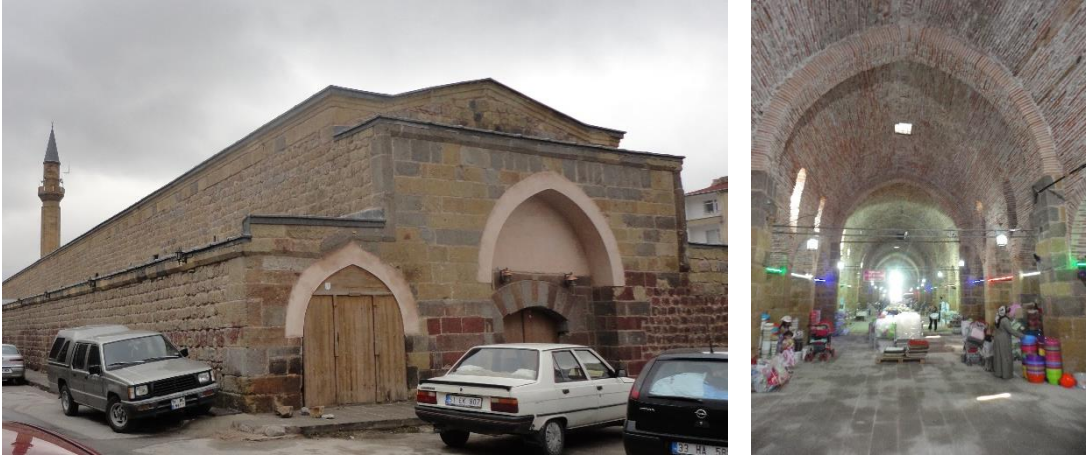
Different from the other traditional buildings in the study area, in the masonry system of Bedesten, brick material is used. While the walls of the Bedesten are built with fine and rough cut stone, the superstructure of the building and its arches are formed with brick. Via alternate use of black and yellowish fine cut stone on the facades where the gates of the building are located, the facades are enlivened (Figure 3.58).

Figure 3.58. Bedesten (Personal Archive)

Bedesten, which has been inactive for a long time, has been rented by the Municipality of Niğde and converted to a place where people who have economical troubles can shop for free. Bedesten is the only building that reached to the present, as a trace that the area was once the historical commercial center. Therefore, maintaining the original function of the building is important to preserve the historical value of the area.

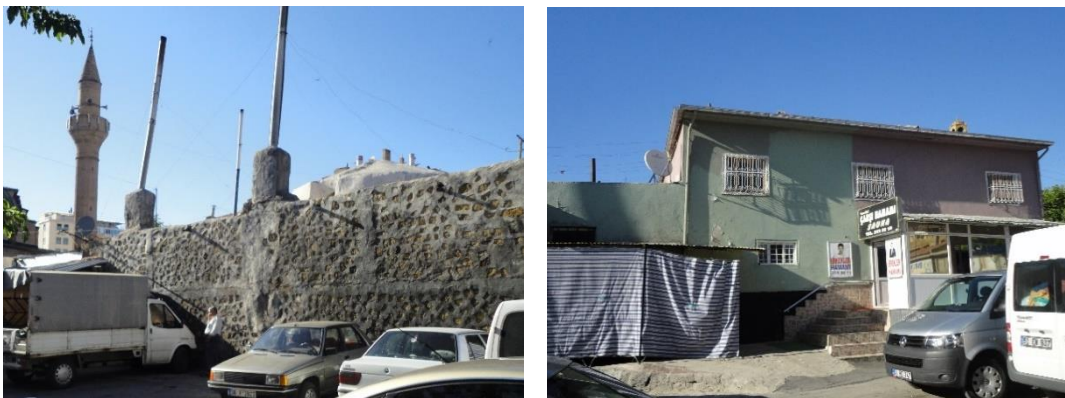
Among the monumental buildings in the study area, Çarşı Hamam has lost its authenticity to a large extent. *Soyunmalık* (changing rooms) section has been rebuilt as two storey reinforced concrete building. The water storage and furnace sections located in the west of the building have been demolished and single storey reinforced concrete shops have been built on their site. The masonry system of the walls of the building is illegible due to interventions made with cement. The roof and chimney of the building are also covered with cement and the smoke is exhausted via zinc pipes (Figure 3.59).

Figure 3.59. Çarşı Hamam (Personal Archive)

The bathing tradition continues in Niğde, and thus Çarşı Hamam is used not only for its health function but also as a monumental building where local people perform social and cultural activities. The Greek School is one of the monumental buildings that maintain its original function. Together with the new structure nearby, it serves as Dumlupınar Primary School (See Figure 3.66).

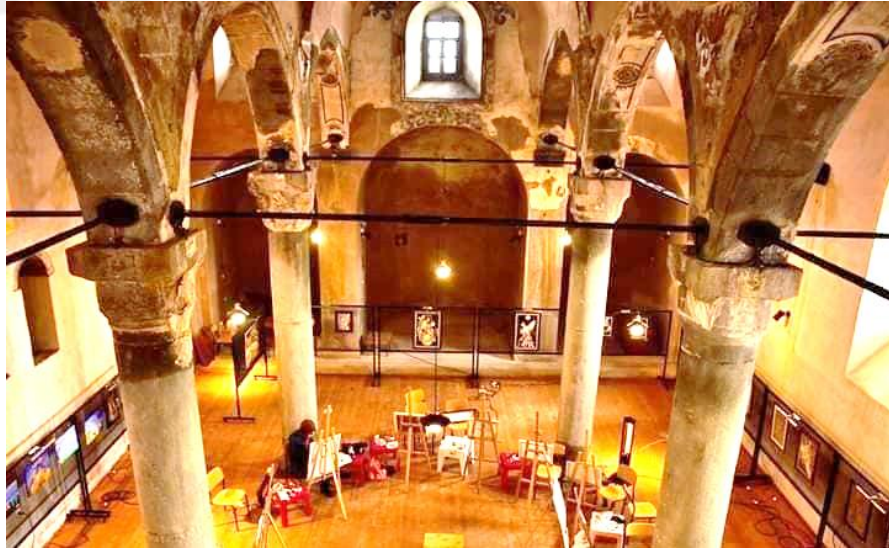
As a result of population change, churches in the study area have been idle for a long time since the 1920s. In recent years, the restoration of H. Stephanos Church has been completed and opened for use as an art gallery of Niğde Municipality (Figure 3.60). H. Prodromos Church was also under restoration, and only interventions such as the renovation of the top cover required for the protection of the building from external factors were performed. Since the necessary restoration works were not carried out inside the church, the re-use of this church has not been achieved yet.

*Figure 3.60.* H. Stephanos Church (Remziye Gedik Archive, <http://www.nigdehaber.com.tr/>)

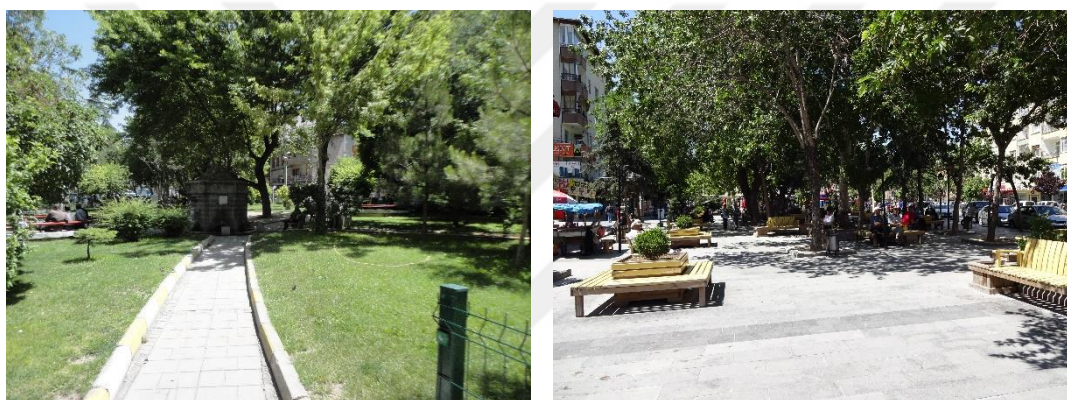
*Figure 3.63. Before and after photographs of Şadırvan Park (Personal Archive)*

The lack of green areas in the historical city center of Niğde is also observed within the boundaries of the study area. Şadırvan Park was previously a green area, but it was transformed into an area where the natural elements were surrounded by a stone paved area. The only pedestrian street of the city, which connects Şadırvan Park to the İstasyon Avenue, also includes small green areas surrounded by stone pavement (Figure 3.63).

As mentioned before, the green areas of the Şadırvan Park have been replaced with andesite pavestones. The pavement material on the streets to the north of the road that connects Şadırvan Park to Kığılı Mosque is the andesite pavestone. Apart from this, the interlocking pavestones are generally seen in the streets surrounding the historical core in the area. There are spots where interlocking stone slabs are missing and the holes are either left empty or filled with tarmac (Figure 3.69).

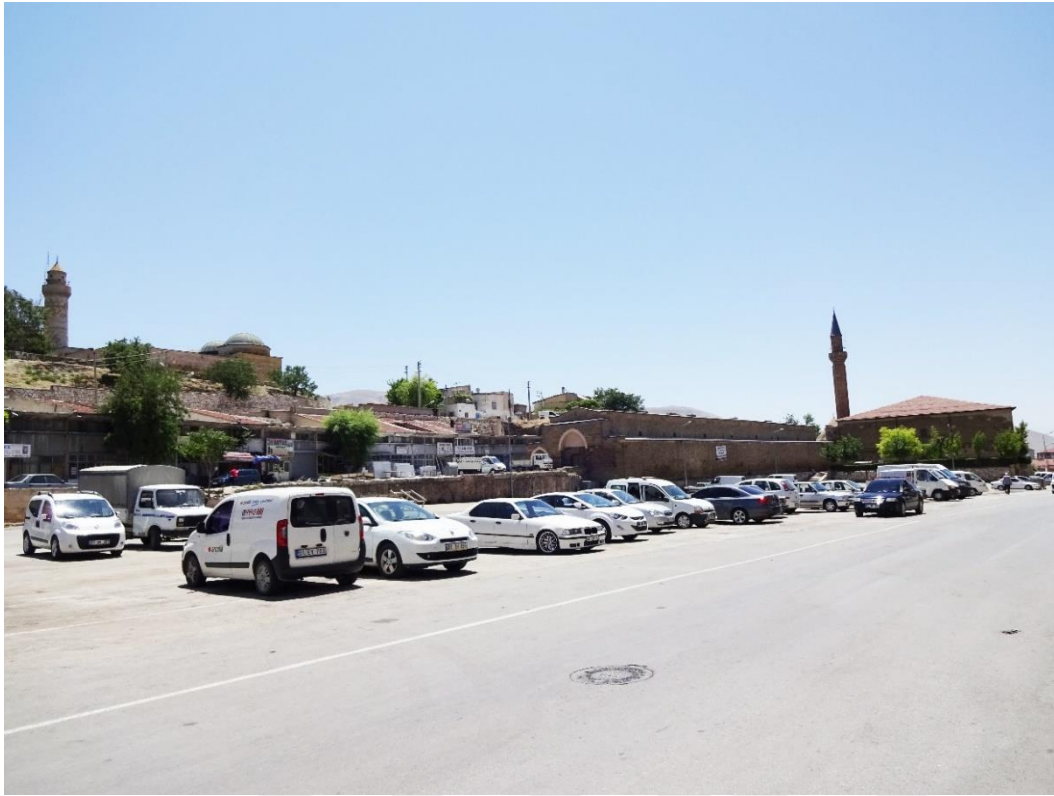
*Figure 3.65.* The undefined open area of the marketplace (Personal Archive)

The most important public open area in the study area is the marketplace which has become an undefined area not integrated because of the destruction of the traditional fabric around Bedesten and Sungur Bey Mosque. Although it is a very large open area, it cannot be used actively. Except for the Thursdays when the local bazaar is gathered, the area is used as an open car park (Figure 3.65).

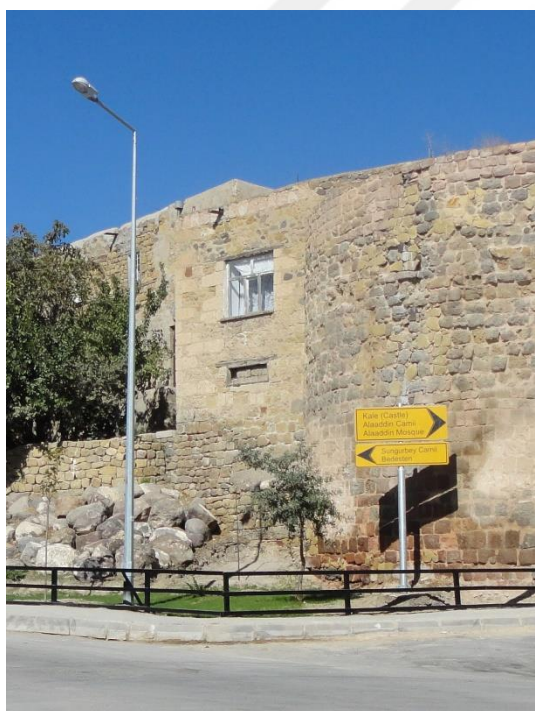
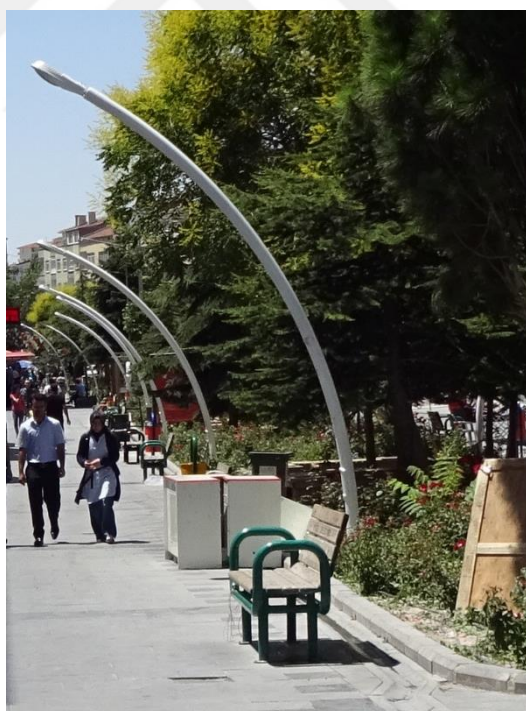
Figure 3.70. Lighting poles (a) castle entrance (b) walk way of Şadırvan Park (Personal Archive)

There are various types of man-made elements of public open areas in Sungur Bey Mosque Market Area (See Figure 3.76). Street lighting is one of the significant man-made elements that maintaining pedestrian safety and producing optimum illumination for vehicles. In the market area, the illumination of the streets that are defined by the new buildings is provided by lighting poles placed at certain intervals. The lighting and the infrastructure of electricity and telephones are buried underground and for this reason there are many electric boxes (Figure 3.70).

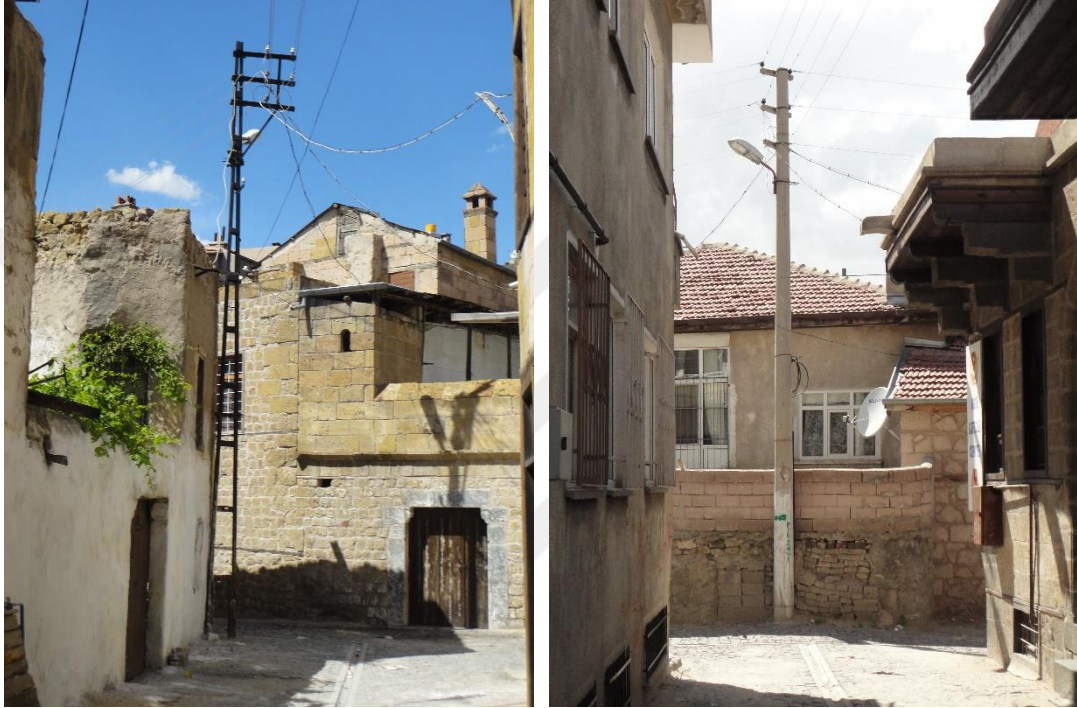
In areas where the historical tissue is dense, electricity and telephone lines are above ground. These areas are illuminated by lights on utility poles (Figure 3.71). Apart from that, there is human-scale lighting poles in the walk way of the Şadırvan Park. Only these lighting elements promote night activities.

*Figure 3.71. Lights on utility poles (Personal Archive)*

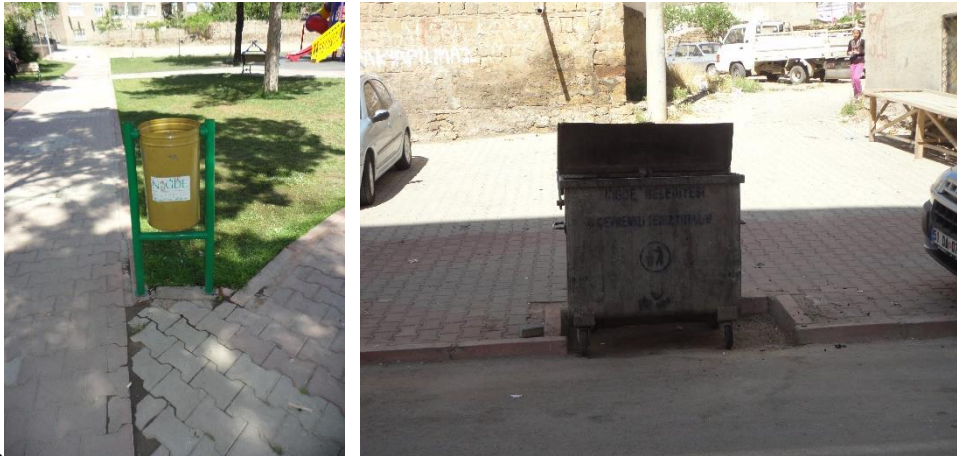
Trash cans are the essential components of the streets. While the cleanliness of the Market area is a challenging issue, there are surprisingly no trash can in this area. Large trash cans were placed in the streets by creating spaces in the pavement. There are some small metal trash cans fixed to the ground around monumental structures and on the walk way of the Şadırvan Park (Figure 3.72).

*Figure 3.72. Trash cans (Personal Archive)*

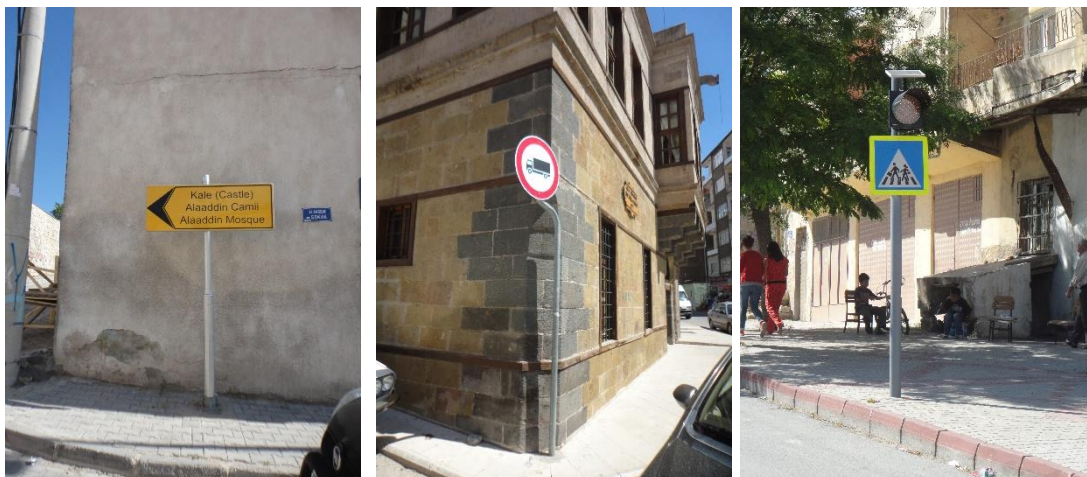
Street and traffic signs are the fundamental man-made elements that regulate traffic flow and provide information on the direction, however, there are few traffic signs in the study area. Traffic signs are placed only at the entrances to the castle area for guidance to monumental buildings. Around Dumlupınar Primary School there are warning signs to ensure the safety of the students. In addition, there are traffic signs around the CSRP area indicating that heavy vehicles cannot be entered into the historical core. Nameplates of the streets are attached to the corner facade of the building no matter if it is historical or new building (Figure 3.73).

*Figure 3.73. Street and traffic signs (Personal Archive)*

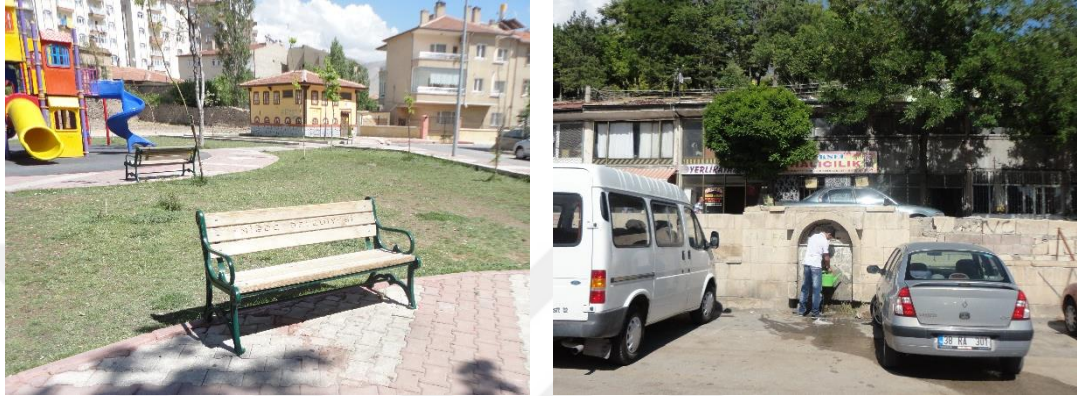
Sitting units are useful components as they provide means for people to relax and interact with others. Sitting units in the area are not sufficient in number. In Şadırvan Park, sitting units where people can spend time together are located. In addition, there are benches in the courtyard of the Sungur Bey Mosque and in the parks with playgrounds (Figure 3.74-a).

*Figure 3.74. (a) Benches (b) Fountain in the market area (Personal Archive)*

Apart from the historical fountains, there is two fountains in the market area, which is generally used by stallholders (Figure 3.74-b). Furthermore, there is a phone booth in the square surrounded by Sungur Bey Mosque and churches.

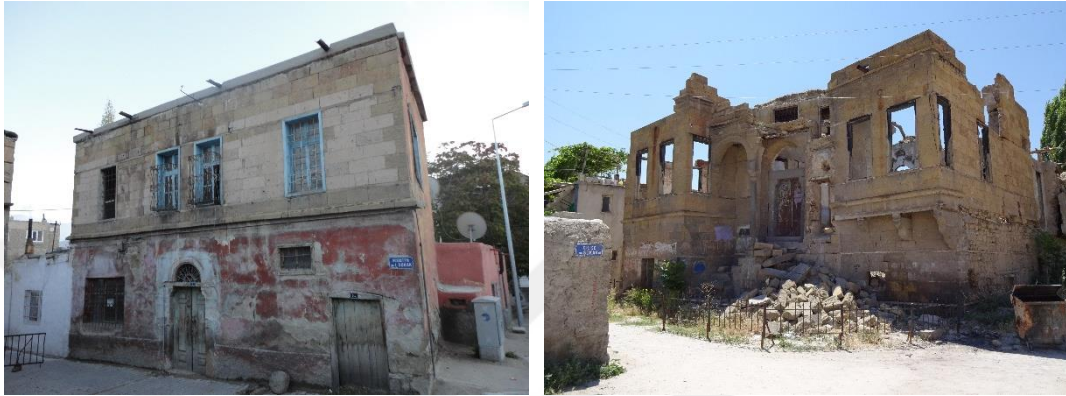
*Figure 3.81.* Abandoned buildings close to H. Stephanos Church (Personal Archive)

One of the main problems in the protection of the Sungur Bey Mosque Market Area is the abandonment of traditional buildings for neglect and their destruction on the grounds that they create a danger to the environment (Figure 3.81 – Figure 3.82). The historical tissue around the churches has been leaving its place to open spaces which are used as undefined car parks. Traditional non-protected lots around the CSRP area are being constructed with new structures that are incompatible with the environment.

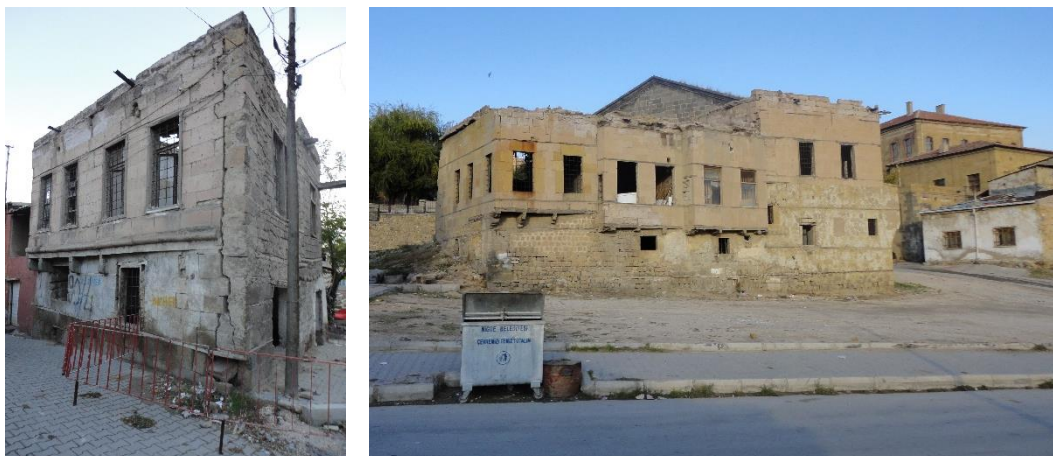
*Figure 3.82.* Abandoned buildings that has been destroyed (Personal Archive)

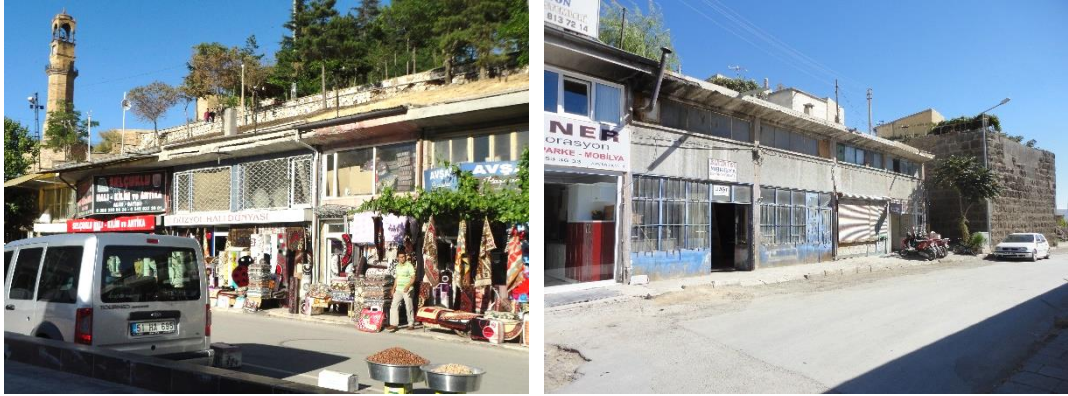
Small-scale new buildings around the market area also affect the physical and visual relationship of the Market area with its environment due to the use of unqualified and incompatible facade and pavement materials and facade irregularities. It damages the dramatic topographical features of Aladdin Hill, which is observable from the market area. However, the commercial functions of these structures ensure the use of the area in times other than the market days and therefore the area remains a historical commercial centre (Figure 3.84).

*Figure 3.84.* Small-scale new buildings around the market area (Personal Archive)

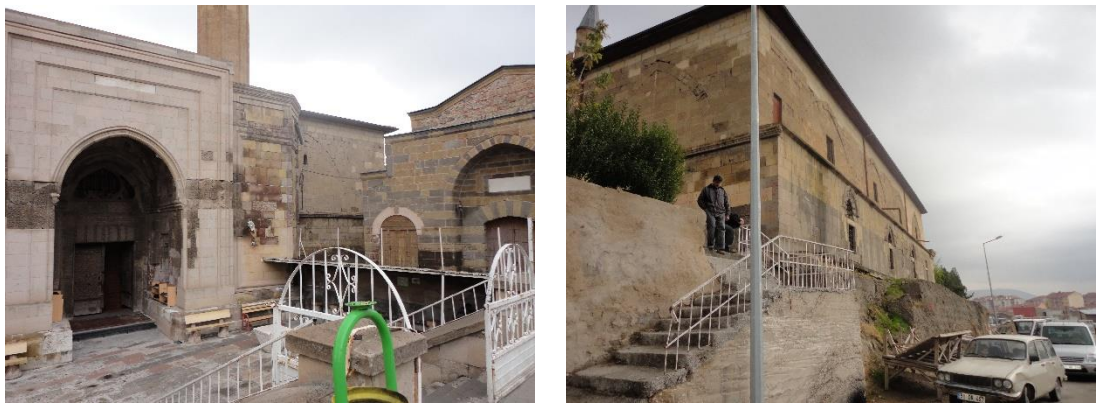
*Figure 3.86. Access to Sungur Bey Mosque (Personal Archive)*

Besides the unqualified pavement materials that destroy the physical character of the area, the elevation differences that occurred during the renewal or change of the street pavements also damage the physical integrity of the area. Access to Bedesten and

Sungur Bey Mosque is problematic since the ground level of these buildings are connected to street level via stairs (Figure 3.86).

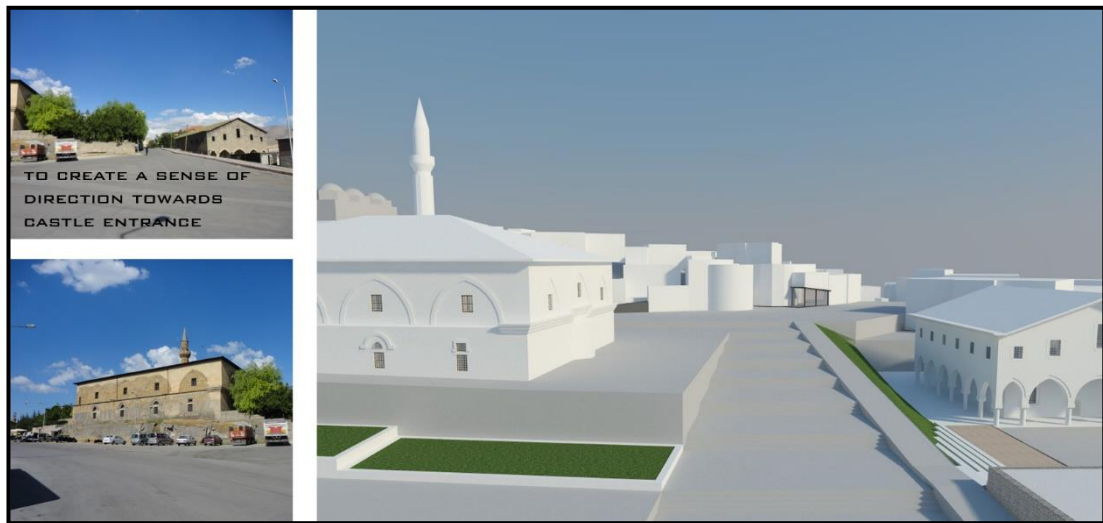
*Figure 4.3.* The proposed access to castle entrance

It is aimed that the visitors, who access to the site through the cultural axis or from the south would assemble in a public square from where the churches and Sungur Bey Mosque would be viewed all together. The visitors will then be directed to the castle area via the stairway, which extends from this spot to the castle entrance. A ramp, which reflects the old street tissue with its pavement will be added next to the stairway for handicapped visitors (Figure 4.3).

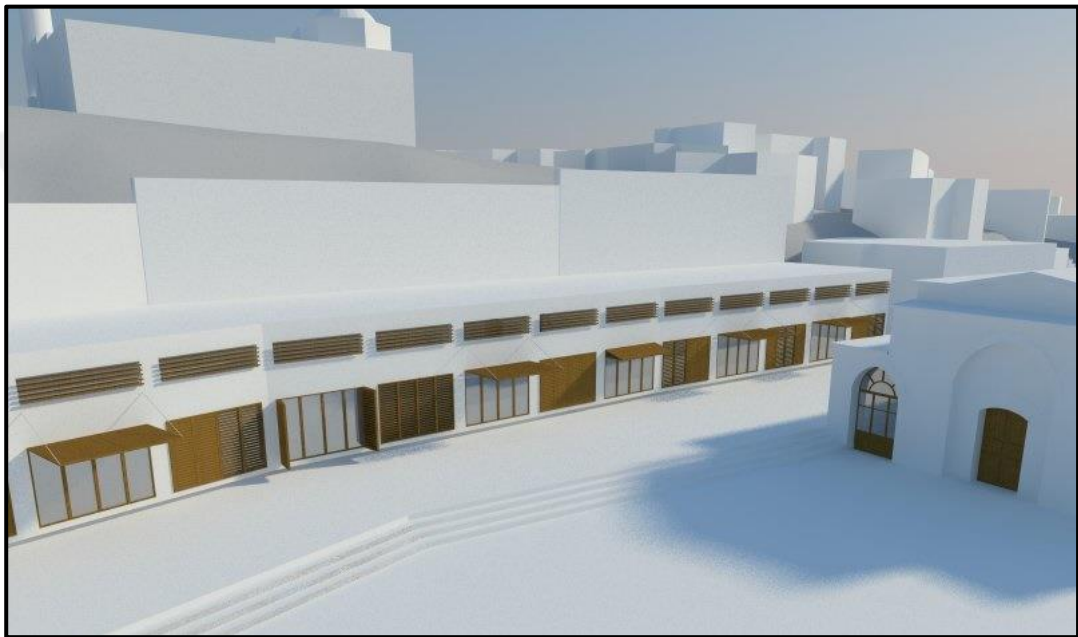
Figure 4.5. Facade arrangements of small shops

Kunt Street, which encircles the castle in the western side is defined as the commercial axis. The facades of the single storey buildings on the street will be improved in order to create the architectural integrity and to maintain commercial functions that serve the local people (Figure 4.5). The continuity of this commercial axis is supported with the Bedesten building. However, as a massive building, Bedesten should not serve for only one commercial function; instead the commercial diversity within the building should be established. For this reason, it is proposed that every three cells of Bedesten will be rented separately to be used for different commercial activities such as souvenirs store, jewellery shop or herbalist's shop. In fact, putting the three entrances

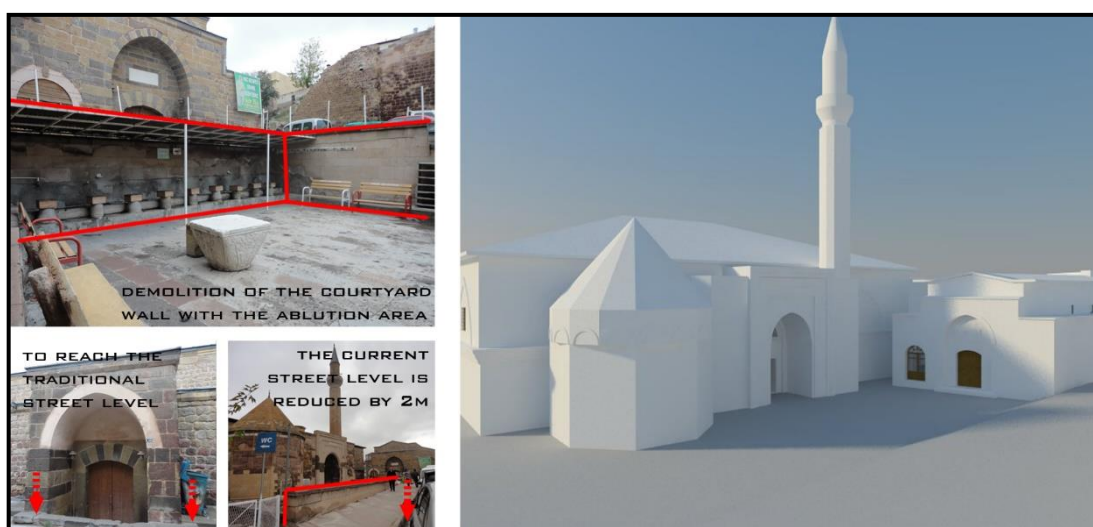
of the Bedesten into use would make positive influence on the interior circulation. In order to achieve this, current street level is proposed to be decreased to 2 m below to reach the original street level. By decreasing the street level, the relationship between Sungur Bey Mosque and its surrounding would also be improved. Removing the courtyard walls of Sungur Bey Mosque and changing the place of the ablution fountain would re-establish the association it had with Bedesten in the past (Figure 4.6). Also, the visual perception and integration of these buildings with the castle entrance area is strengthened.

Figure 4.6. The proposed relation between Sungur Bey Mosque and Bedesten

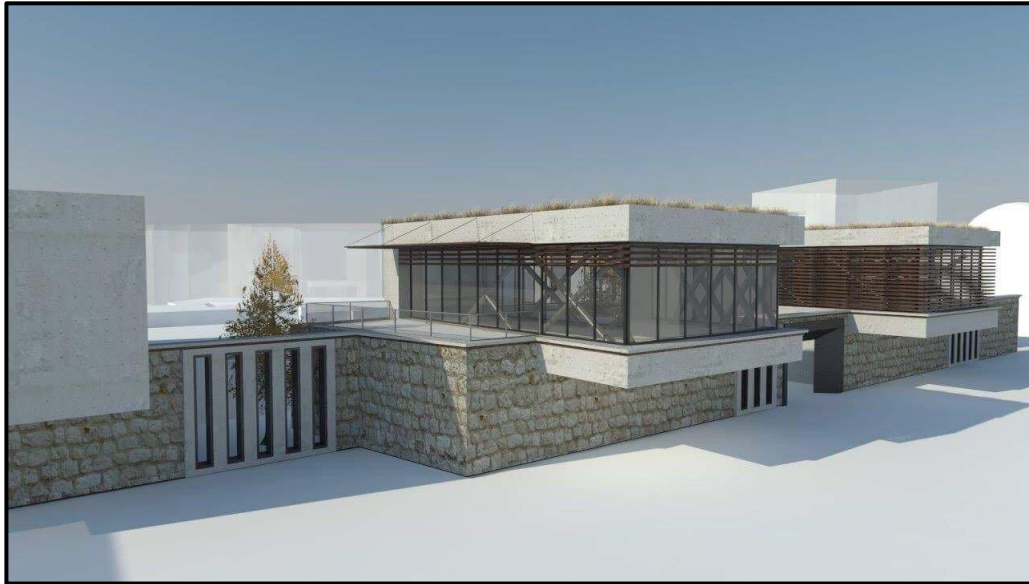
Figure 4.8. Design studios and reading hall

In addition to adapting to the boundaries of the existing street tissue, the axes of the monumental buildings such as Sungur Bey Mosque, Bedesten and Greek Church are used as bases for the orientation of building units and the design of open spaces (Figure 4.7). To the north of the inner street of the faculty is a design studio, lecture rooms and a seminar room. The studios are located around the ground floor and a courtyard on the first floor. The courtyard of the studios is limited with a stone courtyard wall, as was the case with the traditional residential fabric, to create a special space for the students. On the other hand, it is aimed to establish a visual relationship with the street through the openings in the courtyard wall and to be more transparent than the traditional courtyard walls. Mass fragments are emphasized by studio units climbing onto the street above the courtyard wall. While a reference is made to the traditional

texture, it is also ensured that each studio receives light. It is planned to employ movable wooden panels around the studios and to adjust the desired light through these panels (Figure 4.8).

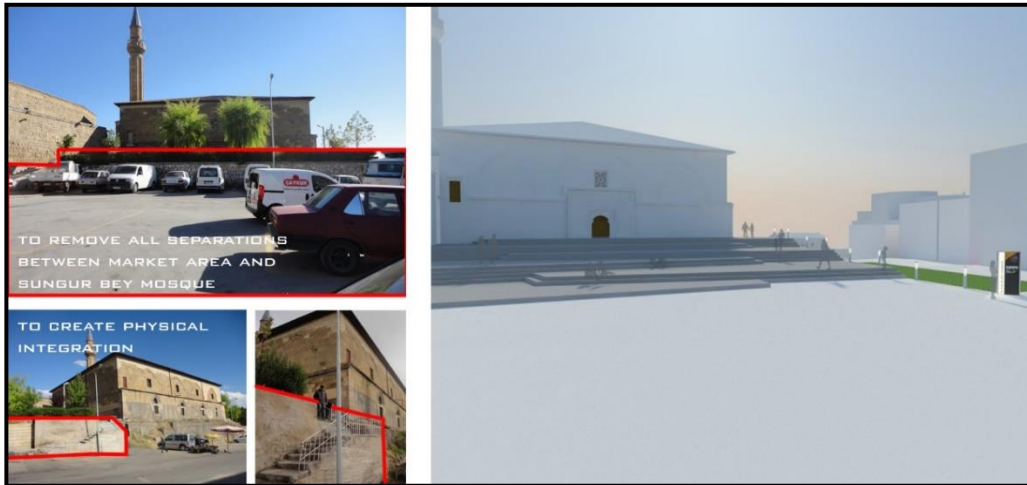
Figure 4.14. The proposed access to Sungur Bey Mosque
