INVESTIGATION OF ROCKFALL AROUND ANKARA CITADEL

A THESIS SUBMITTED TO  
THE GRADUATE SCHOOL OF NATURAL AND APPLIED SCIENCES  
OF  
THE MIDDLE EAST TECHNICAL UNIVERSITY

IN PARTIAL FULFILLMENT OF THE REQUIREMENTS  
FOR  
THE DEGREE OF MASTER OF SCIENCE  
IN  
GEOLOGICAL ENGINEERING

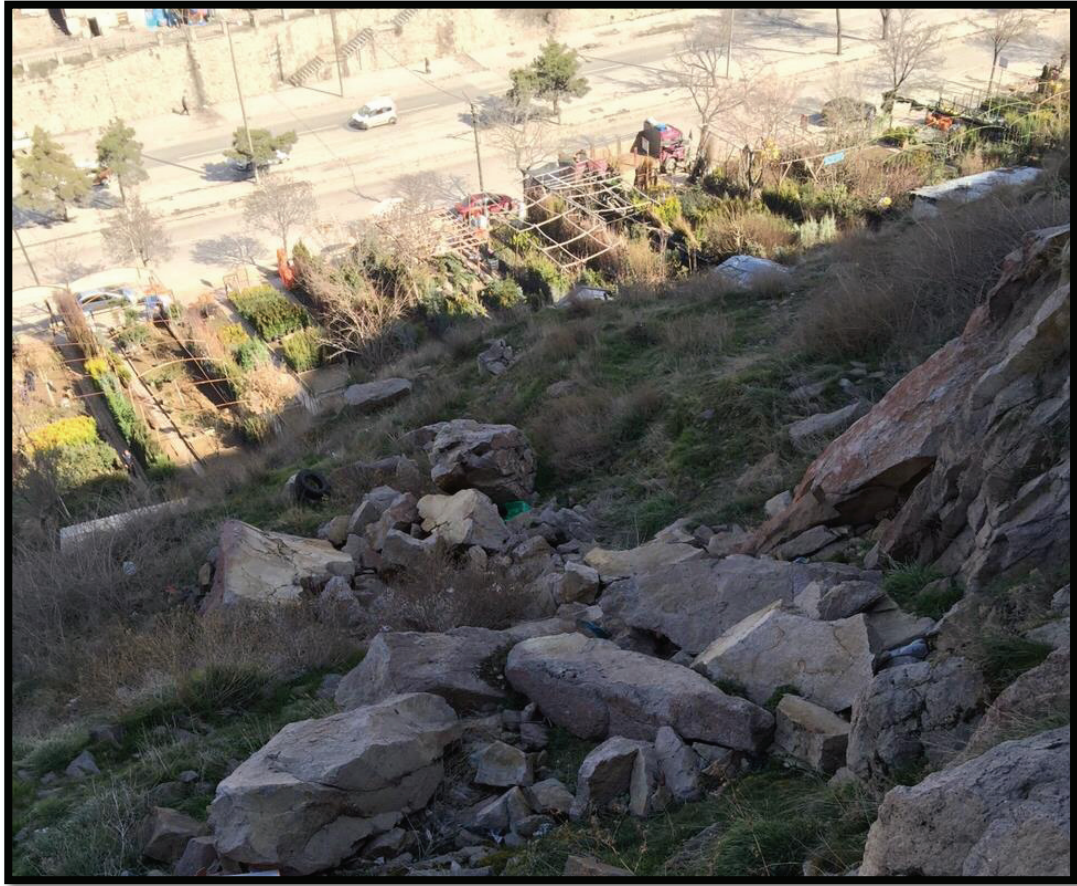
**Figure 1.2** Fallen blocks seen in the study area and the floral shops at the bottom of the hill.

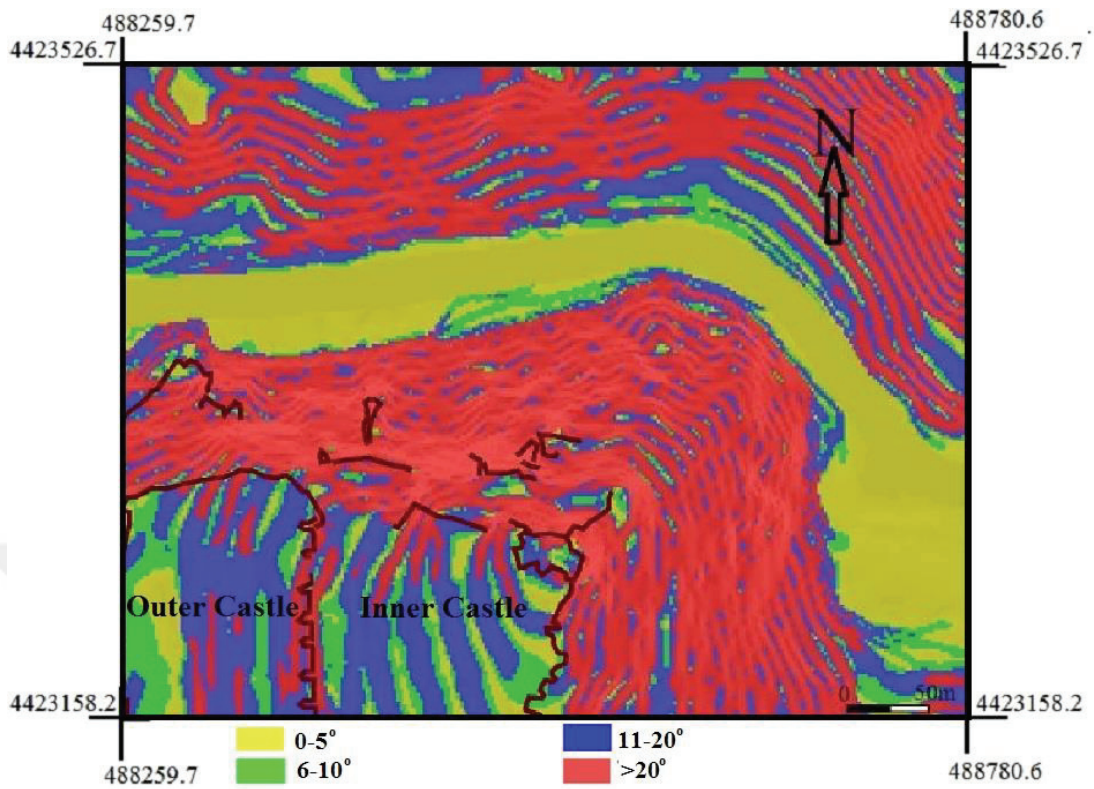
**Figure 1.5** Slope map of the study area.

The slope, aspect and DEM maps of the study area are presented in Figures 1.5, 1.6 and 1.7, respectively. These maps were prepared by TNTmips (2012) software of Macromedia. The ITRF 1996 UTM coordinates of the maps are also given in the figures. DEM map was prepared by polynomial surface modeling method. The slope and aspect maps were derived from DEM. The slope map is divided into 4 groups as shown in Figure 1.5. The aspect map is also divided into 4 classes as North, South, East and West facing. The horizontal and vertical resolutions of the maps are 72dpi.

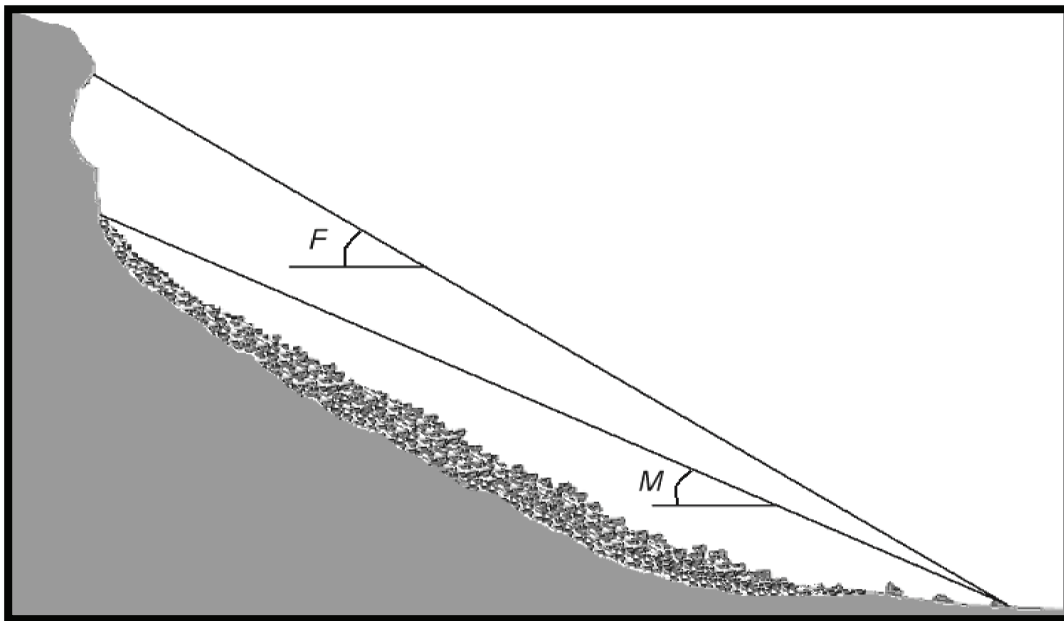
**Figure 2.3** The *Fahrböschung* ( $F$ ) and the minimum shadow angle ( $M$ ) of a talus slope (Dorren, 2003).

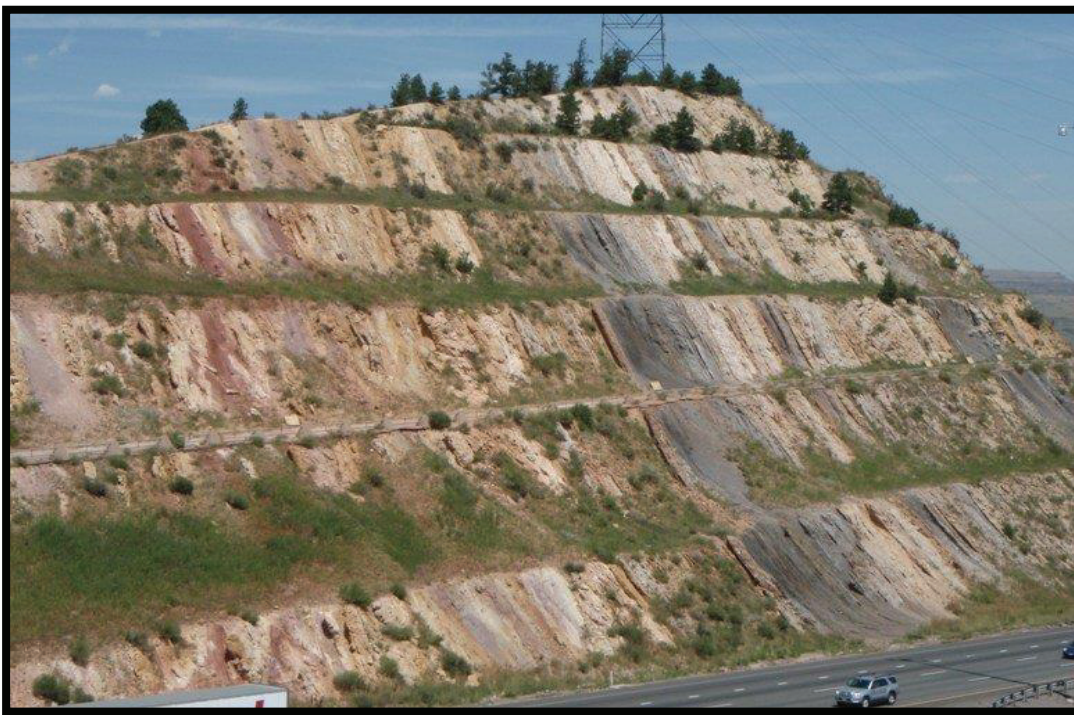
**Figure 2.7** Typical berms structure on the road cut from North Dakota, USA (Panoramio, 2016).

**Berms:** They are used to retard the energy of the falling rock, and they may also increase factor of safety against sliding. Their design is supposed to retain fallen rock from the higher slopes and prevent the further movement of the rock down the slope. To prevent the likelihood of falling rock to bounce off, the berms must be covered with energy absorbing material like sand and gravel (Maerz, 2014). Figure 2.7 shows the typical application of berms on the road cut on North Dakota, USA.

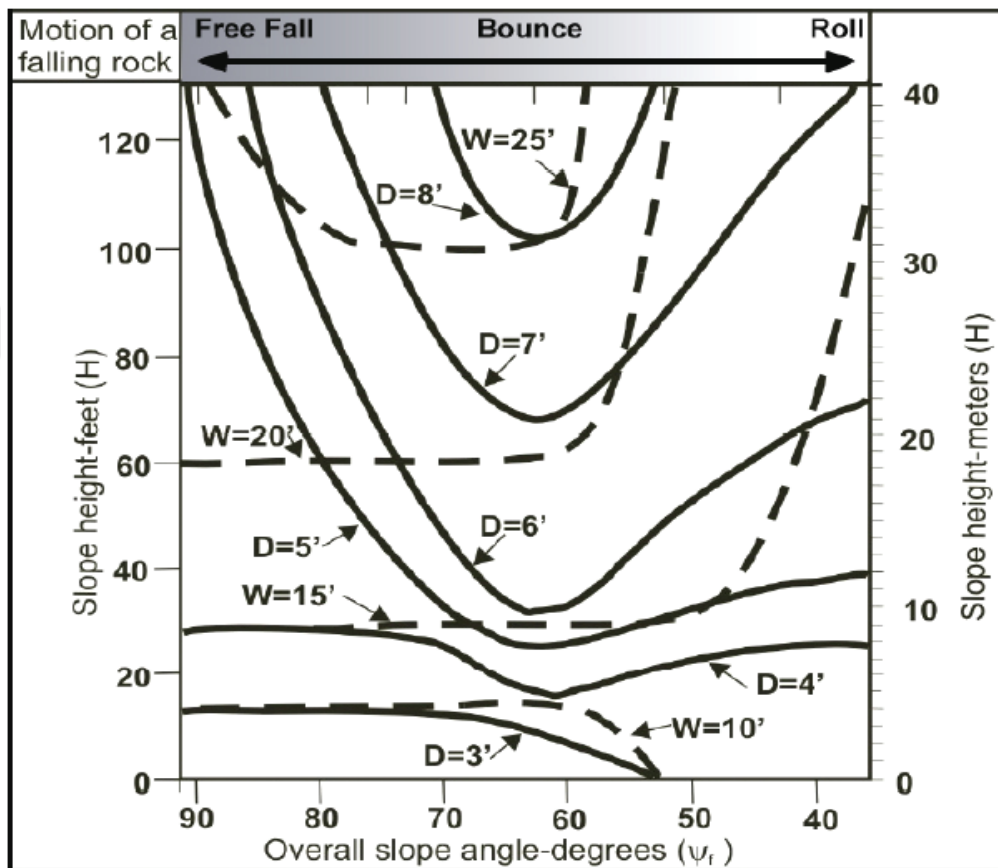
**Figure 2.8** Ritchie's design chart for determining required width (W) and depth (D) of rock catch ditches in relation to height (H) of hill slope (Ritchie, 1963).

structures. Required dimension of a ditch is defined by its base width, inclination and depth, and is related to the height of the face and its slope angle (Wyllie, 2015). Figure 2.8 shows Ritchie's chart for designing ditches, and Figure 2.9 shows a sketch of typical ditch section.

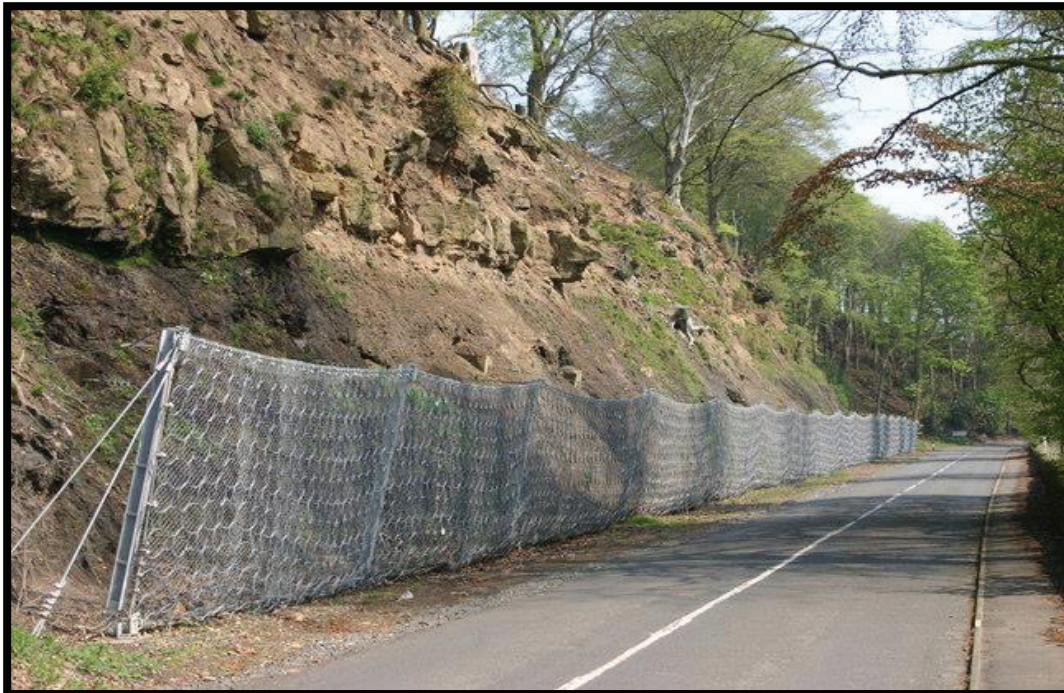
**Figure 2.10** Fences to catch the fallen rocks (Bright Hub Engineering, 2016).

**Fences:** They can be built either on the slope or at the base of the slope. Impact energies and trajectories data are necessary for good designs (Wyllie, 2015). The design of the fences is to slow down the rolling rocks and its angular velocity (Ritchie, 1963). An application of fences to prevent fallen rocks to the road is shown in Figure 2.10.

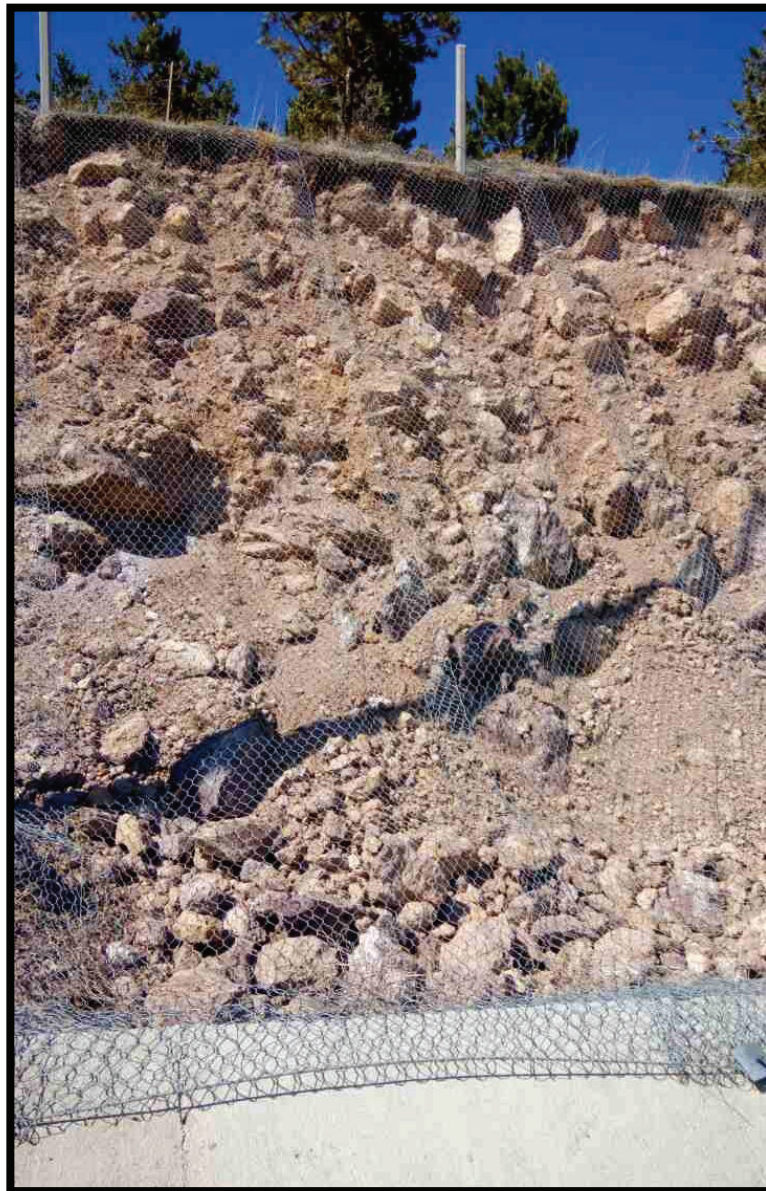
**Figure 2.11** Wire mesh protection over the slope on Kayseri-Develi highway.

**Wire Mesh:** In the cases where there is no suitable space for structures like ditches, wire mesh may be draped over the slope surface (Wyllie, 2015). They can be designed to prevent the detached blocks from reaching the road and enable them to drop only vertically and slowly (Maerz, 2014). The rock slope covered with a typical design of wire mesh on Kayseri-Develi highway is shown in Figure 2.11.

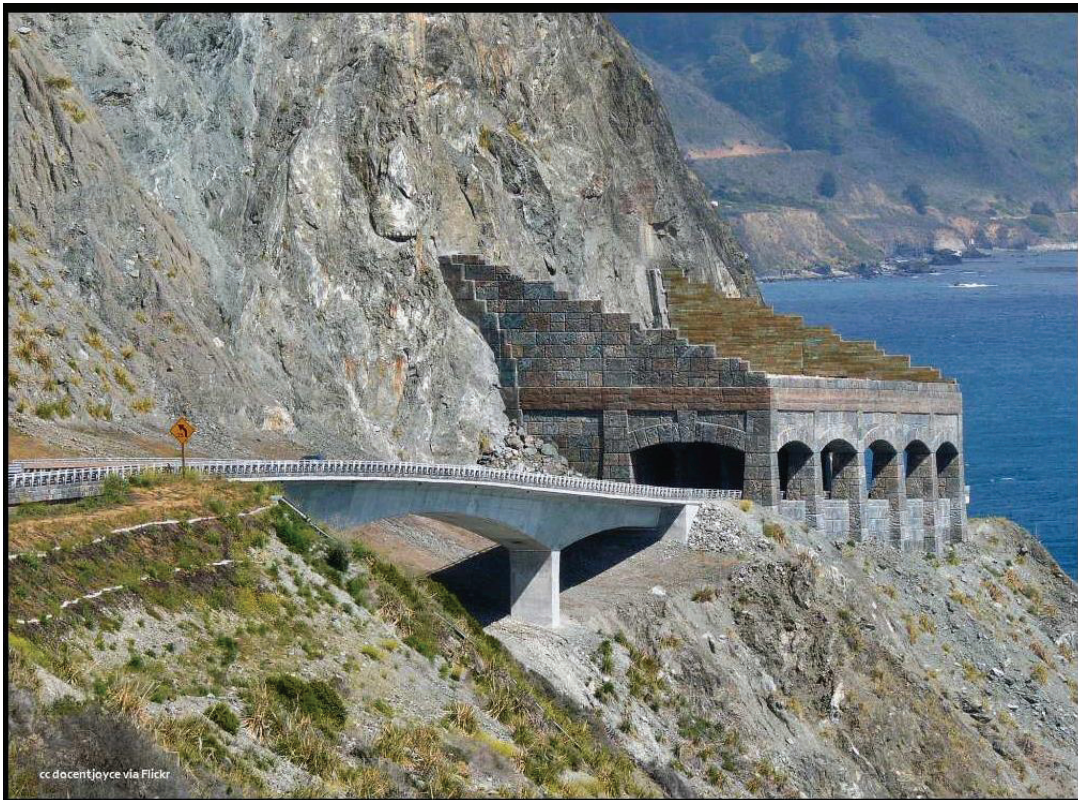
**Figure 2.12** The Rain Rocks rock shed and Pitkins Curve Bridge opened officially in January of 2014 (Discover Central California, 2016).

**Reinforced concrete sheds:** They are usually constructed at the locations where rockfalls are frequent and very sound protection system is necessary for essential facilities such as high traffic volume highway and high speed train (Wyllie, 2015). They can be designed to withstand a high specific energy impact, but they are quite expensive structures (Maerz, 2014). A picture of Rain Rocks rock shed in California is shown in Figure 2.12.

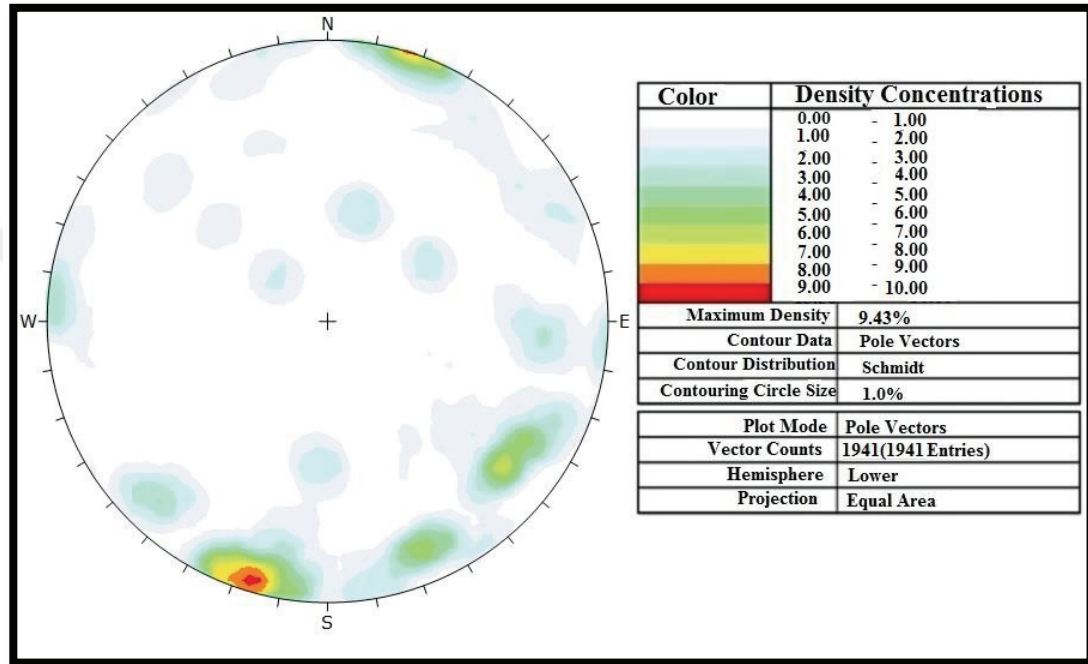
**Figure 3.3** Contour diagram of the discontinuities measured during the scanline survey.

Based on the field studies done around the Ankara Citadel, it was observed that previous rockfall events of various block sizes occurred. The spacing values of flow layers and cooling joints define the sizes of the blocks. The discontinuity data of the scanline survey made at 21 stops around the castle were contoured (Figure 3.3) with the aid of DIPS 6.0 software (Rocscience, 2013).

According to the discontinuity measurements made in the field, there are flow layers with low dip angles. These flow layers are visible but scattered in the areas near the center of the contour diagram in Figure 3.3. There are also a large number of steeply dipping cooling joints that develop in different directions perpendicular to the flow layers. This is evidence that the andesite is highly fractured. Therefore, the discontinuities set are non-systematic.

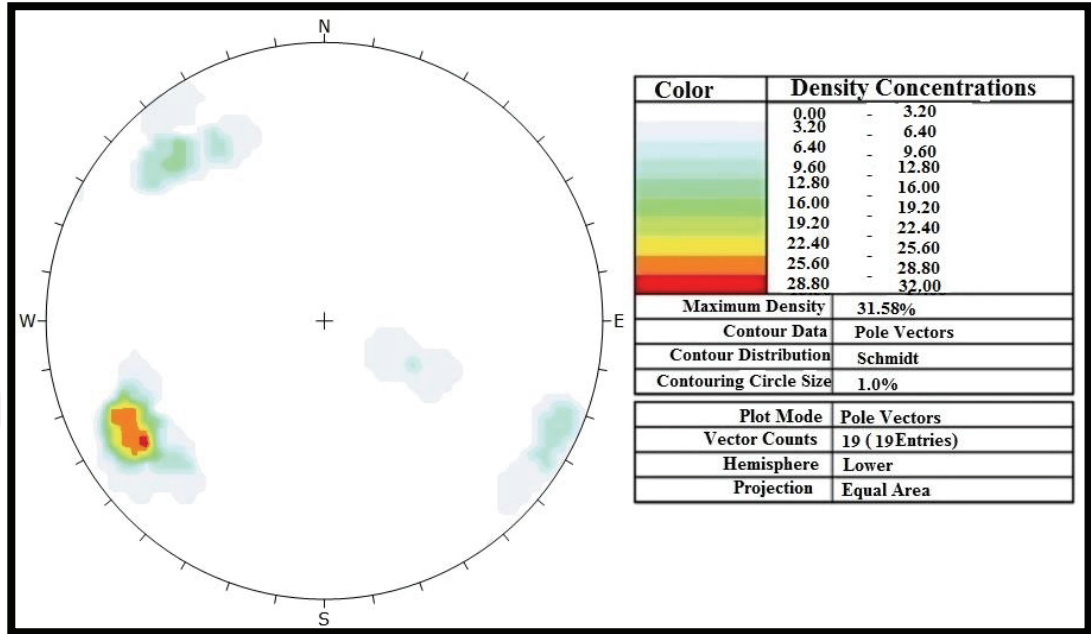
**Figure 3.5** Contour diagram of the discontinuities at the 1<sup>st</sup> location.

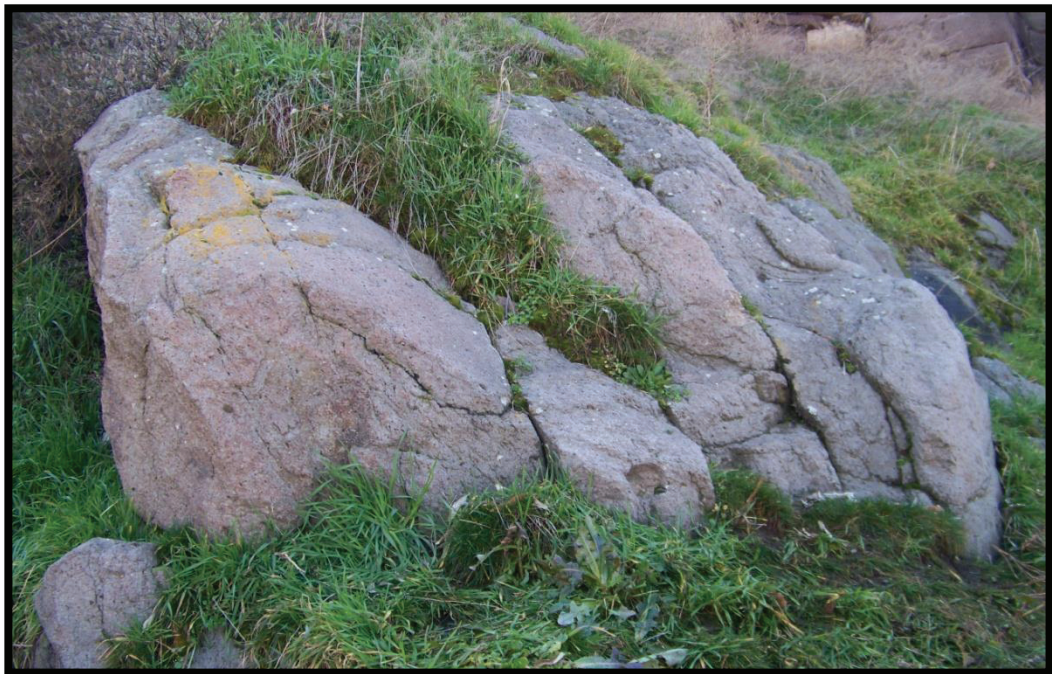
**Figure 3.6** Photograph of the andesite at the 1<sup>st</sup> location.

cooling joints except that they do not infilling material. An outcrop of the andesite is shown in Figure 3.6.

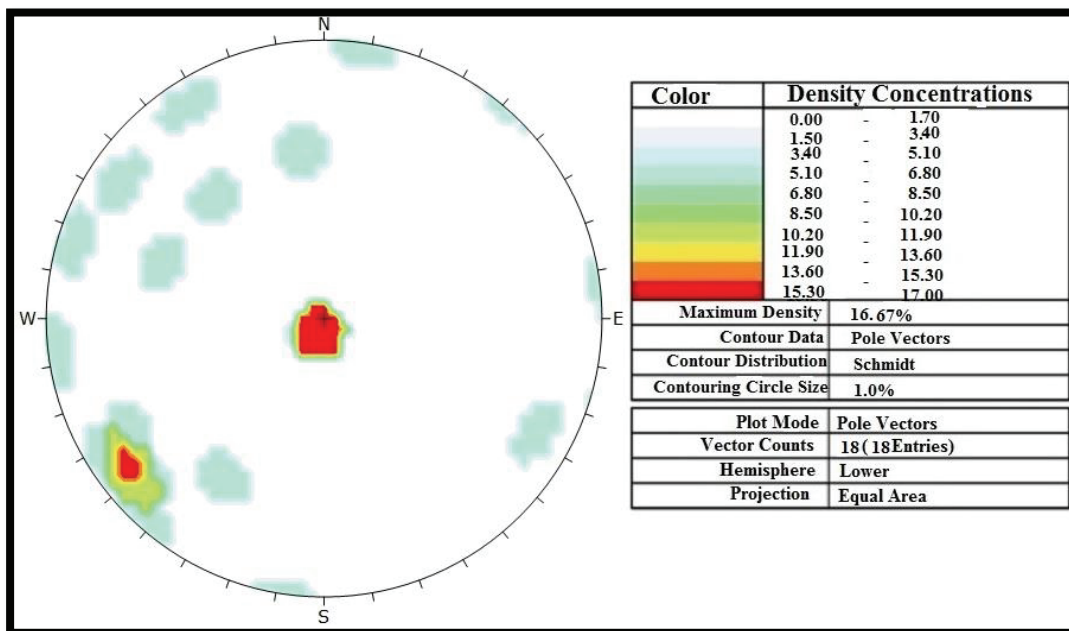
**Figure 3.7** Contour diagram of the discontinuities at the 2<sup>nd</sup> location.

At the second stop, the rock is pinkish grey and slightly weathered. The surface of the discontinuity is undulating rough. The main dip amounts and dip directions of the flow layers are  $04^{\circ}/022^{\circ}$ ,  $05^{\circ}/022^{\circ}$  and  $04^{\circ}/023^{\circ}$ , and those of the slope is  $82^{\circ}/315^{\circ}$ . The contour diagram of the discontinuities is shown in Figure 3.7. The Schmidt rebound hardness ranges from 28 to 38. The joints have spacing values between 30cm and 70cm. The persistence of the joints varies between 50cm and 70cm. The joints have tight to 2mm apertures filled with silty clay only at the surface. The properties of the flow layers are similar to those of the cooling joints but they do not infilling material.

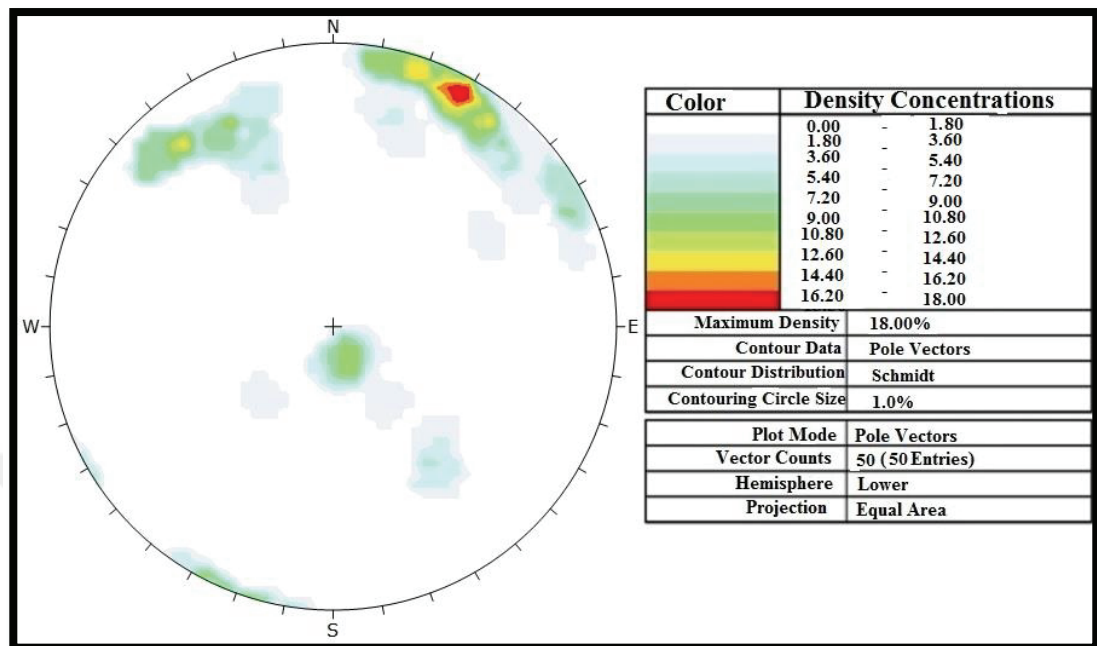
**Figure 3.8** Contour diagram of the discontinuities at the 3<sup>rd</sup> location.

The andesite at the third stop is pinkish grey. The rock shows slightly weathered state. The surface of the discontinuity is undulating rough. The dip amount and dip directions of the slope is  $56^{\circ}/325^{\circ}$ . The contour diagram of the discontinuities is shown in Figure 3.8. The Schmidt rebound hardness ranges from 25 to 30 in this stop. The spacing values of the joints vary between 30cm and 40cm. The persistence of joints ranges from 50cm to 150cm. The apertures are tight to 3cm, and filled with silty clay only at the surface. The flow layers have properties similar to those of the cooling joints except that they do not infilling material.

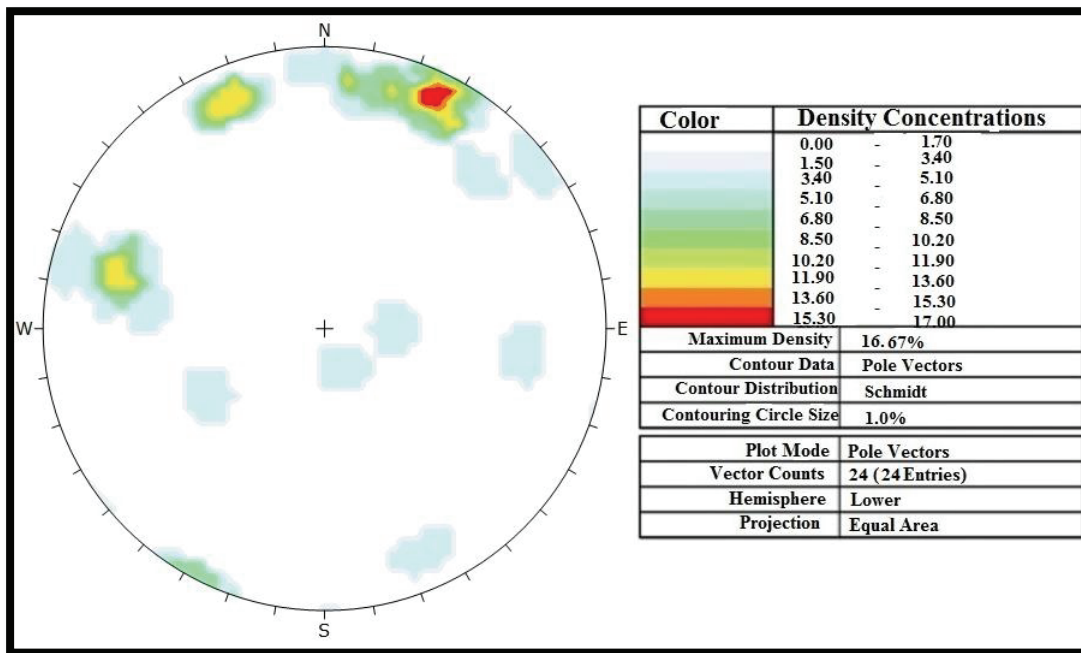
**Figure 3.9** Contour diagram of the discontinuities at the 4<sup>th</sup> location.

At the fourth stop, the rock is pinkish grey and slightly weathered. The surface of the discontinuity is undulating rough. The dip amounts and dip directions of the flow layers are concentrated at  $13^{\circ}/331^{\circ}$  and  $21^{\circ}/270^{\circ}$ . Two slope surfaces were recorded in this stop, and their dip amounts and dip directions are  $62^{\circ}/277^{\circ}$  and  $76^{\circ}/336^{\circ}$ . The contour diagram of the discontinuities is shown in Figure 3.9. The joints have spacing values between 50cm to 110cm. The persistence of the joints ranges from 100cm to 150cm. The apertures are tight to 3cm, and filled with silty clay only at the surface. The properties of the flow layers are similar to those of the cooling joints but they do not have infilling material. An outcrop of the highly fractured andesite is illustrated in Figure 3.10.

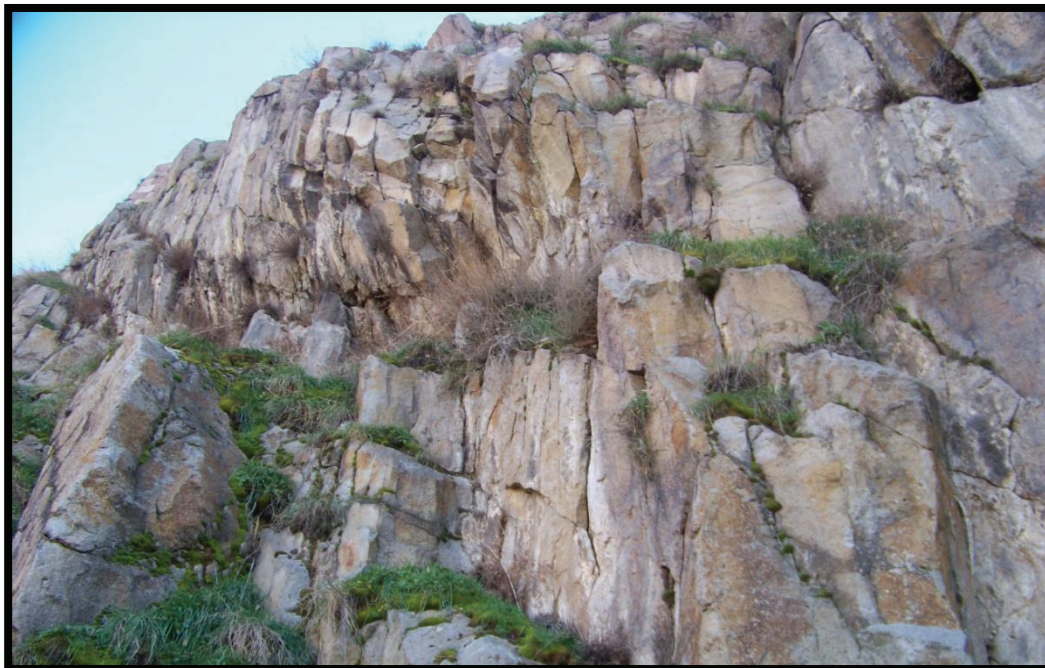
**Figure 3.10** The highly fractured andesite seen at the 4<sup>th</sup> location.

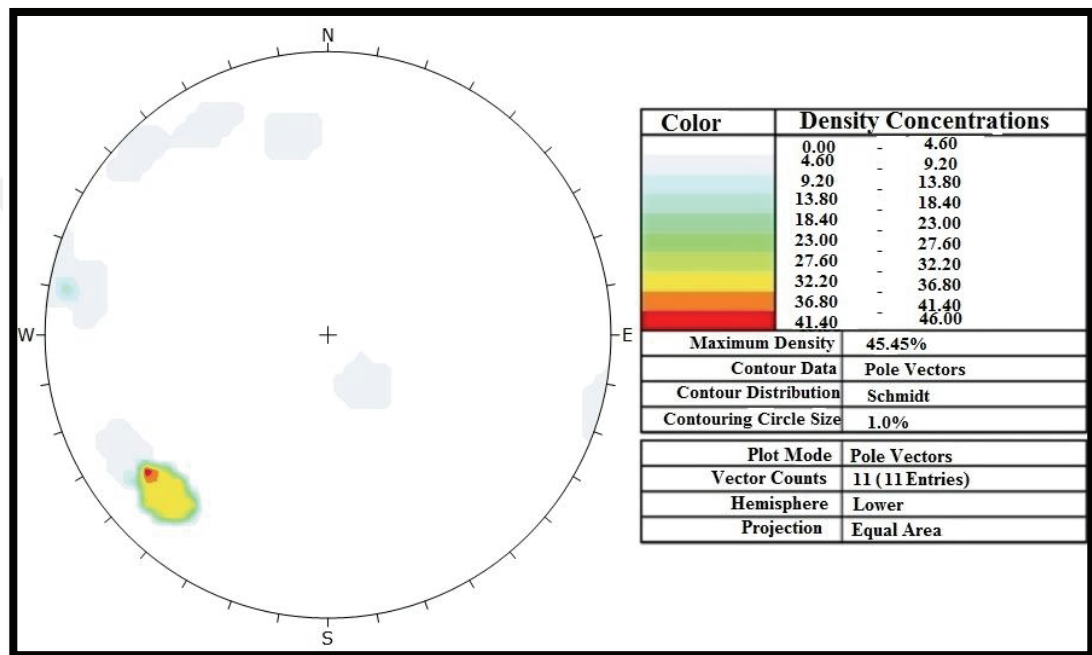
**Figure 3.11** Contour diagram of the discontinuities at the 5<sup>th</sup> location.

directions of the flow layer and the slope are  $18^{\circ}/324^{\circ}$  and  $84^{\circ}/340^{\circ}$ , respectively. The contour diagram of the discontinuities is shown in Figure 3.11. The joints spacing varies between 20cm and 60cm. The persistence of the joints ranges from 60cm to 80cm. The apertures between them are tight to 2 mm, and filled with silty clay only at the surface. The flow layers have properties similar to those of the cooling joints except that they do not infilling material.

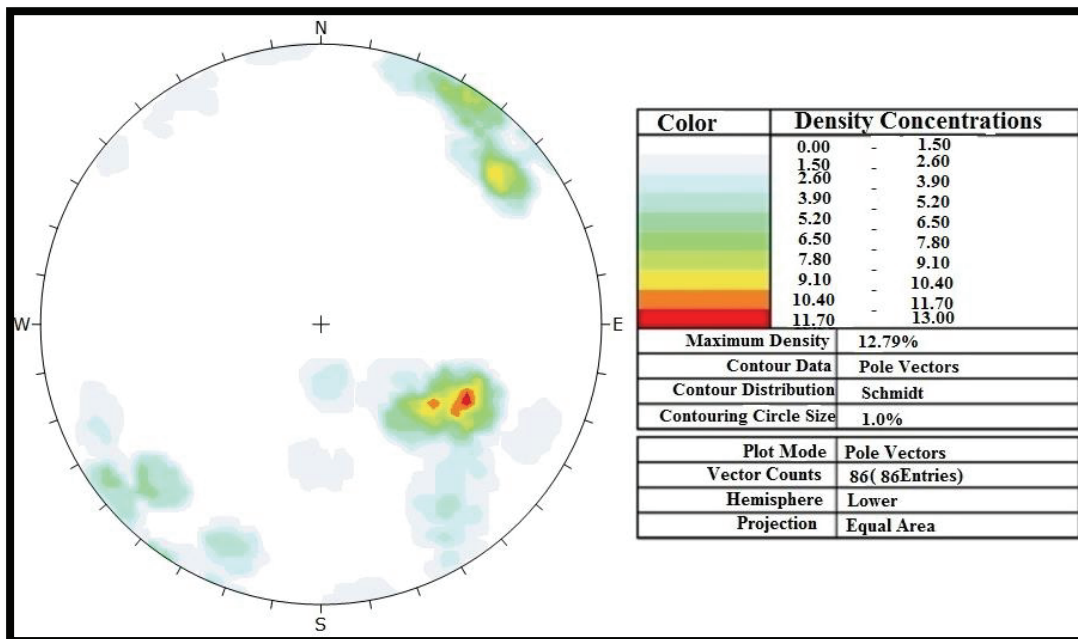
**Figure 3.12** Contour diagram of the discontinuities at the 6<sup>th</sup> location.

At the 6<sup>th</sup> stop, the rock is pinkish grey and slightly weathered. The surface of the discontinuity is undulating rough. The dip amount and dip direction of the slope is  $74^{\circ}/326^{\circ}$ . The contour diagram of the discontinuities is shown in Figure 3.12. The joints have spacing values between 30cm and 60cm. The persistence of the joints ranges from 30cm to 700m. The apertures are tight to 3cm, and filled with silty clay only at the surface. The properties of flow layers are similar to those of the cooling joints but they do not infilling material.

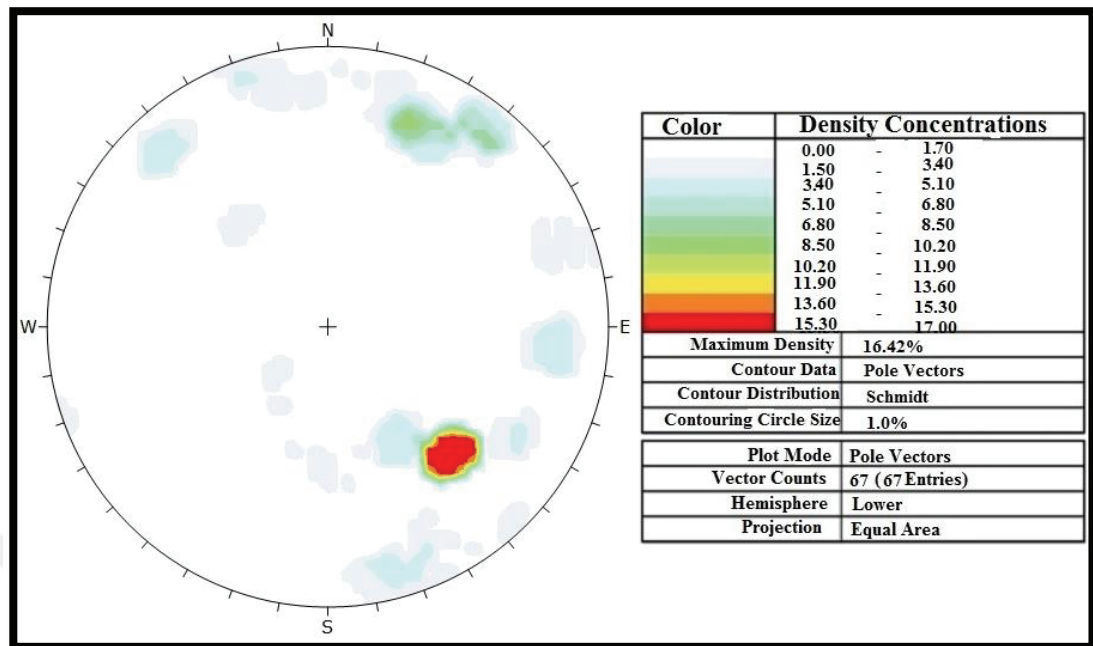
**Figure 3.13** Contour diagram of the discontinuities at the 7<sup>th</sup> location.

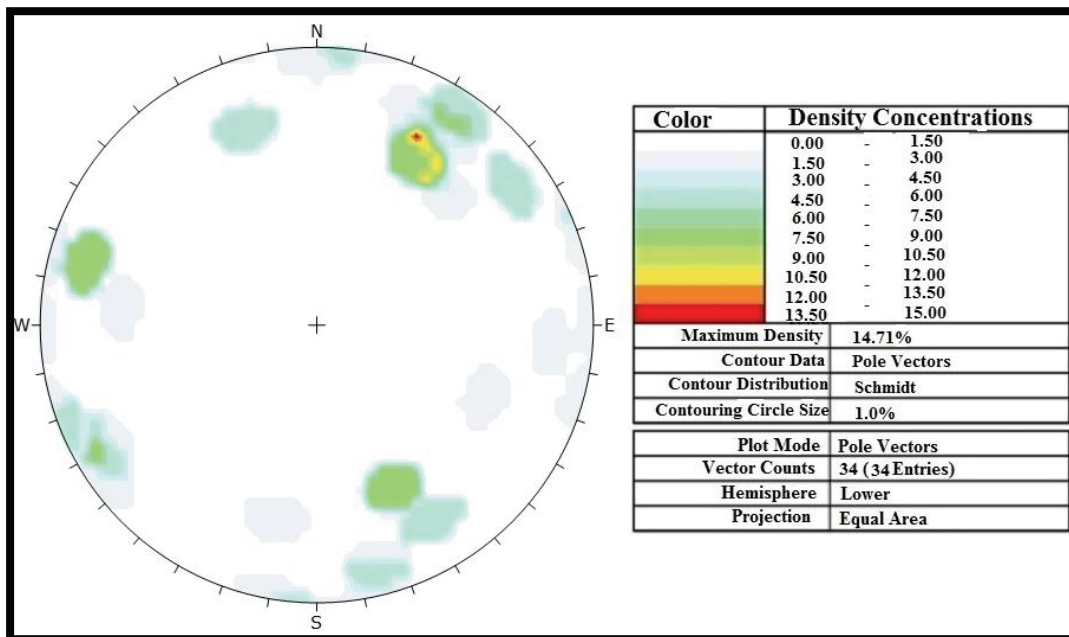
**Figure 3.14** Contour diagram of the discontinuities at the 8<sup>th</sup> location.

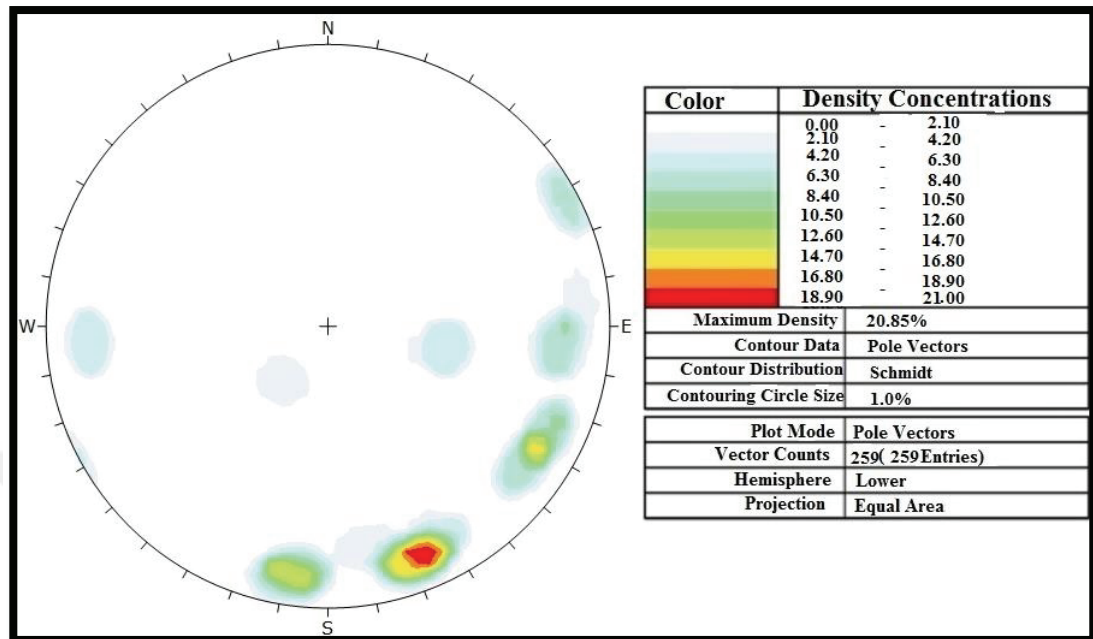
**Figure 3.18** Contour diagram of the discontinuities at the 11<sup>th</sup> location.

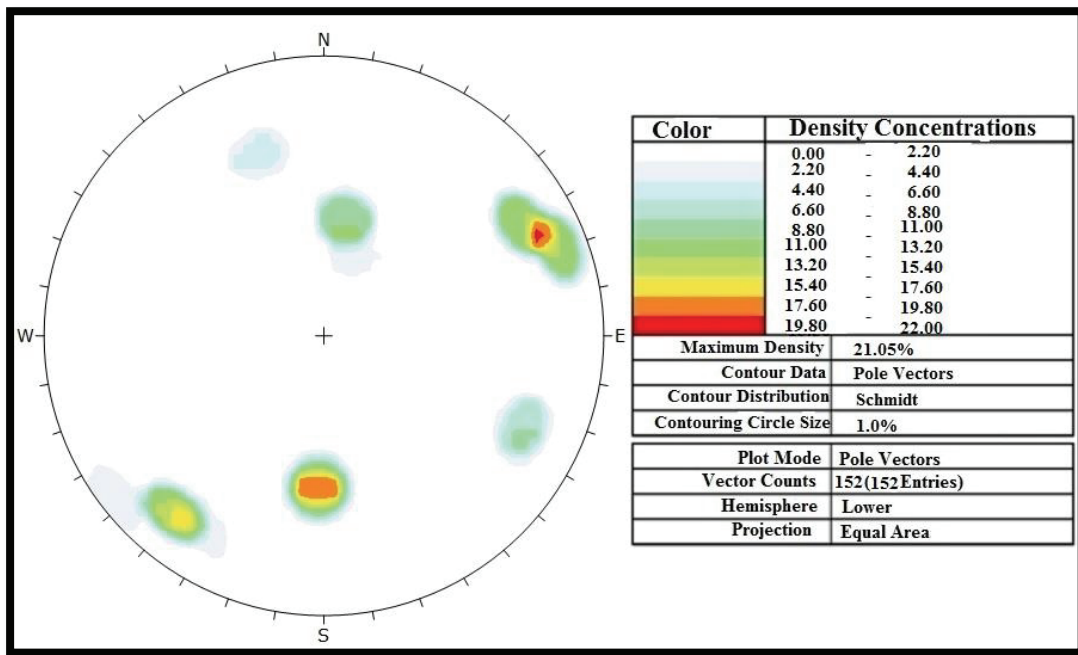
**Figure 3.19** Contour diagram of the discontinuities at the 12<sup>th</sup> location.

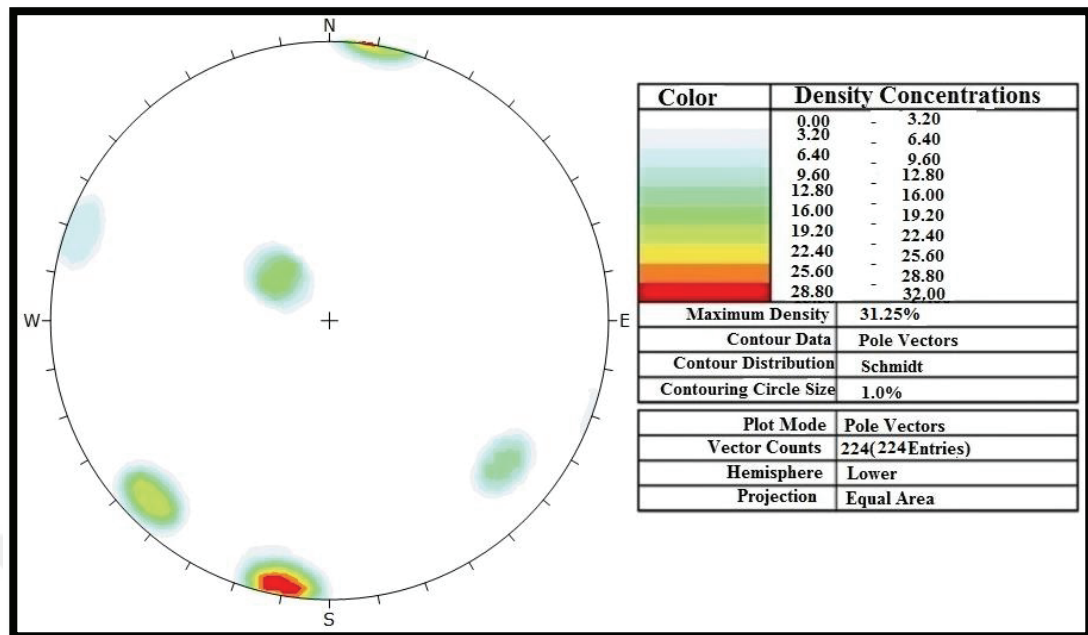
**Figure 3.20** Contour diagram of the discontinuities at the 13<sup>th</sup> location.

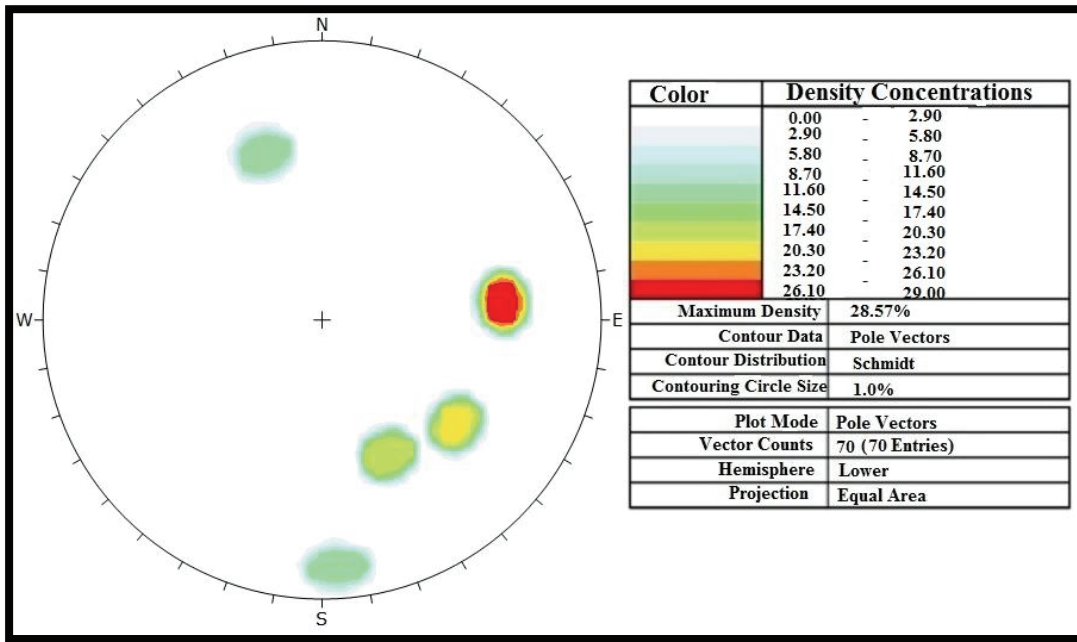
Figure 3.21 Contour diagram of the discontinuities at the 14<sup>th</sup> location.

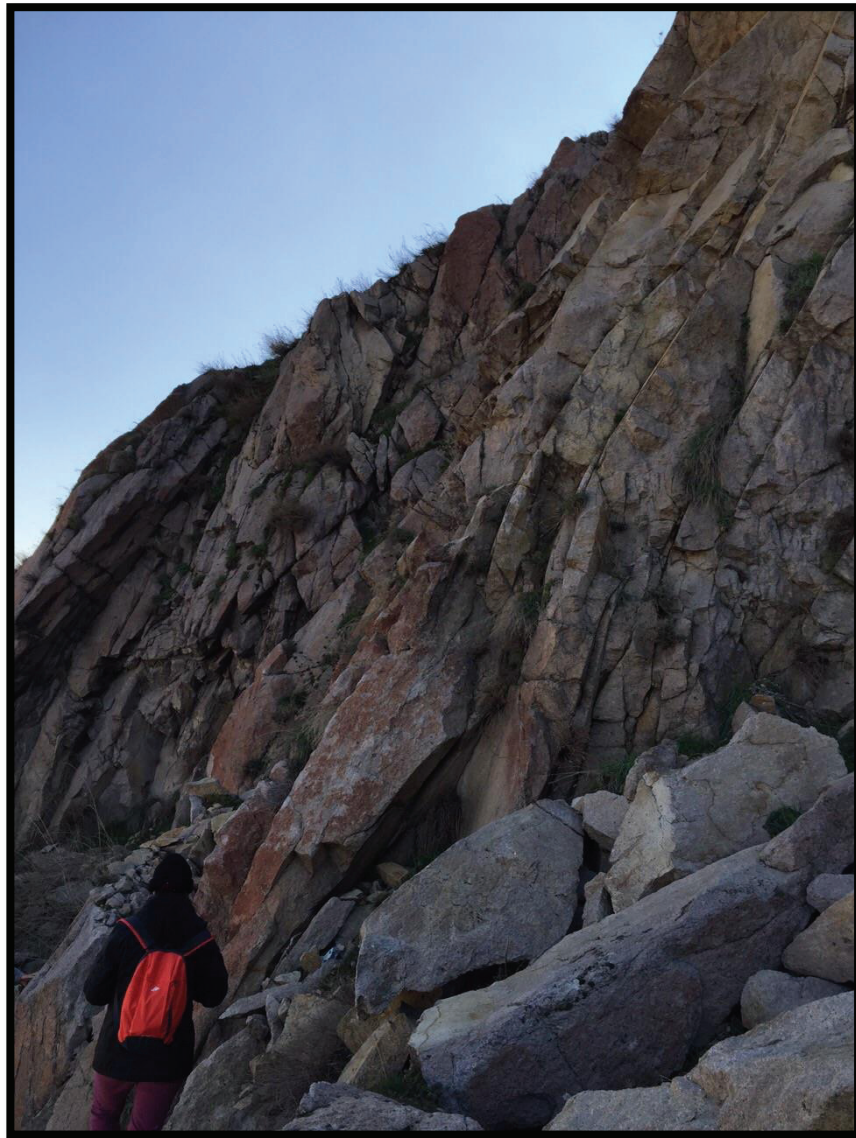
**Figure 3.22** Outcrop of the highly fractured andesite with some blocks already detached and fallen down.

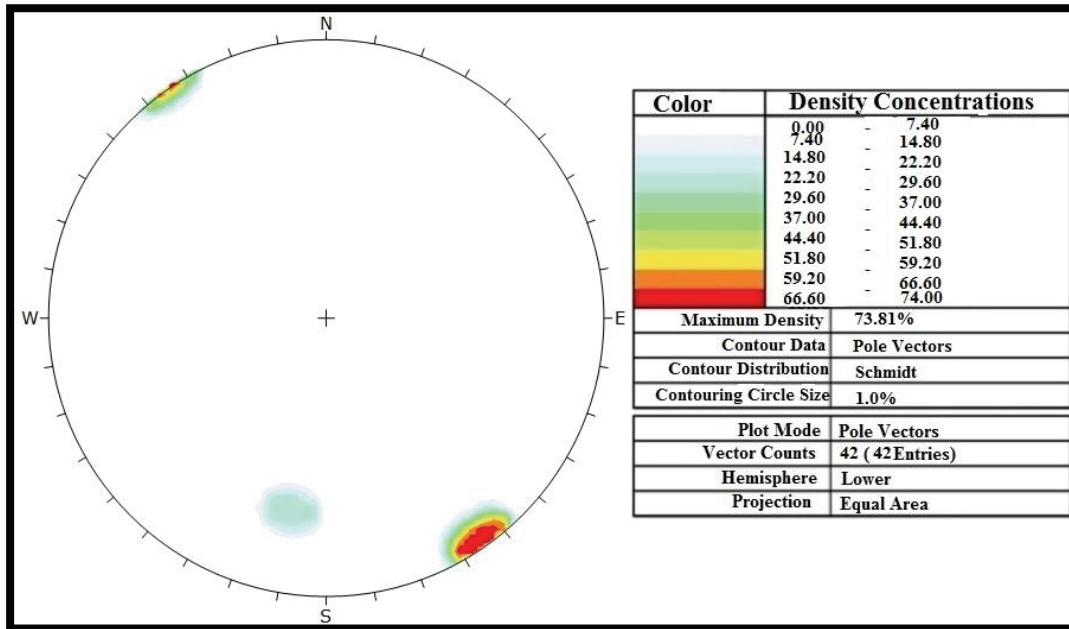
**Figure 3.23** Contour diagram of the discontinuities at the 15<sup>th</sup> location.

only at the surface. The flow layers have properties similar to those of the cooling joints except that they do not infilling material.

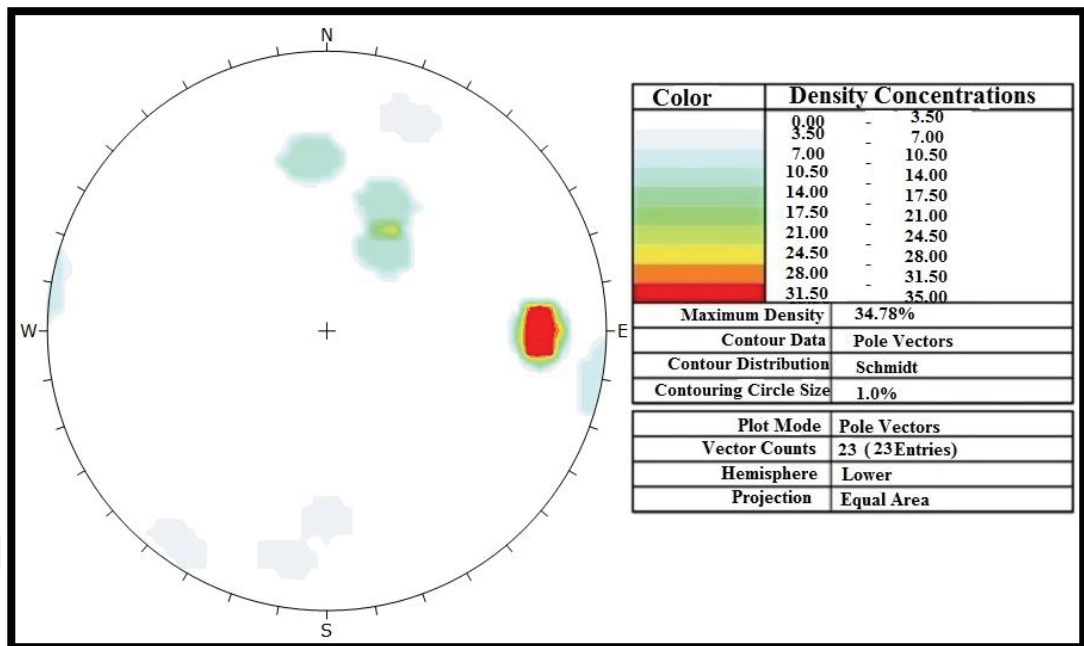
**Figure 3.24** Contour diagram of the discontinuities at the 16<sup>th</sup> location.

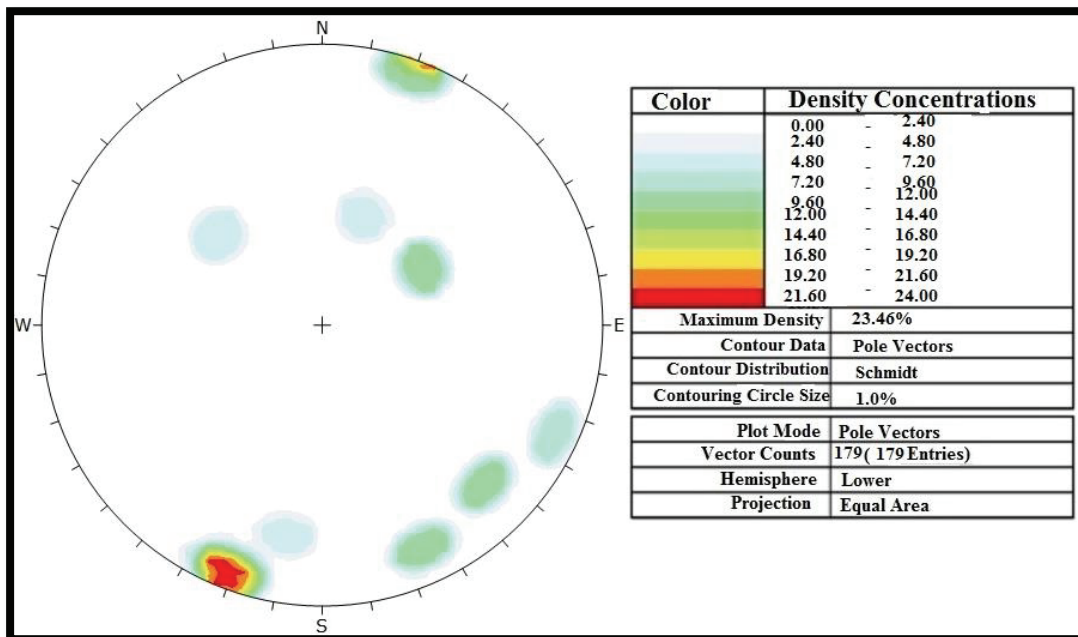
**Figure 3.25** Contour diagram of the discontinuities at the 17<sup>th</sup> location.
