INVESTIGATION OF ROCKFALL AROUND ANKARA CITADEL

A THESIS SUBMITTED TO  
THE GRADUATE SCHOOL OF NATURAL AND APPLIED SCIENCES  
OF  
THE MIDDLE EAST TECHNICAL UNIVERSITY

IN PARTIAL FULFILLMENT OF THE REQUIREMENTS  
FOR  
THE DEGREE OF MASTER OF SCIENCE  
IN  
GEOLOGICAL ENGINEERING

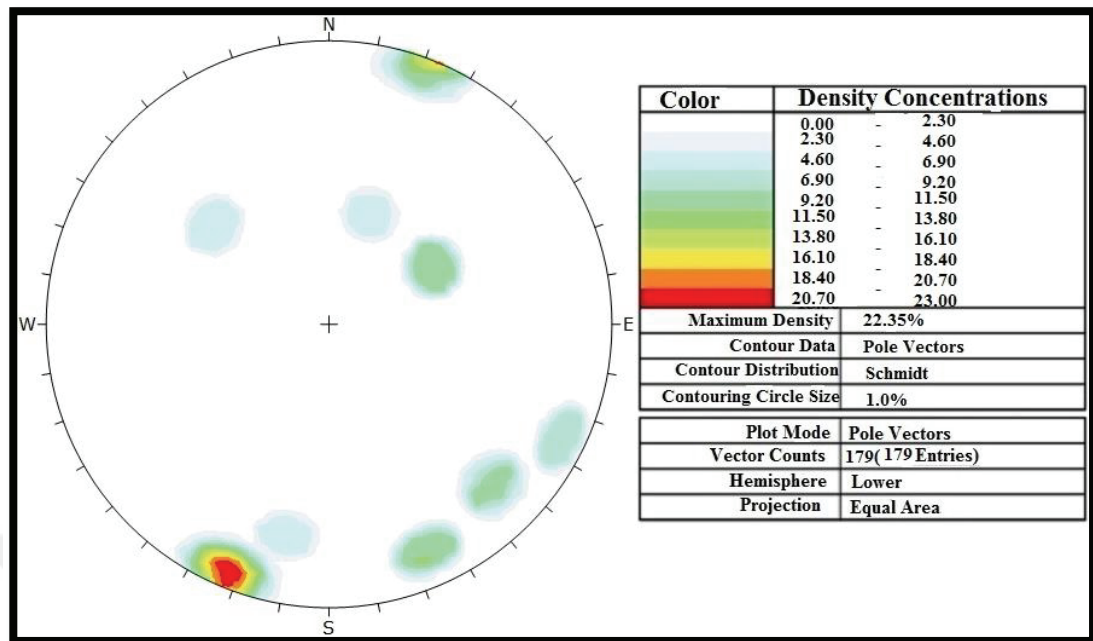
**Figure 3.26** Contour diagram of the discontinuities at the 18<sup>th</sup> location.

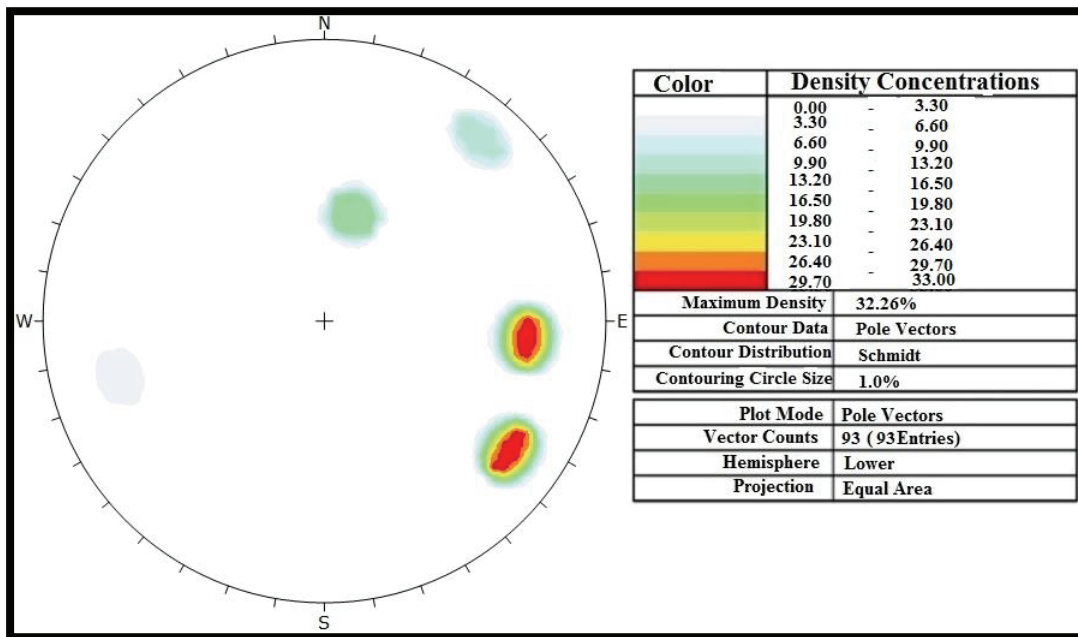
**Figure 3.27** Contour diagram of the discontinuities at the 19<sup>th</sup> location.

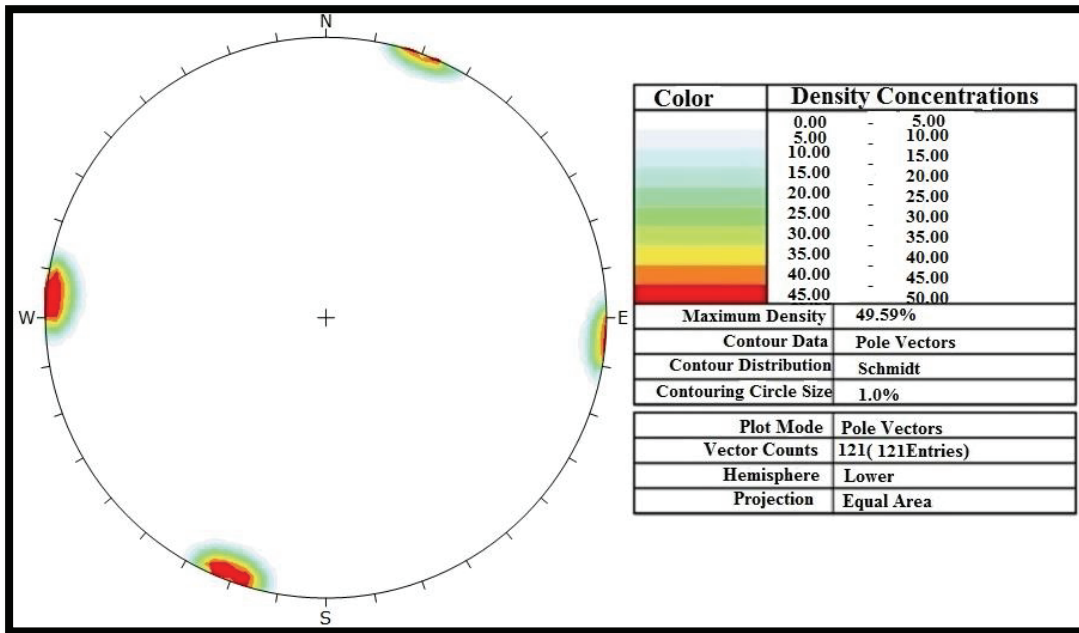
**Figure 3.29** Contour diagram of the discontinuities at the 21<sup>th</sup> location.

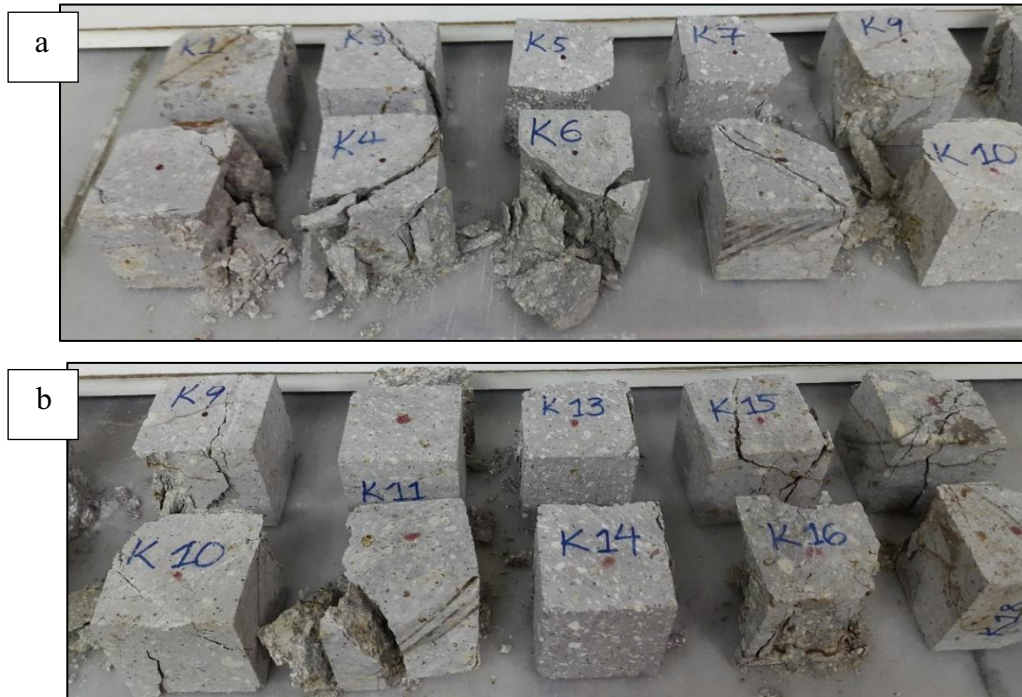
**Figure 3.35** (a) Dry and (b) Saturated samples after UCS test.

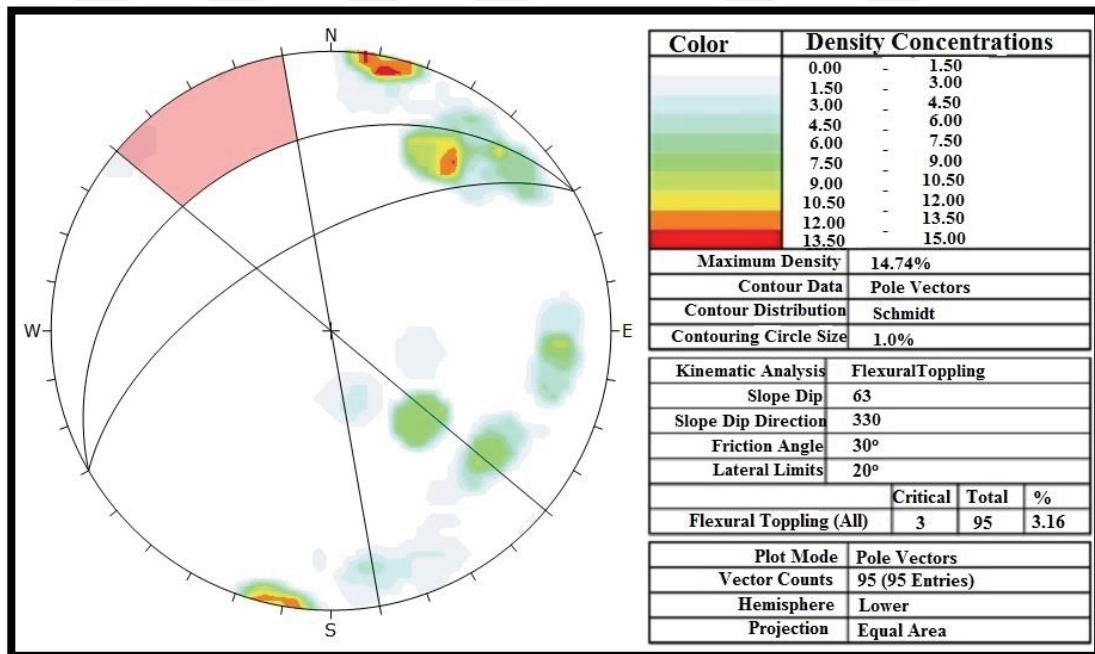
Figure 4.3 Kinematic failure for toppling failure of the 10<sup>th</sup> stop.

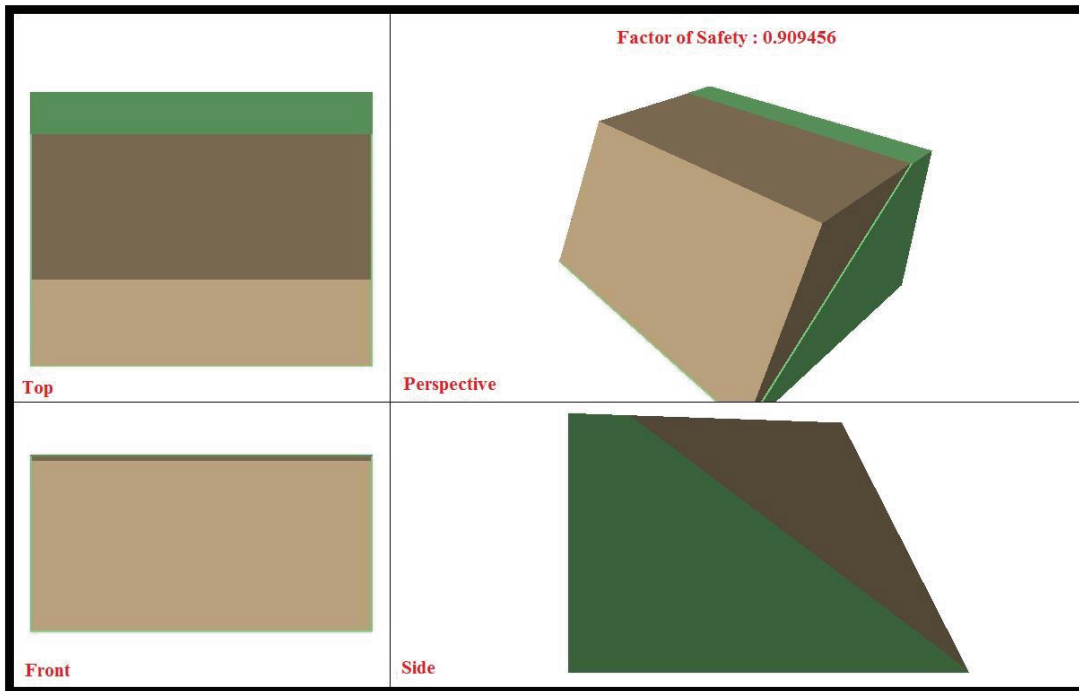
**Figure 4.4** The result of the limit equilibrium analysis of planar failure for the 10<sup>th</sup> stop.

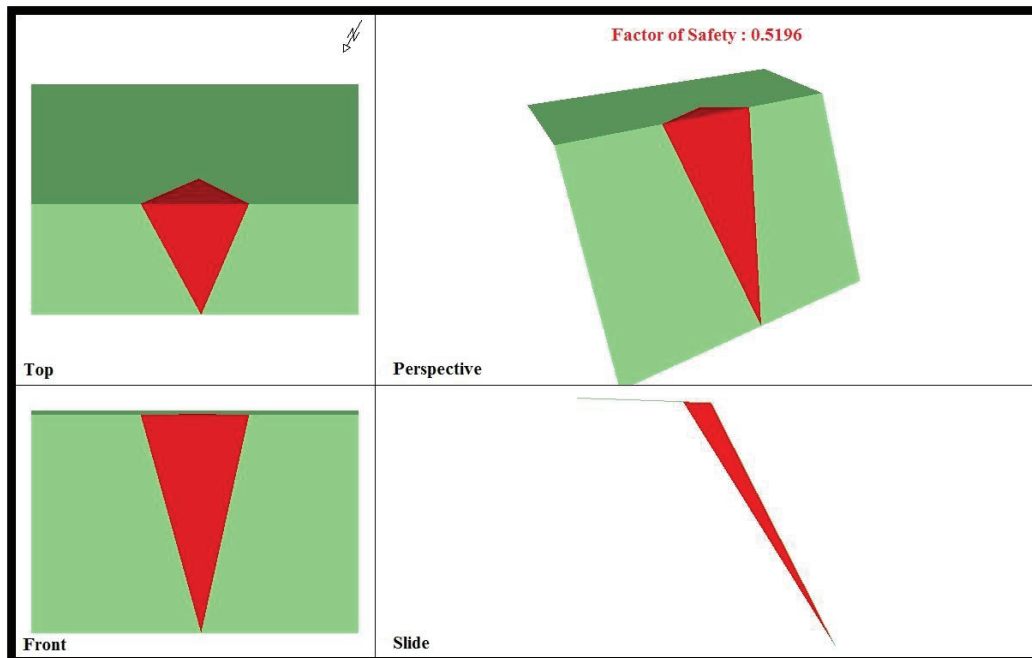
**Figure 4.5** The result of the limit equilibrium analysis of wedge failure of the 10<sup>th</sup> stop.

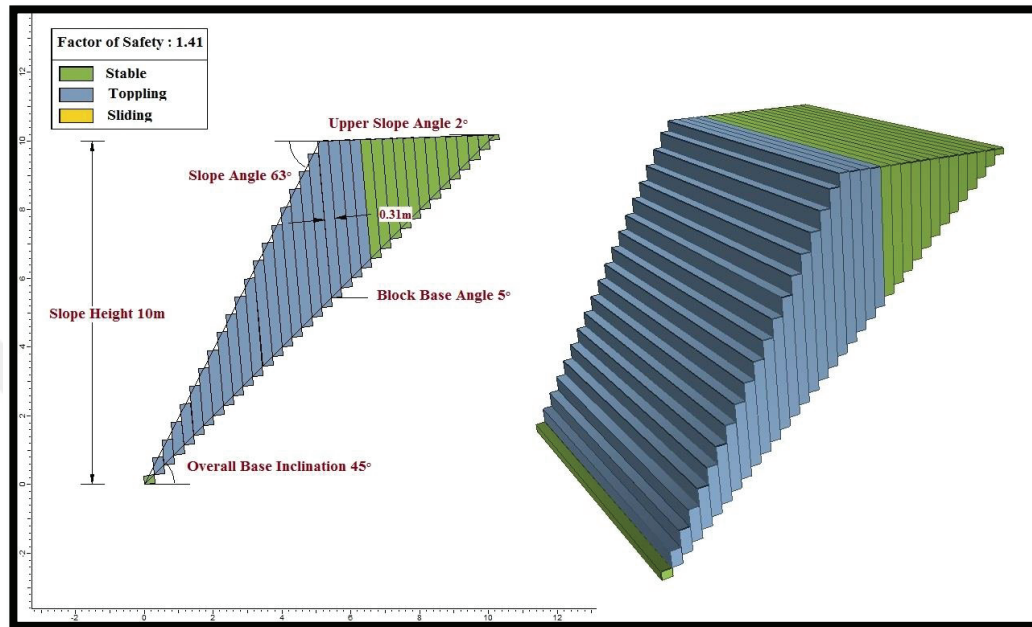
**Figure 4.6** The result of limit equilibrium analysis of toppling failure of the 10<sup>th</sup> stop.

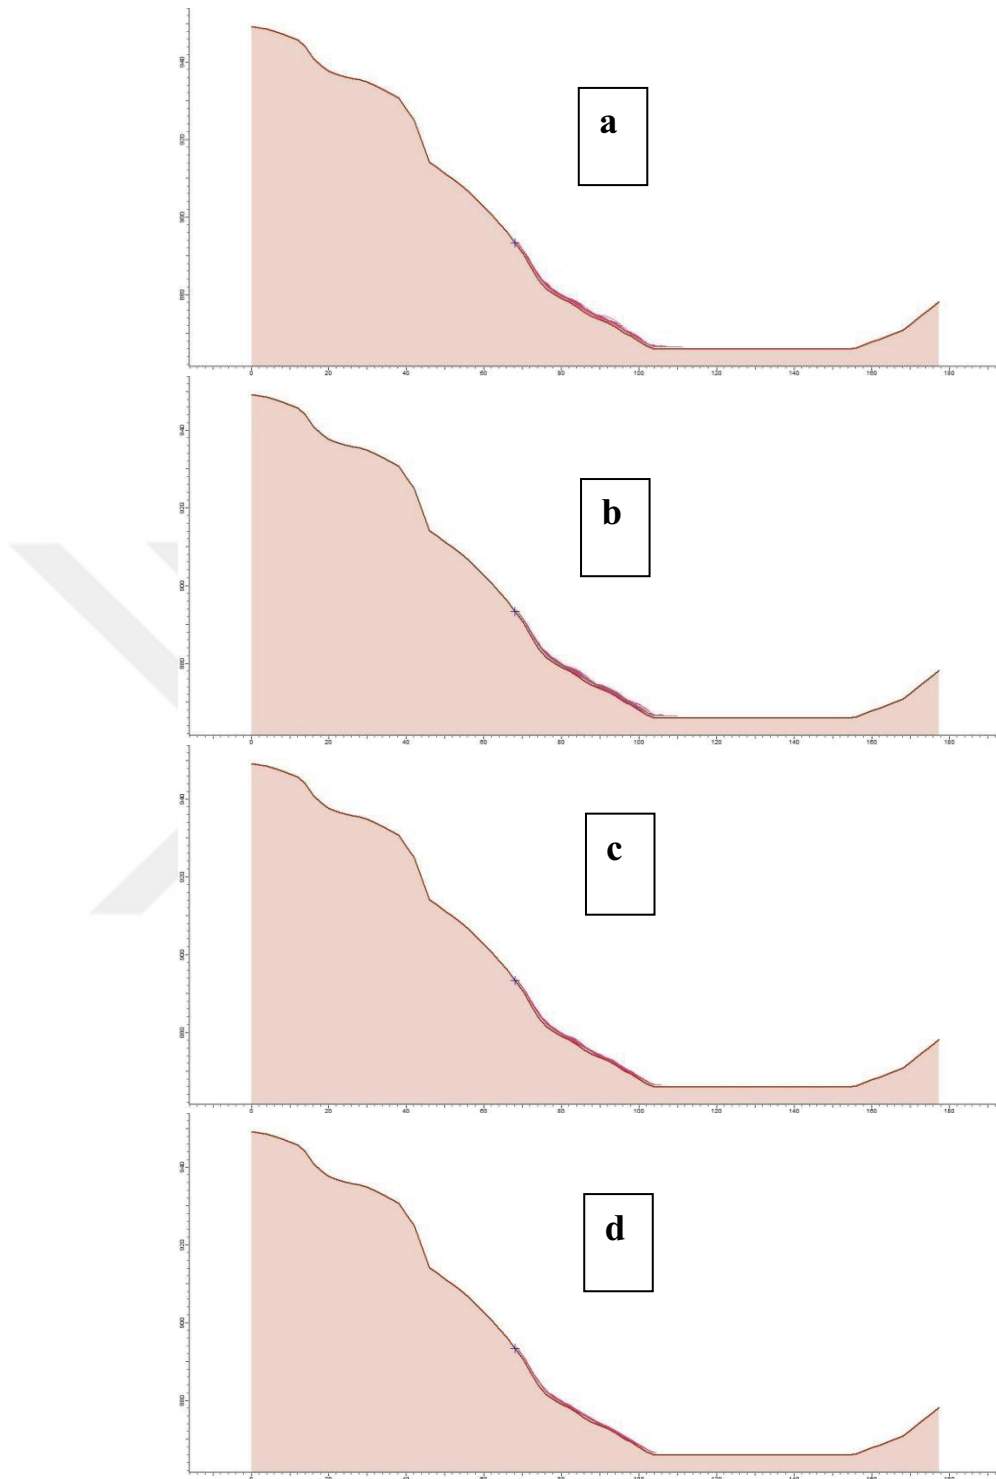
**Figure 4.8** The result of the back analysis using different rolling resistance values of 0.4 (a), 0.65 (c), 0.9(c) and 1.31 (d).

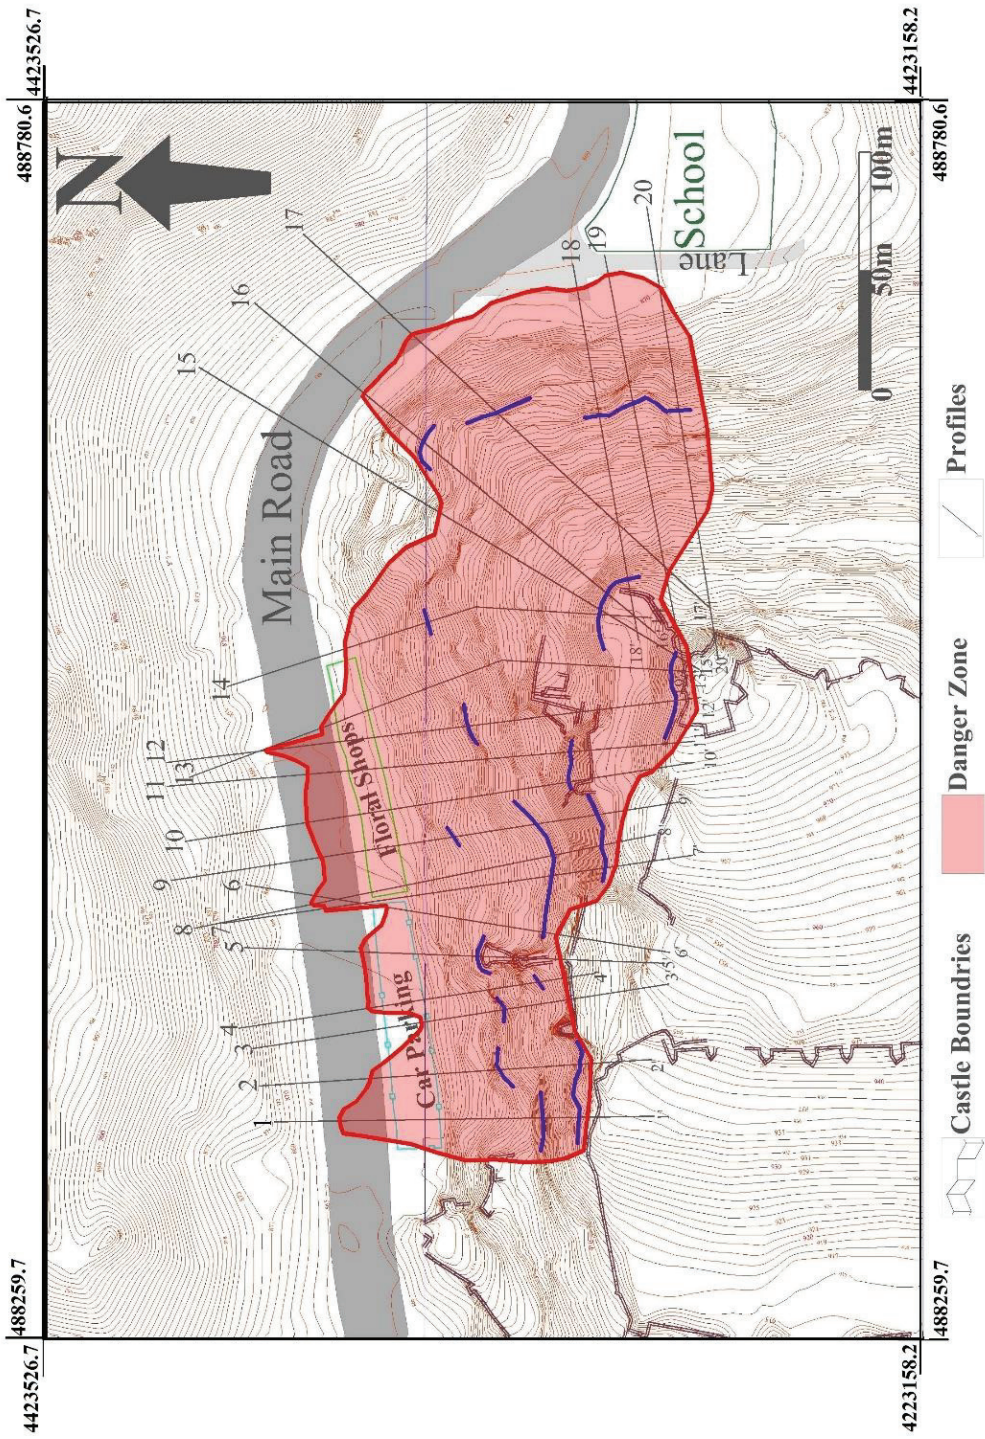
Figure 4.11 Danger zone assessed from the analyses with 500kg weights of rocks.

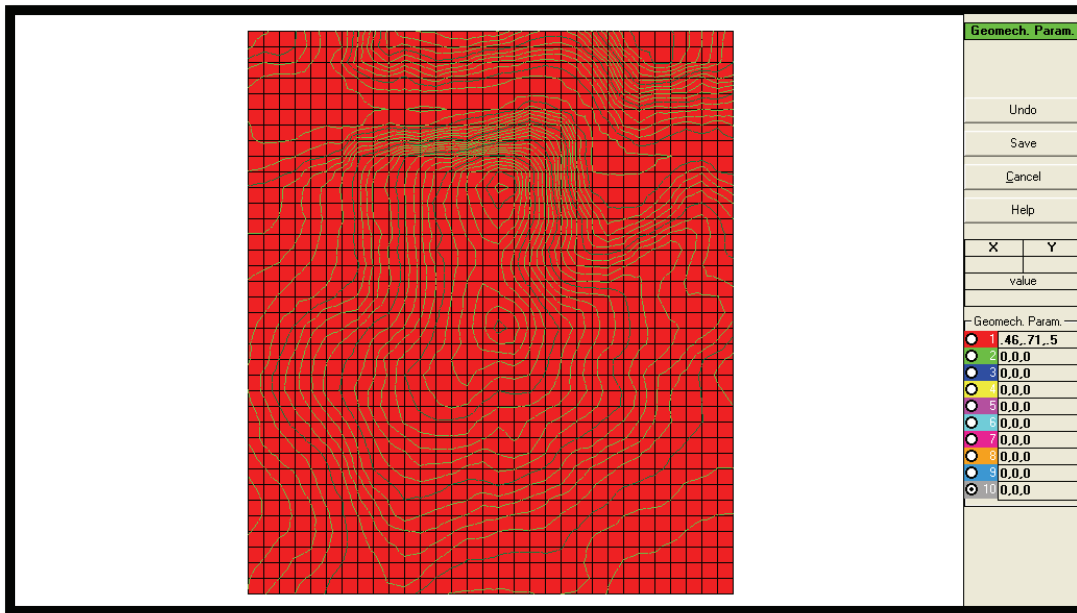
**Figure 4.15** Study area assigned with single set of geotechnical parameters input with one color in the ROTOMAP software.

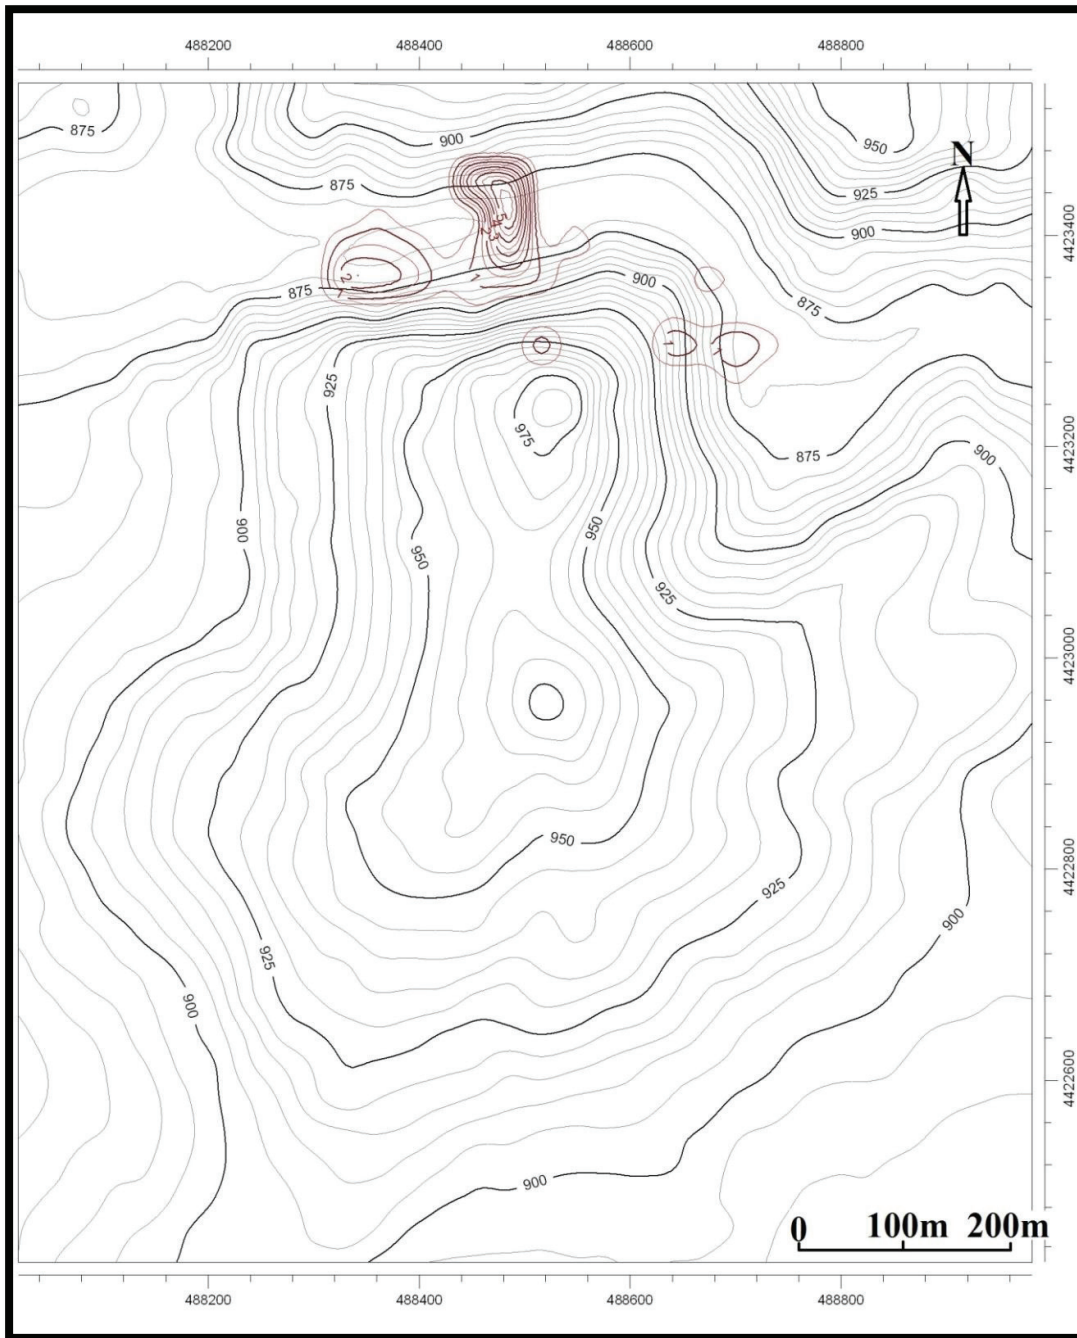
**Figure 4.17** Map with bounce heights obtained from 3D analysis.

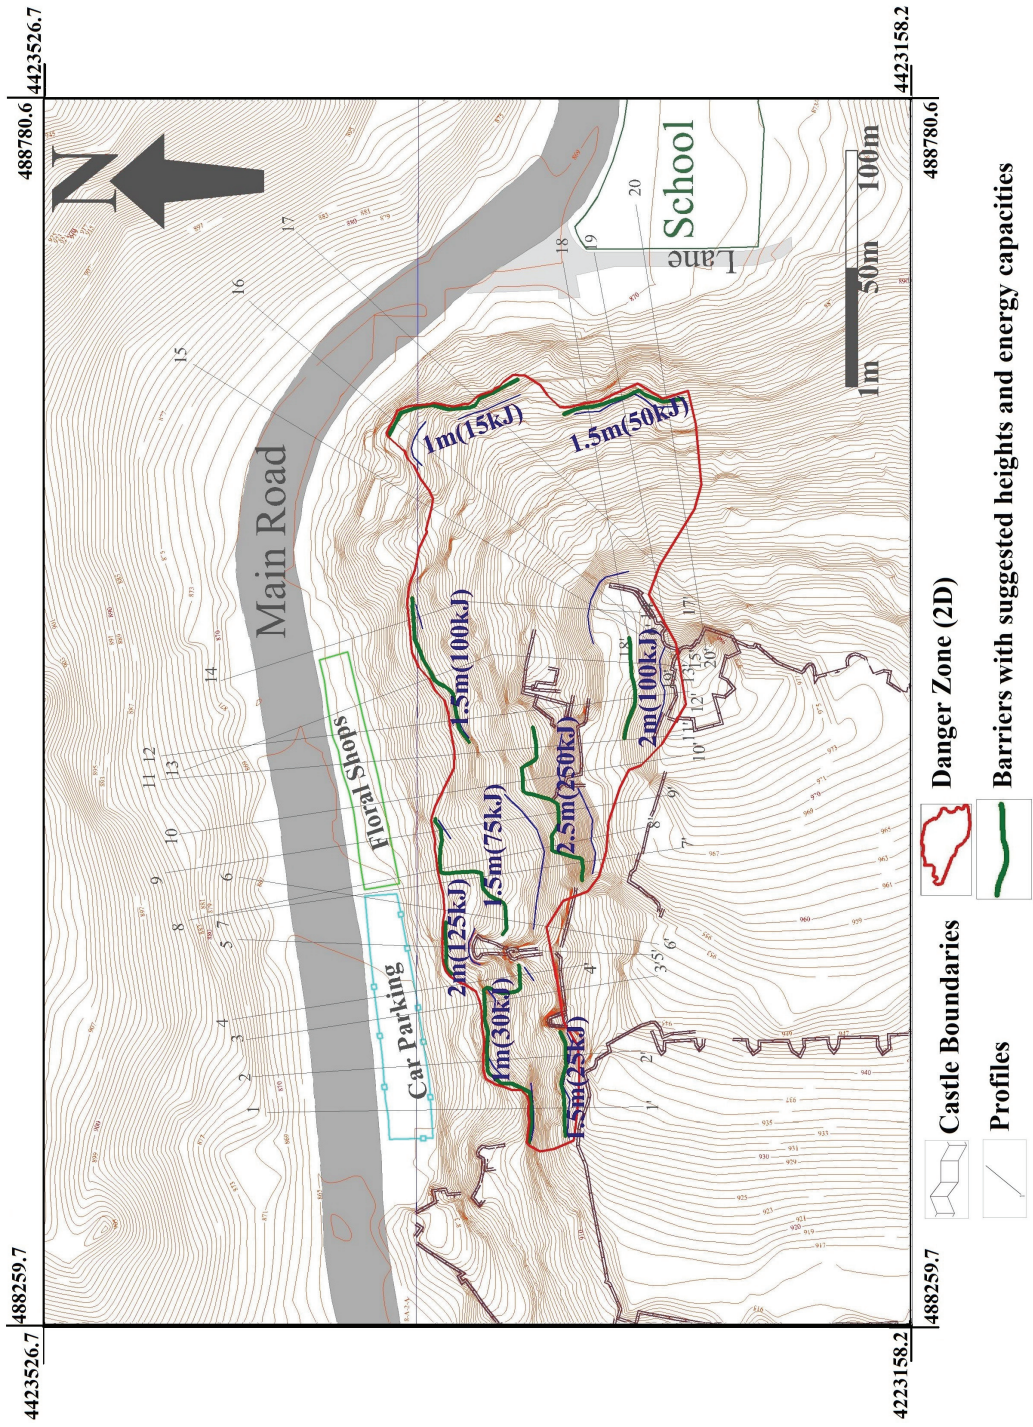
**Figure 5.4** Design for installation of barriers on the slope to prevent rockfall damage in the study area.
