DESIGN OF A HIGH TEMPERATURE EROSION APPARATUS FOR TESTING  
OF BOILER TUBES

A THESIS SUBMITTED TO  
THE GRADUATE SCHOOL OF NATURAL AND APPLIED SCIENCES  
OF  
MIDDLE EAST TECHNICAL UNIVERSITY

OCTOBER 2010

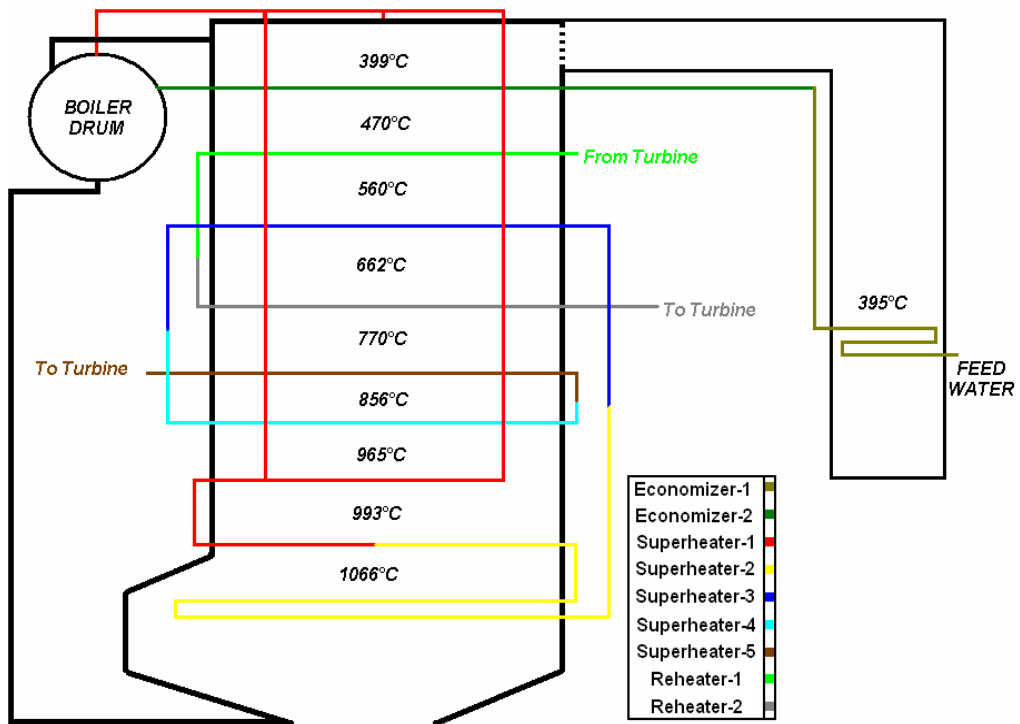
Figure 2.2 Temperature distributions inside the boiler in Çayırhan power plant [7]

In thermal power plants, boiler tubes are selected from different grades of steel. **Table 2.3** gives the material grades used in different parts of boiler in Çayırhan power plant. This plant operates at 538°C and 166 bar pressure. Temperature distribution inside the boiler is given in **Figure 2.2**. As seen in the figure, the temperature is highest in the burning zone and decreases toward the top and across and down to economizer region. Temperature distribution in the boiler tubes are given in **Figure 2.3**. Here the values again refer to Çayırhan power plant. The temperature in the evaporator tubes is quite low. The temperature at the inlet part of the superheater is 346°C and it increases to 538°C at the outlet. At the reheater, the steam returns from the turbine at 364°C and heated up again to 538°C. In the exit zone of the boiler, the temperature in the economizer ranges from 316°C to 250°C.

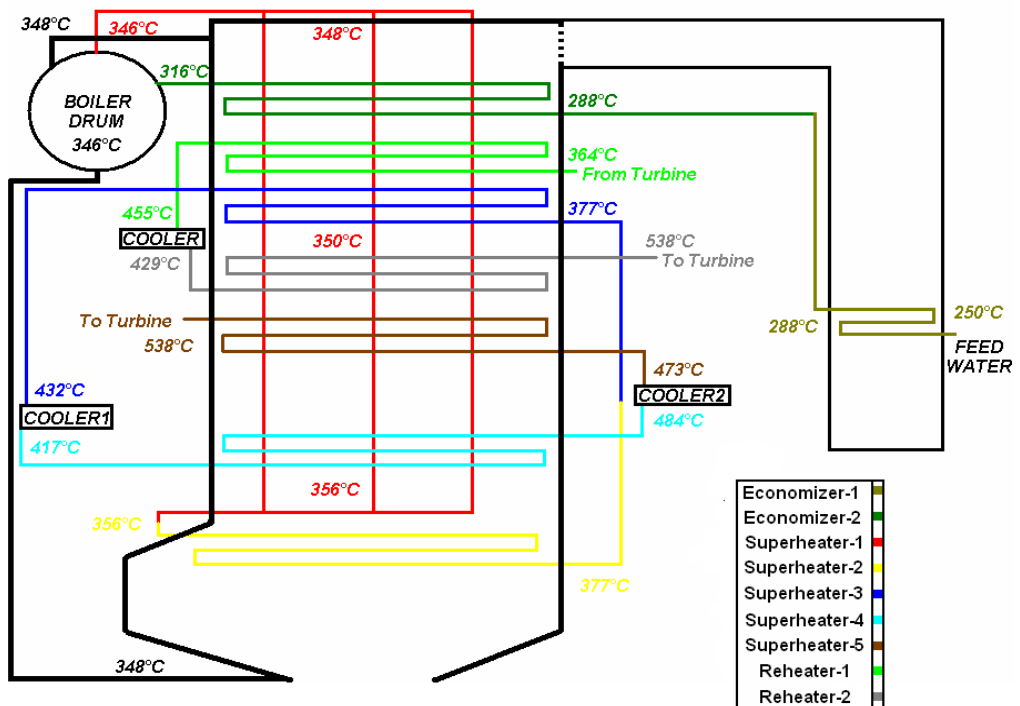
Figure 2.3 Steam temperatures in boiler tubes in Çayırhan power plant [7]

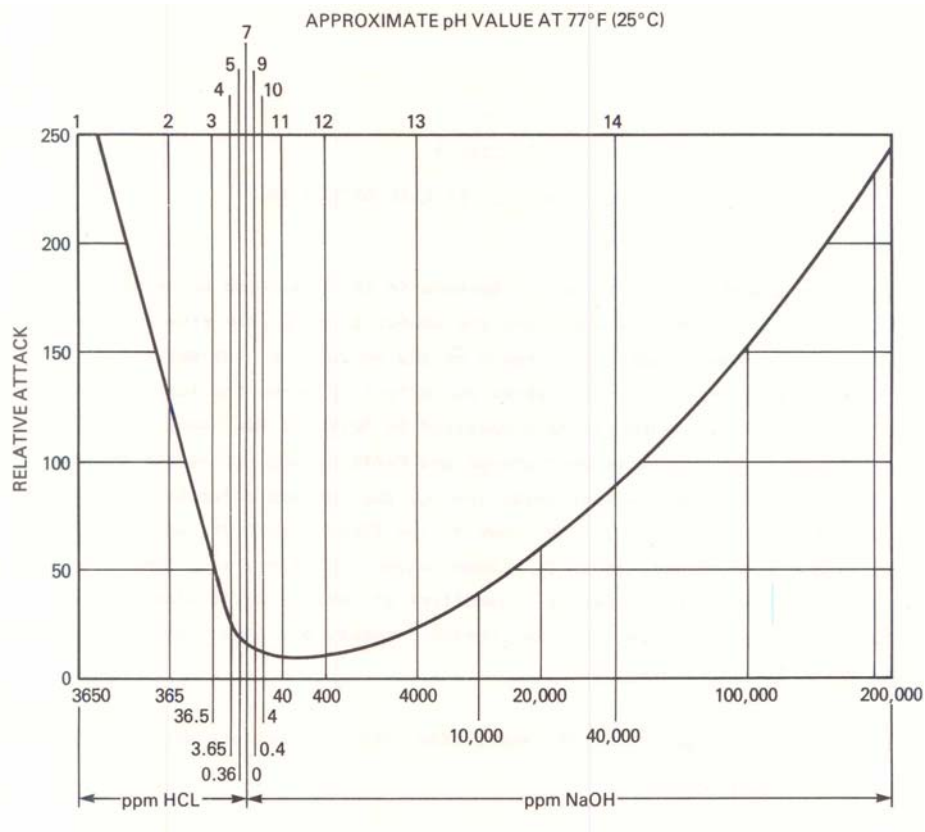
**Figure 2.4** Effect of pH on the rate of corrosion of steel by water at 310°C (Grabowski and Klein, 1964) [9]

that ceases the further reaction [8]. **Figure 2.4** is taken from Grabowski and Klein [9] and shows the rate of attack in steel as function of PH value. The figure shows that the protective magnetite is unstable and soluble at pH values below 5 and above 12. Normally, in the boiler, water treatment is carried out so as to maintain a moderately alkaline environment so as to prevent the oxide dissolution. EPRI subcategorizes the water-side corrosion into four types which are caustic corrosion, hydrogen damage, pitting (localized corrosion) and stress corrosion cracking. (see Ref. 4)

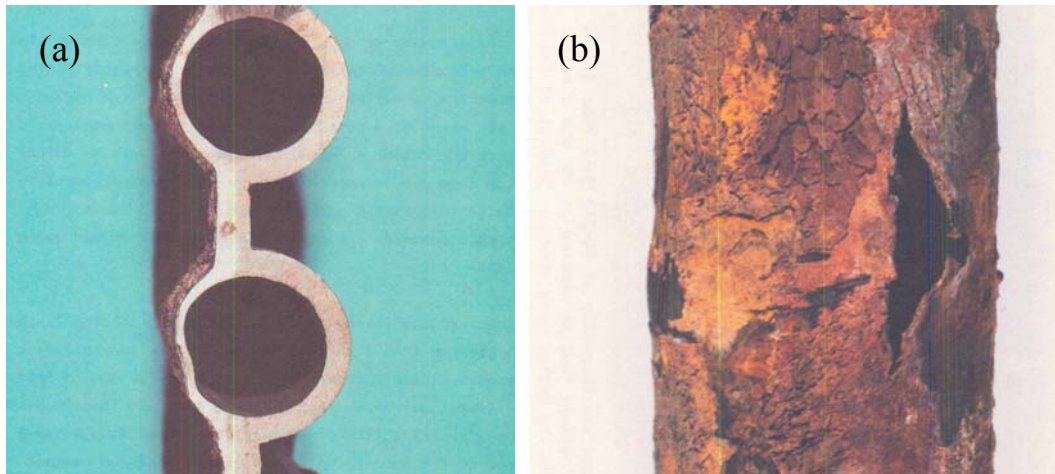
**Figure 2.5 a)** Waterwall fire-side corrosion, **b)** High temperature coal ash corrosion (EPRI Report, 2004) [4]

The fire-side corrosion refers to corrosion formed on the outer surface of the boiler tubes. The occurrence of fire-side corrosion and the operation life of the boiler tube depend on the fuel ingredients and the metal temperatures [4]. According to EPRI, corrosion failure may be subdivided into subcategories as low temperature corrosion, waterwall fire-side corrosion, high temperature coal ash corrosion. An example of waterwall fire-side corrosion taken from the 2004 EPRI report is given in **Figure 2.5**. This corrosion is reported to occur as a result of incomplete fuel consumption, i.e. at reducing atmosphere which results in the formation of low melting point pyrosulfates (less than  $427^\circ\text{C}$ ). These molten pyrosulfates may remove the magnetite formed on the surface of the tube and this causes metal disintegration in the outer surface of the tube [11]. High temperature coal ash corrosion is experienced in the superheaters and reheater tubes [12]. This is also known as liquid phase corrosion and is observed when the metal temperature is in the range between  $595^\circ\text{C}$  and  $705^\circ\text{C}$ .

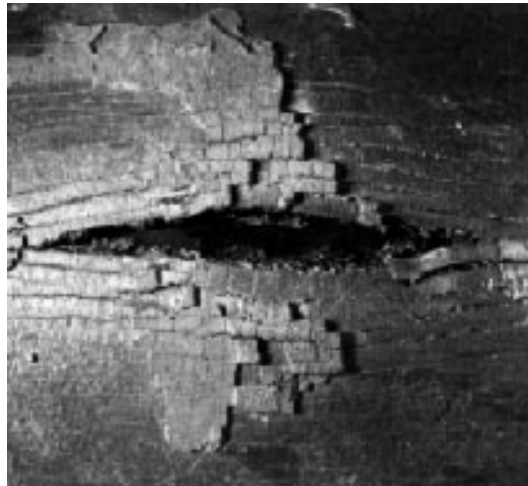
**Figure 2.6** Long-term overheating (Babcock & Wilcox Company) [13]

An example of long-term overheating taken from Babcock and Wilcox [12] is given in **Figure 2.6**. This failure quite common in superheater and reheater tubes is actually a high temperature creep. The timing of failure depends on the level of stress and temperature. The tube may rupture earlier due to high creep rate when the stress and temperature pass over the design values. Long-term overheating failure can be observed also in water wall tubes [13]. In this case, due to scale or deposits that forms at the water-side or due to restricted flow of water/steam, the temperature of the tubes goes up to very high values and the creep failure takes place.

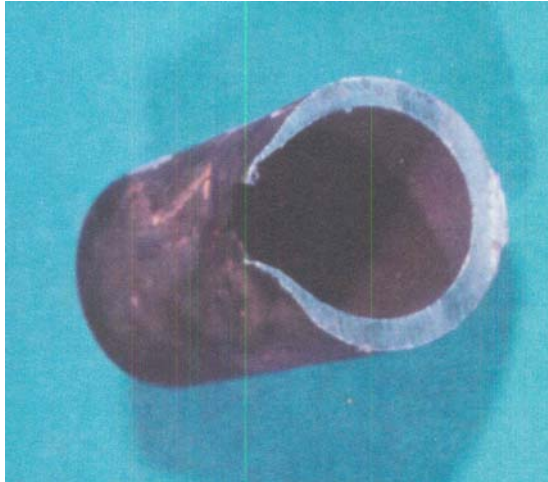
**Figure 2.9** Fly ash erosion thinning and failure (EPRI Report, 2004) [4]

According to EPRI [4], the fly ash erosion is quite common in economizer. As mentioned above, this is due to close spacing of the tubes. Another factor that contributes to this is the fact that the particles are cooler and more abrasive in this part of the boiler. Initially, the erosion leads to smooth, polished surface, but later on the surface deteriorates by the formation of flow traces and the other formations [12]. It then leads to wall thinning and finally to the tube rupture, **Figure 2.9**.

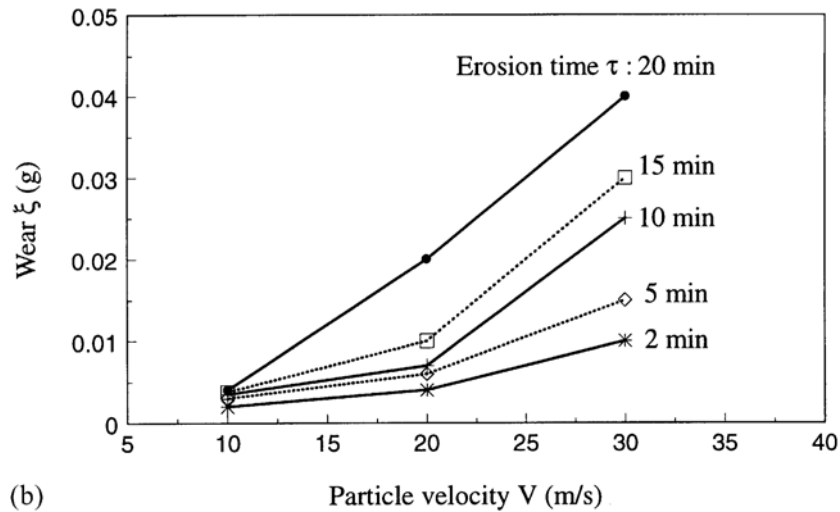
**Figure 2.11** Effect of particle velocity on erosion wears (The erosion conditions are  $c=185.6 \text{ g/m}^3$ ,  $\alpha=90^\circ$ ) (Zhang et al., 2001) [17]

Impact velocity of the ash particles was investigated by Zhang et al. [17] and they found that the erosion rate increases with increasing velocity. **Figure 2.11** is taken from Zhang et al. which shows that the relationship is not linear. As seen in the figure, the erosion rate increases more rapidly at higher values of the impact velocities. Zhang et al. explain this based on the argument that impact energy is proportional to square of the velocity. The effect of the impact velocity was also studied by Suckling and Allen [18] who has reported similar results, see **Table 2.7**.

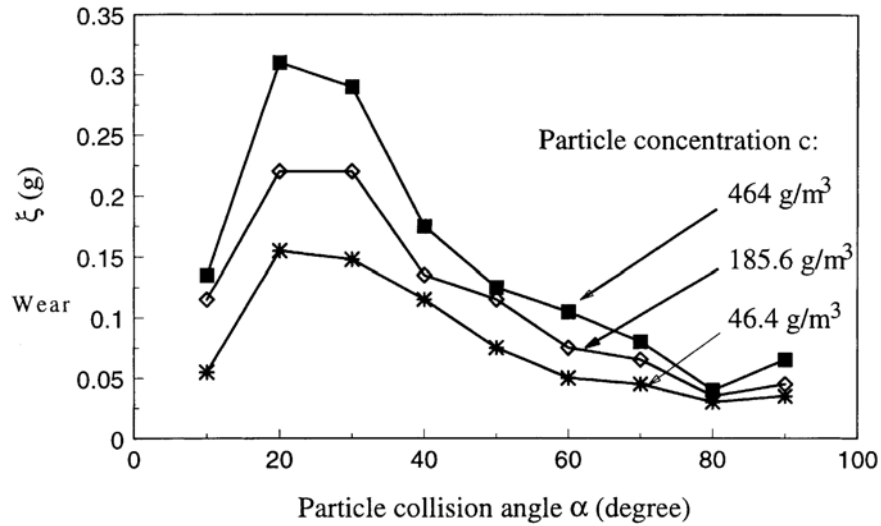
**Figure 2.12** Variation of material removal with particle collision angle (The erosion conditions are  $V=20 \text{ m/s}$ ,  $t=52 \text{ min.}$ ) [21] (Zhang et al., 2001) [17]

Zhang et al. in their study also looked at the effect of the impact angle on the erosion. Working on a ductile tube specimen (AISI 1015), they found that the erosion varied as a function of impact angle. Using SEM (Scanning Electron Microscope) they observed that at rubbing and scratching up to  $10^\circ$  of impact angle. At  $20^\circ$  the effect was in the form of cutting. At  $30^\circ$ , cracking, at  $60^\circ$  extrusion and finally at  $90^\circ$ , they observed sputtering. The effect on erosion, **Figure 2.12**, was such that the rate was highest at impact angle of  $20^\circ - 30^\circ$ .

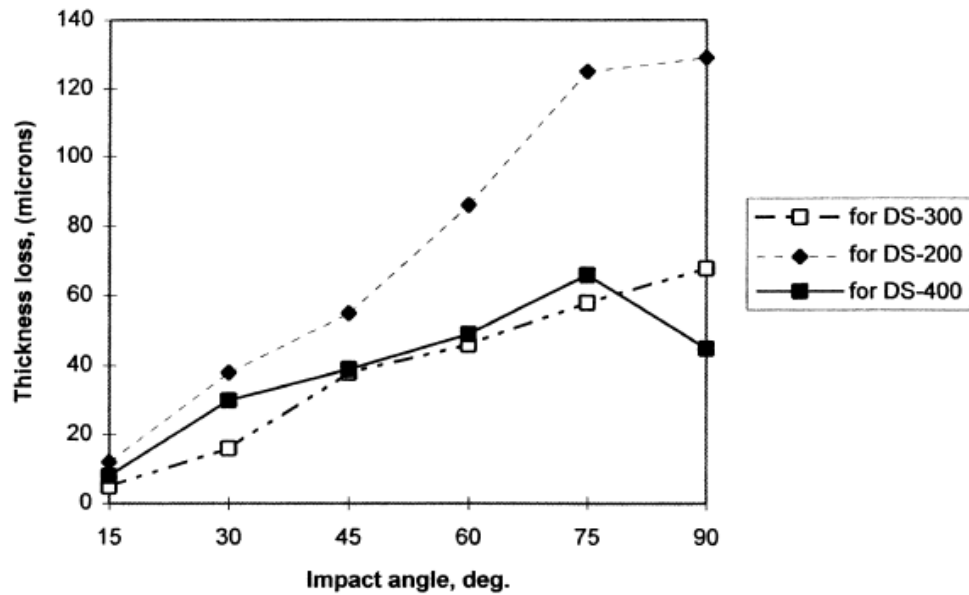
**Figure 2.13** Erosion thickness loss vs. impact angle for three coatings eroded by bed ash (under  $V=60 \text{ m/s}$ ,  $T=300^\circ\text{C}$ ,  $t=5 \text{ hours}$ ,  $375 \text{ g}$ ) (DS-200= $\text{Cr}_3\text{C}_2\text{-NiCr}$ , DS-300= $\text{Cr}_3\text{Cr}_2/\text{TiC-NiCrMo}$ , DS-400= $\text{NiAl-40Al}_2\text{O}_3$ ) (Wang and Lee, 1999) [19]

The effect of impact angle depends on material. Wang and Lee [19] have studied the effect of impact angle on the erosion of NiAl-40Al<sub>2</sub>O<sub>3</sub> (DS400) coating and found that the erosion increases with increasing impact angle, **Figure 2.13**.

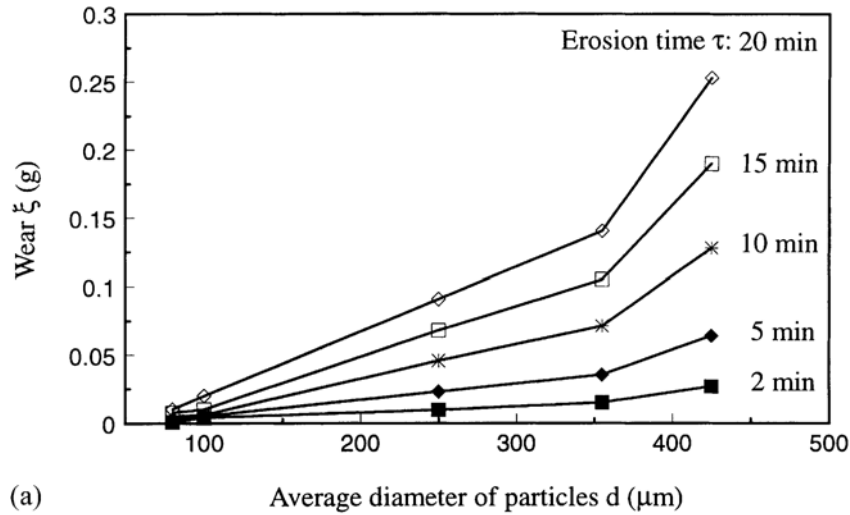
**Figure 2.14** Effect of particle size on erosion wear at various erosion time (The erosion conditions are  $V=20$  m/s,  $c=185.6$  g/m<sup>3</sup>,  $\alpha=90^\circ$ ) [21]

Effect of particle size on erosion has been studied by Zhang et al. [17]. **Figure 2.14** is taken from their study and shows that the erosion increases with increasing particle size. Desale et al. [20] investigated three different erodent material; quartz, alumina and silicon carbide. The sample was AISI 304L steel. They examined the effect of particle shape, defined in terms of a shape factor, on erosion. The properties of the particle samples used in test are given in **Table 2.8**. Besides they observed also the effect of the erodent density on the erosion rate. The study has shown that increasing shape factor leads to erosion rate decrement and but increasing density affects the erosion rate positively. This can be derived from the surface roughness comparisons of the specimens. The surface roughness comparisons of two specimens with different particles at different angles for shallow and normal angle values are indicated in **Table 2.9**.

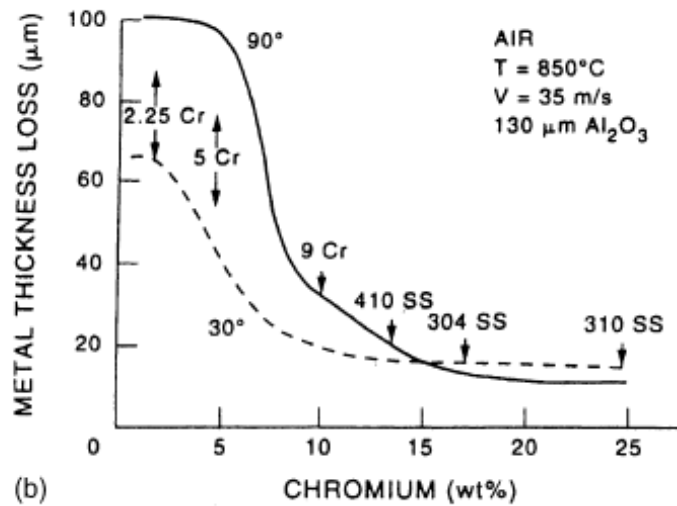
**Figure 2.16** Relationship between content of Cr in steels and erosion rate: a) data obtained by the centrifugal apparatus (particle: SiO<sub>2</sub> (average diameter: 23 μm), particle impingement angle: 30°, temperature of test piece: 700°C) and b) data obtained by blast type apparatus (Hayashia et al., 2003) [22]

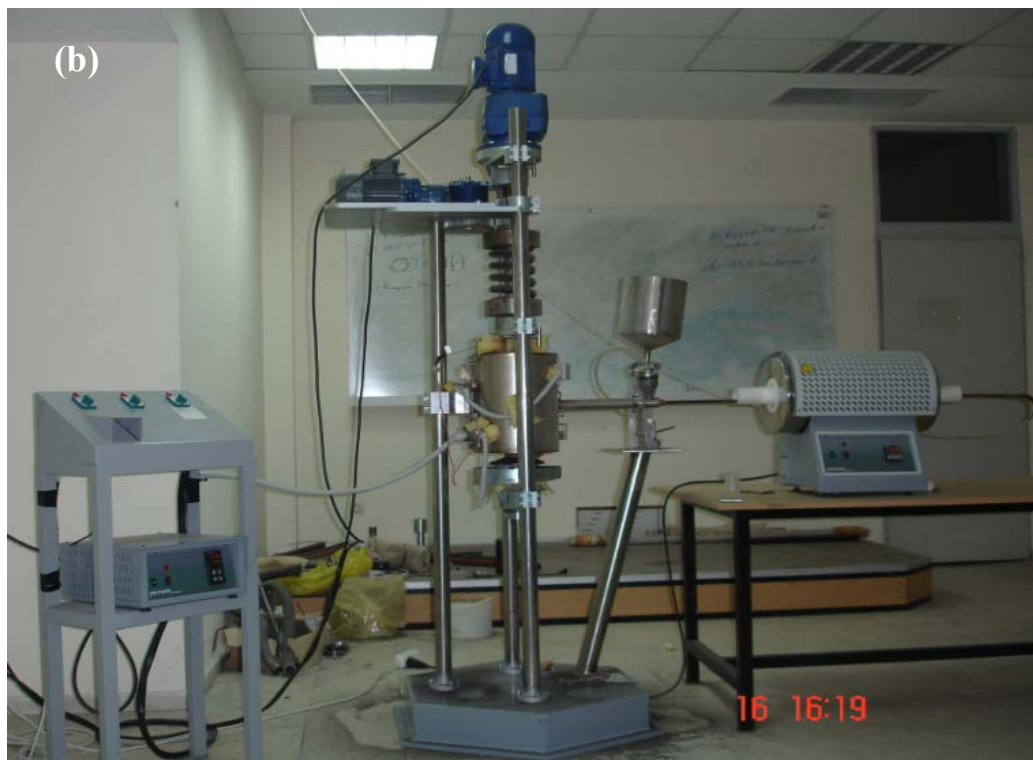
**Figure 3.1 a)** Schematic representation of test setup simulating operating condition of the thermal power plant boiler tubes **b)** Photograph of the test apparatus

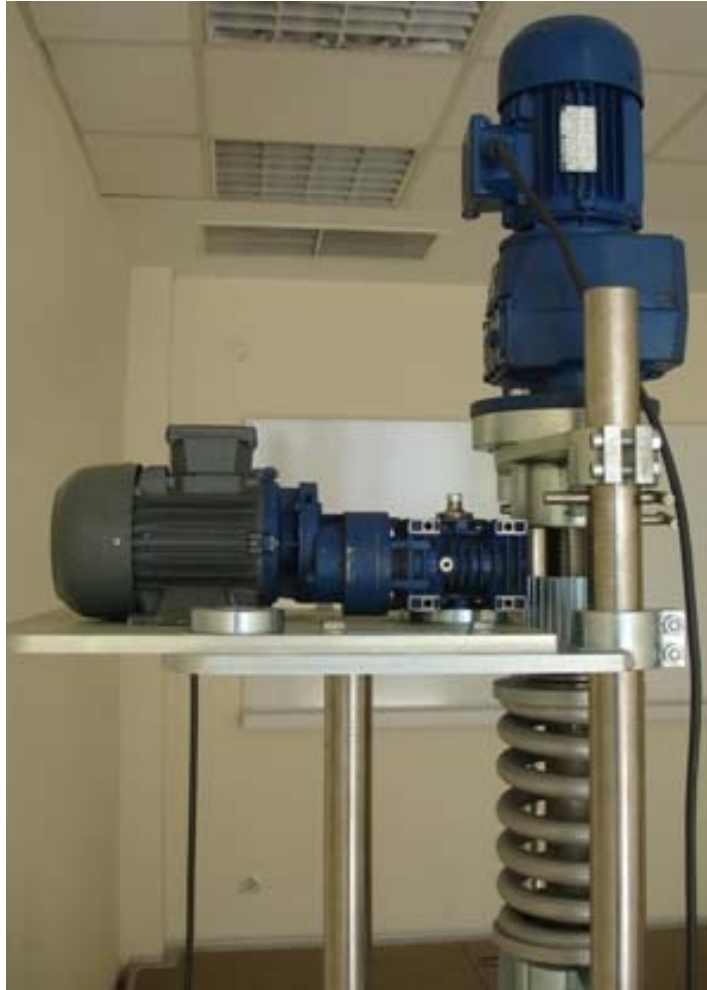
**Figure 3.5** Photograph of reduction gear motors and the spring.

Calculations show that to be able to compress the spring to apply force of 20,000 N it is necessary to apply a torque of approx. 300 Nm on spring gear. Since the reduction gear motor has a torque of 1033 Nm this is more than sufficient to compress the spring.

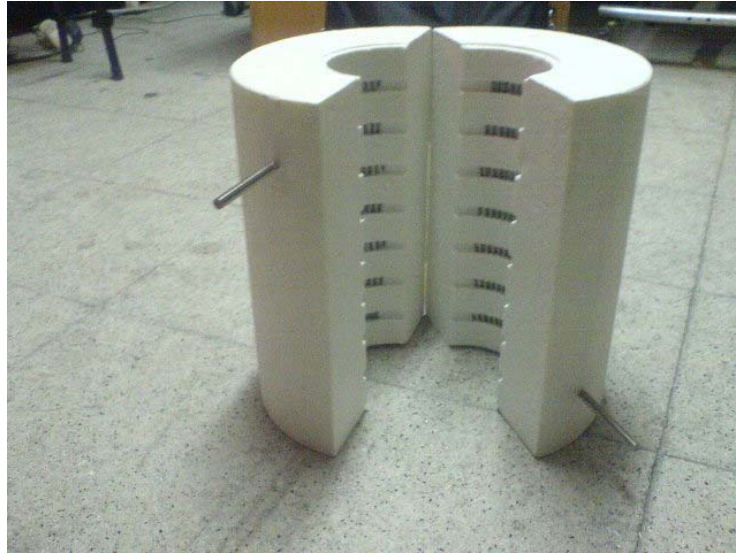
**Figure 4.5** Furnace refractory elements with embedded Khantal resistors

For heating system a split type furnace is used. This unit was connected to platform carrying the reduction gear motor. The furnace refractory ( $\text{Al}_2\text{O}_3\text{-SiO}_2$ ) with

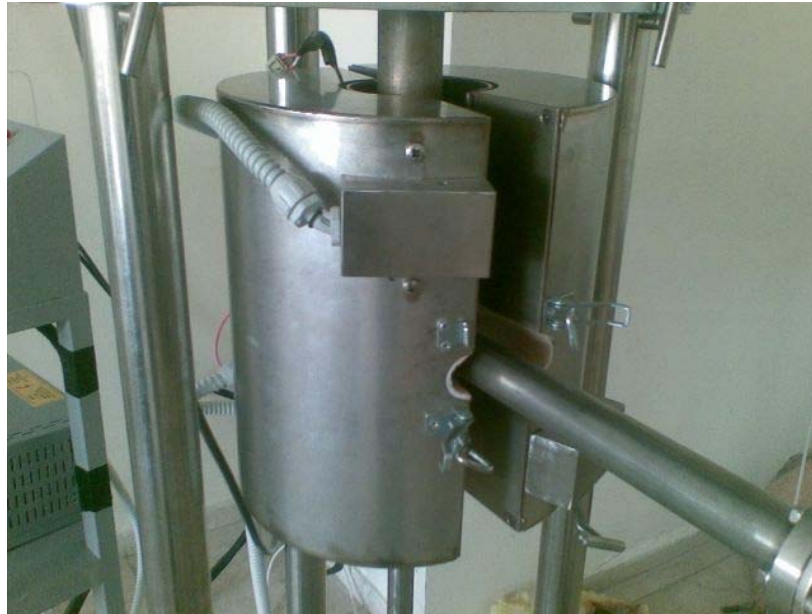
**Figure 3.7** Split furnace used in the experiments

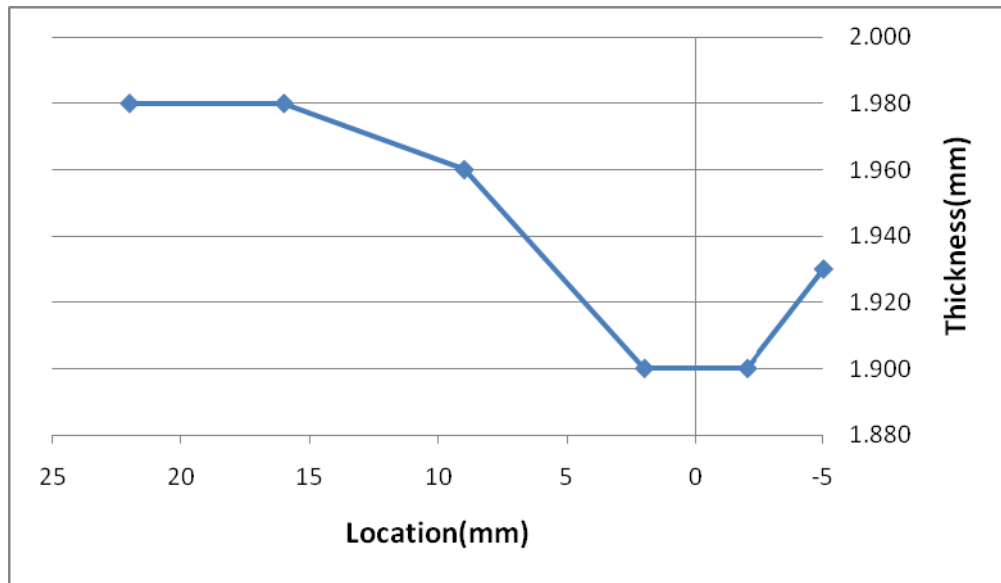
**Figure 4.2** Thickness loss values of 1<sup>st</sup> 10CrMo910 boiler tubes eroded at high temperatures

This thickness loss value may be used as a measure of material erosion. In fact the experiment reported above was repeated with a second sample, their test results are given in **Figure 4.3**, yielding a thickness loss value of 0.075 mm. The values are quite close to each other indicating that the thickness loss is nearly as reliable as the weight loss method used at room temperature.

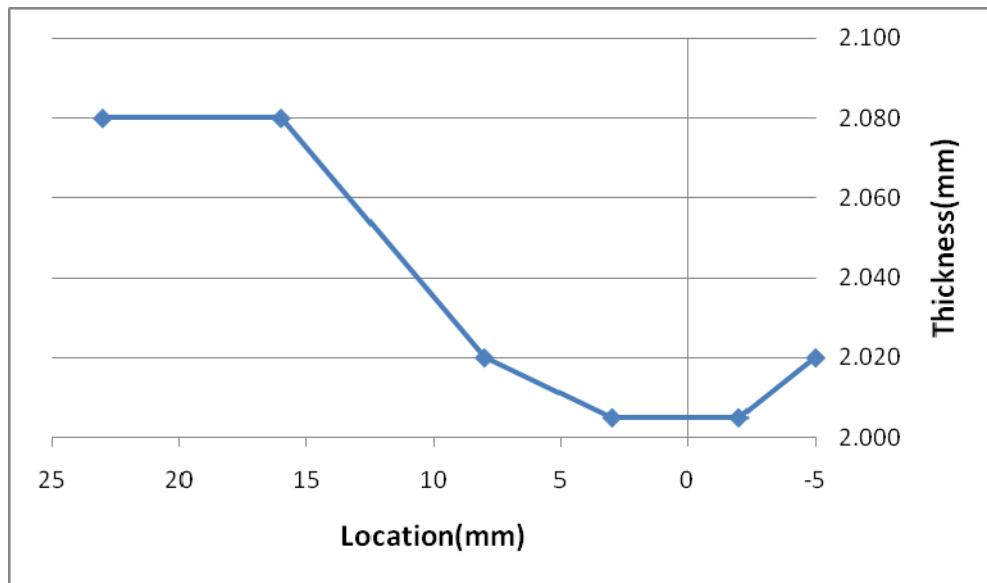
**Figure 4.3** Thickness loss values of 2<sup>nd</sup> 10CrMo910 boiler tubes eroded at high temperatures
