A CRITICAL ASSESSMENT FOR REUSE OF TRADITIONAL
DWELLINGS AS “BOUTIQUE HOTELS” IN URGUP

A THESIS SUBMITTED TO
THE GRADUATE SCHOOL OF NATURAL AND APPLIED SCIENCES
OF
MIDDLE EAST TECHNICAL UNIVERSITY

A CRITICAL ASSESSMENT FOR REUSE OF TRADITIONAL DWELLINGS AS “BOUTIQUE HOTELS” IN ÜRGÜP

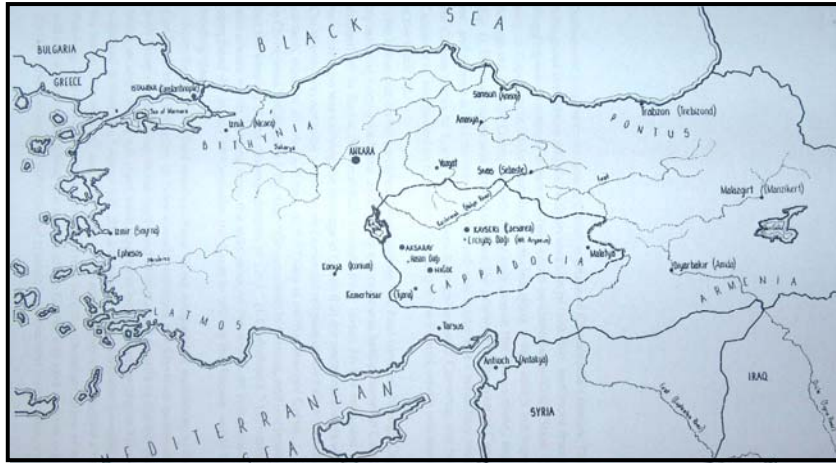
Figure 2.1 Boundaries of Cappadocia³⁵

Cappadocia Region is situated on a wide tableland in Middle Anatolia, which was formed by the ashes and lava of the old volcanoes such as Erciyes, Melendiz and Hasan Mountains. The geographical borders of Cappadocia lies in a wide area in Central Anatolia Region and the geological borders are in a circle of 60 km in diameter which lies in a triangle formed by the provinces of Niğde, Kayseri and Nevsehir. The geological structure of Cappadocia has been an important factor in the historical development and in the development of the physical neighborhood. (see Figure 2.1)

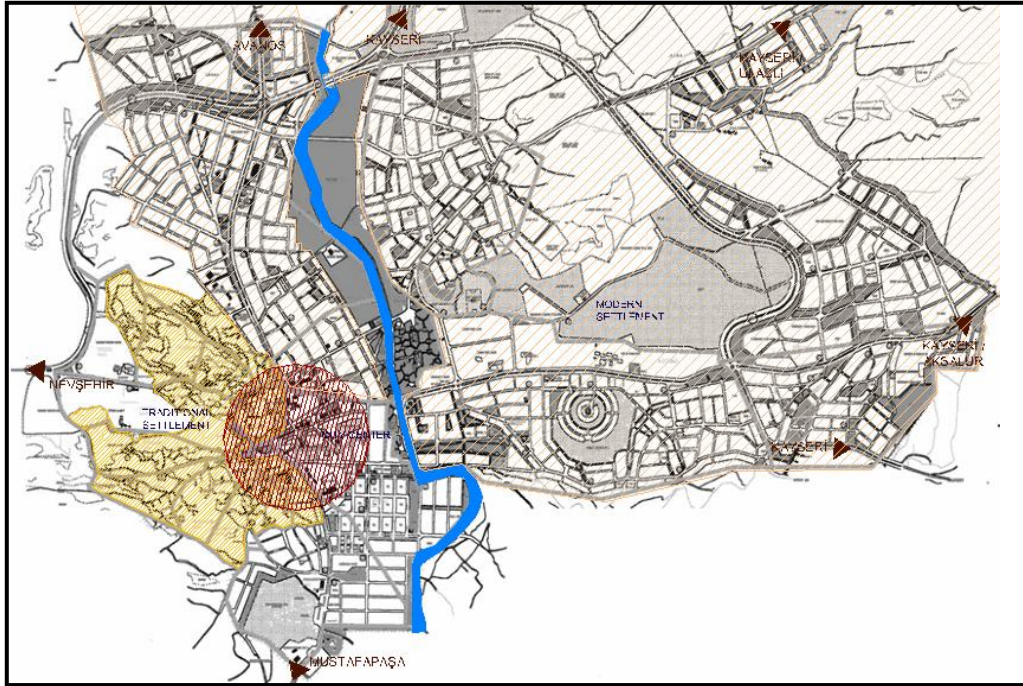
Figure 2.5 Ürgüp City Plan

Ürgüp city which is built on “Damsa Çayı” valley is divided into two sections by the “Damsa Çayı” flowing from north towards south. The west of “Damsa Çayı” is an area in which traditional urban fabric is intensely observed and the city center is found. In this part the “Esbelli Kayası” and “Temenni Tepesi” are important natural structures which attract attention. The city center is located on the area from southeast of “Temenni Tepesi” to “Damsa Çayı”. The east of “Damsa Çayı” consists of the development areas of the city. New residential areas are situated on this region (see Figure 2.5).

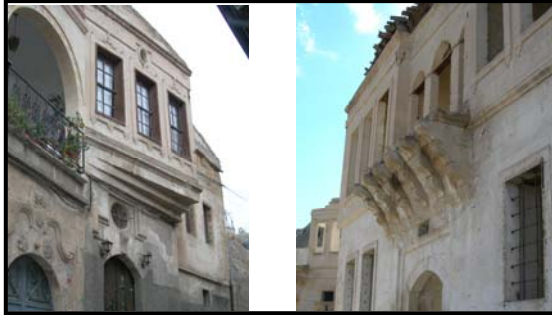
Figure 2.9 Projections

Although the facade order and facade elements in Ürgüp traditional dwellings generally have a symmetric order, they bear characteristics that integrate with the natural environment. The improved stone workmanship provided facades, which covers the structure with ornaments and provided rich visualities. **projections**, the most important element of facades, are arranged as number, form and location of projection. (single projection, double projection, projectioning corner, square and storey projections) And they affect the composition and typology of facades. “Hiding the buttresses with stone ornaments makes the projections as elements that gains characteristic features to dwellings.”⁶³ (see Figure 2.9).

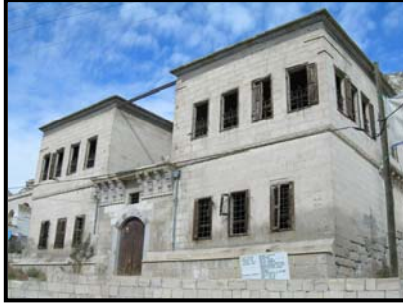
Figure 2.11 Façade organization

doors. Windows are rarely put on the basement floors. The basement windows are small in scale and are covered with iron bars. Windows on the upper storeys, which are bigger in scale than the basement windows and have more ornaments, are placed in groups symmetrically on the facades (see Figure 2.11).

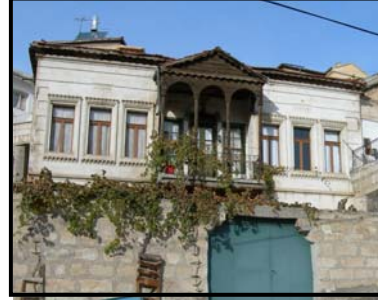
Figure 2.12 Balcony of a dwelling

Another element that attracts attention in the residences is the **eyvan**. The eyvan, which is reflected on the facades with stone ornamented arches, brings a visual richness to the elevations. It is also possible to come across **balconies** over the entrance door in the residences, which are enriched with stone ornaments and have a symmetric facade. (see Figure 2.12)

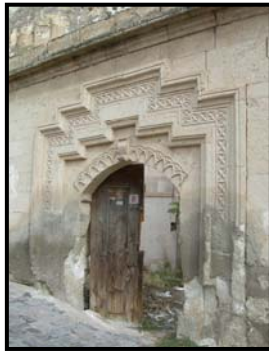
Figure 2.13 A courtyard door

Courtyard Doors: The first of the typology studies made is for courtyard doors. Courtyard doors enabling the transition from street to courtyard have become important elements of street facades with shapes and decorations (see Figure 2.13). According to study; courtyard doors have been observed in two main

groups as rectangular shaped and arched according to the shape of the gap in the facade. However, arched doors in the internal have departed into sub groups as compressed and semicircle arched according to the shape of the arch. In the region examples with or without ornament can be seen in both groups. For this reason, arched courtyard doors have been observed in a separate sub group according to the ornament features.

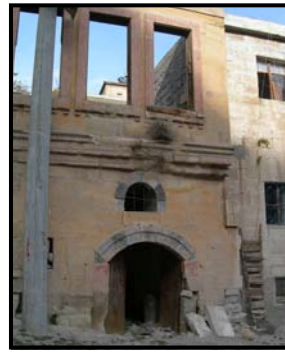
Figure 2.14 Entrance door of a house

Building Doors: Another typology study made is for dwellings entrance doors (see Figure 2.14). According to this; building doors have been summed up in three main groups as amorphous shaped, rectangular shaped and arched doors according to the shape of the gap in the facade. Arched doors have departed into sub groups as semicircle arched and compressed arched in the internal. There are examples with profile and ornament as well. ”In some examples above the arched doors, windows whose surroundings are with or without ornament can be seen.”

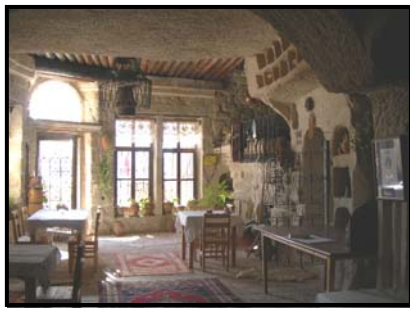
Figure 2.20 Breakfast Saloon

There is a wide, rock caved space for common use at the upper floor. Space is used as breakfast saloon, sitting and resting. (see Figure 2.20) Different sections of the space are separated from each other by level differences, rock caved arches and columns. (see Figure 2.21) Old looking traditional furnitures extensively used to furnish the spaces. Kitchen, storage and such service units are at this floor. Rock caved kitchen opens directly to the terrace. And it has been furnished with contemporary furnitures. Just next to it there is a rock caved storage. There is a rock caved corridor at north. (see Figure 2.22) Through this corridor common living spaces and the kitchen connected together from behind. (see Appendix E: BH1 / 5) There is a terrace in front of the places. Terrace was arranged as an open sitting area. It is covered with a tent which is big enough to cover all the terraces. Using a wooden stair in the terrace one can pass to the terraces and gardens formed by arranging the rocks at the top level.

In the general decoration of the management there is a disorder which is tiresome for the eye. Lots of items which are thought to be peculiar to region such as “sedir”, cauldron and lamp were collected for decoration purposes. But keeping so many furnitures together create a disorder whics is tiresome for the eyes. (see Figure 2.20-2.21)

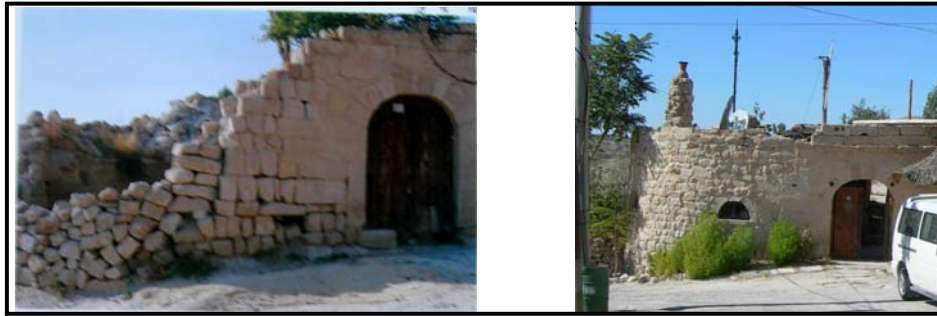
Figure 2.23 Mass alteration in Ürgüp Evi⁸²

Intead of a stone building which seems to be collapsed in the old photos, a new one storeyed building was built in the courtyard. (see Figure 2.23) This new

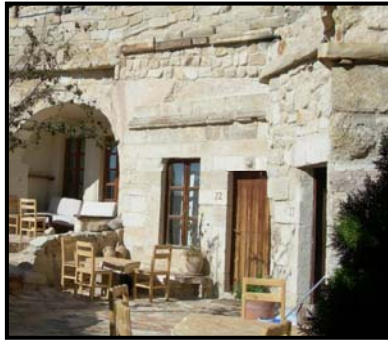
Figure 2.24 Wall additions

Partially collapsed stone walls of the main building⁸³, were repaired using stone material again. For example courtyard wall of the rock caved room at the ground floor and the walls of the space which is used as breakfast hall were added to the building later. However while making these interventions some evidences of the building were destroyed. (see Figure 2.24) All windows and doors of the building has been changed.

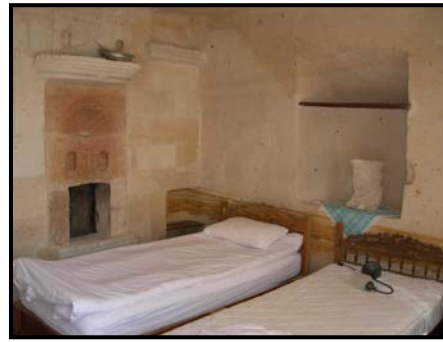
Figure 2.25 Architectural elements

All the spaces at the ground floor of the building are being used as sleeping units as it is suggested in the restoration projects. Inside the rooms bathroom, sitting and sleeping sections are sperated. In some rooms sitting sections are formed by using “sedirs” while in some rooms level differences are used in order to separate sleeping and sitting sections. While wood is used in the floors, ceilings are left as rock caving. Architectural elements such as “niche”, “ocak”, “lambalık” in the rooms are used for decorative purposes. (see Figure 2.25) It has been seen that “niches” were used as cupboard by adding hatches in front of them.

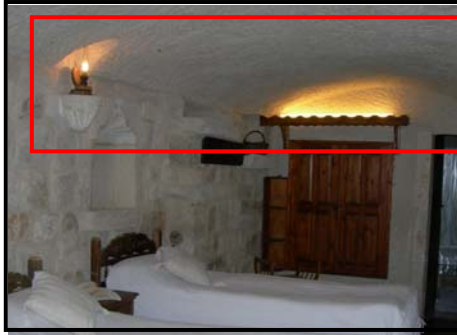
Figure 2.26 Illimination

Indirect illumination was provided by lighting elements placed on top of the wardrobes and inside the “lambalık”s. (see Figure 2.26) Contemporary heating devices are placed inside the room without considering their harmony with the decoration or without trying to hide them. (see Figure 2.27)

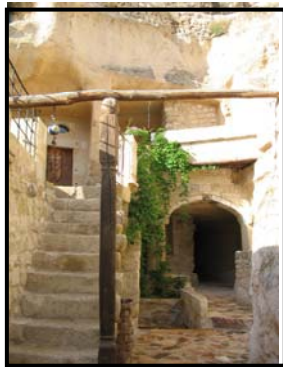
Figure 2.28 Building Lot: 172/9

The entrance to the building lot is from a courtyard door located at the south. The courtyard the west and north of which is surrounded by the L-shaped rock caved main building is surrounded by high stone walls. (see Appendix E: BH1 / 8) Some level differences were created in the courtyard. There is a stone stair leading to the upper floor. (see Figure 2.28)

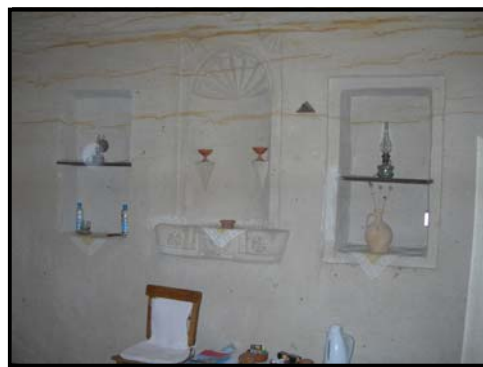
Figure 2.29 Aynalık and Niches in a room

decorative purposes. (see Figure 2.29) Each room has its own bathroom. Bathrooms are furnished with contemporary furnitures.

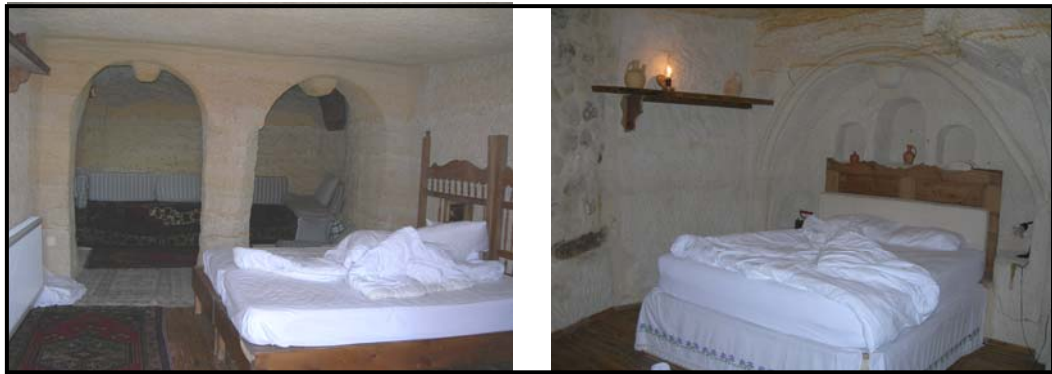
Figure 2.30 rock caved architectural elements in rooms

There are three rock caved rooms at the upper floor. (see Appendix E: BH1 / 8) The room which could be searched in this floor is a suite room. Sleeping and sitting sections of the suite room has been sperated from each other by rock caved columns and arches. (see Figure 2.30) It has its own bathroom. Bathroom is furnished with contemporary furniture.

As it is understood from the evidences of the building in lot 172 / 9; various interventions conducted in the spaces. Bathroom, sitting and sleeping sections of the rooms separated from each other. While sitting sections in some rooms are formed by using “sedir”s, in one room at the upperfloor sitting and sleeping sections are separated from each other using some columns and arches which were formed later. (see Figure 2.30) While wood is used in the floors, ceilings are left as rock caving. Elements such as “niche”, “ocak”, “lambalık”, etc. were used for decorative purposes in the rooms. It has been seen that “niche”s were used as wardrobes by adding hatches in front of them. Columns, arches and niches were caved for decorative purposes at the bed posts. (see Figure 2.30)

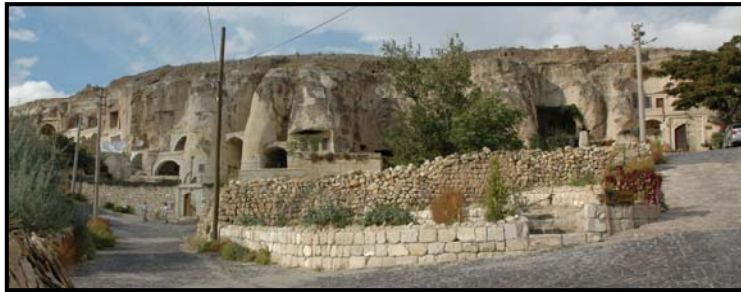
Figure 2.31 Elkep Evi

Elkep Evi consists of 7 traditional dwellings in the Esbelli District. (see Figure 2.31) These dwellings are located at the southern outskirts of the Esbelli kayası, scattered in two different building blocks.⁸⁷ Management is composed of four different parts⁸⁸ which consists dwelling lots reused in different dates.⁸⁹ First part of the hotel was opened to bussiness in 2000 then it was extended by the addition of new parts in time.⁹⁰ By the end of year 2005 restoration applications of a new part was being continued.⁹¹ The facility is referred as a “Butique Hotel” in various sources⁹² and it has a “pension” certificate from municipality.

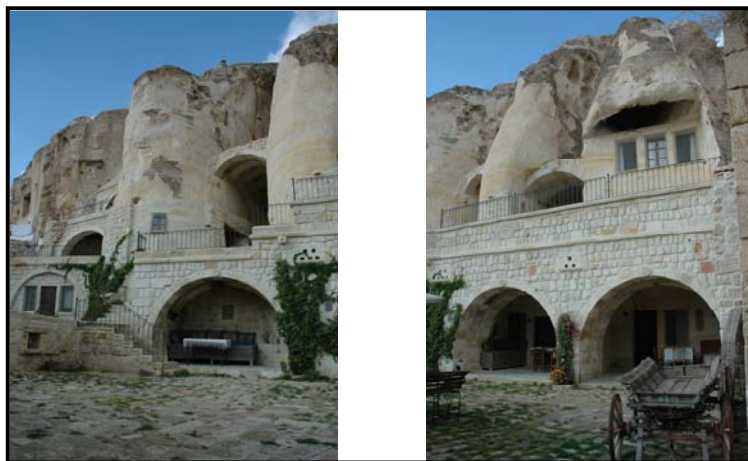
Figure 2.32 Rock caved main building of 172/18

Entrance to the building lot is from south, through courtyard door. The courtyard which is surrounded by high walls has a courtyard pattern of A.1.1. At the north of the courtyard which consists of three storeyed, rock caved main building stands. (see Figure 2.32) There is a staircase in the middle of the courtyard to reach the storages in the lower floor. One can reach to the upper floors using two stairs connected to the sides of the main building.

3 storeyed main building has entrances with “eyvan” and without “eyvan”. (see Figure 2.32) All the units in the building are used as sleeping units and all of them are rock caved.

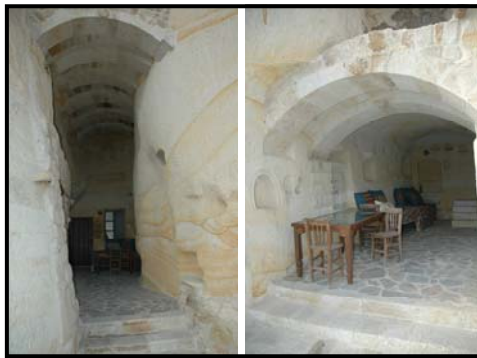
Figure 2.33 Semi-open spaces

There are 5 rock caved sleeping units in the upper floor which can be reached by two different staircases.⁹⁴ One can reach to these units from the terraces passing through “eyvan”s or semi-open areas. (see Appendix E: BH2 / 4). Semi-open spaces between the rocks in this floor are used as the circulation areas and supported with vaults and arches. (see Figure 2.33) There are niches at the walls of these sections which also includes the sitting sections.

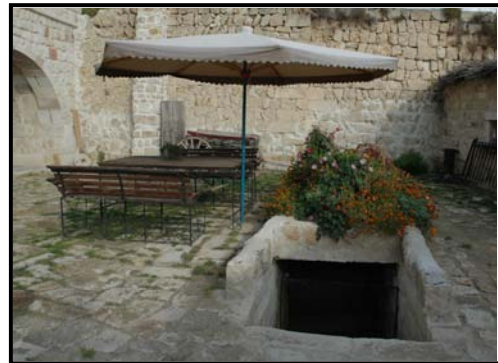
Figure 2.34 Entrance to storages

Below the ground level of the building there is a basement floor. There are storages in the basement. Entrances and ventilations of these storages are opening to the courtyard. (see Figure 2.34)

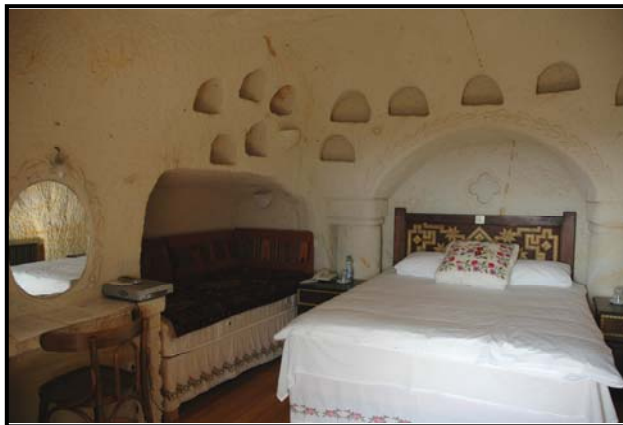
Figure 2.35 Rock caved architectural elements and furnitures in a room

In addition, architectural elements such as columns, arches and “niche”s were rock caved to the walls for decorative purposes. Similarly furnitures such as study table and mirror were rock caved (see Figure 2.35) sitting corner was placed in a rock caved section.

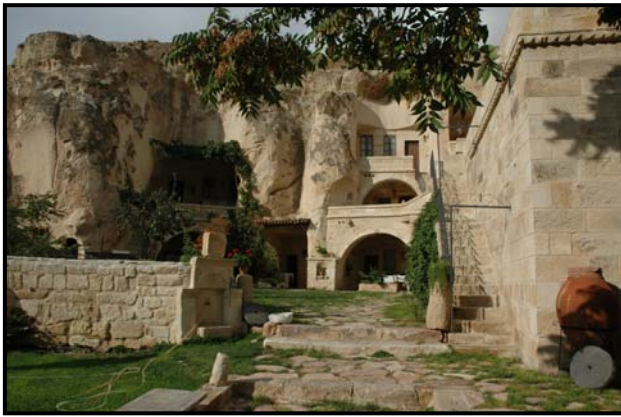
Figure 2.36 rock caved main building of 172/121

Entrance to the building which located at the outskirts of the Esbelli Kayası, is through type courtyard door. At the north of the A.1.3 type courtyard there is a rock carved main building. (see Figure 2.36) Just in front and connected to the main building there is a one storeyed masonry building.⁹⁷ The courtyard is surrounded with high walls. There are niches over the courtyard walls. Some part of the courtyard is arranged as a sitting area. At the corners of this area there are “ocak”s and niches.

3 storeyed rock caved main building has an A.2.b.3 typology. Its entrances are with “eyvan”. All the spaces in the building are used as sleeping units. All of the rooms are rock caved.

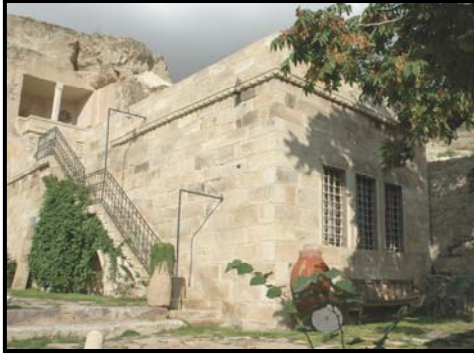
Figure 2.37 Mass alteration

Instead of the place which is shown as partially collapsed in the measured drawings at the east of the courtyard, a new single storeyed masonry building was built to be used an office and common spaces. However this new building is shorter than it was planned in the restoration project where it was extending along the entire east wall of the building. (see Appendix E: BH2 / 7-9 and Figure 2.37)

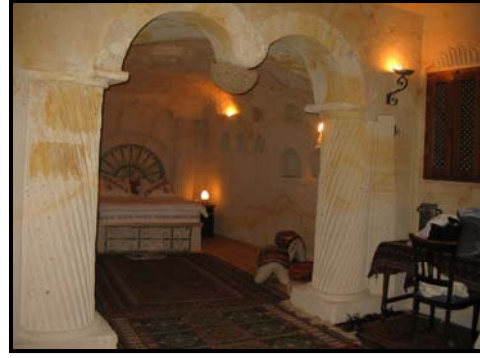
Figure 2.38 Suite room

In the first floor two of the rooms at the north were joined as it was suggested in the project, this wide space is used as a sleeping unit. The suite room in this floor was extended by caving the rocks and sitting and sleeping sections were separated from each other by a passage consisting of rock-caved columns and arches. (see Figure 2.38)

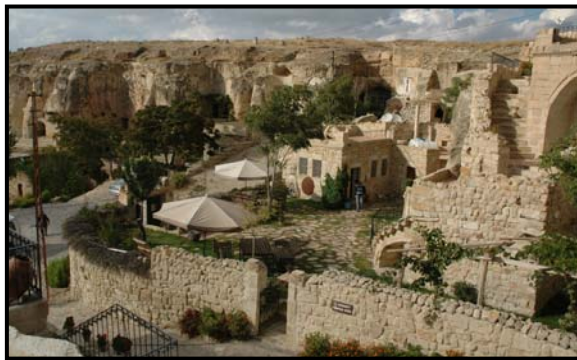
Figure 2.40 Building lot 172/26

The building which is at the 172/26 lot of the facility is located at the southern outskirts of the Esbelli Kayasi.¹⁰² (see Figure 2.40) One can enter the lot through two courtyard doors, one at the west and the other one is at the south. The courtyard, which is at a higher elevation than the entrances, can be reached by staircases. There are bedrooms in the buildings at this lot. But sketches of these bedrooms can not be drawn since it was not possible to enter the rooms.

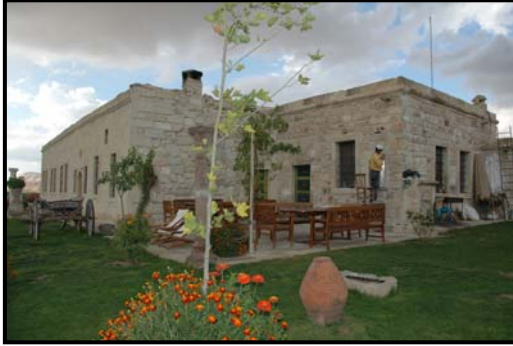
Figure 2.41 Building lot 663/3

The building located at the lot no 663 / 3 is used as common spaces like resting section, dining room and as service units like kitchen and toilet. (see Figure 2.41) It is a single storeyed masonry building opening to the garden. This building is overlooking the general scenery of Urgüp. During the good weather conditions dinner is served to the guests at this garden.

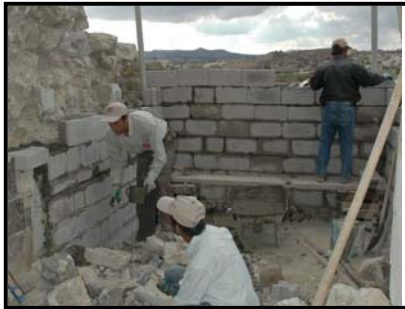
2.43 Construction of brick walls

Architectural elements such as “niche”, “aynalık” were caved to the walls, as well as carving the walls for cleaning purposes. (see Figure 2.42) rooms are being separated by addition of stone walls. Bathrooms are being separated from each room by the additional walls. They are built by using concrete bricks. (see Figure 2.43) Plumbings are installed inside these walls. (see Figure 2.44)

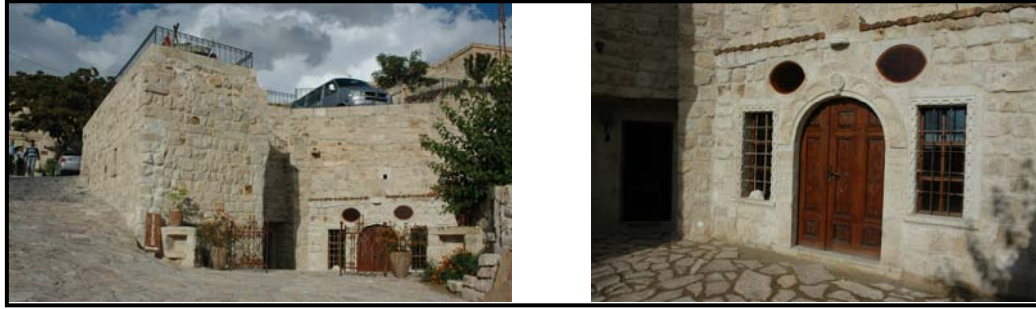
Figure 2.45 Building lot 173/1-2

The buildings which are at the 173/1-2 lot of the facility are located below the elevation of the road. (see Figure 2.45) While the units in 172/1 lot are used as offices and the reception, construction of the units which are planned to be used as bar were being continued by the end of year 2005. The buildings in these two lots connected to each other from inside.

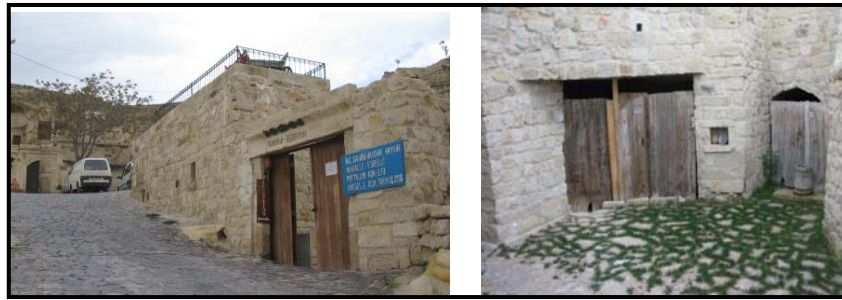
Figure 2.46 Dwelling's view before restoration¹⁰⁵

Courtyard walls, separating the street and buildings from each other were destroyed. (see Figure 2.46) The doors at the entrances of the buildings were altered. Windows were added at the top and side of the reception entrance door. (see Figure 2.46) Different spaces at different levels were connected to form the space which is planned as the bar. The place was extended by caving the rocks.

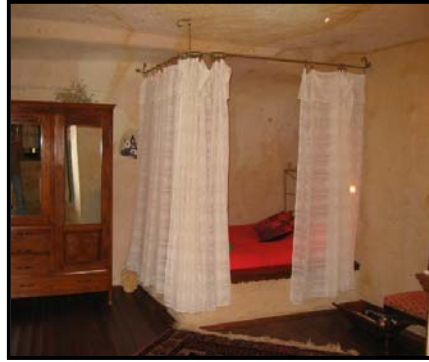
Figure 2.49 Rock caved bed

The interventions conducted on the building were evaluated according to the evidences from the building. According to these evidences; it can be understood that the batrooms of the rooms at the ground floor were obtained by building rock walls inside the rock caved spaces. (see Appendix E: BH3 / 3). And rock caved beds are used in the bedrooms at the ground floor. (see Figure 2.49)

Obtaining furnitures by caving the rocks is an irreversible intervention and at the same time it destroys the evidences of the building and gives wrong information about the building. (see Figure 2.49)

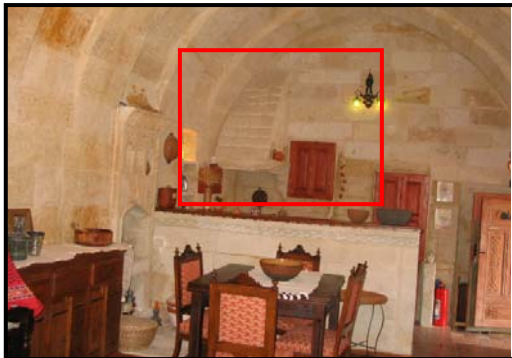
Figure 2.50 Kitchen of suite room

Bathroom of the suite room at the upper floor was added later too. At this section there is a chimney in kitchen which was added to the building later. (see Figure 2.50) Also kitchen counter is a later addition.

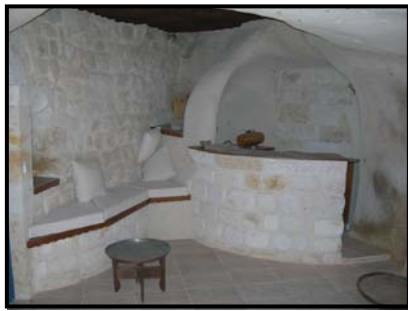
Figure 2.52 Space addition

There is a bar space added to the building by caving below the ground elevation at the entrance. (see Figure 2.52) By the end of year 2005, additions of spaces to this section by caving were continuing. (see Appendix E: BH4 / 4)

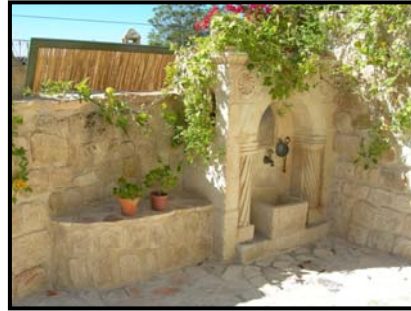
Figure 2.53 Fountain addition

There are some architectural element additions as well as the additions of space in the building. The fountain opposite to the reception in the courtyard is one of the architectural elements added to the building later. (see Figure 2.53) (see Appendix E: BH4 / 4)

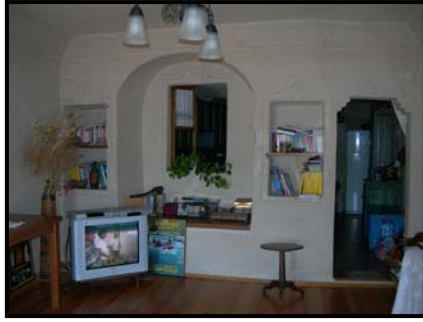
Figure 2.54 Rock caved wall

The common space and the kitchen in the main building were seperated from each other by a rock caved wall. Through a window opened at the arch on this wall, entrance of the light to the kitchen was provided. (see Figure 2.54) There is a chimney which was added later in the kitchen. Workbench of the kitchen was obtained by caving the rock later Workbench of the kitchen was obtained by caving the rock later. (see Figure 2.55) (see Appendix E: BH4 / 4)

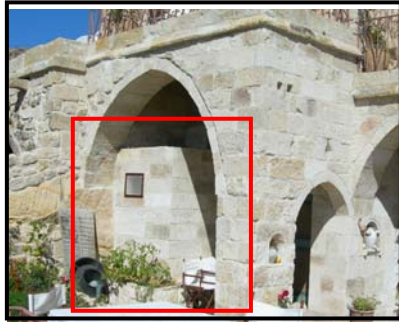
Figure 2.56 Bathroom addition

Bathrooms of the bedrooms were added to the spaces later by building rock walls. These later added places can be perceived from the facade of the building. (see Figure 2.56) (see Appendix E: BH4 / 4)

Interventions are evaluated according to the evidences from the building. Even though the stone bathroom units which were added by building stone walls are harmonious with the building, they spoil the view of the front facade as a mass. (see Figure 2.56) These irreversible interventions make it difficult to perceive the building.

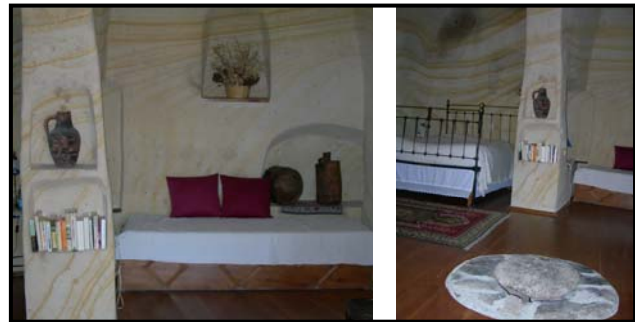
Figure 2.57 Use of architectural elements

Modern, ancient / ancient looking furnitures were used harmoniously in the furnishing of the hotel. The architectural elements in the building were used for decorative purposes. For example, one column in the middle of the place in one of the bedrooms at the ground floor separates sitting and sleeping units from each other while at the same time it constitutes a decorative element which holds books and ornament objects. (see Figure 2.57) Again at the same bedroom “tandır” is displayed for decorative purposes. (see Figure 2.57) Architectural elements such as niche, “aynalık” are used almost all of the spaces for decorative purposes. But authenticity of these objects are subject to discussion.

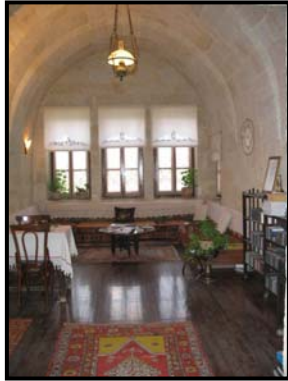
Entrance to the facility is from west through an AK-3b2 type door which belongs to building lot 165 /1. From there one can pass to the reception and to the room at which guests are welcomed. (see Figure 2.59) From the reception one passes to the place which is used as the resting room and internet room. This space is

Figure 2.59 Resting space Figure 2.60 View from terrace

Old looking furnitures and handcrafted products are used in the management which has rock caved and vaulted rooms. Sitting corners are formed using “sedir”s in the resting and sitting rooms. (see Figure 2.59) The niches in the rooms were used for decorative purposes or used as bookshelves. (see Figure 2.64) The staircases from the original building are not used anymore but used as decorative elements. (see Figure 2.65)

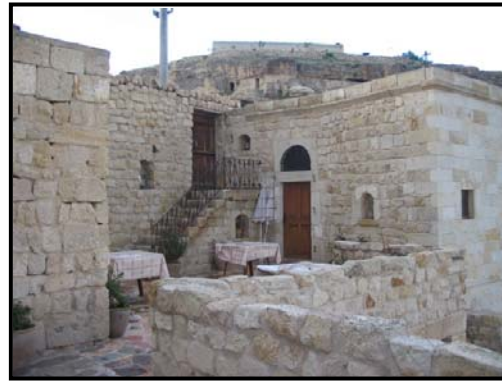
connected to breakfast hall through a corridor from behind. Kitchen is next to the breakfast hall and opens directly to it. (see Appendix E: BH5 / 5) From the terrace which was arranged as a sitting area in front of the breakfast hall one can pass to the building which is used as an office and sleeping unit by the management owner. One exits to the Aksakal Street at the north, from the terrace through a staircase and courtyard door. (see Appendix E: BH5 / 5 – Figure 2.60)

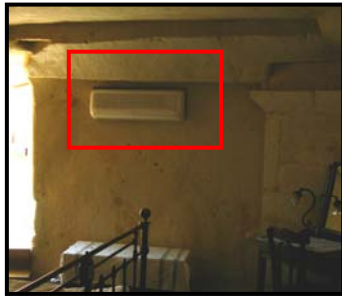
Figure 2.66 Air condition systems in rooms

Air conditioning systems are used in the rooms for heating. Air condition systems are mounted to the walls without considering their harmony with the structure or the furnitures. (see Figure 2.66) Contemporary lighting devices were installed on the walls and ceilings for illumination.

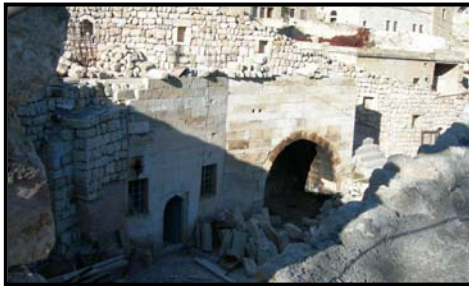
Figure 2.67 Building lot 166/1-2

By the end of year 2005, in these two lots of the facility, restoration studies were still continuing.¹³² (see Figure 2.67) According to the report obtained from Nevşehir Regional Conservation of Cultural and Natural Properties Council; it has been decided to renew the courtyard walls with the same stone material, to

remove the two concrete buildings which are built from bricks later in the courtyard (see Figure 2.68), to strip averagely 1-2 cm from the existing arched and rock caved rooms, to cover the floors of the rooms with wood. As it has been understood from the photographs taken in the area, cleaning works and insulation of the the terraces and roofs with concrete still continue. (see Figure 2.67)

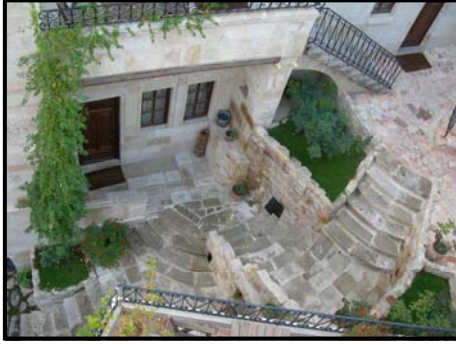
Figure 2.70 Stairs between buildings

There are buildings which are connected to each other with staircases and terraces at different elevation at the west of the courtyard. (see Figure 2.70) The spaces in these buildings are used as sleeping units. Front of the spaces are arranged as common resting areas, while terraces and “eyvan”s are arranged as open, semi-open sitting areas. (see Appendix E: BH6 / 5)

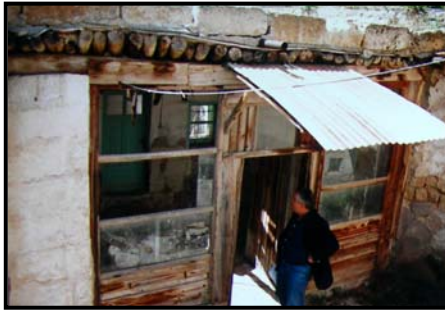
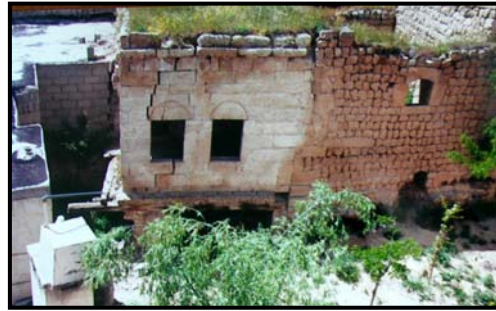
Figure 2.71 Removed masses Figure 2.72 Partially collapsed buildings¹³⁶

The interventions conducted were aimed to obtain a complex in which all units open to a single courtyard.¹³⁵ For this reason, as it has been understood from the Council reports and old photographs building additions at the lots were removed. (see Figure 2.71) Dwelling units were formed by adding new buildings to the lots.

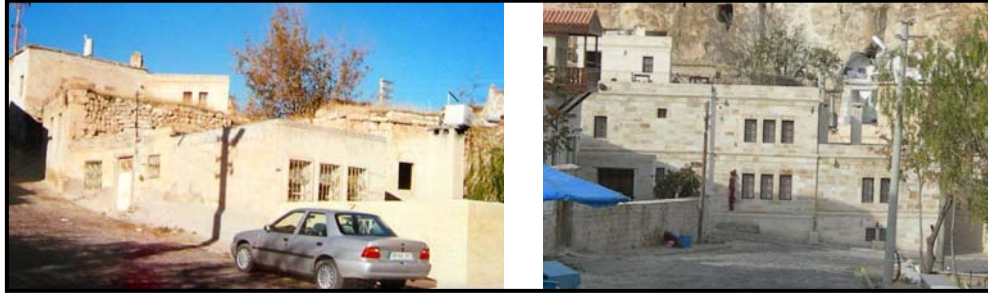
Figure 2.73 Addition of storey¹³⁸

New buildings were constructed following the evidences of the old ones.¹³⁹ As it is understood from the Councilreports, during these applications, addition of the storeys conducted. (see Figure 2.73) During the new constructions stones are used as the construction material to provide harmony with existing structures. During the repairs in the existing structures their surface patterns were changed to obtain a uniform surface pattern in the walls.

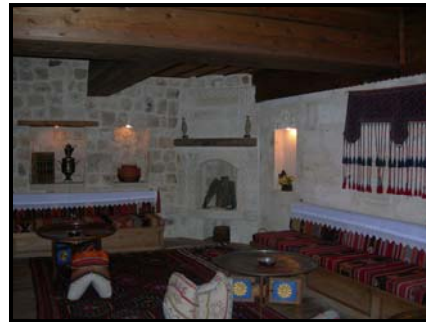
Figure 2.75 Resting room

Ancient looking furnitures and handcrafted products are used in the places. Sitting corners are formed with “sedir”s at the resting and sitting sections. (see Figure 2.75) At one corner of the breakfast saloon, a section with “ocak” in which local foods were cooked is formed. (see Figure 2.76) Architectural elements like niches, lambalık, wardrobe and “aynalık” were used for decorative purposes in the bedrooms and common places. Metal fireplaces were added inside the ocak’s in the rooms. (see Figure 2.76) Modern furnitures are used in the wet spaces of the building and walls are tiled with ceramic up to a certain height.

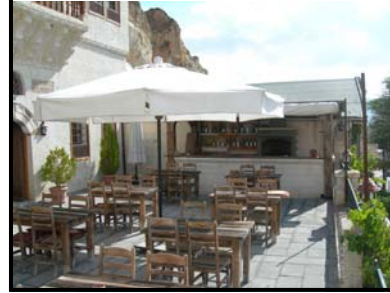
Figure 2.79 View of courtyard

Restaurant and kitchen of the facility is located at the backside of the “konak”. Next to the restaurant there is a bedroom which is rock caved as well. At the courtyard level there are also common toilets and semi-open bar unit. (see Appendix E: BH7 / 3) (see Figure 2.79) From the courtyard one enters to the storages at the bottom floor.

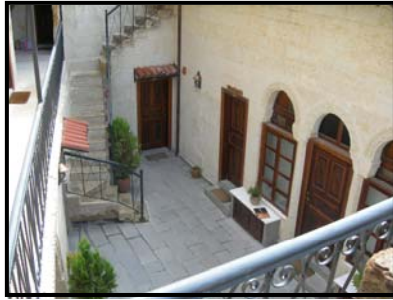
Figure 2.80 Courtyard at second floor

One can reach to upper floor by a staircase from the courtyard. At the terrace where the staircase ends, there is one rock caved suite room (padişah odası). There is an arched passage from the terrace to the courtyard at the back. Three rock caved rooms and the rooms at the second floor of the “konak” open to the courtyard at the back. (see Figure 2.80) Two rooms of the “konak” at this floor

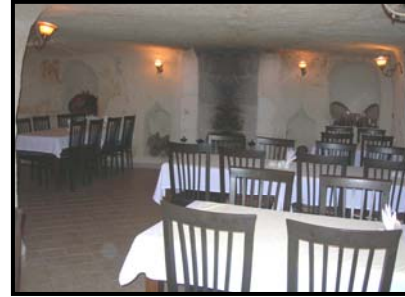
Figure 2.81 Restaurant

Rock caved and vaulted rooms of the management were furnished with ancient furnitures. Sitting sections were formed at the at the common places with beds and “sedir”s. Architectural elements such as “niş”, “ocak” in the restaurant are used for decorative purposes. (see Figure 2.81) In the kitchen, contemporary devices were used. (see Appendix E: BH7 / 4)

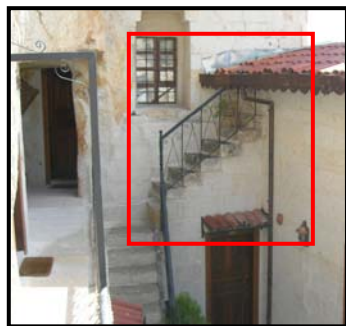
Figure 2.82 Stairs at second floor

At the second floor of the building a staircase from the back courtyard ends at the wall of the “konak”. No evidence of the space, where the stair has used to end, could be found. (see Figure 2.82) (see Appendix E: BH7 / 4)

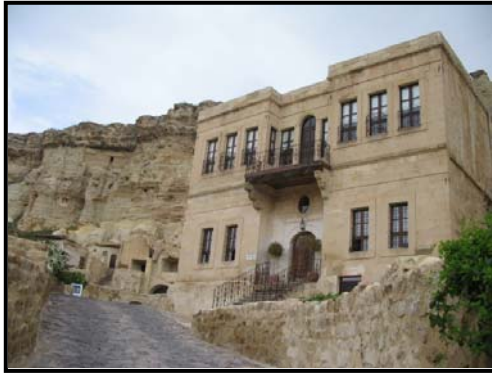
Figure 2.84 “Konak” of Yunak Evleri

This part of the facility was formed by reuse of the two storeyed masonry “Konak” (has B2a4.4 type plan scheme) (see Figure 2.84) at the south of the lot and rock caved service units at the north. It has A.4.3. type inner courtyard open space arrangement. (see Appendix E: BH8 / 20)

Entrance to the “Konak” is through a door opening to the Musa Efendi Street. Building is used as common spaces, reception and office. Reception and office of the establishment, which are at the basement of the building, can be entered through a separate entrance from the Musa Efendi Street. (see Figure 2.84)

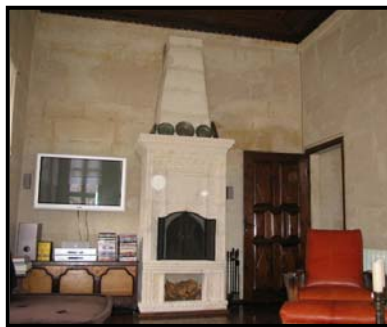
Figure 2.85 TV-room

At the first floor of the “Konak” there are two vaulted rooms opening to the entrance hall. These rooms are used as the TV and internet rooms. (see Figure 2.85) Second floor of the “Konak” can be reached by staircases. At this floor there are two vaulted rooms opening to the “sofa” and one balcony. One of the rooms is used as a resting room and the other is used as a dining room. (see Appendix E: BH8 / 20) (see Figure 2.86)

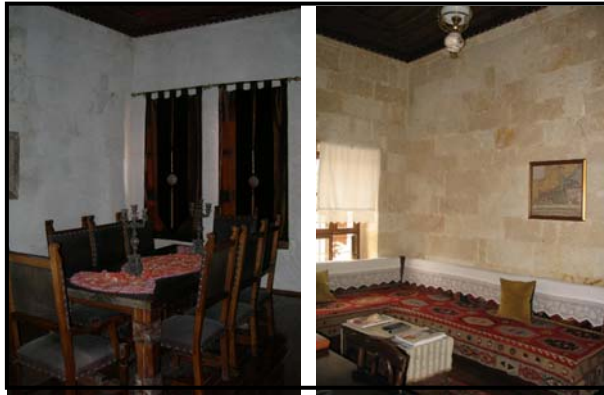
Figure 2.88 Decoration of “Konak”

Rockcaved and vaulted spaces were furnished with modern and ancient furnitures. Sitting sections were formed with “sedir”s in the common spaces. Architectural elements such as niches, “ocak” are used for decorative purposes at the places. (see Figure 2.88)

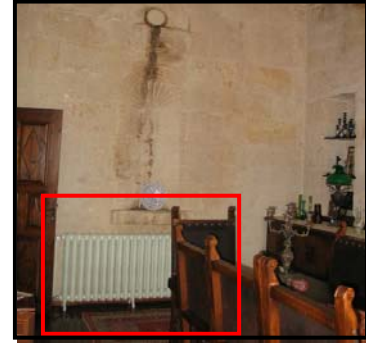
Figure 2.89 Heating system

Contemporary heating devices used for heating are mounted to the walls without considering their harmony with the structure or the furnitures. (see Figure 2.89) Illumination is provided by the contemporary devices hanged from the ceiling.

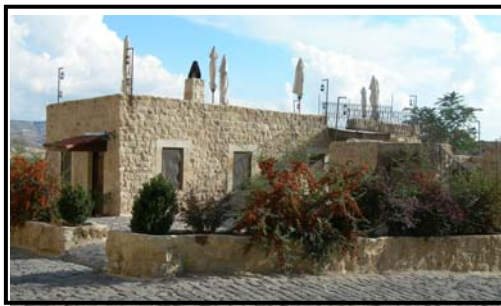
Figure 2.90 Breakfast Saloon

Single storeyed structure which has B1b.1 typology was built using masonry system. (see Figure 2.90) It was obtained by reuse of the service unit which was originally used as a barn. The hall is divided into sections with level differences and arches. At the back section of the building there is an open kitchen which is separated from the breakfast saloon with an arch and curtain and serves to this saloon. (see Appendix E: BH8 / 5)

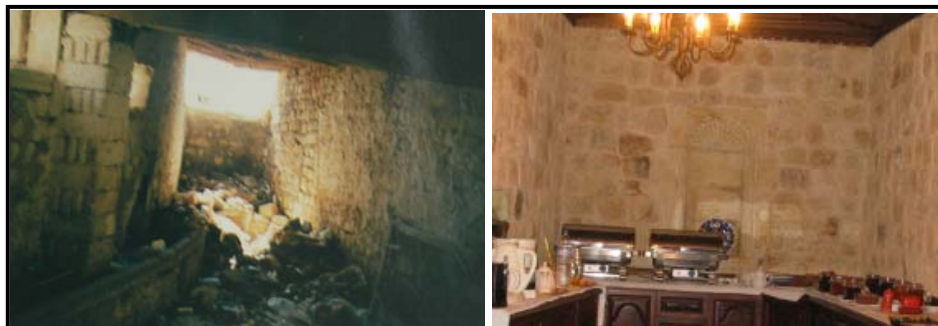
Figure 2.91 Partially collapsed south wall was reconstructed

During the interventions, partially collapsed south wall and south east walls of the building were rebuilt. A niche was constructed over the south wall which is rebuilt with masonry system. (see Figure 2.91) As it is understood from the Councilreports, existing columns and beams of the structure were removed and stone arches were built instead. (see Figure 2.92) By removing the intermediate walls a single place was formed. As it is understood from the old photographs, the fireplace at the entrance was added to the building later. (see Figure 2.92)

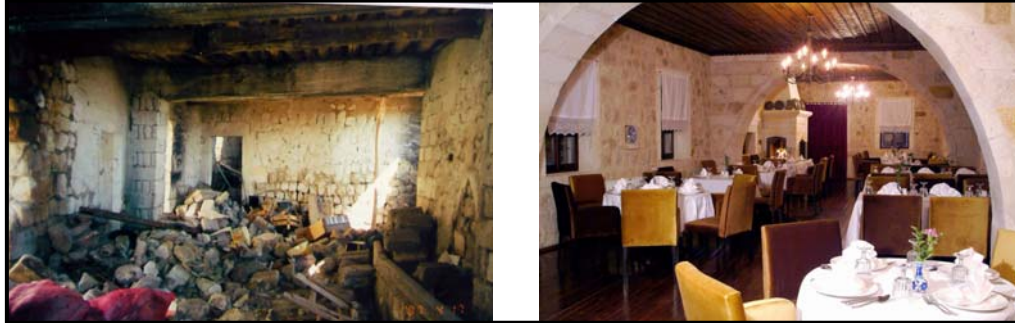
Figure 2.92 Interior views of the building before and after restoration

No evidences could be seen from the period in which the building was used as a barn since the ceiling and floor of the building were covered with wood, doors and windows are replaced. (see Appendix E: BH8 / 5)

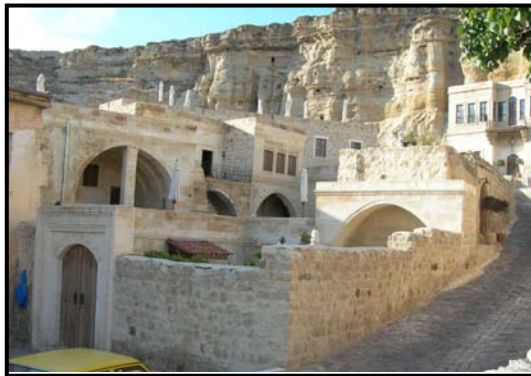
Figure 2.93 Building lot 154/3

Entrances to the building lot are from an AK-3b3 type doors at the south and at the east. Sections of buildings below the ground level are rock caved and the sections above the ground level are masonry. Three-storeyed structure has two courtyards at different elevations. Street sides of the courtyards are surrounded with high walls. Building has entrances with “eyvan” and without “eyvan”. Rooms of the building are used as sleeping units. Since it was not possible to enter the rooms at this section of the facility, detailed information could not be obtained. (see Figure 2.93)

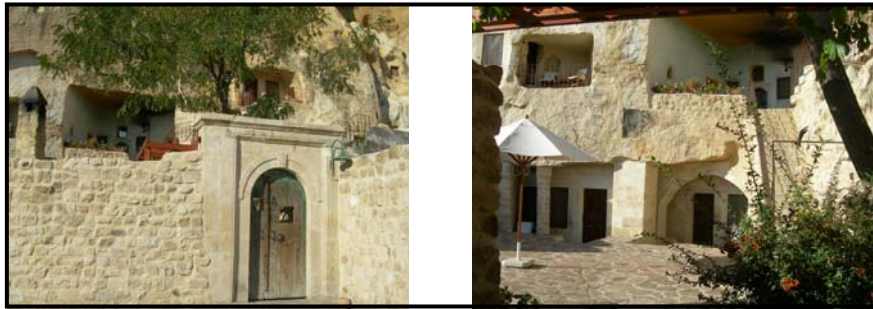
Figure 2.94 Building lot 165/73

Entrance to the building is from an AK-3b3 type door at the south. The courtyard which is surrounded with high walls has an open area pattern of A.1.1. Two

storeyed main building at the north is rock caved. One reaches to the rock caved rooms which are used as sleeping units with the staircases from the courtyard. The “eyvan”s in front of the rock caved rooms are used as semi-open sitting areas. Since it was not possible to enter the rooms at this section of the buildings, detailed information could not be obtained. (see Figure 2.94)

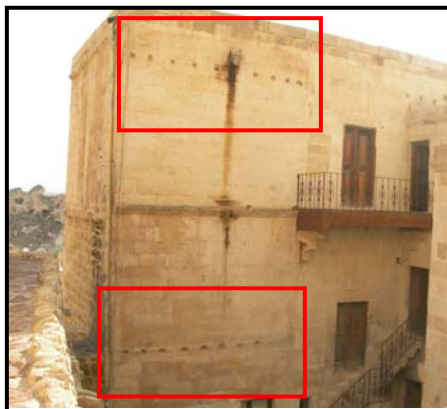
Figure 2.96 Beam evidences

No interventions which could disturb the main line of the “konak” and destroy the evidences have been done during the applications. Plan scheme of the “Konak” and façade pattern could be perceived. Wooden beam evidences of the facades are left untouched. (see Figure 2.96) But the evidences belonging to the barn, which is used as a breakfast saloon now, were destroyed.

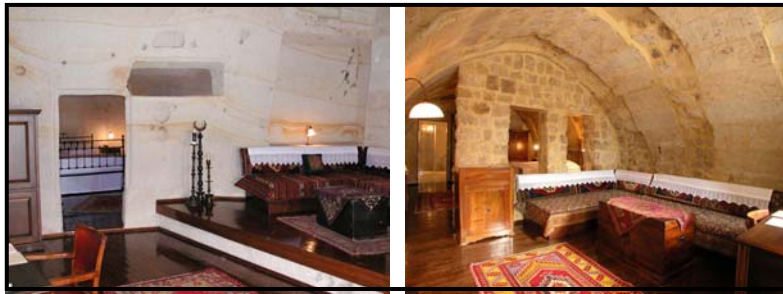
Figure 2.97 Interior views from rooms

Niches were caved into the walls of the rockcaved bedrooms. Some of the niches are used as wardrobes by adding hatches in front of them. There are study sections and sitting sections in the rooms. Sitting sections are separated from the sleeping sections by level differences or by arches, walls in some rooms. Floors of the rooms are covered with wooden materials. (see Figure 2.97- 2.98)

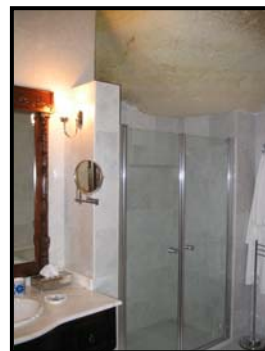
Figure 2.99 View of a bathroom

Wet spaces are furnished with contemporary furnitures. They are tile with ceramic up to a certain height. Rock caved roofs are not covered with any materials. (see Figure 2.99)

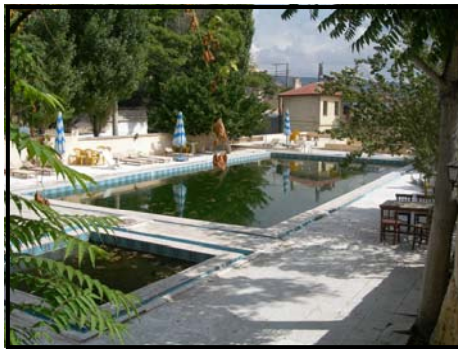
Figure 2.101 Swimming pool

Entrance to the building lot is through a courtyard door at the north. The courtyard is surrounded by high stone walls. There is a two-storeyed “Konak” at the west of the courtyard (see Figure 2.100) and a swimming pool and its service units at east. (see Figure 2.101) Courtyard has two level differences and swimming pool and “konak are separated by this level difference. (see Appendix E: BH9 / 3)

There is a swimming pool added to the courtyard. (see Figure 2.101) Also its service unit which is consist of wet spaces and dressing rooms is added. And a semi-open bar unit is also added to the courtyard. Mass additions also are occurred by adjoining of units such as kitchen, wc and sleeping units. (see Figure 2.103)

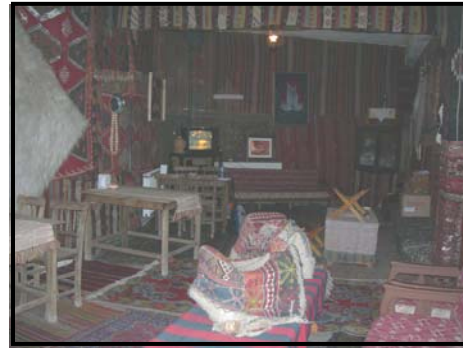
Figure 2.102 Common space

At the first floor of the “Konak” there are two vaulted rooms opening to the reception directly. These rooms are used as sleeping units. Behind the reception and sleeping units there is a common space which is used as TV-room and breakfast saloon. (see Figure 2.102) Kitchen and wet spaces for common use of the establishment, which are at the ground floor of the building, can be entered through a separate entrance from the courtyard. Second floor of the “Konak” can be reached by staircases from resting room. (see Appendix E: BH9 / 3)

In the general decoration of the management there is a disorder which is tiresome for the eye. Lots of items which are thought to be peculiar to region such as “sedir”, cauldron and lamp were collected for decoration purposes. But keeping so many furnitures together and covering walls with carpets create a disorder whics is tiresome for the eyes. (see Figure 2.102)

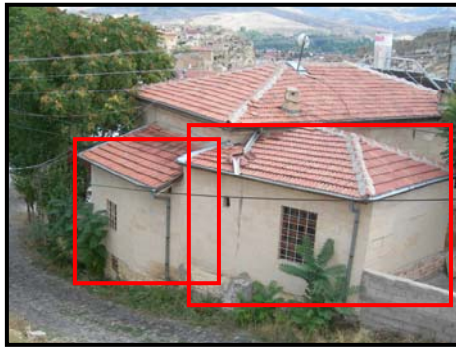
Figure 2.103 Mass additions

It is observed that mass additions to the dwelling disturb the courtyard-street relation.

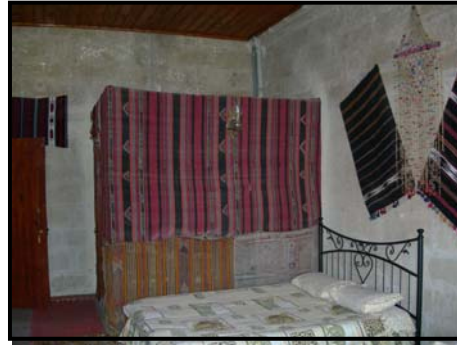
Figure 2.104 Bathroom addition

Bathrooms are separated from the spaces with the addition of stone walls. (see Appendix E: BH9 / 3) Stone walls were built to a certain height. Bathrooms are furnished with contemporary furnitures, walls are covered with tiles. (see Figure 2.104)

Stone walls which separate the wet spaces from sleeping units were built to a certain height. (see Figure 2.104) This provides us to understand the intervention.

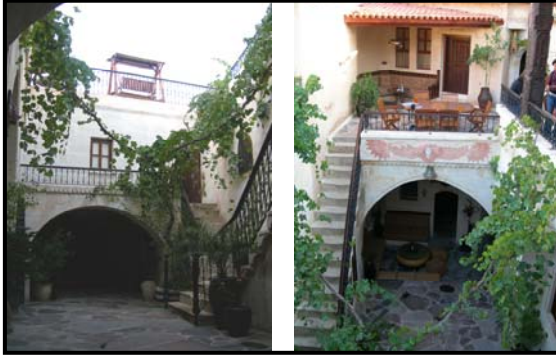
Figure 2.108 Views of courtyard

Three-storeyed main building was constructed by masonry system. But it has rock caved rooms which are underground. At the ground floor of the building there are 5 sleeping units, dinner room and an office. Dinner room and two sleeping units open a semi-open resting space. One can reach to the upper floors with a half-space stair. (see Appendix E: BH11/ 3 and Figure 2.108)

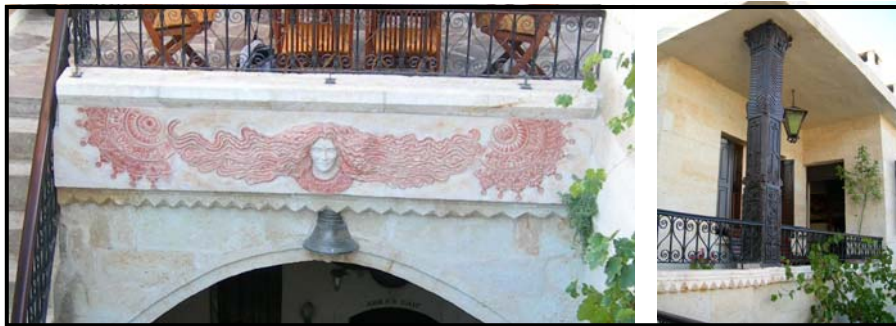
Figure 2.109 Architectural element additions

As Gülcüoğlu mentioned, reliefs and some architectural elements such as columns were added to the building for decorative purposes. (see Figure 2.109) the architectural elements such as doors and windows were altered with reused elements from the collapsed dwellings.

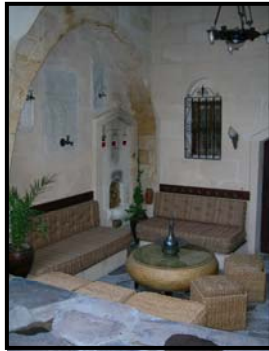
Antique furnitures and handcrafted products are used in the facility which has rock caved and vaulted rooms. Sitting corners are formed using “sedir”s in the resting and sitting rooms. (see Figure 2.110) The niches in the rooms were used for decorative purposes. (see Figure 2.111)

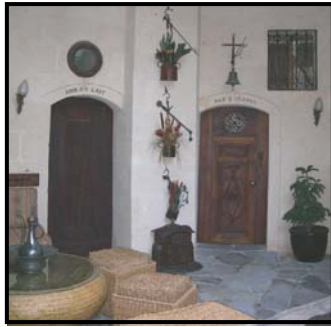
Figure 2.112 Reused doors

During the applications, reused materials were used. It prevents the interventions not perceived. New elements and the original ones can not be distinguished from each other. (see Figure 2.112)

If the Sacred House reviewed generally, it has been observed that as a result of the interventions, interventions conducted later can not be distinguished. Original evidences of the buildings were destroyed during the interventions. These irreversible interventions give wrong information about the dwellings.
