A CRITICAL ASSESSMENT FOR REUSE OF TRADITIONAL
DWELLINGS AS “BOUTIQUE HOTELS” IN URGUP

A THESIS SUBMITTED TO
THE GRADUATE SCHOOL OF NATURAL AND APPLIED SCIENCES
OF
MIDDLE EAST TECHNICAL UNIVERSITY

A CRITICAL ASSESSMENT FOR REUSE OF TRADITIONAL DWELLINGS AS “BOUTIQUE HOTELS” IN ÜRGÜP

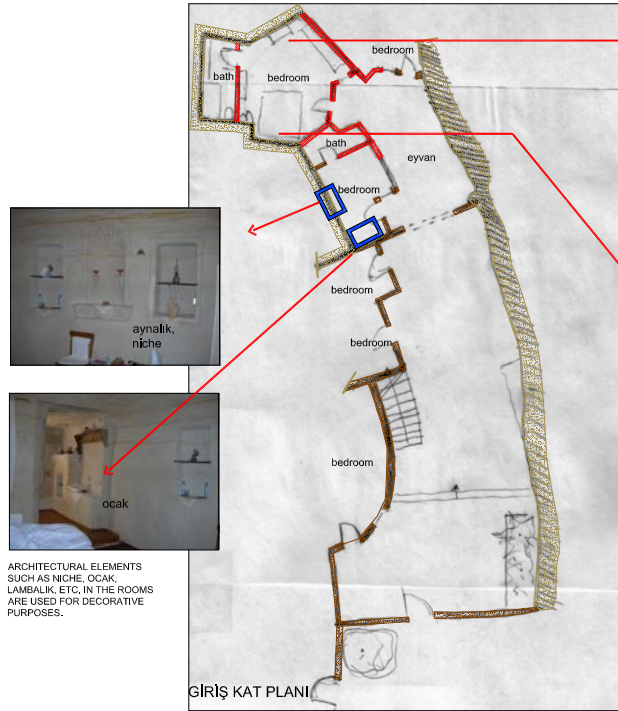
INTERVENTIONS

ARCHITECTURAL ELEMENTS SUCH AS NICHE, OCAK, LAMBALIK, ETC. IN THE ROOMS ARE USED FOR DECORATIVE PURPOSES.

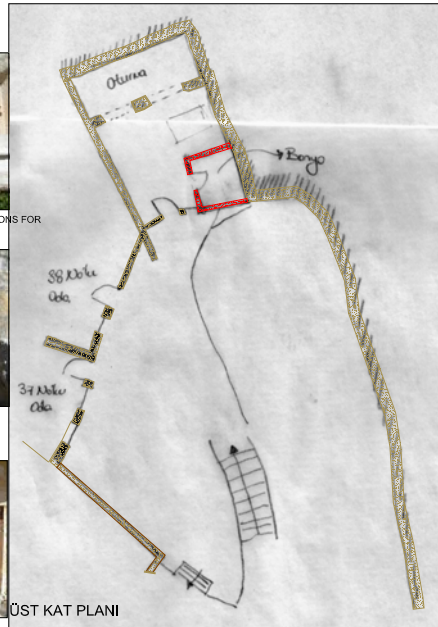
ÜST KAT PLANI

INDIRECT ILLUMINATION WAS PROVIDED BY LIGHTING ELEMENTS PLACED ON TOP OF THE WARDROBES AND INSIDE THE "LAMBALIK'S".

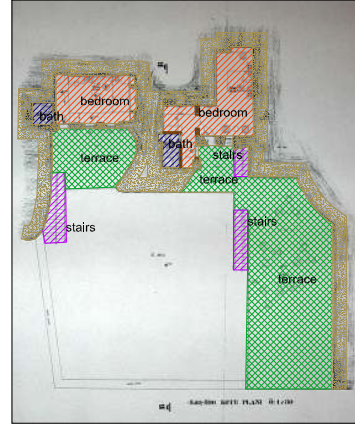
FIRST FLOOR PLAN

ROOMS AT FIRST FLOOR WERE ARRANGED AS BEDROOMS.

RECONSTRUCTION OF PARTIALLY COLLAPSED BUILDING AND TRANSFORMATION IT TO COMMON SPACES ARE SUGGESTED

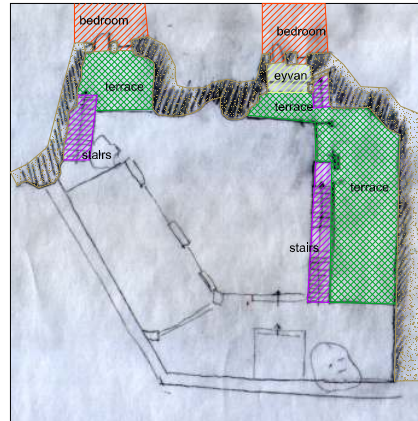
FIRST FLOOR PLAN

There are 4 rock caved sleeping units at the ground floor. The rooms open from the "eyvan"s to the semi-open spaces in front of them. "Eyvan"s are arranged as semi-open sitting areas. Again at this floor, there is a masonry single storeyed building connected to the main building. Office units and common spaces are in this building.

One can reach to the top floor of the building from the courtyard with two different staircases. Rooms open to the semi-open spaces in front of them. Roof of the stone building at the ground floor is being used as a terrace at this floor.

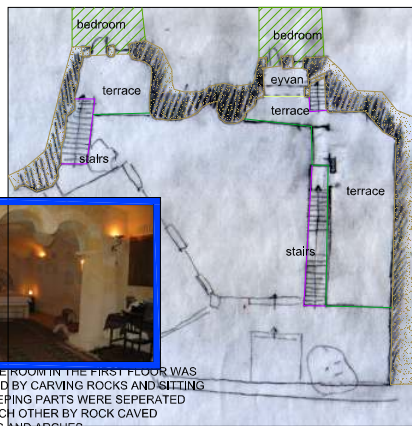
FIRST FLOOR PLAN

NEW COURTYARD DOOR IS DIFFERENT THAN THE ORIGINAL ONE OR SUGGESTED ONE AT RESTORATION PROJECT

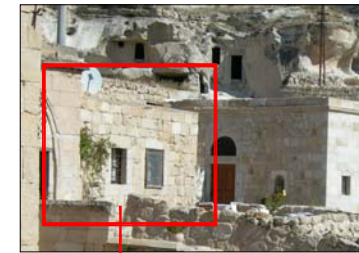
AS SEEN FROM THE PHOTOGRAPH THERE WAS NOT ANY BUILDING NEAR BREAKFAST SALOON BEFORE RESTORATION.

A STONE ONE-STOREYED BUILDING WAS ADDED TO USE AS KITCHEN.

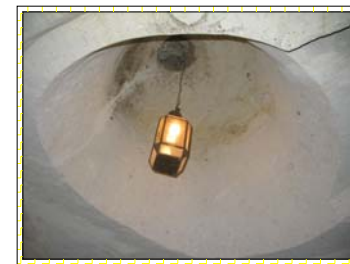
INDIRECT ILLUMINATION WAS PROVIDED BY LIGHTING ELEMENTS PLACED INSIDE THE "LAMBALIKS".

DIRECT ILLUMINATION WAS PROVIDED BY LIGHTING ELEMENTS HANGING INSIDE THE CHIMNEYS

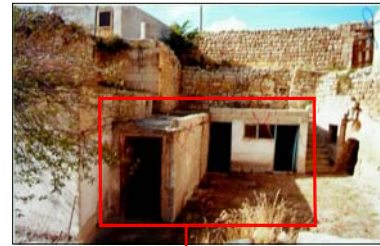
WALLS WHICH WERE DECIDED TO RECONSTRUCT BY STONE

UNQUALIFIED BUILDINGS IN THE LOT THAT WERE DECIDED TO BE REMOVED

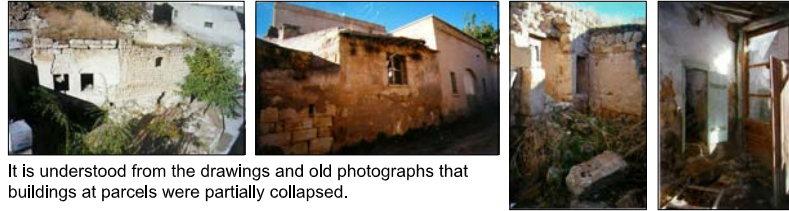
BUILDINGS ARE SEEN ONE STOREY FROM SOUTH ELEVATION

It is understood from the drawings and old photographs that buildings at parcels were partially collapsed.

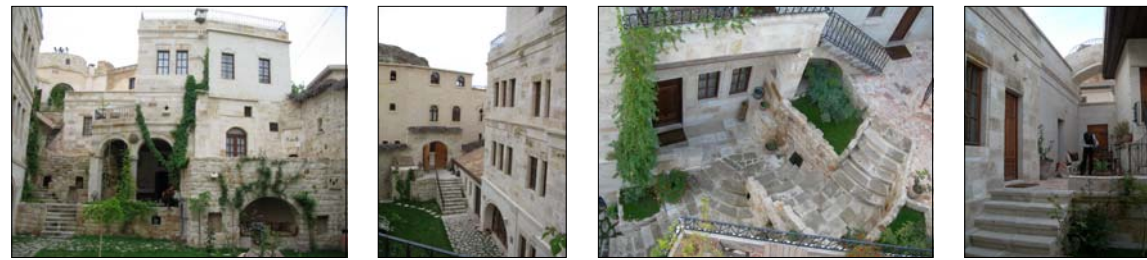
INTERVENTIONS

There are totally 5 traditional dwelling lots in the establishment. The building lots which are next to each other at the same building block. They reused at the same time after the preparation of the restoration projects.

Entrance to the facility is from east through courtyard door. One descends to the courtyard with staircases. There are buildings at the south and west of the courtyard which is surrounded by high walls.

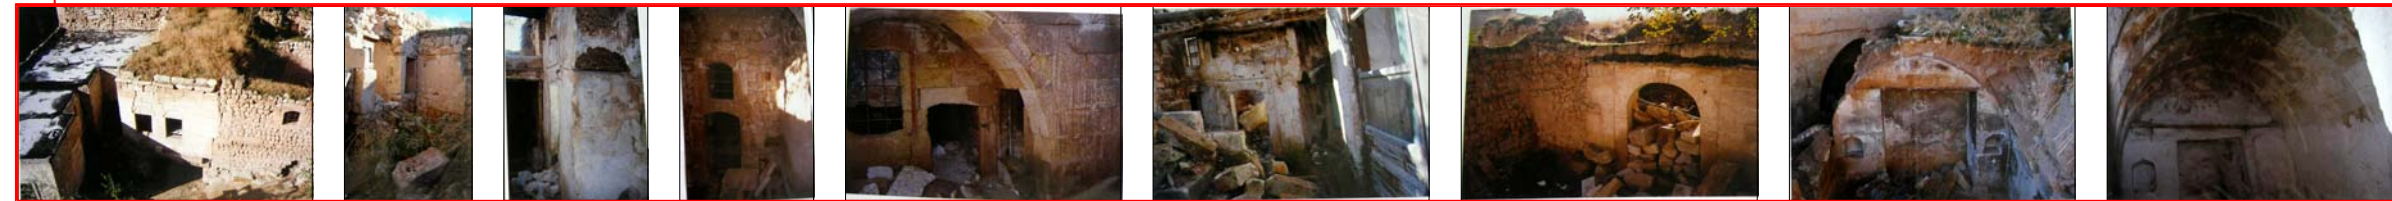
→ VIEWS OF PARTIALLY COLLAPSED BUILDINGS IN PARCELS BEFORE RESTORATION

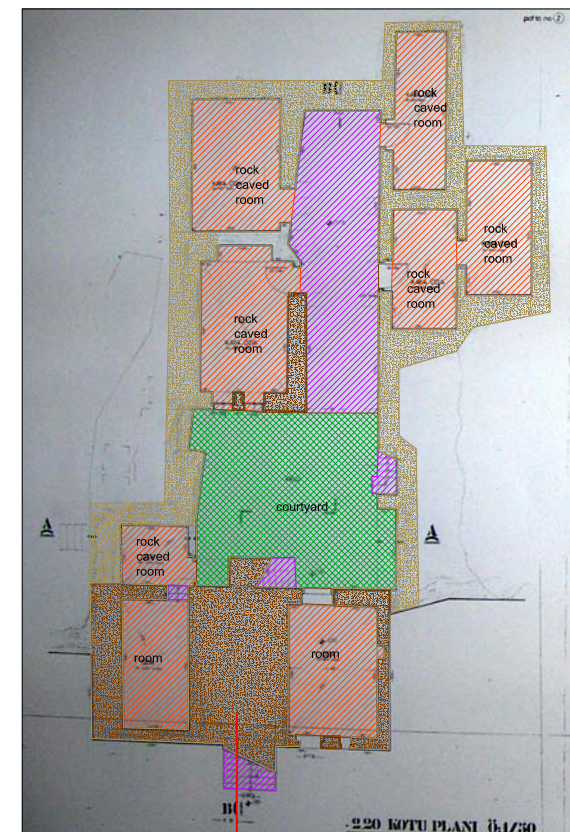
The measured drawings were prepared by Cavit Kartal in 1999. 2 plans, 2 sections and 2 elevations were prepared. There are not any data about the functions of the spaces at the measured drawings. It is understood from the drawings that some rock caved spaces, roof and balcony of the dwelling were collapsed or partially collapsed.

Functions of common spaces were not determined at the restoration projects. Also, any data for the spaces at the basement floor are found at the projects. It was suggested to reconstruct the partially collapsed elements such as roof, balcony, etc. But their details were not defined.

Interventions at the "Konak" and rockcaved structure were mainly; repairing partially collapsed sections and addition of spaces. During the applications, balcony and roof, which seems to be collapsed according to the measured drawings, of the "konak" were rebuilt. The space which used as the kitchen at the moment was obtained by removing the wall between two spaces. Walls and floor of the kitchen was tiled and the roof is plastered. Kitchen is furnished with contemporary furnitures. Rockcaved and vaulted spaces were furnished with modern and ancient furnitures. Sitting sections were formed with "sedir"s in the common spaces. Architectural elements such as niches, "ocak" are used for decorative purposes at the places. Contemporary heating devices used for heating are mounted to the walls without considering their harmony with the structure or the furnitures. Illumination is provided by the contemporary devices hanged from the ceiling.

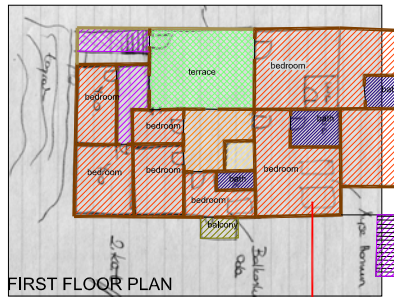
FIRST FLOOR PLAN

BY CONSTRUCTING STONE WALLS IN ROOMS, WET SPACES WERE ARRANGED

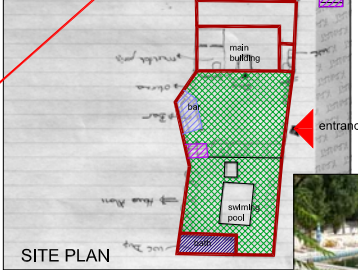
SITE PLAN

WHEN ENTERING THE BUILDING THERE IS A RECEPTION

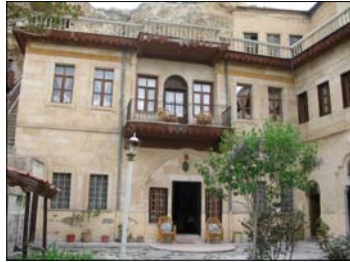
"KONAK" THAT TOUCHES TO A ROCK HAS BOTH VAULTED AND ROCK CAVED SPACES. WHILE VAULTED SPACES ARE USED AS SLEEPING UNITS, ROCK CAVED SPACES ARE USED AS COMMON SPACES AND CIRCULATION AREAS.

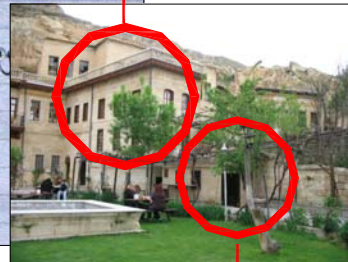
ONE STOREYED MASS ADDITION IS USED FOR RECEPTION

Mass additions are mostly seen in Asia Minor Hotel. A two storeyed building was added for accommodation needs. And a one-storeyed reception unit was also added later. These additions were constructed by concrete but their facades were covered by stone.
