**INVESTIGATION OF PITTING CORROSION MORPHOLOGY OF
ST 37 MATERIAL IN DIFFERENT CORROSIVE ENVIRONMENTS**

M.Sc. Thesis by

Department of Metallurgy and Material Engineering

April, 2018

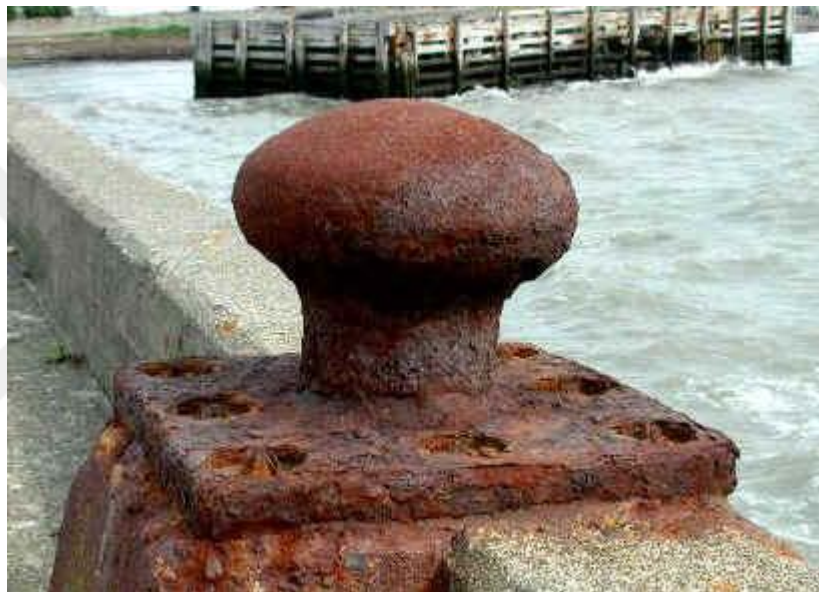
Figure 1.3 Uniform Corrosion [5].

This is also called general corrosion. Uniform corrosion is the most common type of corrosion and is caused by a chemical or electrochemical reaction that results in the deterioration of the entire exposed surface of a metal (Figure 1.3). Uniform etching of metal occurs when the chemical directly attacks on metal surfaces.

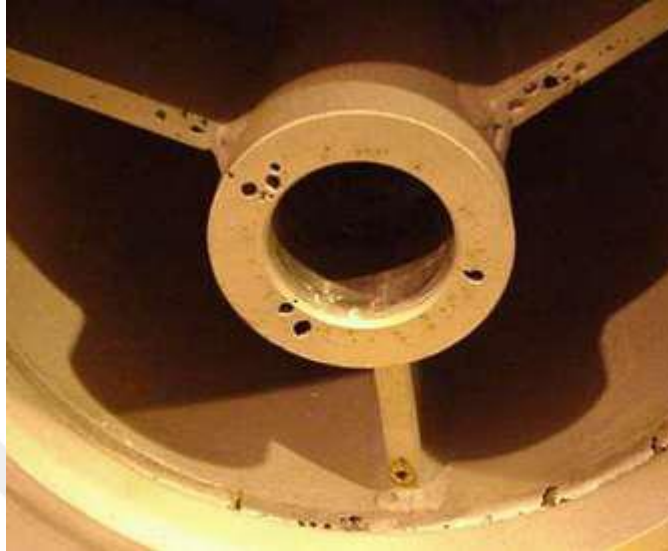
Figure 1.5 The 316L type stainless steel pump, there is a local pitting corrosion [5].

Pitting corrosion occurs in materials that have protective films and corrosion attacks with localized holes on the metal's surface so it can penetrate the metal very rapidly [5].

breakdown and destructive system failure in a very short period of time [13]. Sometimes pitting corrosion can be quite small on the surface but it can be very large below the surface [5].

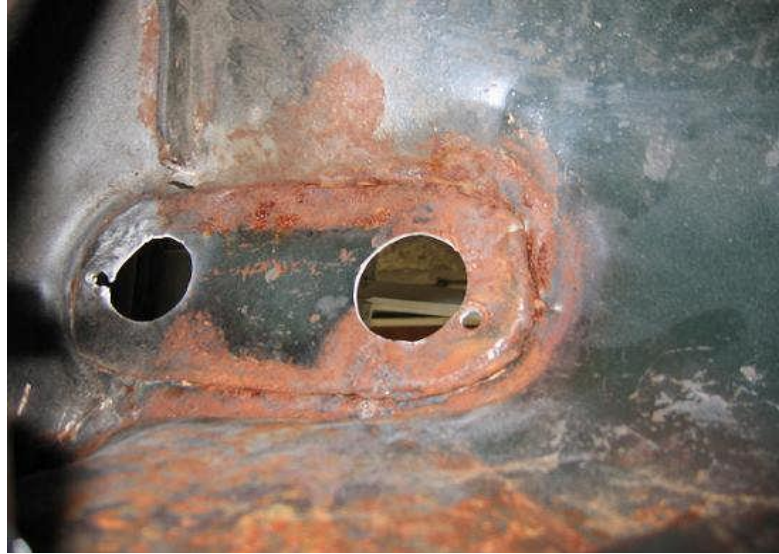
Figure 1.6 It is a corrosion that occurs on the six covered surfaces such as rivets, bolts, gaskets and in intervals [11].

Crevice or contact corrosion is the corrosion produced at the region of contact of between metallic and non-metallic material (Figure 1.6). It may occur at washers, under barnacles, at sand grains, under applied protective films, and at pockets formed by threaded joints. Cleanliness, the proper use of sealants and protective coatings can also be used to control corrosion effects [5-11].

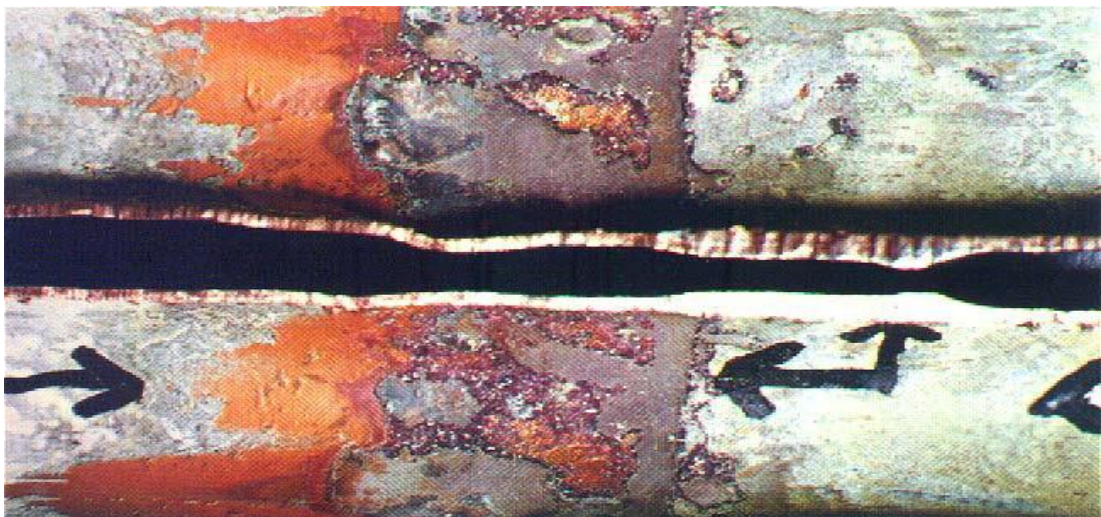
Figure 1.9 Erosion Corrosion in Solder Joints [13].

Erosion corrosion is a result of a combination of an aggressive chemical environment and high fluid-surface velocities [5]. Metal is removed from the surface as dissolved ions and corrosion products are mechanically swept away from the metal surface (Figure 1.9)[13]. Erosion corrosion can be prevented by using a more corrosion resistant alloy [7].

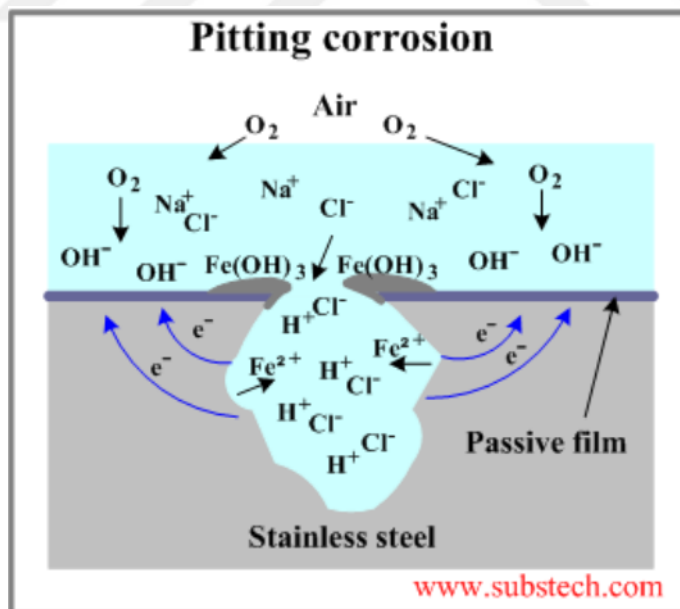
Figure 2.1 Pitting Mechanism [10].

Passive films are very useful for many engineering alloys such as aluminum alloys and stainless steel. The passive films are thin oxide layers that form naturally on the metal surface and greatly decrease the rate of corrosion of the alloys. However, such passive films are often sensitive to localized breakdown resulting in accelerated dissolution of the underlying metal. Especially chloride ions cause that breakdown of a passive film [14]. The chloride ion has a special significance in pitting corrosion. Chloride ions especially exist in seawater, brackish waters, de-icing salts, and airborne salts [7]. The chloride ions causes the attack confined to a small fixed area of the metal surface, it is called pitting corrosion and this mechanism is illustrated in Figure 2.1 [14-10].

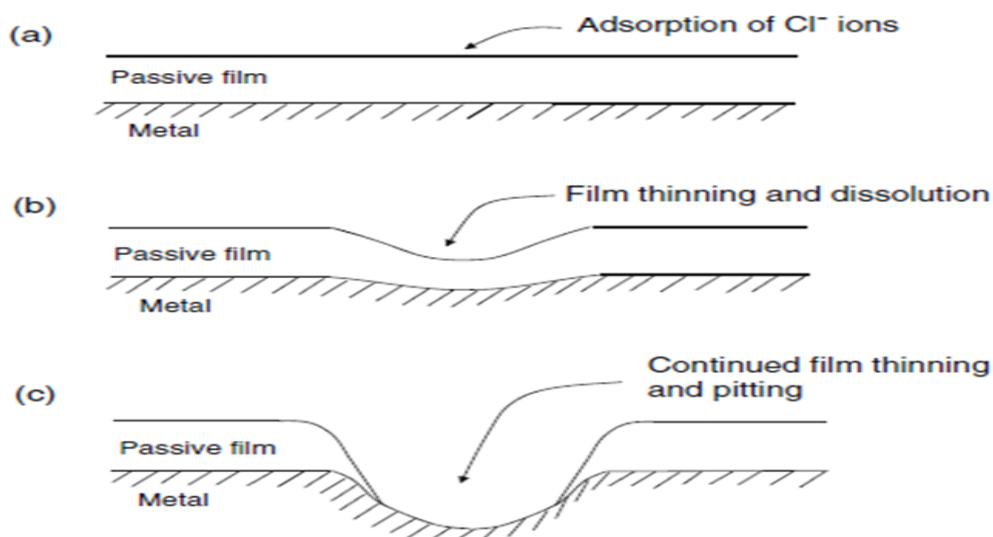
Figure 2.3 The film thinning mechanism of pitting in which chloride adsorption (a) initiates the process of film thinning (b) leading to pitting (c) [7].

According to some researchers these particles precipitate along the grains boundaries and serve as local anodes so formation of initial pits occur on the metal surface [15]. Pitting mechanism is illustrated in Figure 2.3.

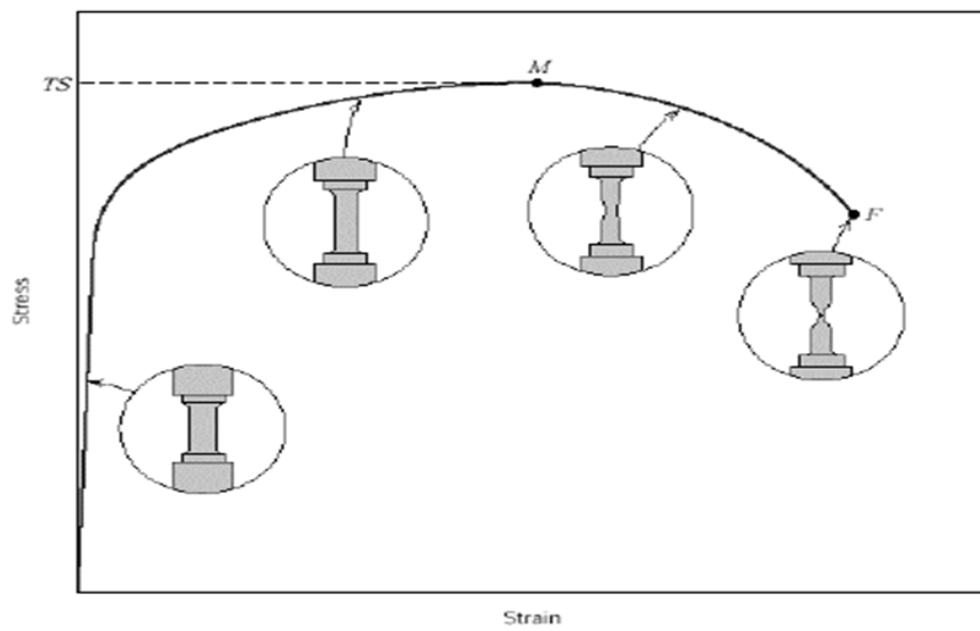
Figure 3.2 Typical Engineering Stress-Strain Behavior to Fracture, Point F. The Tensile Strength is Indicated at Point M. The circular insets represent the geometry of the deformed specimen at various points along the curve [27].

Stress-strain curves and elongation (%) were measured during the test. Figure 3.2 shows the typical engineering stress-strain behavior [27].

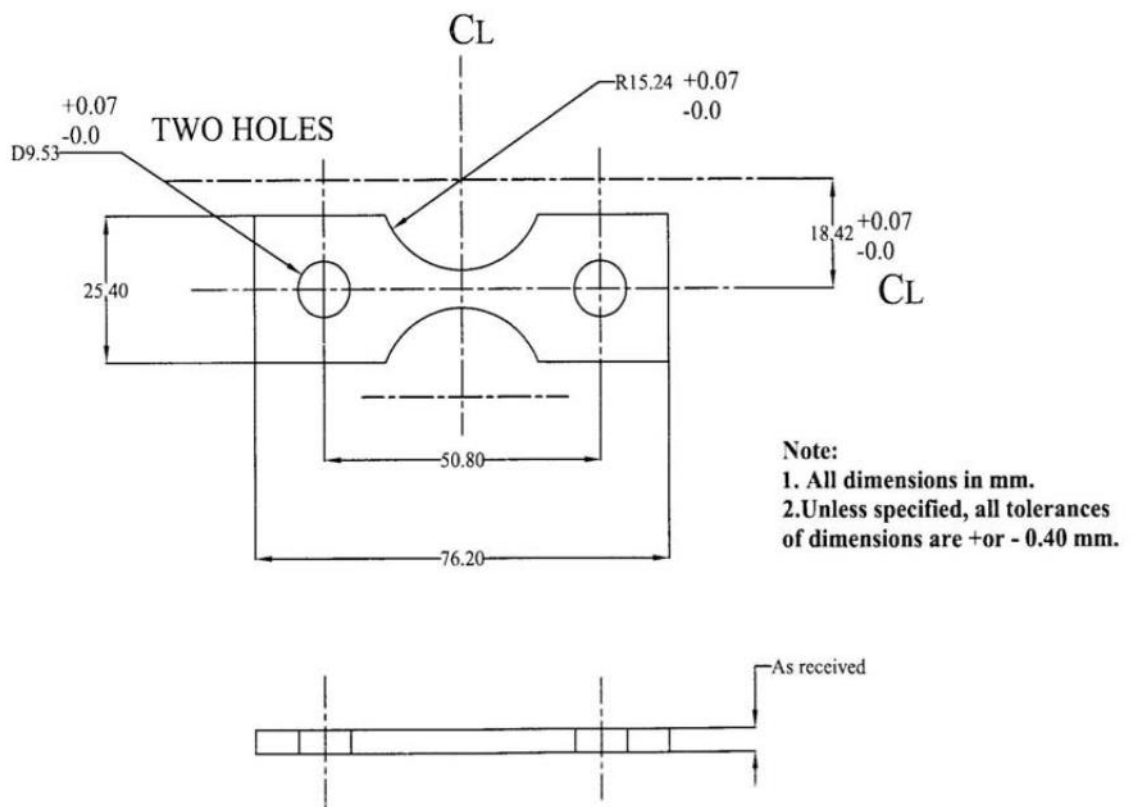
Figure 4.1 Specimen Used in This Study. Adapted from [28].

In this study, specimens shown in Figure 4.1 were used. The specimens were machined in laser cutting machine factory. St 37 sheet metal was obtained and cut according to the ASTM standards as dog bone specimen shape. Dog bone specimens were used in this research because of the combined effect of stress concentration close to center and the pitting corrosion.

In this study, specimens shown in Figure 4.1 were used. After the specimens were machined in accordance with the drawing in Figure 4.1, both sides of the specimens were polished according to the procedure shown in Figure 4.3. Firstly the specimens were polished with abrasive grit size 120 paper. But it was very difficult to clean the surface of the samples. So it was decided to use thicker sandpaper which is grit size 80. Then the sharp corners of the specimens were polished with abrasive grit size 1000 paper. Polishing machine used in the experiments is shown in Figure 4.4. After this step only one side of the specimens was polished to 1 micron and 0.3 micron finish.

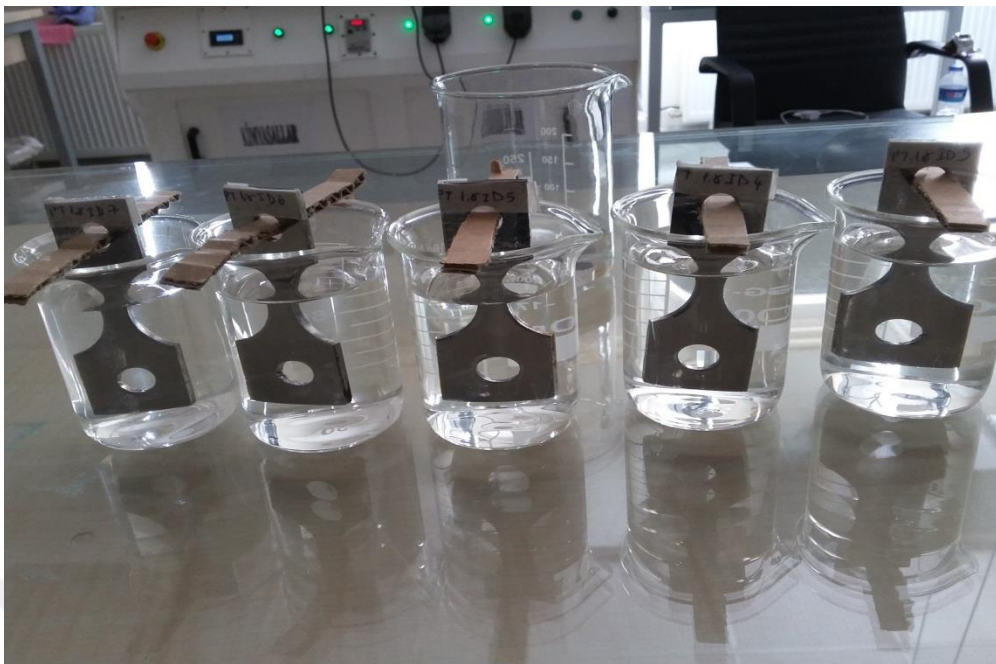
Figure 4.2 Specimens in Solution

Pits on the specimen's surfaces were not observed approximately 24 hours therefore to induce the corrosion pitting and keeping the time shorter, experiments were performed by adding H₂O₂ to the NaCl solutions. The solutions with 1.8% NaCl and 3.5% NaCl were prepared using distilled water with 30 % H₂O₂. Figure 4.2 shows those specimens in solution.

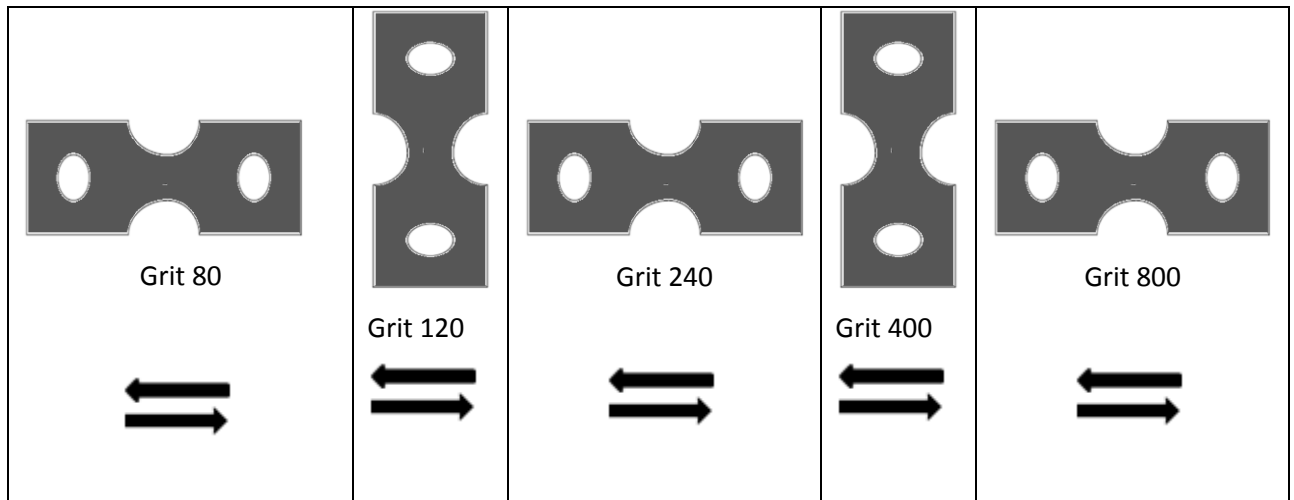
Figure 4.3 Schematic View of the Specimen Polishing with the 80, 120, 240, 400, 800 Grit Sandpaper.

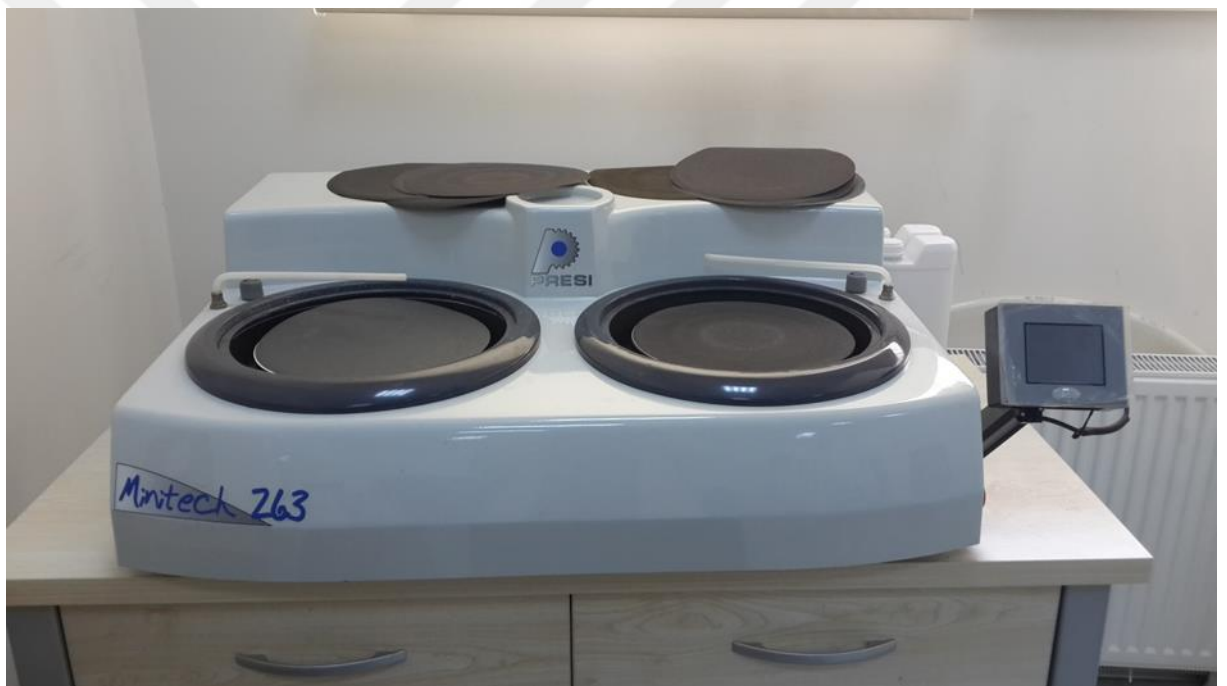
Figure 4.4 Polishing Machine

Scratches, discontinuities, surface faults and residues, etc. were minimized by polishing. In this way, polishing process decreases the probability of the specimen deformity during testing.

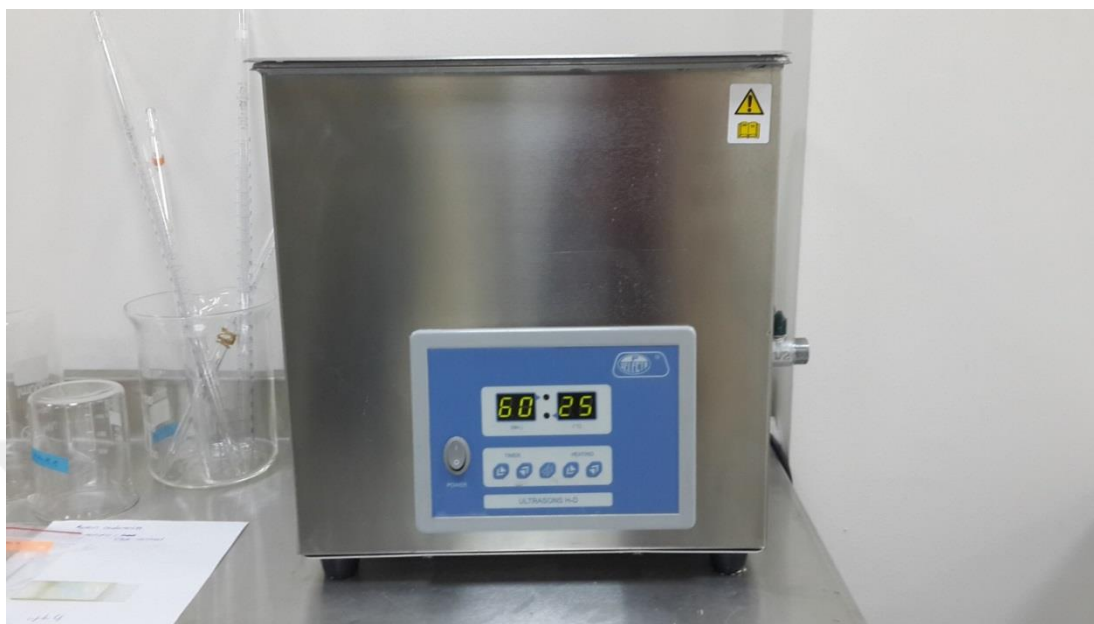
Figure 4.5 Ultrasonic Cleaner

After that, they were cleaned with the acetone in the ultrasonic cleaner and designated with ID numbers. Figure 4.5 shows that ultrasonic cleaner. In Figure 4.6

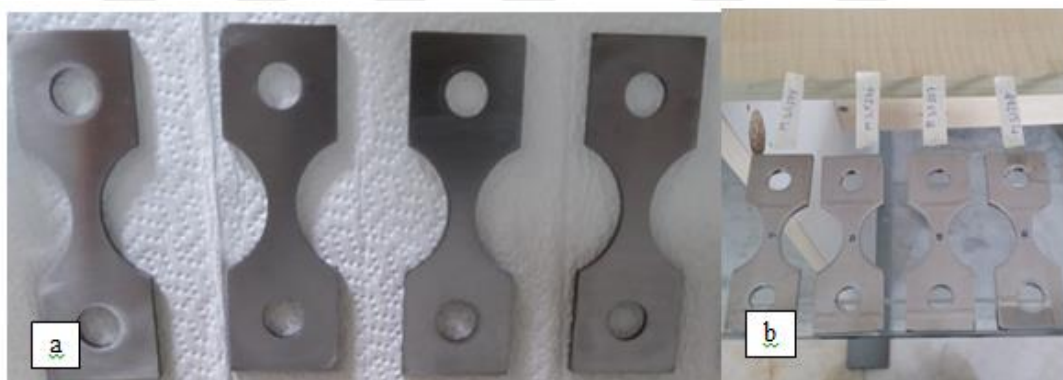
Figure 4.6 (a) Sanded and Ultrasonic Bathed Specimens (b) ID Numbered Specimens For 3.5 % Salinity Solution

(a) and Figure 4.6 (b), specimens treated by ultrasonic bath and the designations of the specimens with the ID numbers are illustrated respectively.

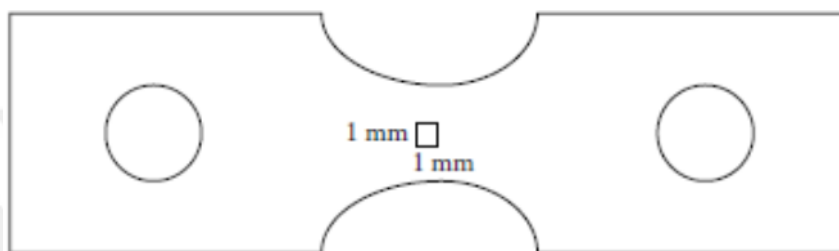
Figure 4.7 Representation of Specimen and 1 mm² Area at the Center

shown in Figure 4.7. Before a specimen was put into the solution, the specimen was painted by fingernail polish except the area at the center of the dog bone, which is an area of 1 mm x 1mm. The reason is to have the corrosion only at the center for examining easily. Fingernail polish was chosen to protect the rest of the area as it contained no metallic substances that could affect the ability to protect the covered surface. Polish was applied three layers with 20 minutes drying periods. Then the samples were stored in a dry environment until tested. Drying of the specimens is illustrated in Figure 4.8. (a and b)

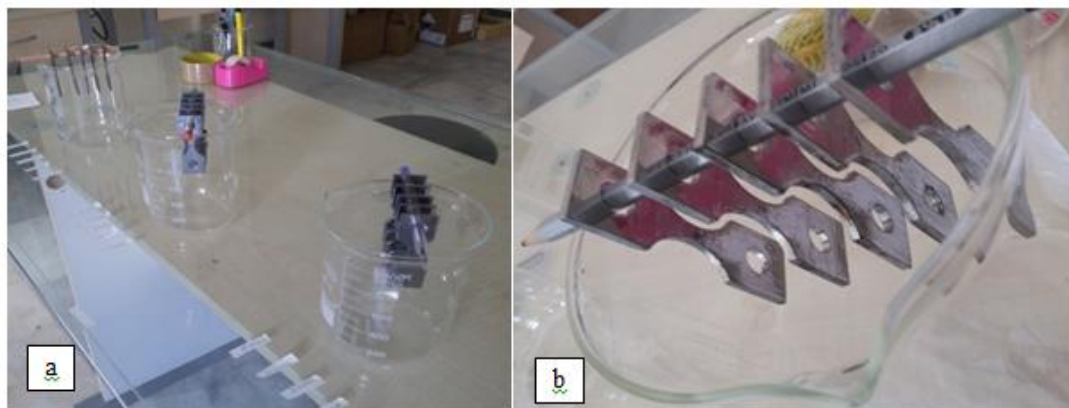
Figure 4.8 (a) Polished With Nail Polish and Dried Specimens (b) Zoom in Image

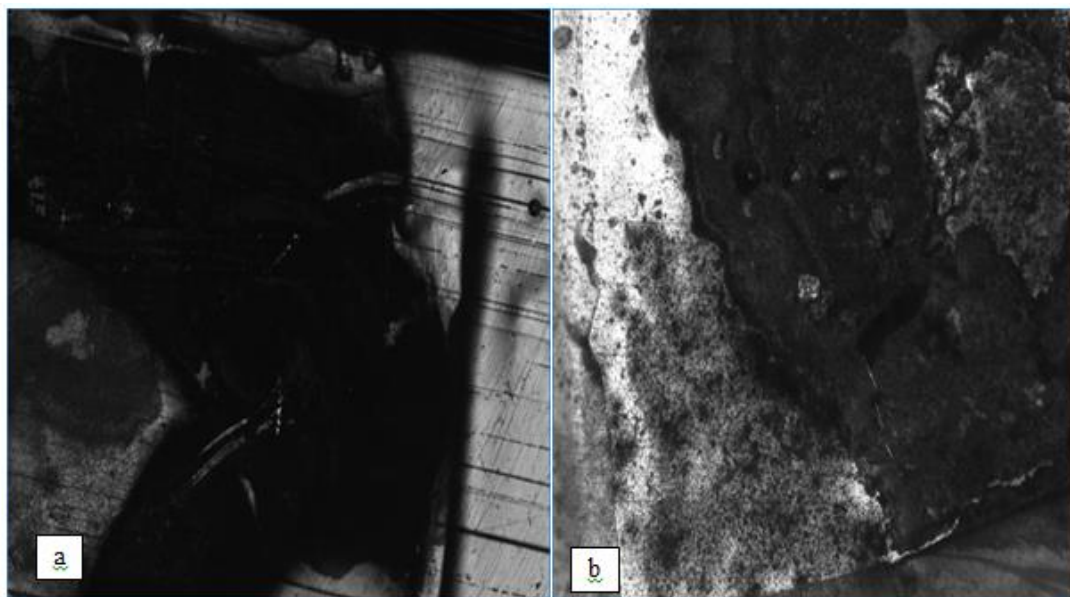
Figure 4.9 (a and b) Pilot Specimens of Corroded Area With 3.5 % NaCl in 3.5 Hours

Firstly specimens stayed in the solution for 3.5 hours. Then the specimens were removed from the solution and cleaned using ultrasonic bath. After the corrosion process, each specimen was investigated by optical microscope for pitting characterization and measurements were taken and recorded to a computer with the help of digital images. The corroded area are illustrated in Figure 4.9 (a and b).

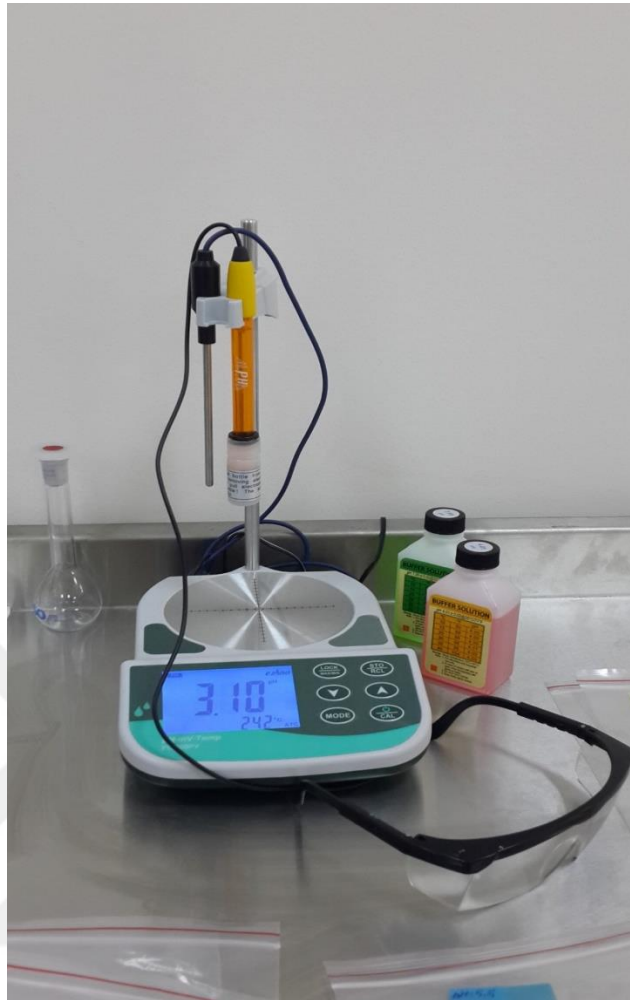
Figure 4.10 pH Meter

In order to investigate the effect of pH to corrosion, the pH values of the solutions were measured before and after the specimens were immersed to solutions. pH meter used in the experiments is shown in Figure 4.10.

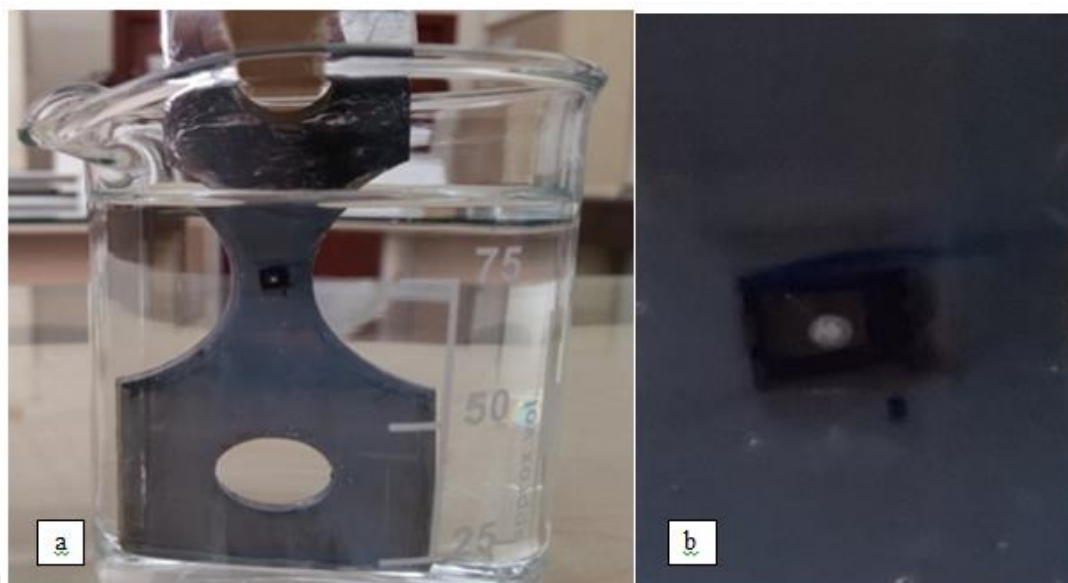
Figure 4.11 (a) An Immersed Specimen in a Prepared Solution (b) Zoom of the Corroded Area

The specimens were put into these solutions for 15 minutes periods, after each period they were observed for pit morphology with optical microscope and the process was repeated three times. The immersion procedure and the corroded area are showed in Figure 4.11 (a and b). End of the process, the pH values of solutions were measured.

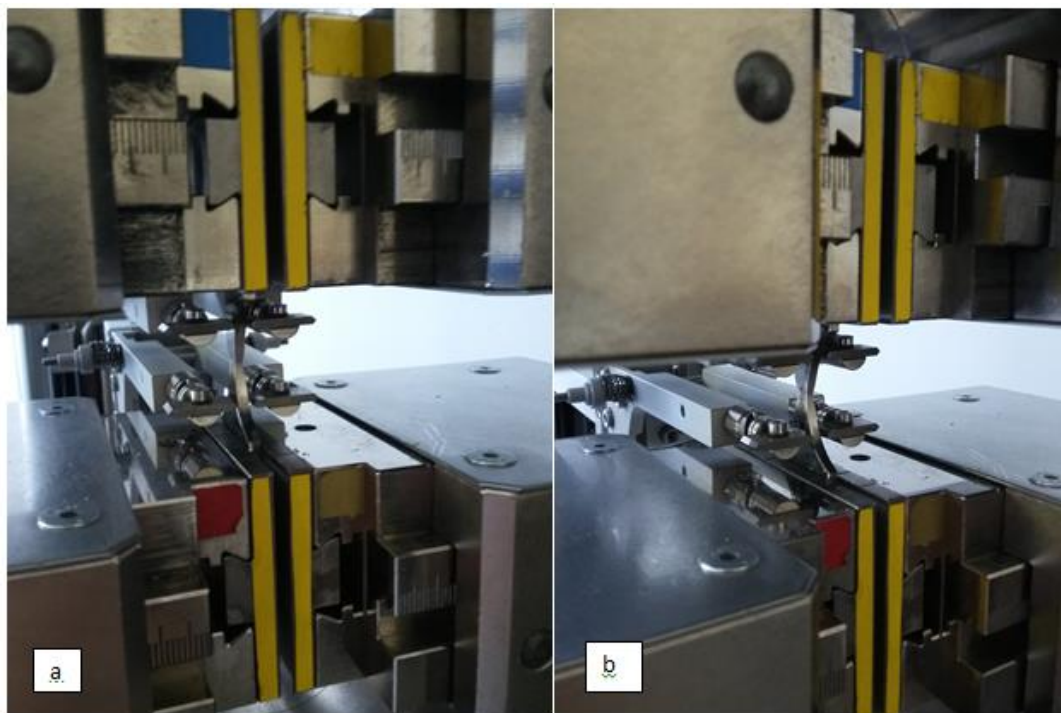
Figure 4.12 (a) Sample Placed in the Device (b) The Breaking Moment of the Specimen

The tensile test was also carried out at 23 ° C and 50% relative humidity. The specimens were pulled with 1 mm/min velocity and the data were recorded. The load and elongation were measured continuously and recorded until failure. Figure 4.12 shows tensile test and Figure 4.13 shows zoom of the breaking area.

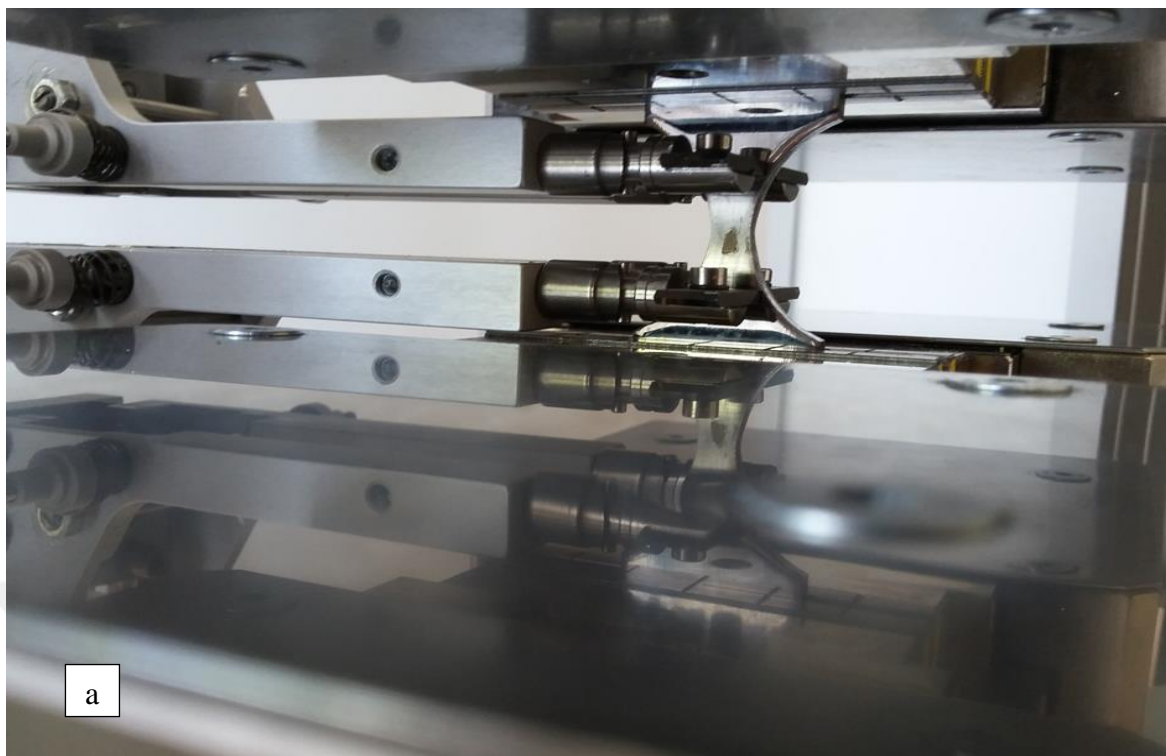
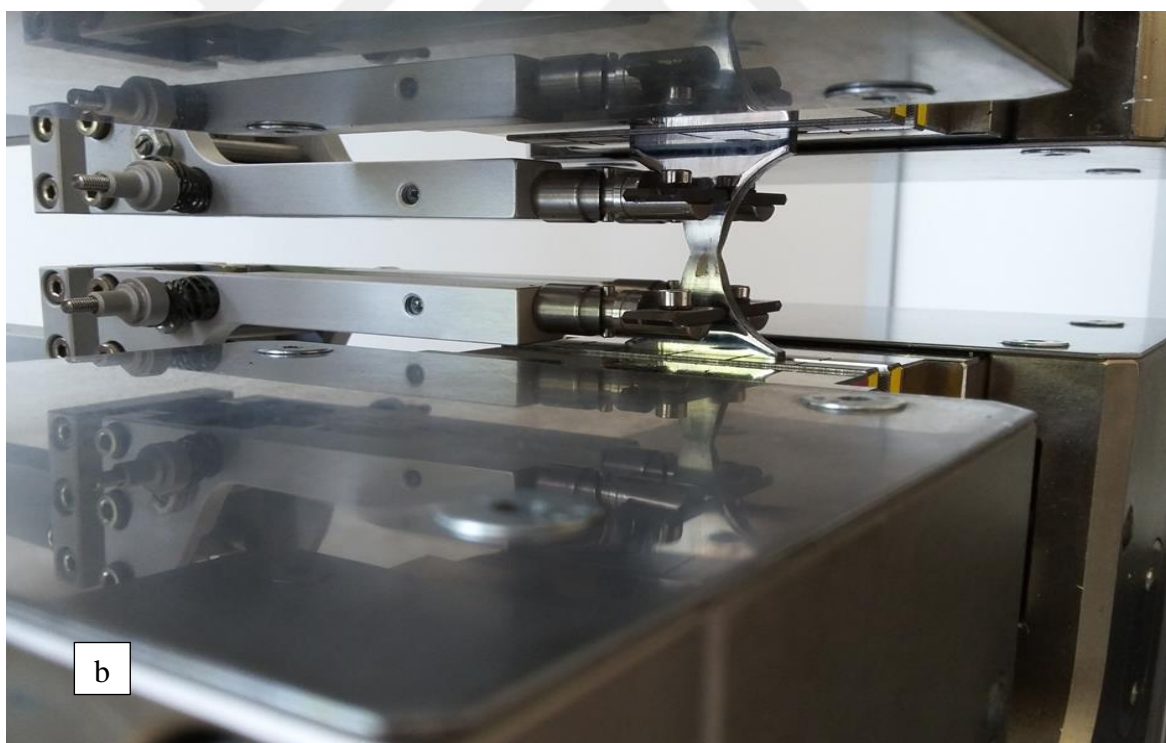
Figure 4.13 Zoom of the Breaking Area (a and b)

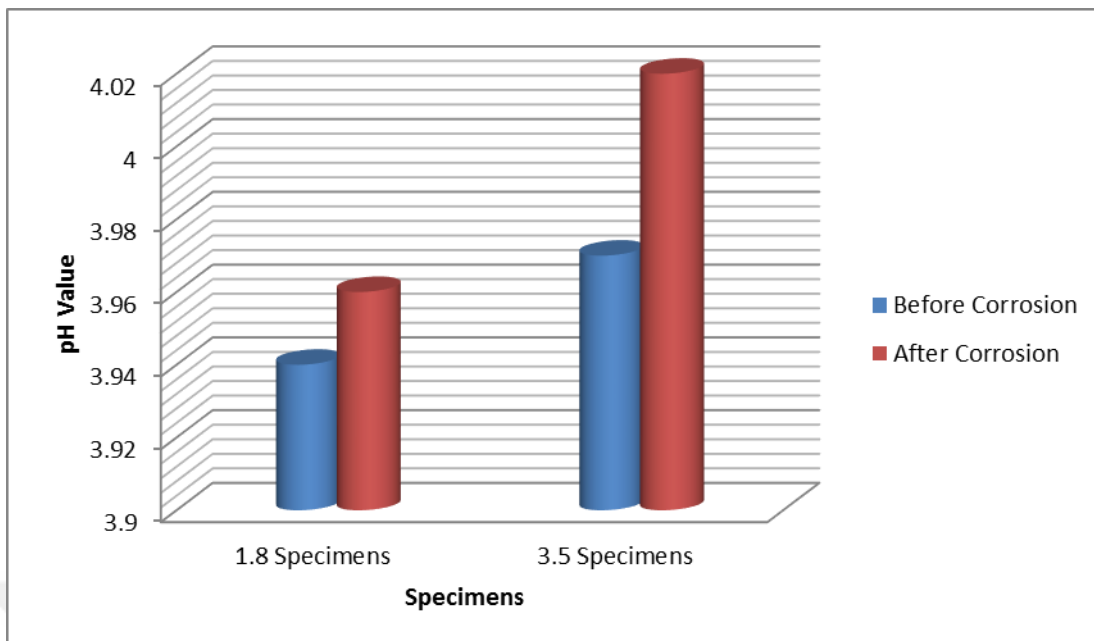
Figure 5.1 pH Value before Corrosion and after Corrosion

Hence, the pH change may not be a significant parameter on the pitting corrosion. However, the reason of the little change may be the short immersion time of specimens.

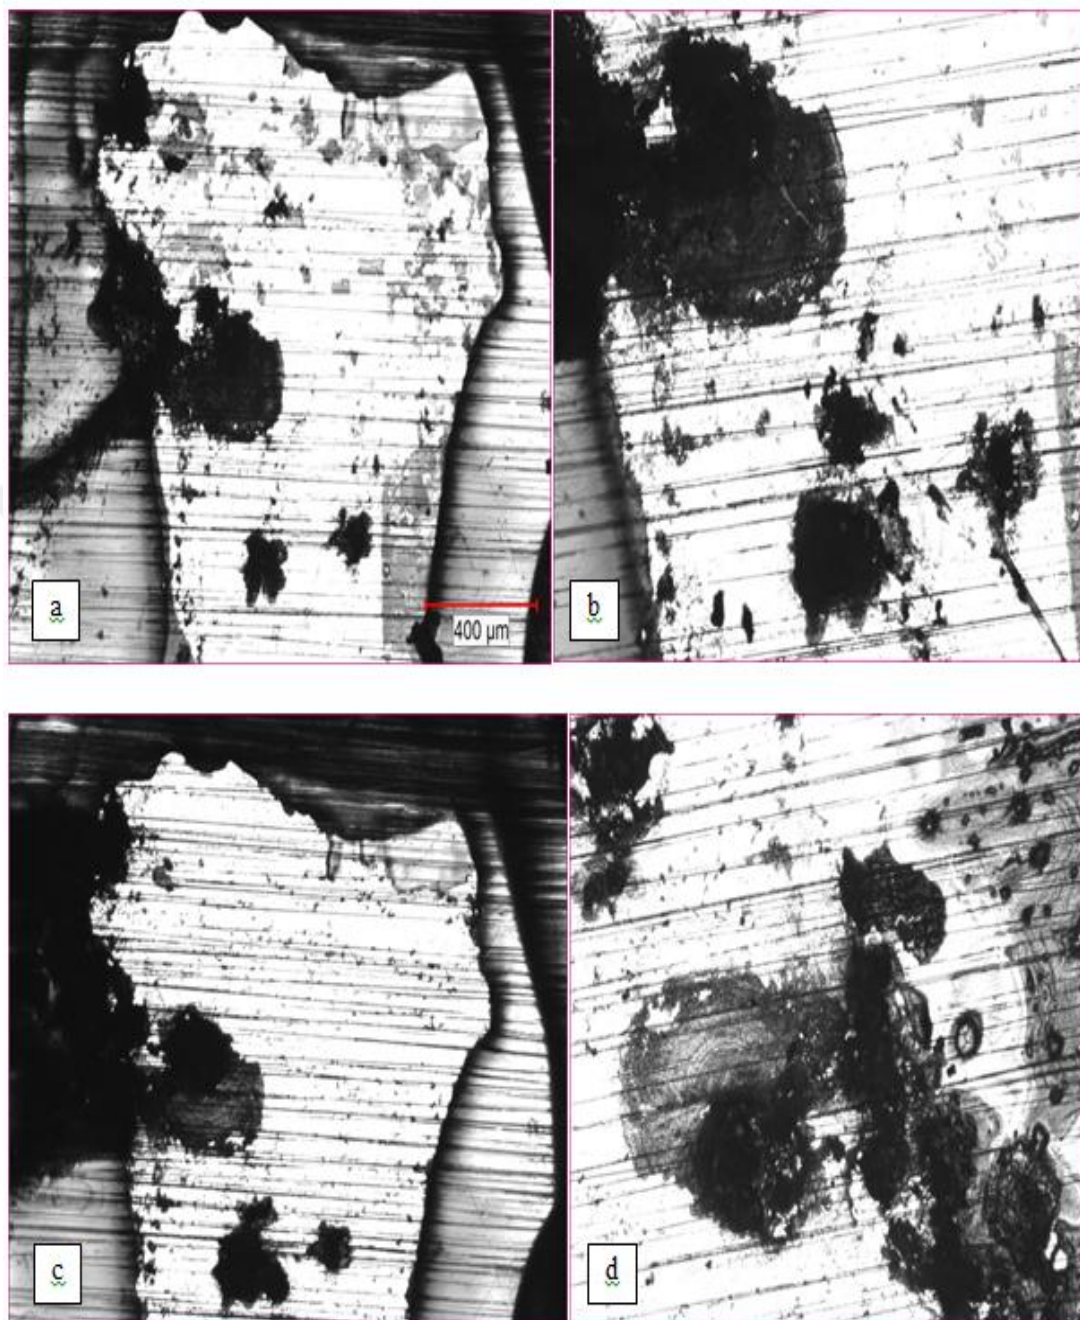
Figure 5.2 The Change in the Pit Morphology of Specimen 1.8 ID 2 at (a) 15 min. (b) 30 min. (c) 45 min. (d) Cleaned with Acetone

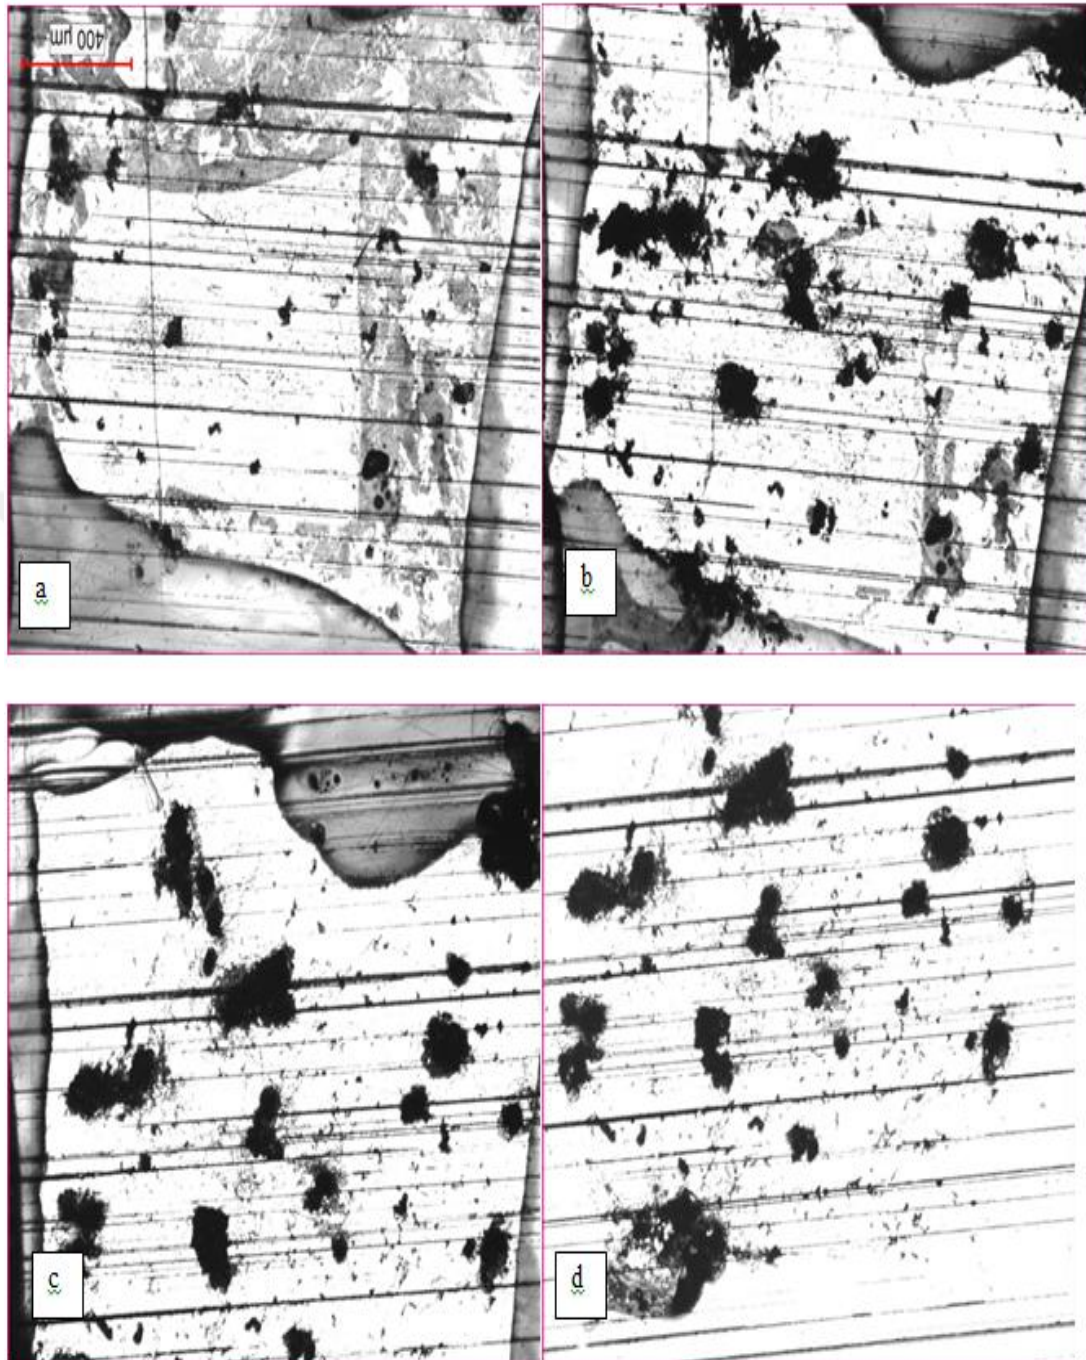
Figure 5.3 The Change in the Pit Morphology of Specimen 3.5 ID 1 at (a) 15 min. (b) 30 min. (c) 45 min. (d) 45 min (Cleaned with Acetone)

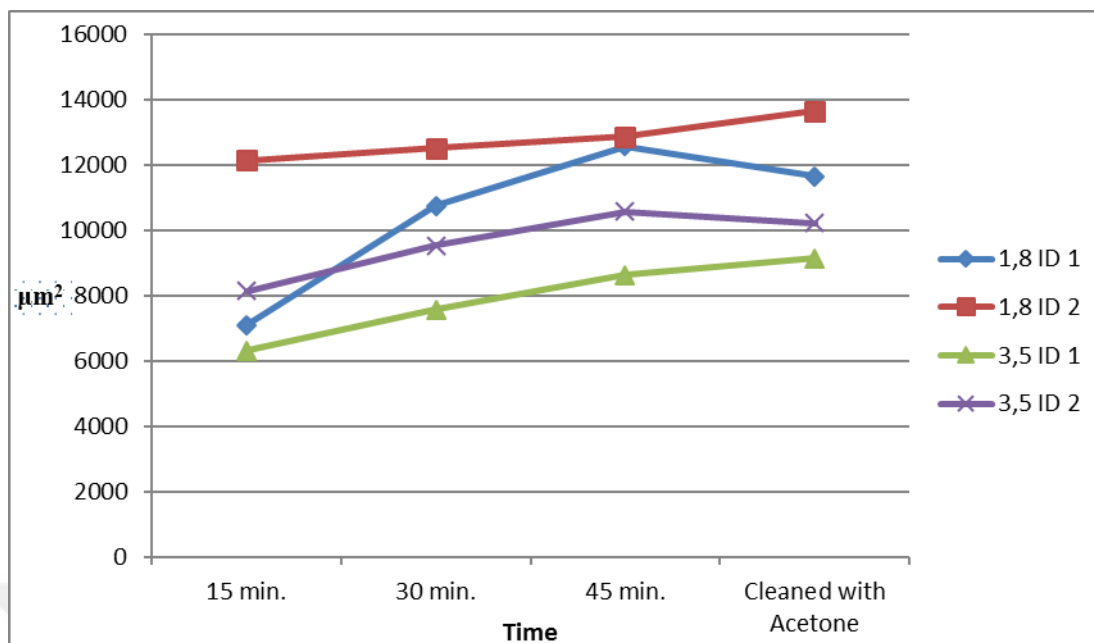
Figure 5.4 The size of the pit

The size of the pits 3.5 ID 2 in (15 min) was $8132 \mu\text{m}^2$, in (30 min.) was $9545 \mu\text{m}^2$, in (45 min.) was $10584 \mu\text{m}^2$ and in (d) was $10225 \mu\text{m}^2$. The reason of decrease in (45 min. with acetone) was due to the acetone addition.

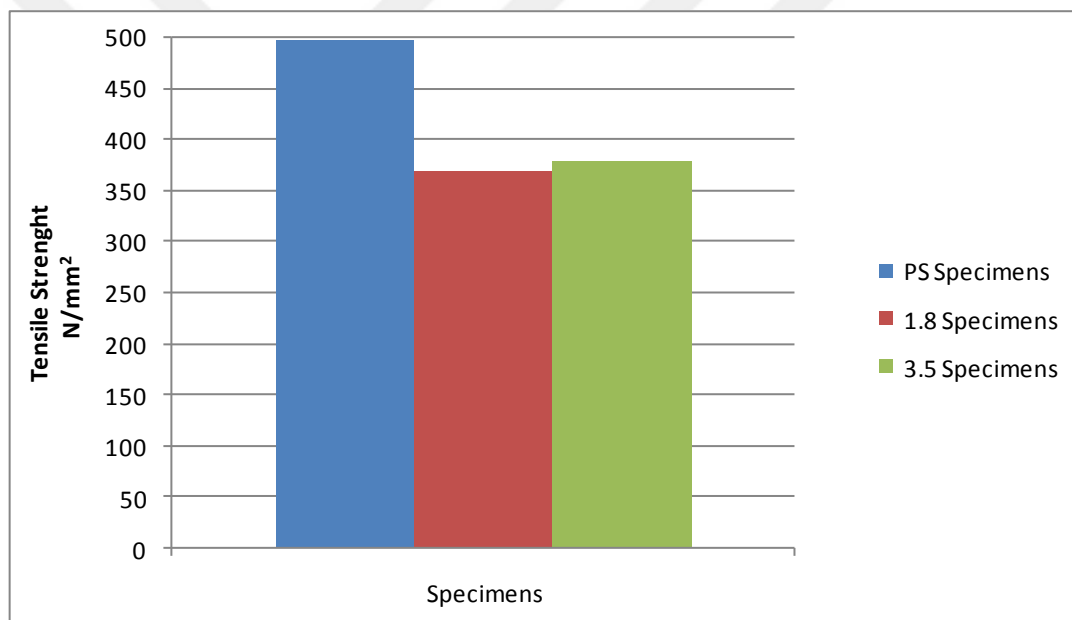
**Figure 5.19** Results of the Tensile Tests

Specimen	Tensile Strength [N/mm ²]	Fracture Strength [N]	Strain Rate [%]
PS Specimen	498	6432	26
1.8 Specimen	369	4352	19
3.5 Specimen	378	4917	21

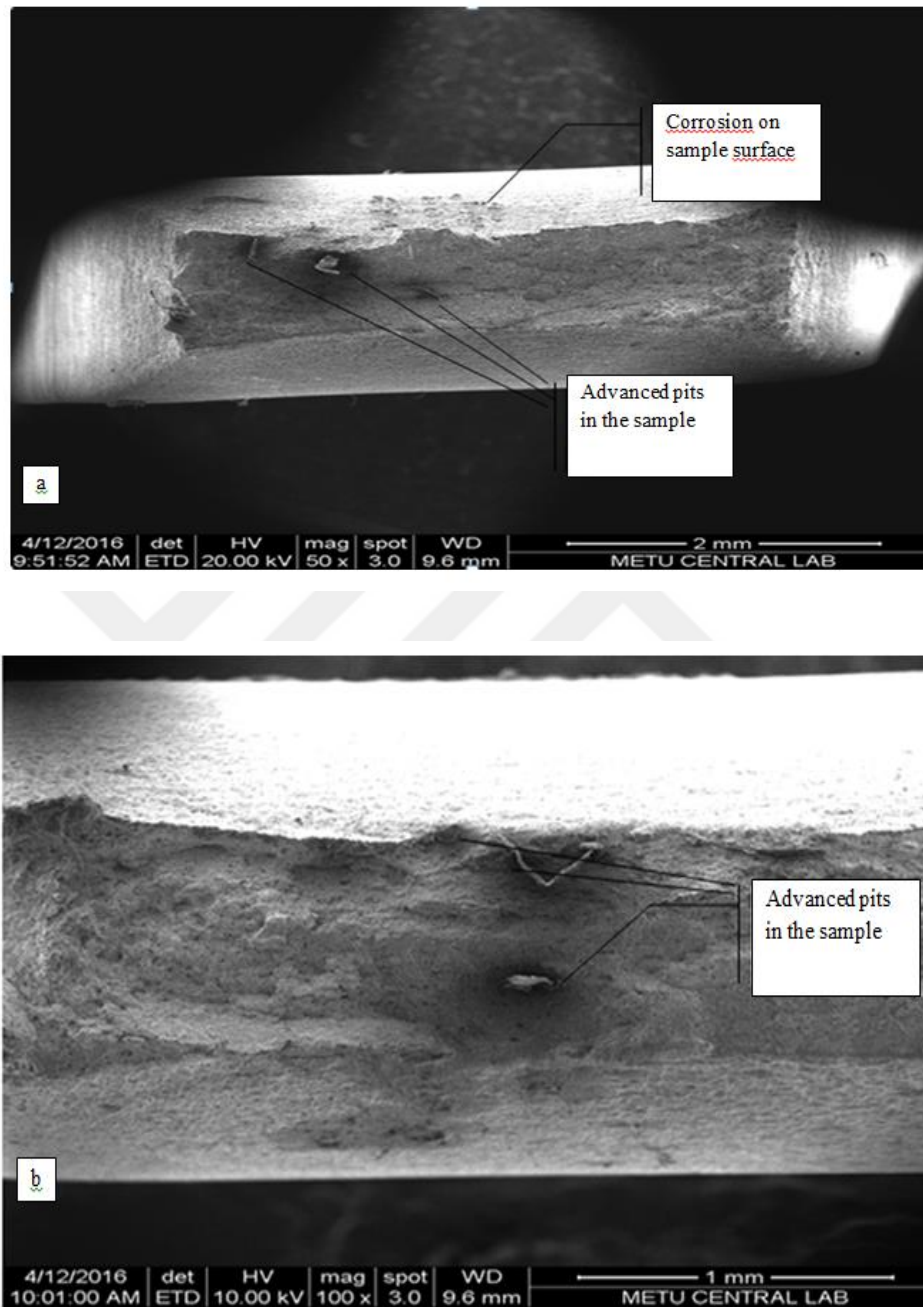
Figure 5.20 From Surface View SEM Micrographs of Specimens Immersed to the (a)&(b) 3.5% NaCl Solution

was also performed. The fracture came from the corroded area at the same time corrosion pits could be observed clearly (Figure 5.20 and Figure 5.21).

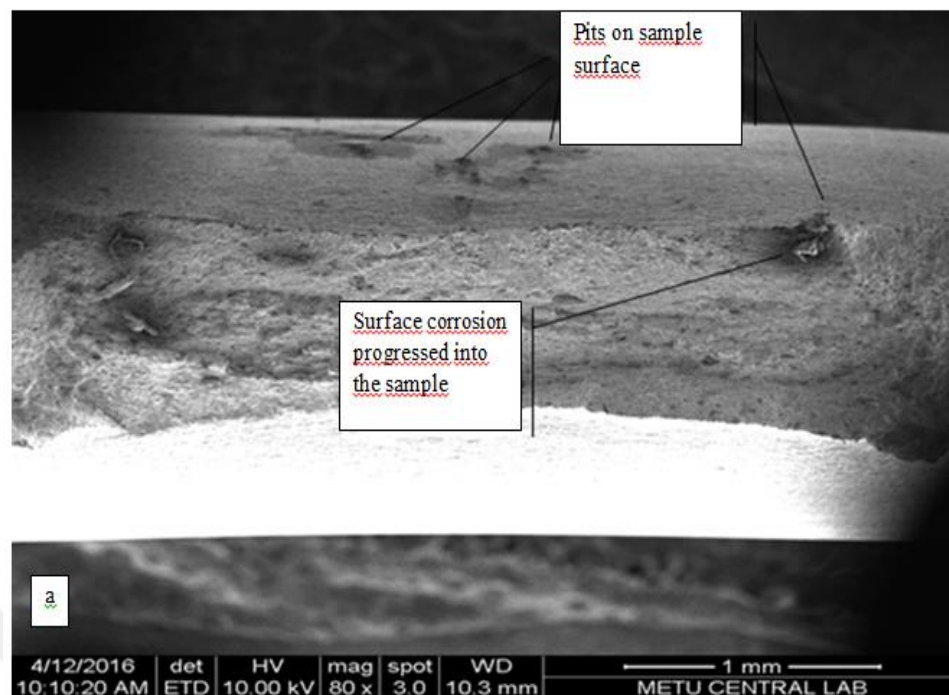
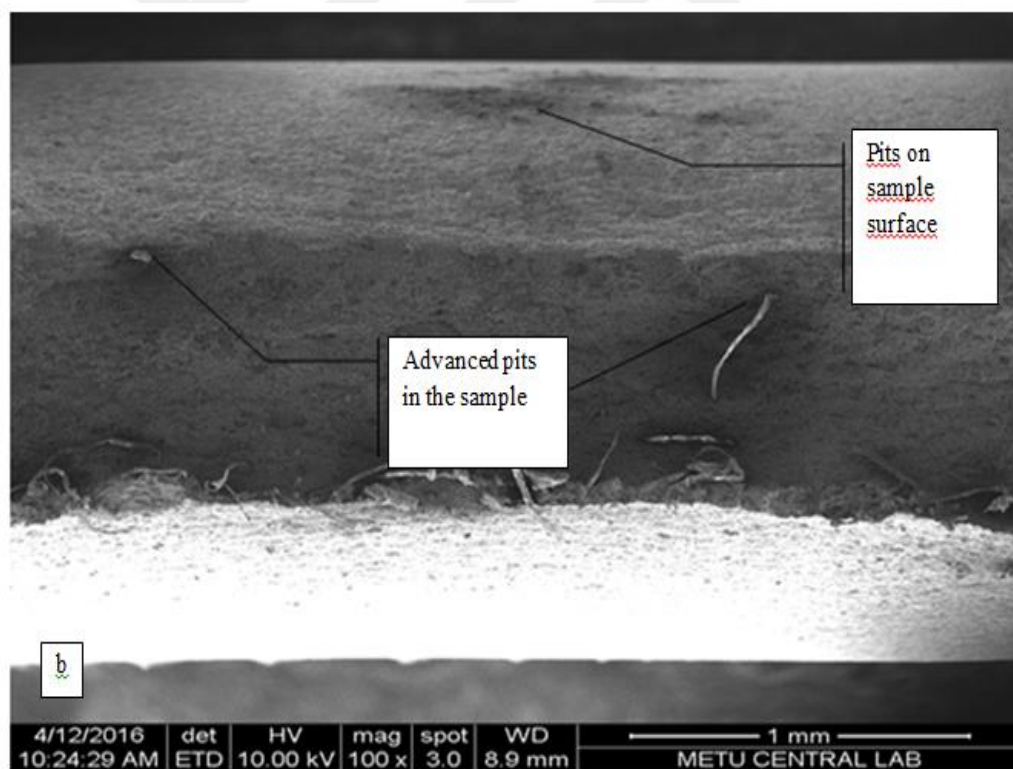
Figure 5.21 From Surface View SEM Micrographs of Specimens Immersed to the (a)&(b) 1.8 % NaCl Solution
