**INVESTIGATION OF PITTING CORROSION MORPHOLOGY OF
ST 37 MATERIAL IN DIFFERENT CORROSIVE ENVIRONMENTS**

M.Sc. Thesis by

Department of Metallurgy and Material Engineering

April, 2018

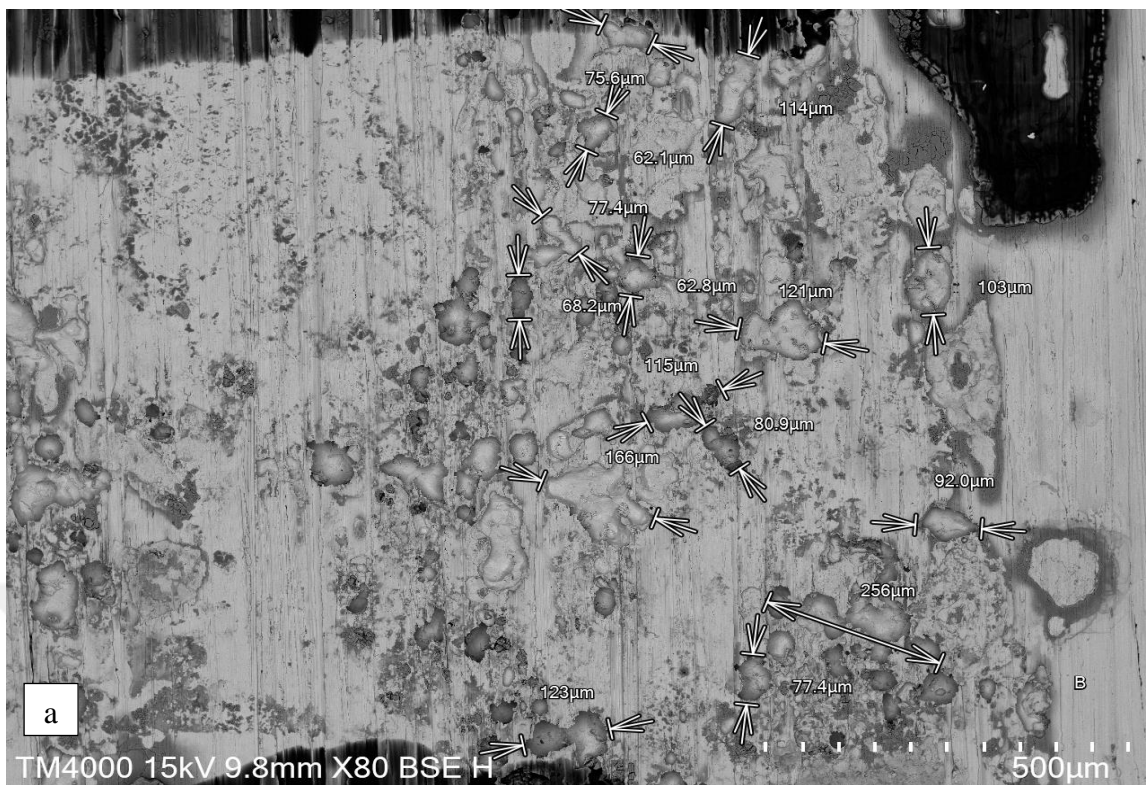
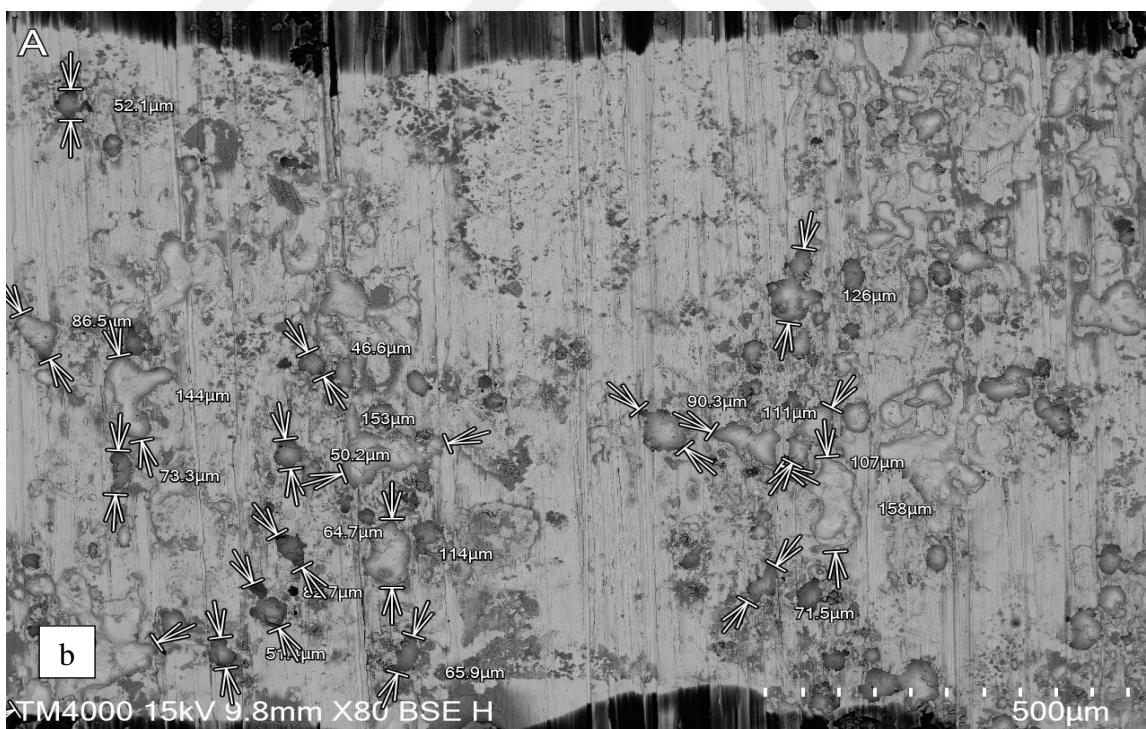
Figure 5.22 Left (a) and Right (b) Surface View SEM Micrographs of Specimens 1.8 ID 3 Immersed to the 1.8% NaCl Solution.

Figure 5.22 (a and b) and Figure 5.23 (a and b) shows the SEM images of corroded surfaces of specimens in 1.8% NaCl and 3.5% NaCl solution before tensile testing. According to the results, the specimens immersed to the 1.8 % NaCl solution showed lower strength than the specimens put to the 3.5 % NaCl solution as unexpected. The reason of this result was that the specimens immersed to the 1.8 % solution had large number of pits on their surfaces after they were corroded and the pits average size were nearly 65-75 μm . But, the specimens immersed to 3.5% solution had few number of pits on their surfaces after they were corroded and the pits average size were nearly 90-100 μm and this results showed that the small and large number of pit reduced strengths unexpectedly. Therefore, the stress rates were different from each other and this was an expected situation. Some researchers stated that increase pitting corrosion decreased the tensile strength and total elongation drastically [35].

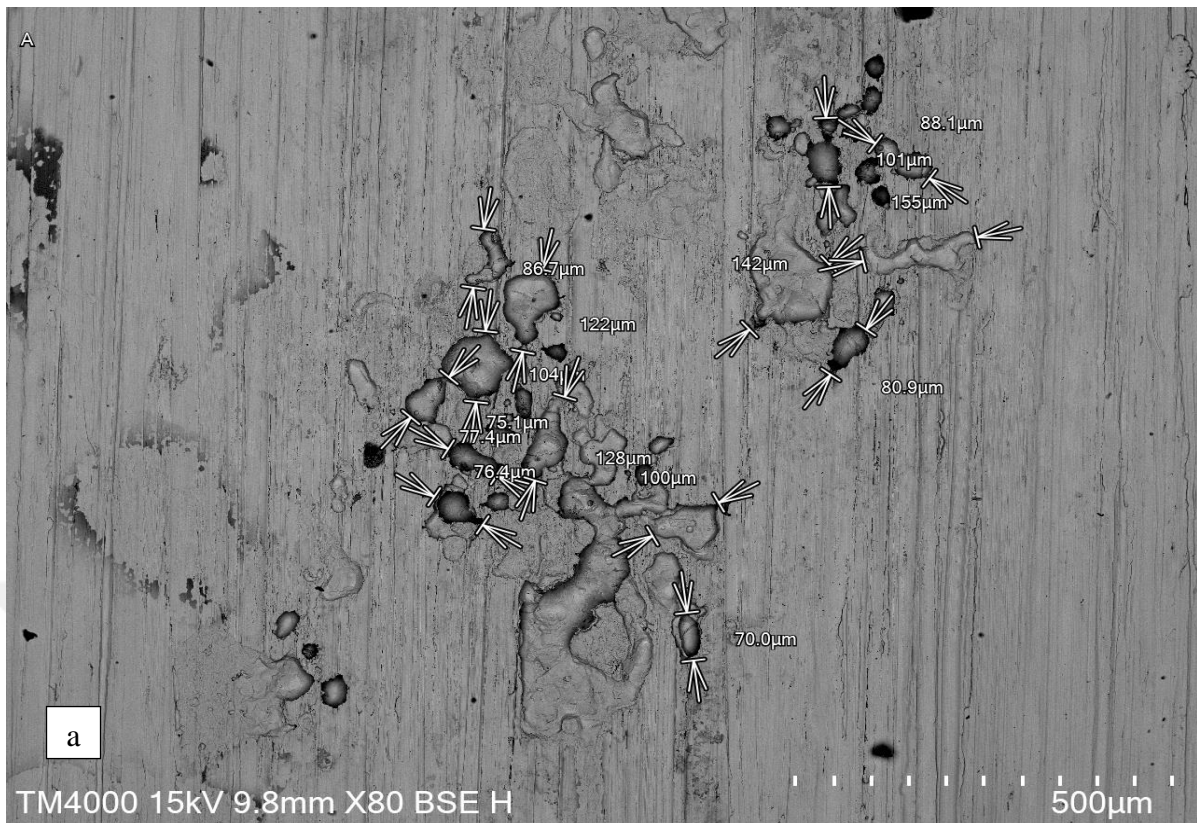
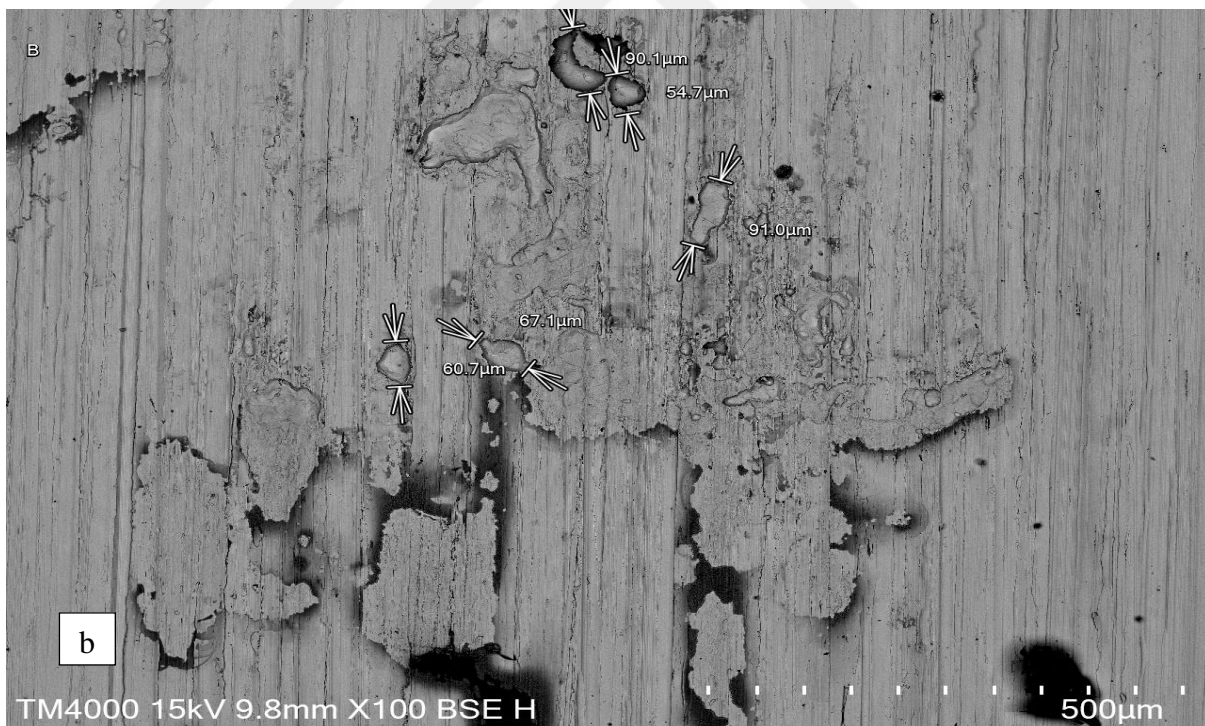
Figure 5.23 Left (a) and Right (b) Surface View SEM Micrographs Of Specimens 3.5 ID 3 Immersed to the 3.5 % NaCl Solution.

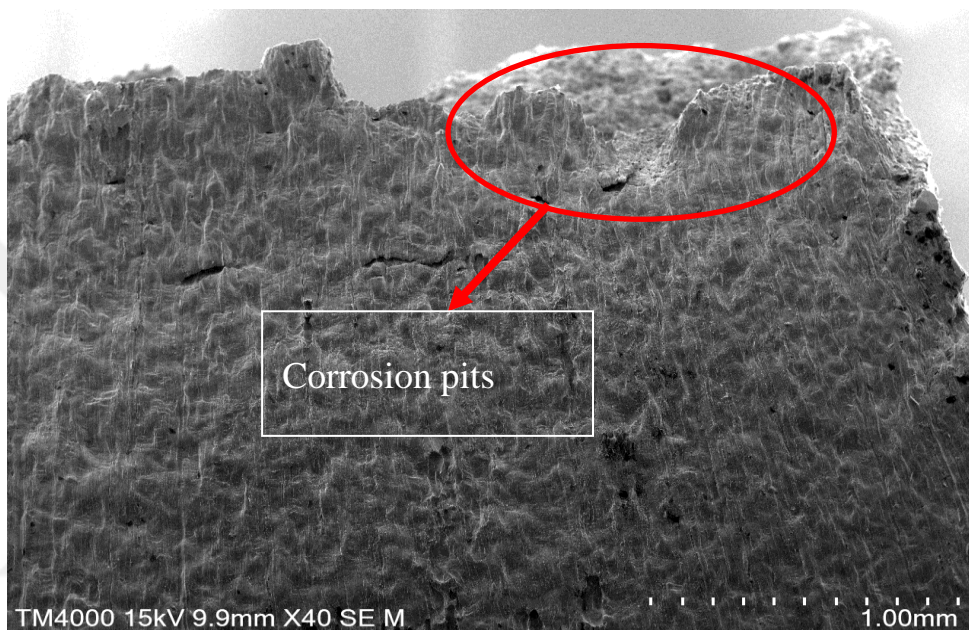
Figure 5.24 From Surface View SEM Micrographs of Specimens 1.8 ID 3

It could not be detected where the fracture came from which pit due to the coalescence of the corrosion pits and hence we observed that several pits combined and formed a single big pit. As it seen from Figure 5.24 and Figure 5.25, for both specimens corroded in 1.8% and 3.5% NaCl solution, the fracture came from the corroded area however it could not detected the origin of the fracture.

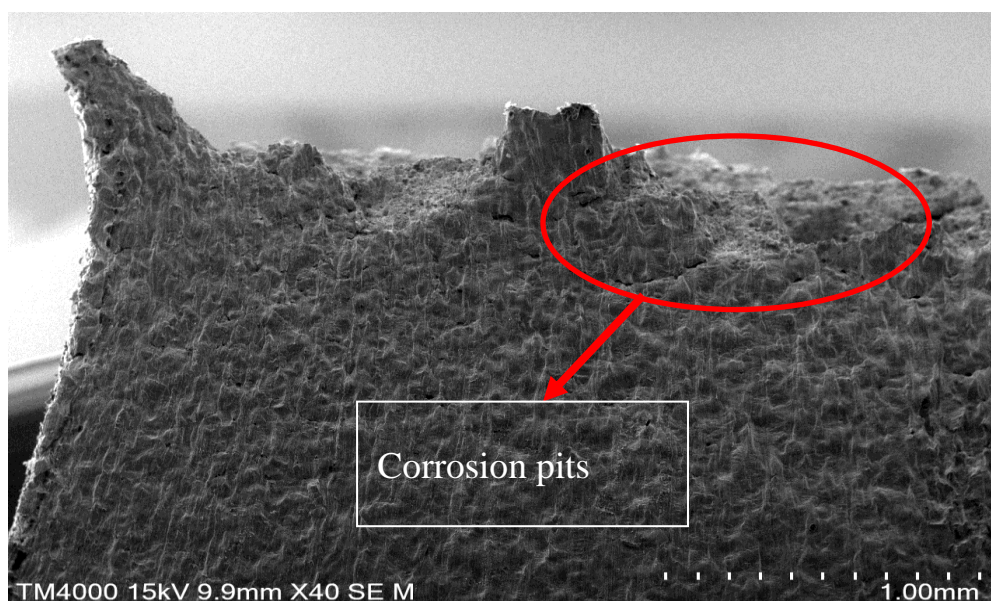
Figure 5.25 From Surface View SEM Micrographs of Specimens 3.5 ID 3

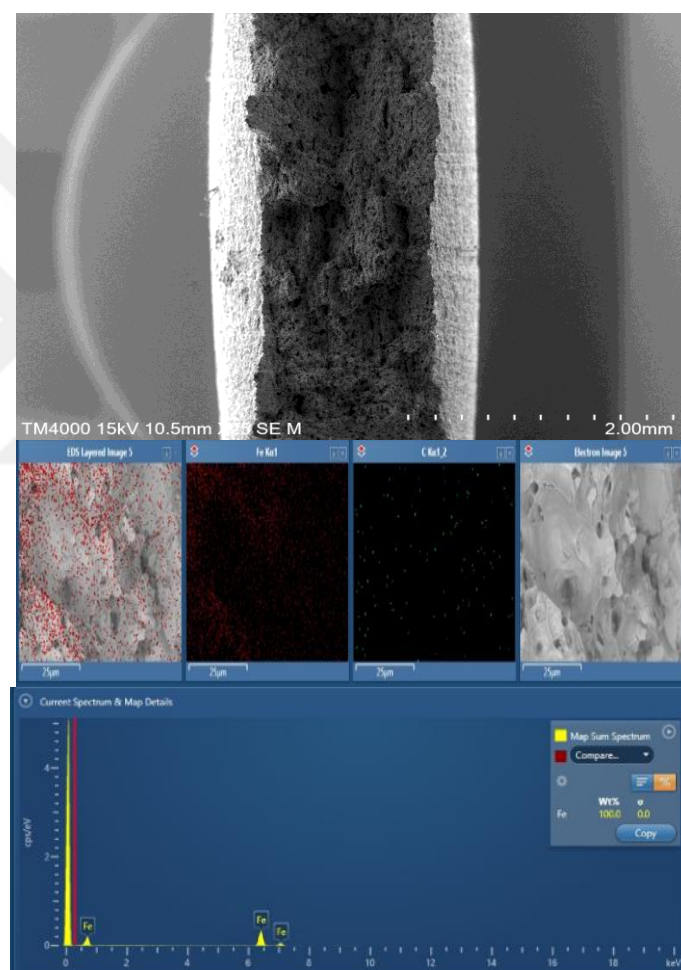
Figure 5.26 EDS Cross Sectional Views of Specimens 3.5 ID 4

Figure 5.26 shows the SEM and EDS images of cross sectional view of specimen 3.5 ID 4. EDS analysis made on cross sectional area illustrated that there were no C elements on fractured region. Because of the lack of C according to EDS analysis it was concluded that the studied material was a low C steel. On the other hand EDS analysis detected C elements on the surface of corroded specimens (Figure 5.27). Because there could be some finger nail polish residue, contains C elements, on the surface.
