**REHABILITATION OF REINFORCED CONCRETE
HAUNCHED BEAM WITH CARBON FIBER REINFORCED
POLYMER (CFRP) STRIPS**

M.Sc. THESIS

This thesis presents the shear behavior of damaged reinforced concrete haunched beams after repaired by injection epoxy and strengthened with unidirectional carbon fiber reinforced polymer strips (CFRP) at shear zone. The beams were designed without steel stirrups in order to fail in shear manner and after then rehabilitated. The experimental investigation was accomplished on twelve RC haunched beams of three different groups. The first group included two prismatic beams were repaired by epoxy injection and strengthened with vertical CFRP strips that have different width, the second group included eight haunched beams with different angles of inclination (10° and 15°). This group was repaired by epoxy injection and strengthened with CFRP strips by two methods, vertical (90°) and inclined (45°) according to the x-axis of the beam. The third group included two beams with an inclination of 5° which is repaired with epoxy injection.

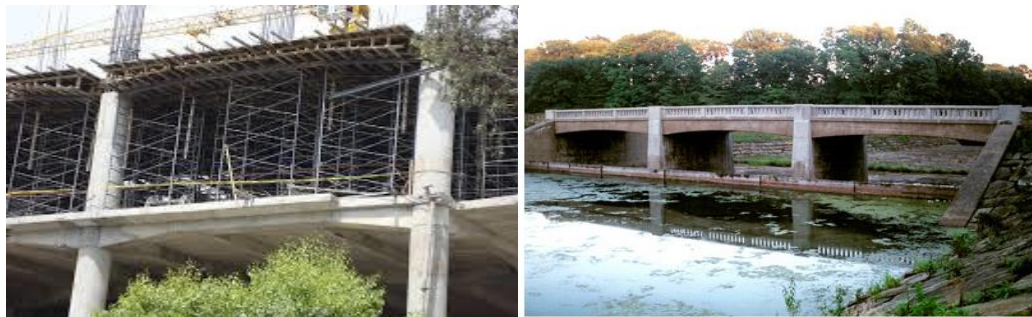
Figure 1.1 Applications of the haunched beams.

Haunched beams are widely used in structures like bridges and mid-rise buildings as seen in Fig 1.1. Despite the fact that it is widely used in current structures, the amount of experimental data available to learn its behavior in shear after rehabilitation and strengthening by carbon fiber reinforced polymer (CFRP) are very few. Like all structural members haunched beams can be exposed to design errors, leading to increase in the live loads and damage caused by earthquakes. The German Code of 2001 showed that there is a weakness in the factor of safety for several bridges because they were based on old codes (Hassan et el, 2015). Therefore, these beams need to be urgently strengthened or rehabilitated. One of the most widely used methods to strengthen concrete members is using the carbon fiber reinforced polymer (CFRP) in particular to strengthen shear zones.

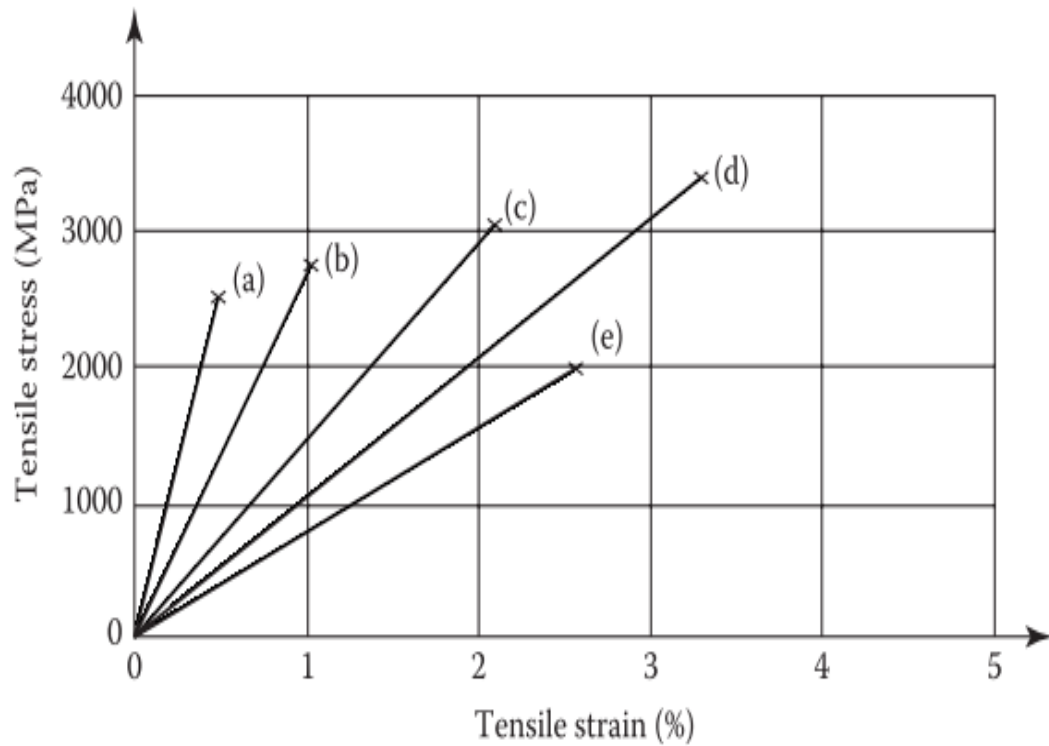
Figure 1.2 Stress–strain curves of typical reinforcing fibers (a) carbon (high modulus); (b) carbon (high strength); (c) aramid; (d) S-glass; and (e) E-glass(Nawaf Khaled 2014)

The mechanical characteristics of fibers are usually more in value than mechanical characteristics of resins. The most widely fibers using in the manufacture of FRP are glass, carbon, and aramid. These types of fibers show a linear elastic behavior under tensile loading up to failure without exhibiting any yielding as shown in Fig. 1.2.

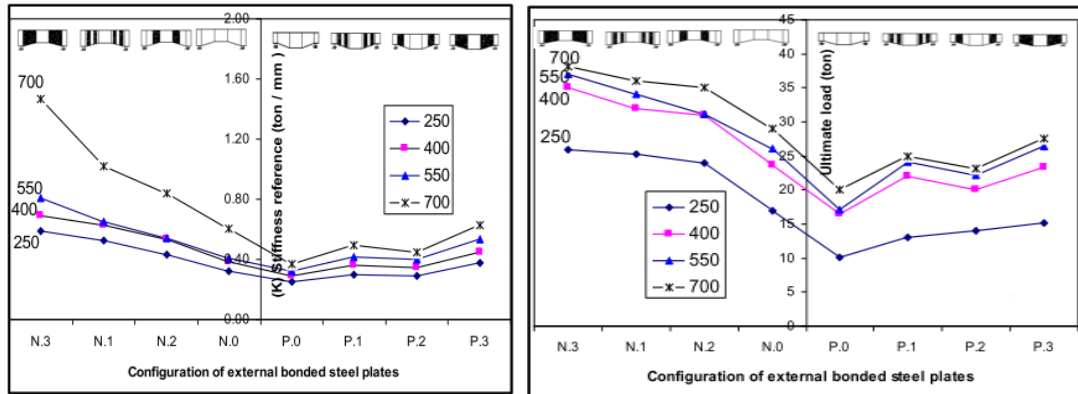
Figure 2.4 Relation between ultimate and stiffness (k) with the mode of beams for all series(Rashwan 2010). Where is this reference in text.

The rest of details can be seen in Fig. 2.3. Through the experiment results, the researcher concluded that, the failure for all un-strengthened beams was shear failure, But after strengthening the type of failure changed from shear failure to shear, compression and flexural with crushing failure at the top of mid span. The stiffness and ultimate load for group N was observed to be greater than group P, as shown in the Fig. 2.4 (Rashwan 2010).

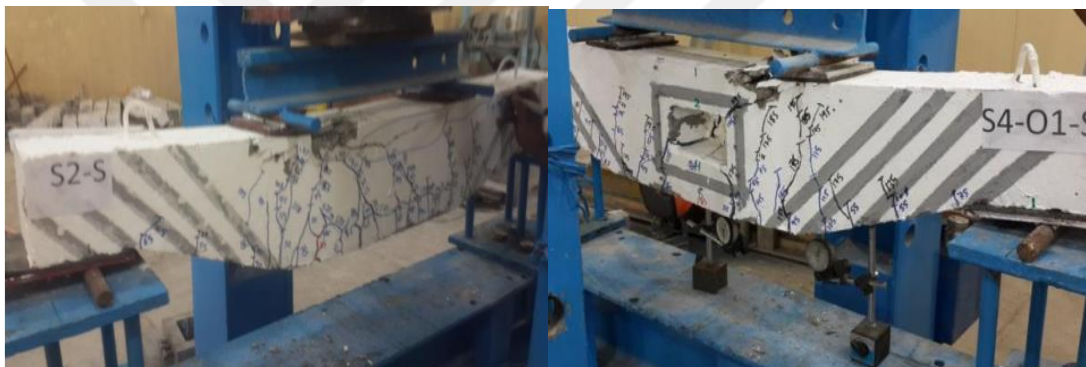
Figure 2.5 Types of failure after strengthening(Dawood & Nabbat 2015). where is this reference in text.

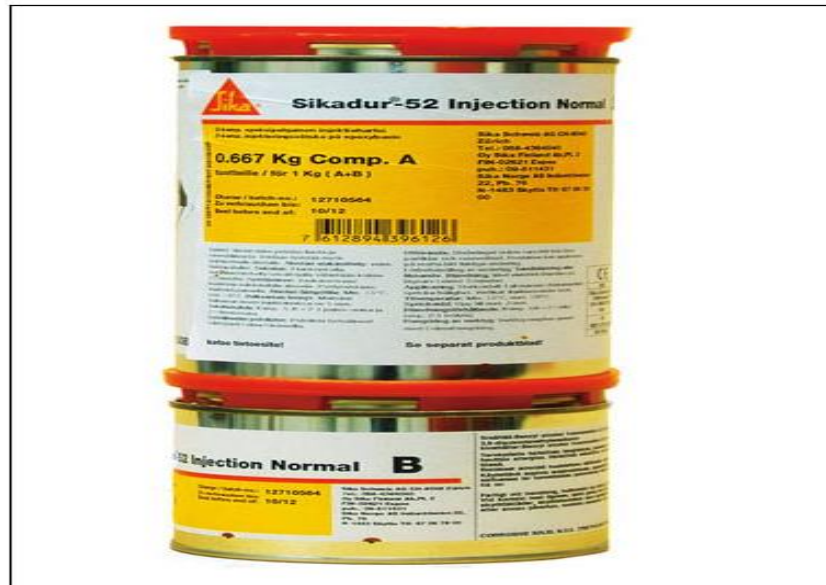
Figure 3.3 Sikadur-52 two components A+B

homogeneous mixture according to the manufacturer's recommendations. Table 3.3 shows the properties of epoxy resin (Sikadur 52).

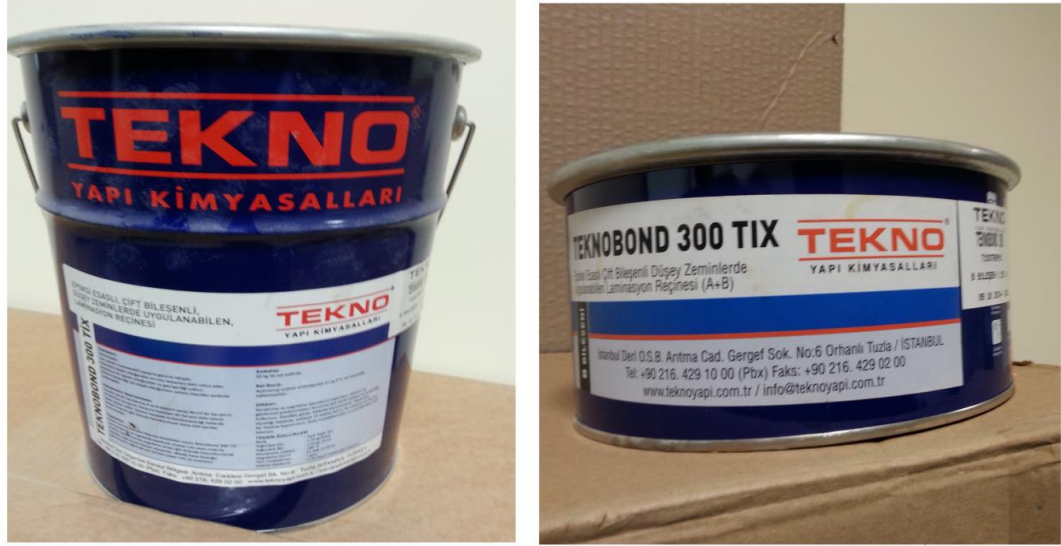
Figure 3.4 TEKNOBOND 300 TIX A+B

The epoxy adhesive used in this study was (Teknobond 300 Tix). It consists of two-component A and B shown Fig 3.4, mixed with a ratio of 1:4 by electric mixer (drill) with a speed of 400 RPM for 2-3 minutes to get a homogeneous mixture according to manufacturer's recommendation. Table 3.4 shows the properties of (Teknobond 300 Tix). The CFRP sheet that used in this study was unidirectional (SPN U 300). The Table 3.5 shows the general properties for the CFRP.

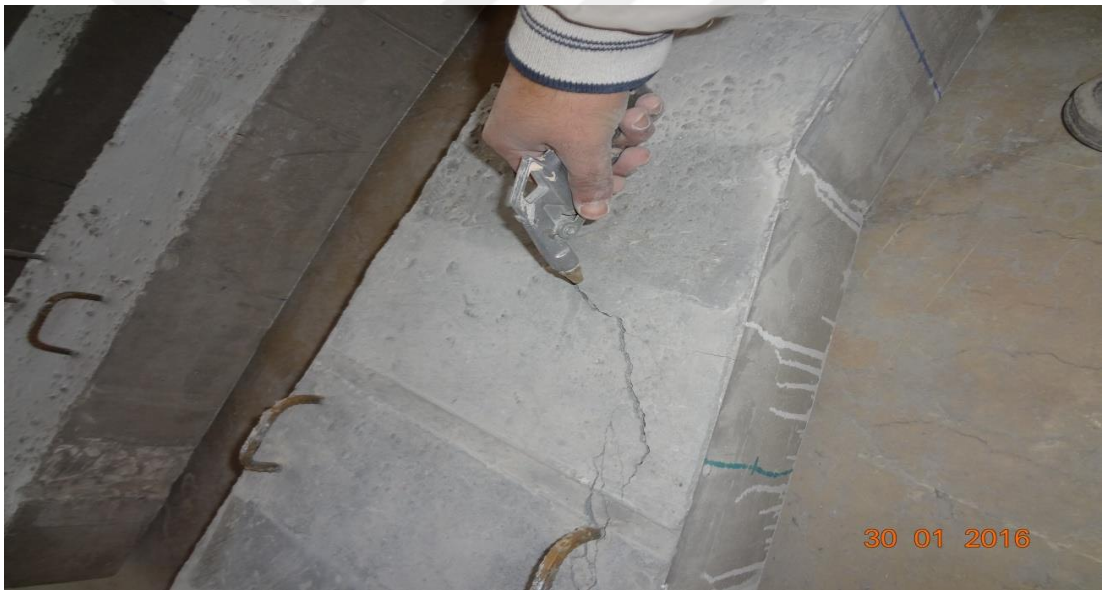
Figure 3.6 Cleaning of cracks by using compressed air.

The cracks were cleaned by using compressed air to remove dust and loose materials, which effect on the efficiency of bonding shown in Fig 3.6.

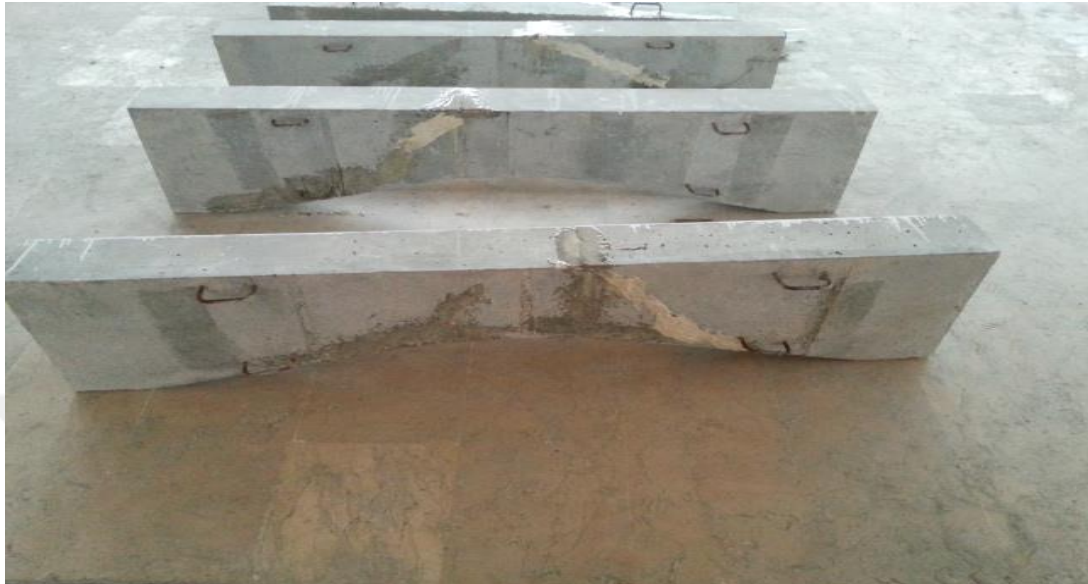
Figure 3.7 Sealing cracks of three faces of the beam

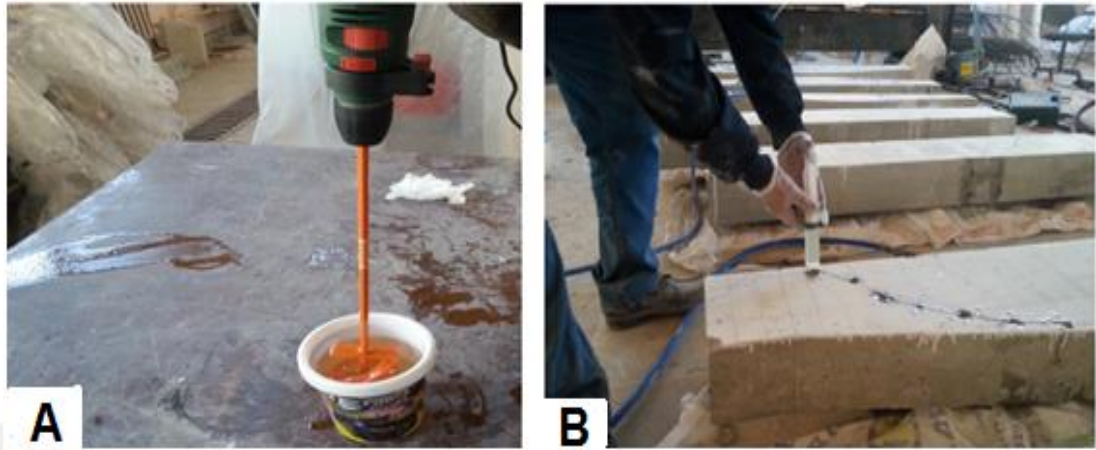
Figure 3.8 (A) Mixing epoxy A+B by using a suitable mixer (b) injection epoxy by gravity.

The two components of high viscosity epoxy A+B were mixed with a proper amount with a ratio of 2:1 by using an electric mixer (drill) with a speed of 250 RPM for three

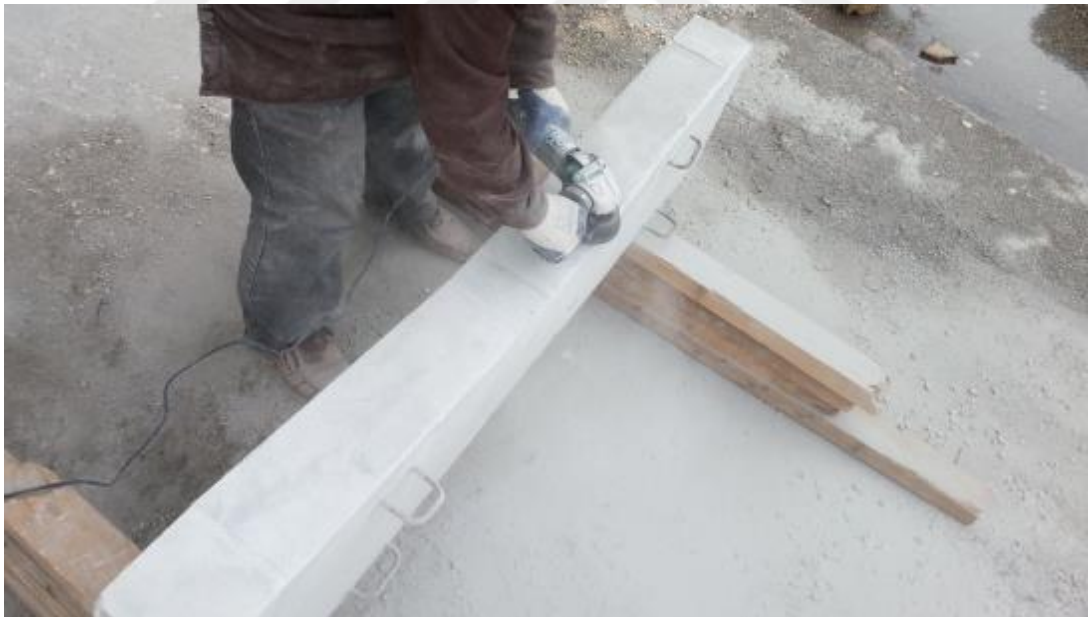
Figure 3.9 Grinding concrete surface before applying CFRP strips.

Fig. 3.19 shows the use of concrete grinder to clean and roughen the surface of beams. The bottom edges of beams were rotated with a radius about (0.5 in) according to ACI 440.2R-08 to avoid the concentration of stresses which lead to premature rupture of the CFRP strips as shown in Fig. 3.10.

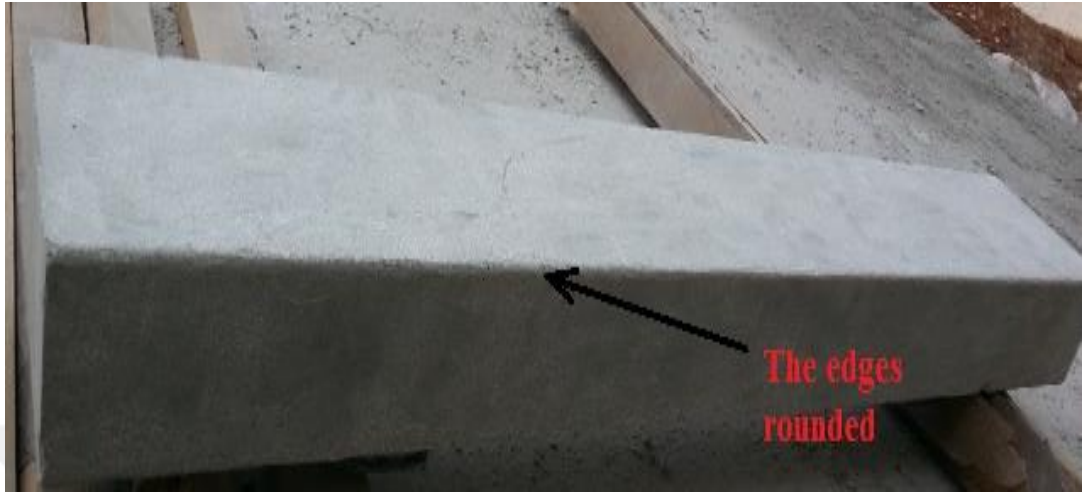
Figure 3.10 Rounded bottom edge in order to reduce the stress concentrations on the CFRP strip

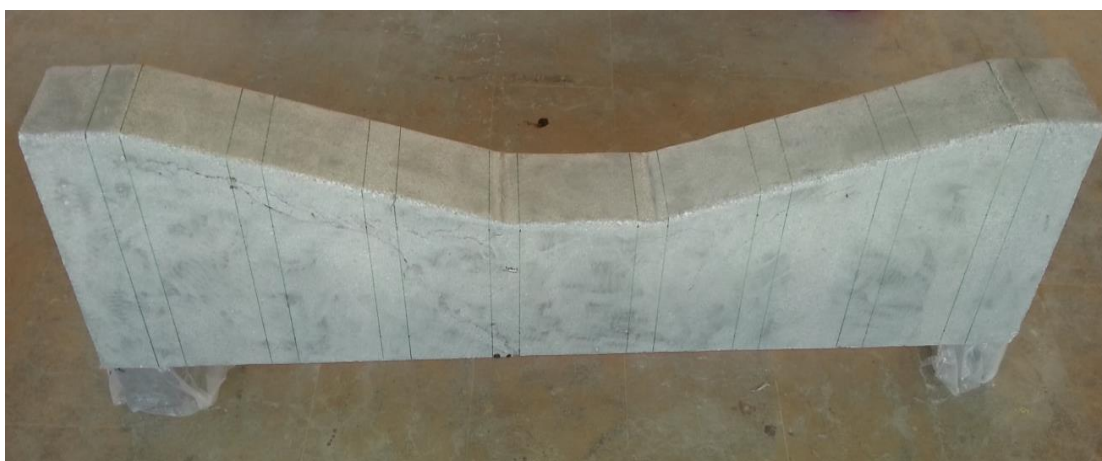
Figure 3.11 Drawing lines for the application of CFRP strip on its specific location.

Before proceeding with the installation of CFRP strips, the concrete surface was cleaned again by using compressed air to remove any remaining dust that results from surface grinding. Lines are then drawn on the surface of concrete to specify the locations as shown in Fig 3.11

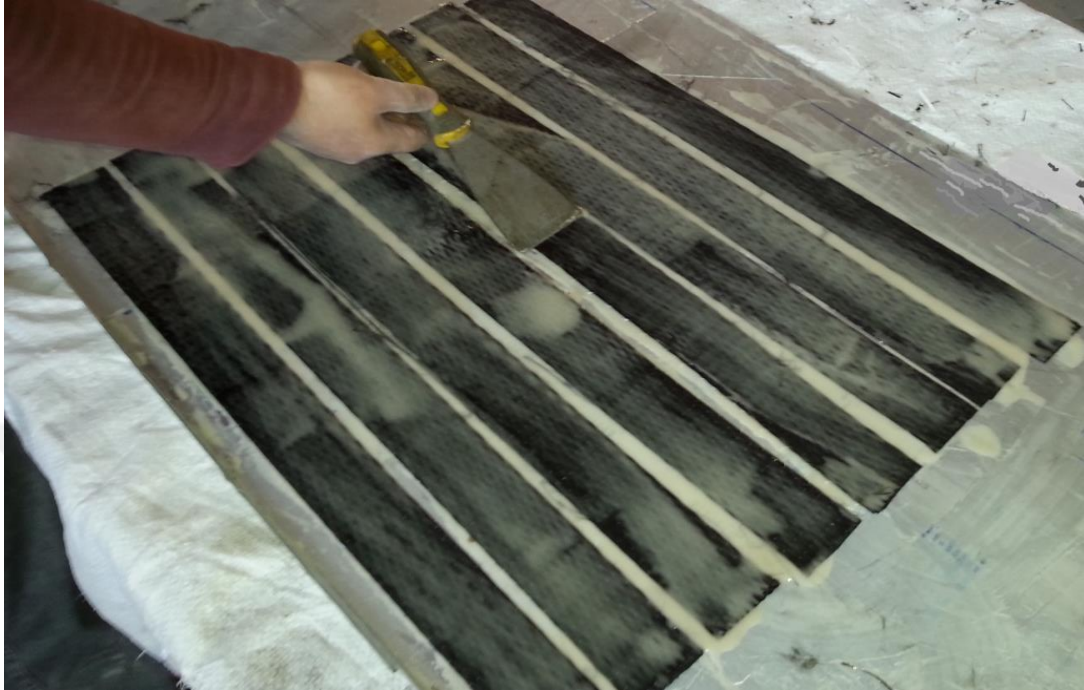
Figure 3.13 Process of impregnation of CFRP sheet with epoxy before installation.

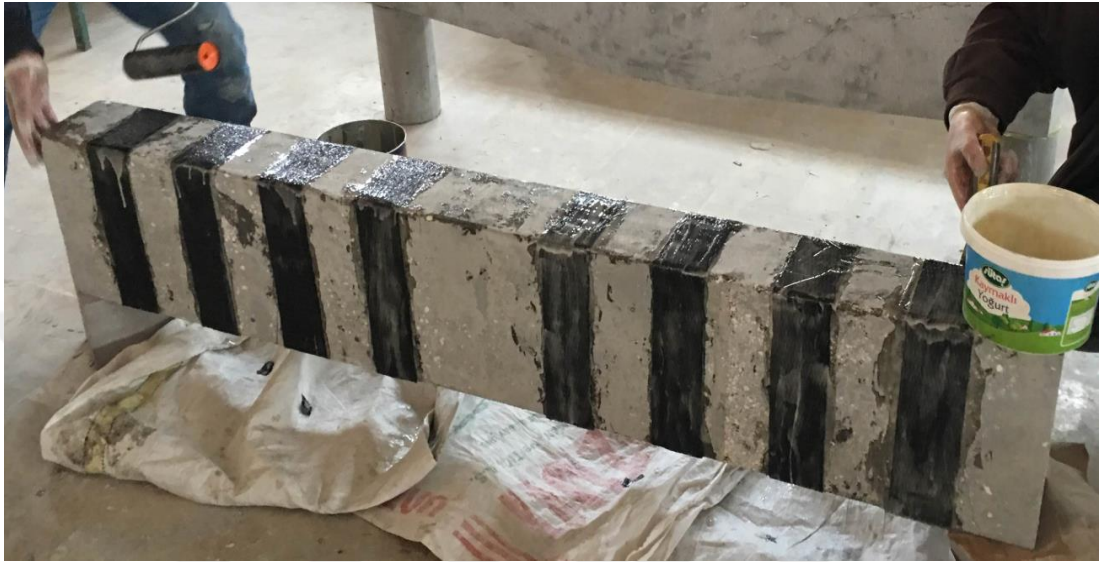
Figure 3.14 Using of knife and plastic roller to press the CFRP

All CFRP strips were cut into proper lengths to avoid wasting in quantity of the carbon sheet as shown in Fig. 3.12. After cutting the CFRP sheet, we started the processes of mixing a suitable amount of two components of epoxy that were used to bond CFRP sheet with concrete surface. The processes of preparing bonding epoxy included two components (A+B) with a ratio 4:1. The epoxy was mixed by using the electric mixer (drill) with a speed of 250 RPM for three minutes. The installation of CFRP sheet was by Wet Lay-up method, which requires to start with impregnation of CFRP sheet with epoxy for two faces to make sure that the process of fiber saturation with epoxy is sufficient as shown in Fig 3.13. The sheets become ready to be installed onto the surface of the beam. The CFRP strips were compressed carefully to expel air bubbles as shown in Fig 3.14 and Fig 3.15.

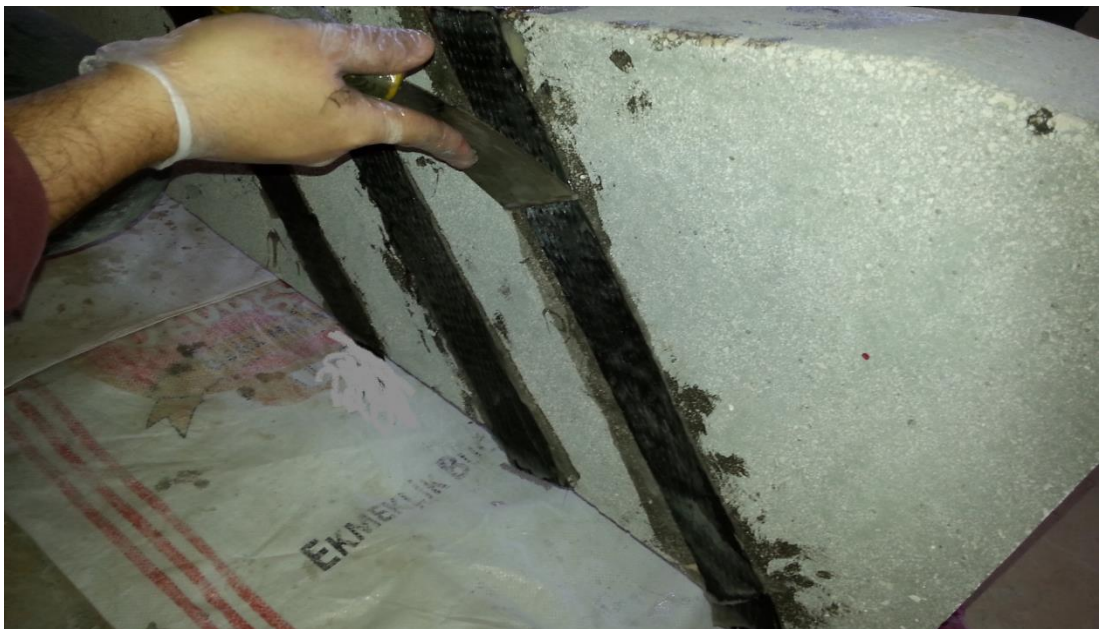
Figure 3.15 Method of compressing the CFRP using a knife.

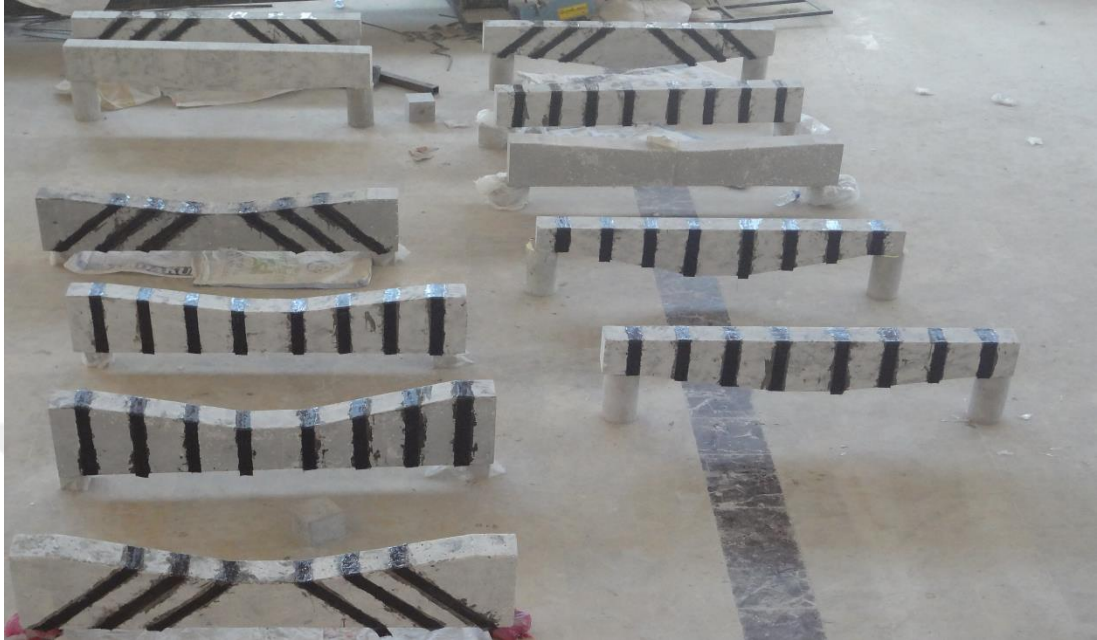
Figure 3.16 Curing of all beams after strengthening.

The configuration of strengthening for all beams is shown in Table 3.6. After the completion of the installation of all CFRP strips on the concrete surface, all beams are stored for seven days in the laboratory where the temperature was 21° to complete the treatment stage as recommended by the manufacturer of the epoxy resin as shown in Fig. 3.16.

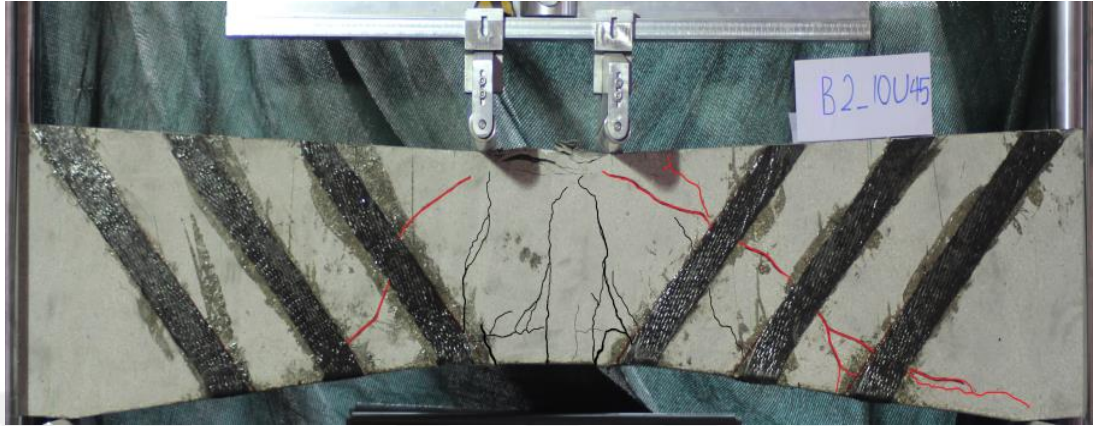
The reason why no debonding was observed in CFRP strips may be due to the high strength of concrete 62 MPa, which improves bonding ability between the CFRP strips.

Figure 4.11 Failure mode of B2-10U45 beam
