M.A. Thesis In Geography

ANALYSIS OF PAVEMENTS FOR DISABLED PEDESTRIANS IN METROPOLITAN CITIES: CASE OF SISLI DISTRICT IN ISTANBUL

Fatih University

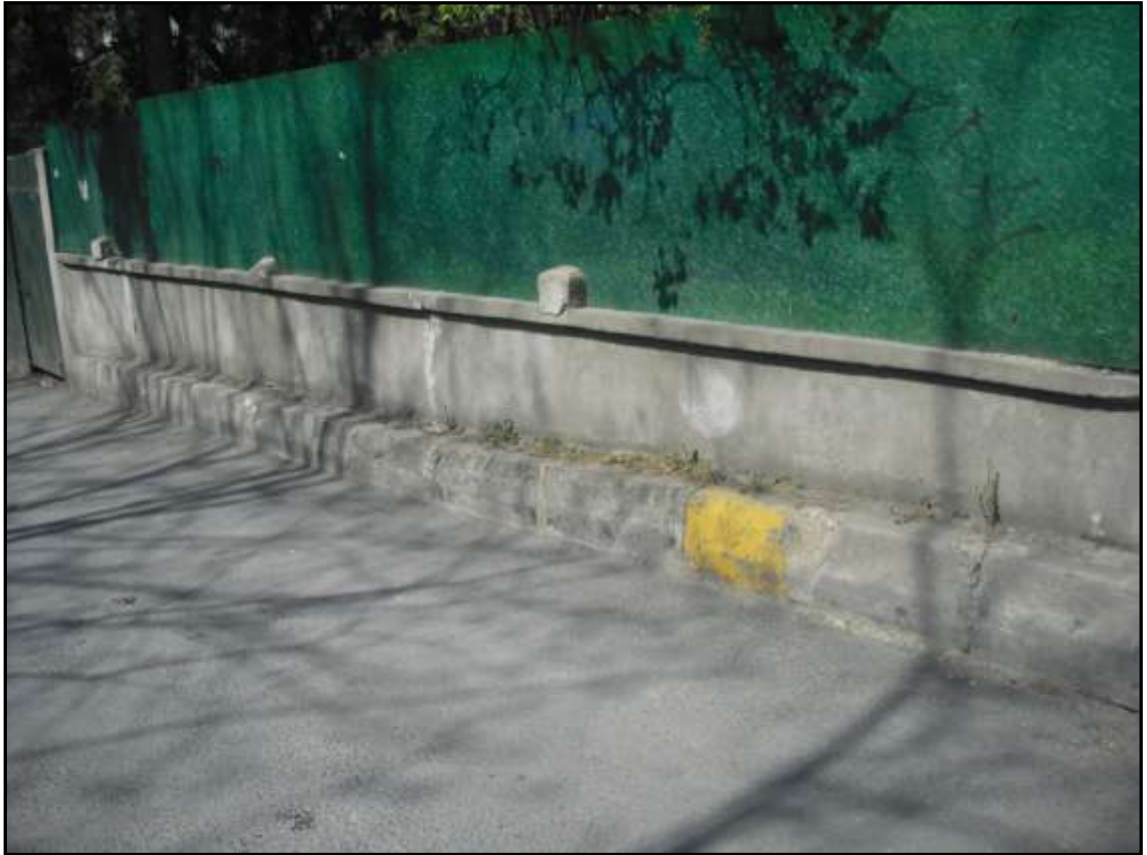
Figure 2. A pavement sample where the pedestrians have to walk

The data collection process was completed within the period between April - June 2010. During the field study, measurements and detection were carried out for four different features on pavements. First, all the roads and streets in study area were examined and the streets with no pavements were listed (Figure 2). Next, all the objects on the pavements of Sişli district were inventoried. These objects were classified as trees, billboards, motor vehicles (automobile, motorcycle), and mushrooms to prevent car parks on the street, buffets, stands, electric poles, trash bins and others. All these objects were mapped and their exact position is shown with numbers (with each object being assigned a different number).

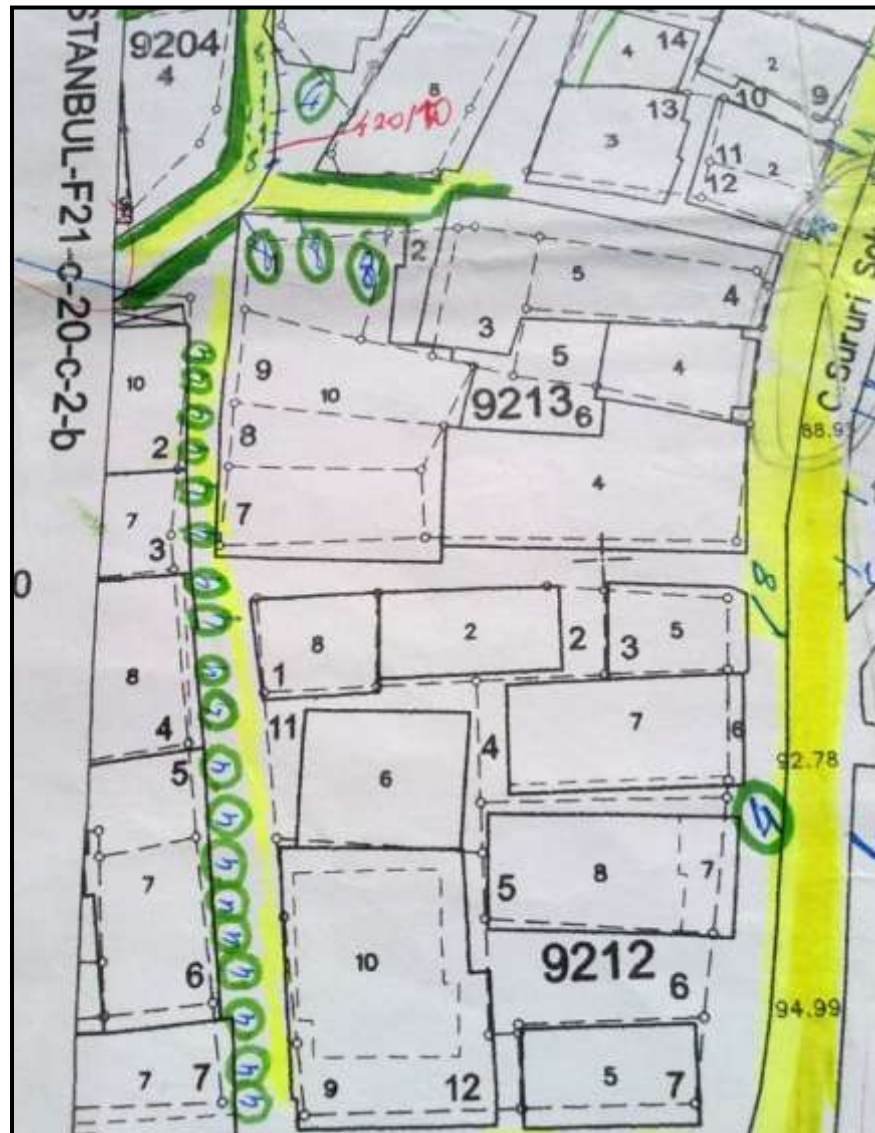
The space between the intervening objects and the two ends of the pavements were measured to find out whether or not these objects obstructed the walking of people on the pavements especially of those who use wheelchairs. Any space with a width under 60 cm was considered not adequate for the passing of wheelchairs and was recorded as such on the maps (Figure 3).

Figure 3. The objects on the pavement segments that obstruct walking

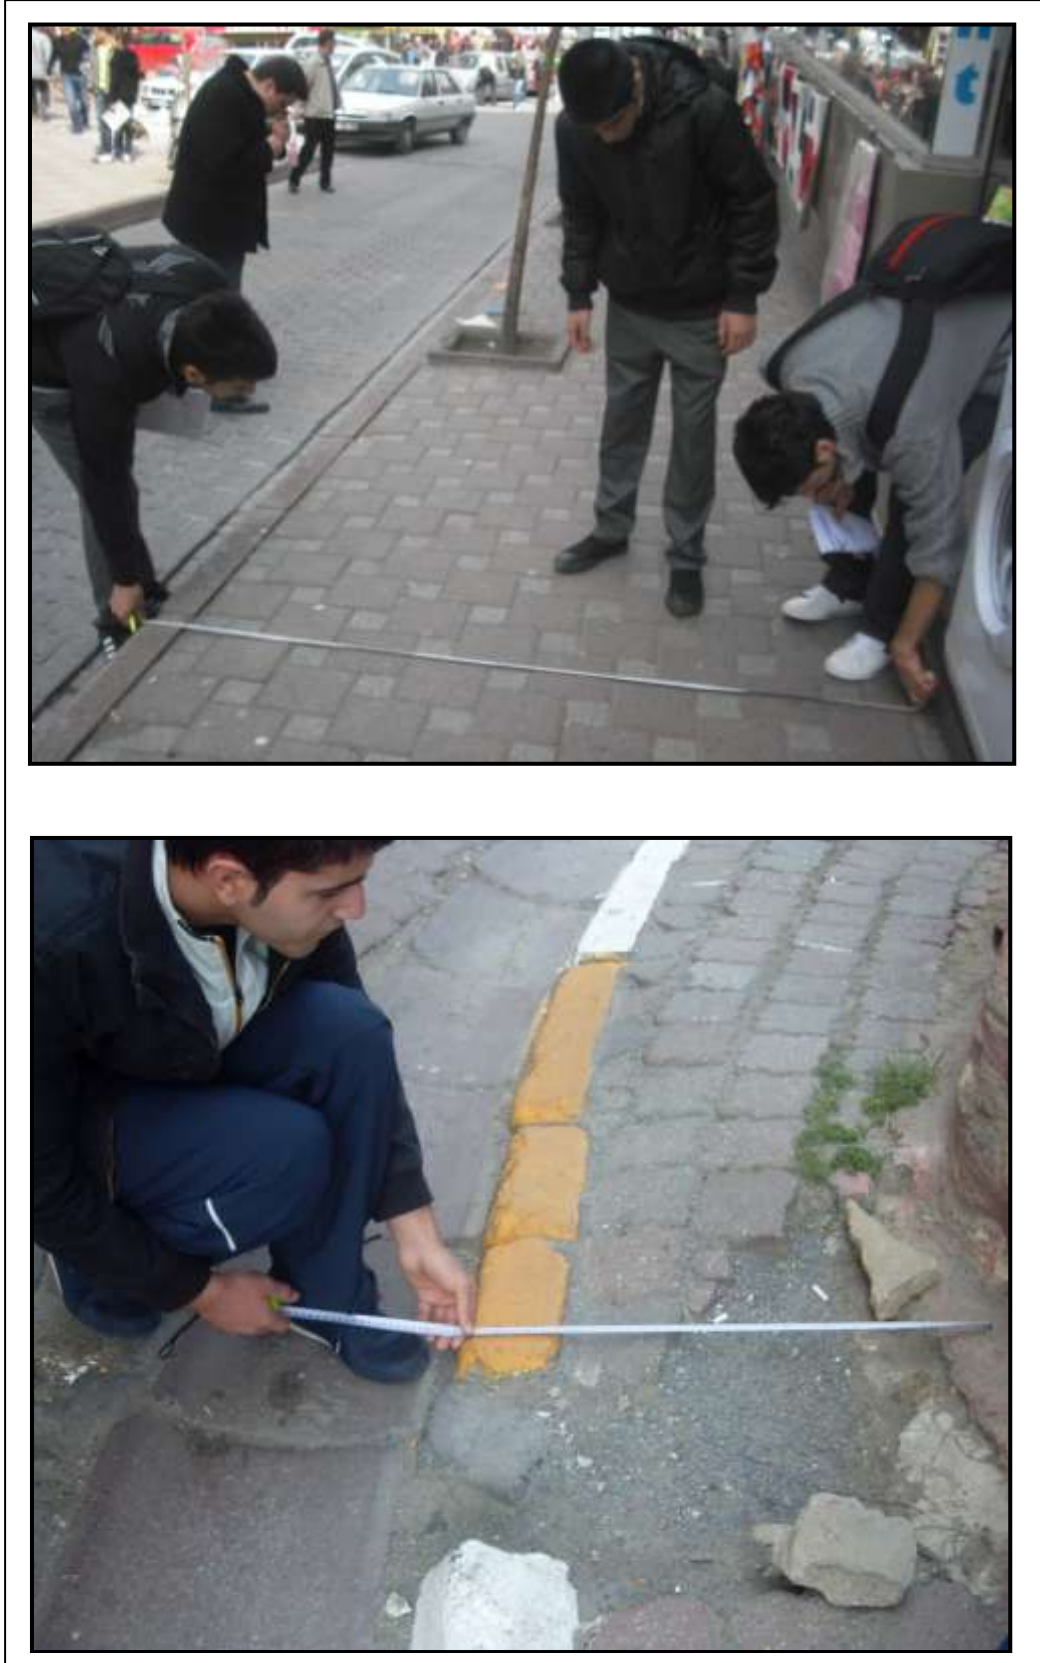
The pavements were measured every 40 steps; wherever the pavements were shorter than 40 steps, they were measured using a meter at the beginning, the middle and the end of the pavements. In addition, in order to have the work consistent with the field, re-measurements were carried out in places where there were sudden changes (for instance bus stops, traffic lights etc.) in the width and height of the pavements (Figure 4).

Figure 4. Measurement carried out on a pavement segment

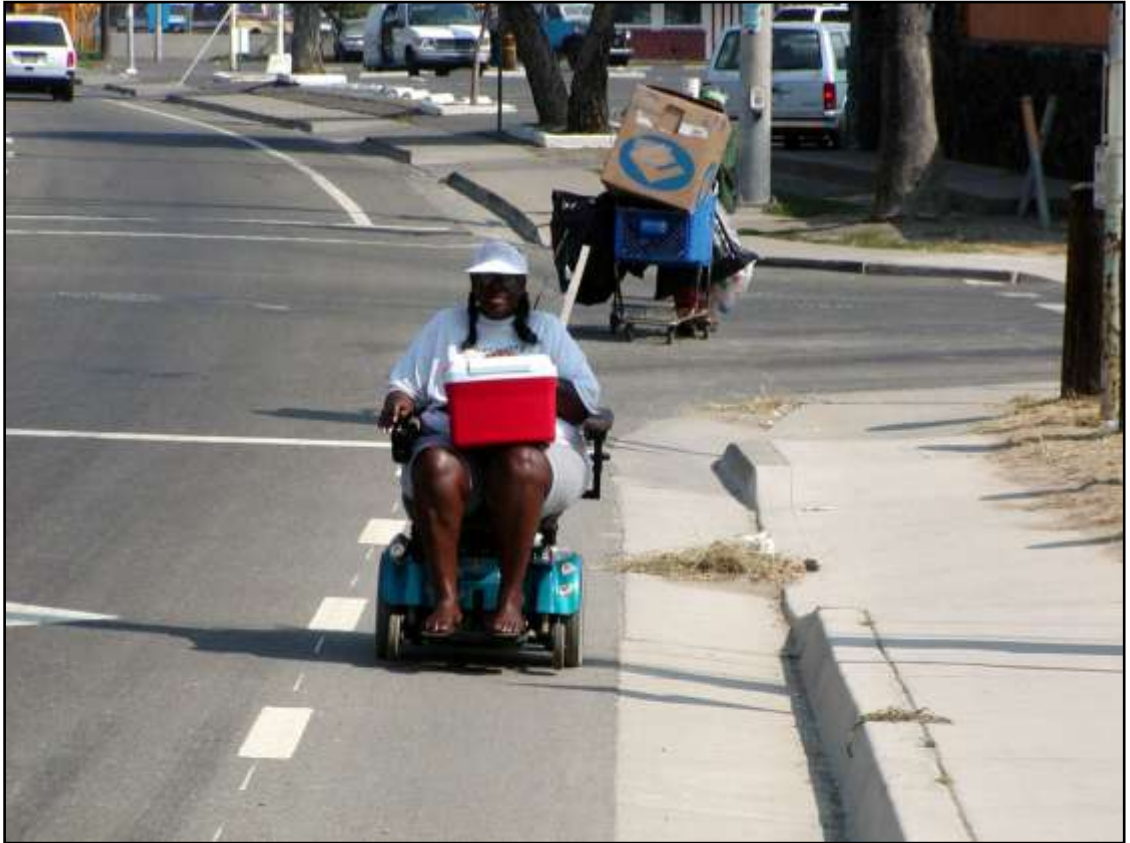
Figure 10. A wheelchair user who has to use the bicycle lane because of wrongly designed ramp at a wide pavement – United States- in 2006 - (www.pedbikeimages.org/ Dan Burder)

The disabled people face many problems in cities with unplanned urbanization. Among these are: visually impaired people cannot cross the streets at traffic lights; they fall down from the high pavements; tackling to the obstacles beside the roads; wheelchair users cannot use the wheelchair because of the ramps and slopes on the street (Figure 10); not being able to get on transportations such as buses, taxis etc.; not being able to enter inside the public institutions due to lack of ramps; having the risk of death on account of too high slopes in some roads. In addition, the disabled people face problems such as being belittled, and

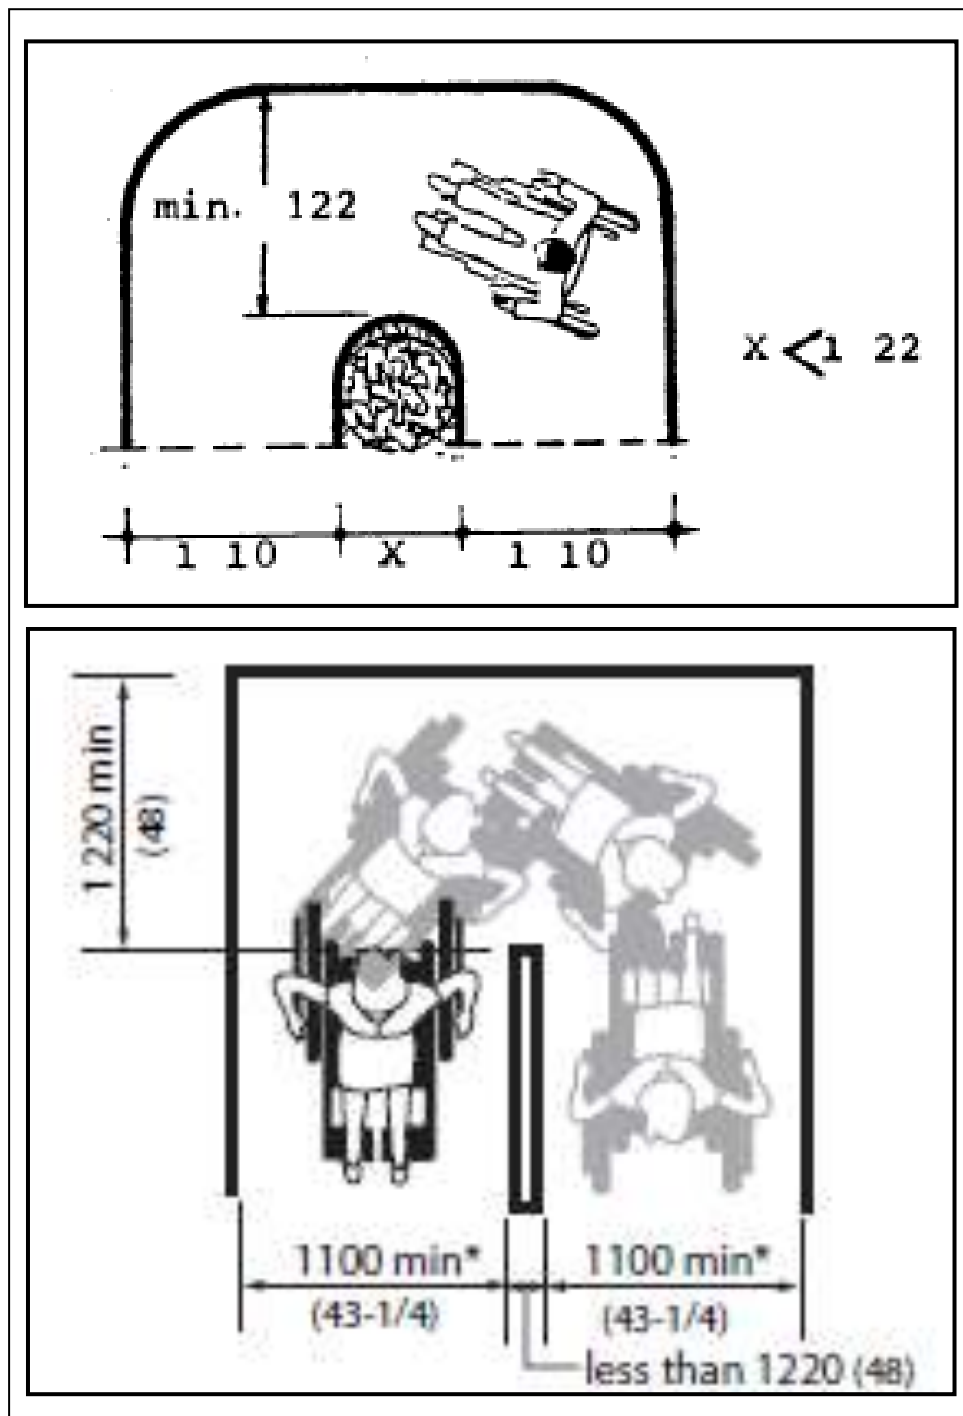
In order for a wheelchair user to turn around whenever he or she comes across an obstacle, 110 cm width and 122 cm pavement length are needed according to both TS 12576 and Facility Accessibility Design Standards (Figure 22).

Figure 22. Required pavement measurements when wheelchair users come across an obstacle on a pavement

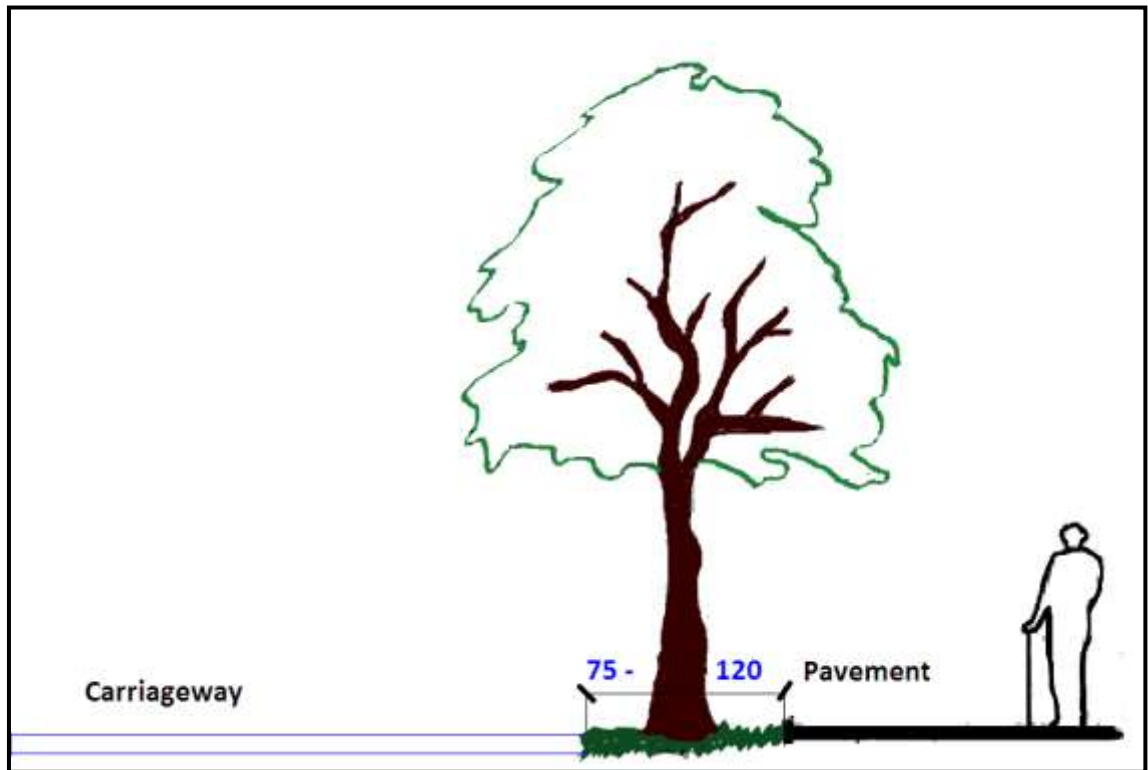
- *Depending on the width of the pedestrian pavement, the trees to be planted between the carriageway and the pavement edges must be in accordance with TS 8146 (the place to be protected for the trees at the pavement stated in TS 8146 City Road and Square Forestation Rules: The measurements of the soil surfaces on the root spreading area is 100 cm to all directions starting from the centre of the tree trunk diameter).*
- *Electricity poles, traffic light poles, decoration plants, vases, pedestrian banisters must be placed at a straight line on a lane with minimum 75 cm, and maximum 120 cm width including the border stones (Figure 23).*

Figure 23. Forestation in pedestrian pavement - Obtained from TS 12576 and redrawn. Measurement unit is cm.

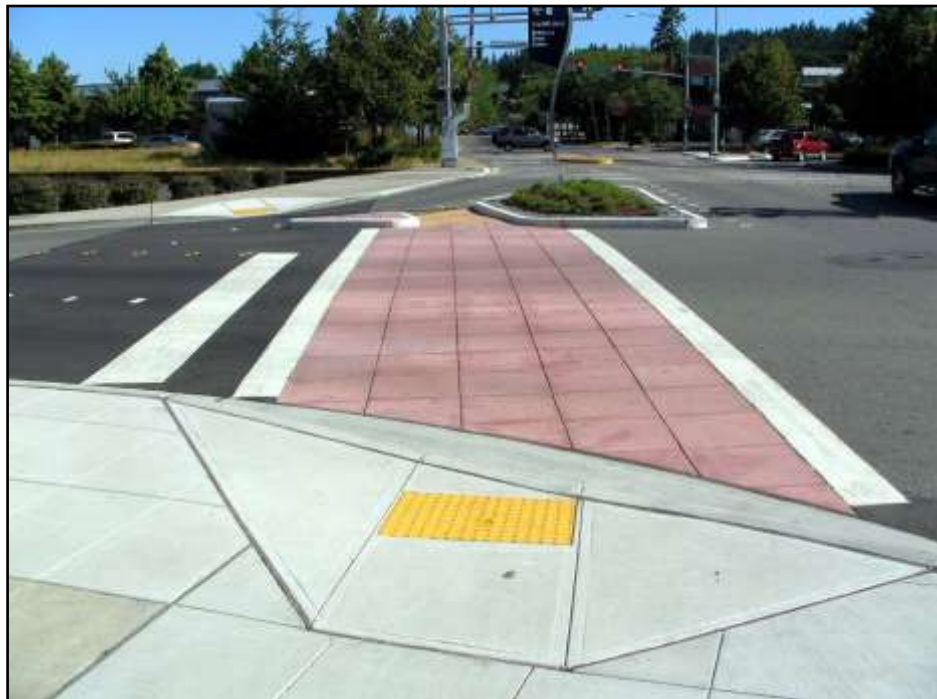
Ramp means, "A walking surface which has a running slope greater than 1:20 (5%) (United States Department of Justice, 1994).The ramps, which were built especially for the old, the visually impaired and baby carriages, are constructed to overcome level differences on the walkways securely (Figure 27).

Figure 27. A sample of a secure slope – Washington – U.S.
(www.pedbikeimages.org / Dan Burder)

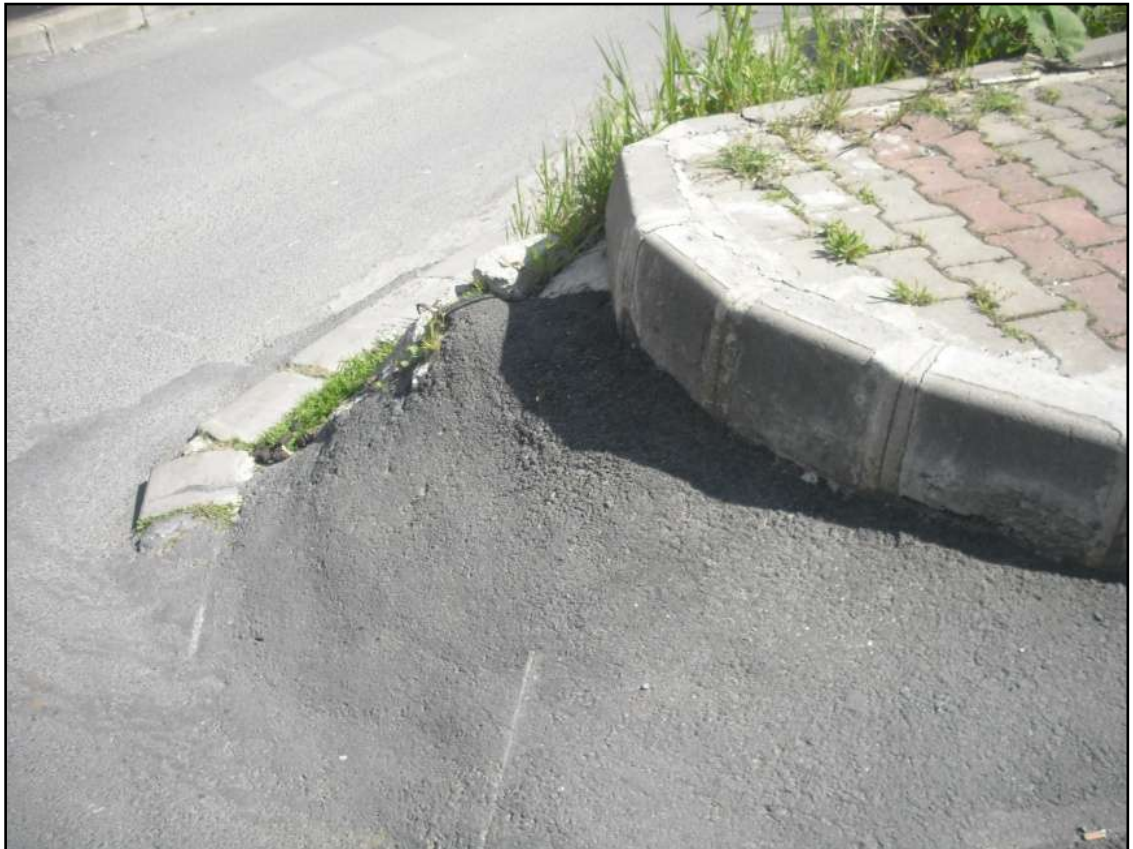
The slopes in ramps are vitally important for wheelchair users. Furthermore, excessive slopes in ramps cause unexpected accidents for the strollers, scooters, and skateboarders as well as for old people, and children (Figure 31).

Figure 31. A sample of a dangerous ramp in the study area

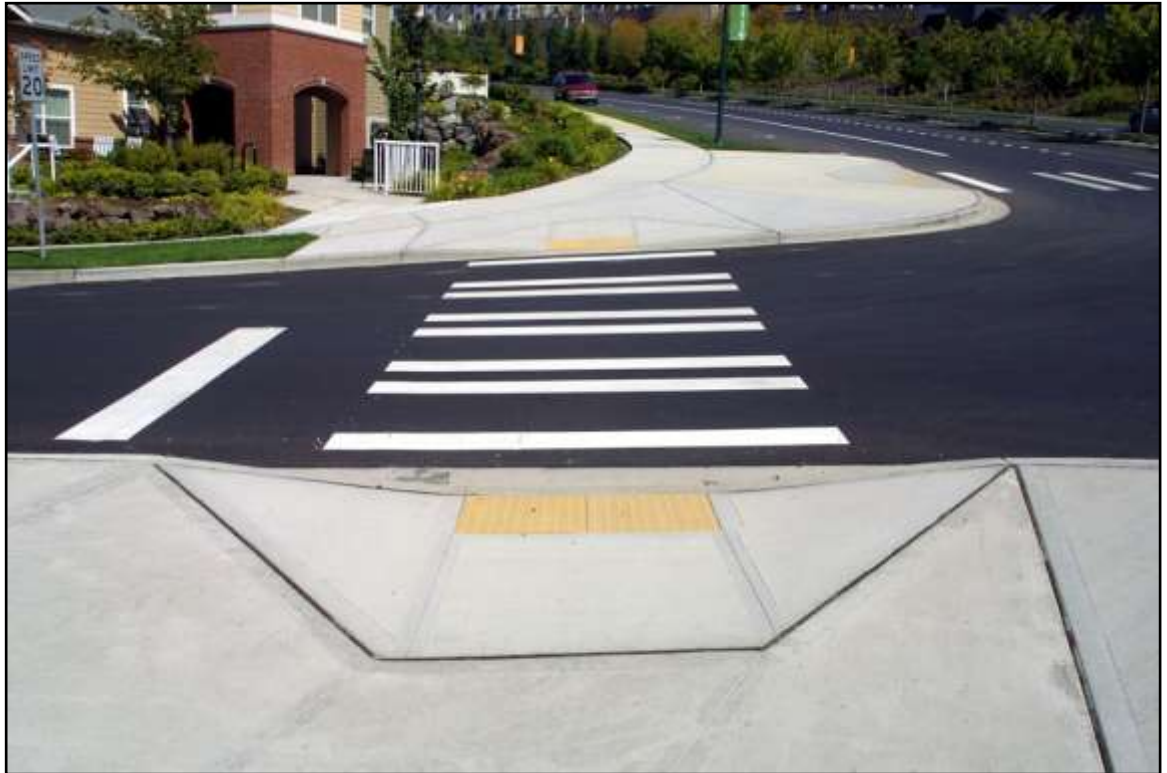
1. There is a smooth place of 150 cm length in different design at the beginning and the end of ramps.
2. The surfaces of the ramps must be covered with hard, stable, non-skidding materials with very little roughness (Figure 35).

Figure 35. Issaquah Highlands, Washington in 2006 (www.pedbikeimages.org / Dan Burder)

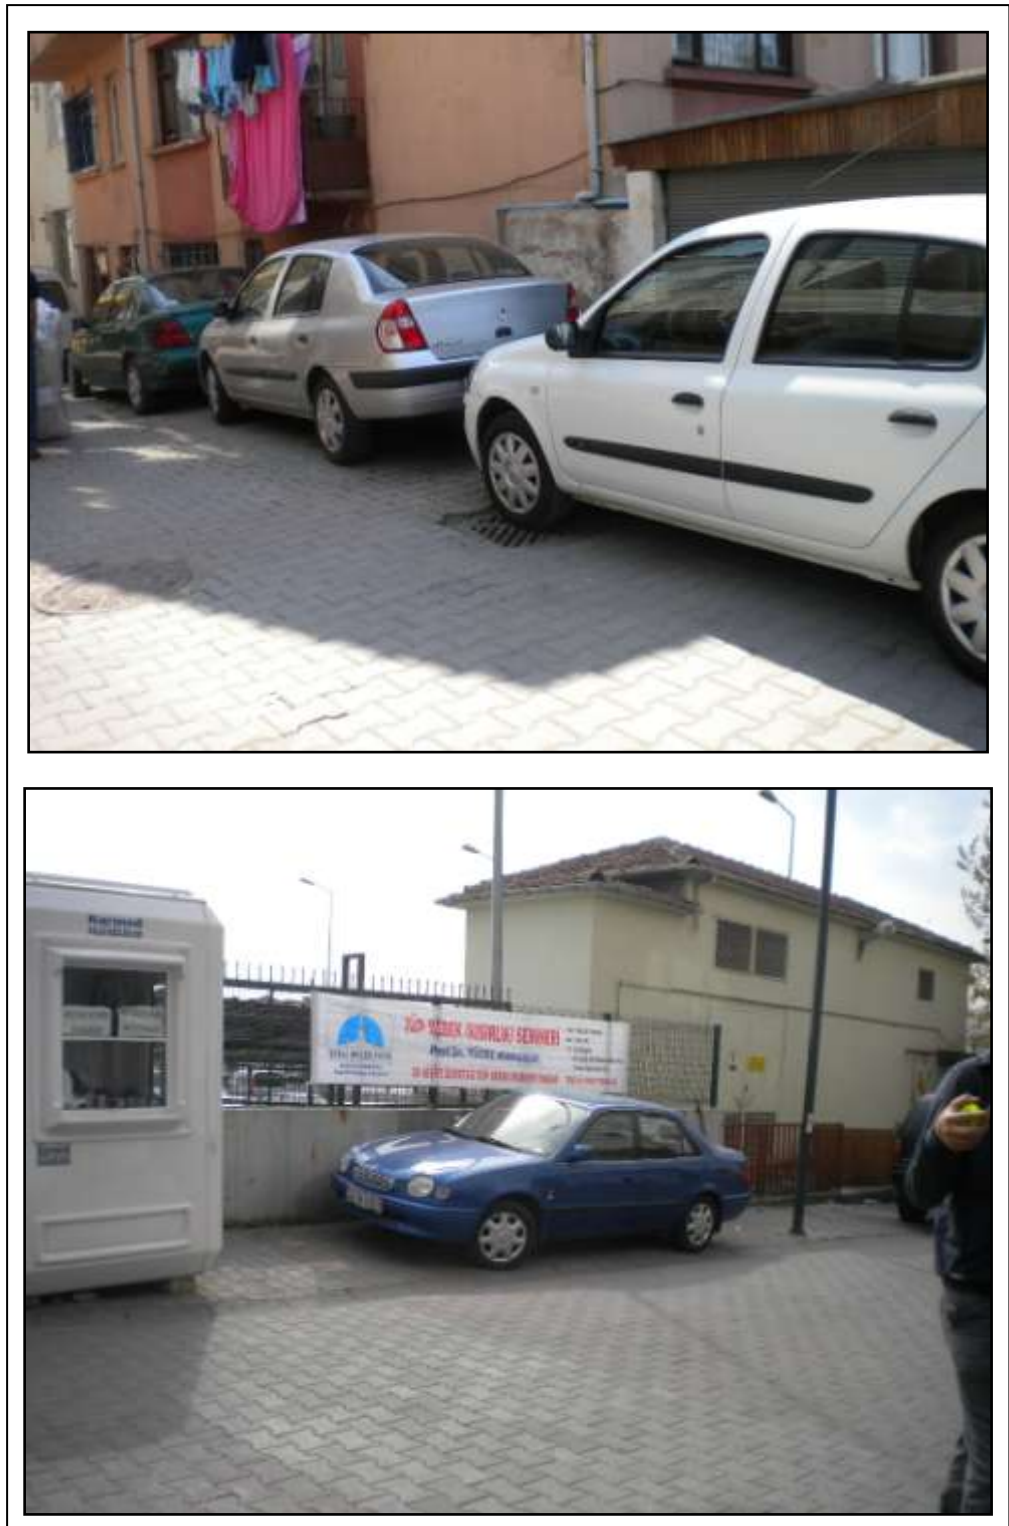
Data, obtained from study area, was analyzed with the use of a computer and numerous conclusions were drawn. Total of 3018 pavement segments were recorded in the study area. Their total length was calculated as 251,122 meters. However, the length of the pavement segment that could be used in study area was 67,075 meters (1118 pavement segment). Accordingly, 26.7% of all the streets and lanes have no pavement and the pedestrians face difficulty in walking on the roads (Figure 36, 37).

Figure 37. The streets did not include pavements

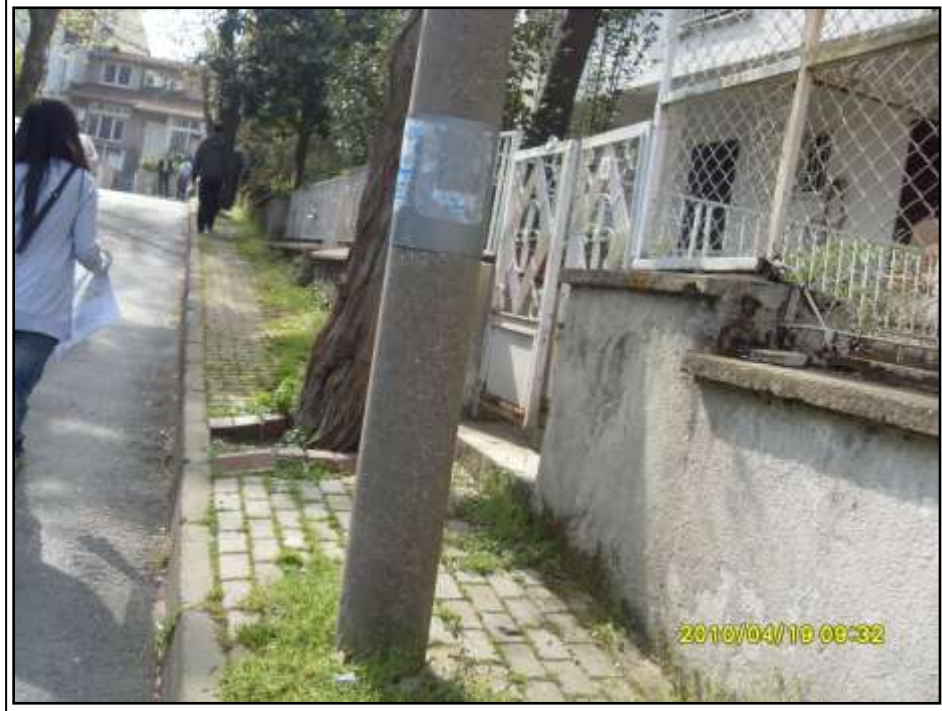
Trees represent of 46% of the obstacles detected on pavements. Then come electric poles with 24.2% and mushrooms with 16.2% (Figure 39). Last are trash bins. The percentage of trash bins to the total ratio of the objects is 0.2% (Table 5).

Figure 39.The pavement segments which include objects

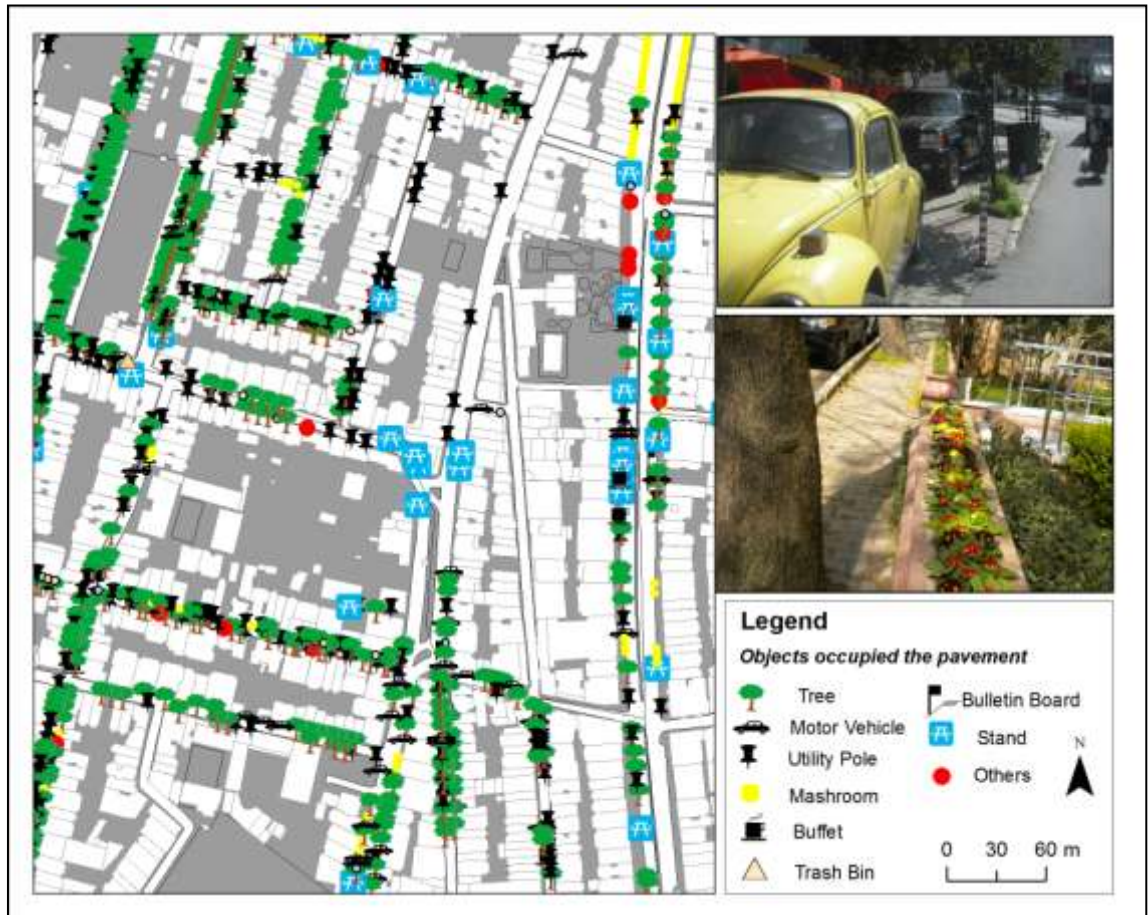
The objects in the study area are illustrated on the map below with symbols in a part of the study (Figure 40).

Figure 40. Objects occupied the pavements were shown on the map with different symbols

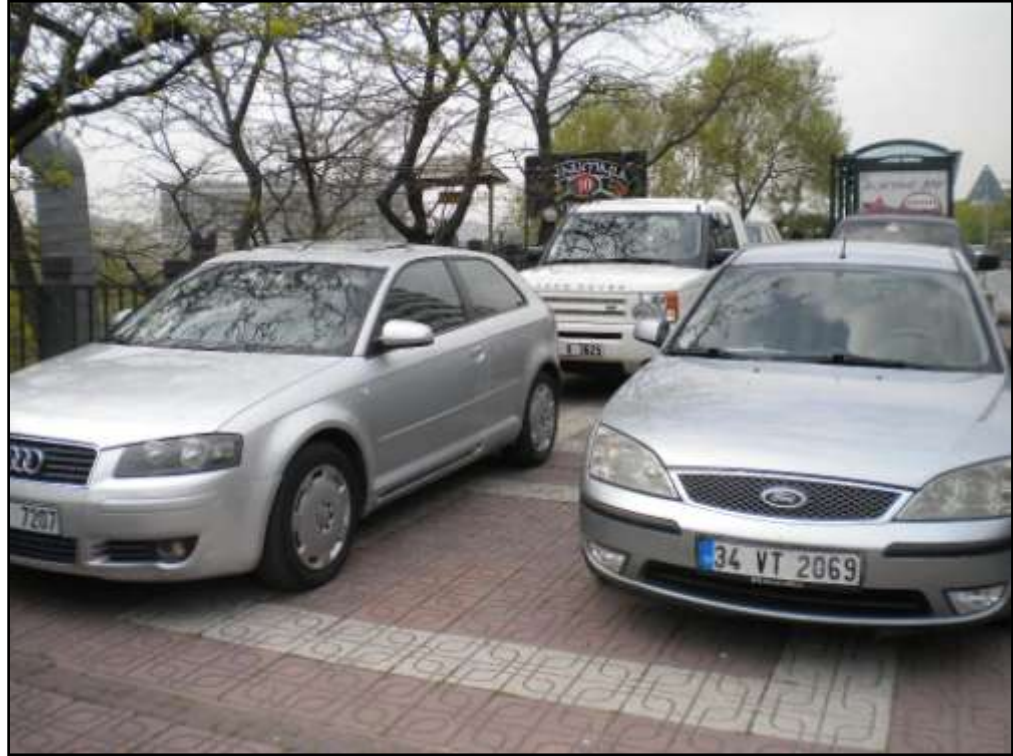
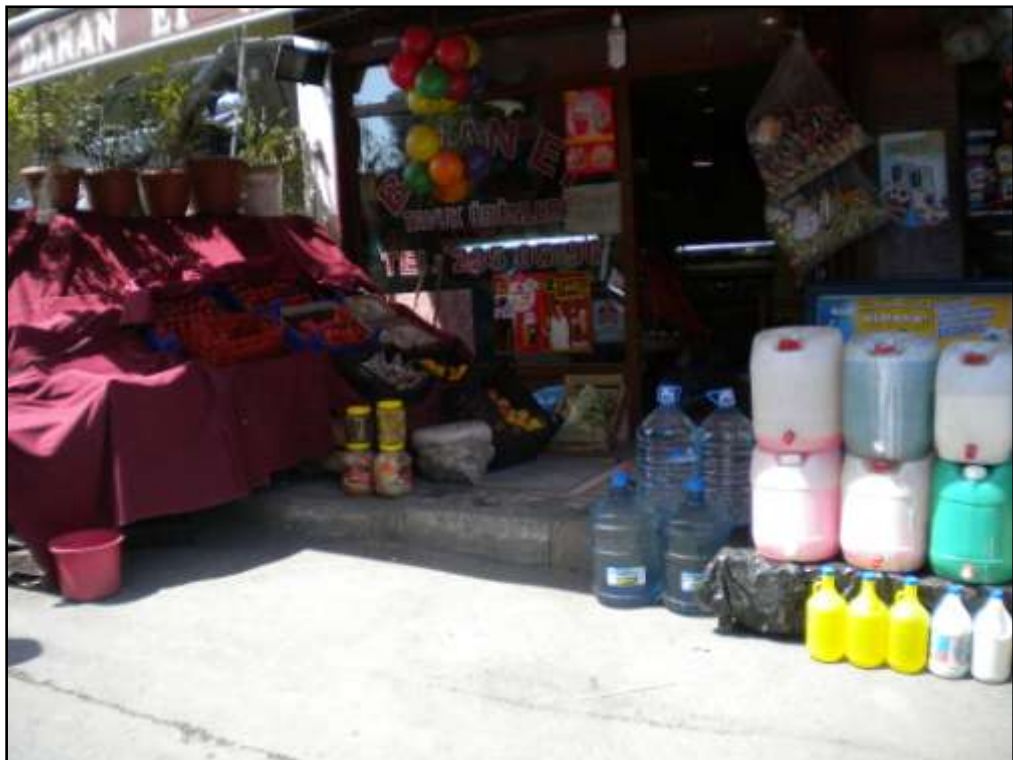
Every 46 buffets, 44 stands and 40 vehicles out of 100 cause obstacles for the disabled people to use the pavements (Figure 41). The mushrooms beside the pavements are the least obstructing in the use of pavements by disabled people (only 15% of them are in this situation). Then follow trees (16%) and electric poles (19.9%).

Figure 41. The pavement segments which include objects that prevent disabled's passage on the pavements

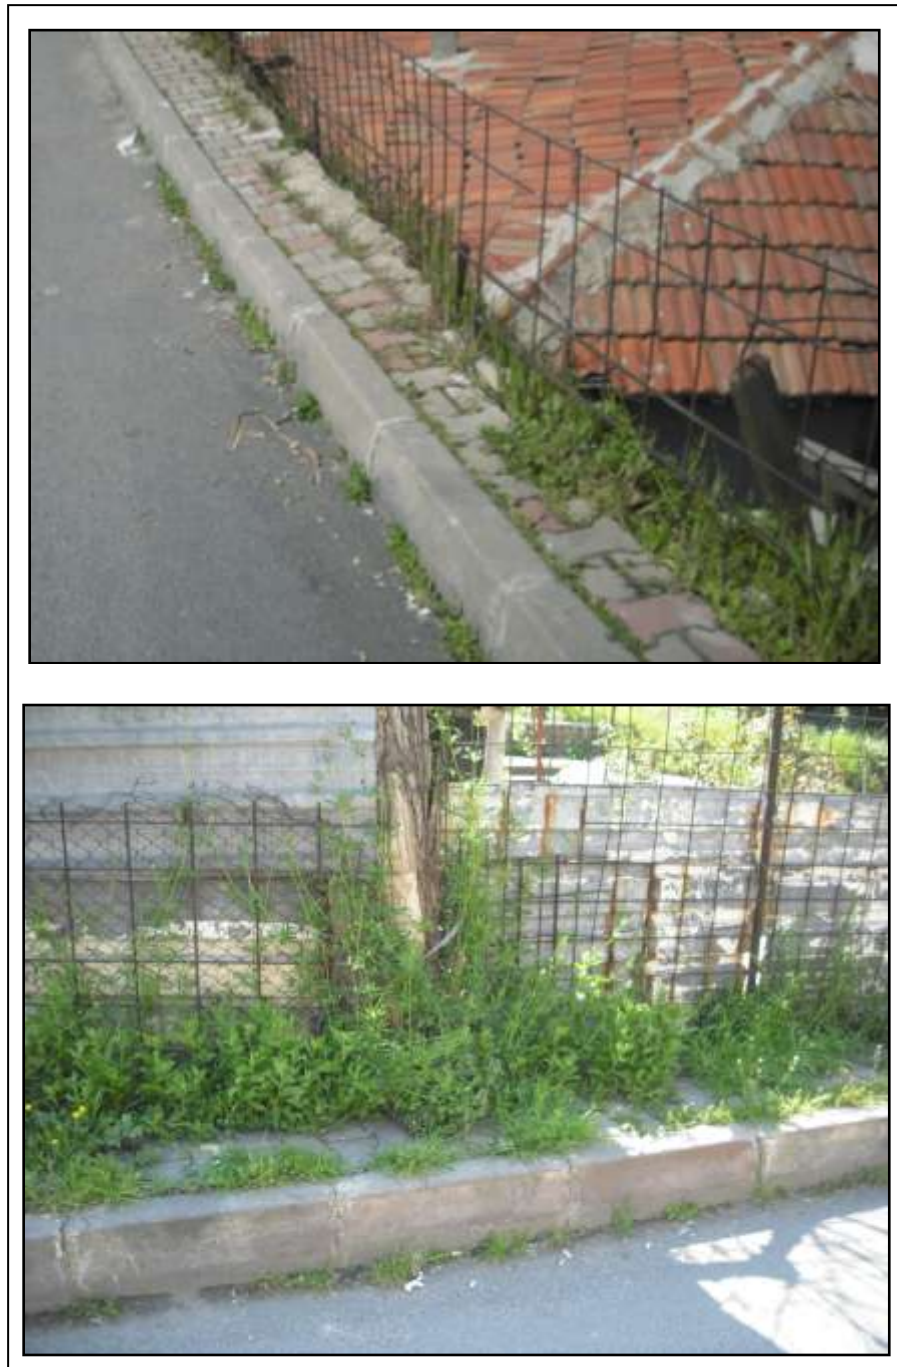
As seen in Table 8, the pavement segments which have less than 50 cm width, form the approximately half of the study area (Figure 42). There are 533 pavements segments that are up to the standards. Accordingly, 82.4 % of the pavements segments are below the standard width. The pavements segments with standards sizes form only 17.6 % of the total.

Figure 42.Pavement segments which have less than 50 cm width

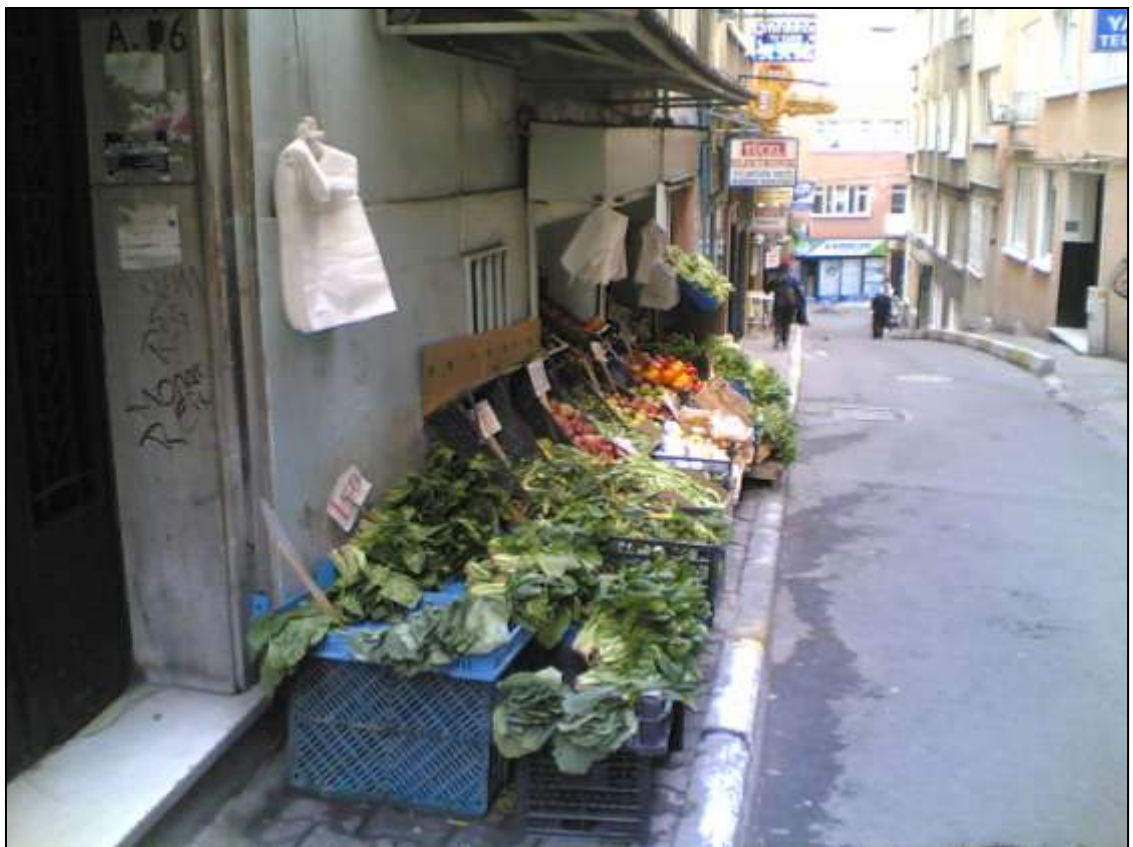
educational facilities are centered. Pavements in the area are often renewed for these places are immensely used by the town dwellers as well as those that come from outside the locality. On the contrary, Table 11 also illustrates that the width and height of the pavements in Eskişehir, Feriköy and Halaskargazi neighborhood is under the standards on account of unplanned urbanization and the changes of sudden slopes. There are many places with over 25 % of slope level especially in Eskişehir neighborhood. The fact that Feriköy is among the oldest places of settlement, there are less social places, and business centers, and unplanned urbanization which pave the way for the pavements to be below standard measures. Unplanned urbanization is the main factor for not having standard pavements in Halaskargazi neighborhood. The streets and roads became narrower and the pavements were not built in certain standards owing to unplanned urbanization.

Figure 43.A narrow street in Halaskargazi district

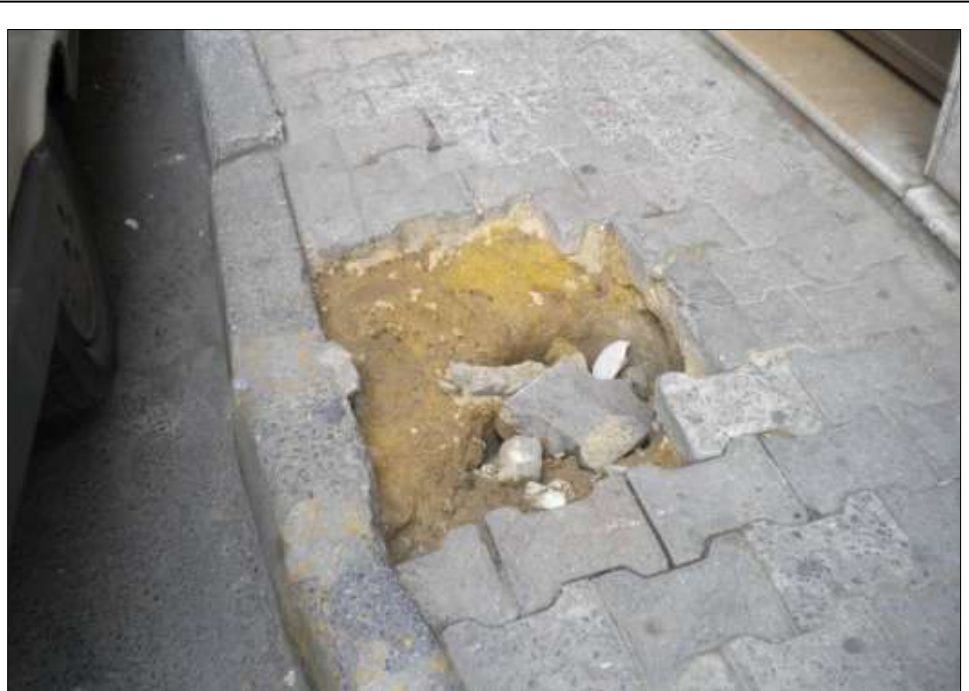
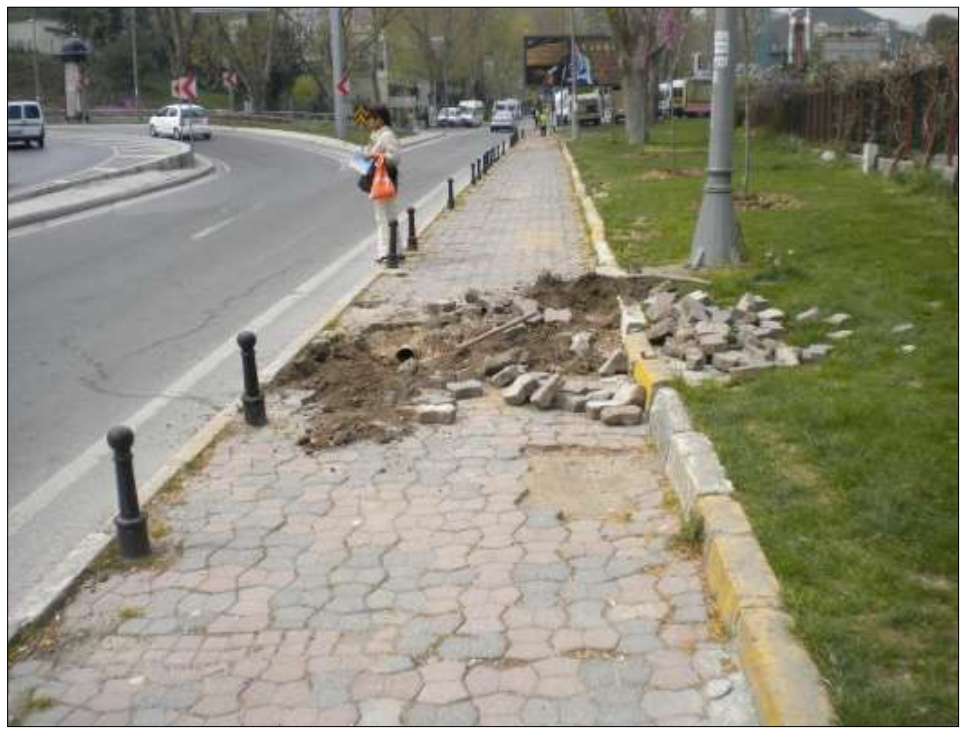
The distribution of broken surfaces according to the neighborhoods is illustrated in Table 12. Accordingly, Ergenekon neighborhood has the highest number of broken surfaces followed by İnönü and Fulya neighborhoods (Figure 45). Kaptanpaşa and Halaskargazi have no broken surfaces.

Table 12 illustrates that broken surfaces are especially more in Ergenekon and İnönü neighborhoods on account of the fact that the pavements were built long ago. The pavements were rubbed off by the time being, and those places have not been repaired or no new pavements have been built. Hence, the ratio of the broken surfaces increases day by day. Moreover, the effect of slope in the field contributes too little to have broken surfaces in these neighborhoods.

Figure 45. Broken surfaces in the study area

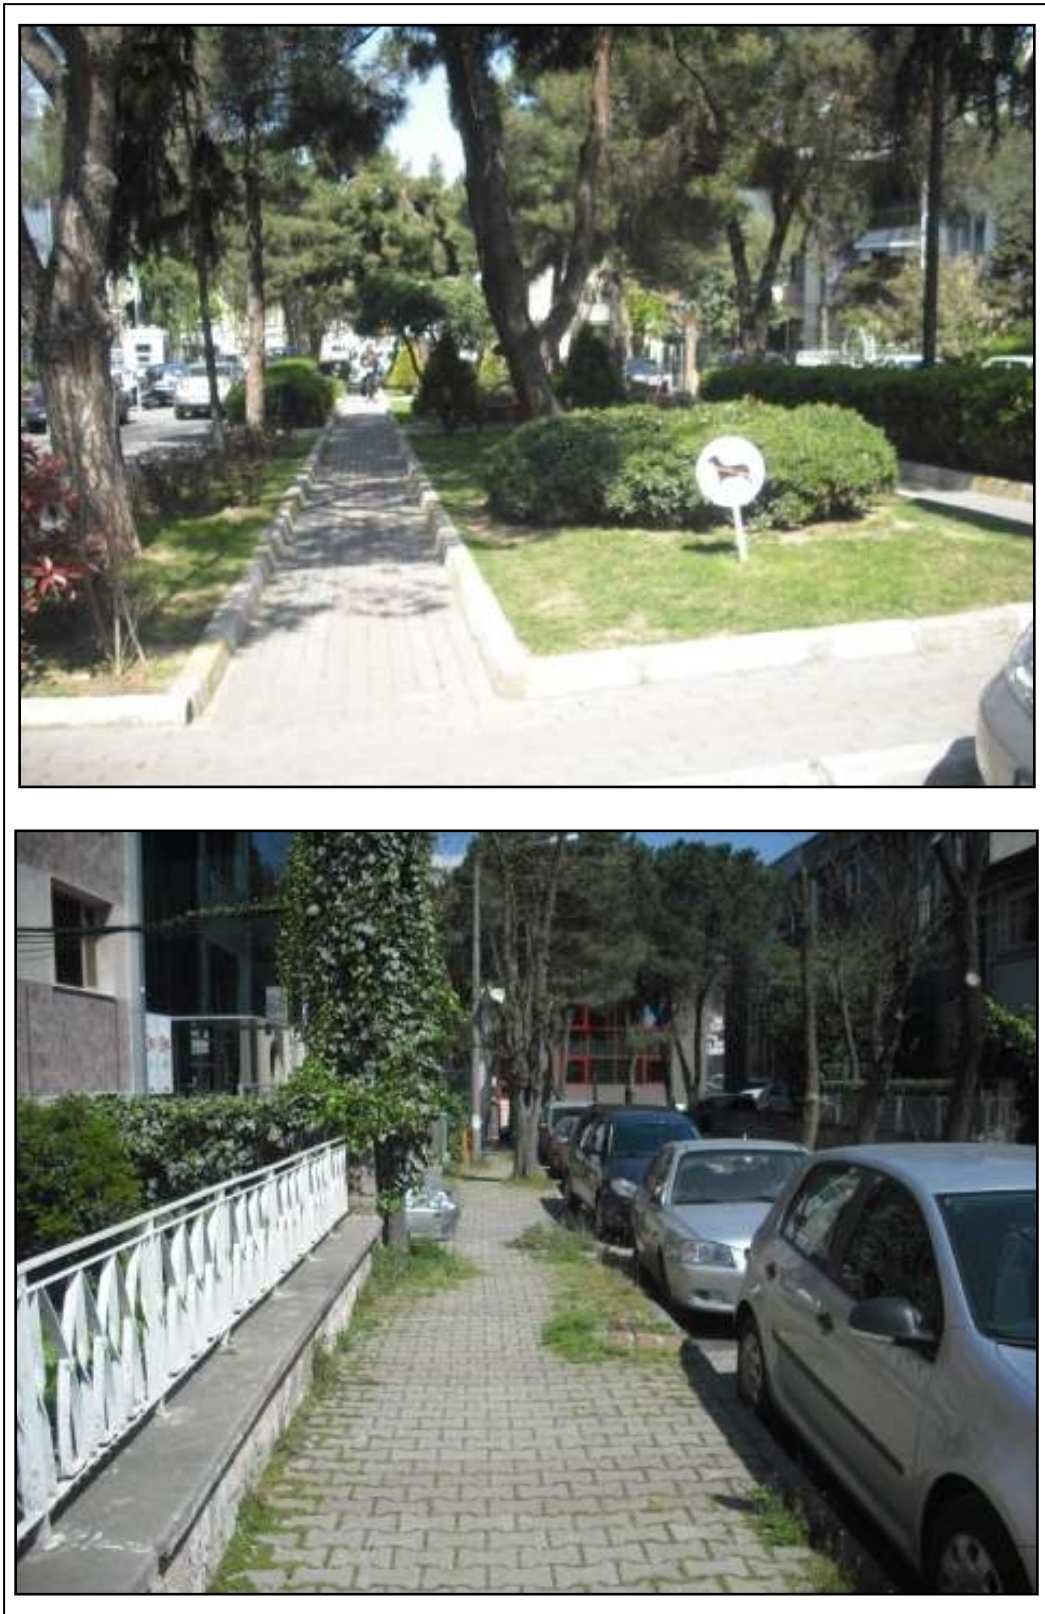
Figure 49. Pavement segments in the study area with ideal slope degree on which disabled people can walk safely
