M.A. Thesis In Geography

ANALYSIS OF PAVEMENTS FOR DISABLED PEDESTRIANS IN METROPOLITAN CITIES: CASE OF SISLI DISTRICT IN ISTANBUL

Fatih University

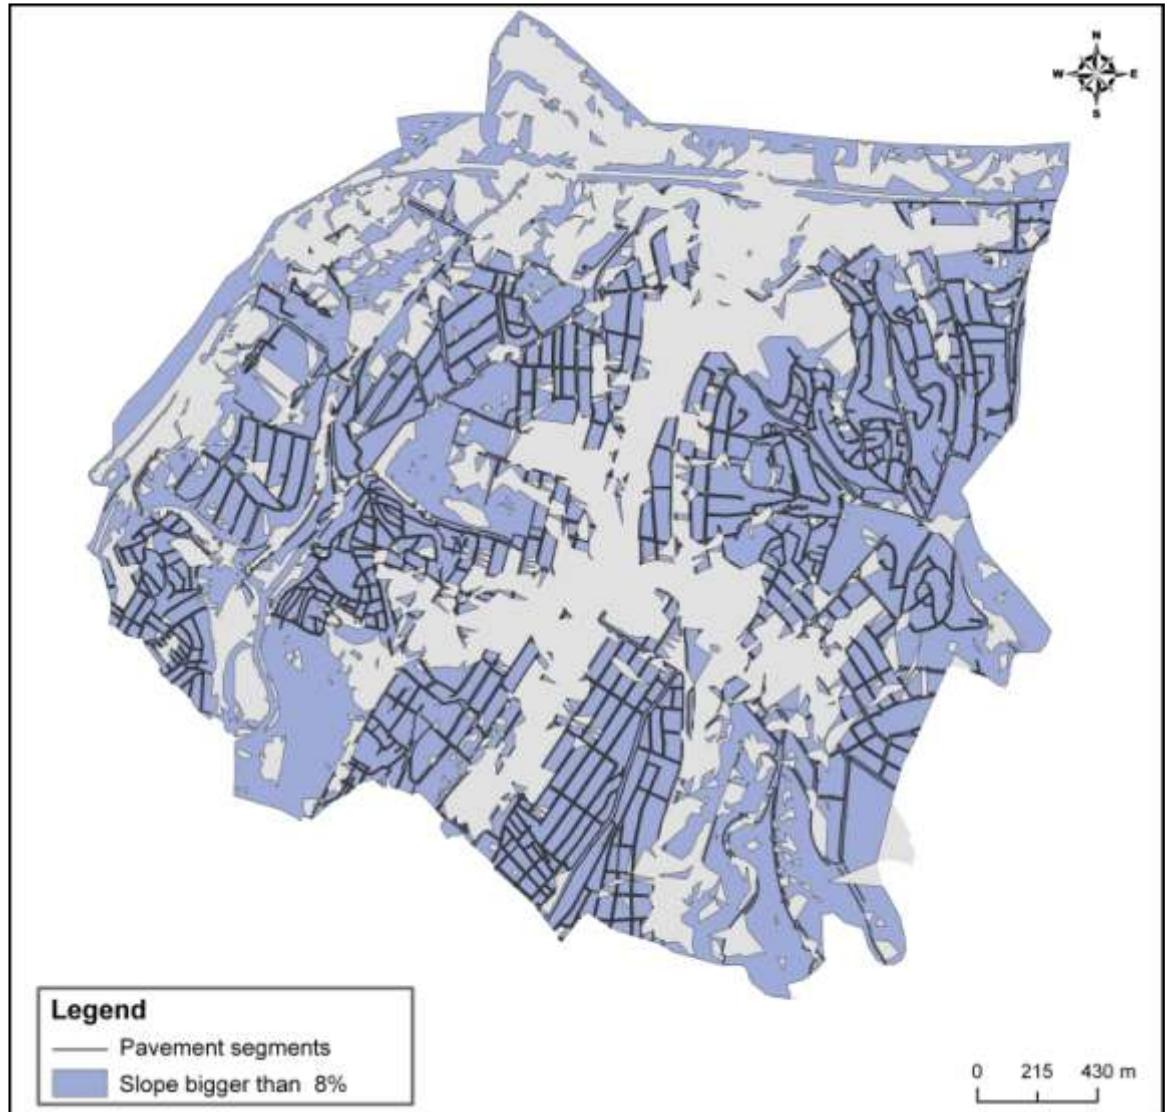
There are 2681 pavement segments with no suitable degree of slope ($>8\%$) that disabled people cannot use safely in the study area (Figure 50).

Figure 50. Distribution of slope bigger than 8%

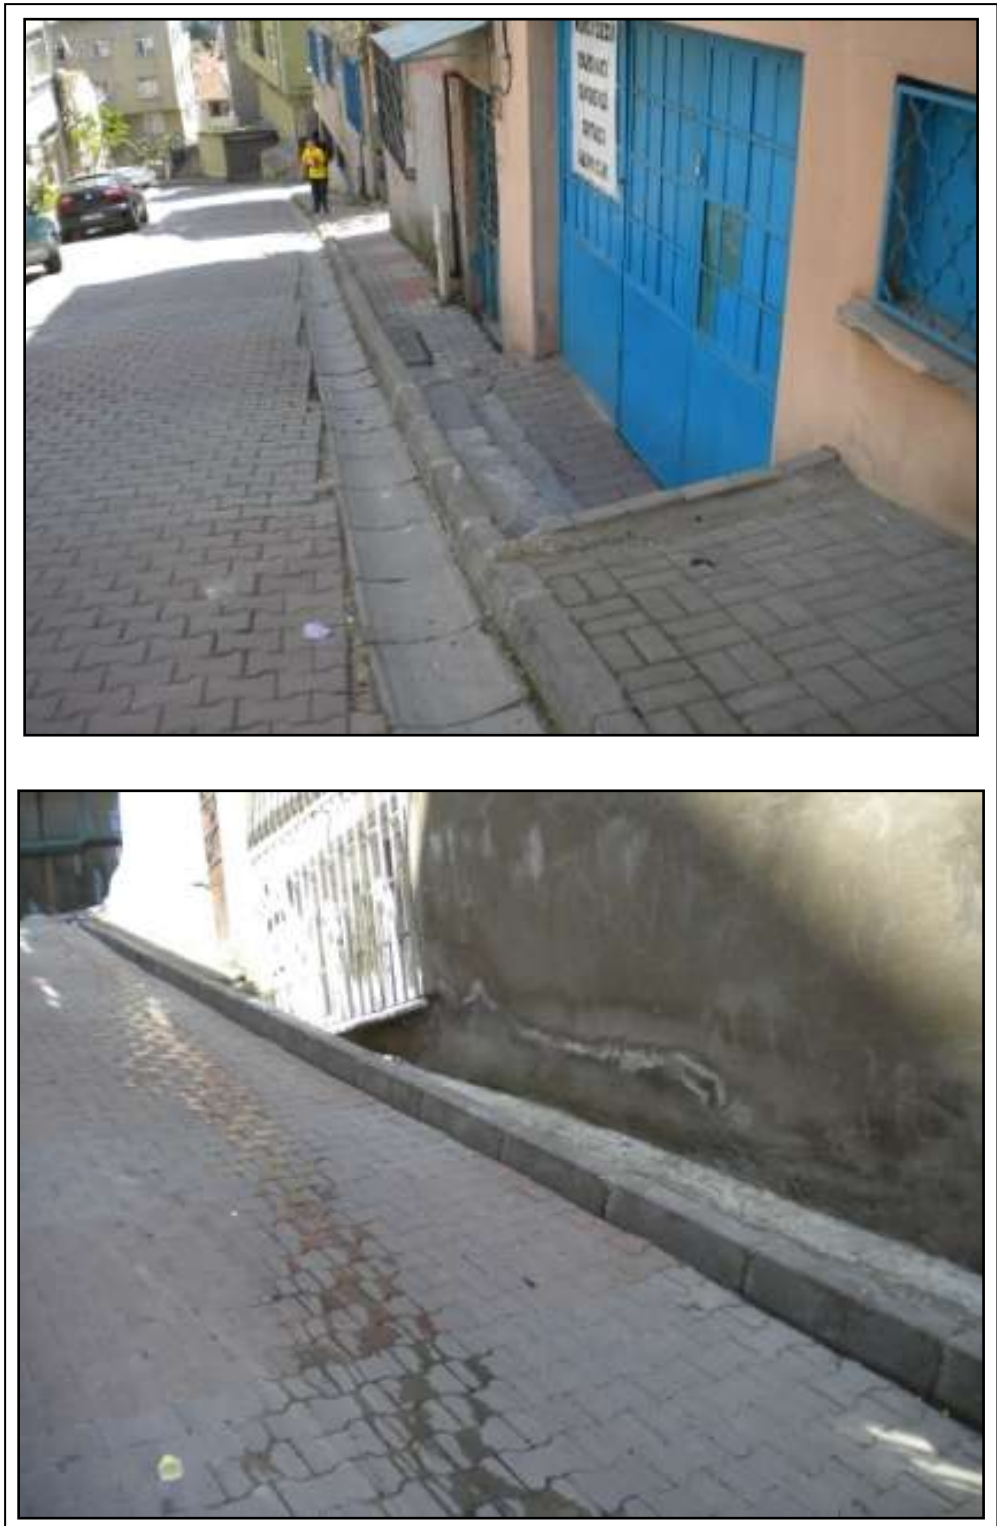
When the distribution of pavement segments with no ideal degree of slope ($>8\%$) is analyzed, Merkez neighborhood has the most number of ideal pavement segment slope with 12.3%. Then follow Cumhuriyet and Paşa neighborhoods. However, Ergenekon neighborhood has the highest number of pavement segments with no ideal degree of slope followed by Kaptanpaşa and Duatepe neighborhoods (Table 15).

Figure 51. Slope exceeds 8%

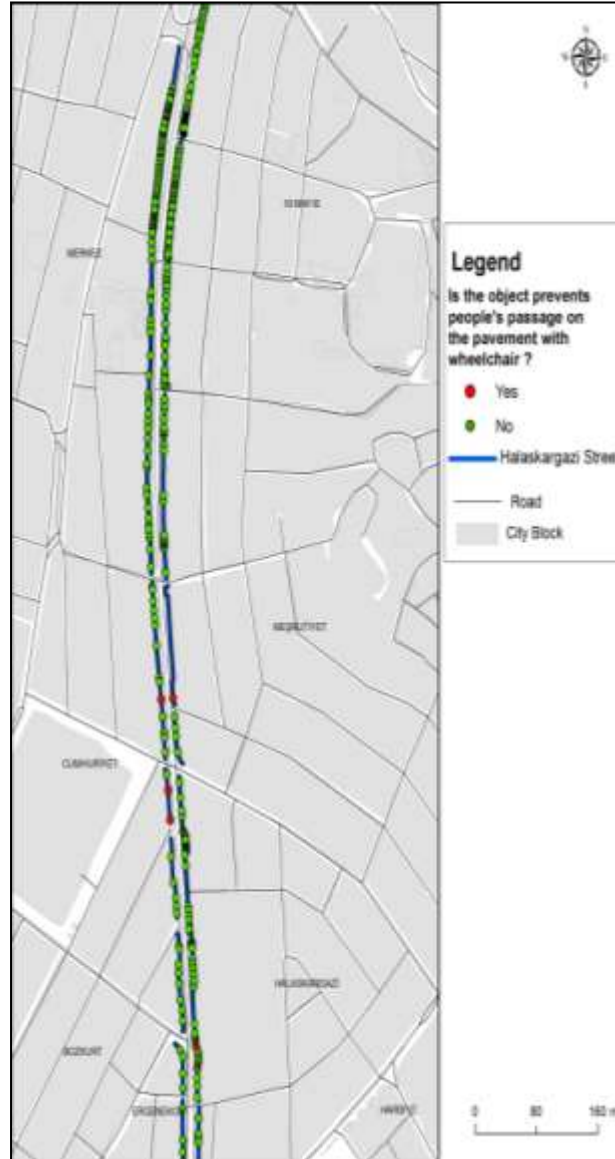
Halaskargazi Street shares the same condition. There is 2149 meters long pavement segment detected on this street. There are 389 objects in total on these pavement segments. Six of the objects cause obstacles for the disabled people to use the pavements. The rest of the objects do not pose any problem for the disabled people to use the pavements. There are four ramps on the same street that could be used by the disabled people. If 32 ramps are constructed on this street, the disabled people can use the pavements on the street without the help of anyone (Figure 54).

Figure 54. The pavement segments which include objects that prevent or not prevent disabled people passage on the pavements on Halaskargazi Street
