IMPROVING THE SOCIO-CULTURAL AND ENVIRONMENTAL GAIN OF DEAD AND STRICKEN AREA:

"Piazza Marconi Environmental Restoration Project"

THESIS FOR THE DEGREE OF DOUBLE MASTER OF ARCHITECTURE

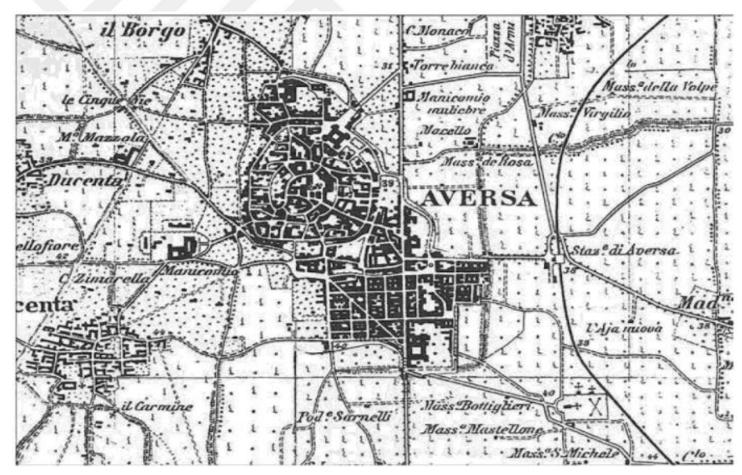
Figure 3. Norman Military Style center design of Piazza Marconi / Aversa (Istituto Geografico Militare, 1905)

The original urban center was surrounded by just ditches and embankments. (Amirante, 1998,p.38) In the new urban reality, the church takes on a role and a central location, not only as a religious symbol but also a place for the community meeting. The radial-model adopted has no contemporary evidence in the Italian territory, strongly influenced by tradition Roman colonial. In France it is noted, in many urban areas, centered on the cathedral: examples are Bram and Brive. _(Figure 2.1-2.2). We can see these Norman military style center design in Piazza Marconi. _(Figure 3)

- Norman foundation nucleus (eleventh century) to radiocentric plan formed by annular and radial roads in the center the Cathedral of St. Paul .
- The orthogonal structure of Lemitone district (XVII century) located southeast of the original nucleus. (url1)

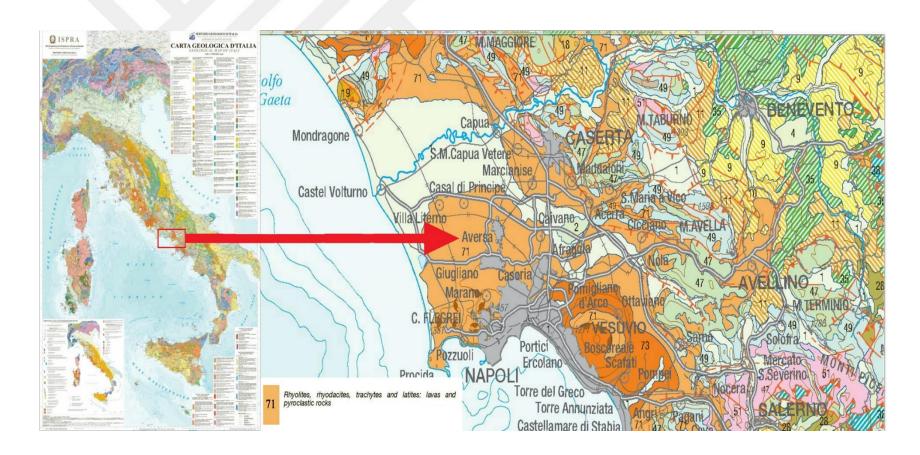
Figure 4. Geological Map of Piazza Marconi /Aversa (url2)

The present data is summarized and it is seen that there are not any weak soil according to these data.

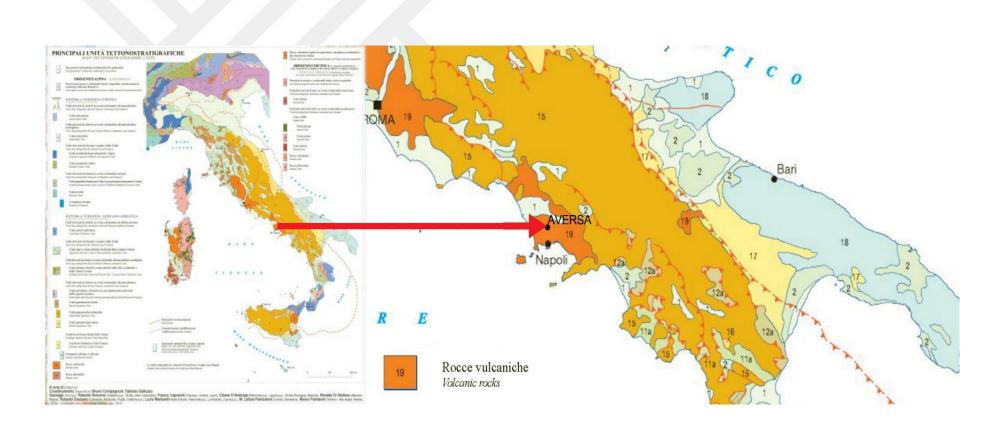
Figure 5. Tectonical Map of Piazza Marconi /Aversa (url3)

This analysis were conducted using the present tectonic map at hand. The islandic arc volcanism occurs when a moving part of the solid lithosphere, which forms the outer crust of the earth, gets close to another part and plunges underneath it. In this event, which takes millions of years to occur, if there is sea over the tectonic plate on the top, the ourcropping magma forms volcanic islands through the dissipation in the sea, and these islands are lined up in the form of an arc. The earthquakes are either tectonic or volcanic. Aversa is situated 25 km to the southeast of Vesuvius. Therefore the tectonic movements are volcanix in nature. Vesuivus is a stratovolcano. Stratovolcanoes are volcanoes with a high conic shape formed of lava, tuff and ash layers (Zernack, A.,V.,2008). These volcanoes are characterized with steep slopes and periodic eruptions. The viscosity of the lava erupting from the stratovolcanoes is low and the lava cools and hardens before it gets far. The magma contains acidid or high-moderate silica (rhyolite, andesite, and dacite). (Figure 5)

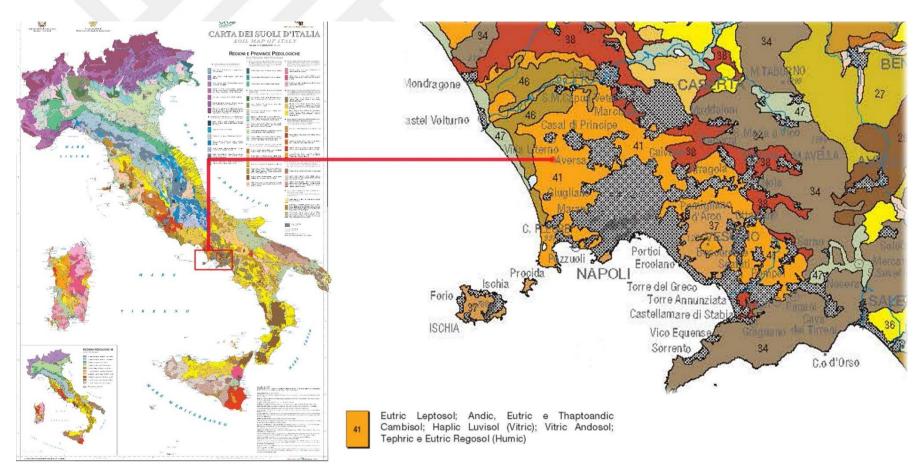
Figure 6. Soil Map of Piazza Marconi /Aversa (url4)

Worn out volcanic glass are found on the surface and andic soil with high organic matter concentration is found in the survey area. In addition, euric leptosols, thaptoandic cambiosol, vitric andisol and euric rogosol (humic soil) are found. (Figure 6) If the overlying material and buried soil exhibit the characteristics of Histosol, Technosol, Cryosol, Leptosol, Vertisol, Fluvisol, Gleysol, Andosol, Planosol, Stagnosol ya da Arenosol, they are classified as one soil (Url:3)

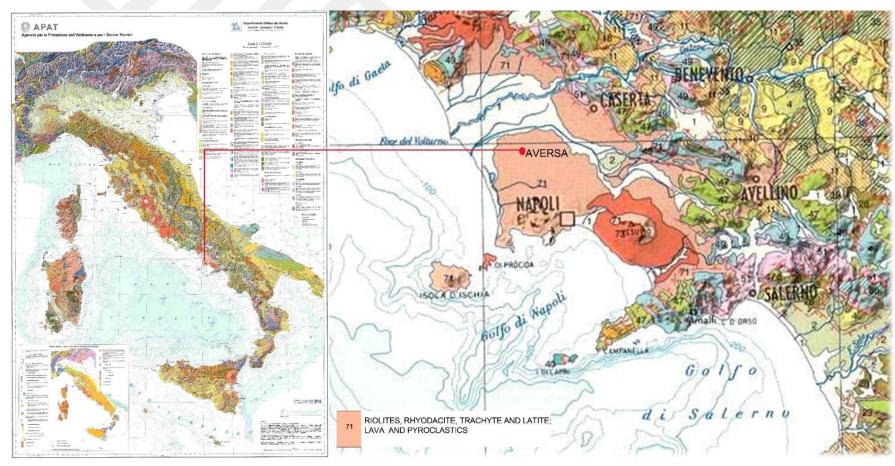
Figure 7. Lithological Map of Piazza Marconi /Aversa (url5)

The lithological element found in the project area is the volcanic product and have the characteristics of "ROCK". (Figure 7)

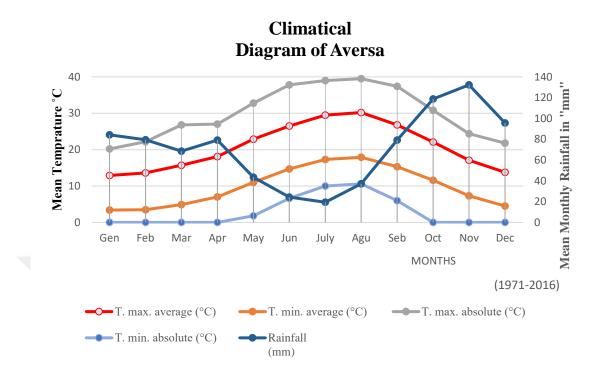
Table1.2. Climatical Diagram of Aversa from 1971 to 2016

When the data obtained from the Italian Air Forces Meteorology Division is examined, it is seen that, between 1971 and 2016, the coldest month was January with an average temperature of +8.2 °C, while the hottest month was August with an average temperature of +24.1°C. There is frost in 18 days per year, averagely. An average of 39 days have temperatures equal or greater than +30°C. The lowest value between these years was measured as -6.4°C in February 1993, and the highest value was +39.5°C in August 1981.

An average of 81 days are rainy per year. The average rain fall per year is 862 mm. The lowest rainfall is in summers and the highest is in autumn. Winter is the season with the highest rainfall after autumn. There is fog 39 days per year, averagely. The average relative humidity per year is 74.3%. The lowest relative humidity is in June, July and August with 71%, and the highest rate is in November and January with 78%. According to the values defined by the World Meteorological Organisation, as the climatic normal between 1961 and 1990, the coldest month is January with +8.0°C average temperature and the hottest month is August with ay +23.6°C average

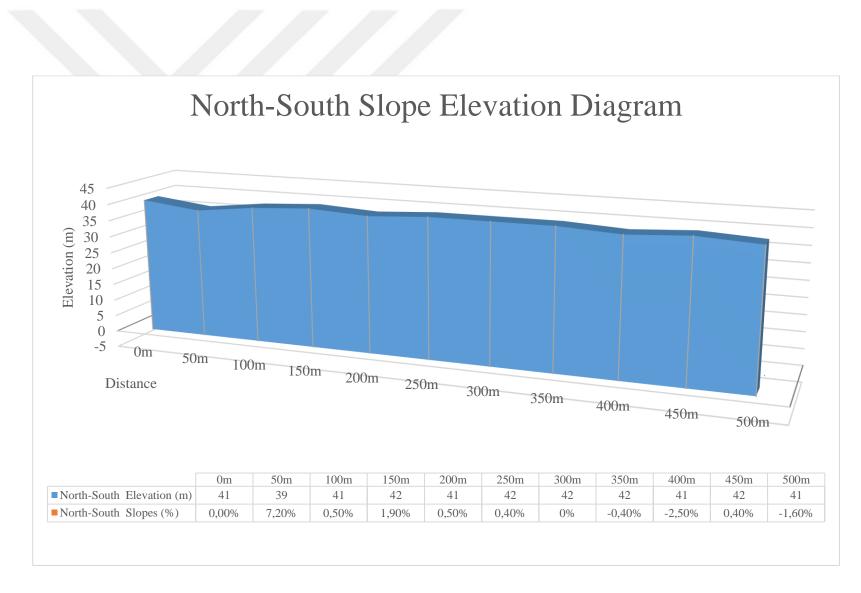
Tables 2.1.North-South Slope Elevation Analysis

The slope gradients, in the project area, vary between 39 and 41 meters and the average gradient between 2.1% and 3%. The maximum gradient is 12%. The gradients are investigated separately as North-South gradient and West-East gradient._{(Tables 2.1.(a)-2.2(b))}. A topological map was created with the data obtained from the project area. (Figure 8.1.(a) – 8.4.(d). The gradient analysis covers a 200.000 m2 area including the project area.

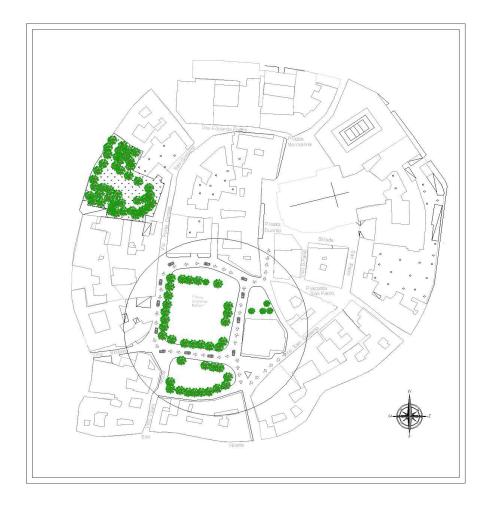
Figure 9. Cadastral Subdivision of Piazza Marconi

Piazza Marconi, which is the project area is situated in the borders of Via S. Marta, Via Sellito, Via Cirillo and Via S Nicola, and is at the exact center of the radial city order. _(Figure 9)

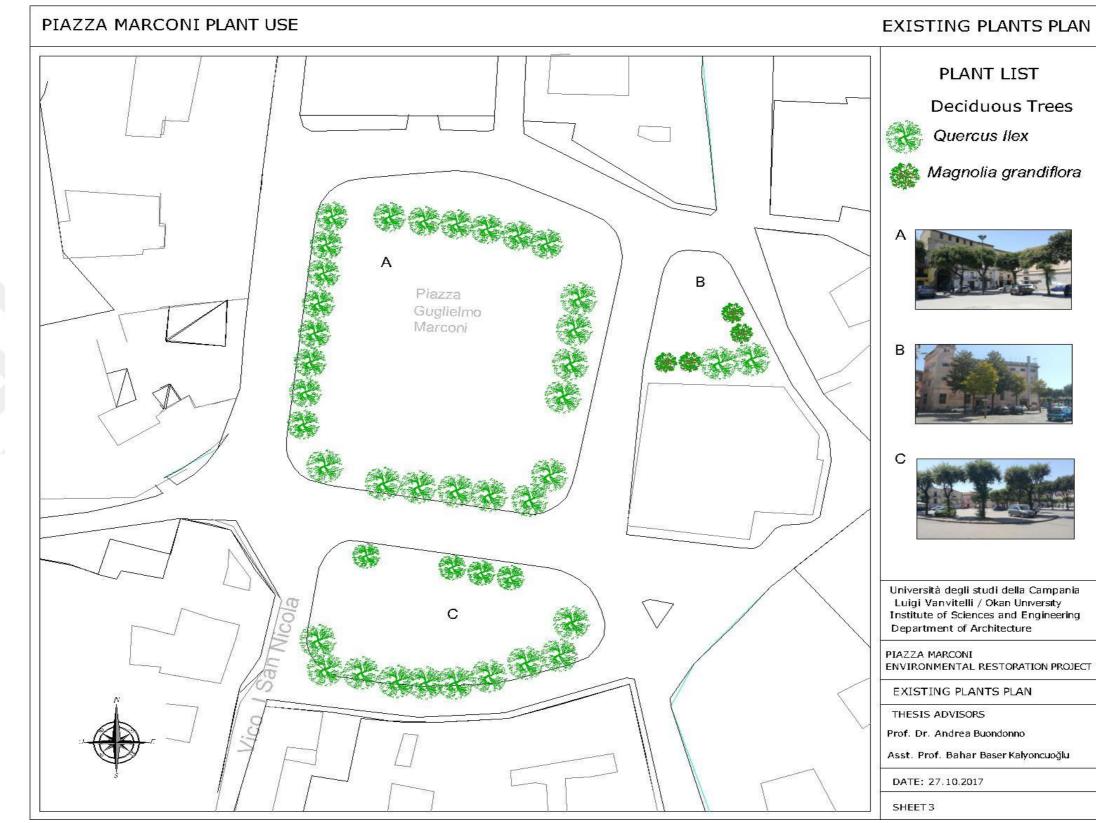
Figure 11. Existing Plants Plan

2 plant taxon are detected in the selected region, the Piazza Marconi. There are 46 *Quercus ilex* tree, 28 of which are located in the middle section of the area at four corners; 16 of which are at the southern part of the square, one of which was cut afterwards; and 2 at the parking area. Also there are 4 *Magnolia grandiflora* trees at the parking area.(Figure 11)

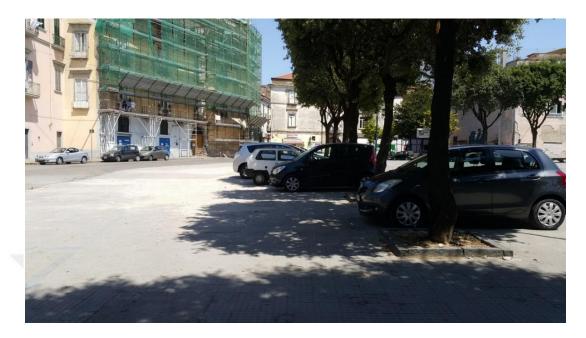
they park their vehicles disorderly. (Figure 14.1,14.2) For this reason the pedestrians have difficulty in using this square as it is supposed to be. In the meantime, the present situation lacks an aesthetic appearance and this renders Piazza Marconi less significant but more dangerous.

Figure 14.1. Marconi Square (Piazza Marconi) Irregular Parking-1 (Demirci, Didem,12.06.2017)

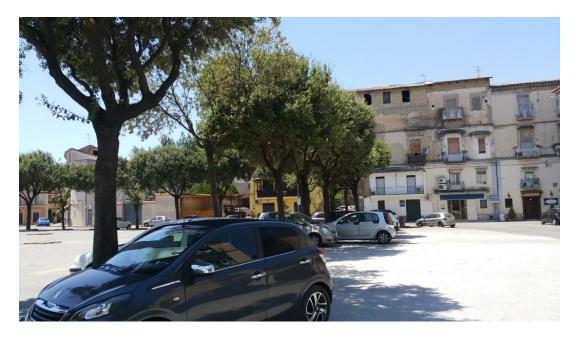
Figure 14.2. Marconi Square (Piazza Marconi) Irregular Parking-2 (Demirci, Didem, 12.06.2017)

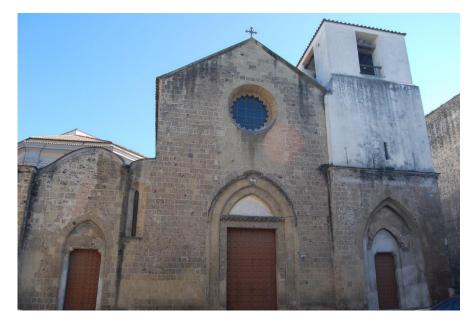
It was once the site of encounter and exchange of merchandise from another origin people like Jews, Arabs, Byzantines, and Lombards. The church has an exposed tufa facade with three ogival-shaped portals. On the right, embedded in the structure, is the bell tower, unfinished. Also the bell tower, also of the eleventh century. At the Tibet of the dome on the octagonal cruise, two semi cupolas of the sides of the transept and the lower apse are supported. (Figures 18.1-18.3). (url19)

Figure 18.1.Fasade of Church of Santa Maria in Piazza (Demirci, Didem, 12.06.2017)

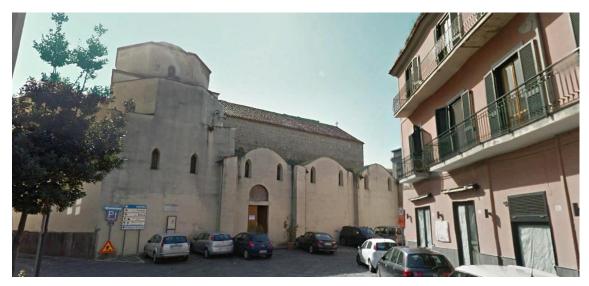
Figure 18.2.North Side Facade of Church of Santa Maria in Piazza (Demirci, Didem, 12.06.2017)

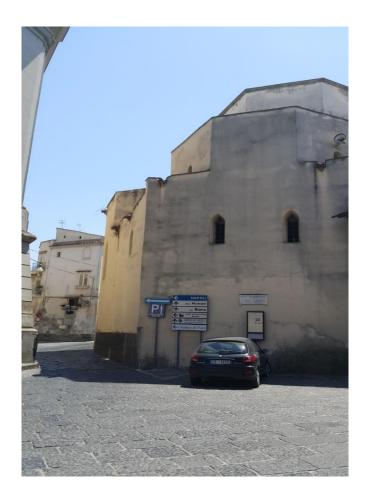
Figure 18.3. North Side Facade of Church of Santa Maria in Piazza Dome Part Corruption-1 (Demirci, Didem, 12.06.2017)

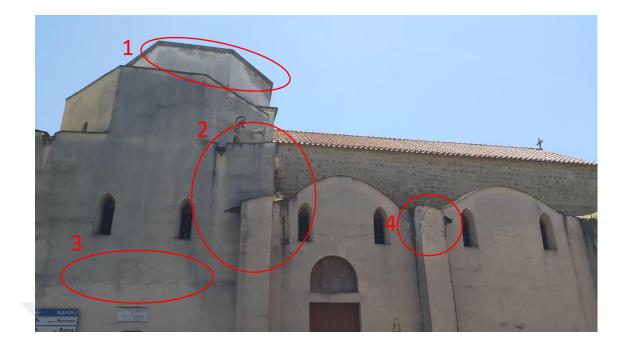
Figure 18.4 North Side Facade of Church of Santa Maria in Piazza Dome Part Corruption-2 (Demirci, Didem, 12.06.2017)

- 1. Facade pollution
- 2. Affusion and facade pollution caused by external factors.
- 3. Plaster crack
- 4. Pouring plaster : 0.5-1 cm thickness

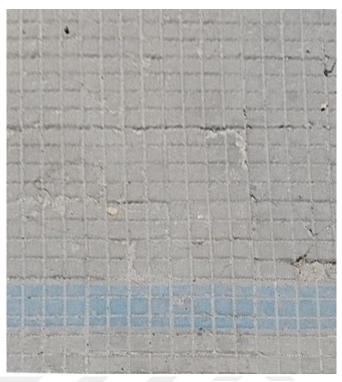
Figure 25. Concrete Square Parquet (Demirci, Didem, 12.06.2017)

Deteriorations, which are located in square, are too much attract the attention. At the current situation concrete square parquet covering was used in the middle area and island part._(Figure 25) Because of wrong use of space and wrong car parking deformations and levels occured on the floor. With this levels on the concrete plates which are footing on ground, there is tearings, crashes, affusions._(Figure 26).

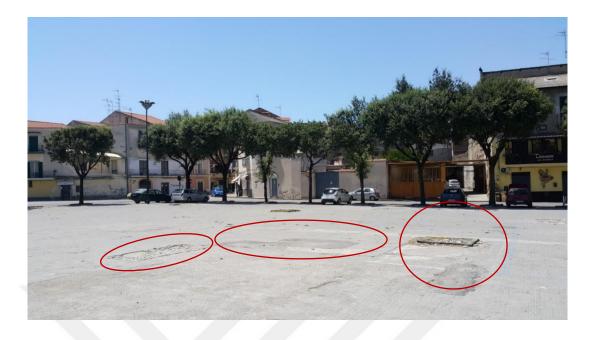
Figure 27.1. Floor Deterioration-2 / Modified Asphalt Operation. (Demirci, Didem,12.06.2017)

These and other deformations are continuously discontinuous, and the explanations that may be in one or in combination usually include the kind of sensitivity that is required to make a rigorous reasoning. To define the damage, these are damage types that provides big value. Because this shows us how the area is used. We see that the strength value of the concrete is exceeded in places where breaks and deterioration occur. Also we understand that these deteriorations happen because of more than ones pressure force. This tells us whether there is any possible or continuous tension or pressure in damaged areas and other areas that have not yet been damaged. At the same time, when these damage causes were investigated and broken points were examined, it was concluded that the material used in the field was inadequate due to insufficient workmanship and inadequate drainage. On the other hand, an improvement made by using modified asphalt was tried to be applied in the parts of the ground. (Figure 27.1-27.2) Because of frequent afforestation, some of the plazas were tried to be planted rather than afforested, but later dismantled due to the fact that the vehicles can move easily or due to an unknown reason. So that the part of the separating stones that separates the afforestation from the ground is also damaged. (Figure 28).

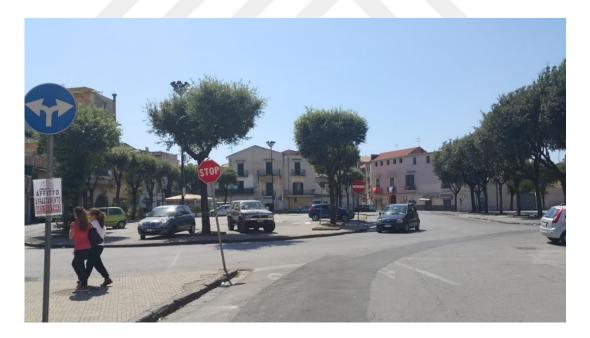
Figure 29.1. Asphalt Deterioration-1/ Patch Operation

On the road stone mastic asphalt used. On the asphalt section we can see that there is second type abrasion. When you compared the biggest grain size which is 12.5 mm to the Type 1 wear, it gives us much higher wear ratio. This applied at places like without heavy and non-stop traffics usually light car otoparks, sport areas, walking lanes. The soil structure was further deteriorated by applying modified asphalt on top of it due to deterioration afterwards. (Figure 29.1) If we inspect the current asphalt we can array the levels of deterioration and fatigue in three groups from low to middle and to high. Multiplex deterioration has occurred at the beginning of the lines connected to Piazza Marconi, which is generally the side streets of the asphalt roads. (Figure 29.2) Very important damages happen at the roads because of too much vehicle. Due to the horizontal and vertical stresses that occur as a result of these overloads, the surface of

the asphalt breaks shortly, cracks and seats. Reason of this, ground actually consist of 25x40 black granite stones. Not to mention the fact that this granite parquet stones damaged because of vehicle traffic. Except for these important factors which cause the road cover to deteriorate, faulty patches are degraded due to faulty manufacturing such as inadequate drainage, use of inappropriate -filling materials and insufficient compaction. This situation aesthetically decrease the road quality significantly.

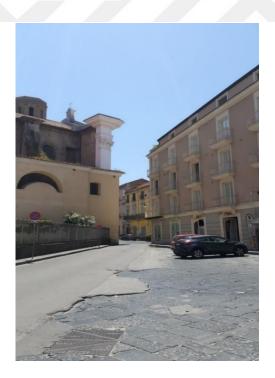
Figure 29.3 Asphalt Deterioration-3 / Asphalt Application on Granite & Multilevel Asphalt Degradation. (Demirci, Didem, 12.06.2017)

Another important issue that causes short-term deterioration is the highway cracks caused by freezing and thawing especially in the winter months in regions where temperature difference is high at night and day. Specially it has a climate like Aversa. Because of the temperatures of 40 degrees in the summers and the subsequent damage caused by the use of vehicles and people can not be ignored.(Figure 29.3)

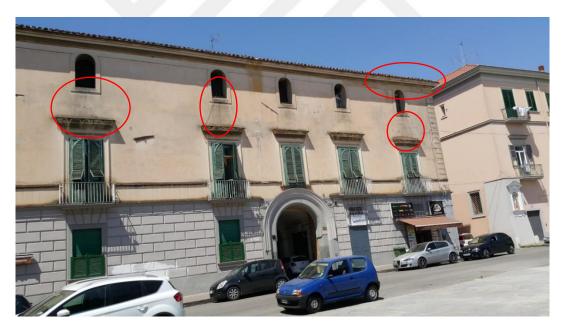
Figure 30.2. Facade Corruption depend on Squalidity and 0.5-1,5 cm Plaster Deformations and affusion. (Demirci, Didem, 12.06.2017)

Buildings, which are located around the square, are also very deteriorated. First of all deterioration reasons investigated, boil down to historical environment and its component size like Piazza Marconi. Climatic as well as human use and usage in different functions deteriorations are increasingly increased. Frontage deterioration determines are done for the buildings that in the square and around the square. There is plaster deteriorations because of building obsolescence and the lacking of care. Nearly at everyone of them there is plaster deteriorations and pours between 0,5-1,5 cm. (Figure 30.1-30.3) At the innovation of cutting not remained faithful to the original parts. Ground floors have been enlarged for use in showcases and shops. Because of this frontage integrity has been broken. All of the different structural frontages have been changed. The random placement of tablets has created visual pollution on the field. Aircon and external units are placed in such a way as to cause visual pollution regardless of the frontage.

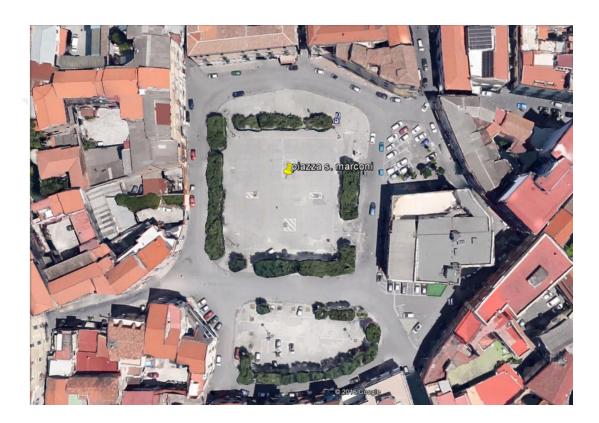
Figure 34. Existing afforestation in current area

There are concrete elevation structures in the project area which sustains the planimetric durability of the instalments. Currently, there's a plantation area in the middle of the square with "*Quercus ilex*" *Holm oak ve* "*Magnolia grandiflora*" trees. (Figure 34)

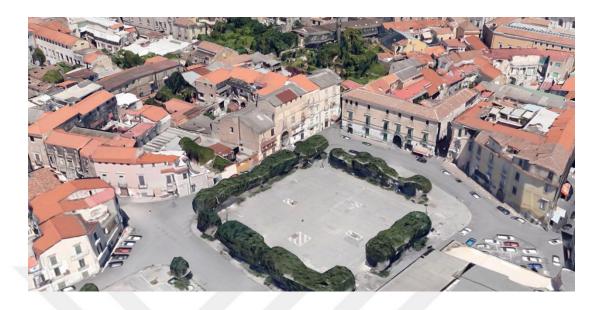
Figure 36. Piazza Marconi-Current situation of A side

When the present status of Piazza Marconi is observed from the A side, we encounter the view of deformed buildings, and we see two rows of *Quercus ilex* trees._(Figure 36) The thermal ratio of this side is lower than other sides and it is situated to the north. Thus, the main sitting area is relocated here. The external floor of the sitting area is natural travertine pavement and natural stones are used for the inner floor. In the anticipated design, *Laurus nobilis* trees with shading features are used to conceal this area. Also, semi-shading and aromatic trees such as *Acacia dealbata, Corylus colurna, Hibiscus syriacus, Prunus serrulata 'Kanzan',* are used around this area to let the certain amount of sunlight to access the area._(Figure 37)

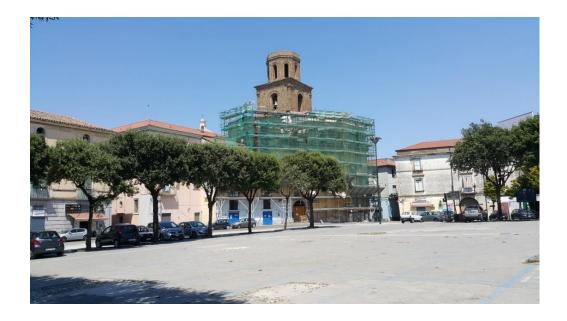
When we look at the present status of the Piazza Marconi from B side, we see the building with incomplete restoration and the Cattedrale Duomo San Paolo. The *Quercus ilex* species seen at the A side continues at this site too. B Side receives more sunlight than A Side. (Figure 38) Therefore, thich tissued and shading trees such as *Acacia dealbata, Cercis siliquastrum, Erythrina crista-galli, Olea europaea* are placed closely in the anticipated design. Also some shrubs are placed as in the A side. The mix lawn areas is placed by thick fixture sodding and is supported with Monadic Flagstone Path in B Side. The Monadic Flagstone Path enabled the circulation in the space by connecting to the main pedestrian walk inside and outside the Piazza Marconi and to the C Side. By this means, the users can continue their walk and activities without being separated from the natural environment. (Figure 39)

Figure 38.Piazza Marconi-Piazza Marconi-Current situation of B side (Demirci,Didem,12.06.2017)

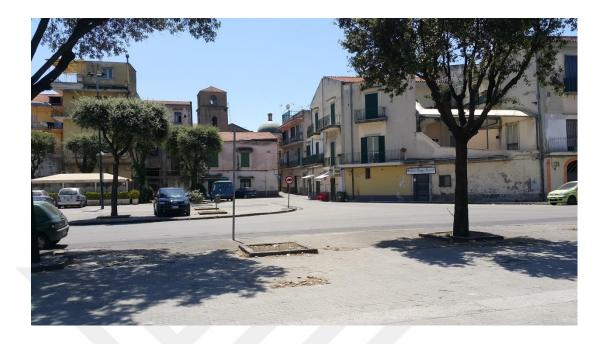
When we observe from this side, we see that it receives the most sunlight. When we look at the present status of Piazza Marconi from D Side perspective, we are confronted again with the deformed façades of the buildings. The lined up *Quercus ilex* arbour is seen here too. (Figure 42) In the anticipated design, it is planned to cut the piercing sunlight by placing tight-leaved and shading species such as *Acacia dealbata*, and *Celtis australis*. (Figure 43)

Figure 42. Piazza Marconi- Piazza Marconi-Current situation of D side (Demirci,Didem,12.06.2017)

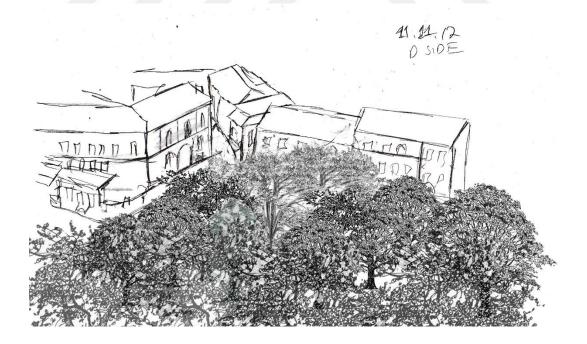
Figure 43. Piazza Marconi-Proposed view sketch of D side

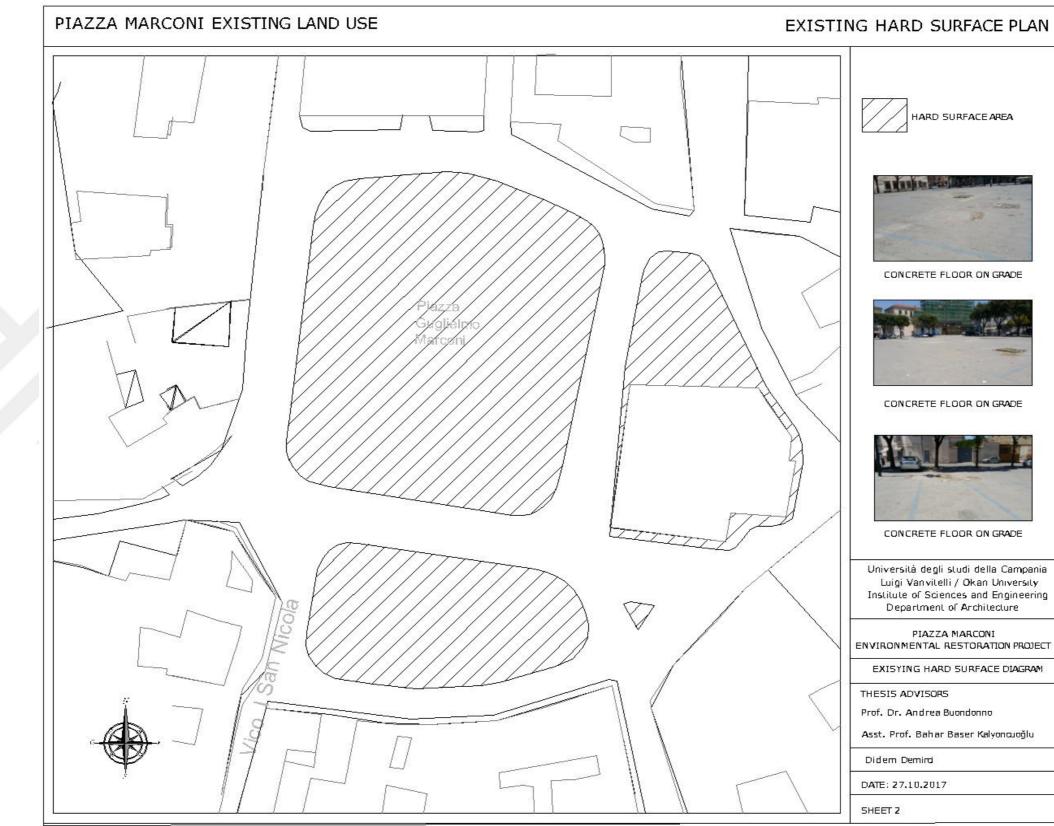
Figure 44.Existing hard surface plan of Piazza Marconi

The E side comprises the central area of Piazza Marconi. It is the place where the sun is felt the most in the area. We see that the area is divided into lots in its present status. This area is shaped due to the mergence of the lots in B side and C side. On this basis, the present firm soil is shown in 'Figure 44' below. Each one of these lots are used, not as the square, but as irregular parking lots as mentioned before. In the anticipated design, these discrete lots are merged into one and the project area is expended and an area covering 5803 m2 is obtained.(Figure 45)

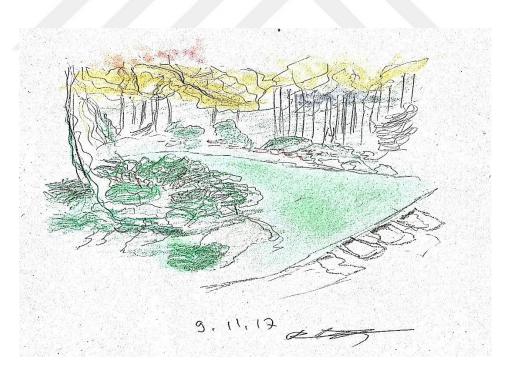
It is anticipated that the Flagstone Paths accessing the green space, that provide circulation together with the main pedestrian walks, should be supported with dolomite stones. Thus, it would be ensured that the visitors feel the Norman influence more and at the same time they are not separated from the nature. This aspect would also ecologically benefit the soil.

In addition, an ecosystem pond is added to the central section of the E side to render the ecological balance sustainable and this pond was enriched with hydrophytic plants.

Figure 50. Piazza Marconi-Proposed view sketch of E side (Demirci,Didem, 09.11.2017)

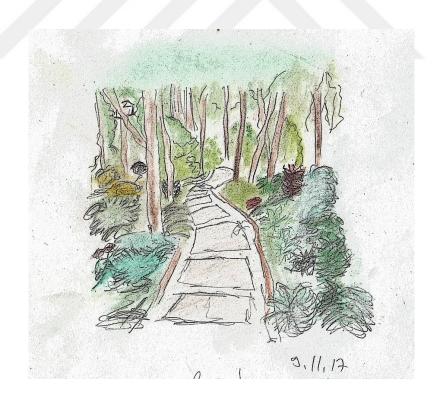
Figure 52.1.Piazza Marconi-Proposed view Monadic Flagstone Path in B Side to C side in E side, East part sketch (Demirci,Didem, 09.11.2017)

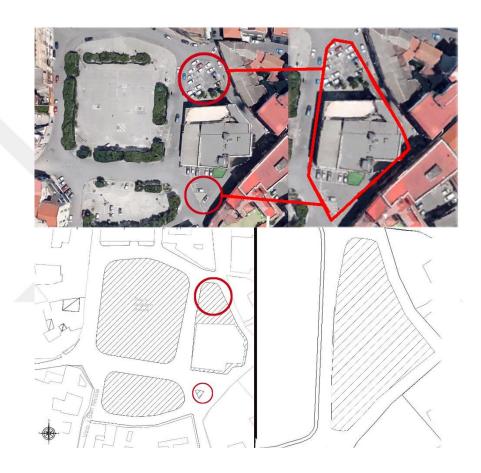
Figure 53.Piazza Marconi proposed parking area

portion of the southern section of the C side is taken and combined with the central area and the F side is rendered parallel to the E side. In this way, the main road has taken a regular form and regained its standard dimensions.

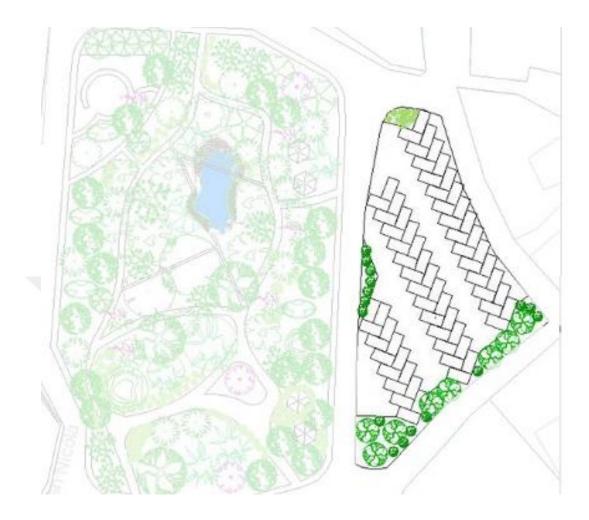
Figure 54. Afforestation of car park

The anticipated parking area is designed in accordance with the contraflow course of the vehicles. Thus the vehicle circulation is regulated too. The parking area plan is presented in Figure 53. In addition, the section is planted with trees and shrubs, resistant to parking area conditions and vandalism, such as *Corylus colurna and Lavandula angustifolia*.(Figure 54).

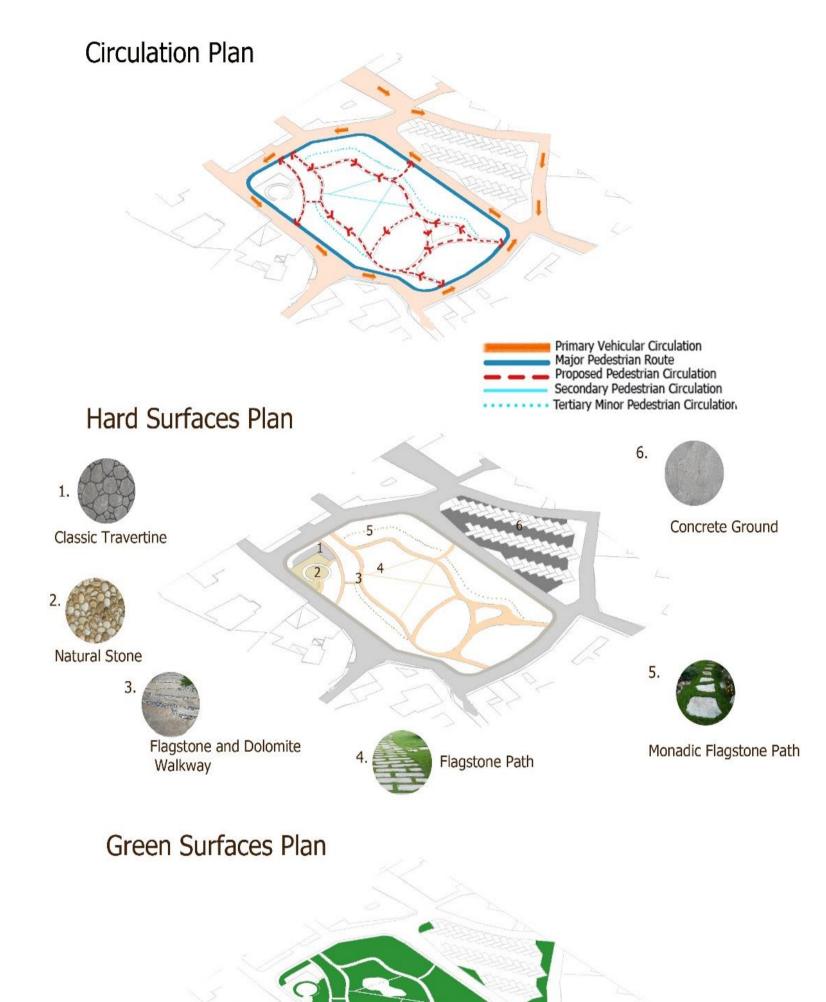
The circulation plan, hard surface plan and green surface plan inclusive of the whole project are presented in Figure 55.

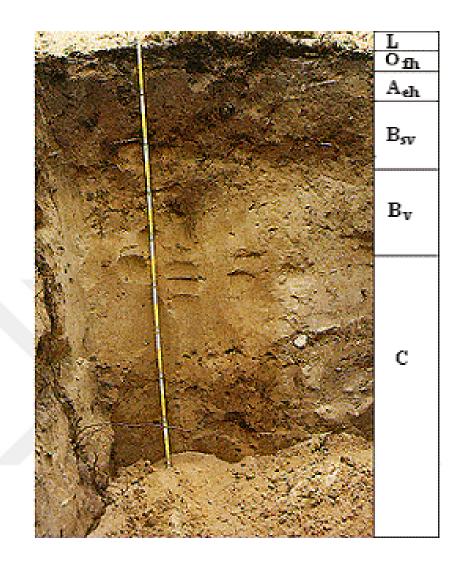
Figure 56. Cambisol profile (url20)

Morphological characteristics of the `typical' Cambisol profile has an ABC horizon sequence with an ochric, mollic or umbric A-horizon over a cambic B-horizon that has normally a yellowish-brown colour but that may also be an intense red. Cambisols in poorly drained terrain positions may show `redoximorphic' features. (Figure 56)The soil texture is loamy to clayey. Signs of beginning clay illuviation may be detectable in the cambic horizon but the clay content is normally (still) highest in the A-horizon.(FAO, 2006)

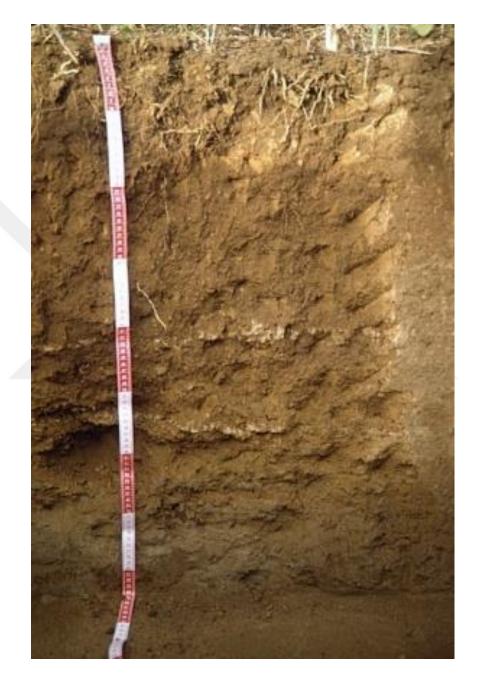
Figure 57. Andosol profile (url 21)

Morphological characteristics of the `typical' Andosol has an AC or ABC profile with a dark Ah-horizon, 20 to 50 cm thick (thinner or thicker occurs) on top of a brown Bor C-horizon. Topsoil and subsoil colours are distinctly different; colours are generally darker in humid, cool regions than in tropical climates. The average organic matter content of the surface horizon is about 8 percent but the darkest profiles may contain as much as 30 percent organic matter. The surface horizon is very porous, very friable, and has a crumb or granular structure. In some Andosols, the surface soil material is smeary and feels greasy or unctuous; it may become almost liquid when rubbed, presumably because of sol-gel transformations under pressure (`thixotropy'). Andosol soil profile is showing on Figure 57.

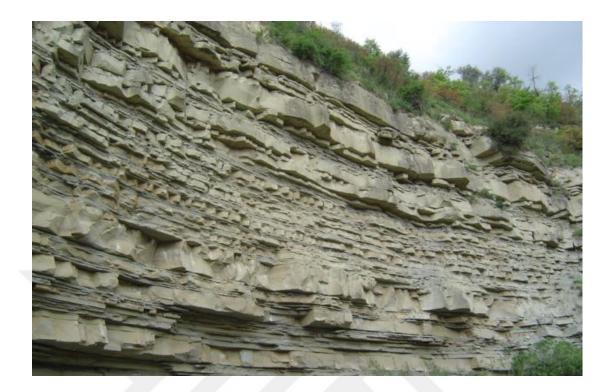
Figure 58. Spetacular turbidite outcrop. (Gorgoglione Flysch, Miocene, South Italy,2004) (url23)

The volcanic rock elements present in the project area generally forms compact masses. These cannot be separated throughout cracks and discontinuities. Their joints are short (between 5 and 80 cm), frequent (more than 10 per meter), wavy, moderately textured, gerenally linerless and tightly sealed. After a thin weathering close to the surface, the joints are spread up to 1 mm and argillisation is observed. (Figure 58)

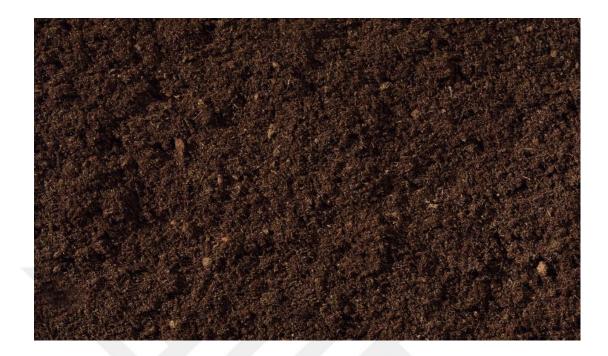
Figure 59. Composting (url24)

The compost would increase the functionality of the detoriated soil and it would become self productive. Compost contains elements with high enrichment factors such as carbon (C), Nitrogen (N), Sulphur (S) and low enrichment factors such as Sodium (Na), Magnesium (Mg), Aluminium (Al), Potassium (K), Chlorine (Cl), Calcium (Ca), Manganese (Mn) and Iron (Fe). These latter elements are minerals important for plant growth _(Figure 60). In addition to the Nitrogen (N) that has enrichment factor 80, the highest in the compost, the next benefical element is Carbon (C) with 52 factors._(Figure59)

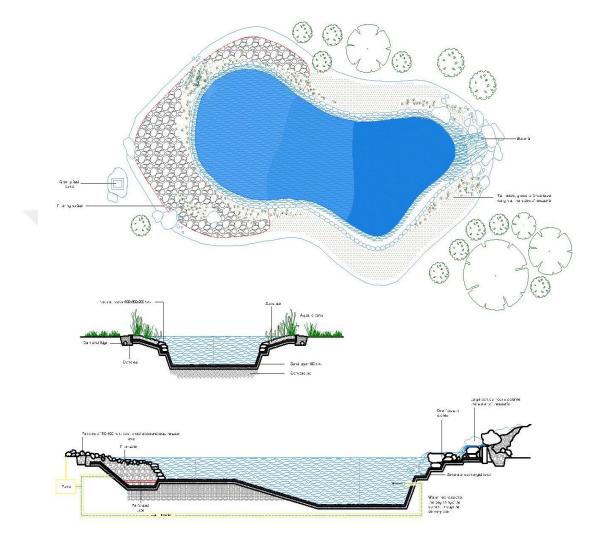
Figure 60. Ecosystem Pond Detail Sheet

Carex sp., Typha minima, and Iris sp. are chosen as hydrophytic plants since they would provide colour and texture, in addition to their natural filtering features. They are of great importance with regard to the health of the whole ecosystem.
