**CONSERVATION PROBLEMS OF HISTORIC
WALL PAINTINGS OF TAXIARHIS CHURCH
IN CUNDA, AYVALIK**

**A Thesis Submitted to
the Graduate School of Engineering and Sciences of
İzmir Institute of Technology
in Partial Fulfillment of the Requirements for the Degree of**

In Architectural Restoration

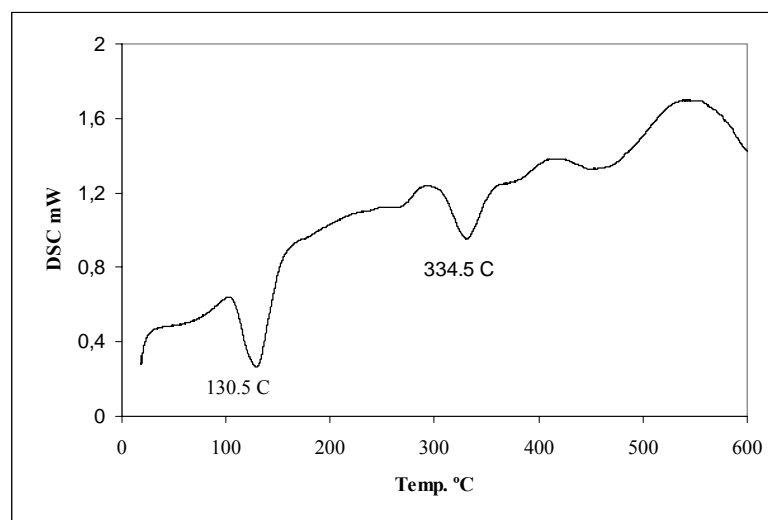
Figure 5.14. DSC graph of binding media used in the second period paintings (NN.Br)

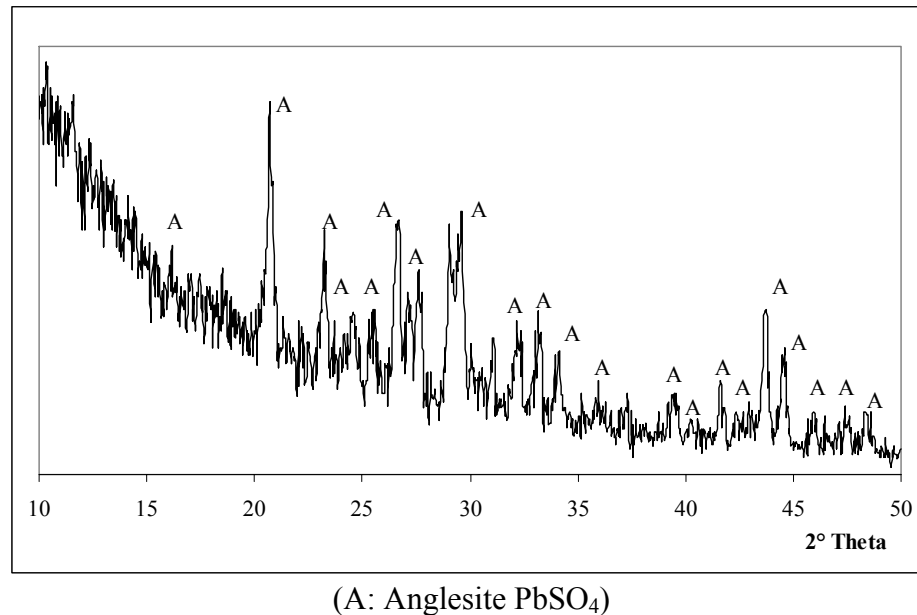
In the mineralogical analyses of the all paint layers by XRD, anglesite (PbSO_4) was mainly observed in the XRD spectrum (Figures 5.25 and 5.26). Anglesite is known to be used as bleaching substances in oil paintings (Clark 2002). Thus, anglesite may have been used in the making of priming layer of the paintings. Determination of Pb and S in the EDS analyses of the priming layer also supports such a finding.

Figure 5.25. XRD pattern of Blue/Green painted fine plaster from the first period, A.P₁.BI/G

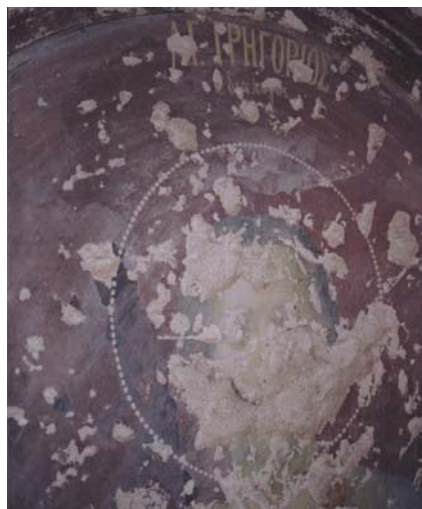
Figure 5.38. Loss of plaster and painting layer due to dampness in the painting no:4 on the main apse of the church
