**PROPERTIES OF ROMAN BRICKS AND MORTARS
USED IN SERAPIS TEMPLE
IN BERGAMA**

**A Thesis Submitted to
the Graduate School of Engineering and Sciences of
İzmir Institute of Technology
in Partial Fulfillment of the Requirements for the Degree of**

in Architectural Restoration

**by
Özlem ASLAN ÖZKAYA**

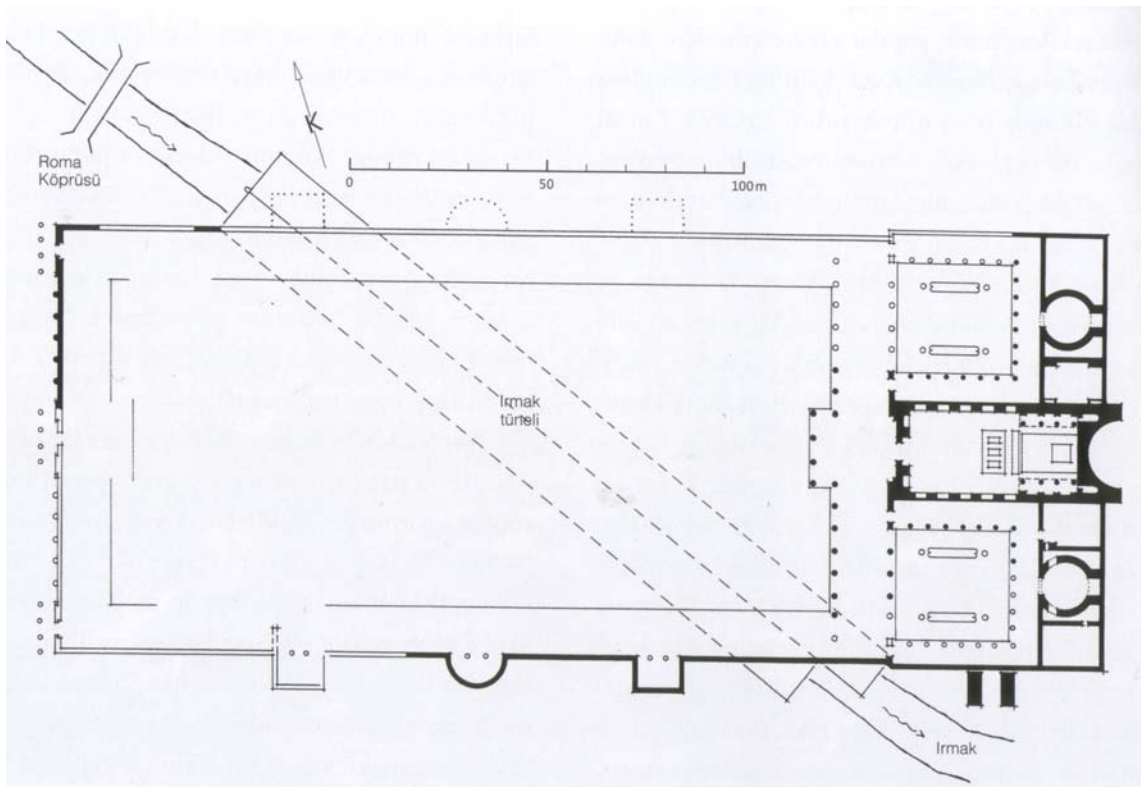
Figure 2. 9. Plan of the Serapis Temple complexes (Radt 2002)

The main structure had been built of red bricks; and that is why the structure was called The Red Courtyard. The diameter of the monumental round stone structures on both sides are 12 m. Between the main structure and the round, structures on both sides are small atriums surrounded by 9x15 meter-wall (Trappmann 1970). The dimensions of the square atriums in front of the round tower structures are nearly 40x40m., and a line of columns was standing on one side of those atriums. The other three sides of the atriums were surrounded by galleries (Radt 2002).

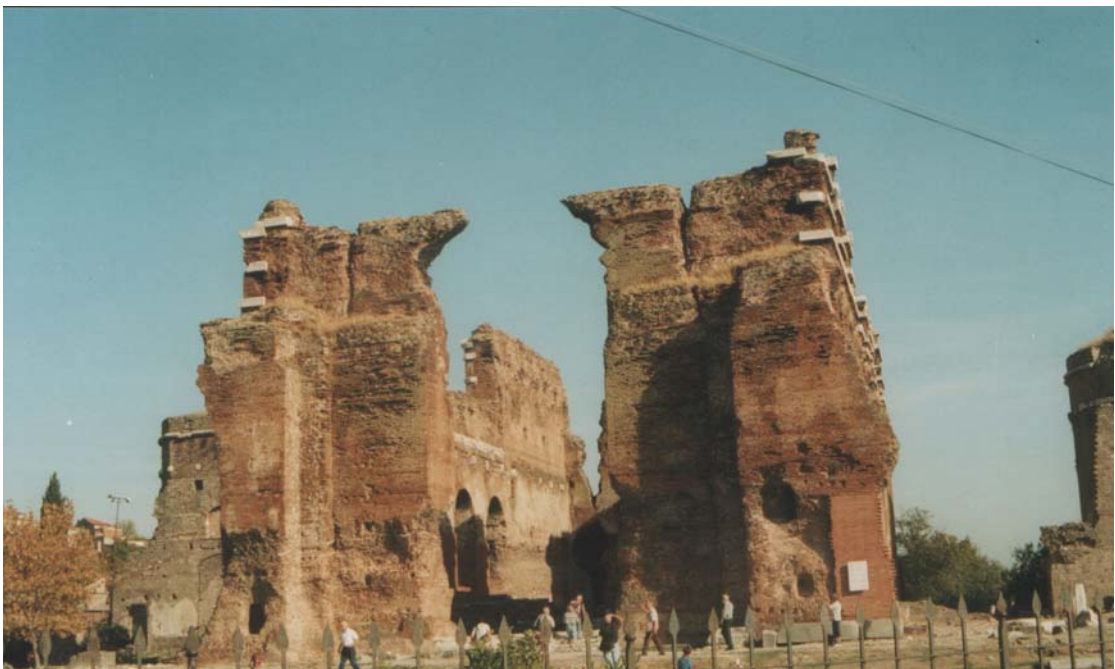
Figure 2. 10. A view of the north-west elevation of the entrance to the Serapis Temple (2004)

The entrance to the main temple was through the atrium at the north-west front of the structure. The width of the door was over 7m, and its height was 14 m (Figure 2.10). The door had been surrounded with heavy marble frames and there was a threshold over the door, which was made of a monolith marble weighing 70 tons and it is still sitting in its original place (Radt 2002).

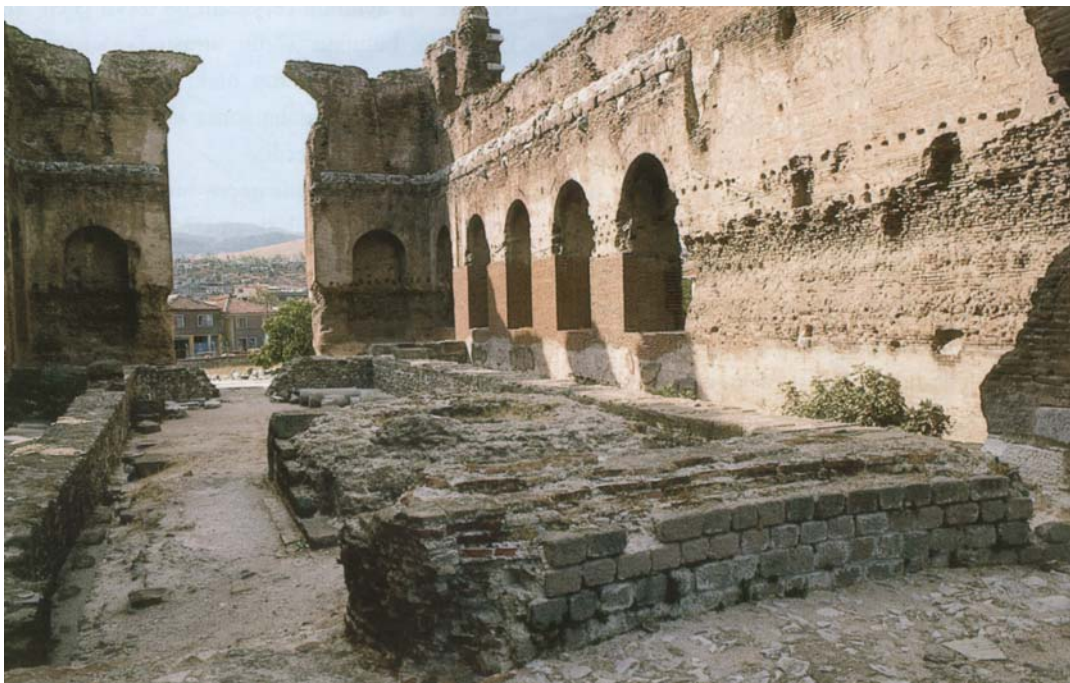
Figure 2. 12. Wall ruins belonging to early Byzantine period in the Serapis Temple.
(Radt 2002)

When The Serapis Temple had been converted to a church, two walls, which were as high as a human and made of Horasan mortar mixed with stone pieces, had been built from the front to the back, extending to the corners of the abscissa (Figure 2.12). The abscissa itself, which could be seen from the entrance of the church, and the marble surrounding it had been built inside the old temple. The walls dividing the huge ancient place into three sections formed the base for the two lines of columns in the church. The foundation walls of the church were much higher than the ancient ground of the Red Courtyard. On the long walls of the Red Courtyard, repeating in equal distances, marble pales under andesite bands, which had been badly damaged due to fire, were among the additional structures built for the church. These used to support the ground of a gallery as a console (Radt 2002).

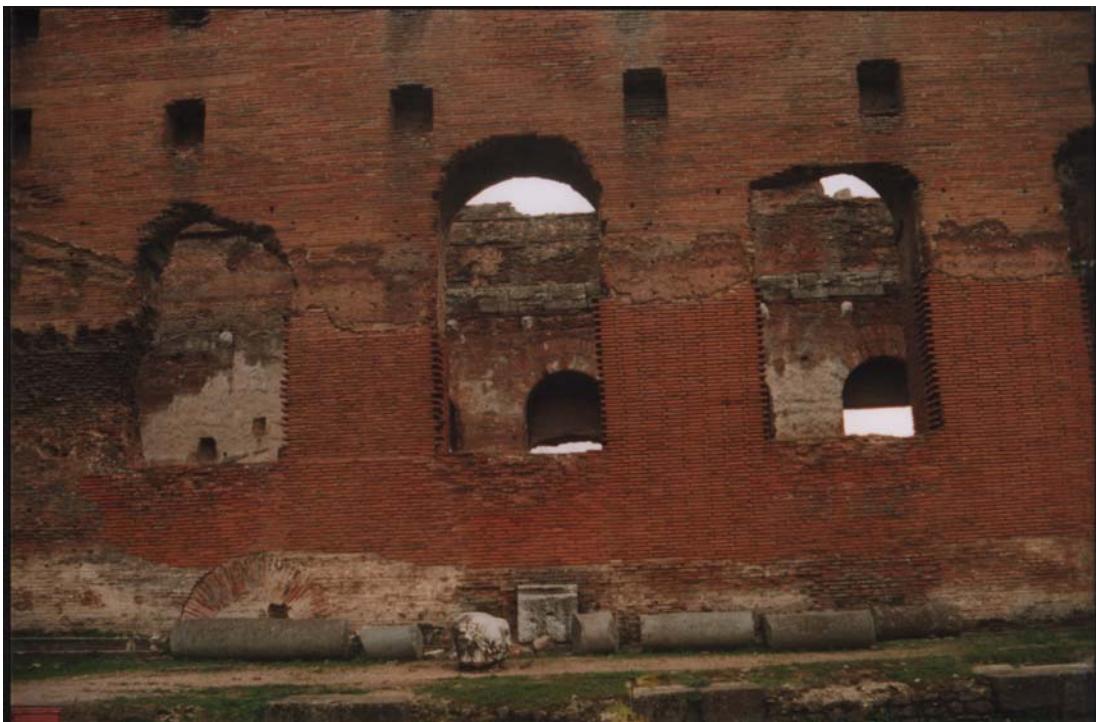
Figure 2. 13. A view of the north-east elevation of the restoration sections of the structure carried out in 1940s in the Serapis Temple (2004).

The Director of Museum Osman Bayatlı carried out the restoration works especially of the southwest and south sections of the Serapis Temple, which are in danger, in the 1940s. The construction of a preservation-based wall was done using baked-clay tiles, which were specially made for this work. These restoration works had been given full support by the Regional Governor Kazım Dirik at the time (Figure 2.13-2.14) (Radt 2002).

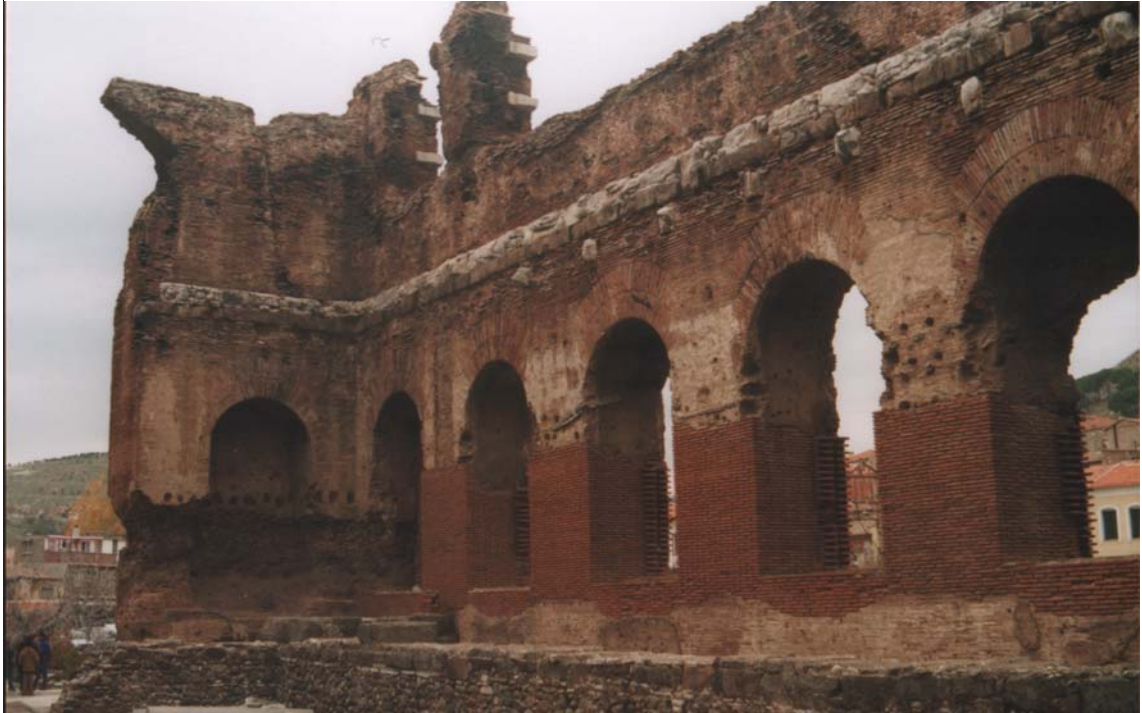
Figure 2. 14. An interior view of the restoration sections of the structure carried out in 1940s in the Serapis Temple (2004).

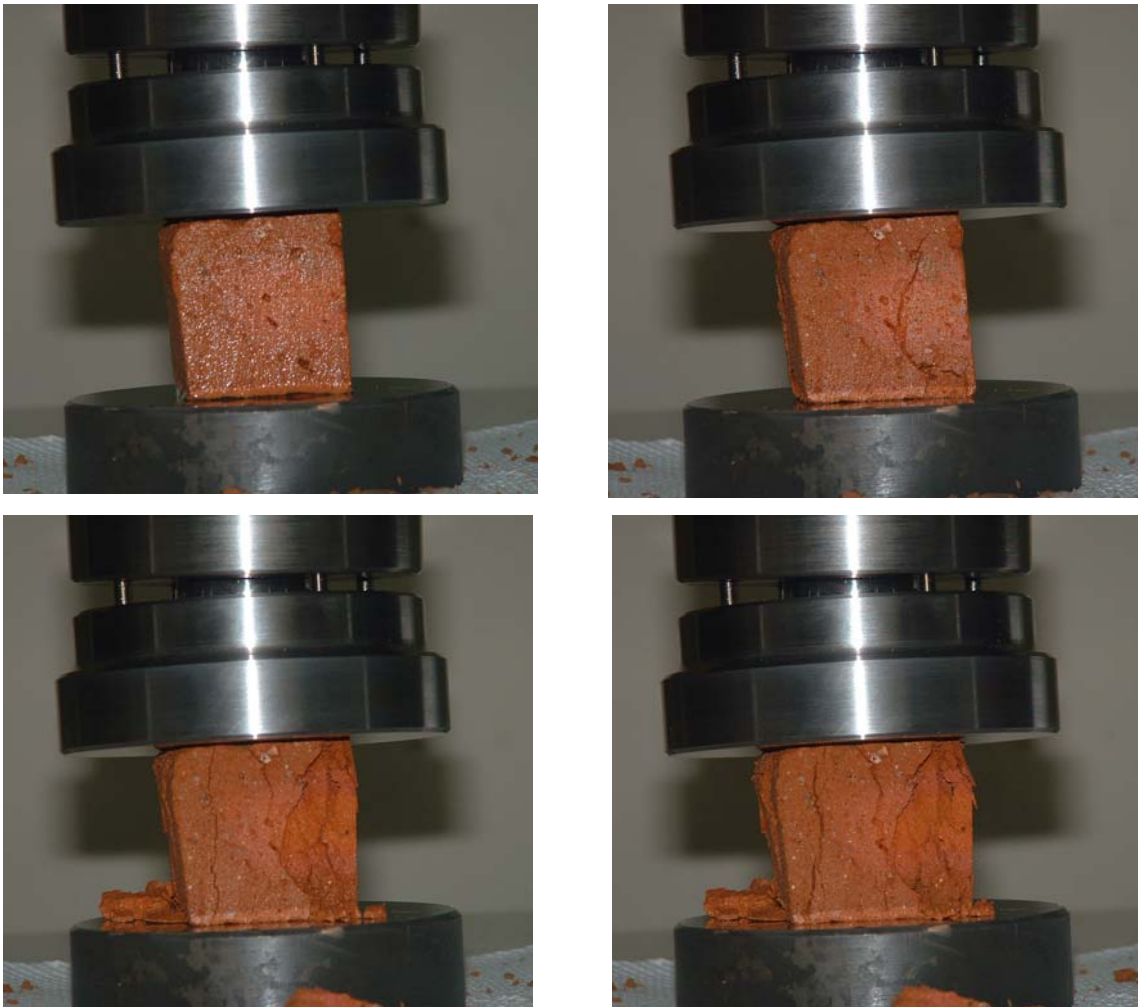
Figure 3. 25. Images showing how uniaxial compressive strength test was carried out.

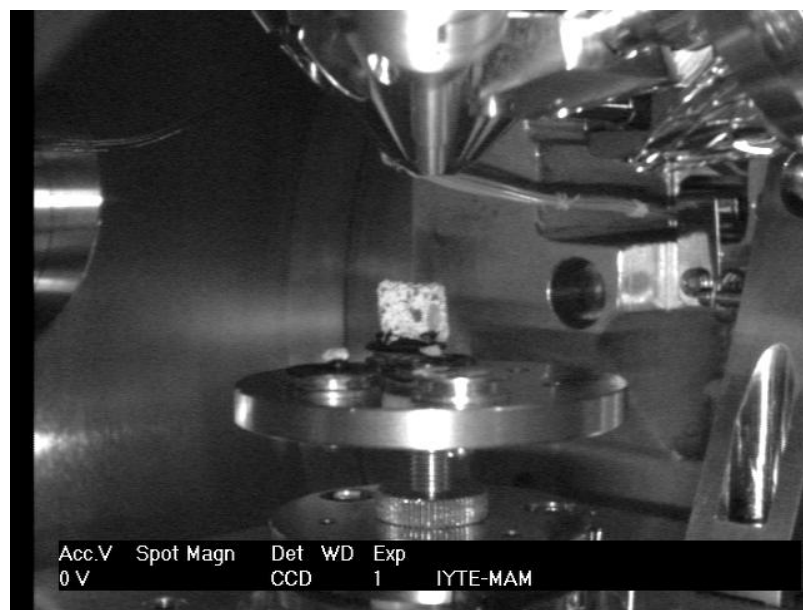
Figure 3. 26. Image of Philips XL 30S-FEG Scanning Electron Microscope

Chemical compositions and microstructural properties of brick and mortar matrices, lime binder and aggregates were determined by Philips XL 30S-FEG Scanning Electron Microscope (SEM) equipped with X-Ray Energy Dispersive System (EDS) (Figure 3.26). EDS analysis was performed on the lime binder, aggregates, brick and mortar matrices, which were ground to a fineness of less than 53 μ m and then pressed into pellets, in order to determine their chemical compositions.

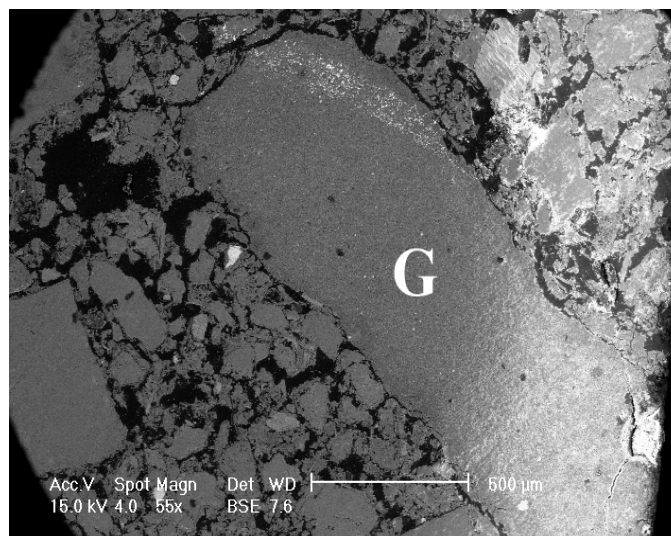
Figure 4. 1. BSE (back-scattered electron) image of a grog particle in the brick (G: Grog)

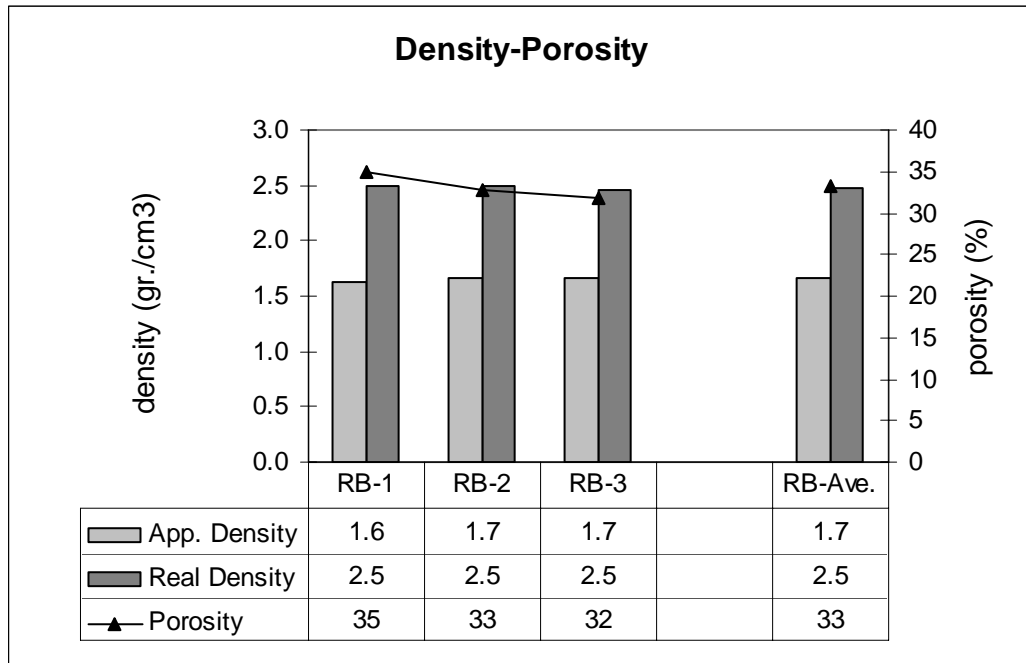
Figure 4. 2. % Porosity and density values of Roman bricks

The density and porosity values of Roman bricks used in the temple are in the same range with other Roman bricks used in historic structures in Toledo, Spain and Sicily (Lopez-Arce and Garcia-Guinea 2004, Cardiano et al. 2004).

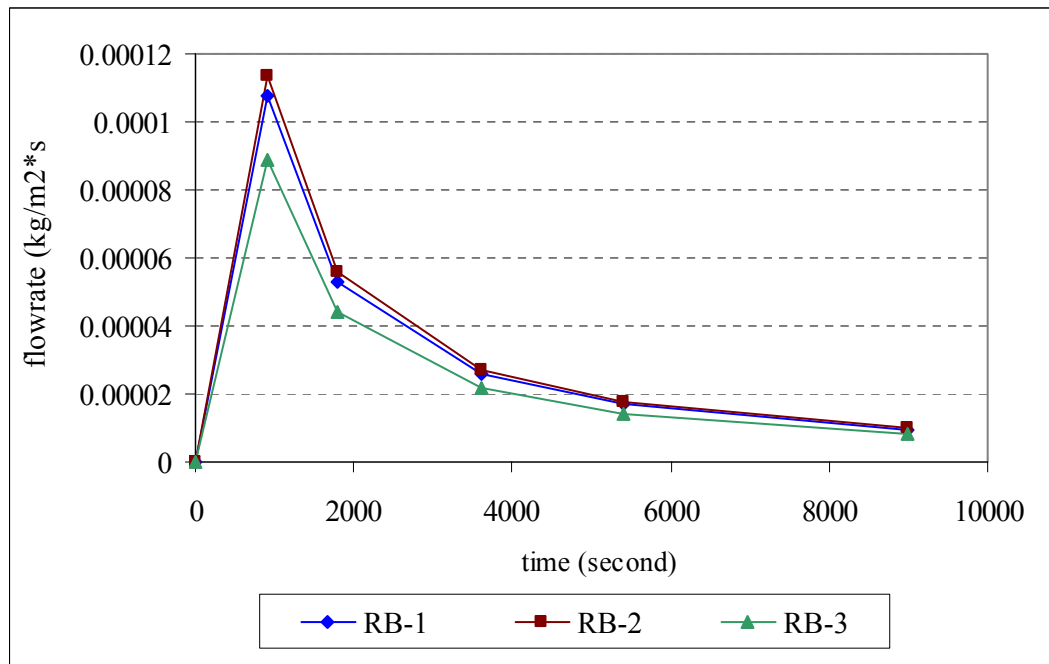
Figure 4. 3. Drying rates of the Roman bricks

within 15 minutes. This can show that the bricks have a high percent of large pore sizes in their total porosity.

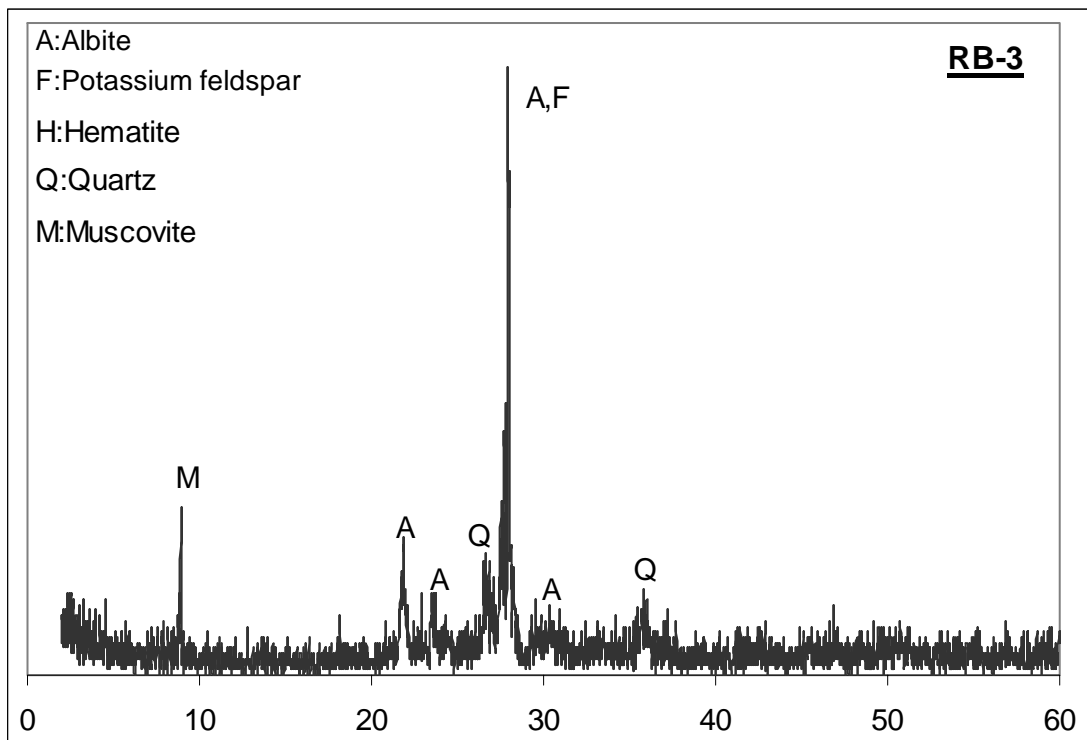
Figure 4. 6. XRD pattern of the Roman brick sample (RB-3)

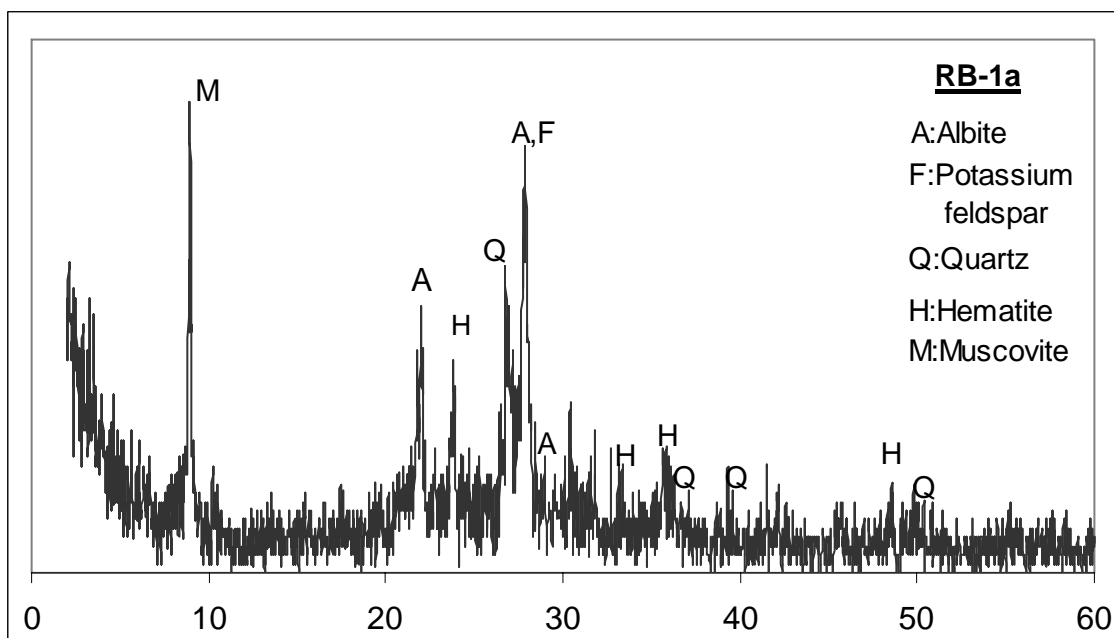
Figure 4. 7. XRD pattern of the heating at 900°C Roman brick sample of RB-1

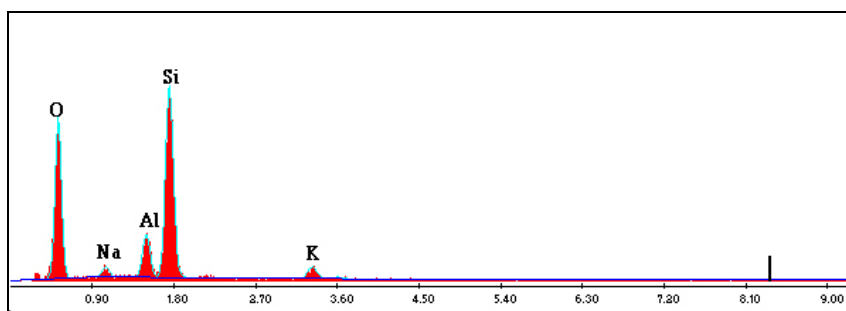
Figure 4. 10. BSE (back-scattered electron) images, EDX spectrums and elemental compositions (%) of a grog particle and brick matrices (RB-1).

Most of the grog pieces found in brick samples show similiary elemental composition with the brick matrix, but some of the pieces have different chemical compositions (Figure 4.9-4.10). This shows that grog particles were not always belonging to the original bricks.

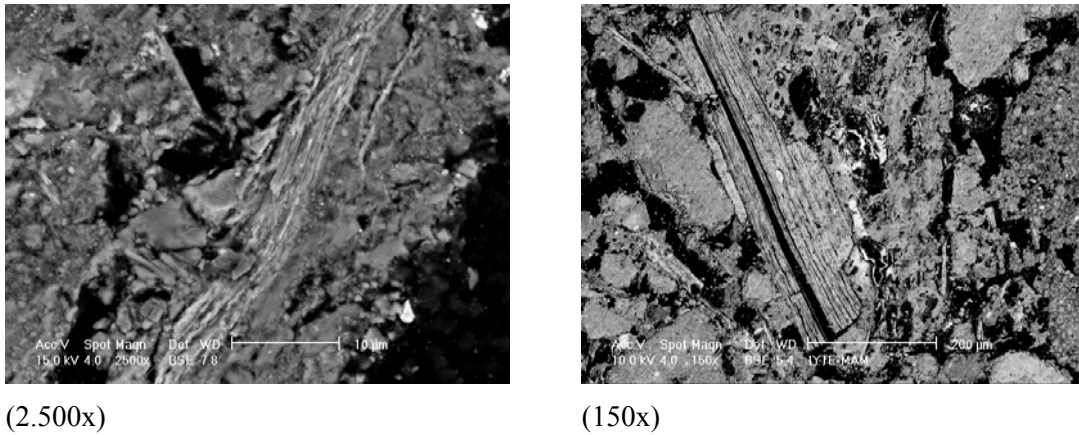
Figure 4. 11. BSE images of quartz and feldspar crystals in the Roman brick matrix (RB-1)

Quartz, feldspar and hematite are the main minerals found in the composition of the Roman brick (Figure 4.11). In these matrices, valuable metals such as platinum and copper have been observed in trace amount. These elements are found together with elements such as silicon and iron (Figure 4.12-4.19). This indicates that raw material used in the Roman brick manufacturing sources contain valuable metals.

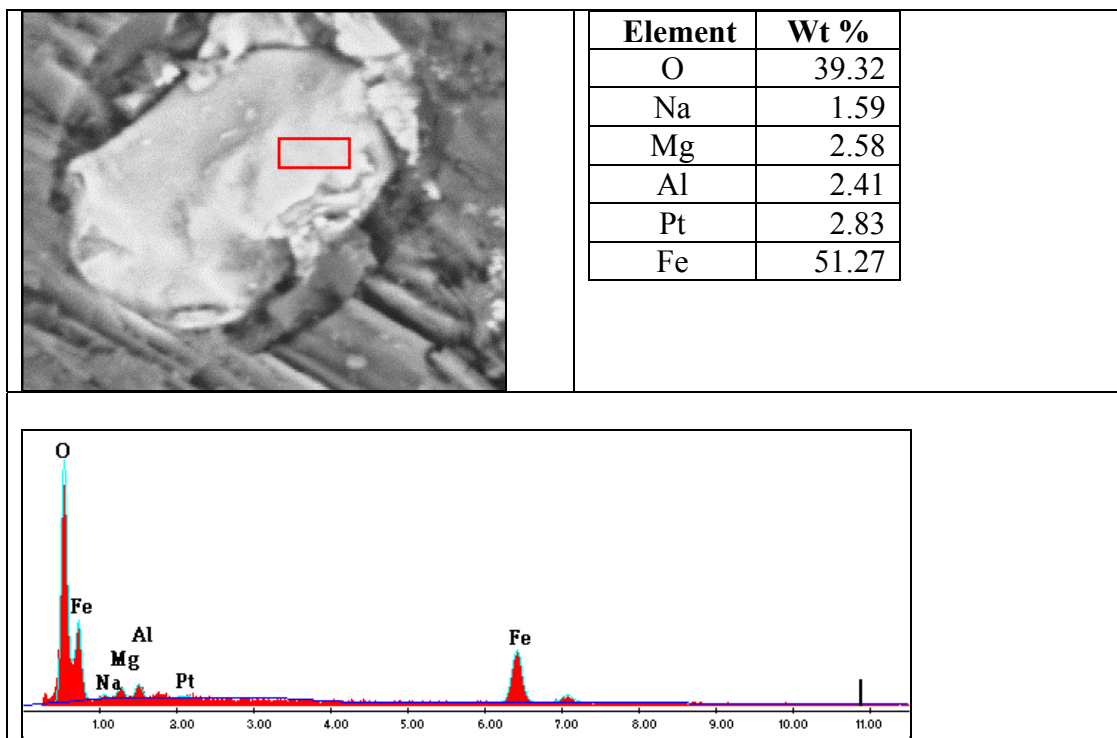
Figure 4. 12. EDX spectrum of iron and platinum containing particle in the brick matrices (RB-1)

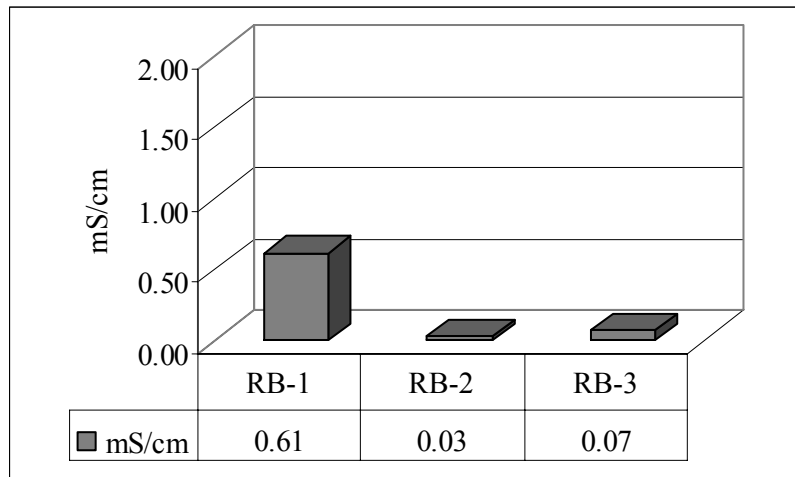
Figure 4. 20. Pozzolanic Activity values of Roman bricks.

In the Roman bricks used in the construction of Serapis Temple, the values found were lower than that, which shows that these bricks did not have good pozzolanic properties (Figure 4.20). This may indicate that the raw materials containing clay minerals were not enough to produce high amounts of pozzolanic amorphous substances. Similar results were also observed in the bricks used in some historic structures (Baronia and Binda 1997).

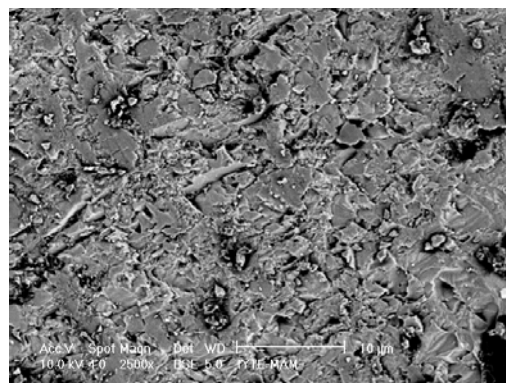
Figure 4. 21. BSE image of general texture of the intervention brick matrix (IB-4)

The intervention bricks have light brown color and fine textured matrix with some small grog particles (Figure 4.21).

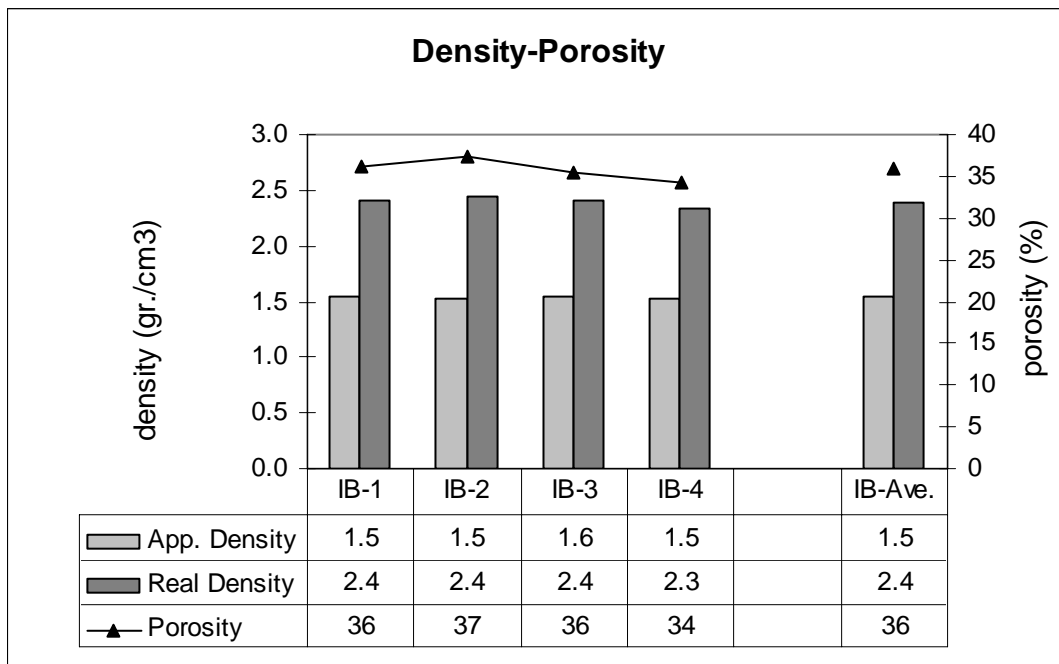
Figure 4. 22. % Porosity and density values of intervention bricks

The porosity and density values of intervention bricks and original bricks found were nearly the same. The porosity values of intervention bricks ranged between 34 - 37 %, and the average value was 36 %. The apparent density values of intervention bricks varied between 1.5 - 1.6 gr/cm³, and the average value was 1.5 gr/cm³. The real density values of intervention bricks varied between 2.3 - 2.4 gr/cm³ and the average value was 2.4 gr/cm³ (Figure 4.22).

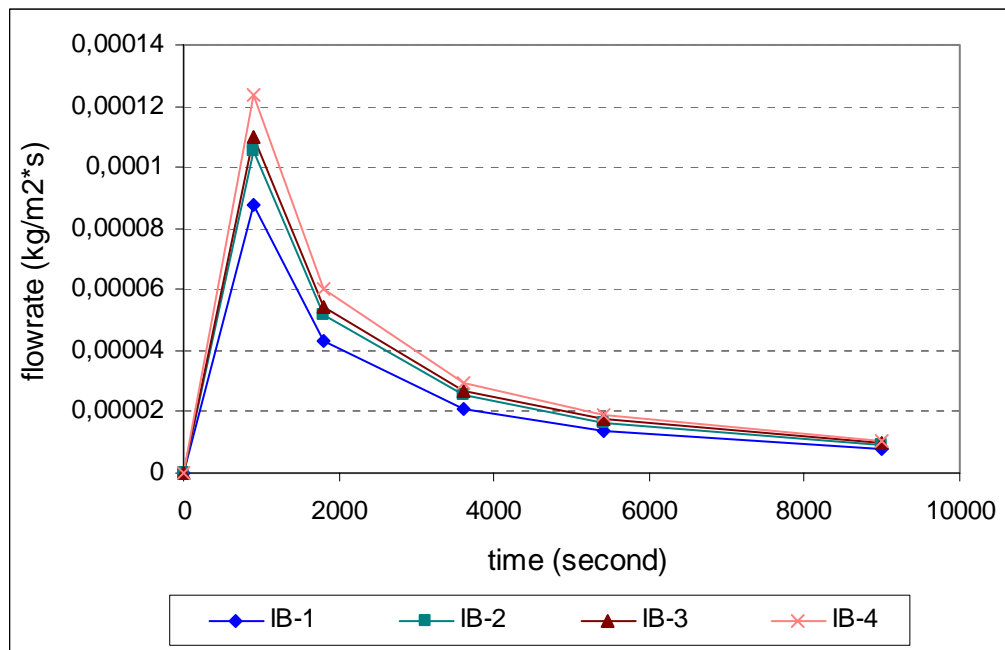
Figure 4. 23. Drying rates of the intervention bricks

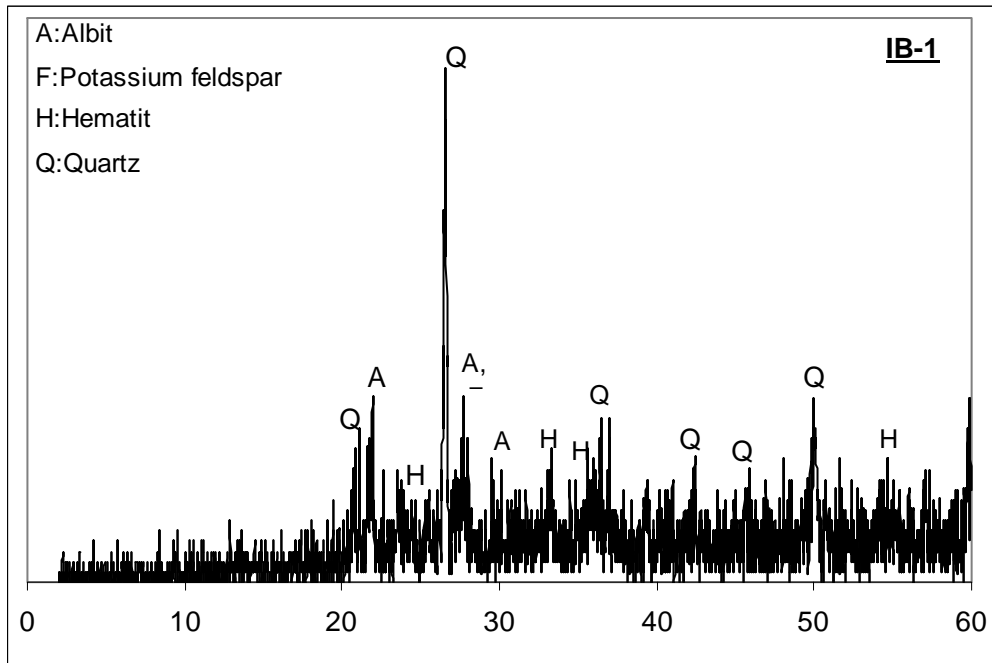
Figure 4. 24. XRD pattern of the intervention brick sample of IB-1

Roman ones. Presence of hematite peaks in the XRD spectrum shows that their baking temperature was over 850 °C. These results show that original Roman and intervention bricks had been baked at approximately the same temperatures.

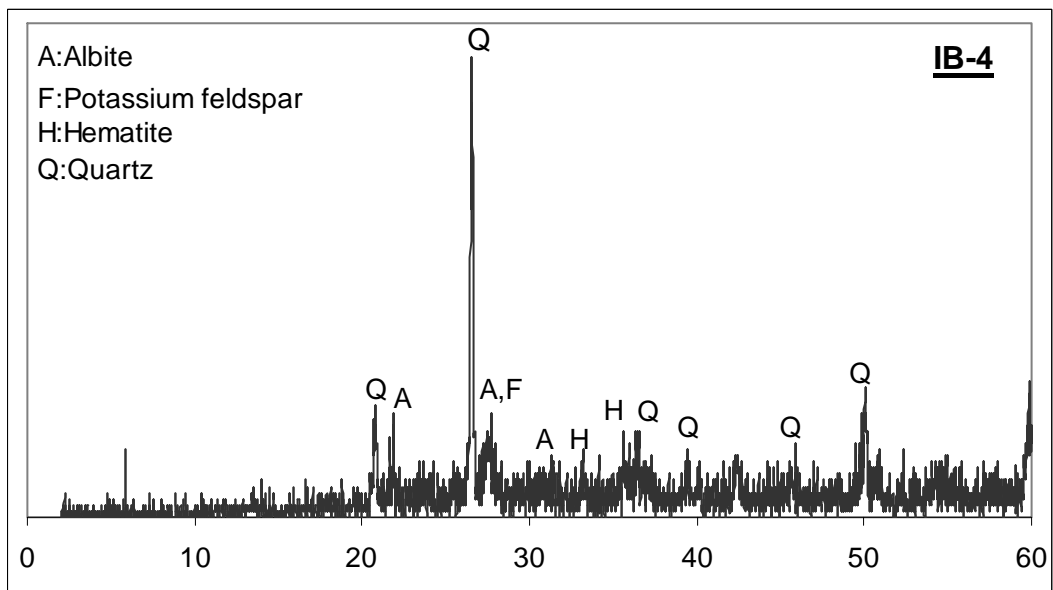
Figure 4. 27. XRD pattern of the intervention brick sample of IB-4

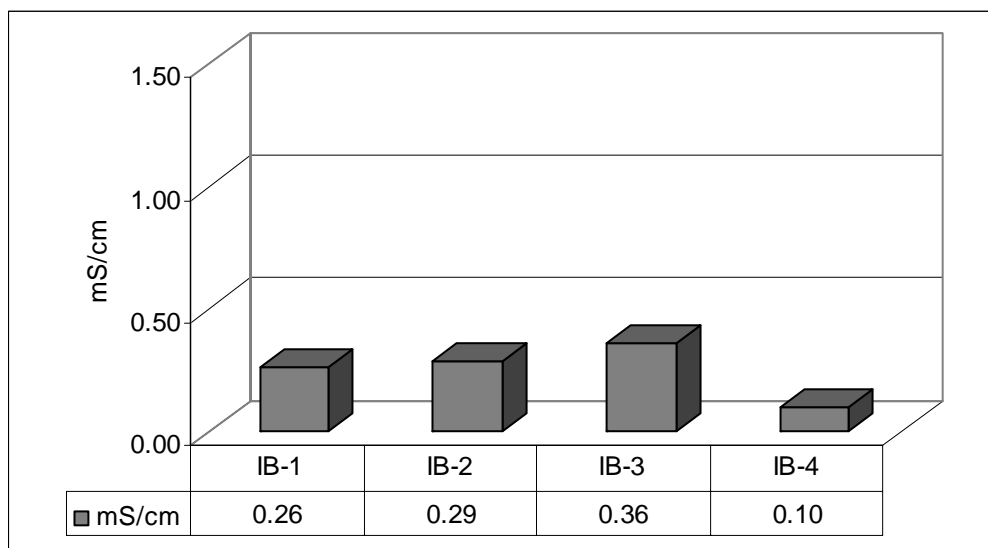
Figure 4. 31. Pozzolanic Activity values of intervention bricks

The pozzolanic properties of the intervention bricks have been identified by the method used in Roman Period bricks, and it was found that the intervention bricks, just like Roman Period bricks, had low pozzolanic activity values (Figure 4.31).

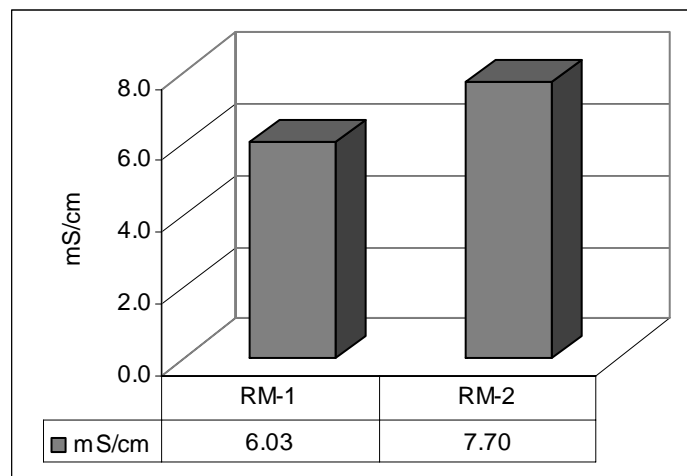
Figure 4. 36. Pozzolanic Activity measurements of fine aggregates of Roman mortars (less than 53 μm).

Pozzolonic activities of the fine aggregates used in Roman mortars were found to be about 7 mS/cm (Figure 4.36). This show that the aggregates can be considered very good pozzolan which acquires a hydraulic character of the mortar.

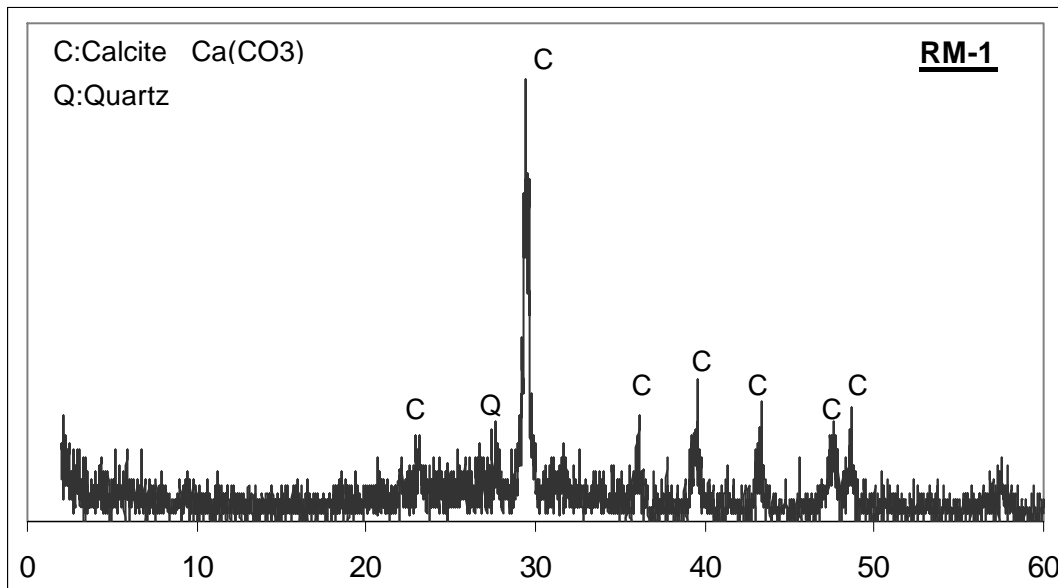
Figure 4. 37. XRD patterns of the Roman mortar matrices

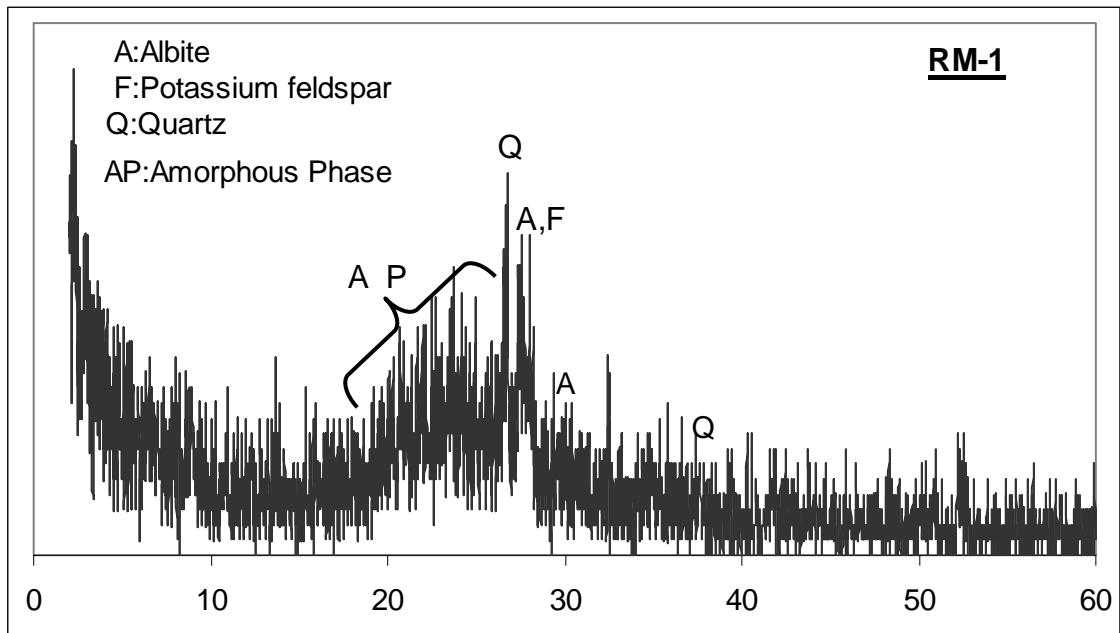
Figure 4. 39. XRD pattern of the fine aggregates used in Roman mortar

XRD patterns of fine aggregates used in the Roman mortars showed that they were composed of albite, K-feldspar and quartz. In their XRD patterns, a diffuse band between 20-30 degrees was observed. This band showed the presence of pozzolanic amorphous silica confirmed by pozzolanicity test is the natural pozzolanic materials which give hydraulic character of the lime mortars (Figure 4.39).

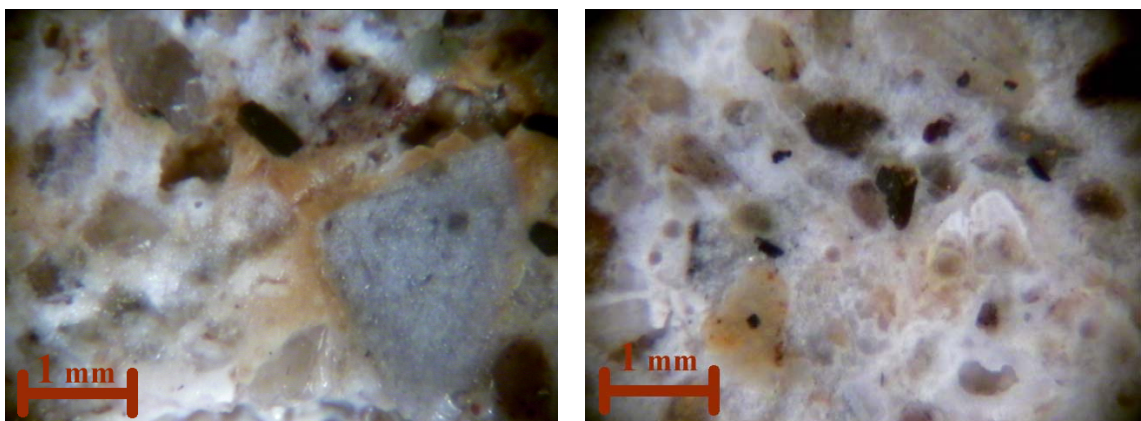
Figure 4. 40. Stereo microscope images showing good adhesion between aggregates and lime (RM-1).

Roman mortars have a stiff and compact appearance. The cohesion between aggregates and lime is strong. Lime-aggregate interface is generally free from fissures and cracks (Figure 4.40-4.41).

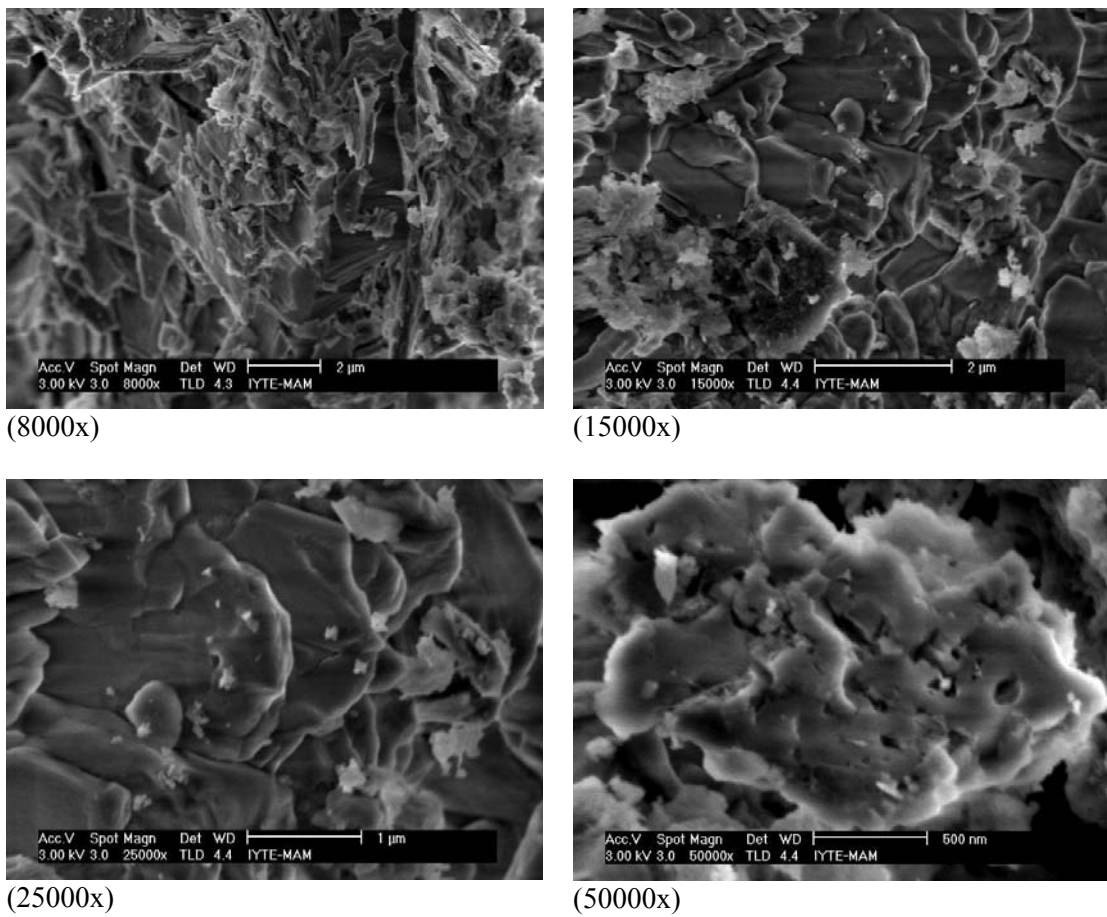
Figure 4. 44. SE (secondary electron) images of glassy phases in the amorphous pozzolanic aggregates (RM-1)

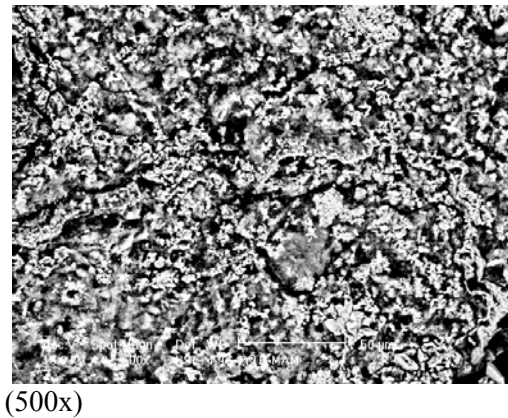
Figure 4. 46. BSE image of the mortar matrices with fine aggregates (RM-1)

Microstructural characteristics of mortar matrices with fine aggregates were determined by SEM analysis. The mortar matrices exhibit uniform structure with their fine pores. The fine pores occupied about 30 % of the whole matrices determined by phase analysis by SEM (Figure 4.46). The uniform matrices may show the well mixing process of lime with fine aggregates.

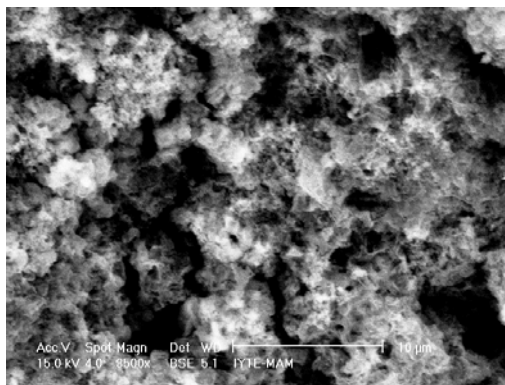
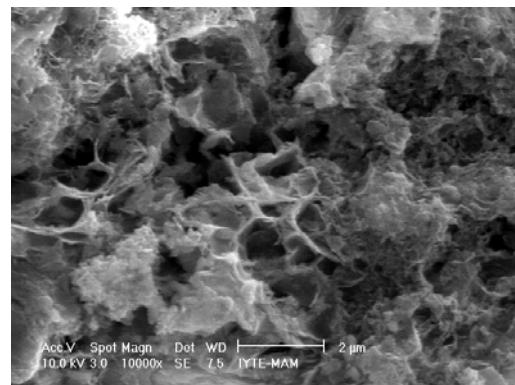
Figure 4. 47. BSE and SE images of calcium aluminum silicate hydrate crystals in Roman mortar (RM-1)

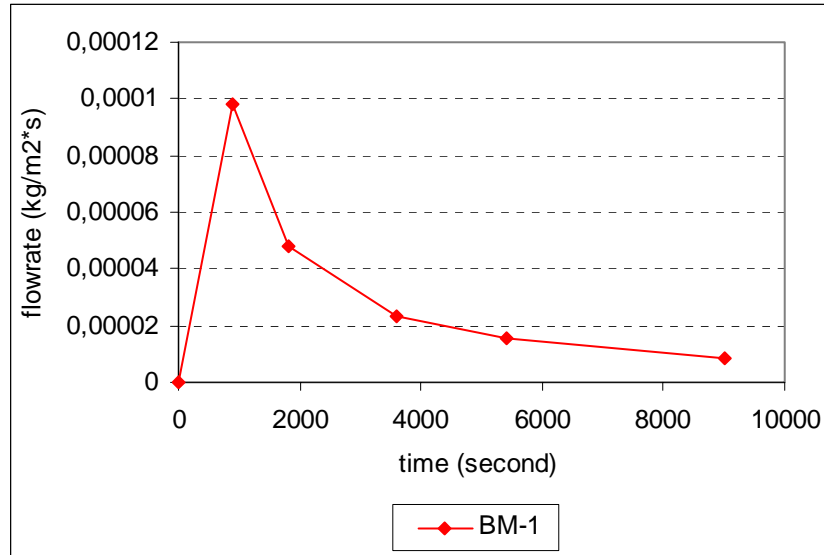
Figure 4. 51. Drying rates of the Byzantine mortars by weight loss versus time and surface area.

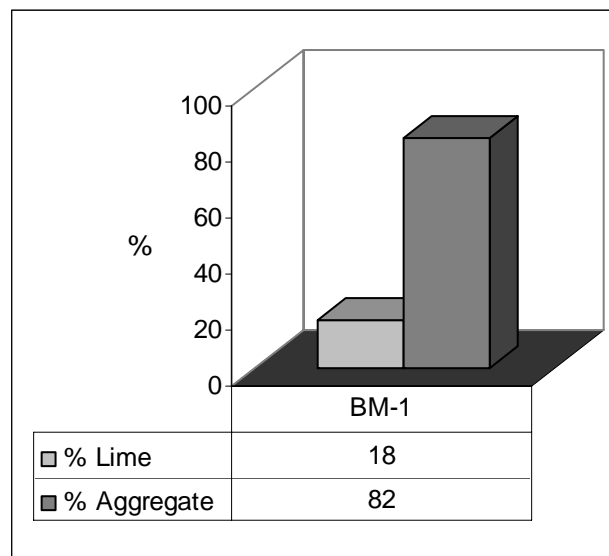
Figure 4. 52. Lime-Aggregate ratios of Byzantine mortars

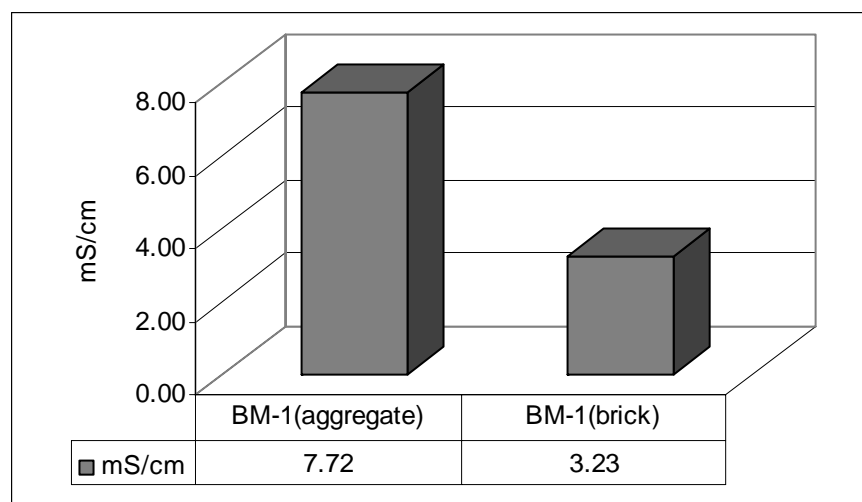
Figure 4. 54. Pozzolanic Activity measurements of fine aggregates and brick aggregates used in Byzantine mortars (less than 53 μm).

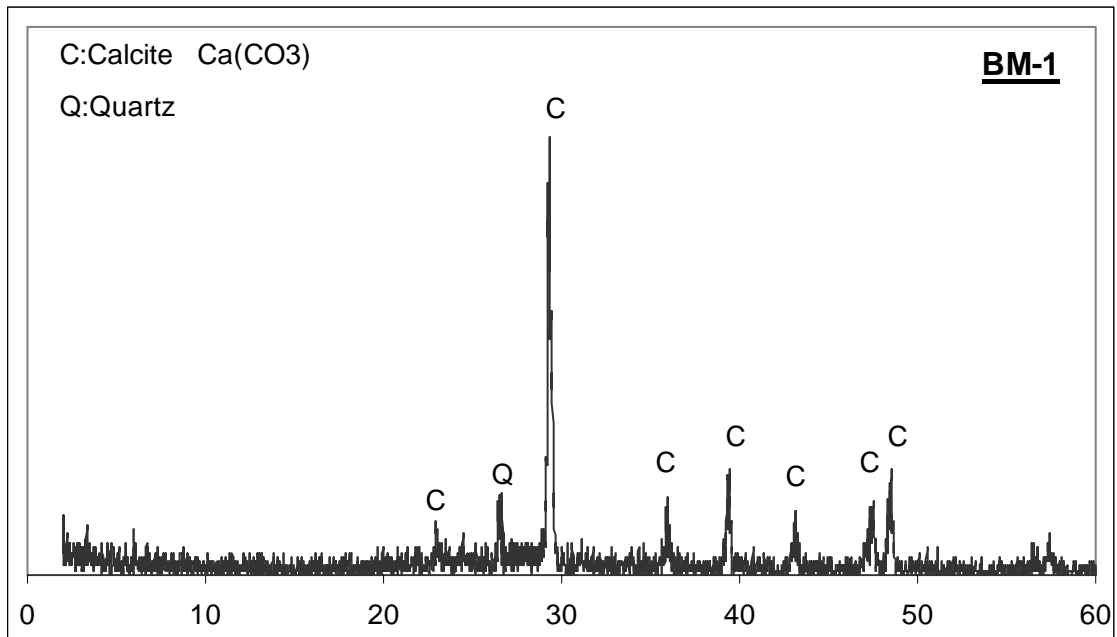
Figure 4. 55. XRD pattern of the Byzantine mortar matrices
