**PROPERTIES OF ROMAN BRICKS AND MORTARS
USED IN SERAPIS TEMPLE
IN BERGAMA**

**A Thesis Submitted to
the Graduate School of Engineering and Sciences of
İzmir Institute of Technology
in Partial Fulfillment of the Requirements for the Degree of**

in Architectural Restoration

**by
Özlem ASLAN ÖZKAYA**

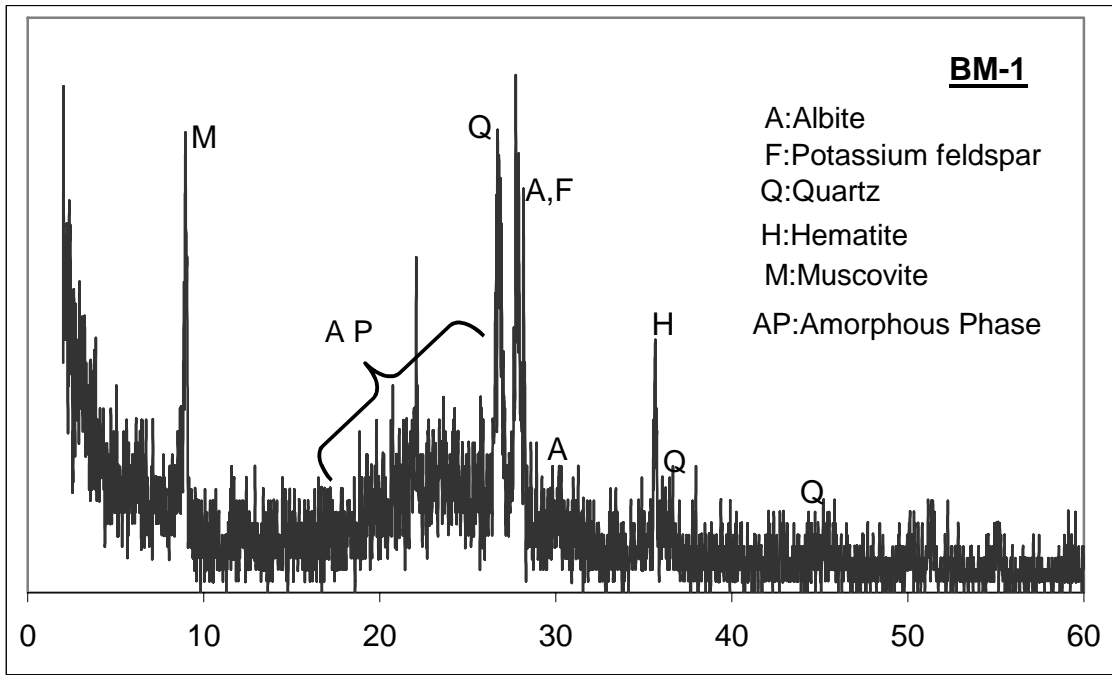
Figure 4. 56. XRD pattern of the fine aggregates used in Byzantine mortar

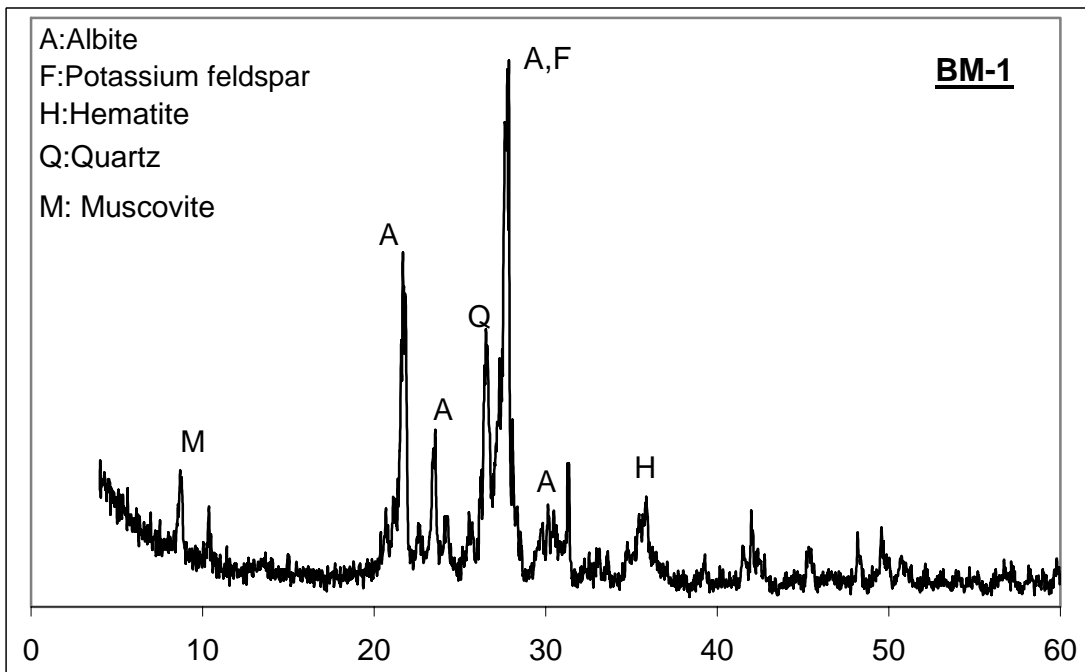
Figure 4. 57. XRD pattern of the brick aggregates used in Byzantine mortar

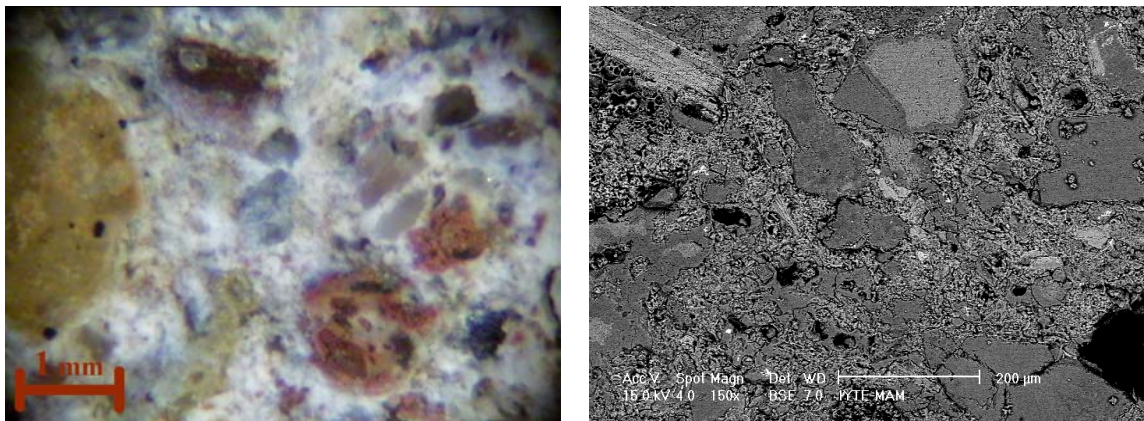
Figure 4. 58. Stereo microscope and BSE image showing good adhesion between aggregates and lime in Byzantine mortar matrix (BM-1).

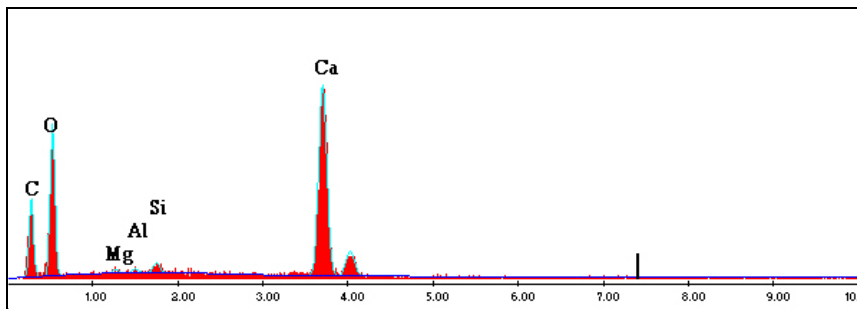
Figure 4. 63. SE images of sparry calcite crystals (~10 µm) and their EDS analysis in the white lumps observed in the Byzantine mortar sample.

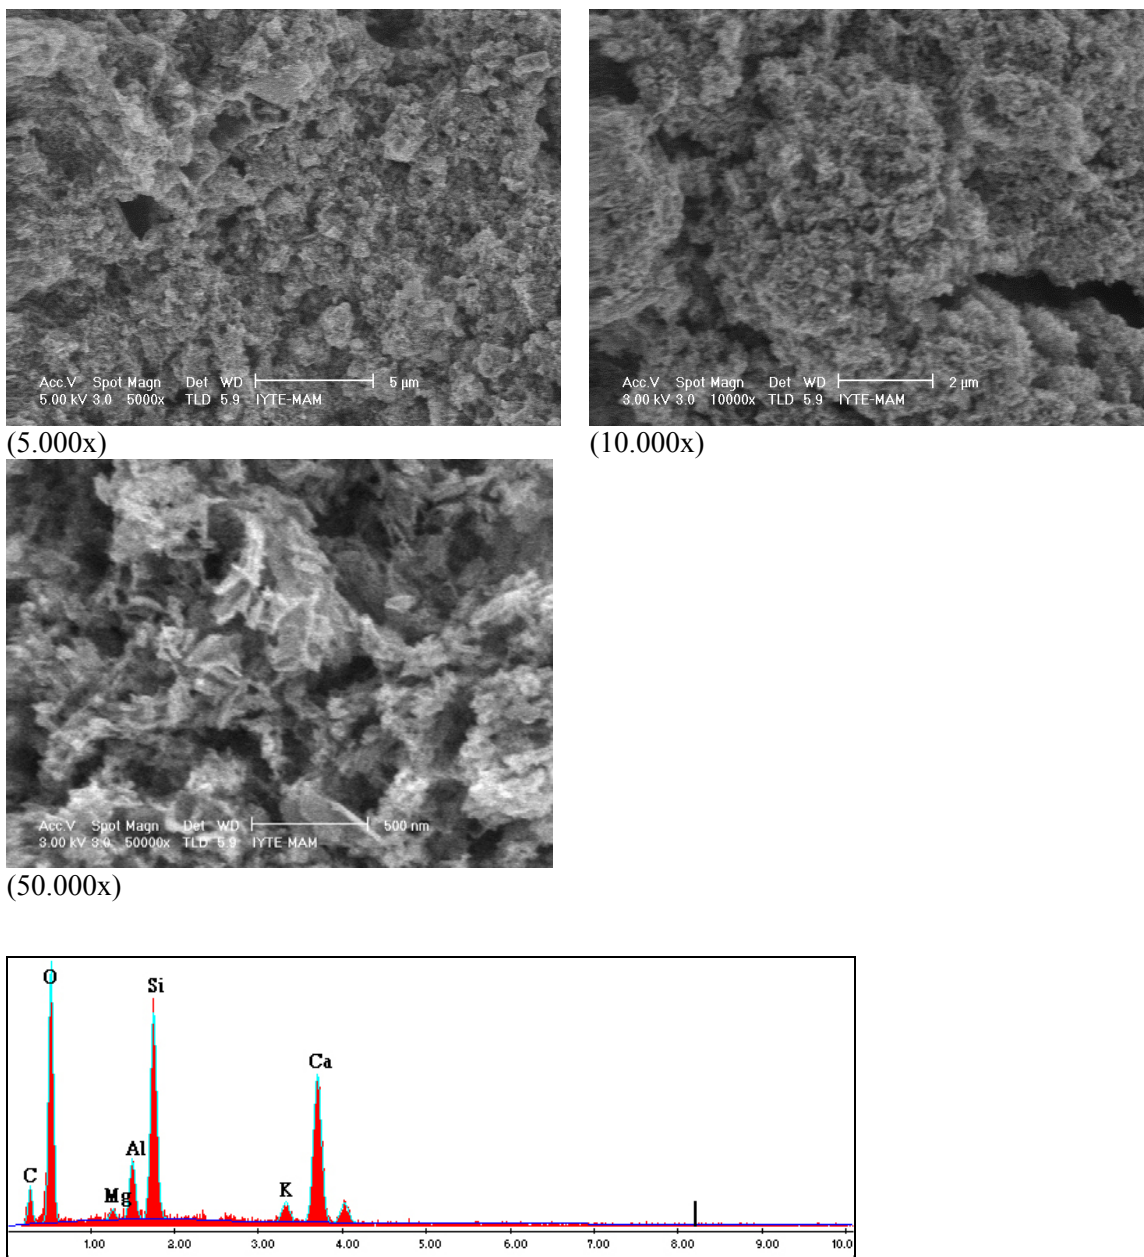
Figure 4. 64. SE images of CSH formation and their EDS spectrum in the Byzantine mortar sample.

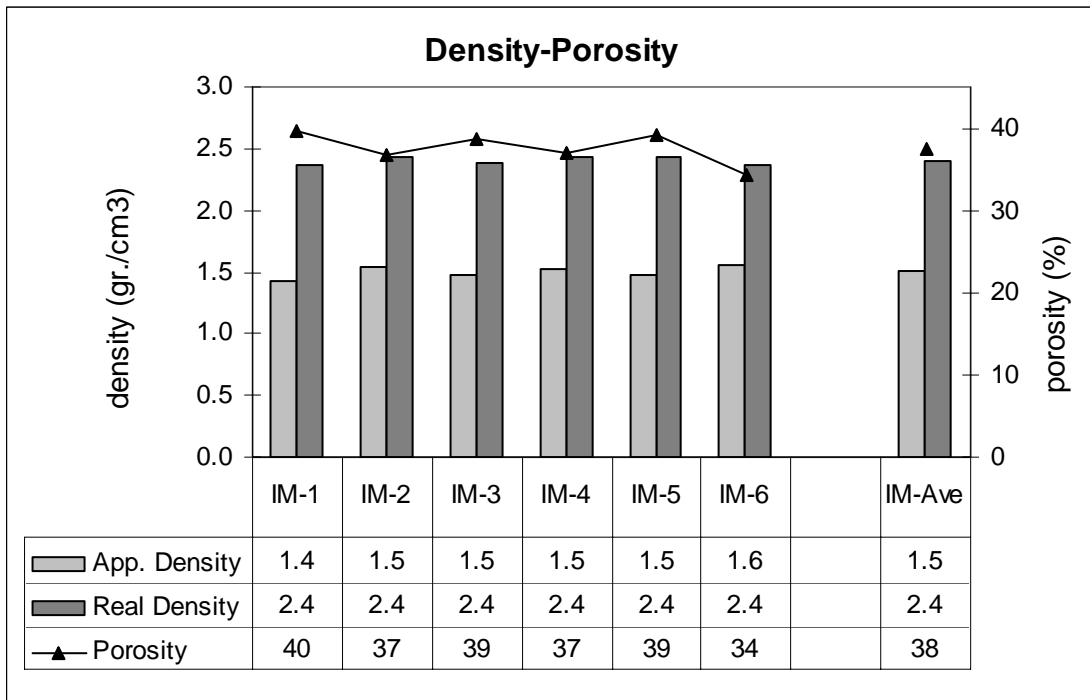
Figure 4. 66. Porosity and density value of intervention mortars

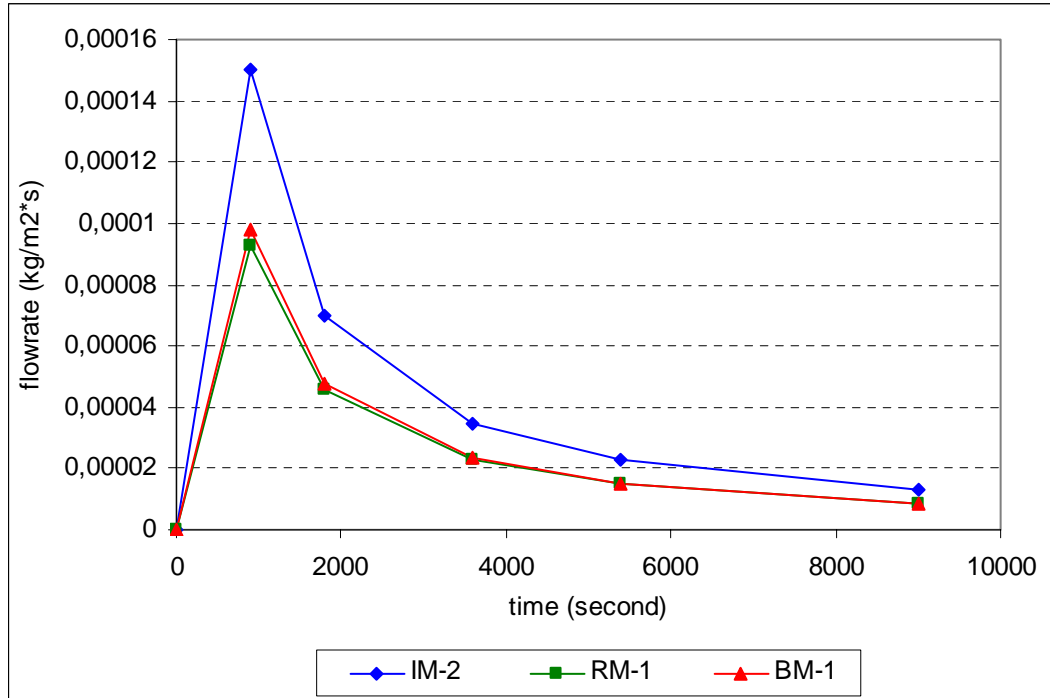
Figure 4. 67. Drying rates of the mortars by weight loss versus time and surface area

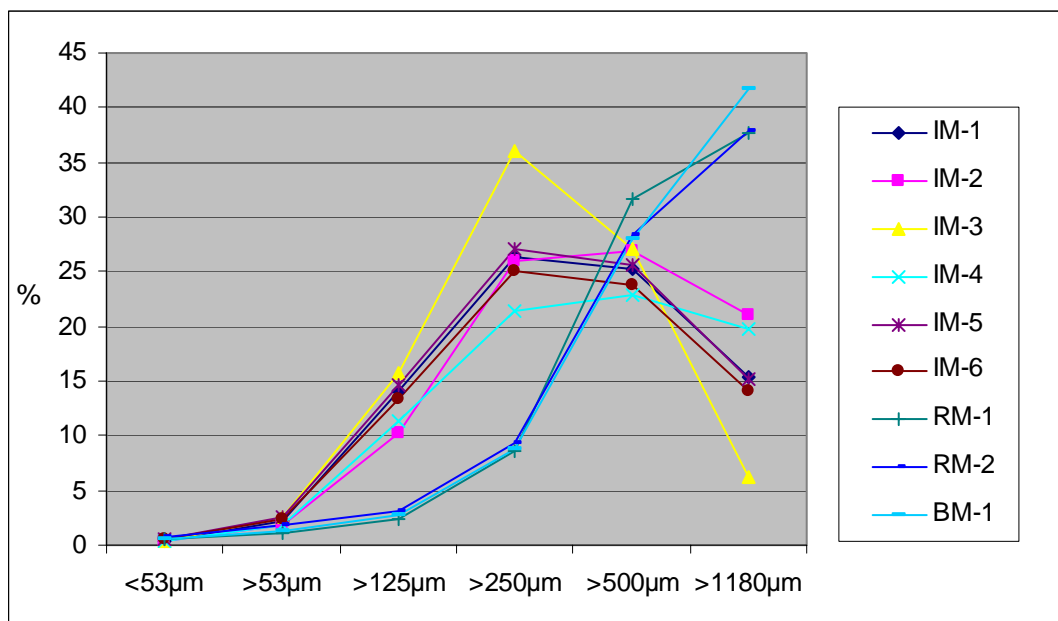
Figure 4. 69. Particle Size Distribution curves of the aggregates used in mortars

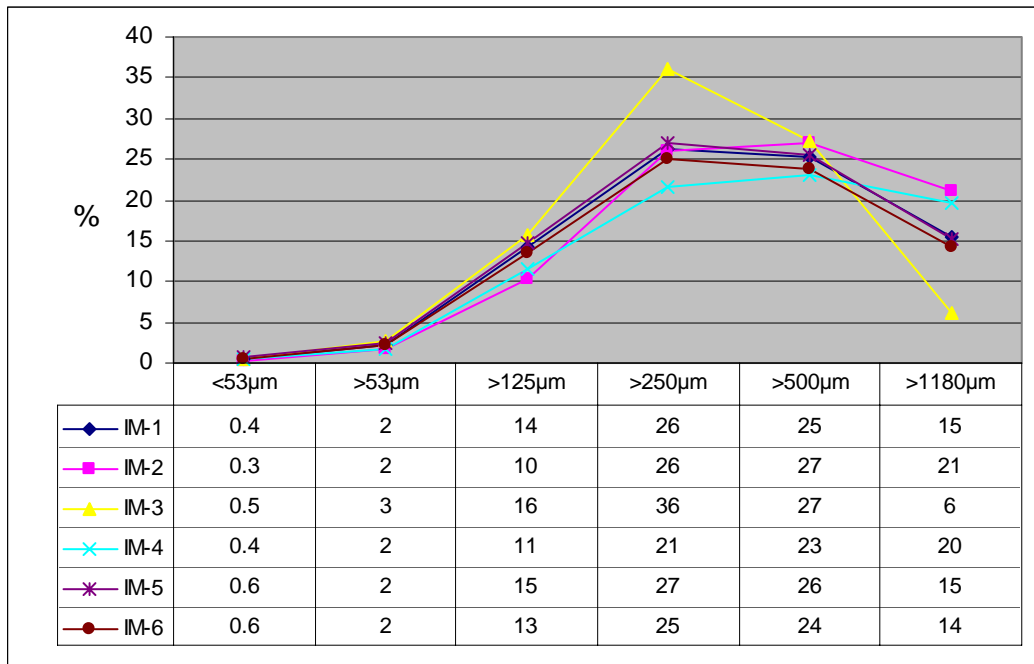
Figure 4. 70. Particle Size Distribution curves of the aggregates used in intervention mortars

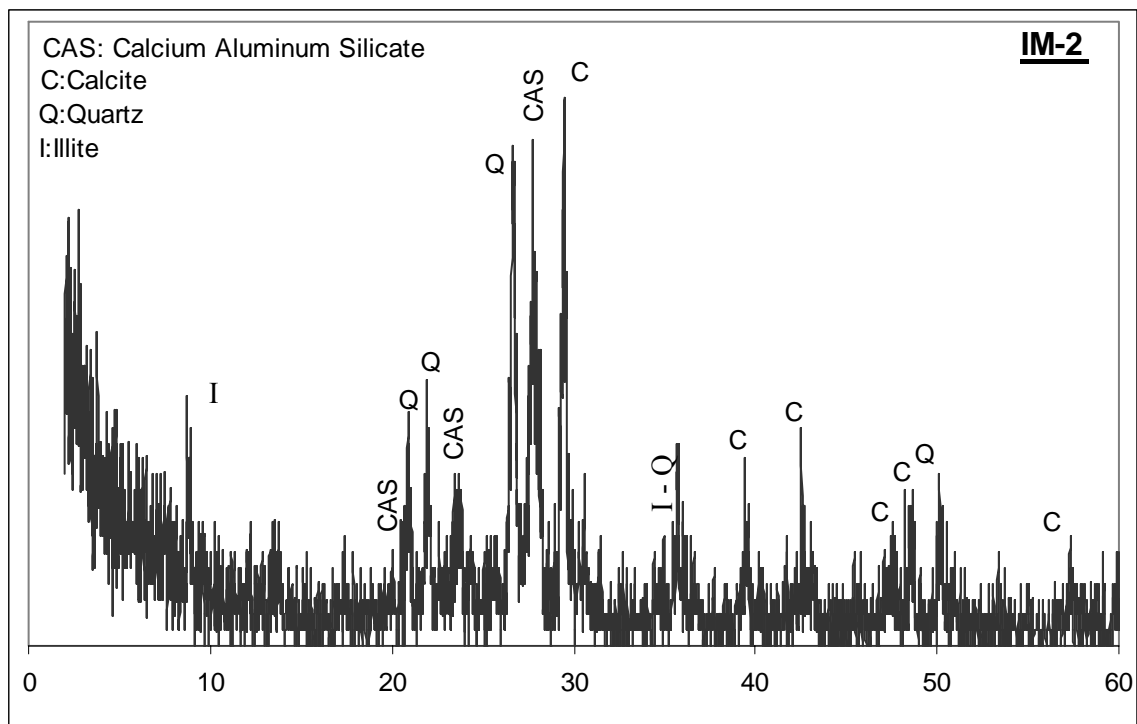
Figure 4. 72. XRD pattern of the intervention mortar matrices

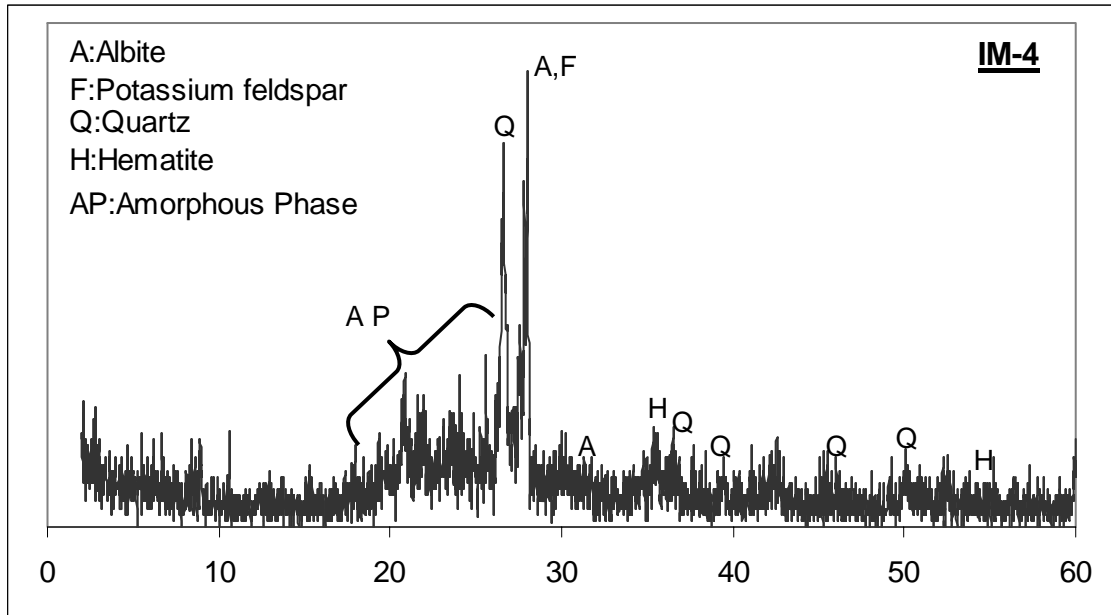
Figure 4. 73. XRD pattern of the fine aggregates used in intervention mortar

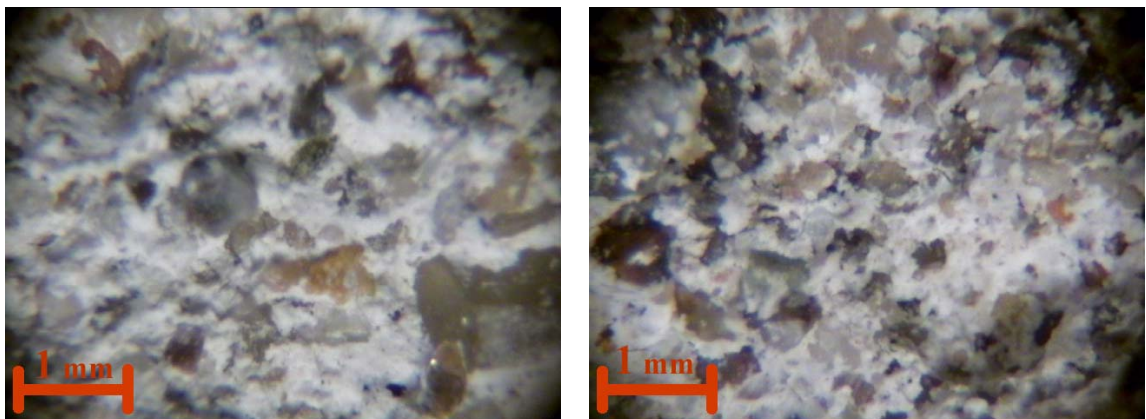
Figure 4. 74. Stereo microscope image showing weak adhesion between binder and aggregates of IM-1

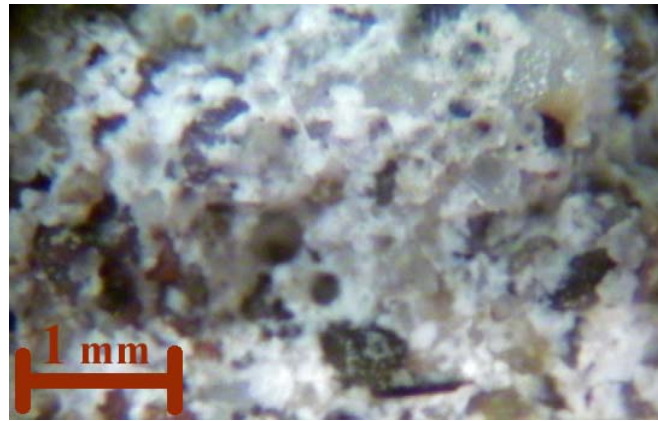
Figure 4. 75. Stereo microscope image showing weak adhesion between binder and aggregates of IM-1.

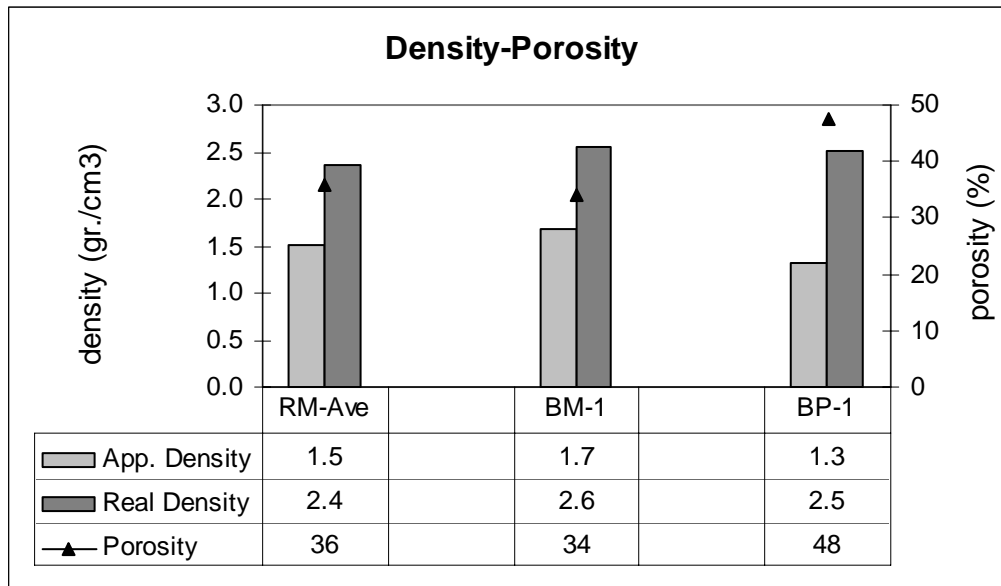
Figure 4. 80. Porosity and density of mortars and Byzantine plaster

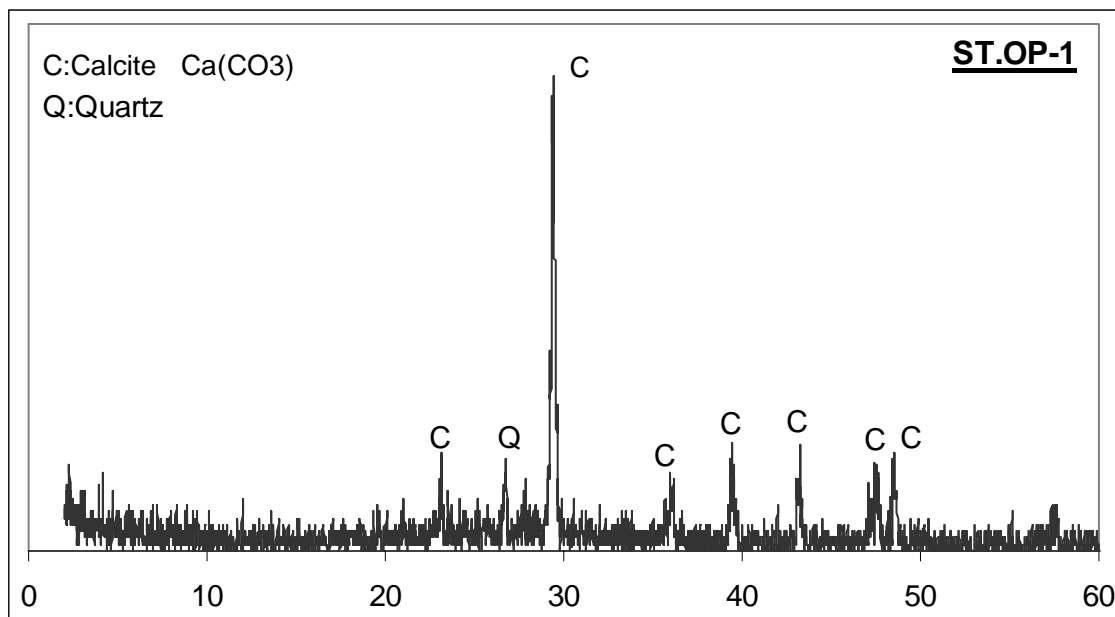
Figure 4. 84. XRD pattern of the Byzantine plaster

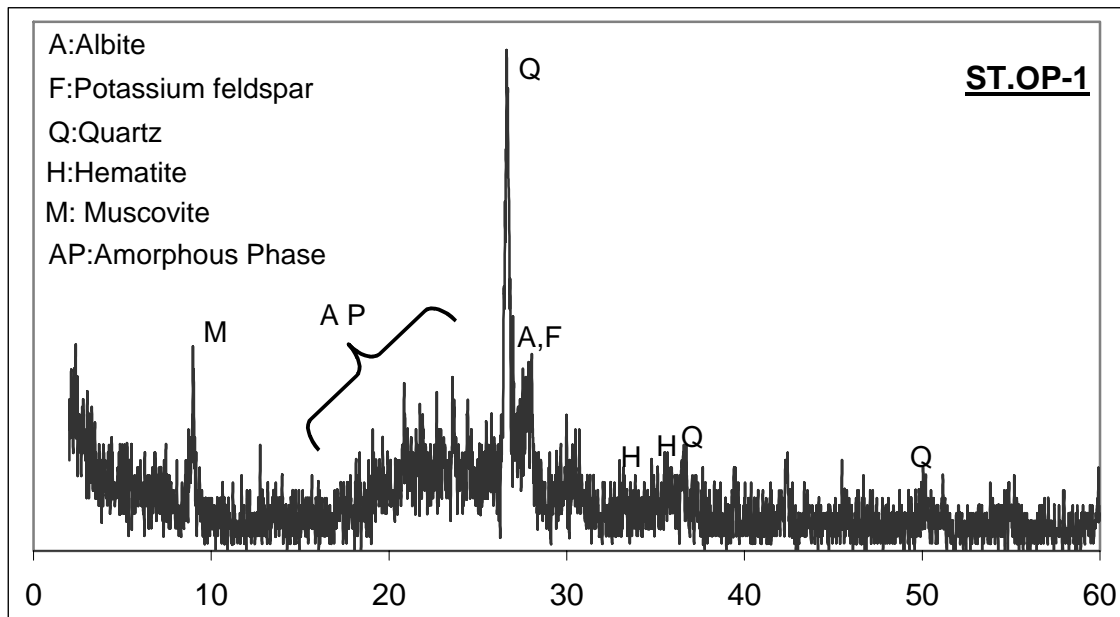
Figure 4. 85. XRD pattern of the brick aggregates used in the Byzantine plasters

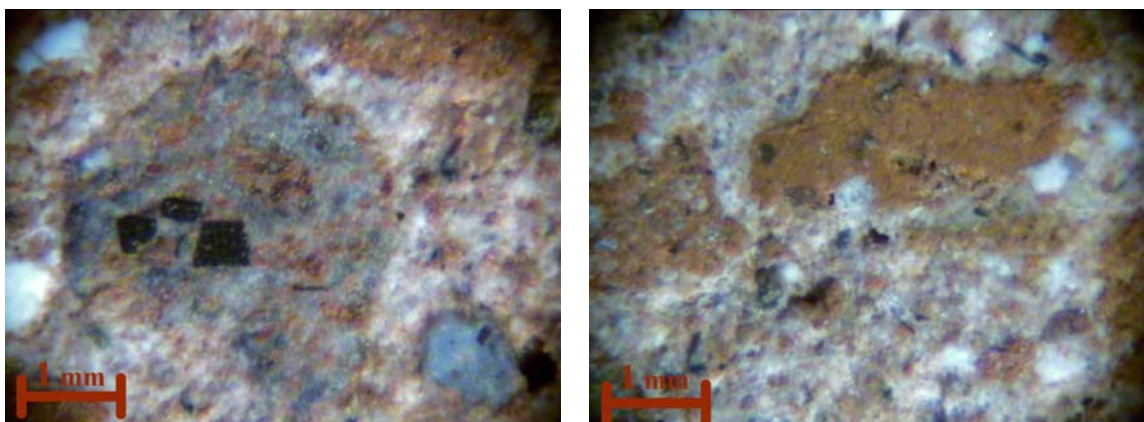
Figure 4. 86. Stereo microscope image showing good adhesion between binder and aggregates of BP-1 sample.

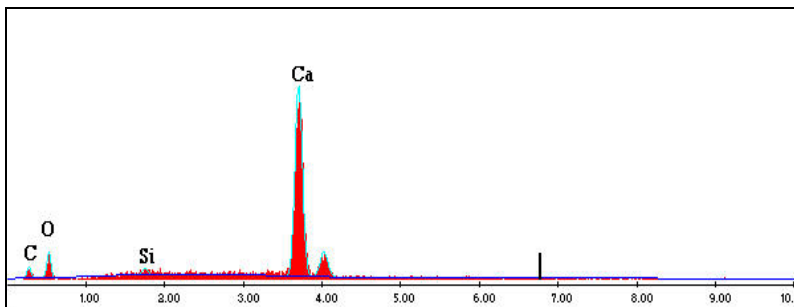
Figure 4. 89. Micritic calcite crystals and their EDS analysis in the white lumps observed in Byzantine plasters.

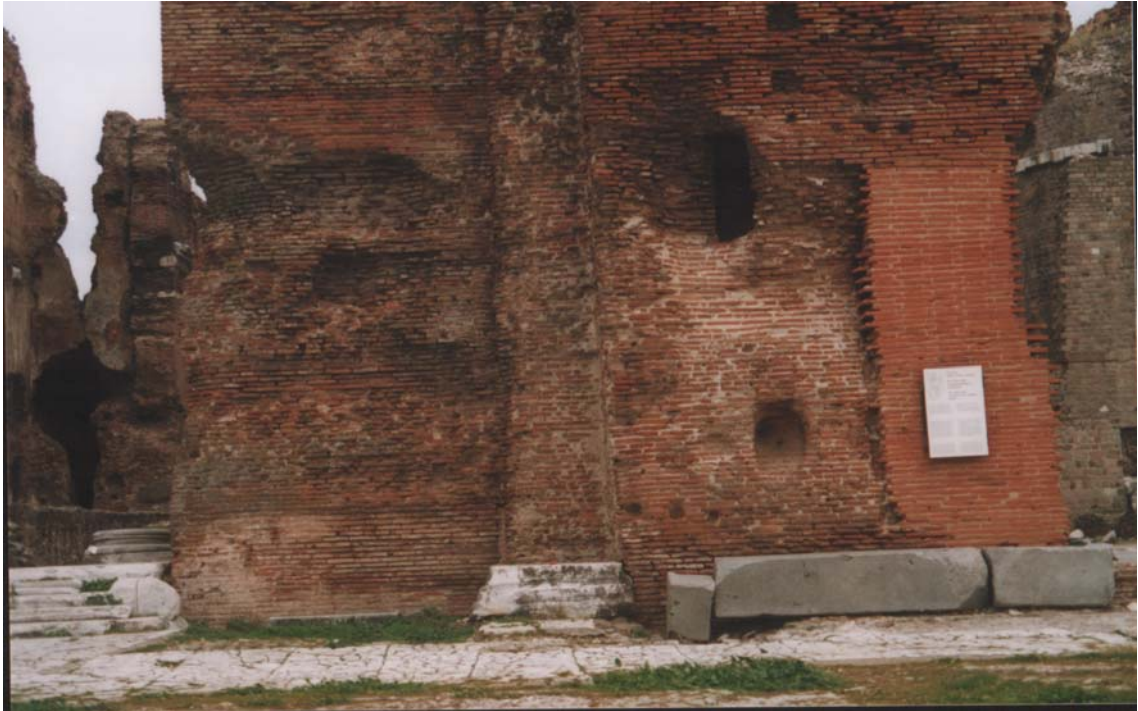
Figure 4. 95. The building materials is affected by soluble salts (2004)

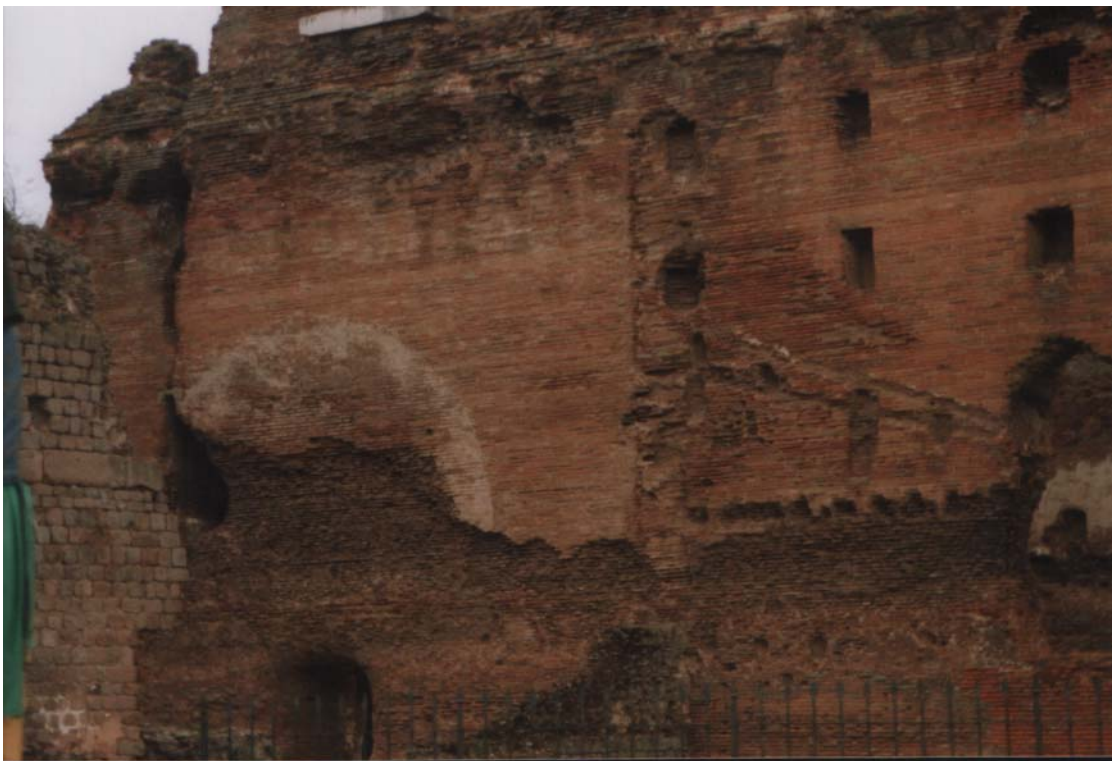
Figure 4. 96. Loss of material in the north-east elevation (2004)
