**ANALYZING THE MULTI-STORY RESIDENTIAL BUILDINGS IN
TERMS OF SUSTAINABILITY, DISABILITY ACCESS AND
EARTHQUAKE DURABILITY; EXAMPLE PROJECTS FROM
1980-1990,1990-2000,2000-2013 PERIODS**

Department of Architecture

2014

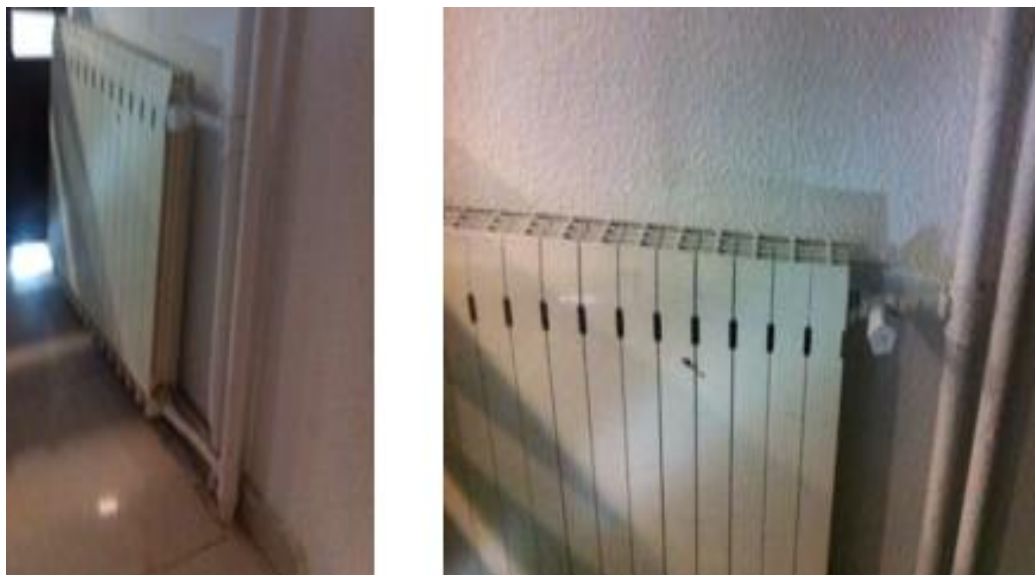
Figure 4.2 Heating Fixtures at Ataköy Etap Konutlari

Atakoy uses central heating systems in order to distribute heating energy for each unit. The building still uses the initial heating system installed during construction. There is no technological energy preserving tools used in heating, therefore units are not energy efficient in heating. Considering that there is no thermometer system being part of the unit heating fixtures, every unit pays for the heating equally.

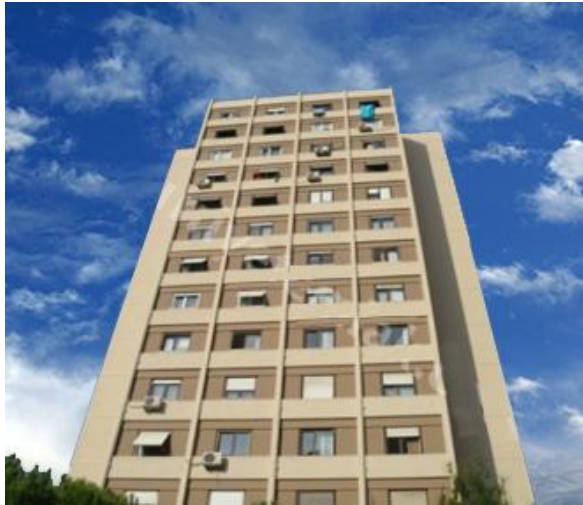
Figure 4.3 Outside AC units at Ataköy Etap Konutlari

As AC system, the building is not equipped with any central cooling or ventilation system. The outside units has been witnessed from outside of the building randomly at in use units. This indicates that the building is not energy efficient in its cooling and ventilation systems. Considering that the ACs are chosen by the residents, it is unknown if the A+ energy efficient fixtures has been chosen.

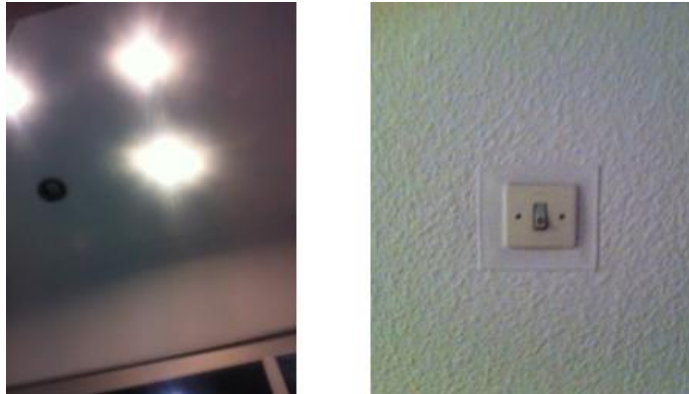
Figure 4.5 Common Apartment Lighting at Etap Konutlari

The building uses switch style lighting systems in the corridors and stairs. There is no photocelled lighting fixtures in use. There are quite a few number of spot light bulbs in use, which uses high levels of energy and should not be used in apartment lighting.

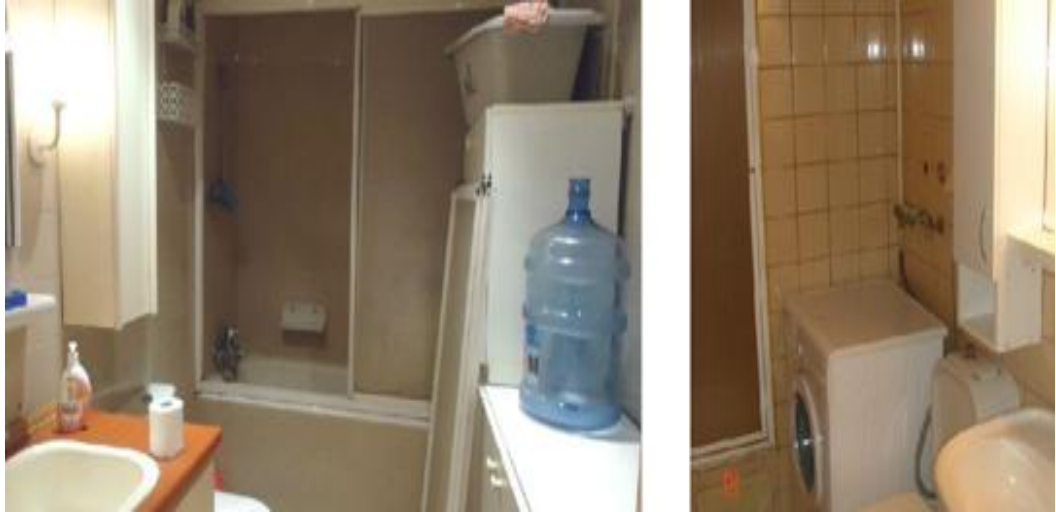
There is no water waste control system existing in the building. Majority unit owners installed their own faucet, shower and stall in their in their unit depending on their preferences. The originally installed fixtures are the most basic ones even available at the time of install. Therefore it is noted that an improvement is necessary for the control of waste water.

Figure 4.6 Foccets and showers installed in Etap Konutlari

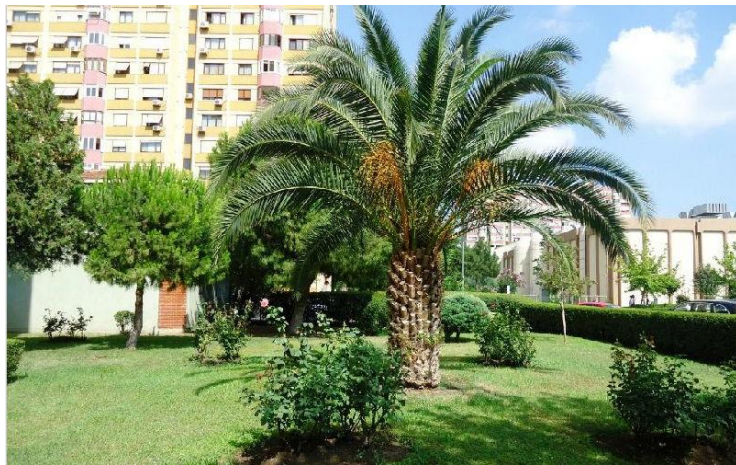
There is no rain water reservation available in the premises. The watering is done through the hoses available in the garden at the times assigned by the property management. It is noted that there is a significant water waste exist in the current system.

Figure 4.7 Garden View of Etap Konutlari

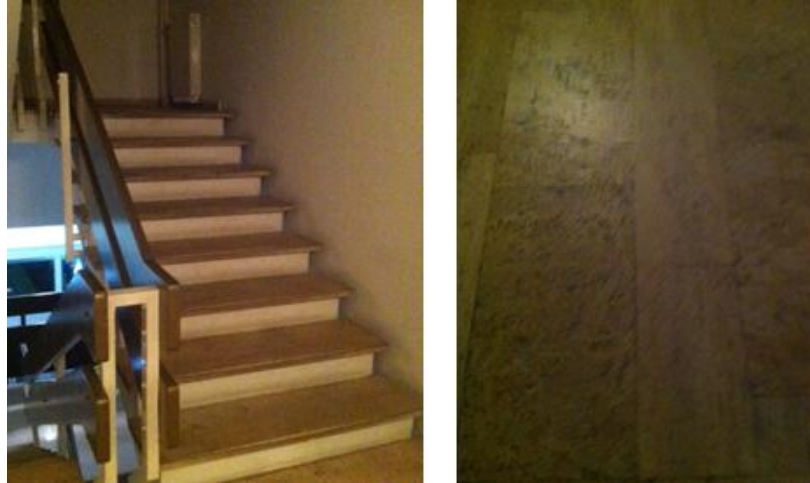
Figure 4.8 Stairs and Hardwood Floors at Etap Konutlari

Mainly local materials used in the construction of Etap Konutlari. The ceramics used in stairs and units, hardwood flooring, and door fixtures have been supplied locally. The local products have been preferred because of being const effictive not because of their efficiancy.

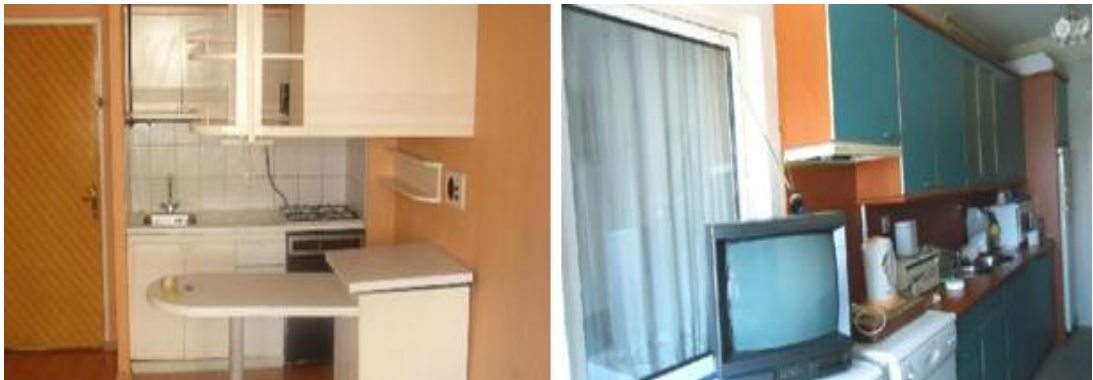
Figure 4.9 Different Kitchen Fixtures in Etap Konutlari

Some flooring was done using traverten stones from 1980's. Afyon marble was used in stairs, wood was used for stair railings. The PVC material was used in windows and it is indicated that the materials for windows were not chosen locally. The countertops are also witnessed to be made of local marble.

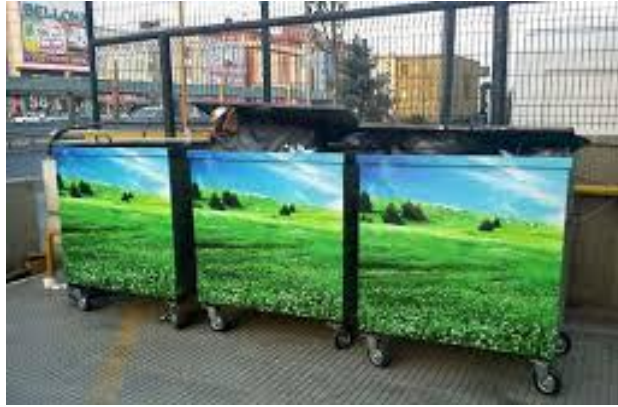
Figure 4.10 Available Garbage Containers Outside of Etap Konutlari

There is no indicated waste management available in premises. The recycling was not a common case in 1980's and no further action has been taken towards it. There is no designated area for waste. The residents know the garbage collection times daily and bring their own waste to the assigned garbage bags outside of the premises. There is no food disposal available in units.

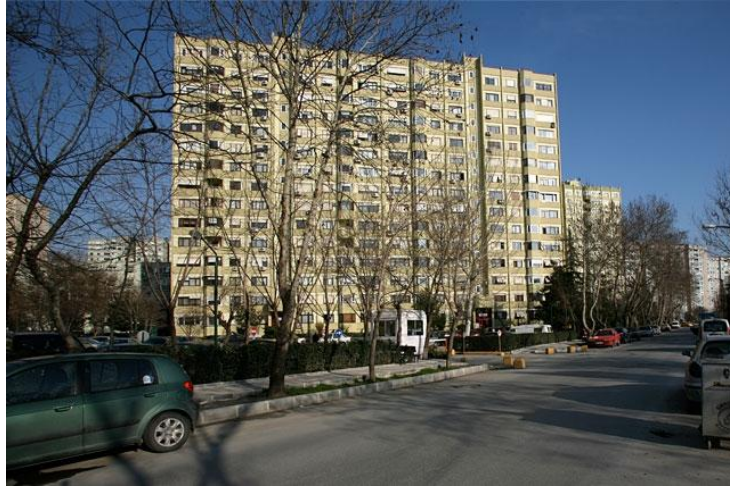
Etap Konutlari resides in Atakoy, Istanbul, area accepted as high earthquake risk portion of the city. Geologically, Bakirkoy-Atakoy is classified as young ground; therefore the the foundation of the constructions are expected to be a specific level. The 66% of the houses available in Bakirkoy is existing upon an old stream bed. The buildings existing on stream beds are known for being weak towards carriage and stress towards earthquake activities. Considering that majority of the buildings in the neighborhood is built prior to 99 earthquake, and were not inspected through newer regulations during construction.

According to the shocking report published by Istanbul Technical University and Istanbul University, 35% of the buildings in the area are in high risk, while 23% lies in low risk parts of the city. The report further indicates that 6,000 buildings including schools, hospitals and general publish premises ought to be demolished and rebuilt if necessary. Considering the facts about vicinity, it is indicated that the building resides in high risk area and

Figure 4.11 View of Stories from Outside at Etap Konutlari

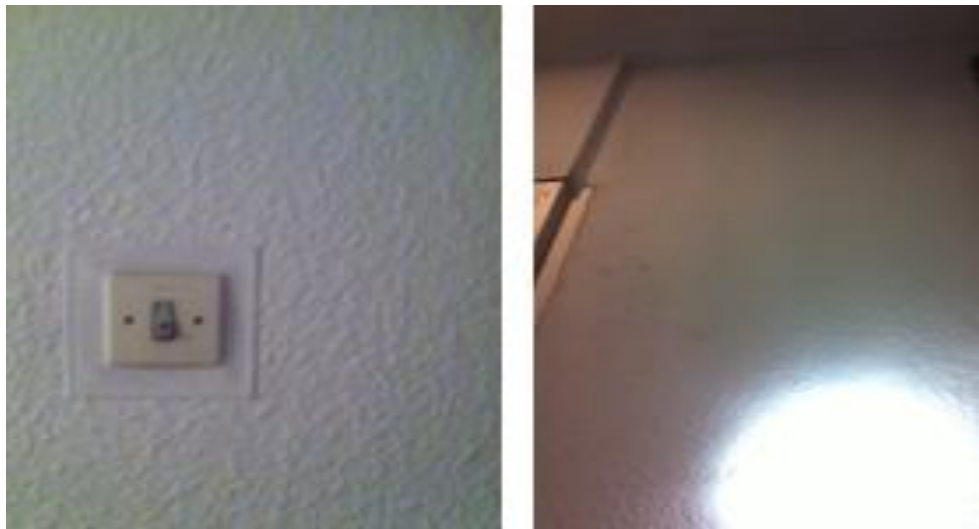
It is indicated that the building structure is not compatible with disabled living requirements. The door has been replaced with automated door functionality. The lighting is manual, able to turn up with a switch.

Figure 4.13 Lighting Switches at Etap Konutlari

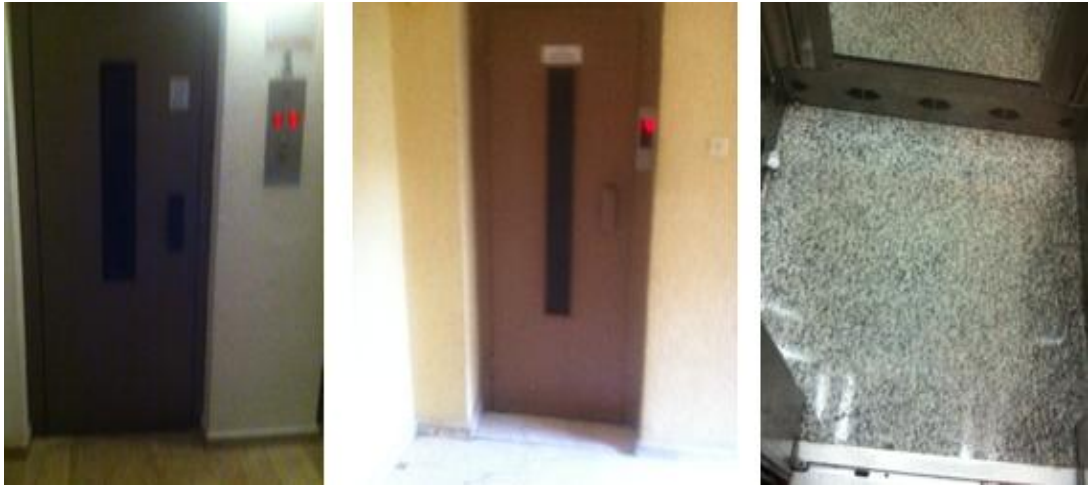
Figure 4.14 Elevators at Etap Konutlari

Ataköy Etap Konutlari, there is only one elevator existing in each building. The dimensions of the elevators are 110 cm by 130 cm, which are below the required specifications for disabled elevator dimensions. Therefore this creates big issues for disability living experience.

Considering that the elevators had been upgraded, the railing height within the elevator is 90 cm, which is acceptable, nonetheless.

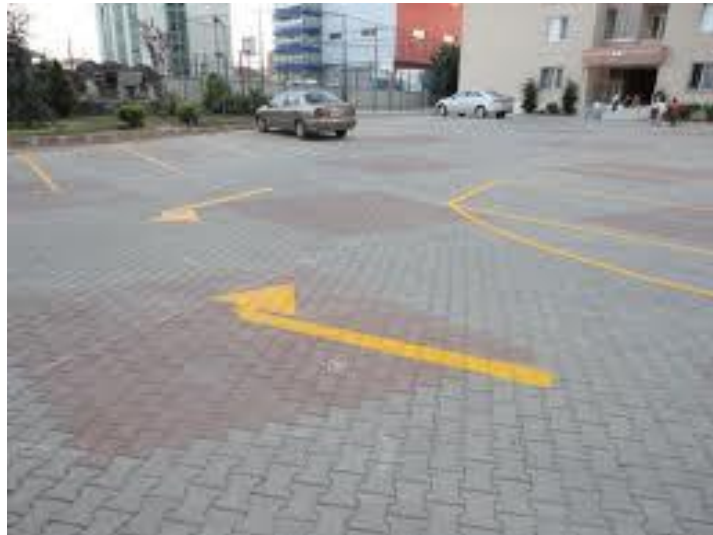
Figure 4.15 Image From Parking Lot of Etap Konutlari

There is existing reservation done for disabled parking. So it can be a difficult ride from the area where car is parked to the entrance of the buildings. This is a big complication for individuals with disabilities.

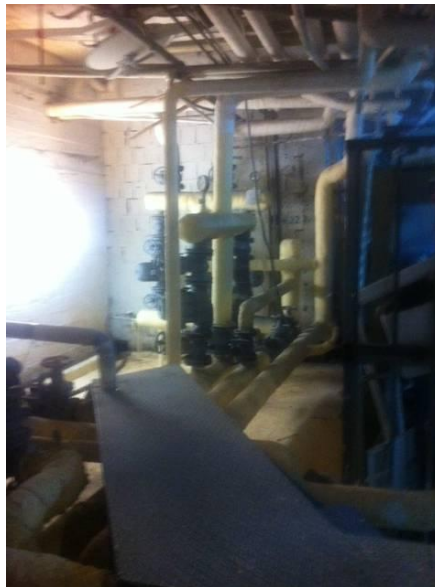
Mert Kule Building is equipped with central heating center that distributes the same amount of heating to all units. There has not been any upgrades and the building still uses the system. There could not be any equipment creating energy efficiency for heat was found.

Figure 4.17 Heating Control Room at Mert Kule

When investigating the Heating Control Room, all the equipment used for heat distribution was found to be dated back to 1980-1990 era.

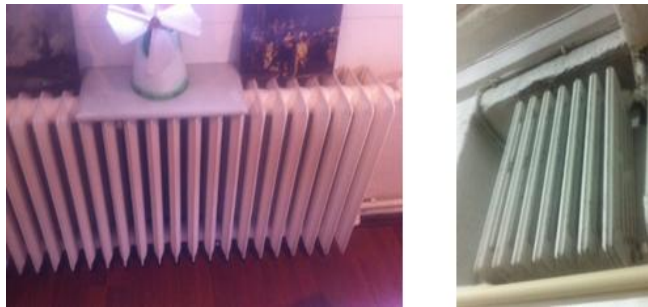
Figure 4.18 Unit Heating Equipment at Mert Kule

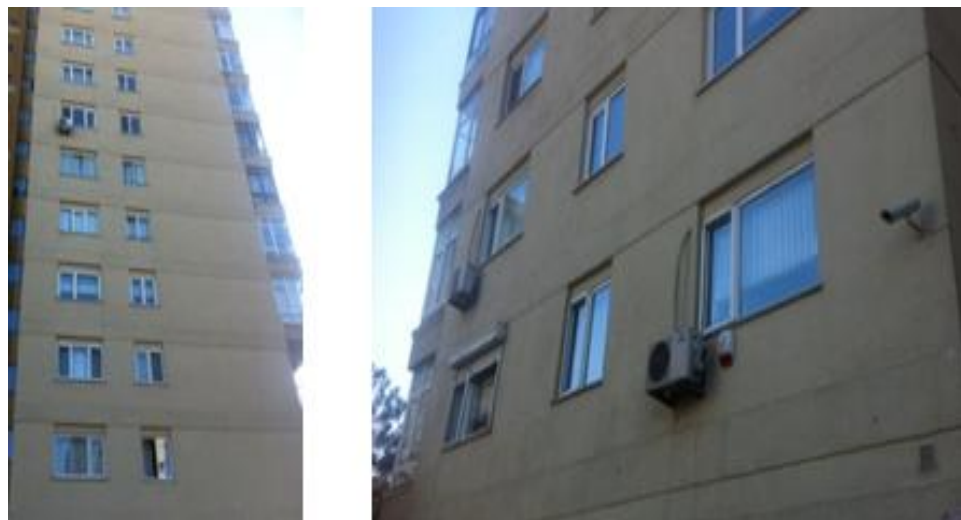
Figure 4.19 Outside AC units at Mert Kule

The AC and ventilation systems have been used randomly by the tenants, even though there is no central planning or infrastructure existing. The outside units of AC equipments have been spotted randomly out of windows. Since the equipment was purchased by the tenant depending on their preferences, the energy efficiency is not existing in the building.

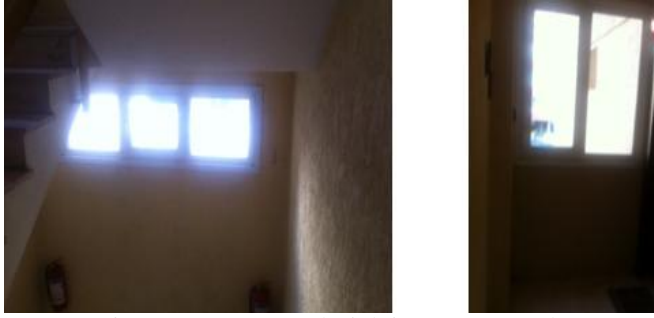
Figure 4.20 Natural Lighting at Mert Kule

There is no heat isolation on the building and according to the property manager Merih Ruacan, there are no such expectations existing for an upgrade. The windows are used for natural lighting in every single room in the building allowing ventilation also to be done through windows. There is no evidence of technology that automates the AC and ventilation in the building.

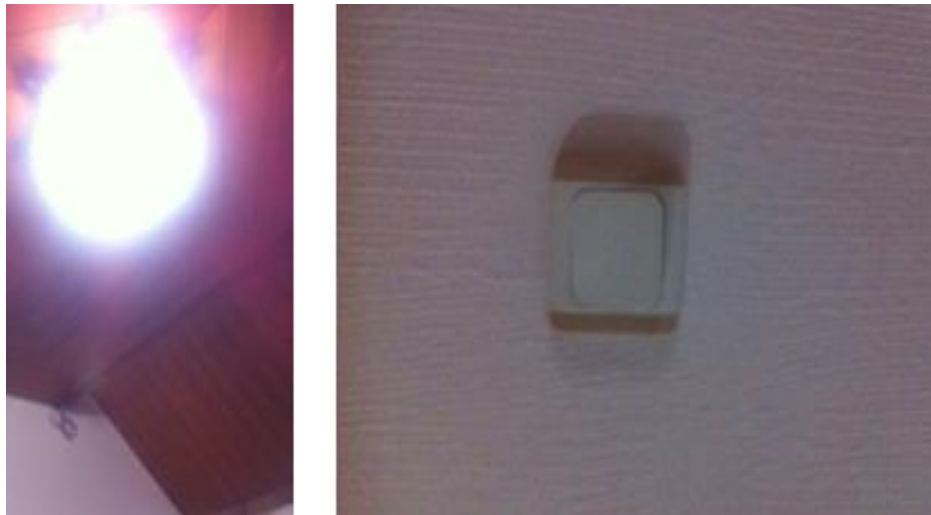
Figure 4.21 Lighting Equipment and Bulb at Mert Kule

The lighting in the building carries the glimpses of the era. There are still light switches and there is no work towards automation. Incandescents bulbs are in use, which uses high levels of energy.

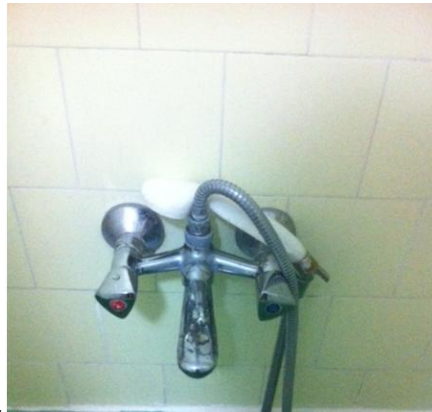
Figure 4.22 Shower Heading in the Batroom at Mert Kule

There is no systematic water waste management and the fixtures appear to carry the glimpses of 1980-1990 era. Property manager indicated that many residents are still using the initially installed foccets, shower systems, and toilet seats.

The leakage is evident in the building at foccet joints and the waste of water is creating an insufficient environment. It is inevitable to conclude that the fixutres needs upgrading in order to be caught up by todays standards. There is no central watering for the garden in premises. The garden is watered by the gardener. There is no existing preperation and work towards automated garden watering. There is no efficiancy existing at Mert Kule.

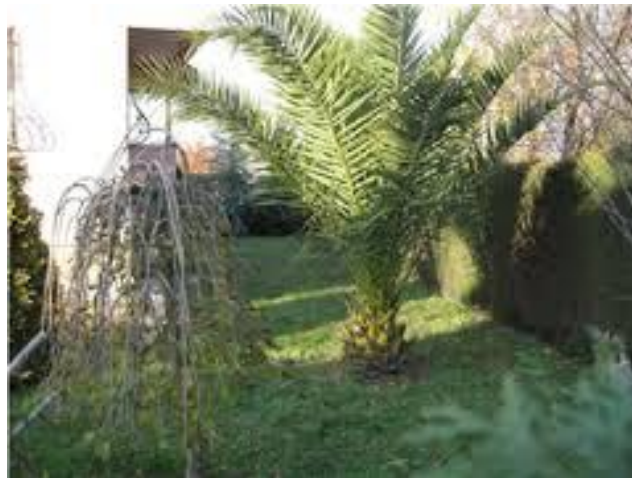
Figure 4.23 Garden Space at Mert Kule

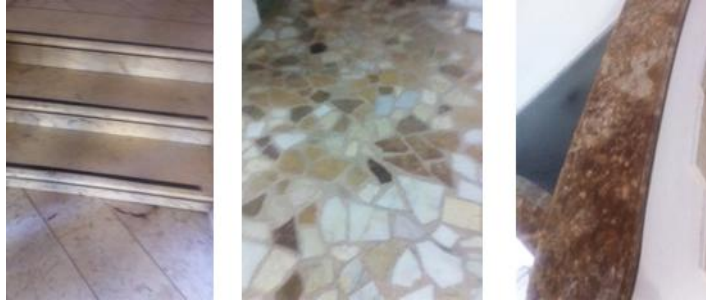
Figure 4.24 The Materials Used at Mert Kule

There are local materials used in the construction phase. The non local materials such as PVC windows and the wood used in door gates are imported from a different region. The ceramics and stones used throughout the building and it is indicated that the apartment is sustainable in material usage.

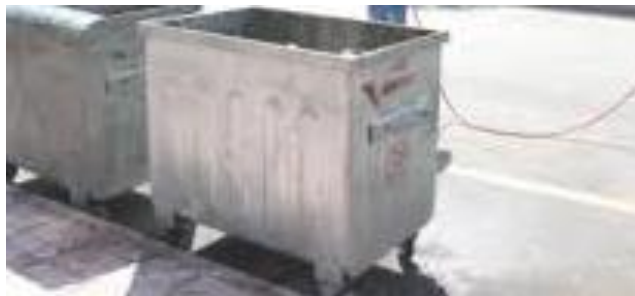
The only waste recycling system existing is garbage container outside; no existing indoor recycle or garbage room is found. There is no separation of waste and recyclable materials. The garbage is collected by the municipality at the specific times of the day and the residents are obligated to take out their trash. There is no existing food disposals installed in the units.

Figure 4.25 Waste Containers on the street at Mert Kule

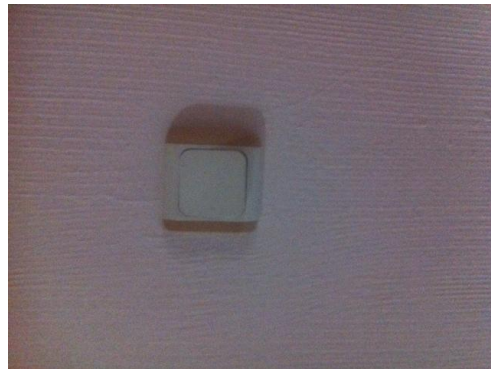
After entering the building it is visible to conclude that there is no automated lighting available for disabled individuals and they have to find and reach to the switches to turn on the lights. But the switches found to be in acceptable height for the individuals with wheel chair.

Figure 4.30 Switches at the Entrance of Mert Kule

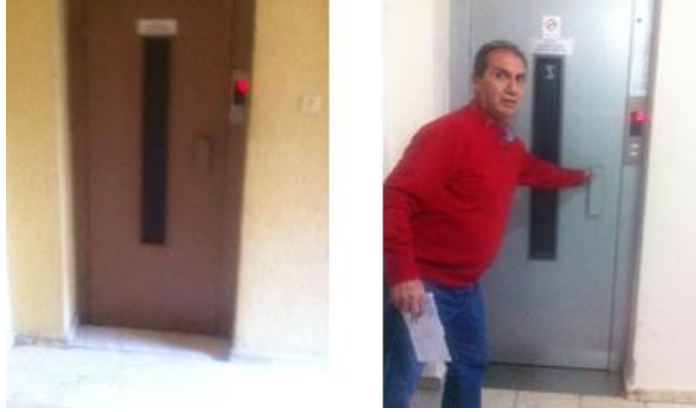
There is only one elevator in operation at Mert Kule. The dimensions of the cabin is 150 cm by 130 cm, which are below the required dimensions for wheeled individuals. It is indicated that the doors open manually and this creates difficulties for individuals with wheel chairs.

Figure 4.31 Elevators at Mert Kule

The elevators have been replaced and therefore the railing heights are not in expected height, 90 cm. The doors of the elevators are automated, which also eases disabled individuals travel experience within the building.

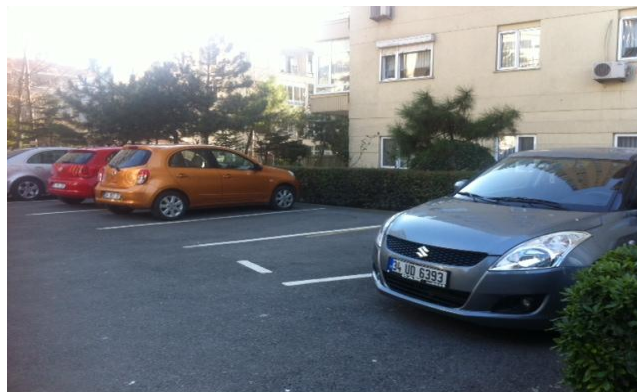
Figure 4.33 Outside Parking Structure at Mert Kule

It is indicated that there is no available reserved parking spaces for individuals with disabilities. The parking structure is outside and there is no planning work towards creating designated spaces.

There is not enough parking space for individuals with disabilities; according to TS 12576 regulations, the 2% allowance has not been met.

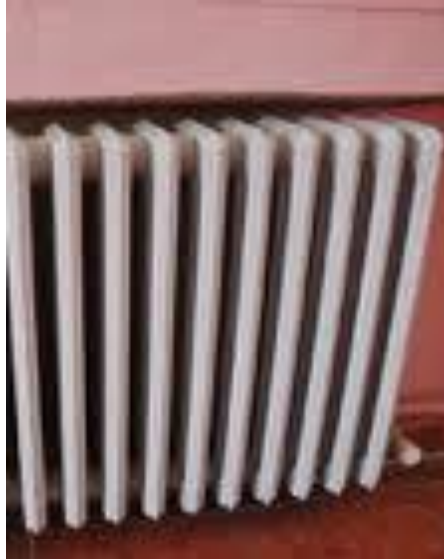
Figure 4.35 Heating Fixtures at Atakent Bostanli

There is a central heating system available at the building. The type of fuel used on premises are coal. There is no available technological equipment to measure energy efficiency.

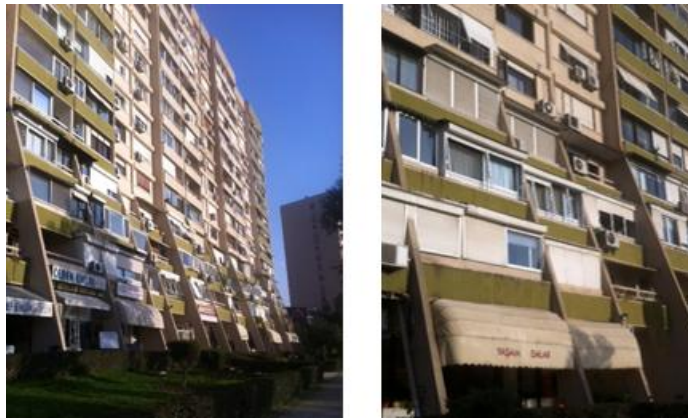
Figure 4.36 View from Outside of Atakent Bostanli

Since the AC cooling and ventilation systems were not installed during construction and since then, there has not been any improvement done. The units that carry cooling systems were located randomly outside of the units. Since the equipment was chosen by the tenants, the energy efficiency was not concluded.

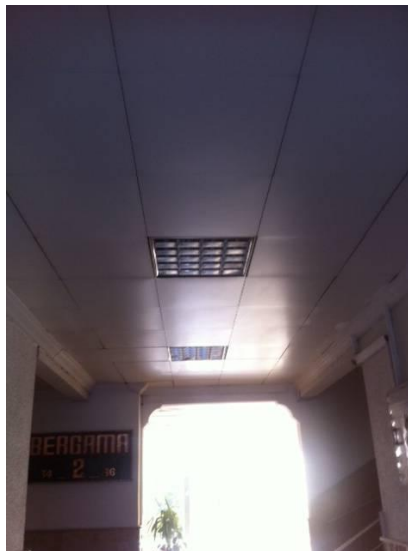
There is no energy efficiency in lighting of the building; there are quite a few LED lighting bulbs in use as well as florecent lighting. There is no photocell centered lighting, therefore there is no energy savings system are in use.

Figure 4.38 LED Lighting at Atakent Bostanli

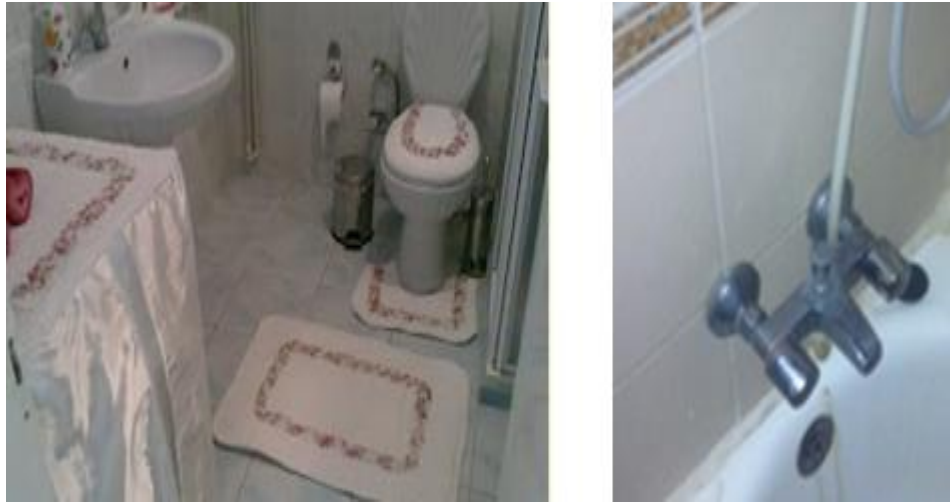
There is no fixture use for water waste reduction. The old style flushing systems were found in the premises, as well as old style foccets.

Figure 4.39 Bathroom Fixtures at Atakent Bostanli

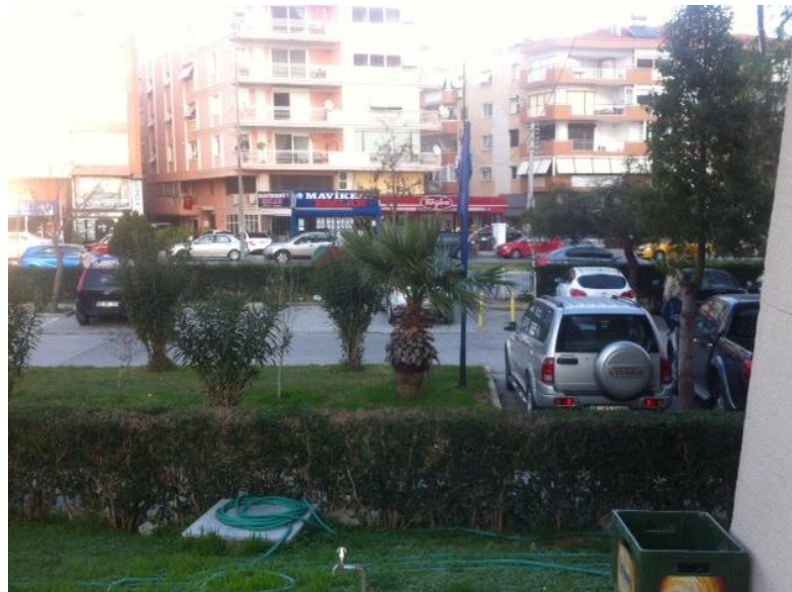
Figure 4.40 Garden at Atakent Bostanli

There is no work done towards preserving rain water for usage. The garden watering is done through the hose available at the garden. The gardener does the watering and hence there is an ongoing water waste in the process.

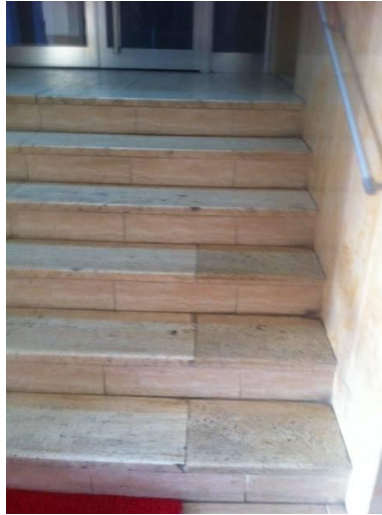
Figure 4.41 Marble Stairs at Atakent Bostanli

The local materials have been chosen in the processes and same materials are mainly in use right now. The ceramics were used in stairs and bathrooms and wood flooring was used in units.

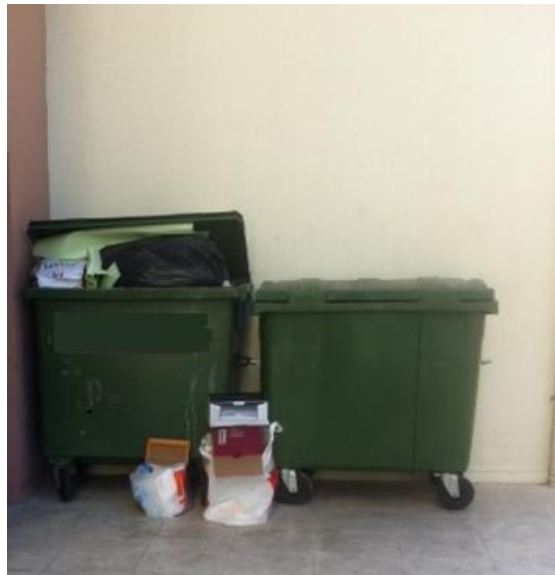
Figure 4.42 The Waste Containers

At the premises, there is no work has been done towards waste management. The garbage has been collected daily by the municipality garbage trucks by the designated times each day. There is no separation of the waste as well as food disposal in units are not existing.

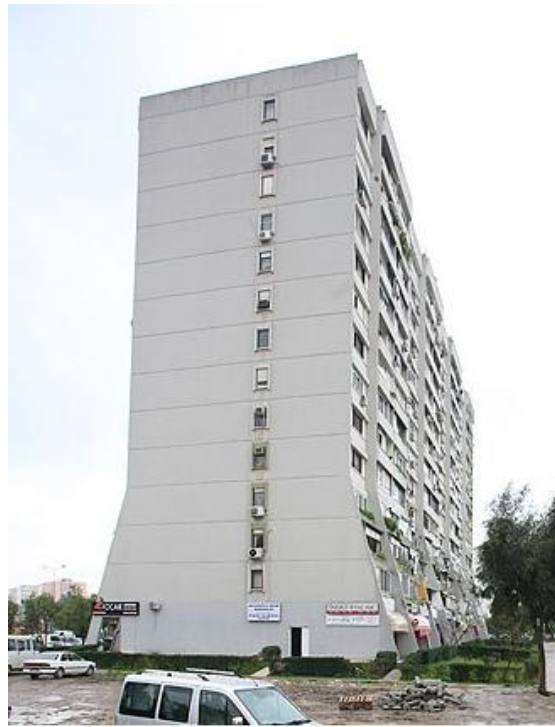
There is no indication whether the ground situation has been considered during the construction. The building though is partially symmetric and there is evenly weight distribution. The building has not been damaged during 1999 Earthquake.

Figure 4.43 Symetric Design of the Building at Atakent Bostanli

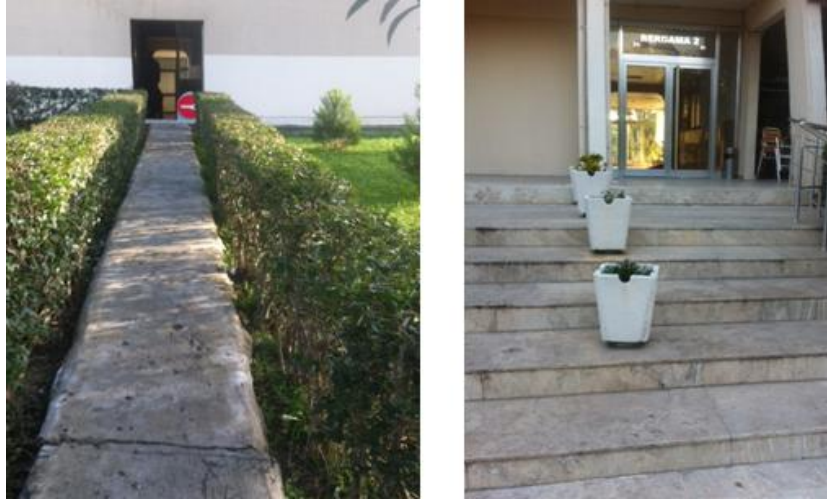
Figure 4.44 Entrance and the ramp on site at Atakent Bostanli

When looking at Atakent Bostanli, there is no existing ramping available at the building. There is a small ramp available off site from the door but even that one lacks the dimensional requirements.

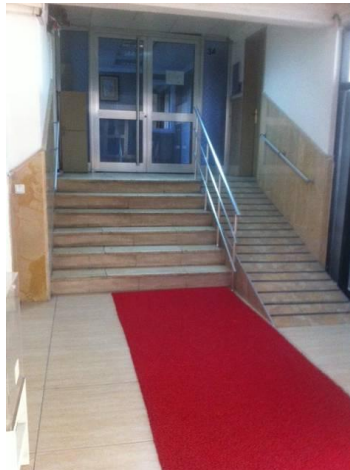
Figure 4.45 Entrance of the Building at Atakent Bostanli

It is indicated that the entering and exiting the building for individuals with wheel chairs is complicated. The entrance doors at the building is not automated therefore complicates it further. On top of that, the lighting is not automated, hence complicates the process for disability access.

Also the ramp in the building for the unit access is not complied with requirements, the width is only 80 cm, and the railing is not proper for disability access.

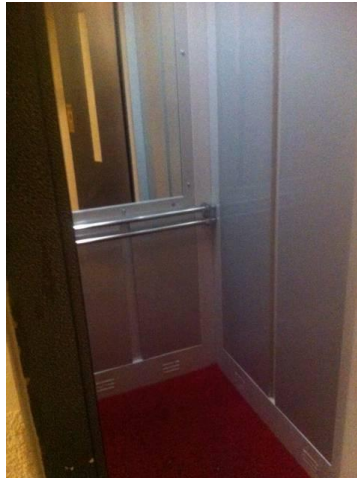
Figure 4.46 Elevator at Atakent Bostanli

There are two elevators at Atakent Bostanli. The entrances are 75 cm wide, which is not enough for individuals with wheel chairs.

The doors of the elevators are found to be manually operated. Therefore the entrance and exit is complicated for individuals with wheel chairs. The railing height was found to be 100 cm which is partially aligned with regulations

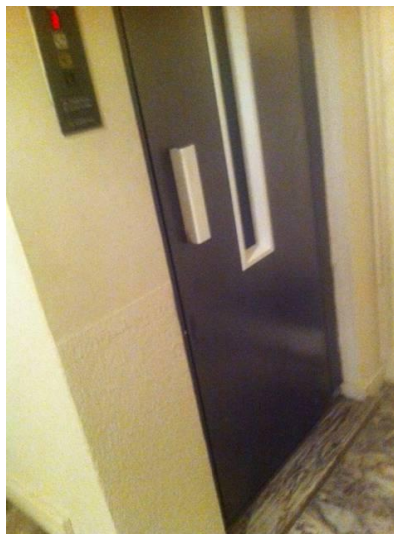
Figure 4.47 Elevator Doors at Atakent Bostanli

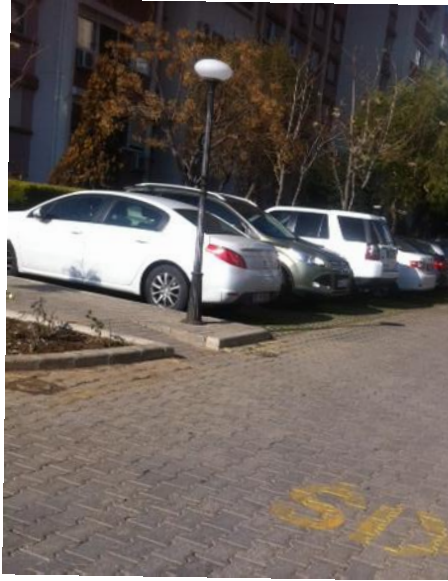
There are designated spaces for disabled individuals to park on premises. There is a parking structure within the complex and the designated spaces were found in the closest proximity. However the transportation to and from the parking lot is lacking disability consideration.

Figure 4.48 Parking Lot at Atakent Bostanli

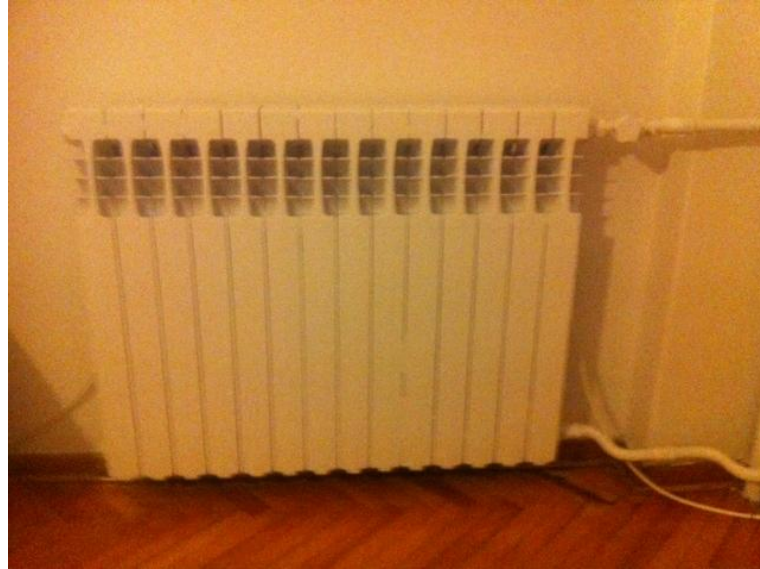
systems. With the self-contained systems, each unit can decide the amount of heat and energy usage and pay for the heating as they use. The common areas of the apartments have not been heated and they did not use any heat measurement tools through out the buildings.

Figure 4.50 Heating System in the units at Tercuman Sitesi

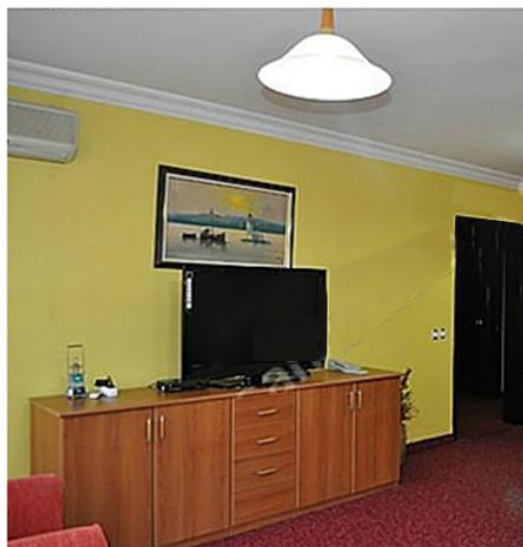
There is no central cooling system to be found in the facilities. Tenants use personal cooling systems if they desire. Since the option is left to the tenants, energy consumption was not in consideration for the building management. The cooling systems are allowed to be located in balconies only, due to the aesthetics requirements of the management.

Figure 4.51 cooling system at Tercuman Sitesi

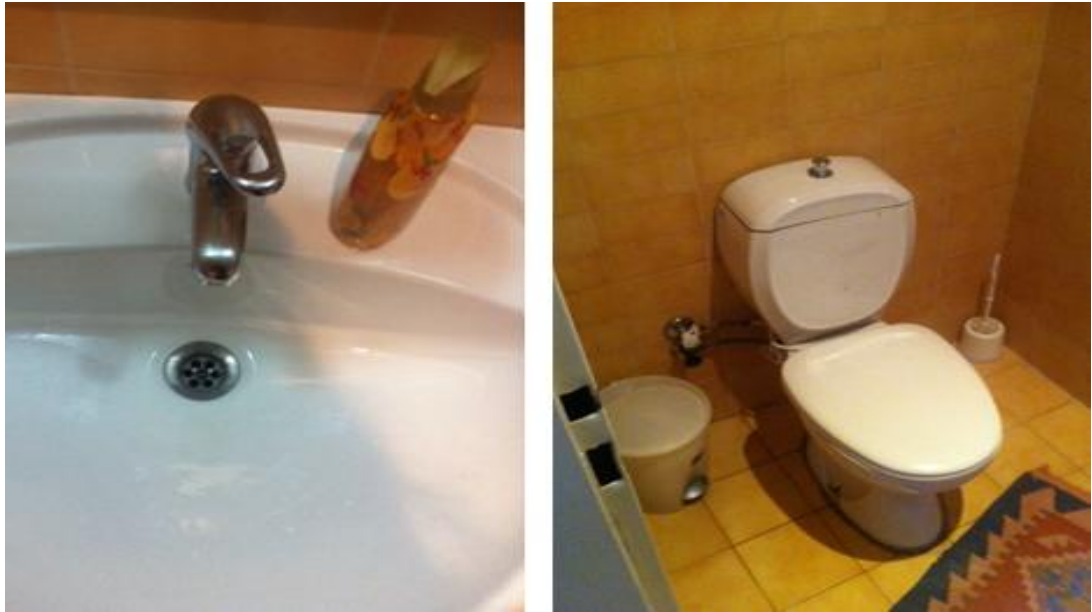
Figure 4.54 Water Fixtures of units

It is indicated that the buildings did not have any restrictions or material usage eliminating waste of water. The use of old class reservoir systems and the materials used in fosses and bathtubs are not efficient.

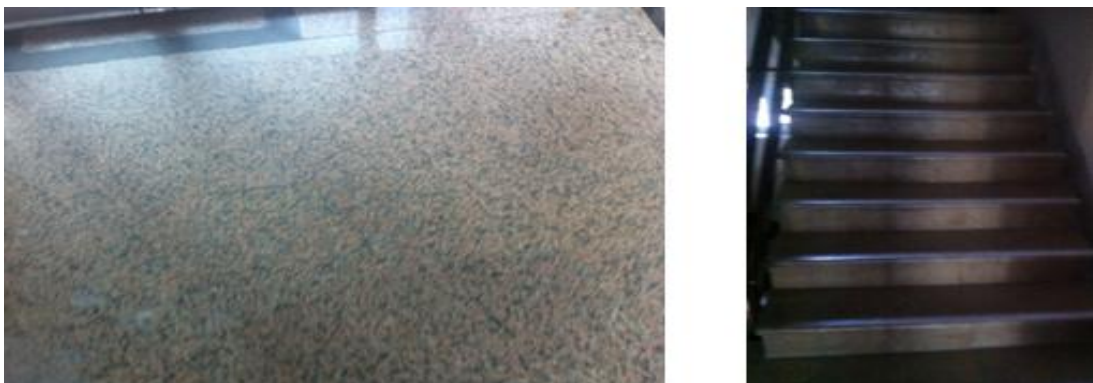
Considering the material usage at Tercuman Sitesi, local materials have been used in entrances and ceramics on the stairs and in the bathrooms, hardwood floorings and door woodworkings. It is indicated that when it came to material choices, the near local product have been chosen in order to eliminate the transportation and logistic needs.

Figure 4.55 Use of local materials in selected parts of the building

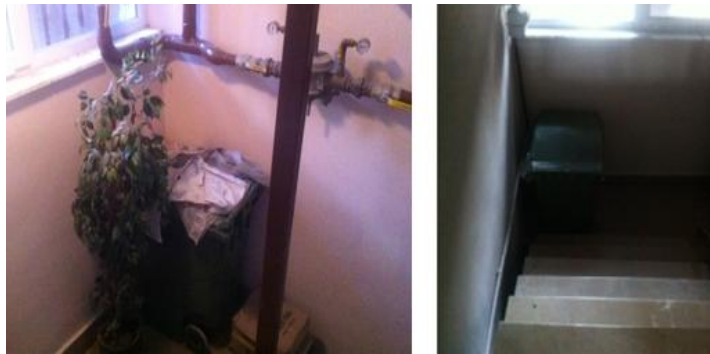
The waste management in the properties are managed by collecting the garbages on selected days. There is no sign of seperation or granulation systems' existance. The building attendant is mainly responsible of thr waste management services, where he collects the waste of each unit and delivers them to the bins assigned to each building. Then the bins are emptied out by the municipality waste management services once a week.

Figure 4.56 Waste management within the buildings

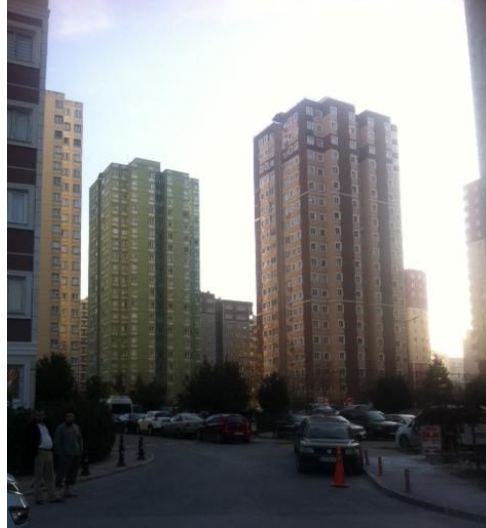
The information regarding to the base testing and use of materials according to the earthquake durability factors could not be found regarding to the apartment complex. According to the complex management, the grade of the cement and steel used in the construction of the apartment complex is capable of earthquake durability factors. Considering the symetric design of the buildings, it is noted that, each property is capable of distributing the weight evenly.

Figure:4.57 Symetric design of the frontal view

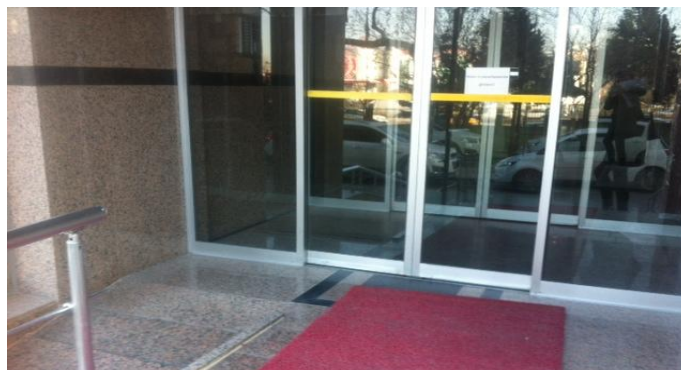
The entrance doors at the buildings have been replaced with automated doors which enable the accessibility for disabled individuals with ease. The width of the doors are 210 cm, which is also suitable for wheel chair access.

Figure 4.59 Entrance of Blok A of Tercuman Sitesi

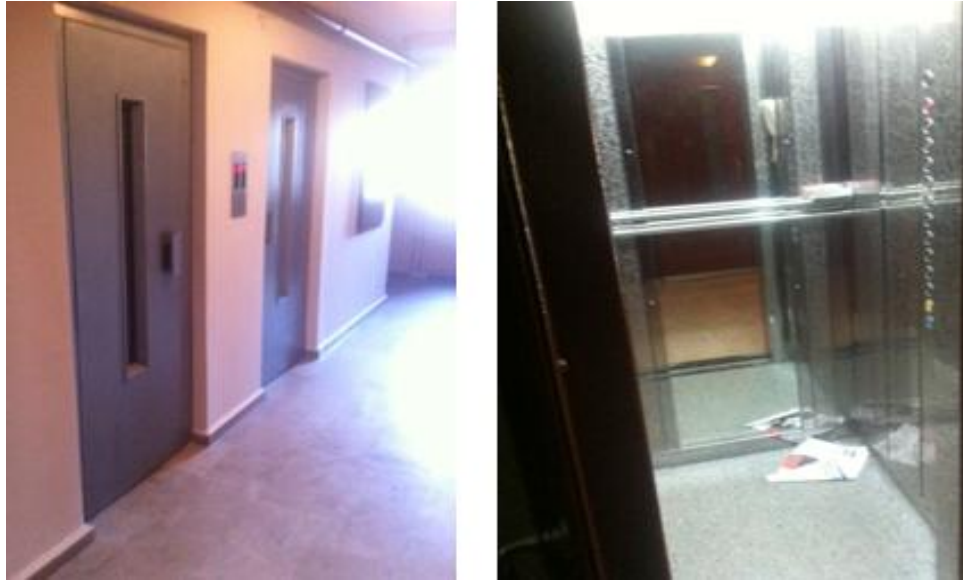
Each building in Tercuman Sitesi consists of two elevators. The dimensions of the cabins are 93 cm by 95 cm, which is partially aligned with the requirements for disabled accessibility. The doors of the elevators on the other hand are not automated, which is a burden for wheel chaired individuals, who needs to adjust the move around in order to open the doors of the elevators.

Figure 4.62 Elevator entrance from the lobby of Blok A Tercuman Sitesi

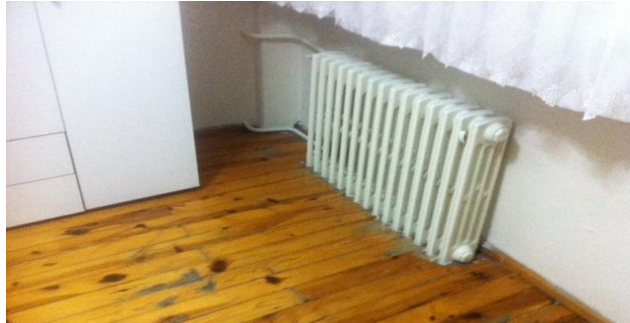
Figure 4.66 Heating Instrument in units at Sepas Sitesi

At Sepas Sitesi, there is a central heating in order to control effective energy usage. The type of fuel used for heating is natural gas. In the building, it is indicated that there was no technological energy preservation module. There is no specific heat measurement tools, and the heating bills are evenly distributed to the residents, according to the property manager Murat Hizarci. Therefore saving money on heating is not an option for residents.

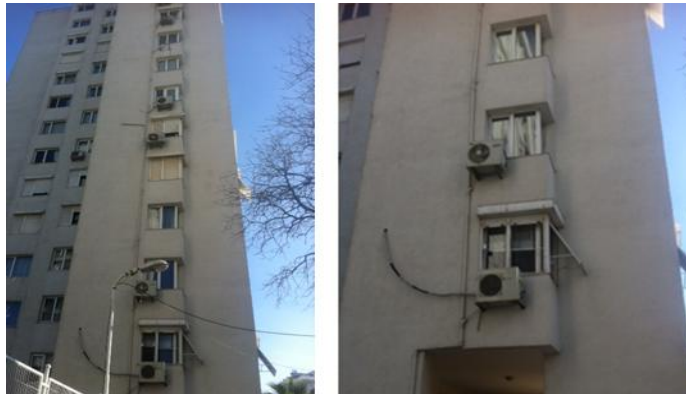
Figure 4.67 Wall Style Split AC Models

Considering that the building was not equipped with central cooling system, the AC systems are individually operated and purchased. The outside AC units are randomly located under the windows throughout the building. There is no sign of A+ energy waste prevention in the equipment.

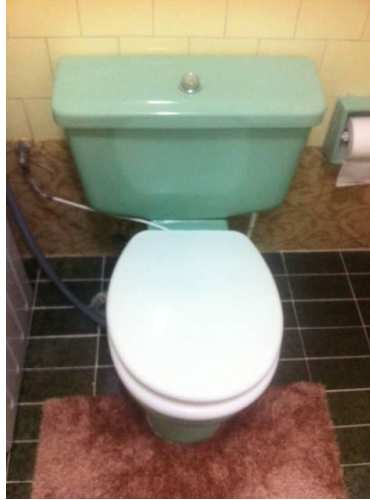
There is no selective materials such as fossets and reservoirs in place, in order to use of water efficiently at Sepas Sitesi. It is noted that old style fixtures have been in use, which reflects negatively on the use of clean water. However, it is also noteds that the fixtures used were the best quality and branded materials of their time, though they did not see any improvement.

Figure 4.70 Toilet Pan found in Sepas Sitesi

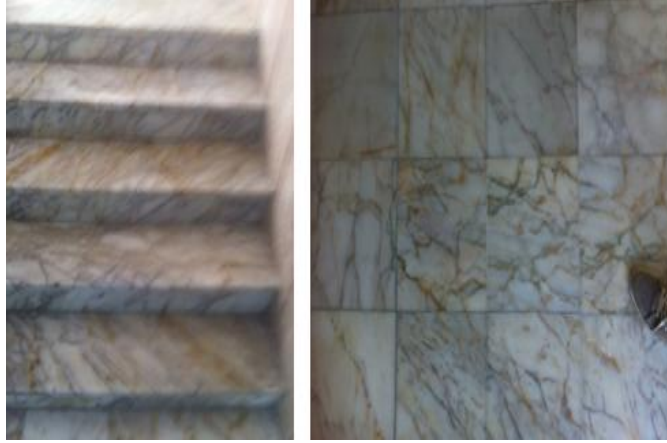
Figure 4.72 Afyon Marbels Used in the Premises

At Sepas Sitesi, the local materials used for entrance and stair marble, bathroom ceramics and wood flooring. The certain marbles were imported from Afyon by a local supplier. The material decisions made depending on the suppliers' distance from the construction zone. The materials used from 1990 are still in use in the premises.

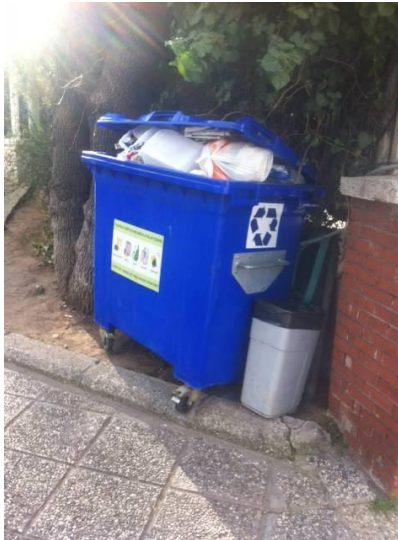
Figure 4.73 Waste Disposal Area

The waste management is done through the property assistants by collecting unit waste regularly and daily. The waste collected is put together in the garbage containers outside of the properties, which is then picked up by governing vicinity bodies. There is no spepration of waste and recyle, nor the waste disposal mechanisms.

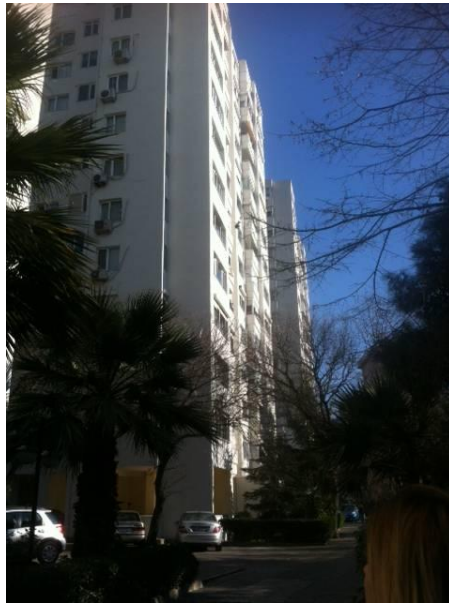
Figure 4.74 Symetric view of Sepas Sitesi

According to the property management, the grade of cement and steel is appropriate of the time's construction process. Even then, this does not constitute a guarantee of earthquake durability. One of the positive elements of the architecture is that the buildings were somewhat symetric and eliminates the possibility of uneven weight distribution. The building did not get any damages during or after 1999 Marmara Earthquake. Even then, considering today's factors, the complex is aiming to make reinforcing in order to prevent any future damages may occur through earthquake forces.

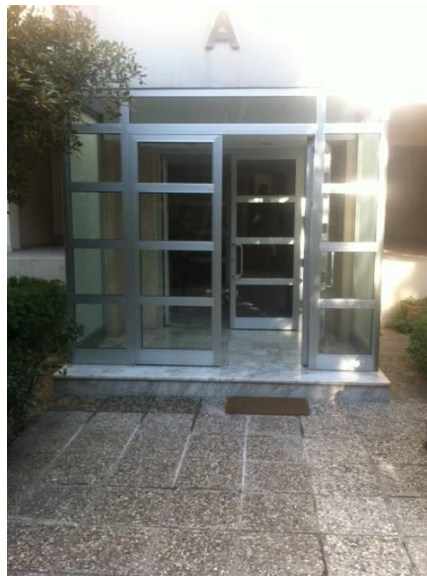
Figure 4.75 Entrance of Blok A Sepas Sitesi

When you look at the Sepas Sitesi generally, it is indicated that there are no efforts towards accessibility for wheel chaired individuals. There is no existing ramp at the entrance of the building, even though the entrance does not also consist stairs. It is noted that accessing the building with wheel chair is difficult and accessing the unit within the building is even harder. Furthermore the door is not automated which creates further complications for individuals with wheel chairs.
