**ANALYZING THE MULTI-STORY RESIDENTIAL BUILDINGS IN
TERMS OF SUSTAINABILITY, DISABILITY ACCESS AND
EARTHQUAKE DURABILITY; EXAMPLE PROJECTS FROM
1980-1990,1990-2000,2000-2013 PERIODS**

Department of Architecture

2014

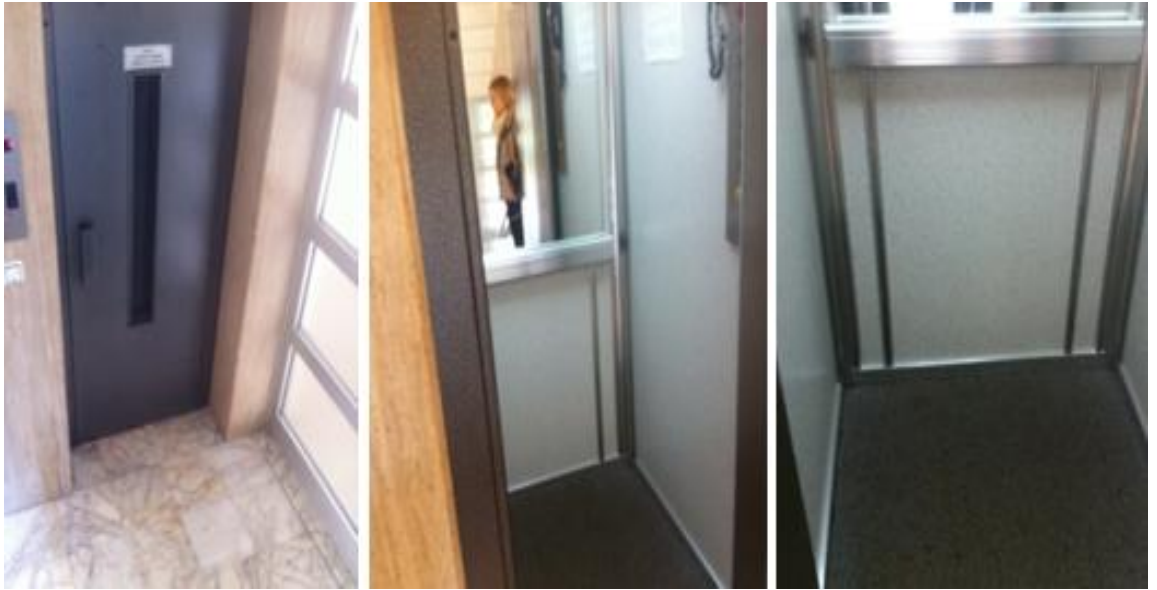
Figure 4.76 Elevators at Sepas Sitesi

There are two sets of elevators in each building at Sepas Sitesi. The measurements of the elevator cabins are 90 cm to 90 cm, which are below the required dimensions for the individuals with wheel chairs.

The doors of the elevators are not automated, which makes difficulties for individuals with wheel chair. The height of the cabins, on the other hand, is 106 cm, which is accepted level for elevators designed for disabled individuals.

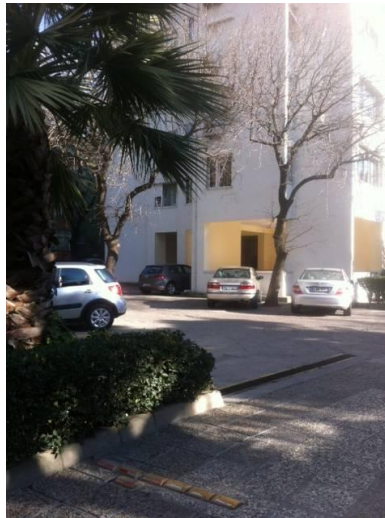
Figure 4.77 Parking Structure at Sepas Sitesi

At Sepas Sitesi, there is not a designated parking spot for disabled individuals. There is a 90-vehicle parking lot for the residents but there is not one for specifically designated for disabled individuals to be found. 2% requirement enforced by TS12576 cannot be witnessed in these premises.

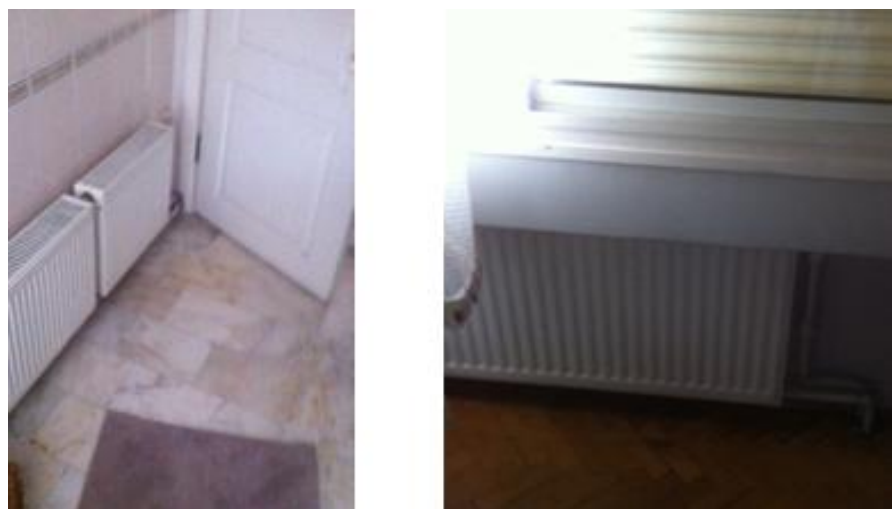
Figure 4.79 Heating Fixtures at Pamukkale Konutlari

At Mavisehir Pamukkale, the central heating that was installed during construction is still being in use with the fuel being coal. There is no existing technological temperature measurement for heating in the units, therefore the residents open windows when they feel it is too hot inside. Therefore the energy efficiency in heating is not even existing.

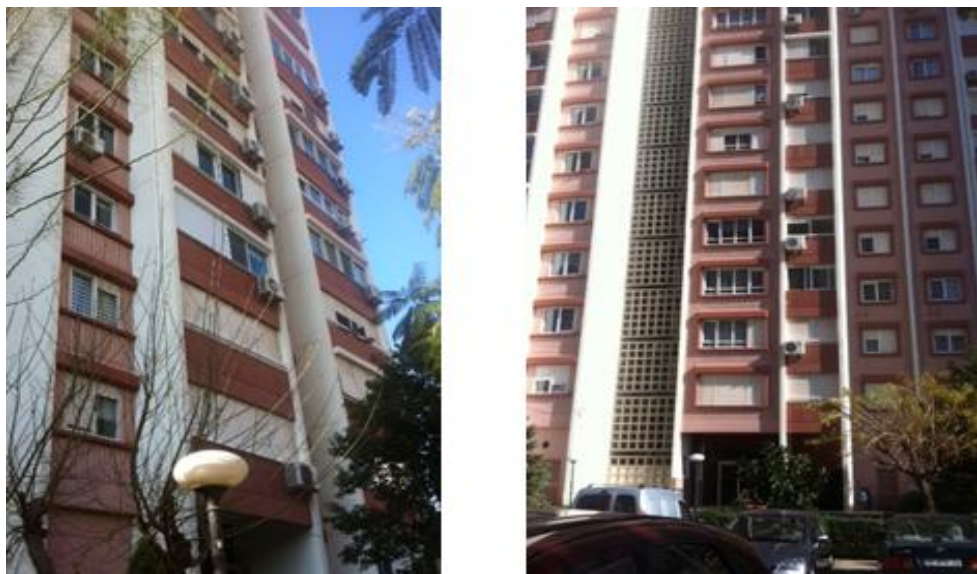
Figure 4.80 Outside Facades of AC Systems at Pamukkale Konutlari

As there is no central air conditioning system, air conditioning system at Pamukkale Konutlari, it has been observed in the building that facades has been observed externally in units. Due to the lack of central air conditioning system in the building, and each user's individual preferred like air conditioning energy savings is understood to be ignored.

There is designated spaces for outside facades and therefore the outlook of the building at least had been preserved.

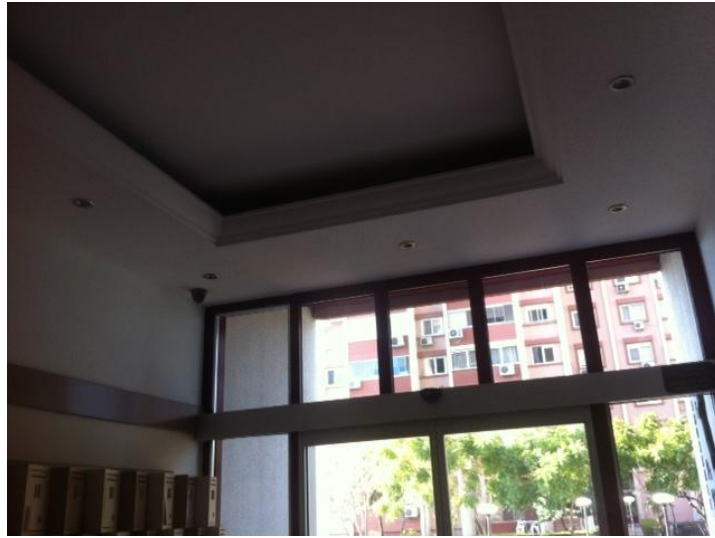
Figure 4.82 Spot Lights at the entrance of Pamukkale Konutlari

Considering that there is not enough natural lighting available in the building, there is continuous need for additional lighting, therefore energy consumption. It is noted that there is photocell lighting fixtures installed in the building. However the spot lights used in premises use high levels of energy and are against the initial efforts done towards energy preservation.

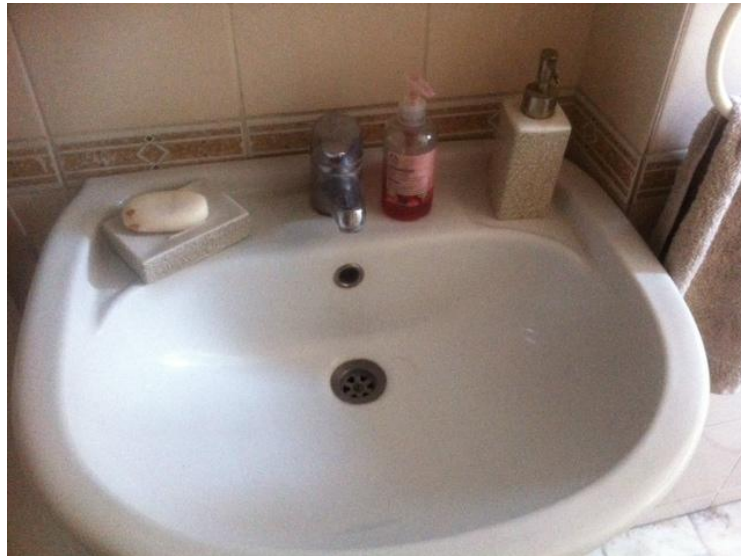
Figure 4.84 Bathroom Foccet at Pamukkale Konutlari

For the use of water efficiently, the foccets installed do the most work, and it shall be considered as only water preservancy effort found in the units.

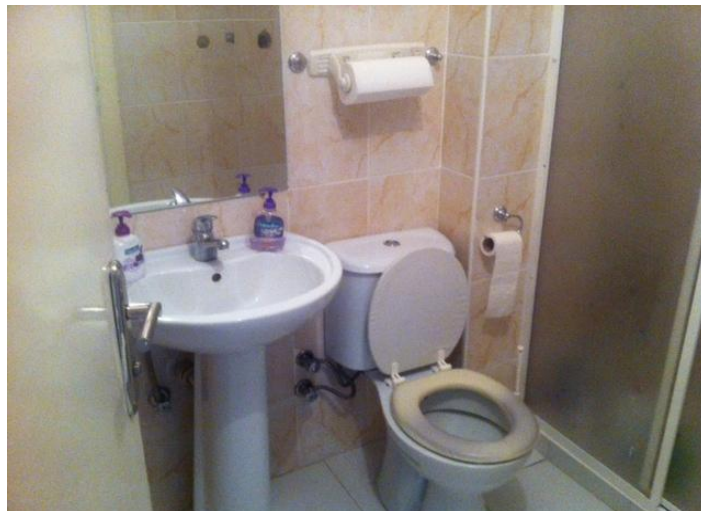
Figure 4.85 Bathroom View at Mavisehir

Even though majority of the residents upgraded to more up to date equipment in their units, it was observed that some still use the initially installed equipments. Therefore the water waste management is not existing in the premises.

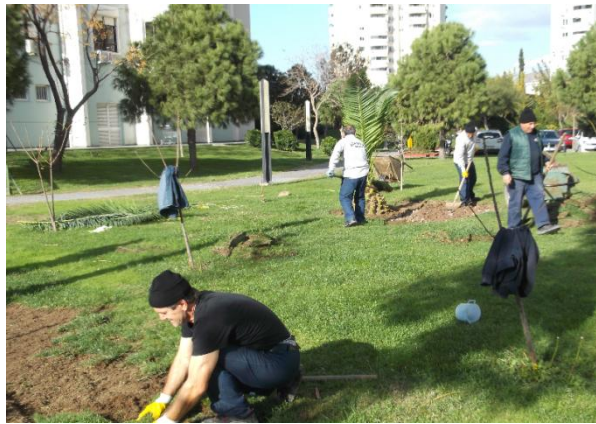
Figure 4.86 Garden View at Pamukkale Konutlari

There is no use of rain water in the premises. The garden watering is done through the gardener at the specified hours of everyday. Therefore there is an

ongoing waste of water in watering processes. Moreover, the management does not have any plans to automate the watering system.

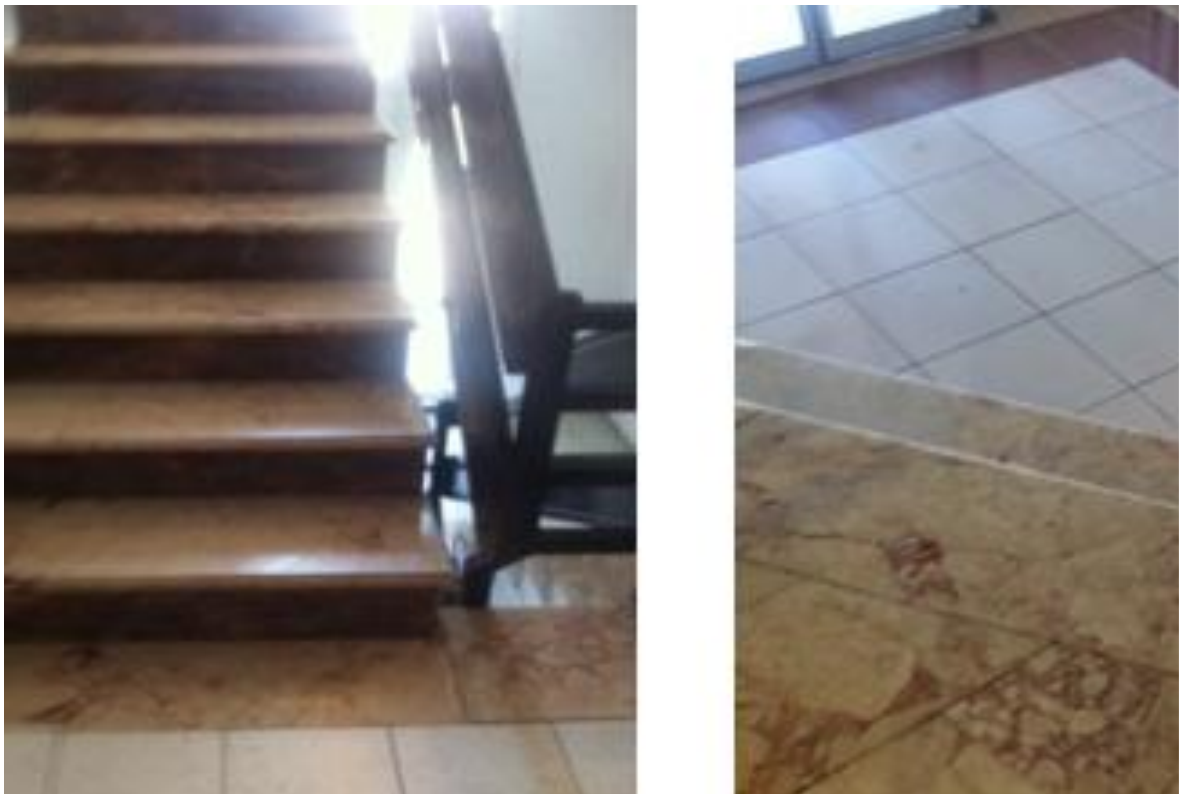
Figure 4.87 Marble and Ceramic use at Pamukkale Konutlari

There is quite a few materials that have been chosen during the construction locally. However the decision making did not happen considering sustainability but it was made due to cost effectiveness.

The marble was used for the stair and the flooring was done with ceramics. The railings were made out of wood and all these materials were supplied locally.

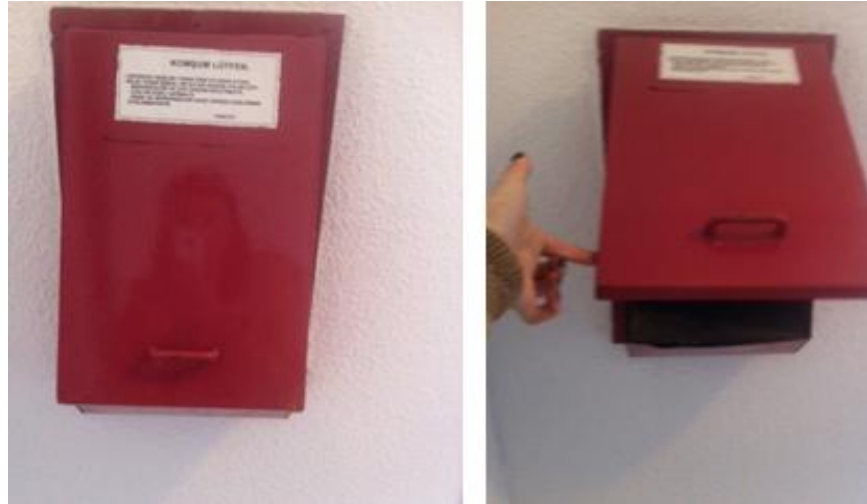
Figure 4.88 Garbage Shutes at Mavisehir Pamukkale

There is no waste management system in effect at the buildings. The tubes used for garbage disposal was installed and the garbage is collected in the garbage rooms, then collected garbage is disposed by the municipality garbage trucks.

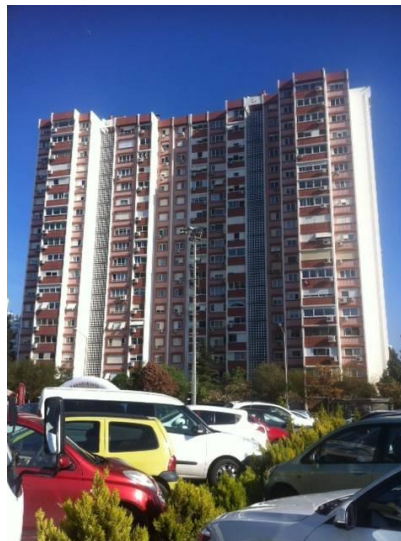
Figure 4.89 Outview of the Apartment Complex at Mavisehir

The building was designed symetrically and the occupancy levels were aligned with the necessary distribution model. Therefore this does not indicate any risk for earthquake durability. Pamukkale Mavisehir Konutlari was built Emlak Bank A.S and the inspection was done in 90's by the third party companies, therefore there is no recent inspection regarding to earthquake durability in the buildings.

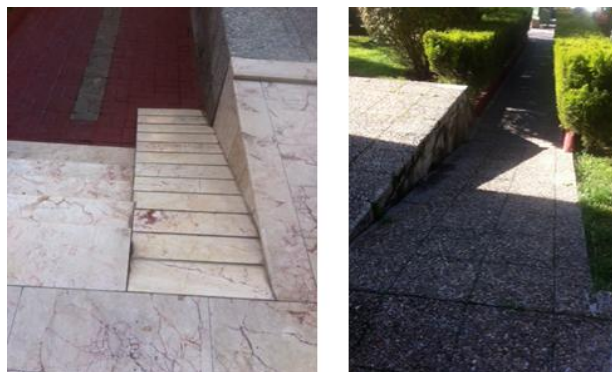
Figure 4.90 Entrance Ramps at Pamukkale Mavisehir

At the premises, there is partial consideration towards disabled accessibility. The ramp can be found at the entrance doors and path to the entrance is designed with 2 meters wide, which should allow any wheel chaired individual to travel through. The opening at the end of the ramp, by the door is big enough for individuals with disabilities to maneuver.

However there is no use of railing in the ramps. The width of the ramp as well as the slope is not acceptable considering the minimal requirements for disability access standards. The slope was found to be more than 10% and the width is less than it should be (70 cm.)

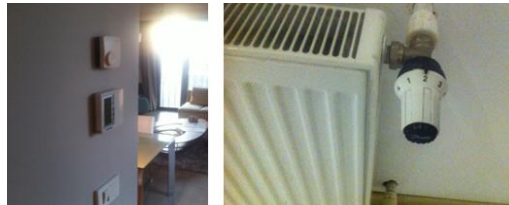
Figure 4.95 Automation and Smart Heating

At Elysium, the efficient energy usage for heating is dealt with individual heating systems. Each unit is responsible for their heating needs and the amount of heating they use. The residents would pay according to their usage. The type of fuel used is natural gas. There is an automation systems in place for the temperature levels which allows the building itself to auto control the amount of energy being used for heating, cooling and ventilation.

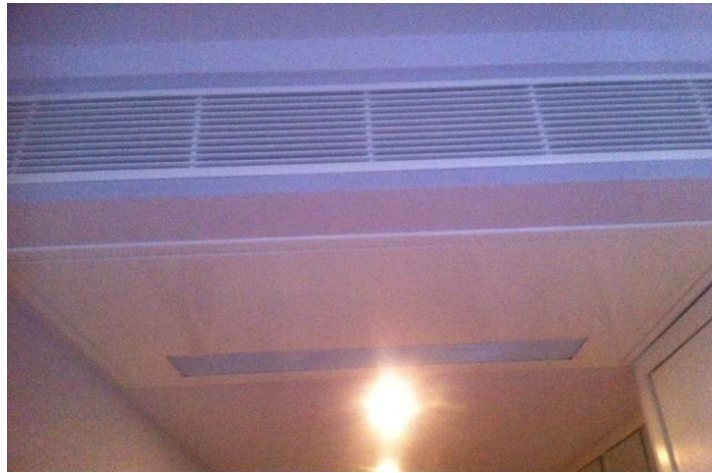
Figure 4.96 Cooling System is designed aesthetically

There is a systematic cooling systems in place for each unit; the outside units are prelocated and designed according to the building architecture. Since the cooling systems were placed during construction, they were all placed with A+ energy preserving electronics.

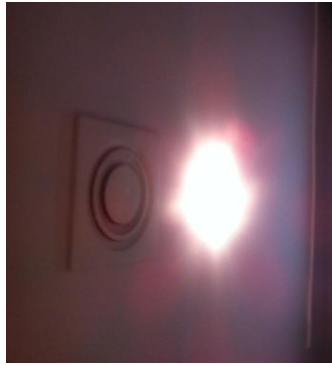
Figure 4.97 Bathroom ventilation Unit

In the building, there is a window in every room. This gives possibility of controlling the air ventilation and natural airing options. Besides this, there is a ventilation system in the bathrooms. The back draw of this situation is that usage of tobacco in one bathroom can be felt and smelt from another unit. This is one of the biggest concern for the tenants.

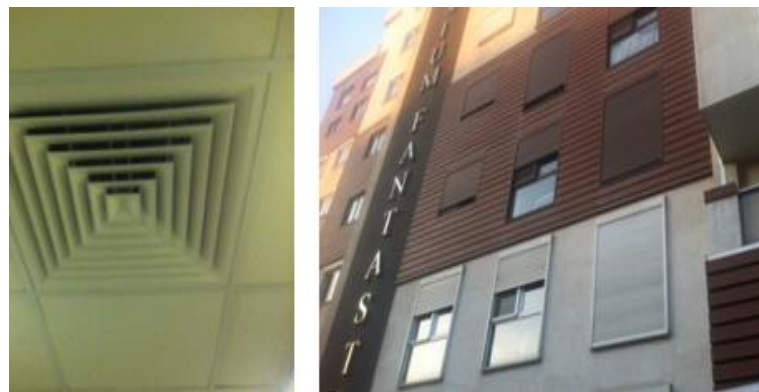
Figure 4.98 Blind System's outlook and hallways ventilation

Moreover, there is an automated blinds systems existing. Thus, they can use to block sun during the summer months and maintain the heat of the room and save energy relatively. Within the building, there is no designed natural lighting options. Though there is still designed indoor ventilation systems existing in the hallways and entrances.

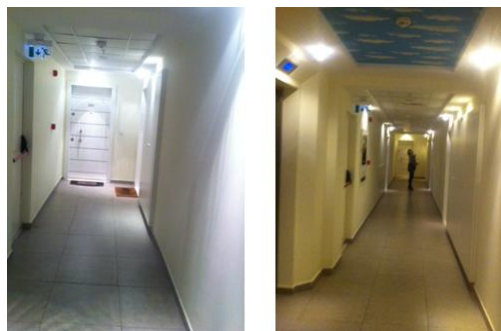
Figure 4.99 Lighting and LED Bulbs

There are energy conserving lighting fixtures are in use in Elysium Fantastico Bomonti. The entrance of the building has automated lighting fixtures in order to eliminate waste of energy consumption. The fixtures used in the building are all top brands in their fields and all are up to date.

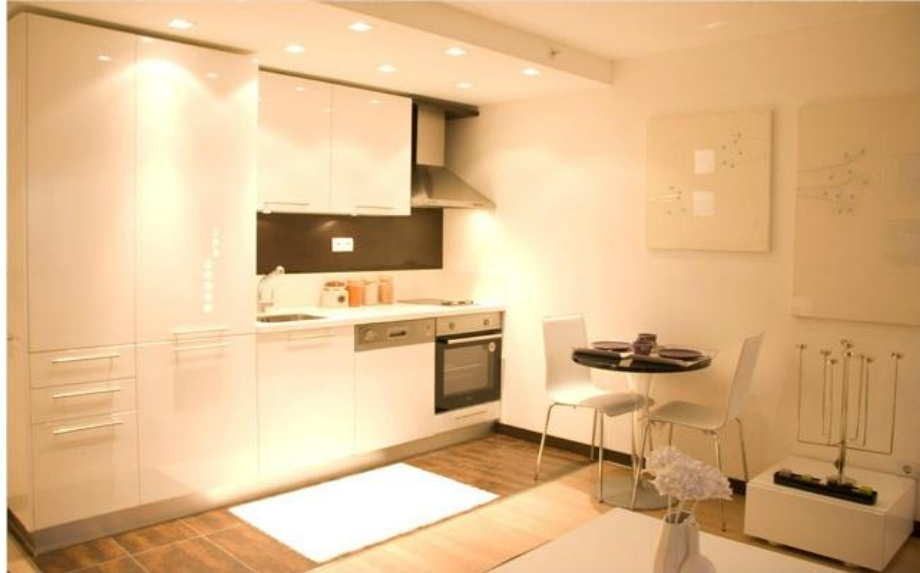
Figure 4.100 Built-in Kitchen Fixtures

Within the units, built-in kitchen fixtures, oven and fridge were placed during construction therefore the A+ energy saving modules were chosen. The fixtures found in the units are up to date and the most modern and efficient ones found in today's market place.

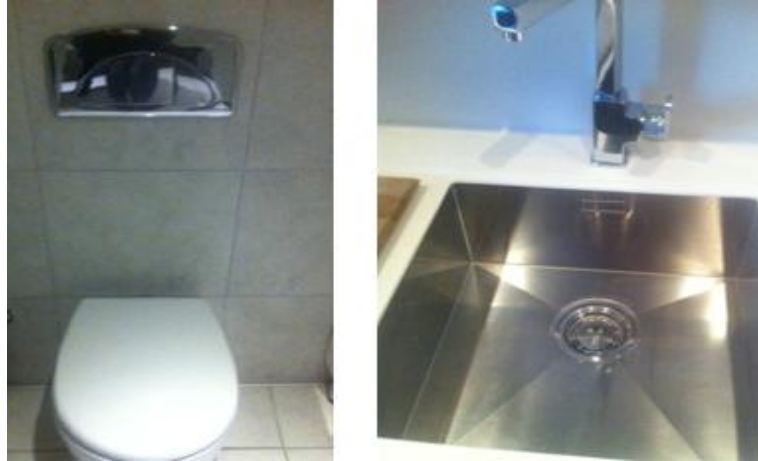
Figure: 4.101 Reservoir, flush system, faccets

In order to use water effectively and eliminate the waste, the fixtures used in units are all top of their line and certified efficient ones. In the units, staged watering toilets have been placed. While normal flushes would come with one option and use of 4 lt. Of water at once, at Elysium, two stage flushing was initialized, depending on the waste 2 lt or 4 lt water can be flushed down. This would automatically eliminate the waste of water. In the units, the faucets and the showers were designed to preserve waste of water. The Blanco brand fixtures are currently known to be the most efficient in their field.

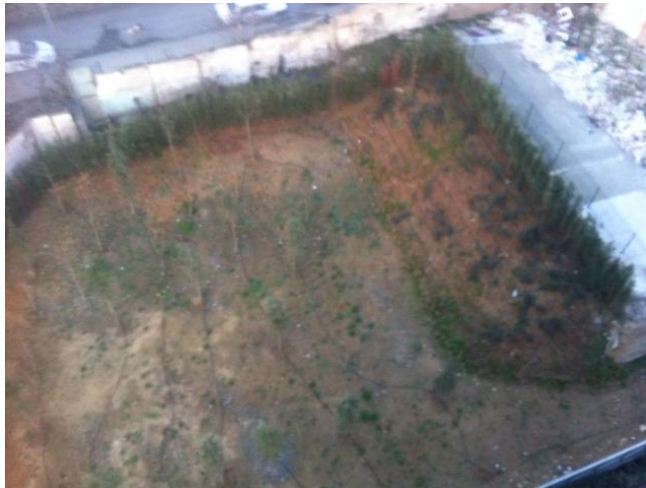
Figure :4.102 Dripping Watering system of the green space

There is project related to save of rain water at the facilities. The watering of the green spaces are done automatically, at designated hours. This would save the amount of water used in operations. Furthermore, the watering is done with dripping technique.

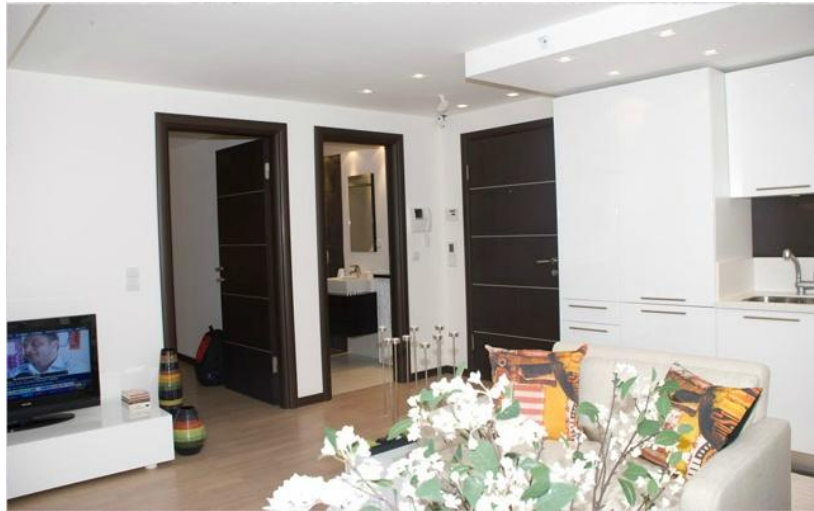
Figure :4.103 Room Material usage

The effective use of materials have been accomplished by using national materials in stairs and bathroom ceramics, wood flooring and building entrances. But for the rest international materials have been used.

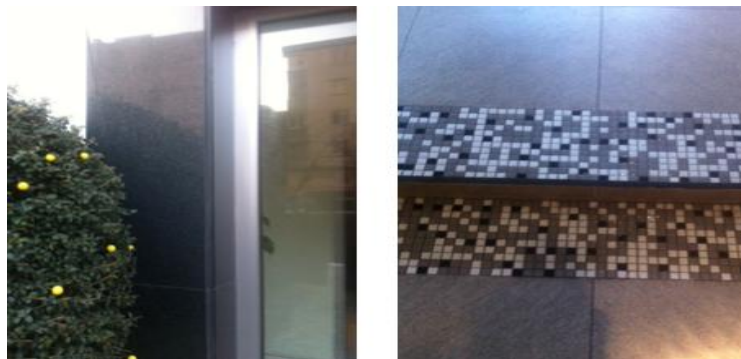
Figure 4.104 Use of stones and tiles in the premises

Use of wood is witnessed in living room and bedrooms. The wood used for flooring is described as 1st class flooring. Turkish natural stones are known to be world famous and Elysium Fantastic Bomonti used some of these stones in their mazaic and ceremic designings. The entrance is designed with using granite stones.

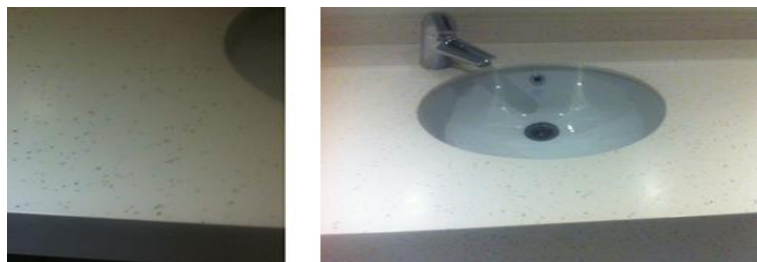
Figure 4.105 Acrylic Countertops in Kitchen and Bathroom

The waste management started from inside of the units and carried out to the property as a whole. In the kitchen and bathrooms, the recycled material have been used, the acrylic counters were visible.

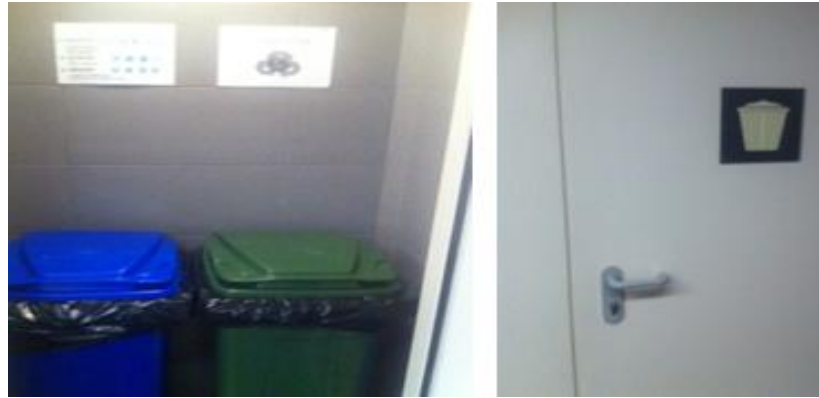
Figure 4.106 Waste Management Rooms and Separation Bins

The waste of units are being collected in the waste rooms located in each floor. The attendants will then deliver these wastes to the vicinity waste management truck in designated days of the week. Moreover, there are separation of waste in certain designated rooms within the premises. The importance of waste management can be witnessed in the premises.

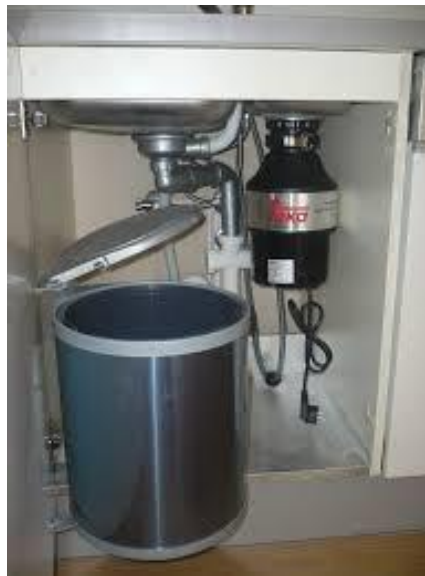
Figure 4.107 In Unit Food Disposals

There are food disposal units installed in each unit. This would reduce the amount of waste and decrease the amount of food being disposed, relatively reduce the amount of pest management.

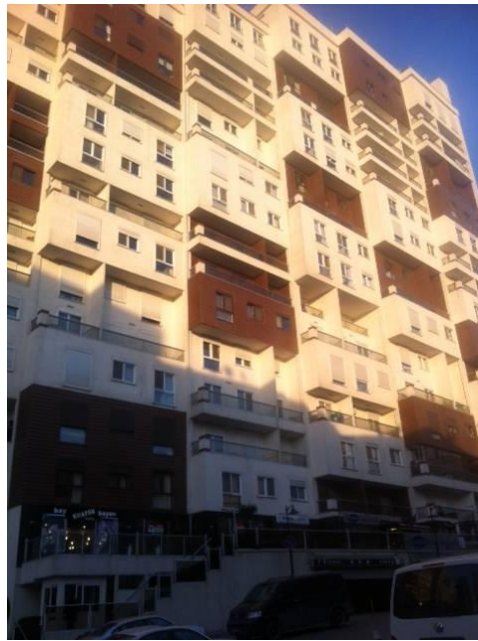
Figure :4.108 Elysium Story level Outside View

The carrier system colons must have consisted of steel enforced concrete beams that are at least C30/40 quality measurement is indicated in the construction technical specifications. The story level of the building is chosen depending on the development level and flooring capabilities for the foundation needs.

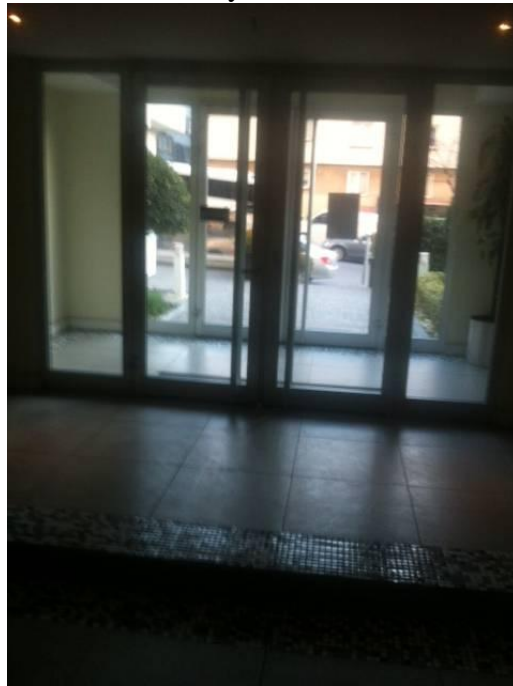
Figure 4.109 Elysium Fantastic Building Entrance

When investigating Elysium Fantastic with terms of accessibility, the building is suitable for individuals with wheel chairs. There is a ramp in the entrance for these individuals to access to building with ease. The open space in front of the building is optimal for individuals with wheel chairs (250 cm. Also, this measurement will allow the individuals to make necessary maneuvers. The doors

are not automated doors but can open easily with a button for disabled individuals. Also the door handles are designed to be 90 cm high from the ground in order to allow these individuals to reach out easily.

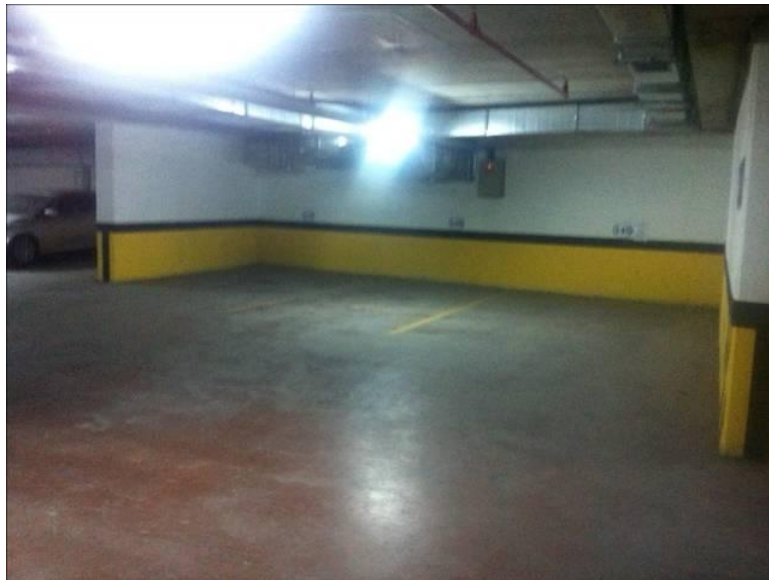
Figure 4.111 Parking structure for disabled individuals at Elysium

The parking structure is designed to be aligned with the needs of disabled individuals. There are quite a few disabled parking spots available for use. The disabled parking spots are designated to be closer to the building entrances in order to accommodate the needs of these tenants and guests. The parking spaces for disabled individuals are designed to be 350 cm by 500 cm, which is within the standards of disability accessibility.

The 2% quota required by TS12576 can be found in this premise, actually carrying more than 4% of the parking spots being reserved for disabled individuals.

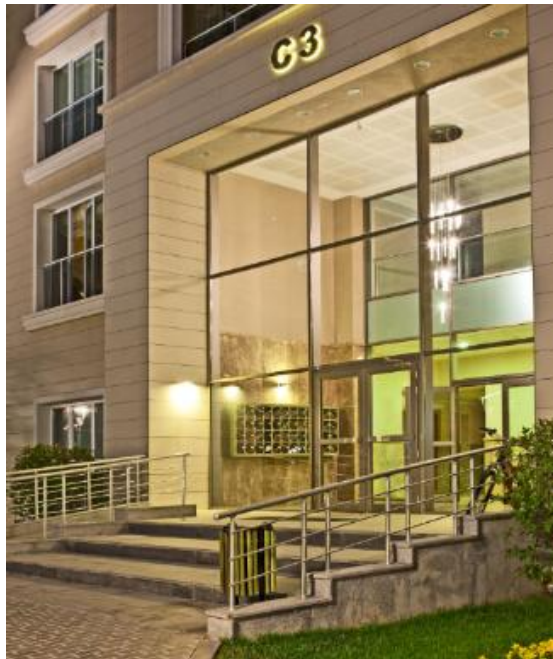
Figure 4.114 LED Lighting at the entrance at Metrokent

Inside the building, there is no natural lighting and air ventilation, therefore there is an automated ventilation and AC system intact. There are energy conservant lighting and bulbs are in use. At the entrance of the building, photocell sensed lighting is being used to eliminate the waste of energy.

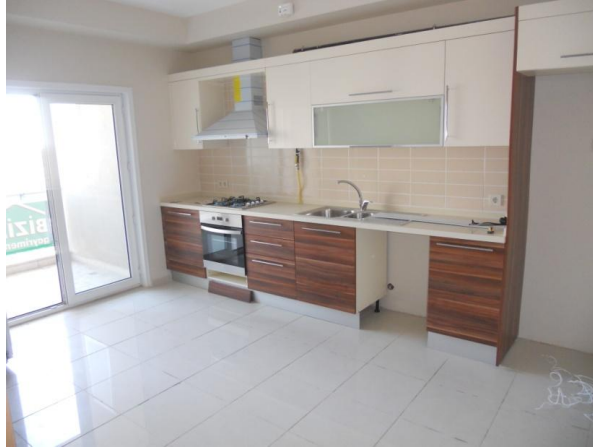
Figure 4.115 Built-in Kitchen Fixtures at Metrokent

In the units, there are built-in paddle box, oven, and stove in place, the A+ grade energy preserving equipments. With this way, the building aims to reduce the energy usage within the units as well as the commonly used apartment spaces.

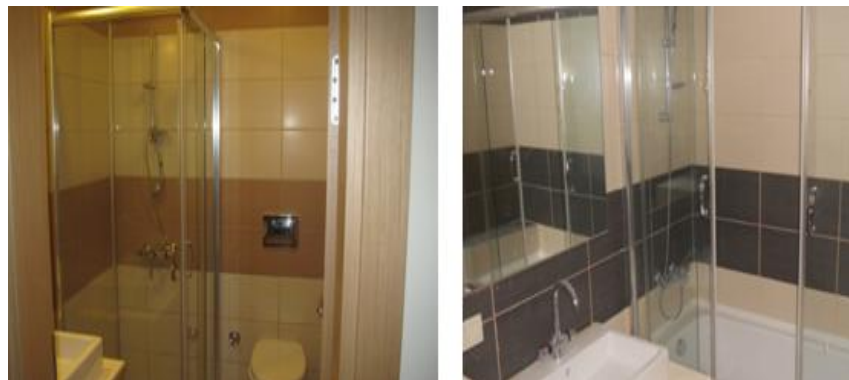
Figure 4.116 Bathroom Equipments to save water at Metrokent

In order to use water efficiently, the building is equipped with luxury class fixtures and branded equipment. The two staged reservoir system can be witnessed in the premises. The stage one uses 4 lt. of water while the stage two reservoir uses 6 lt. of water. The showerheads and foccets placed in the units are aiming to save water and reduce the waste as well.

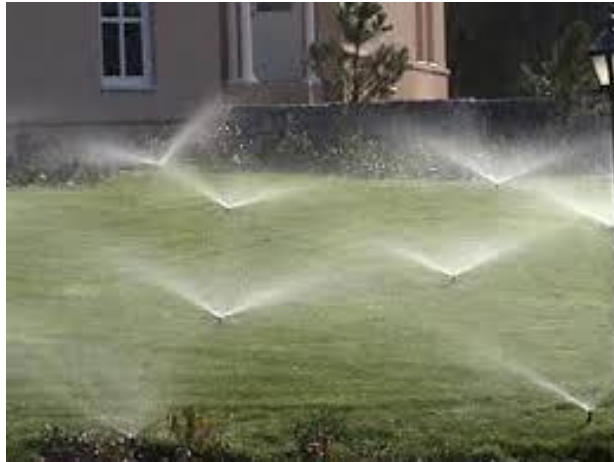
Figure 4.117 Water Sprinkle System at Metrokent

There is no existing work towards saving rain water. The use of retained rain water explained to be very expensive system to set up and therefore even many new properties do not maintain a rain water circulation systems just yet. In the premises the garden watering is done automatically, at the hours predesignated. The sprinkler system is used to water the green spaces.

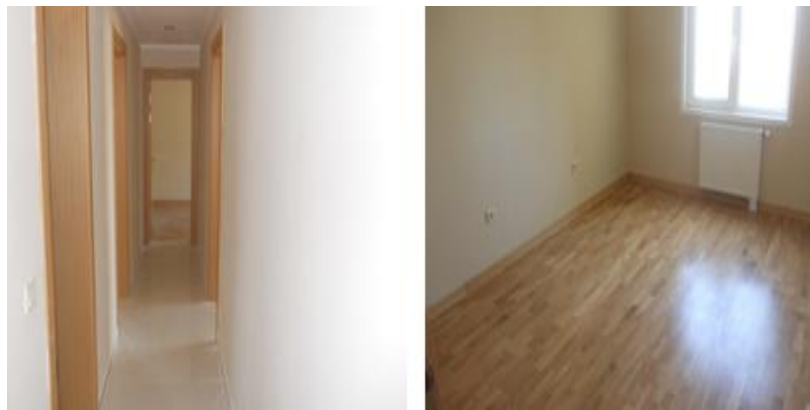
Figure 4.118 Wood Flooring and the Wood door structures at Metrokent

The materials used in the permises are mainly up to date foreing luxurious materials. Only at the entrance hall, stairs and bathroom ceramics, wood flooring, and the door structures are supplied locally.

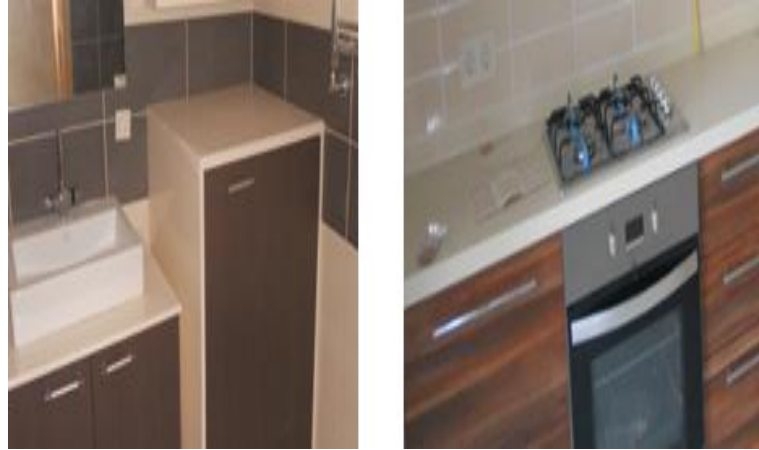
Figure 4.120 Acrylic Countertops at Metrokent

The waste management is done not only through reducing the waste of consumed goods, but it is also done by using recycled materials in the construction. In kitchen and bathrooms, recycled materials have been used such as acrylic countertops.

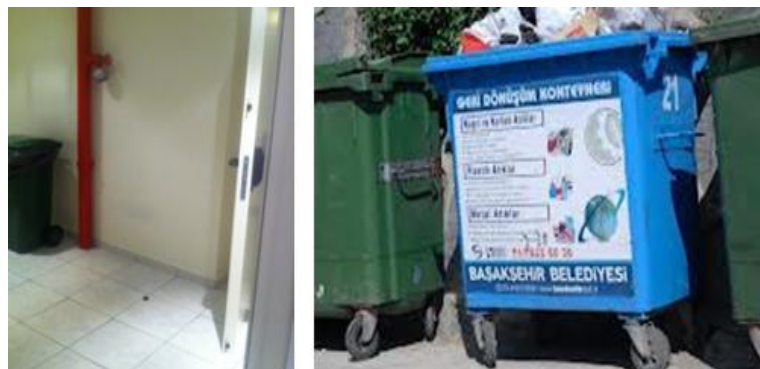
Figure 4.121 Waste Management at Metrokent Basakşehir

The waste management in the building done by collecting unit waste at specified hours of every day by the building attendants. Attendants then deliver these to designated waste areas. The waste then collected by the municipality garbage trucks. The municipality also provided recycling bins for the residents to save recyclable waste but the building does not enforce on recycling.

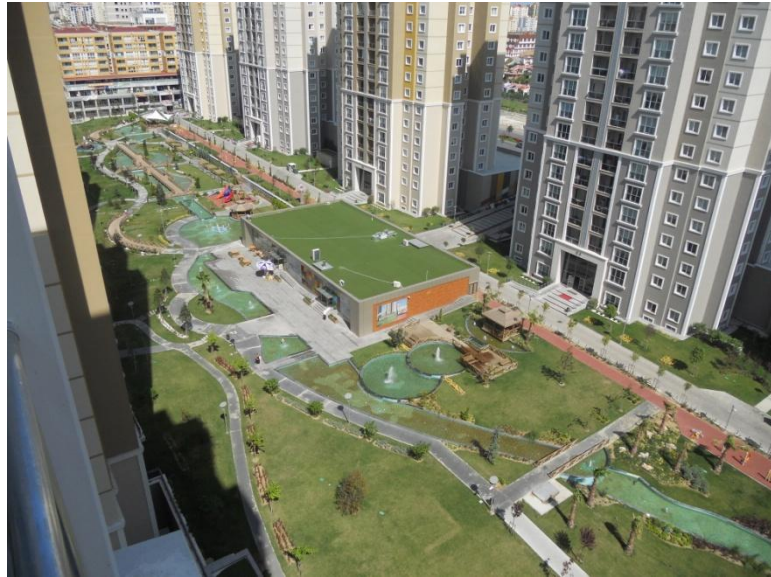
Figure 4.123 Designated Emergency Meeting Space

The transportation around the housing complex allows any search and rescue efforts to be completed accordingly. Also, the building consists of necessary emergency exits and emergency meeting areas in open spaces.

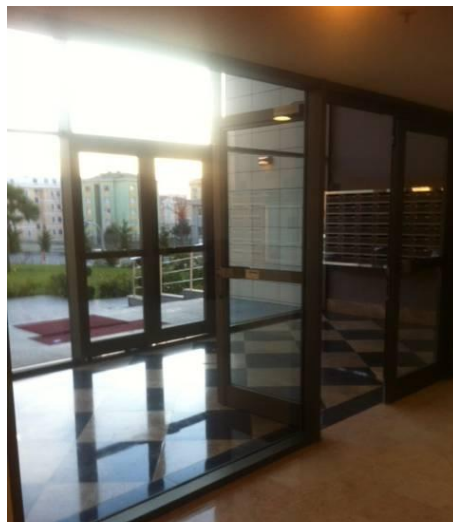
Figure 4.124 Building Entrance at Metrokent

When analyzing the Metrokent buildings, it is noted that the all necessary steps for disability access has been taken into an account. According to the measurements done on sight, there is a ramp available at the entrances and the open space on top of the ramp is 220 cm and it allows the individuals with wheel chair to operate and maneuver with ease. The entrance doors are designed to push through and open inside. This allows the individuals to access in easily.

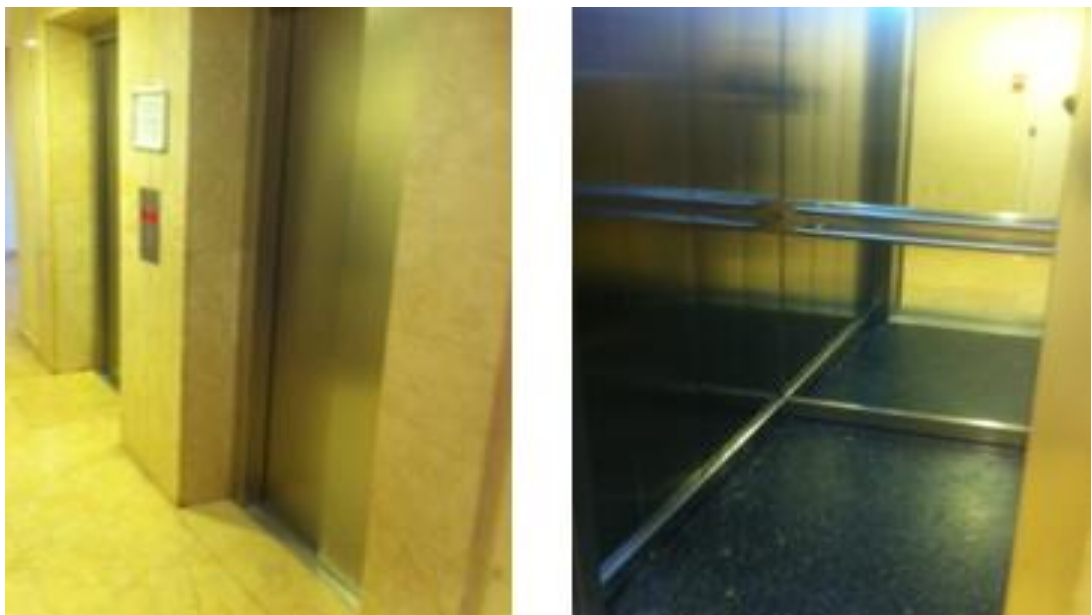
Figure 4.126 Elevators at Metrokent

There are two elevators in the each building. The dimensions of the elevators are 150 cm to 150 cm and the doors are automated, which are both suggested elements of disability access. The width of the elevator doors are calculated to be 100 cm and the handlebars inside are 95 cm high.

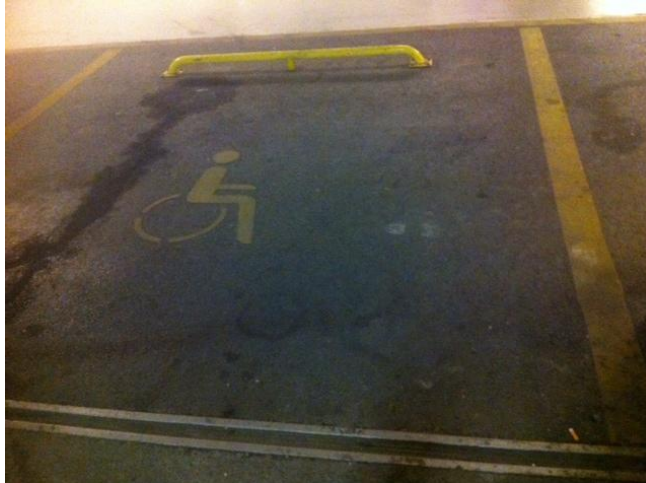
Figure: 4.127 :Designed parking space for disabled residents at Metrokent

The parking area in the facility is designed to allow individuals with disabilities to operate vehicles easier and it makes transportation to and from the parking lot with the least efforts. The dimensions of the parking spaces are designed to be 350 cm by 350 cm, which are the recommended space dimensions.

There are enough number of designated parking spaces witnessed on premises; therefore it does not occur to be more than 1 designated parking space for each building aty the moment.

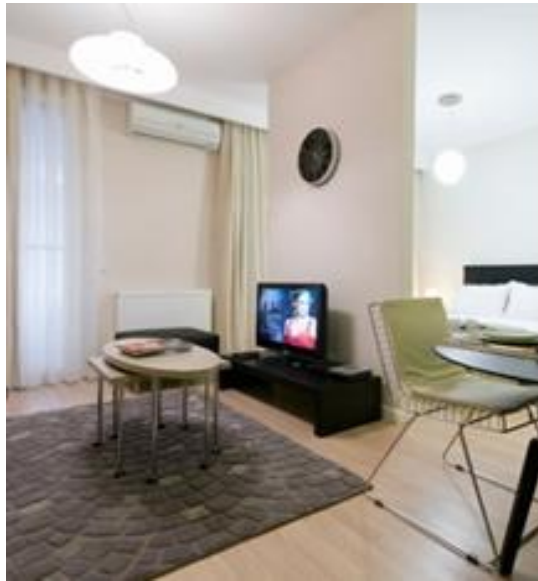
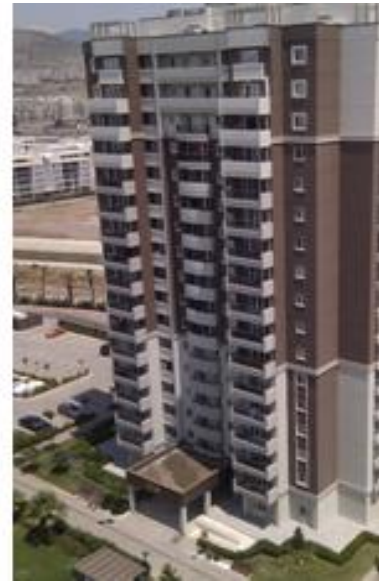
Figure 4.129 The AC Systems from Inside and Outside of the Units at Mavisehir

There is preinstalled AC systems in units for AC cooling. Therefore the outside units of the AC equipments are also pre located in the balconies. The AC equipment installed by SOYAK was chosen as R410A type A+ energy efficient; that does not damage the Ozone plate.

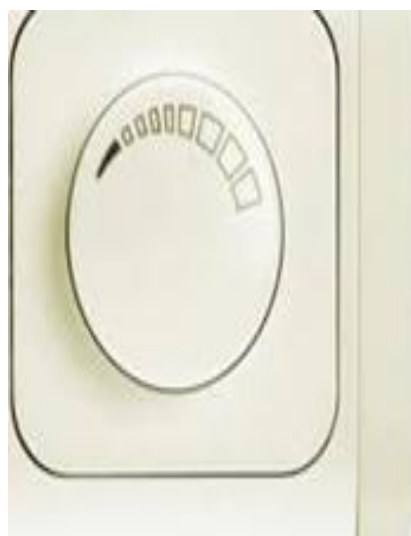
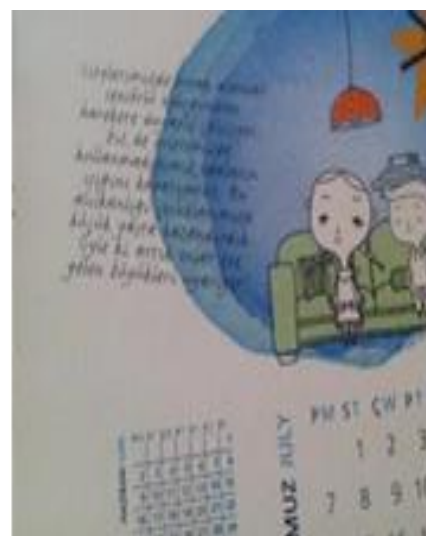
Figure 4.130 Dimmer and Lighting Directions at Mavisehir

The building uses energy efficient light bulbs and fixtures. There are dimmers installed in the units and the residents can control the level of light they use as well as the energy they waste.

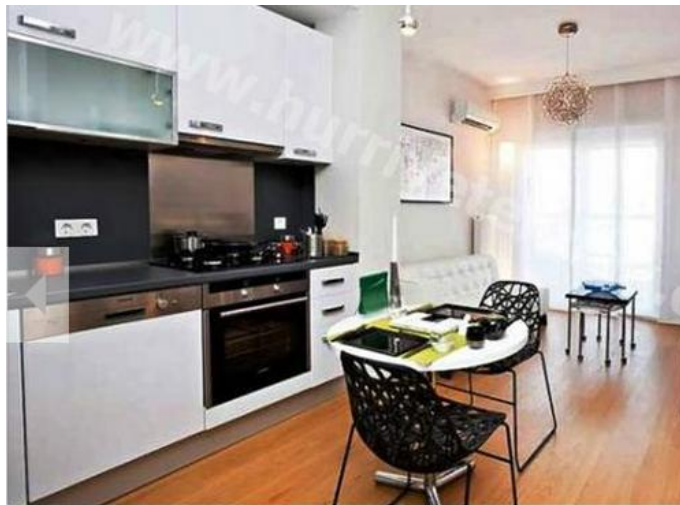
Figure 4.131 Pre Installed Kitchen Equipment at MAVisehir

In units, the pre installed equipments such as ventilation hood, oven, stove were chosen to be A+ energy efficient.

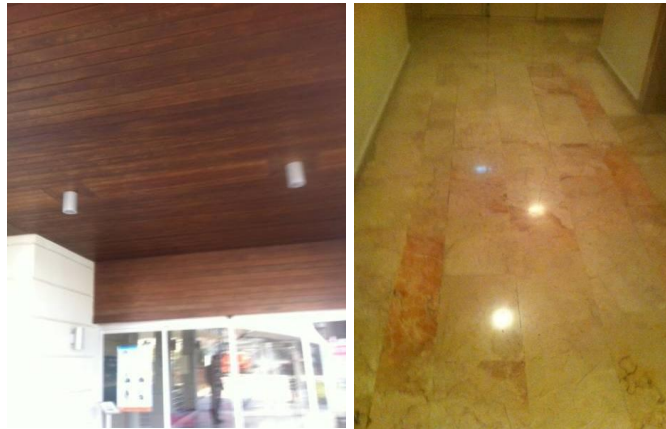
Figure 4.136 Stones used in the Building at Mavisehir

It is well known that the natural stones found in Turkey are precious and they were heavily used in the buildings both for sustainability factors and aesthetics.

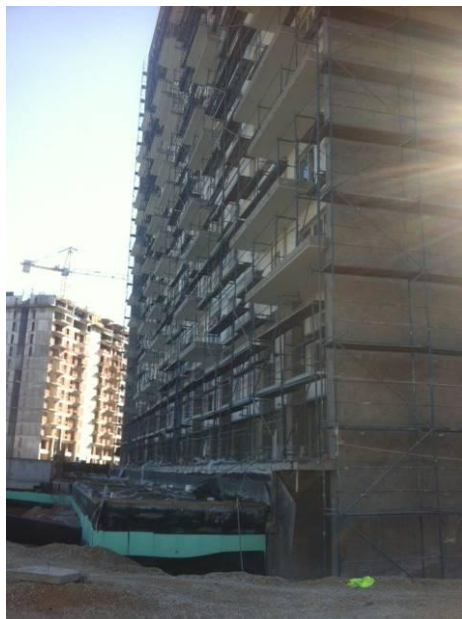
Figure 4.138 Concrete Support System at Mavisehir

The ground consists of 6 to 7 meters of dirt and deeper than 7 meters is consisted with swamps and partially rocks. Therefore during the construction, the stability was achieved by using concrete support systems horizontally aligned at the base of the construction. Considering that the ground is susceptible for moisture, 80 fore collons have been placed as well.

The structural design and the amount and degree of steel quality and concrete level is accordance with the requirements. The amount of stories available on premises is allowed by the government and considered safe for the structure. The symetric design and the weight distribution allows buildings to be stable in case of sysmic movements.

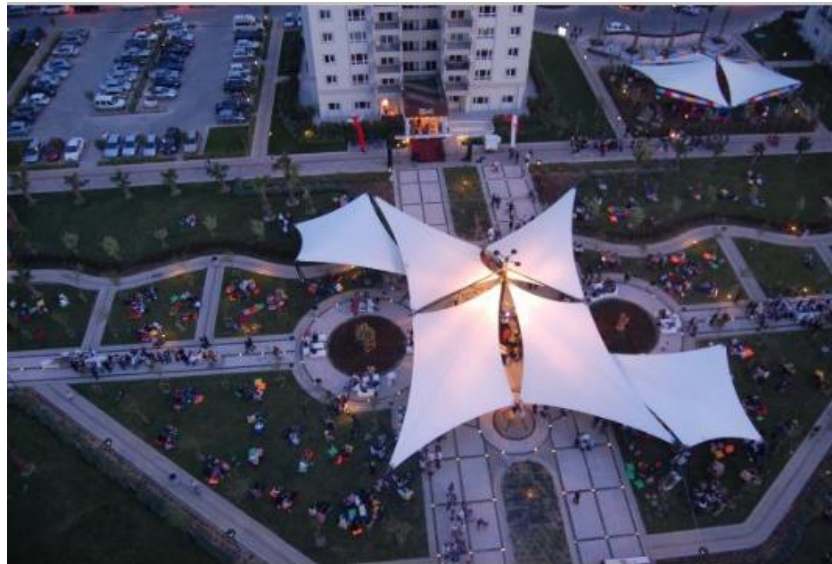
Figure 4.139 Meeting Area for Emergency Situations at Mavisehir

During the construction phase, the engineering firm PMD has consulted SOYAK to make sure all the components are earthquake safe. Last but not least, the earthquake evacuation and meeting areas have been designated and all the necessary transportation areas are present for any search and rescue team that might be in need.

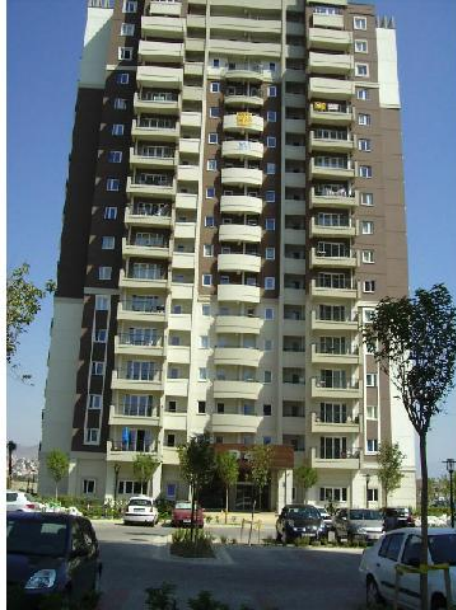
Figure 4.140 Building Entrance at Mavisehir

When investigating the building, the availability of the necessary tools for disability access is found to be present. There is a ramp existing at the entrances, the open space at the end of the ramp is suitable for individuals with wheel chairs to make maneuvers. The entrance doors are found to be automated and sliding which enables accessing with ease for wheel chaired individuals.

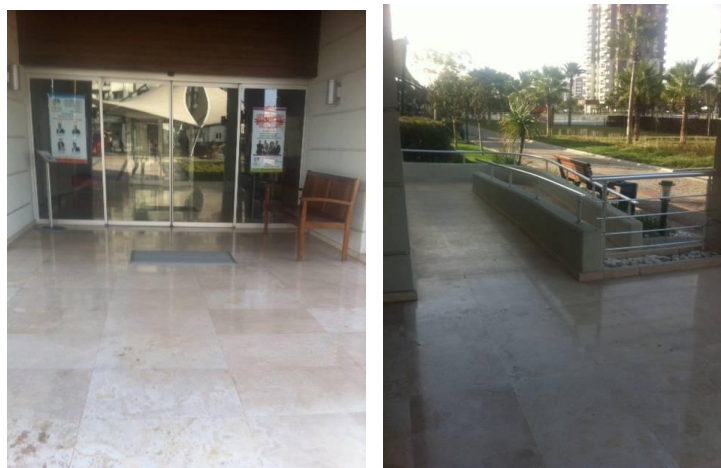
Figure 4.141 Entrance of the building and Railings at Mavisehir

After entering the building it was indicated that there is an automated lighting fixtures in use. The ramps used in the premises are 110 cm wide and that are aligned with the standards, same as the slope of the ramps which were found to be 6%.The railings used on the sides of the ramp to be found effective for disability use. Width of the entrance door is 180 cm which is enough for any wheel chair to get in and out.

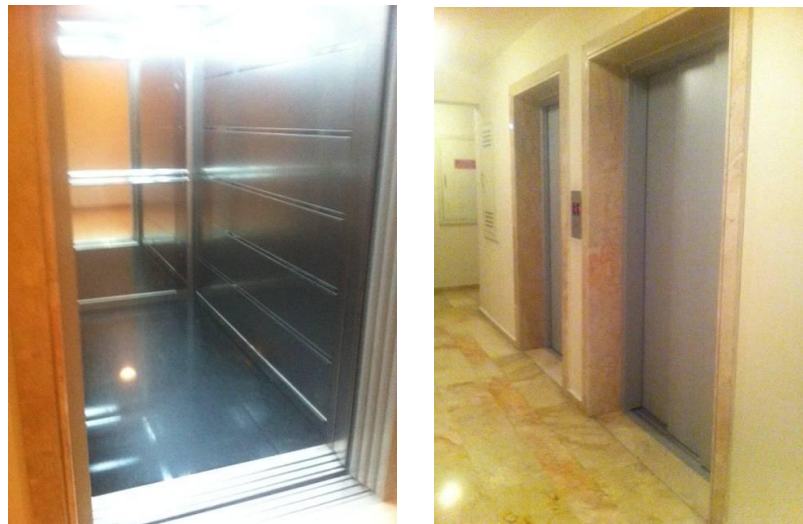
Figure 4.143 Elevators at Mavisehir

There are two elevators in each building. The dimensions of the elevators are found to be 160 cm to 140 cm with 10 person capacity. The dimensions are

found to be acceptable for disability access. The elevator entrance is 100 cm wide and the railing exists at 87 cm high from the floor, which are both acceptable for the disability access as well.

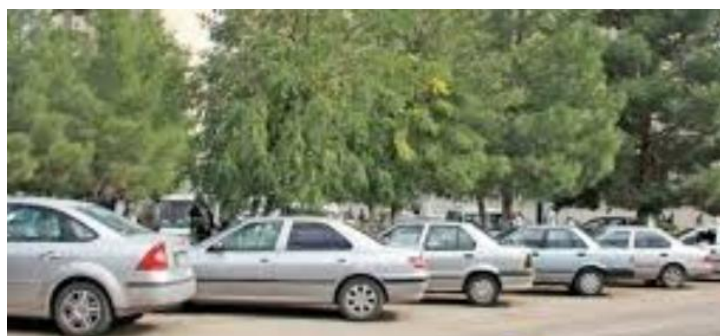
Figure 4.144 Disability Parking Spaces

There are enough and appropriate parking spaces reserved for disability uses. The reserved disabled parking spaces can be found at the closest locations to the entrances and the 2% allowance requirement has been met by the building.
