YASAR UNIVERSITY
INSTITUTE OF SOCIAL SCIENCES
MASTER IN TOURISM MANAGEMENT
MASTER THESIS

THE ASSESMENT OF MUSEUMS IN IZMIR IN REGARDS TO ACCESSIBILITY

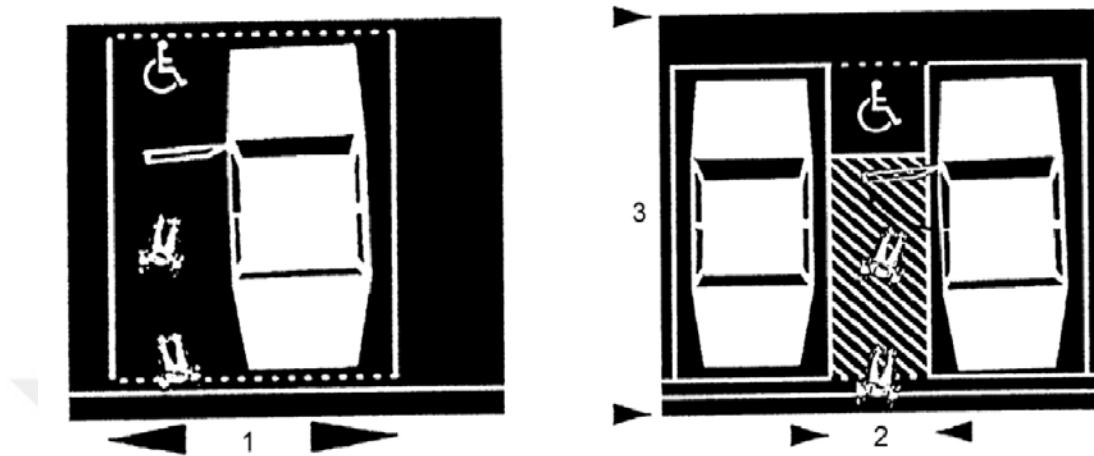
Figure 3: General Measurements of Parking Area

1- 4000 mm 2- 1500 mm 3- 6000 mm (TS 9111 4.4.1. Figure 10)

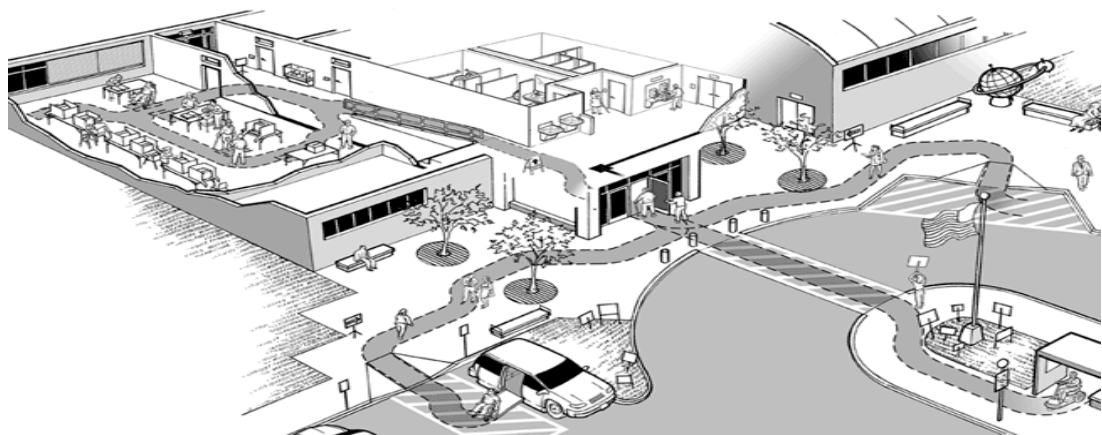
Figure 4: Sample of an Accessible Route to Buildings

Entrances required to be accessible should be part of an accessible route. Such entrances should be connected by an accessible route to public transportation stops, to accessible parking and passenger loading zones, and to public streets or sidewalks if available. They should also be connected by an accessible route to all accessible spaces or elements within the building or facility (ADA Guidelines 4.14.1.).

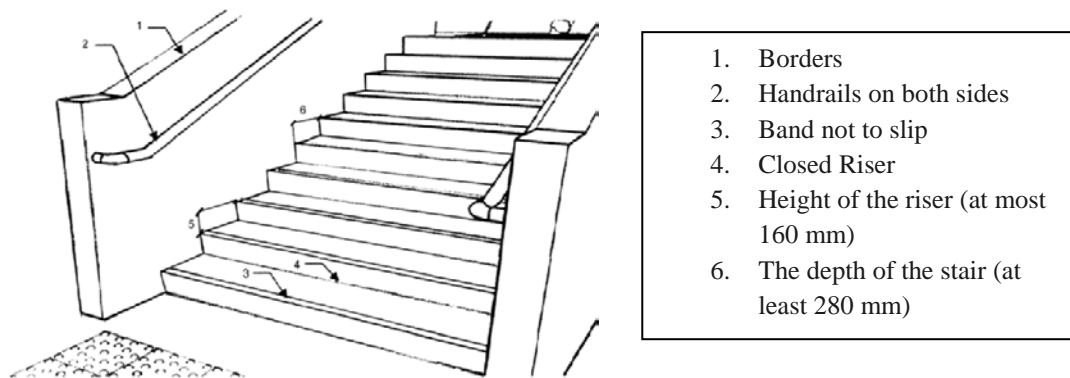
Figure 5: Features of Accessible Stairs (TS 9111 4.7.1.3.1 Figure 57).

There should be perceivable surface on the beginning (600 mm) and the end (600 mm) of the stairs (TS 9111 4.5 figure 27). There should be hard, matte and non-slip surface on the stairs. The depth of the stairs should be at least 280 mm and height of the stairs should be at most 160 mm. There should be band on the front of each stairs not to slip (TS 9111 4.7.1.3.1). Stairways should have handrails at both sides of all stairs (ADA Guidelines 4.9.4.). Handrails should be continuous along both sides of stairs (ADA Guidelines 4.9.4.(1)).

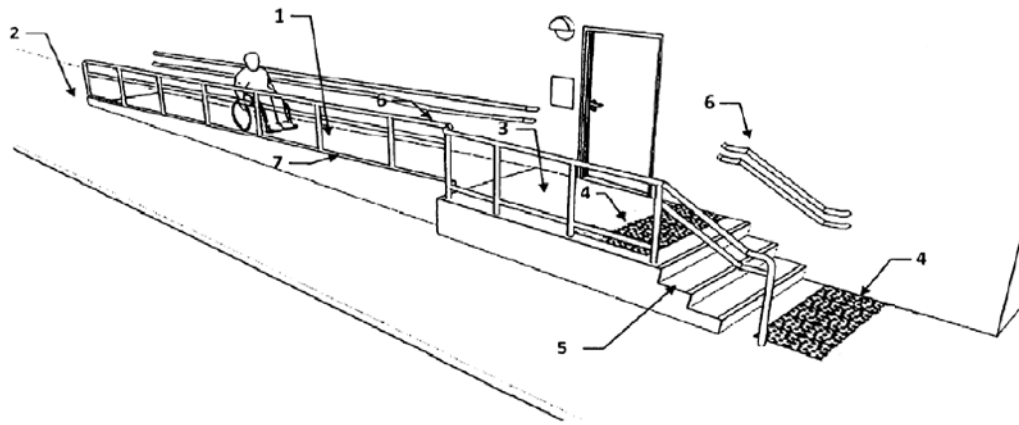
1. Slope of the ramp (at most %8), width of the ramp (915 mm)
2. Stairhead
3. Maneuvering space 1500 mm x 1500 mm
4. Perceivable surface on the beginning (600 mm) and the end (600 mm)
5. Accessible stairs and stairs' band not to slip
6. Handrails on the both sides of stairs
7. Minimum 50 mm high curbs

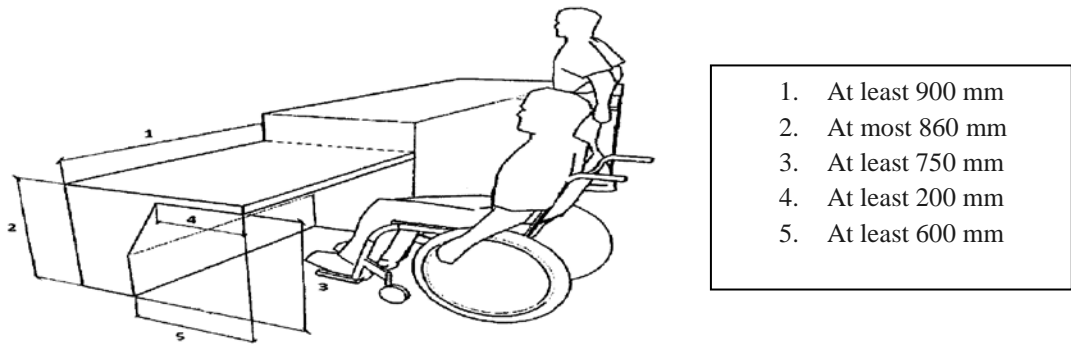
- 1. At least 900 mm
- 2. At most 860 mm
- 3. At least 750 mm
- 4. At least 200 mm
- 5. At least 600 mm

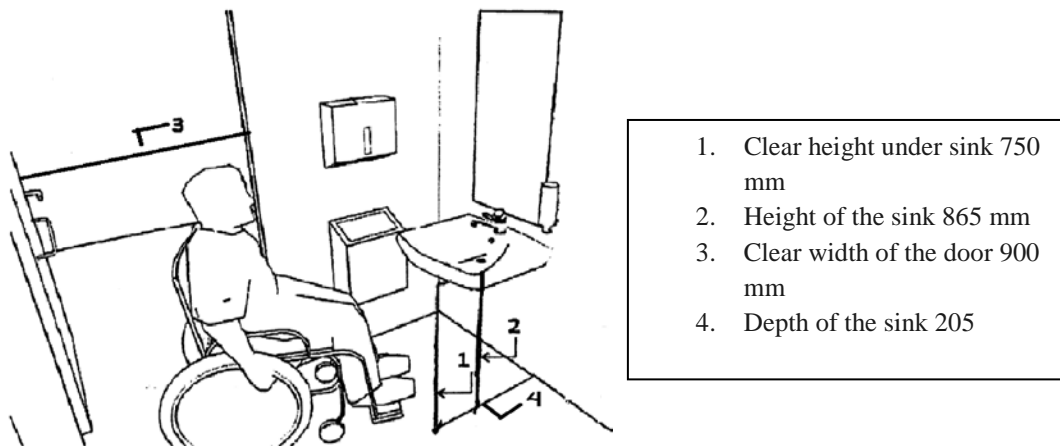
Figure 9.1: Measurements of Some Accessible Toilet Equipments

Accessible toilet rooms should be on an accessible route (ADA Guidelines 4.22.1). There should be signs to direct people with disabilities to the toilet in every part of the building (TS 9111 4.8.2.3). The door of the toilets should be accessible for the people with disabilities. It should open outwards (TS 9111 4.7.3.1). Door handles should be usable from both sides for emergencies (TS 9111 4.6.2.1). The doorways should have a minimum clear opening 900 mm width the door open 90 degrees (TS 9111 4.6.2.1). Minimum clear floor space dimensions for toilets in accessible "unisex" toilet rooms should be 1220 mm x 1525 mm (ADA Guidelines 4.22.3) The maximum height of the mirror should be 900 mm above the finish floor. Pedestal sinks should not be used, there should not be cabinet under the sink. There should not be angular lines of the sink (TS 9111 4.7.3.1 figure 78) Sinks should be mounted with the counter or rim no higher than 865 mm above the finish floor (ADA Guidelines 4.24.2). The maximum height of the sink should be 860 mm, the clear height under the sink should be 750 mm and the depth under the sink should be 205 mm (TS 9111 4.7.3.7)

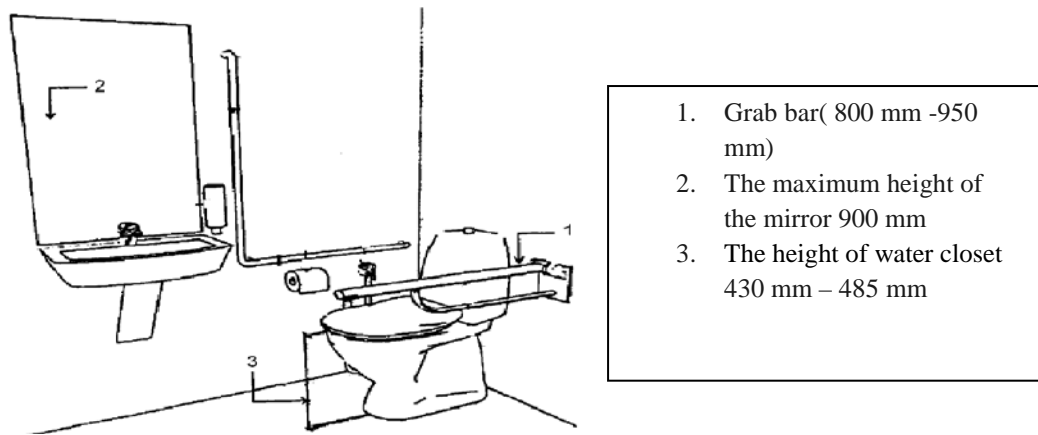
Figure 9.2: Measurements of Some Accessible Toilet Equipments

The height of water closets should be 430 mm to 485 mm, measured to the top of the toilet seat (ADA Guidelines 4.16.3). There should be emergency button or rope in the toilet to call for help in any case (TS 9111 4.7.3.7)

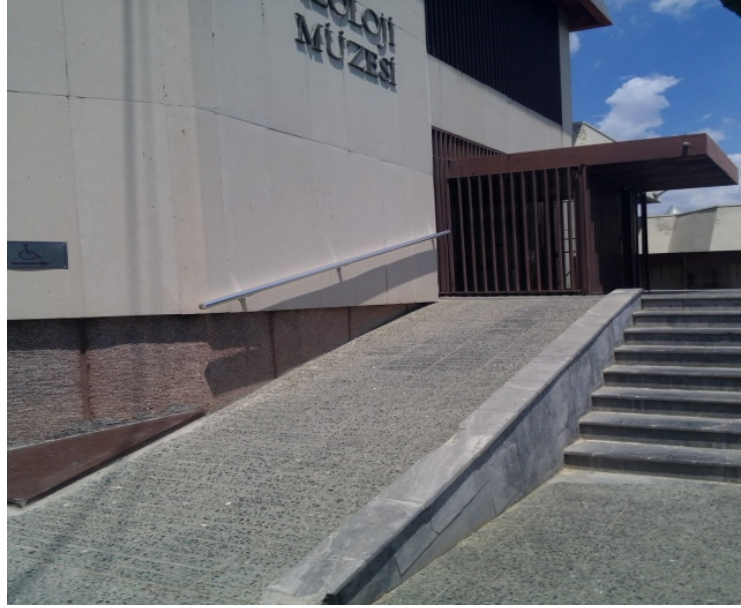
Entrance is not connected by an accessible route to public transportation stops, accessible parking and passenger loading zones, and to public streets or sidewalks. Entrance is not on the level with the street. There is 1200 mm elevation difference between the level of the street and the level of the building. So there should be a ramp or an elevator to go in to the museum. However there is no elevator and accessible ramp which has less than %5 slopes. The slope of the ramp is %27.

Figure 10: Entrance of Archaeology Museum

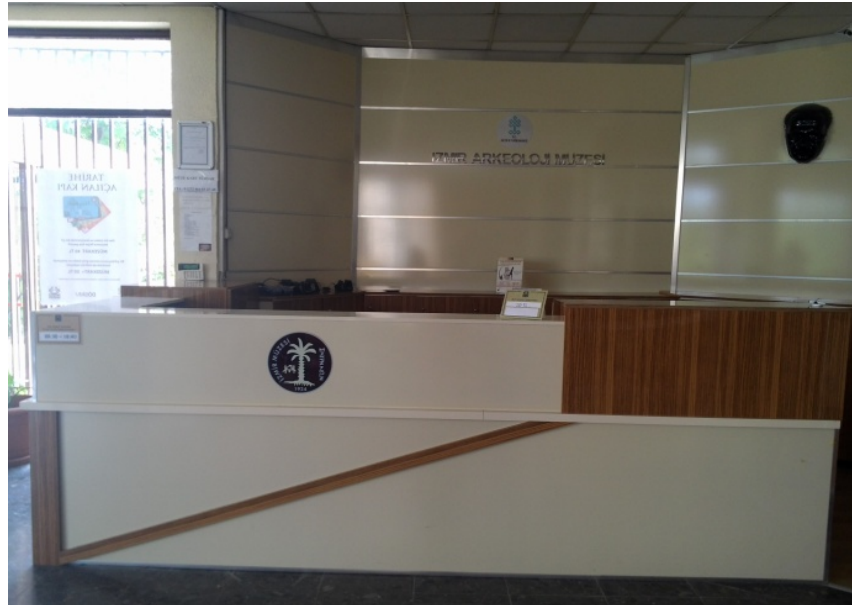
There is a desk at the entry of the building for getting information and help if need; however it is not appropriate according to the standards.

Figure 11: Information Desk of Archaeology Museum

The height of the desk is 1220 mm. It causes for individuals who use wheelchairs not to be able to see the officer. They cannot communicate each other eye to eye. So individuals who use wheelchairs may feel bad himself. Knee space is 135 mm deep. Therefore, people in wheelchairs cannot approach to the desk. They may accept the guide dog (service animal) if required. There is enough space to maneuver for people in wheelchairs in front of the desk.

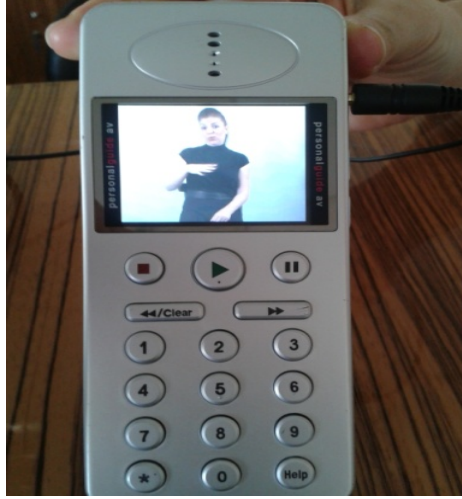
Figure 12: Interpreter Device

They have the interpreter devices that visitors can listen and watch about the museum while one visiting the museum.

There are many points numbered in the exhibition area in the museum. When one comes one of the numbered exhibition point, one should press the stated number written on the board. There are some videos which has sign language interpreter. She explains what there is on the numbered point in the museum with the sign language. People who have hearing impairments watch the videos and people who have vision impairment listen to the recordings about the objects which are exhibited in the museum. The person who has vision impairment has to get a help from the officer or his friend for visiting the museum. Because, there is no raised character on the board and one who has vision impairment can not understand on which number of point is standing in front of him. Officers may help if anybody would like officer to help. They have a plan to provide wheelchairs if required.

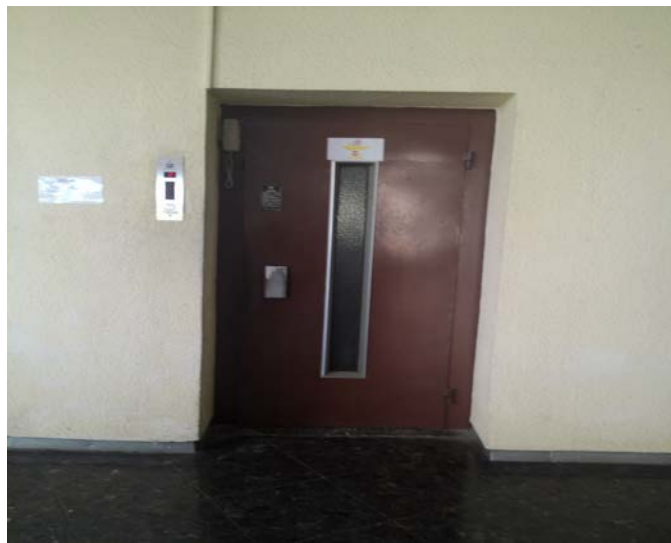
This is a museum which has two-storey exhibition area. So, there has to be an elevator in the building and there is an elevator. The door of the elevator is not opened and closed automatically. So, there is no device for reopening and remaining for 20 seconds. On the other hand there is enough space to maneuver in front of the elevator with the wheelchairs. The capacity of the elevator is 630 kgs. The width of the cabinet is 1100 mm, however the depth of the cabinet is less than required; it is 1150 mm. The clear width of the elevator's door is also 790 mm that is less than required 900 mm. The lighting inside and outside of the cabinet is enough for moving carefully.

Figure 14: The Elevator of Archaeology Museum

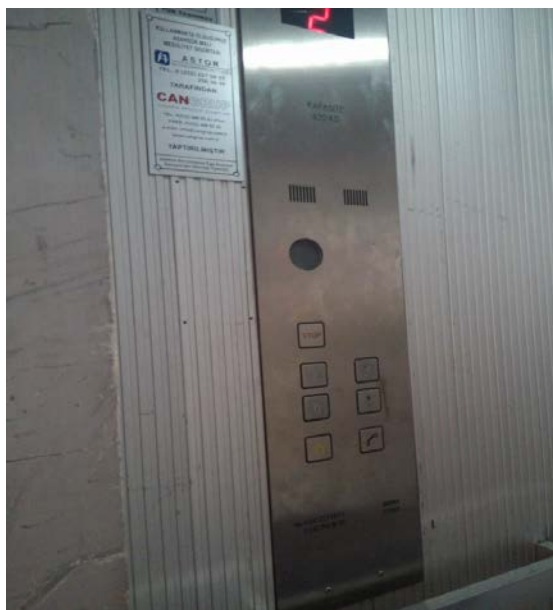
Figure 15: The Control Panel of the Elevator

The control buttons inside and outside of the cabinet are almost appropriate according to the standards. These are all located between 900 mm and 1370 mm above the finish floor. All buttons are sized 30 mm x 30 mm and they are all raised, however there is no Braille Alphabet on them.

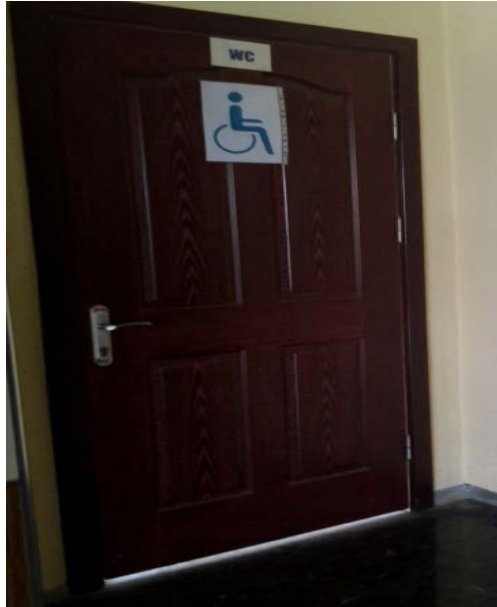
Figure 16: The Toilet Door of Archaeology Museum

There is a toilet especially designed for people with disabilities in the museum. There is just one toilet for men and women, all people use the same cabinet. There is no sign to direct people towards to the toilet for disabled people. One cannot understand whether there is a toilet especially for disabled people or not. But there is a sign of disability on the toilet door.

The clear width of the toilet door is 900 mm. The door opens outwards. There is no emergency button or rope inside the toilets in case of emergency. Door doesn't open from both sides in case of emergency.

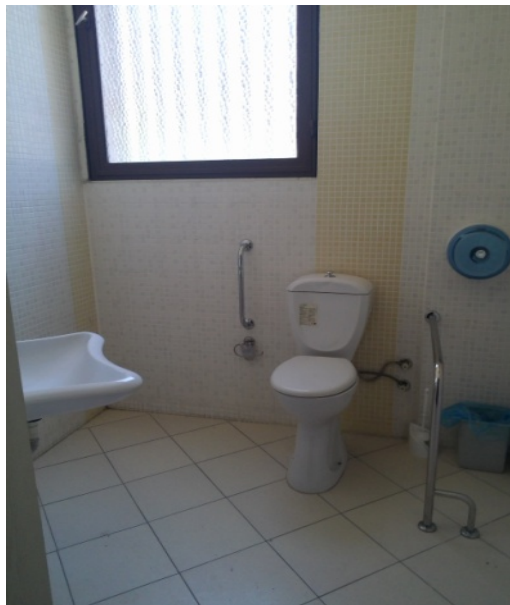
Figure 17: Inside of the Toilet

The clear maneuvering space in the cabinet is 1100 mm x 1200 mm. This is a little bit narrower than it should be, however one can approach the water closet from the front side of it and can wash his hand easily by using the accessible sink. So the maneuvering space in the cabinet is enough to use the toilet without any barrier. The beginning height of the mirror is 1100 mm above the finish floor and there is no sloping mirror on the wall. Therefore, one who use wheelchair may have a difficulty about seeing himself on the mirror. Although the beginning height of the mirror is 1100 mm above the finish floor, if there was a sloping, one can see himself and mirror would be a useful for people who use wheelchairs. Pedestal sinks was not used and there is no cupboard under the sink; that means there is no barrier to approach to the sink. The lines of the sink are round that means there is no danger using the sink in the cabinet. The height of the sink is 800 mm which is appropriate for people who use wheelchairs. The clear height under the sink is 650 mm and this a little bit shorter than it should be. That means one who has wheelchair may not approach to the sink because the short length of the sink. The depth under the sink is 300 mm which is even deeper than it should be. The height of water closet is 500 mm that is a little bit higher than it should be. That means one who use wheelchair may have a difficulty about passing to the water closet from his wheelchair. The grab bars used on both sides of the water closet are on the 700 mm, which had to be at least 850 mm, above the finish floor.

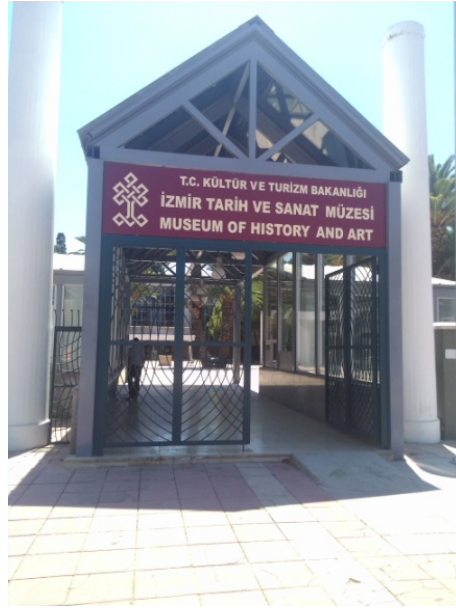
Main entrance is connected by an accessible route to public transportation stops, accessible parking and passenger loading zones, and to public streets or sidewalks. Main entrance is not on the level with the street. There is 140 mm elevation difference between the level of the street and the level of the main entrance. There is a ramp whose slope is %12. The slope of the ramp is too much; however, because the length of the ramp is just 1150 mm, it is not hard to go in a complex by using this ramp.

Figure 18: Entrance of Izmir Museum of History and Art

The width of the ramp is appropriate and it is 1220 mm. There is no curb and handrail of the ramp. Thereby, if there is an uncontrolled situation while going up using ramp, individuals who use wheelchairs may have a difficulty to get the control again without handrails. However the length of the ramp is not too tall as much as it causes an uncontrolled situation.

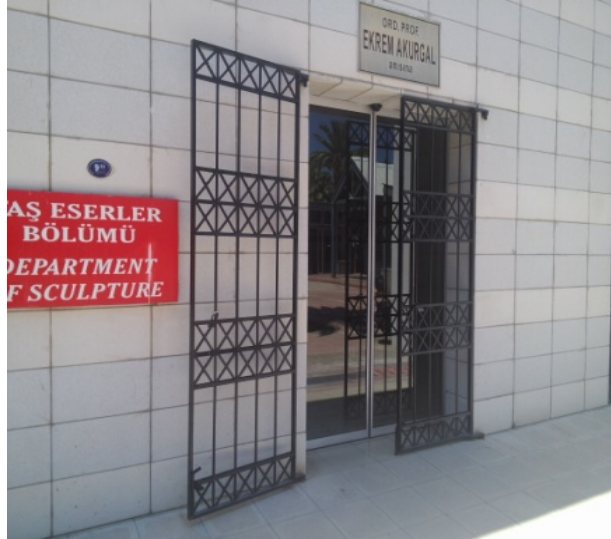
Figure 19: The Entrance of Sculpture Department

Entrance of the building in which stone ruins exhibit has an accessible route. There is no elevation difference between the level of the general area of the complex and the level of the exhibition area floor. The width of the entrance gate is 1800 mm and it opens automatically when someone approaches the gate of the exhibition saloon.

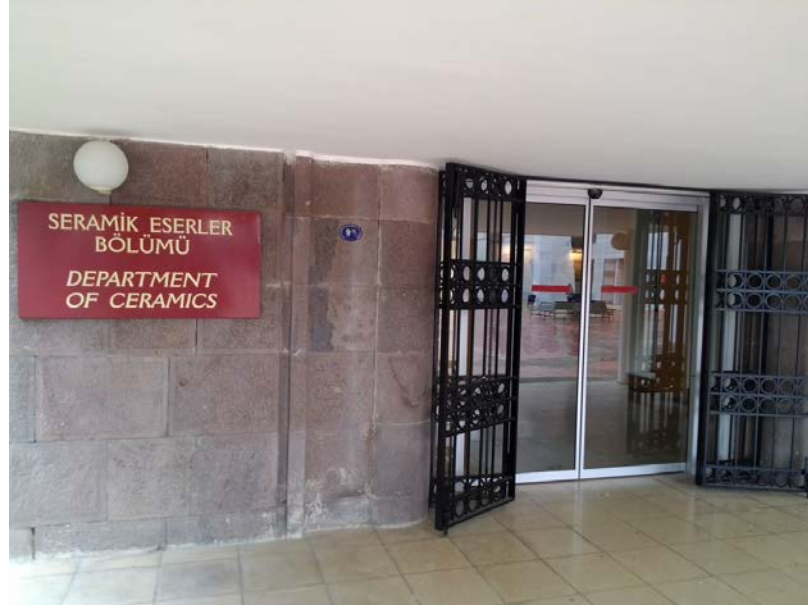
Figure 20: The Entrance of Ceramics Department

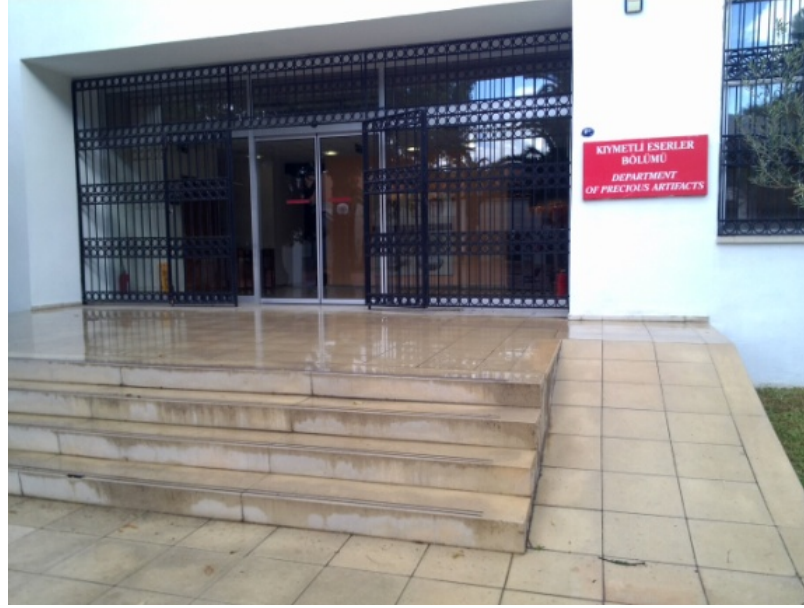
Entrance of the building in which ceramic ruins exhibit has an accessible route, too. There is no elevation difference. The width of the entrance gate is 1800 mm and it opens automatically when someone approaches the gate of the exhibition saloon. Entrance of the building in which precious ruins exhibit is not on the level with the floor of the general area. There are stairs and a ramp to go in a building. The ramp whose slope is %24 is not an accessible for people who use wheelchairss. They cannot go in a building on one's own. The width of the ramp is 1350 mm however there is no curb and handrails on the ramp. Because it is a little bit high, if there is an uncontrolled situation while going up using ramp, individuals who use wheelchairs may have difficulty to get a control again and have some problems.

Figure 21: The Entrance of Precious Artifacts Department

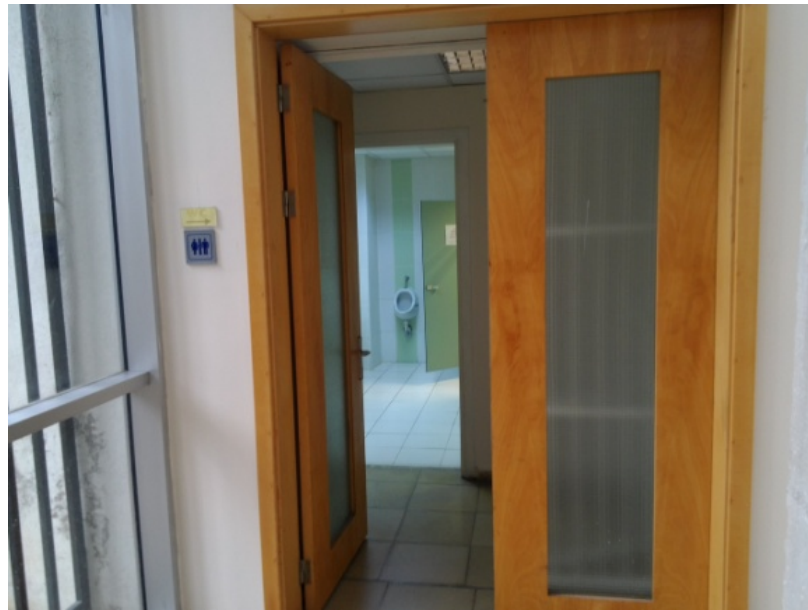
There are toilets for disabled people in the building in which stone ruins exhibit. However there is no sign towards to the toilet for disabled people. One cannot understand whether there is a toilet especially for disabled people or not. When one enters the toilet, then he can see that there is a toilet for disabled people.

Figure 22: Entrance of Toilets

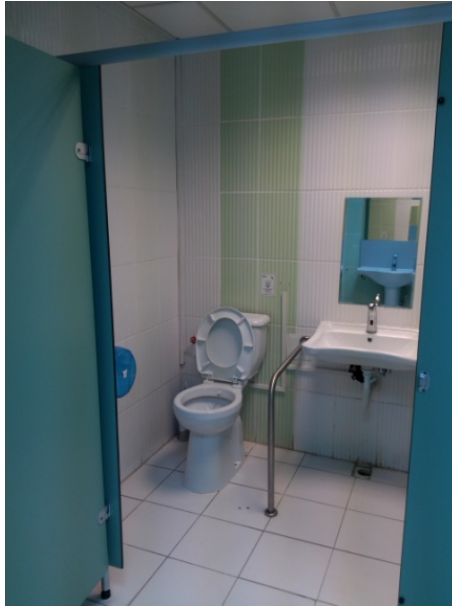
Figure 23.1: Inside of the Toilet

The clear width of the door of the cabinet is 1000 mm. The door opens outwards. When any emergency, there is no emergency button or rope inside the toilets. Door doesn't open from both sides for emergencies. The clear maneuvering space in the cabinet is 750 mm x 1500 mm. The clear depth of the toilet is 750 mm which is not enough for maneuvering for people who use wheelchairs in the cabinet. The beginning height of the mirror is 1000 mm above the finish floor and there is no sloping mirror on the wall. Therefore, one who use wheelchair may have a difficulty about seeing himself on the mirror. Although the beginning height of the mirror is 1000 mm above the finish floor, if there was a sloping, one can see himself and mirror would be a useful for people who use wheelchairs.

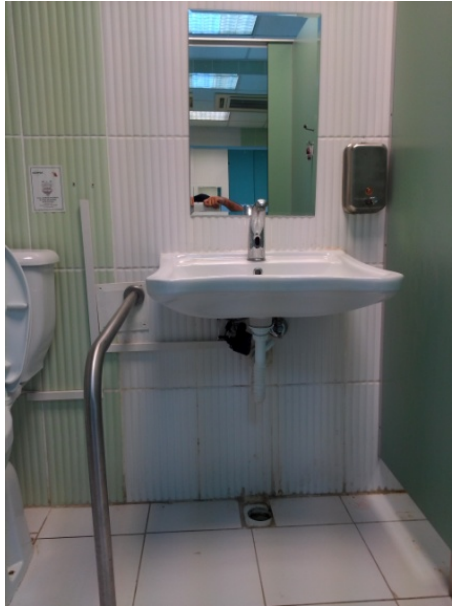
Figure 23.2: The Sink of the Toilet

Pedestal sinks was not be used and there is no cupboard under the sink; that means there is no barrier to approach to the sink. The lines of the sink are round that means there is no danger using the sink in the cabinet. The height of the sink is 830 mm which is appropriate for people who use wheelchairs. The clear height under the sink is 750 mm and the depth under the sink is 300 mm which is even more than it should be. The height of water closet is 520 mm that is a little bit higher than it should be. That means one who use wheelchair may have a difficulty about passing to the water closet from his wheelchair. The grab bar used on one side of the water closet is on the 750 mm, which had to be at least 900 mm, above the finish floor.

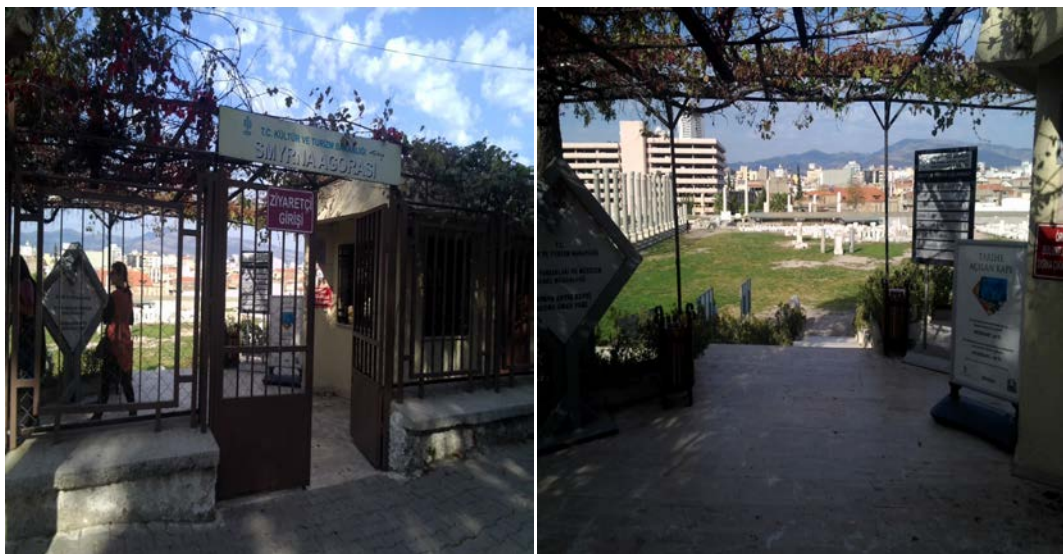
There are two entrances to go in the museum. One of them is not connected by an accessible route to public transportation stops, accessible parking and passenger loading zones, and to public streets or sidewalks. This entrance is not on the level with the street. And there are stairs after this entrance and that makes this main entrance not accessible.

Figure 24.1-2: Entrances of Agora Open Air Museum

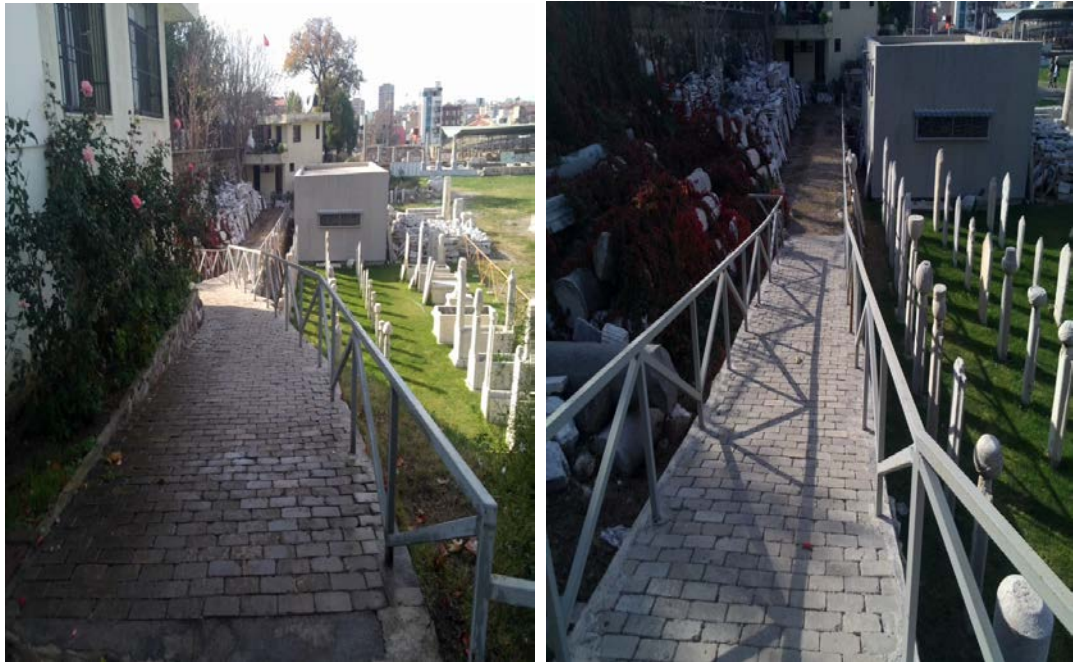
The other entrance which is connected by an accessible route to public transportation stops, accessible parking and passenger loading zones, and to public streets or sidewalks, is an entrance actually for cars. Because the main entrance is not accessible for people who use wheelchairs, they direct them to the car entrance to go in the open air museum. There is elevation difference between the entrance and the area where the stone ruins exhibit. One should go down by using stairs and ramp.

Figure 25: 1-2. Ramps at the Entrances of the Agora Open Air Museum

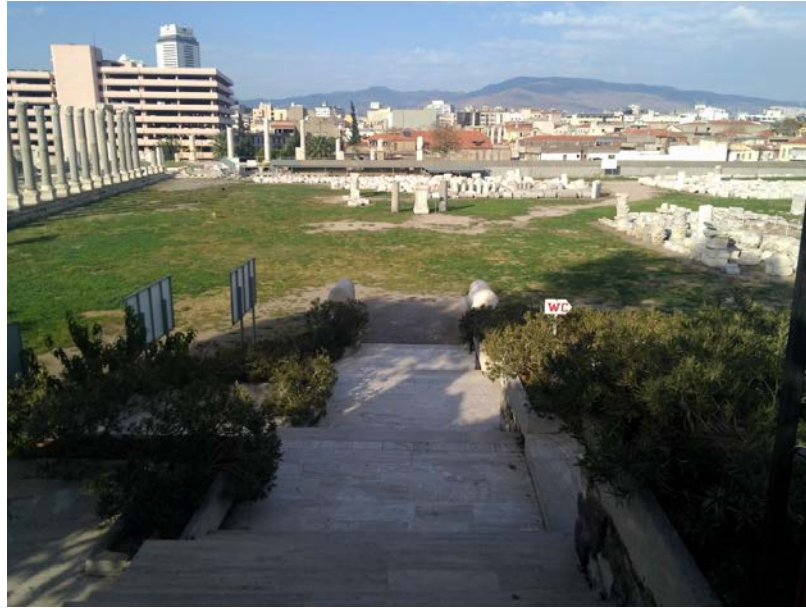
stairs. A person who has vision impairment may have a difficulty about stepping the stairs. Stairs have hard, matte and non-slip surface. The width of the stair is 270 mm which is 10 mm lower than it should be. The height of the stair is 150 mm. There is no slip band not to slip on the front side of the stairs and there is no handrail on both sides of the stairs. People who have vision impairment may have difficulty while going down the museum.

Figure 26: The Stairs at the Entrance of Agora Open Air Museum

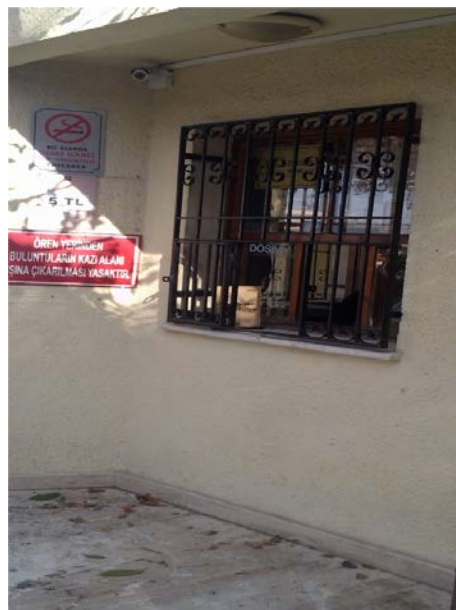
Figure 27: The Ticket Counter at the Entrance of Agora Open Air Museum

There is a ticket counter on the entrance of the museum. There is a window to communicate with the officer. The height of the window is 1000 mm which is 135 mm higher than acceptable amount. The width of the window is 900 mm which is appropriate. There is no depth for knee space. Thus people in wheelchairs cannot approach to the window to communicate with the officer. They may accept the guide dog (service animal) if required. There is enough space for people in wheelchairs in front of the desk. There is no sign language interpreter service for those who have hearing impairment and there is no any device to tell about the museum to those had vision impairment and show about the museum to those had hearing impairment. Officers may help if anybody would like officer to help. They can not provide wheelchair to help while visiting the museum for those who have difficulty about movement. There are no signs to show where can go outside of the area for people who have hearing impairment. There is no audible and visible alarming system for people who have visual and hearing impairment. If any emergency, people had vision impairment and hearing impairment cannot understand this emergency situation.

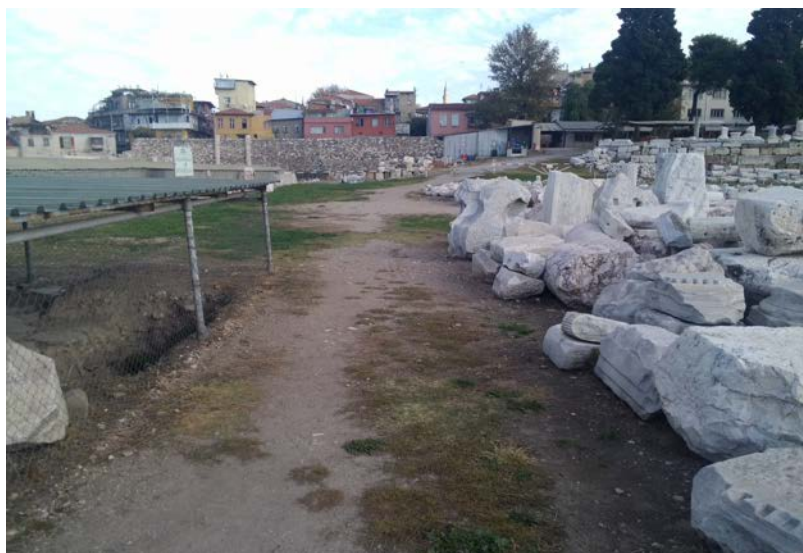
Figure 28: One of Corridor of Agora Open Air Museum

There are lots of corridors among the stone ruins. The narrowest gap among the corridors is 2600 mm. This is even 1700 mm more than it should be. People who use wheelchairs can get a tour among the stone ruins comfortably and easily. There is one more storey where is located under the general museum storey. People who use wheelchairs should go down by using an elevator. However there is no elevator and also there is no ramp in that point. Because, the excavation works have been going on in that storey, there are stairs which is temporary. There are stone gate inside the corridors on that floor. The width of the gate is 1050 mm and the height of the gate is 2100 mm.

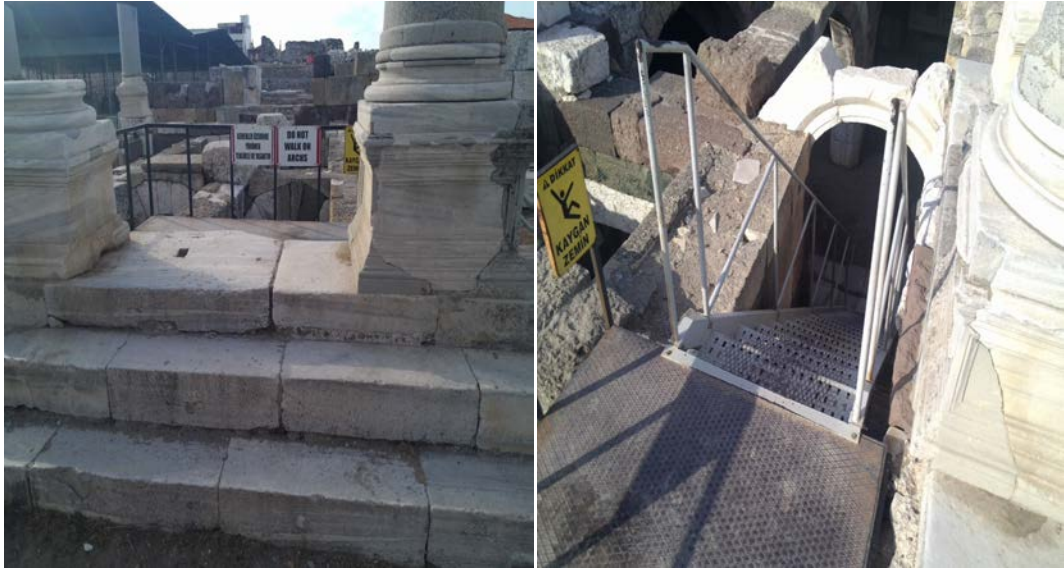
Figure 29.1-2: Passing to the Down Floor from the Main Floor

Until the excavation works ends, it is not possible to go down for people who use wheelchairs to see the water channel and the other stone ruins which are exhibited on that storey. There is no emergency escape alarming system, which is visible and audible, for people who use wheelchairs, people who have visual impairment and people who have hearing impairment. Unfortunately, there is no toilet designed for disabled people in the museum. There are two toilets for men and women; however there is no cabinet for disabled people in those two toilets.

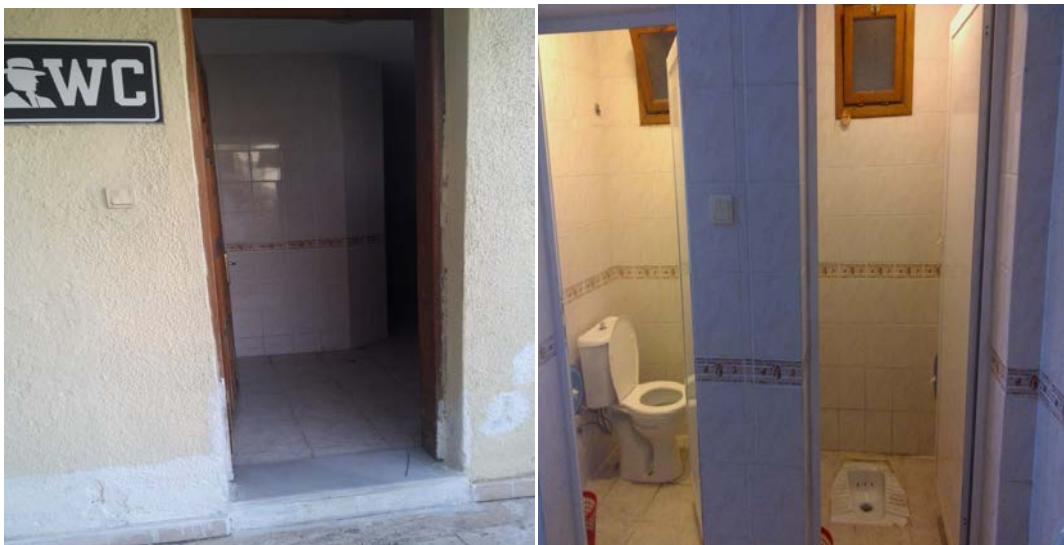
Figure 30.1-2: Entrance and inside of the toilets

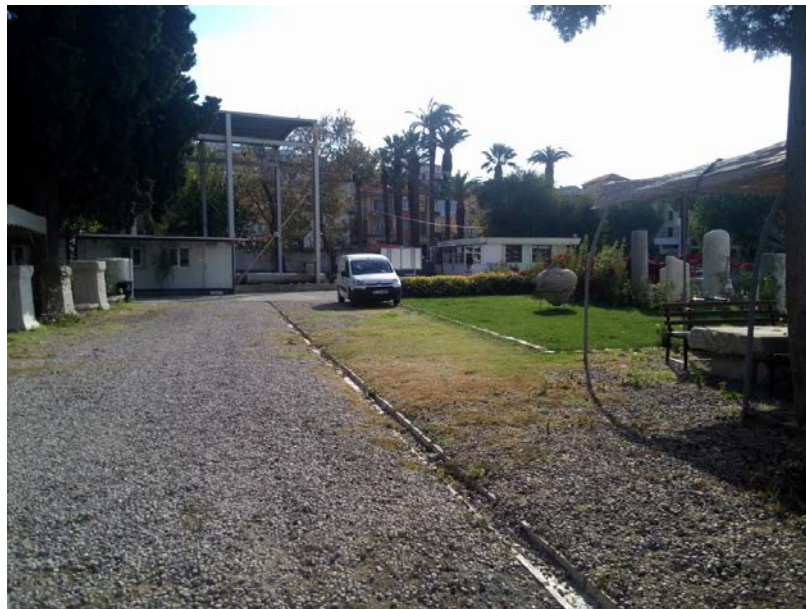
There is parking place in front of the museum main gate. However there is no special parking place allocated for the disabled people. However there is a parking place which is accessible when people who use wheelchairs go in to the museum from the other gate of the museum. They can find a place to park there. They are able to find a little bit wide area for parking and go out from the parking area easily and go in the exhibition area by using ramp. There is a space which has more than 3600 mm width, more than 6000 mm depth and more than 1500 mm for maneuvering in the parking area.

Figure 31: Parking Area of Agora Open Air Museum

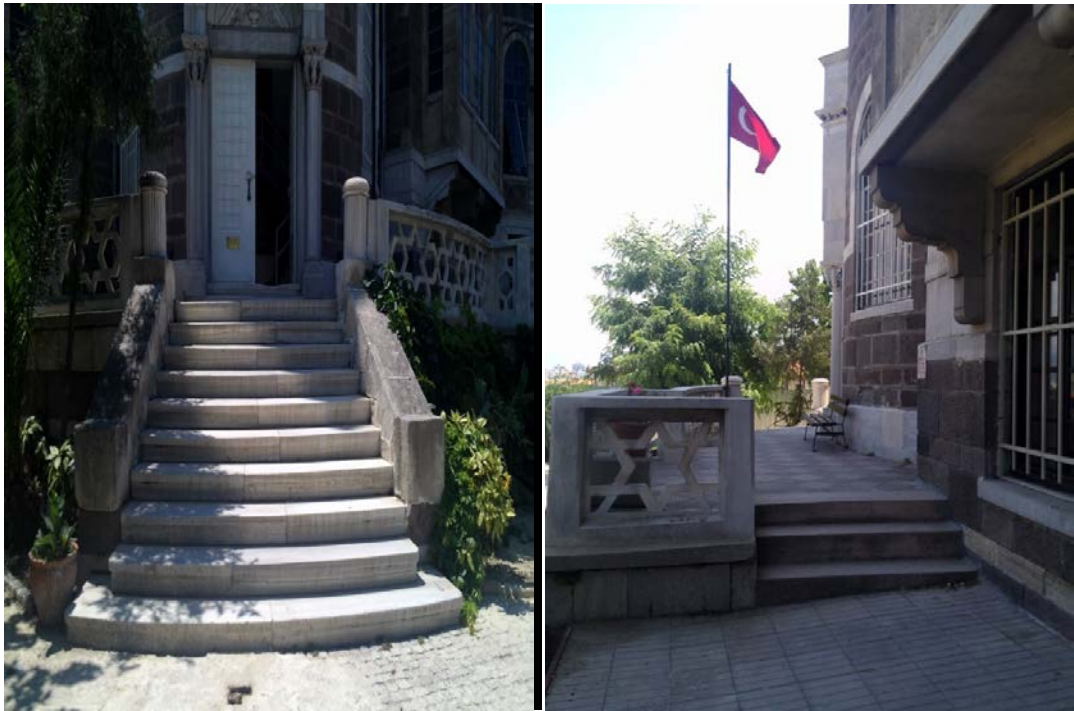
elevator or ramp at the entrance of the building. There is no possibility to enter this museum for those people in wheelchairs without any help.

Figure 32.1-2: Entrances of Ethnography Museum

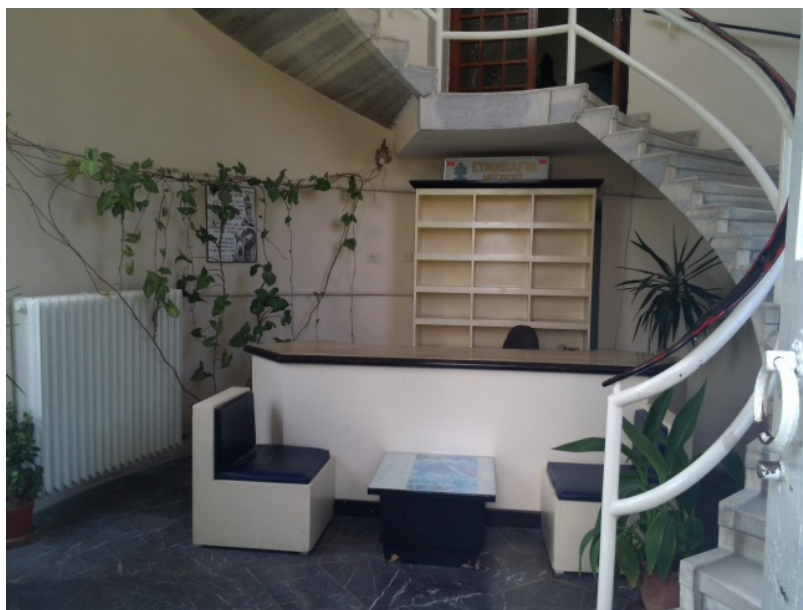
Figure 33: Information Desk of Ethnography Museum

There is a table at the entrance of the building for getting information and help if it is need. It is appropriate according to the standards. Height of the desk is 850 mm. There is no knee space to make people with disabilities possible to approach to the desk. But one who is in the wheelchair doesn't need to approach to the table. One may approach to the coffee table. There is enough space to approach and to maneuver. They may accept the guide dog (service animal) if required. Officers may help if anybody would like officer to help. There is no sign language interpreter to give information about the museum for people who have hearing impairment. They can not provide wheelchair to help while visiting the museum for people who have difficulty about movement.

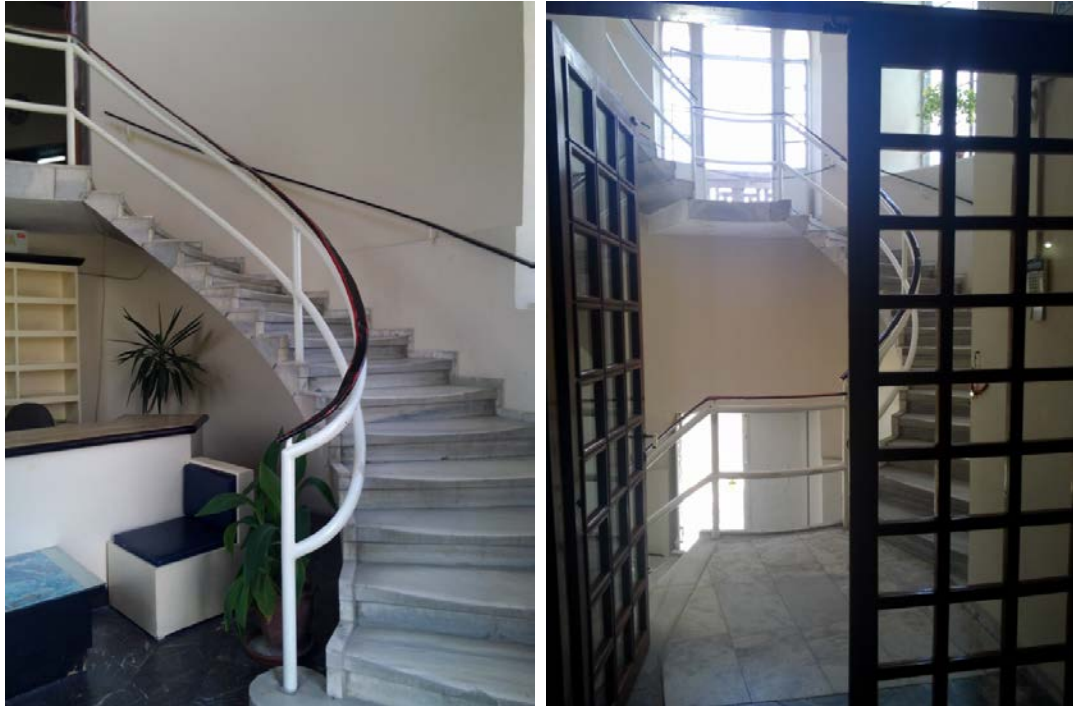
There are two separate stairs to go in the building on the entrance. There is no perceivable surface on the beginning and on the end of the stairs. A person who has vision impairment may have difficulty about when s/he should start and stop stepping the stairs. Stairs have hard, matte and non-slip surface. The width of the stair is 24 mm, this value is a little bit narrower than it should be. The height of the stair is 160 mm. This value is appropriate according to the standards. There is no slip band not to slip on the front side of the stairs. There are stone handrails at the both sides of the stairs.

Figure 34. Stairs of Ethnography Museum

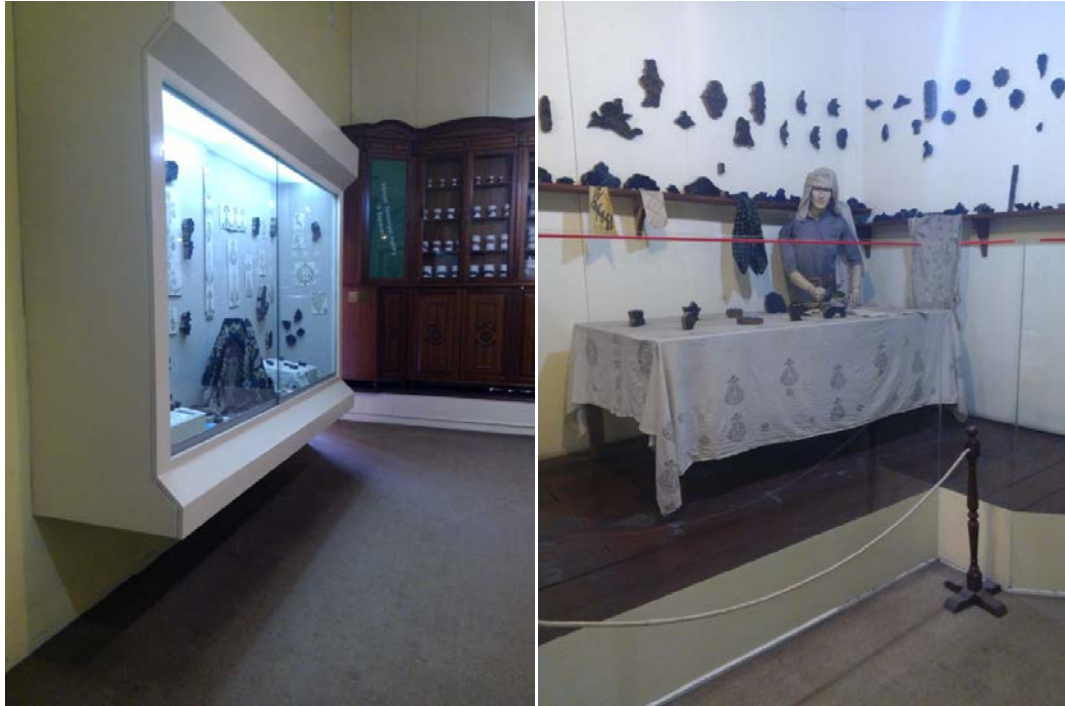
The museum is accessible in regards to internal movement. There are lots of rooms in the building. The widths of the doors of these rooms determine how much the museum is accessible in regards to internal movement. The width of the narrowest door is 880 mm which is 20 mm narrower than required. However, this makes people who use wheelchairs possible to pass from one room of the building to another. The height of the objects exhibited between 750 mm and 2300 mm. One who use wheelchair could see the objects in the museum.

Figure 35.1-2: Height of the Objects Exhibited in the Museum

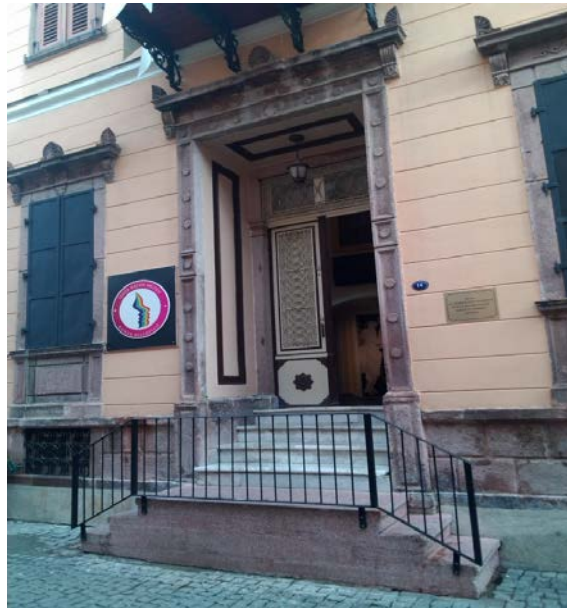
Figure 36: Entrance of Izmir Museum of Women

Entrance is not connected by an accessible route to public transportation stops, accessible parking and passenger loading zones, and to public streets or sidewalks. Entrance is not on the level with the street. There is 1260 mm elevation difference between the level of the street and the level of the entrance. So there should be a ramp or an elevator to go up to the entrance level. However there is no elevator or

ramp at the entrance of the building. There are two separate stairs on the right and the left sides of the entrance.

Widths of these stairs are 500 mm; that means the entrance of the museum is so narrow. There is no possibility to enter this museum for those people in wheelchairs. There is no perceivable surface on the beginning and on the end of the stairs. A person who has vision impairment may have difficulty about when s/he should start and stop stepping the stairs. Stairs have hard, matte and non-slip surface. The width of the stair is 310 mm, this value is even more than it should be. The height of the stair is 180 mm. This value is a little bit higher than desired. There is no slip band not to slip on the front side of the stairs. There are handrails at the edge of the stairs.

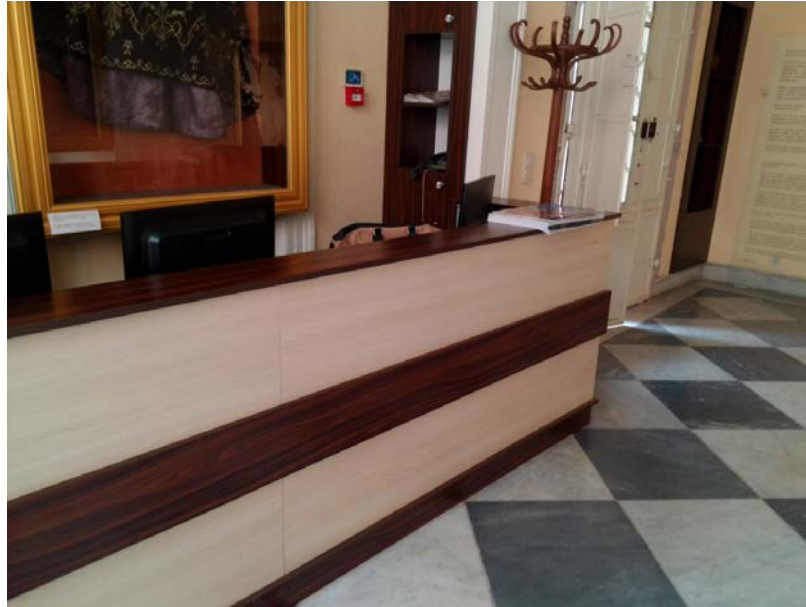
There is a desk at the entrance of the building for getting information and help if it is need, however it is not appropriate according to the standards. Height of the desk is 980 mm. Thus, individuals who use wheelchairs cannot see the officer. And also officer can not see the visitors who use wheelchair while sitting behind the desk. They cannot communicate each other eye to eye without standing up.

Figure 37: Information Desk of Izmir Museum of Women
