YASAR UNIVERSITY
INSTITUTE OF SOCIAL SCIENCES
MASTER IN TOURISM MANAGEMENT
MASTER THESIS

THE ASSESMENT OF MUSEUMS IN IZMIR IN REGARDS TO ACCESSIBILITY

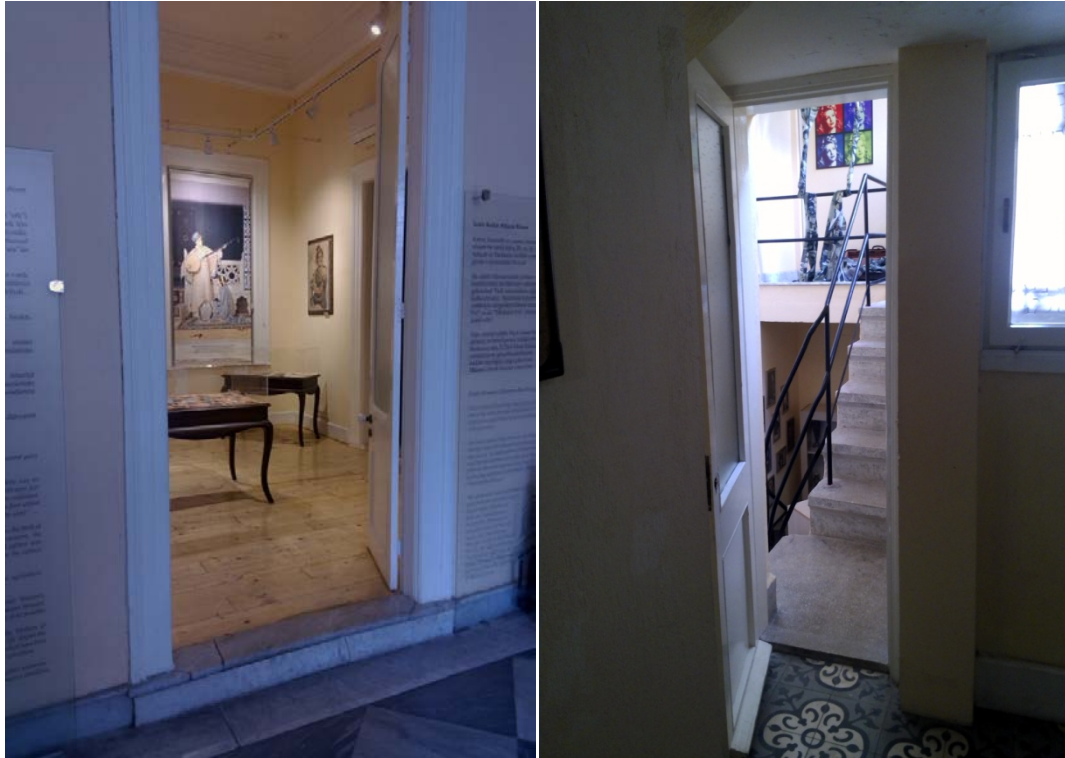
The museum is not accessible in regards to internal movement. There are lots of rooms in the building. The widths of the doors of these rooms determine how much the museum is accessible in regards to internal movement. The narrowest door of the doors is 460 mm which doesn't make people who use wheelchairs possible to pass from one room of the building to another.

Figure 38.1-2: Doorsteps inside the Museum

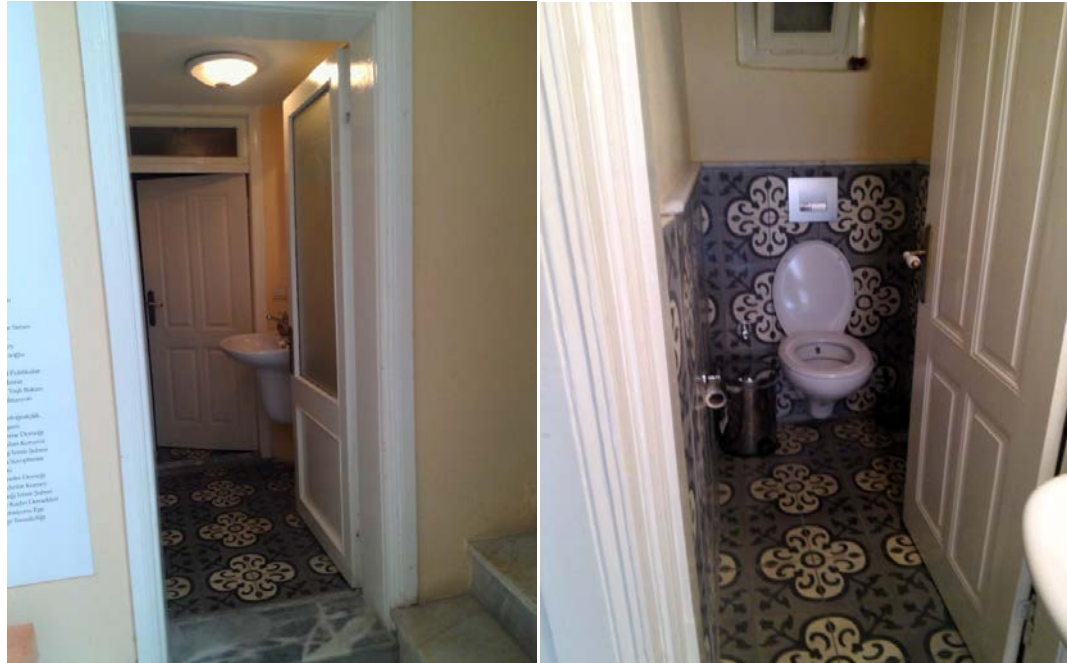
There is no accessible toilet especially designed for people with disabilities in the museum. There is just one toilet for men and women, all people use the same cabinet.

Figure 39.1-2: Entrances of the Toilet

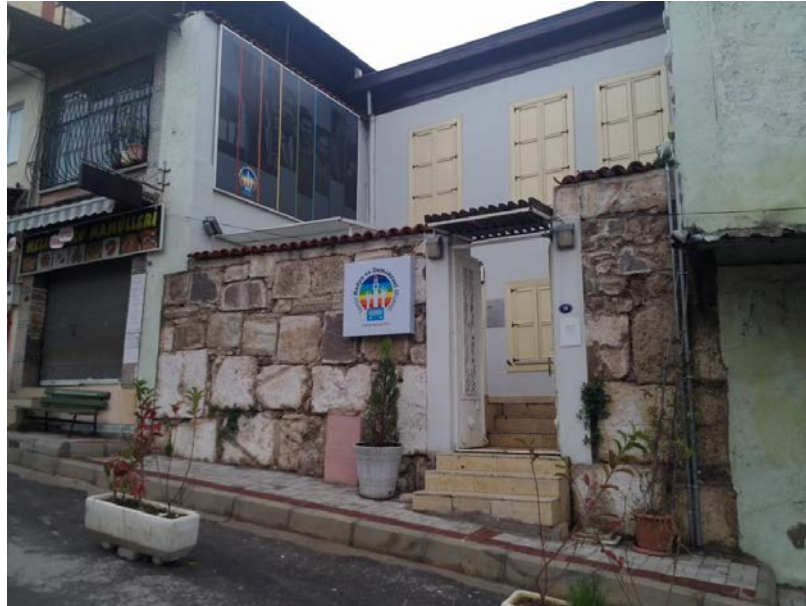
Main entrance is not connected by an accessible route to public transportation stops, accessible parking and passenger loading zones, and to public streets or sidewalks. Main entrance is not on the level with the street. There is a sidewalk which has no access from the street with any ramp. And the entrance is on the sidewalk with 6 stairs.

Figure 40: Entrance of the Museum of Radio and Democracy

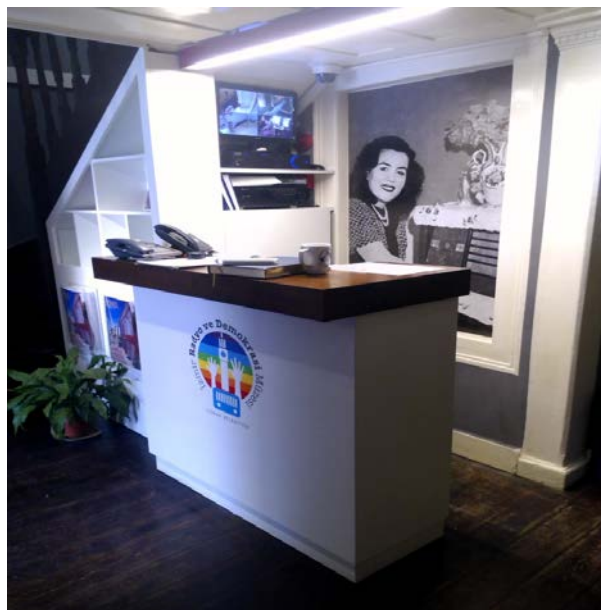
There is an information desk in the building. The width of the information desk is 1200 mm which is even wider than it should be, however the height of the desk is 1060 mm which is not accessible especially for people who use wheelchairs. Knee space is just 130 mm which individuals who use wheelchair cannot approach to the desk well.

Figure 41: Information Desk of the Museum

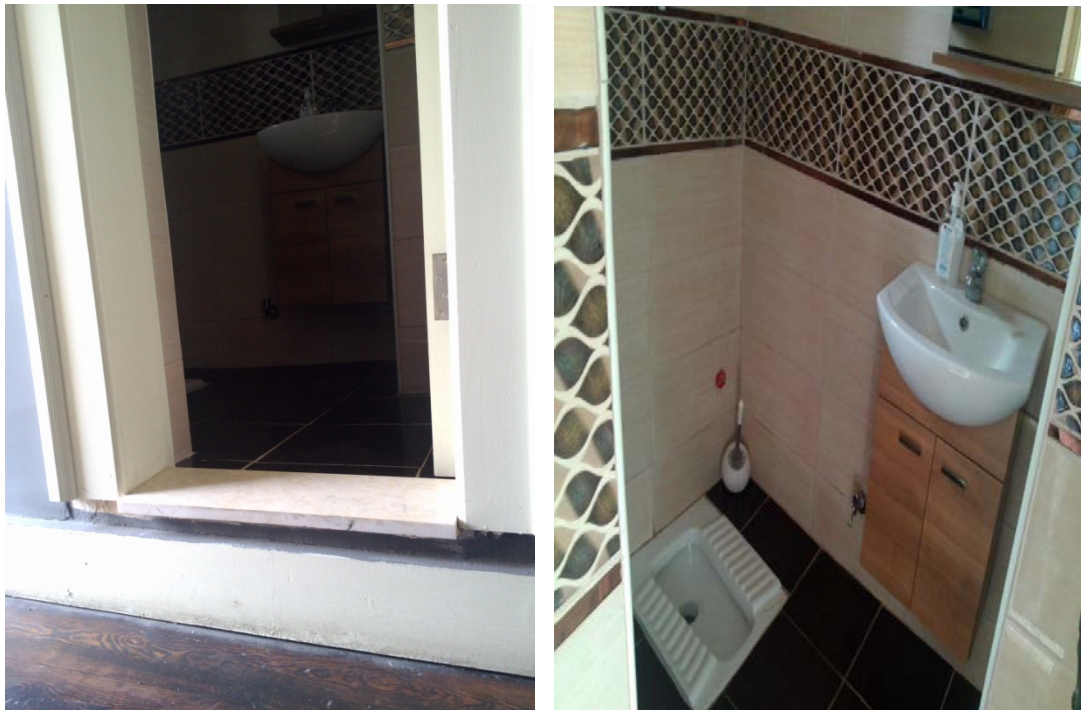
Figure 42.1-2: Entrance and inside of Toilet

There is no accessible toilet especially designed for people with disabilities in the museum. There is just one toilet for men and women, all people use the same cabinet. There is 220 mm elevation difference between the level of the hall and the level of the toilet.

So there should be a ramp, however there is no ramp to go up to the toilet. The clear width of the toilet door is 460 mm which is almost half of the value that should be according to the standards. The door doesn't open outwards and there is 800 mm x 800 mm space for maneuvering inside the toilet. Thus it is not possible to go in the toilet for people in wheelchairs. There is no emergency button or rope inside the toilet in case of emergency. The door of the toilet doesn't open from both sides for

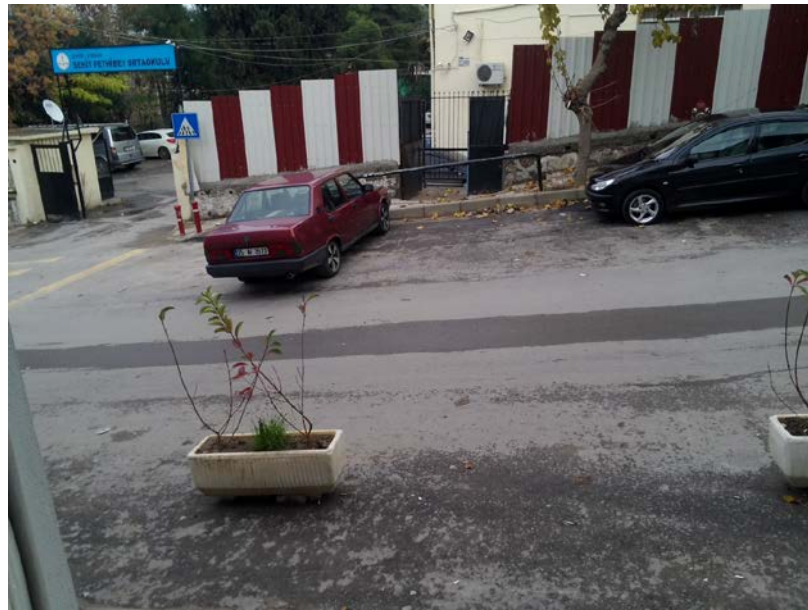
There is no parking area especially for people with disabilities. There are some places where people can park their car on.

Figure 43: Parking Area of the Museum of Radio and Democracy

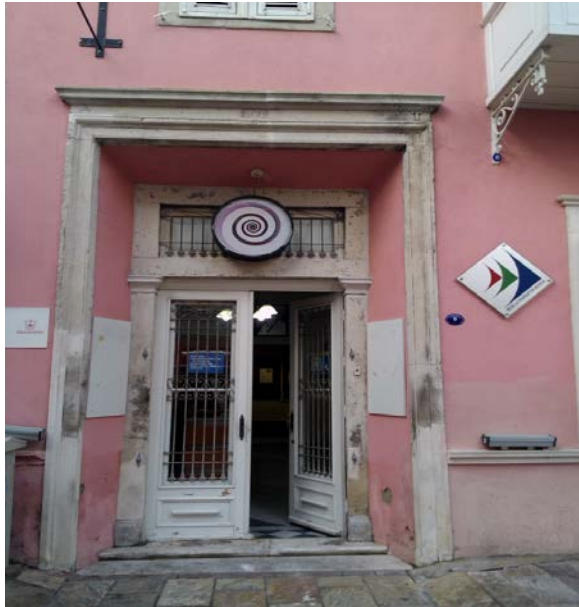
Figure 44: Entrance of the Joy and Cartoon Museum

Main entrance is connected by an accessible route to public transportation stops, passenger loading zones and public streets or sidewalks. Main entrance is on the level with the street. So there is no need to ramp or stairs to go in the museum.

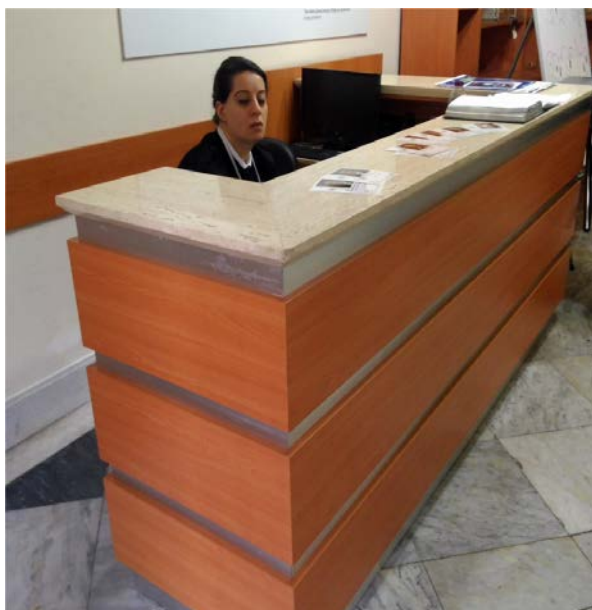
Figure 45: Information Desk of the Joy and Cartoon Museum

There is an information desk in the building. The width of the information desk is 2360 mm which is even wider than it should be, however the height of the desk is 1060 mm which is not accessible especially for people who use wheelchairs. There is no knee space. So, individuals who use wheelchair cannot approach to the desk.

There is enough space that is 1400 mm x 4000 mm for maneuvering. They may accept the guide dog (service animal) if required. However all things are the objects that need to be seen. There is no sign language interpreter service for those who have hearing impairment. Officers may help if anybody would like officer to help. They can not provide wheelchair to help while visiting the museum for people who have difficulty about movement. There is visual signs to show where can go outside of the building for people who have hearing impairment in case of emergency. There is audible alarm system; however there is no visible alarm system for people who have hearing impairment in the museum.

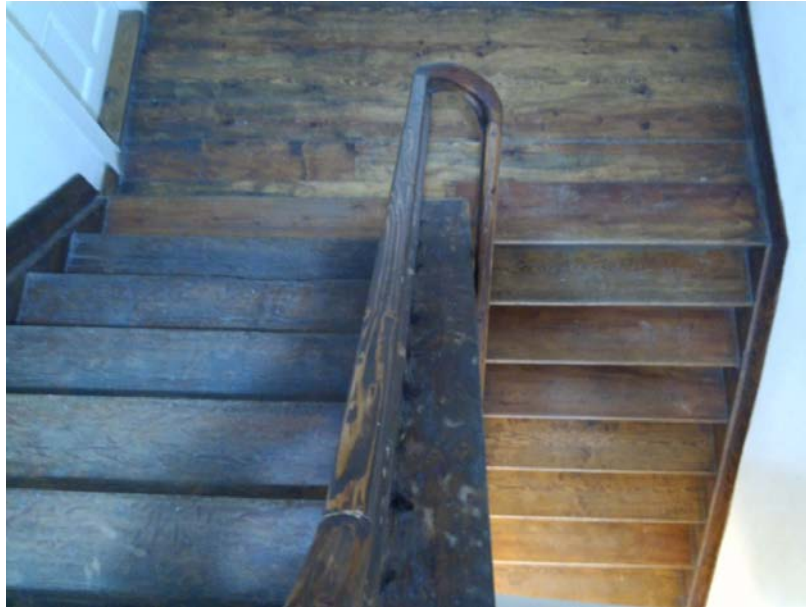
Figure 46: Stairs of the Museum

This is a museum which has two-storey exhibition area. So, there has to be an elevator in the building. Unfortunately there is no elevator in the building to go up the second floor. So, it is not possible to go up and visit the second floor of the museum for people who use wheelchairs. There are stairs in the building to go up to the second floor of the museum.

There is no perceivable surface on the beginning and on the end of the stairs. A person who has vision impairment may have a difficulty about when s/he should start and stop stepping the stairs. Stairs have hard, matte and non-slip surface. There is no slip band not to slip on the front side of the stairs. The width of the stair is 300 mm which is even wider than it should be. The height of the stairs is 180 mm which is a little bit higher than it should be. One who has vision impairment may have difficulty while stepping. There are handrails at the edge of the stairs.

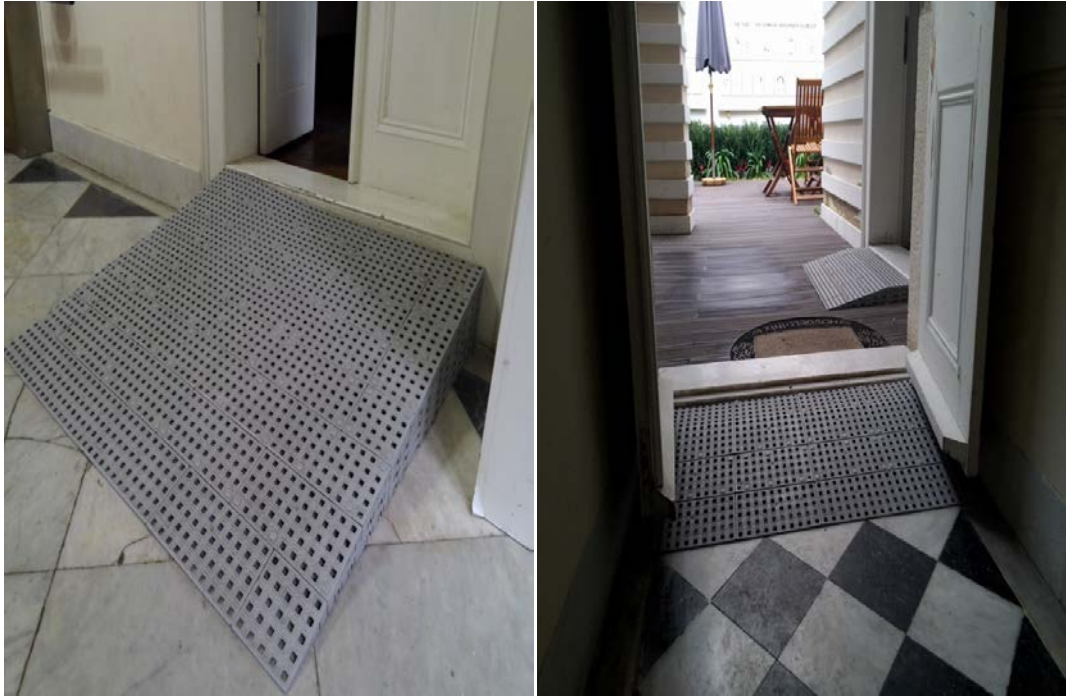
Figure 47.1-2: Ramps used for entering to rooms inside of the museum

There is elevation difference between the levels of the rooms and level of the hall of the museum while passing from the hall to a room. To eliminate the elevation difference, they use portable ramp for passing a room from the hall for people who use wheelchairs. The width of these portable ramps is 1000 mm. There is no curb and handrail of these ramps.

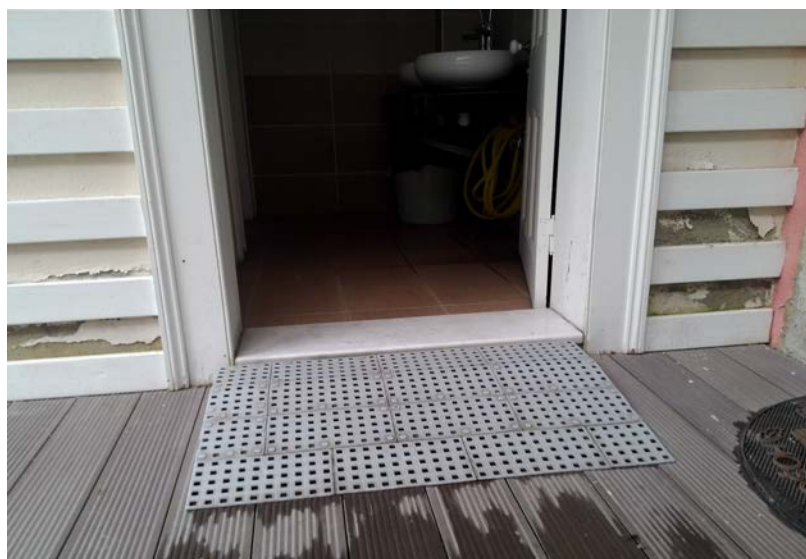
Figure 48: Ramp used for entering the toilet

There is no accessible toilet especially designed for people with disabilities in the museum. There is 160 mm elevation difference between the floor of the exhibition area and the floor of the toilet. So there should be a ramp. There is a ramp to eliminate the elevation difference.

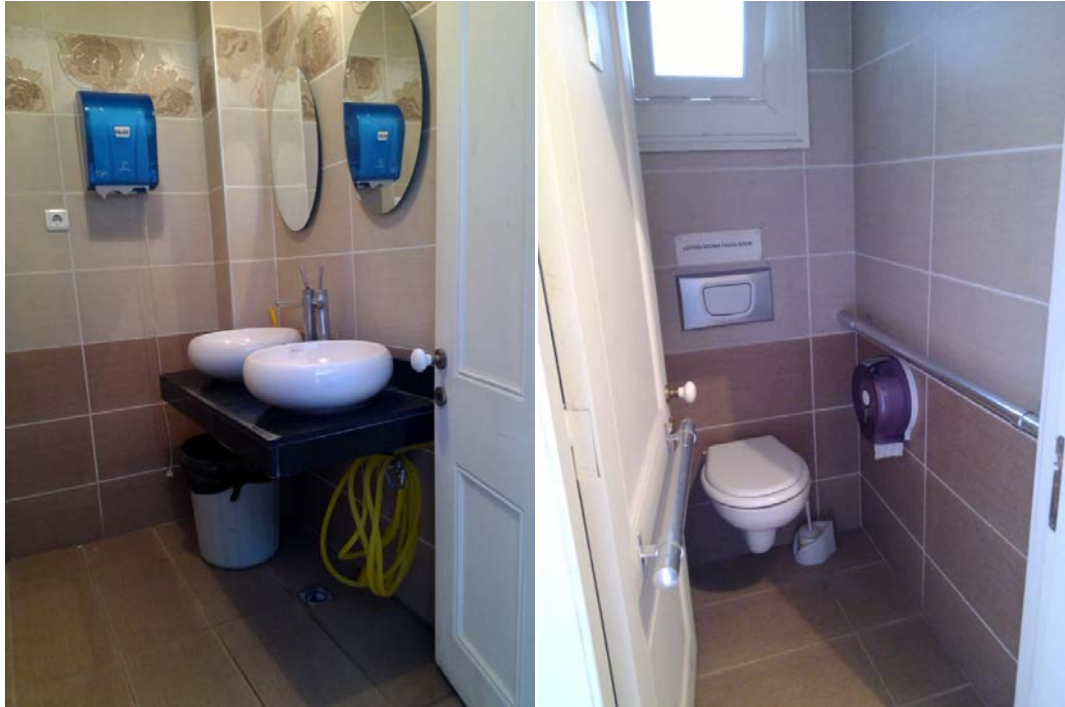
Figure 49.1-2: Entrance and inside of the Toilet

The clear width of the toilet door is 750 mm which is not appropriate for people who use wheelchairs to go in the toilet. The door doesn't open outwards and there is 600 mm x 600 mm space for maneuvering inside the toilet. Thus it is not possible to go in the toilet for people in wheelchairs.

There is no emergency button or rope inside the toilet in case of emergency. The door of the toilet doesn't open from both sides for emergencies. The beginning height of the mirror is 1250 mm above the finish floor and there is no sloping mirror on the wall. Therefore, one who use wheelchair have a difficulty about seeing himself on the mirror. Pedestal sink was not used and there is no cupboard under the sink. The height under the sink is 630 mm and the depth under the sink is 550 mm which is even deeper than it should be. However, because there is just 630 mm under the sink, it is not possible to approach to the sink. The lines of the sink are round that means there is no danger using the sink in the cabinet. The height of the sink is 900 mm which is a little bit higher than it should be for people who use wheelchairs. The height of water closet is 480 mm. There are grab bars in the toilet, but because it is not possible to go in by the wheelchair, they cannot help people who use

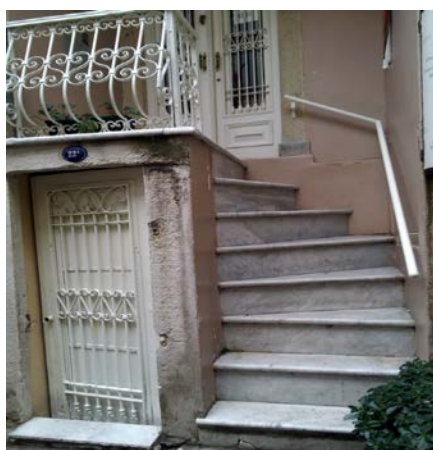
Figure 50: Entrance of Izmir Mask Museum

Entrance is not connected by an accessible route to public transportation stops, accessible parking, passenger loading zones and public streets or sidewalks. Entrance is not on the level with the street.

There is 2500 mm elevation difference between level of the street and the level of the entrance of the building. So there should be a ramp or an elevator to go to the building level. However there is no elevator or ramp at the entrance of the building. There is no possibility to enter this museum for people who use wheelchairs.

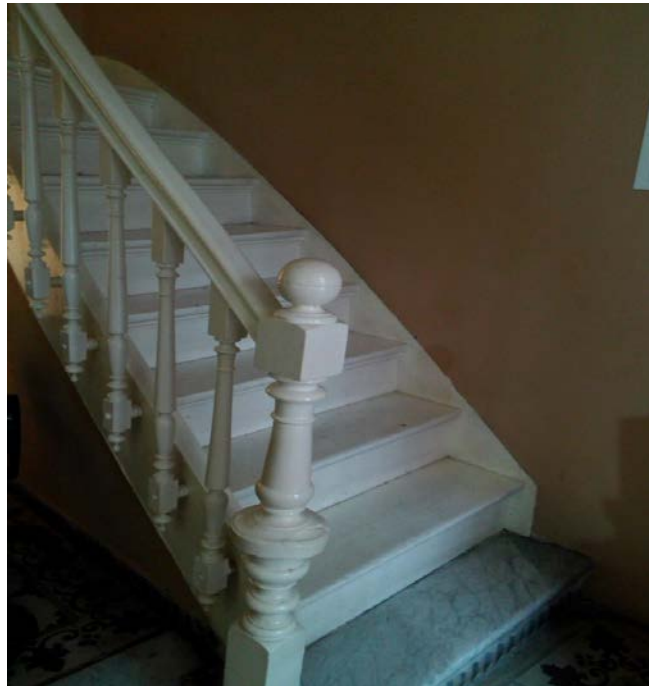
Figure 52: Stairs of the Museum

This is a museum which has two-storey exhibition area. So, there has to be an elevator in the building. Unfortunately there is no elevator in the building to go up the second floor. So, it is not possible to go up and visit the second floor of the museum for people who use wheelchairs.

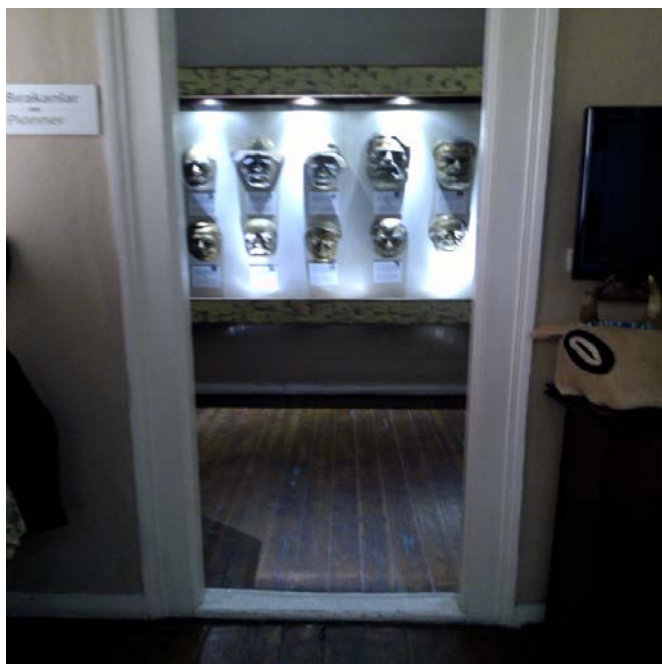
Figure 53: One Doorstep at the Second Floor of the Museum

The museum is not accessible in regards to internal movement. There are few rooms and the width of the doors of these rooms determines how much the museum is accessible in regards to internal movement. The narrowest door of the building is 750 mm which doesn't make people who use wheelchairs possible to pass from one room of the building to another.

Inside of the rooms, the distance between the objects exhibited is at least 210 mm which is even more than it should be. However one who use wheelchair cannot go up to second floor and cannot go in to the rooms which has 750 mm wide door.

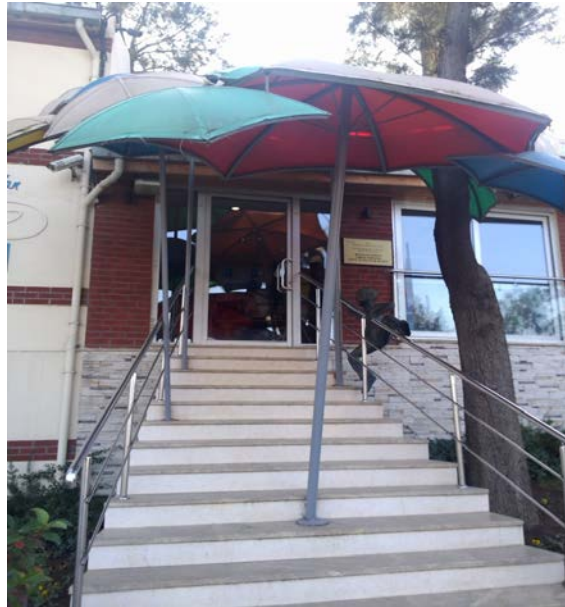
Figure 54: The Entrance of Umran Baradan Toy Museum

Entrance is not connected by an accessible route to public transportation stops, accessible parking, passenger loading zones and public streets or sidewalks. Entrance is not on the level with the street.

There is 2500 mm elevation difference between the level of the street and the level of the entrance of the building. So there should be a ramp or an elevator to go to the building level. However there is no elevator or ramp at the entrance of the building. There is no possibility to enter this museum for people who use wheelchairs.

There are stairs at the entrance to go in the building. There is no perceivable surface on the beginning and on the end of the stairs. A person who has vision impairment may have difficulty about when s/he should start and stop stepping the stairs. Stairs have hard and matte; however the stairs has no “non-slip” surface. It is possible to slip while stepping the stairs in case any bad weather condition. The width of the stair is 280 mm; this value is appropriate. The height of the stair is 170 mm. This value is a little bit more than desired. There is no slip band not to slip on the front side of the stairs. There are handrails at the both sides of the stairs.

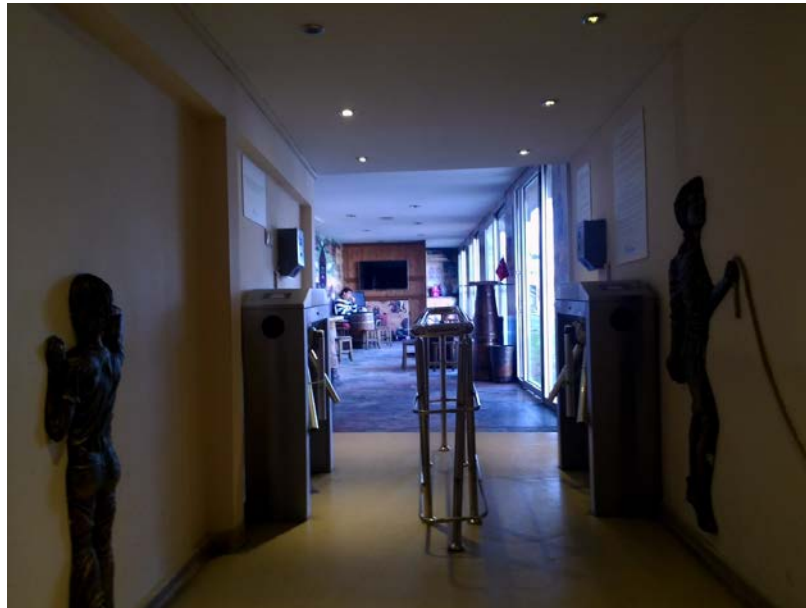
Figure 55: Turnstiles at the Entrance of the Museum

After entering the main gate of the museum, there are turnstiles. To enter the museum was paid before. But it is free of charge to go in the museum recently. There is no need to be turnstile at the entrance. The clear width of these turnstiles is 530 mm, so it is not possible to go in the museum for people who use wheelchairs. These unnecessary turnstiles cause not to go in for people who use wheelchairs.

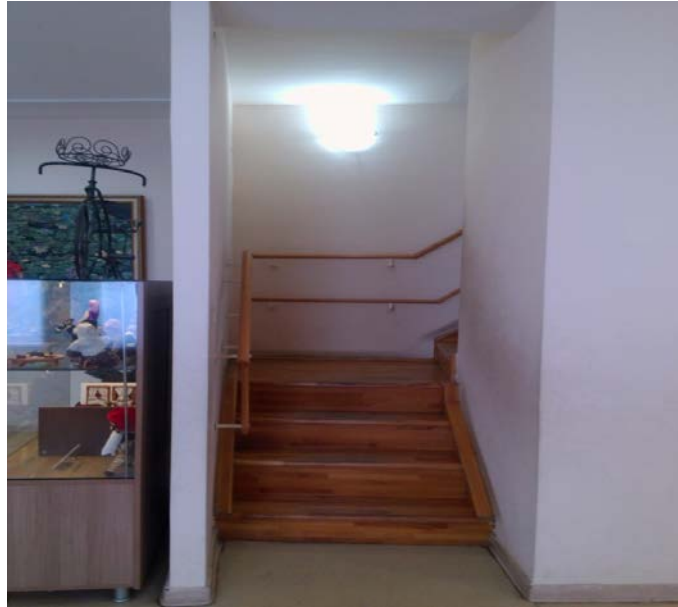
Figure 56: The Stairs inside of the Museum

This is a museum which has two-storey exhibition area. So, there has to be an elevator in the building. Unfortunately there is no elevator in the building to go up the second floor. So, it is not possible to go up and visit the second floor of the museum for people who use wheelchairs.

There are stairs to go up to the second floor. There is no perceivable surface on the beginning and on the end of the stairs. A person who has vision impairment may have difficulty about when s/he should start and stop stepping the stairs. Stairs have hard and matte and “non-slip” surface. The width of the stair is 280 mm; this value is appropriate. The height of the stair is 200 mm. This value is a little bit more than desired. There is no slip band not to slip on the front side of the stairs. There are handrails at the edge of the stairs.

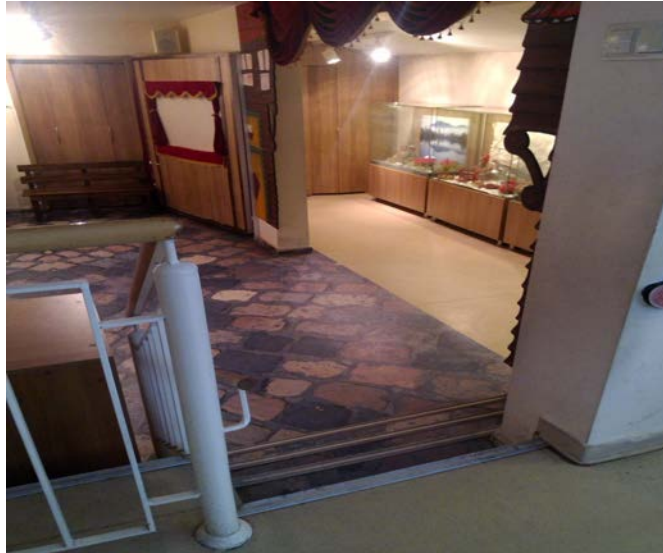
Figure 57: The Passing Point by Stairs at the Second Floor

The museum is not accessible in regards to internal movement. There are few parts of the museum which one can go pass by using the stairs, however there is no ramps in these parts.

That doesn't make people who use wheelchairs possible to pass from one part of the building to another. Inside of the parts, the distance between the objects exhibited is at least 1100 mm which is even more than it should be.

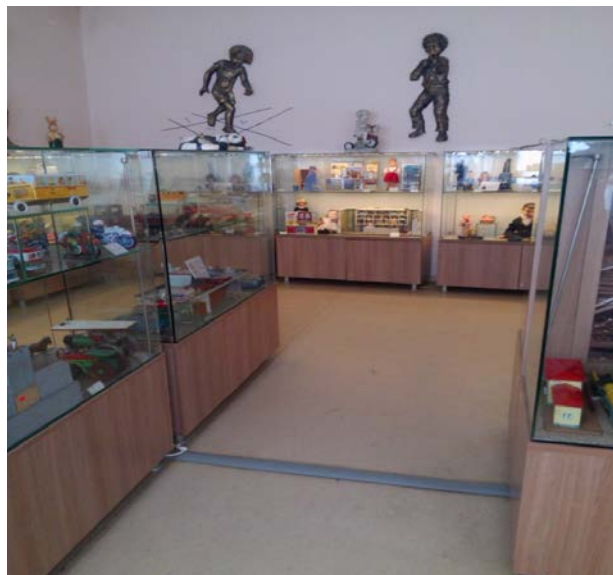
Figure 58: A Corridor at the Second Floor of the Museum

However one who use wheelchair cannot go to the other parts, so the situation that the distance between the objects exhibited is at least 1100 mm is not important.

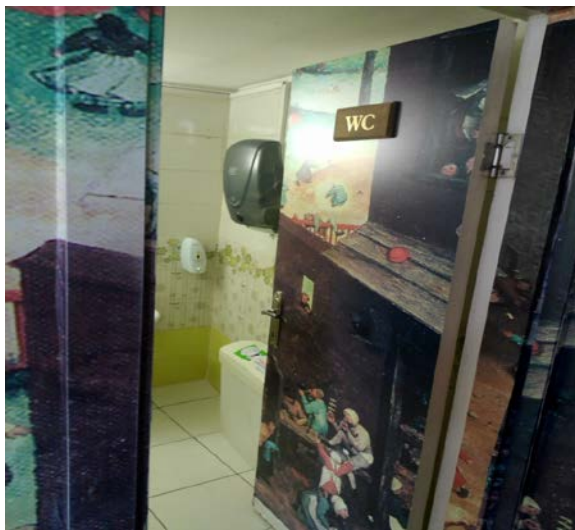
Figure 59: The Entrance of the Toilet

There is no accessible toilet especially designed for people with disabilities in the museum. The clear width of the toilet door is just 590 mm which is not appropriate for people who use wheelchairs to go in the toilet.

The door doesn't open outwards and there is 1100 mm x 1200 mm space for maneuvering inside the toilet. Thus it is not possible to go in the toilet for people in wheelchairs. There is no emergency button or rope inside the toilet in case of emergency. The door of the toilet doesn't open from both sides for emergencies. There are two different tall sink in the toilet. One of them is for the adults the other is for the children. They actually design this sink for the children, however, at the same time, this sink is appropriate when the height of the mirror and the height of the sink are considered.

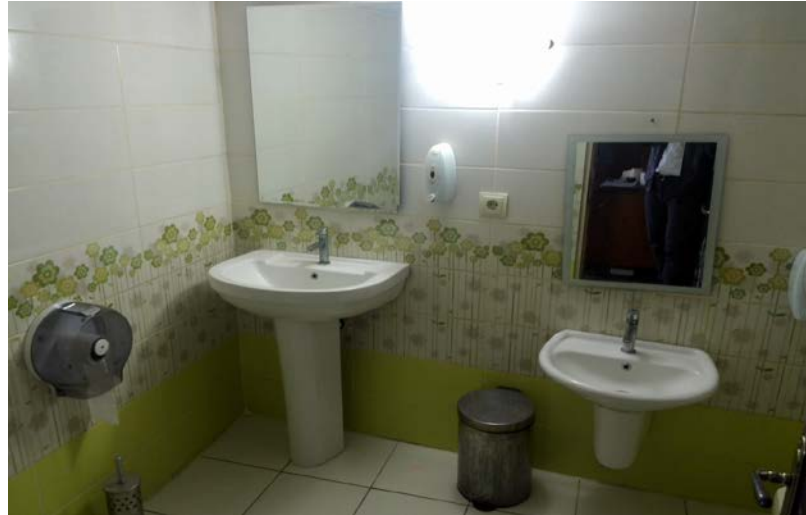
Figure 60: Inside of the Toilet

The beginning height of the mirror is 820 mm above the finish floor and there is no sloping mirror on the wall. But, one who use wheelchair can see himself on the mirror. Pedestal sink was used and there is no cupboard under the sink. The clear height under the sink is 500 mm and the depth under the sink is 350 mm which is even deeper than it should be. However, because there is just 500 mm height under the sink, it is not possible to approach to the sink. The lines of the sink are round that means there is no danger using the sink. The height of the sink is 620 mm which is appropriate for people who use wheelchairs.

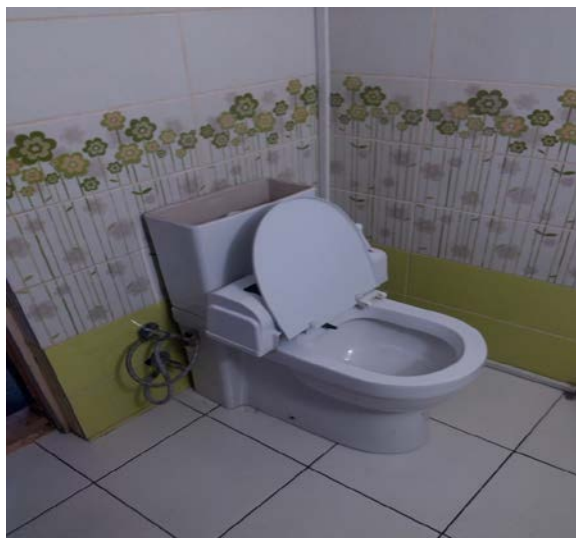
Figure 61: The Water closet of the Toilet

The height of the water closet is 400 mm. This water closet is also for the children and so it is in the acceptable measures. There is no grab bars in the toilet.

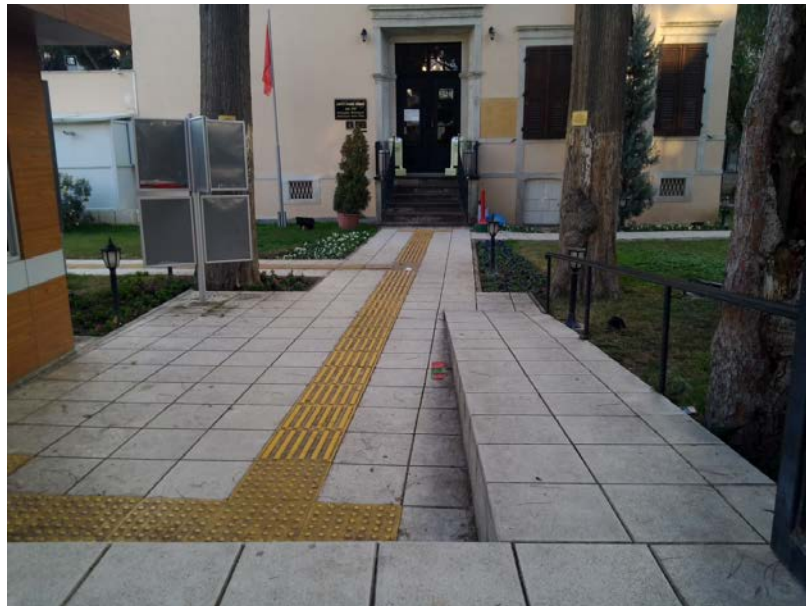
Figure 62: The Entrance of the Complex

Entrance of the complex is connected by an accessible route to public transportation stops, accessible parking, passenger loading zones and public streets or sidewalks. However, the entrance of the building is not on the level with the street. There is 2500 mm elevation difference between the street and the entrance of the building. So there should be a ramp or an elevator to go to the building level. However there is no elevator or ramp at the entrance of the building. There is no possibility to enter this museum for people who use wheelchairs.

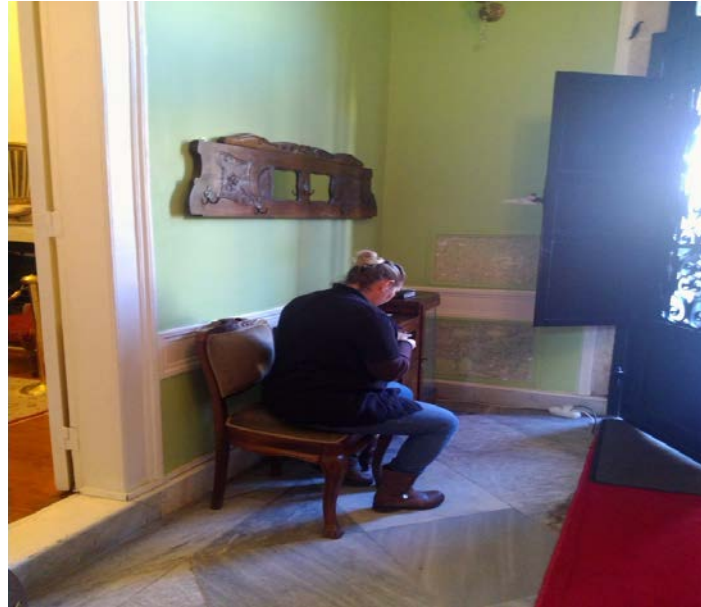
Figure 64: Chest of Drawers used for Information Desk

There is no desk at the entry of the building for getting information and helping if required. There is a chest of drawers and one chair on the entrance of the museum.

The height of the chest of drawer is 700mm. The width of the chest of drawer is 500 mm. The officer and the visitor may communicate each other eye to eye without standing up. They do not accept the guide dog (service animal) if required. There is enough space which is 4000 mm x 8000 mm for people in wheelchairs in front of the desk. Officers may help if anybody would like officer to help. There is no sign language interpreter to give information about the museum for people who have hearing impairment. They can not provide wheelchair to help while visiting the museum for people who have difficulty about movement.

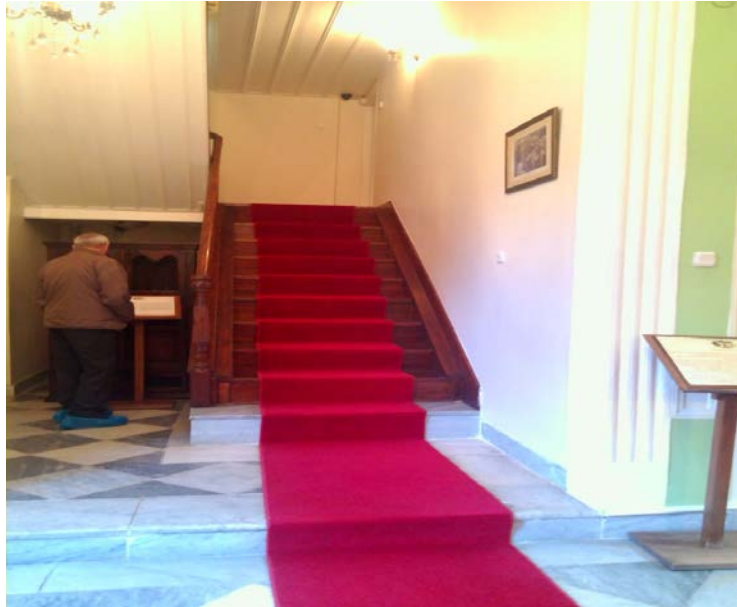
Figure 65: Stairs inside of the Museum

This is a museum which has two-storey exhibition area. So, there has to be an elevator in the building. Unfortunately there is no elevator in the building to go up the second floor. So, it is not possible to go up and visit the second floor of the museum for people who use wheelchairs.

There are stairs to go up to the second floor. There is no perceivable surface on the beginning and on the end of the stairs. A person who has vision impairment may have difficulty about when s/he should start and stop stepping the stairs. Stairs have hard and matte and “non-slip” surface. The width of the stair is 320 mm; this value is appropriate. However the height of the stair is 320 mm which is even not appropriate for the people who have not any impairment. This value is too much for people with disabilities. There is no slip band not to slip on the front side of the stairs. There are handrails at the edge of the stairs.

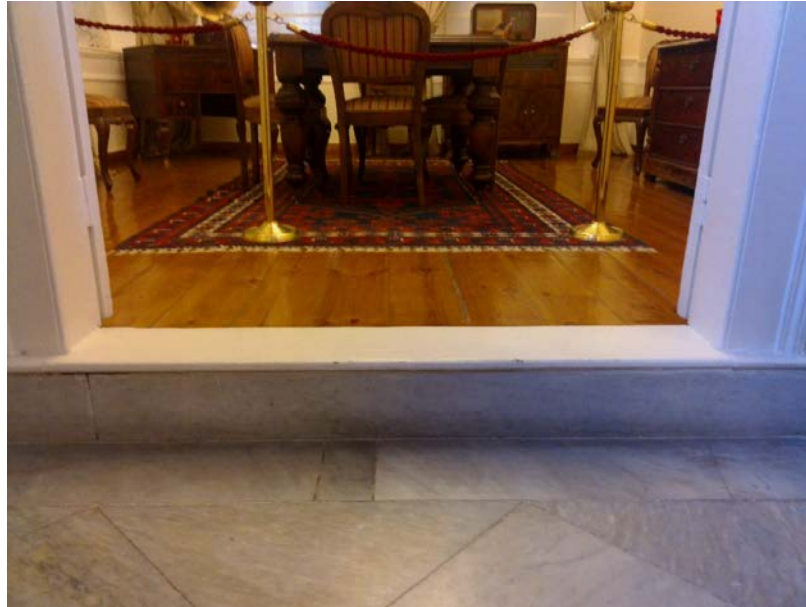
Figure 66: One of Doorsteps inside the Museum

The museum is not accessible in regards to internal movement. There are a few rooms of the museum. The entrances of these rooms have elevation differences between the level of the hall and the level of the floor of the rooms.

So, there should be ramps to go in these rooms; however there is no ramp on the entrance of these rooms. That doesn't make people who use wheelchairs possible to pass from one room of the house to another. Inside of the rooms, the distance between the objects exhibited is at least 800 mm which is a little bit lower than it should be. However one who use wheelchair cannot go in to the rooms, so the situation that the distance between the objects exhibited is at least 800 mm is not important.

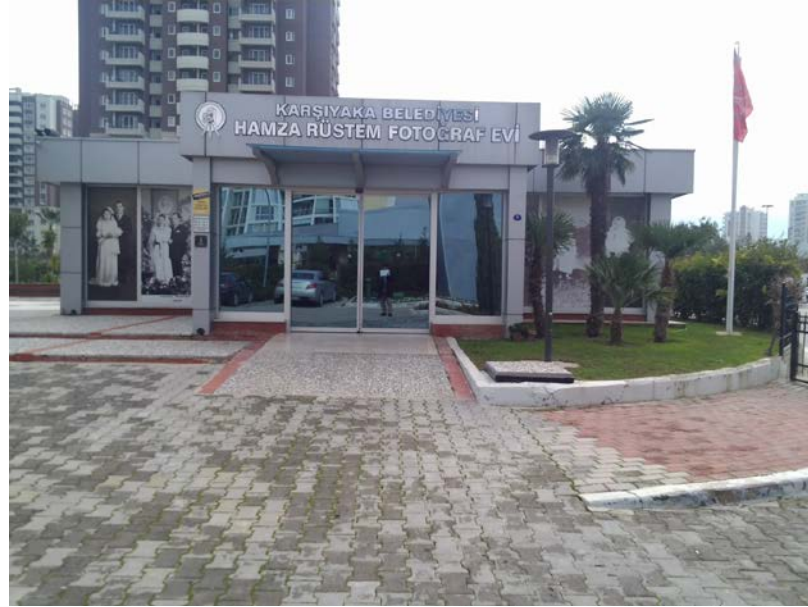
Figure 67: Entrance of Hamza Rustem Photograph House

Main entrance is connected by an accessible route to public transportation stops, passenger loading zones and public streets or sidewalks. Main entrance is on the level with the street. So there is no need to ramp or stairs to go in the museum.

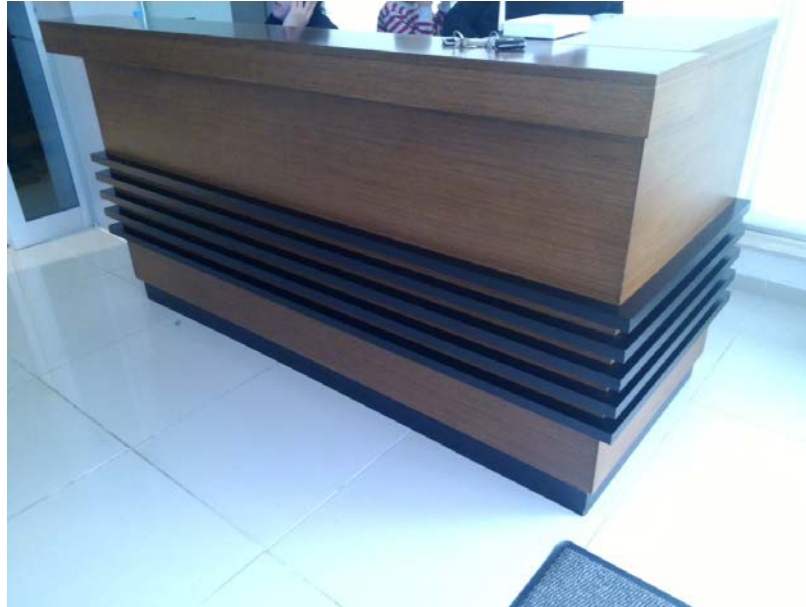
Figure 68: Information Desk of the Museum

There is an information desk in the building. The width of the information desk is 2080 mm which is even wider than it should be, however the length of the desk is 1080 mm which is not accessible especially for people who use wheelchairs. There is 60 mm knee space. So, individuals who use wheelchair cannot approach to the desk.

There is enough space that is 1650 mm x 2500 mm for maneuvering. They may accept the guide dog (service animal) if required. However all things are the objects that need to be seen. There is no sign language interpreter service for those who have hearing impairment. Officers may help if anybody would like officer to help. They can not provide wheelchair to help while visiting the museum for people who have difficulty about movement. However if one who has difficulty about movement call the officer at least one day ago before his visit, they may provide wheelchair by having help from the municipality. There is no visual signs to show where can go outside of the building for people who have hearing impairment in case of emergency. There is audible alarm system; however there is no visible alarm system for people who have hearing impairment in the museum.

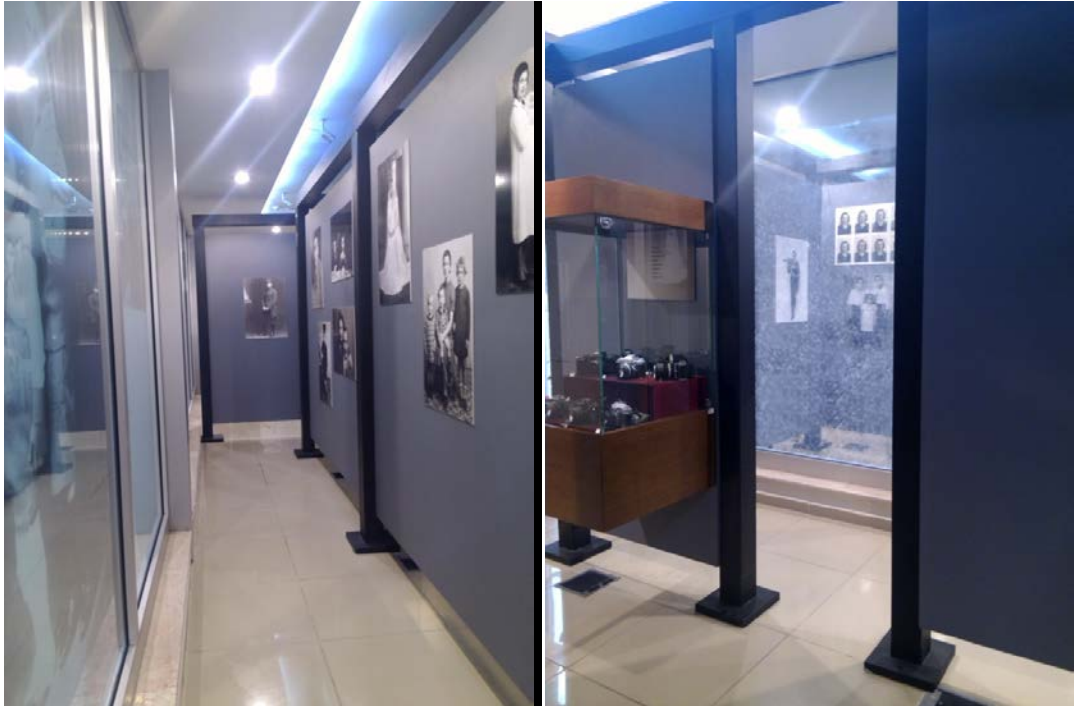
Figure 69.1-2: Corridors inside the Museum

There are some corridors in the exhibition area in the museum. The narrowest pass of these corridors is 540 mm which is 360 mm narrower than it should be. One who use wheelchair can not go in to this corridor.

Even if one able to go in to this corridor from one entry of it, he has to go out from the same entry. However there is no enough space for maneuvering to turn back in this corridor. Other corridors have 1240 mm width. The height of the object exhibited is between 900 mm and 1650 mm.

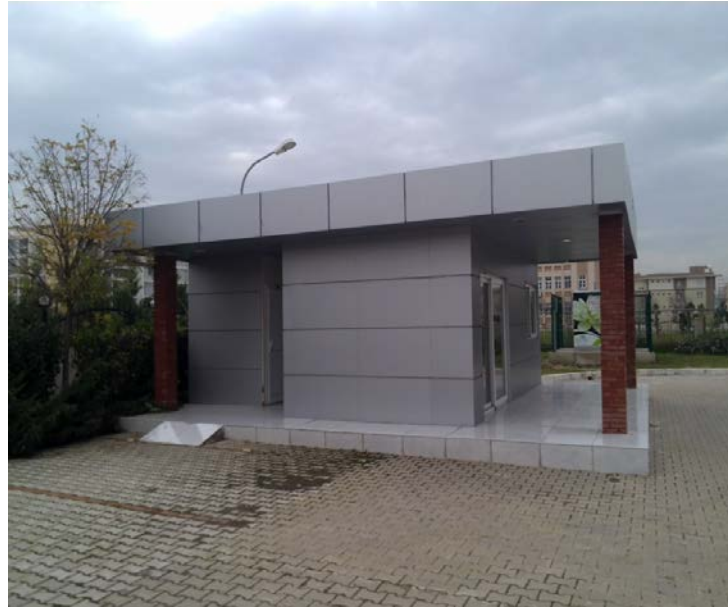
Figure 71: Toilets of the Museum

There is a toilet especially designed for people with disabilities. However it is located in a different building from the main building of the museum. There is no sign to make people direct to this toilet. One has to ask for the toilet about where it is.

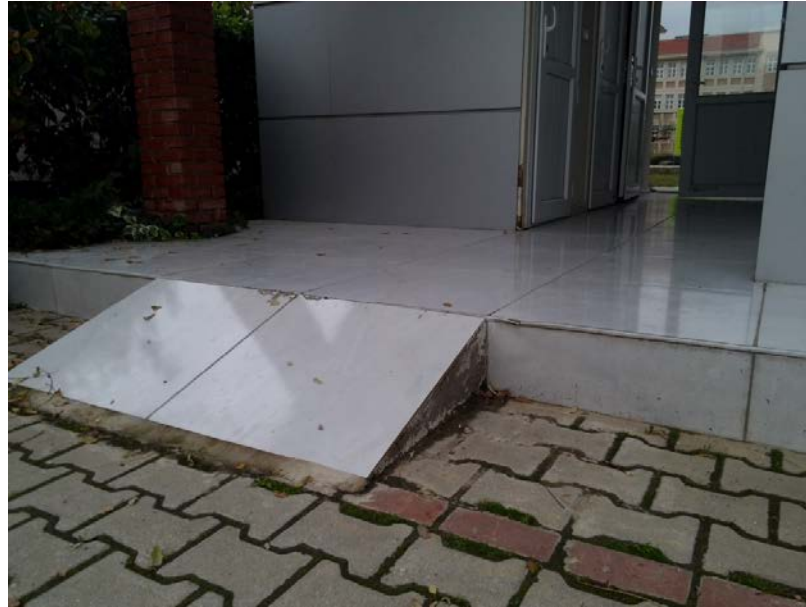
Figure 72: Ramp used for entering to Toilet of the Museum

There is 200 mm elevation difference between the level of the street and the level of the building that has the toilets. So there should be a ramp. There is a ramp to eliminate the elevation difference. The slope of this ramp is %33, this value is much more than it should be.

Although the length of the ramp is just 660 mm, one who use wheelchair has a difficulty about using this ramp to go to the toilets. One has to need for help to push his wheelchair to go up to the level of the toilet. There is no curb which has to be at least 50 mm at the both sides of the ramp. There are no handrails which have to be at the both sides of the ramp. The width of the ramp is 1200 mm which is even a little bit wider than it should be.

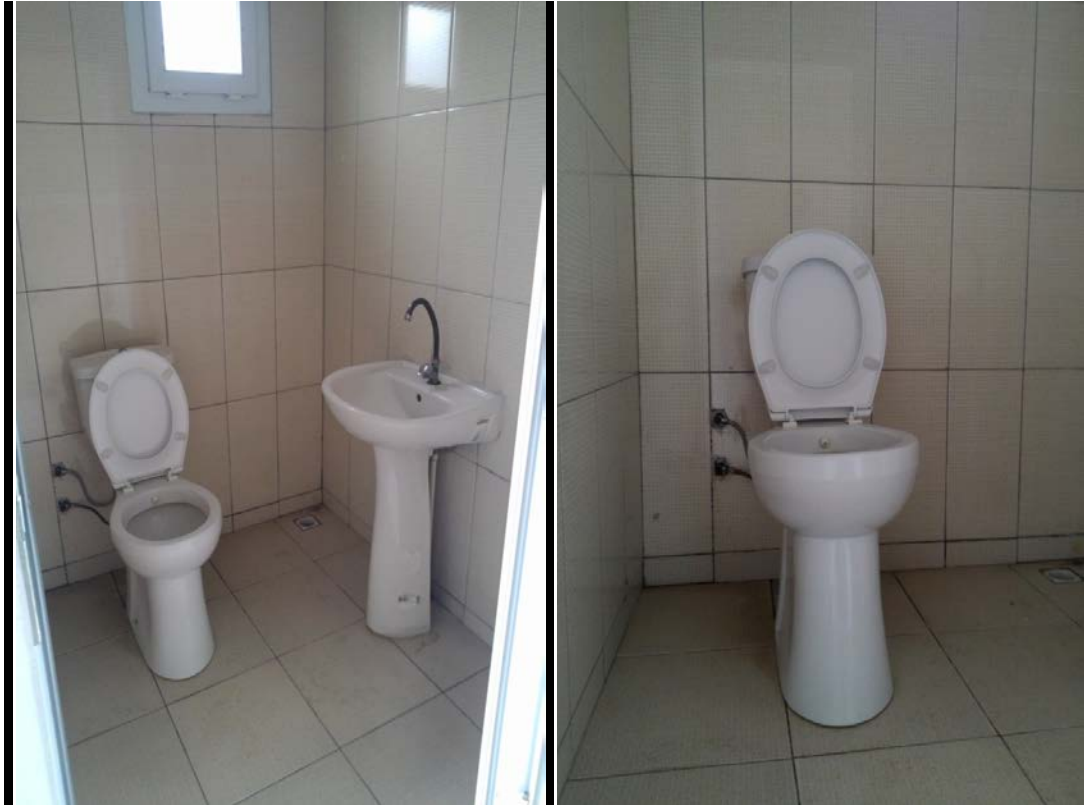
Figure 73: Inside of the Toilet

There is a disability sign on the door. The clear width of the toilet door is 840 mm which is not appropriate for people who use wheelchairs to go in the toilet. The door opens outwards and there is just 750 mm x 900 mm space for maneuvering inside the toilet. Thus it is not possible to move in the toilet for people in wheelchairs.

There is no emergency button or rope inside the toilet in case of emergency. The door of the toilet doesn't open from both sides in case of emergency. There is no mirror on the wall. Pedestal sink was used and there is no cupboard under the sink. The clear height under the sink is 650 mm and the depth under the sink is 550 mm which is even deeper than it should be. However, because there is just 650 mm height under the sink, it is not possible to approach to the sink. The lines of the sink are round that means there is no danger using the sink in the cabinet. The height of the sink is 820 mm which is appropriate according to the standards for people who use wheelchairs. The height of the water closet is 450 mm. There is no grab bars in the toilet that means it is very difficult to pass to the water closet from the wheelchair. There is an open area parking place outside of the museum.
