YASAR UNIVERSITY
INSTITUTE OF SOCIAL SCIENCES
MASTER IN TOURISM MANAGEMENT
MASTER THESIS

THE ASSESMENT OF MUSEUMS IN IZMIR IN REGARDS TO ACCESSIBILITY

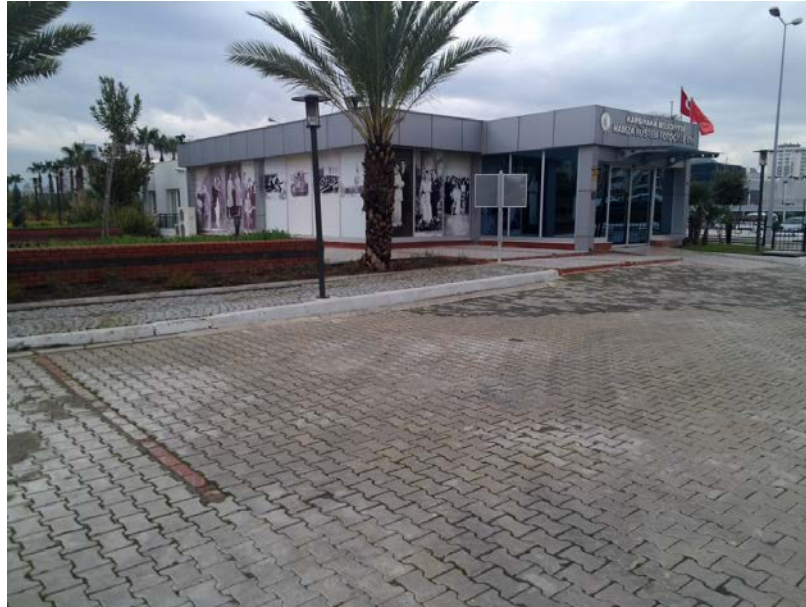
Figure 74: Parking Area of Hamza Rustem Photograph House

There is no sign that means it is especially for the disabled people. However the officers direct disabled people who came to the museum by his own car to this area which is located just next to the main gate of the museum. The width of the parking area for the disabled people is 4500 mm which is even 900 mm wider than required. One who use wheelchair may get off the car easily and pass his wheelchair without having a maneuvering problem. The depth of the parking area is 8500 mm which is again 2500 mm deeper than it should be according to the standards. There is a good lightening equipment to help about seeing well.

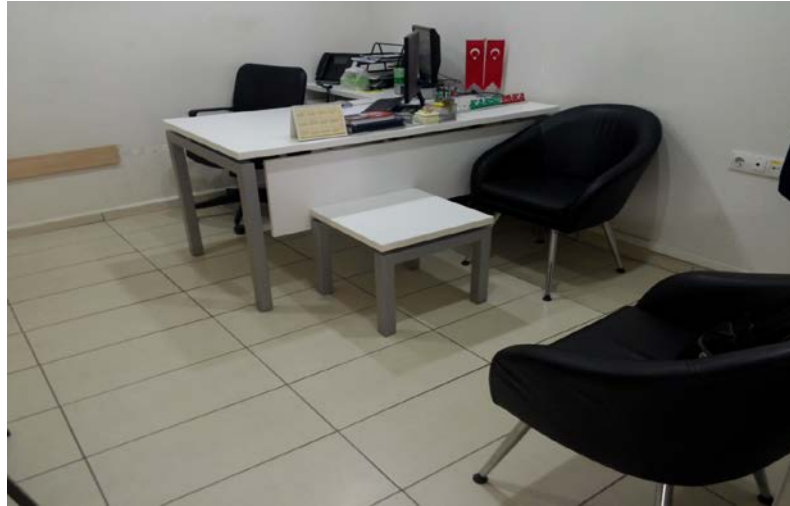
Figure 76: Information Desk in a Room of the Museum

There is an information room where one may have information about the museum in the building. There are two chairs and a table in the room. The width of the table is 1000 mm which is even wider than it should be and the length of the desk is 750 mm which is accessible especially for people who use wheelchairs. There is no knee space and there is no need. One who has wheelchair may approach to the table. Officer and the visitor who has wheelchair can see each other while both of them sitting.

There is an enough space that is 1500 mm x 1500 mm for maneuvering. They may accept the guide dog (service animal) if required. However all things are the objects that need to be seen. There is no sign language interpreter service for those who have hearing impairment. Officers may help if anybody would like officer to help. They can not provide wheelchair to help while visiting the museum for people who have difficulty about movement. However if one who has difficulty about movement call and tell the officer about his need at least one day ago before his visit, they may provide wheelchair by having help from the municipality. There are visual signs to show where can go outside of the building for people who have hearing impairment in case of emergency.

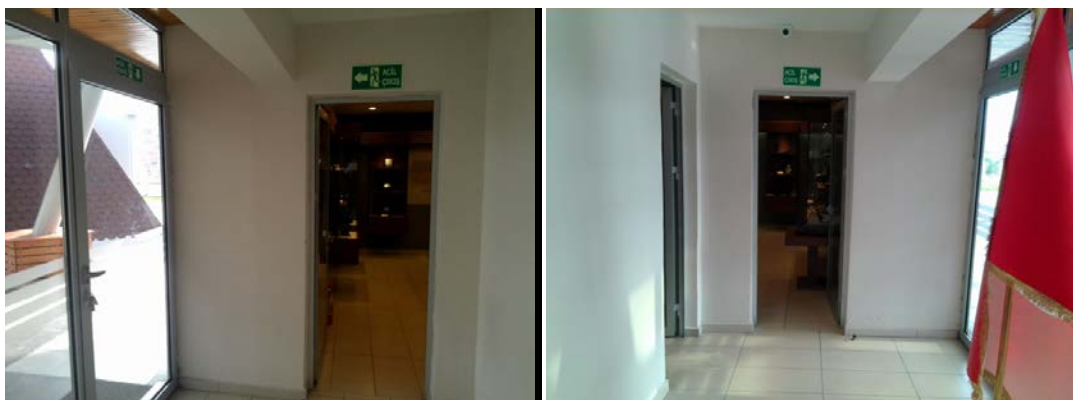
Figure 77.1-2: Visual Signs to Escape in Emergency

There is audible alarm system; however there is no visible alarm system for people who have hearing impairment in the museum.

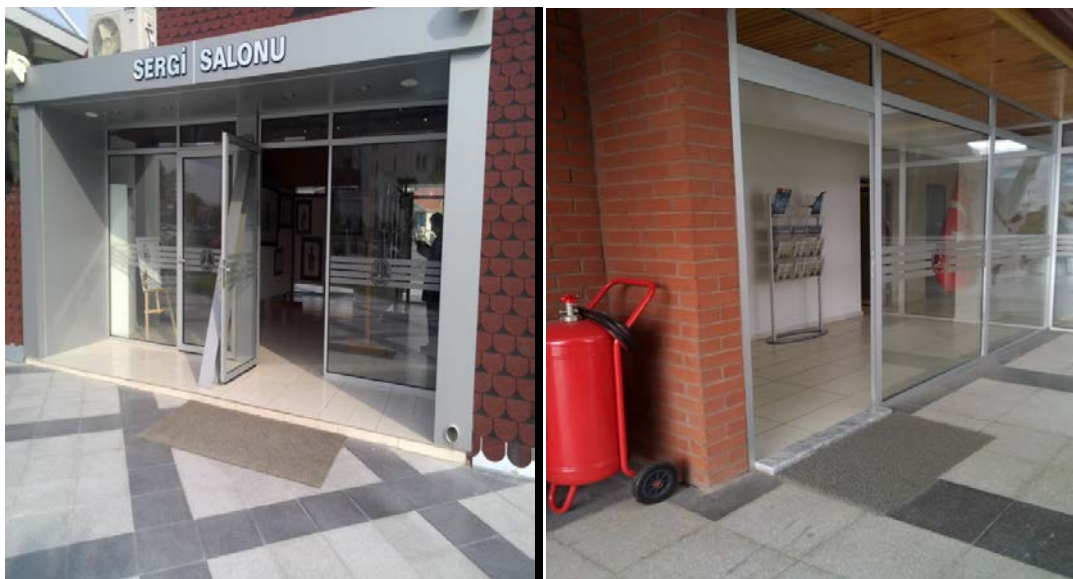
Figure 78: Doorsteps of the Buildings in the Complex

This is a museum which has one-storey exhibition area. So, there is no need to be an elevator or the stair in the building. However, there is 80 mm elevation difference on the entrance of the first building of the museum and also there is 50 mm elevation difference on the entrance of the second building of the museum. But unfortunately there is no ramp on these two entrances.

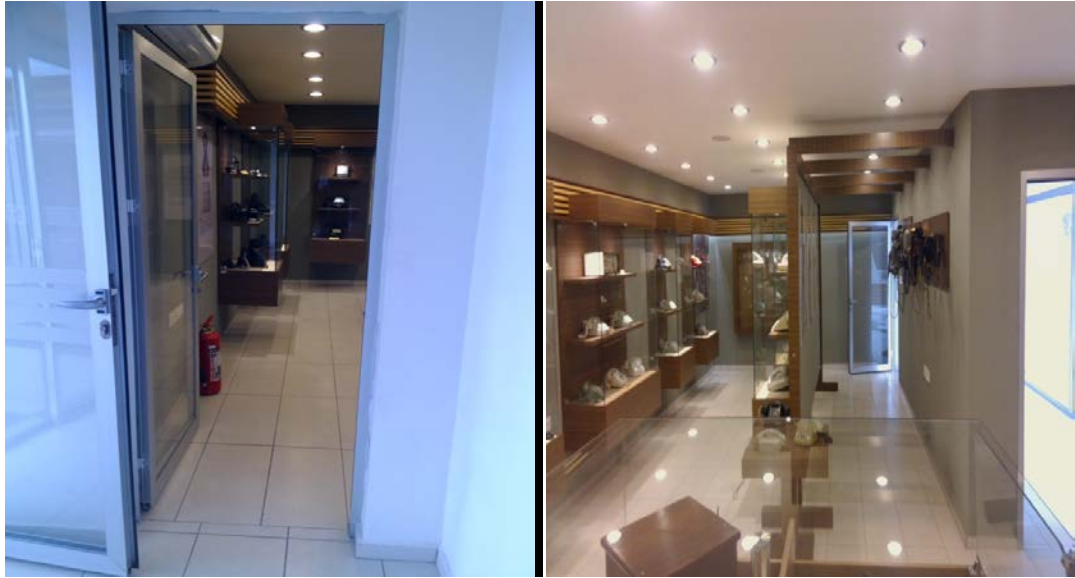
Figure 79: Entrance and Exit of an Exhibition Door.

There are some exhibition rooms in the second building of the museum. The narrowest pass of these rooms is 670 mm which is 270 mm narrower than it should be. One who use wheelchair can not go in to this room.

The exit door of this room is 770 mm, so one who has wheelchair may try to go in to and go out of this room from the same door. The height of the object exhibited starts from 670 mm and 770 mm. Thus these all objects that are exhibited on the first and the second shelf can be seen by people who have wheelchair, however the objects exhibited on the third shelf can not be seen by them. The width of the corridor between the glass cases is 1060 mm. So this is the width which is appropriate for the people who use wheelchairs.

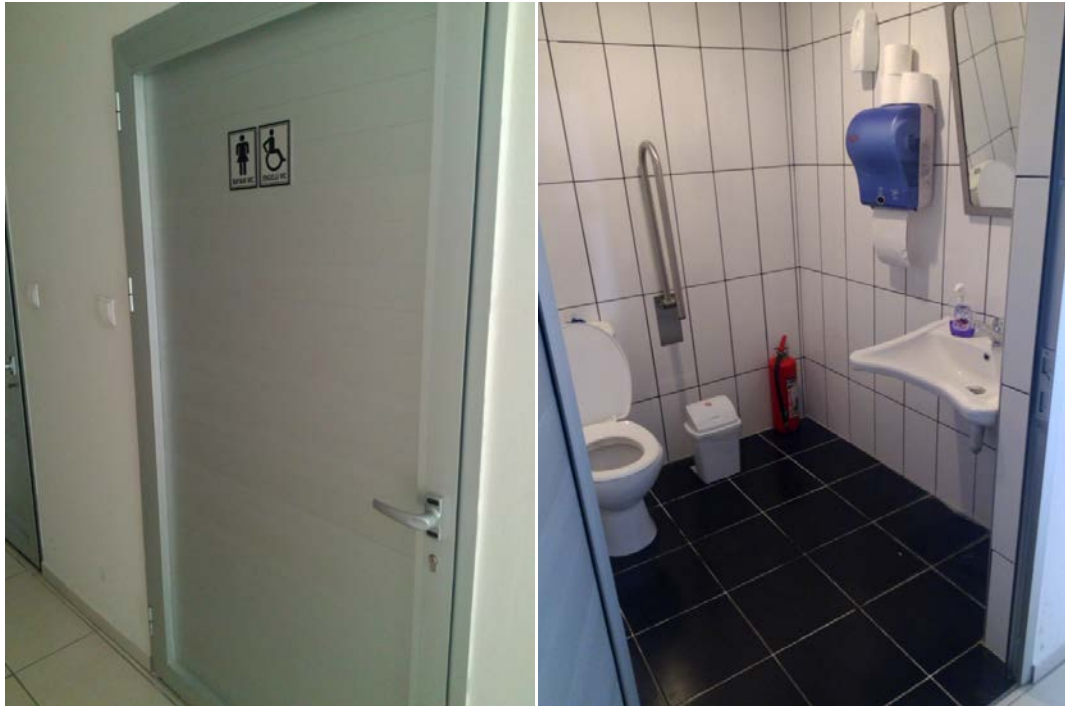
Figure 81: The Door and the Entrance of the Toilet

There is a toilet especially designed for people with disabilities. There is no sign to make people direct to the toilet. One has to ask for the toilet about where it is. There is a sign that means this is for the disabled people, on the door.

The clear width of the toilet door is 980 mm which is appropriate for people who use wheelchairs to go in to the toilet. The door opens outwards and there is 1000 mm x 1100 mm space for maneuvering inside the toilet. Thus it is a little bit difficult to maneuver, but it is possible to move in the toilet for people in wheelchairs. There is no emergency button or rope inside the toilet in case of emergency. The door of the toilet doesn't open from both sides in case of emergency. There is a mirror on the wall and the mirror has a slope. Although the height of the mirror starts from the 1200 mm, one who use wheelchair can see himself on the mirror thanks to this slope of the mirror.

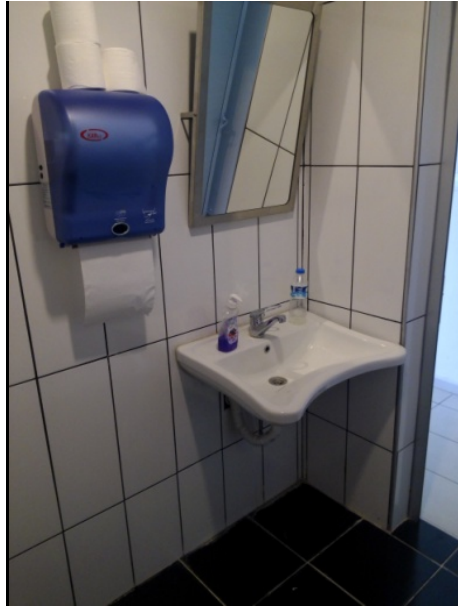
Figure 82: Inside of the Toilet

Pedestal sink was not used and there is no cupboard under the sink. The clear height under the sink is 740 mm and the depth under the sink is 300 mm which is even deeper than it should be. The lines of the sink are round that means there is no danger using the sink in the cabinet. The height of the sink is 780 mm which is appropriate according to the standards for people who use wheelchairs. The height of the water closet is 430 mm. There is a grab bar which has height between 790 mm and 1530 mm on the left sides of the water closet in the toilet.

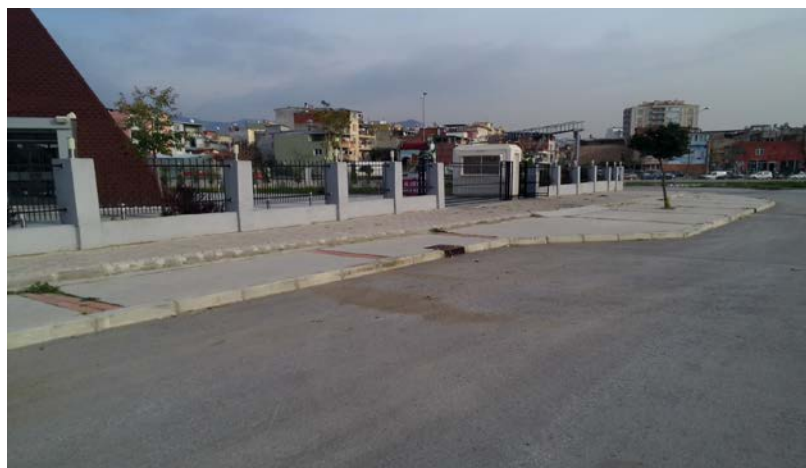
Figure 83: Parking Area of Communication Museum

There is an open area parking place outside of the museum. There is no sign that means it is especially for the disabled people. However the officers direct disabled people who came to the museum by his own car to this area which is located just next to the main gate of the museum. The width of the parking area for the disabled people is 5000 mm which is even 1400 mm wider than required. One who use wheelchair may get off the car easily and pass his wheelchair without having a maneuvering problem. The depth of the parking area is 10000 mm which is again 4000 mm deeper than it should be according to the standards. There are good lightening equipments to help about seeing well.
