EXPERIMENTAL RESEARCH ON SEISMIC RETROFITTING OF R/C EXTERIOR
BEAM-COLUMN-SLAB JOINTS UPGRADED WITH CARBON FIBER REINFORCED
POLYMER (CFRP) SHEETS

Master of Science

Graduate Program in Civil Engineering

Boğaziçi University

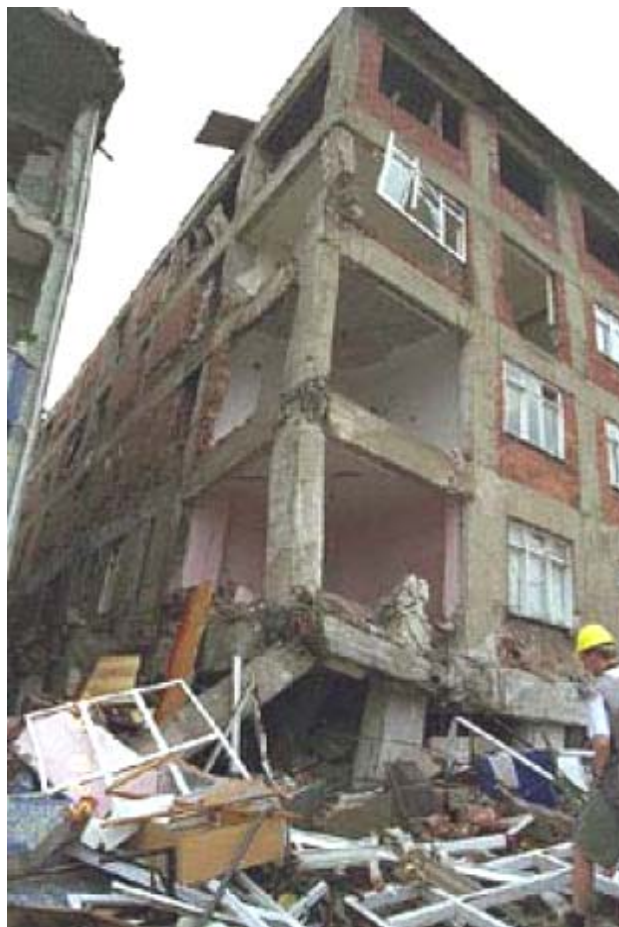
Figure 2.1. Damage on beam-column joint during Kocaeli EQ (Sezen *et al.*, 2000)

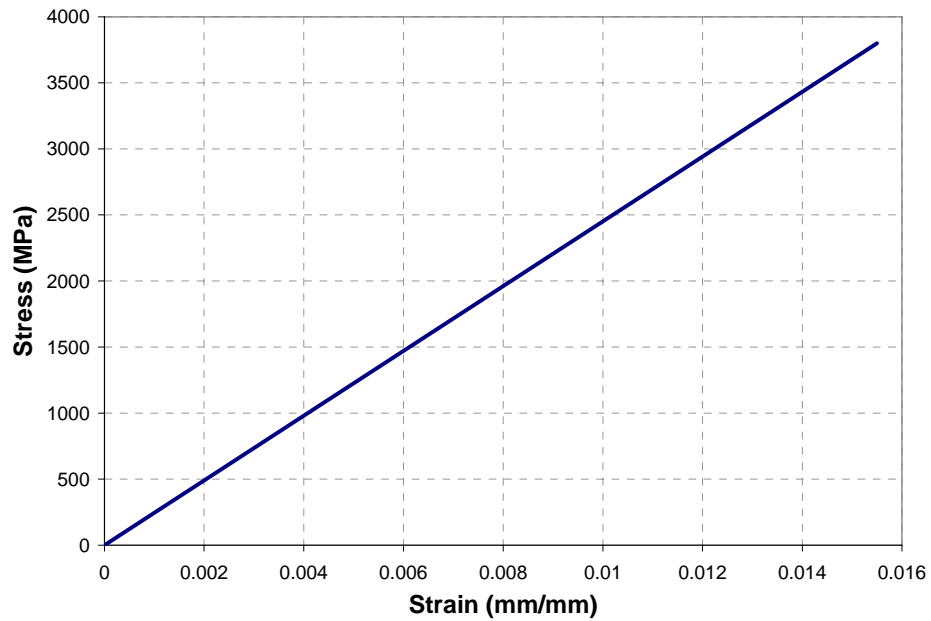
Figure 3.23. Stress-Strain Relations of CFRP

Nominal Thickness	0.176 mm/ply
Ultimate Tensile Strength (0°)	3800 MPa
Tensile Modulus (0°)	240 GPa
Ultimate Rupture Strain (0°)	1.55 %

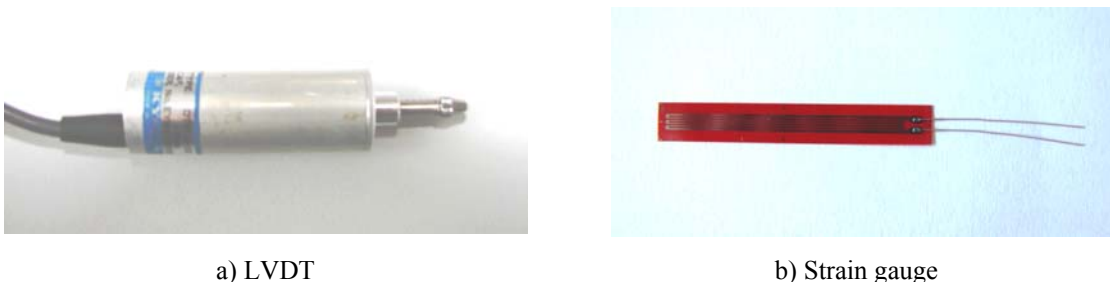
Figure 3.27. LVDT and strain gauge

Mainly, two types of instrumentation were applied to specimens in order to make required analysis of the sections, member responses and system behavior. All the movement of members and sections on the critical locations were measured with linear variable differential transformers (LVDTs). Possible critical sections of the members were analyzed and strain values of the rebars were measured using strain gauges. After the application of CFRP sheets, strain values on possible failure zones were also measured by the strain gauges.

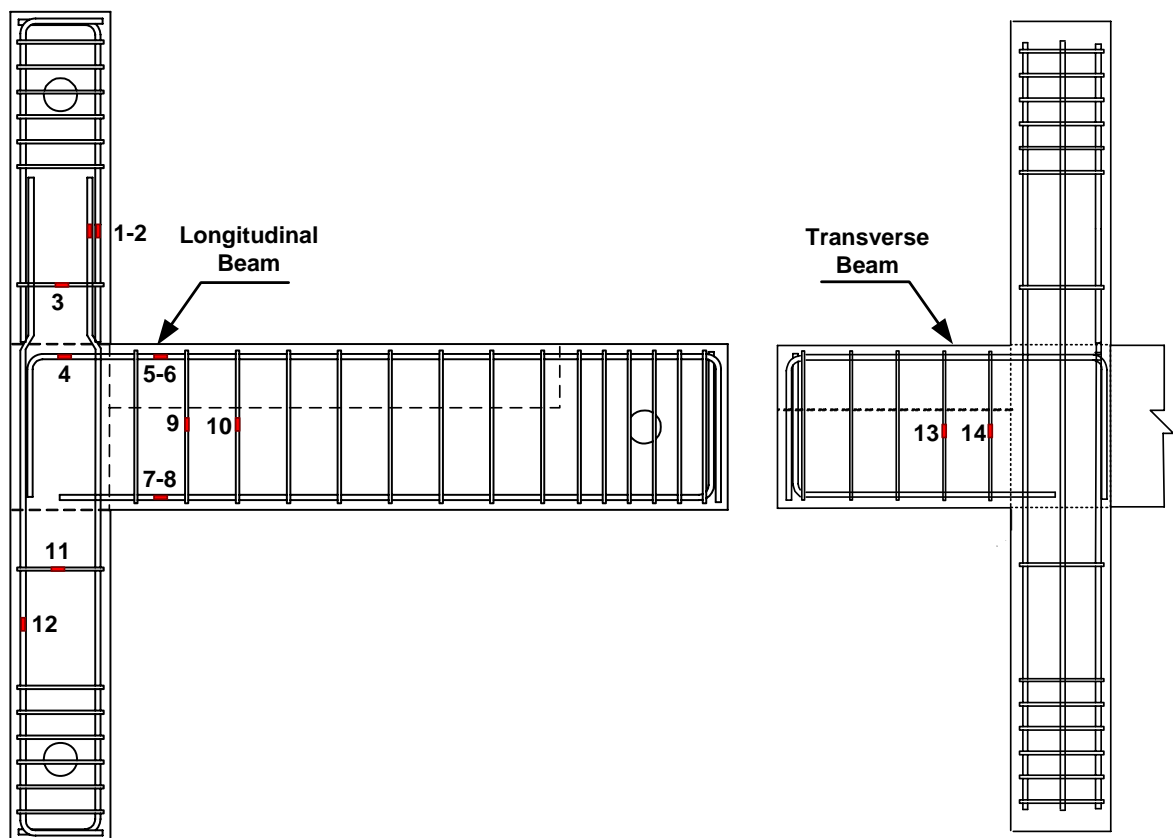
Figure 3.29. Location of strain gauges on rebars of beams and columns

As it was mentioned above, strain gauges were located on the critical sections. Details of strain gauge locations are the same for all of the specimens, except the locations of strain gauges on slab reinforcements. US3-E-Control specimen does not have floor slab and therefore such application cannot be mentioned. Amongst the US3-ES specimens, US3-ES-Control specimen has 11 extra strain gauges on the floor slab rebars with respect to other US3-ES specimens. The aim of application of extra strain gauges is to define the strain contours on floor slab and see the contribution of the slab on behavior of joint and longitudinal beam. Figure 3.29 illustrates the location of strain gauge instrumentation on column and beam rebars. Details of strain gauges on slab rebars are given in Figure 3.30.

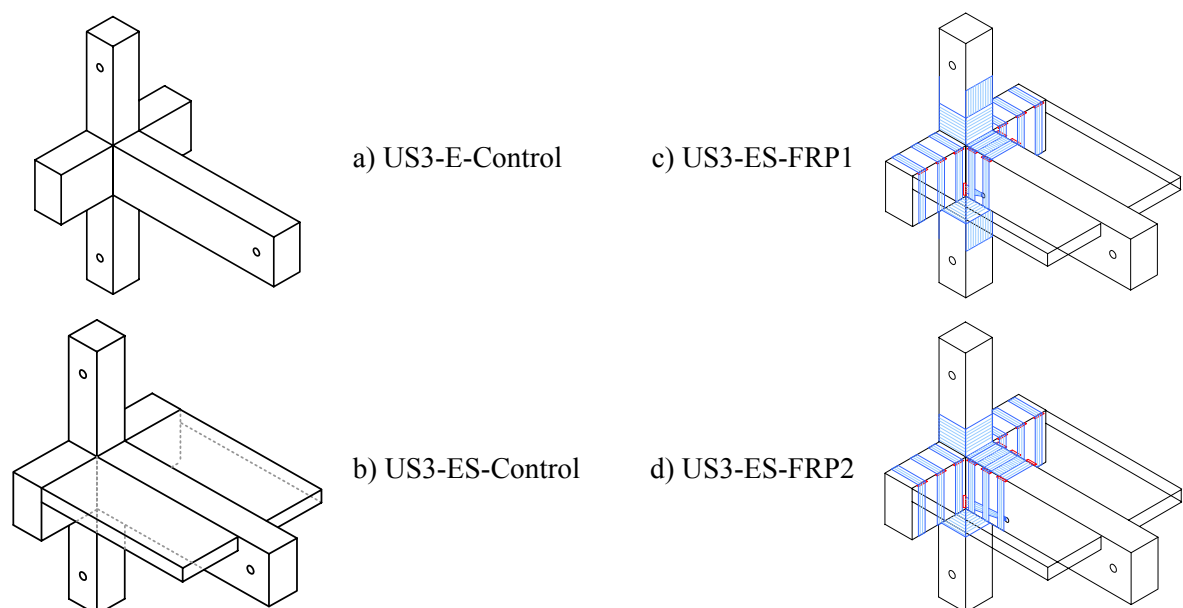
Figure 4.1. Description of test specimens

Before the discussion of the experimental results, repeating the names of the specimens is very helpful in understanding of the test outcomes properly. Figure 4.1 illustrates the specimens which were tested through this study.

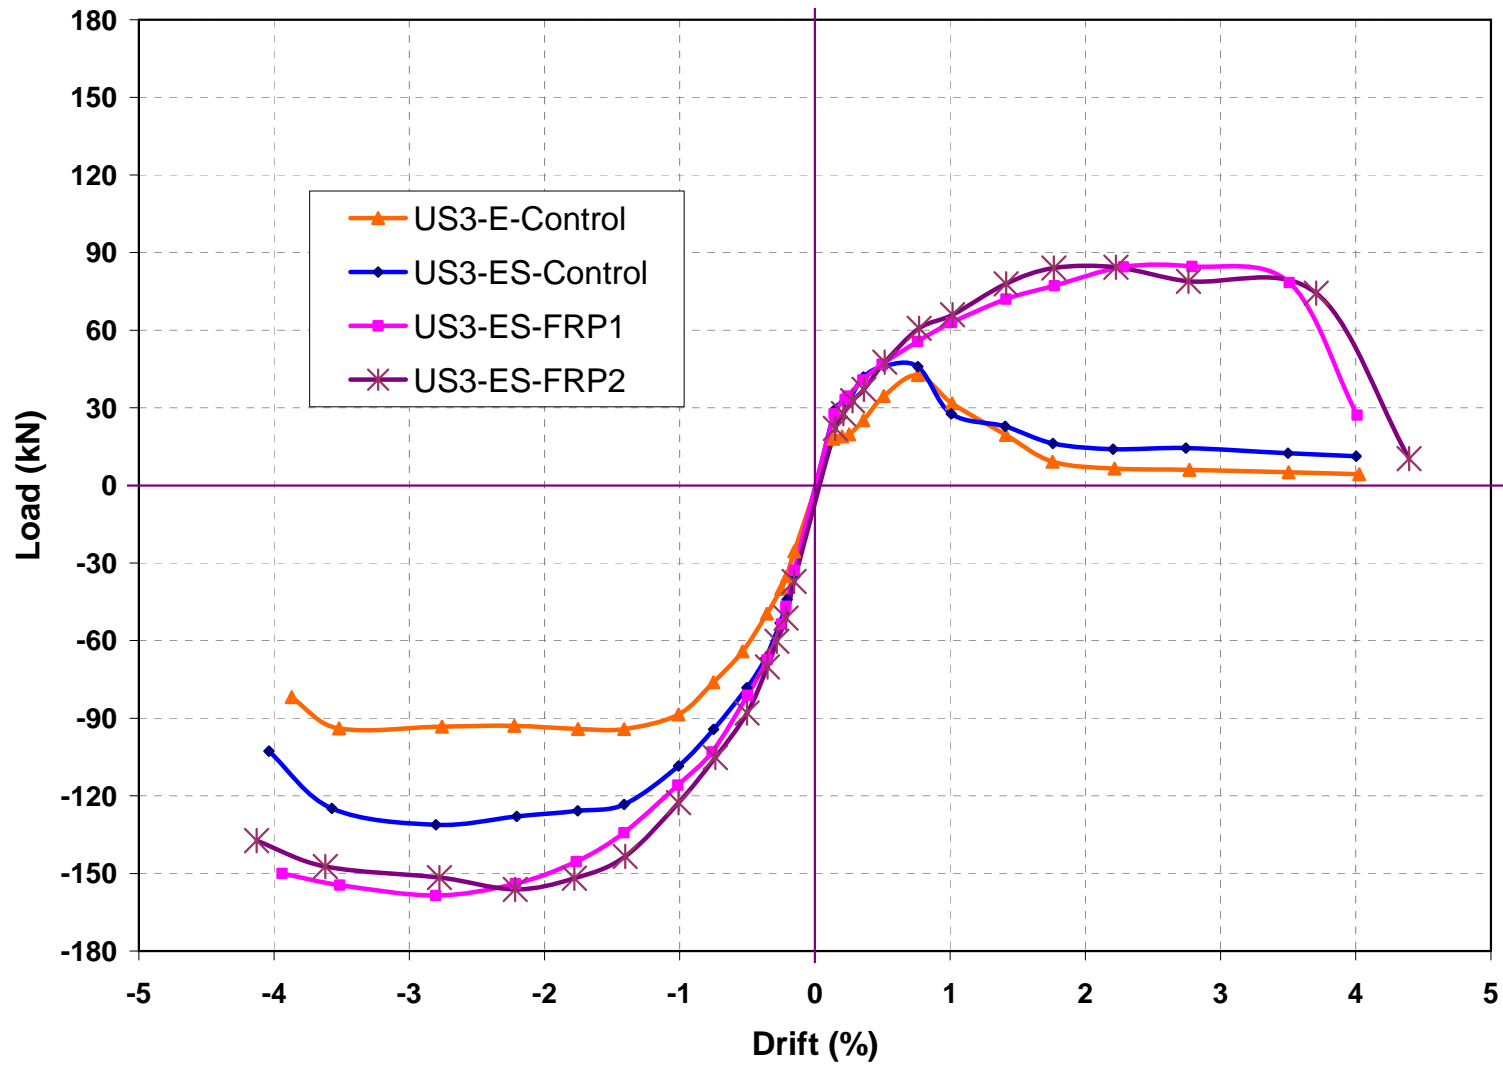
Figure 4.6. Comparison of lateral load versus story drift response of specimens

Envelope curves of specimens obviously demonstrate the enhanced behavior of beam-column joints after strengthened with CFRP sheets. On the following parts, such enhancement would be discussed in terms of other important parameters, like energy dissipation and deformation capacities. The behaviors of retrofitted specimens are so similar under cyclic loading and they present a great improvement especially in the push direction of loading.

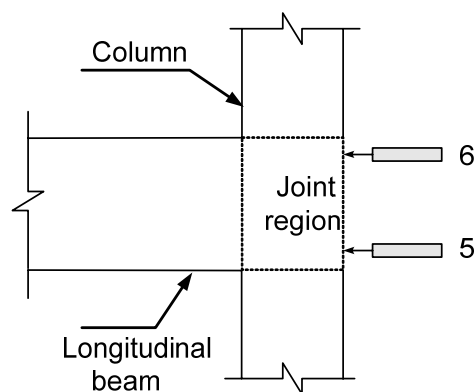
Figure 4.26. Shear deformation readings at joint region

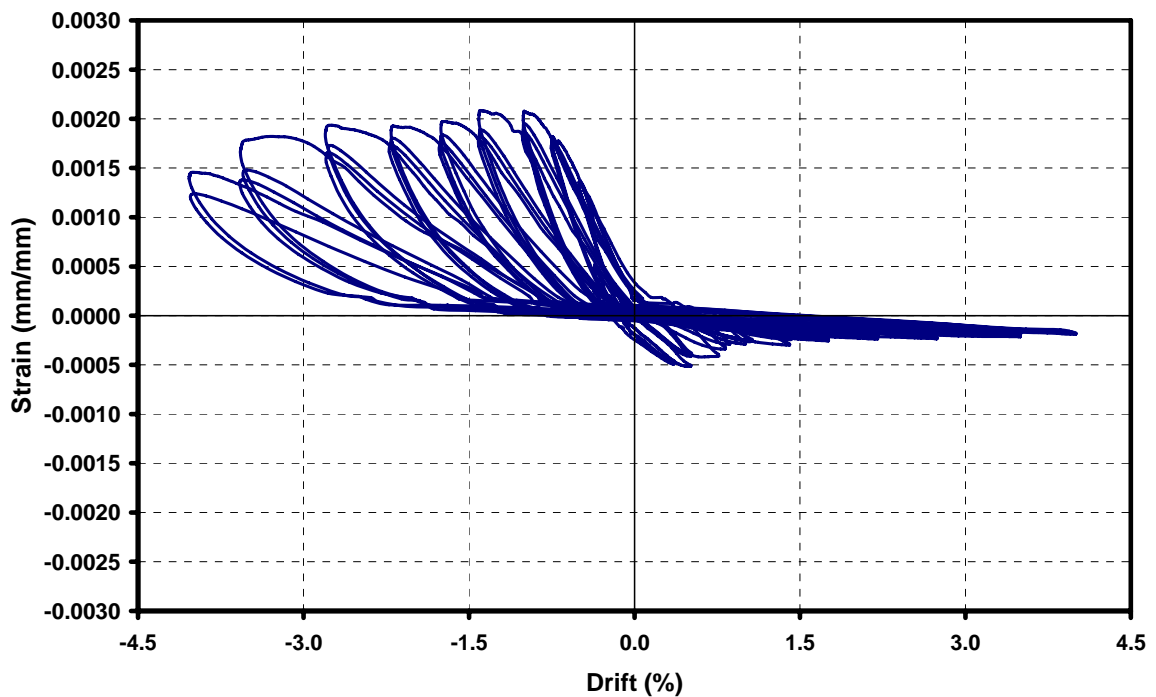
Figure 4.54. Strain versus drift graph of gauge #18 for US3-ES-Control

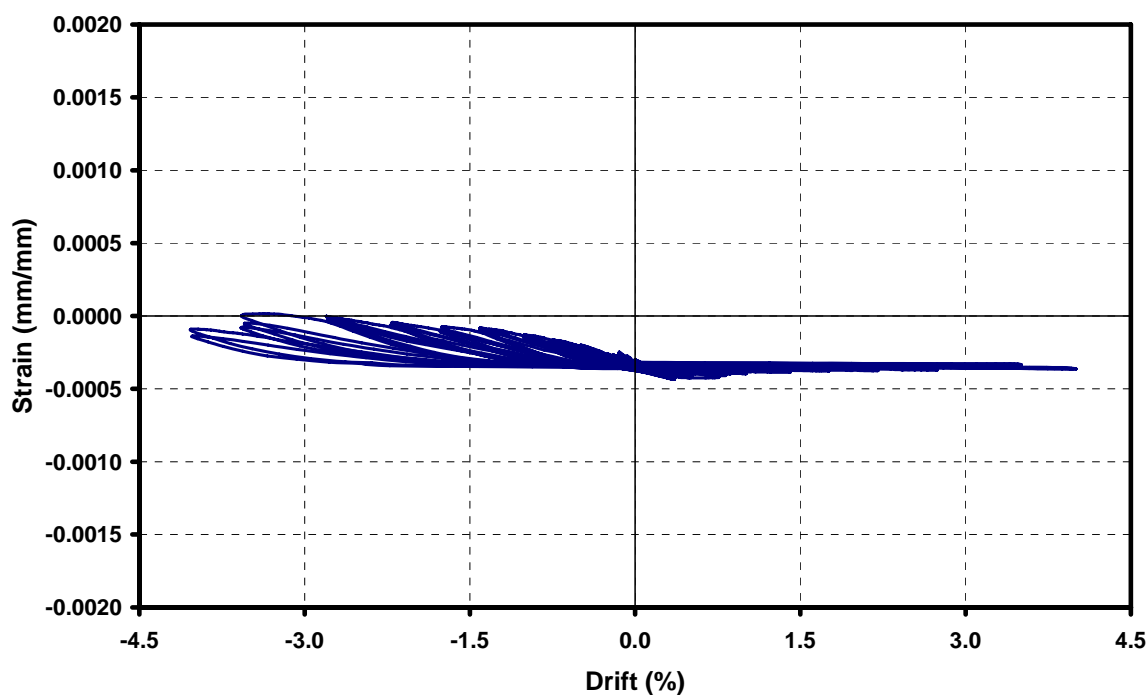
Figure 4.62. Strain versus drift graph of gauge #12 for US3-ES-Control
