INTERVENTION STRATEGIES FOR REHABILITATION OF THE  
ARCHITECTURAL HERITAGE IN TRIPOLI CASTLE IN RED SARAYA  
DISTRICT

A THESIS SUBMITTED TO  
THE GRADUATE SCHOOL OF NATURAL AND APPLIED SCIENCES  
OF  
ÇANKAYA UNIVERSITY

IN PARTIAL FULFILLMENT OF THE REQUIREMENTS  
FOR  
THE DEGREE OF MASTER OF SCIENCE  
IN  
INTERIOR ARCHITECTURE

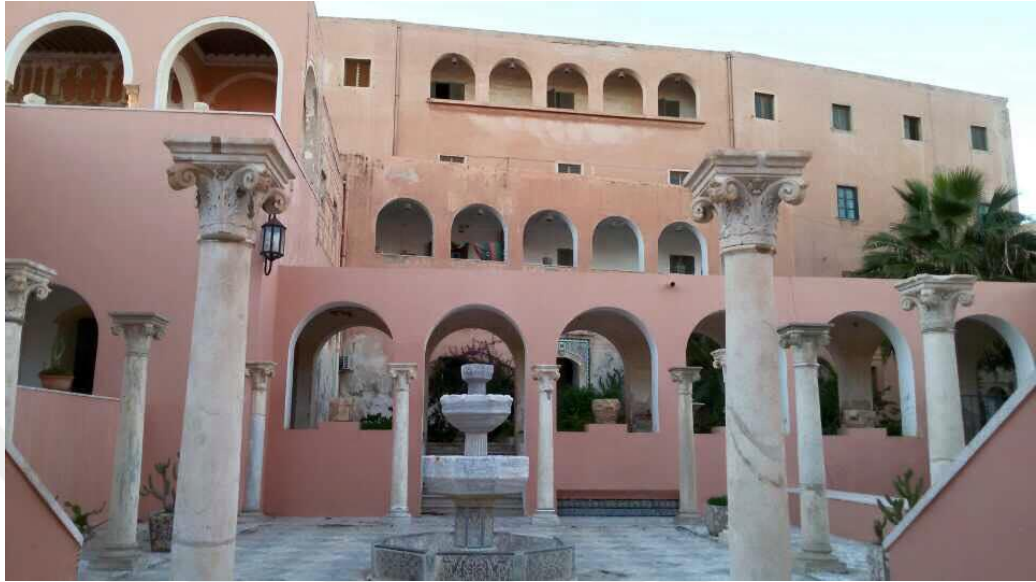
Figure 2.10: A yard in the Red Saraya with Roman and Byzantine remaining columns and a fountain from the Karamanli period (Author's collection)

The majority of the structures built within the Tripoli castle are referred to the Spanish invasion period, where the architectural structure was built around courtyards. Figure 2.7 shows an alley that leads to the main courtyard of the castle. Figure 2.8 is a view from the courtyard looking into the main building of the castle consisting of five floors. The entrance from the courtyard is provided through stairs to the main floor, which is a yard containing remaining columns from the Roman and Byzantine periods, as well as a fountain from the Karamanli period, as shown in Figures 2.9 and 2.10.

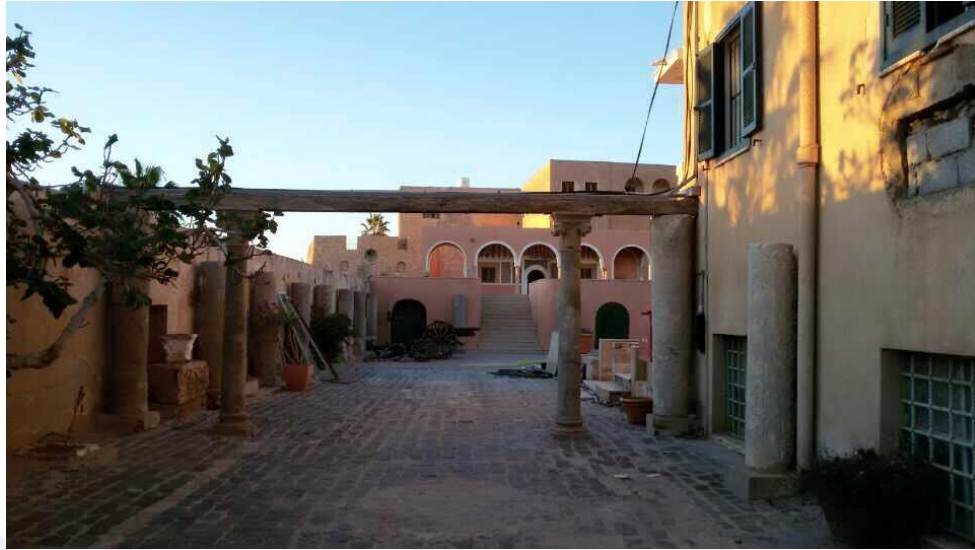
Figure 2.11: A view from the side of a building built during the Karamanli period into the Red Saraya (Author's collection)

There are parts of the castle that show the transition between the Red Saraya built during the Spanish rule and the Karamanli and Ottoman periods. The Red Saraya was mainly used for ruling purposes and defending against any invasions; however, the structures built during the Karamanli period were used as residential structures for the ruler, his family and close elites. Figure 2.11 shows a view from the Karamanli structures towards the Red Saraya built during the Spanish rule. Several columns, plant pots and sculptures from the Roman and Byzantine periods, which are used for ornamentation or structural purposes, can be observed.

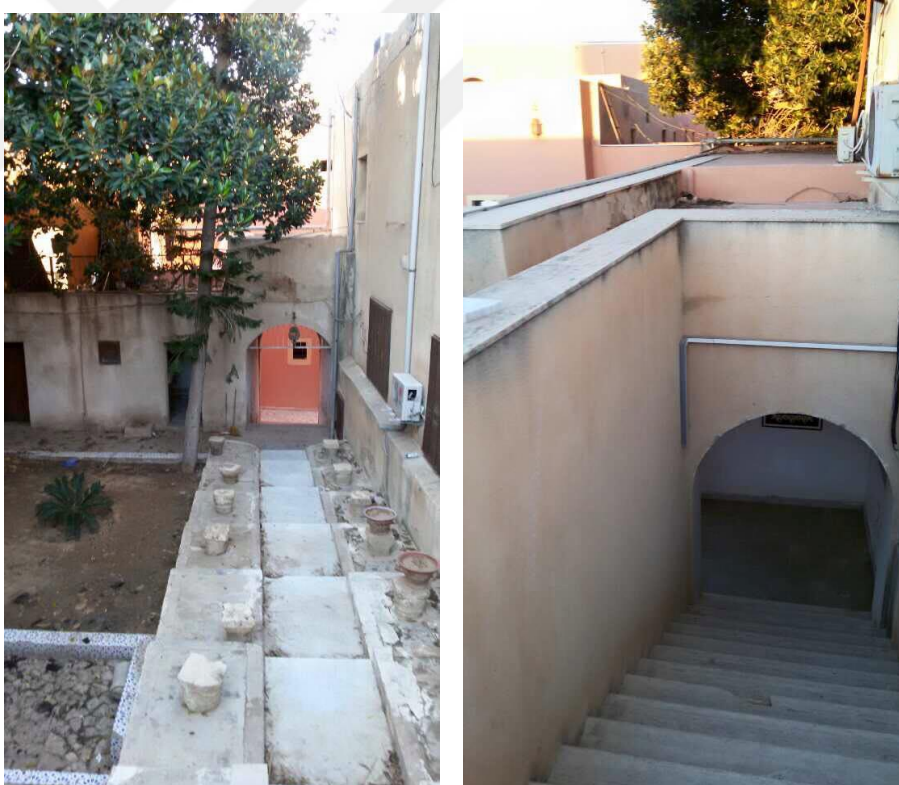
Figure 2.12: Parts of the Red Saraya that were not included in the rehabilitation plans (Author's collection)

Moreover, the red painting that is shown in the various figures are recently performed as part of the rehabilitation plan of the castle. Parts that were not painted nor rehabilitated can also be noticed, as shown in Figure 2.12. It can be observed that no painting has been performed, in addition to unorganized and unfixed stairs, planting areas and arches.

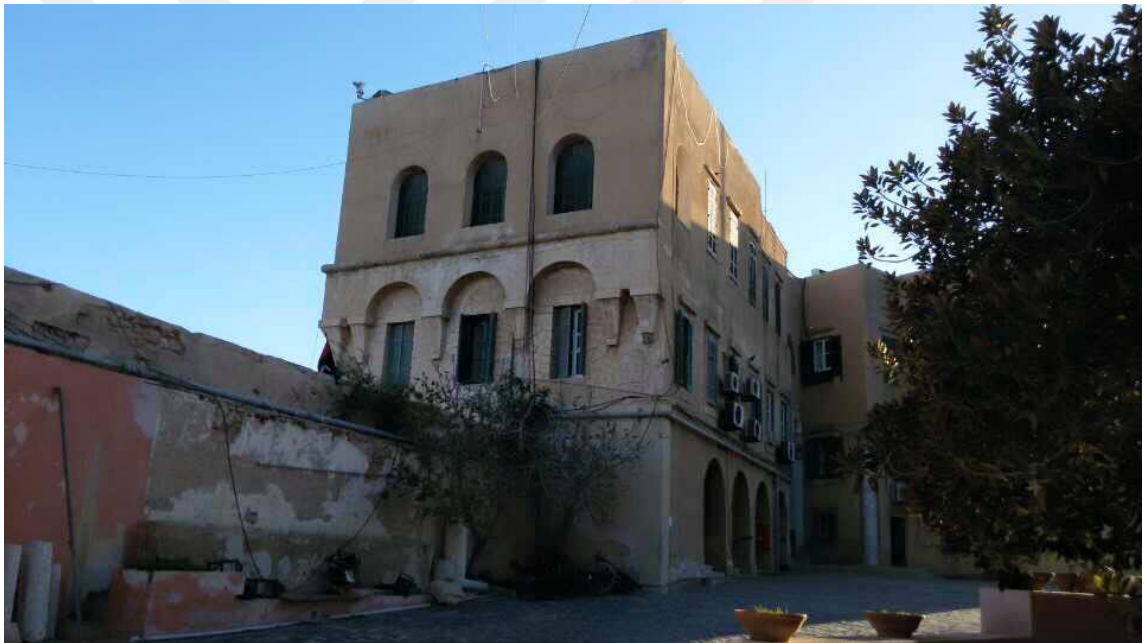
Figure 2.13: A building built during the second Ottoman period (Author's collection)

The second section of Tripoli castle was built during the second Ottoman and Karamanli periods. Figure 2.13 shows a building integrated within the castle that was built during the Ottoman time and used as offices for the Ottoman rulers at that period. The architecture of the building is different from the previously reviewed Red Saraya, which was built during the Spanish rule. The Red Saraya external view shows flat walls with red color painting with windows flushed within the wall structure. Nevertheless, the middle floor of the building shown in Figure 2.13 contains arched structures around the windows with stone wall textures.

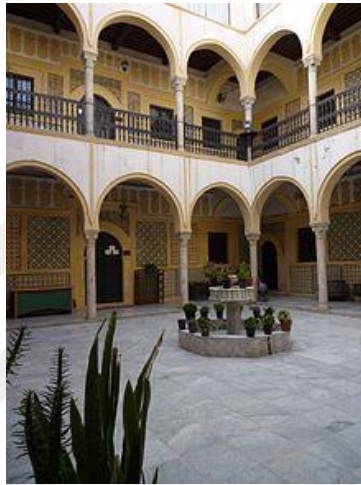
Figure 2.14: The courtyard of Karamanli ruler residence looking into the rooms (Author's collection)

During the Karamanli rule of Tripoli, the main buildings that were added to the castle structure are the residential units for the ruler and his entourage. Figures 2.14 to 2.17 show the interior parts of the Karamanli residences. The house is structured around a main courtyard and the different rooms are distributed around in an open structure. Moreover,

a passage between the courtyard and the rooms is provided, where the arches in the wall adjacent to the courtyard are supported by ornamented columns and the walls adjacent to the rooms are fully ornamented with ceramic tiling of different colors and artworks. Depending on the level of the person residing in the house, the level of ornamentation differs from a residence to another.

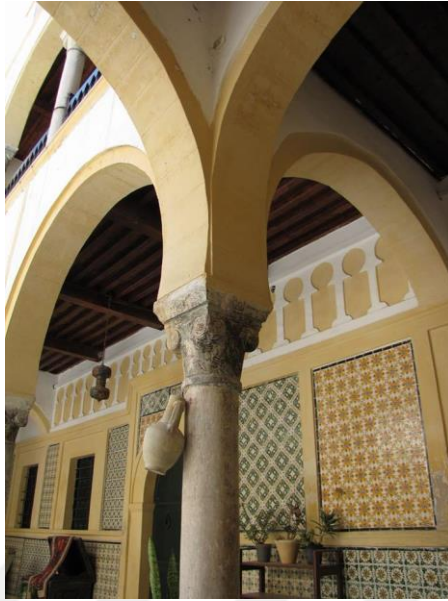
Figure 2.16: Interior walls of the Karamanli ruler's residence with colored mud accents and ceramic artwork (Author's collection)

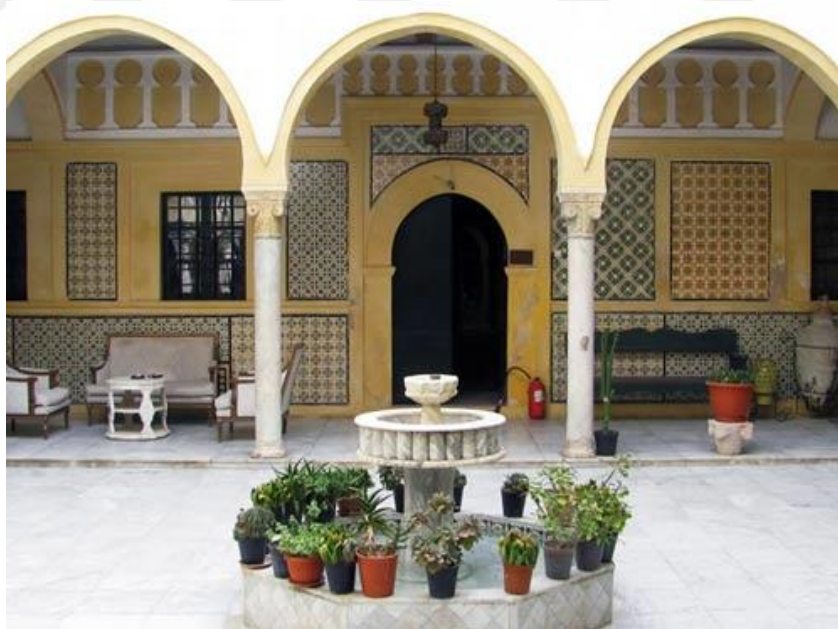
Figure 2.17: The courtyard of Karamanli ruler's residence showing the middle fountain and the internal ornamented walls (Author's collection)

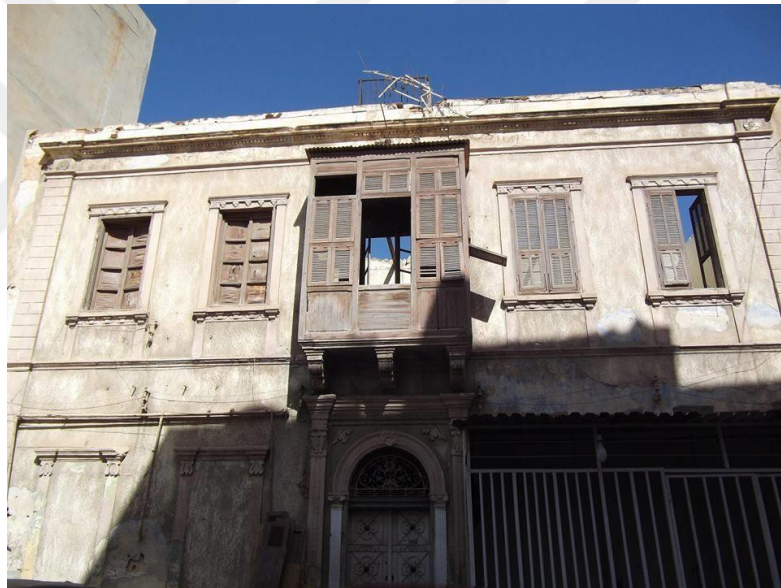
Figure 2.18: A front view of a house in Tripoli castle that has not been rehabilitated (Author's collection)

Similar to the Red Saraya case, there are parts of the Karamanli courtyards and residences that has not been rehabilitated, as shown in Figures 2.18 to 2.21. The different views of the houses and examples show unclean wall finishing and broken windows and doors. The internal view also indicate that the houses has been ignored from the rehabilitation works with limited and uncoordinated fixations for some doors, stairs. Several uncoordinated piping and wires can be noticed in the figures. The courtyard between the houses is also not rehabilitated with planting areas with several damages and adjacent walls that need structural and aesthetical rehabilitation.

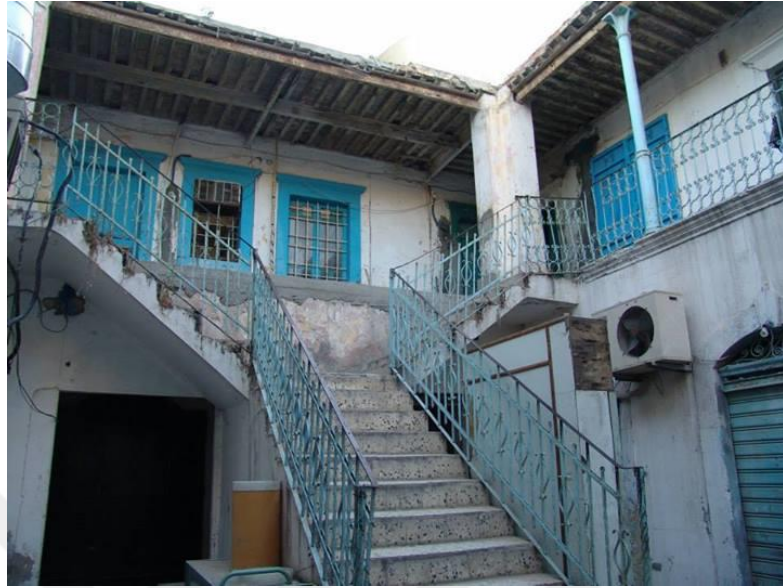
Figure 2.19: An internal view in a house in Tripoli castle that is not rehabilitated (Author's collection)

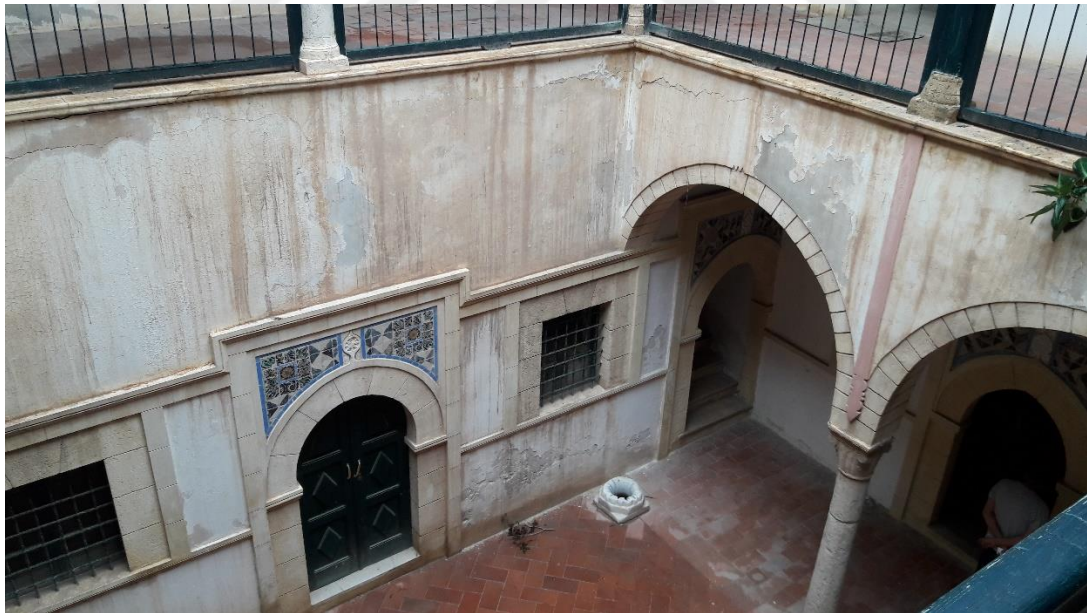
Figure 2.20: A Karamanli residence with required rehabilitation (Author's collection)

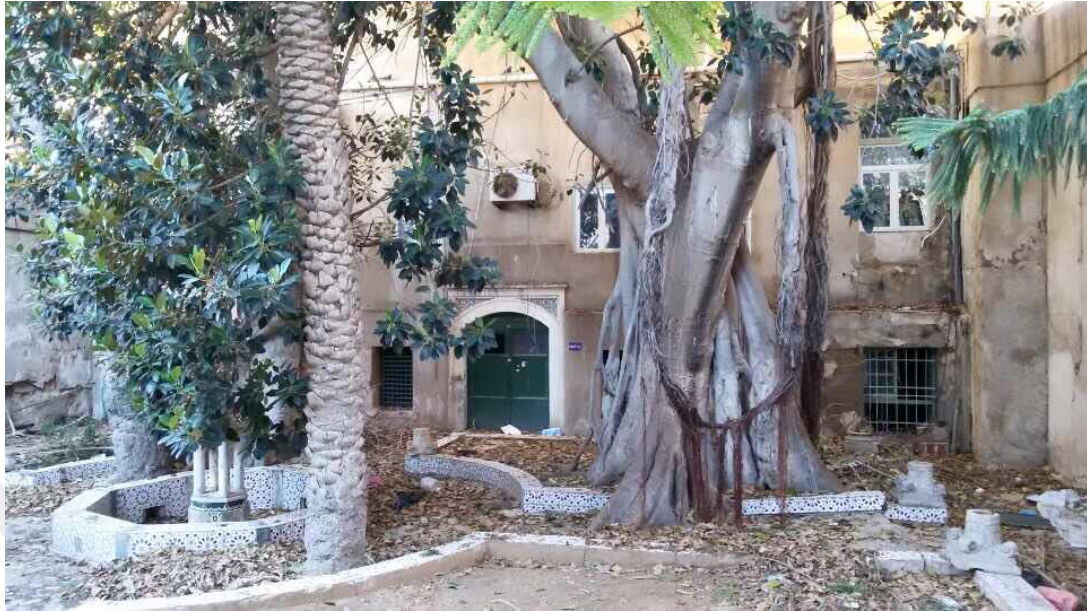
Figure 2.21: A courtyard between houses in Tripoli castle that needs rehabilitation (Author's collection)

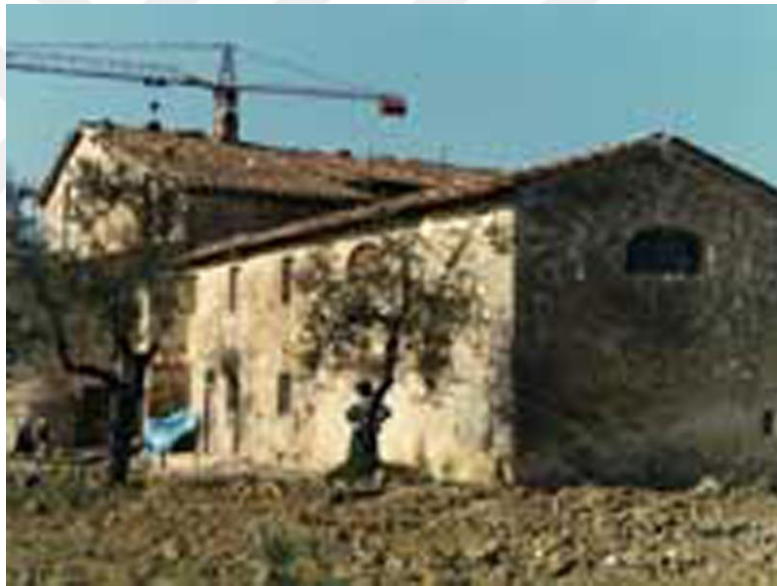
Figure 3.5: Villa Le Torri before restoration (Le Torri, 2013)

Another example of restoration of Italian villas and houses is Le Torri, which is a historic Italian Villa built in the beginning of the 1800s by the Florentine family. The current owners of the villa have restored it and turned it into a luxurious lodging facility for getaway travelers. The restoration process included dismantling parts of the villa in order to use it in the restoration of other parts, as the owners wanted to use the authentic material in the process. Other facilities were added such as the swimming pool in order to adapt to the needs of the guests and increase the usability comfort. Figures 3.5 and 3.6 show villa Le Torri before and after restoration in the mid-1990s (Le Torri, 2013).

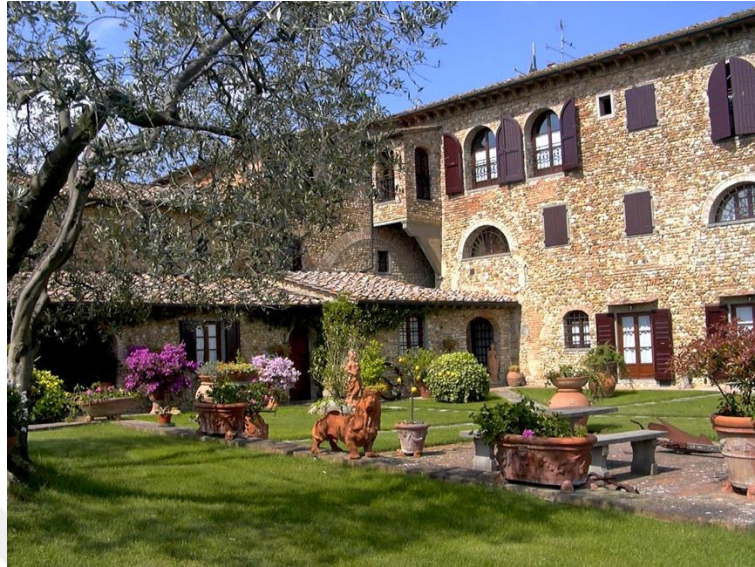
Figure 3.6: Villa Le Torri after restoration (Le Torri, 2013)

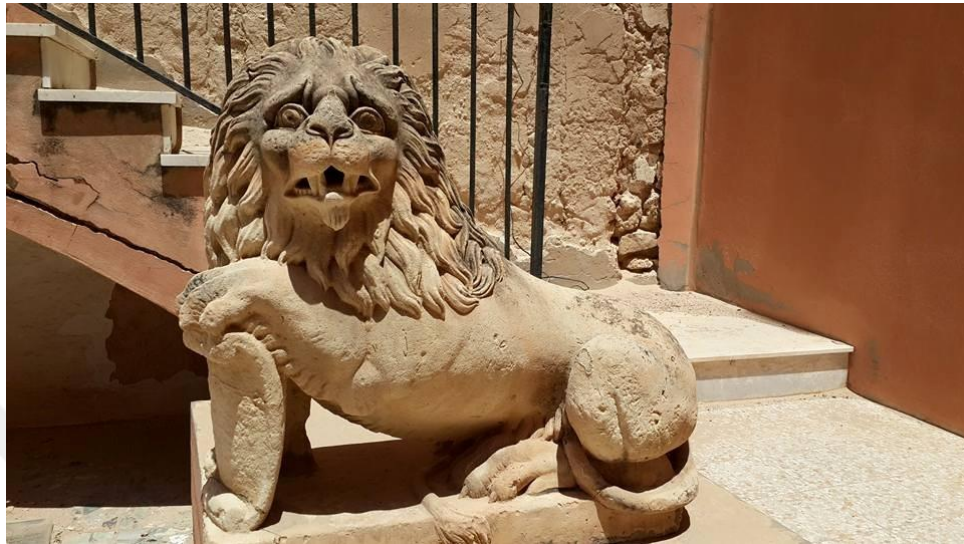
There are several cracks that are observed within the different buildings in Red Saraya. Figure 4.1 shows a structural crack within the stair slab from the bottom side and the width of the Crack exceeds 10 millimeters. The presented crack example has several consecutive cracks that are close to each other, which requires an extensive treatment and strengthening. The ancient wall shown as the back surface of the stair was rehabilitated in an earlier period; however, several cracks can be observed that requires assessment and

Figure 4.1: Structural and unknown cracks in a stair and backwall at Red Saraya. (Author's collection)

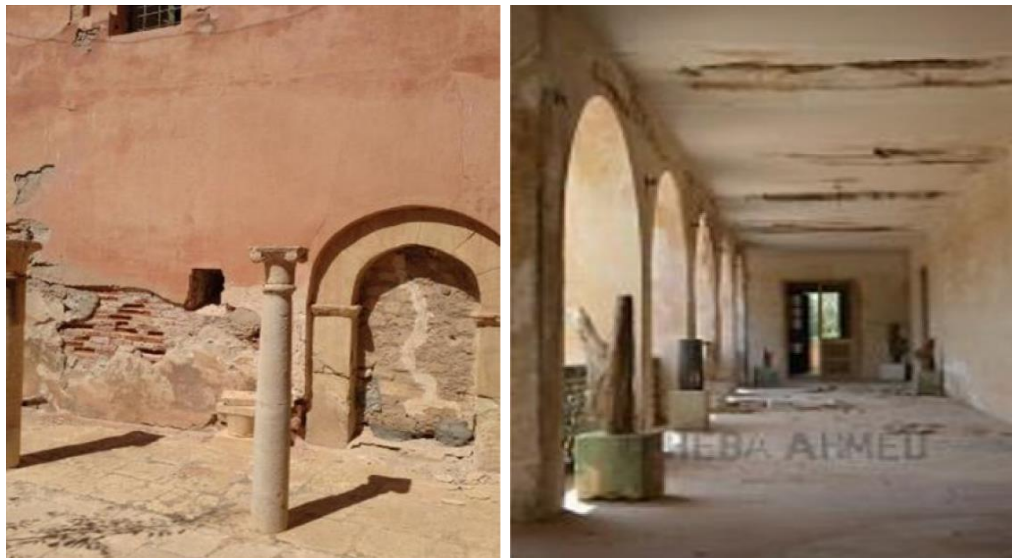
treatment. Figures 4.2 show other examples of cracks within the walls and slabs of Red Saraya in Tripoli Castle.

Figure 4.2: Deep cracks in the walls and slabs of Red Saraya. (Author's collection)

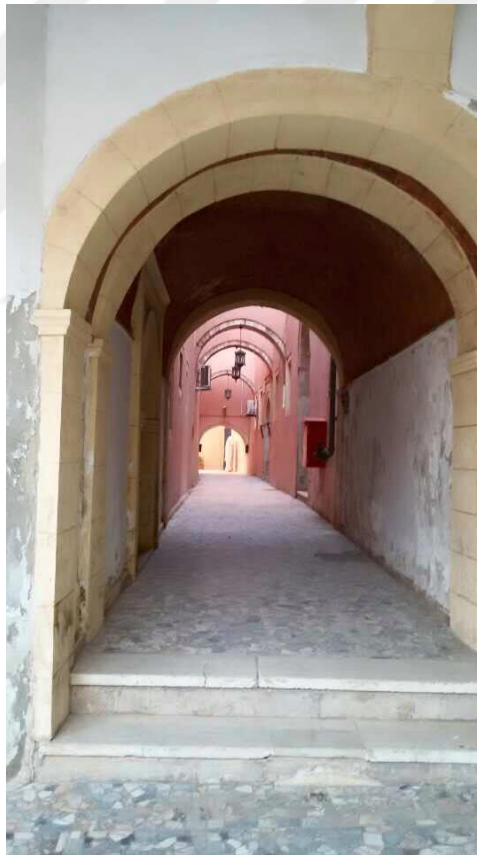
Figure 4.3: Parts of the Red Saraya that received rehabilitation measures and requires minimal repair and intervention. (Author's collection)

The maintenance performed to the structure of the Red Saraya was not extensive, as it addressed some of the main structure within the castle, while ignoring other parts. Despite the time passed since the last maintenance performed, some of the structure is still keeping the same acceptable condition. Nonetheless, these areas require a minimal intervention in order to inspect the surfaces and repair the painting and any broken elements. Figure 4.3 shows the rehabilitated parts of the castle, while Figure 4.4 shows some parts that have been ignored in the last rehabilitation plan.

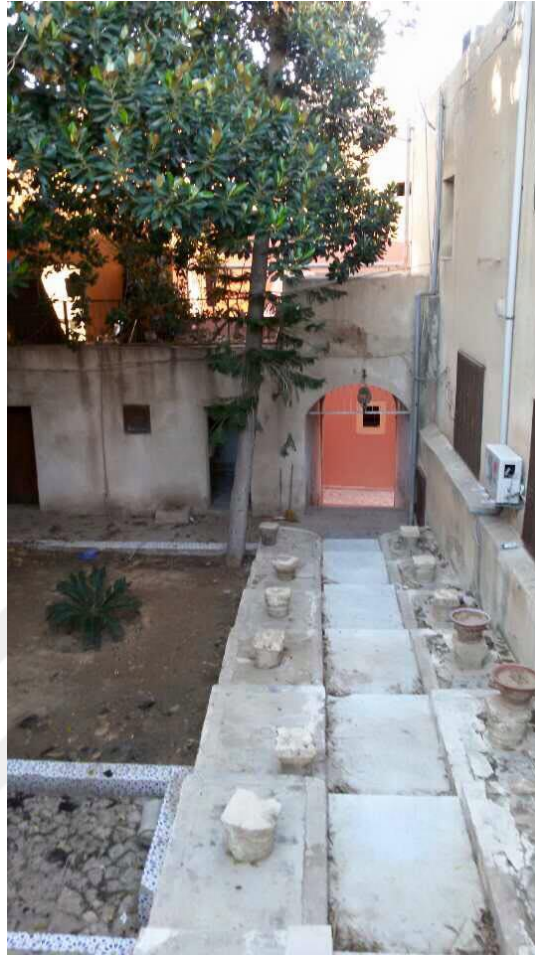
Figure 4.4: Parts of the Tripoli Castle that were not included in the rehabilitation plan before and requires further intervention. (Author's collection)

It is apparent from the condition of the different parts of the structure that no clear and periodical maintenance plan is in place, as some parts were addressed, and others were ignored. Moreover, it can be observed that modern services have been added to the ignored parts and used as offices or gallery halls from the other side. Thus, the maintenance plan shall include all the parts of the castle, while ensuring that parts from different era are identified and presented.

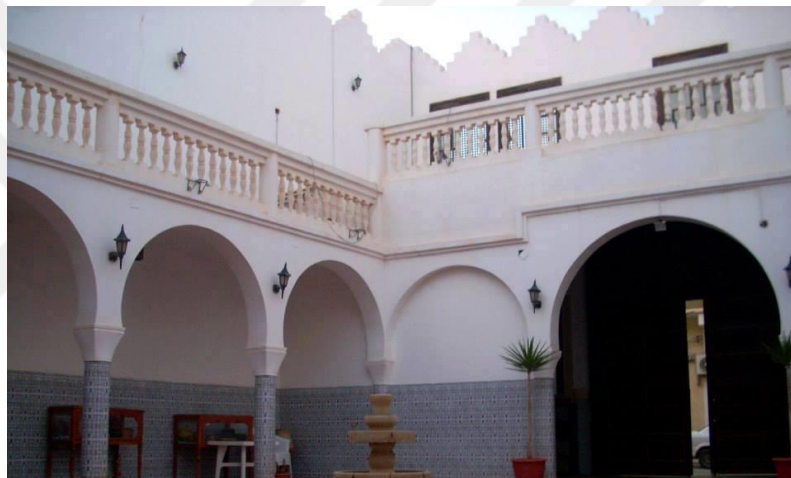
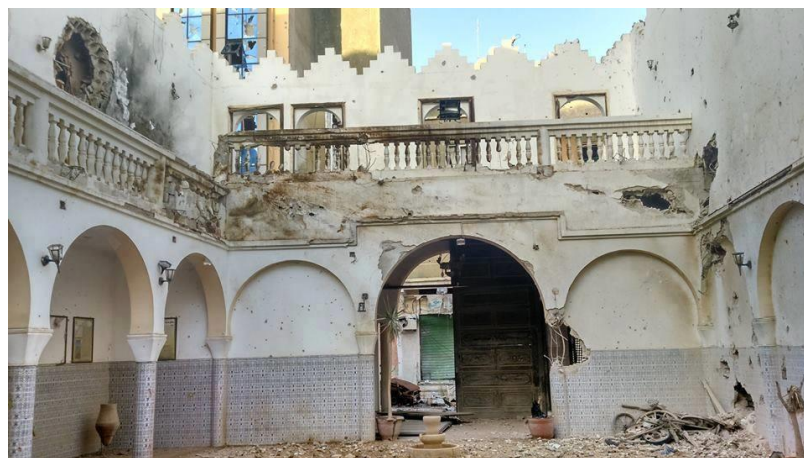
Figure 4.5: A courtyard in the Saraya before and after a war attack. (Author's collection)

After the revolution in Libya in February 2012, the political and military control of the city has been unstable since then. Several historical and archeological structures have been affected as they were used by rebels and militias. Moreover, the Red Saraya structures have been impacted by the war status in the country, where some of them were demolished or damaged. Figure 4.5 shows a courtyard in the Saraya before and after a war attack on it with rockets.

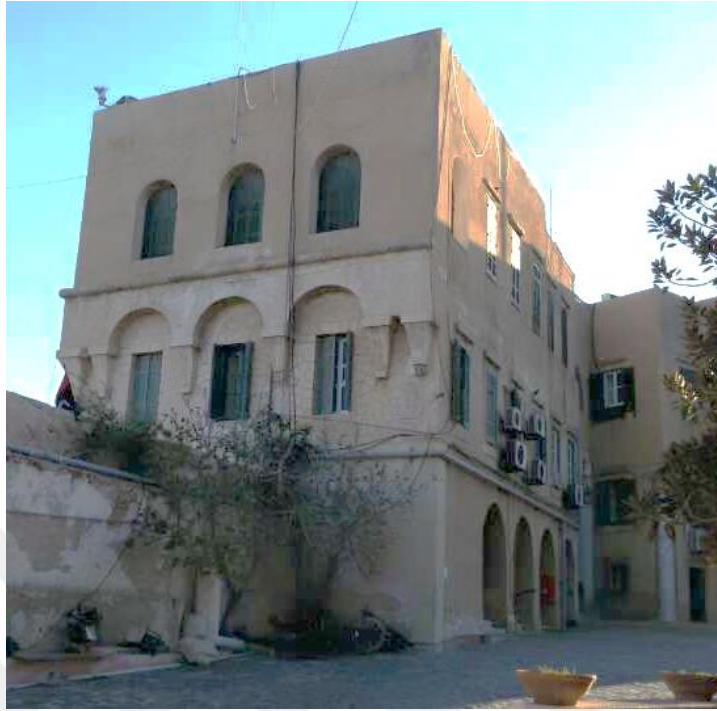
Figure 4.7: A building in Tripoli Castle where modern utilities have been added without a clear rehabilitation plan, ruining its historical and cultural values. (Author's collection)

It is possible to find some misused buildings or parts within the targeted heritage structure, which mainly are the result of ignorance of the governmental bodies and NGO's. In the Red Saraya, misuse is observed in a few parts, where buildings have been used for offices and storage spaces without paying attention to their historical and cultural value. Figures 4.7 and 4.8 show some examples of misuse, as modern utilities have been added and structure has been ignored, leading into the deterioration of the structures' conditions. Moreover, some areas have witnessed the addition of inappropriate finishing material that does not match the original material used.

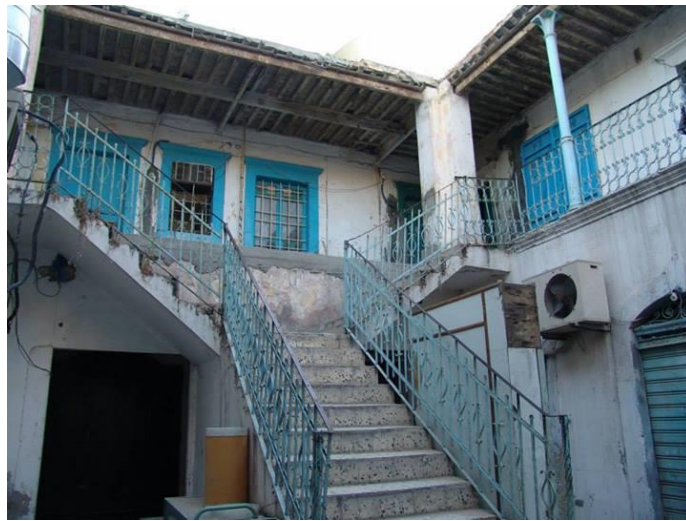
Figure 4.8: A house in Tripoli castle with the addition of inappropriate material and utilities. (Author's collection)
