**A CASE STUDY FOR CUTS IN SOFT SOILS**

In this respect, the landslide which had occurred at TAG motorway during the excavation of cut slopes between Km.141+400 and Km.141+700 is investigated as a case study. The required analyses are performed in order to determine the residual strength parameters by both laboratory tests and back calculation method. In the light of these analyses, it is determined that the real cause to slip is the inadequate slope application on the soft soil conditions.

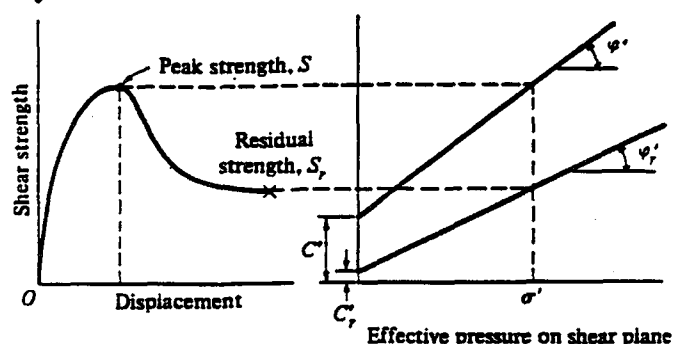
FIGURE 2.1. Shear Strength Characteristics Skempton 1964 (2)

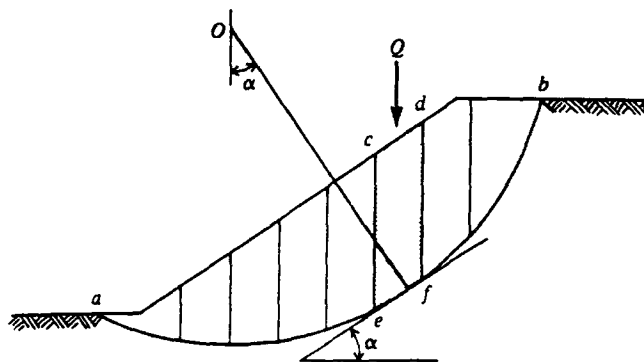
FIGURE 2.2 Modified Bishop Method

In Bishop modified method, the mass of soil as illustrated at Figure 2.2. is divided into many vertical slices. The forces acting on each slice are evaluated from the limit equilibrium of the slices. The equilibrium of the entire mass is determined by the summation of the forces on all the slices. A typical slice (cdfe) is shown in Figure 2.3.

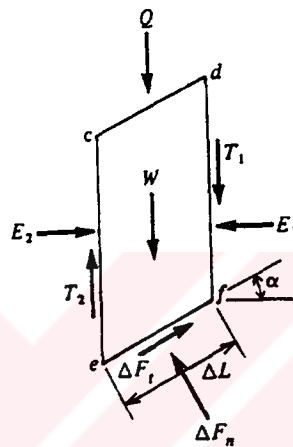
FIGURE 2.3. Method of Slices  
Bishop A.W. 1955 (14)

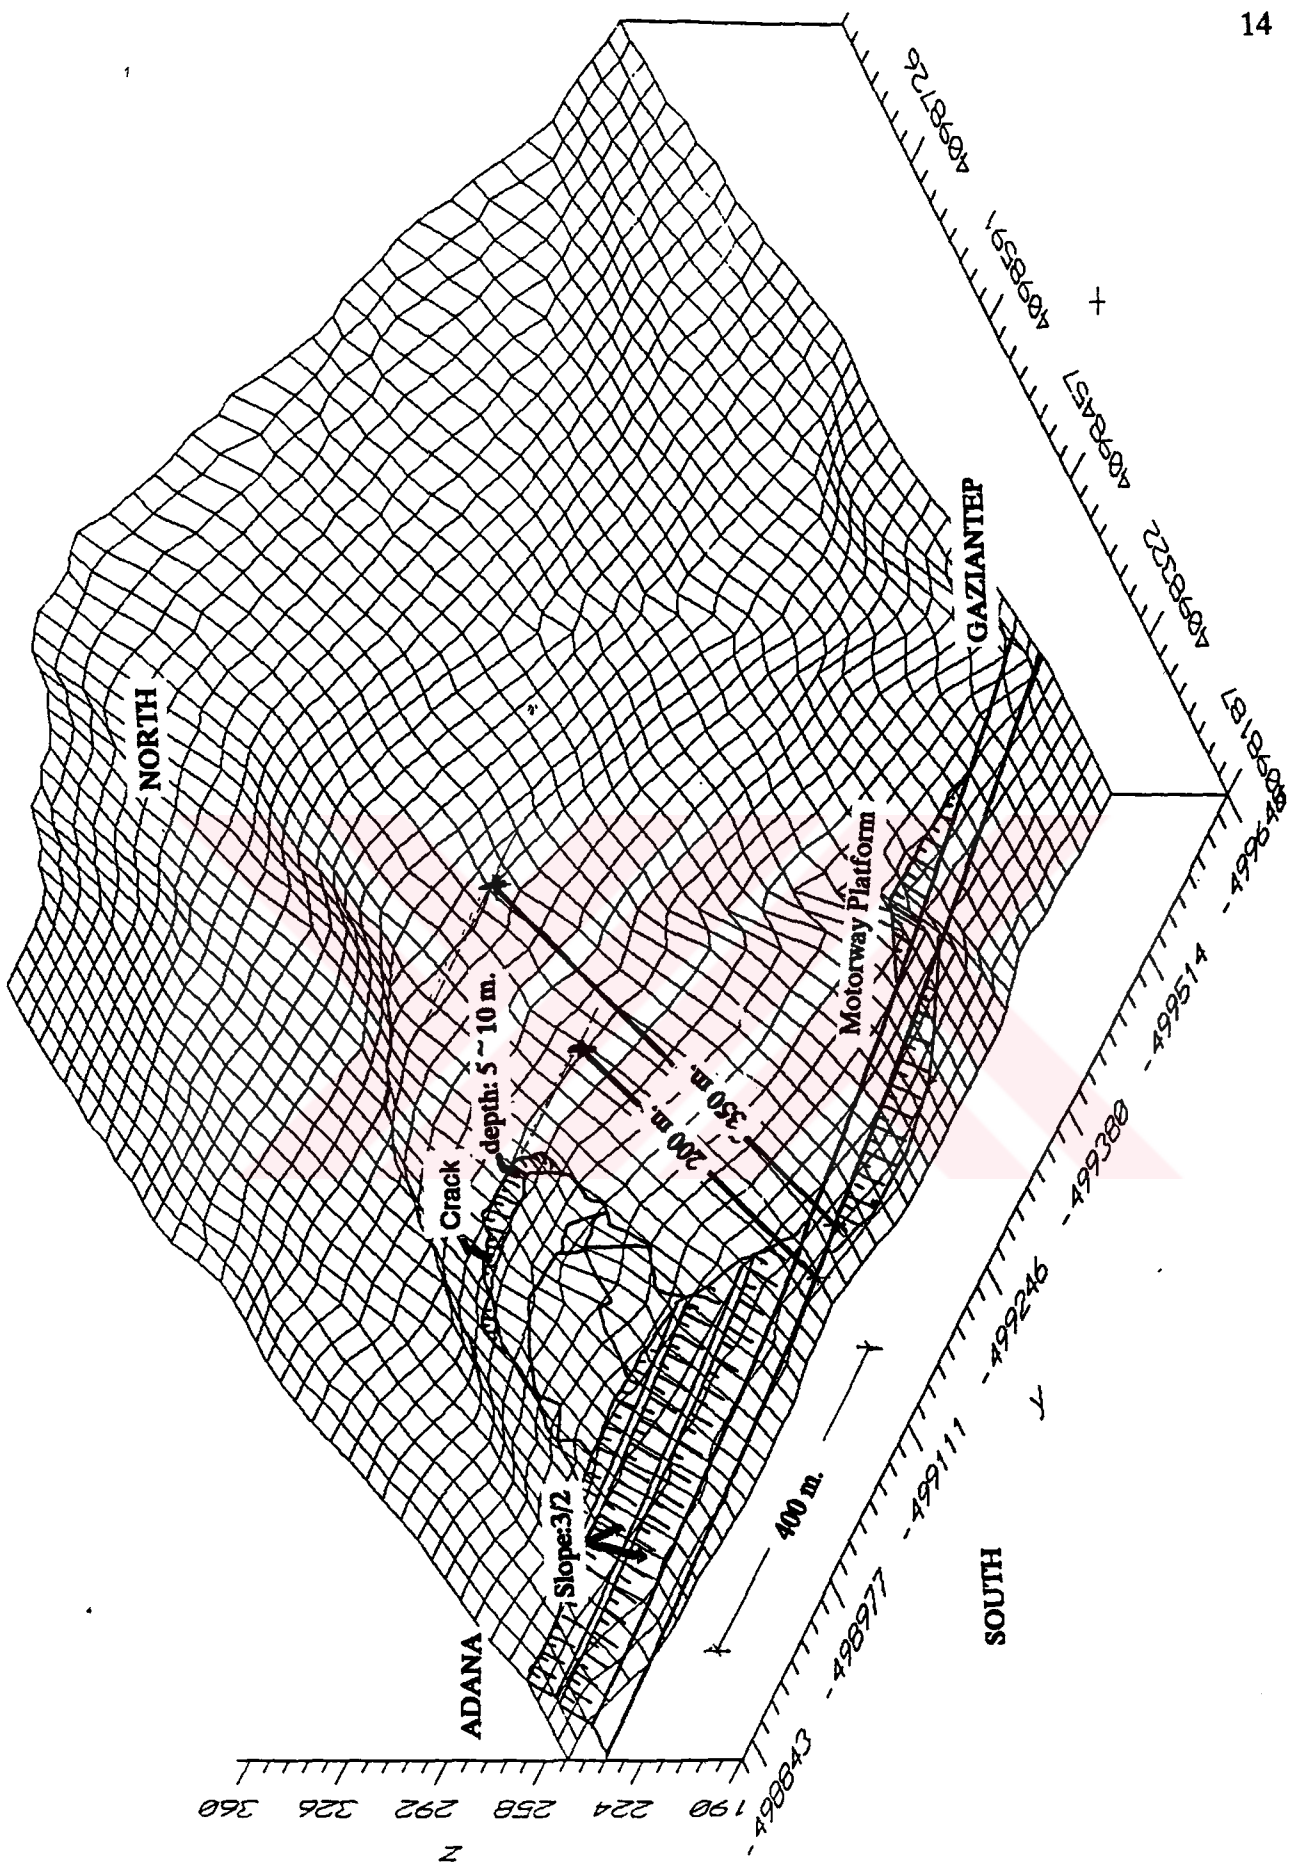
The area where the slide took place is a hilly to almost mountainous zone. The origin is rocky and spilit formations. However, in the course of time, slope debris material was accumulated by weathering and erosion of the rock formations. This was formed as a coverage on the rock formation at the end. The slide has occurred as a result of sliding this slope debris material. The depth of the slide material was 10 ~ 20 m. During the slide, tension cracks were formed approximately 200 m. away from the motorway platform. The width and depth of these cracks were 5 ~ 10 m. The slide topography is illustrated at Figure 3.2.

FIGURE 3.2. Slide Topography

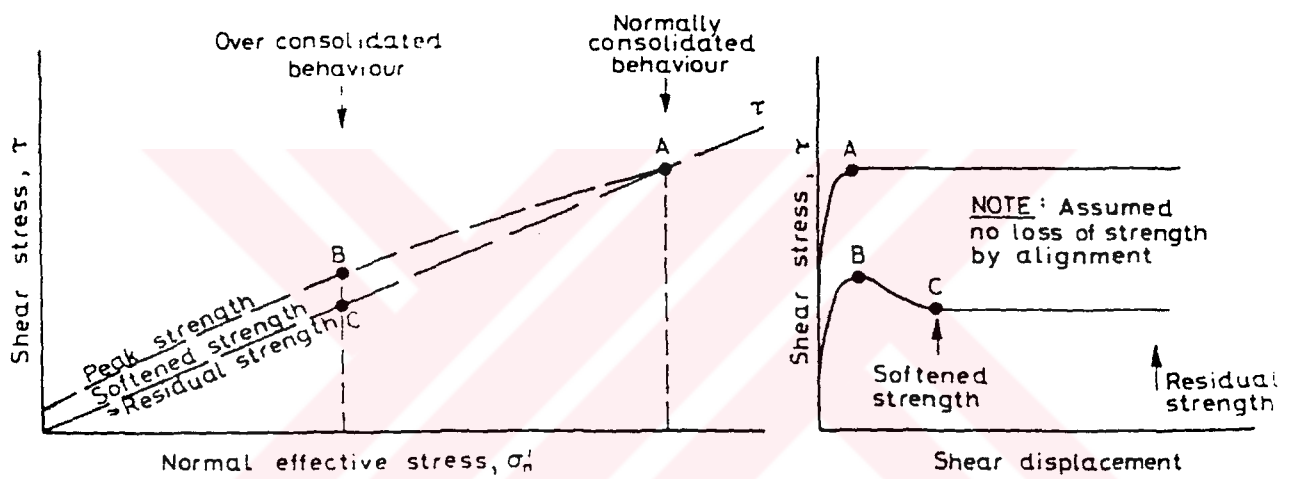
**FIGURE 5.1. Residual Shear Strength and Peak Shear Strength (12)**

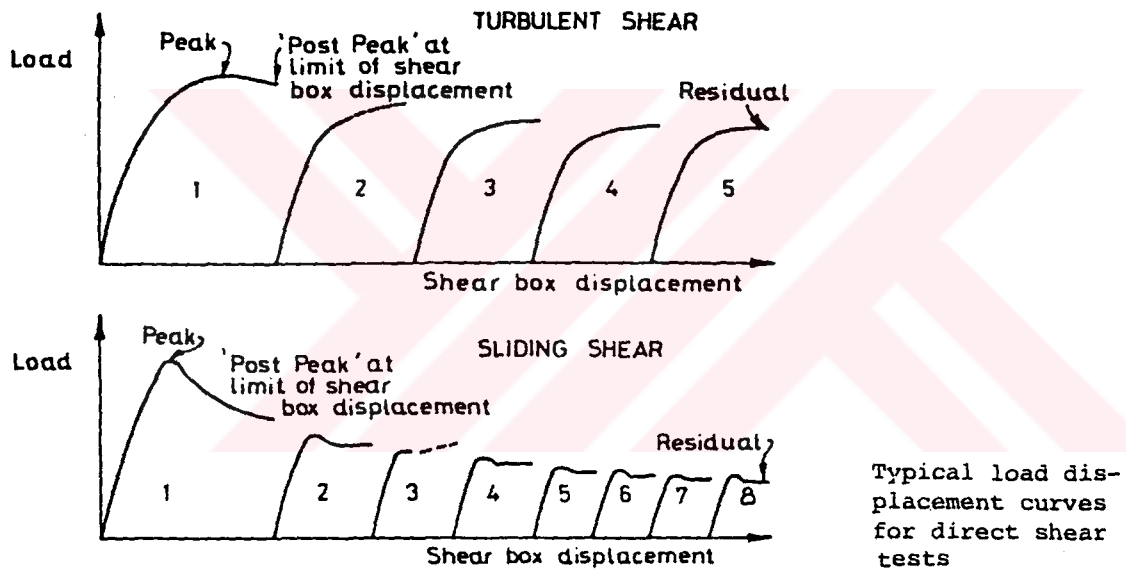
Typical load displacement curves for direct shear tests

FIGURE 5.2. Turbulent and Sliding Shear (12)

The test is usually saturated consolidated drained (CD) with the sample sheared at slow constant rate of displacement, so that pore pressures due to shearing are dissipated giving drained conditions. Typical load displacement curves for "turbulent" and "sliding" shear are shown in Figure 5.2.

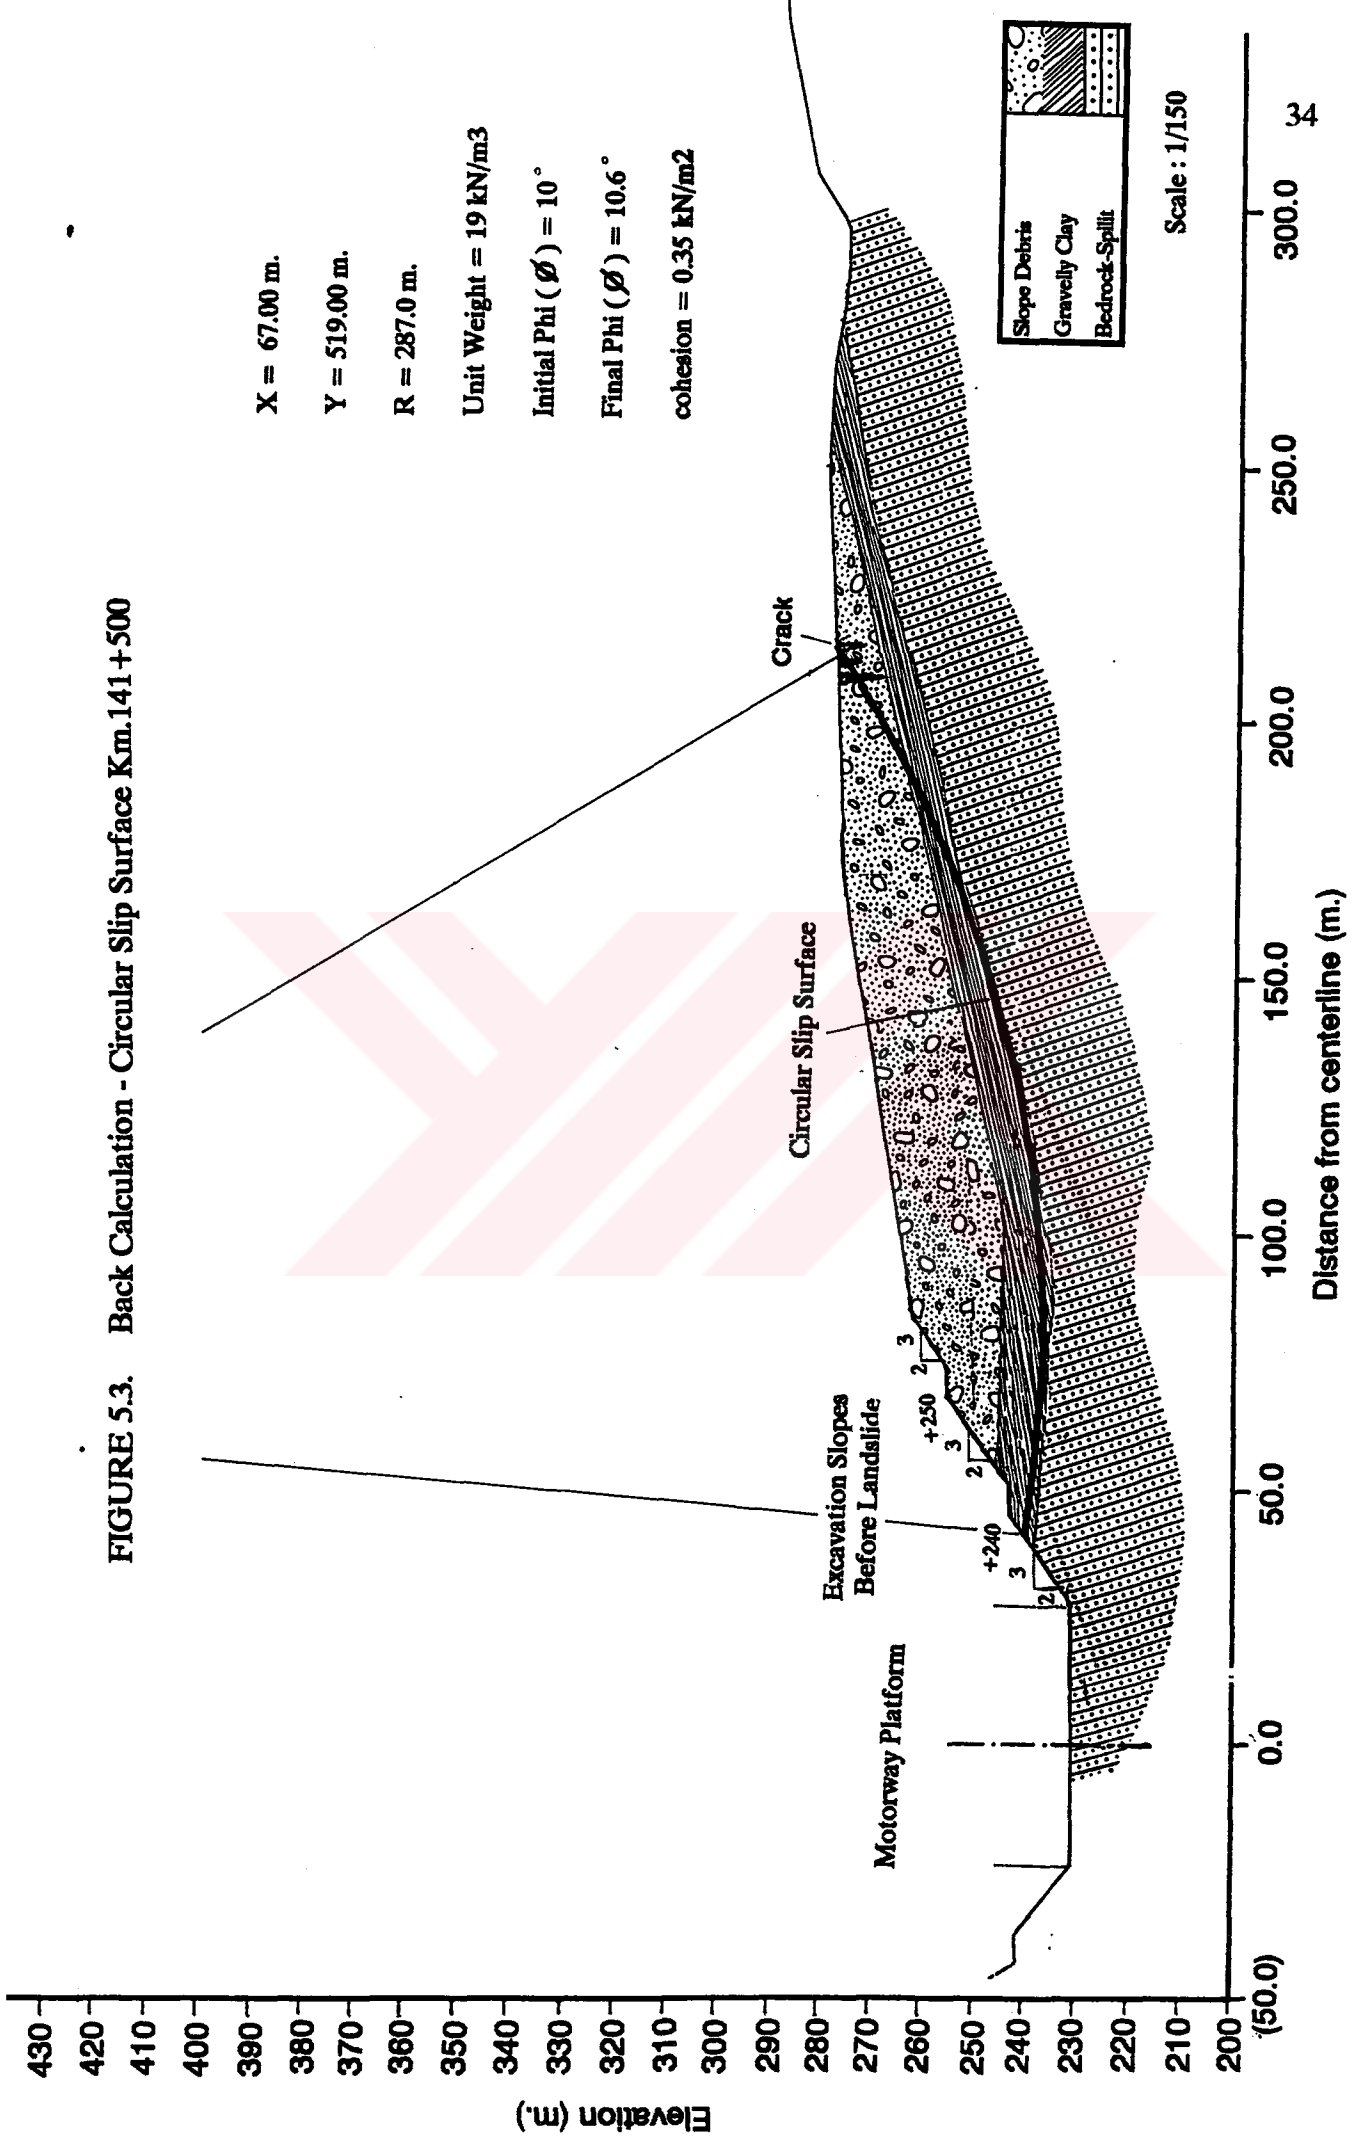
The first case study is performed on the Km.141+500 section. The subsoil conditions had been determined previously during the trial pits excavation. In figure 5.3 the section is illustrated and the back calculation method is performed based on this section. As stated before, a computer program (8) has been used, the data and the results of the computer calculations are given in the Appendix (4).

**FIGURE 5.3. Back Calculation - Circular Slip Surface Km.141+500**

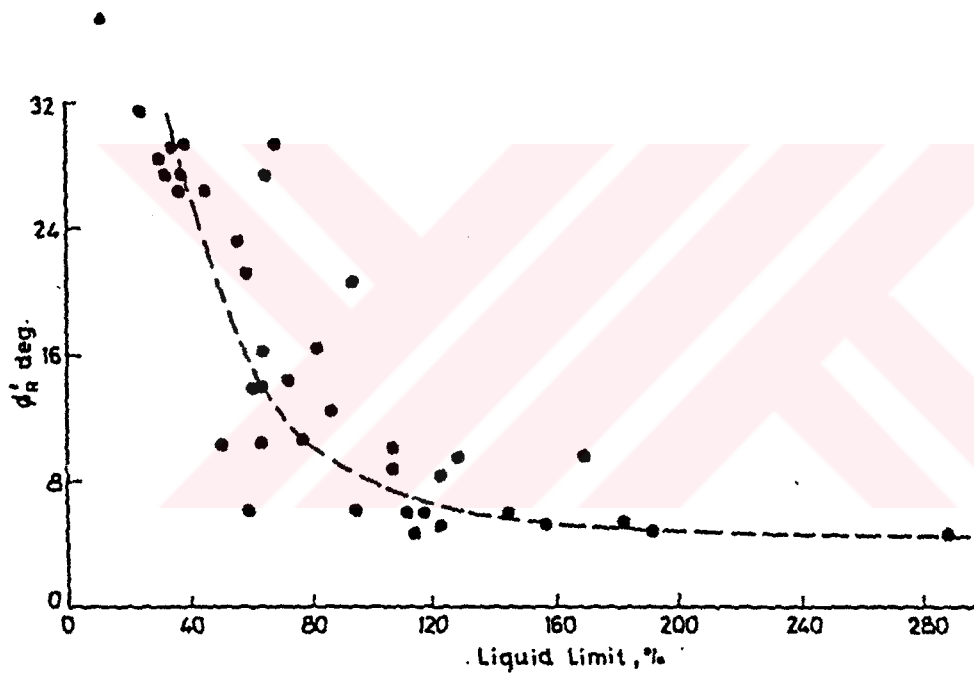
It can be concluded that the results from laboratory tests and Figure 5.11. indicate no difference, and also it is observed that the results which has high liquid limit has low internal friction angle.

FIGURE 5.11. Relation between LL,  $\phi_R$

<u>Sample</u>	<u>LL (percent)</u>	<u><math>\phi_r'</math>(degree) from Figure 5.1.</u>	<u><math>\phi_r'</math> (degree) from Figure 5.11.</u>
1A	44	32	>24
1B	42	34	>24
CBR1	76	14	11.5
CBR2	72	13	12

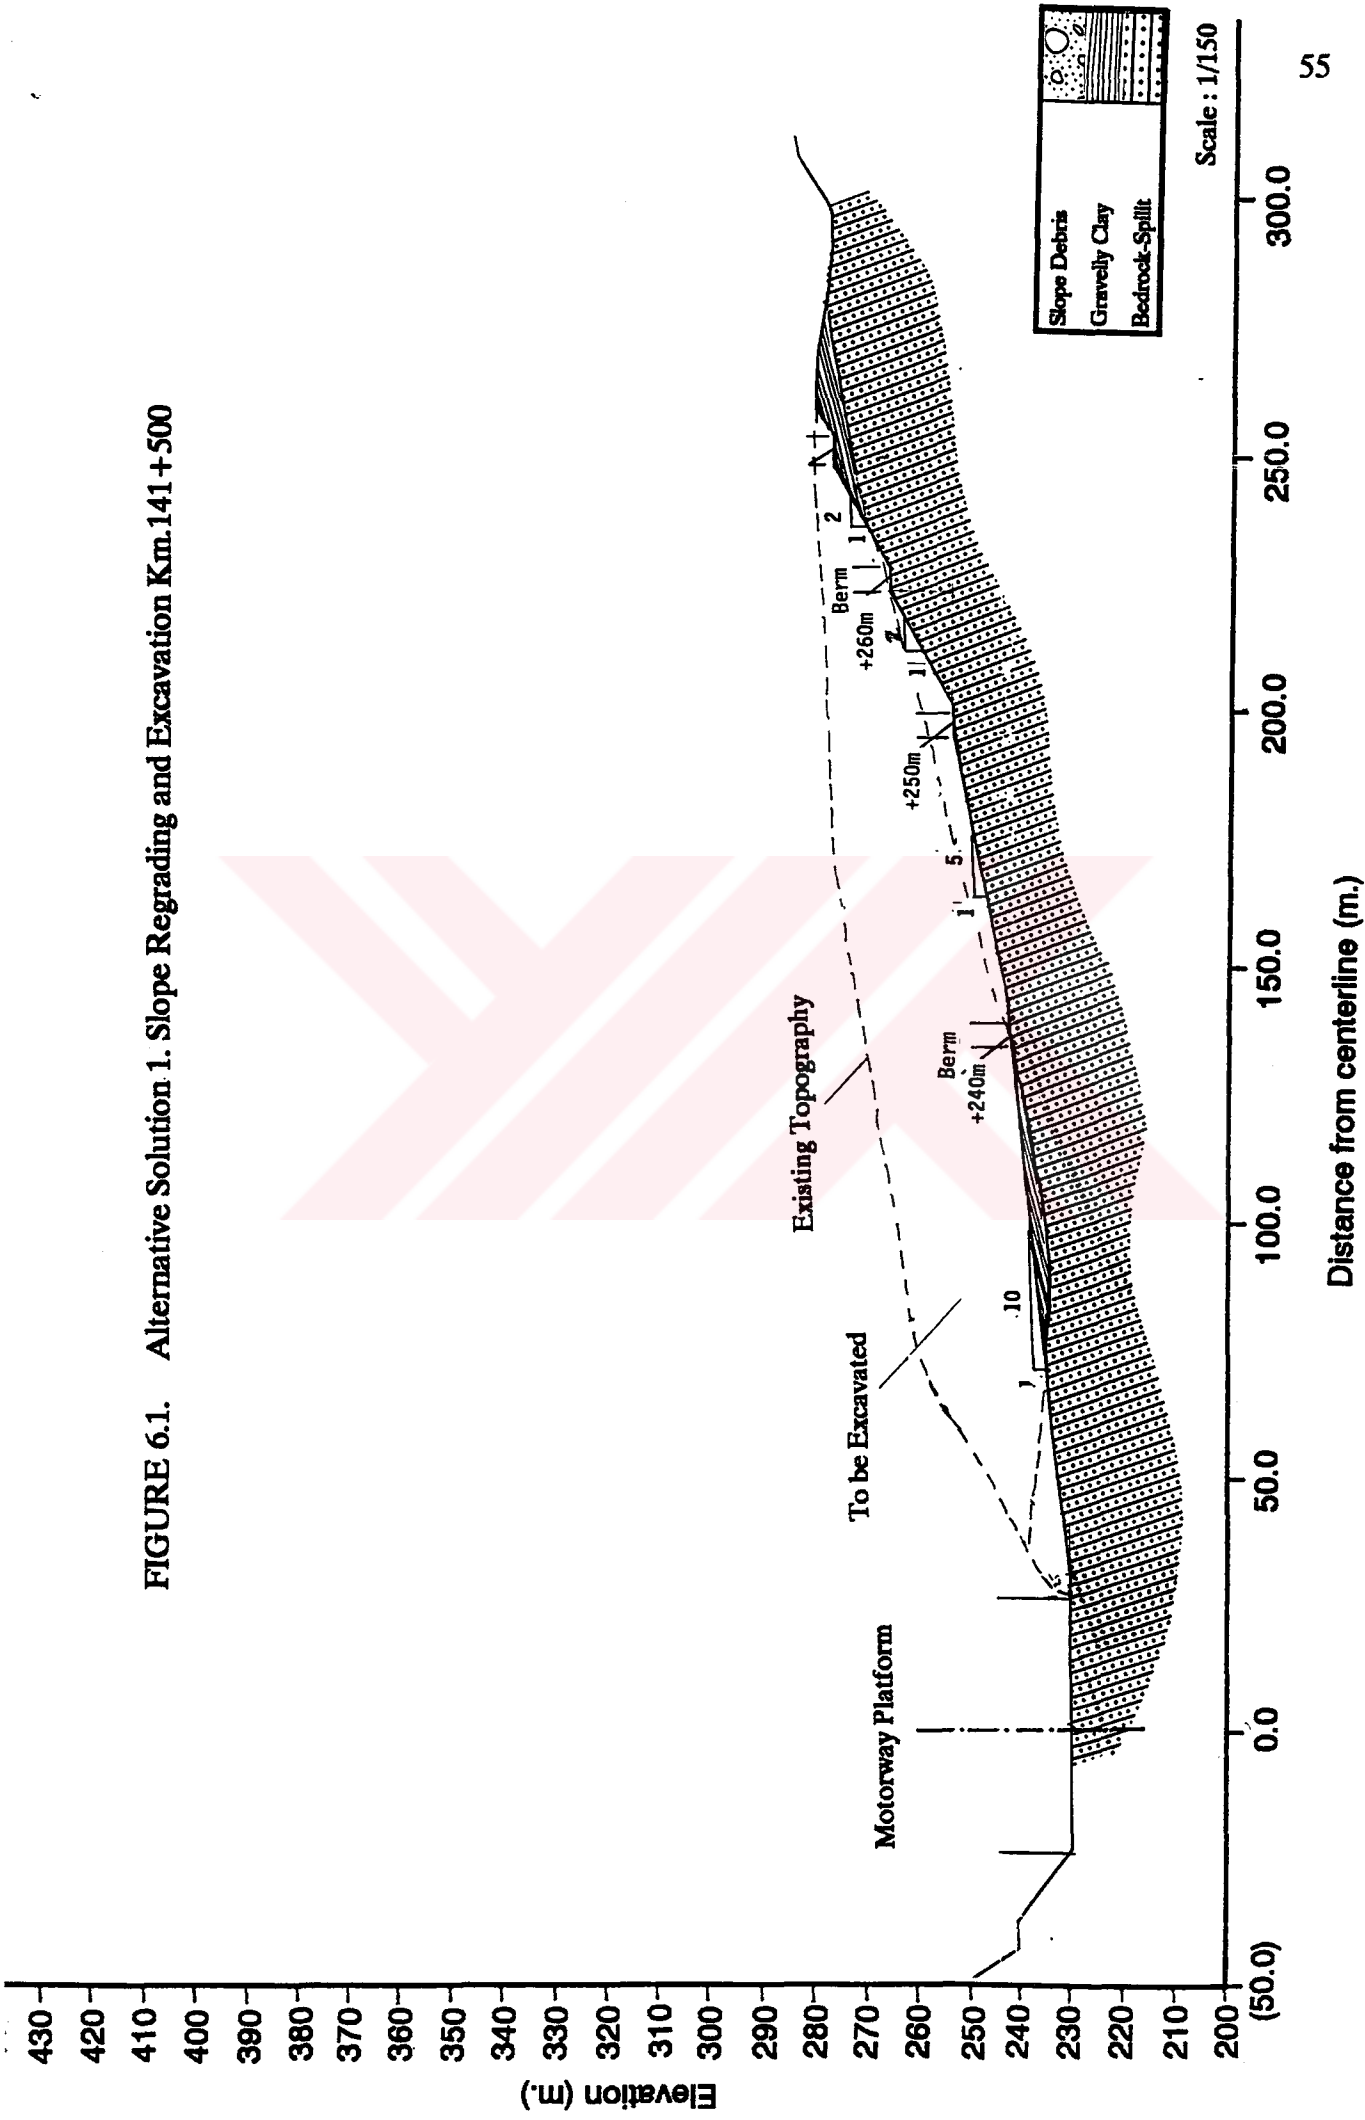
FIGURE 6.1. Alternative Solution 1. Slope Regrading and Excavation Km.141+500

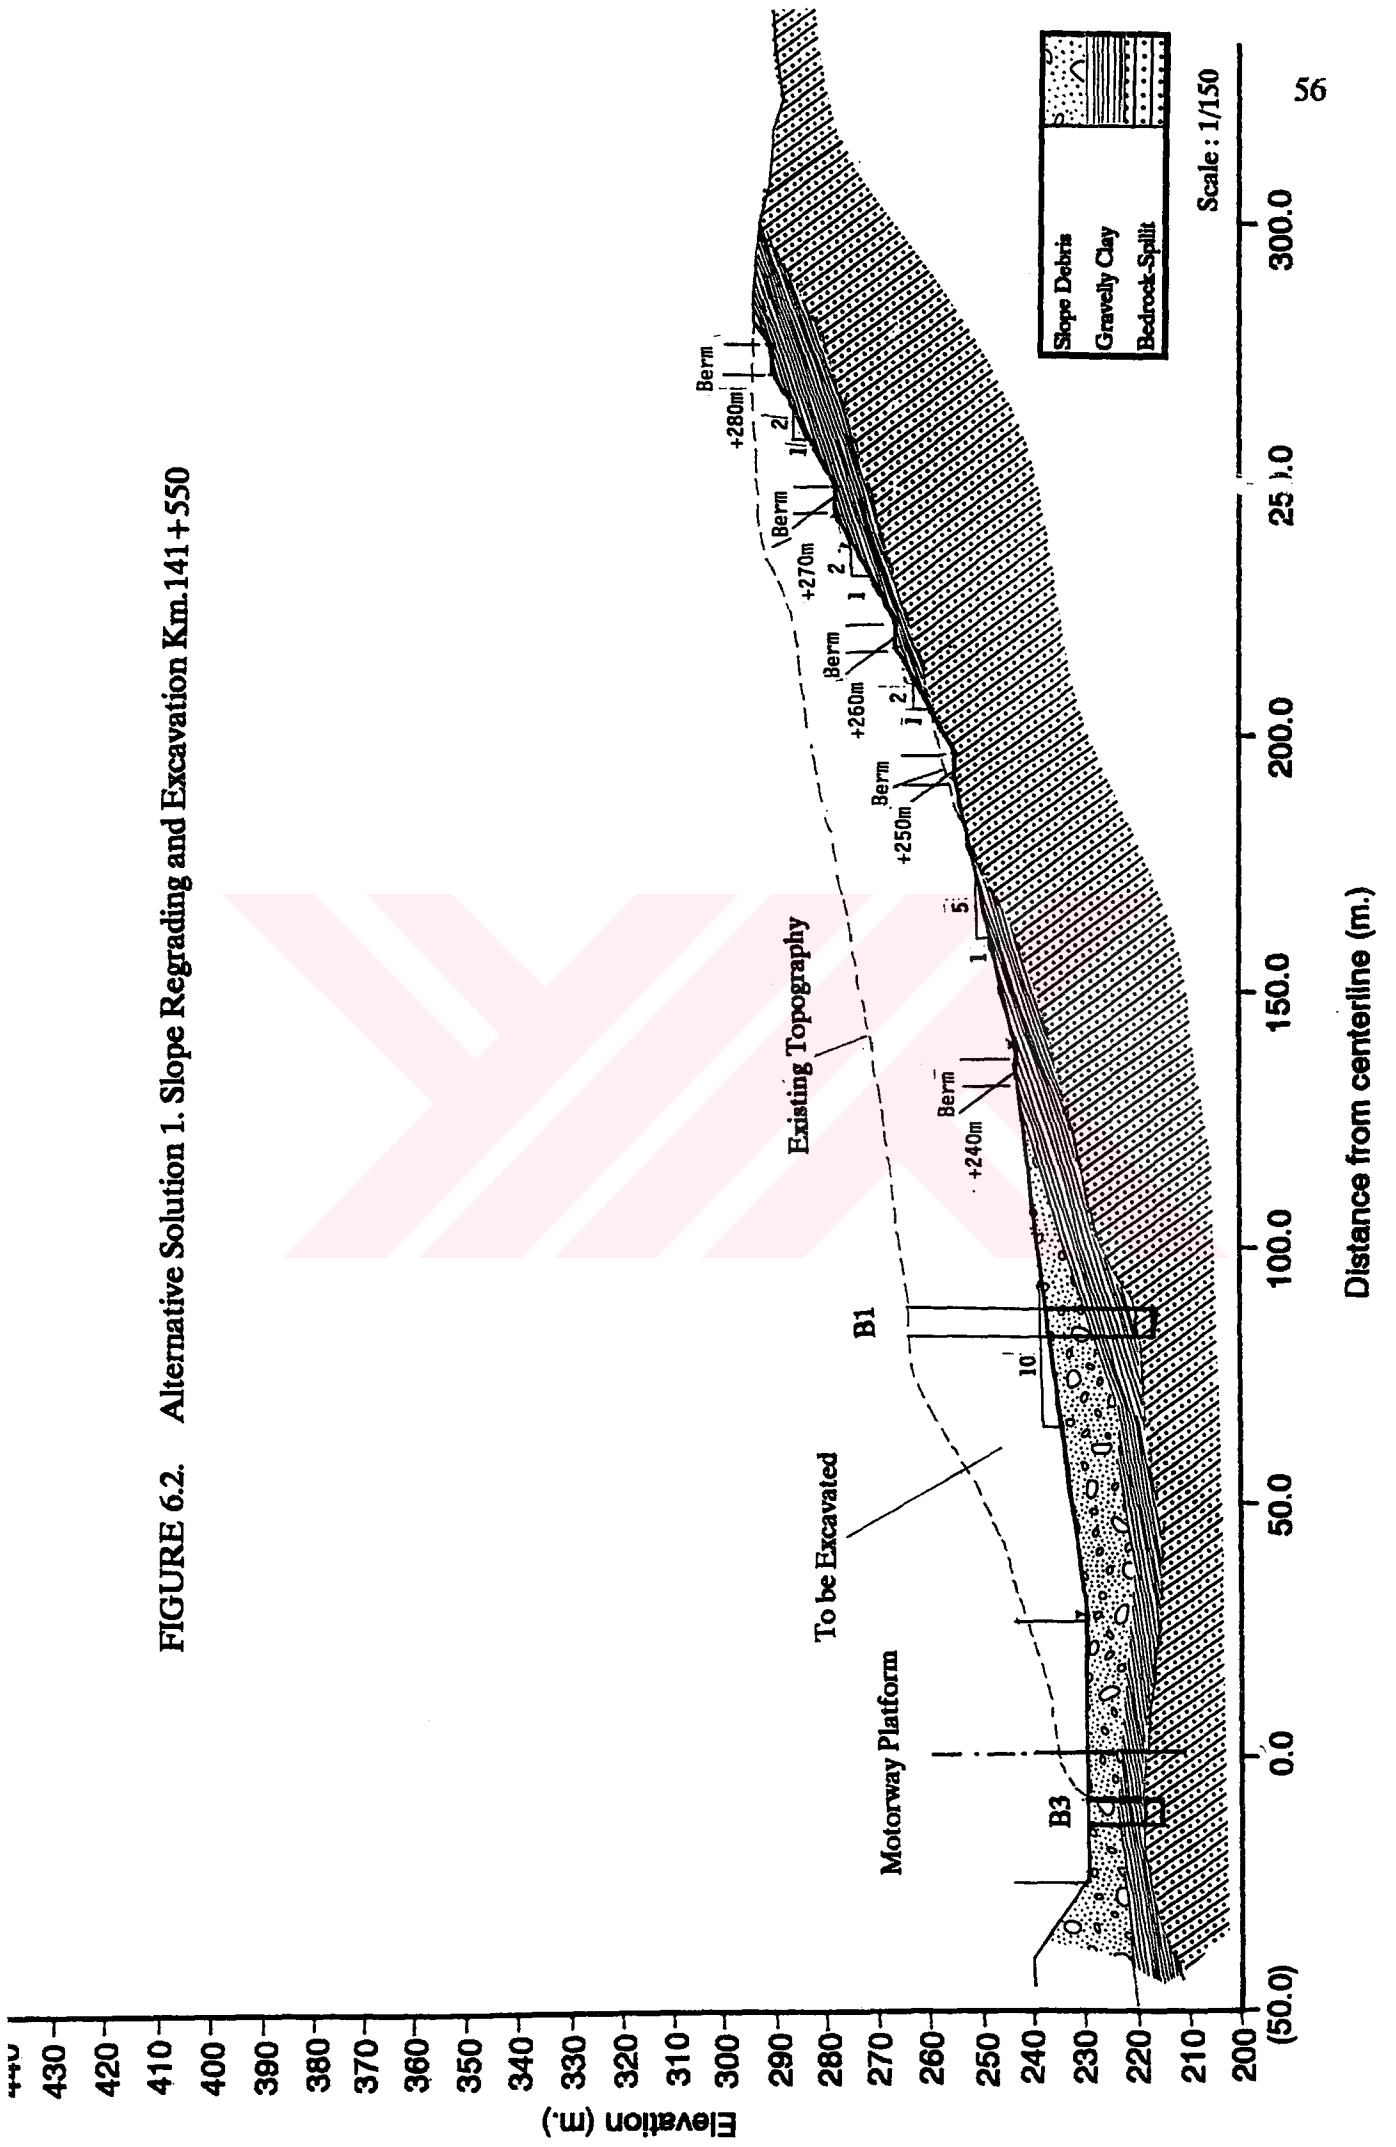
FIGURE 6.2. Alternative Solution 1. Slope Regrading and Excavation Km.141+550

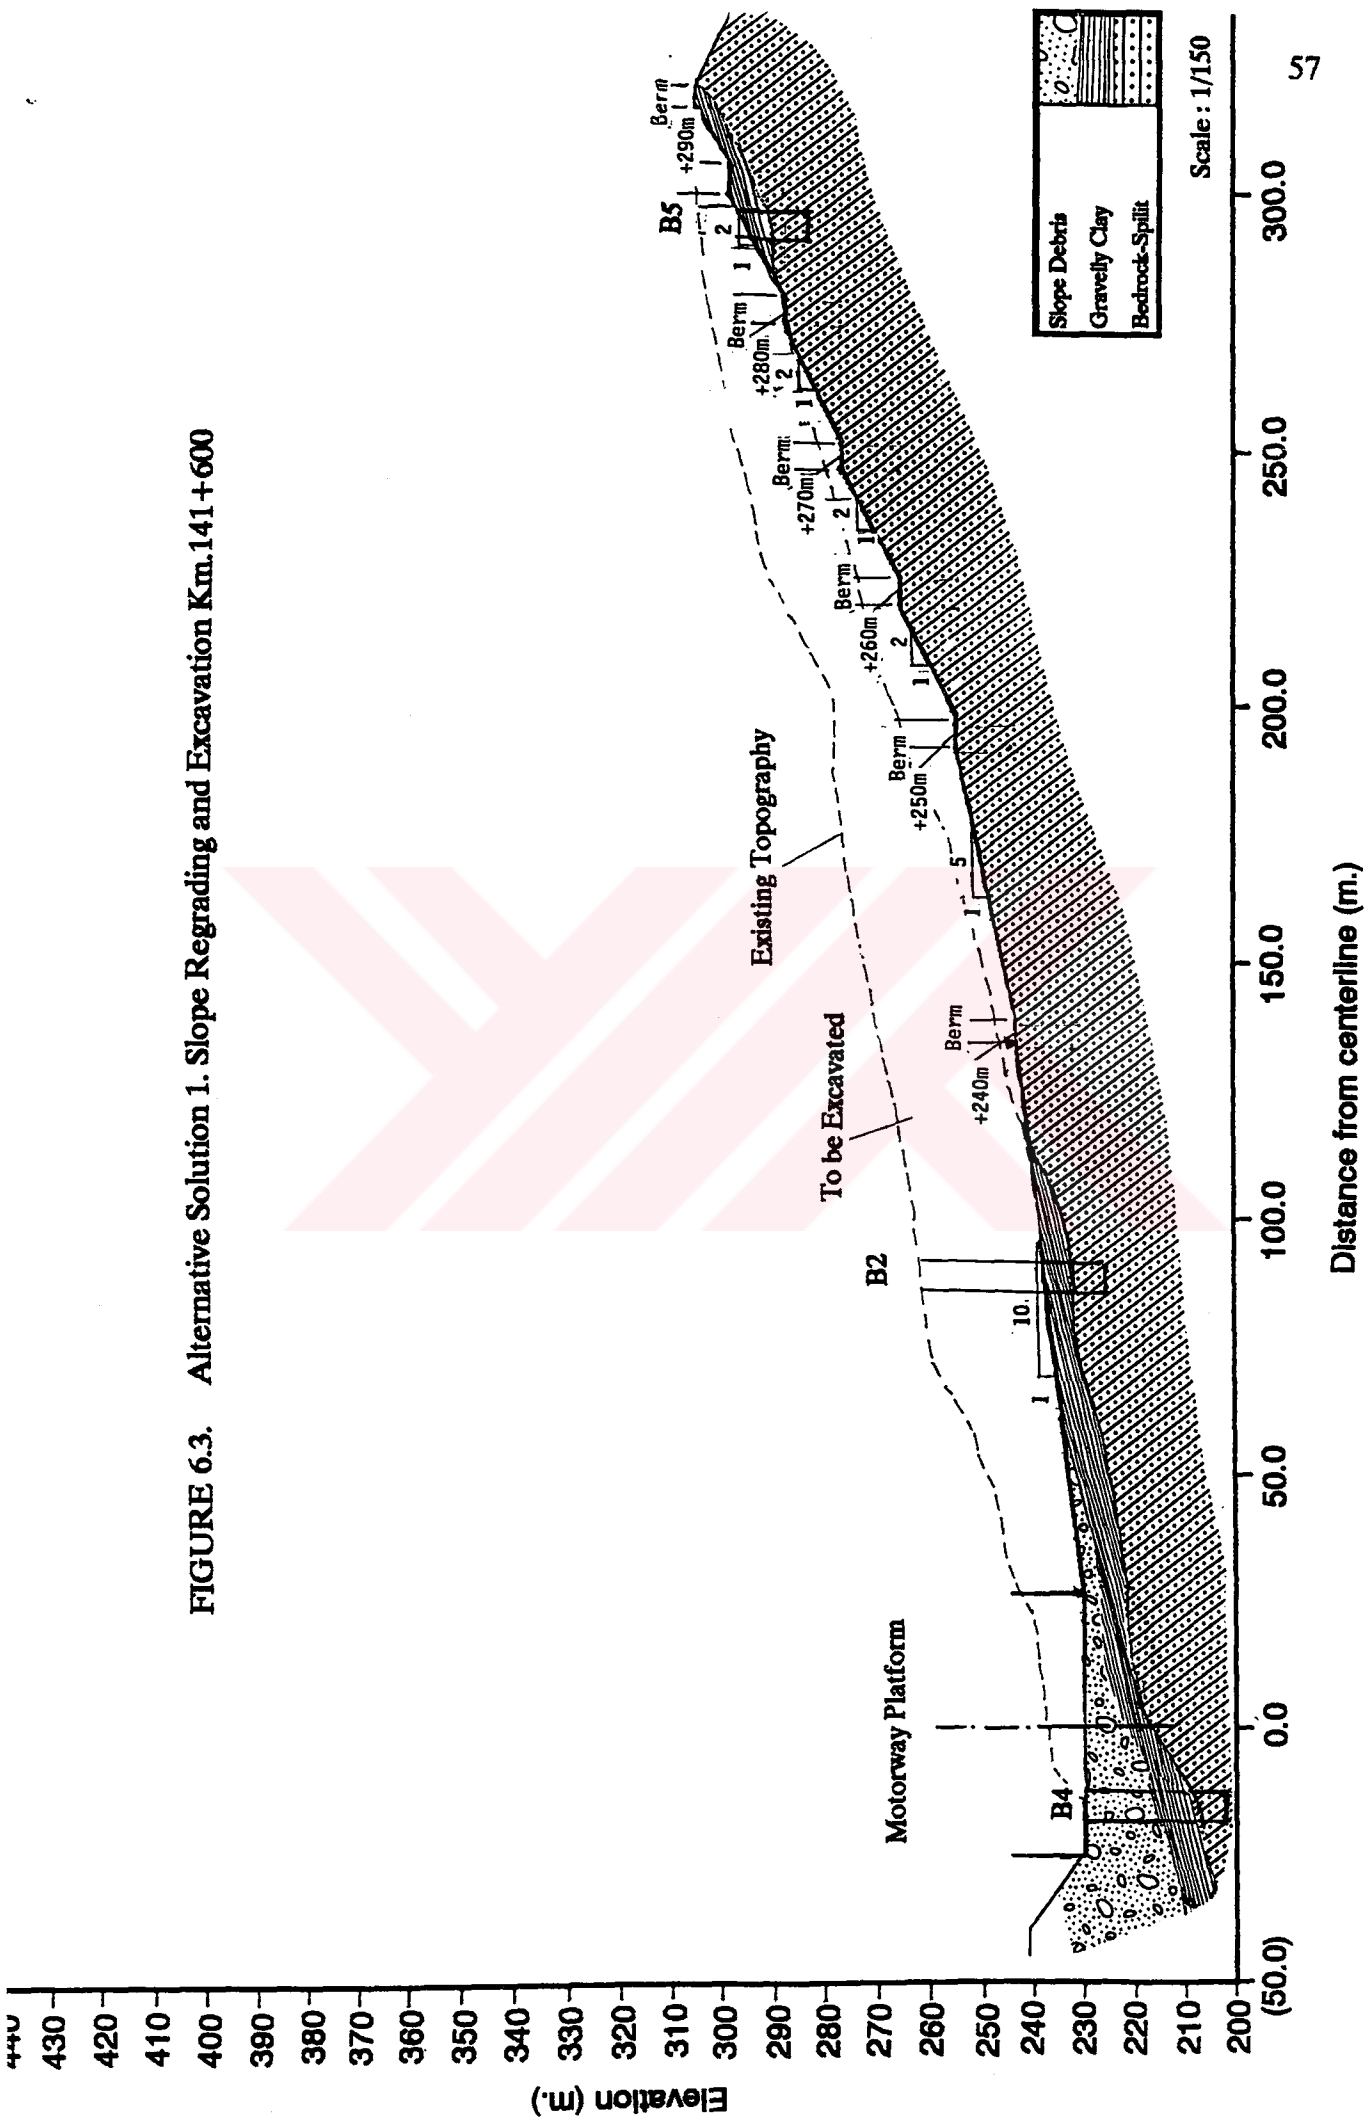
FIGURE 6.3. Alternative Solution 1. Slope Regrading and Excavation Km.141+600

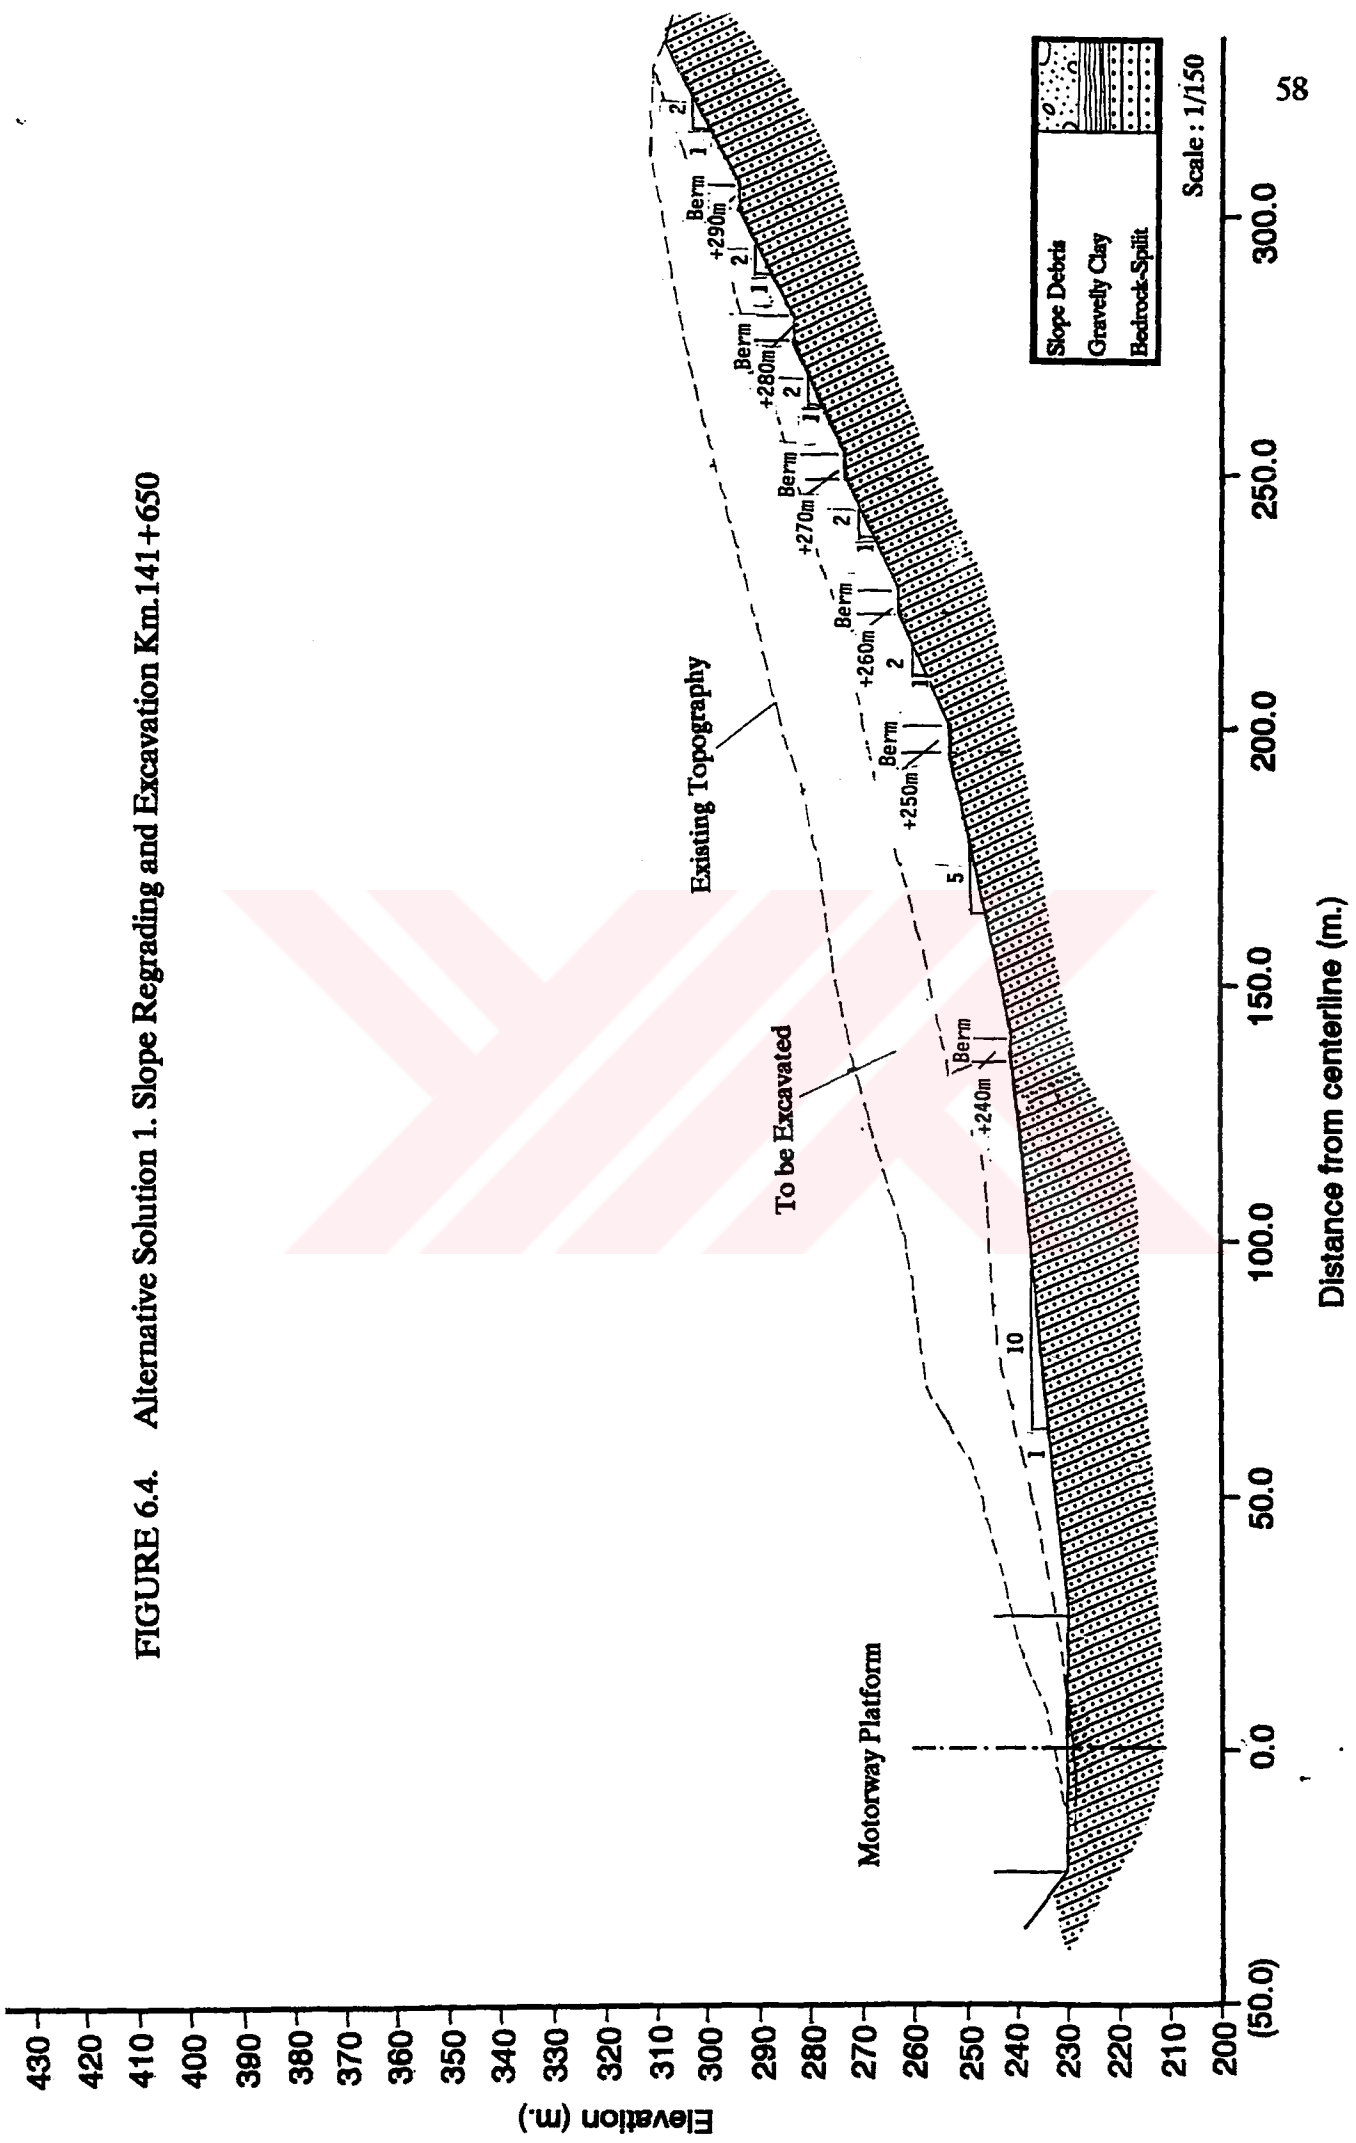
FIGURE 6.4. Alternative Solution 1. Slope Regrading and Excavation Km. 141 +650

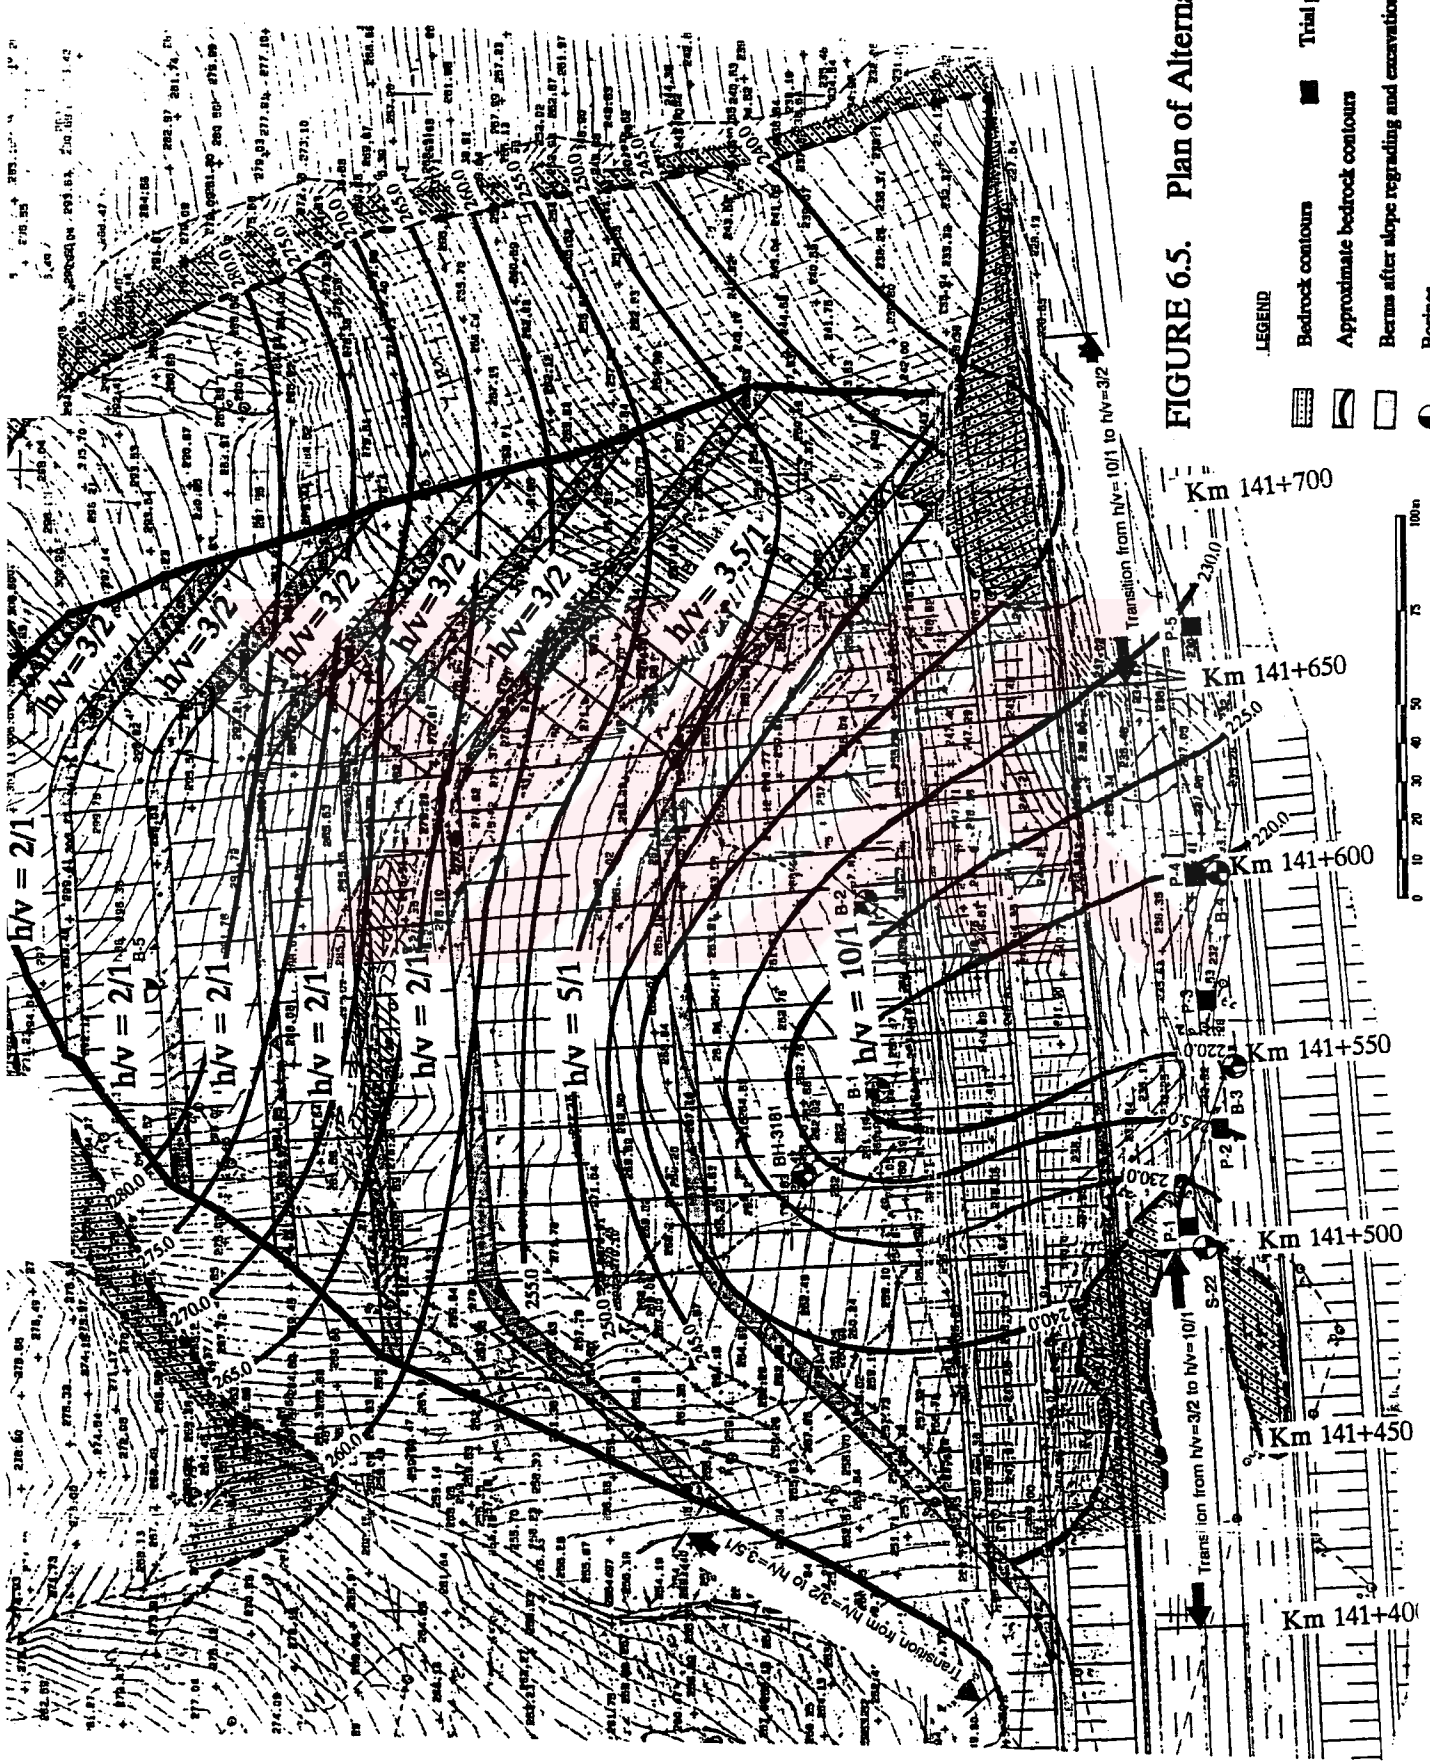
FIGURE 6.5. Plan of Alternative Solution 1.
