**A CASE STUDY FOR CUTS IN SOFT SOILS**

In this respect, the landslide which had occurred at TAG motorway during the excavation of cut slopes between Km.141+400 and Km.141+700 is investigated as a case study. The required analyses are performed in order to determine the residual strength parameters by both laboratory tests and back calculation method. In the light of these analyses, it is determined that the real cause to slip is the inadequate slope application on the soft soil conditions.

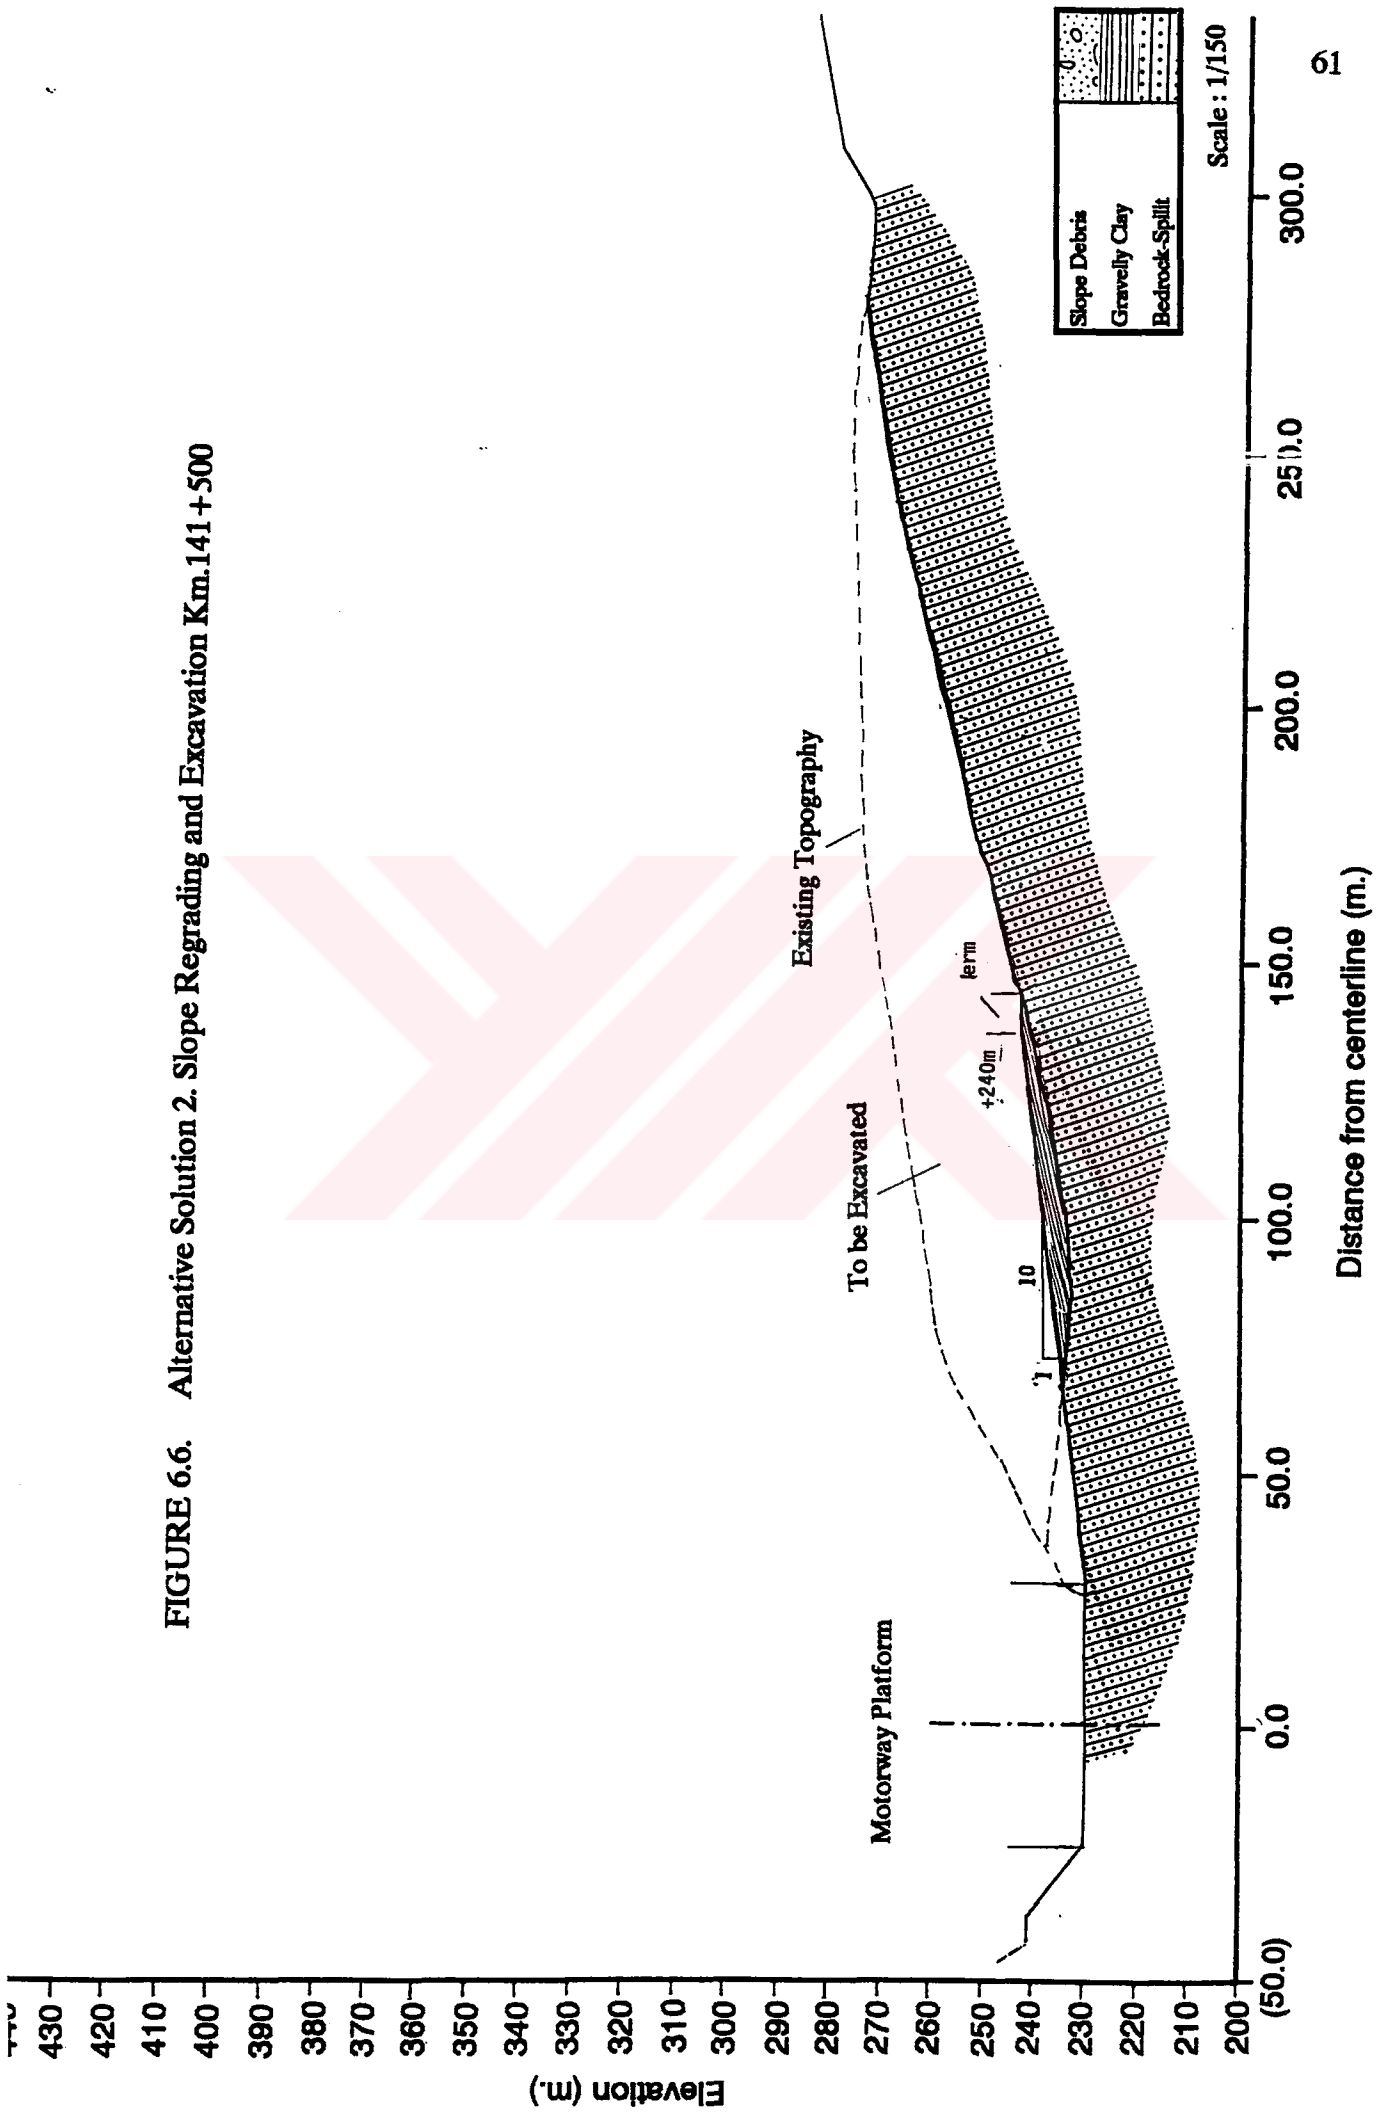
**FIGURE 6.6. Alternative Solution 2. Slope Regrading and Excavation Km.141 + 500**

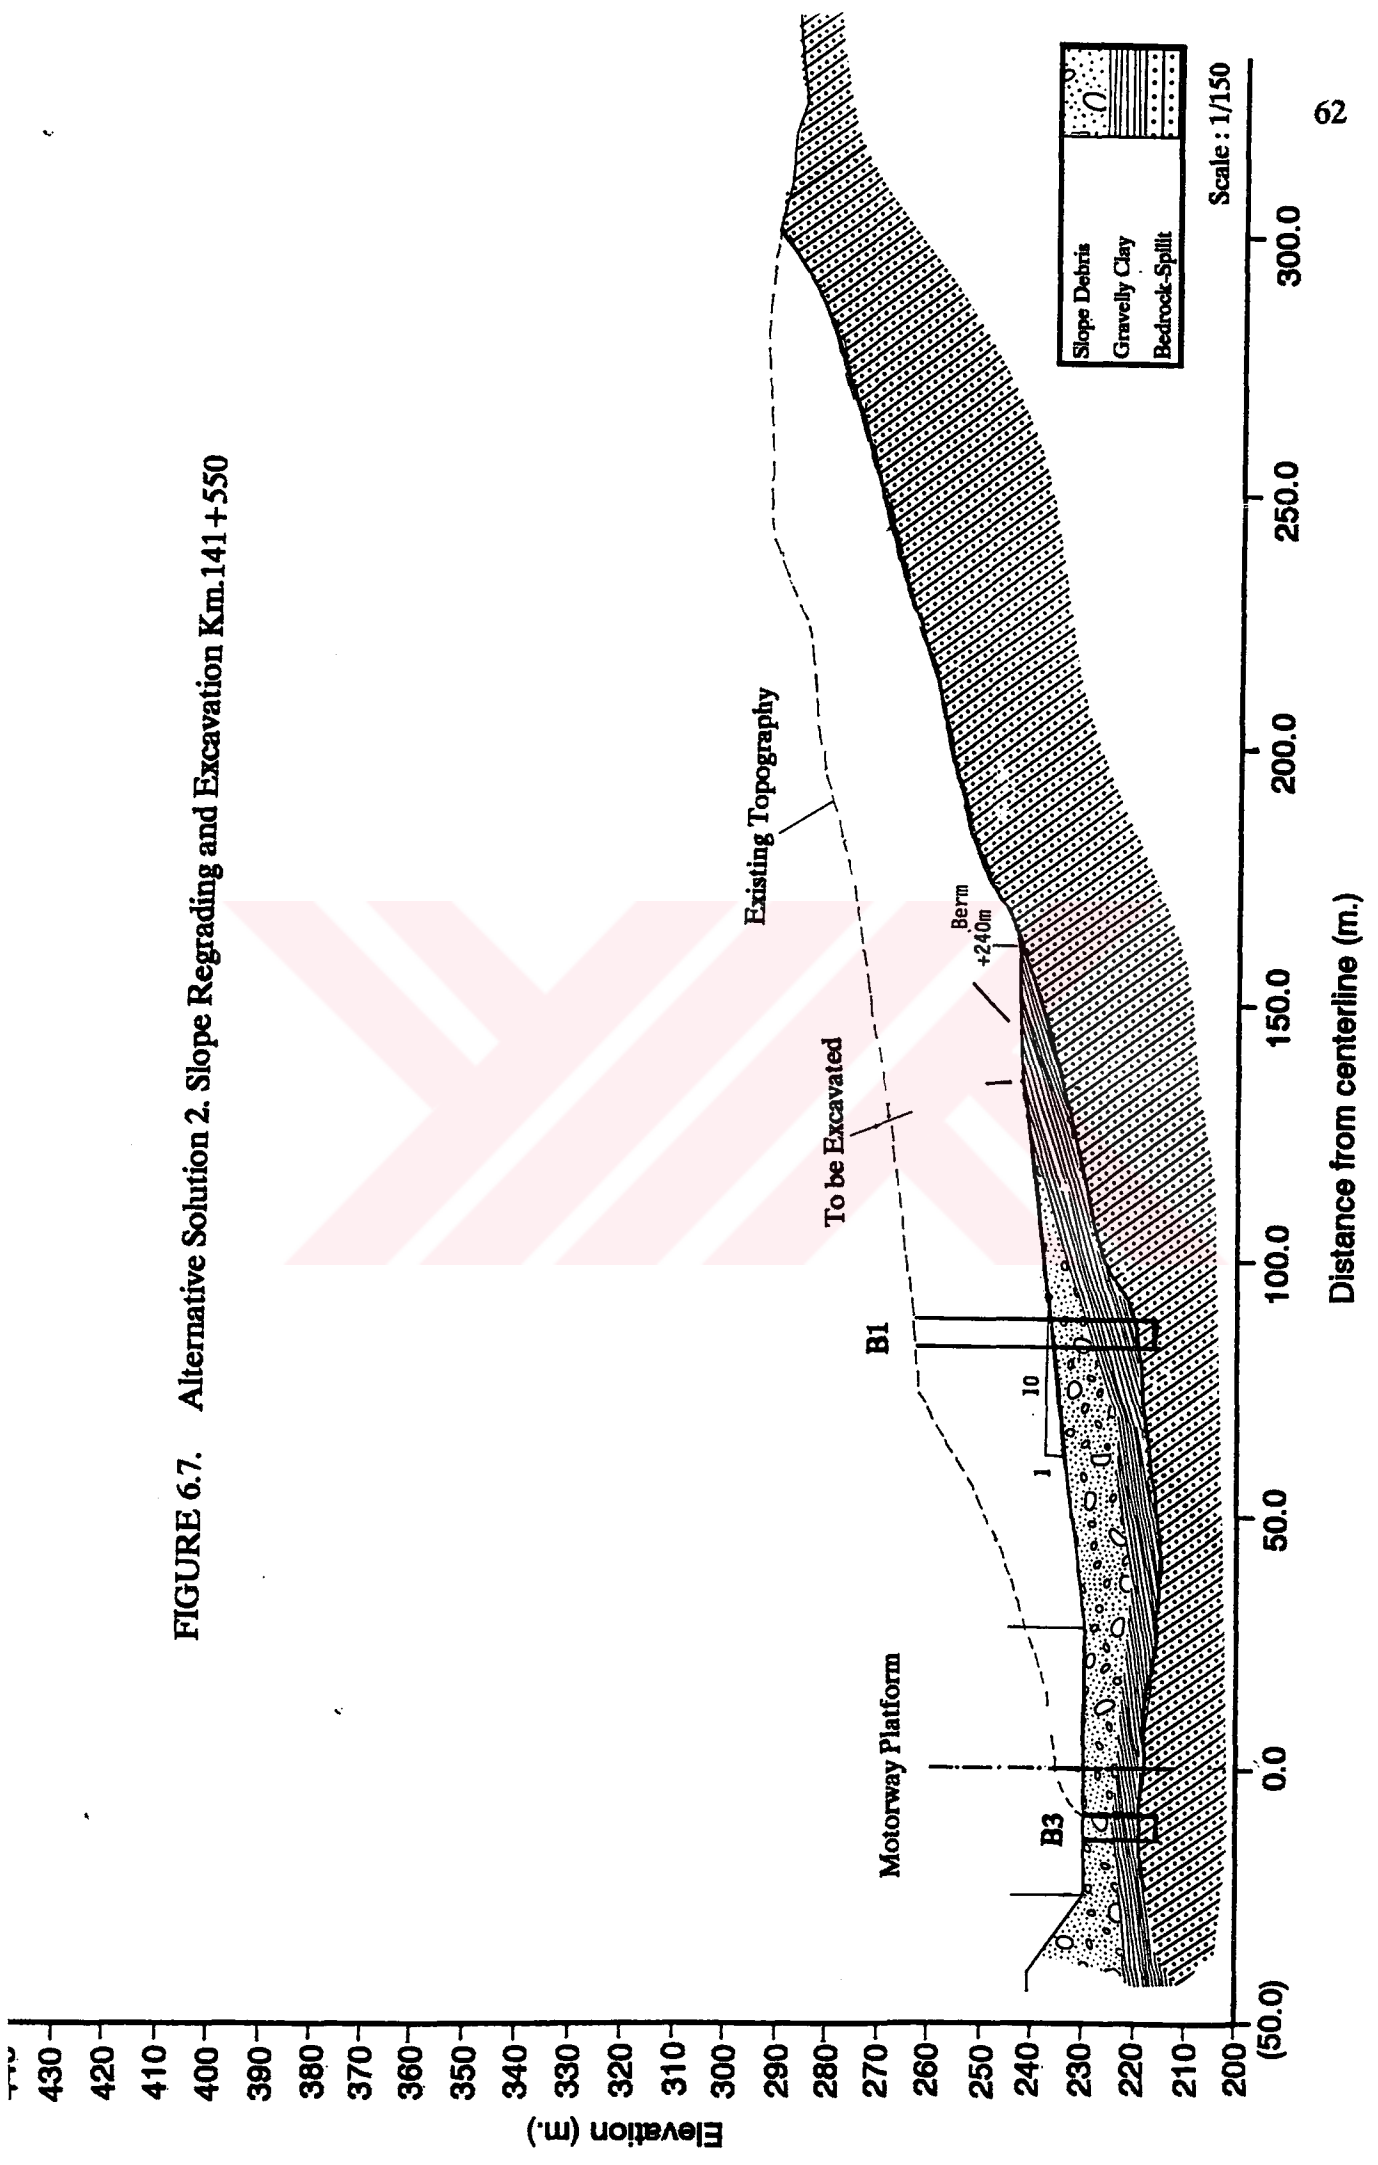
FIGURE 6.7. Alternative Solution 2. Slope Regrading and Excavation Km.141+550

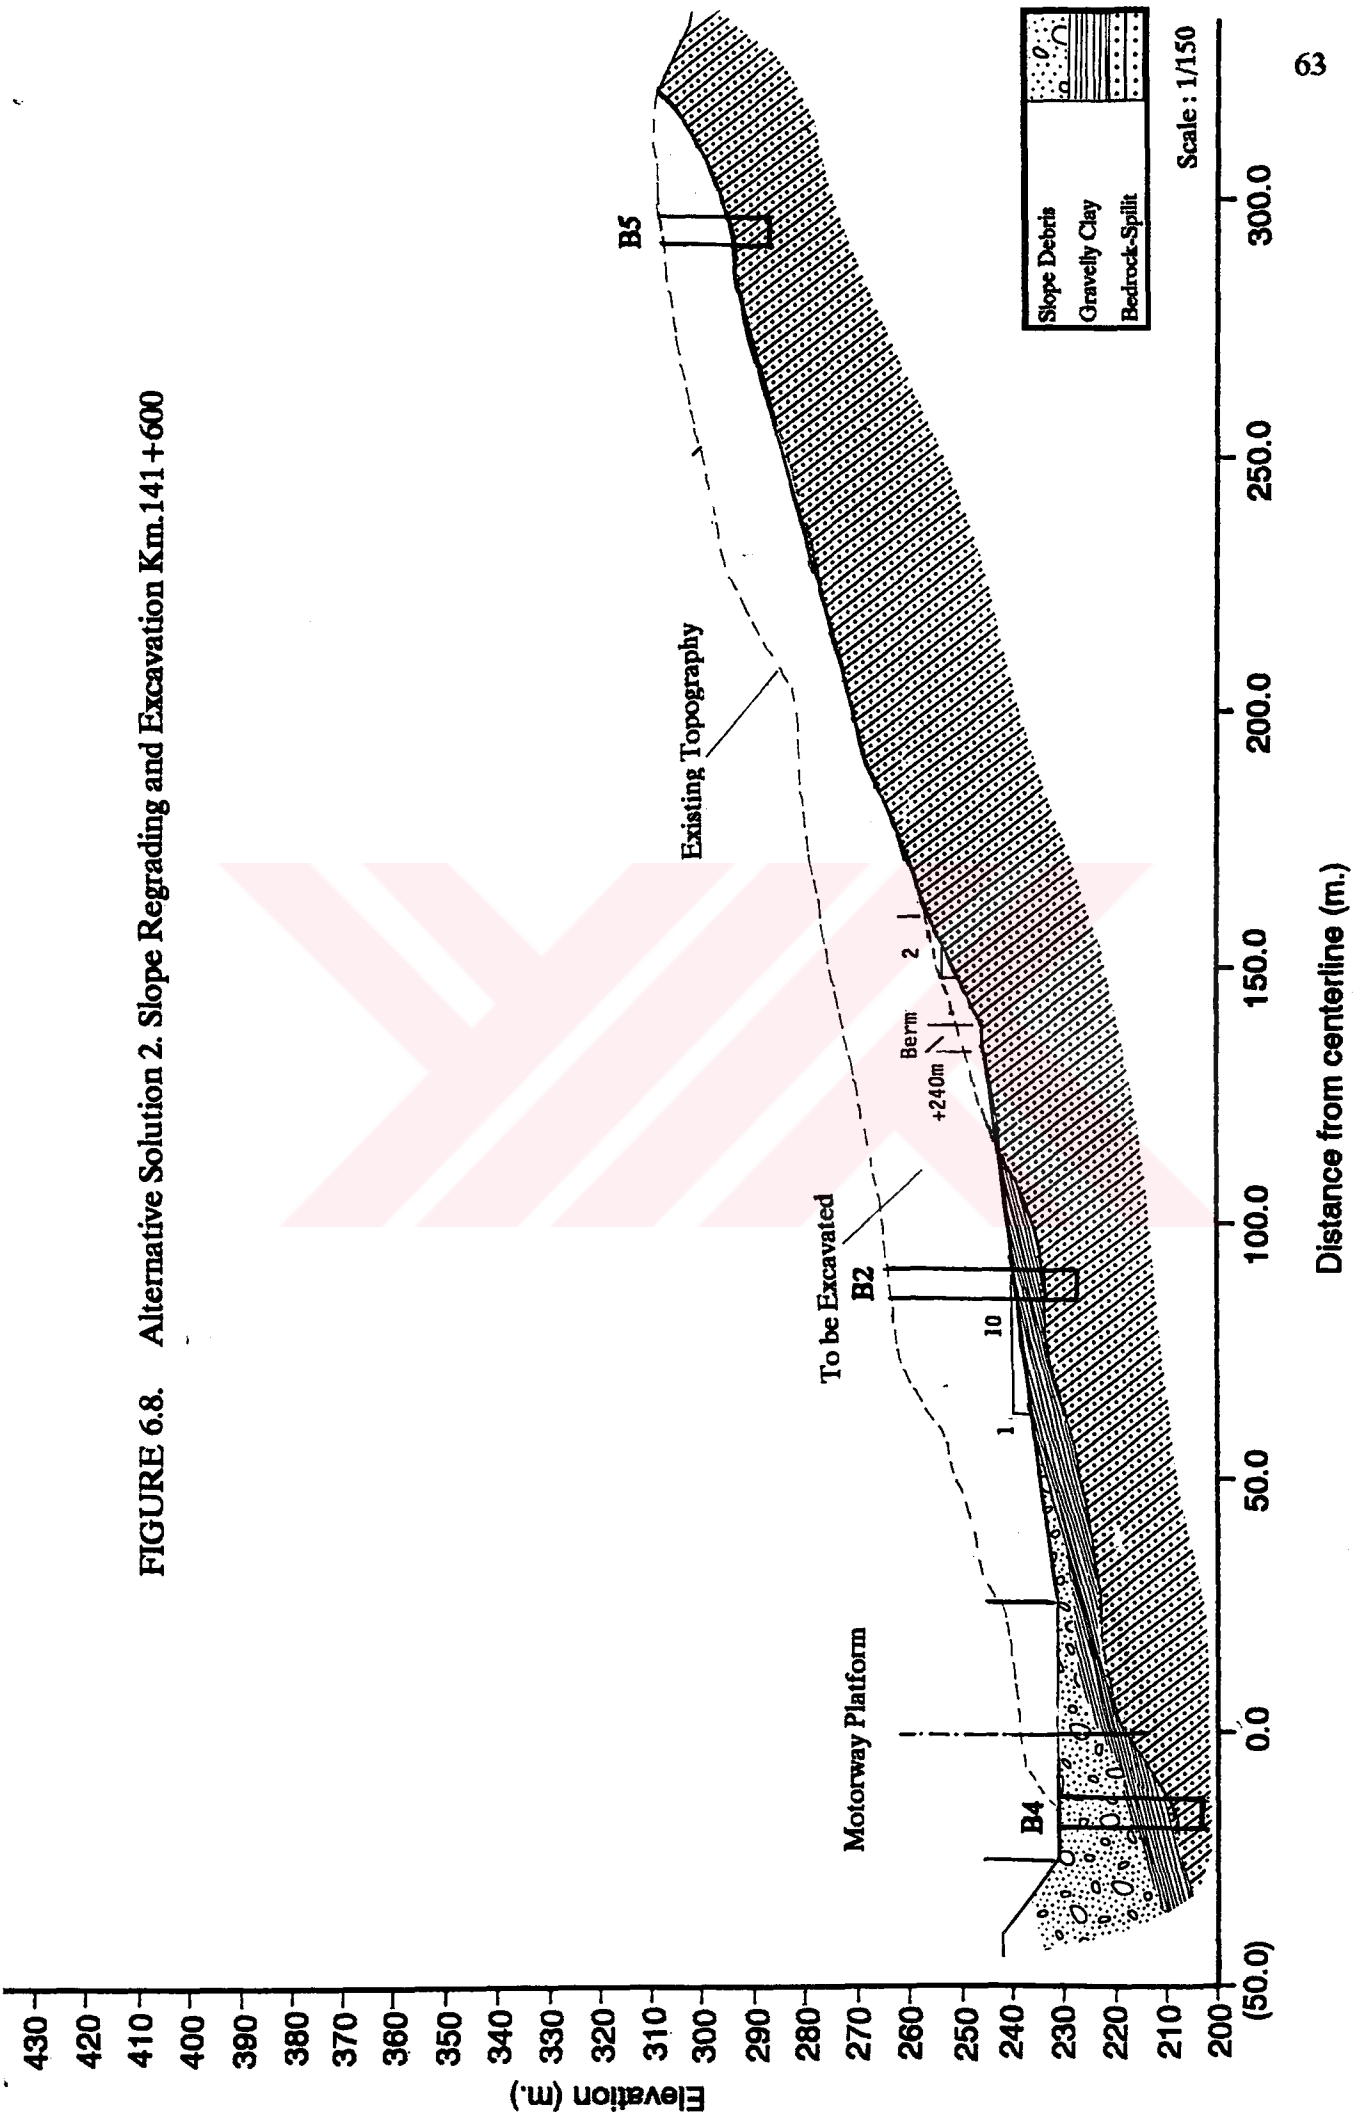
FIGURE 6.8. Alternative Solution 2. Slope Regrading and Excavation Km.141 + 600

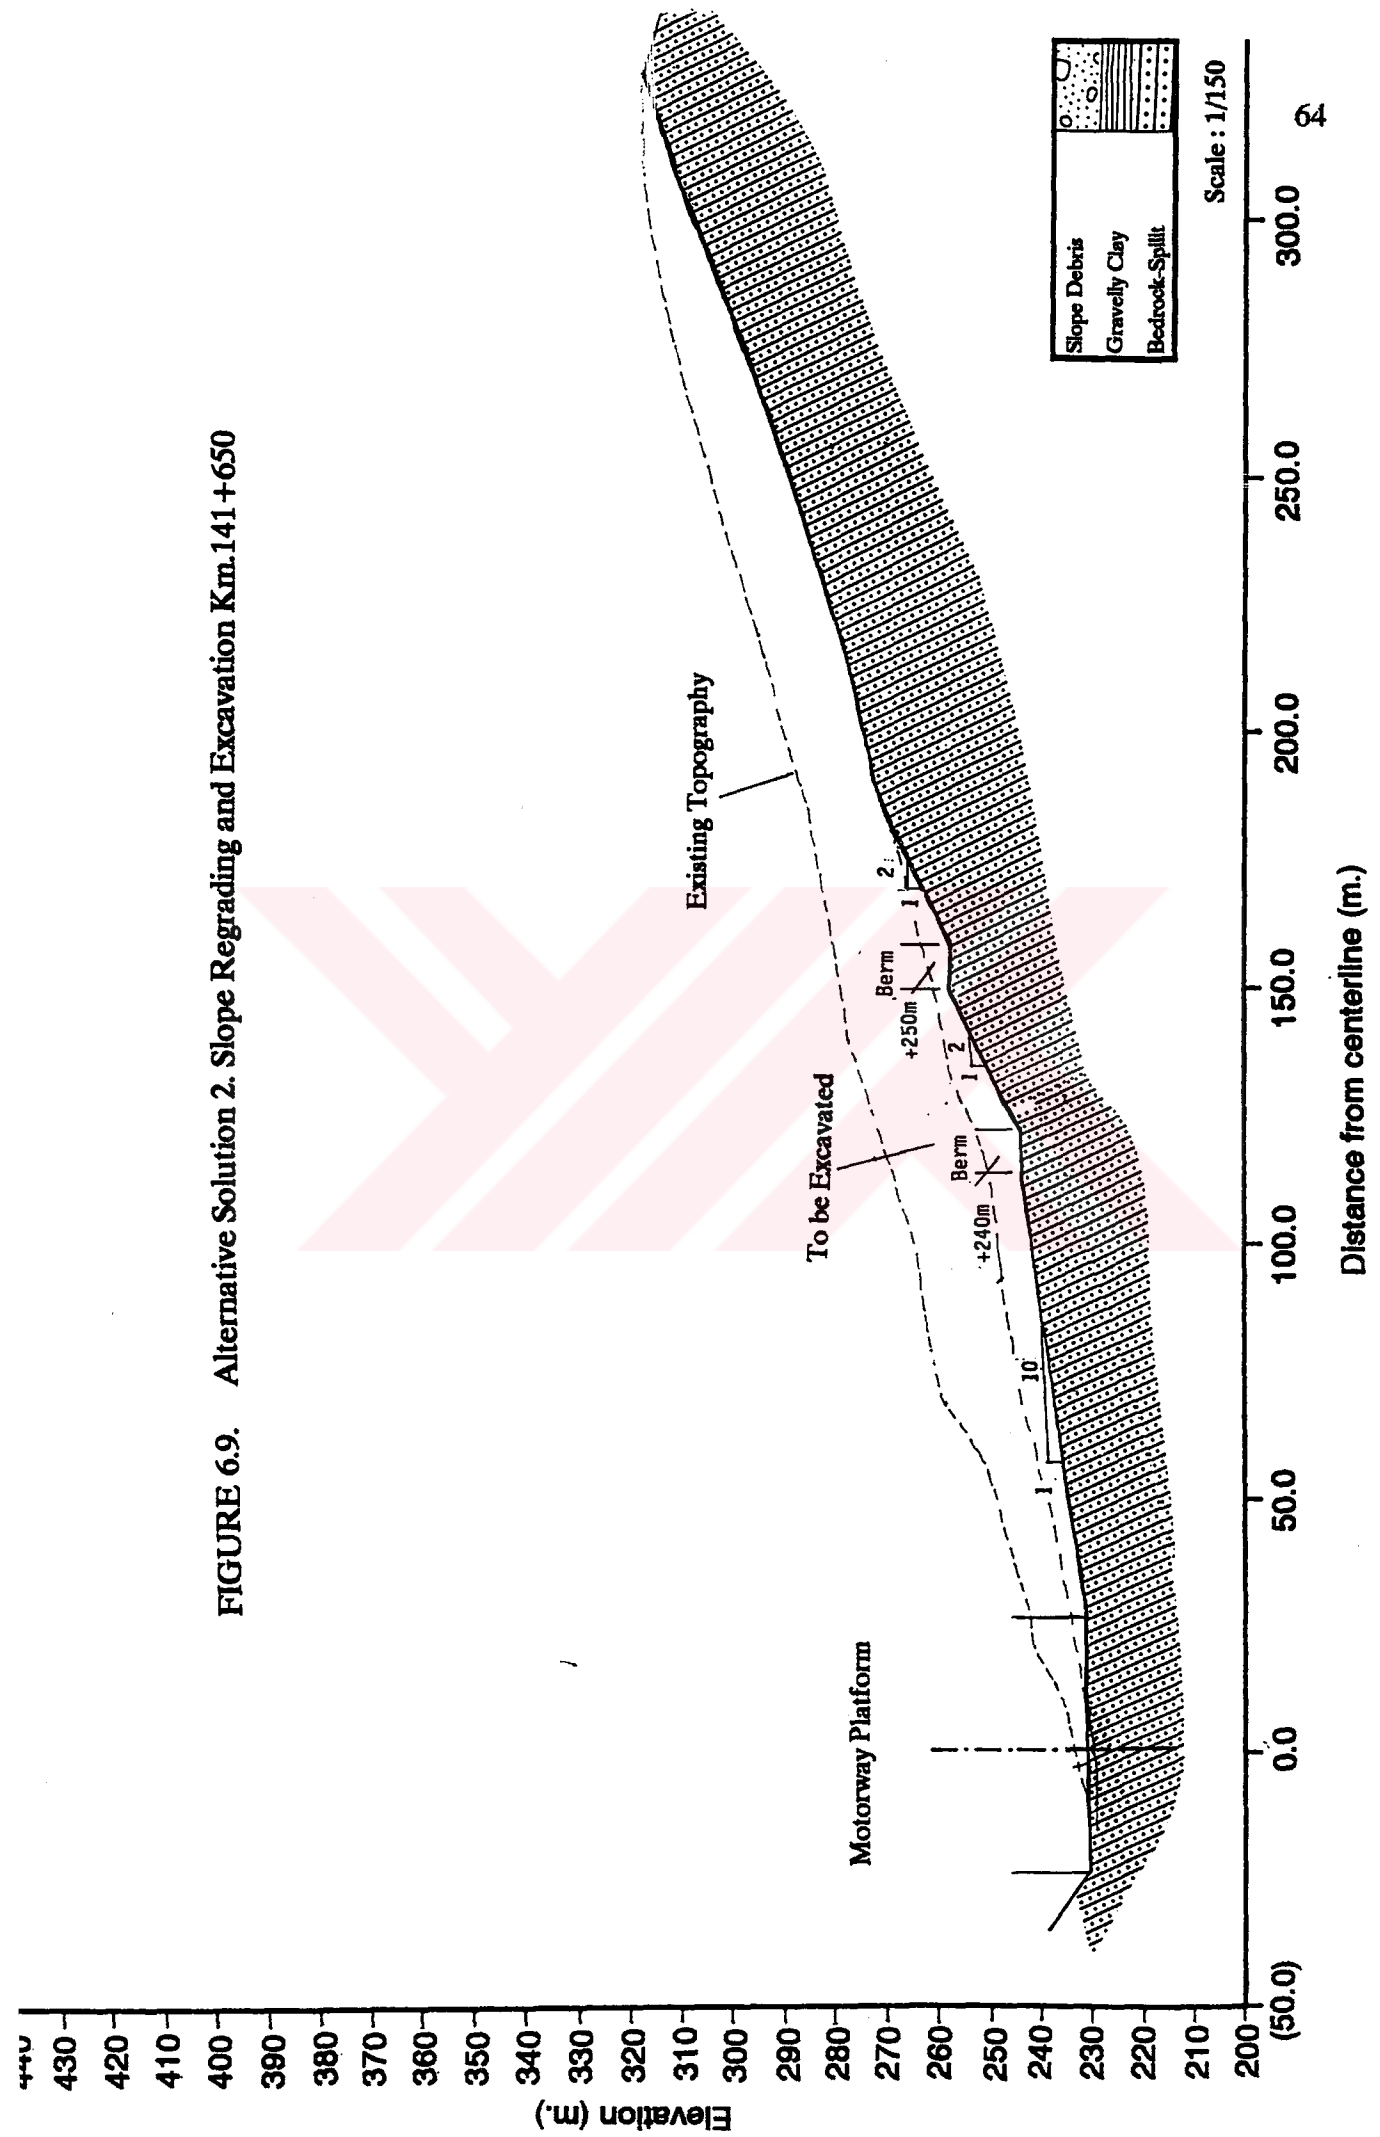
FIGURE 6.9. Alternative Solution 2. Slope Regrading and Excavation Km.141+650

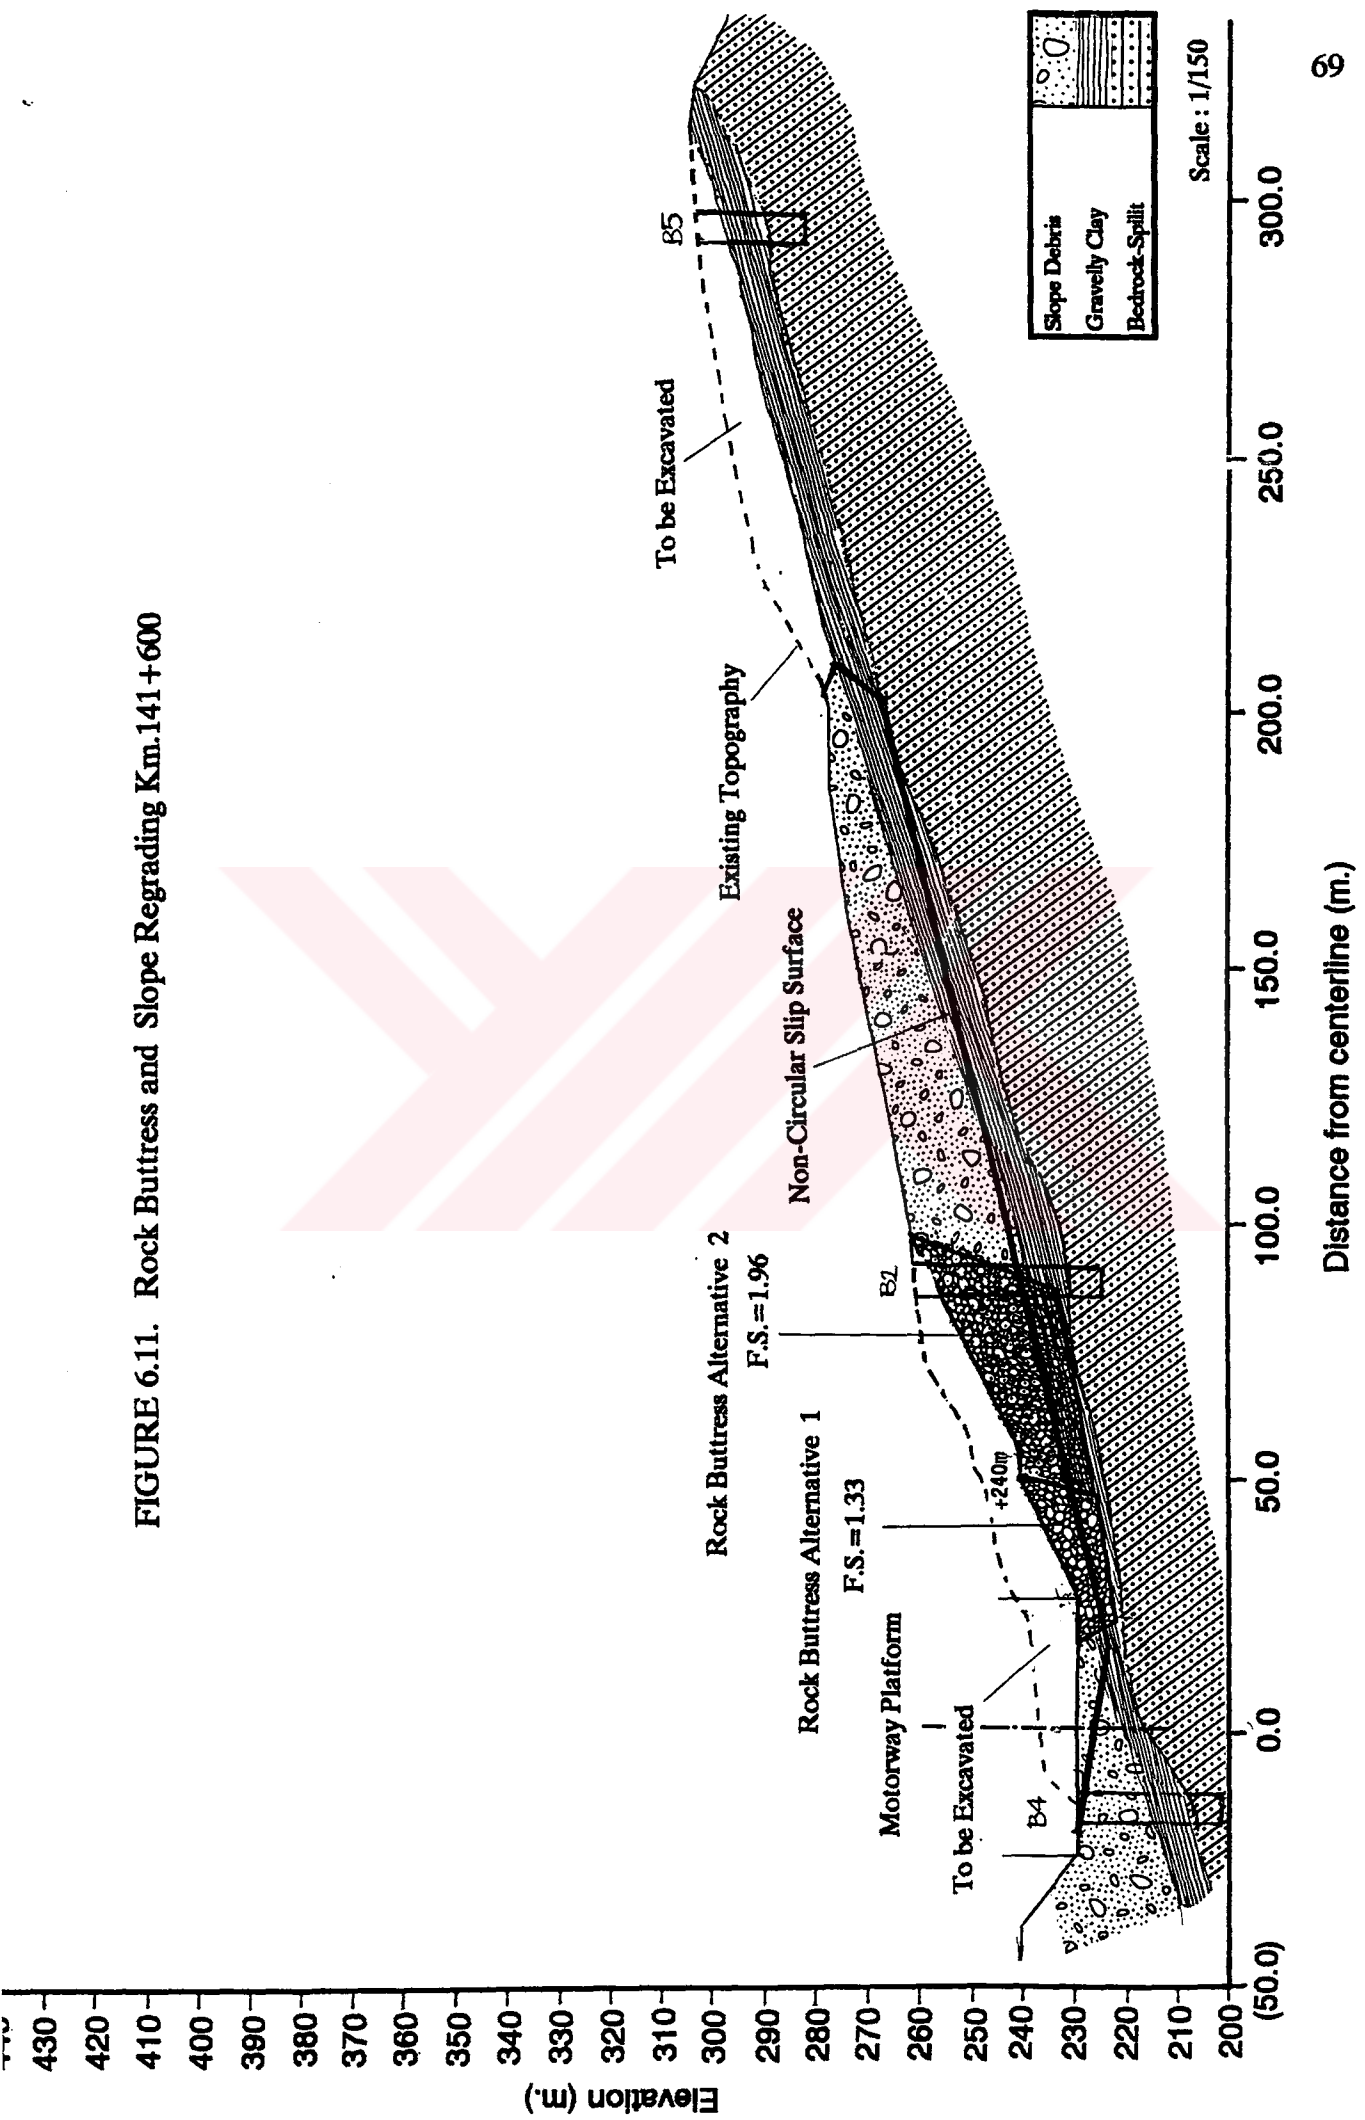
FIGURE 6.11. Rock Buttress and Slope Regrading Km.141 + 600

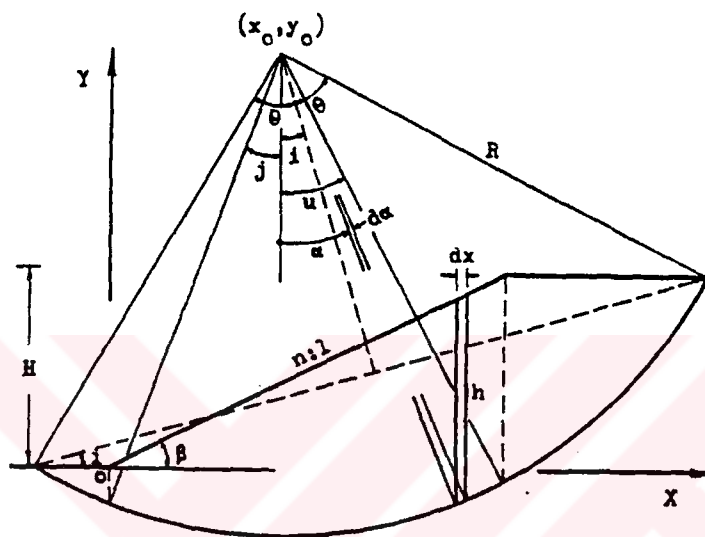
Figure A1.1 Typical geometry in slope stability analysis  
D.H.He (13)

The origin of the coordinates defines at the toe of the slope. The point  $(x_0, y_0)$  is the center of the failure circle. The factor of safety  $F$ , is defined as that by which available shear strength should be reduced so as to bring it into equilibrium with mobilized shear stress. The available shear strength is calculated on the basis of Mohr's Coloumb failure criterion. The sliding mass is divided into slices inwhich its width is  $dx$ . Therefore the factor of safety of the Bishop's modified methodis expressed in the form of integrations as stated in the chapter I.

Before start to derive the back calculation formulas , it is needed to obtain the factor of safety with great precision by direct integration over the whole slip surface. It will be assumed that the potential slip surface passing from the beneath the toe of the slope is a circular arc. A section of a slide is illustrated at Figure A1.1

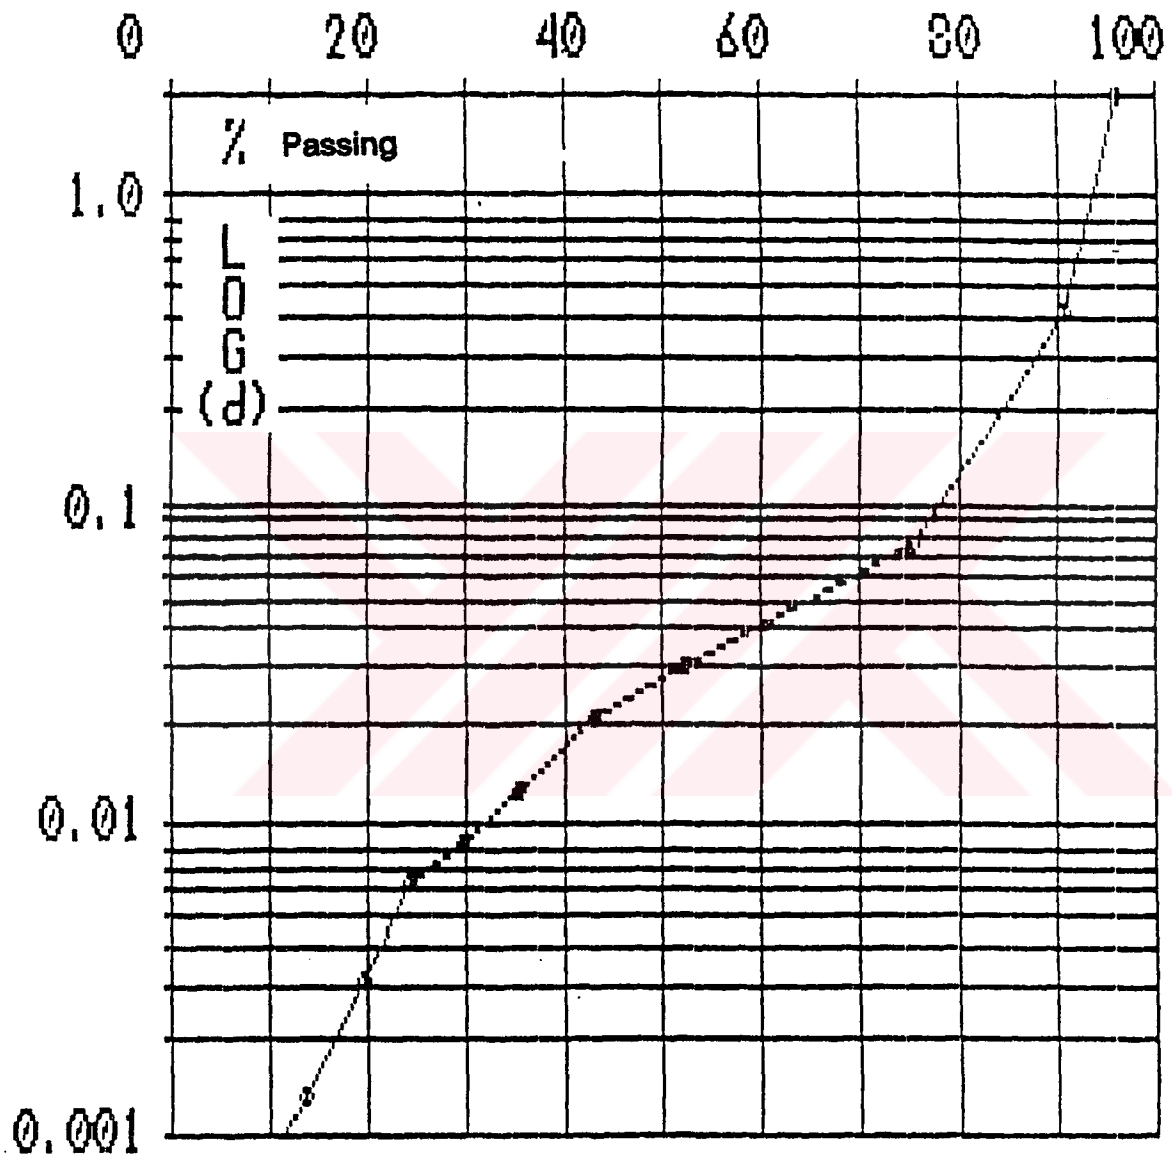
FIGURE A3.1.1 Sieve analysis on sample no.1A

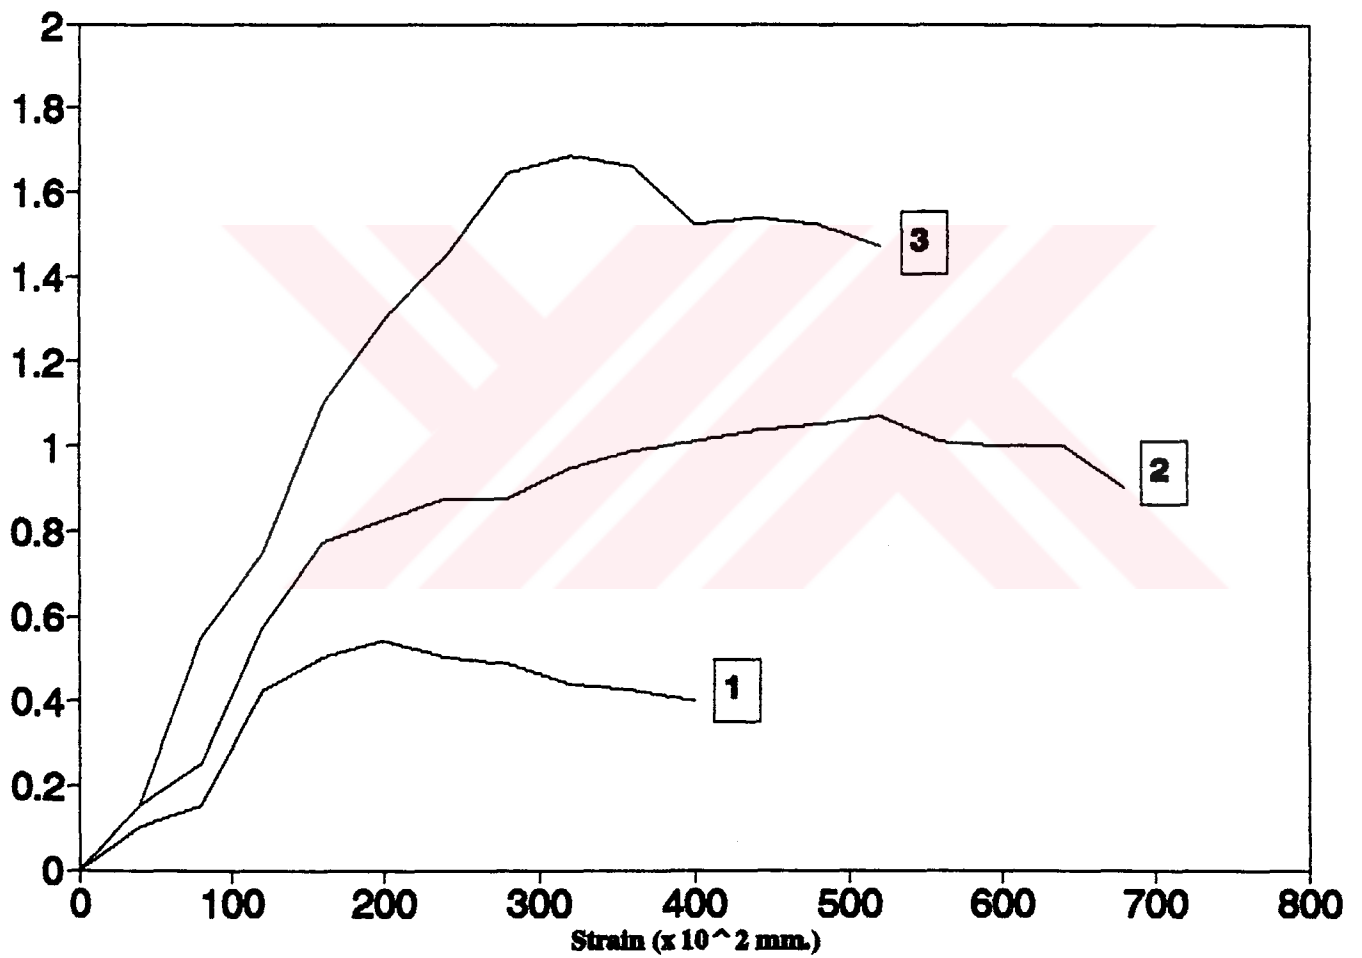
FIGURE A3.1.2 Residual direct shear test

Sample no.1A 1st. Shear

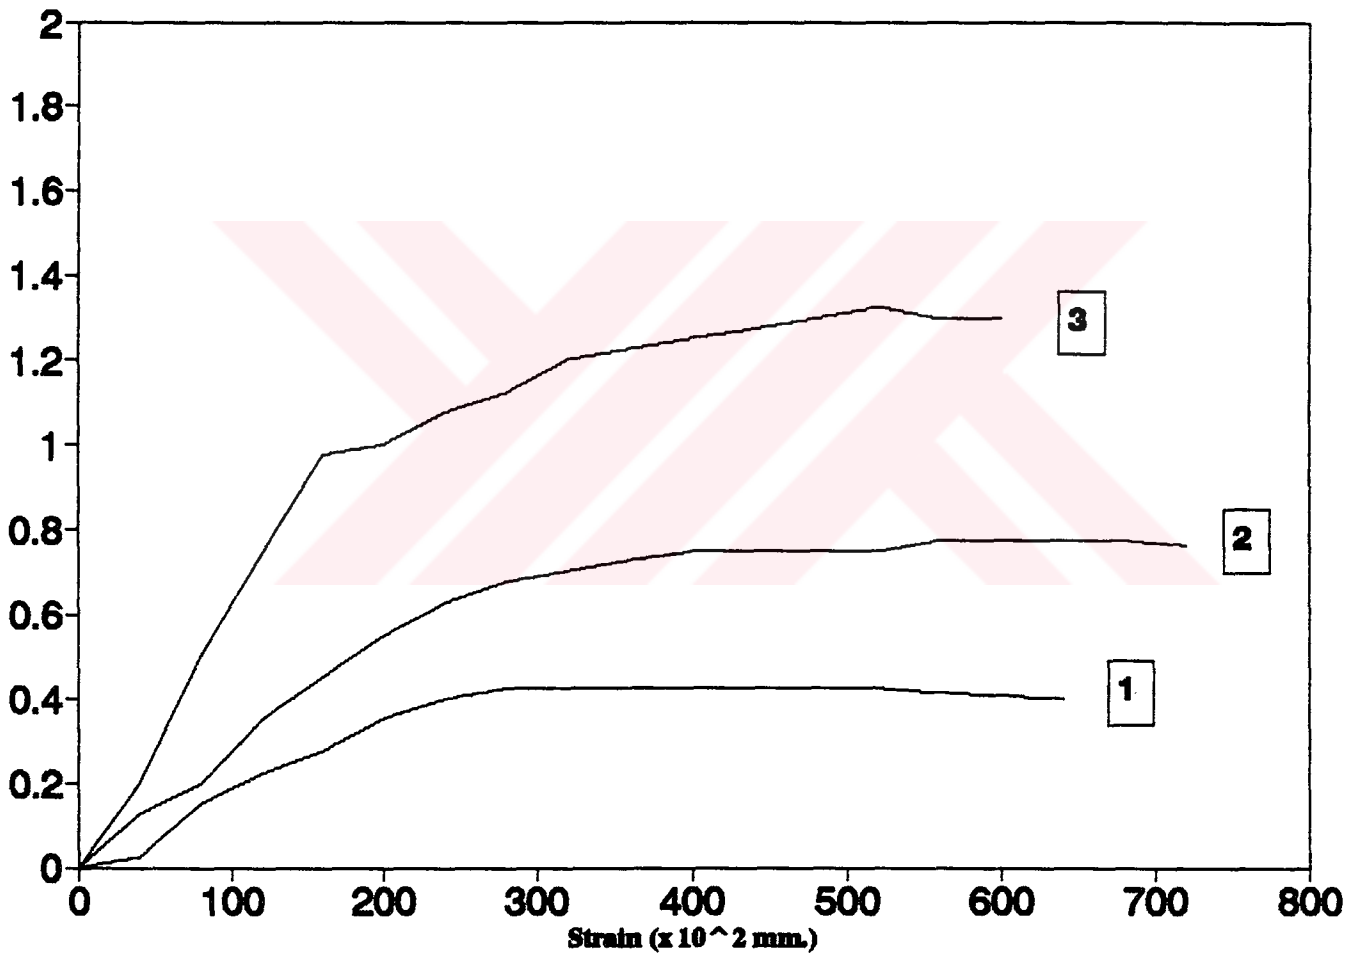
FIGURE A3.1.3 Residual direct shear test

Sample no.1A 2nd. Shear

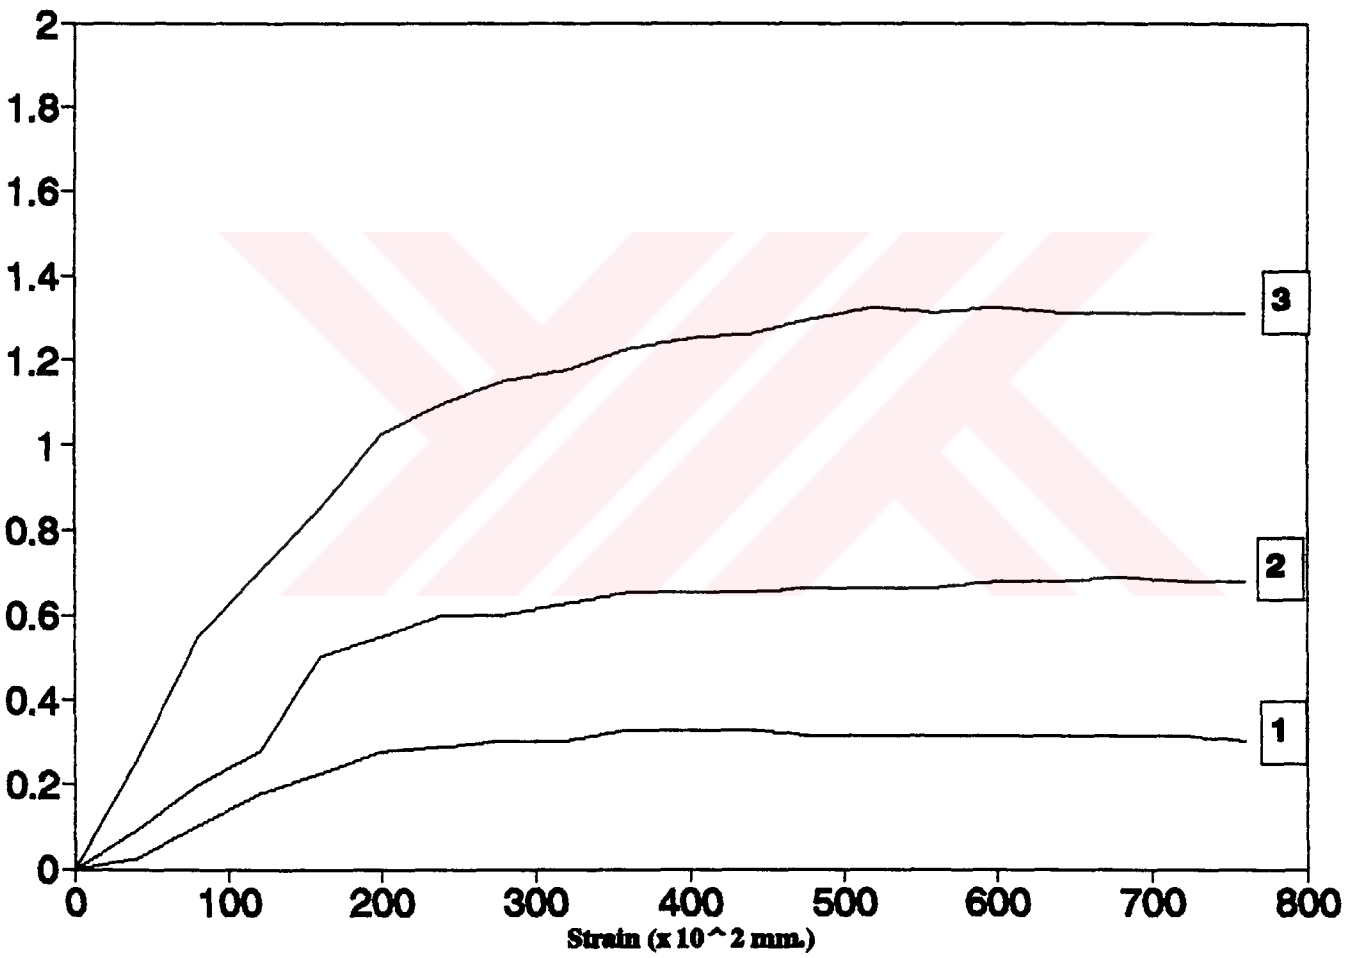
FIGURE A3.1.4 Residual direct shear test

Sample no.1A 3rd. Shear

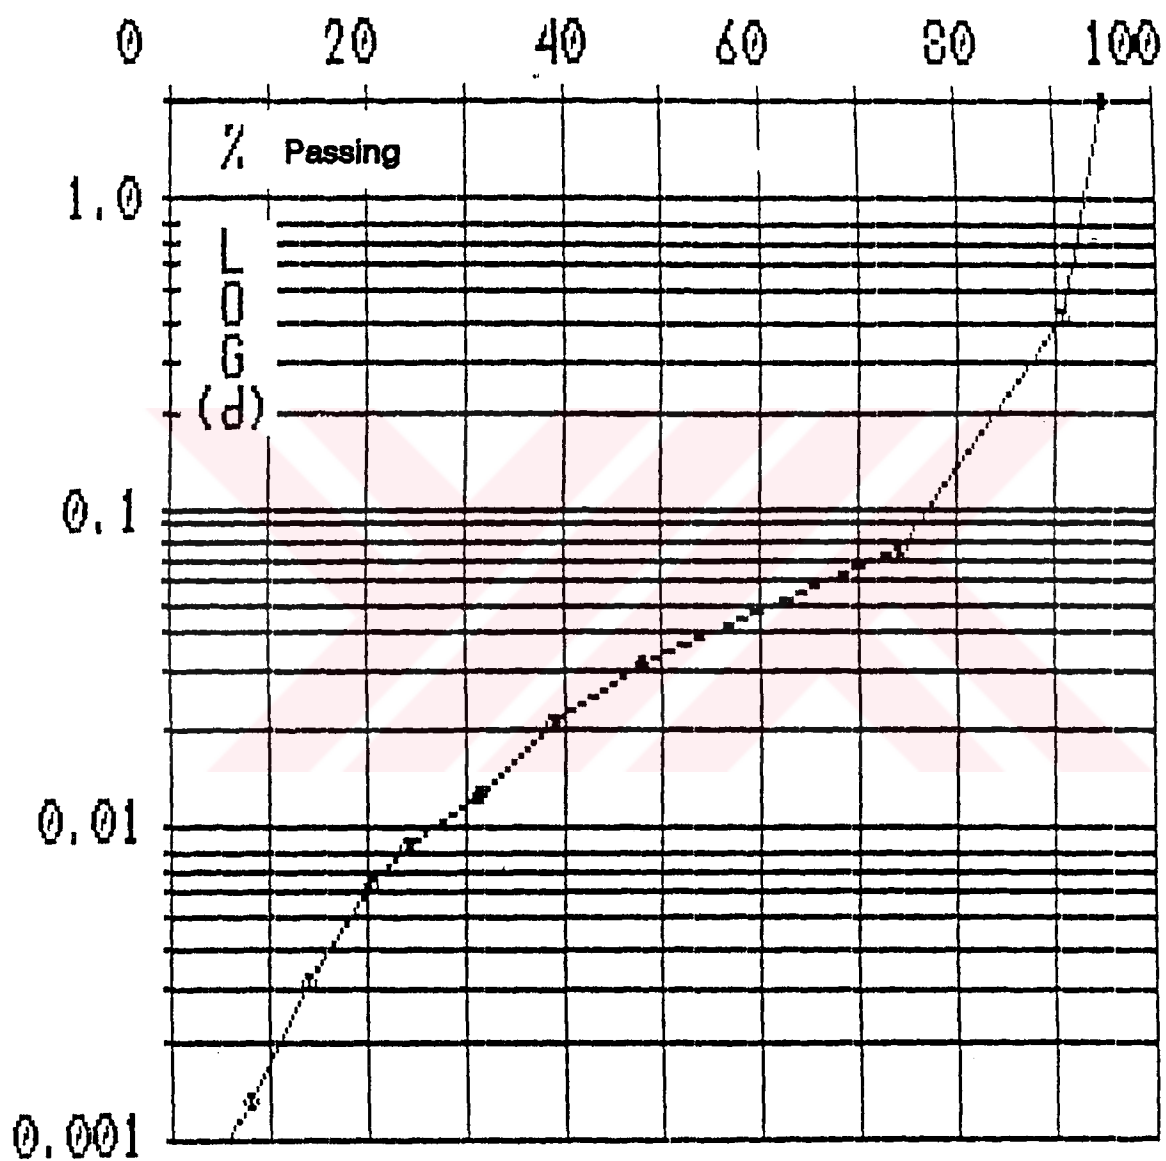
FIGURE A3.2.1 Sieve analysis on sample no.1B
