**A CASE STUDY FOR CUTS IN SOFT SOILS**

In this respect, the landslide which had occurred at TAG motorway during the excavation of cut slopes between Km.141+400 and Km.141+700 is investigated as a case study. The required analyses are performed in order to determine the residual strength parameters by both laboratory tests and back calculation method. In the light of these analyses, it is determined that the real cause to slip is the inadequate slope application on the soft soil conditions.

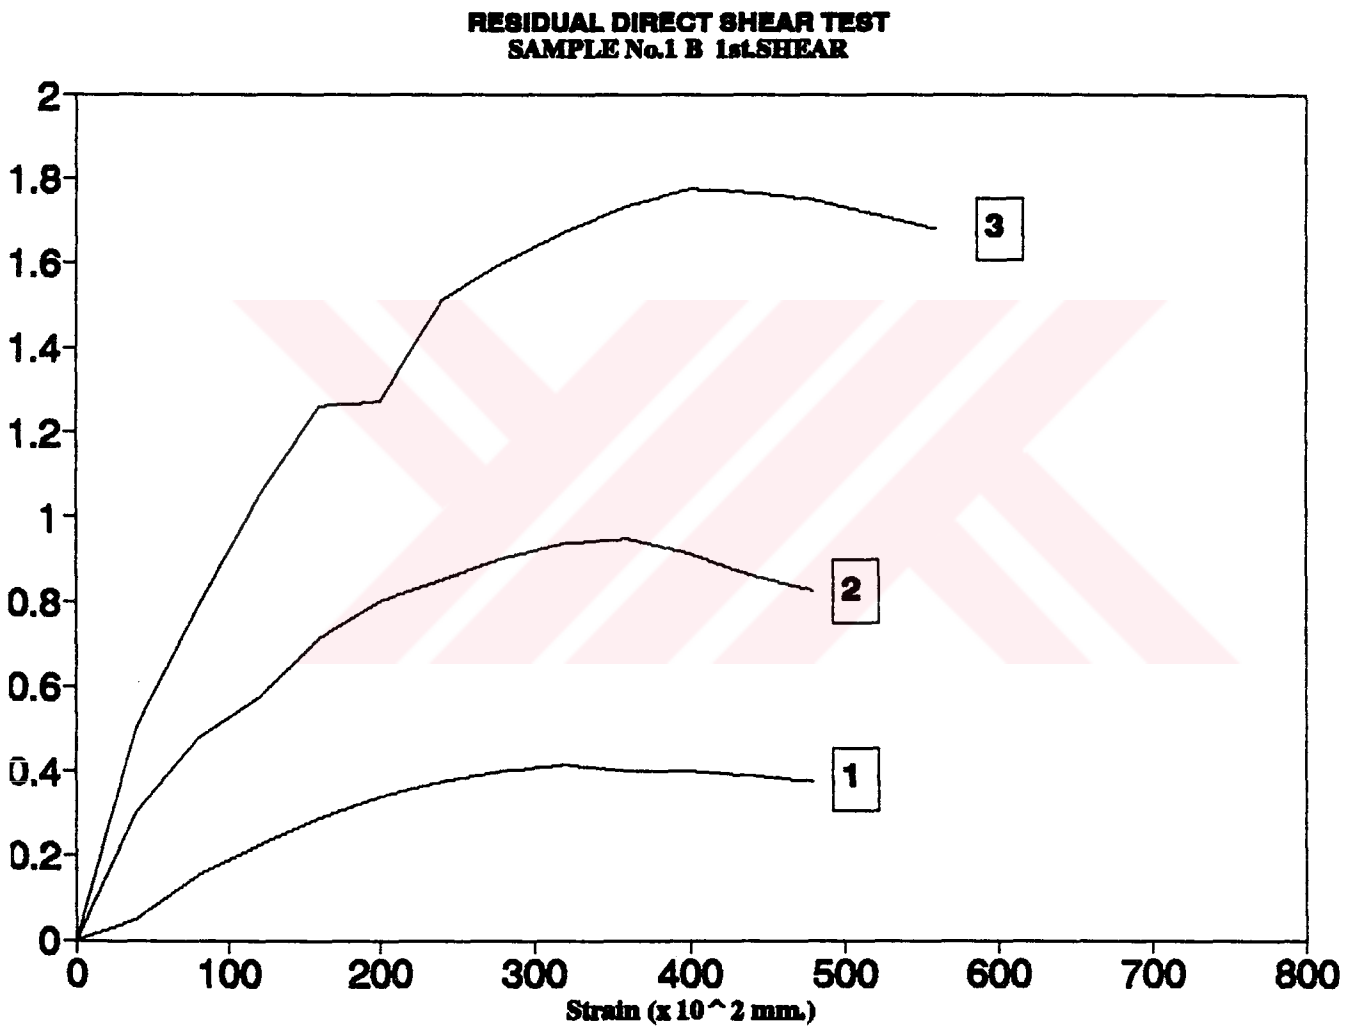
FIGURE A3.2.2 Residual direct shear test

Sample no.1B 1st. Shear

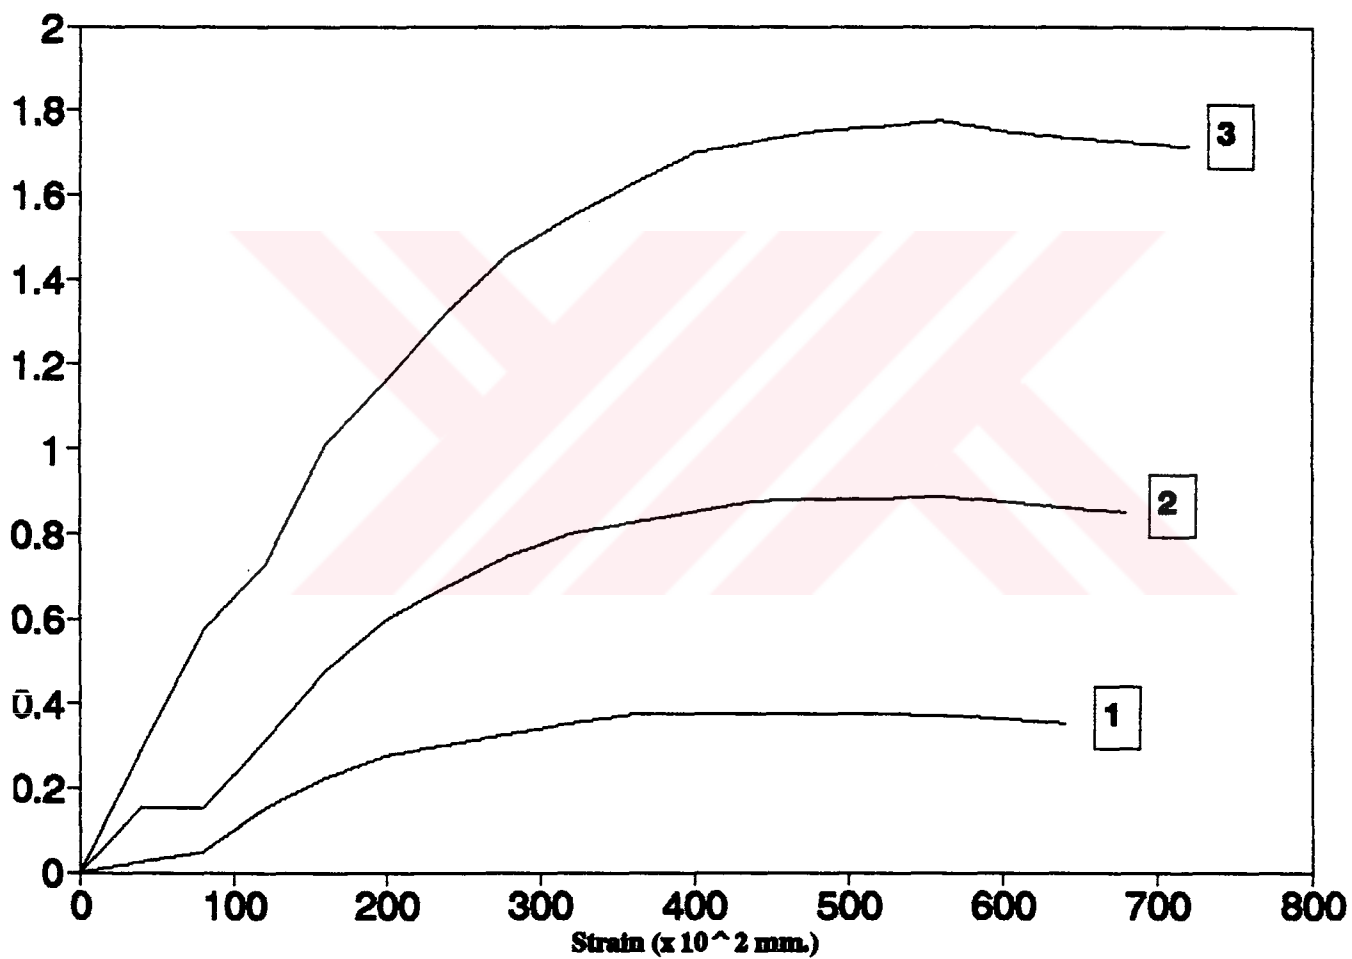
FIGURE A3.2.3 Residual direct shear test

Sample no.1B 2nd. Shear

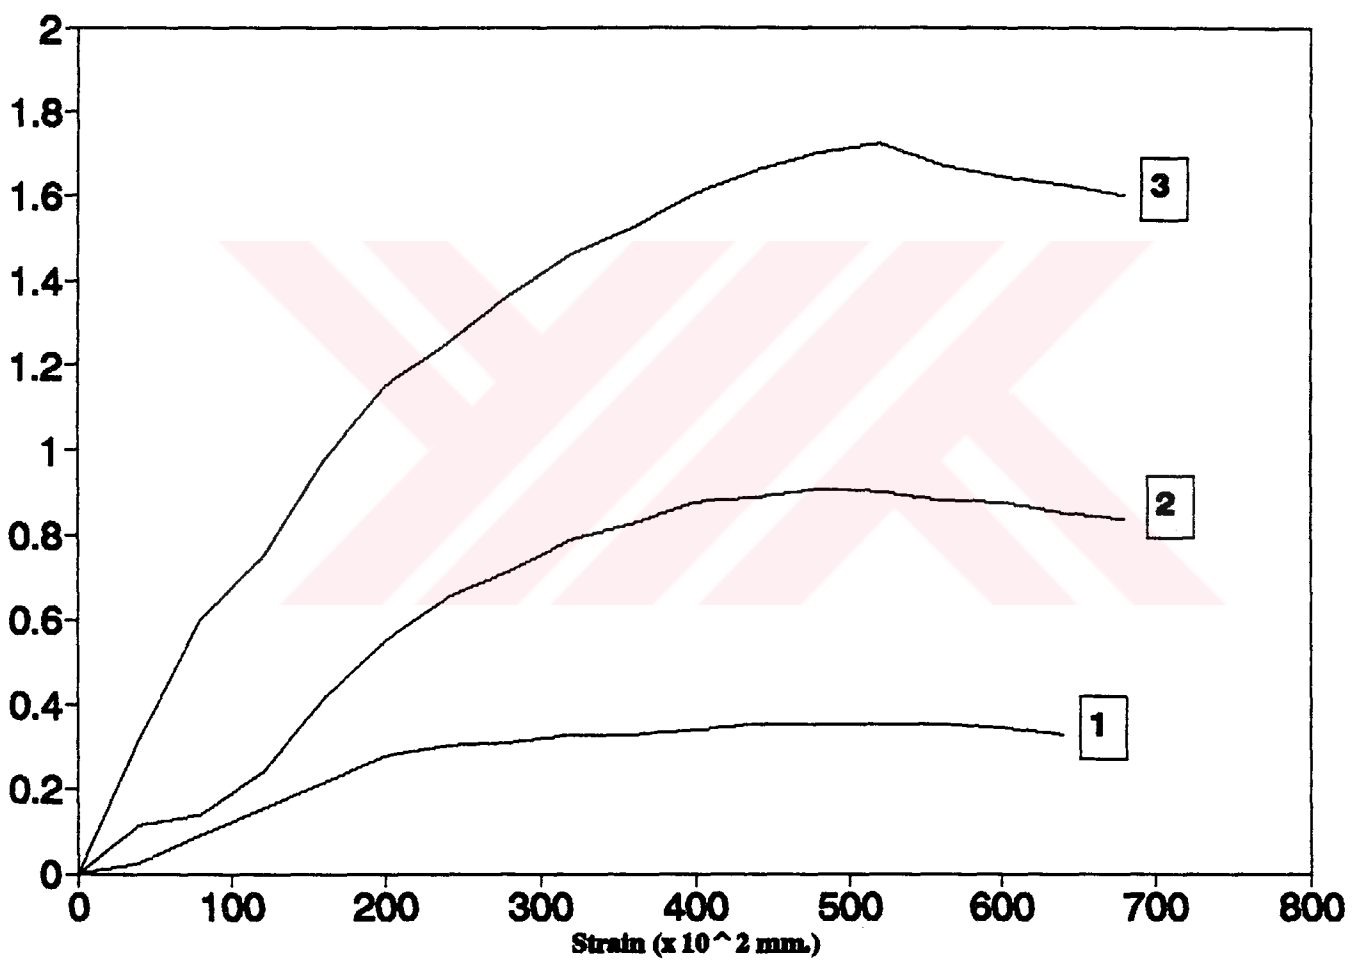
FIGURE A3.2.4 Residual direct shear test

Sample no.1B 3rd. Shear

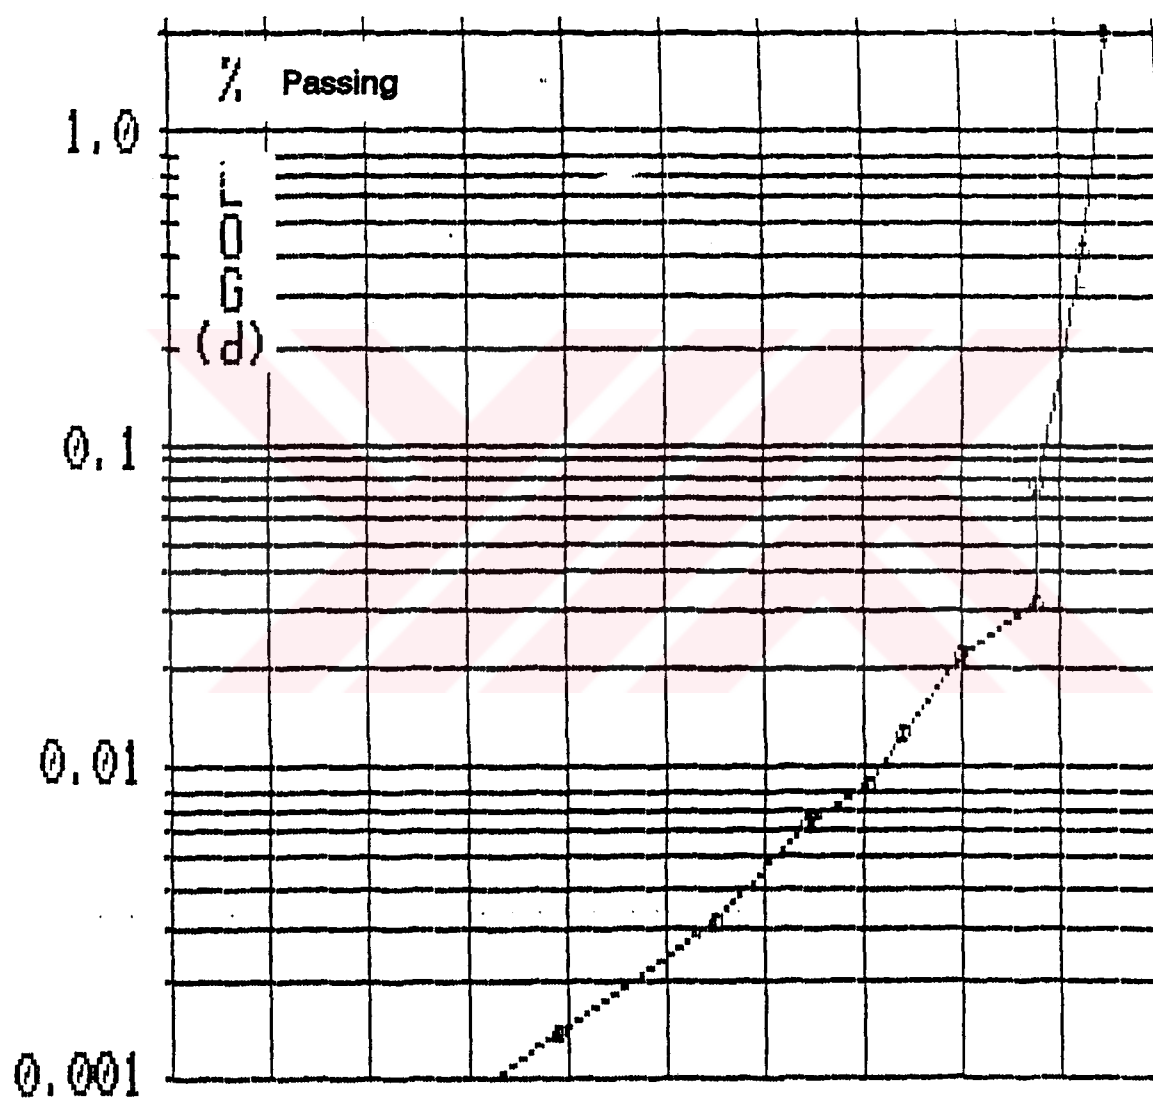
FIGURE A3.3.1 Sieve analysis on sample no.CBR1

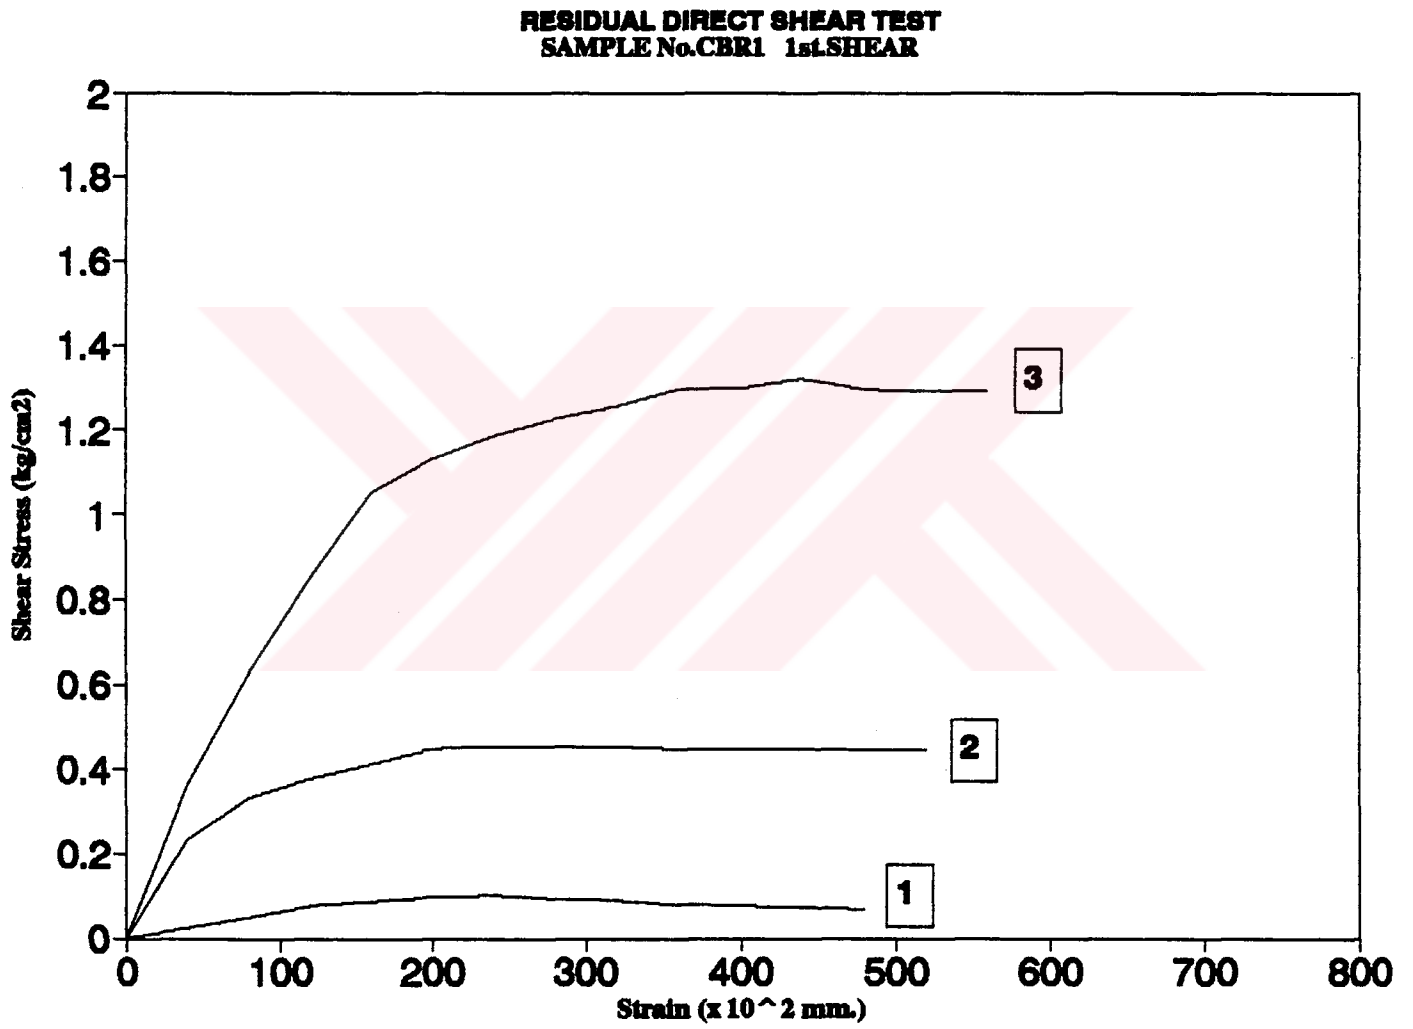
FIGURE A3.3.2 Residual direct shear test

Sample no.CBR1 1st. Shear

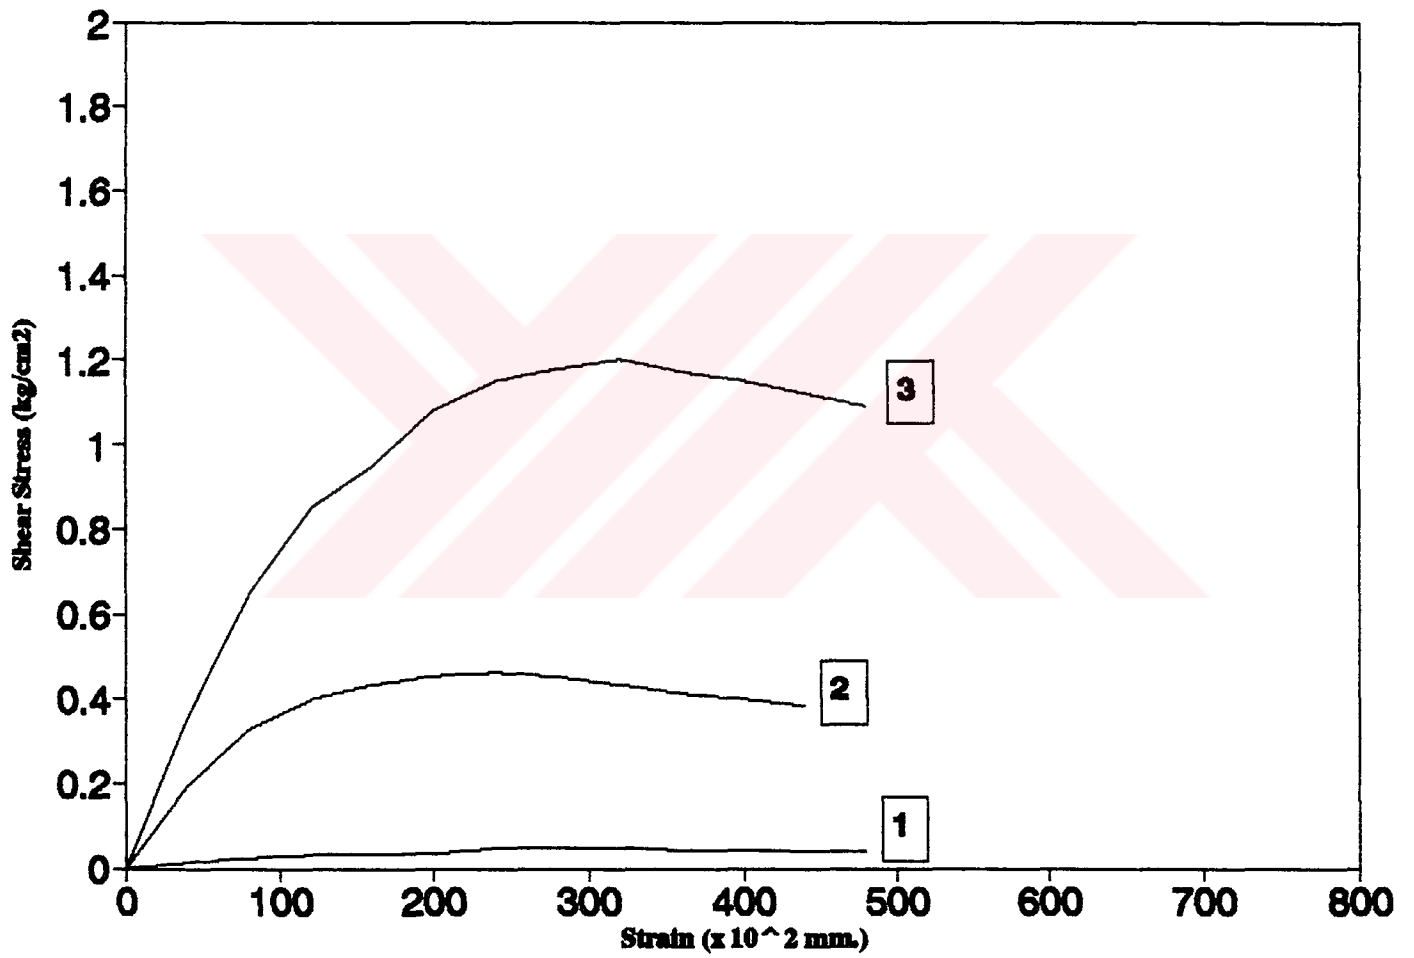
FIGURE A3.3.3 Residual direct shear test

Sample no.CBR1 2nd. Shear

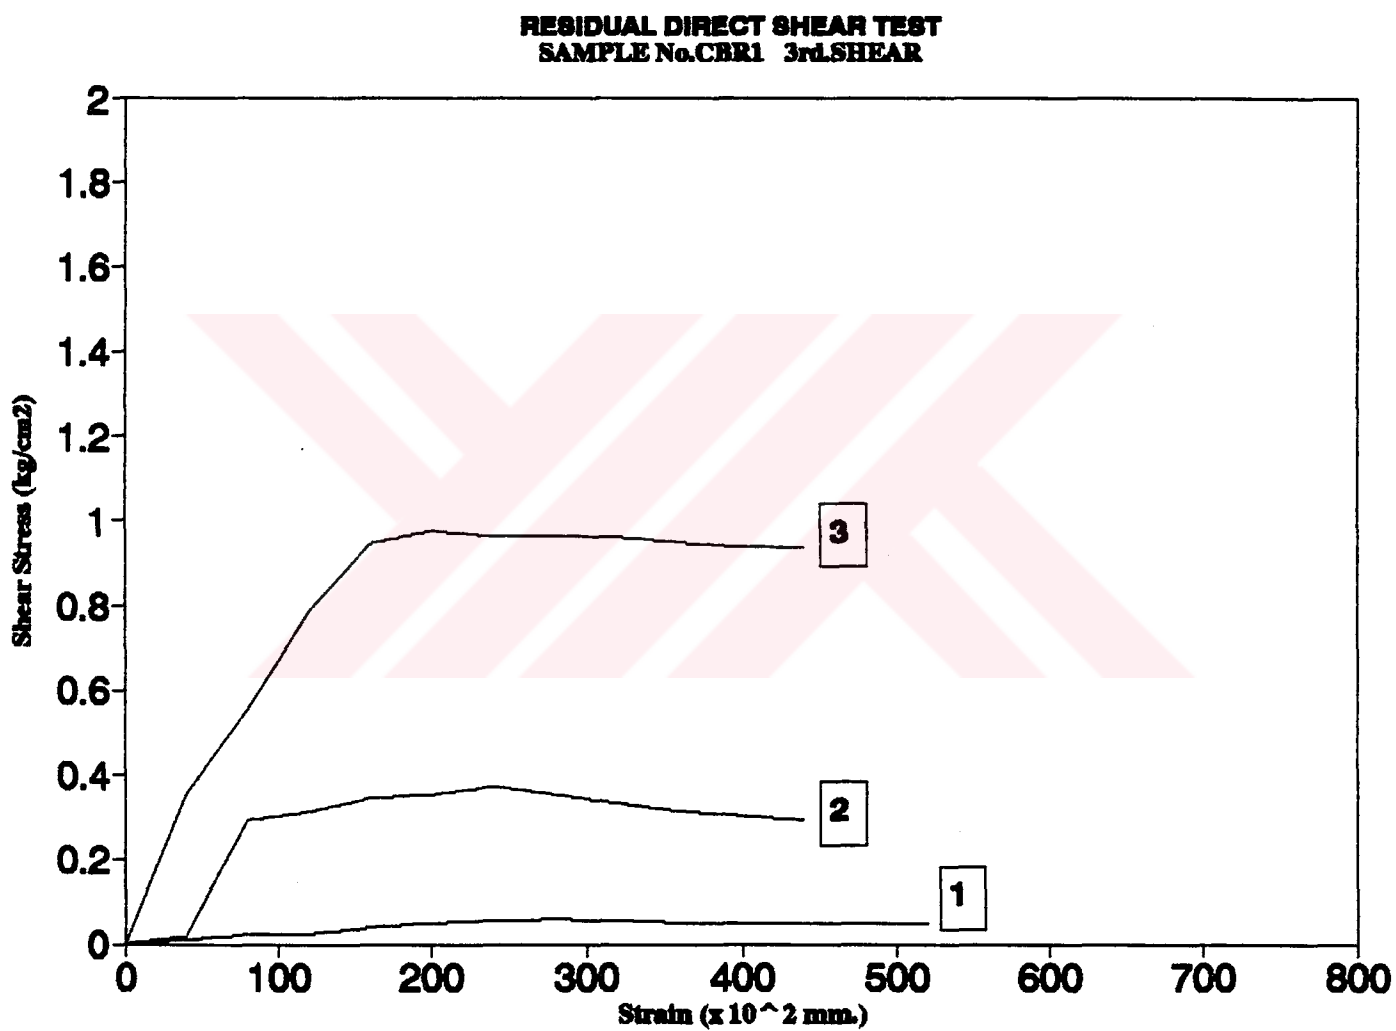
FIGURE A3.3.4 Residual direct shear test

Sample no.CBR1 3rd. Shear

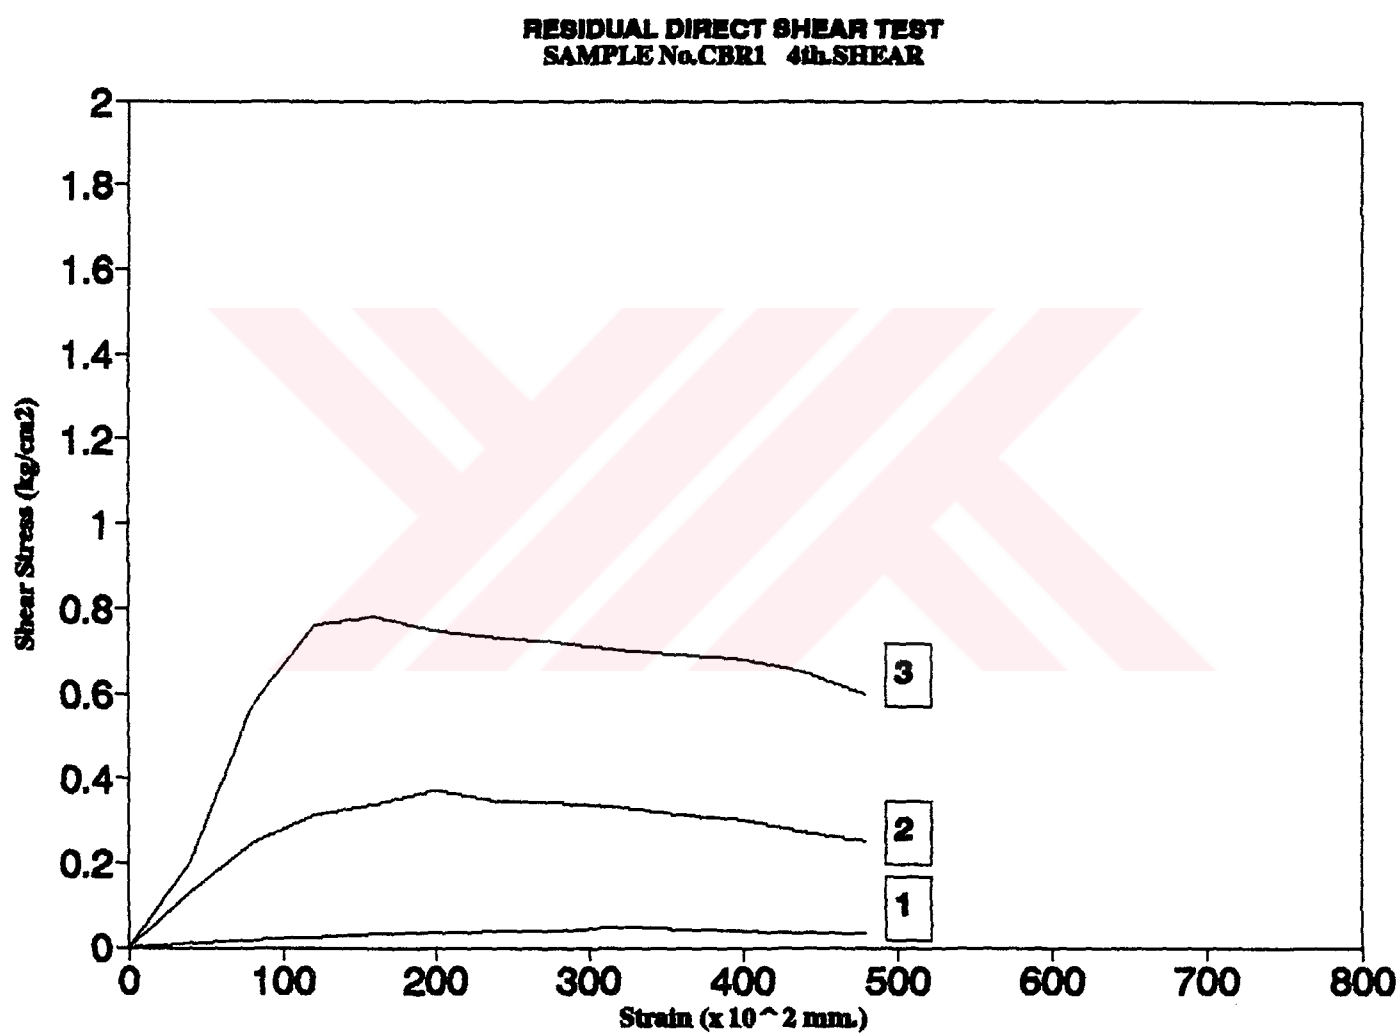
FIGURE A3.3.5 Residual direct shear test

Sample no.CBR1 4th. Shear

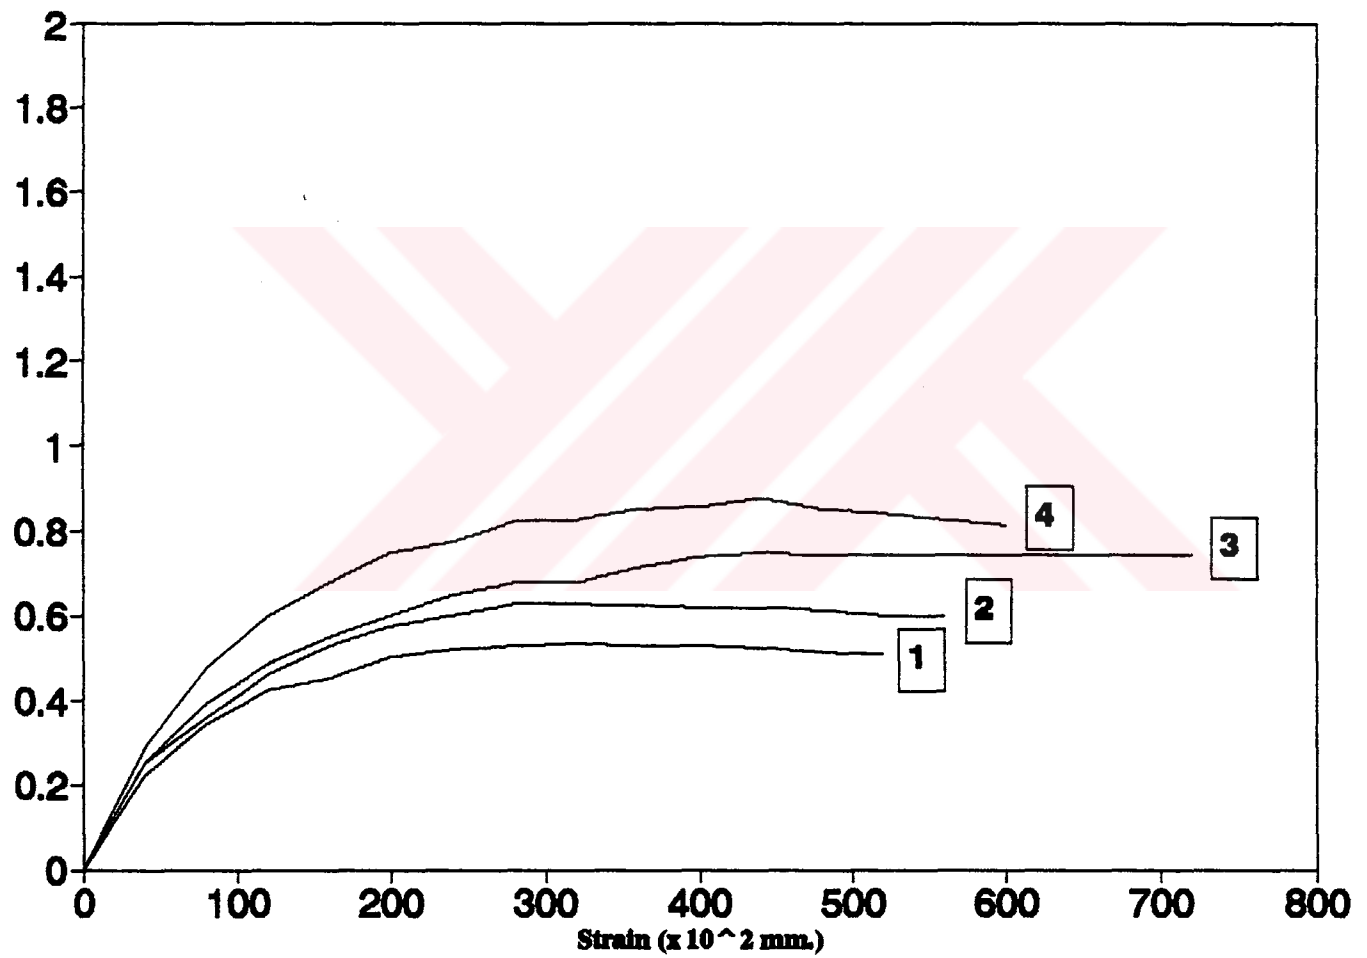
FIGURE A3.4.1 Residual direct shear test

Sample no.CBR2 1st. Shear

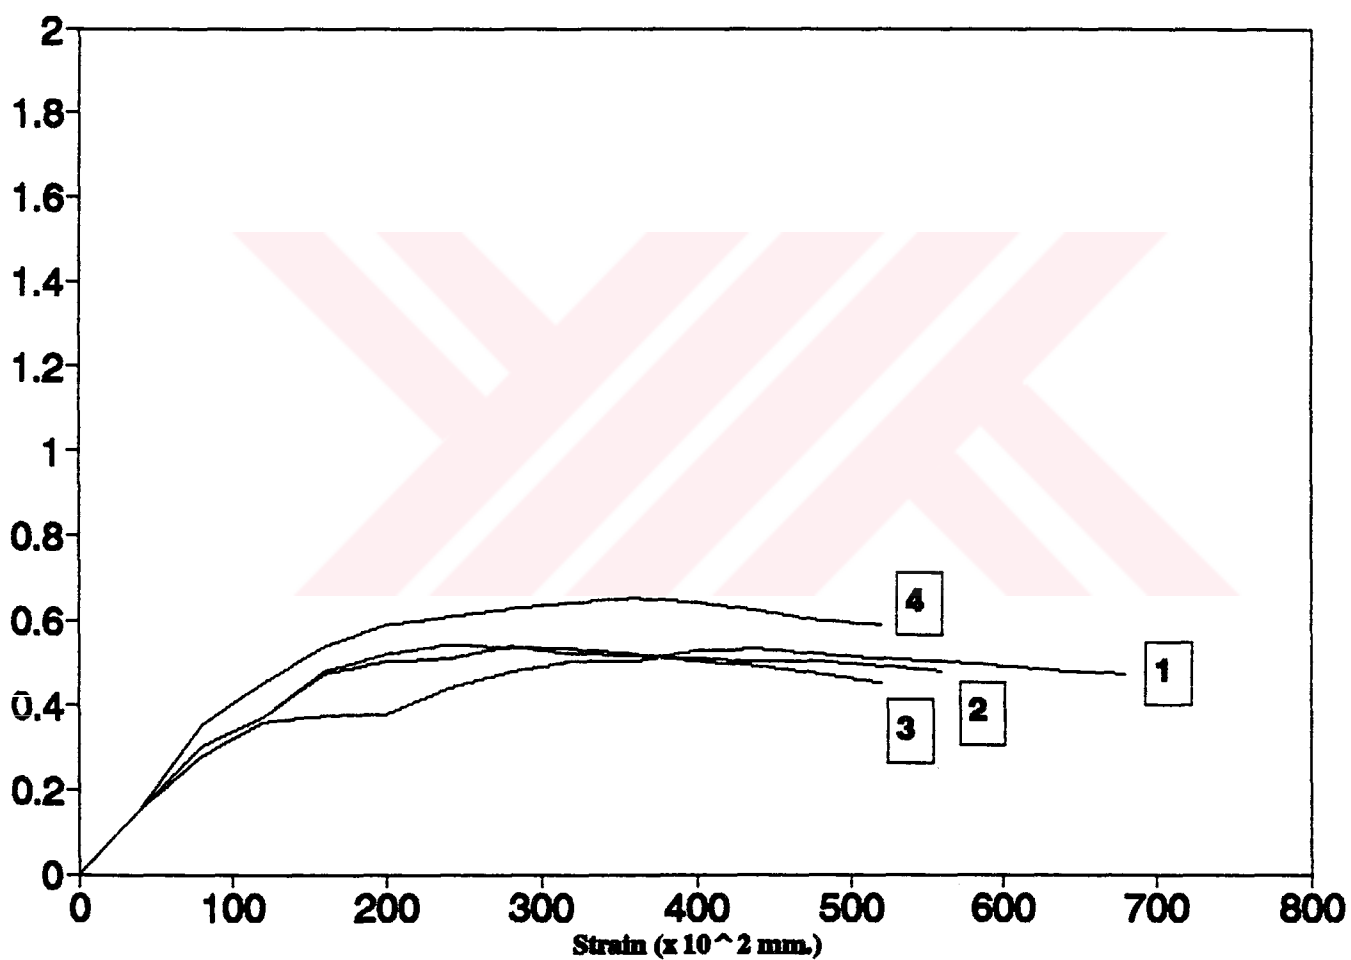
FIGURE A3.4.2 Residual direct shear test

Sample no.CBR2 2nd. Shear

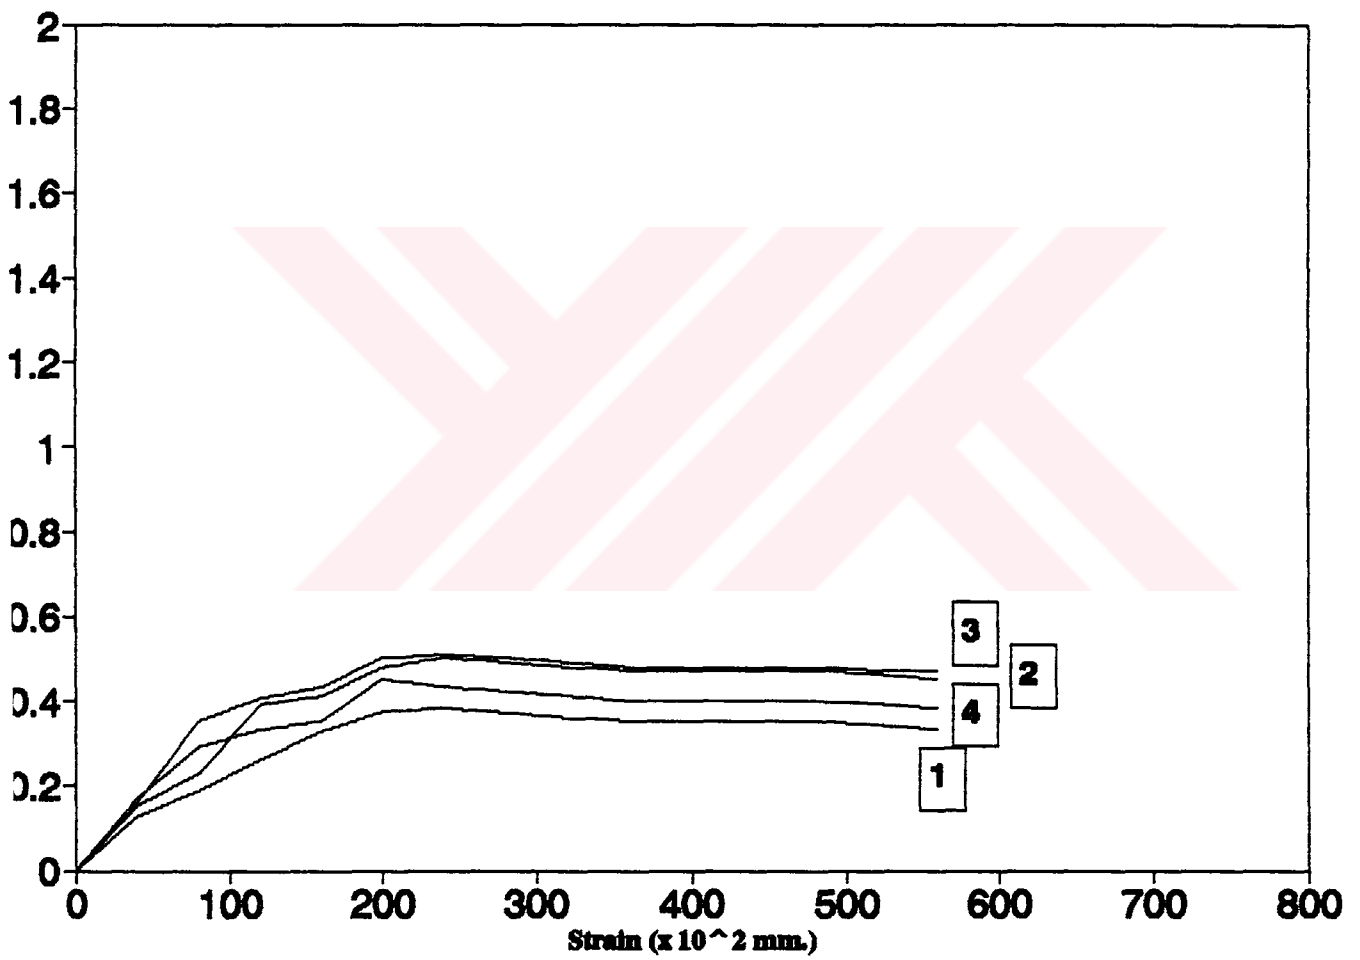
FIGURE A3.4.3 Residual direct shear test

Sample no.CBR2 3rd. Shear
