**MATERIAL ANALYSIS OF HURMAN CASTLE AND  
RECOMMENDATIONS FOR RENOVATION**

**İNŞAAT MÜHENDİSLİĞİ BÖLÜMÜ  
YÜKSEK LİSANS TEZİ**

**GÖKHAN GÜMÜŞBURUN**

**OCAK - 2019**

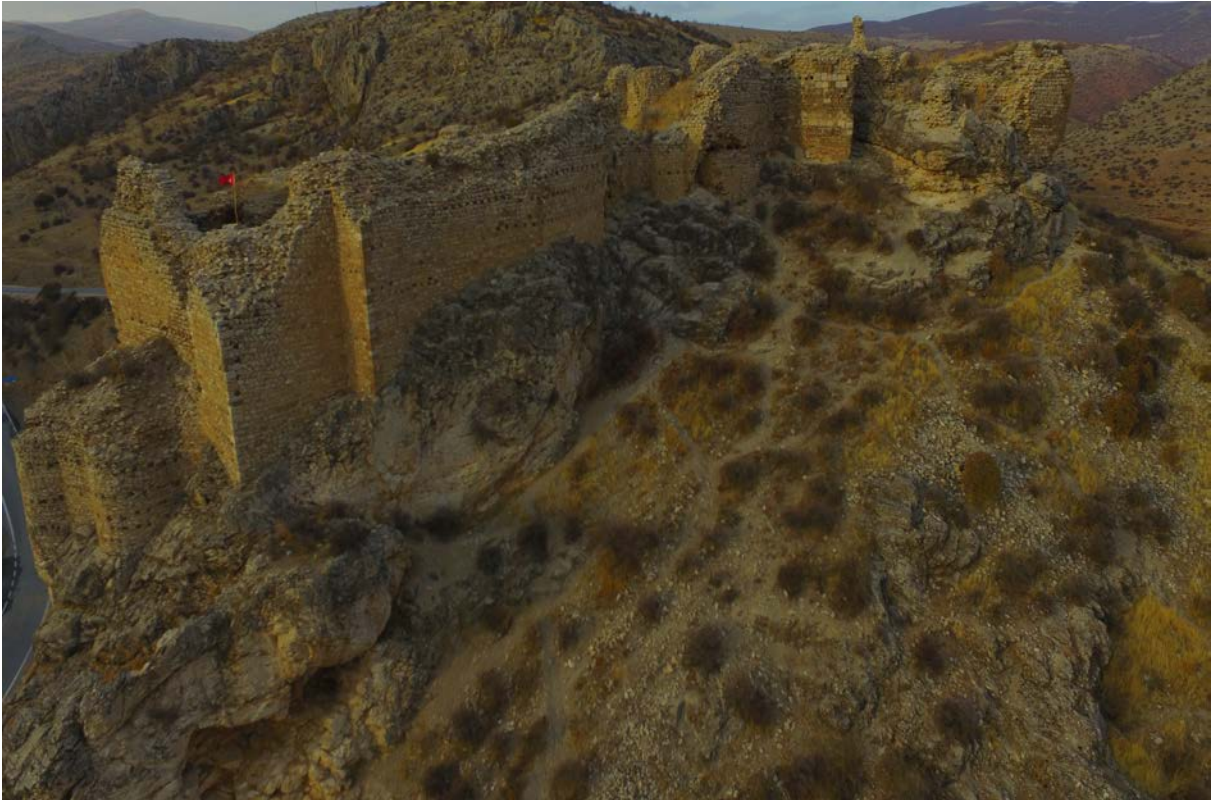
**Photo 5 .** General View of the Southern Front

The fortress has come to our day as a ruin and has been destroyed by treasure hunters. Although the fortification walls of the building are somewhat intact, the interior walls were destroyed. 1318 H / 1900 m . in the saluted city of Aleppo province; An Hurman Fortress is located on a small hill 9 hours away from the Elbistan accident and the Hurman River runs around. This fortress is at an altitude of 50 cubits and estimated at 500 terbata. I Deru in many rooms of transit- time interior walls are walls that I have been around Munha also available. " Chi in the appended is mentioned ( Ottoman Provincial Yearbooks Aleppo , 2012: 357). According to this information , it is understood that the rooms inside the castle were destroyed, but the fortification walls were present. The building was constructed by the Ministry of Culture . It was registered with the decision no. 1284 of 1992. However , no studies have been carried out on the preservation and restoration of the fortress (Photo: 5, 6 , 7) .

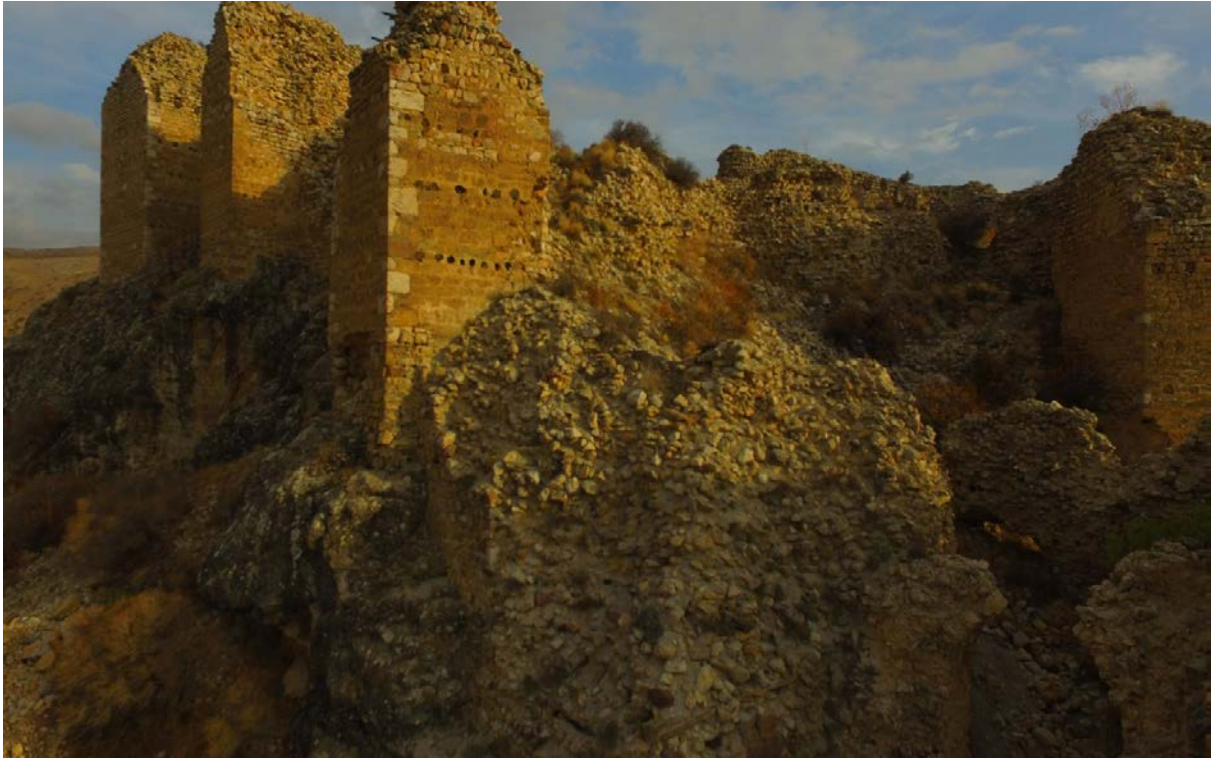
**Photo 8 . Wall of KD 9-10**

The fortress is enclosed by a narrow arched door with a height of 2.20 m and a height of about 5.40 m , reinforced by two bushes of rectangular cross section on the western side of the northern façade (Photo : 8 , 9) .

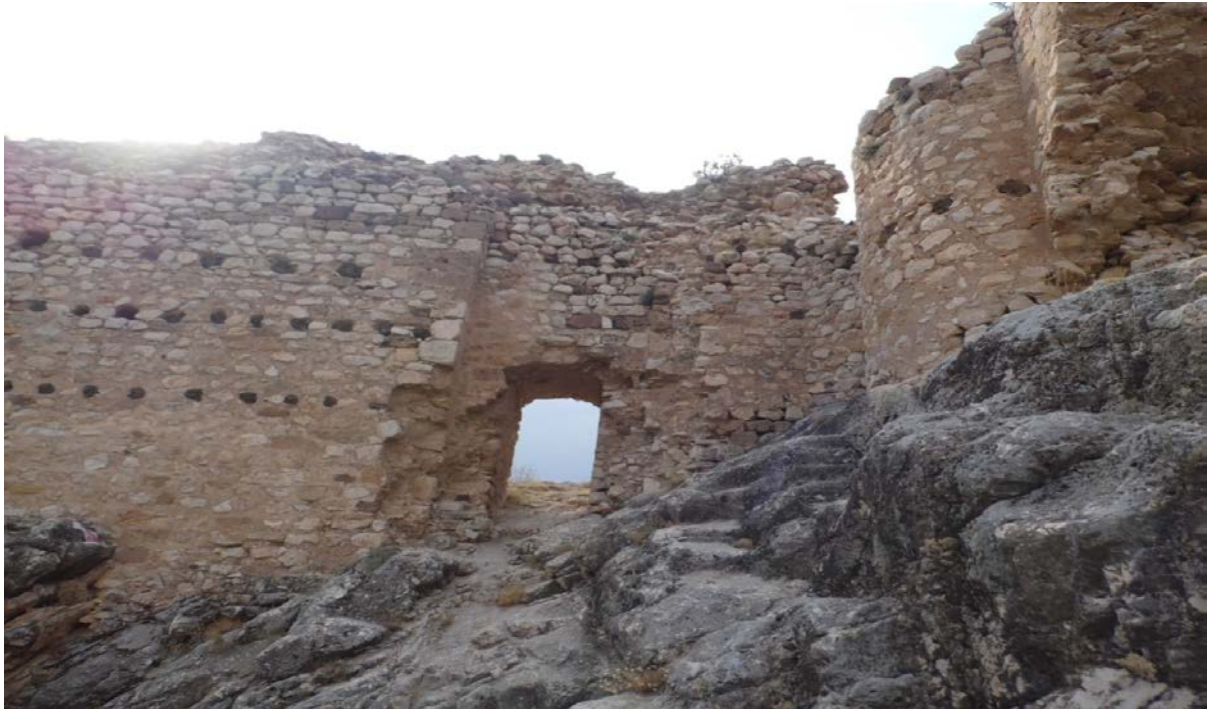
**Photo 10 .** Wall of GD 12-15

But the door was destroyed. In addition, there is a small gate with a lower arch at the southern front, approximately 1.20 m wide and 2.50 m high (Photo: 10, 11, 12, 13).

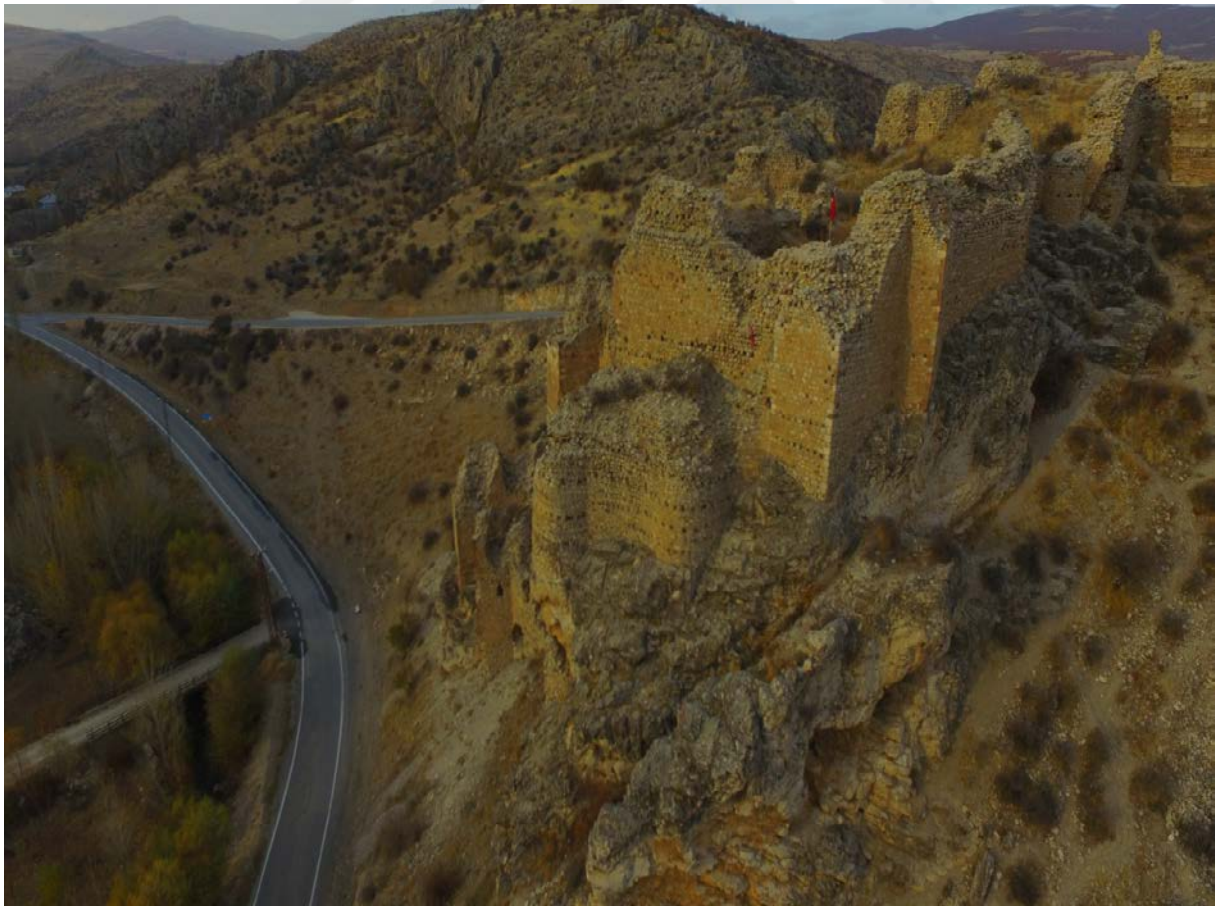
**Photo 14 .** General view of the Western Front

The castle has a magnificent view from the outside. The walls, which were built on an average of 2.70 m , were reinforced with a total of fourteen towers, three from the east and the west, two from the south and six from the north . The bushings, whose widths range from 3.00 m to 7.20 m and are made in different sizes , are constructed as triangles, three as semicircles and ten as rectangular sections. The fortification walls were reinforced with a total of fourteen towers , three on the east and west, two on the south and six on the north . Bushes from the walls of 0.58 m to 6.55 m between protruding outwards. also Because of the topographical structure of the rocky hill, the fortress walls are gradually reinforced by a double row of towers that rise gradually as the castle is attacked by the north and west sides . The upper walls and the upper part of the bushes were destroyed and the height of the existing bushes ranged from 5 m to 12 m . The wooden walls in the bastions with the walls of the walls of the bastions and the walls of the bastions have not survived. Because the upper parts of the bushes were destroyed, some of them were filled with stone and soil (Photo: 14 , 15 , 16 ).

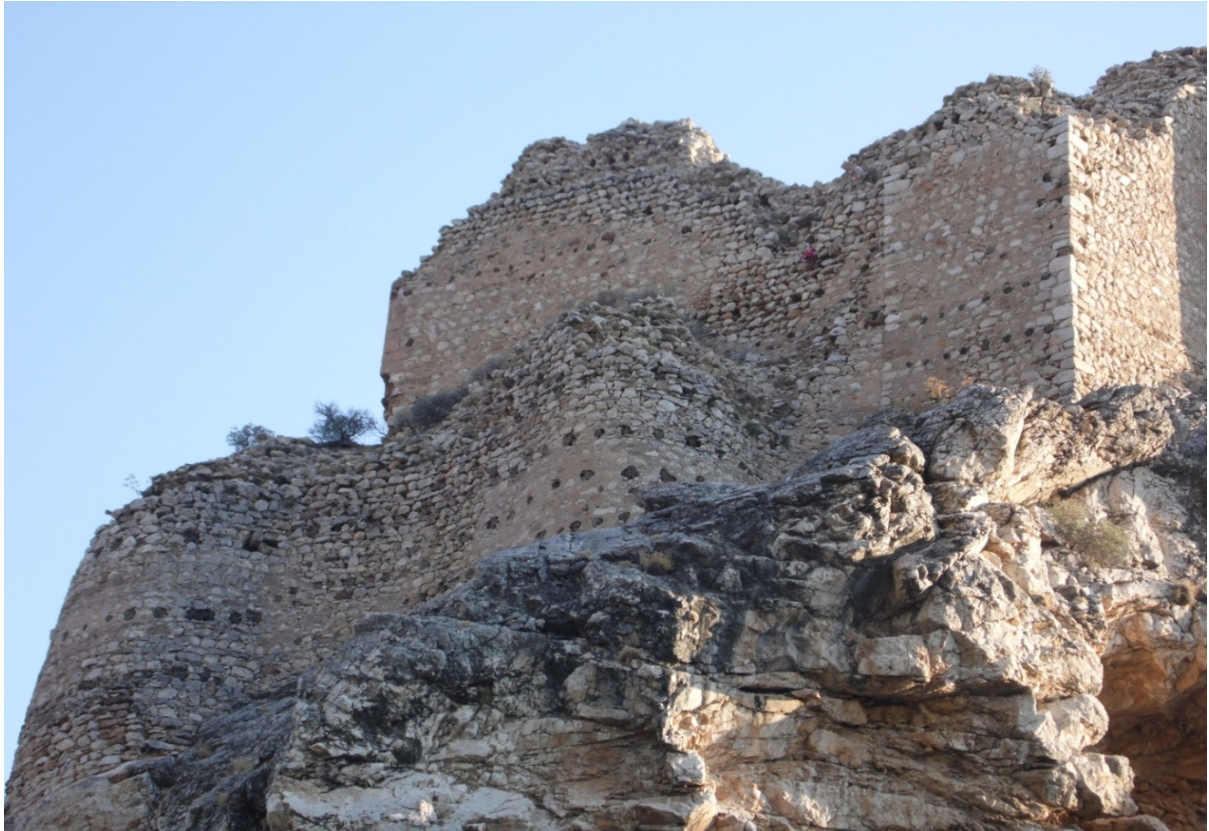
**Photo 28 .** BDU 1-3 BD 1-2-3-4-5

The Western Front is shaped according to the rocky area where the topographic structure of the hill is used well and the rocky walls are used as the two walls. From the north-west direction, in the lower body of the building, it is a square-shaped bush, approximately 4.94m.x4.49 m. The upper part of the sign is completely destroyed. As a material, rubble and lime mortar were used. The outer surface of some parts of the bush is covered with finely cut, smooth cut stones. There are two rows of wooden beams in the structure . The remains of the remains are collapsed from the base and the upper part and the material is rubble stone and lime mortar as in the whole fortress structure. wall On the surface of the wall, shiny smooth cut stones are found. There are two large openings in the main section and the middle section on the wall remains . From the foundation wall of the wall of the three wooden timber draws attention. In the northern part of this wall is a crib arched door opening with a width of 1.98 m . Rubble stones on the surface of the door have been poured, and there is a loophole of 0.31 m x 0.32 m in the west direction of the door . The fortification walls of the fortress entrance were destroyed to a large extent. In this section, rock mass is seen. Ruined fortification walls at the base level of rock mass continues in the upper part of 1:35 m x 1.63 m in dimensions to a large opening is observed. In the continuation of the rock mass, as can be seen from the material, approximately 10.00 m long masonry is observed. On the wall, a circular opening and the subsequent wall weave system are seen to have collapsed from the upper section. In this section, the rock cave formed a space. This venue is still the continuation of the rock mass as a whole, we see that

opening is another square with a size of 1.07 x 1.45 m . According to the topography of the rock mass, the walls continue to break inward and end in the south . From the point of its breaking, the fortification wall is 2.58 m wide and 16.65 m long. Although the wood surface is seen in three rows on the wall surface, the continuity of the wooden beams along the surface is not seen. 1.11 m on the wall x 1:48 There is an opening near the square where m is less than 0.30 x A further opening of 0.32 m is seen. The upper part of the fortification is completely destroyed, but as the castle structure, The material repeats the material seen in the entire fortress structure (Photo: 28, 29, 30, 31, 32, 33, 34, 48, 49, 50, 51).

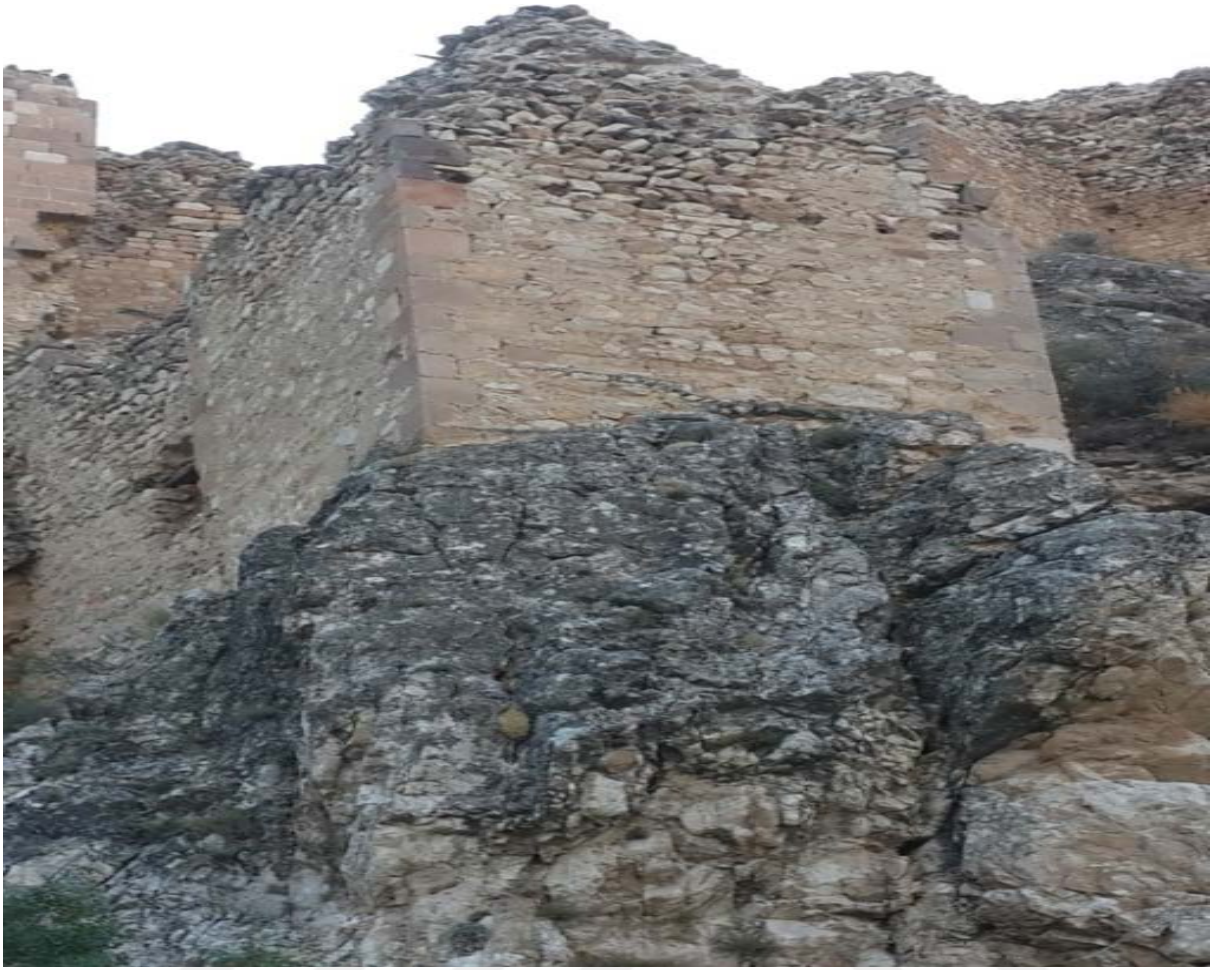
**Photo 44.** BD 11

Starting from the north-west direction, in the upper body, it is seen that the structure of the tower, which has a shiny smooth cut stone with a square plan located on the rock mass, is seen as being collapsed. Located inside walls made of dođru4.36m.girint continue on and near the square 0:55 m x 0.70 There is an opening in dimensions m . Afterwards, the fortification walls were completely demolished and the walls of the walls continued to the south west direction . Again in this direction, two round towers are observed by following the shape of the rock mass . The tower structures, which were largely demolished, are a continuation of each other. The first of the cylindrical towers is 5.72 m in length and 5.60 m in height and 4.28 m in length and 6.78 m in height . Building walls horizontal The four-storey wooden siding placed in it is noticeable. Although rubble stone and lime mortar is seen as a knitting system , in some parts thin cut stones are seen. The upper part of the cylindrical towers completely collapsed and consists of rubble and bushes (Photo: 45, 46, 47 ) .

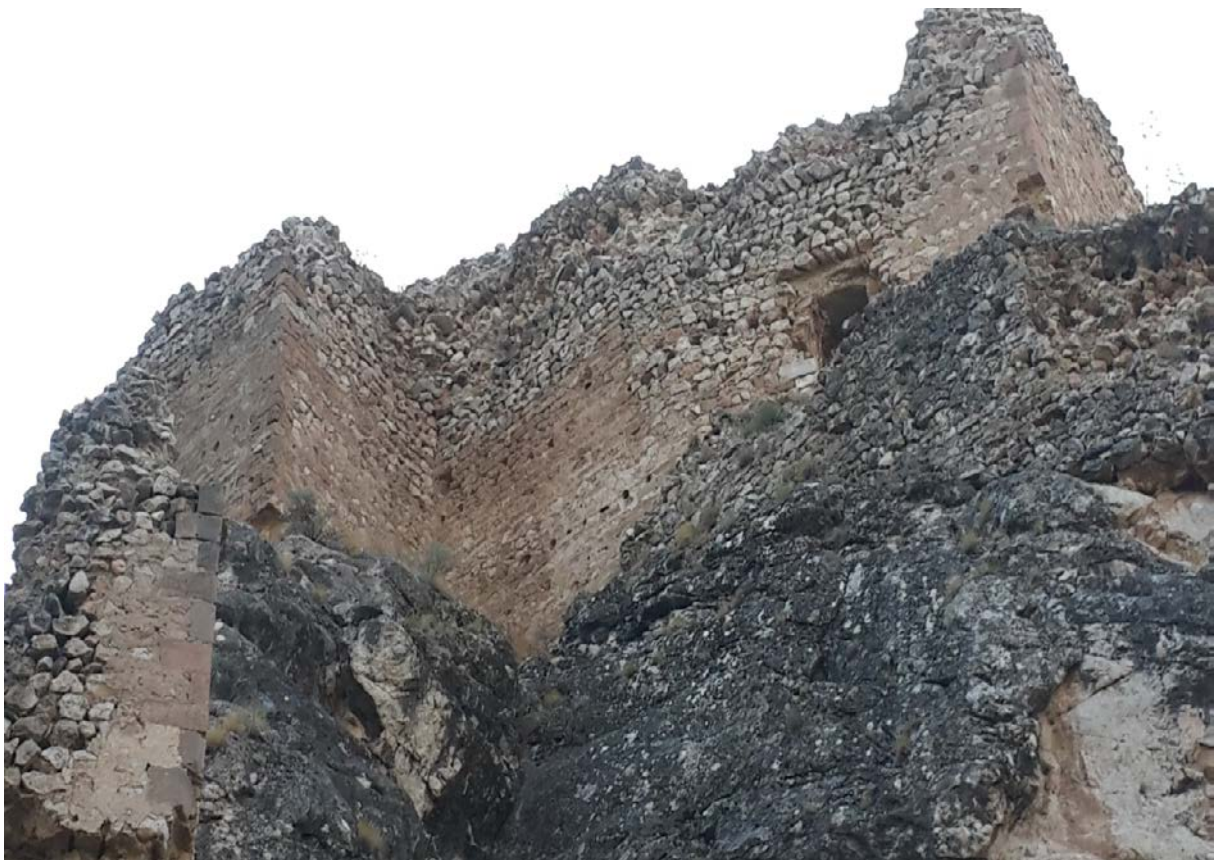
**Photo 48.** BDU 4-5-6

The western wall of the sign with a square plan is located in the north. The upper part of the bush is completely destroyed. 5.76 m in size, as material, rubble stone and lime mortar used. The outer surface of some parts of the bush is covered with finely cut, smooth cut stones. Smooth cut stones appear to have been cast in place. There are two rows of wooden beams in the structure . There are heaps of stones in the structure. This shows us that the structure continues in the west direction. The building continues at the end of the rubble stone piles . 4.93 remnant space between two m ' is. In the rock mass where more planned according to the shape, the frame structure for a bush-shaped 4:41 x 4:49 m in size structure of the upper portion are extant. Burcun construction material across the castle used as rubble stone lime mortar and bright cut stones on the outer surface. It is seen that the walls were destroyed in places. In the upper body of the structure , a row of wooden beams is seen. There is an opening of 0.32 x 0.34 m near the square in the north direction of the sign structure . In the upper part of this

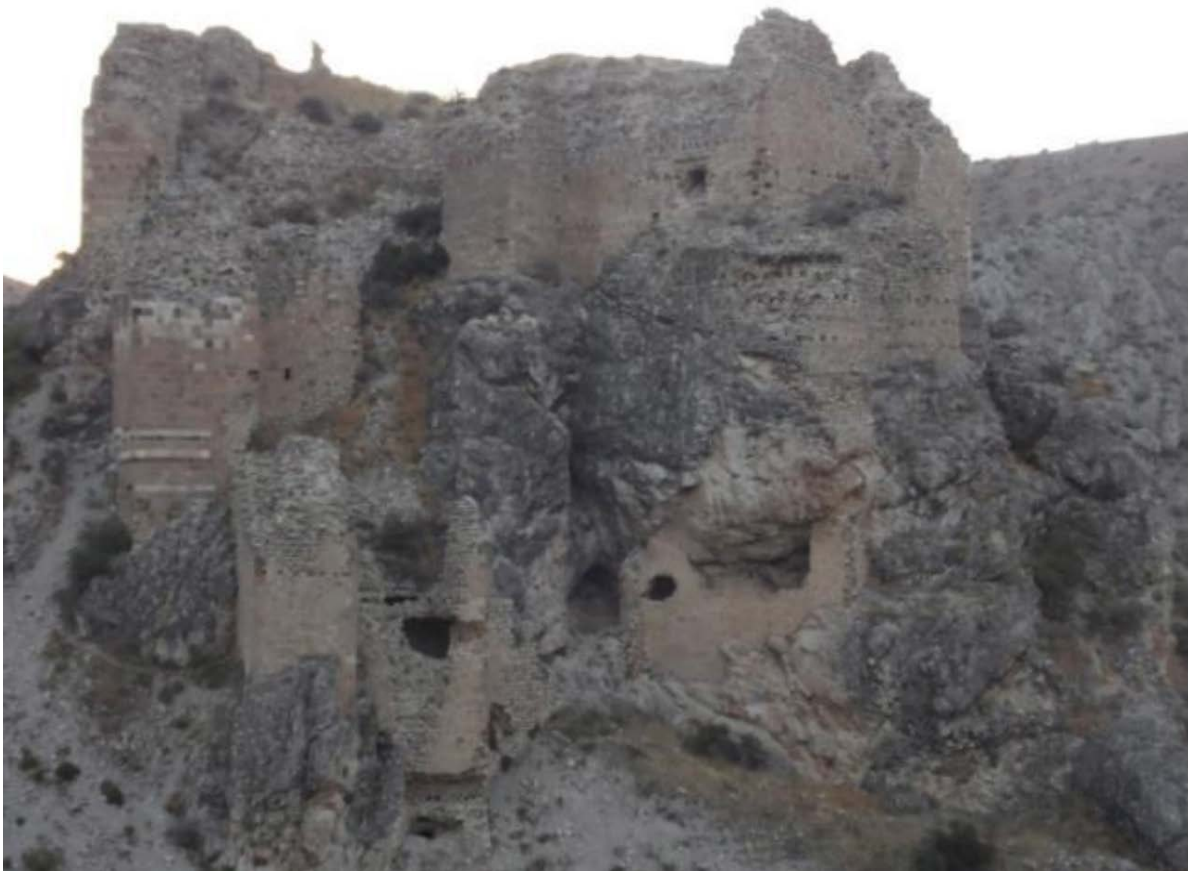
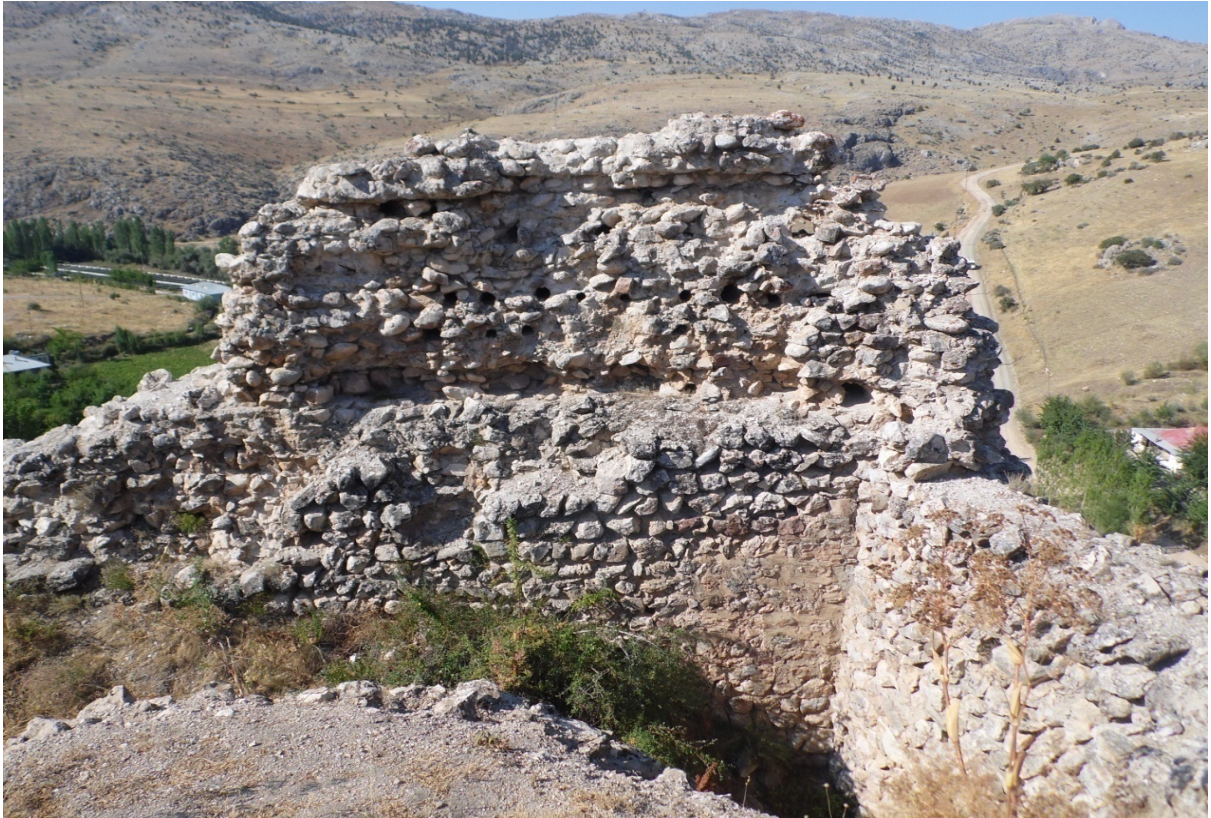
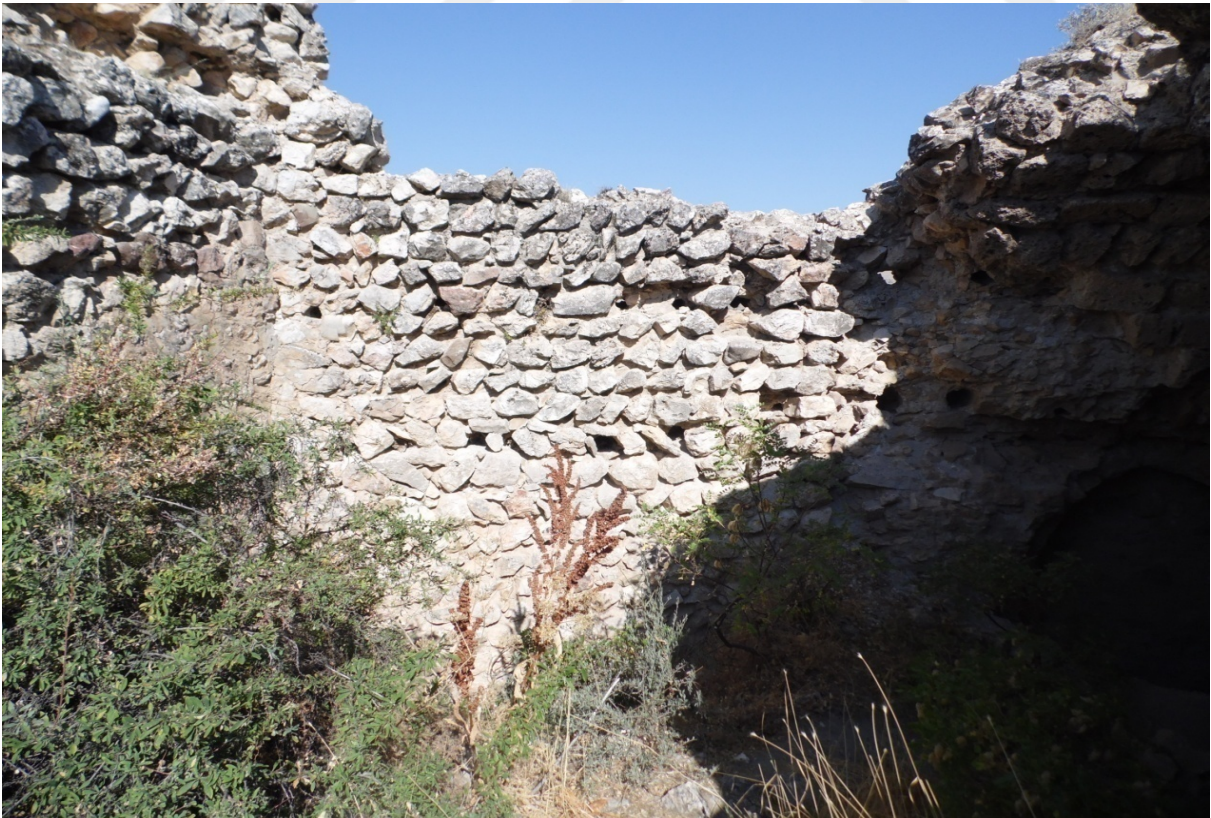
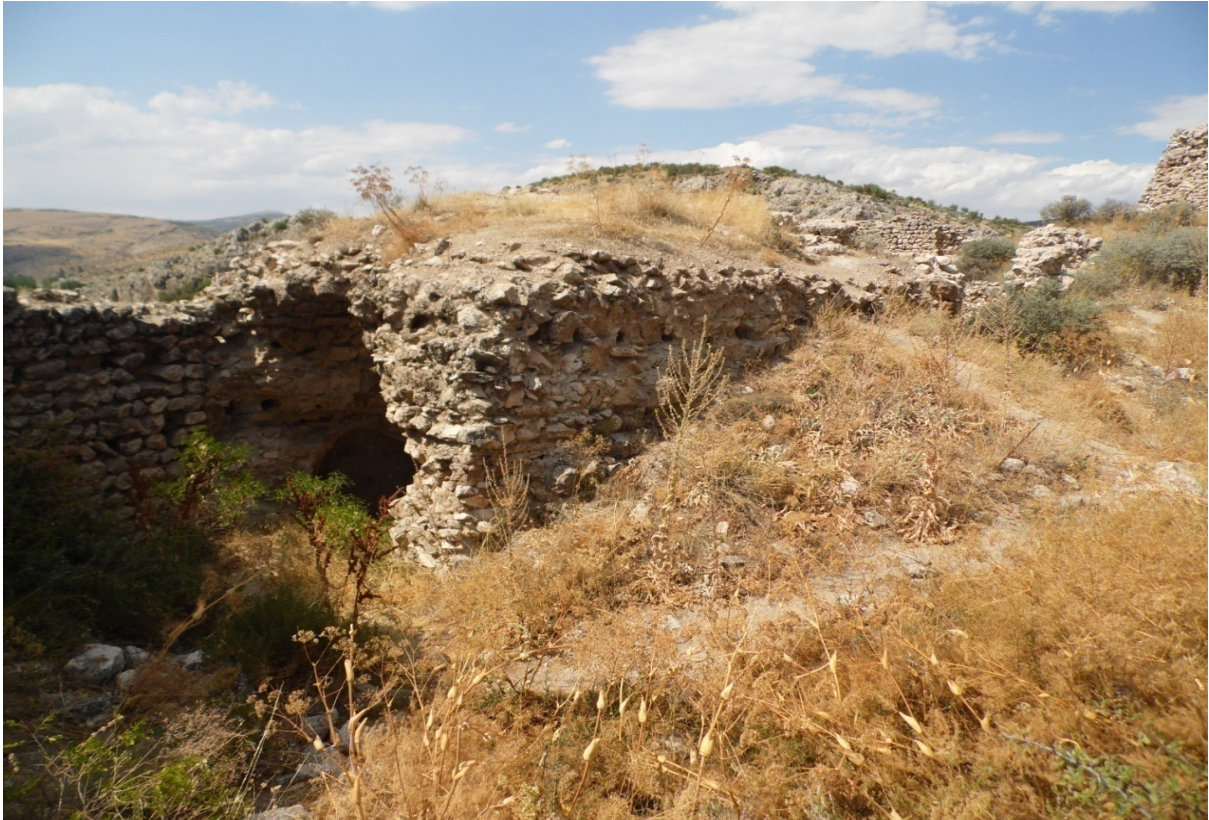
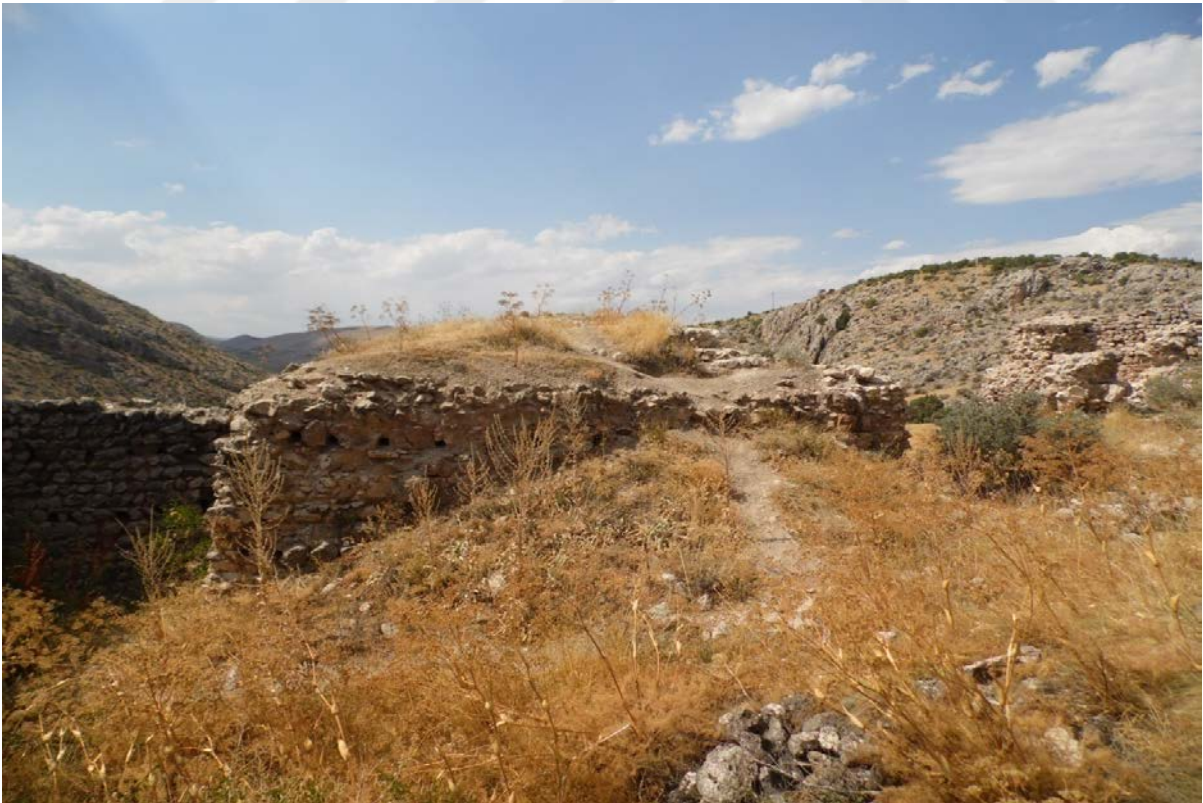
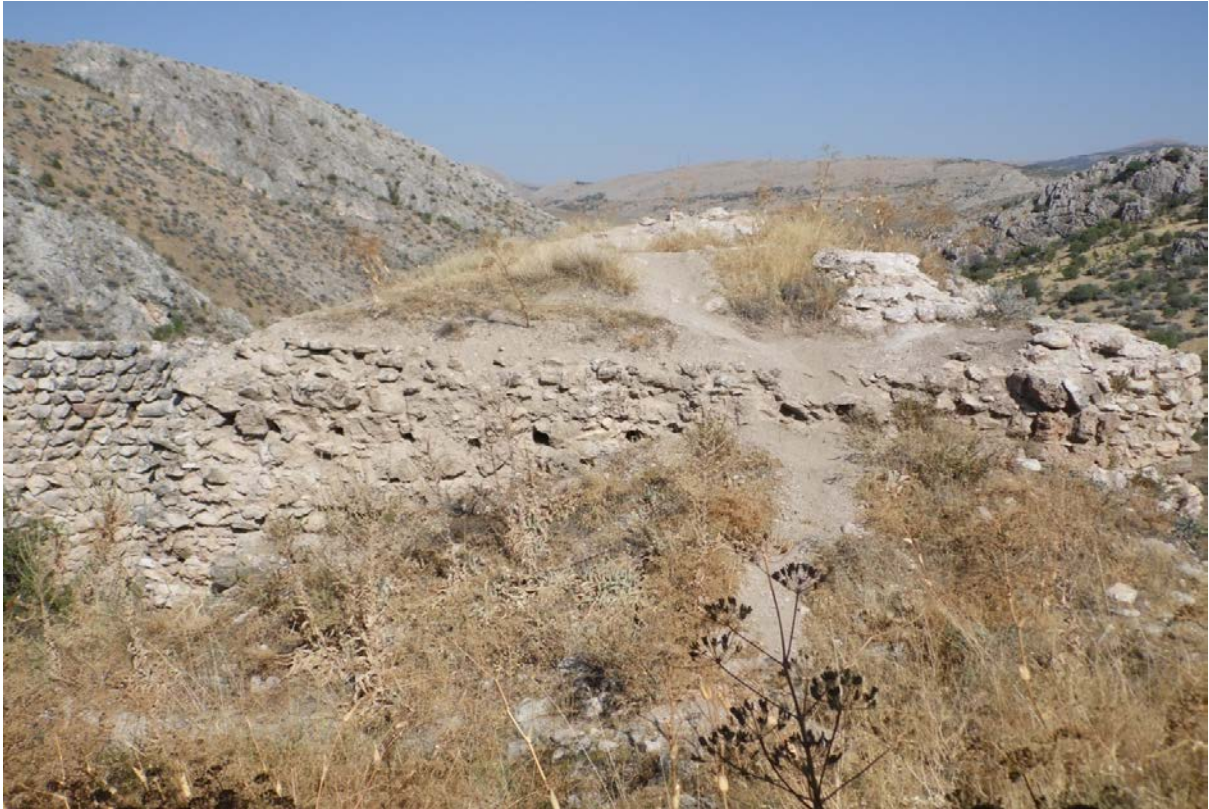
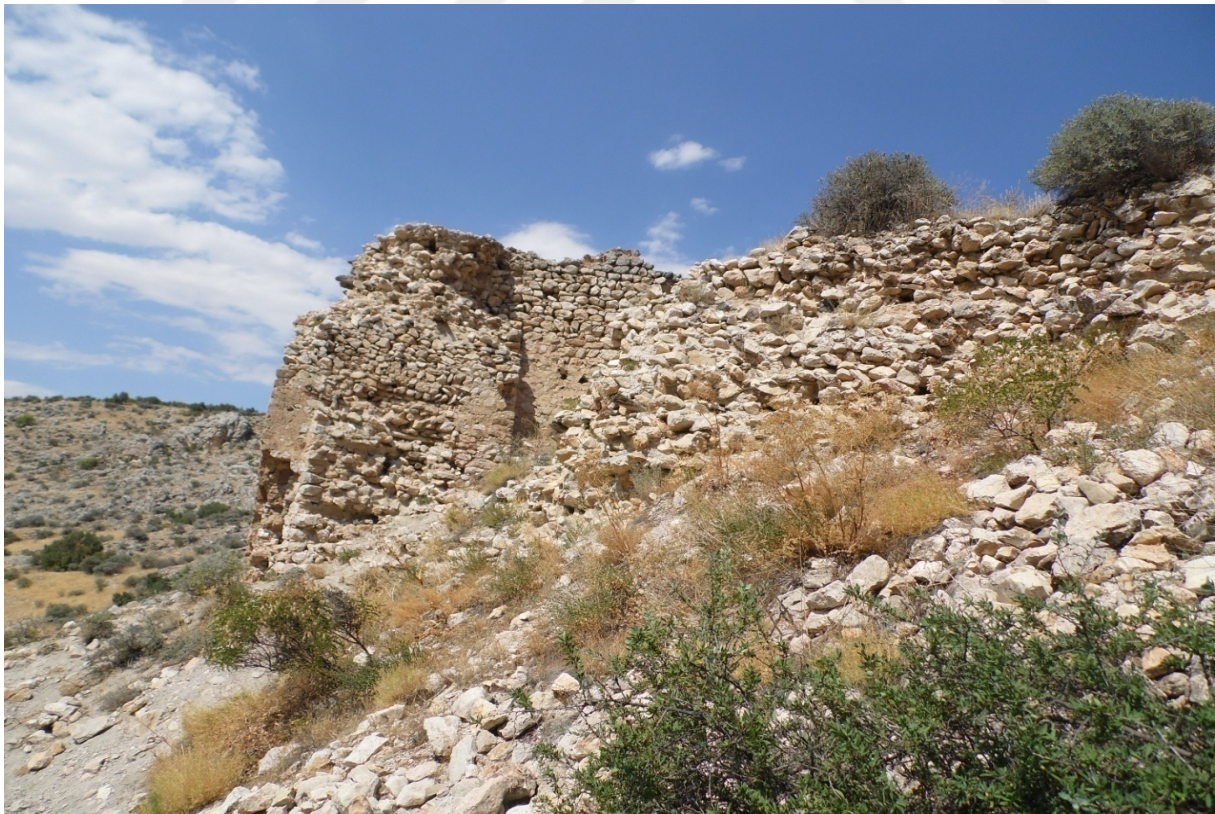
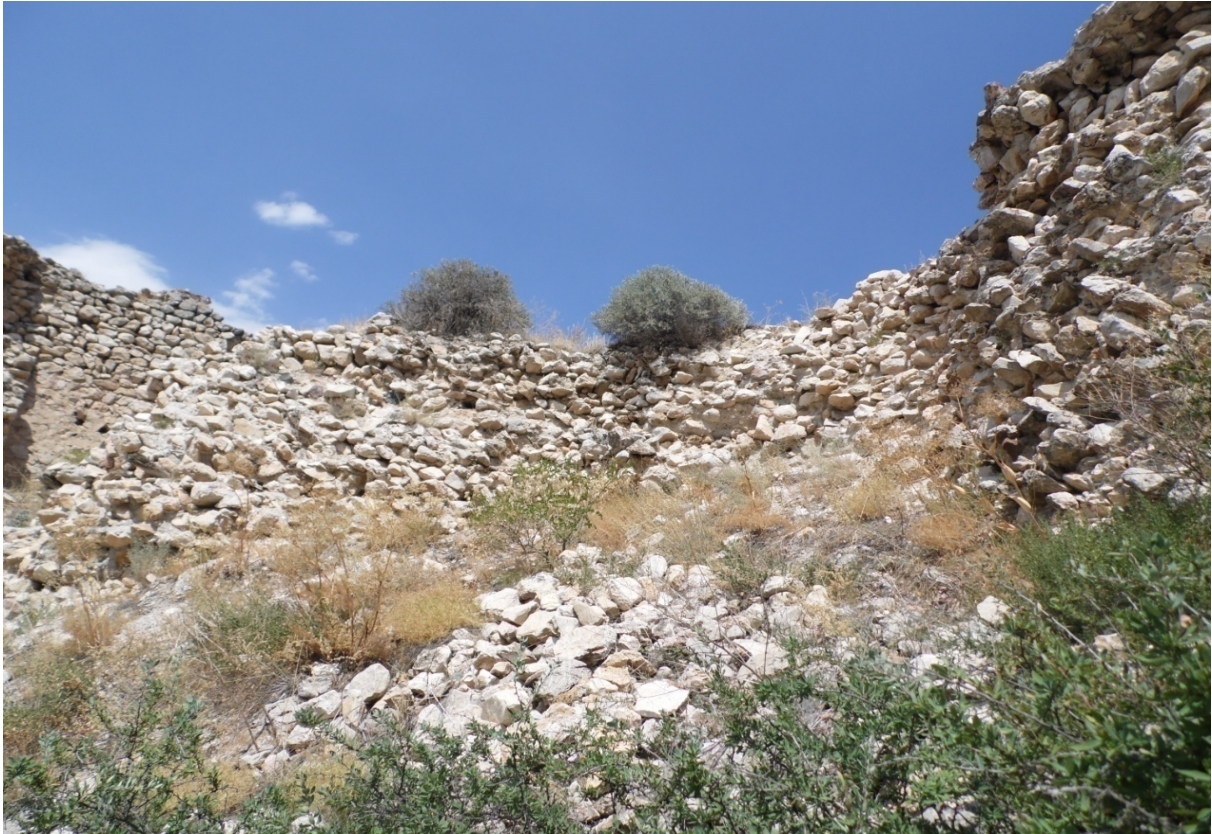
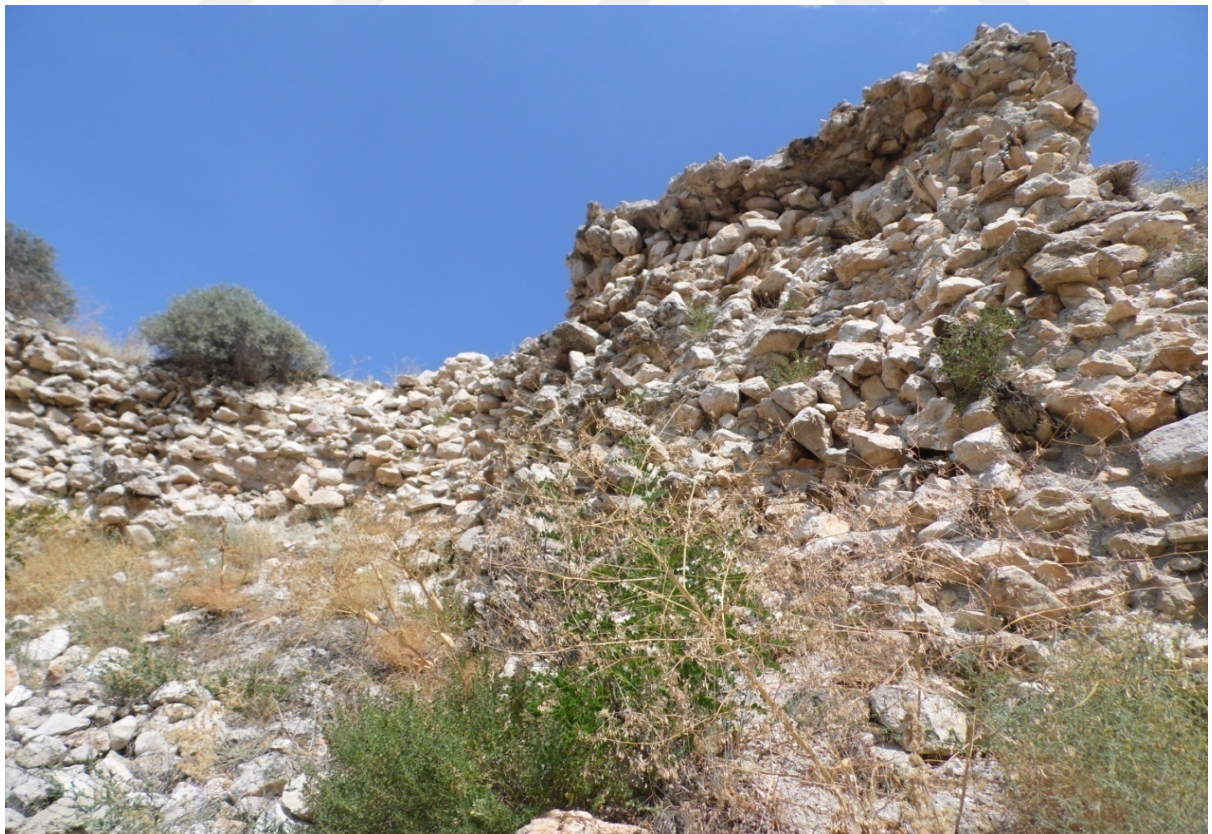
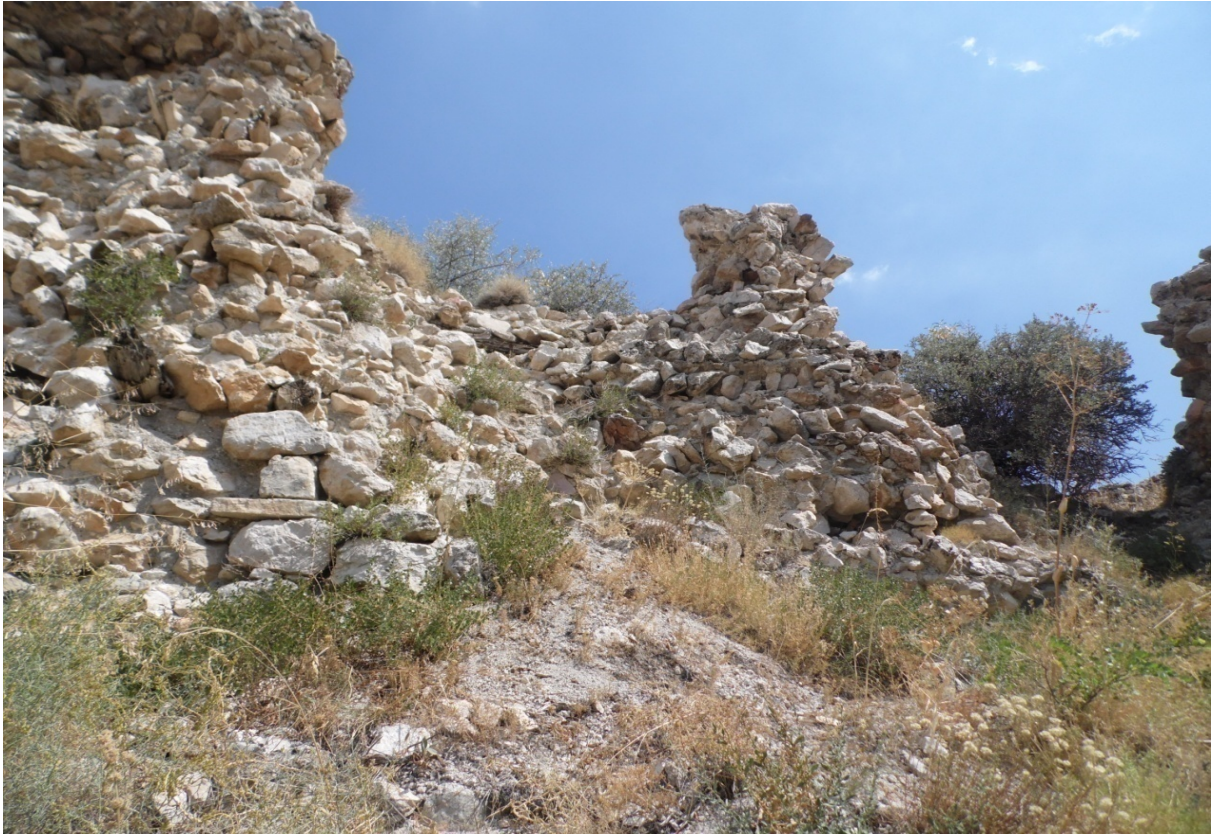
The inside of the building is filled with rubble and rubble stones poured from the structure and thus the ground is raised. There is not much information about the interior space because it is filled with rubble pile inside the bushes on the western front. The ruins of the walls, which are thought to be inside the fortress, appear in places within the castle. In the construction of the places inside the fortress, rough roughing and rubble stone were used (Fig. 4, Photo: 52, 53, 54, 55, 56, 57, 58, 59, 60, 61).
