**MATERIAL ANALYSIS OF HURMAN CASTLE AND  
RECOMMENDATIONS FOR RENOVATION**

**İNŞAAT MÜHENDİSLİĞİ BÖLÜMÜ  
YÜKSEK LİSANS TEZİ**

**GÖKHAN GÜMÜŞBURUN**

**OCAK - 2019**

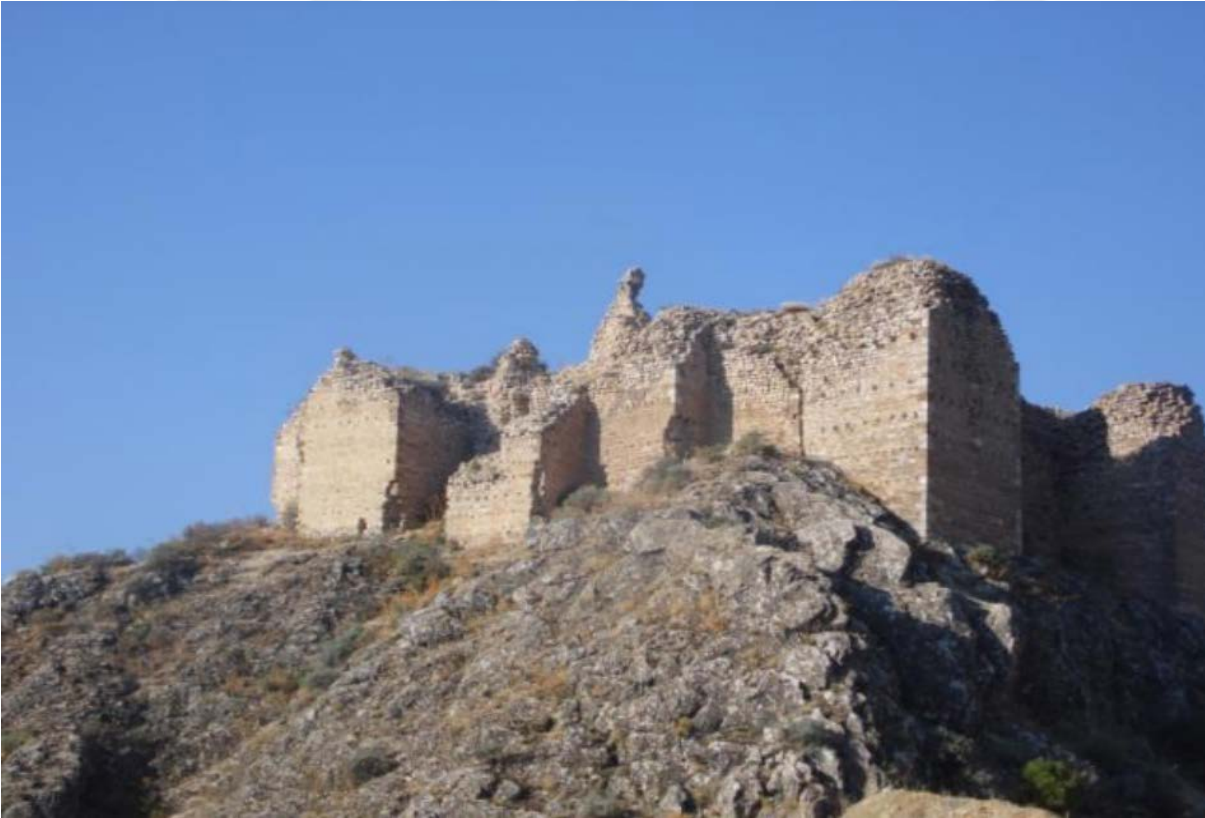
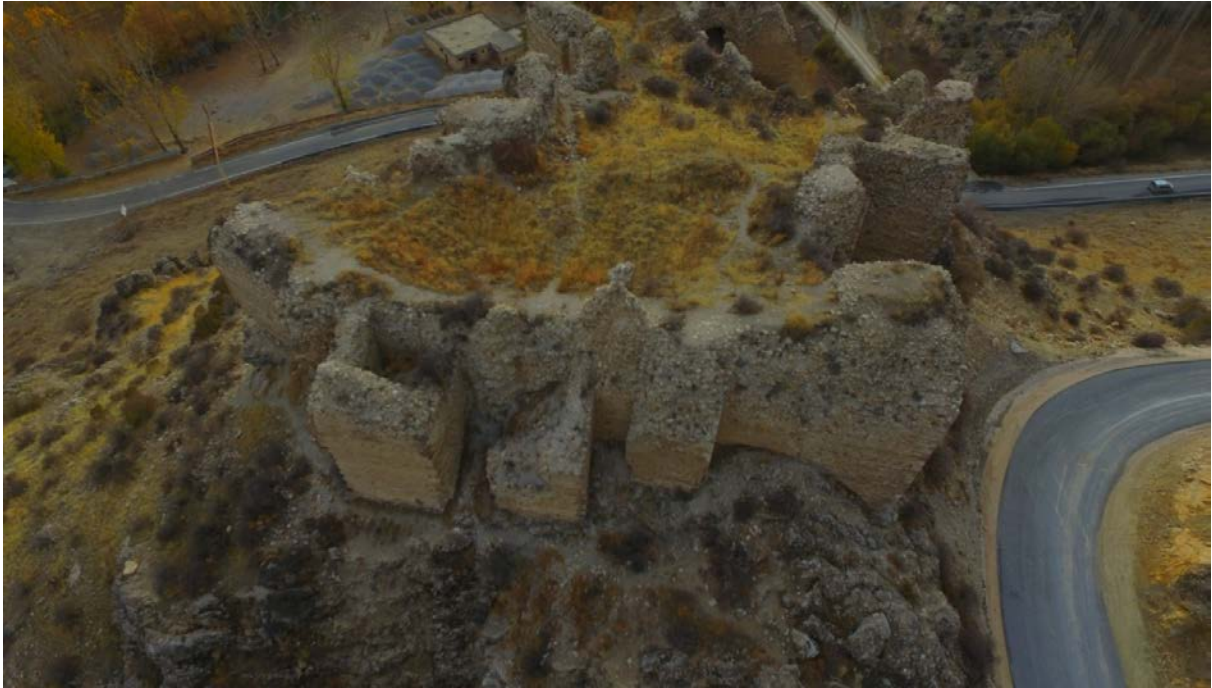
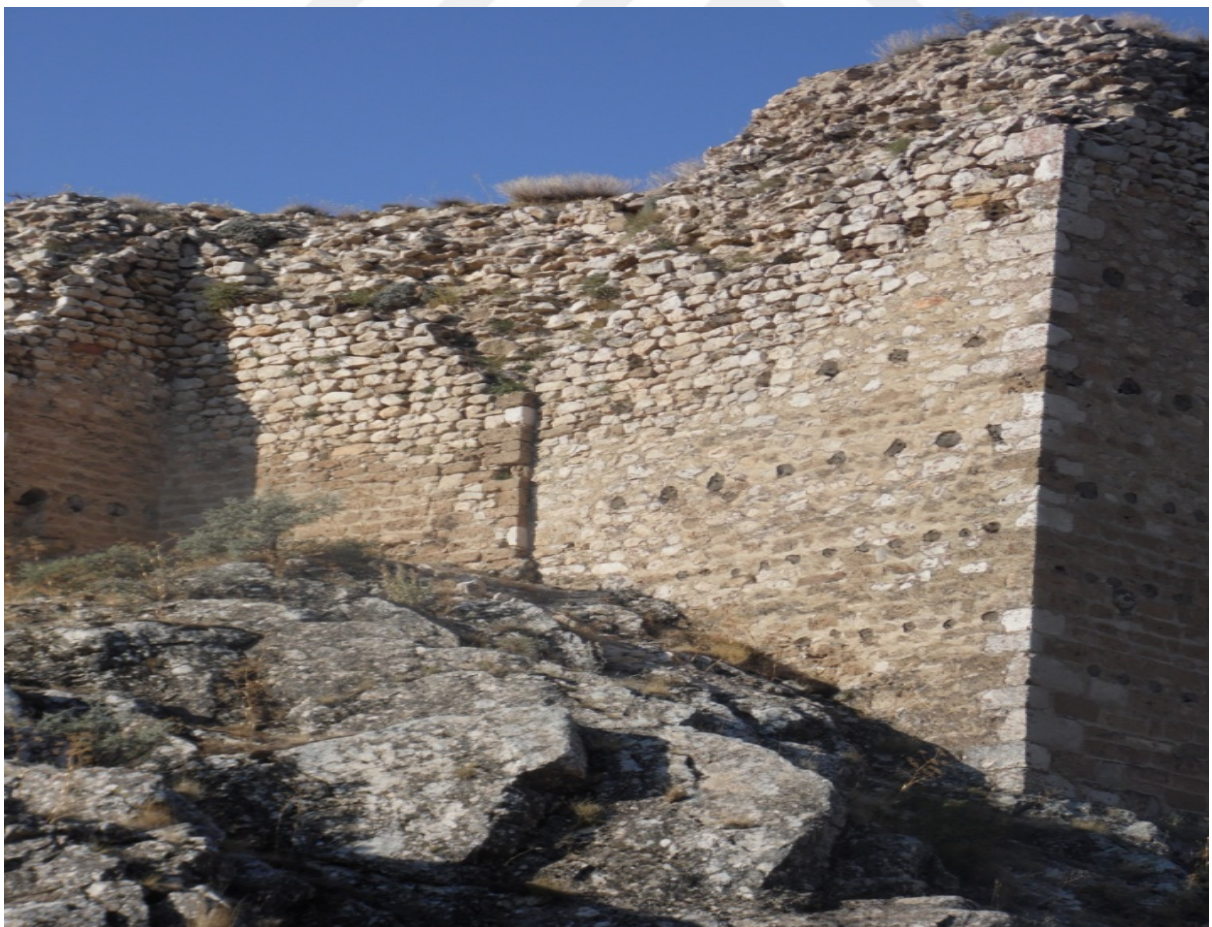
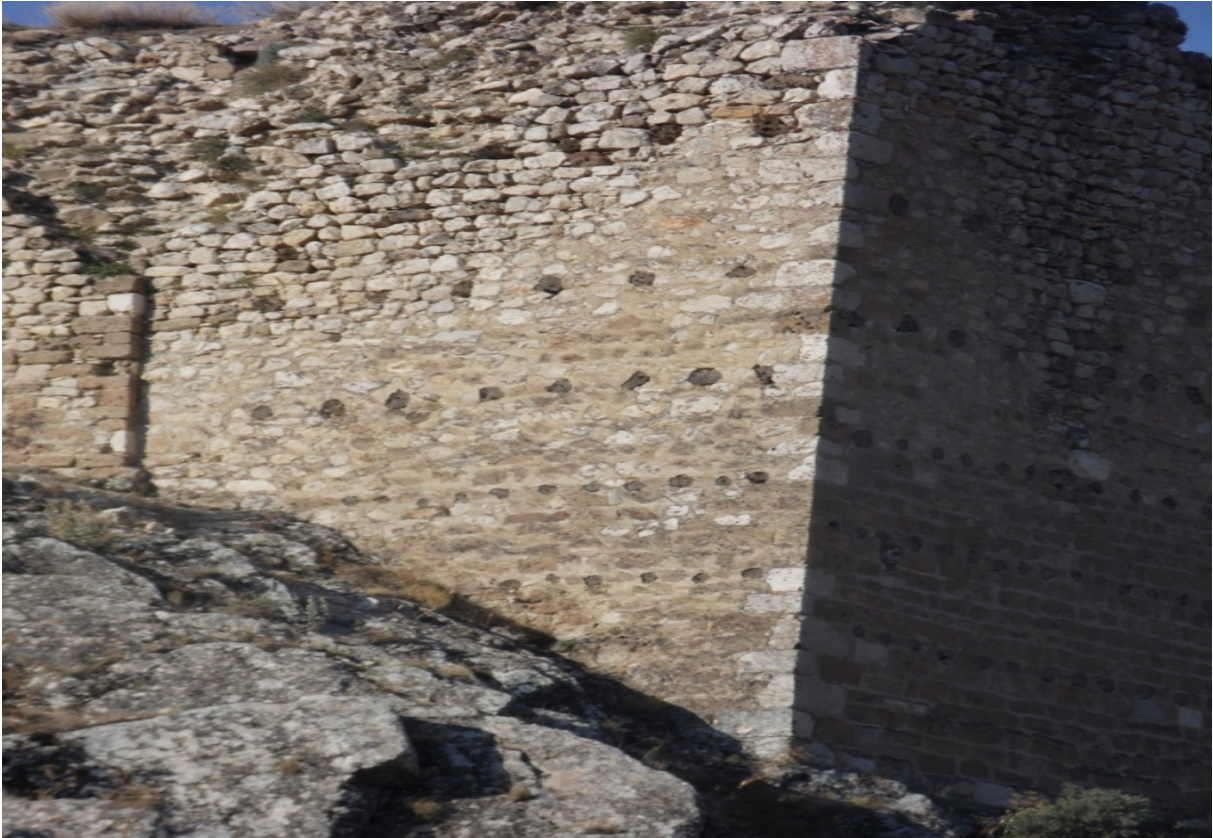
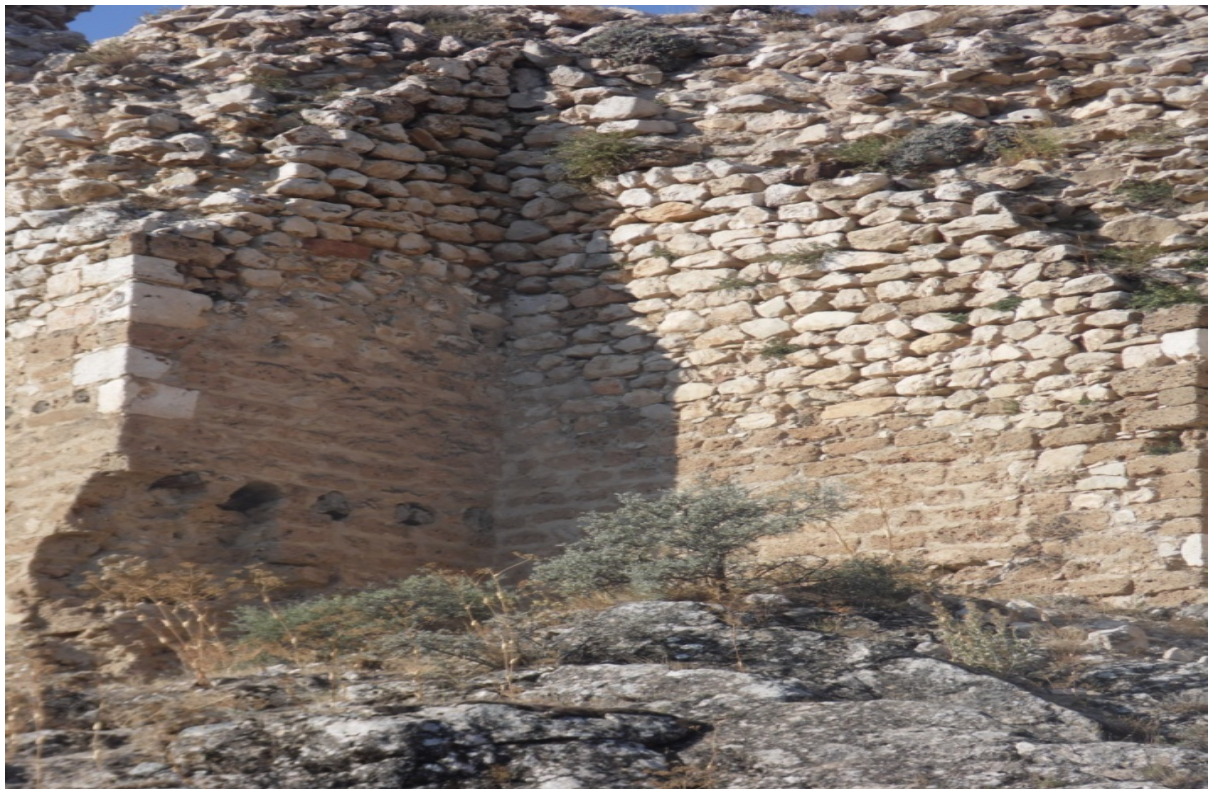
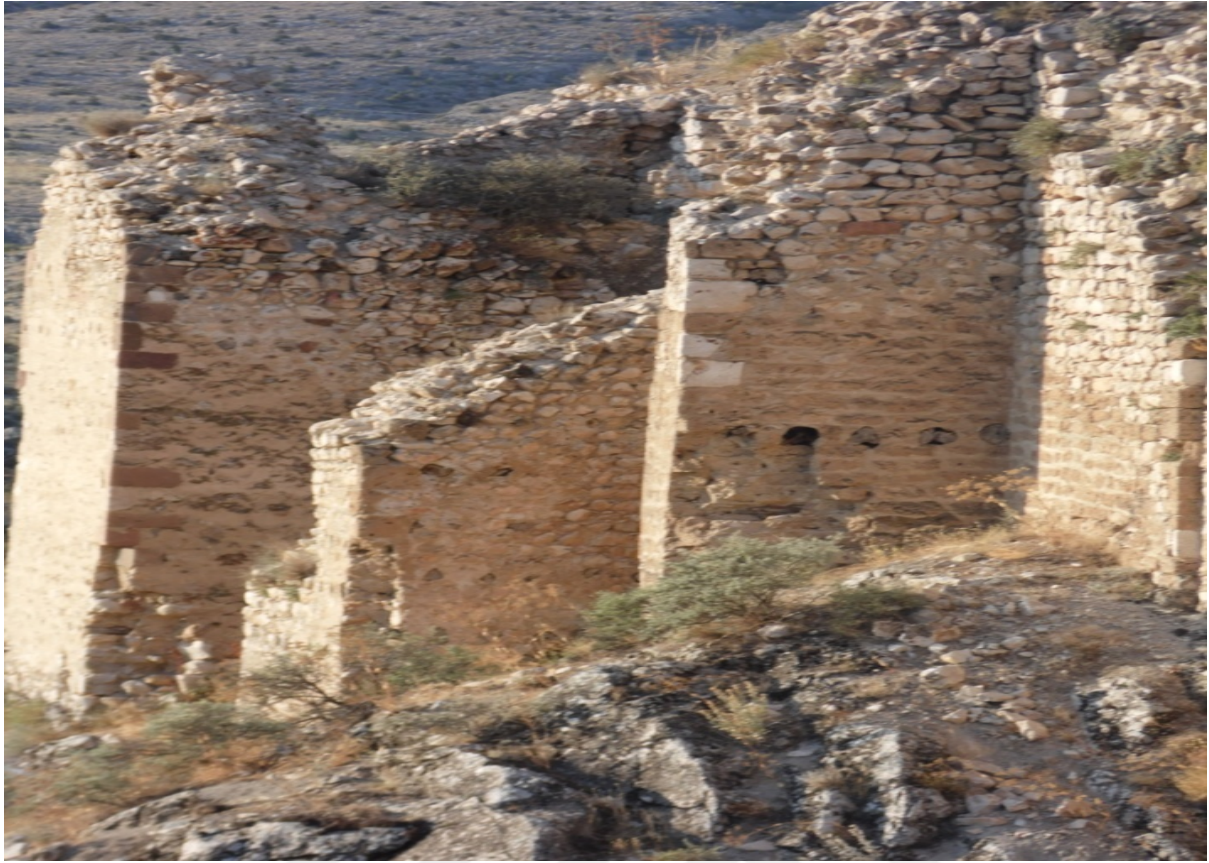
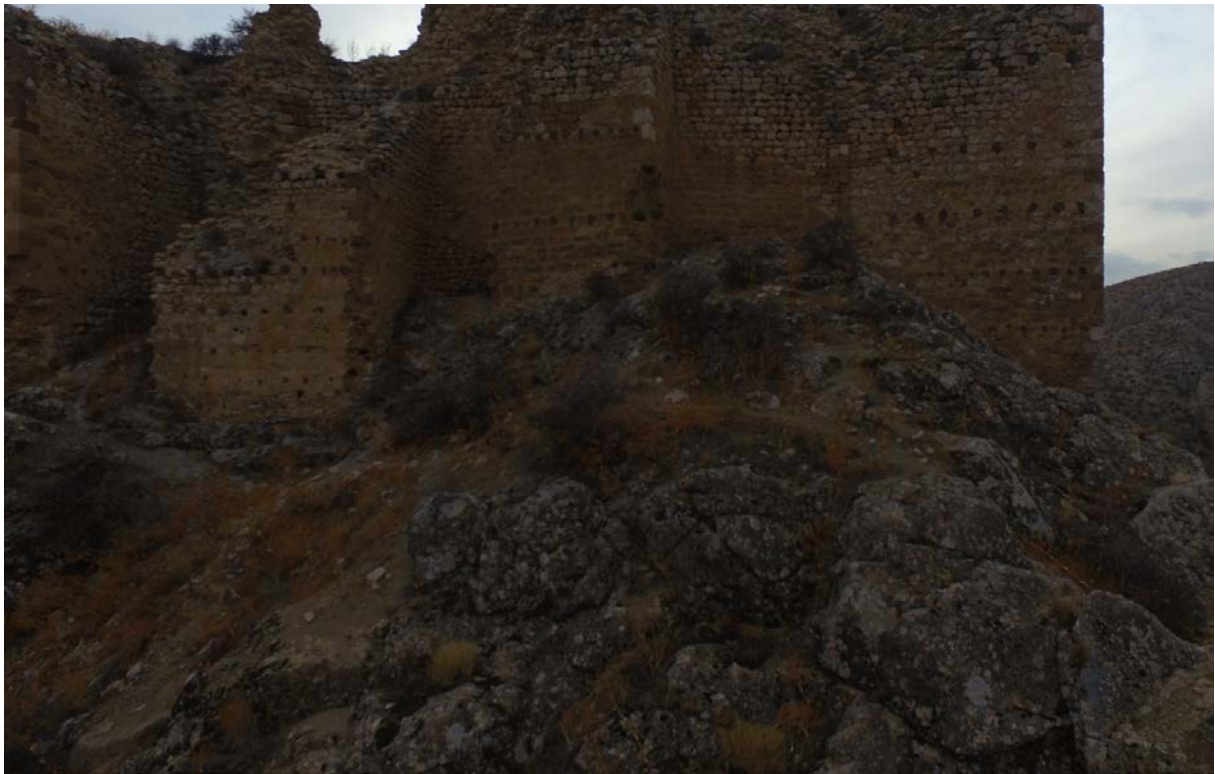
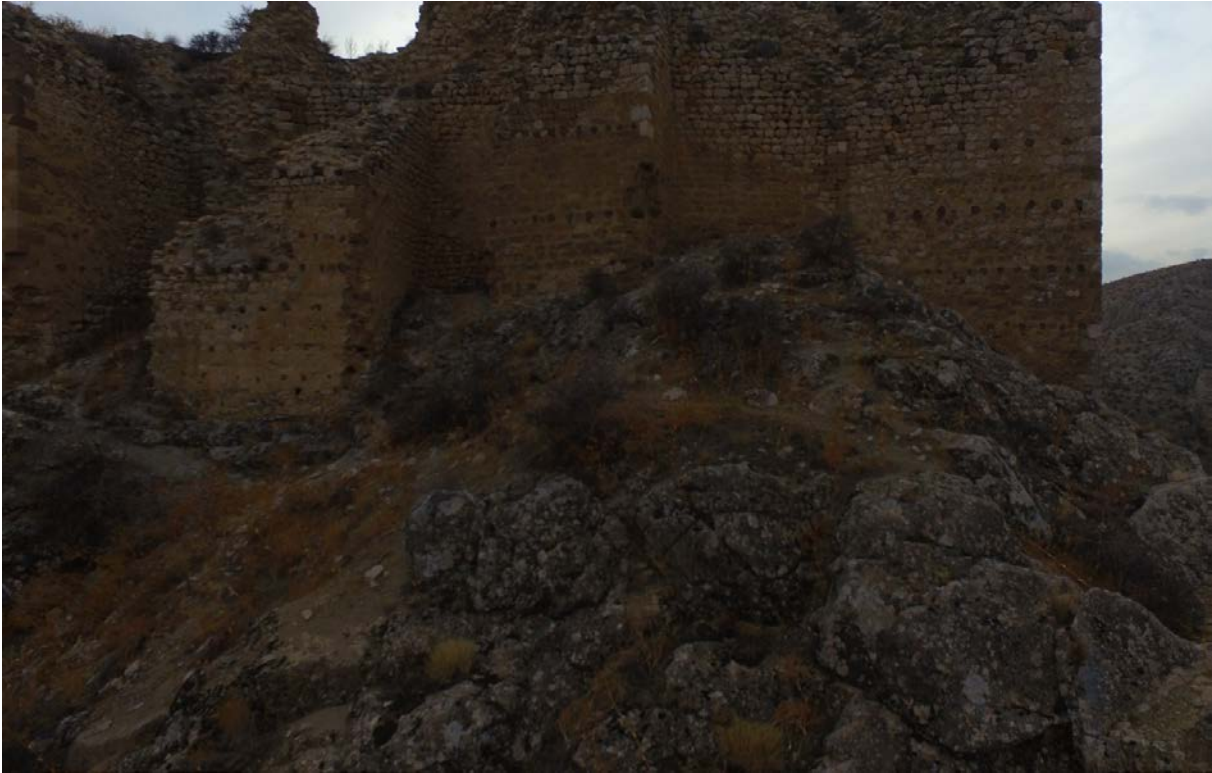
The Front facing the road has a plan shaped according to the topography of the rock mass. Three towers can be seen along the eastern wall . From the south-east, the upper part of the structure of the tower, which was built on a rock- sized 6.10 x 4.55 m square, is in ruins. In the horizontal plane, six rows of wooden beams are seen along the wall surface. Knitting system is rubble stone and lime mortar and smooth cut stones are used on the wall surface. In the continuation of the sign structure, the fortification wall continues for 4.00 m . Shaped frame, the second bushing structure of 3.20 m in height and 5.60 m width of the top walls of the part of the structure more bush-ruined 5.00 m continues. Next, another square structure with a square plan appears. Upper section and part of the base part of ruined structure of the horoscope 4.36 x 1.15 m in dimensions. Two rows of wooden roofs are seen in the western wall . On the south facing wall of the burial structure, a row of wooden beams is noted. In the continuation of the sign structure, the fortification wall is 4.25 m. Along the wall surface there are five rows of wooden beams . Knitting system is rubble stone and lime mortar

and smooth cut stones are used on the wall surface . The eastern Front is located on the rock mass and has taken its shape by drawing zigzags according to the shape of the rock mass ( Figure 5 , Photo : 62 , 63 , 64 , 65 , 66 , 67 , 68 , 69 , 70 , 71 , 72 , 73 , 74 , 75 , 76 , 77 ) .

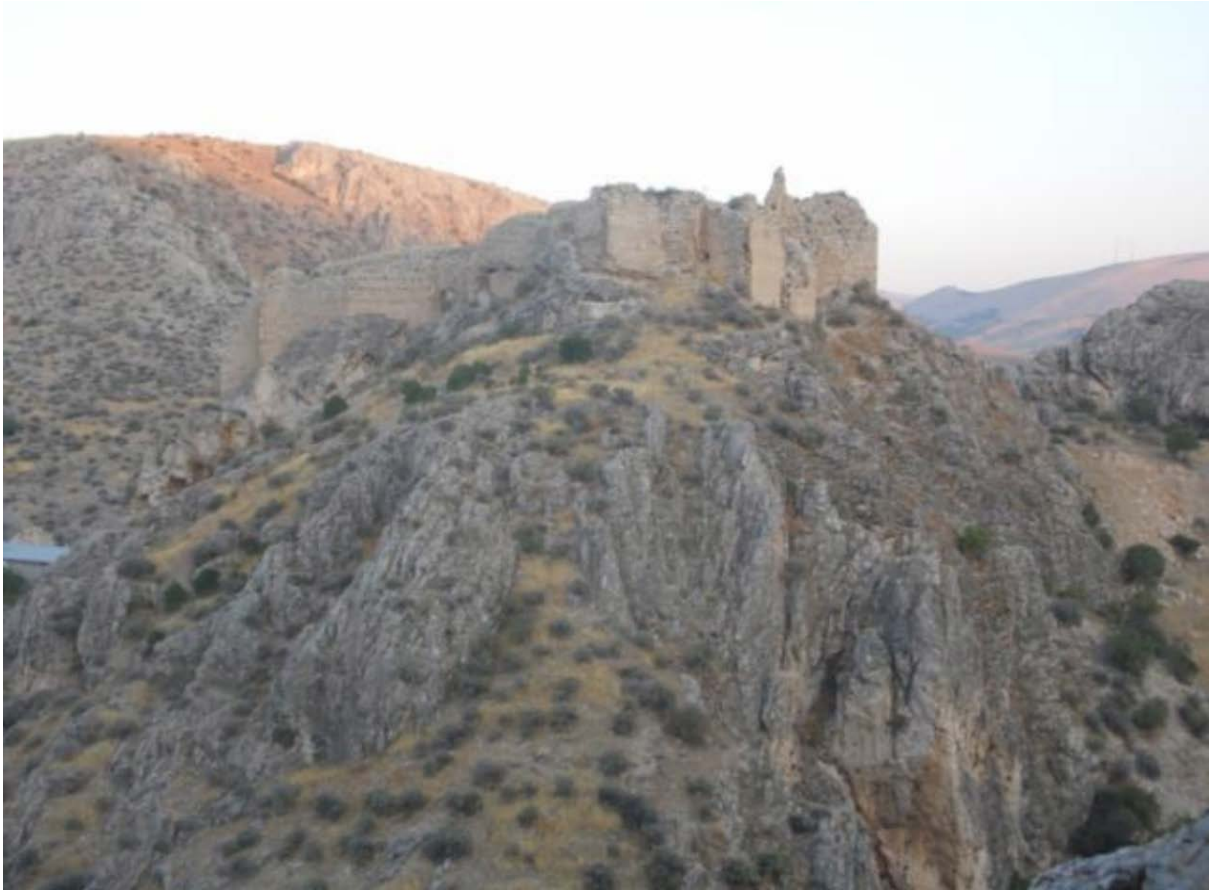
**Photo 79 .** General View of the Southern Front

According to the topography of the rock mass, it is seen that the South Fortification walls continue with zigzags. Coarse rubble stone was used in the knitting system. Rock mass supports the walls. The length of the southern fortification wall was 54 m in total and was built with rough stones (Photo: 79 ).

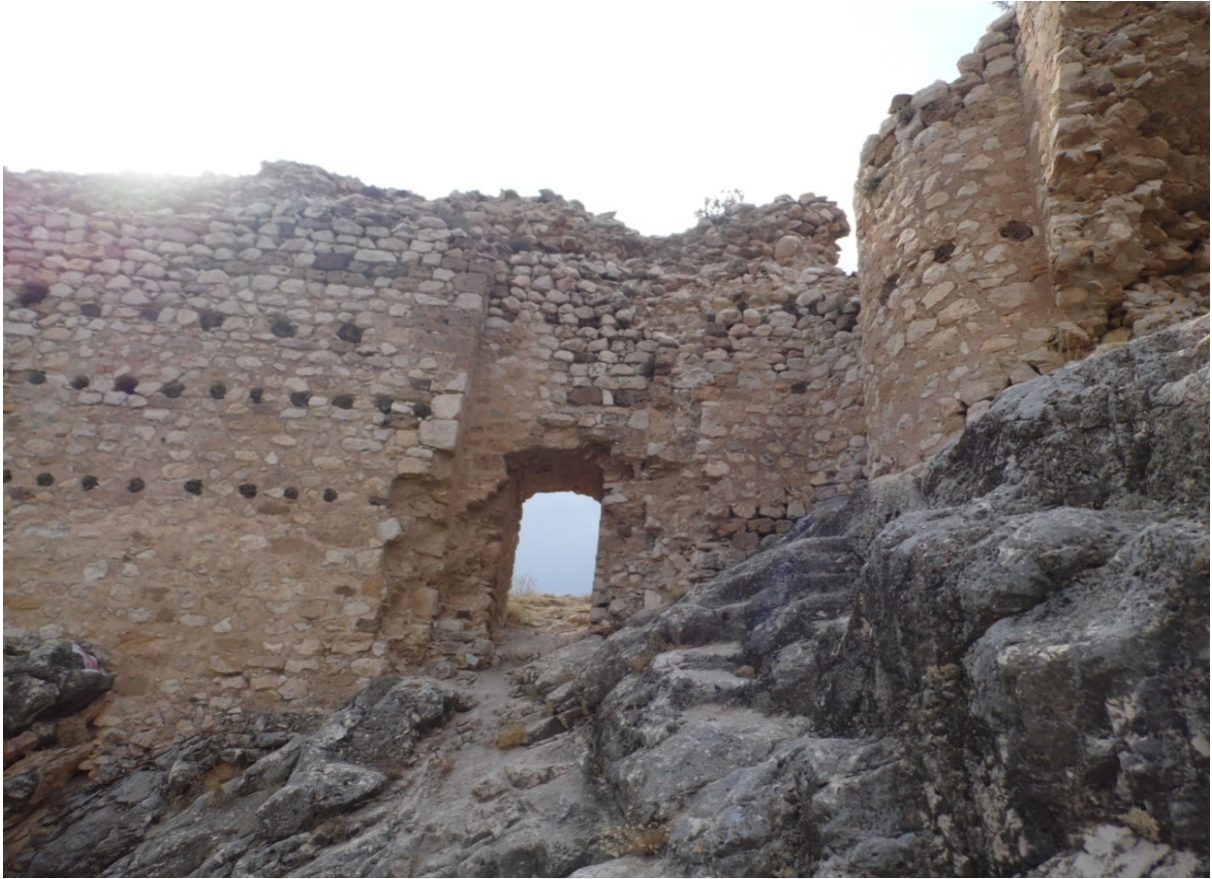
**Photo 86 .** Wall of GD 12 - 15

A pathway leading from the rocks towards the south reaches this door. In the south-west direction, the door does not take place symmetrically from the topography. 2.10 m width from the outer side of the door beam heights of up to 2:53 m ' is. The arch of the door which was observed to be arched and the stones in the body part were poured (Photo: 86 ).

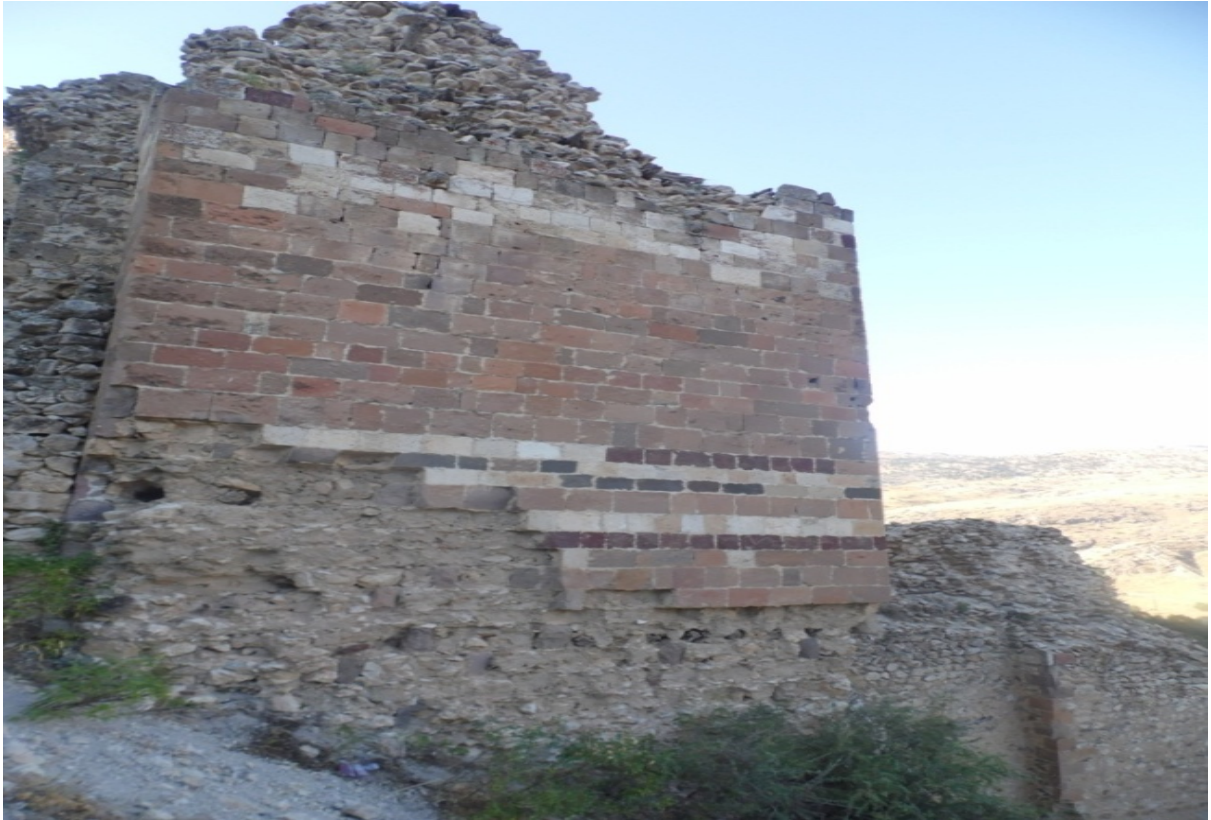
**Photo 97 . Wall KD 15**

From this section, the fortress structure is inclined to the west direction according to the structure of the rock mass. On the surface of the wall 1.03 x 0.87 m. There is an opening close to the square. Just above this opening, wooden beams are remarkable. The upper part of the fortification wall where rubble stone and lime mortar mesh system is seen is completely destroyed. The fortification wall ends at 1.00 m and ends with the north wall of the tower in the west. The material is the same as the whole castle. The upper part of the building is collapsed and is in the form of a rubble. In some places, cut stone material is seen on the wall surface (photo: 8, 97, 98, 105, 107).

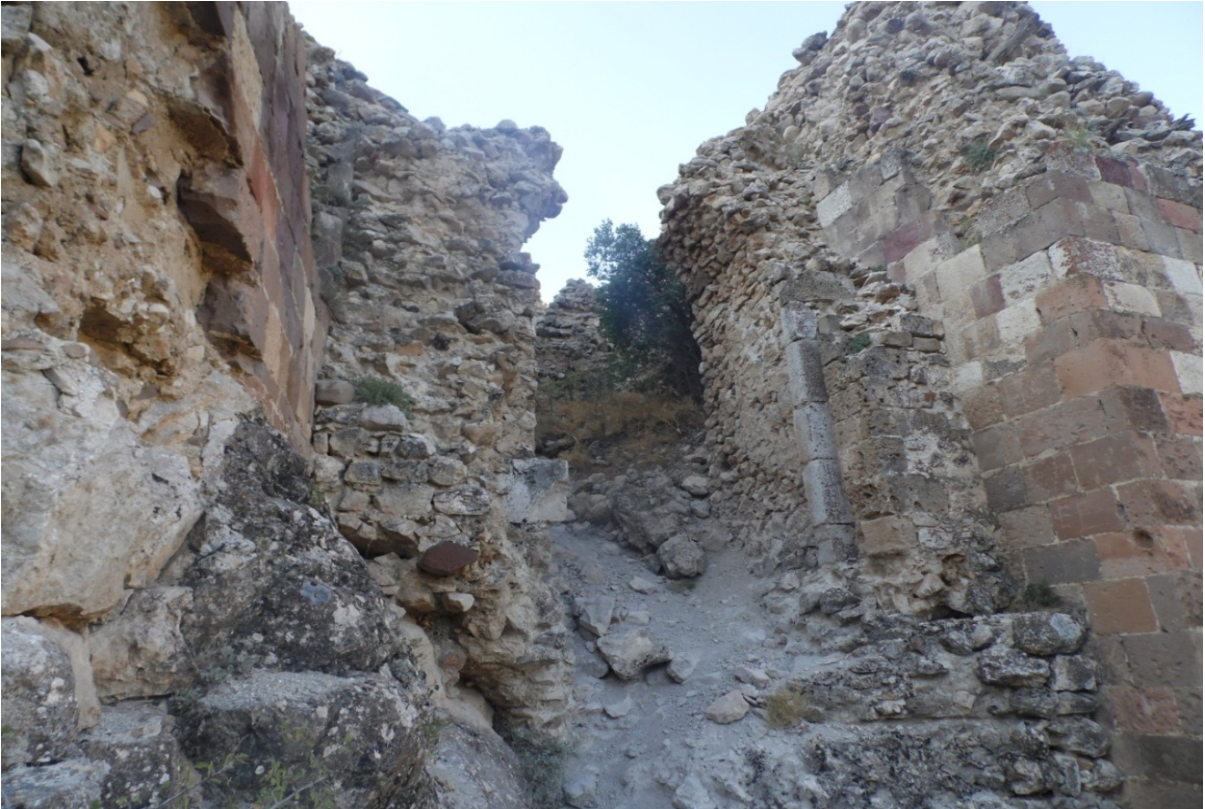
**Photo 99 .** Wall KD 7

walls of the main entrance door, whose upper part has been demolished, are in ruins. Stones are spilled and this façade is terminated by a square plan of the north-west direction. In the north-west direction, the upper part of the square-planed horseshoe structure, which is 7.65 x 5.67 m tall, protruding 2.34 m out of the main entrance gate, has been completely destroyed and is in the form of a rubble. It is seen that the main part is more stable than the upper part and it is covered with smooth cut stones. It is observed that the bush structure of the smooth stone pavement on the surface of the fortification wall has been poured at the foundation level (Photo: 8, 99).

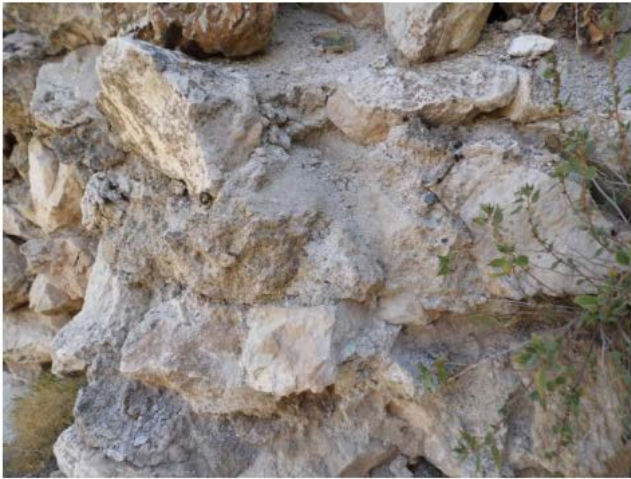
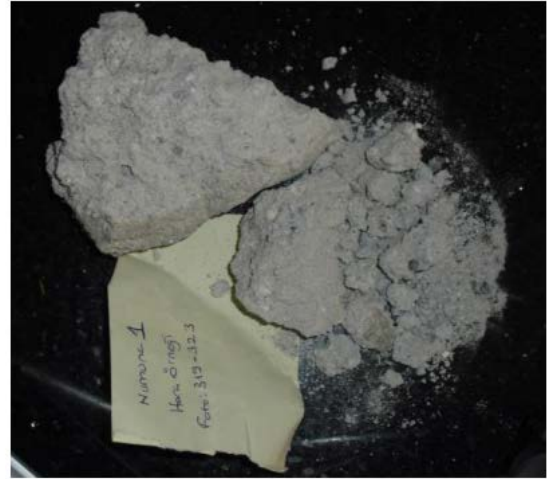
**Photo 109 .** Number 1 of the sample taken and the first view of the laboratory environment

**Sample No. 1:** Sample contains lime and coarse-grained aggregate aggregate . No substance was found as puzolon.

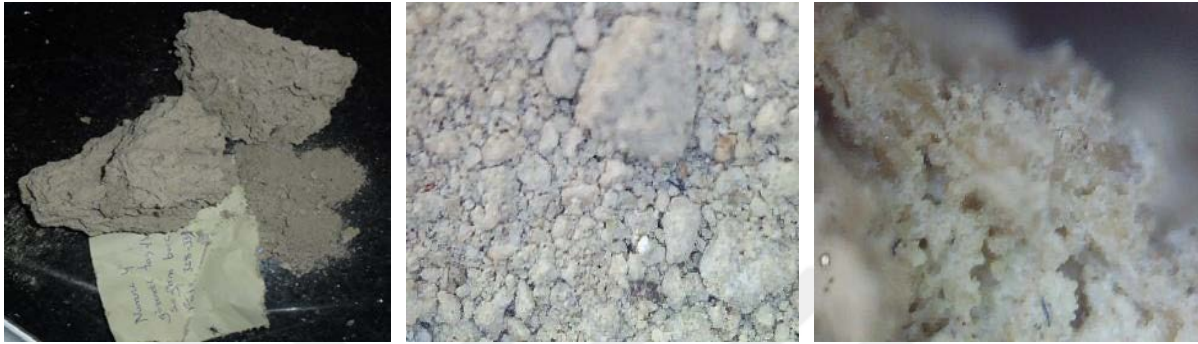
**Photo 118.** Image with 100 times and 250 times the magnification of the sample number 4

**Sample No. 4:** The sample contains lime and wood-ash together with fine-grained stream aggregate. The structure of the amorphous lime structure under the microscope shows how pure the structure is.

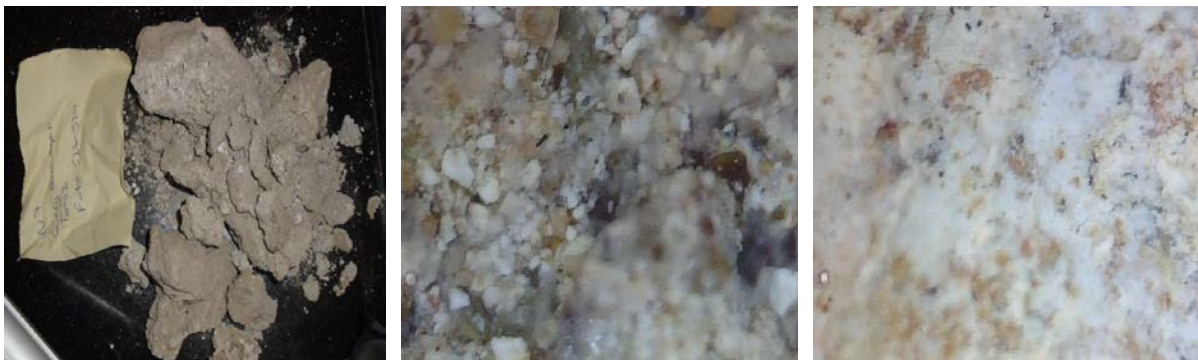
**Photo 122 .** Image with 100 times and 250 times the magnification of the sample number 7

**Sample No. 7:** The sample contains lime and wood ash together with fine-grained stream aggregate. As wood ash is used without being eliminated properly, it is seen as relatively large pieces. However, these parts are thinner than the number 6 material.

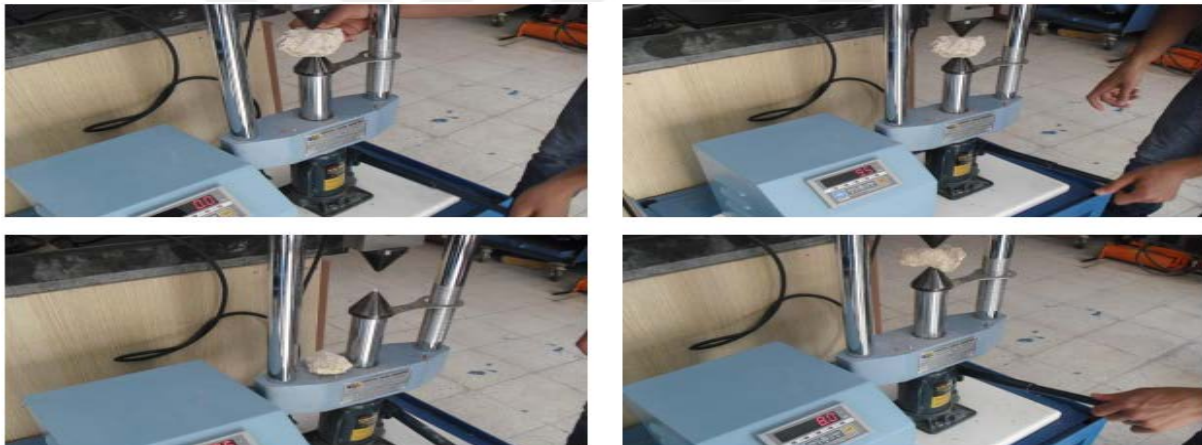
**Photo 123 .** Specimens subjected to point load test in laboratory environment

Samples taken from construction mortar in laboratory environment were tested on point load instrument. At the end of the experiment, the point load strength of the building mortar was measured and recorded. The result obtained is shown in tabular form in the test form. This table will help us to give information about the strength of the mortar to be redesigned.

In terms of average strength, the new mortar design must also be close to the existing mortar, so that the old mortar and the new mortar are adapted. This situation is important in terms of the life of the structure in many respects and most importantly the difference between the new mortar to be applied together with the old mortar.

If the mortar to be redesigned is stronger than the existing mortar; some of the parts built with the existing mortar will remain intact due to the force against the new mortar and may cause damage to other places, perhaps undamaged places today. On the contrary, the repaired places will be destroyed again by damage.

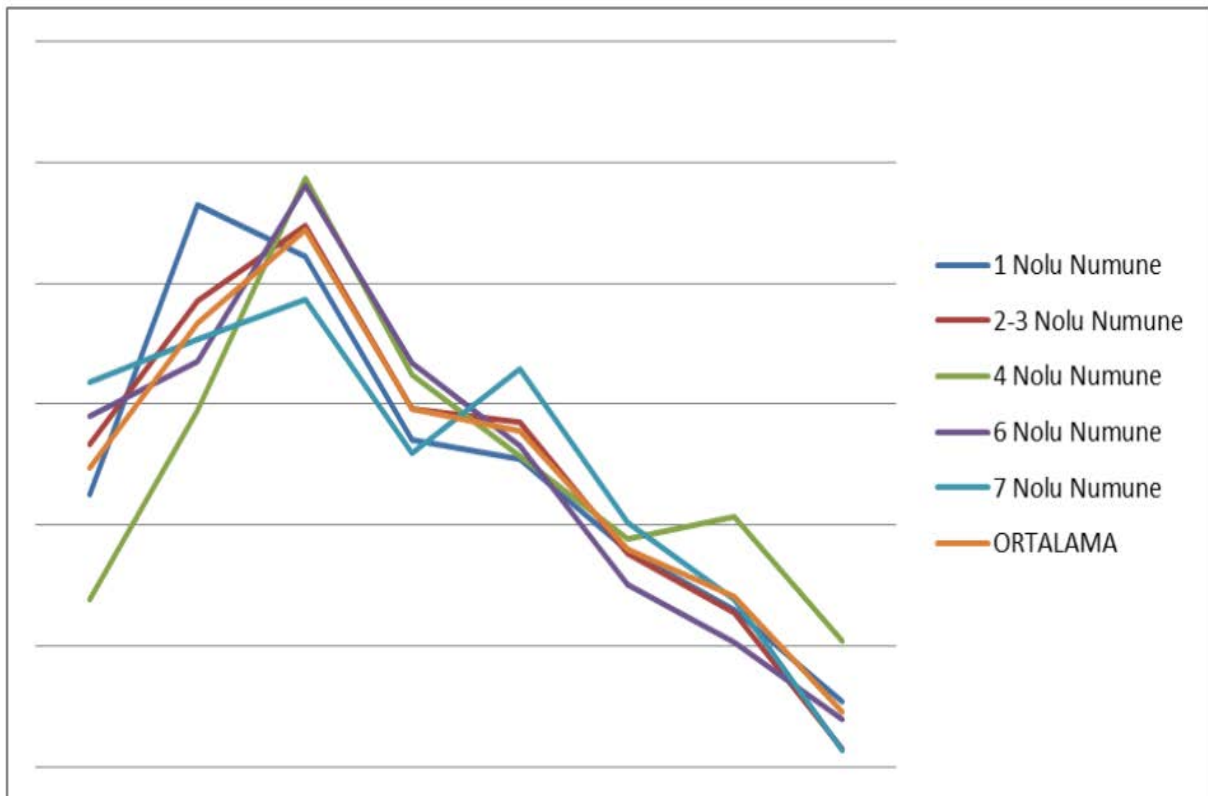
**Figure 14.** Comparative Graph Representation of Sieve Analysis Y-axis sieve diameter-X-axis overlay material

The above graphs allow the sieve analysis to be displayed collectively in proportion to each other. As it is understood from here, mortar samples contain a repetitive table in many respects. However, some detail points should not be overlooked. The material no. 4 started with a very fine material and the number 1 sample had a larger aggregate. They may be different from those who prepare the mortar, or the possibility of segregation at the sample point taken in the mortar should not be ignored.

This table will enable us to have information about the biggest grain diameter of the mixture materials which will be used in the design of the new mortar mortar.

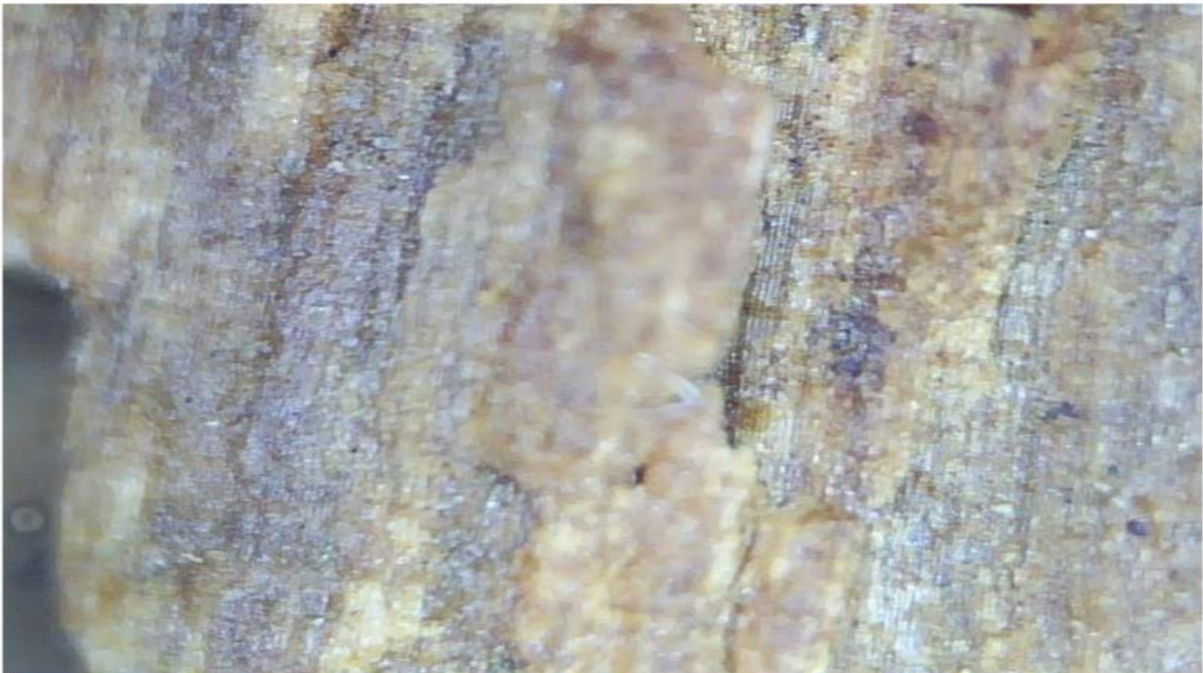
**Photo 130 .** Wood Sample from Resin Wood

We have already mentioned in the previous chapters that wood samples have been obtained from a resinous tree. Tree species that can be grown in this region should be investigated. According to the art history report, pine species should be investigated in the vegetation of the close environment of the building.

According to the date of construction, pine species can be examined according to the vegetation cover of the region and the results obtained can be compared with the existing samples.
