**REORGANISATION OF TRADITIONAL DWELLINGS
IN BARTIN ASMA STREET
ACCORDING TO THE USER CHARACTERISTICS**

**A THESIS SUBMITTED TO
THE GRADUATE SCHOOL OF NATURAL AND APPLIED SCIENCES
OF
THE MIDDLE EAST TECHNICAL UNIVERSITY**

ÇİLER BUKET TOSUN

MARCH 2001

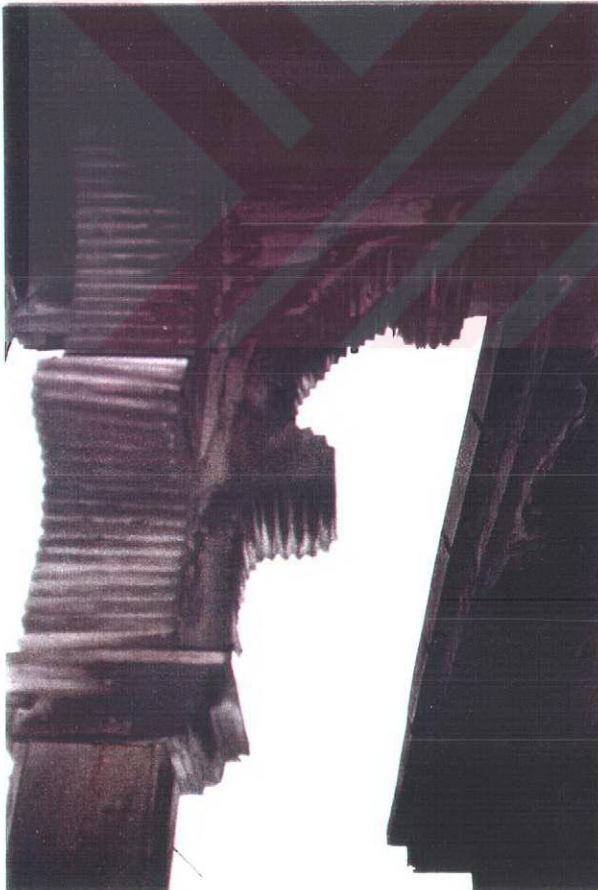
DETAIL FROM THE BALKONY

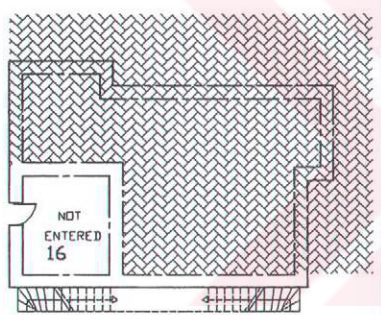
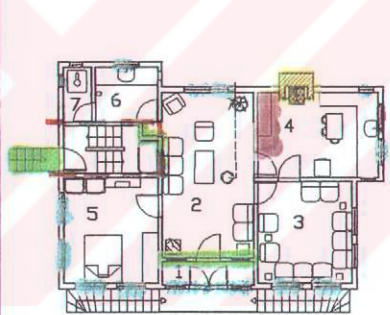
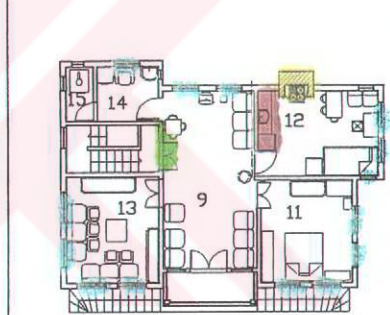
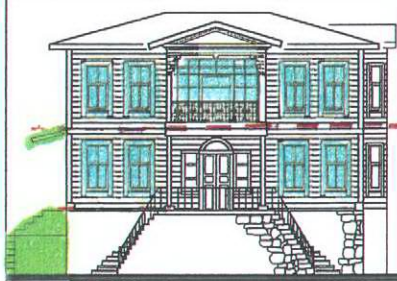
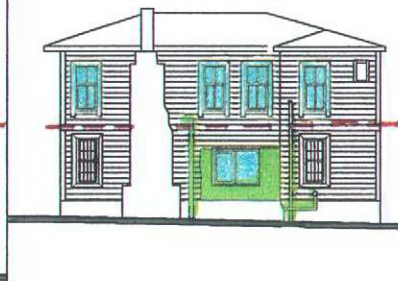
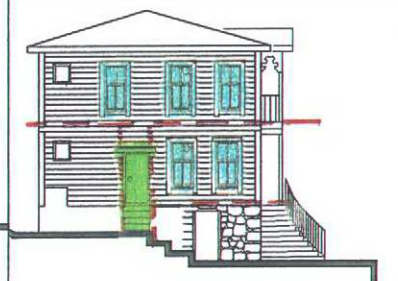
ALTERATIONS OF FLOOR AND CEILING COVERINGS	THE CEILINGS OF THE SPACES 2, 4, 7 IN THE FIRST FLOOR ARE CHIPBOARD THE FLOOR COVERING OF THE SPACE 6 IS SCREED AND OTHERS ARE OILCLOTH WHERE AS SPACE 7 IS COVERED WITH CERAMICS IN THE FIRST FLOOR. CARPETS ARE PRESENT ON ALL OF THE FIRST FLOOR COVERINGS.			
EVALUATION OF THE ALTERATIONS	THE BUILDING HAS PRESERVED MOST OF ITS ORIGINAL VALUES. ALTHOUGH IT IS DIVIDED HORIZONTALLY. THE PLAN SCHEME CAN EASILY BE SEEN. WITH DIVISION ONLY THE USAGE OF STAIRCASE IS CHANGED AND AN ENTERENCE TO IT IS LOCATED. BESIDES IT HAS SOME OF ITS PLAN ARCHITECTURAL ELEMENTS REMOVED. MOST OF THE WINDOWS ARE REPLACED WHERE THE DOORS ARE ORIGINAL. CONSEQUENTLY THE CEILING COVERINGS ARE REPLACED IN THE FIRST FLOOR ONLY. THE BUILDING IS STUCTURALLY IN GOOD CONDITIONS EXCEPT THE RASING DAMP AND RAIN PENETRATION PROBLEMS BESIDES THERE IS AN INSECT PROBLEM ON THE TIMBER ELEMENTS

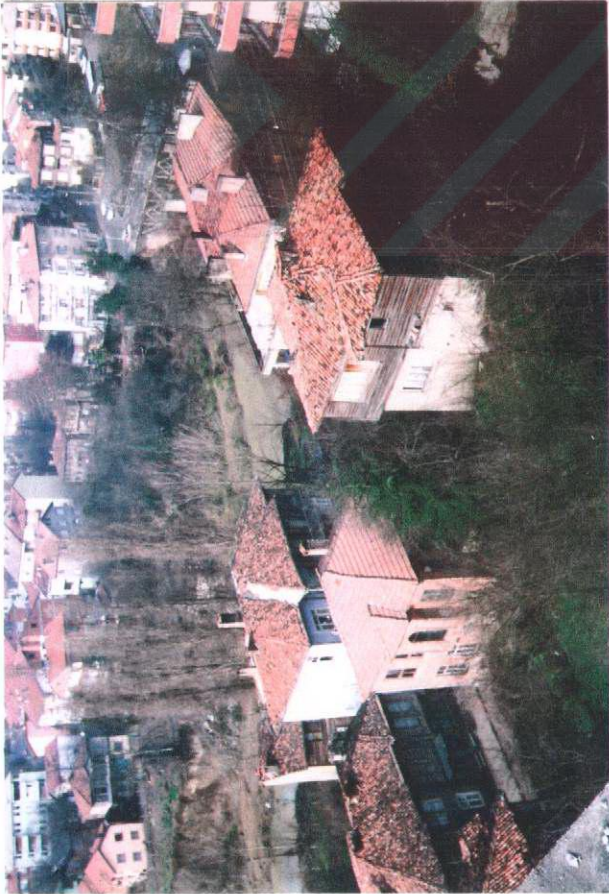
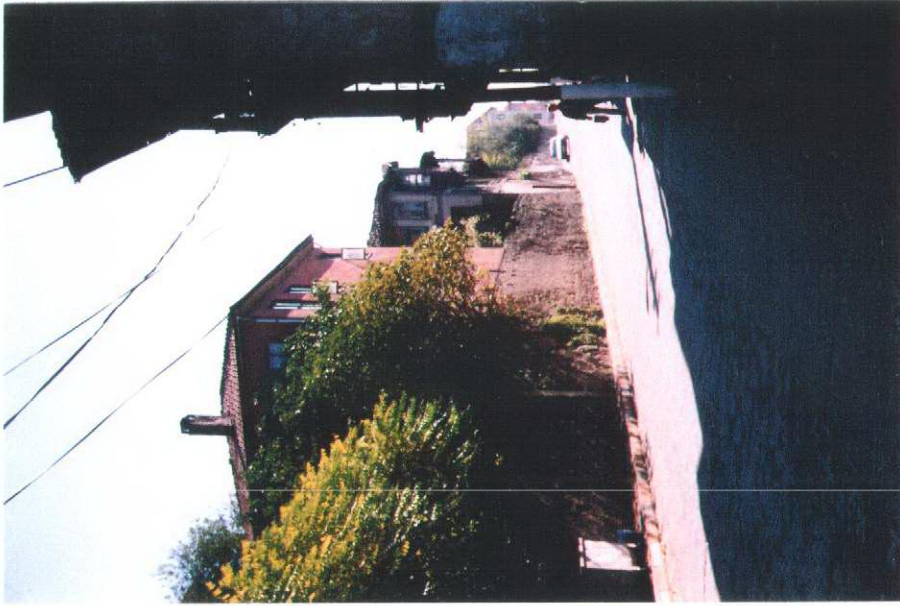
Figure 7.1: Photographs of No:64

THE STREET FACADE

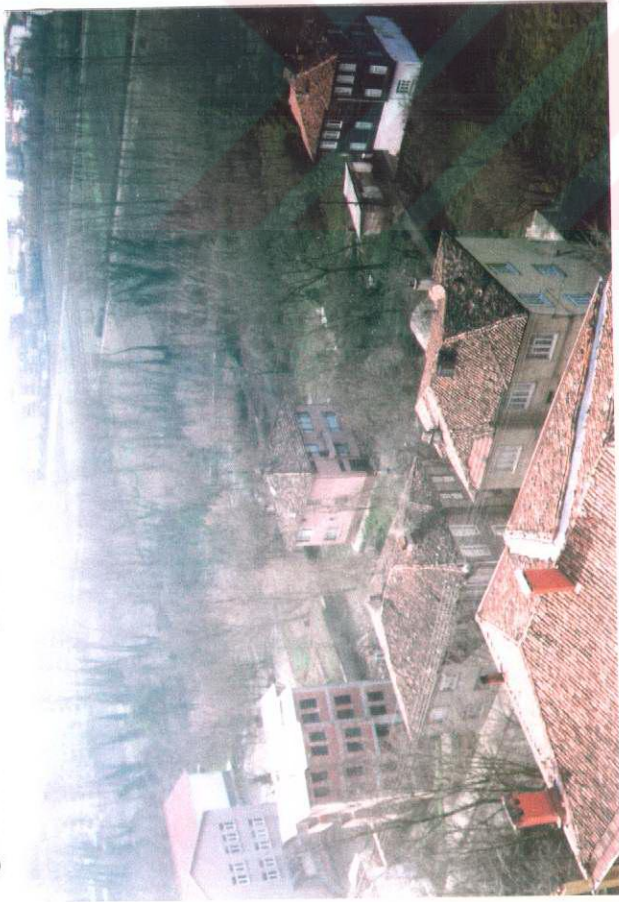
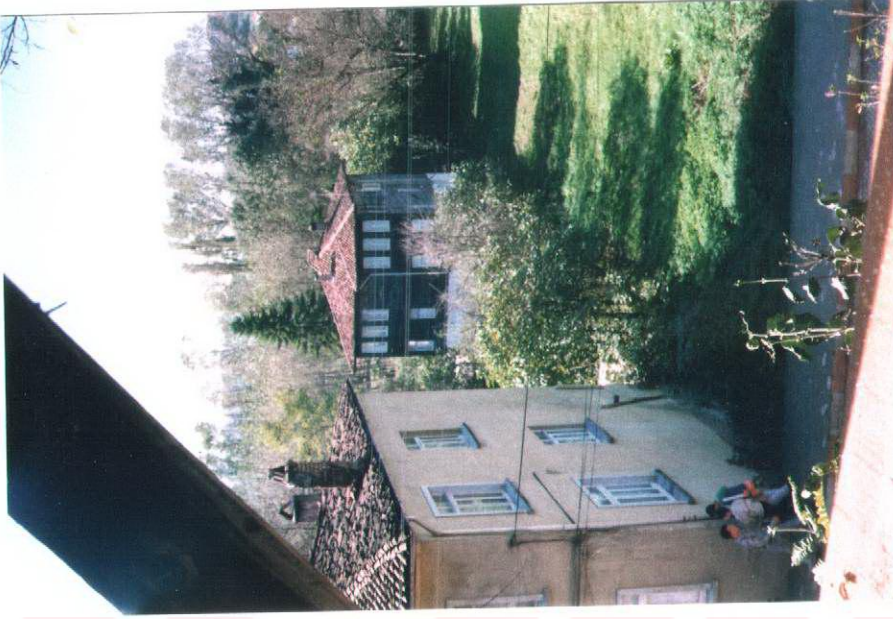
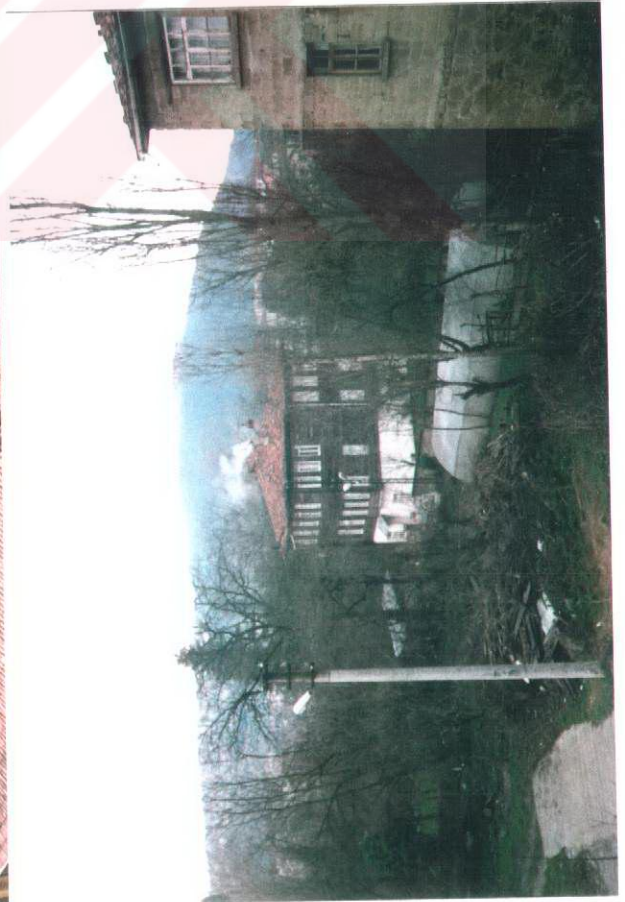
Figure 9.1: Photographs of No:71

PROBLEMS OF THE BUILDING		
<p>THE BUILDING IS STRUCTURALLY IN GOOD CONDITION. THE INSECT ATTACK PROBLEM AT THE TIMBER ELEMENTS IS THE MOST SEVERE PROBLEM IN THE BUILDING. AND IT HAS DISCOLORISATION AND FIBERISATION ON THE TIMBER COVERINGS OF THE FACADE. THERE ARE MATERIAL LOSS AT THE TILES AND GUTTER OF THE BUILDING. THERE IS A CEMENT USAGE AT THE BASEMENT FLOOR.</p> <p>A FAMILY OF 3 MEMBERS WITH LOW INCOME IS LIVING IN RENT AT THE BASEMENT FLOOR. THE SPACE USAGE ARE NOT ENOUGH FOR THEM FOR A CONTEMPORARY LIVING STANDARTS. THE OWNERS, A FAMILY OF TWO, ARE LIVING AT THE SECOND FLOOR. BUT THE SPACE ORGANISATION IS NOT GOOD AS ALL THE SPACES ARE THOUGHT TO BE USED AS BEDROOM. THE KITCHEN IS NOT HEALTHY AND ENOUGH. THE FIRST FLOOR IS NOT USED MAINLY BECAUSE IT IS USED AS A STORAGE OF FURNITURE WHICH AR FOR THE SON OF THE OWNERS. THEY WANT THEIR CHILD LIVE THERE WHEN HE IS MARRIED.</p> <p>THERE ARE TWO ROOMS, A COMMON SPACE SPACE OF THE STAIRCASE AND ABDESTLIK SPACE AT THE STORIES. BOTH THE PLAN ORGANIZATION AND THE USAGE OF THE SPACES ARE NOT SUITABLE TO BOTH THE SPACE CHARACTERISTICS AND CONTEMPORARY LIVING STANDARTS.</p> <p>THE NEED FOR BATHROOM SPACE IS SOLVED BY ADDITION OF A BATHROOM SPACE IN THE ABDESTLIK SPACE. SO A BETTER SOLUTION FOR SPACE ORGANISATION IS NEEDED. AN ENOUGH KITCHEN SPACE IN HEALTHY CONDITIONS IS STILL NEEDED. BESIDES, MOST OF THE ARCHITECTURAL ELEMENTS ESPECIALLY CUPBOARDS ARE NOT IN USE ALTHOUGH THEY ARE IN USABLE CONDITIONS.</p>

CORRECTIONS	
<p>THE RESTITUTION SCHEME SHOULD BE STUDIED MORE DETAIL AFTER THE PLASTERS AND THE FACADE COVERING AT THE BACK FACADE IS TAKEN OUT AND THE TRACES ARE SEEN. THE CORRECTIONS SHOULD BE DECIDED AFETR THIS RESEARCH.</p> <p>DEFORMATIONS IN THE BUILDING, DUE TO THE DETERIORATION OF STRUCTURAL AND NON-STRUCTURAL TIMBER ELEMENTS SHOULD BE CORRECTED. THE FULLY IETERIORATED TIMBER ELEMENTS SHOULD BE REMOVED. THE NEW TIMBER ELEMENTS, THE SOUND PARTS OF TIMBER STRUCTURAL ELEMENTS AND NON-STRUCTURAL TIMBER ELEMENTS SHOULD BE TREATED WITH THE PRESERVATIVES WHICH THE EXPERTS SHOULD DECIDE; AGAINST THE DETERIORATION EFFECT OF SUN, WATER, INSECT, AND FUNGI ATTACK.</p> <p>THE NEW FACADE COVERING AT THE BACK FACADE SHOULD BE TAKEN OUT ACCORDING TO APPROACH 4</p> <p>THE WINDOWS SHOULD BE OPEENED ACCORDING TO APPROACH 4</p>	
COMPLETIONS	
<p>ACCORDING TO APPROACH 7: THE TRACES OF REMOVED CUPBOARDS, THE TRACES OF STAIRCASE SHOULD BE PRESERVED WITHOUT ANY INTERVENTION.</p> <p>ACCORDING TO APPROACH 5: THE MISSING WINDOW ELEMENTS AND THE M?SS?NG ELEMENTS OF THE ARCHITECTURAL ELEMENTS SHOULD BE MADE</p>

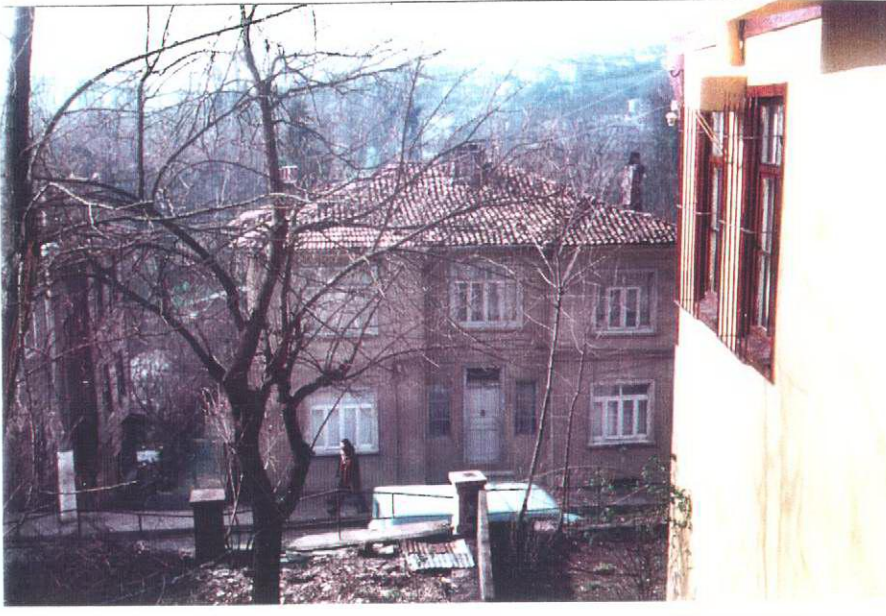
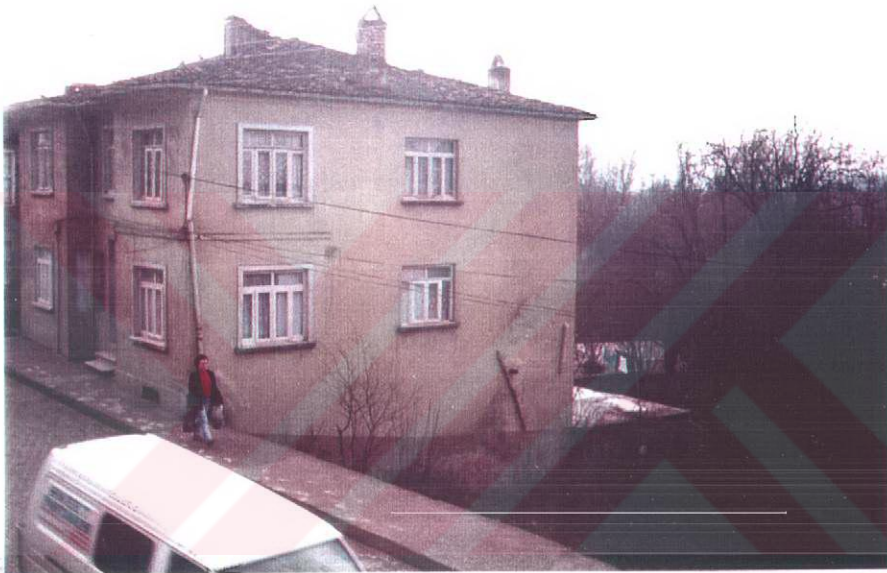
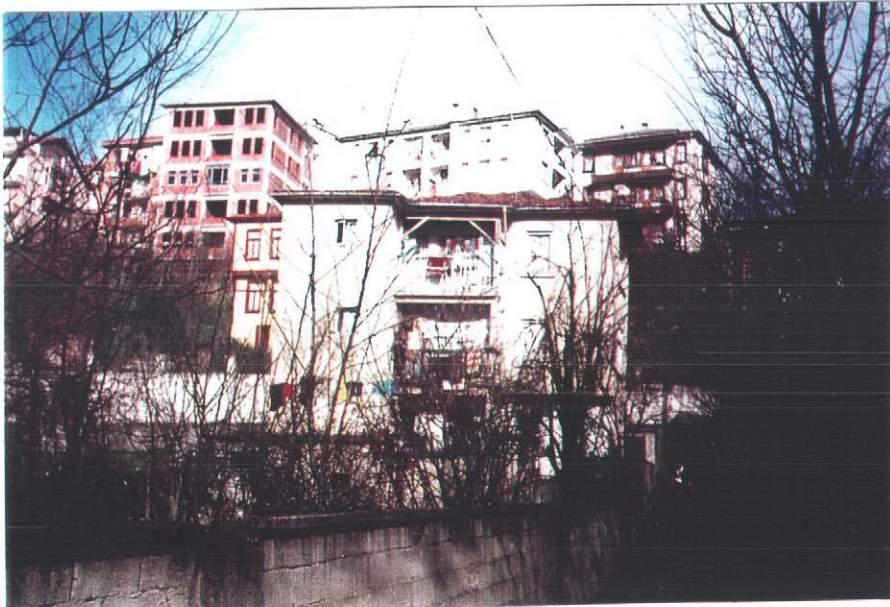
Figure 10.1: Photographs of Building No:73

BUILDING NO:73 THE PHYSICAL PROBLEMS OF THE BUILDING		10.5
	STRUCTURAL DEFORMATIONS	MATERIAL DETERIORATIONS
STRUCTURAL ELEMENTS	DAMPNESS SEVERE PROBLEM AT THE BASEMENT FLOOR; ON ITS WALLS, FLOOR AND EVEN ITS CEILING	TIMBER INSECT ATTACK DISCOLOURISATION FIBERISATION
	SETTLEMENT DETTLEMENT AT THE SECOND FLOORS BALCONY	STONE RISING DAMP DETACHMENT
ARCHITECTURAL ELEMENTS	PARTIALLY COLLAPSED AND MATERIAL LOSS THE FIREPLACES AT THE BASEMENT FLOOR AND THE COURTYARD	TIMBER STONE INSECT ATTACK DISCOLOURATION
EVALUATION OF THE DEFORMATION AND DETERIORATIONS		DAMPNESS IS THE MOST EMERGENT PROBLEM IN THE BUILDING. THE SEVERE DAMPNES IN THE BASEMENT FLOOR IS BECAUSE OF THE FLOOD THAT HAD HAPPENED IN 1997. OTHER PROBLEMS ARE CAUSED BY DAMPNES. THE FIREPLACES ARE PARTIALLY COLLAPSED AND ARE NOT USED TODAY.
CHANGES		SCALE OF THE SKETCH DRAWINGS:
<ul style="list-style-type: none"> ● DIVISION ○ VERTICALLY ● HORIZONTALLY ● PARTIALLY COLLAPSED ● REMOVED ● REPLACED ● ADDITION ● NOT USED

PROBLEMS OF THE BUILDING	
<p>THE BUILDING IS HAVE SEVERE DAMPNES PROBLEM AT THE BASEMENT FLOOR. THE SETTLEMENT PROBLEM AT THE BALCONIES IS IMPORTANT AS WELL AS THE INSECT ATTACK PROBLEM AT THE TIMBER ELEMENTS. MOREOVER, THE ONLY ORIGINAL ARCHITECTURAL ELEMETS; THE FIREPLACES HAVE PARTIALLY COLLAPSED AND MISSING PARTS.</p> <p>A FAMILY OF 4 MEMBERS AT THE BASEMENT AND FIRST FLOORS AND A FAMILY OF 5 MEMBERS AT THE SECOND FLOOR WITH LOW INCOME ARE LIVING IN RENT. THE SPACE USAGE ARE NOT ENOUGH FOR THEM FOR A CONTEMPORARY LIVING STANDARTS.</p>	
GENERAL EVALUATION	
<p>AS A TRADITIONAL DWELLING, THE BUILDING HAS DOCUMENTARY AND CULTURAL VALUES. IT HAS LOST MOST OF ITS HISTORICAL VALUES. IT HAS LOST THE ORIGINAL PLAN SCHEME AND MOST OF ITS ARCHITECTURAL ELEMENTS. IT HAS SERIOUS CHANGES BECAUSE OF THE USAGE OF THREE DWELLING UNITS IN THE STORIES. THE BUILDING SHOULD BE REORGANISED AFTER A DETAILED STUDY FOR THE RESTTTUTION SCHEME IS DONE. IT HAS FUNCTIONAL VALUE TO BE USED IN ITS ORIGINAL "WELLING" FUNCTION. BUT A NEW REORGANISATION ACCORDING TO DECIDED NEW USER CHARACTERISTICS SHOULD BE DONE. WHICH THE CONTEMPORARY LIVING STANDARTS IS REQUIRED ACCORDING TO THE SPACE CHARACTERISTICS.</p>

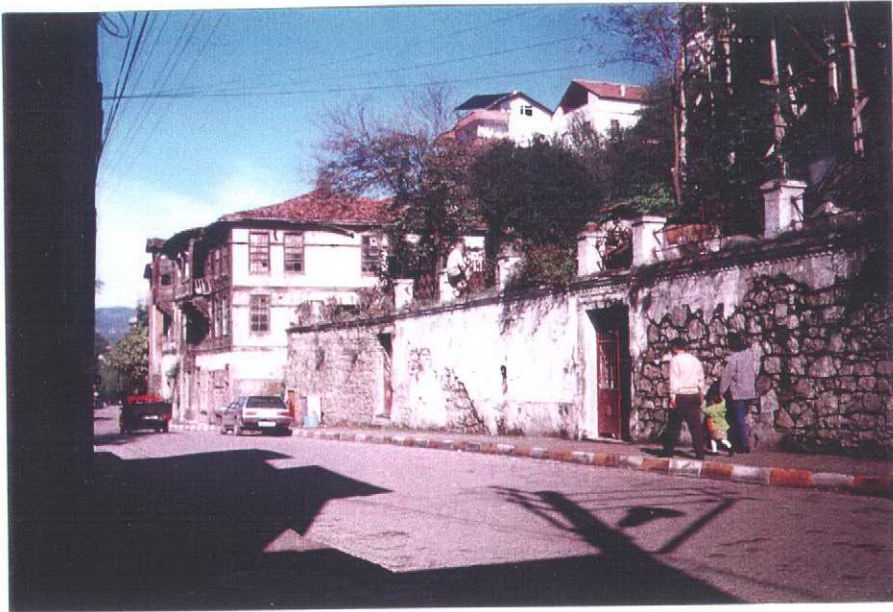
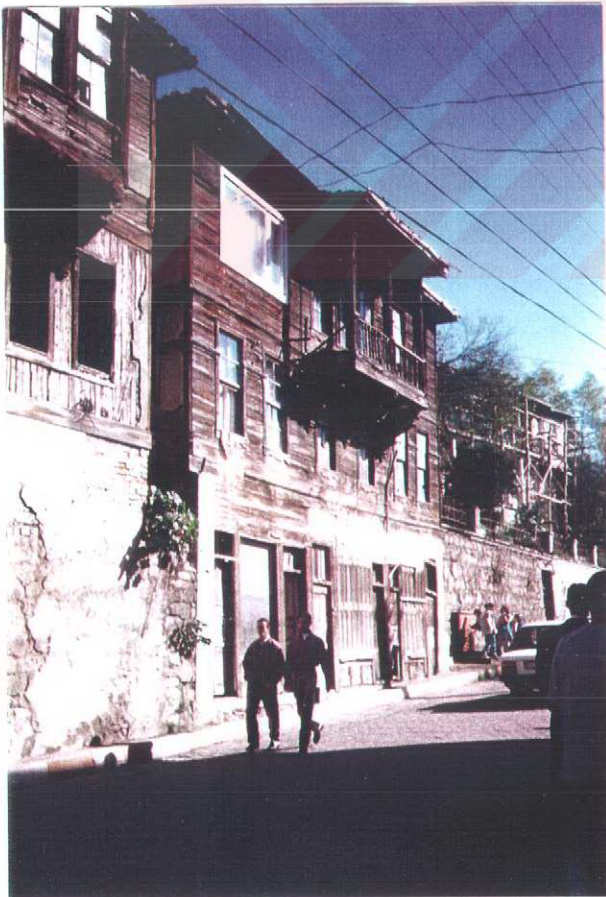
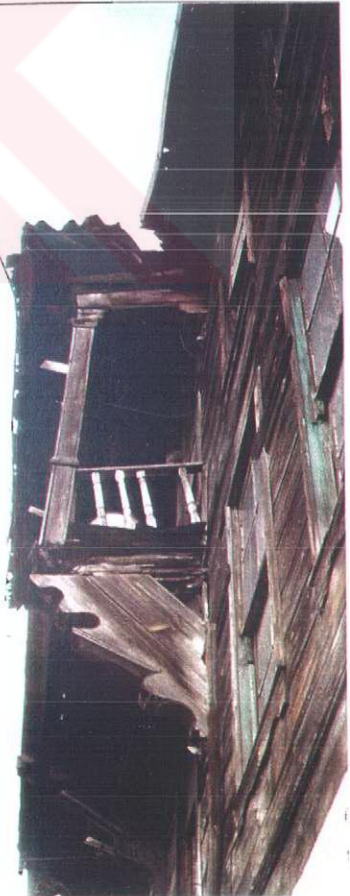
In type B, No 58-60 and No:42 have balcony at the top floor. No:42 (*Figure 6.1*) has entrance threshold under it, where No:58-60 (*Figure 11.1 and Figure 11.4*) has another criteria of having shops at the entrance floor.

Figure 11.1: Photographs of No:58-60

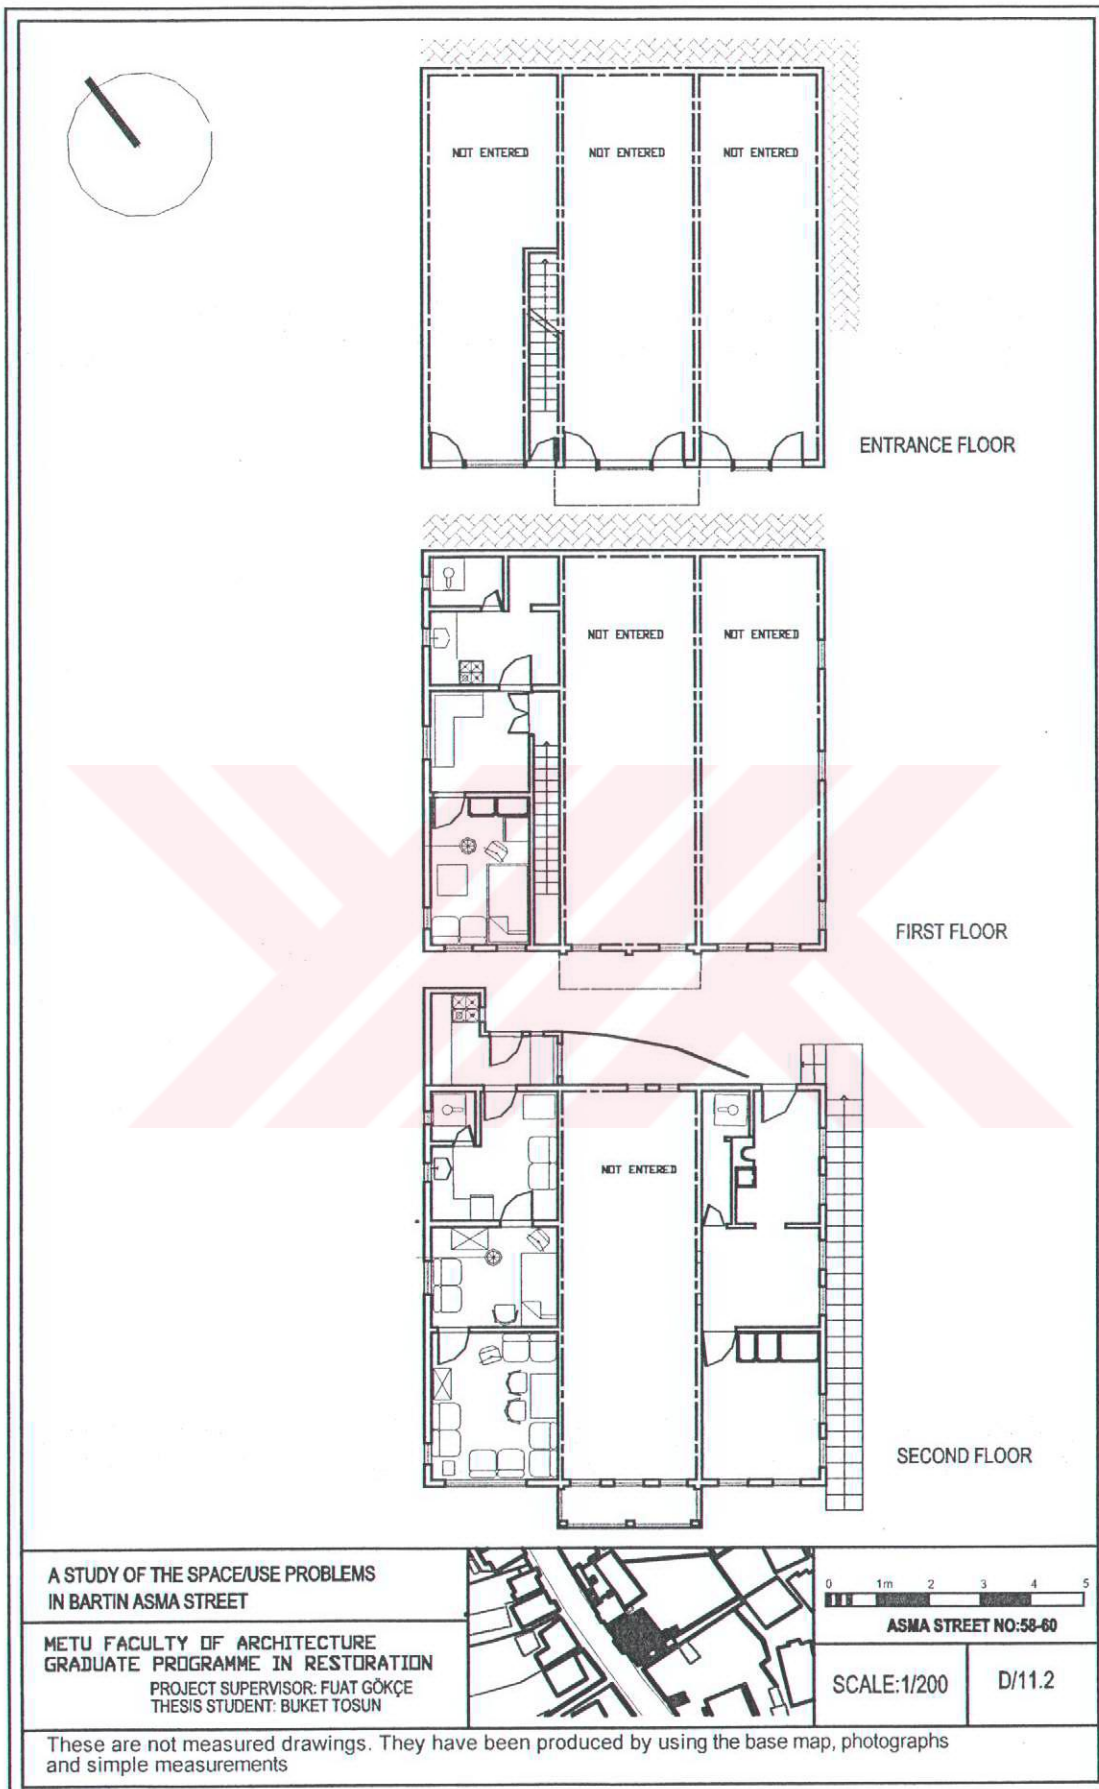
In the third type No:58-60 (*Figure 11.3*) is considered to have common space located in between three rooms, in its restitution scheme.

Figure 11.3 Sketch Drawings of Plans of The Building No:58-60

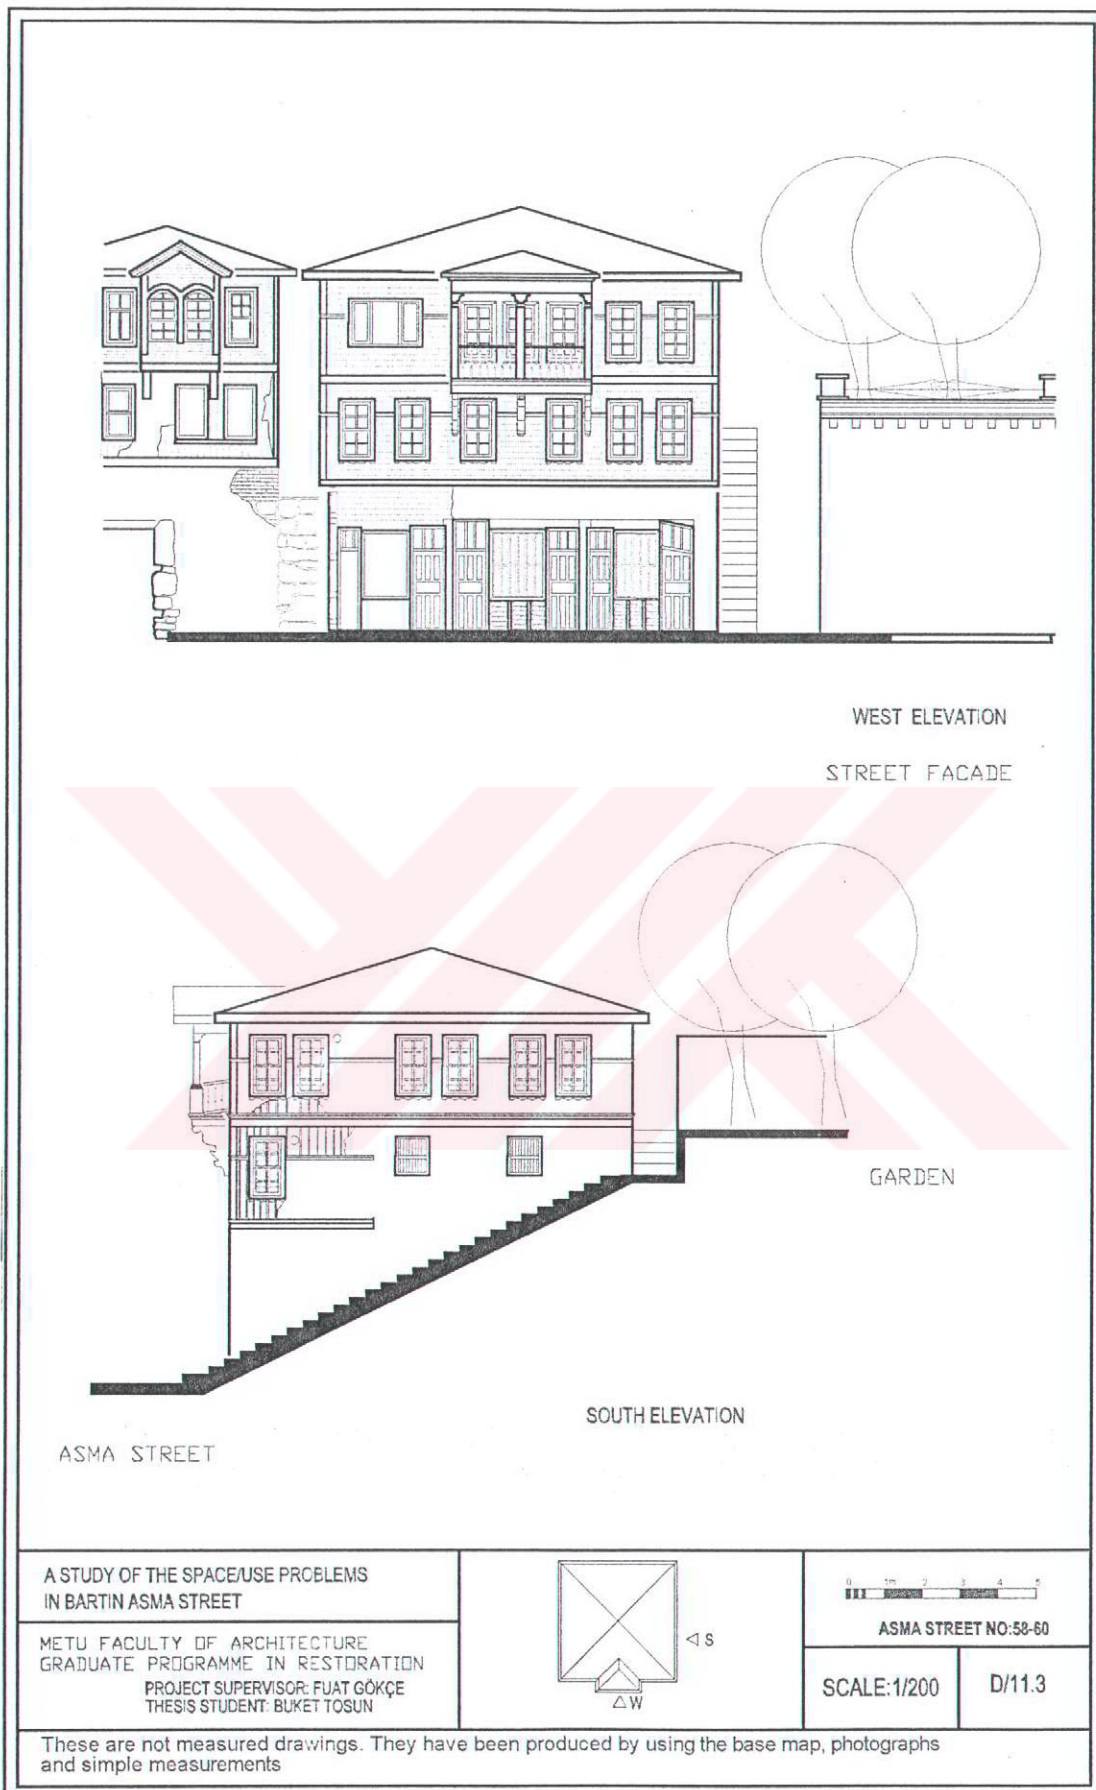
Figure 11.4 Sketch Drawings of Facades of the Building No:58-60

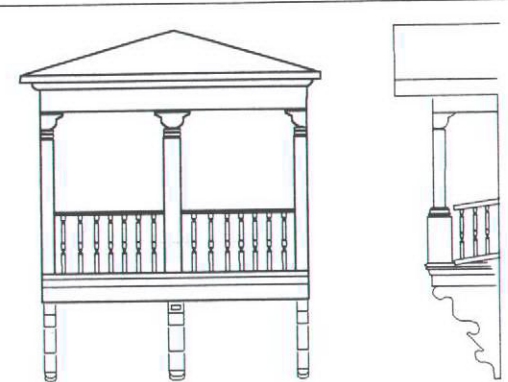
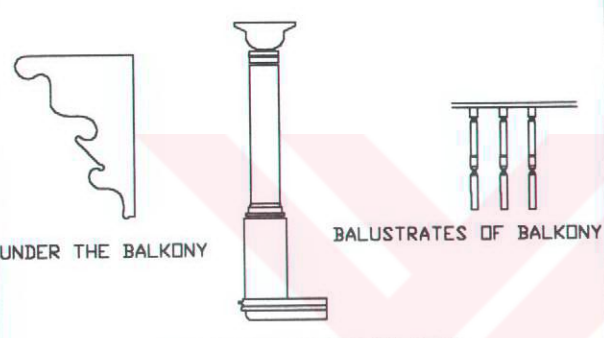
BUILDING NO:58-60		ANALYSIS:THE FACADE QUALITY OF THE BUILDING		11.3
PROJECTIONS		BALKONIES		
DO NOT HAVE

TIMBER STRUCTURAL ELEMENTS		OTHER DETAILS

<p>UNDER THE BALKONY</p> <p>THE POSTS ON THE BALKONY</p> <p>BALUSTRATES OF BALKONY</p>
