**CONSERVATION PROBLEMS OF SEMİZ ALI
PAŞA MADRASA AND DISCUSSION OF ITS
CURRENT STATE**

Master Thesis

MOUHANAD ABOUDAN

İSTANBUL, 2016

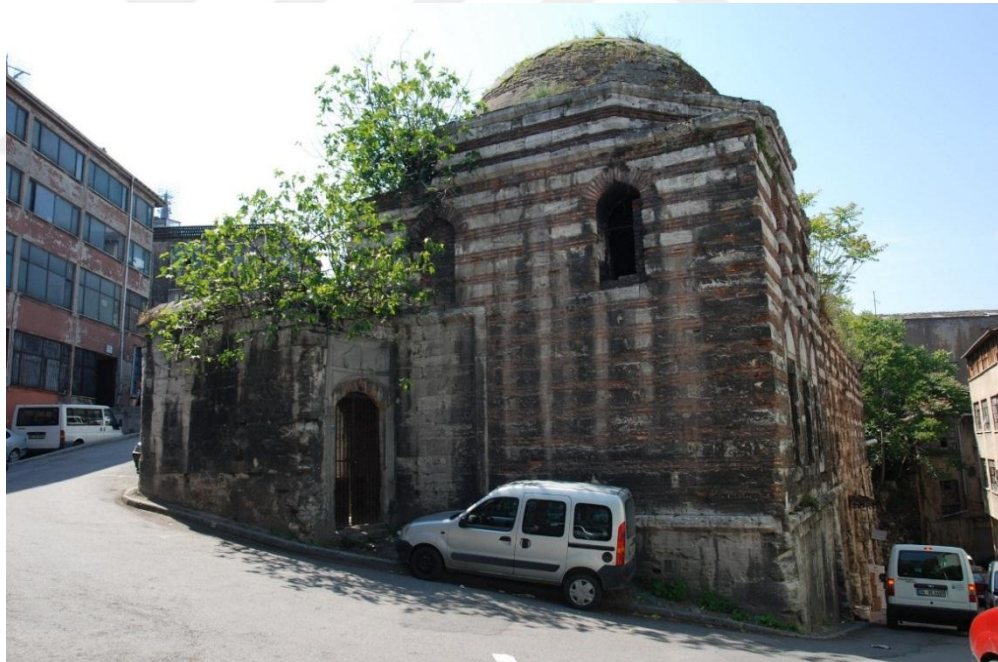
Trees and plants which can negatively affect buildings include creepers and ivy, among other types. They grow alongside the structures, especially on the walls, causing them decay and deteriorate in multiple ways (Figure 3.1).

Figure 3.1: Plants and Trees on Siyavuşpaşa Madrasa in Istanbul

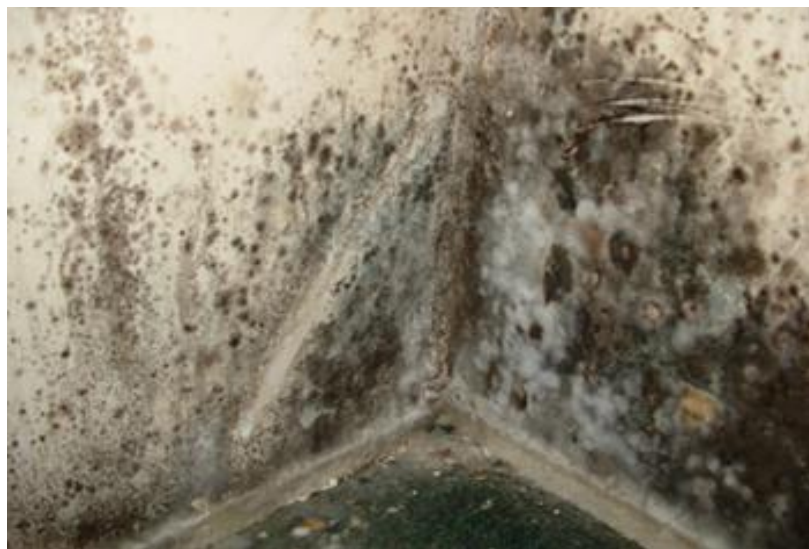
Algal deposits could cause damage, but on the other hand it produces acid which could provide a protective layer, shielding the surface from the effect of wind (Feilden, 1982, p. 131, Kaptan, 2010, p. 14). Fungus can cause serious damage to the buildings' materials. It can be visibly seen in the shape of spots and patches on the materials. Fungi do not need sunlight to grow, and instead they just need an adequate amount of water and oxygen (Figure 3.2).

Figure 3.2: Spots and Patches on a Wall Due to Fungus

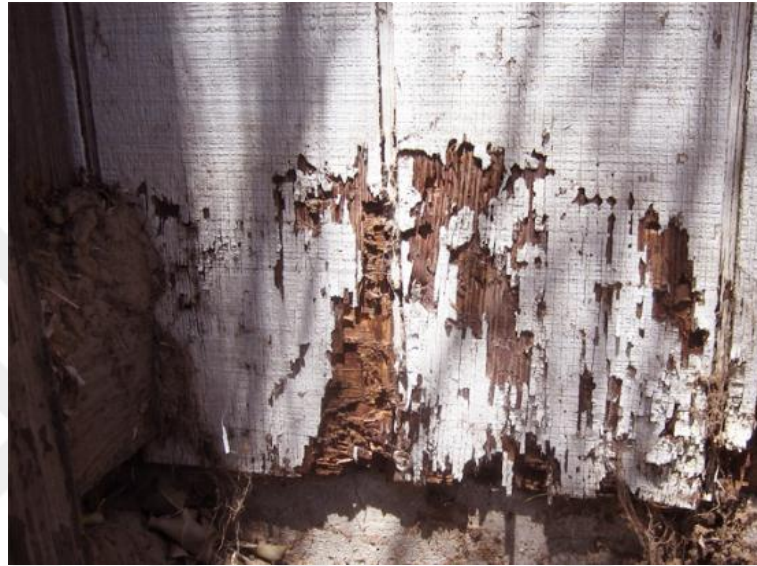
Minute fungi causes wood to decay and rot, which in turn contributes toward providing a suitable environment for insects. (Feilden, 1982, pp. 132-133). Insects such as beetles, carpenter bees, woodworms, and termites can cause massive damage. They weaken the wooden materials by attacking structural timbers and creating several small holes in them (Figure 3.3) (Feilden, 1982, p. 135, Croci, 2000, p. 53).

Figure 3.3: Insect Damage (Termites) on Wood

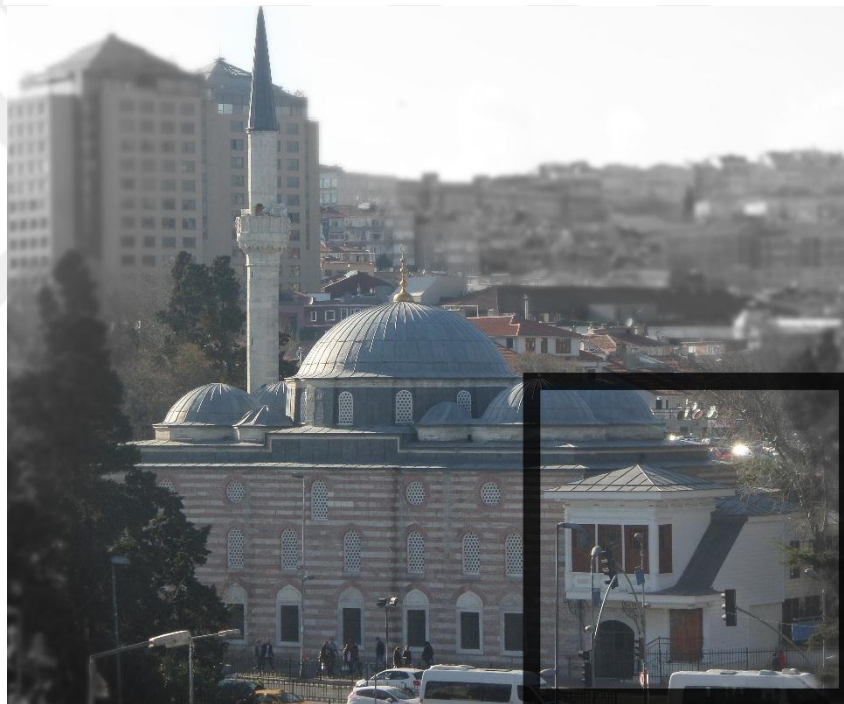
Increasing the weight of a structure changes its structural behavior. Some cases could include adding construction elements such as an attic or a projection (Croci, 2000, p. 43) (Figure 3.4).

Figure 3.4: Oriel Addition at Sinan Pasha Mosque in Istanbul

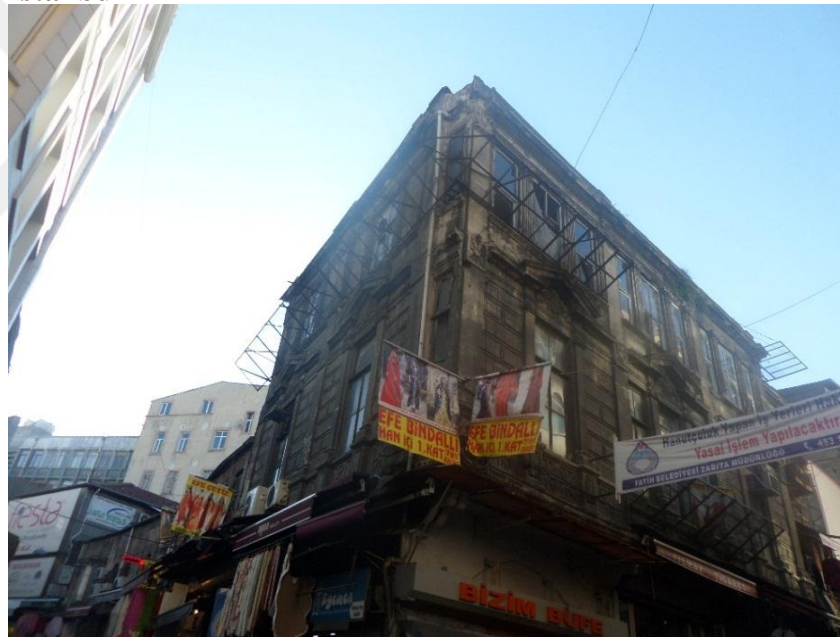
Smoke is considered to be one of the effects which causes decay to historical buildings. It is a result of the incomplete combustion of fuels. Usually it arises from burning inside power stations and vehicles. When its carried with the wind it could make layer of tarry soot which is an acid (absorbed sulfur dioxide) and could cause deterioration, especially to metal materials (Figure 3.5) (Feilden, 1982, pp. 109-110).

Figure 3.5: Effect of Air Pollution on a Historical Building

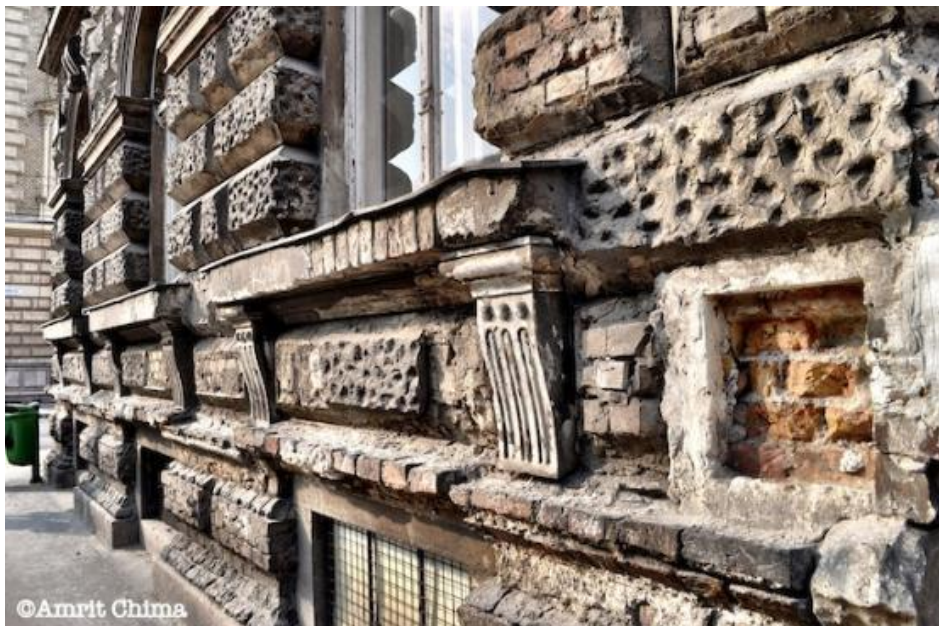
Sand and pebbles could also cause historical buildings to erode, especially when they are carried by the wind. The wind increases the abrasion of exterior materials when small pieces of cobble frequently hit the surface. Over time it could cause large holes to appear in the facade (Figure 3.6) (Feilden, 1982, pp. 109-111).

Figure 3.6: Building Decay Caused by Pebbles in Hungary

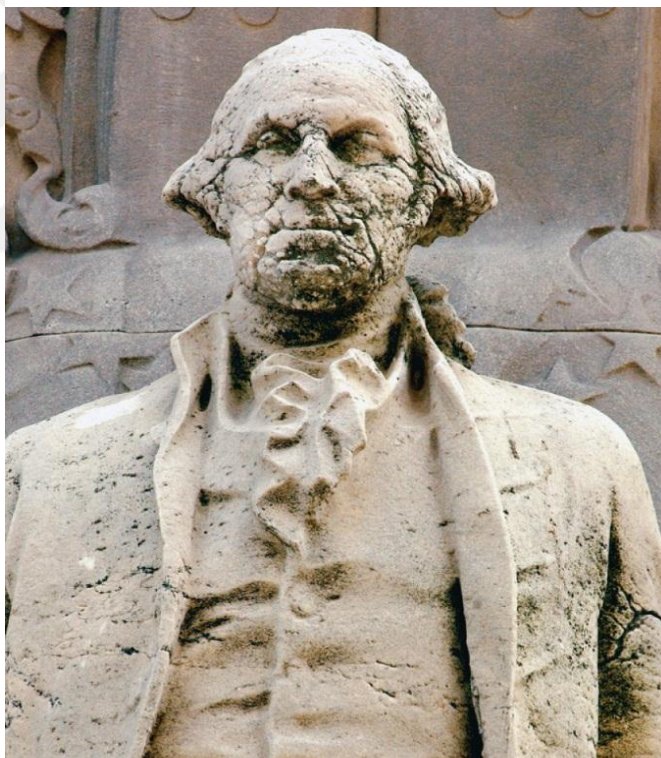
Acid rain is considered as one of the causes of deterioration, especially to statues. Acid rain contains sulfate which harms surface materials such as limestone, marbles and sandstone (Figure 3.7) (Fielden, 1982, p. 160).

Figure 3.7: Damage of Acid -Containing Water

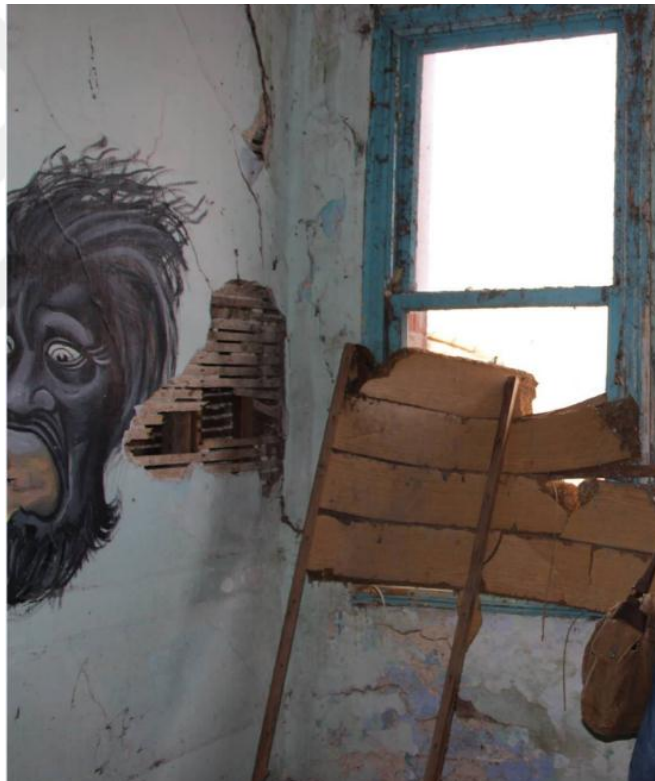
There are factors that can lead to the ignorance of maintenance of historical buildings such as the economic state, legal reasons, and property issues. Usually, massive deterioration can occur in historical buildings if they are used as a shelter by the homeless (Figure 3.8) (Kaptan, 2010, p. 19, Kasmó, 2008, p. 55).

Figure 3.8: Damage in a Building Used as a Homeless Shelter

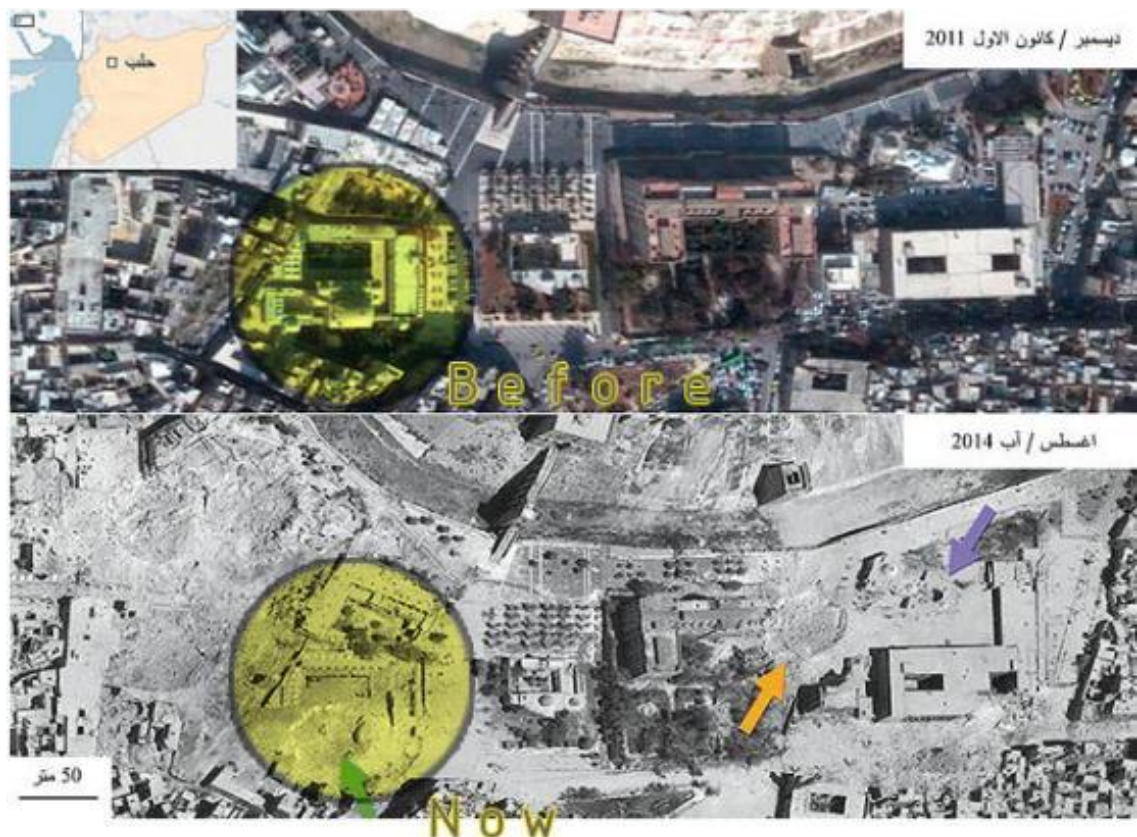
One example is the Mostar Bridge, which was destroyed by shells. Another example is Khusruwiyah Mosque in Aleppo, which was completely destroyed from explosions (Figure 3.9) (Kaptan, 2010, p. 19, Croci, 2000, p. 54).

Figure 3.9: The Entire Demolition of Khusruwiyah Mosque

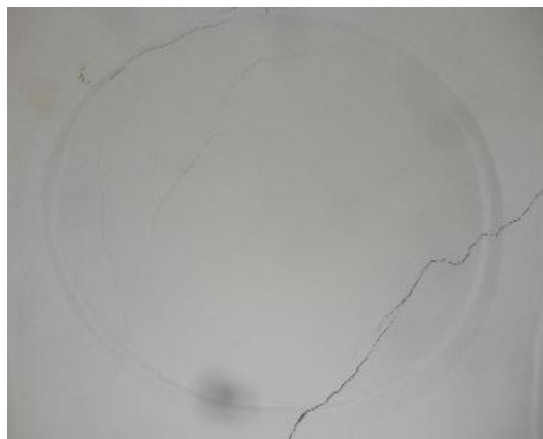
Figure 3.19: Damage of Dome Semiz Madrasa Istanbul

The force of gravity has an effect on the dome and could cause it to crack when the vertical forces are perpendicular to the base of the dome. In addition, those cracks separate the parts of the domes' arches and cause the dome to lose its stability (Figure 3.19) (Kaptan, 2010, pp. 41-42).

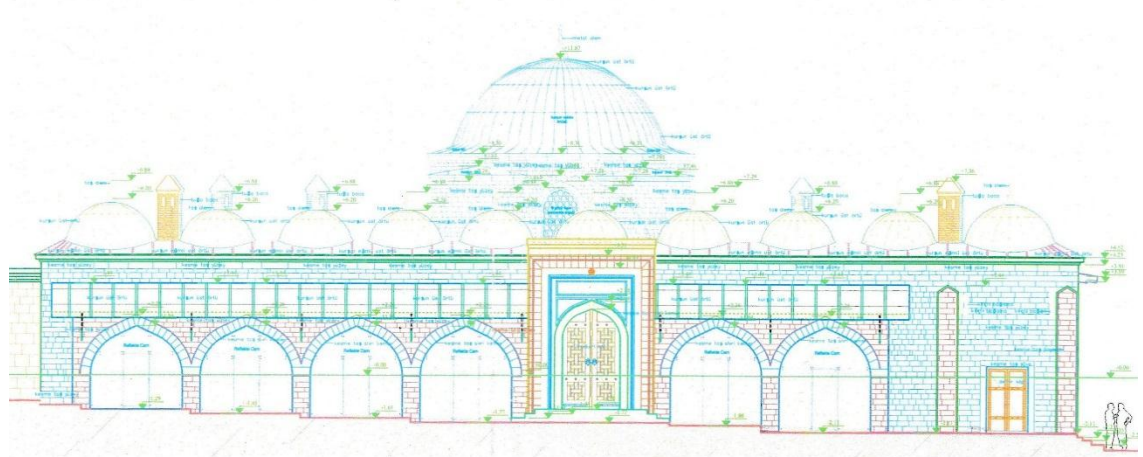
Figure 4.20: Northeastern Façade of Madrasa

The façade's wall is made of limestone plaster; this wall has a lot of cracks and structural problems due to neglecting.

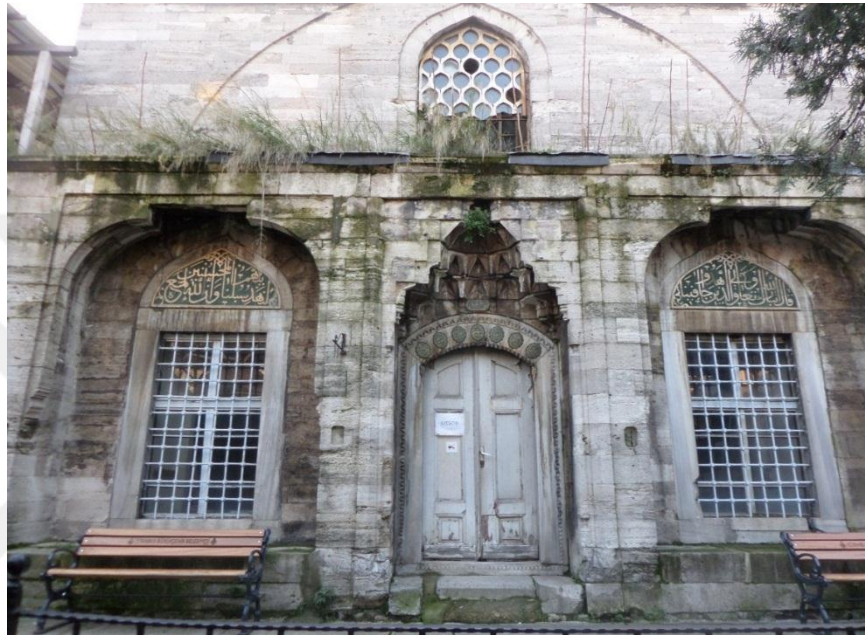
Figure 5.21: Façade of Classroom (G4G8F4F8)

There are inscriptions on the main façade of the main classroom. There is Chapters of the Quran besides Muqarnas. Therefore, the inscriptions are on three parts, the first one is above the entrance door of the Classroom and the other two are on both sides of the entrance (figure 5.21).

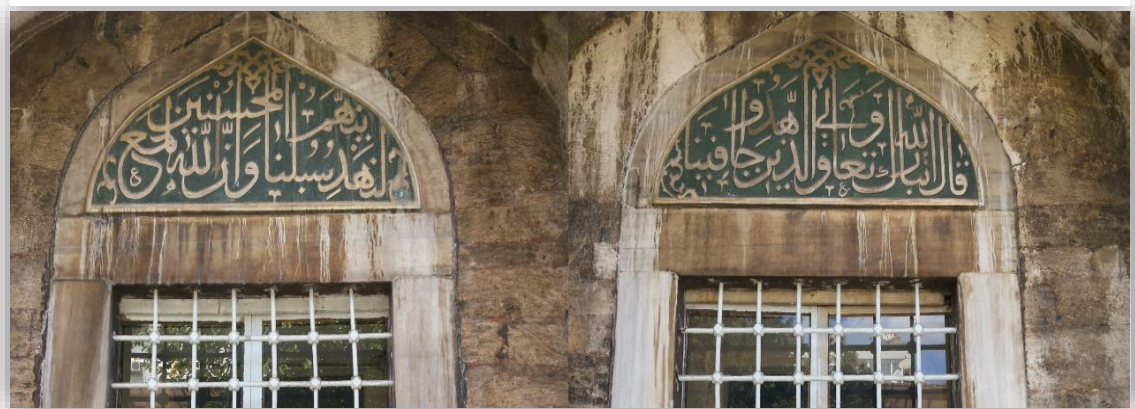
Figure 5.22: Inscription above Windows(G4G8F4F8)

In figure 22, we could notice the icons on both sides above the windows, those icons suffer of salting, flake and staining (figure 5.22).

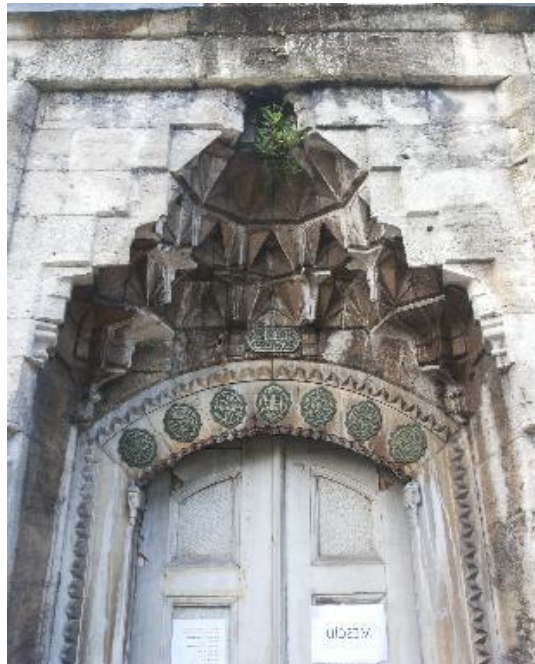
Figure 3.6: Lotus Unit on the Entrance (G6G7F6F7)

In figure 6, the entrance of classroom has many Decorative elements and most of them suffer from many Damage , the marble elements surrounding the door of classroom suffer of staining and salting, while the muqarnas squinch suffered of detaching, fluorescence and staining(Figure 3.6).

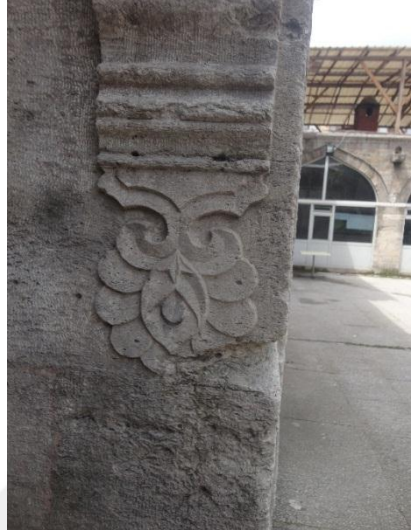
Figure 3.9: Flower Inscription

The small Inscriptions on the inside of bursa arch that has a flower shape suffered from detaching (figure 3.9).

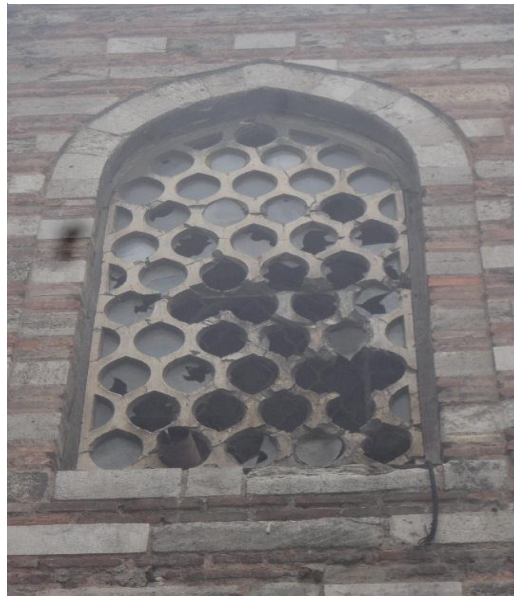
**Figure 5.24: Cells of Window
(I5I7H5H7)**

The upper window of classroom, which overlooks the street, has six-party cell's shape and the blanks vitrified. That window suffered from massive damage such as staining, detaching and missing pieces of glass (Figure 5.24).

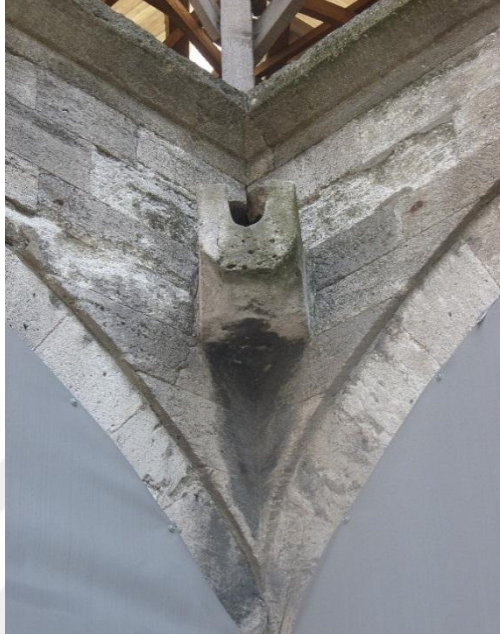
**Figure 5.25: Damage of Rain Gutter
(G2G3F2F3)**

The rain gutter (G2G3F2F3) suffered from damage such as salting, alga and staining and those damage occurred in most of the rain gutters of madrasa (Figure 5.25).

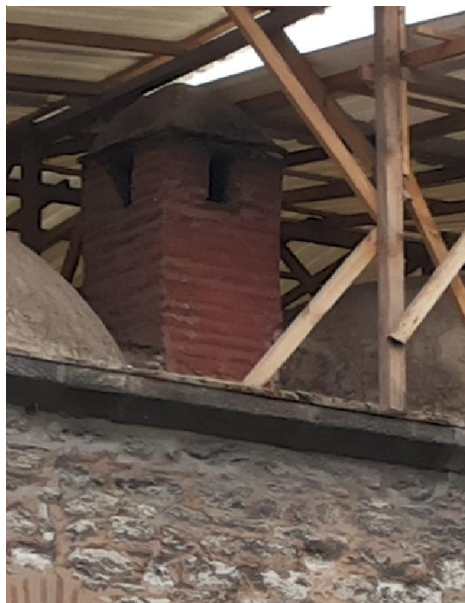
**Figure 5.26: Damage of
Chimney's Stacks**

The chimneys suffer from damage such as salting and staining and those damage occurred in most of the chimneys of madrasa (Figure 5.26).

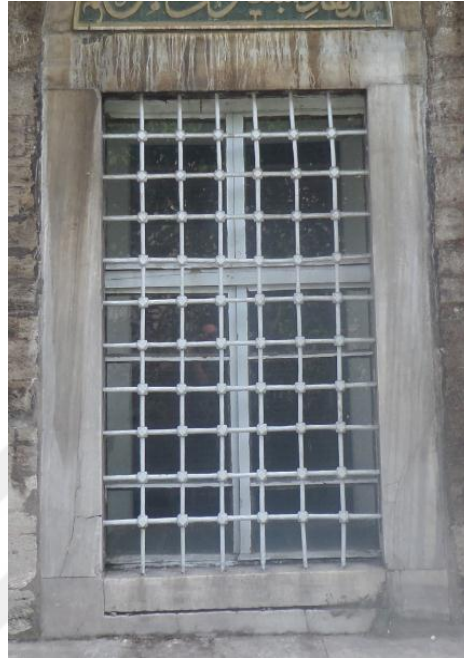
Figure 5.27: Window of Classroom (G5G6F5F6)

The marble surrounding the left window of façade of the classroom (G5G6F5F6) Suffer from salting, staining, cracks, detaching and flake (Figure 5.27).

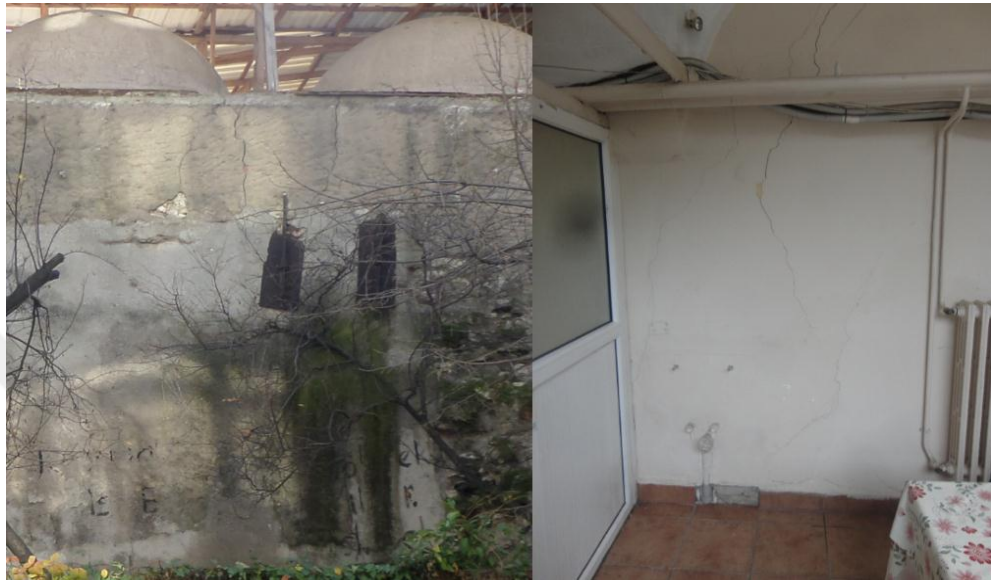
Figure 5.37: Damage of Wall (A8A10) 1. Exterior Face of wall

The exterior part of the arcade wall (A8A10) suffer graffiti, lichens, detaching, staining and (vertical and diagonal) cracks (structural damage), and the diagonal cracks appear on the interior part of the wall (Figure 5.37).

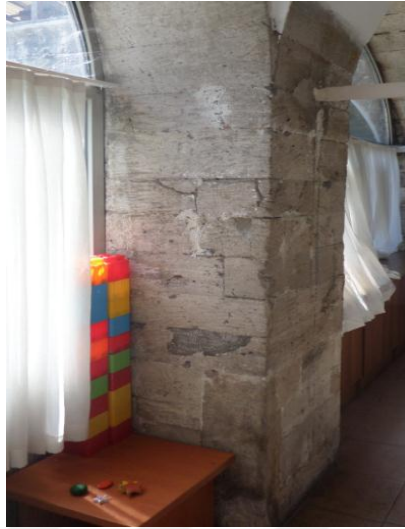
Figure 5.42: Damage of Pillars (B8)

The Pillars (B8) suffer from damage such as staining, cracks, and detaching (Figure 5.42).

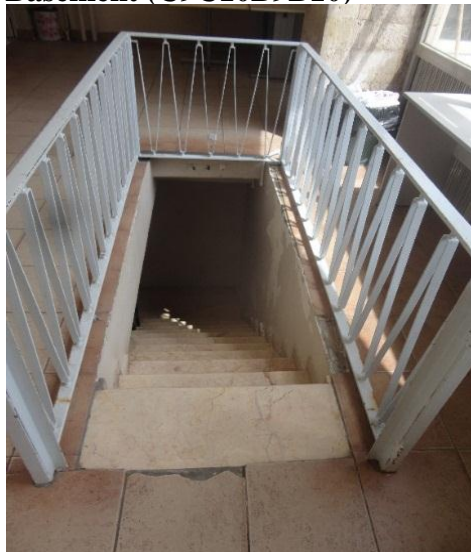
Figure 5.43: the Stairs of Basement (C9C10B9B10)

1958 was the last time the madrasa were restored and the restoration process finished in 1960, and they added a staircase that leads to the basement, another entrance was opened on the new road also the portico of madrasa is fitted with glass and the chimney of students rooms got closed, (Goncuoglu, 2011, p. 405). The added staircase through the restoration process in 1958 which was located on the arcade and lead to basement (C9C10B9B10) (Figure 5.43).

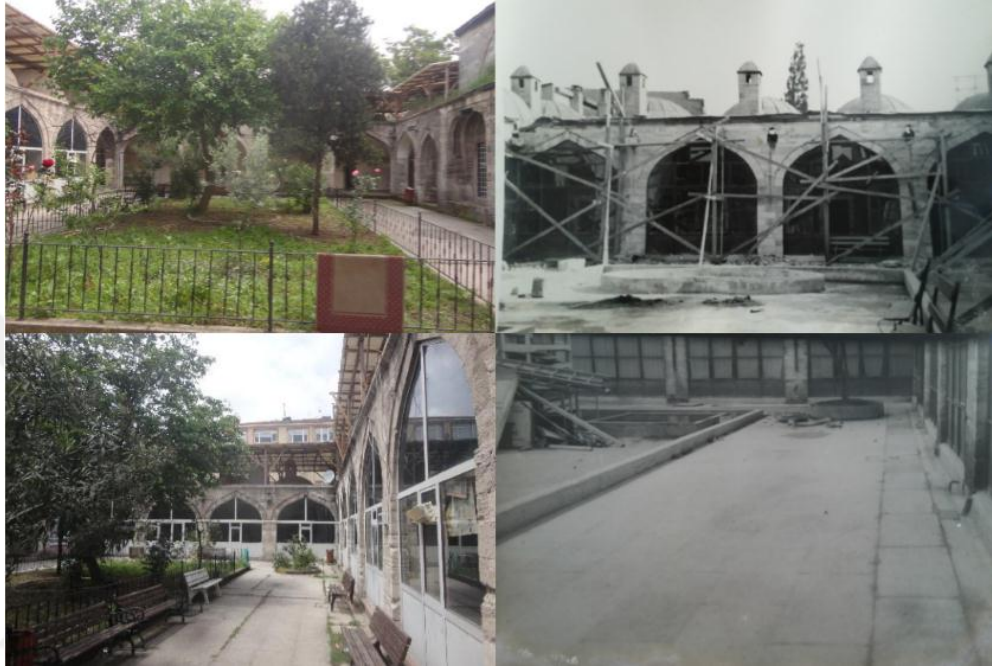
Figure 5.44: Intervention of Courtyard

The intervention on the madrasa's courtyard through the restoration process in 1958, was covering the ground with a layer of concrete, adding basins for plants in the center area of the courtyard and small basins for the garden, and they fitted the portico of madrasa with glass (Figure 5.44).

The plants' basins in the center of the courtyard, which were added during restoration in 1958 need to be removed because they do not have any historical value as well as their potential damage to the structure of the madrasa (Figure 5.114). According to the 11th article of the Venice Charter it is possible to remove some elements if they do not hold any historical value and the removal will not affect the original elements (ICOMOS, 1964).

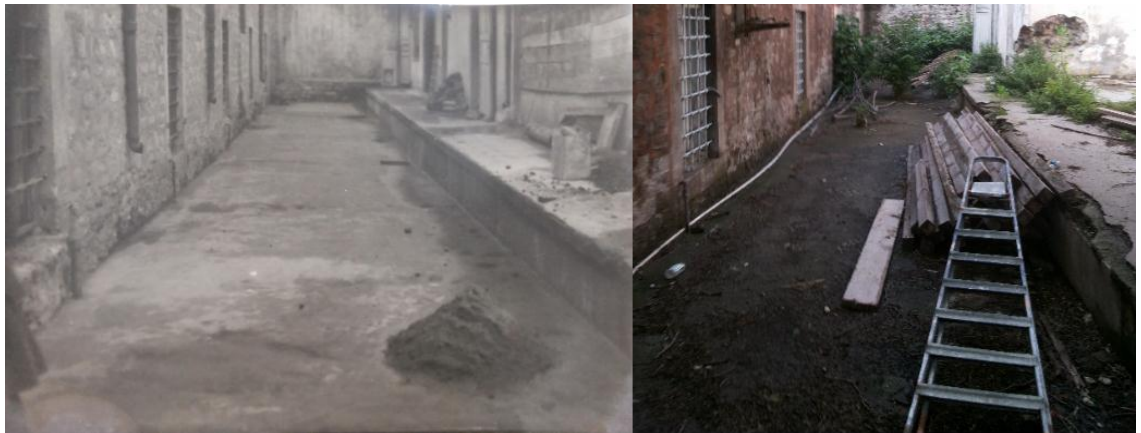
Figure 5.45: Intervention of Side Courtyard

There was intervention to the side courtyard of madrasa, which is located on the south western façade that occurred through the restoration process in 1958, where they covered the ground with a layer of concrete on two levels (Figure 5.45).

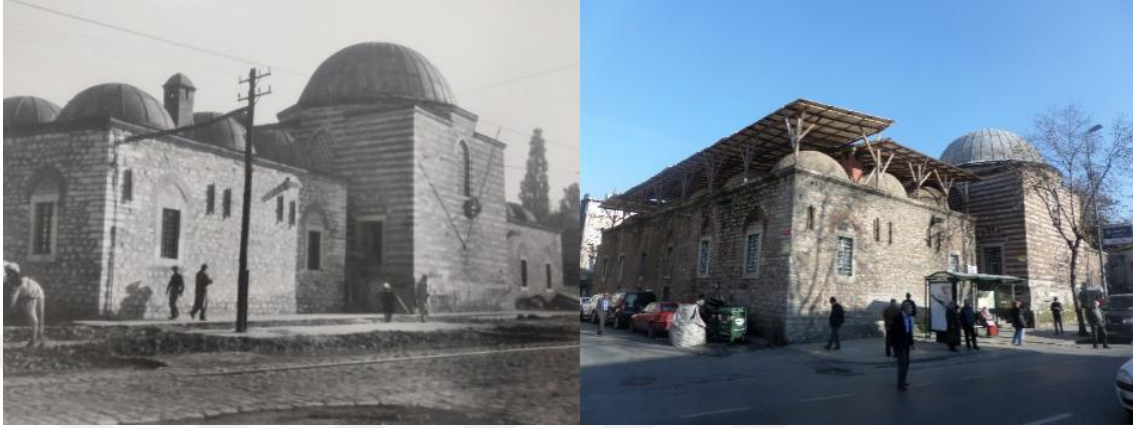
Figure 5.46: Intervention of Level of Main Façade

The main façade of madrasa, which is located on the new main road, was under intervention through the restoration process in 1958, where they removed the sidewalk, which increased the height of madrasa (Figure 5.46).

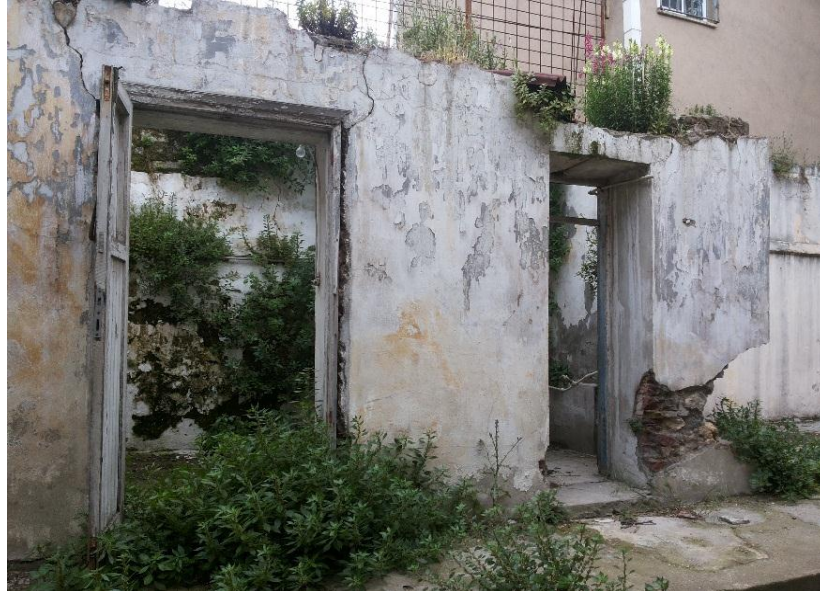
Figure 5.47: Addition of Toilets of Side Courtyard

The addition of toilets on the side courtyard of the madrasa, which is located on the south western façade, occurred in the restoration process in 1958(Figure 5.47).

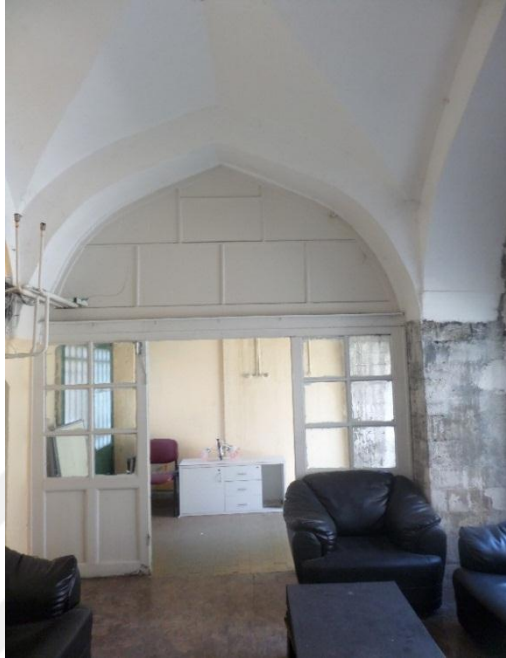
Figure 5.48: The Addition of Partition (G4F4)

The addition of the partition, which is placed on the arcade (G4F4) made from metal and wood (Figure 5.48).

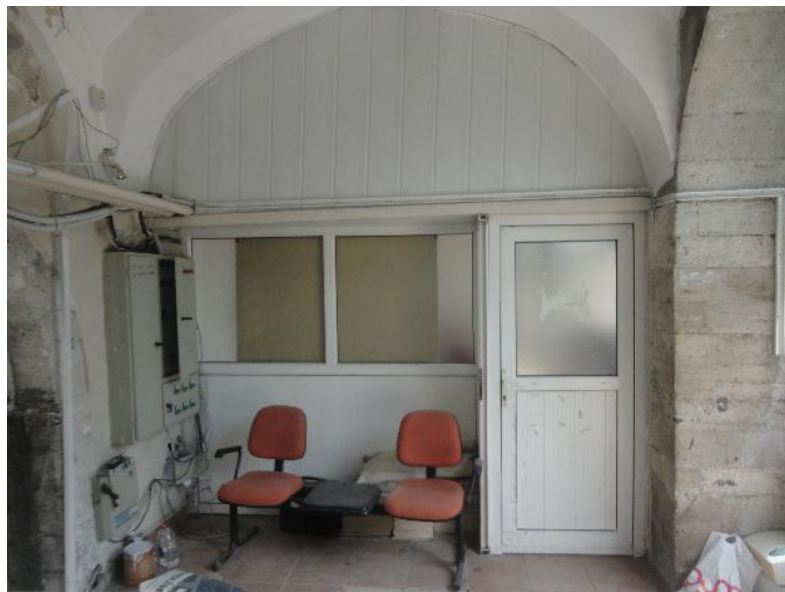
Figure 5.49: The Addition of Partition (A6B6)

The addition of the partition, which is located on the arcade (A6B6) made from plastic and glasses (Figure 5.49).

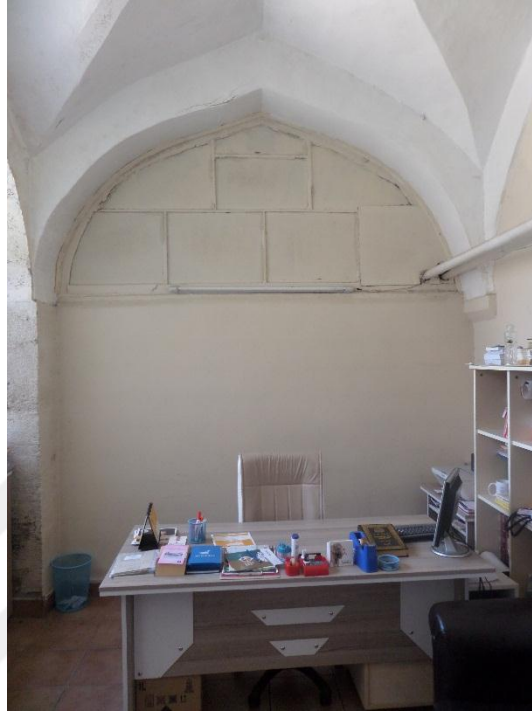
Figure 5.50: The Addition of Partition (G8F8)

The addition of wall, which is located under the arcade (G8F8) made of glasses and concert (Figure 5.50).

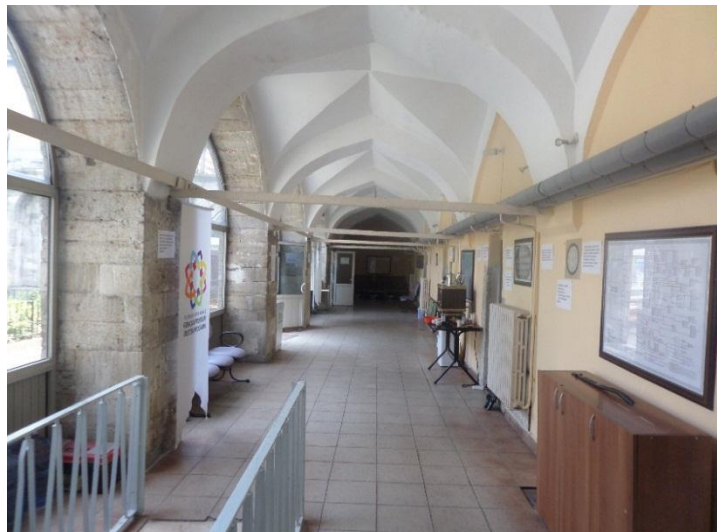
Figure 5.51: The Addition of Pipes and Electric Wires in Arcade

The addition of Pipes, electric wires and heating devices, that is located in the arcades of madrasa (Figure 5.51).

Wrong interventions caused many massive damage to the madrasa, such as removing the lead covering the domes of madrasa, which caused many damage such as flakes. Also, the addition of a new staircase leads to the basement caused many cracks especially on the basement's wall. While adding new heating pipes and electrical wires made many holes on the building's walls.

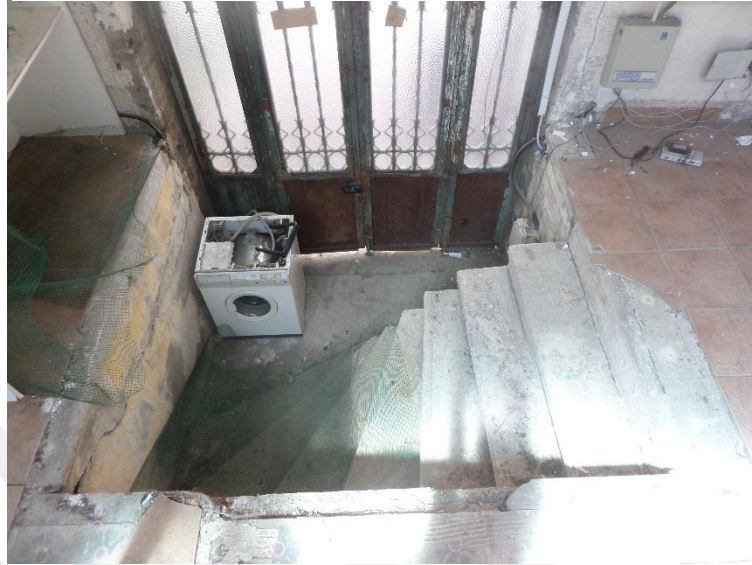
Figure 5.52: The Addition of New Staircase

Removing old staircase and adding new one (A6A7B6B7), located under the arcades of madrasa (Figure 5.52).

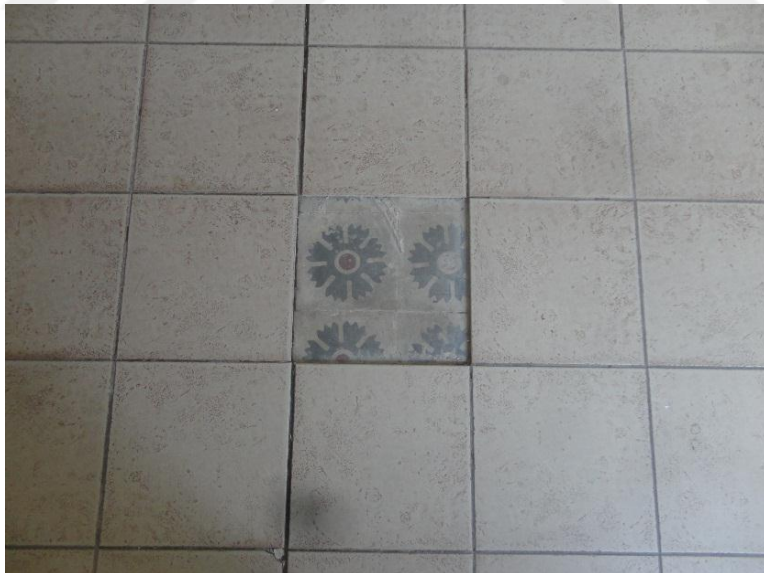
Figure 5.53: The Addition of Tiles

Addition of new tiles above the original tiles in most of madrasa (Figure 5.53).

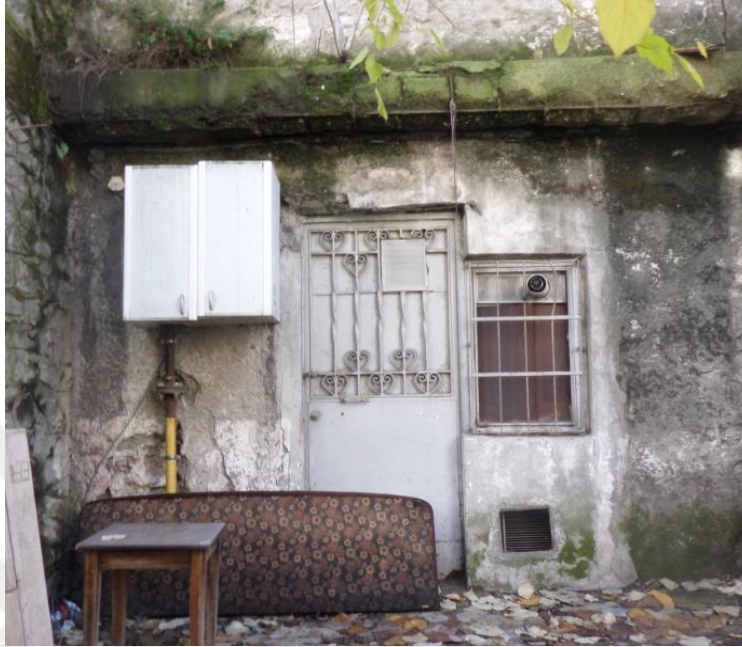
Figure 5.54: The Addition of Door (A10A11)

Addition of iron windows and doors (A10A11) which leads to the basement of madrasa (Figure 5.54).

The addition of iron windows and doors that lead to the basement (A10A11) on the northeastern part of madrasa should be removed and replaced with a new gate made of materials compatible with the type of madrasa. According to the ICOMOS charter, any new materials that will be used should be harmonious with the original material of the historical building (ICOMOS, 2003) (Figure 5.126).

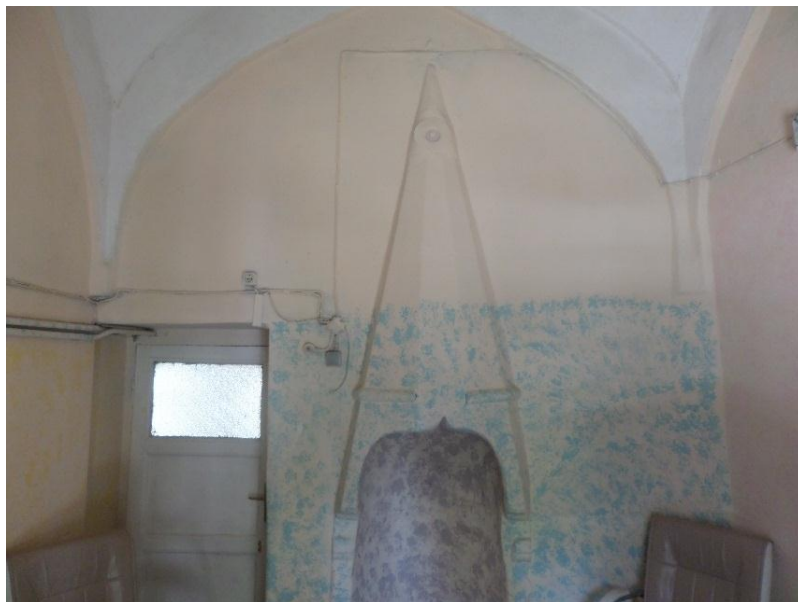
Figure 5.55: The Chimney of Room (H2H3G2G3)

Removing all chimneys of madrasas cells except for one of them, which is located in room (H2H3G2G3) (Figure 5.55).

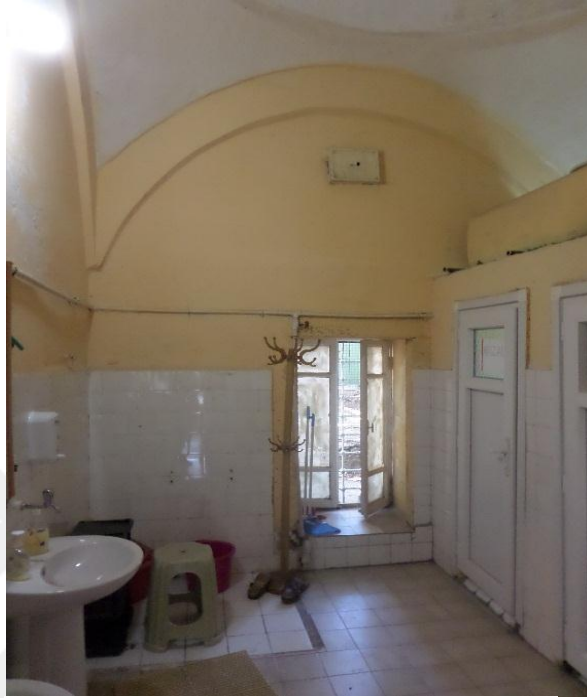
Figure 5.56: The Addition of the Bathroom in Room (E1E2G1G2)

changing the room (E1E2G1G2) into a bathroom and adding toilets cabins, a sink and ceramic on the walls of the room (Figure 5.56).

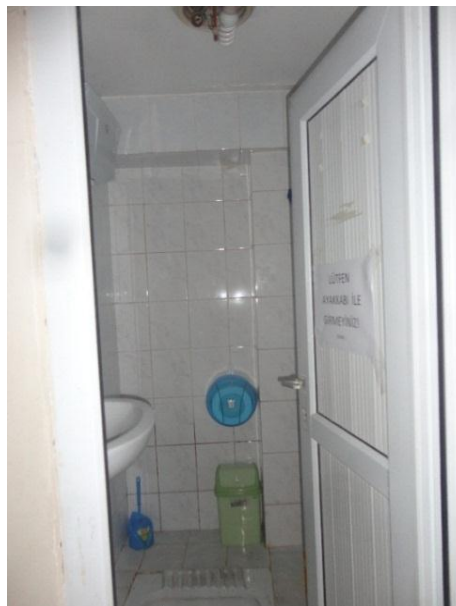
Figure 5.57: The Addition of Toilet (A9A10B9B10)

The addition of a toilet, located in the basement of madrasa (A9A10B9B10) (Figure 5.57).

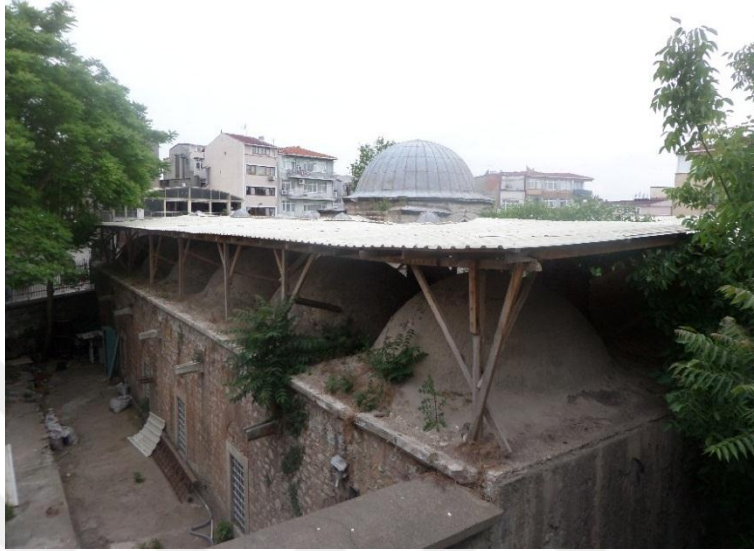
Figure 3.44: The Remove of Lead of Domes

All of the lead domes were stolen by thieves except for classrooms dome (Figure 3.44) (*Bilim ve insan vakifi restorasyon clasima raporu*).

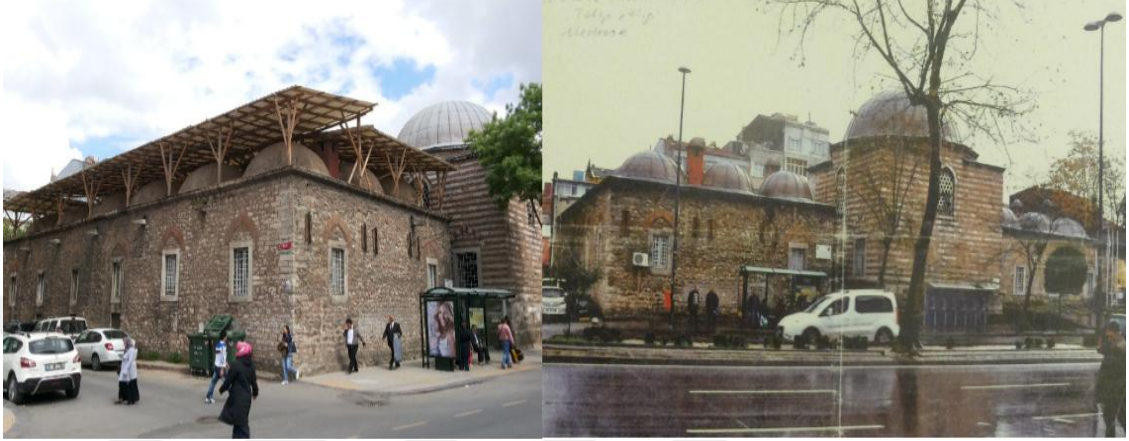
Figure 6.3: The Lead of Domes 1. After Removal 2. Before Removal

One of the interventions was stolen which caused a large amount of damage to the domes because of rain leaking. Article 12 of the Venice Charter emphasizes that "the replacement of missing parts should be integrated with the whole, however should be differentiated from the original missing part" (ICOMOS, 1964) (Figure 6.3).

Therefore, it is necessary to replace the lead covered domes with new ones that are distinguished from the original lead covering (*Bilim ve insan vakifi restorasyon clasima raporu*) (Figure 5.132). The steps that are located in front of the main façade should be removed because these steps do not have any historical value and they are deteriorating the façade (Figure 6.4).
