**CONSERVATION PROJECT OF LATİFE HANIM
HOUSE IN KARŞIYAKA, İZMİR**

**A Thesis Submitted to
the Graduate School of Engineering and Sciences of
İzmir Institute of Technology
in Partial Fulfillment of the Requirements for the Degree of**

in Architectural Restoration

**by
Esra DİPBURUN**

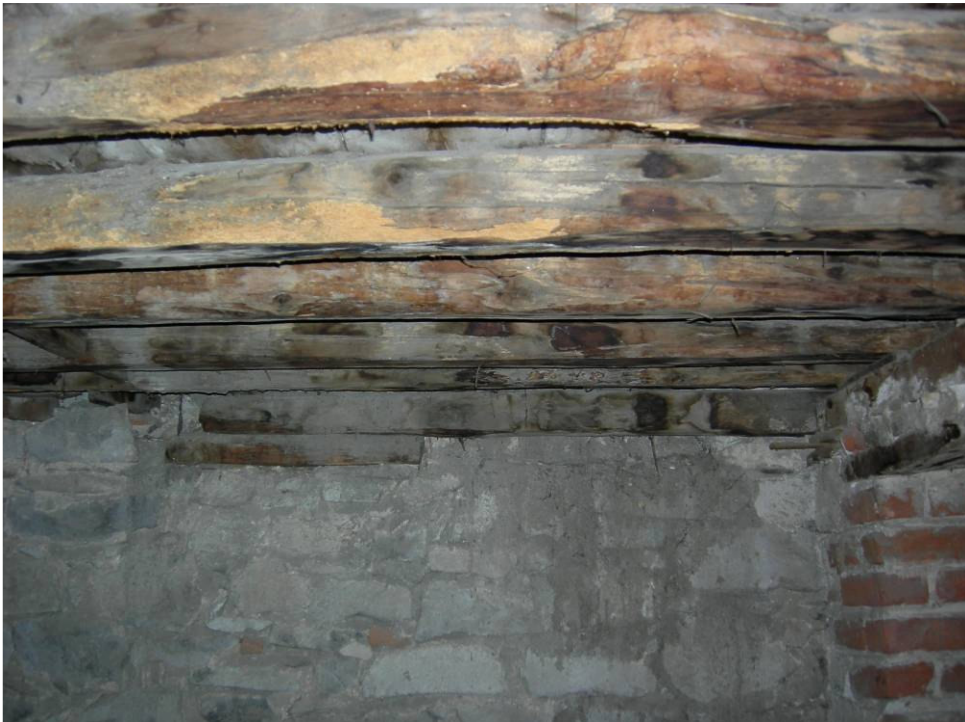
Figure 2.13. The ceiling of storage space 2 at the basement.

Storage space 2, at the southern side of the corridor, is entered through an opening (0.75 by 2.00m.). Since the ceiling is exposed; timber joists of the floor of the room 3 at the ground level can be observed from here (Figure A.3, Figure 2.13). They are rectangle in shape and have 40 cm. intervals. The walls of the space are not plastered. The masonry bond of the stone walls is observed (Figure 2.14). The southern wall of the space extends to the garden with two window openings (0.75 by 0.60m.). The windows are double leafed and made of iron (Figure 2.12). The floor of the space cannot be observed at present because of the rubble waste.

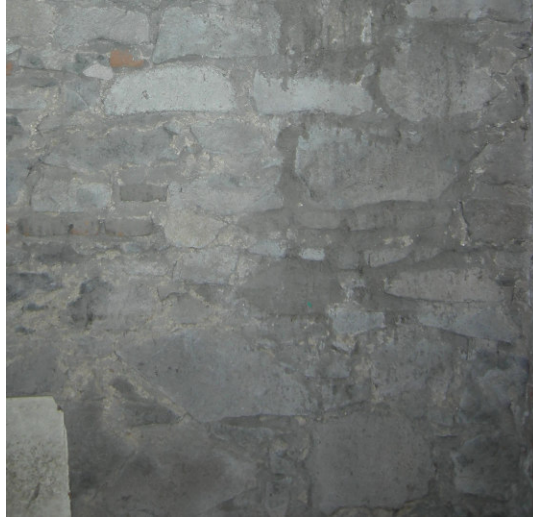
Figure 2.14. Exposed stone walls of Space 2 at the basement.

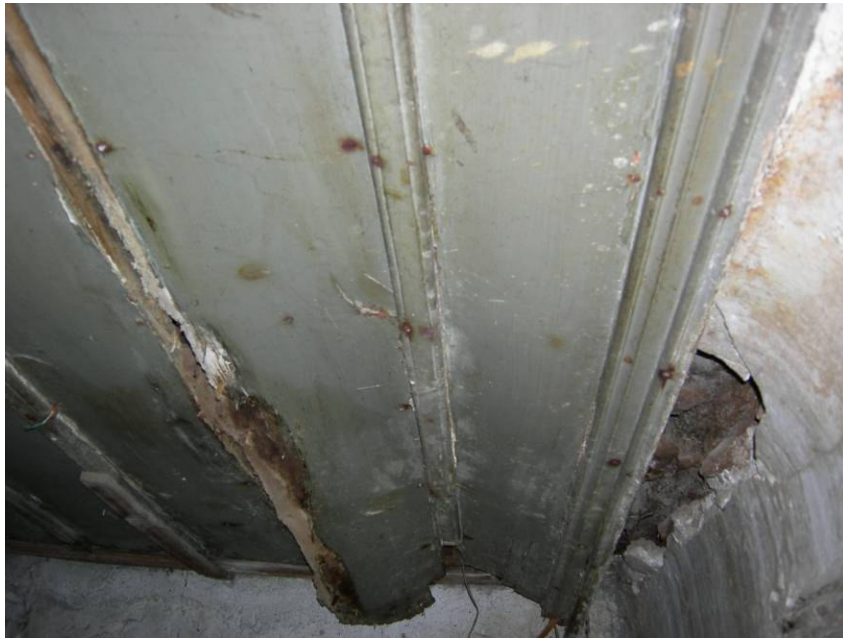
Figure 2.17. The ceiling of wet space 2 at the basement floor.

The bathroom, wet space 2, which is rectangle in plan (1.75 by 2.00m.), is entered through a door opening (0.60 by 1.95 m.), that has no leaf at present. The ceiling of the bathroom is covered with wood laths and there are gypsum moldings at the sides where the ceiling and the walls connect (Figure 2.17). Material deterioration is observed on some of the wood laths. The walls are plastered. The northern wall extends to the garden with a window opening (0.75 by 0.60m.). On the northern wall, there is a ceramic pipe (\emptyset 0.15m.) which is placed 0.30 m. away from the corner (Figure 2.18). On the eastern wall of the bathroom, there is a marble basin (Figure 2.19). On the southern wall of the bathroom there is an inner window (0.60 by 0.60m.) which provides connection with the sub-space (Figure 2.20). The leaf of the window is lost at present.

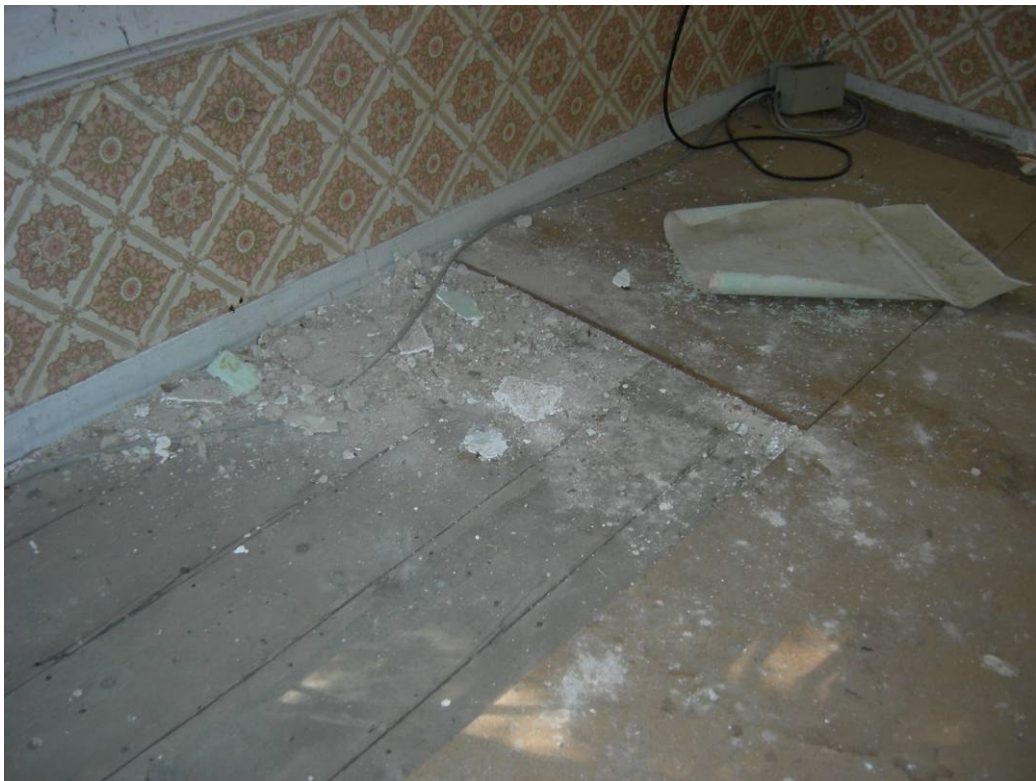
Figure 2.34. The floor covering of room 1.

The room at the south-western corner of the hall, room 1, is almost square in plan (4.67 by 4.19m.) and it is entered through a double leafed door (1.30 by 2.40m.) by one step ascending from the hall (Figure 2.31). The ceiling is covered with wood laths and there are timber moldings at the joining zone of the ceiling and walls (Figure 2.32, Figure A.5). The walls of the room are covered with wall-paper (Figure 2.31). There is a timber chair rail that runs along all the walls of the room. It is 15 cm. in thickness and painted in white oil paint. The southern and the western sides of the room extend into the garden with two window openings (1.10 by 2.20m.) on each side (Figure 2.33). The floor of the room is covered with chipboard at present, the original timber covering is observed at some parts beneath it (Figure 2.34).

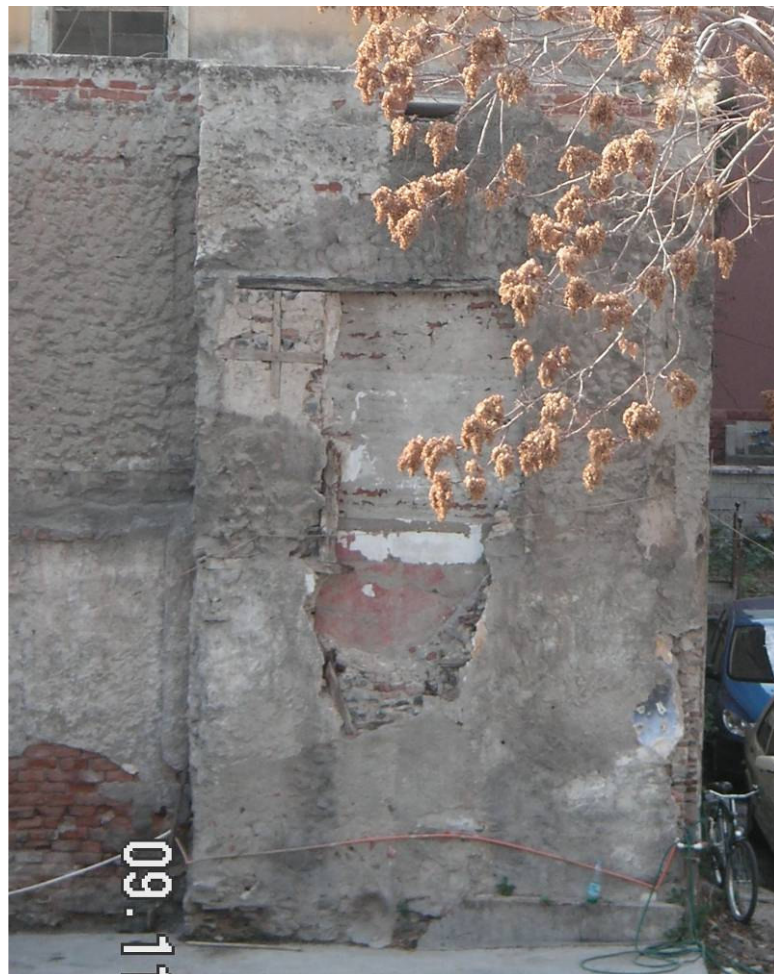
facade (Figure 2.93). This wall gives the impression that is original wall with its construction system and its plaster on it. The construction system of the wall is timber skeleton with stone and brick infill. Some part of the wall is ruined and this ruined part shows a character as it was a door opening originally. There is another wall seen under beneath this ruined part.

Figure 2.93. The projected wall of the annex.

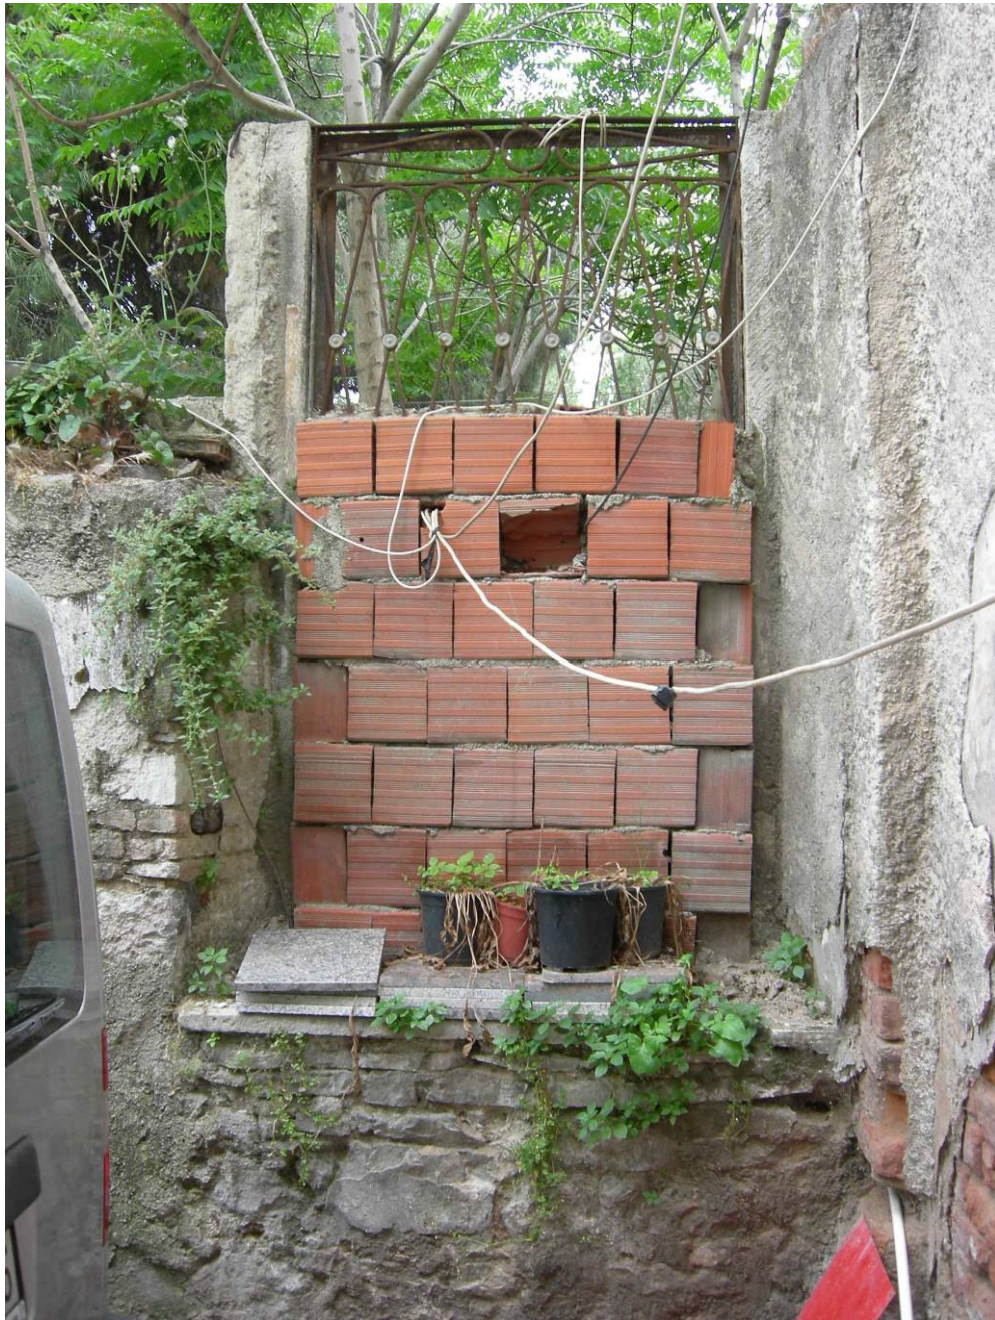
Transformation of the annex that flanks the house at the east is the most important alteration observed in the house. The ground floor of the annex is composed of two spaces, a room at the northern and a wet space at the south which is divided into smaller sections with low separation walls. In order to decipher the originality of this annex, the construction techniques of its walls are investigated. Only the northern wall of the room and a wall piece at the south are observed as stone masonry. The wall piece at the south is more similar in workmanship and thickness to the basement walls of the main building, also its window it contains has an iron grill with same details as those in the main building (Figure 2.111). Because of this reason, this wall piece is considered as original. Because of the presence of this original wall piece, the annex is considered as a transformed space.

Figure 2.111. The masonry wall piece at the south of the annex.

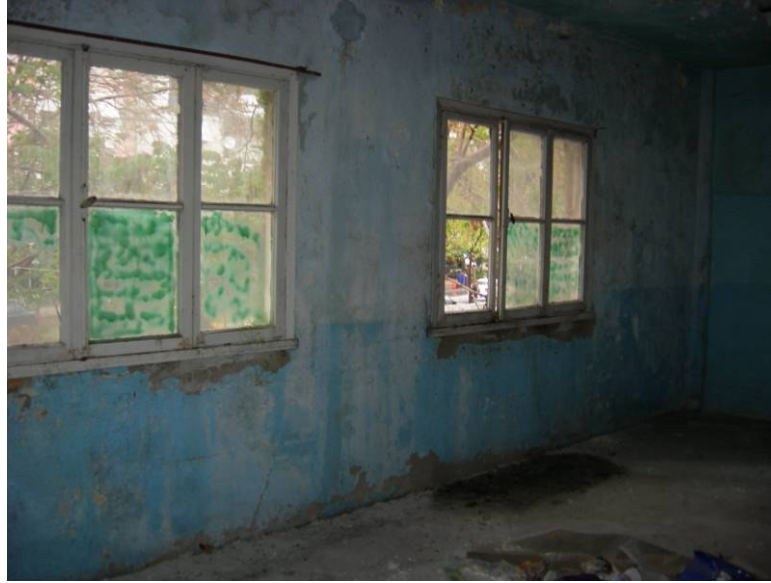
The additions in the building are observed as spatial additions and element additions. The spatial additions are the spaces of the annex at the mezzanine floor. The construction technique of the floors of this space is reinforced concrete and the walls are brick masonry. Since they are inconsiderate structures, the spaces of the annex at the mezzanine floor are considered as later additions (Figure 2.112). The additional elements observed in the house are as follows:

Figure 2.112. The additional rooms of the annex at the mezzanine floor.

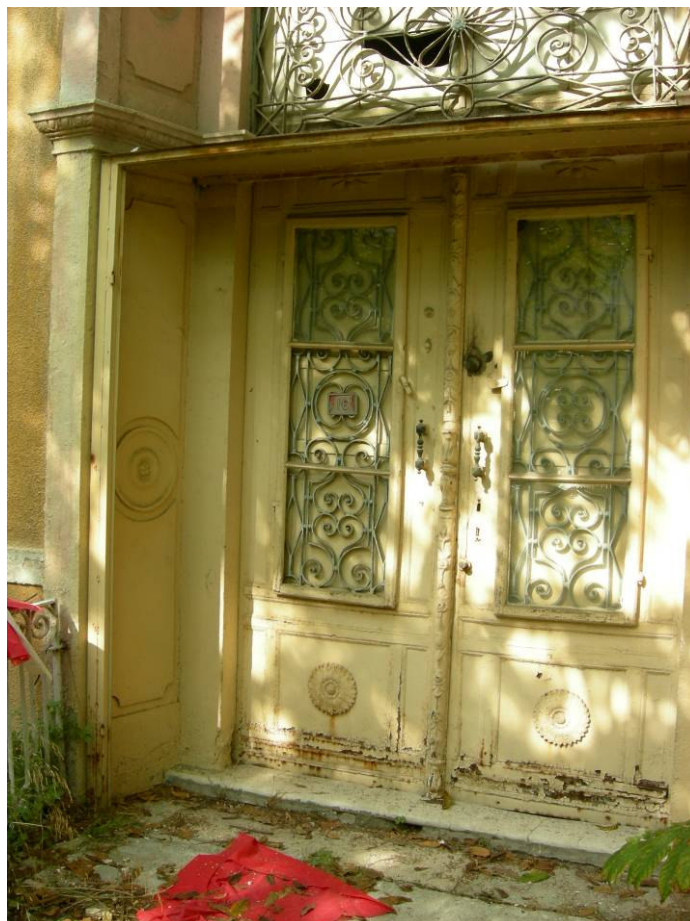
The addition of supporting studs (Figure 2.11, Figure D.2) at the basement floor, addition of metal joinery at the entrance space (Figure 2.113), the addition of separation door between the stairwell (Figure 2.29, Figure D.10) and the inner hall and the addition of chipboard panels over the original floor covering of rooms at the ground floor (Figure D.3).

Figure 2.113. The additional metal joinery at the southern entrance.

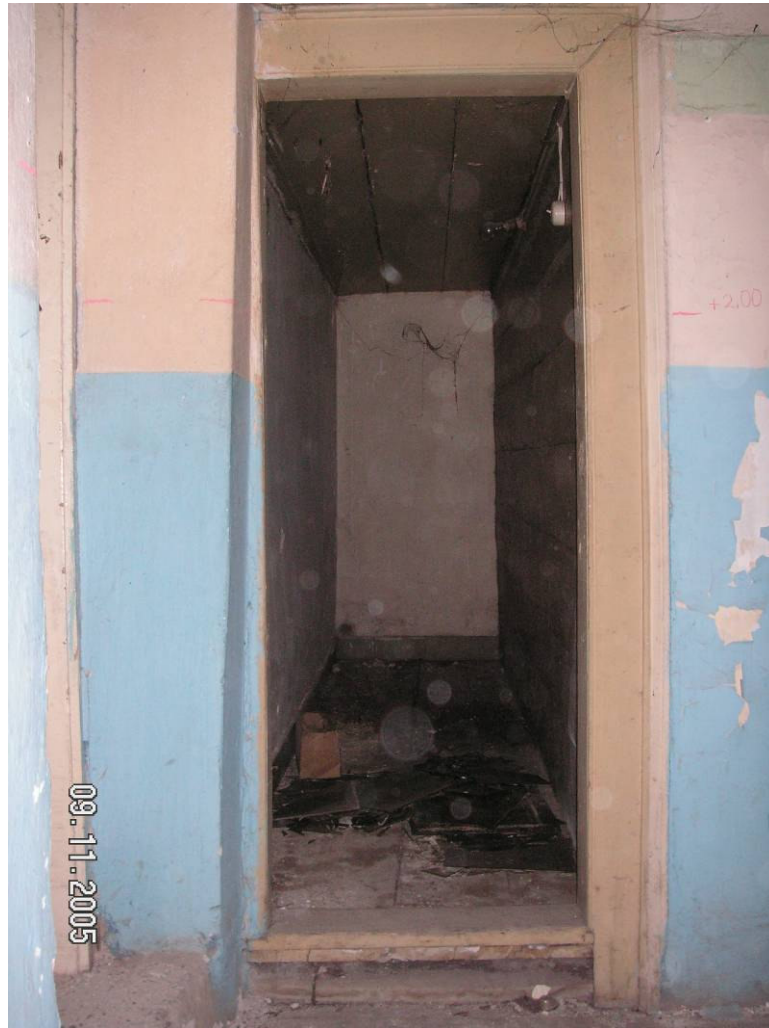
The loss elements are observed at various spaces in the building. All the window shutters of the ground and first floor windows are missing. Door leaves of the wet space 1 and 2 at the basement, door leaves of the rooms at the mezzanine floor (Figure 2.114, Figure D.5), door leaf of the wet space at the first floor, and window leaves of wet space 1 and 2 at the basement and window leaves of room 6 (Figure 2.76) at the first floor are missing. The lids of the kitchenette cupboards are lost as well (Figure 2.101).

Figure 2.114. The dark space that has no door leaf at present.

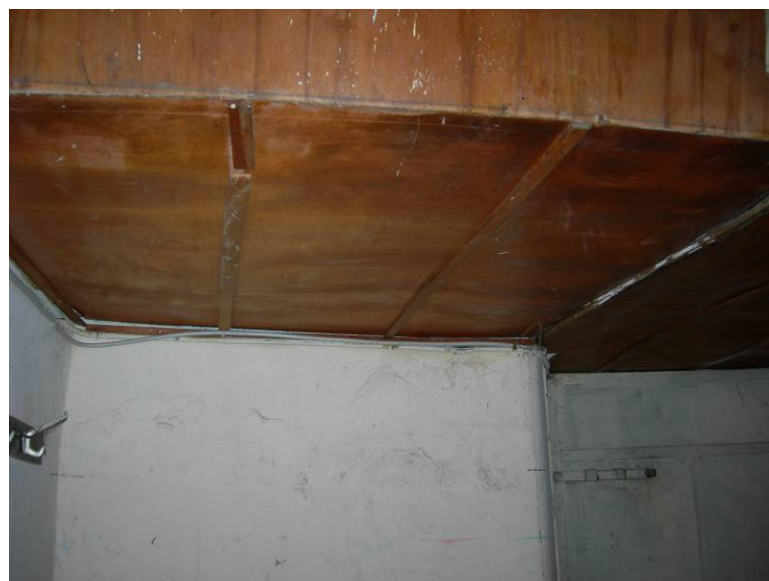
The renewals are observed on the floor coverings and ceiling coverings in the building. The floor coverings of room 6 and the hall at the first floor are renewed with timber covering with a width of six cm. The ceiling covering of the room at the mezzanine floor is renewed with plywood covering (Figure 2.55, Figure D.6). The ceiling of the space at the ground floor, which is under the stair landing, is renewed with plywood (Figure 2.115, Figure D.4). The balusters of the stair are other renewed elements observed in the house. The original baluster is renewed with unqualified timber bars (Figure 2.116). The handrail of the stairs seems as original. The renewal of the exterior plastering on the facades and on some walls at the basement and the mezzanine floor are other alterations observed.

Figure 2.115. The renewed ceiling covering of space under the stair landing.

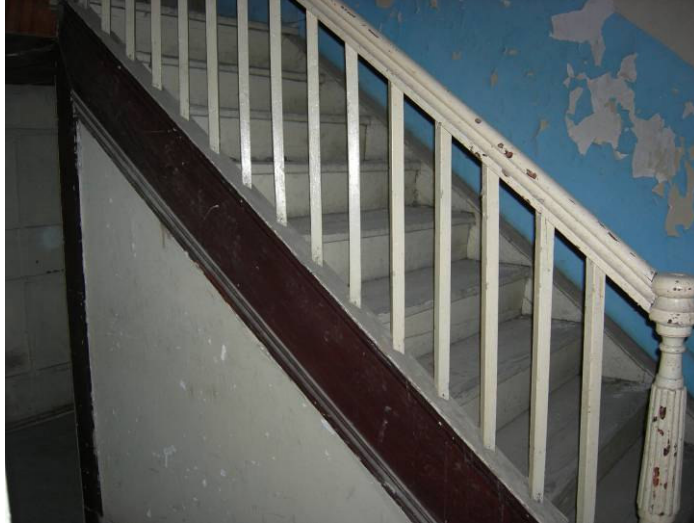
Figure 2.116. The renewed balusters.

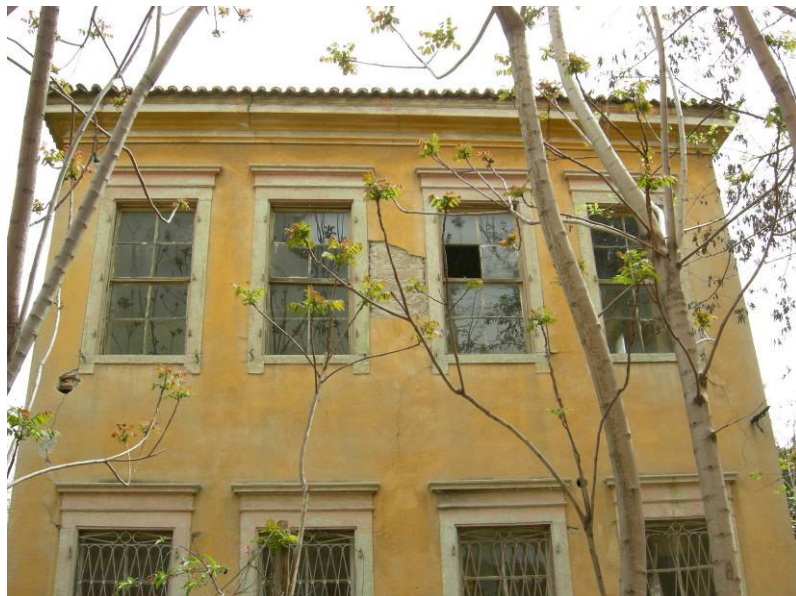
It is observed that Latife Hanım House in Karşıyaka has limited structural problems (Appendix E). The cracks observed at the western wall, emerged after the earthquakes in November 2005¹ (Figure 2.117). Especially those at the northern corner of the western wall are the most important structural failures in the building. These are detachments in the mentioned wall starting from the cornice level and continuing uptil to the starting zone of the ground floor level. (Figure 2.118). When the distribution of the cracks on this western wall are considered, it is understood that the excess number of openings create a great load on the masonry wall piece between the ground and the first floor opening series (Figure 2.119). The majority of the cracks are located at this area. A long, but thinner crack is observed at the southern corner of this wall as well (Figure E.12). It is assumed that the link between the floor and this western wall is not strong enough. In turn, cracks are have formed².

Figure 2.119. The distribution of openings on the western wall.

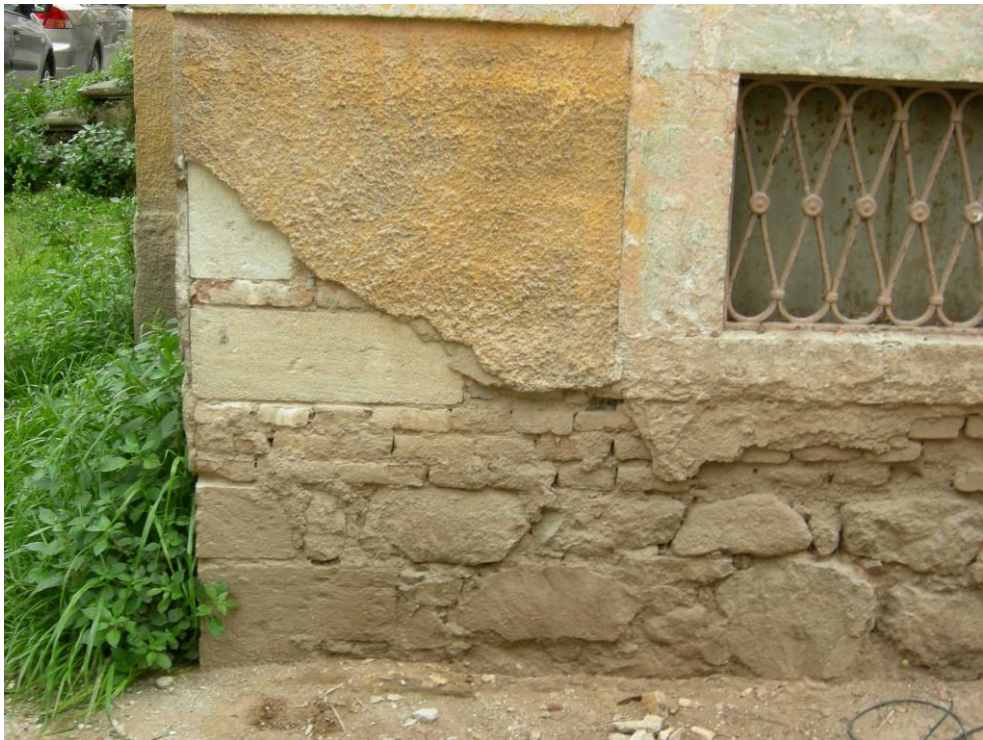
At basement level, rising damp³ is the most important source of deterioration. On the bottom parts of the walls of the basement floor, up to level of 1.20 m., loss of plaster and salt crystallization are observed at the interior and at the outside because of the rising damp (Figure 2.122, Figure 2.123, Figure E.9). In addition, because of the lack of ventilation in the basement, the relative humidity⁴ of the basement is high. The ceiling coverings of the basement are deteriorated because of the high air humidity that cause fungi and insect formation. On the timber beams of storage space 1 and storage space 2, there are holes or white stains in timber due to insect attack and fungi attack (Figure 2.124, Figure 2.125). Also the timber studs in storage space 1 have losses at the edges. In wet space 1 and wet space 2 at the basement floor, the decay in wood laths is observed due to fungi formation (Figure 2.126). Due to high air humidity in the basement, the gypsum moldings and paints are also deteriorated; discoloration is observed on them (Figure 2.126, Figure E.1).

Figure 2.123. The loss of plaster on the bottom part of the exterior walls.

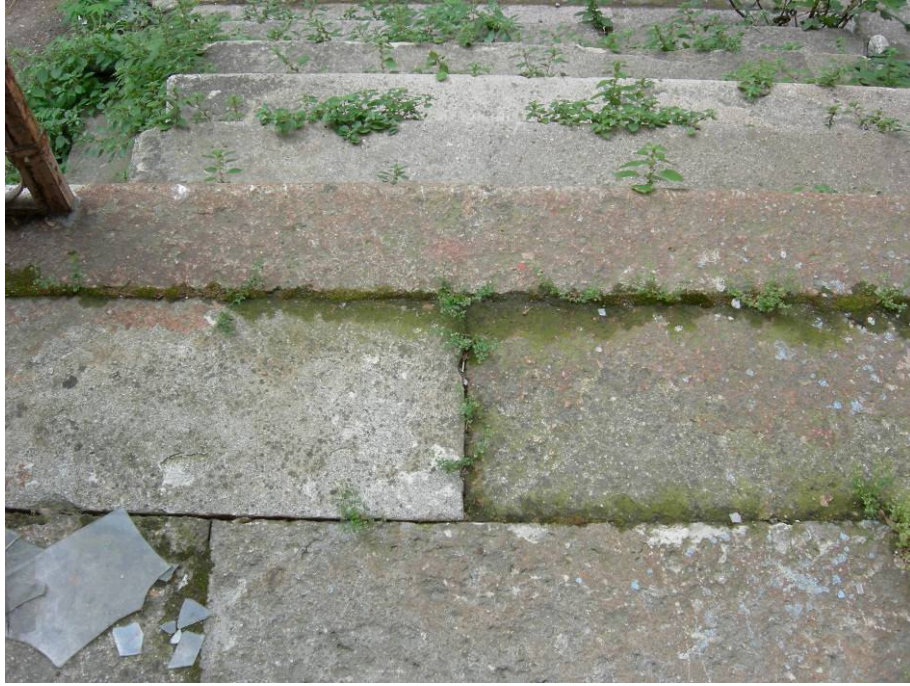
On the two terraces, there are plant formations in the joints between the stones due to detachment after settling of the ground (Figure 2.127). On some of the stones, there is microbiological growth due to rising damp (Figure 2.128). On some stones of the stairs leading to the terraces, flaking off the stone, discoloration and crust formation are observed due to air pollution (Figure E.3, Figure 2.129).

Figure 2.128. Microbiological growth on the stone coverings of the northern terrace.

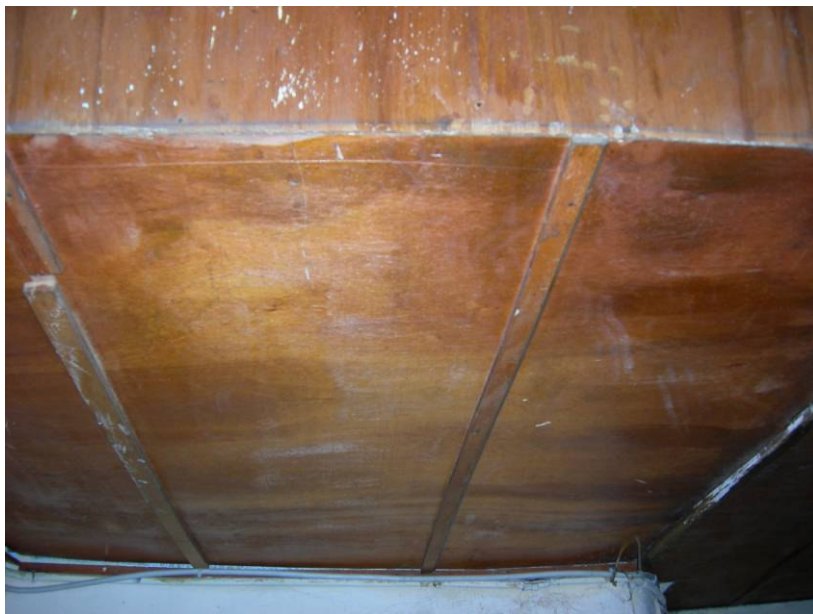
Figure 5.2. The plywood ceiling covering of the space under the stairwell which should be removed.

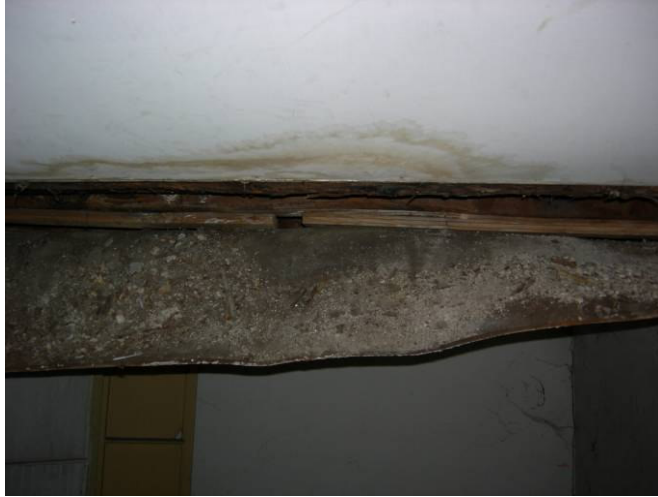
Figure 5.3. The plywood ceiling covering of storage space at the mezzanine floor that is suggested to be removed.

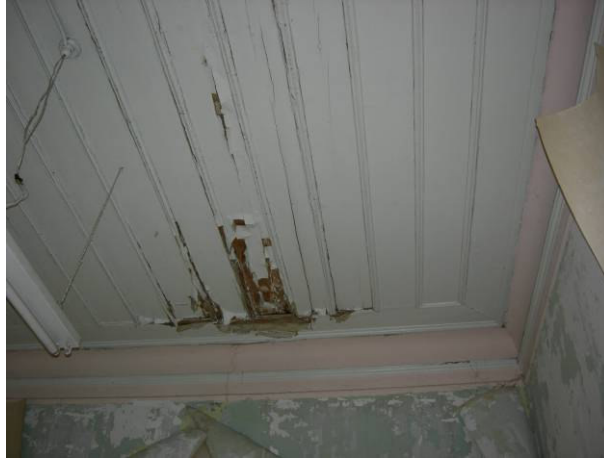
Figure 5.8. The deteriorated wood laths that are suggested to be removed.

laths. The deteriorated timber laths of the ceilings of room 1 and room 3 at the ground floor are suggested to be replaced with chemically protected timber laths after removing the oil paint on them (Figure 5.8, Figure I.4). The lost paint on the entrance door and the iron balustrades are suggested to be replaced with paint in original compositions⁸ (Figure I.11, Figure I.3). The deteriorated parts of the kitchenette cupboards are suggested to be removed and replaced with similar type of timber. At the mezzanine floor, the deteriorated timber beams of the storage room are suggested to be replaced with chemically protected timber beams and the deteriorated parts of the plaster on the ceiling of the stairwell are suggested to be replaced with plaster in original composition⁹ (Figure 5.9). Also the cement plaster on the walls of storage space and the stairwell must be removed and replaced with mud plaster in original composition. At the first floor, the deteriorated gypsum plaster of the ceiling covering of the hall is suggested to be replaced with plaster in original composition (Figure 5.10). In the renewal of the plastering of the ceiling of the hall, the ornamentations should be cut off and moved down, and consolidated. The supporting elements should be repaired. Compatible repair plaster should be prepared. Ornamentation should be replaced. Plastering and white wash should be completed. Also the deteriorated timber ceiling coverings of rooms 4, 5 and 6 (Figure 5.11) are suggested to be replaced with chemically protected timber coverings (Figure I.8). The deteriorated plaster on the walls of the room 6 should be completed with plaster in original composition (Figure 5.12). Since there is extensive amount of dampness observed on the first floor ceilings, it is thought that the roof structure may be highly deteriorated. After further surveys at the roof, if it is necessary, the deteriorated timber elements should be replaced with chemically protected timber roof structure. Also, the broken tiles should be replaced with new ones. Also, the cement plaster on the exterior walls must be removed and replaced with plaster in original composition.

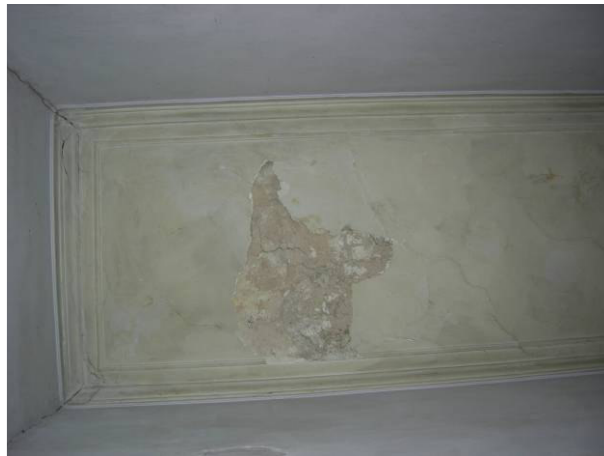
Figure 5.9. The plaster that is suggested to be replaced with plaster in original composition.

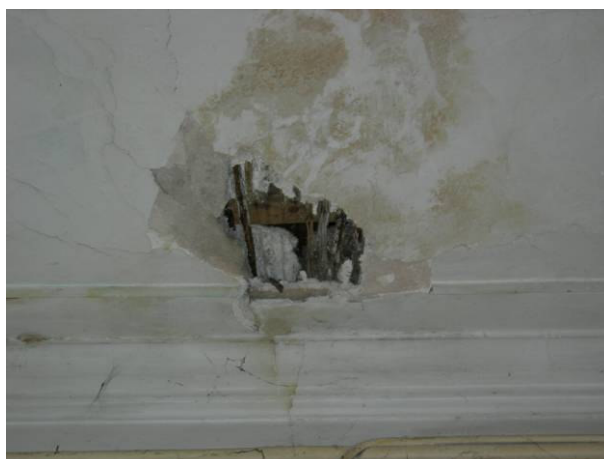
Figure 5.10. The plaster and the deteriorated wood laths that are suggested to be removed.

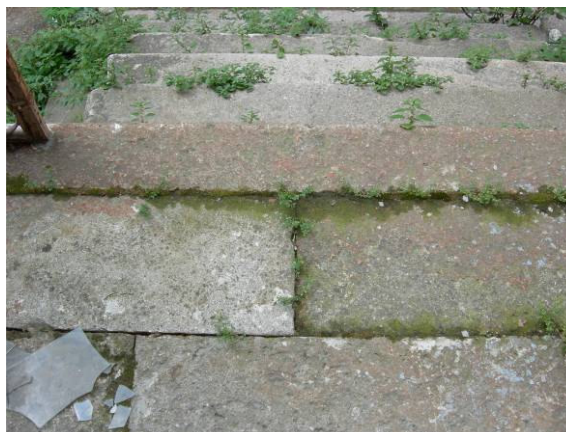
Figure 5.13. The rust stains on the stone that are suggested to be cleaned.

The cleanings are suggested: The soluble salts on the walls of the basement should be cleaned with the aid of leaching packs or poultices¹² (Figure I.1, Figure I. 9). On some of the stones covering the terrace, there are rust stains due to corrosion of iron balustrade (Figure 5.13). These stains should be removed.¹³ The crust on the stone

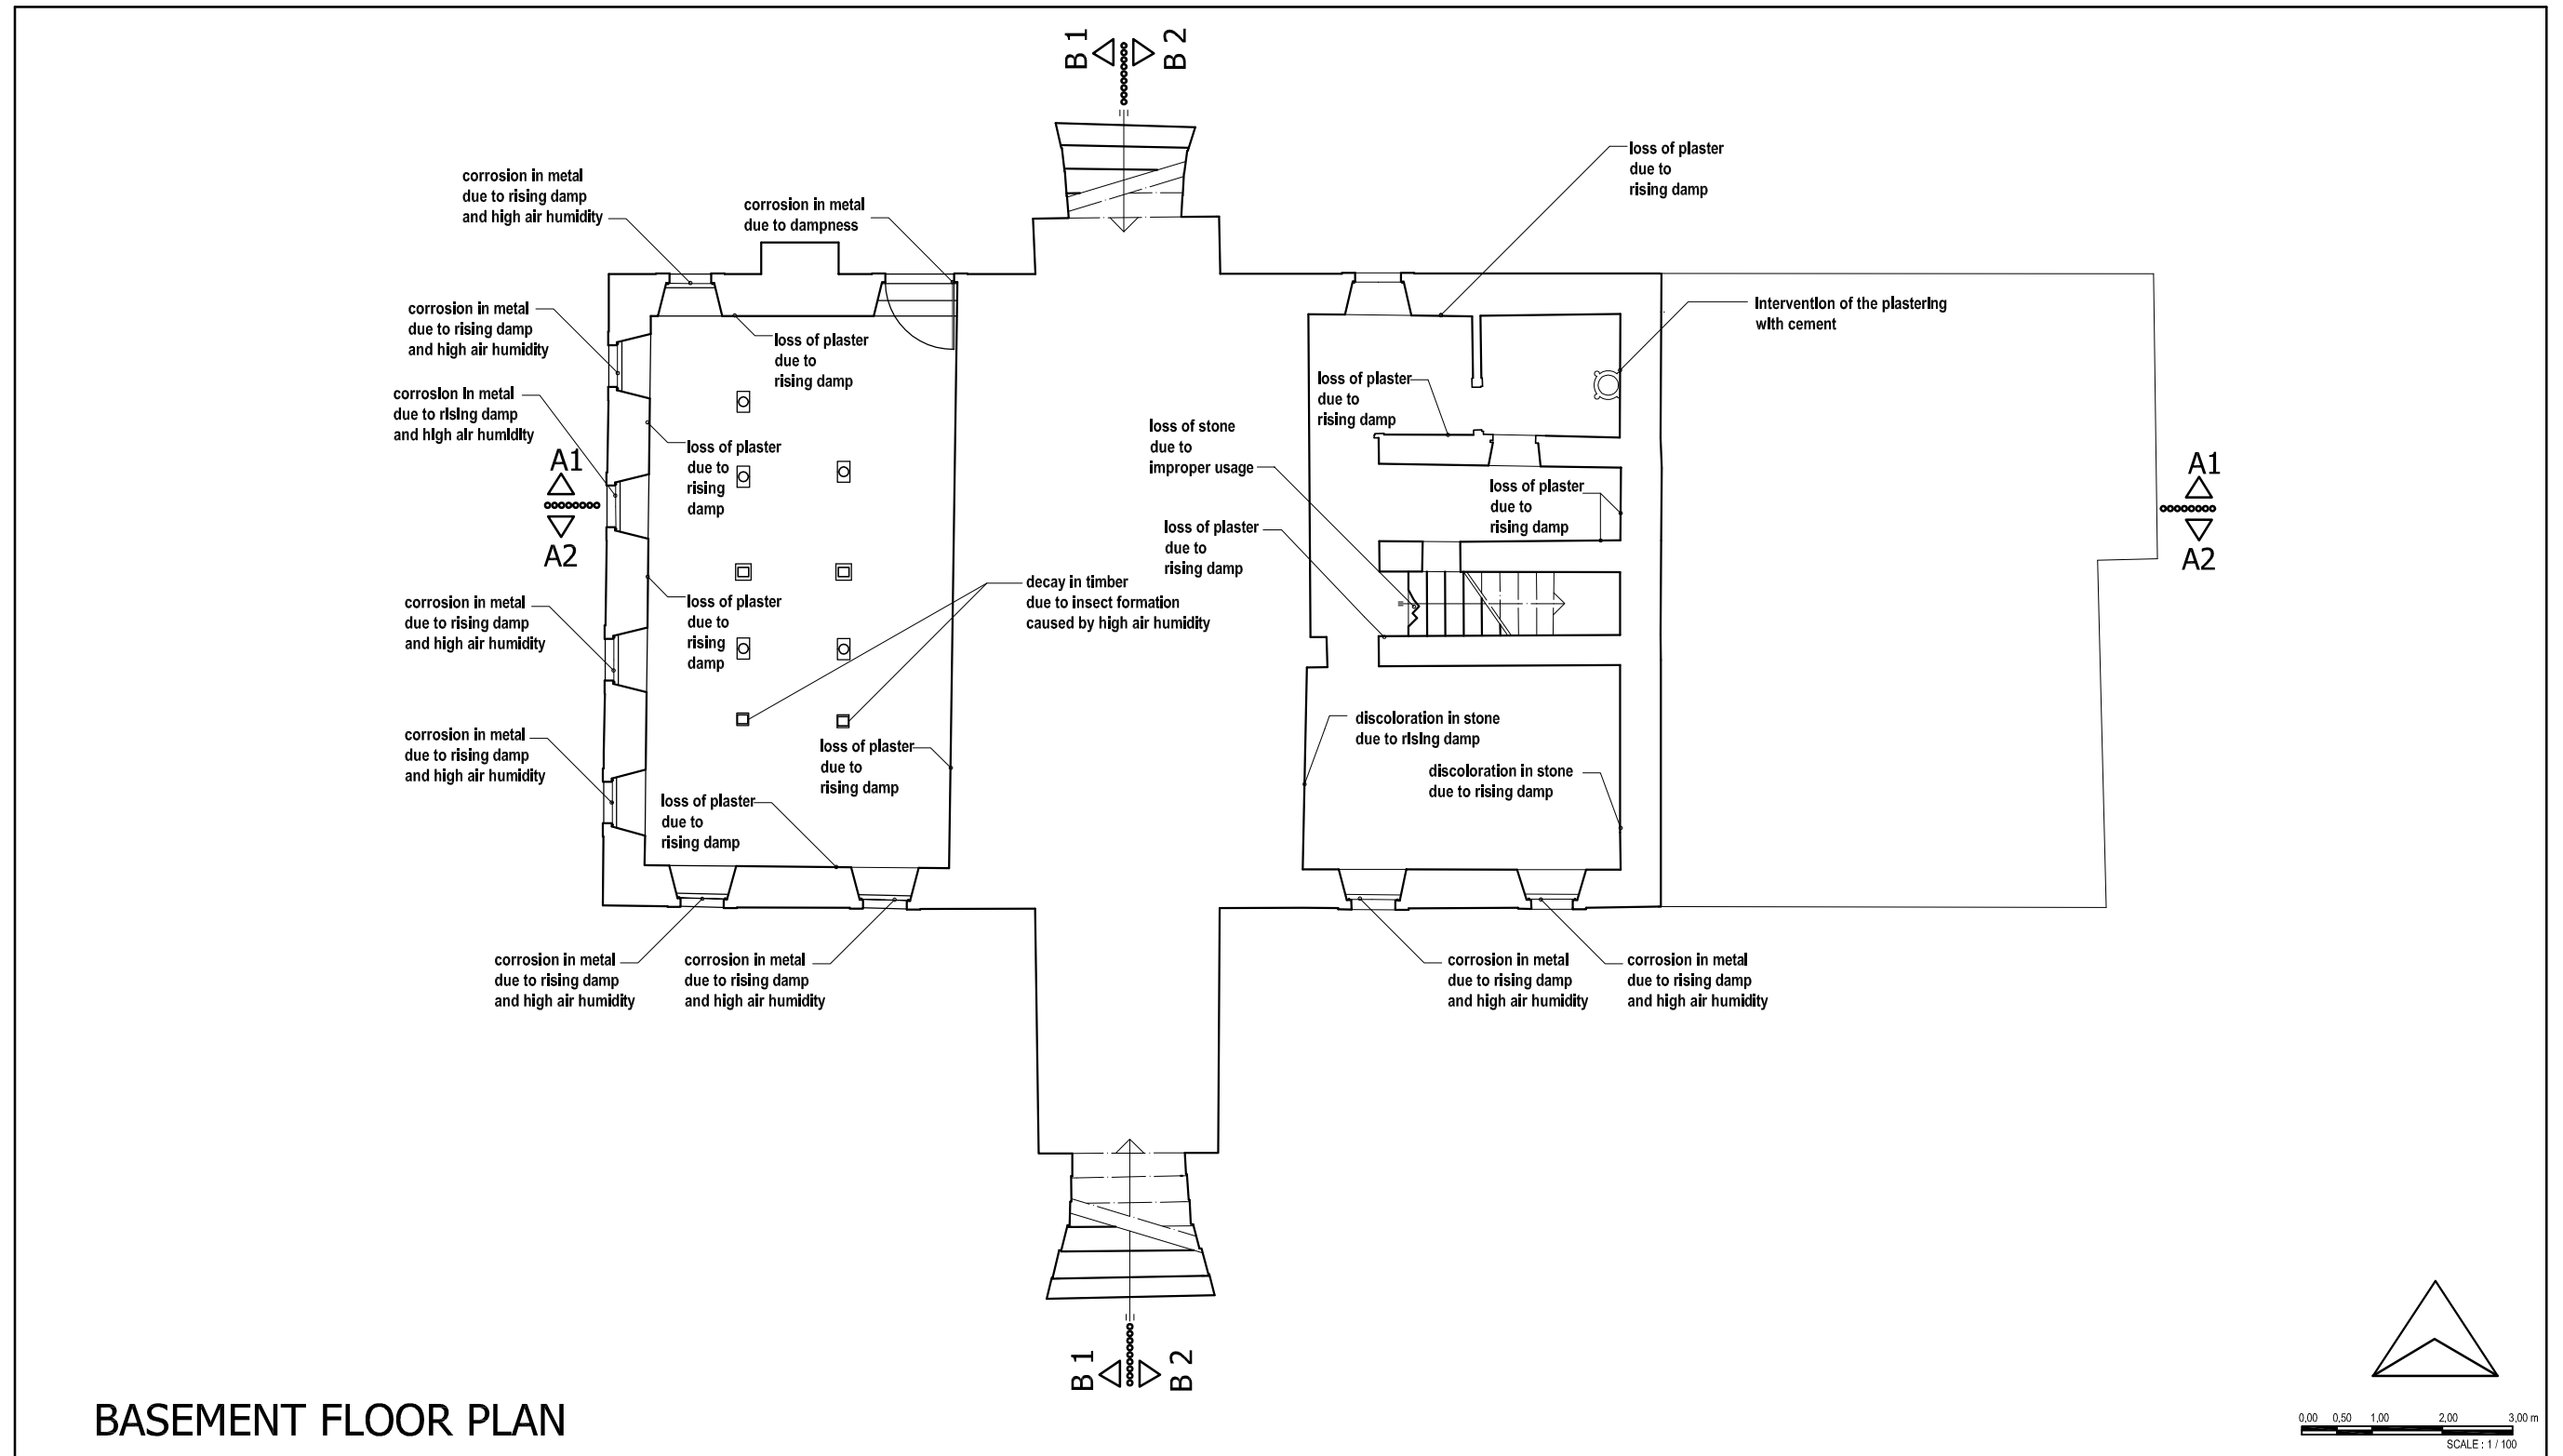
Figure E.1. Visual Analysis of Structural Damage and Material Decay, and their Possible Causes- Basement Floor Plan

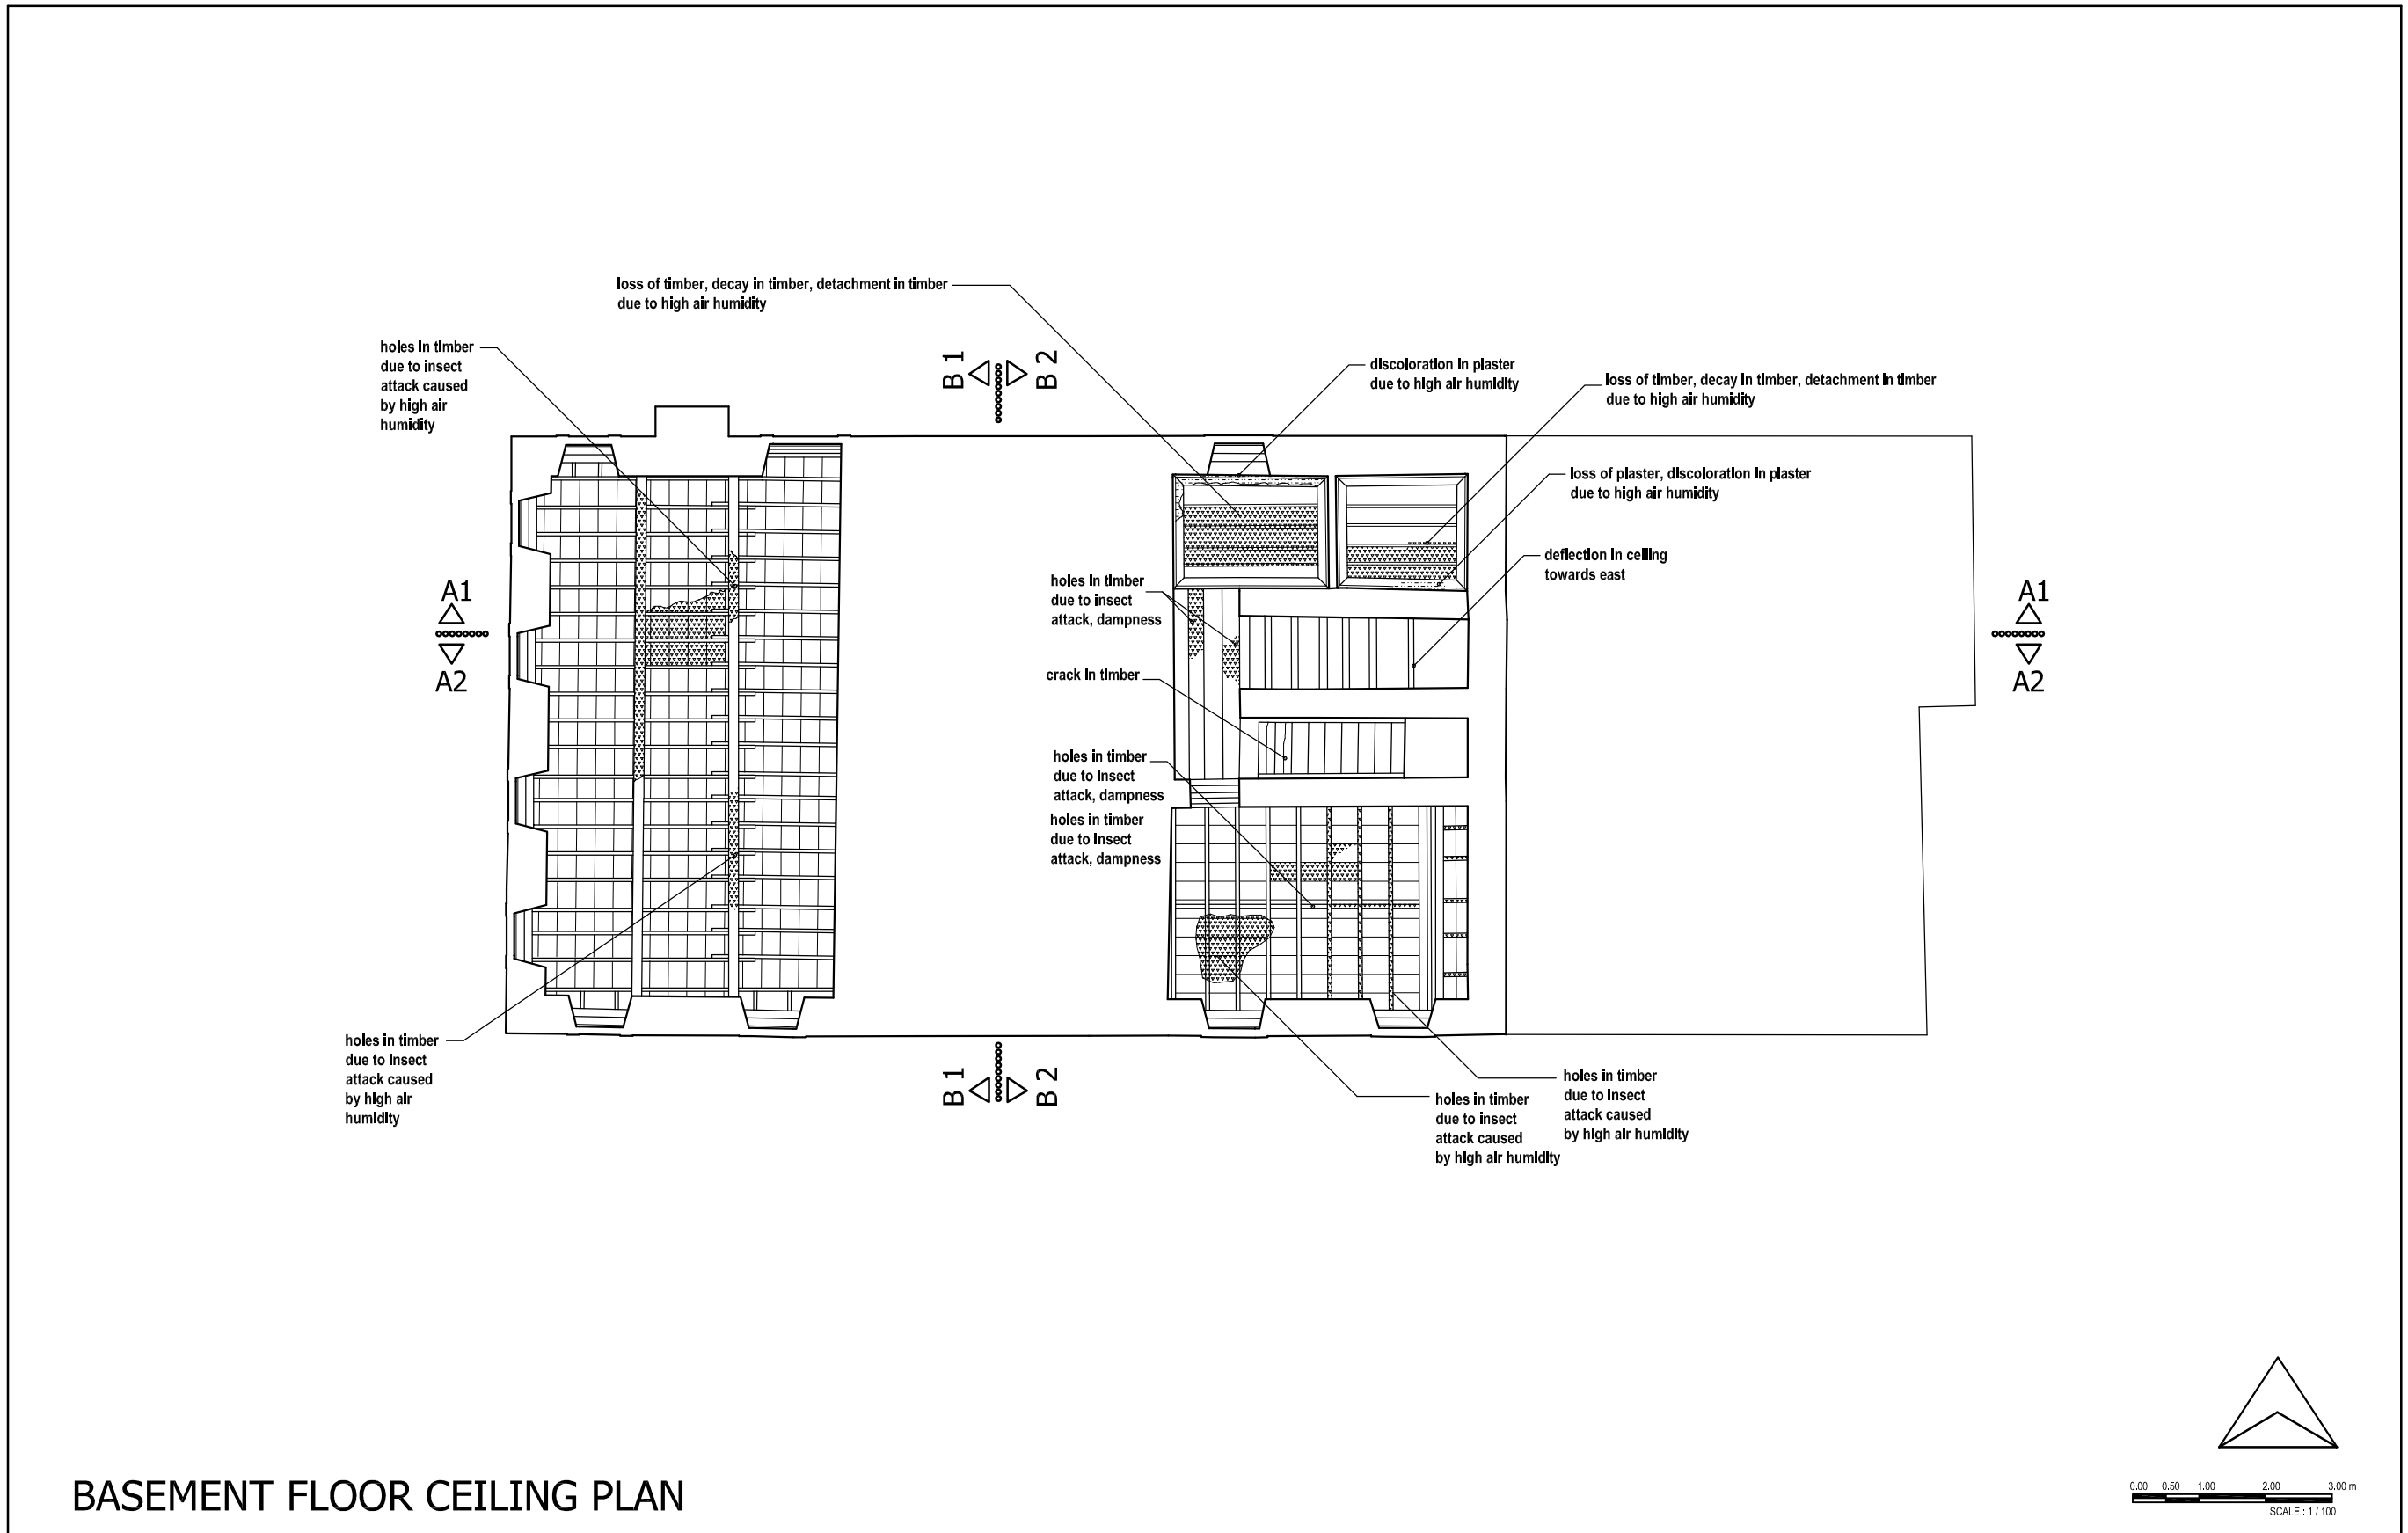
BASEMENT FLOOR CEILING PLAN

Figure E.2. Visual Analysis of Structural Damage and Material Decay, and their Possible Causes- Basement Floor Ceiling Plan
