**CONSERVATION PROJECT OF LATİFE HANIM
HOUSE IN KARŞIYAKA, İZMİR**

**A Thesis Submitted to
the Graduate School of Engineering and Sciences of
İzmir Institute of Technology
in Partial Fulfillment of the Requirements for the Degree of**

in Architectural Restoration

**by
Esra DİPBURUN**

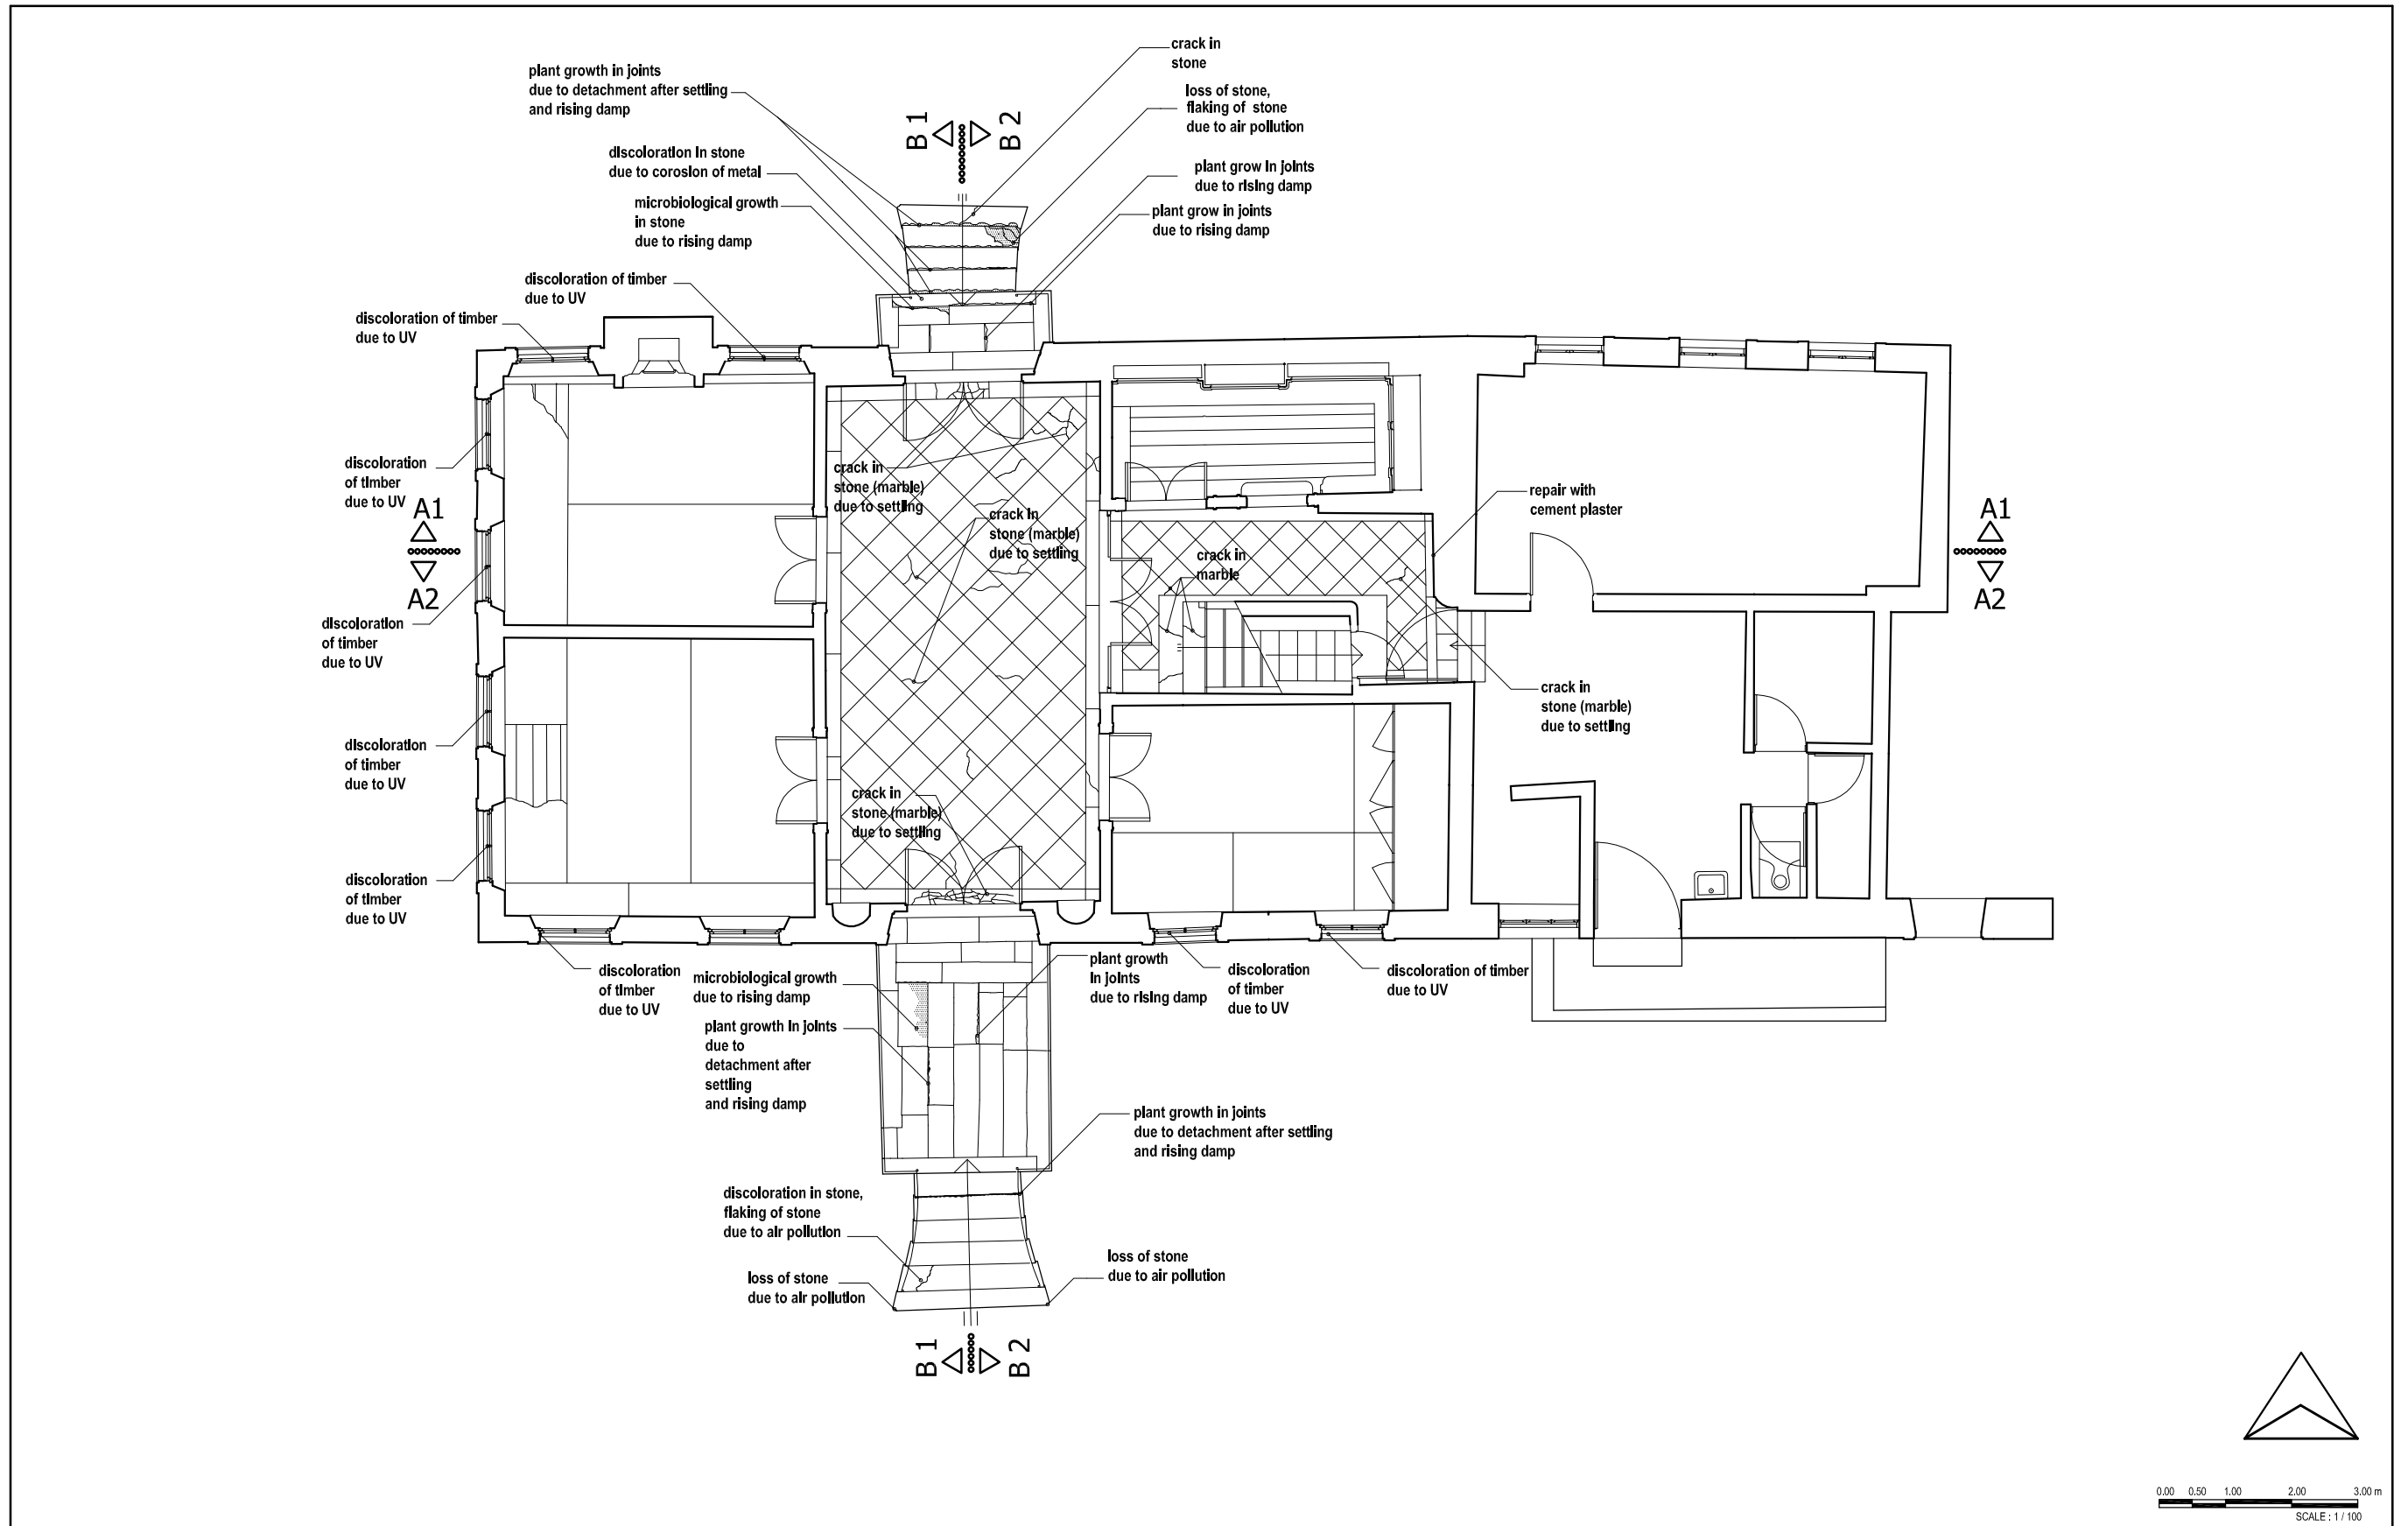
Figure E.3. Visual Analysis of Structural Damage and Material Decay, and their Possible Causes- Ground Floor Plan

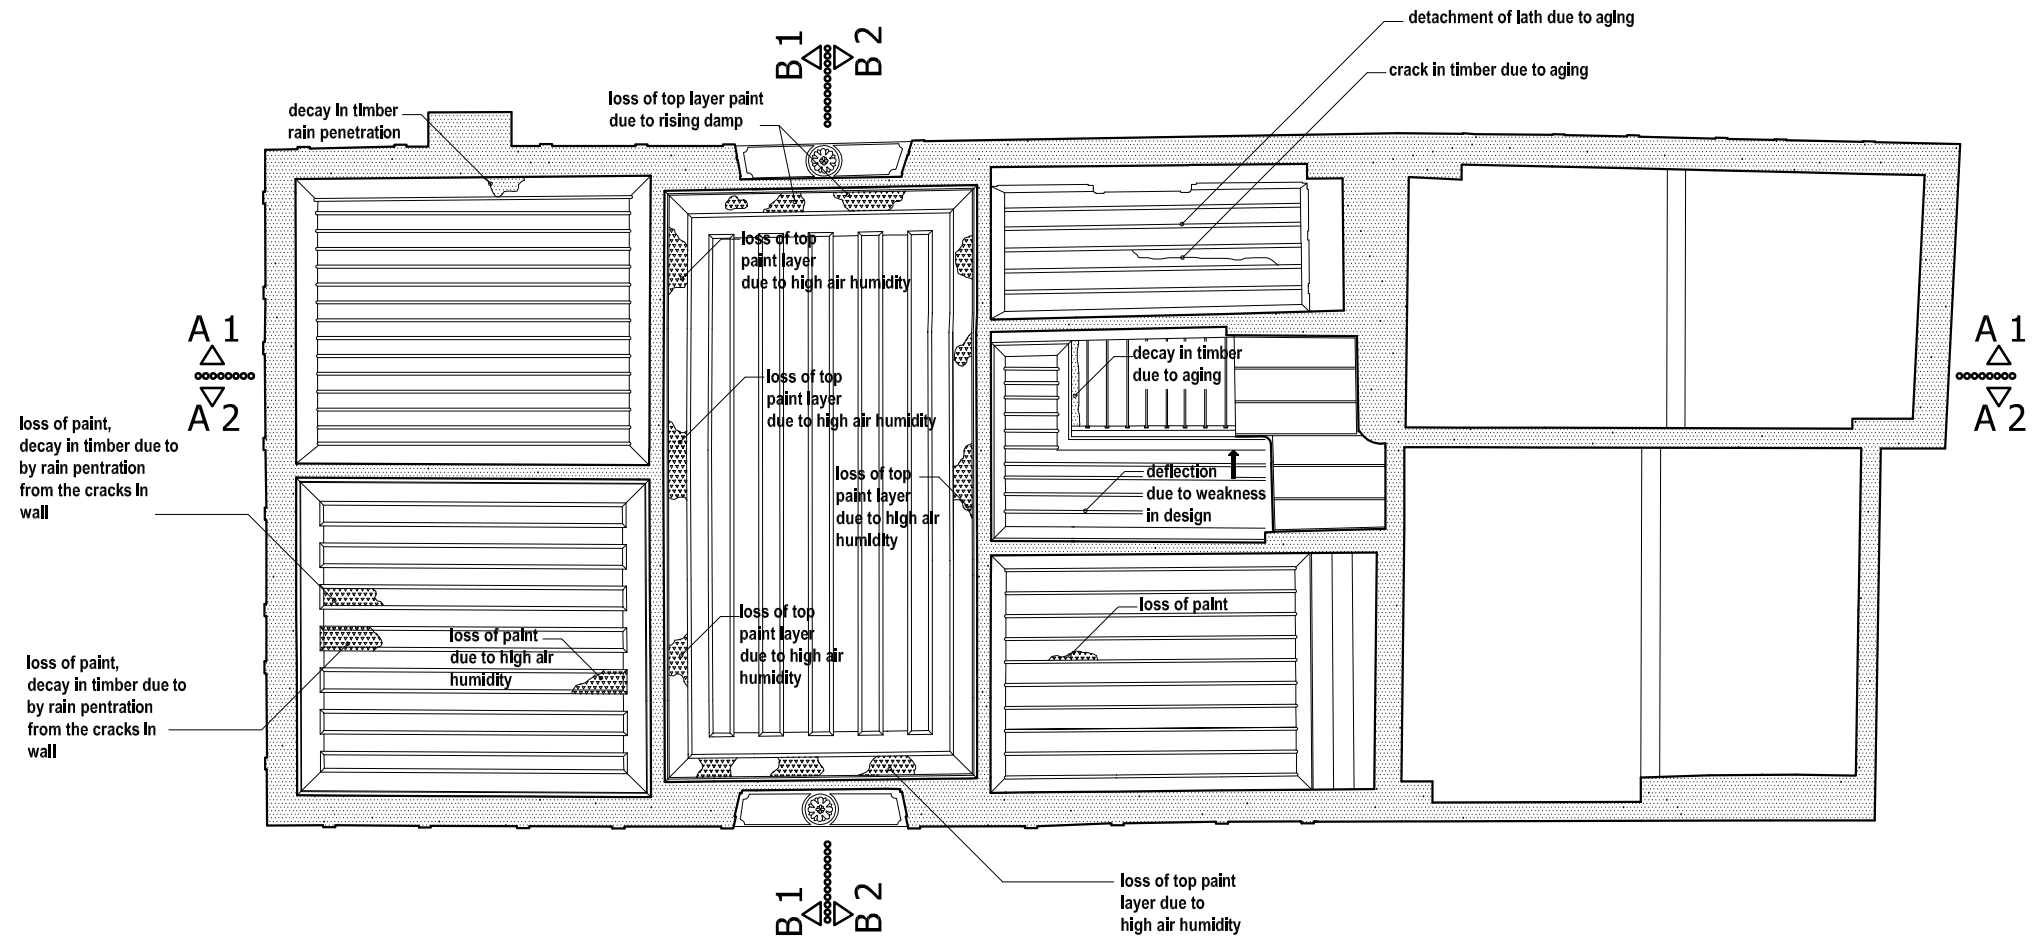
GROUND FLOOR CEILING PLAN

Figure E.4. Visual Analysis of Structural Damage and Material Decay, and their Possible Causes- Ground Floor Ceiling Plan

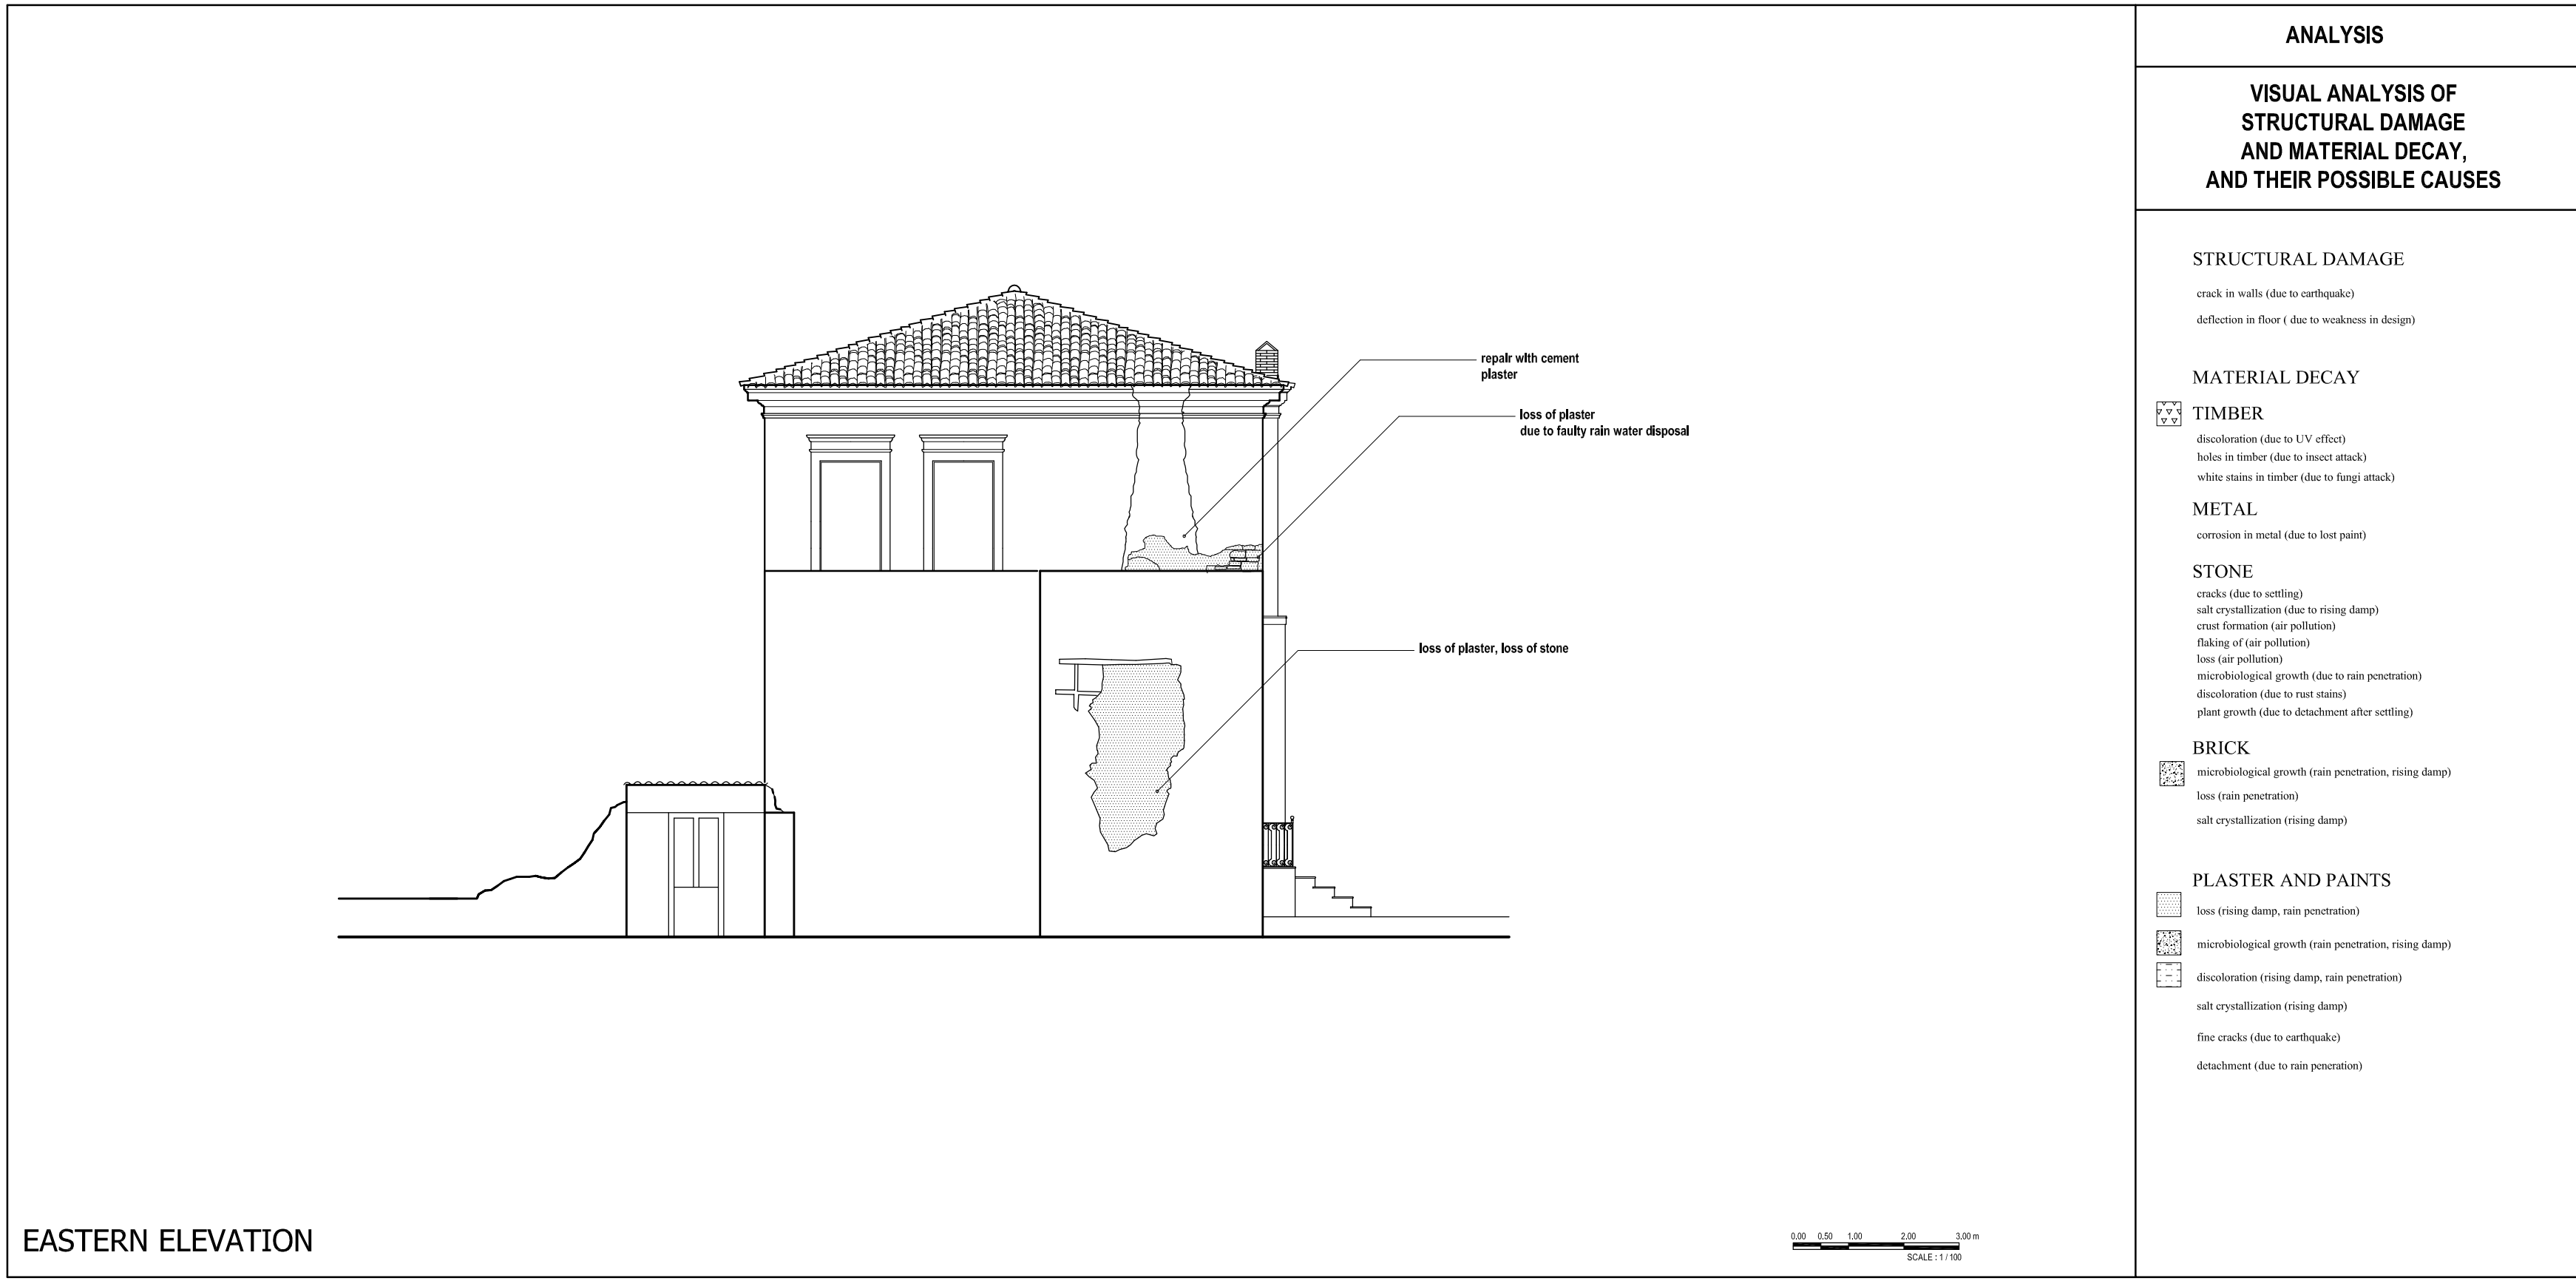
Figure E.14. Visual Analysis of Structural Damage and Material Decay, and their Possible causes- Eastern Elevation

ANALYSIS	
VISUAL ANALYSIS OF STRUCTURAL DAMAGE AND MATERIAL DECAY, AND THEIR POSSIBLE CAUSES	
STRUCTURAL DAMAGE	
crack in walls (due to earthquake)	
deflection in floor (due to weakness in design)	
MATERIAL DECAY	
	TIMBER
discoloration (due to UV effect)	
holes in timber (due to insect attack)	
white stains in timber (due to fungi attack)	
METAL	
corrosion in metal (due to lost paint)	
STONE	
cracks (due to settling)	
salt crystallization (due to rising damp)	
crust formation (air pollution)	
flaking of (air pollution)	
loss (air pollution)	
microbiological growth (due to rain penetration)	
discoloration (due to rust stains)	
plant growth (due to detachment after settling)	
BRICK	
	microbiological growth (rain penetration, rising damp)
loss (rain penetration)	
salt crystallization (rising damp)	
PLASTER AND PAINTS	
	loss (rising damp, rain penetration)
	microbiological growth (rain penetration, rising damp)
	discoloration (rising damp, rain penetration)

salt crystallization (rising damp)	
fine cracks (due to earthquake)	
detachment (due to rain penetration)
