**EVALUATION OF INTERVENTIONS
IN WESTERN STOA OF AGORA
IN İZMİR**

**A Thesis Submitted to
the Graduate School of Engineering and Sciences of
İzmir Institute of Technology
in Partial Fullfilment of the Requirements for the Degree of**

in Architectural Restoration

**by
Necmiye Funda YAKA**

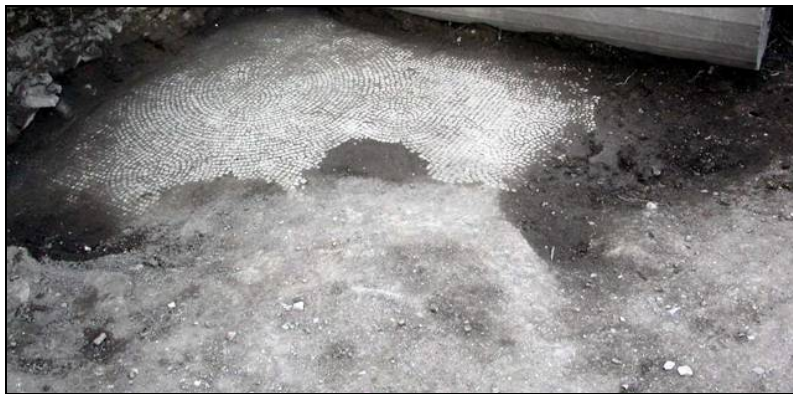
The mosaic hall found and documented in the 1940s was left uncovered. It was still present in 1969 however, is completely destroyed today, except for some parts which were left unexcavated (Figure 3.46, Figure 3.47, Figure 3.42)

Figure 3.47. The remains of mosaics in 2005.

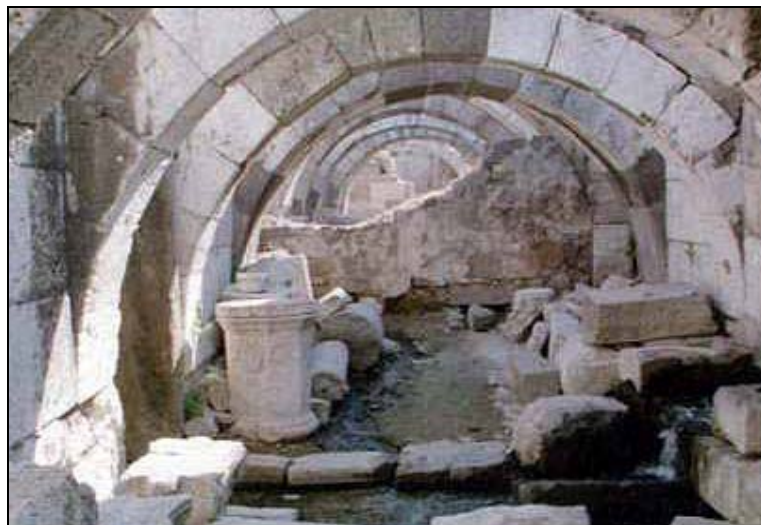
In the second place, an altar found in the northwest basement gallery that was left exposed to weathering does not exist today. Built with rubble stone masonry, plastered and painted with plant and animal figures, the altar collapsed after some years. Many photos taken by visitors of the site reveal the phases of the destruction of the monument (Figure 3.48, Figure 3.49, Figure 3.16).

Figure 3.49 The altar does not exist anymore around 1990.
(Source: WEB_25 2006)

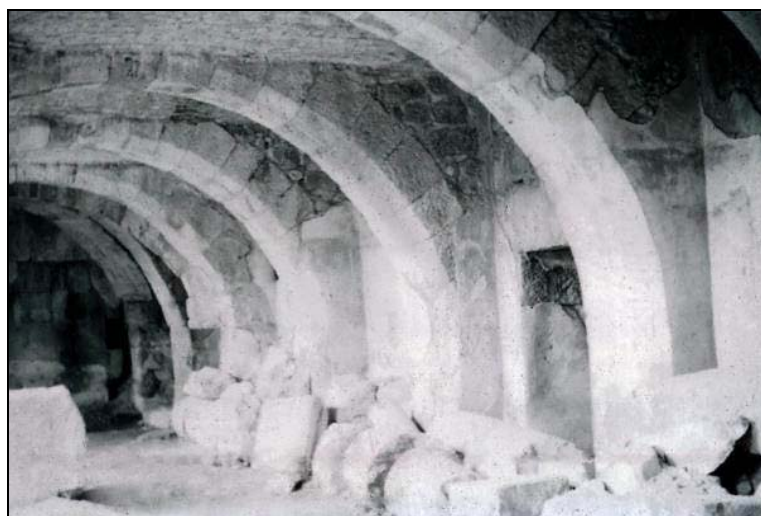
Thirdly, the plasters found in the lower galleries do not exist today. These plasters became detached from the walls due to weathering problems (Figure 3.50).

Figure 3.50. The plasters seen on the walls in December 1961 do not exist today.
(Source: WEB_24 2006)

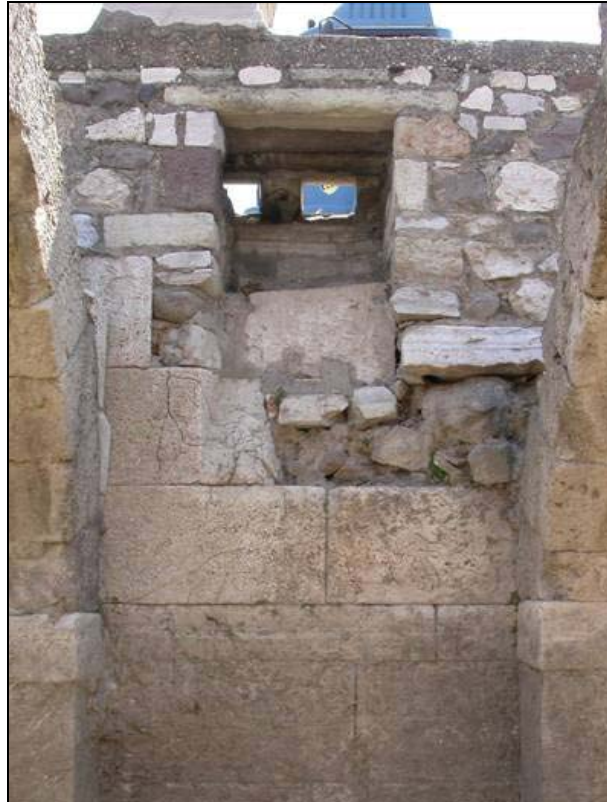
Figure 3.53. The present situation of the east wall and the windows.

It is observed that the construction system and details do not match with the original parts. That is, reconstructions started before the excavations were completed in the West Stoa also were applied without much analyses of the structure. In brief, implementations comprise many faults at the details of the windows and mouldings. To start with, mouldings seen in Figure 3.52 were not applied in the reconstructions. As stated under heading 3.3.2. mouldings reflect the earlier construction system of the West Stoa. Considering their importance, they should be placed in the former implementation.

The original windows were opened to the steps of stylobate with narrowing section both in horizontal and vertical line. The windows opened to the riser of the steps with only one space. However, reconstructions were applied as seen in the figure without regards to the original (Figure 3.53).

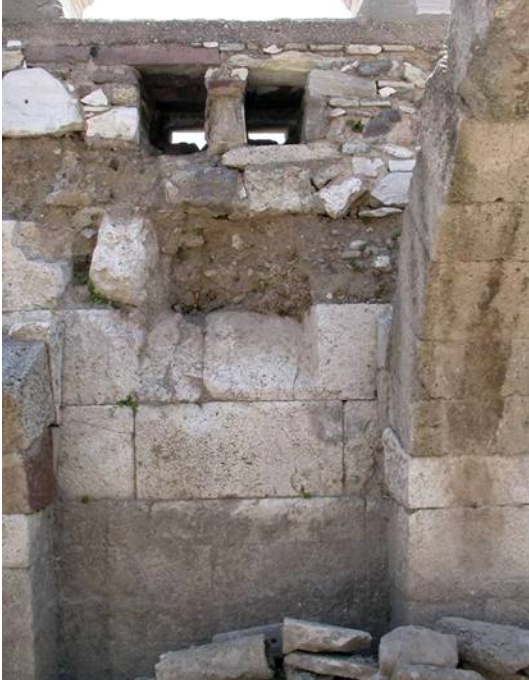
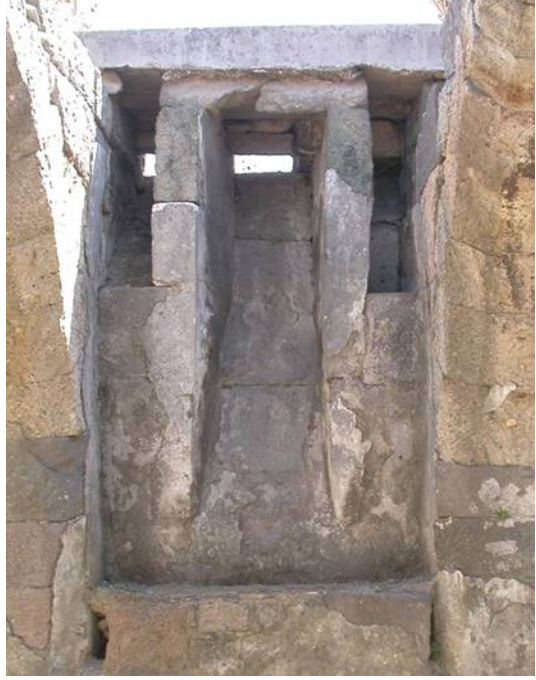
<p>Window of the West Stoa (reconstruction)</p>	<p>Window of the Basilica</p>

Besides, the reconstruction implementation resembled not the windows of the West Stoa but the Basilica. When windows of the two buildings are examined in the Figure 3.54, the Basilica's windows consist of three parts both inside and outside. However, West Stoa's windows consist of one division inside and two outside.

Figure 3.54. Analyses of the windows opening to the stylobate. The Basilica windows were imitated for the reconstruction of the windows of the West Stoa.

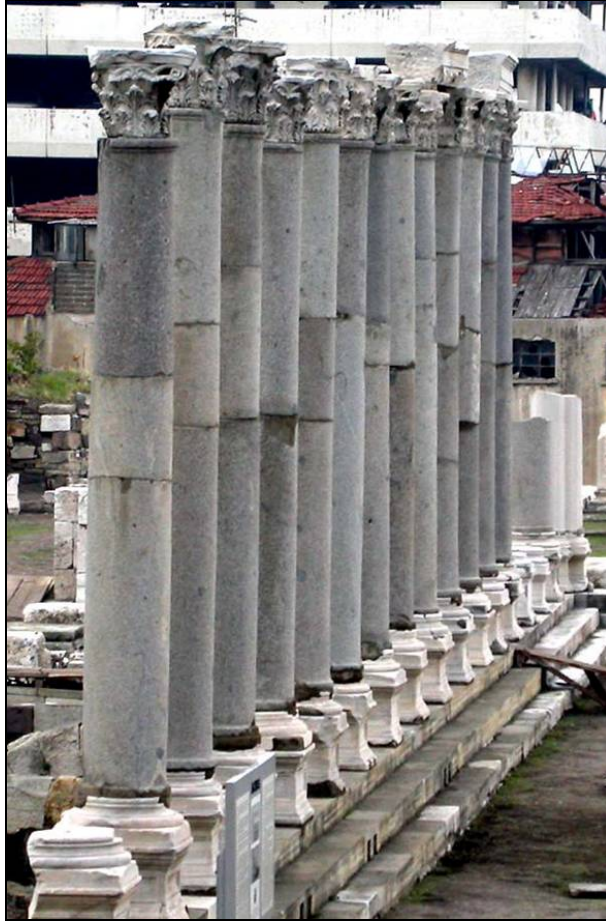
Figure 3.57. The re-erected columns on the façade of the West Stoa.
(Source: The archives of the Agora excavation, 2005)

Columns bear on the column bases were reconstructed with original broken pieces. Five of them were reconstructed with two, 8 of them were reconstructed with three pieces of columns (Figure 3.57). Diameter of the columns should get narrower as they rise gradually. In contrast the unified pieces do not narrow straightly, especially at the joints. That is because the use of discordant diameters of column pieces added to each other.

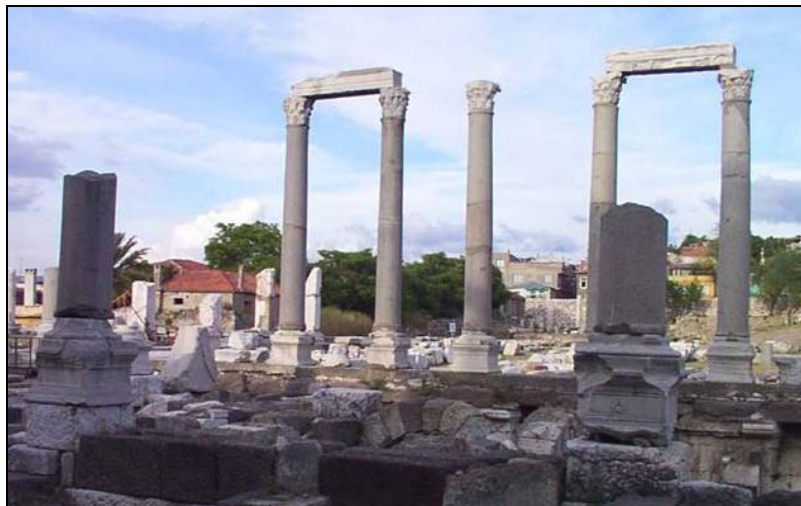
Figure 3.59. The distances vary between the columns and the longest ones are with the architraves.

Column capitals are similar in characteristics but different orientations when compared to each other. However, two architraves were placed over the capitals which do not belong to the West Stoa because they are longer than the original column axes (Figure 3.59). In order to place these architraves, columns were lined with longer distance than the others.

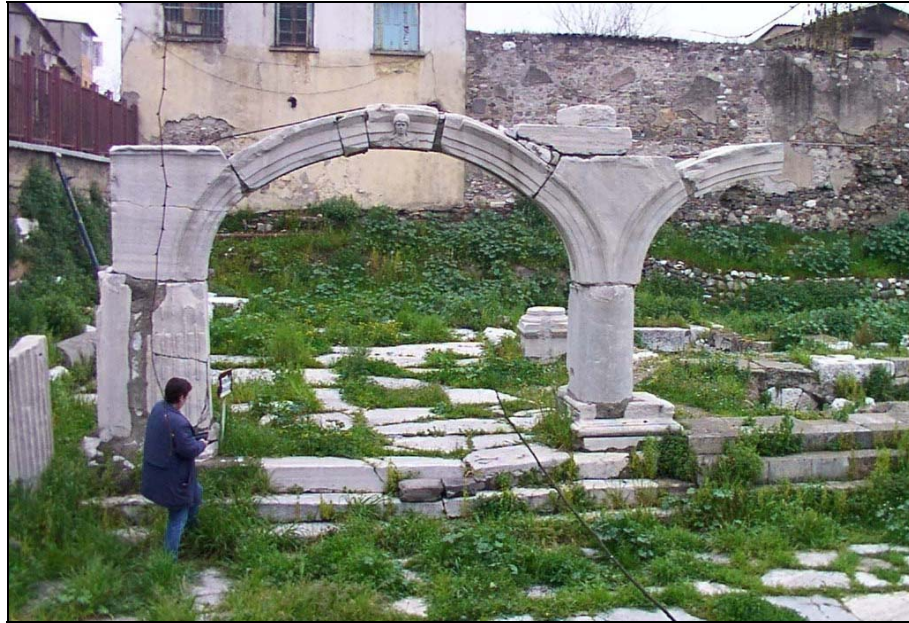
With reference to the restitution investigations, anastylosis of the gate has many mistakes including placement, proportion of the structure and the use of pieces (Figure 3.60). Initially the elevation of the arch was incorrect when compared with the columns. In other words, the gate was as high as the ground floor columns since it was a continuation of the West Stoa.

Figure 3.60. The reconstruction of the West Gate.
(Source: The archives of the Agora excavation, 2003)

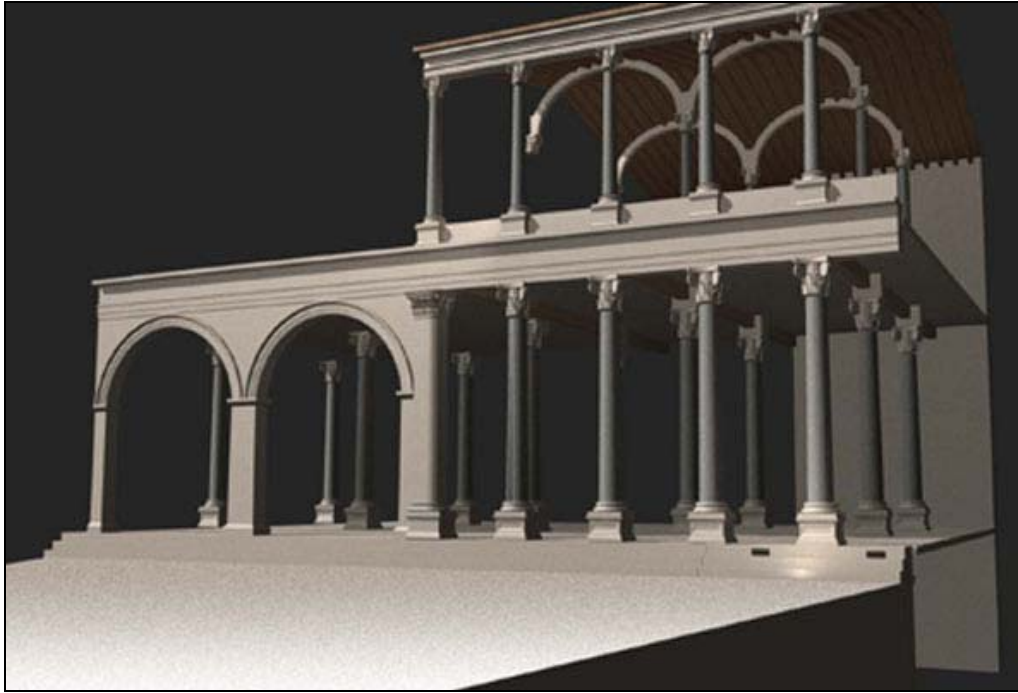
The West Stoa was illustrated as two arches in the reconstruction, which was an accurate decision. Even so, the beginning of the second arch was placed through the north, conversely it should be through the south because the West Stoa is placed on the north but a Roman road is on the south under the 816 Street (Figure 3.61).

Figure 3.61. The reconstruction of the southern east façade of the West Stoa and the West Gate.
 (Source: The archives of the Agora excavation, 2005)

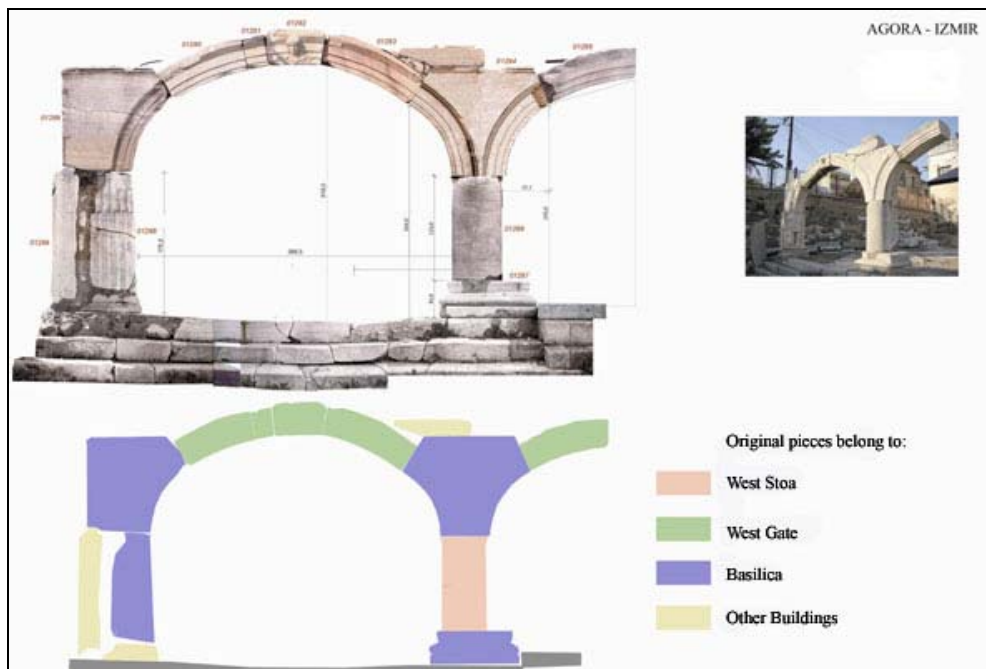
Last, it is necessary to mention, the extant original materials were used in the reconstruction. The voussoirs and the keystone do not match each other from the point of the profile and arch lines. That reveals, some pieces used in the anastylosis do not belong to the structure. As illustrated in the figure springers on two sides thought probably belong to the Basilica (restitution studies not completed yet), further half columns reveal the original characteristics of the West Gate (Figure 3.62).

Figure 3.62. The figure illustrates the materials of the reconstruction regarding the original structure.
 (Source: The archives of the Agora excavation, 2004)

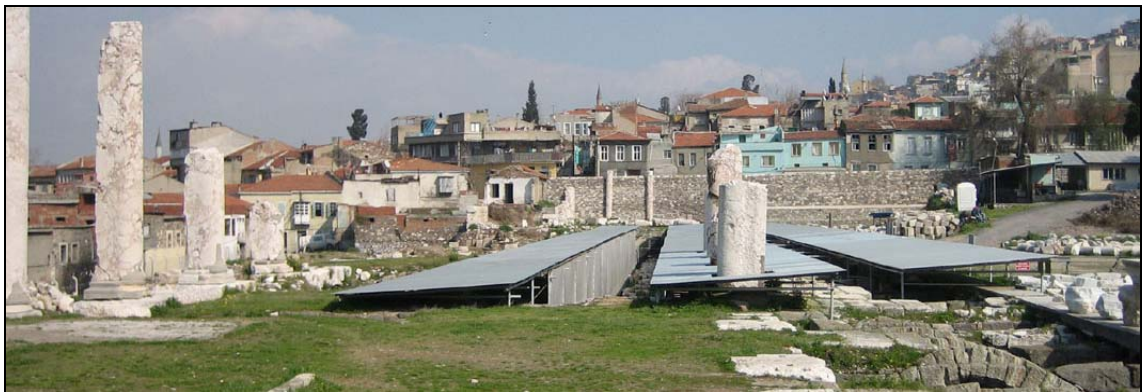
Figure 3.66. The temporary protecting shelters for the lime plasters and the graffiti on.

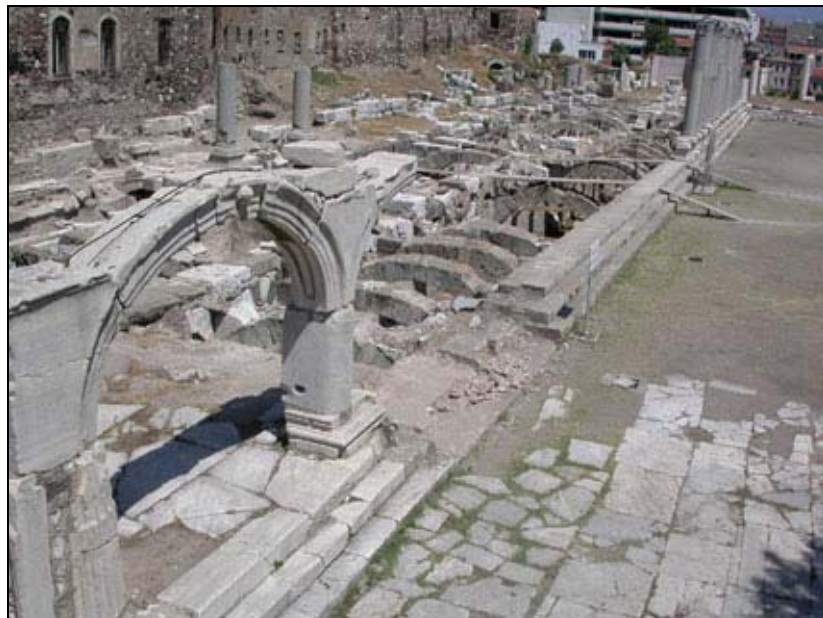
The recent situation of the gate has been analyzed and evaluated under heading 3.5.1.2.3 (Figure 4.5). In summary, the reconstruction of the structure includes mistakes which resulted in the wrong impression of the monument. To illustrate, initially, incorrect pieces which belong to other building parts were used in the reconstruction, secondly, the horizontal and vertical proportions of the arch are not correct, eventually the placement of the second section had been presented in the wrong direction (Figure 3.60), (Figure 3.62). Because of these mistakes, the existing reconstruction needed to be disassembled and a new reconstruction project was decided upon that must be applied.

Figure 4.5. Reconstruction of the West Gate.
(Source: The archives of the Agora excavation, 2004)

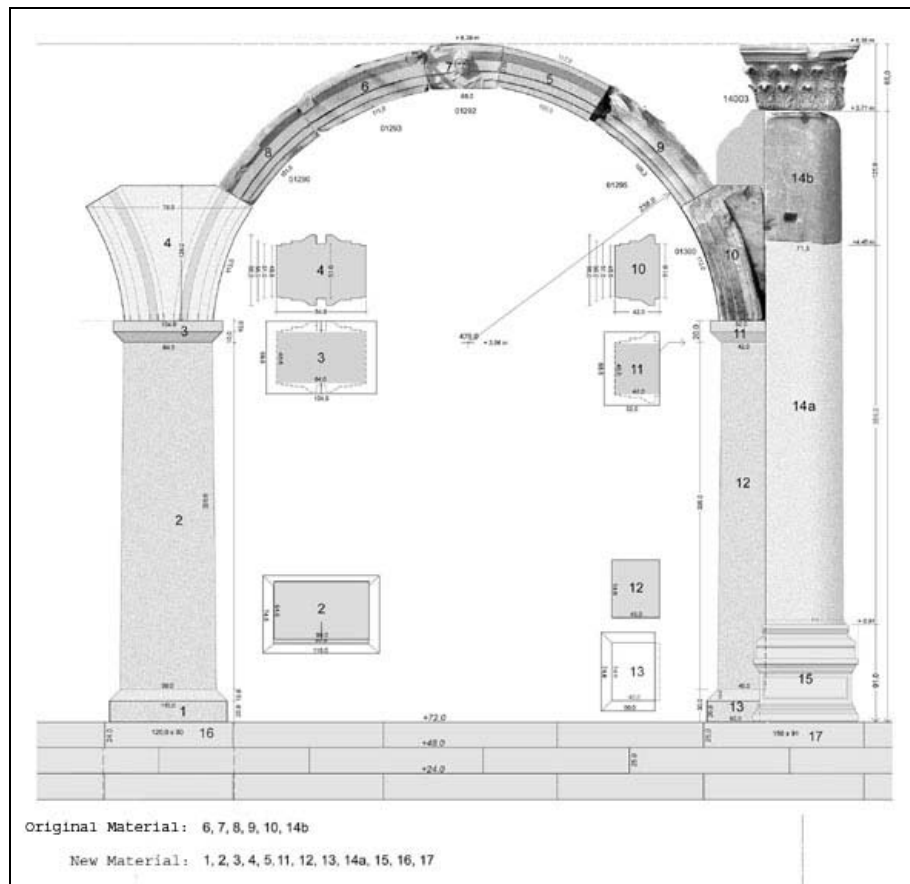
Figure 4.6. Reconstruction project of the West Gate.
 (Source: Archives of the Agora excavations, 2004)

According to the reconstruction proposal, the extant architectural pieces should be used initially. The lacking parts would be constructed with similar properties of material to the original. Although experimental investigation of the materials was not executed, Marmara marble was found to be the most similar to the original material (by the stone experts). In addition to the 7 original pieces, 9 more pieces are needed in order to reconstruct the arch (Figure 4.6). All pieces should be montaged with bronze clamps and enclosed with lead and epoxy.

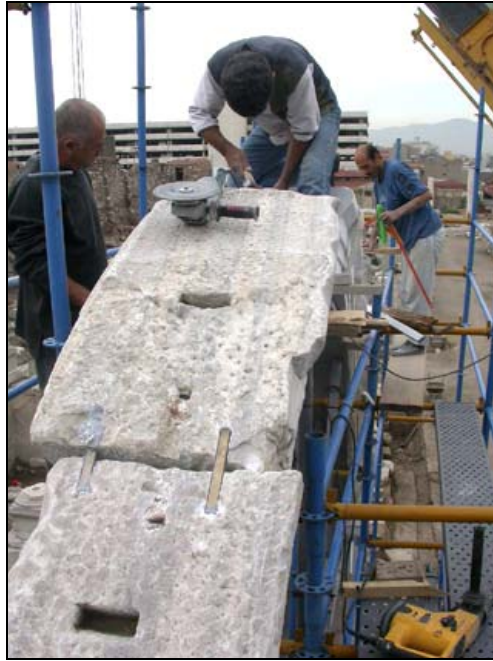
First the upper step of the stylobate was placed, and then the abutments, column base and the column, which had been newly constructed, was placed. Later on the springers were placed according to the reconstruction project. The one on the right side was an extant one found in storage, conversely the left one was a newly constructed one which is also a springer of the second arch on the south side. All vertical components (connections) were applied with two cylindrical bronze clamps at each connection (Figure 4.11). Afterwards 4 voussoirs, one of which was newly constructed, were placed on two sides. Finally the keystone was placed on the center of the arch. All pieces of the arch were first loaded on the staging, then clamped with two bronze vertical clamps as seen in Figure 4.12 (The original clamp place on the center is not stable anymore).

Figure 4.12. Upper face of the voussoirs; dovetail cuts, original clamp place and applied bronze clamps are seen. (Source: Archives of the Agora excavations, 2004)

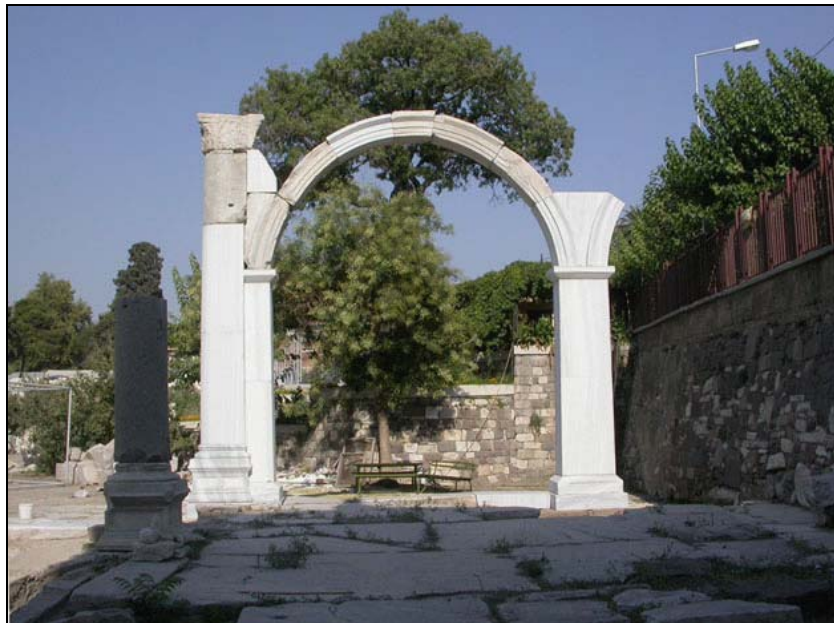
The proposal for reconstruction was prepared regarding the recent restitution studies. The reconstruction implementation of the West Gate remains distinguishable as a new work on its original spot. It is constructed with both original and new materials (Figure 4.14). Although no analysis have been done in order to decide their compatibility, new materials made of Marmara marble is considered similar to the original. Regarding they are natural materials, the implementation can be evaluated as compatible with existing original material in the scope of this study. In addition, form, dimension and construction system of the reconstruction is compatible with the original structure according to the recent restitution studies.

The reconstruction of West Gate is available for the future studies since no original components have been damaged and the structure is stable enough in order to allow for further necessary interventions.

Figure 4.14. The reconstruction implementation of the West Gate.

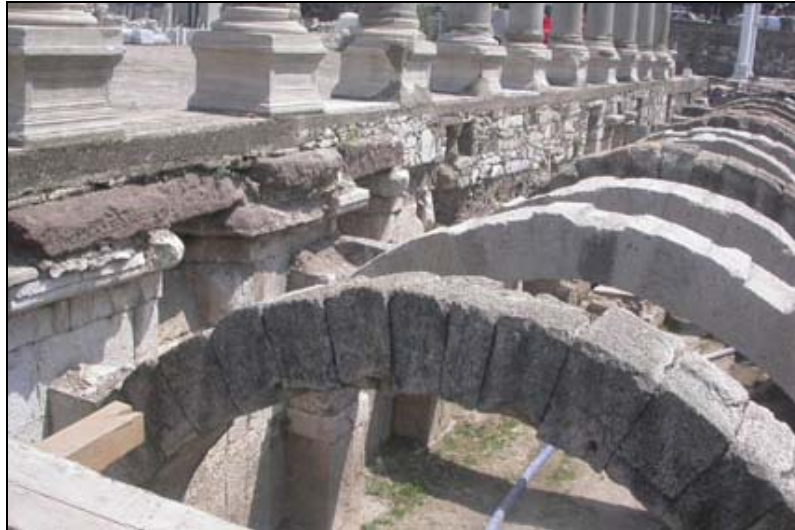
Three periods of the structure are observed on the east border of the West Stoa. These are, the primary construction in Hellenistic era, second is the addition of abutments bearing to the wall and the final is the latest implementations dated between 1932 and 1943 (Figure 4.15). Today the recent situation of the structure reveals the previous alterations (Figure 4.16). In the Roman era, 30 arch abutments had been added to the structure with various distances. The stairs climbing to the ground floor were constructed on the north side occupying the wall between the 1st and 3rd axes. A 55 cm thick wall was constructed in front of the wall between the 24th and 30th axes in order to build cistern 1. Additionally partial flooring at -3.25 m, dating to the Roman era was found between the 12th and 14th axes the aim of which is not defined yet

Figure 4.15. The east side of the West Stoa.

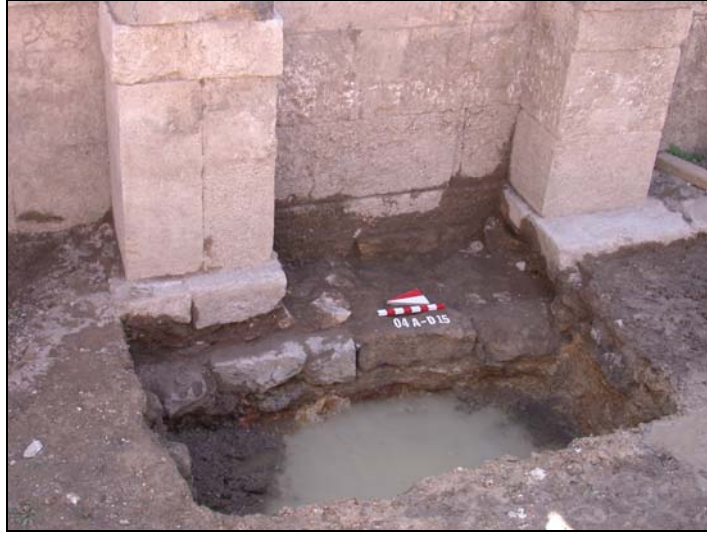
Figure 4.20. The sounding work between 4th and 5th axes reveals the foundation of the wall.
(Source: Archives of the Agora excavations, 2004)

Before starting the reconstruction proposal, the east wall and its architectural elements had been documented and analyzed in detail. Later on sounding excavations were done at different parts of the wall to investigate the foundation of the structure. It was determined that the stylobate and the east wall have separate foundations. The foundation of the stylobate ends at -1.72 m while the east foundation continues to -5.41 m “(Cingöz et al. 2004)”. Finally, a part of the stylobate implementation had been removed with the permission of the İzmir 1st Numbered Conservation Council of Cultural and Natural Heritage by decision numbered 1 dated 05.08.2004. The south part of the lateral implementation was removed to reveal the original remains of the wall in order to get exact information about the construction technique of the structure.

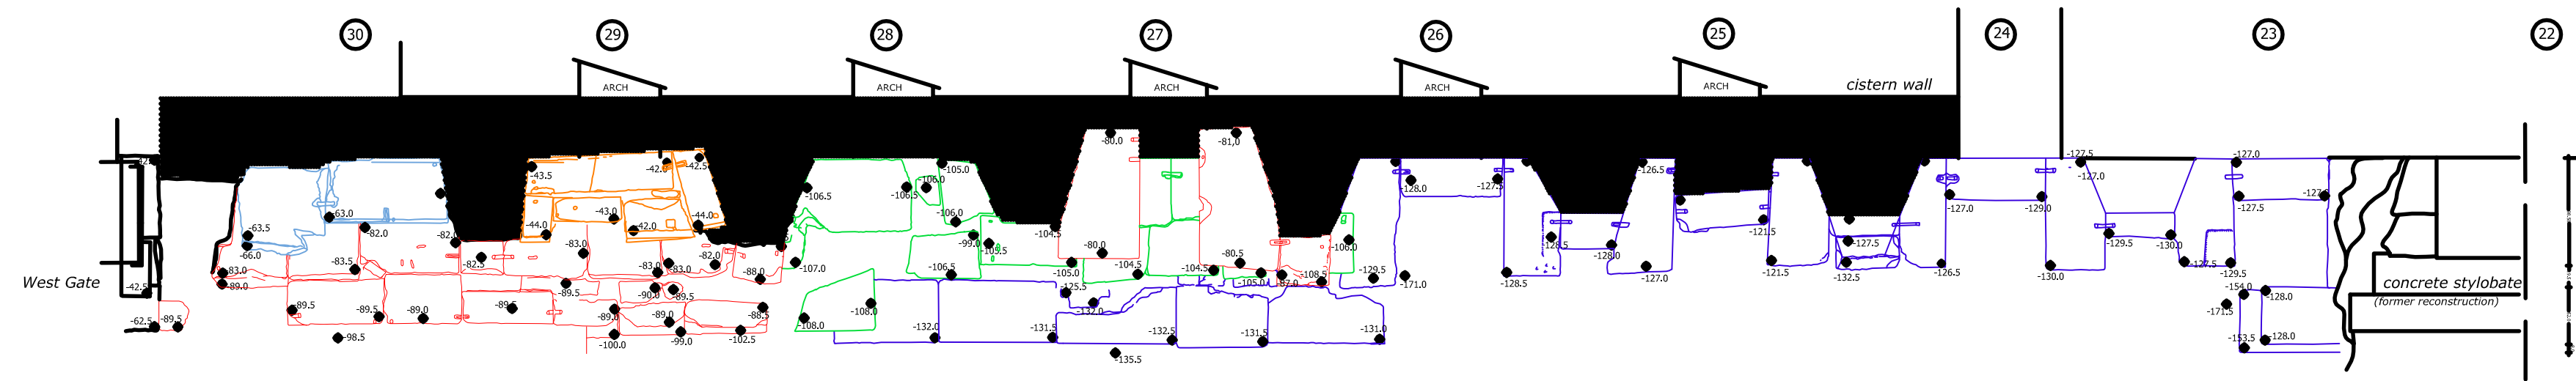
When the concrete stylobate between the 22nd and 30th axes was taken away the position of the extant pieces and connection traces gave information about the construction system of the wall. However, a cistern wall starts at the 24th axis and continues to the end, which restricted the investigations. In this situation, the wall had to be observed from the upper surface of the extant pieces not to destroy any remains. The reconstruction proposal was restricted with the implementation area because the following investigations should be done for such studies.

The original pieces were found in various levels between the 6th and 2nd courses increasing from north to south (Figure 4.17). It only exists until the 6th course between the 22nd and 26th axes. Then, the 5th course is observed between the 26th and 28th axes, further three stones belonging to the 4th course are placed between the same axes. In

Figure 4.22. Measured drawing of the east wall between 22nd and 30th axes.
(Source: Archives of the Agora excavations, 2004)

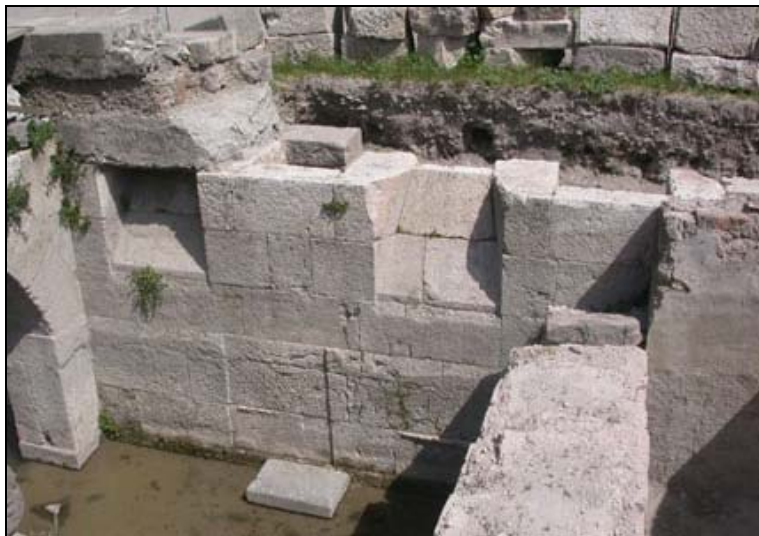
Figure 4.25. The east wall of the West Stoa, after the removal of the stylobate at 23rd axis.

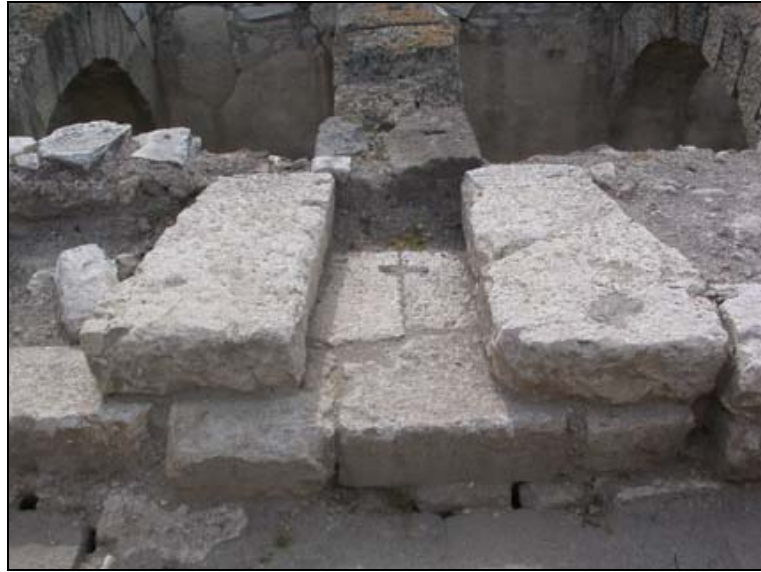
Thirdly, in the 4th course at the 27th axis, there is not a complete window opening, however, all other components are observed. For instance, two headers and a stretcher are clearly observed between the 26th and 28th axes while other remains are partially observed between the 28th and 30th axes due to the existence of the upper courses. Additionally, the filling under the stylobate in the 4th course level existed at the same interval (Figure 4.26). Some new pieces belonging to the 4th course were also found on the site. They were placed in the proper places in the reconstruction proposal. The form and the location of the other pieces were decided according to the characteristics of the extant ones (Figure 4.30).

Figure 4.27. The 27th axis reveals the construction technique of the 5th and 4th courses.

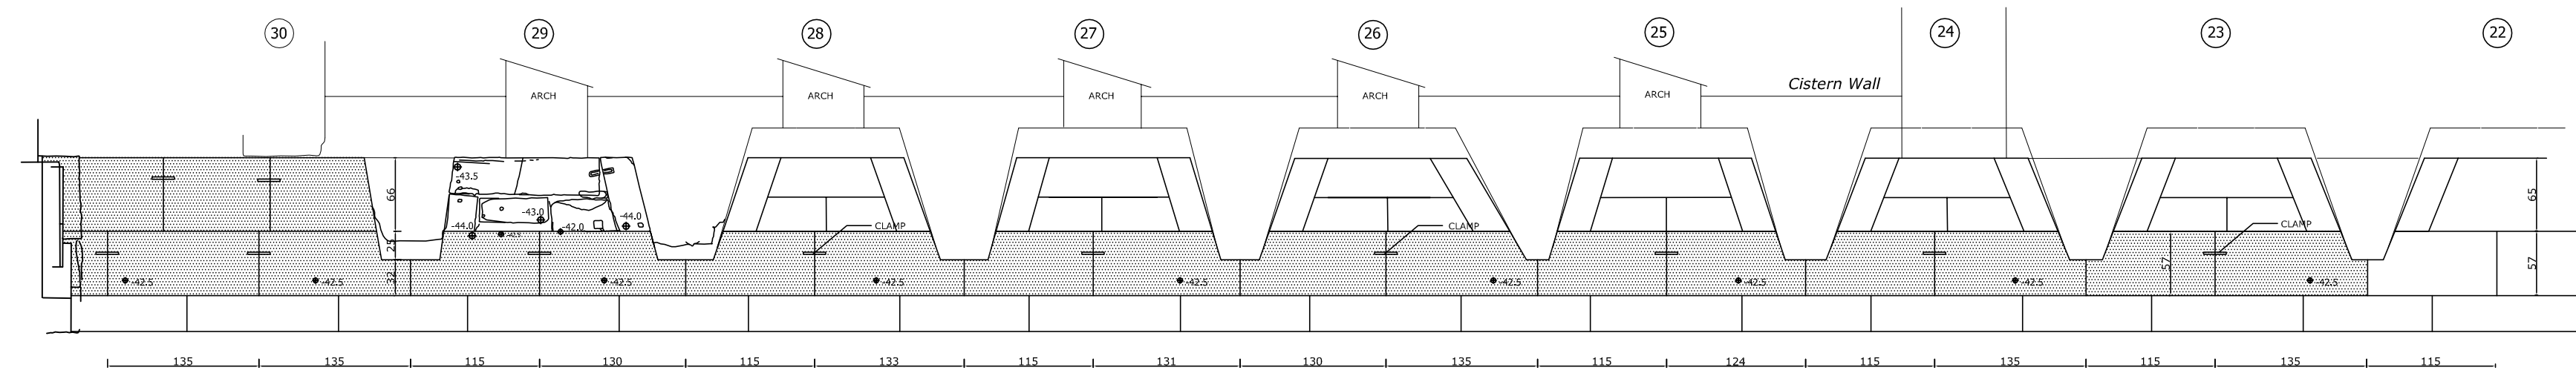
Figure 4.32. Reconstruction project for the 2nd course of the east wall between 22nd and 30th axes.

and then the distance between them would be adopted. According to the proposal project 135 cm cut stones are appropriate to be placed behind the windows with the center alignment at the third step (Figure 4.31). Then the second step should be placed as the joints located on the center of the windows and cut as shown in the reconstruction project in order to ensure the continuity of the windows to the first step (Figure 4. 32).

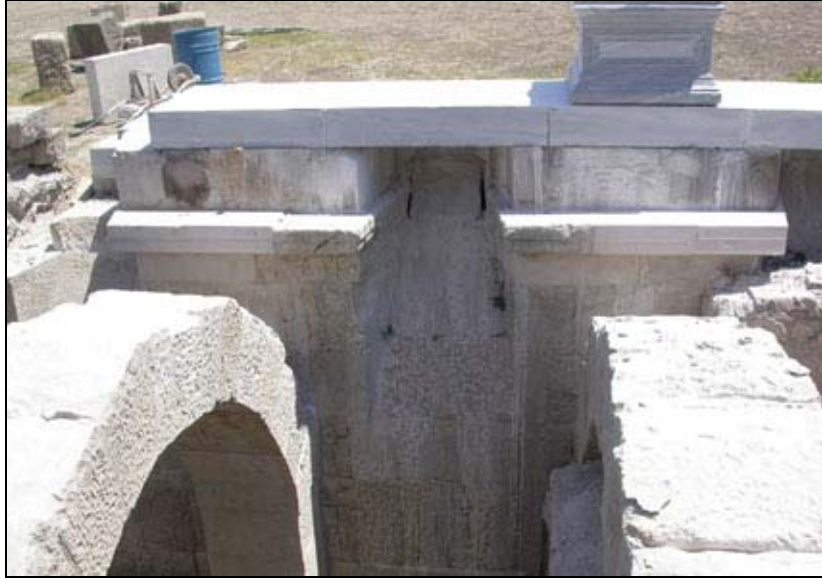
Figure 4.35. Reconstruction implementation of the window between 23rd and 24th axes.

The reconstruction implementation of the stylobate started in June 2005 with the placement of the stones on the 6th course. Each course was implemented as stated in the reconstruction project except for some problems due to the hardness of the marble (The Marmara marble was too hard to cut, for this reason, the second line had a few different measures than the project). The Bursa beige marble was used in the complete course of the 6th, 5th, 4th and west surface of the 3rd course (Figure 4.34). The other placed on the 3rd course composed the last step of the stylobate and the 2nd and 1st courses were constructed with the Marmara marble as stated in the reconstruction project (Figure 4.35).

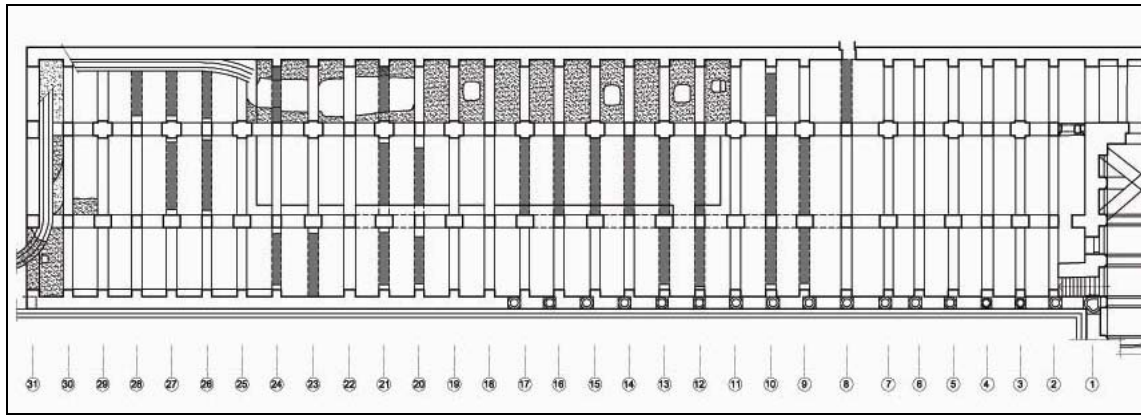
Figure 4. 37. The collapsed arches are shown in grey.

Although not planned among the intervention decisions concerning the Agora, the reconstruction of the ruined arches were decided by the administration of the excavation. These reconstructions were planned to make the anastylosis of the arches which were destroyed (collapsed) during the recent excavations and the arch components had been kept to be re-erected later on.

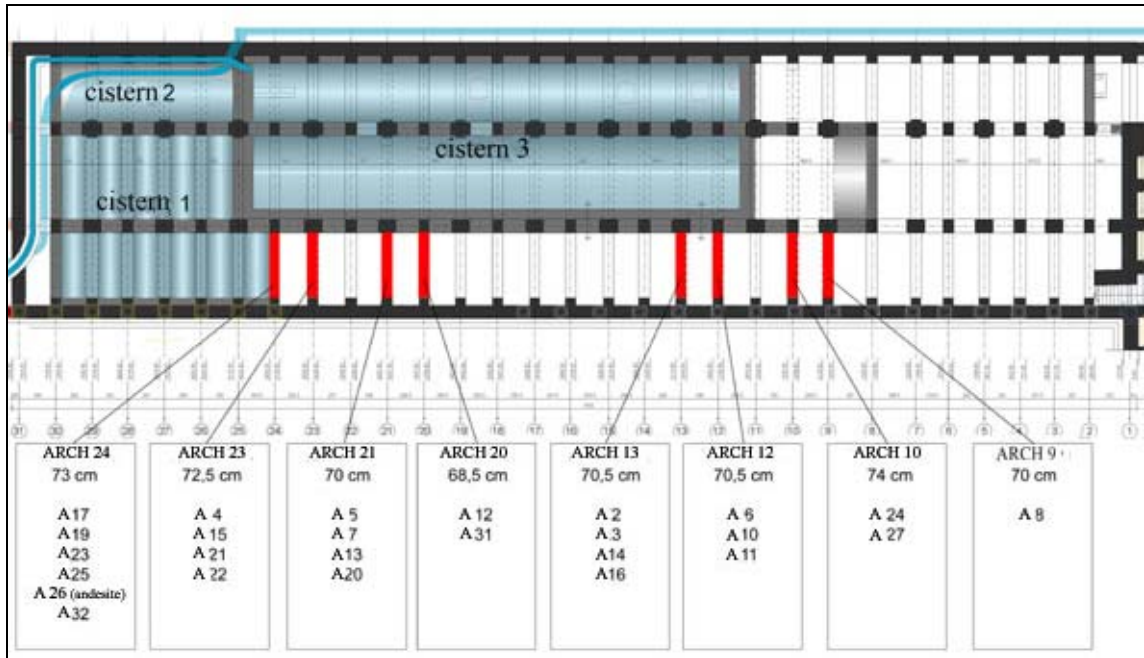
Figure 4.40. The figure shows the implemented arches and the extant voussoirs to be used in the reconstruction. (Source: Archives of the Agora excavations, 2005).

The reconstruction project was prepared regarding the theoretical drawings. A total of 8 arches of the east nave were planned to be reconstructed in this study. In total 24 extant voussoirs were decided to be used in appropriate places of the reconstruction. The voussoirs were classified according to the sizes to be reused in Figure 4.40. Since the span of the arches varied, the voussoirs would be used in the exact measure but the keystones would be adjusted “(Taşlıalan 2005b)”.

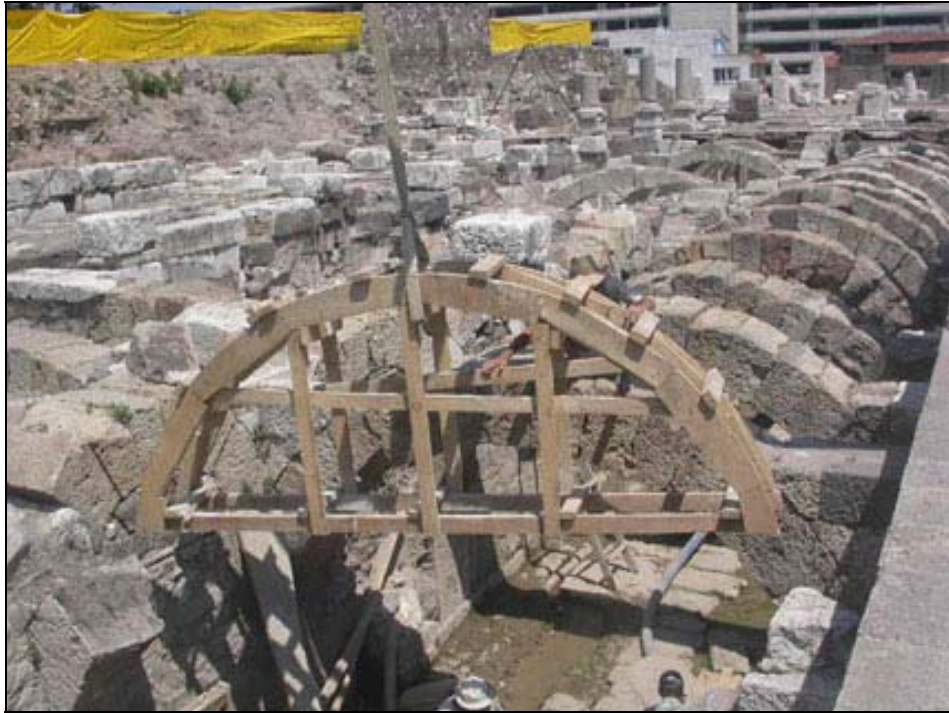
Figure 4.41. The timber staging is placed initially.
(Source: Archives of the Agora excavations, 2005)

A timber staging with the arch for the reconstruction implementation was built initially (Figure 4.41). Then the voussoirs were placed on the staging. Each voussoir was constructed with similar measures but not identical. The extant voussoirs were used in the reconstruction process initially (Figure 4.42). Finally the keystone was placed on the arch. The voussoirs implemented were in divesting measures in order to have the similar appearance with the extant arches which are dated to Roman era (Figure 4.43). Tufa was used to construct new voussoirs since they reveal similar properties with the Roman arches.

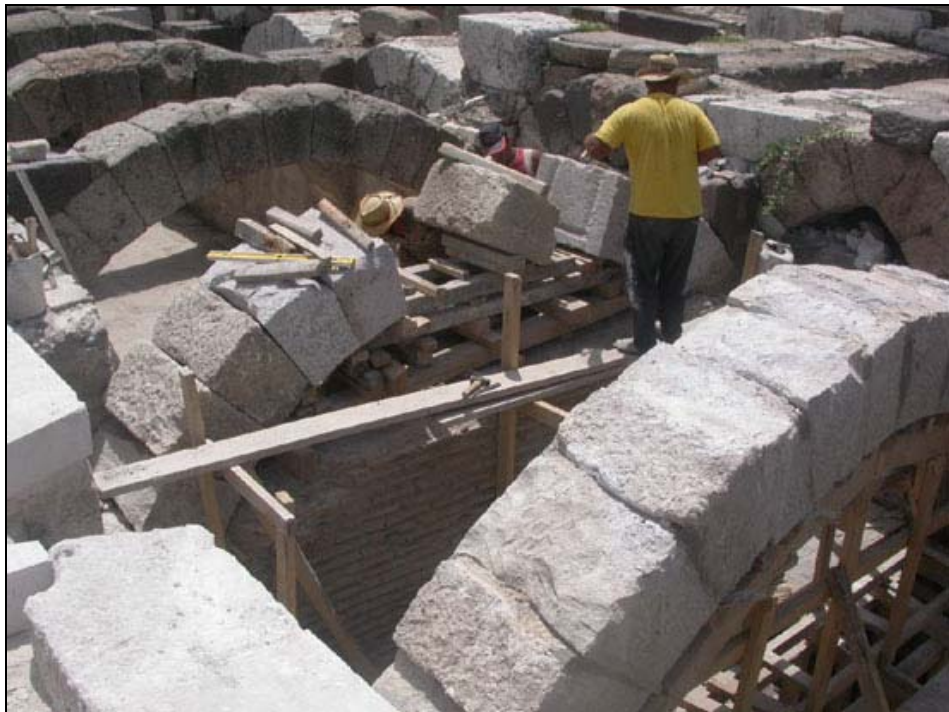
Figure 4.42. The reconstruction process of the arches.
(Source: Archives of the Agora excavations, 2005)

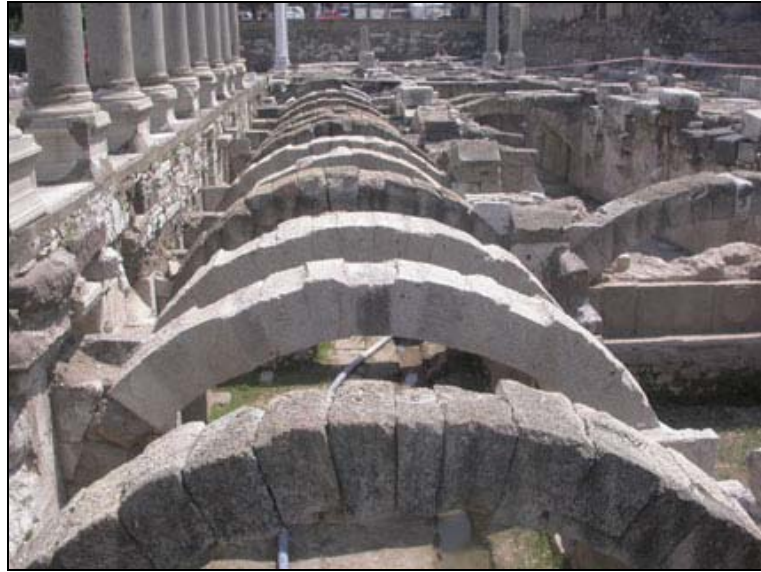
Figure 4.43. The state of the arches after the reconstruction implementation.

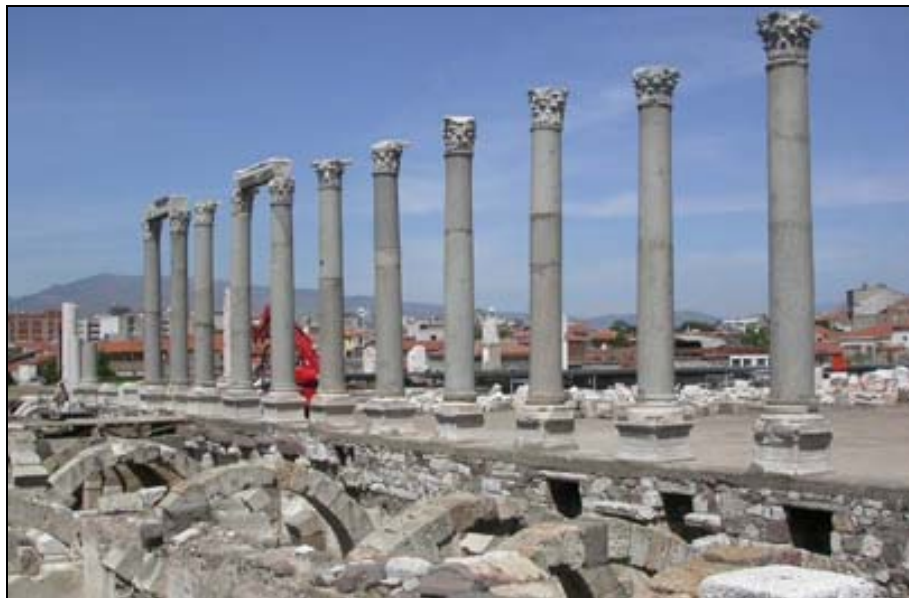
The east façade of the West Stoa partially stands on the north side including the anastylosis of 13 columns, capitals and two architraves (Figure 4.44). This state of the structure was due to a prior implementation which was stated under heading 3.5.1.2.2. The anastylosis of the 5 columns were implemented by unification of two pieces and 8 columns were implemented with three pieces of columns. The joint edges of the pieces reveal that concrete material was used during the implementations. Further some ancient reconstruction marks are also displayed at the edges of the column pieces (Figure 4.45). This leads to the idea that, the West Stoa was destroyed in an earthquake and repaired at least once. Further, fractured columns were reused after being reunified with the clamps.

Figure 4.44. Recent state of the West Stoa east facade columns.

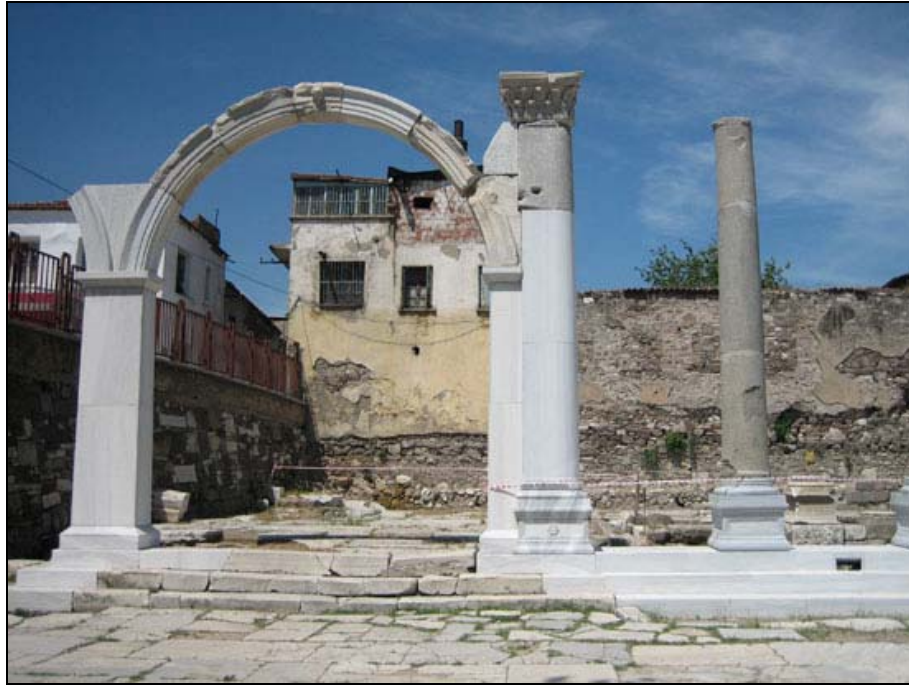
Figure 4.46. Reconstruction implementation of the West Gate and the 30th column of the West Soa.

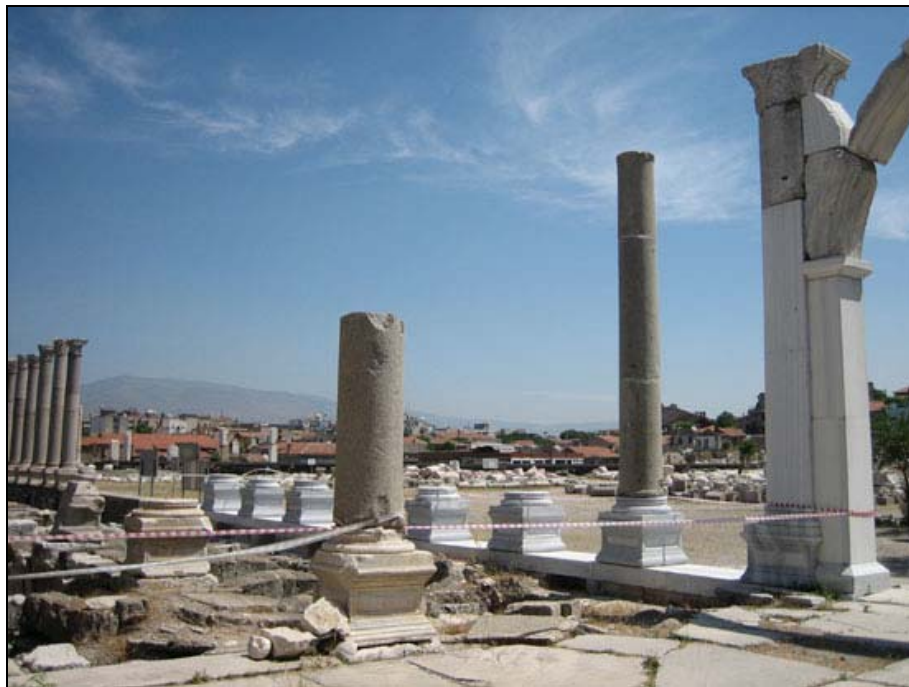
After the reconstruction of the stylobate, column bases were constructed in the atelier from the Marmara marble. Seven bases were constructed and placed on the first step of the stylobate with 3 clamps and lead applied around the clamps. Later on the implementation of the columns started. First 30th column was unified from the pieces shown in the project, afterwards placed on the newly constructed bases. It was montaged with three clamps as stated in the proposal of project (Figure 4.46). The implementation studies had been stopped when the re-erection of the columns started. As stated under heading 4.2, the aim of this process was to acquire the unity of the West Gate and the West Stoa as in the Roman era. On the contrary, the recent state of the West Stoa presents a discontinuous and artificial structure due to unfinished implementations.

Figure 4.47. The implementation studies finished after re-erection of the 30th column.

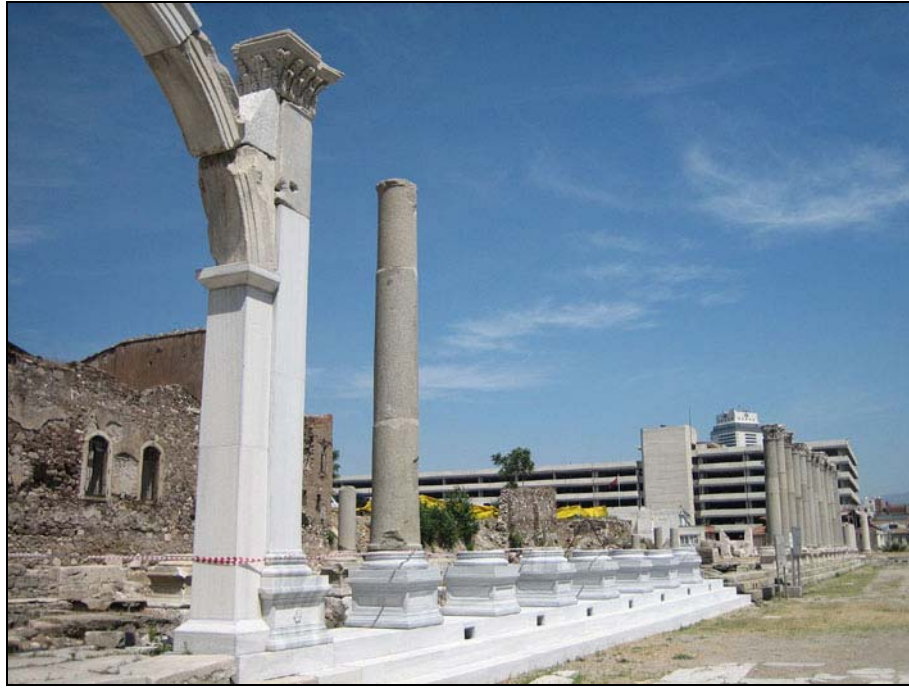
Figure 4.48. The present appearance of the West Stoa, 2006.

The proposal of anastylis of the columns will be evaluated in this study since the interventions have not been completed yet. The new application of the columns will be distinguishable due to the unification technique of the column pieces. Original pieces will be used in the column anastylis while all the bases were built with new material, Marmara marble (Figure 4.48). The bases were built according to the existing original ones with compatible materials.
