**MODELLING OF THE OIL SPILL IN M/V LADY TUNA ACCIDENT
AND THE EVALUATION OF THE RESPONSE OPERATION
IN SIMULATED CONDITION WITH PISCES-II**

M.Sc. THESIS

2019

PİRİ REİS UNIVERSITY

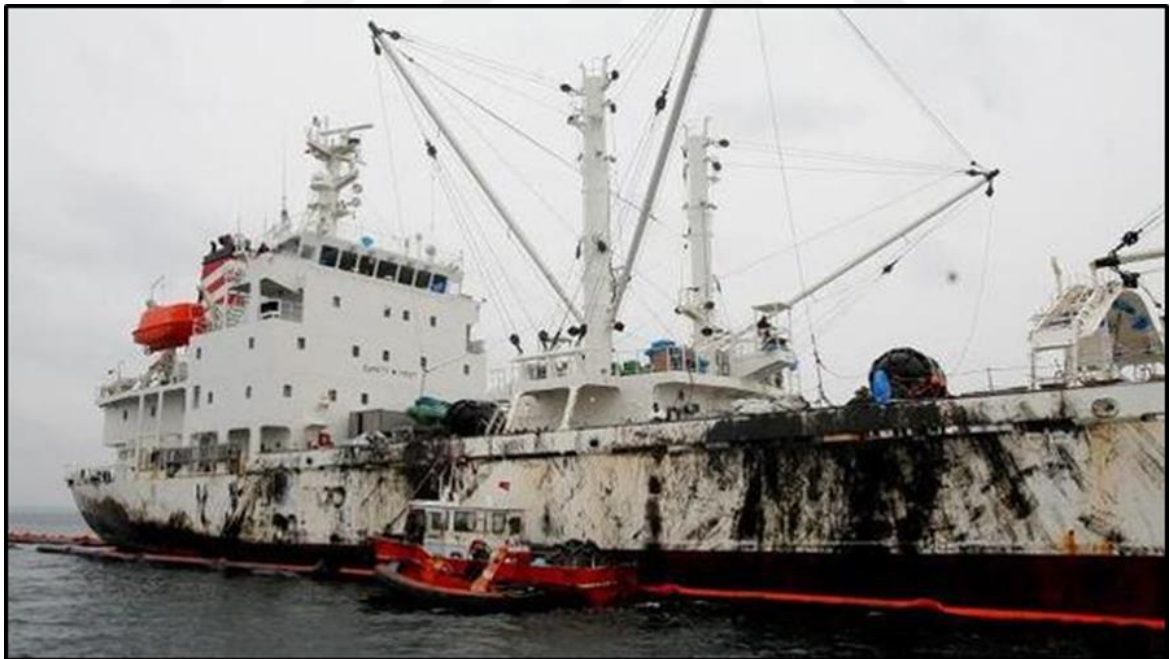
The weather report of the Çeşme station after the accident is presented in Figure 7.13. It shows that the violent storm occurs after the accident when the fuel oil continued to flow into the sea from M/V Lady Tuna vessel. It has been thought that the physical insufficiency of the barrier placed around the ship and the extreme weather conditions increased the volume of the spilled oil (Figure 7.14). It is clear; the delayed response operation was managed following the accident.

Figure 7.14. The Containment Booms were used to Control the Oil Pollution (URL-6, 2017).

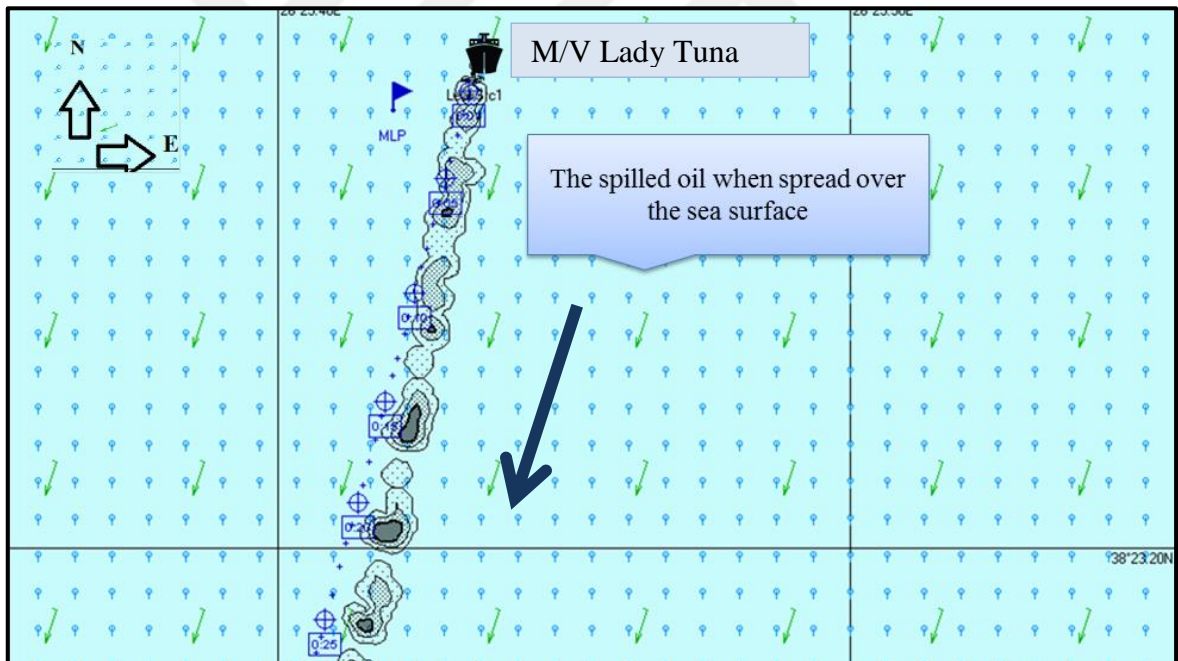
In the first scenario, no response resources were used during the simulation. As soon as the oil is spilled, it immediately starts to spread on the sea surface. The fate of spilled oil water movement rapidly breaks up oil films, which drift on the water surface as shown in Figure 8.10. During the simulation in one hour, amount of spilled and floating oil were 5 tons/per hour, evaporation and dispersion of the spilled oil did not begin.

Figure 8.10. Scenario-1: Movement of the Oil Spread over the Sea Surface (Δt : 1h).

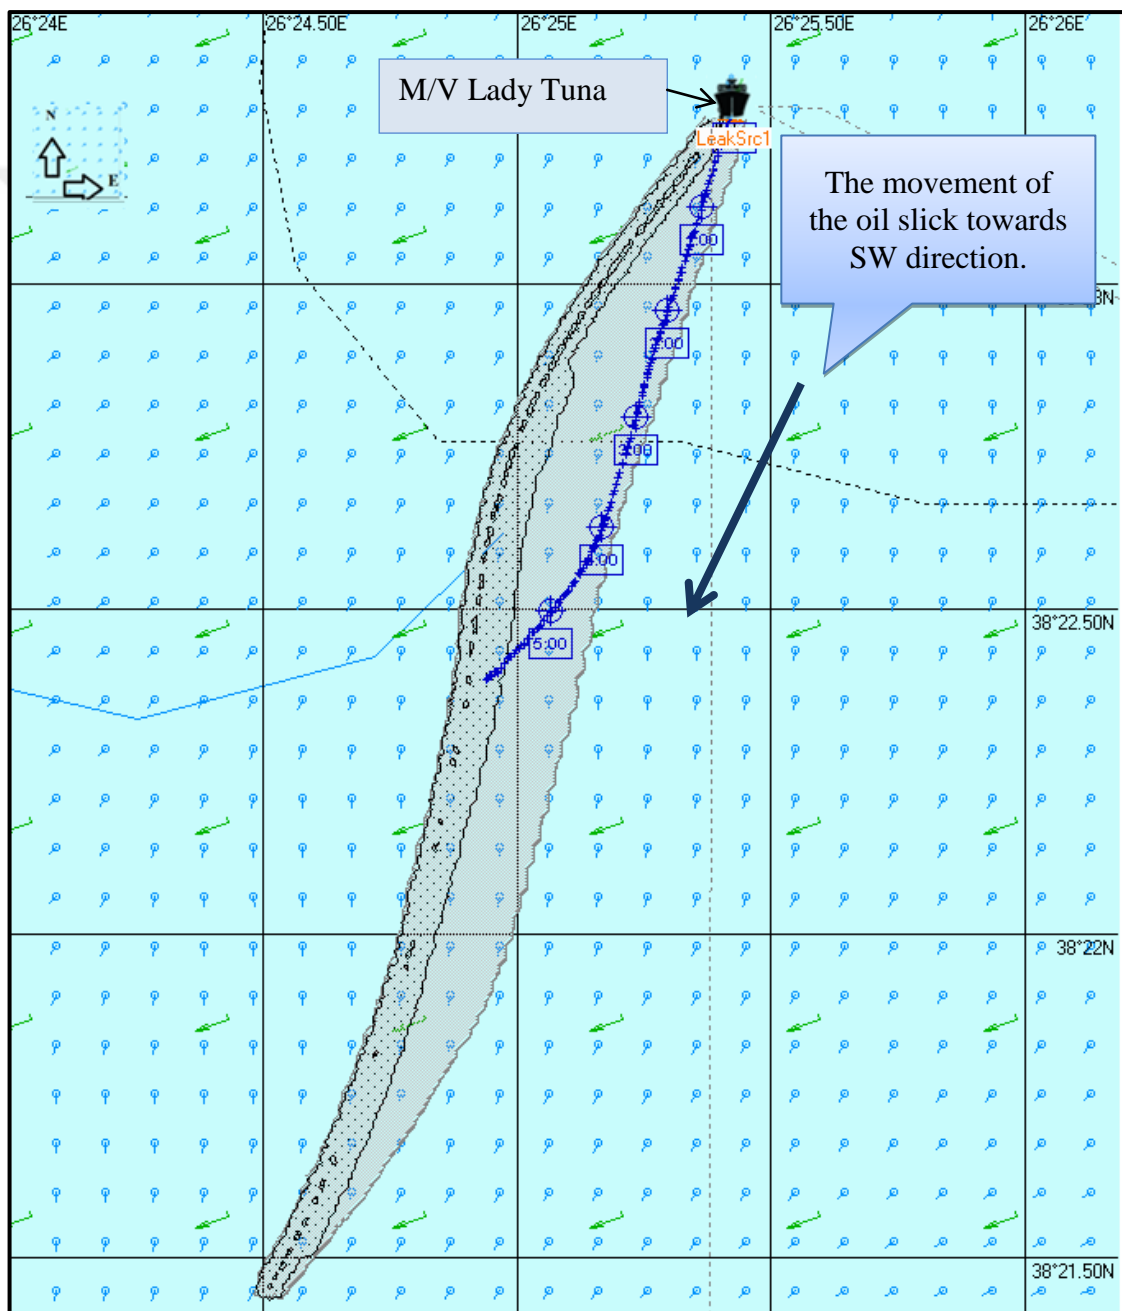
The effects of winds and currents significantly affect the spread of oil. The movement of the oil slick after the accident was towards SW direction which drifts in response to the wind and the current (Figure 8.11).

Figure 8.11. Scenario-1: The Movement Direction of the Oil Slick (Δt : 6 h).

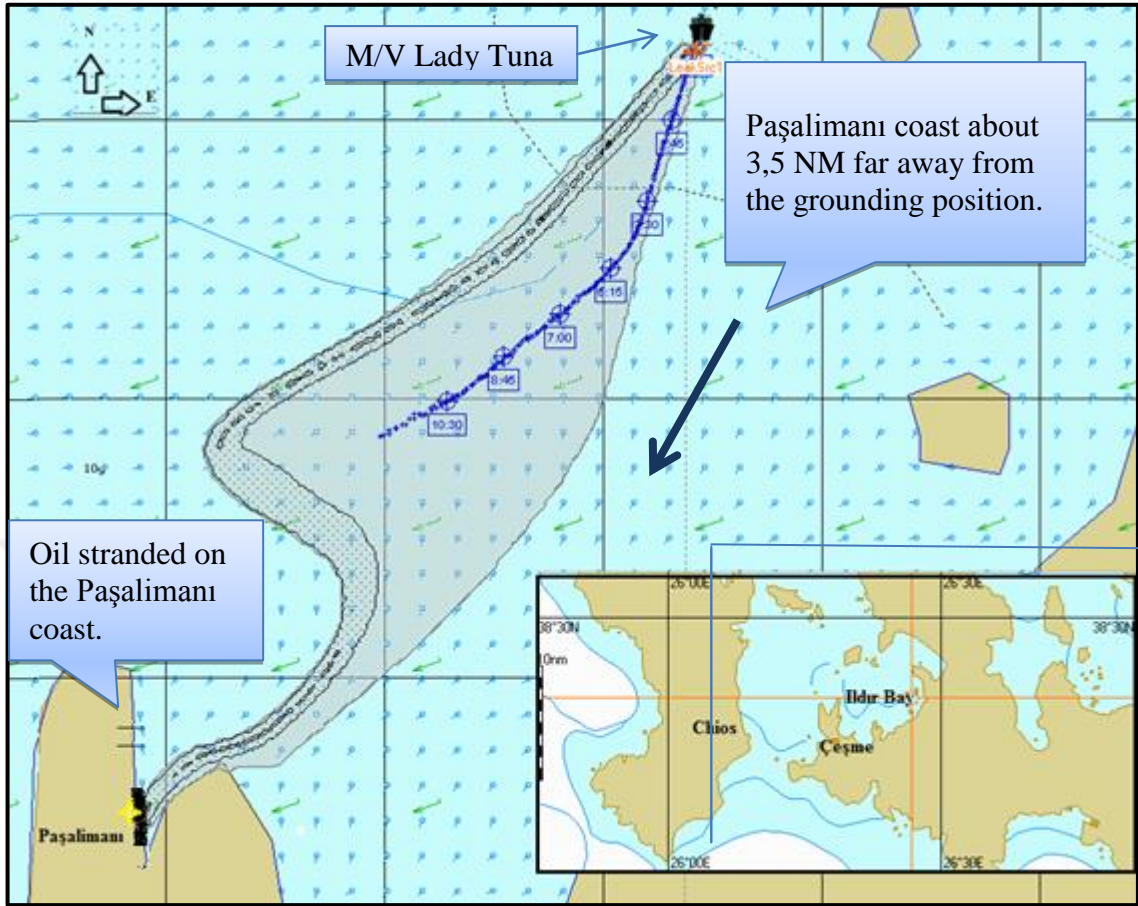
The program showed the information “Oil impact on land” on the window screen. It means that the amount of stranded oil increased after this. The oil reached on the Paşalimanı coast about 12 hours later following the spillage. There is about 3,5 NM far away from the accident position as shown in Figure 8.12. It is compatible with the information as İzmir's Directorate of Environment and Urbanization “the area surrounding Paşalimanı was the most affected by pollution”.

The area shown in gray indicates the area where oil is spreading for up to 12 hours from the beginning of the scenario. The amount of spilled oil was 60 tons after 12 hours from the accident. The oil reached on the Paşalimanı coast about 12 hours after the accident but this was a too small amount of the spilled oil (0,02 %). The pollution and spillage parameters after 12 hours from the accident are presented in Table 8.6.

Figure 8.12. Scenario-1: The Oil Stranded on the Paşalimanı Coast (Δt : 12 h).

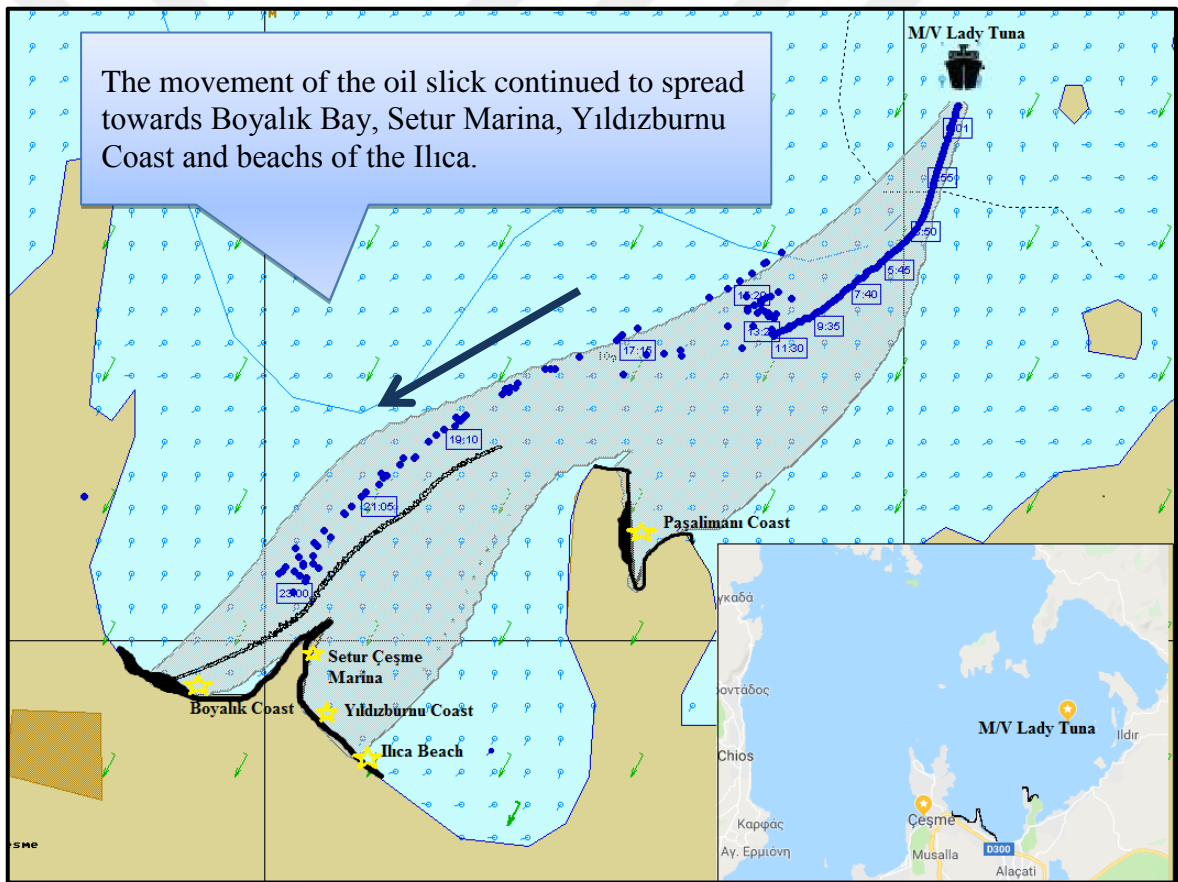
The spreading process resulted in increase of the slick area. The movement direction of the oil slick after 24 hours from the accident showed that oil stranded from Paşalimanı coast towards the Boyalık Bay, the Yıldızburnu coast (about 6 NM far away from the accident position), the Setur Çeşme Marina and the beaches of the Ilıca (Figure 8.13).

Amount of stranded oil was 26.4 tons (36.4%) after 24 hours from the spillage. Moreover, the evaporated and the dispersed oil rate increased very slowly because of high viscosity of the spilled oil type (Table 8.7).

Figure 8.13. Scenario-1: The Movement Direction of the Oil Slick (Δt : 24 h).

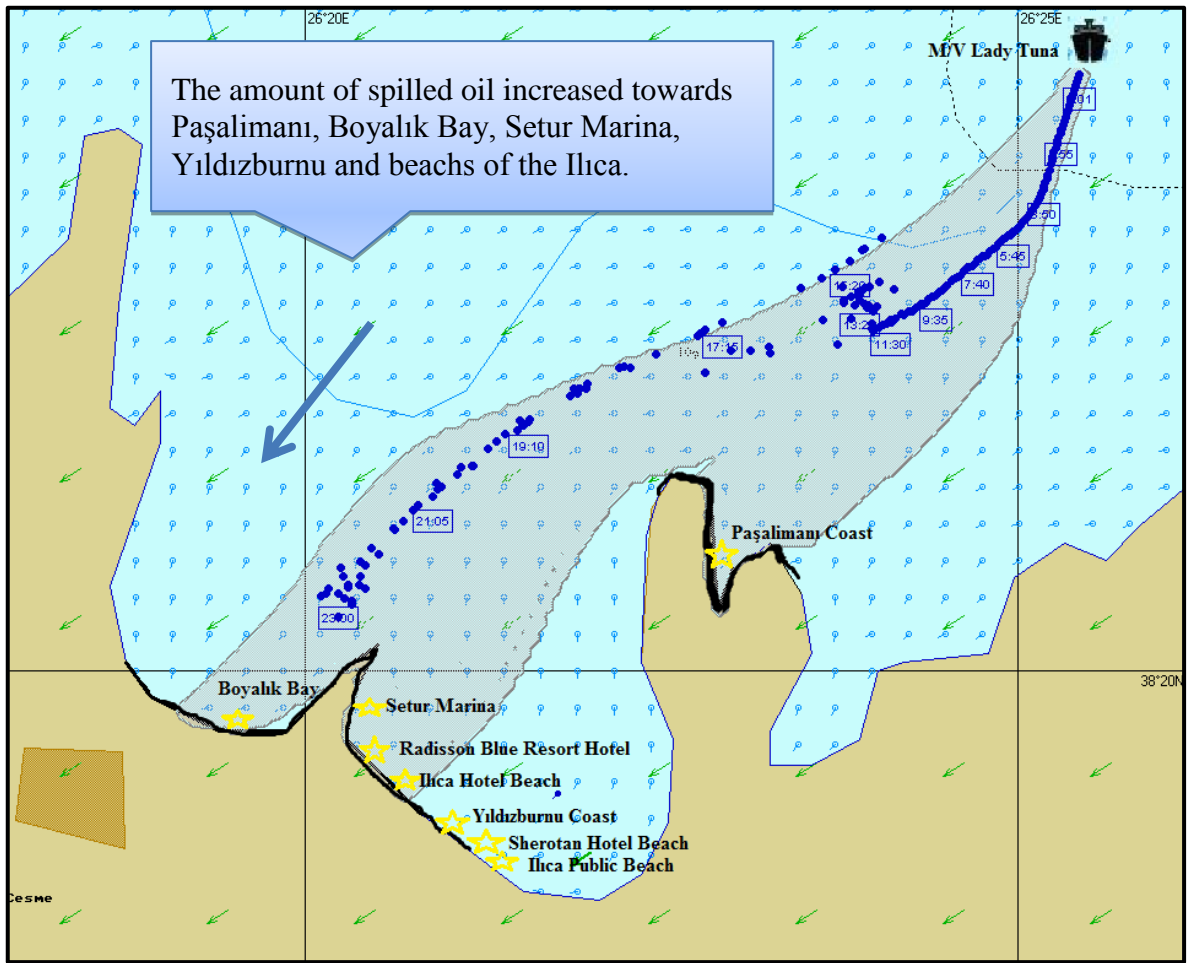
- As the amount of spilled product increased, the spilled area grew and the oil stranded the coasts of the Ildır. The oil slick continued to spread towards the Boyalık Bay, the Setur Marina, the Radisson Blue Resort Hotel beach, the Ilıca Motel beach, the Yıldızburnu coast, the Sherotan Çeşme Hotel beach and the Ilıca's public beaches.
- The display of oil pollution in gray color indicates the size of the entire polluted area from the start of the scenario until 36 hours following the spillage.
- The movement of the oil on the surface of the sea is shown in Figure 8.14, depending on the environmental conditions, the properties and amount of the spilled oil.

Figure 8.14. Scenario-1: The Movement direction of the oil slick (Δt : 36 h).

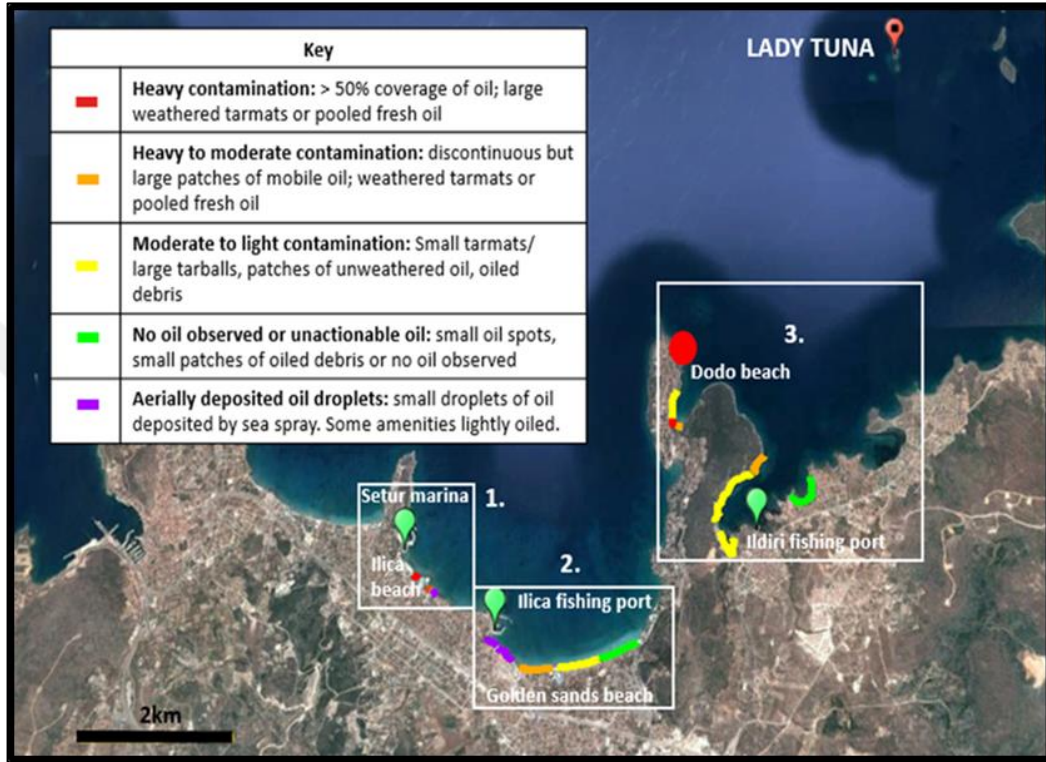
In addition, Çubuk M. (2017) studied on the recent pollution events and presented the M/V Lady Tuna oil spill problem and polluted areas that close to the simulation study (Figure 8.15).

Figure 8.15. The Polluted Areas after the Accident (Çubuk, M., 2017).

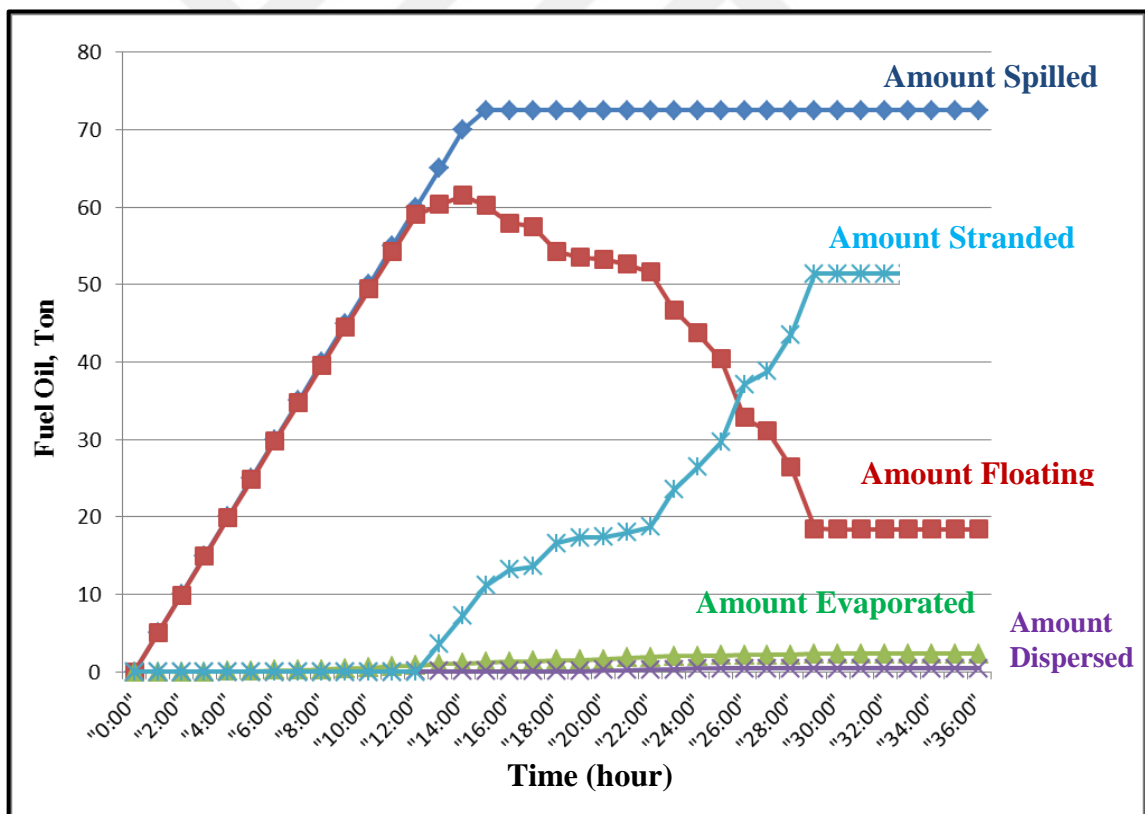
The Scenario-1 ended 36 hours after the accident and from this time spreading of the oil will continue depending on meteorological conditions especially wind direction and the surface current on the sea. As a result of the study, it was available to determine and compare the spill and pollution statistics occurred after the incident in the simulated condition as graphically (Figure 8.16). So, the following results are obtained in the Scenario-1;

- The amount of stranded oil (which began about 12 hours after the spillage), is 51,4 tons (70,9 % of the spilled oil) as well as the floating oil amount is 18,4 tons (25,4 % of the spilled oil).
- The remaining amount of the spilled oil were dispersed (0,51 %) and evaporated (3,18 %). It means the evaporation and dispersion rate is very low due to the nature of the oil (IFO 180, the heavy fuel oil) as well as the moderate sea state.
- The amount of floating oil increased until 14 hours following the accident. After this time the floating oil rate decreased because the oil reached on the coast as well as the fuel leakage ended after 14 hours and 30 minutes.

Figure 8.16. The Graphic of the Spill/Pollution Statistics of the Scenario-1.

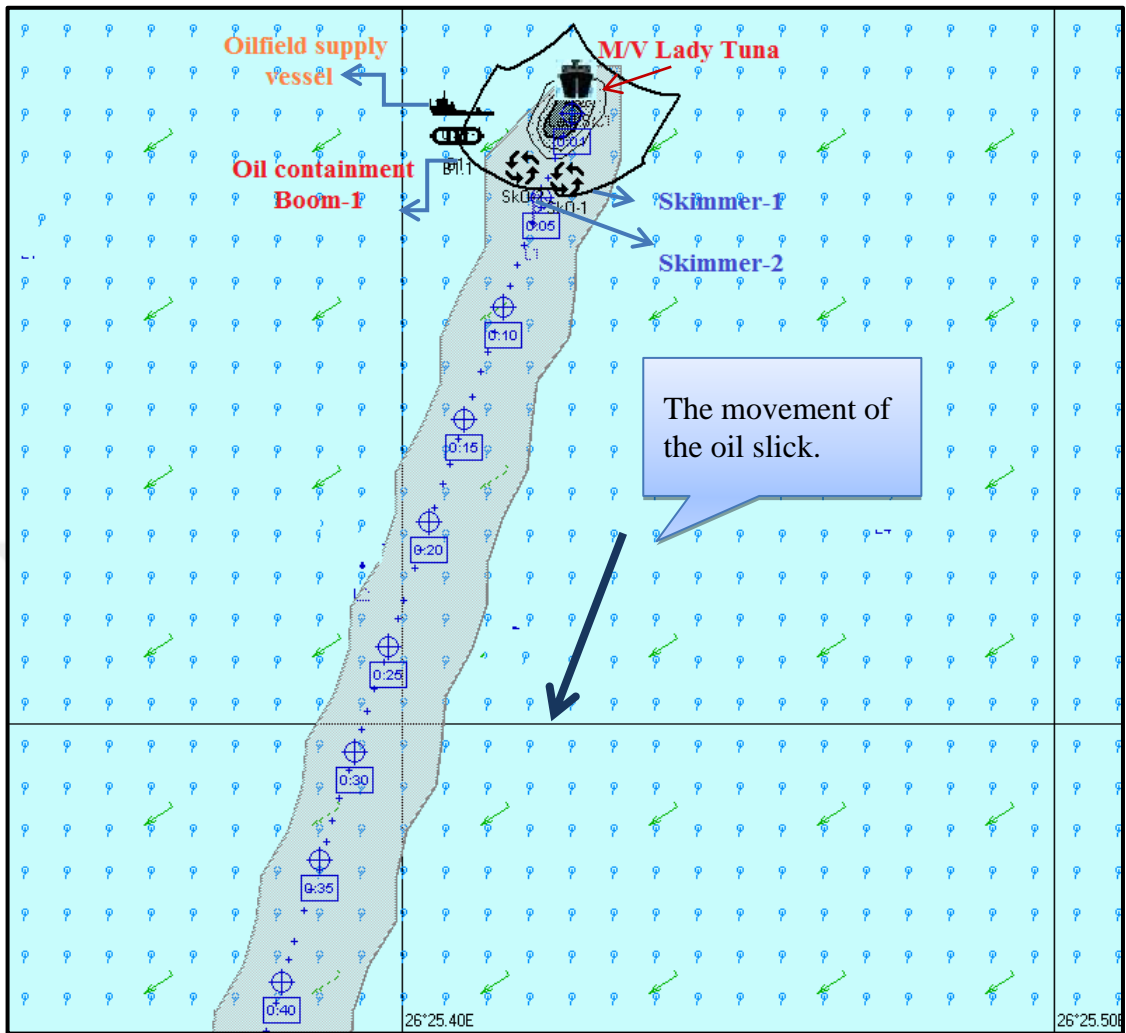
Before the response resources start to the task, about 15 tons oil spill to seawater in three hours. Oil spill parameters of the scenario after five hours from the spillage are presented in Table 8.13. During the simulation, 10 tons oil, which is 40,2 % of the spilled oil, were recovered after the response operation (Figure 8.17).

Figure 8.17. Response Operation with Oil Containment Boom Formation-1 and Skimmers.

The accident occurred at 10:40 UTC (13:40 LT) on 18 December 2016. The open water Boom-1 and the Oleophilic skimmers were placed on the sea at 13:40 UTC. The deployed Boom-1 prevented spreading of the oil slicks. The Oleophilic Skimmers-1 and Skimmer-2 removed the floating oil from the point they located in the boom formation. An oilfield supply vessel assisted the operation.
