**PERFORMANCE ANALYSIS OF REPAIRED CARBON FIBER COMPOSITE
MATERIALS WHICH HAVE BEEN MANUFACTURED IN AEROSPACE
INDUSTRY**

MASTER THESIS

Mechanical and Aeronautical Engineering

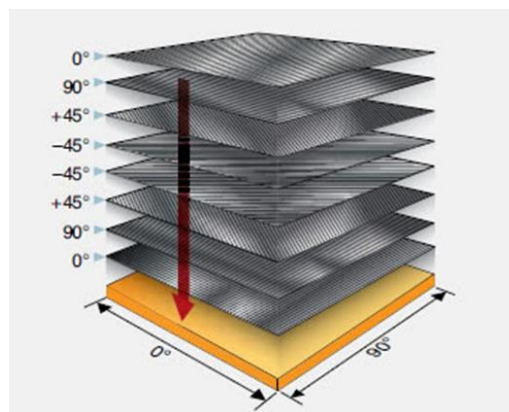
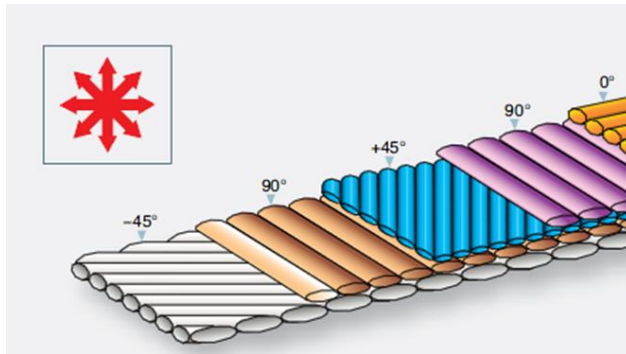
Figure 1.1: Composite materials.

Figure 1.2: Composite materials.

The composite structures of interest are mainly components composed of laminated plies as shown in Figure 1.1. and Figure 1.2.

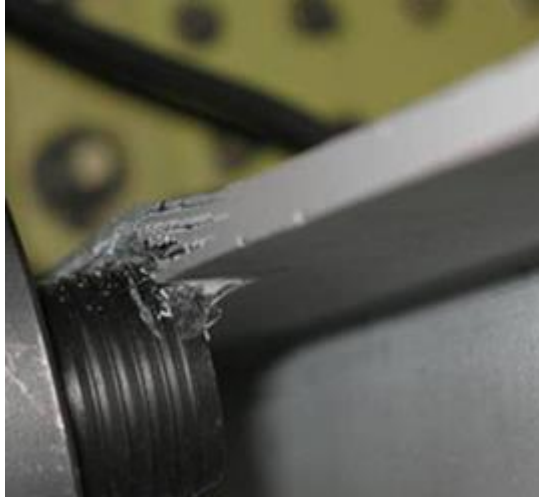
Figure 1.3: Impact damage example 1.

Figure 1.3. and Figure 1.4. are some of the examples to result of impact damage.

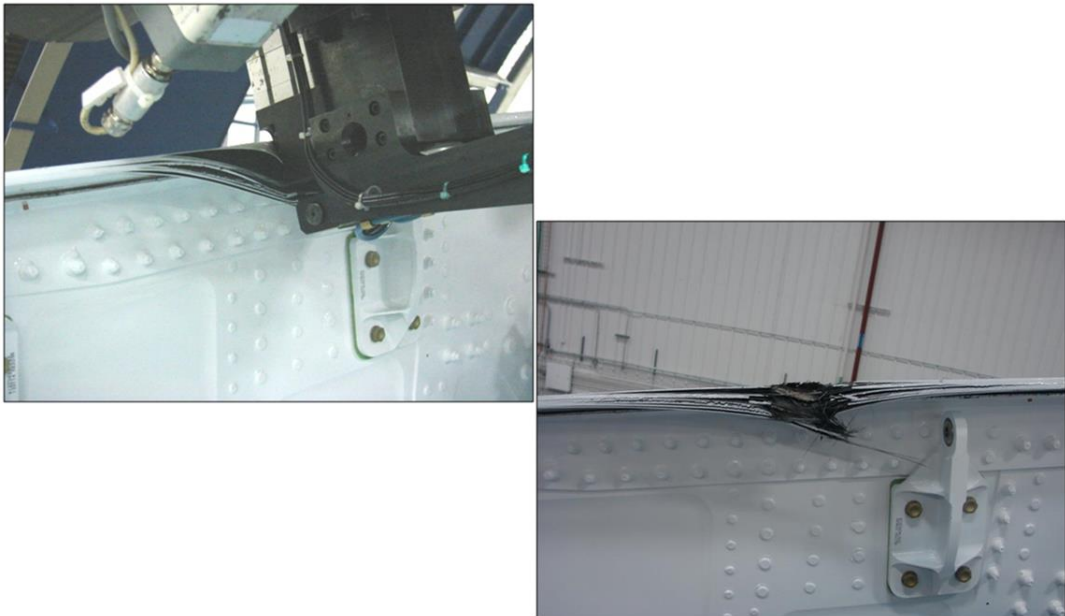
Figure 1.4: Impact damage example 2.

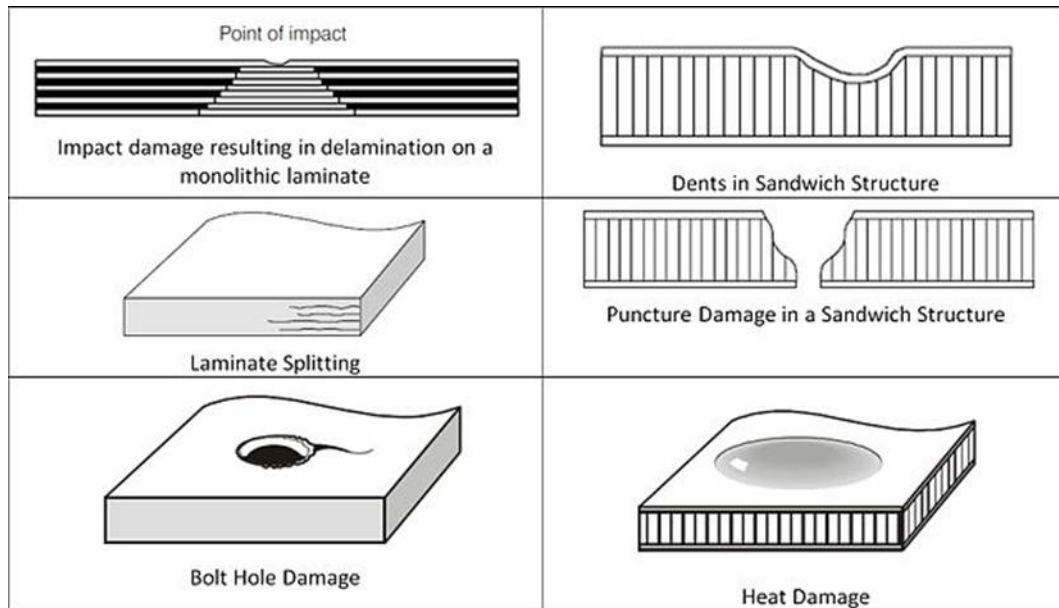
Impact energy is usually more extensive than metals. Some of the damage types on composite structures are shown in Figure 1.5

Figure 1.5: Damage types on composite structures [3].

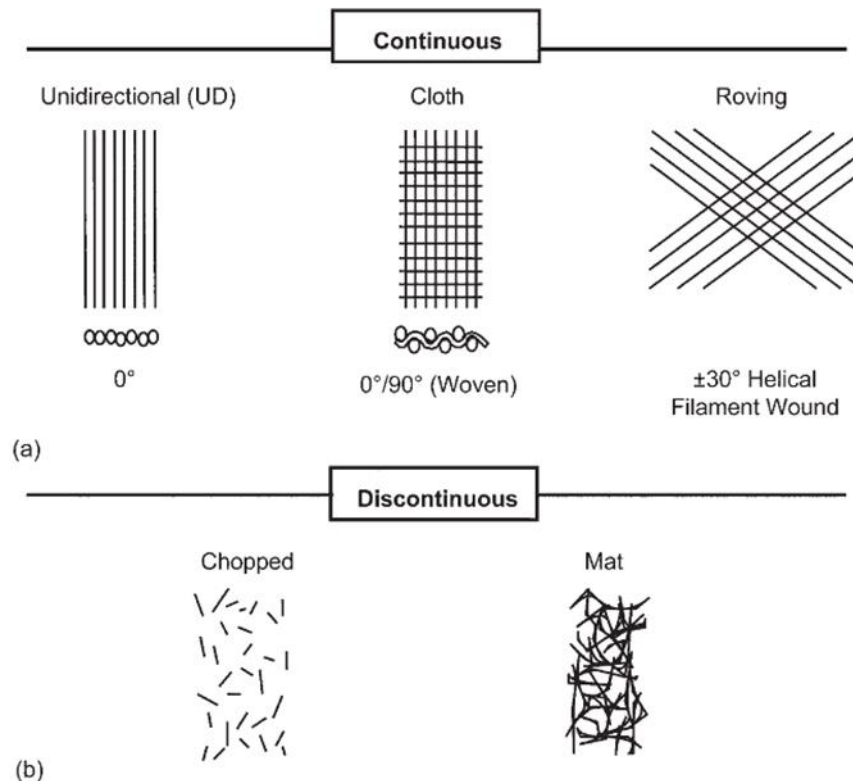
Continuous (UD, Cloth and Roving) reinforcement types are the most general one's on aerospace industry (Fig. 2.1).

Figure 2.1: General reinforcement types.

fibers generally have a random orientation. Examples of continuous fiber orientation shown on Figure 2.1(a) and also discontinuous reinforcements are shown on Figure 2.1(b). Continuous-fiber composites are generally made by laminates by stacking single sheets of continuous fibers in different orientations.

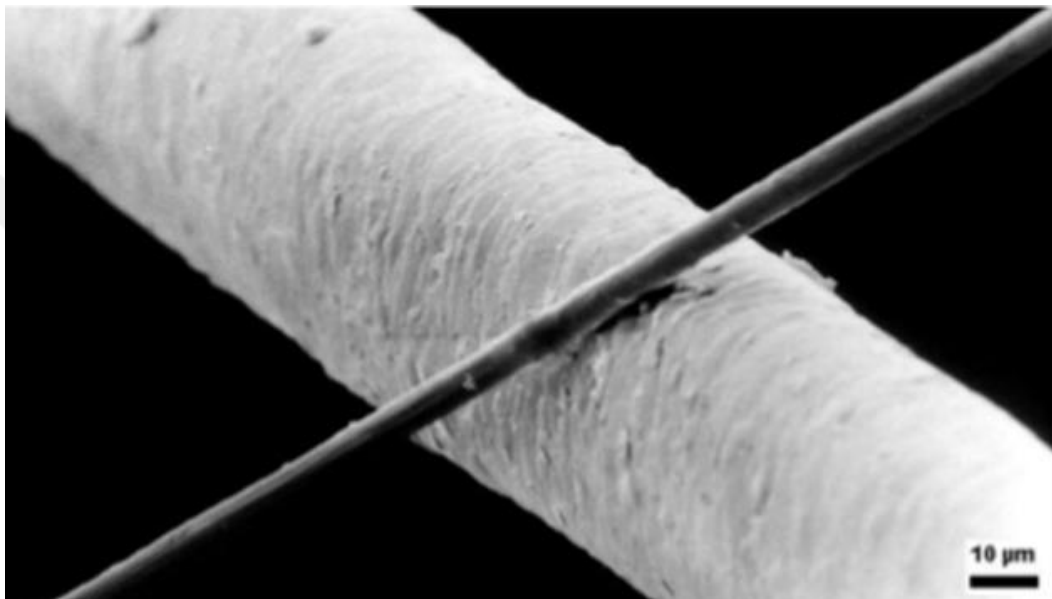
Figure 2.2: Compare of a human hair and carbon-fiber.

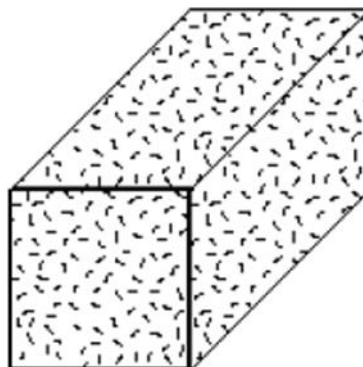
Figure 2.3: Random fiber composites.

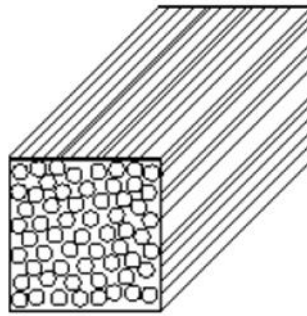
Figure 2.4: Continuous fiber composites.

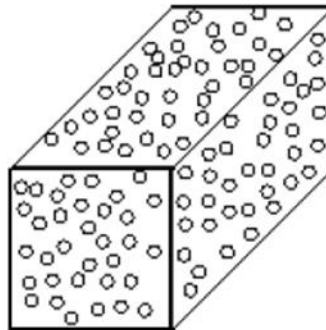
Figure 2.5: Particulate composites.

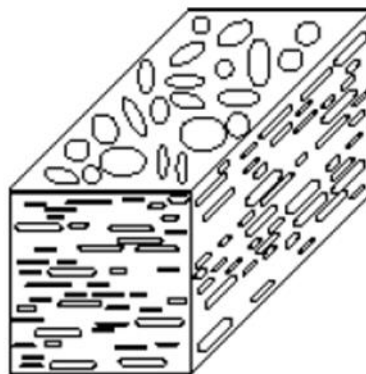
Figure 2.6: Flake composites.

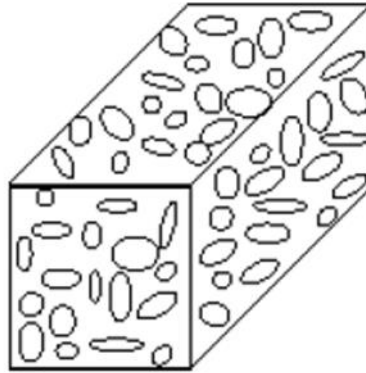
Figure 2.7: Filler composites.

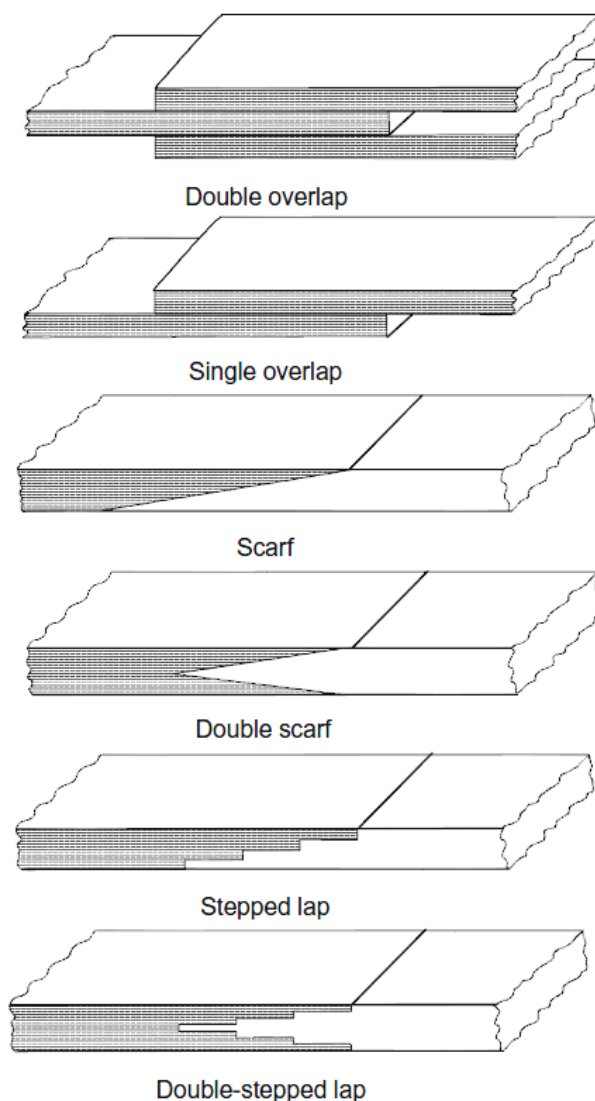
Figure 3.1: Main types of joint configuration used for repairs to composite structure.

Figure 3.1 shows different types of repairs. There are a lot of types of repairs on aviation industry but most common used is scarf repairs.

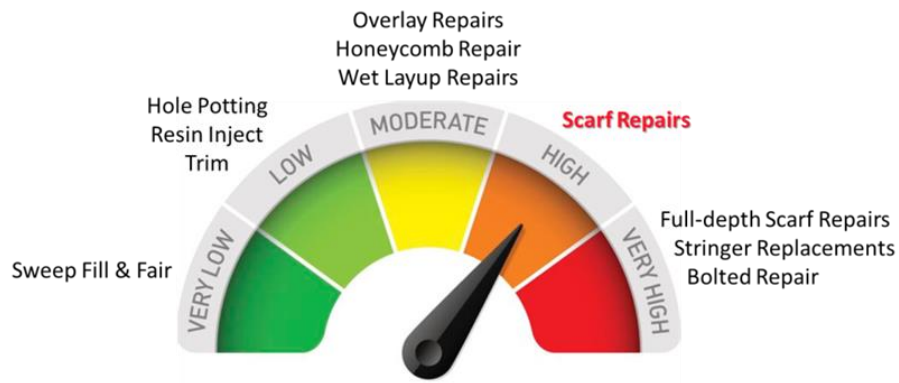
Figure 3.2: Repair types and repetitiveness table.

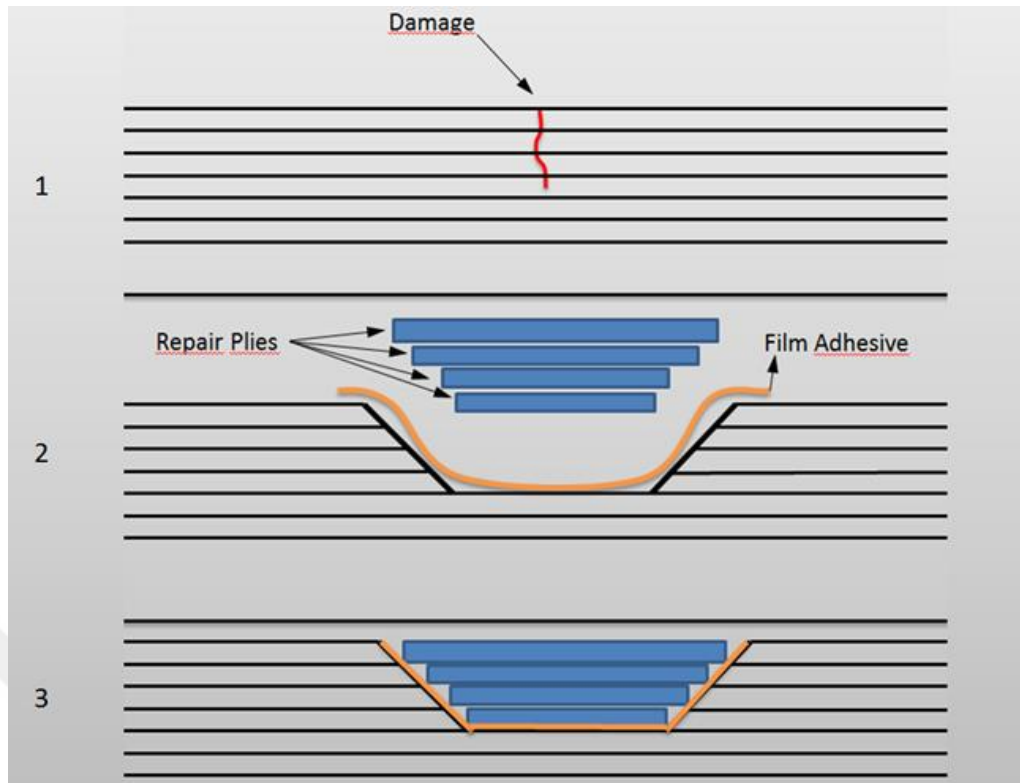
Scarf repair reconstructs full structural and mechanical characteristics like before repair. Each ply of the carbon fiber laminate is removed ply by ply from the damage area and replaced with reinforcement plies.

Figure 3.3: Scarf repair.

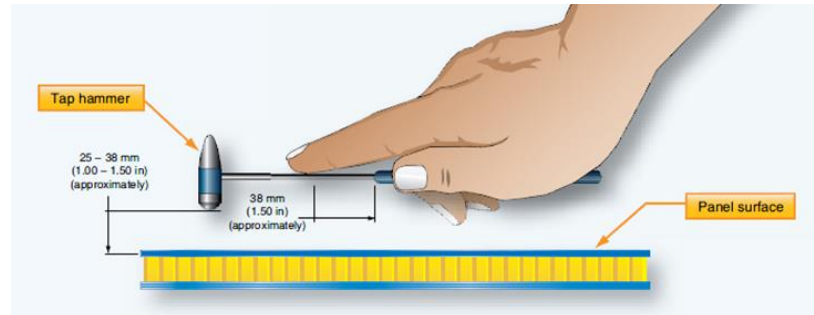
The size and depth of damage to be repaired must be observed using nondestructive control (NDI) method. As a result of NDI Inspection delamination/damage and delamination depth below the surface and damage width composites will be discovered. One of the popular techniques is tap testing shown on Figure 3.3, tap inspection is used with a lightweight object, such as a coin or hammer, is used to locate damage. Advantages of tap inspection are; it is simple and

Figure 3.4: NDI method - tap inspection.

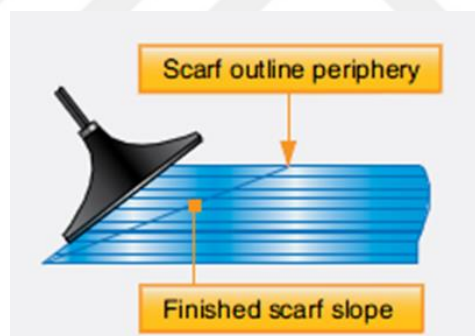
After the damaged area has been determined, the damaged laminate must be removed. The taper remove (scarf angle) should be less than 5° to minimize the shear strains along the bond line.

Figure 3.5: Taper remove of laminates.

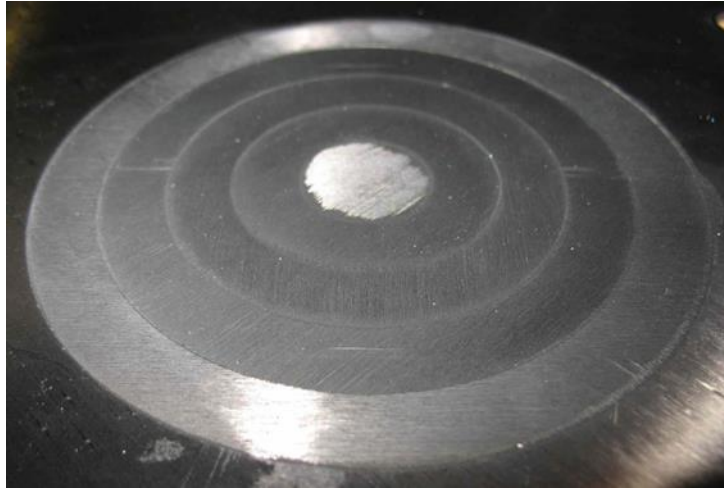
Figure 3.6: Scarf Repair taper laminate removal example 1.

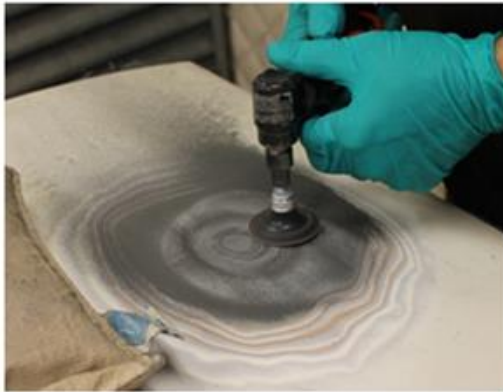
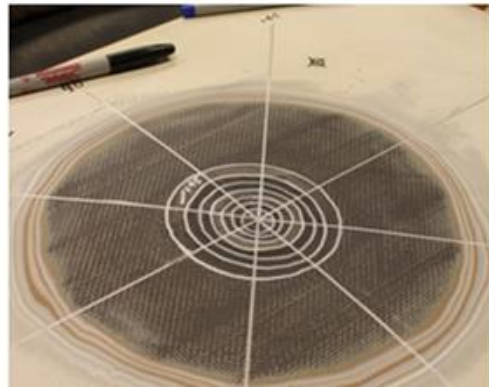
Figure 3.7: Scarf Repair taper laminate removal example 2.

The Figure 3.7. on the left picture shows the scarfing, or taper sanding, process where a large amount of auto-clave cured material is being removed around the damaged area. The image on the right shows the final scarf with the ply outlines highlighted. After this step, the repair plies will be cut out of new material, laid up onto the part, and cured onto the part to form the repair.

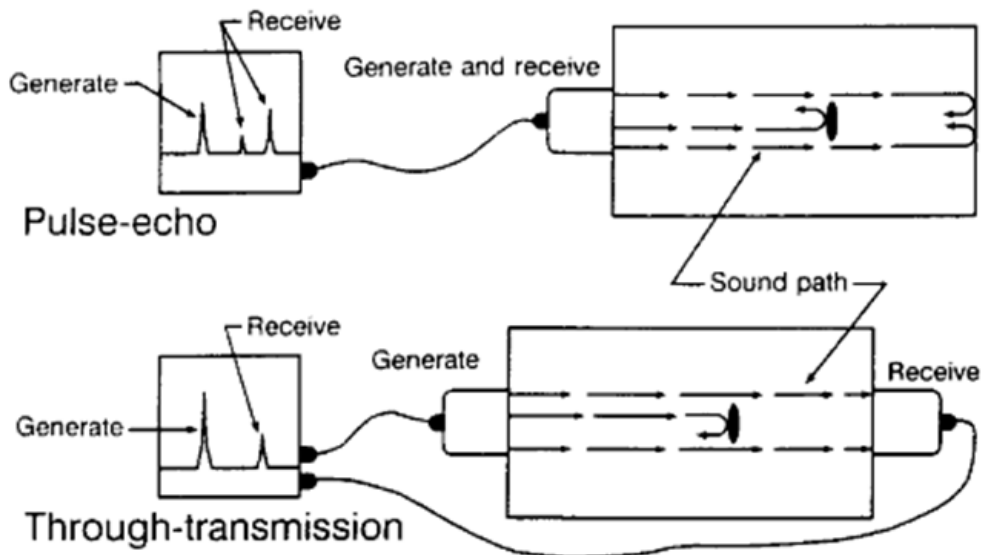
Figure 4.1: Ultrasonic inspection.

Ultrasonic inspection is an NDI technique that uses sound energy moving through the test specimen to detect discrepancies. Sound energy passing through the specimen and displayed on a computer data program.

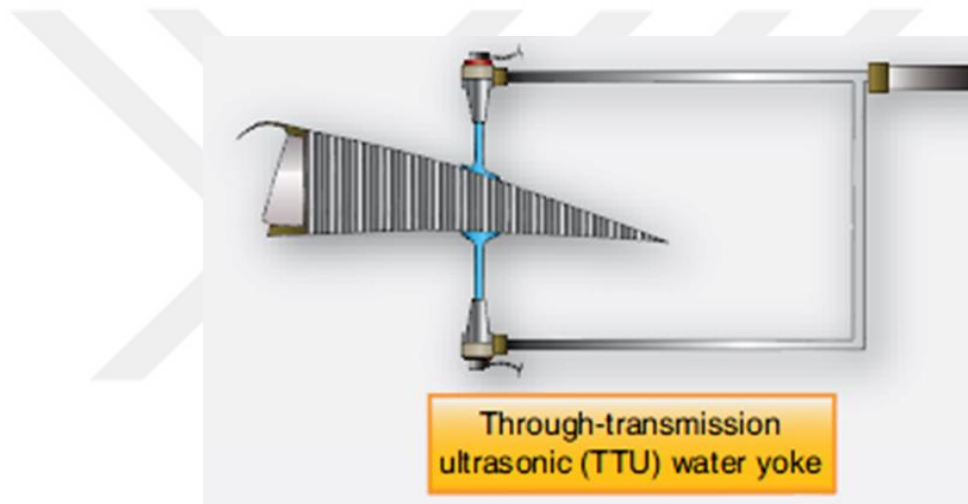
This inspection employs two transducers, one to generate and a second to receive the ultrasound. A defect in the sound path between the two transducers will interrupt the sound transmission. The magnitude (the change in the sound pulse amplitude) of the interruption is used to evaluate test results. Through transmission inspection is less sensitive to small defects than is pulse-echo inspection.

Figure 4.2: NDI method – TTU inspection.

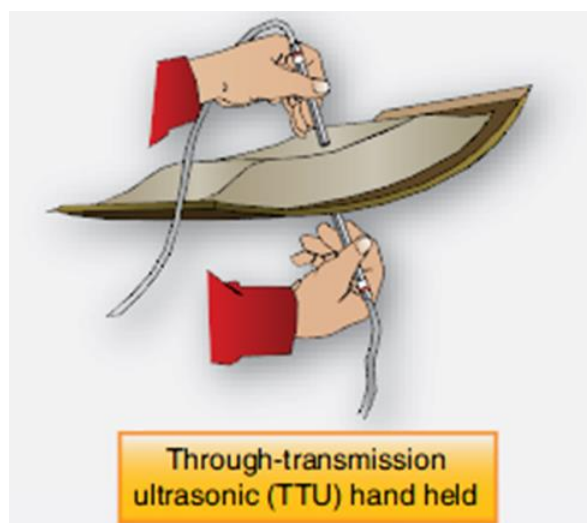
Figure 4.3: NDI method – manual TTU inspection.

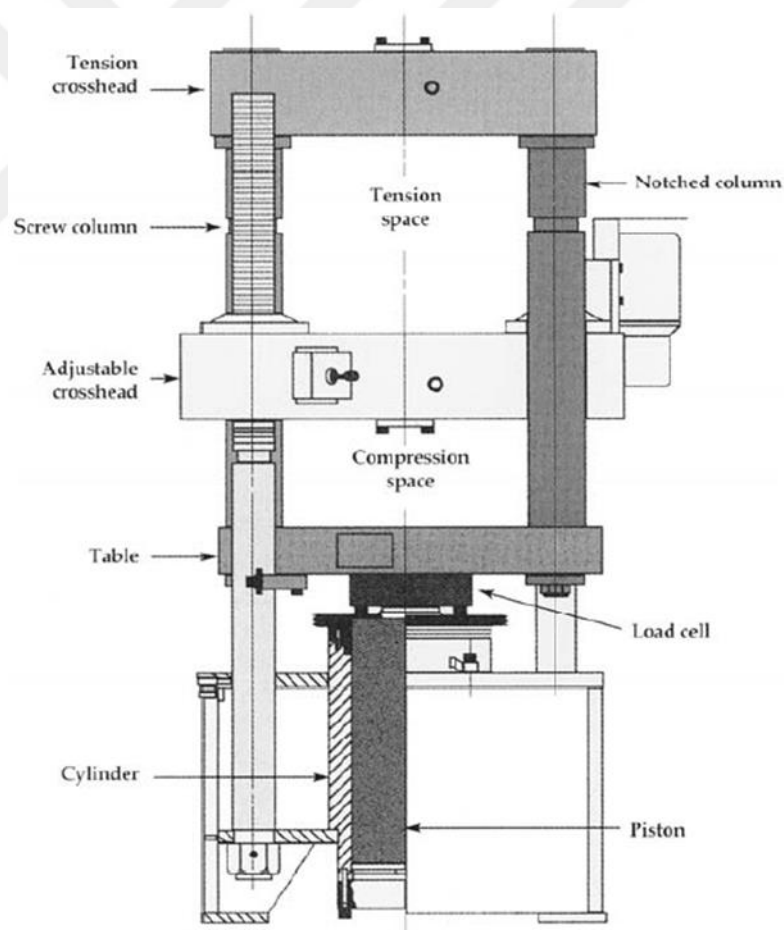
Figure 4.4: Universal tensile test machine.

Testing machines can be electromechanical or hydraulic. Electromechanical machines are based on an electric motor which can be adjustable. Motion loads the specimen in tension. Speed can be changed by changing the speed of the motor. Hydraulic testing machines are based on a single or dual-acting piston that moves the load up or down. In a manual operated tensile testing machine, operator adjusts the pressure-compensated the valve to control the rate of loading.

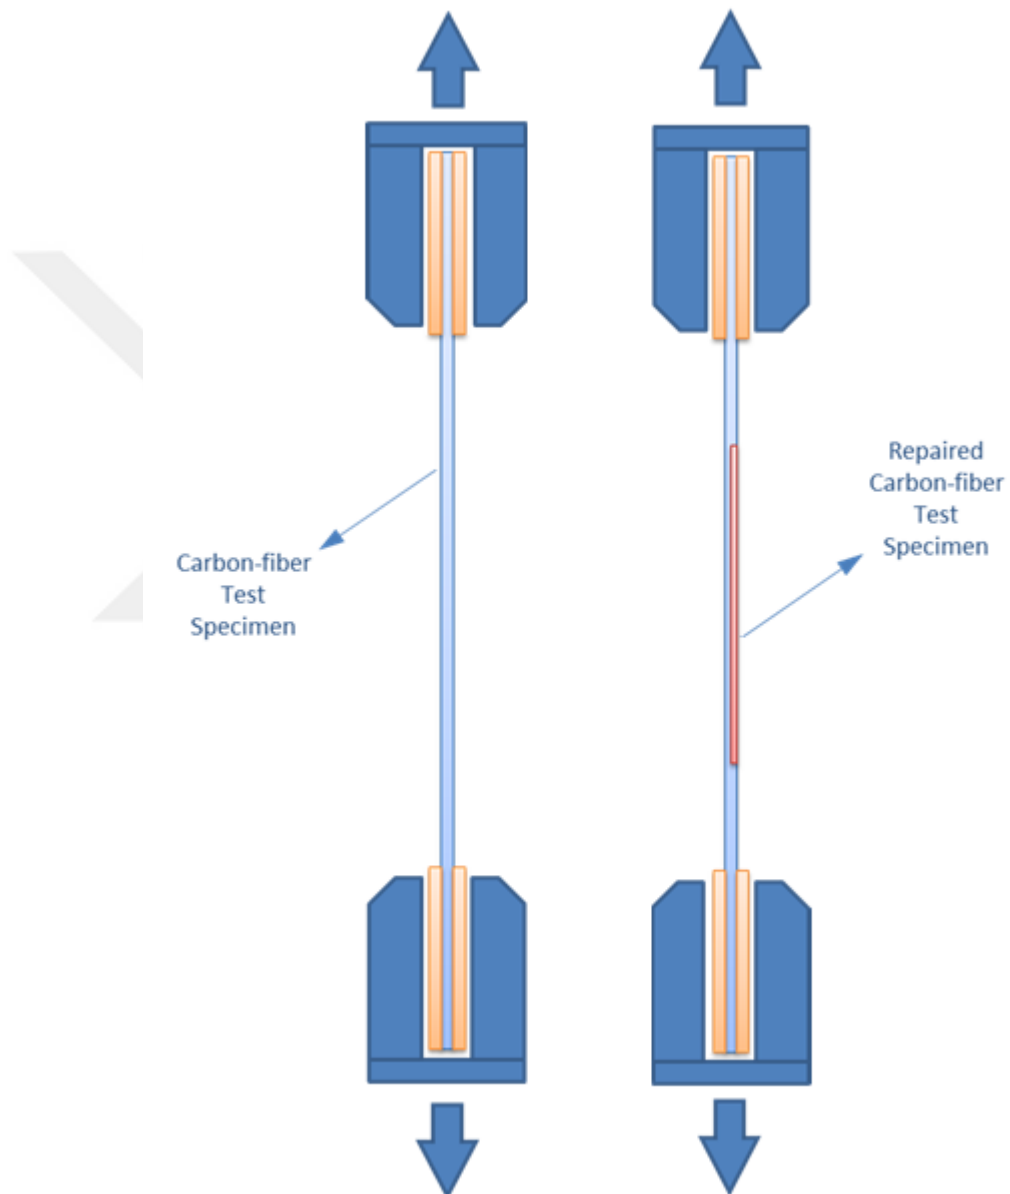
Figure 4.5: Tensile test.

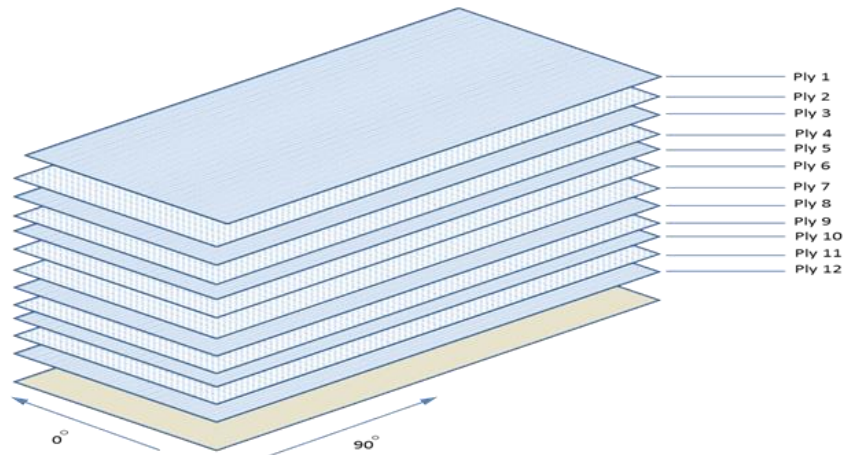
The laying-up process was completed inside a clean room where there was temperature and humidity control. The temperature was 21°C and the humidity was 45%. The UD Prepreg lay-up process was completed in accordance with the orientations that have been given in Figure 5.1. After the lay-up process was completed on all of the test specimens, they were prepared for the autoclave cure.

Figure 5.1: Ply sequence of the test specimens.

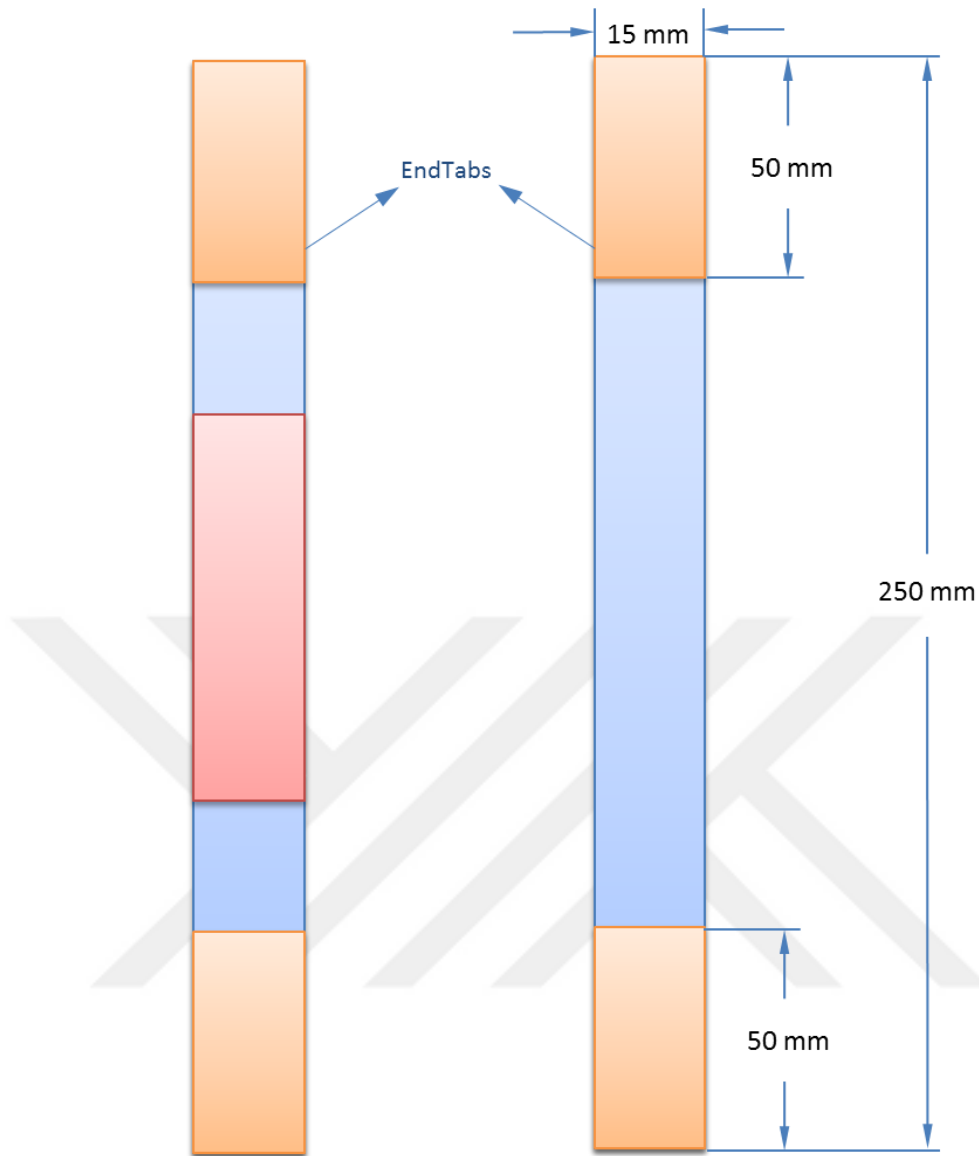
The nondestructive inspection was completed and no defects were observed on the test specimens. The final view of the test specimens has been given in Figure 5.2.

Figure 5.2: Test specimens.

The dimensions of the test specimens were prepared in accordance with the DIN 2561 standards.

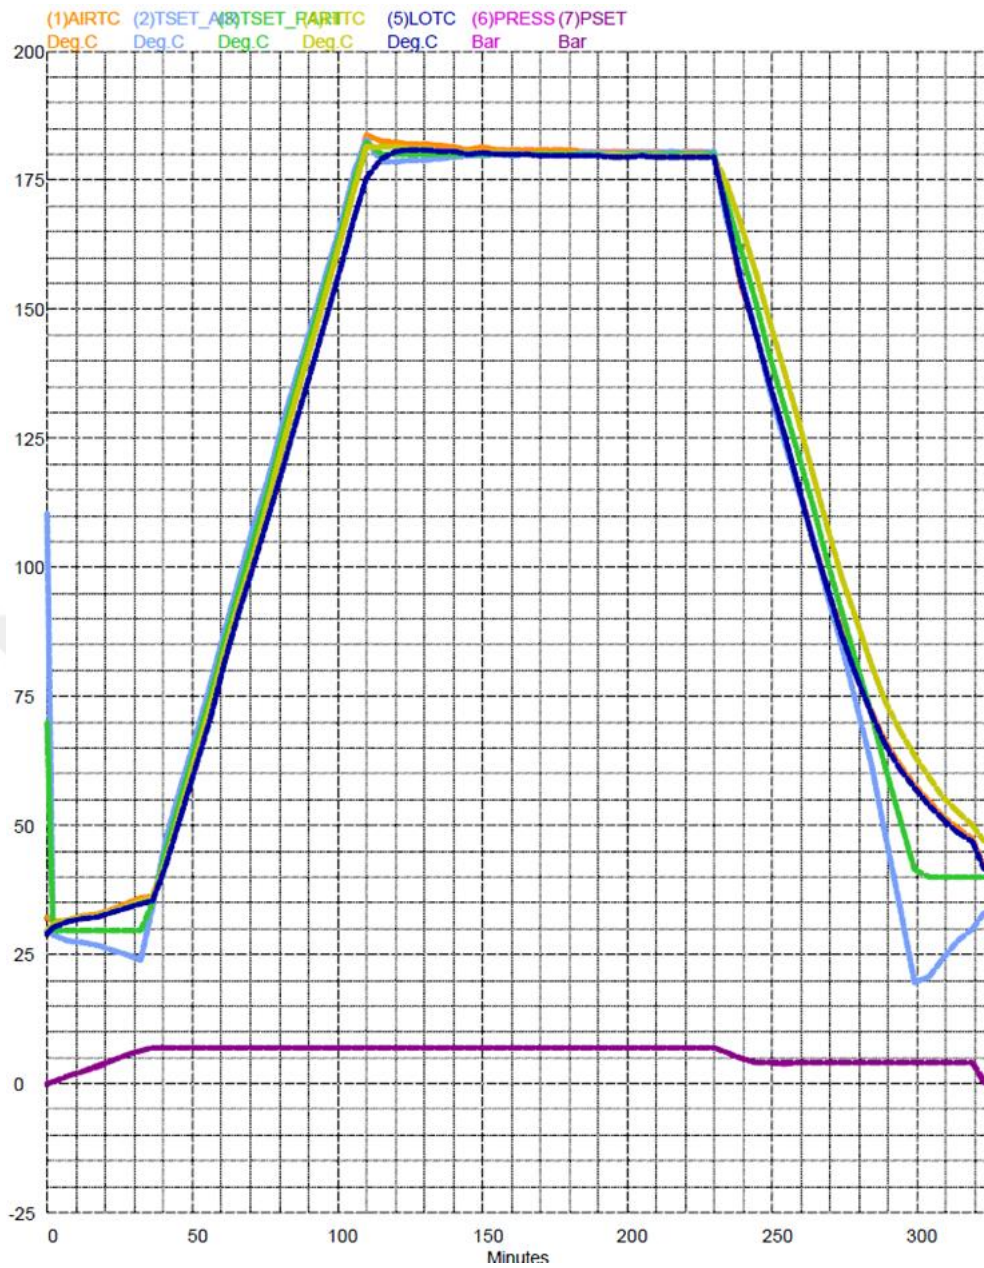
Every step of the manufacturing process has been recorded and controlled for obtaining applicable specimens. The autoclave/cure process is very important for the manufacturing process and should be completely under control. Five thermocouples were used to chart the pressure/temperature changes. The records of the thermocouples for pressure and temperature have been given in Figure 5.3. below:

Figure 5.3: Pressure/Temperature diagram.

All of the information on temperature and pressure for the curing operation has been given in Figure 5.3.

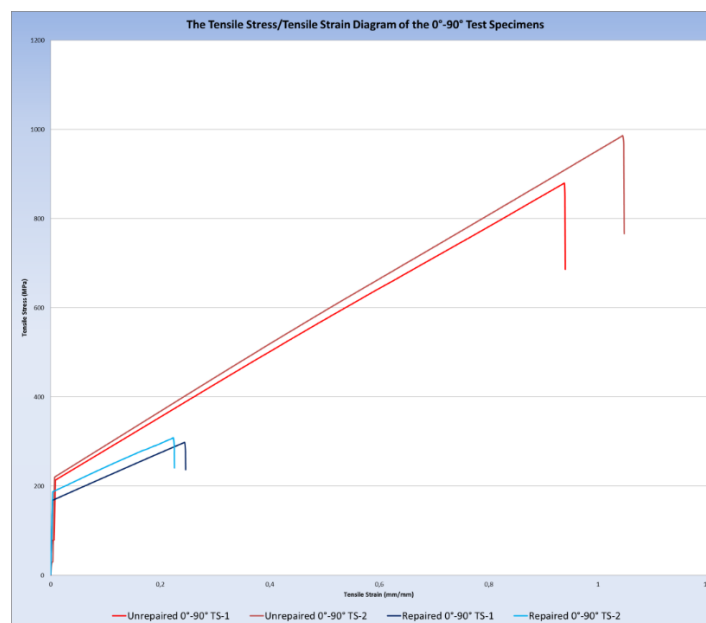
Four pieces from the 10 test specimens were chosen to show on the stress/strain graph (Figure 6.1). The results are those that are the closest to the average. All of the results have been given in Table 6.1.

Figure 6.1: Four pieces from the 0°-90° test specimens in the tensile stress/tensile strain graph.

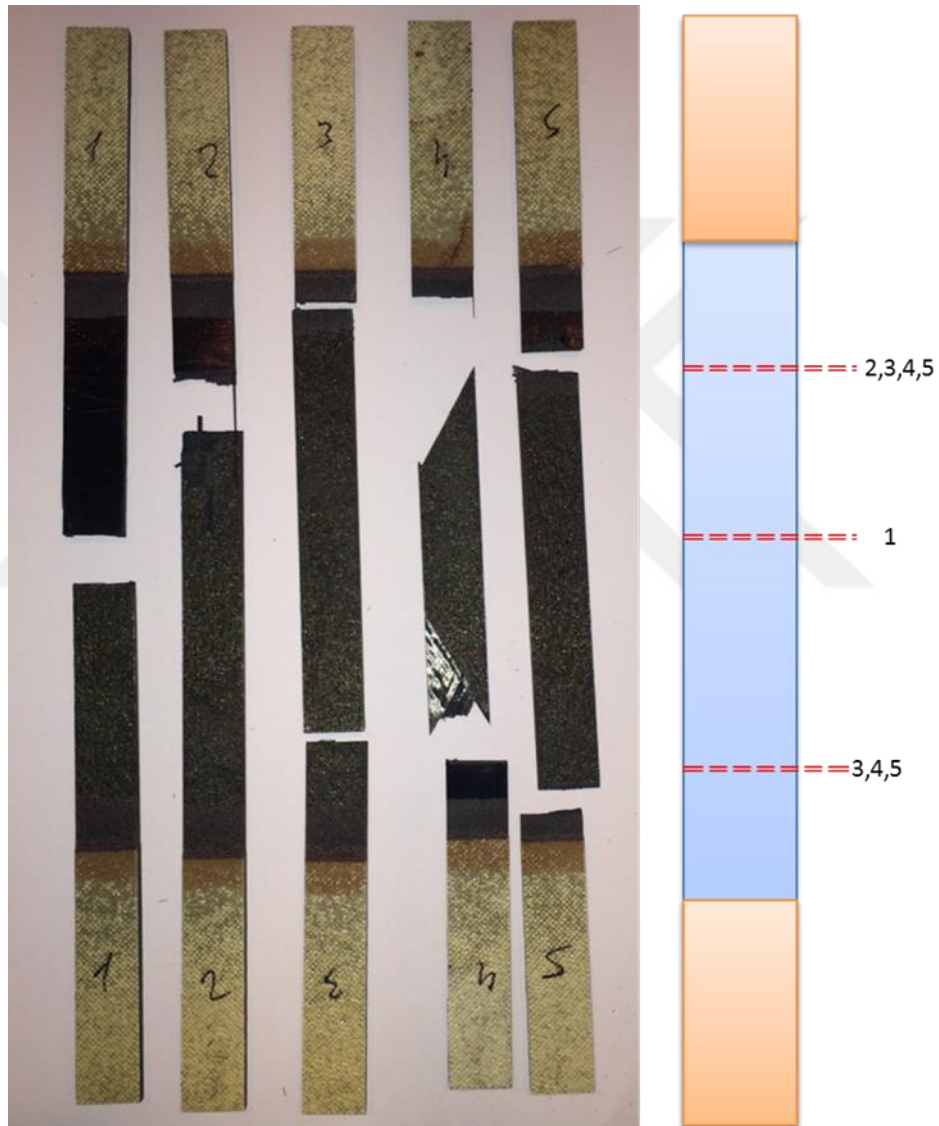
Figure 6.2: The unrepaired 0°-90° test specimens after the tensile test.

The maximum tensile stresses of the test specimens were measured between 880 MPa and 912 MPa (Table 6.1). As shown in Figures 6.2 and 6.3., the breakage angles were the same as the lay-up orientations.

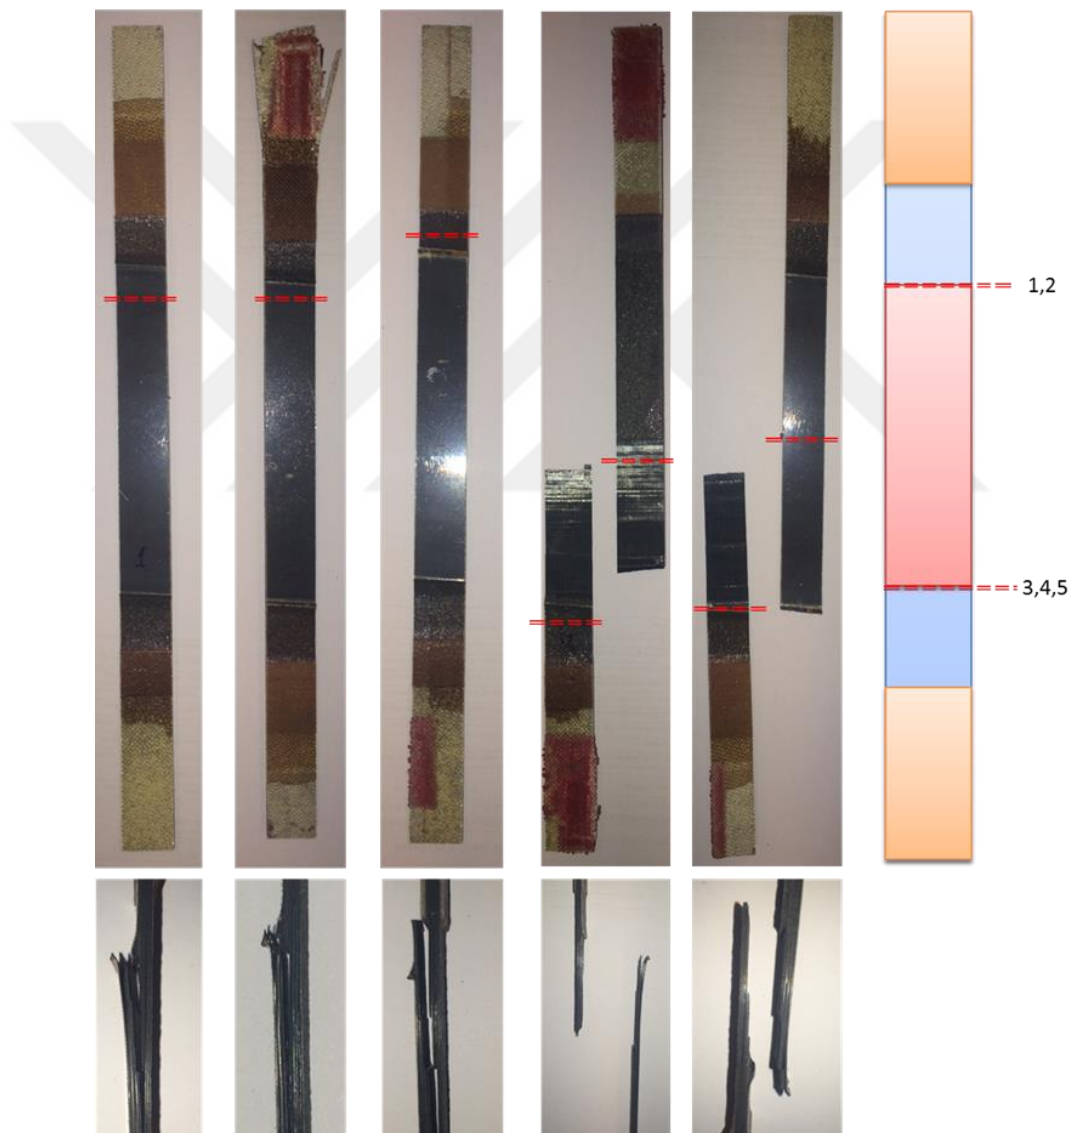
Figure 6.3: The repaired 0°-90° test specimens after the tensile test.

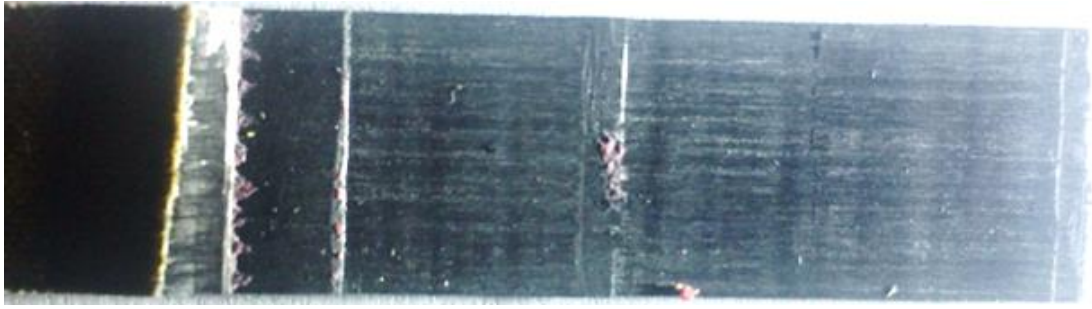
Figure 6.4: The repair plies of the 0°-90° test specimens.

It was observed that the repaired 0°-90° test specimens had a 3 times larger tensile resistance compared to the 15° test specimens (Tables 6.1 and 6.2). The maximum tensile stresses measured for the repaired 0°-90° test specimens were between 272 MPa and 343 MPa (Table 6.1). The results showed that cracks started from the edges of the repair surface (Figure 6.4).

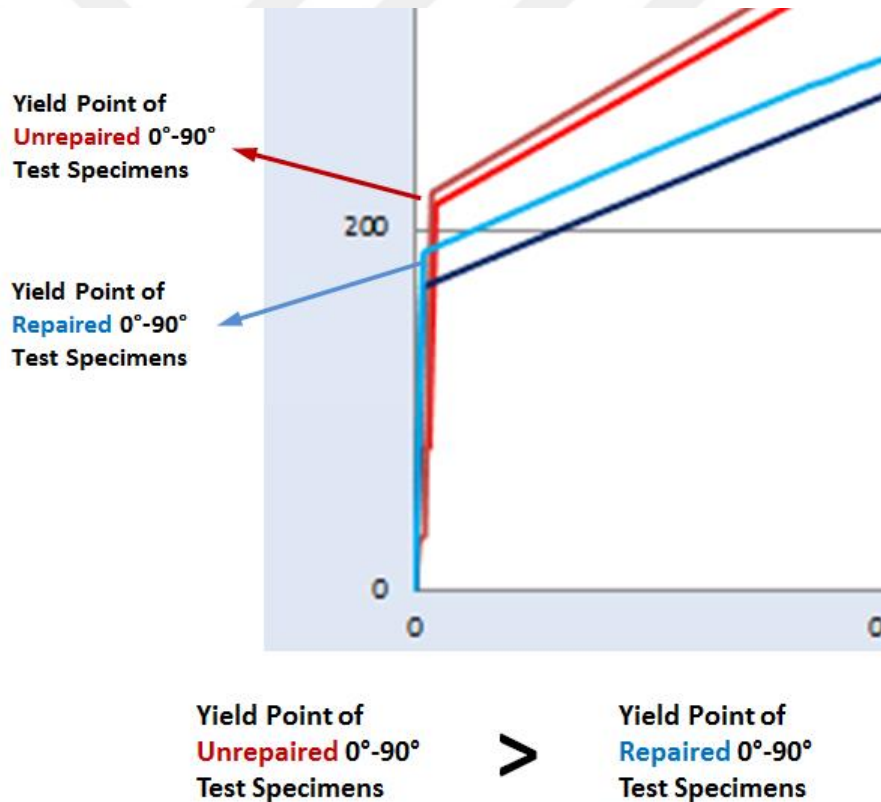
The yield point of the unrepaired 0°-90° test specimens was higher than the repaired test specimens as it was given in Figure 6.5. The unrepaired (original) test specimens showed slightly stiffer properties than the repaired specimens on the 0°-90° lay-up carbon fiber composite materials.

Figure 6.5: The yield strength points of the 0°-90° test specimens.

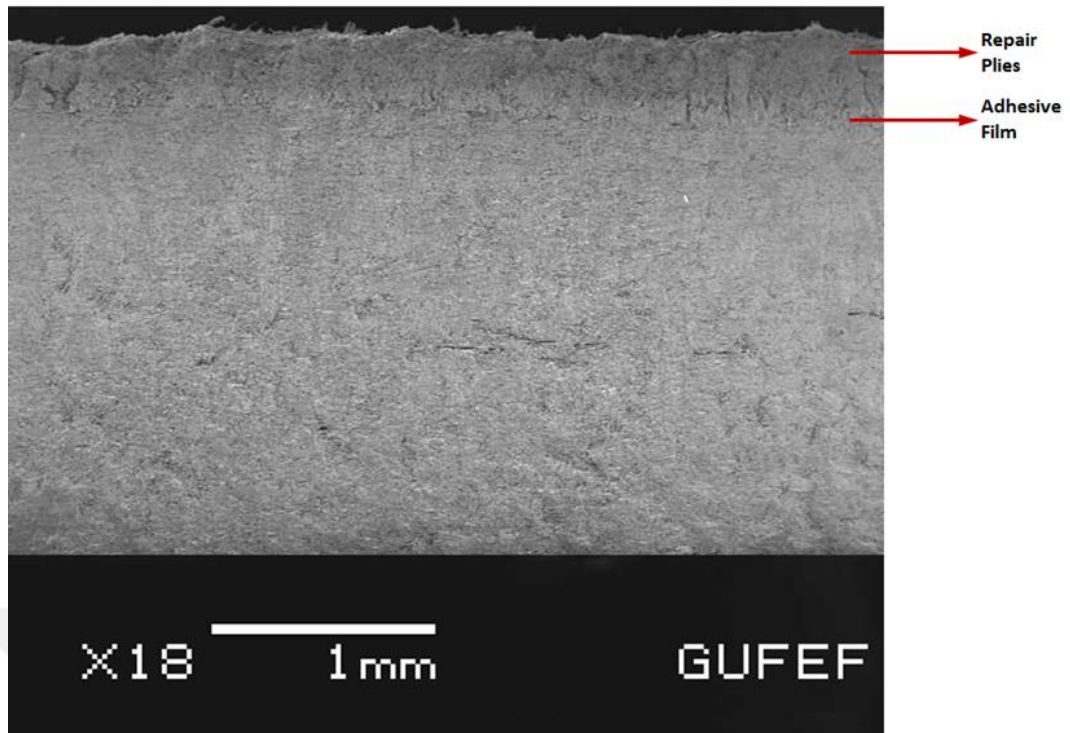
Figure 6.6: The SEM view 1.1 for the 0°-90° test specimens.

It was observed that the repair plies bonded perfectly with the original plies. No disbonding or delamination was observed during the SEM examinations. As expected, the repair plies had the same angularity as the plies removed for repair.

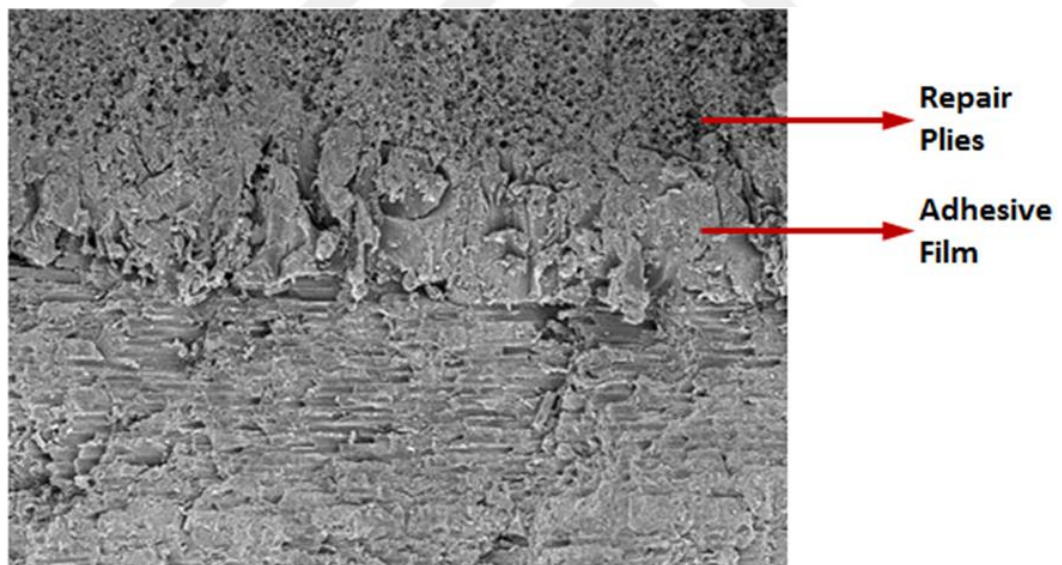
Figure 6.7: The SEM view 1.2 for the 0°-90° test specimens.

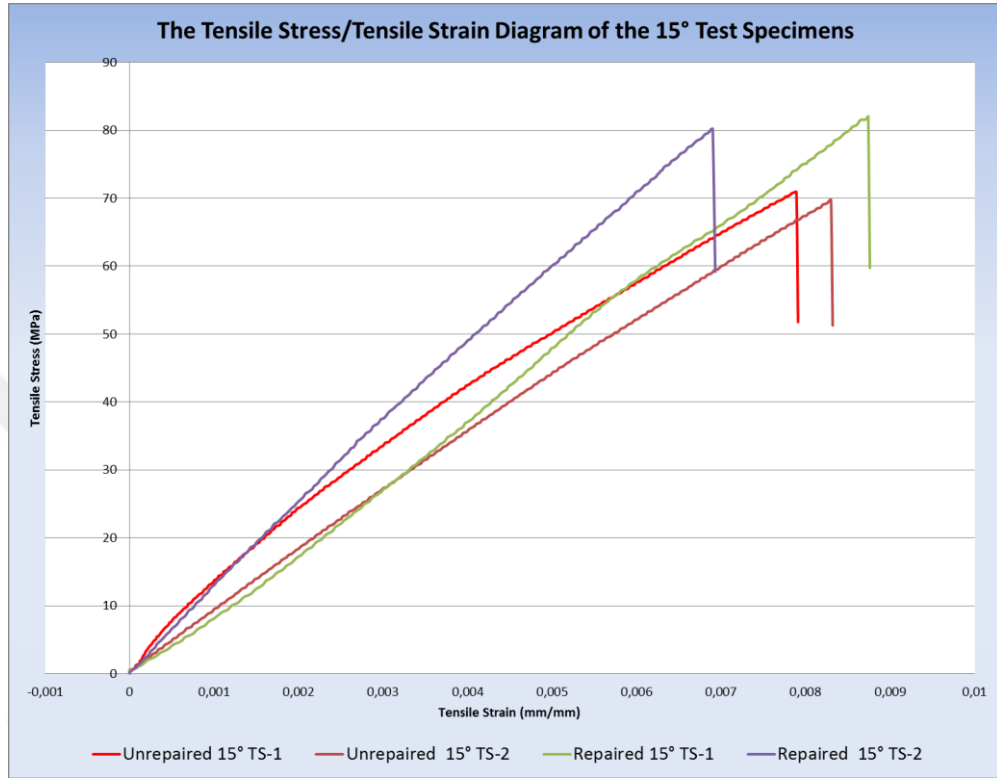
Four pieces from the 10 test specimens were chosen to show in the stress/strain graph. The results given in Figure 6.8. are the ones closest to average.

Figure 6.8: Four pieces from the 15° test specimens in the tensile stress/tensile strain graph.

It was observed that both the repaired and unrepaired 15° test specimens showed brittle properties in the stress/strain diagram (Figure 6.8). The “brittle” manner was due to the fact that the curve is linear until it breaks or fractures with no bending of the curve at high loads. Consequently, there is no permanent change in the original shape during this test and hence, no ductility.

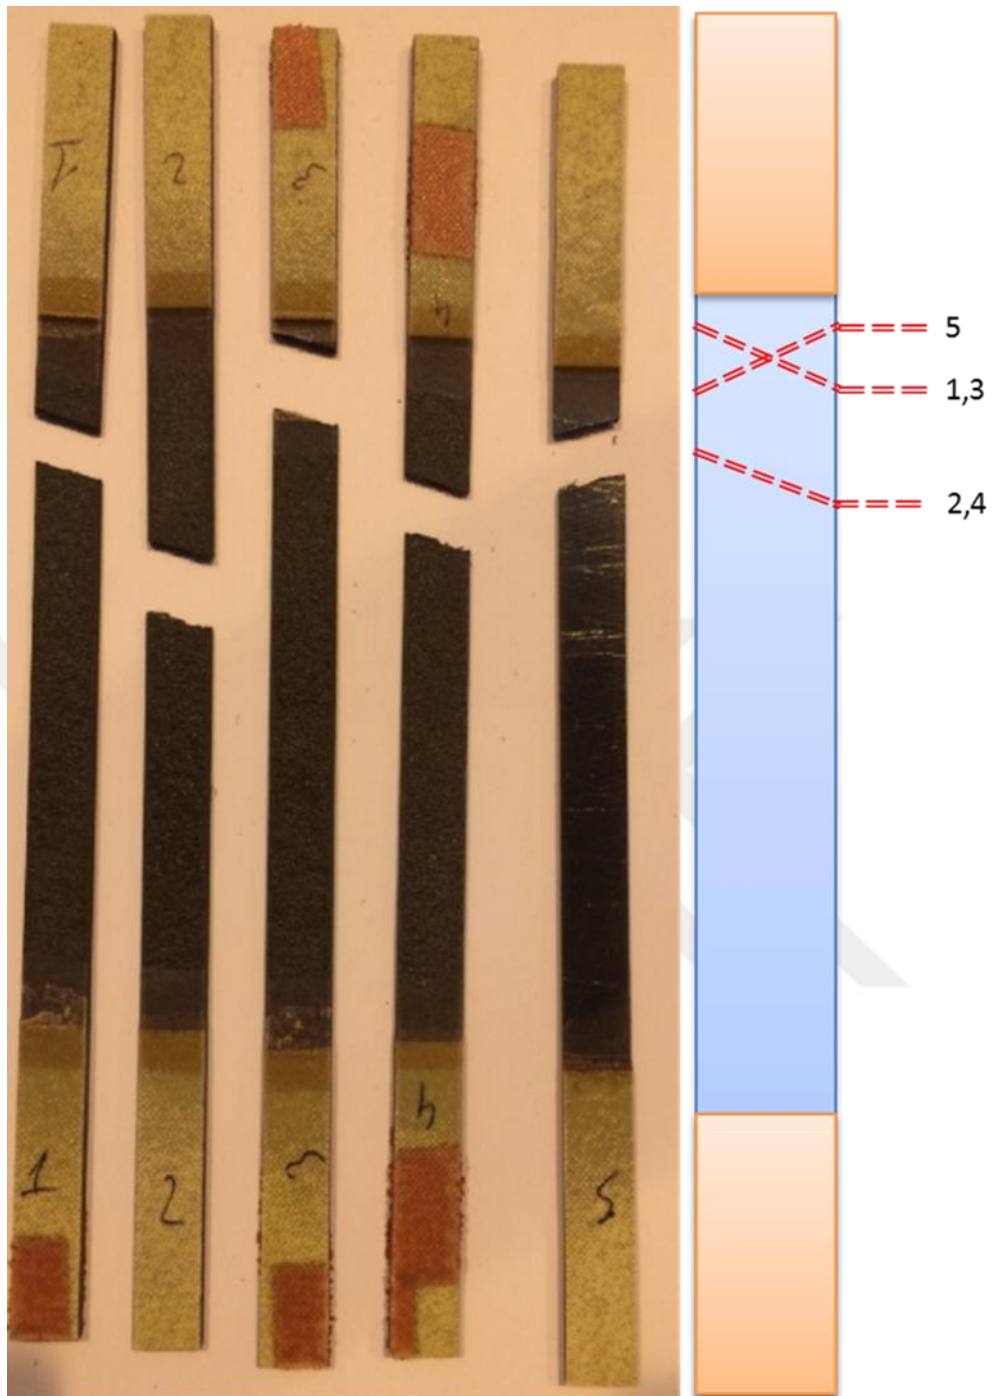
Figure 6.9: The unrepaired 15° test specimens after the tensile test.

The maximum tensile stresses of the unrepaired 15° test specimens were measured between 70 MPa and 73 MPa (Table 6.2).
