**PERFORMANCE ANALYSIS OF REPAIRED CARBON FIBER COMPOSITE
MATERIALS WHICH HAVE BEEN MANUFACTURED IN AEROSPACE
INDUSTRY**

MASTER THESIS

Mechanical and Aeronautical Engineering

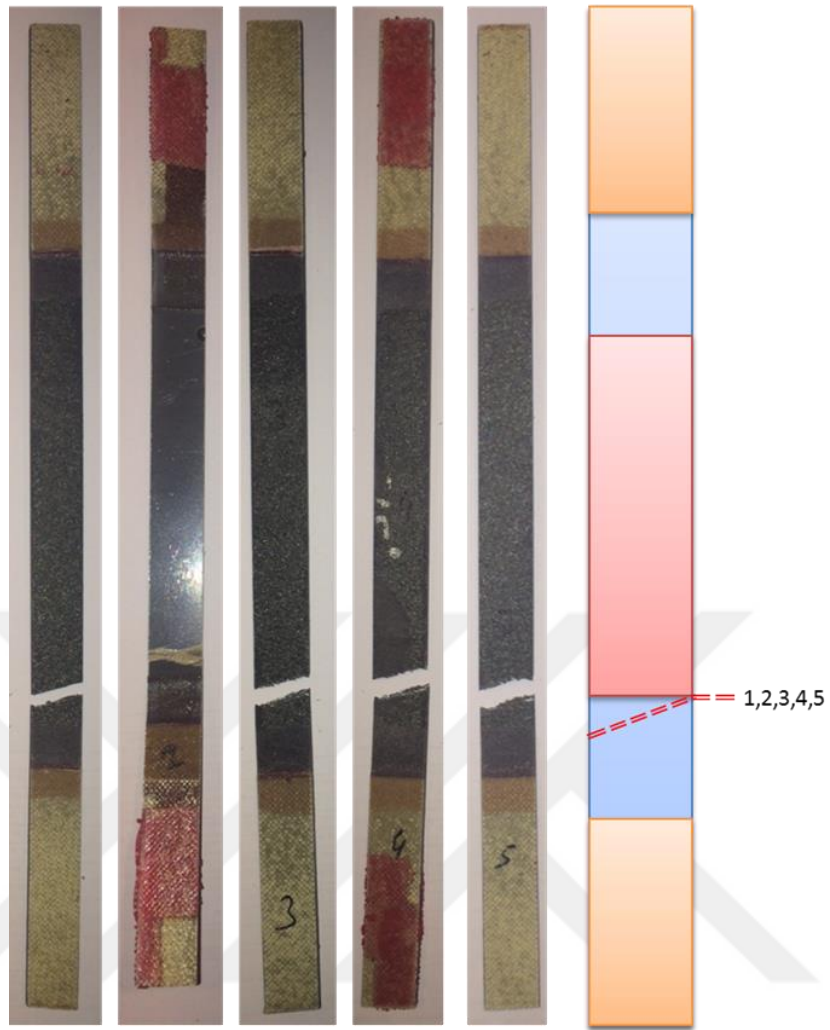
Figure 6.10: The repaired 15° test specimens after the tensile test.

It was observed that the repaired 15° lay-up test specimens had broken at approximately the same point. The breakage points start from the edges of the repair plies and continue for approximately 15° (Figure 6.11).

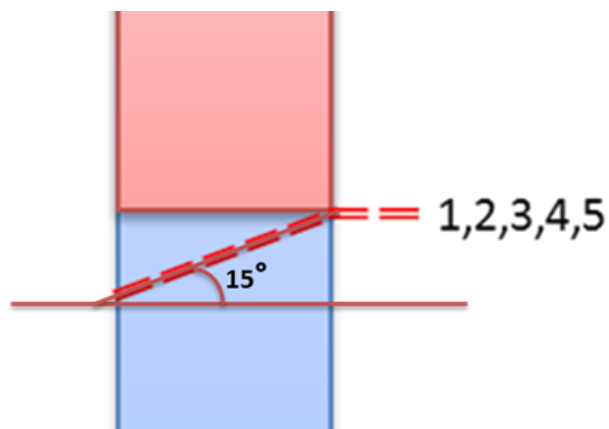
Figure 6.11: The breakage angle on the 15° test specimens after the tensile test.

The repair surface edges were observed to be the weakest points on the repaired 15° test specimens. The maximum tensile stresses of the repaired 15° test specimens were measured between 80 MPa and 85 MPa (Table 6.2).

The breakage points have the same angle as the original orientations (Figure 6.11).

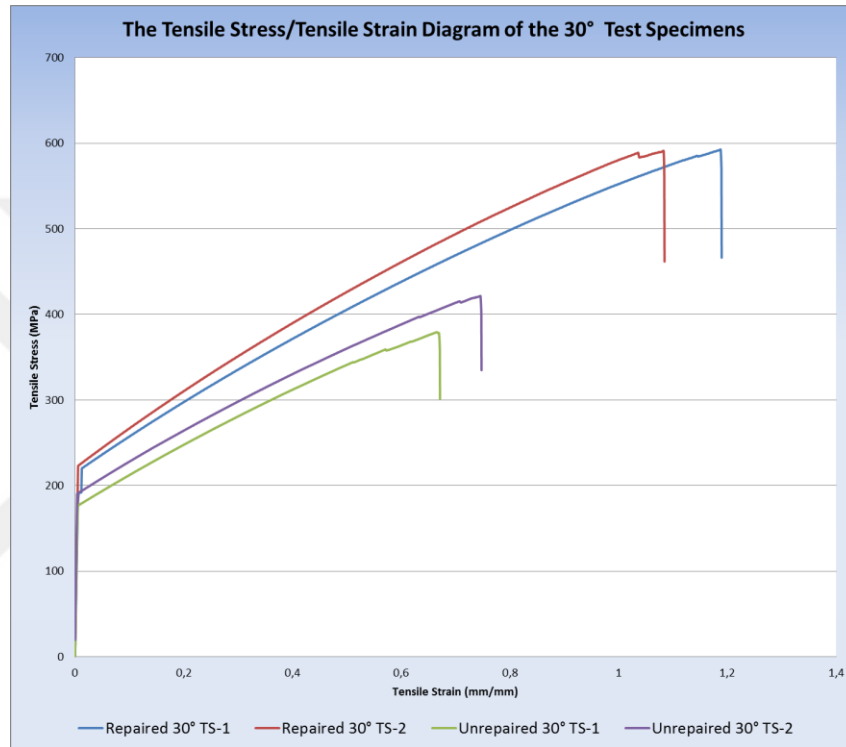
Four pieces from the 10 test specimens were chosen to show in the stress/strain graph (Figure 6.14). The results are the ones closest to average.

Figure 6.14: Four pieces from the 30° test specimens in the tensile stress/tensile strain graph.

It was observed that the yield points of the repaired 30° test specimens were higher than the unrepaired ones (Figure 6.14).

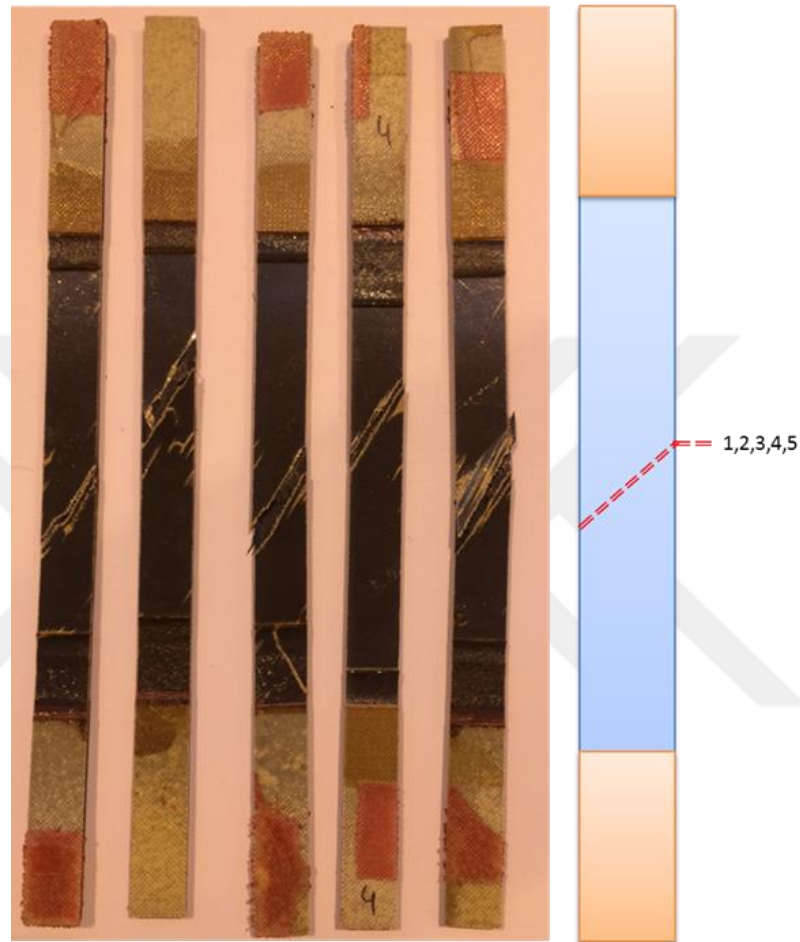
It was observed that 5 pieces of the unrepaired 30° test specimens had broken at approximately the same point (Figure 6.15). The maximum tensile stresses of the test specimens were measured between 379 MPa and 421 MPa (Table 6.3). When the

Figure 6.15: The unrepaired 30° test specimens after the tensile test

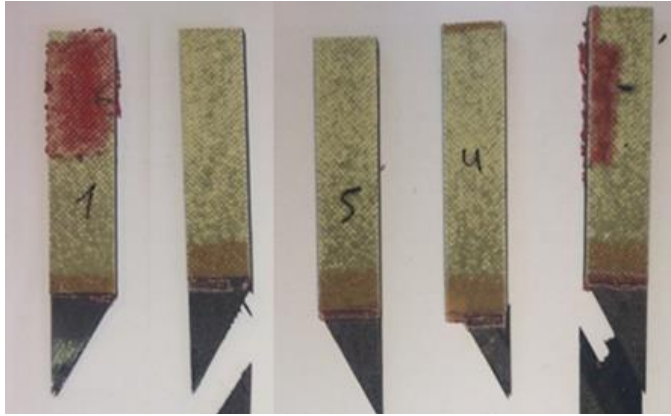
Figure 6.16: The breakage points of the repaired 30° test specimens.

The tensile test showed that the repaired 30° test specimens had very high tensile stress resistances (Figures 6.34 and 6.35). The maximum tensile stresses of the 30° lay-up test specimens were measured between 587 MPa and 919 MPa (Table 6.3). As was shown in Figure 6.17., all of the repaired 30° test specimens fell to pieces during the tensile test. Breakages started from the edges of the largest repair plies, which are on the external surface (Figure 6.16).

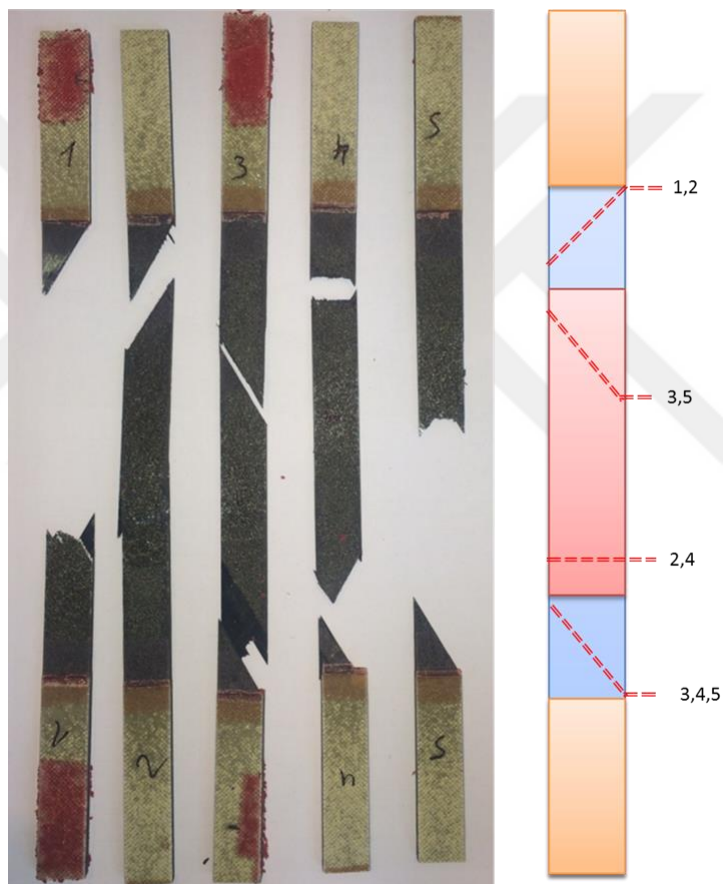
Figure 6.17: The repaired 30° test specimens after the tensile test.

60° lay-up test specimens. Cracks were more similar in the repaired 30° lay-up test specimens (Figures 6.17 and 6.31).

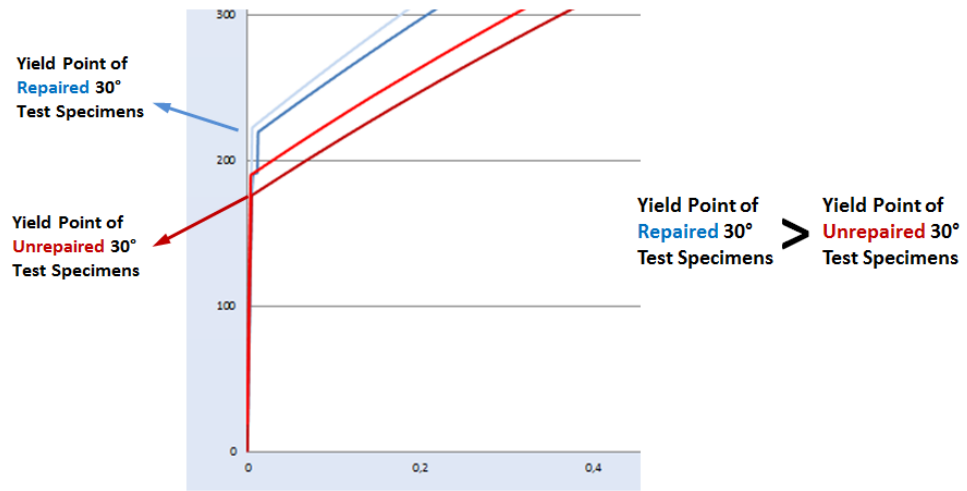
Figure 6.18: The yield strength points of the 30° test specimens.

We observed that repaired test specimens have higher yield strength points (Figure 6.18).

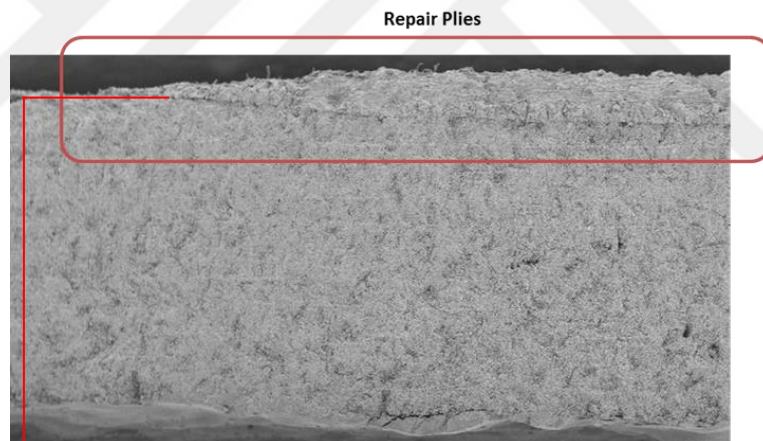
Figure 6.19: The SEM micrograph 3.1 for the 30° test specimens.

A disbonding discrepancy was observed between the repaired plies and the original plies, but this disbanding was at a tolerable level and the test specimens were acceptable in accordance with the related AIRBUS specifications. As can be observed in Figure 6.21. below, some more disbond micrographs were taken of the 30° test specimens, but they were all acceptable.

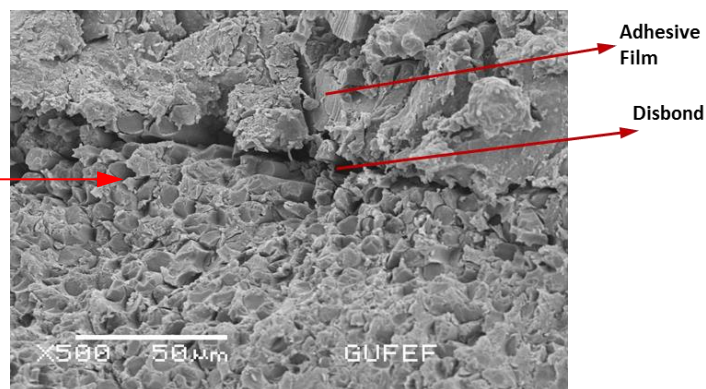
Figure 6.20: The SEM micrograph 3.2 for the 30° test specimens.

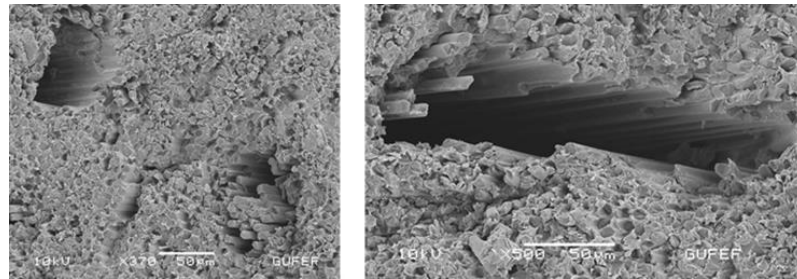
Figure 6.21: The SEM micrograph 3.3 for the 30° test specimens.

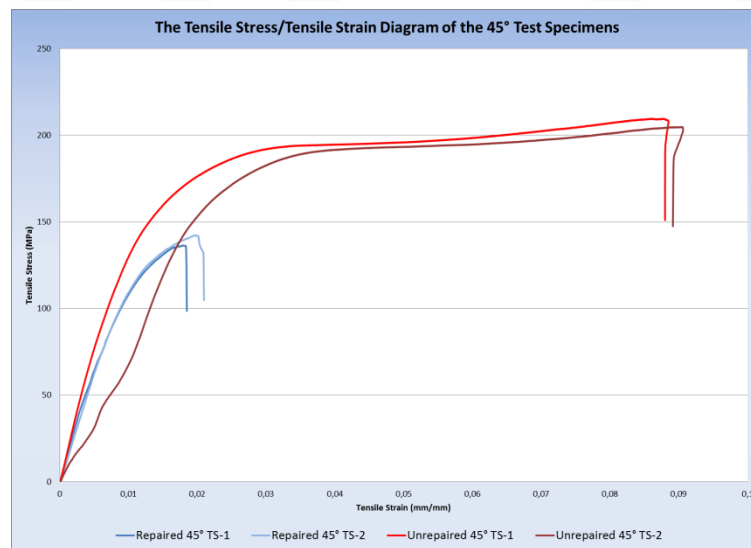
Four pieces from the 10 test specimens were chosen to show in the stress/strain graph (Figure 6.22). The results are the ones closest to average.

Figure 6.22: Four pieces from the 45° test specimens in the tensile stress/tensile strain graph.

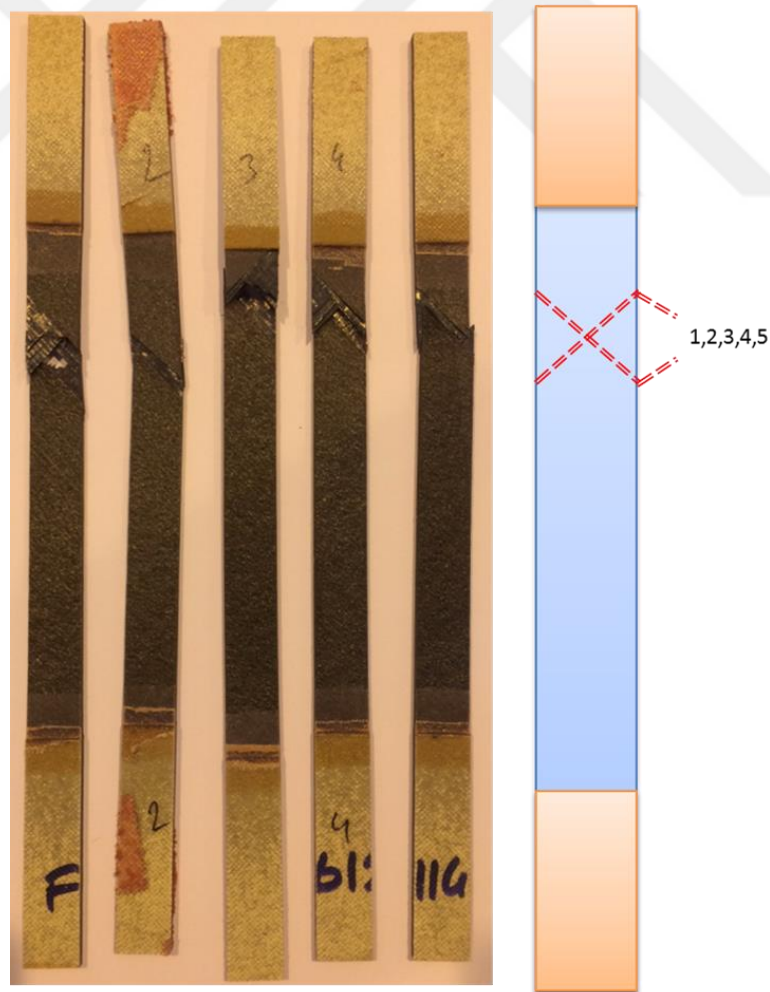
Figure 6.23: The unrepaired 45° test specimens after the tensile test.

As can be observed in Figure 6.23, the breakage angles are the same as the lay-up orientations.

It was observed that 5 pieces of the unrepaired 45° test specimens had broken at approximately the same point (Figure 6.23). The maximum tensile stresses of the unrepaired 45° test specimens were measured between 191 MPa and 210 MPa (Table 6.4). As can be observed in Figure 6.24., the repaired 45° test specimens were broken from the middle of the test specimens. The maximum tensile stresses of the 45° test specimens were measured between 133 MPa and 144 MPa (Table 6.4).

The breakages were starting from the repair plies (Figure 6.23) on the repaired test specimen materials, but were broken close to the mid-point on the unrepaired/original test specimens (Figure 6.24).

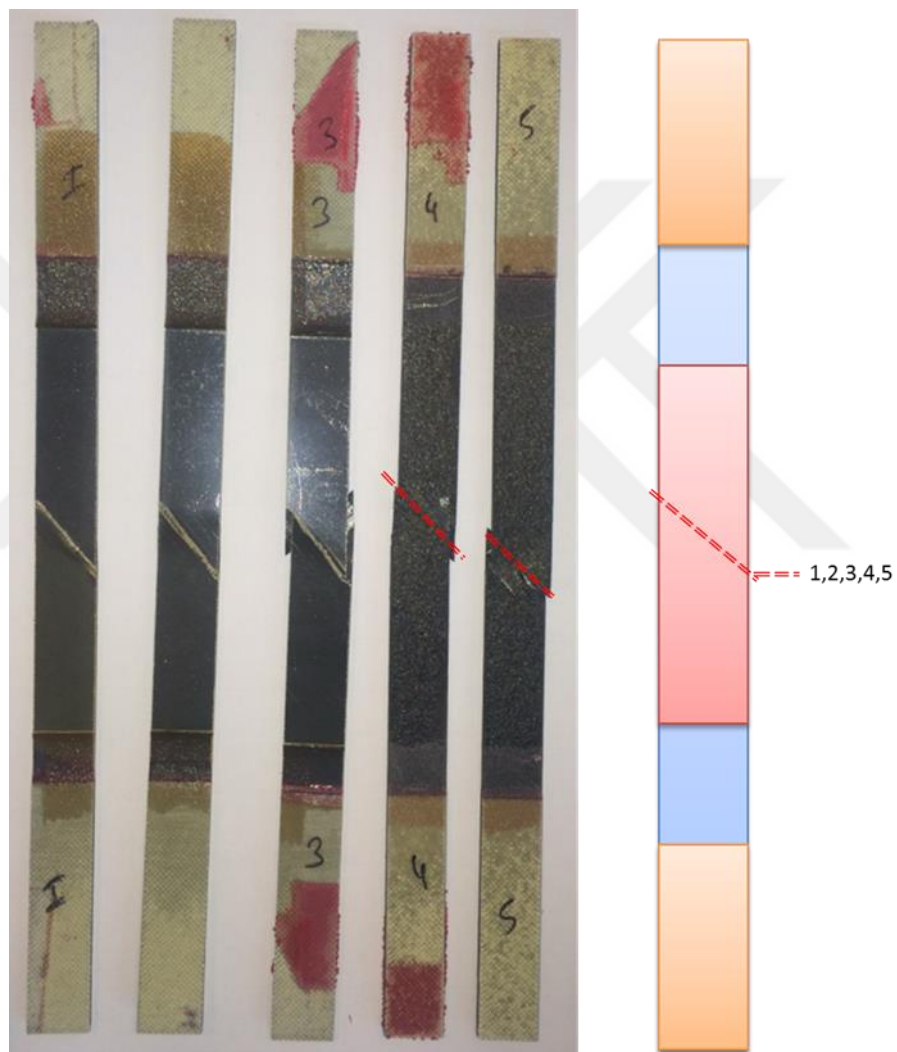
Figure 6.24: The repaired 45° test specimens after the tensile test.

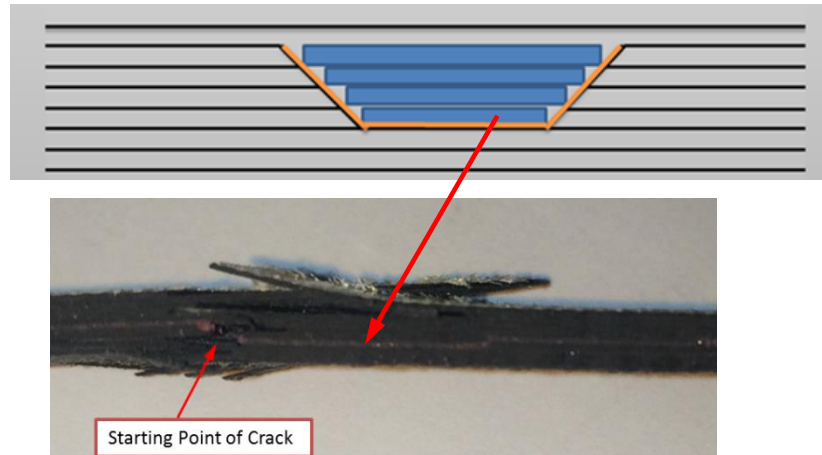
The breakage/crack starting point has been shown in Figure 6.25

Figure 6.25: The repaired 45° test specimens after the tensile test.

Repair plies can be seen on Figure 6.25. We observed that breakages started from the smallest repair ply.

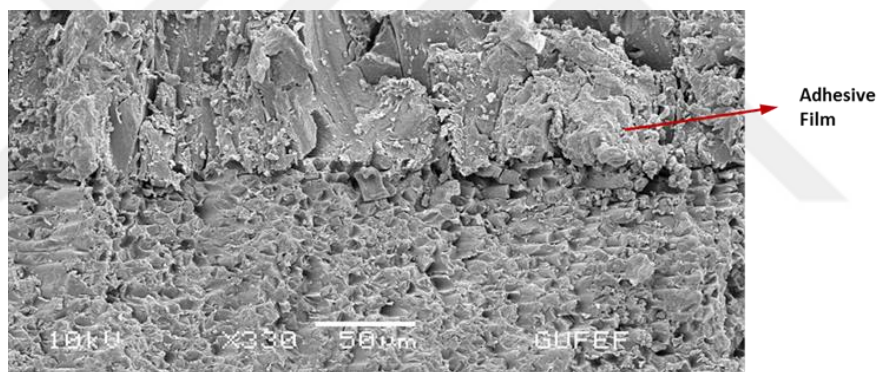
Figure 6.26: The SEM micrograph 4.1 for the 45° test specimens.

We examined that the repair plies bonded perfectly to the original plies and there were no disbanding discrepancy.

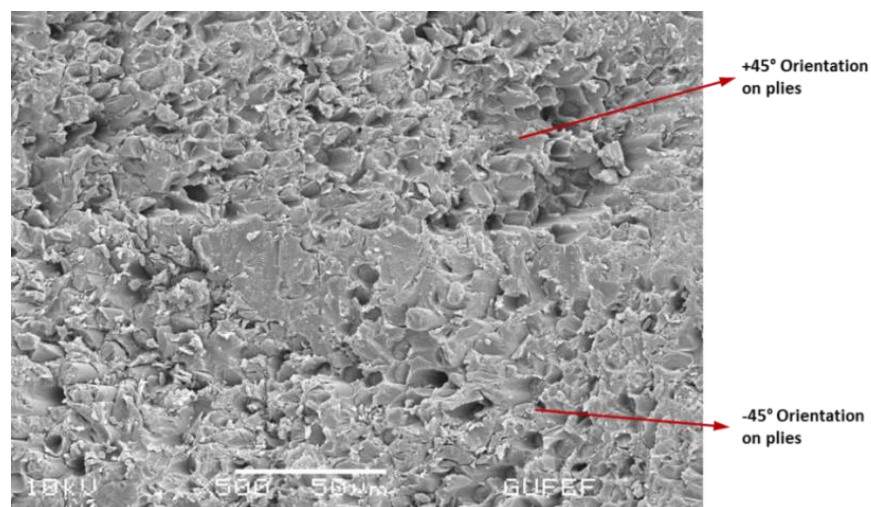
Figure 6.27: The SEM micrograph 4.2 for the 45° test specimens.

The ply orientation has been shown in Figures 6.27. and 6.28.

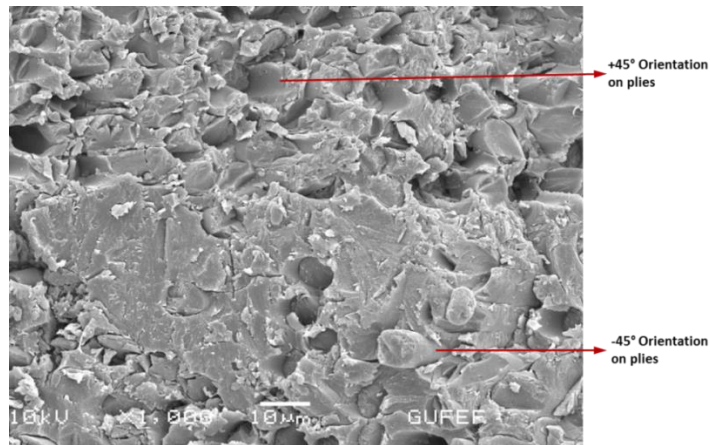
Figure 6.28. The SEM micrograph 4.3 for the 45° test specimens.

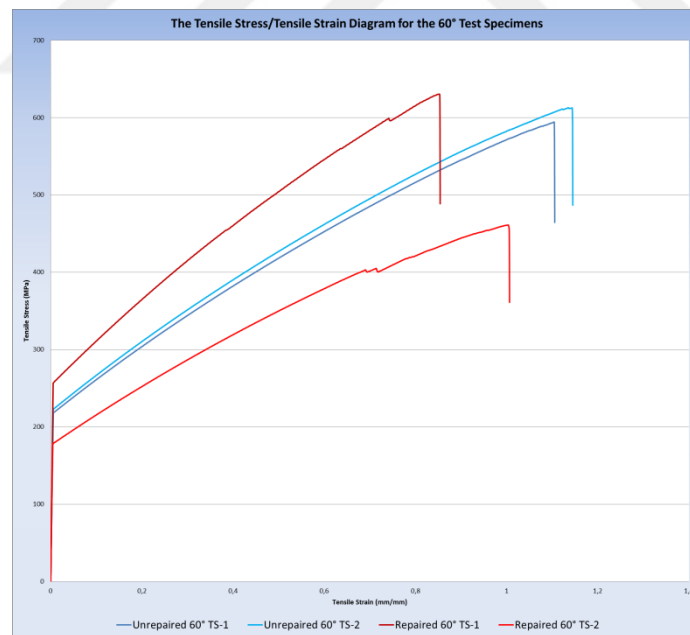
Four pieces from the 10 test specimens were chosen to show in the stress/strain graph (Figure 6.29). The results are the ones closest to average.

Figure 6.29: Four pieces from the 60° test specimens in the tensile stress/tensile strain graph.

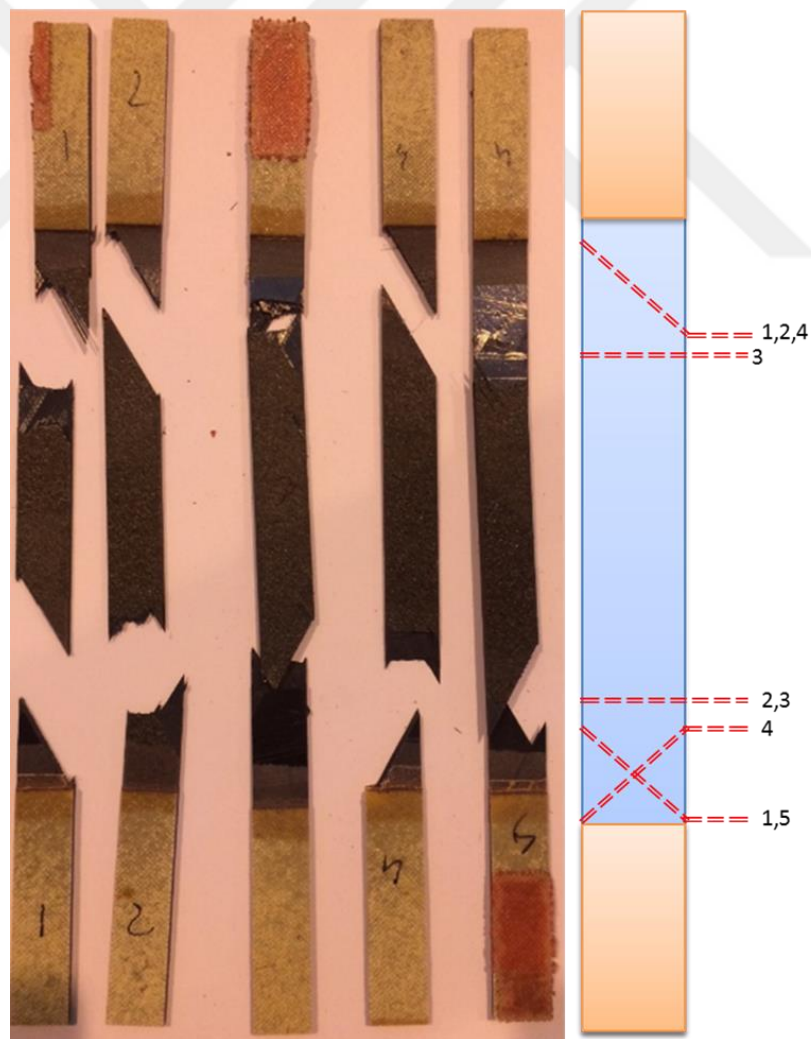
It was observed that 5 pieces of the unrepaired 60° test specimens had broken from approximately the same point. There were 2 breakage points on all of the test specimens (Figure 6.30). The maximum tensile stresses of the test specimens were measured between 591 MPa and 613 MPa (Table 6.5). Breakage points were very close and cracks had the same angles as the original orientations.

Figure 6.30: The unrepaired 60° test specimens after the tensile test.

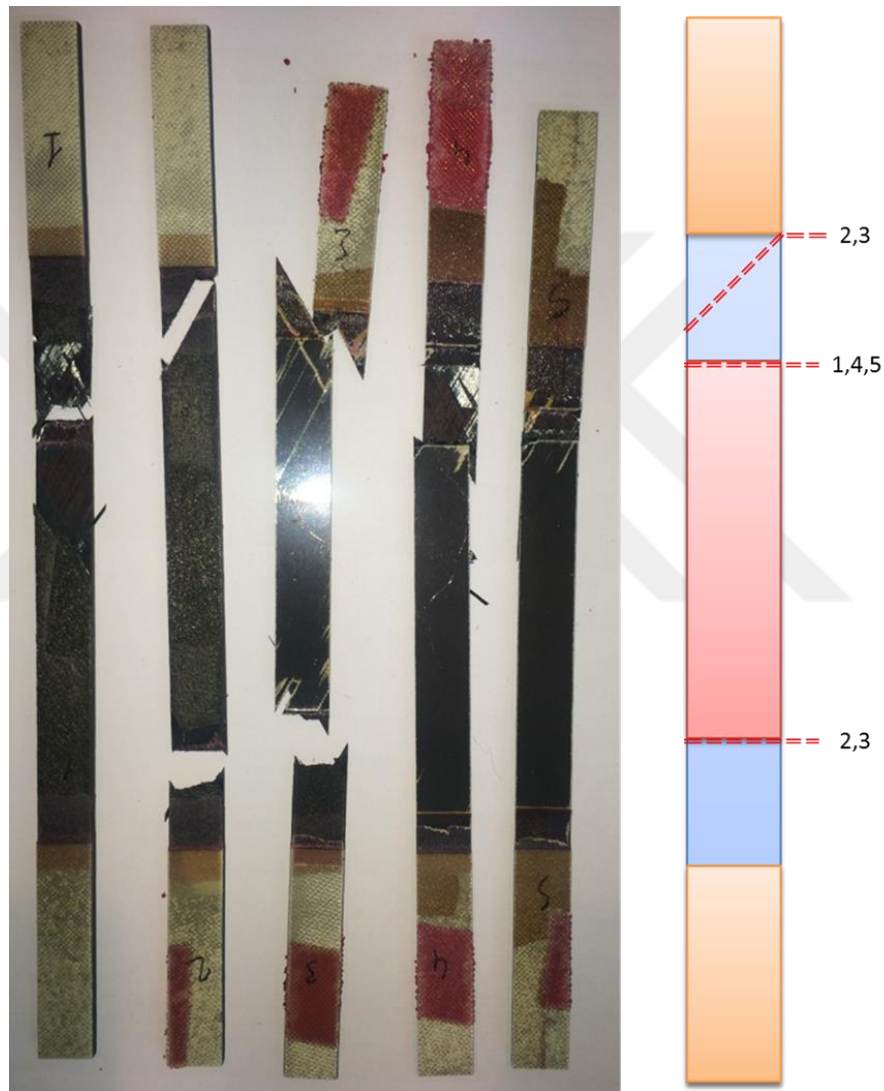
As shown in Figure 6.31., all of the repaired 60° test specimens fell to pieces during the tensile test. The repaired 60° test specimens had high tensile stress resistances, like the repaired 30° lay-up test specimens (Table 6.4). The maximum tensile stresses of the repaired 60° test specimens were measured between 491 MPa and 692 MPa. Breakages started at the edges of the largest repair plies, which are on the external surface.

Figure 6.31: The repaired 60° test specimens after the tensile test.

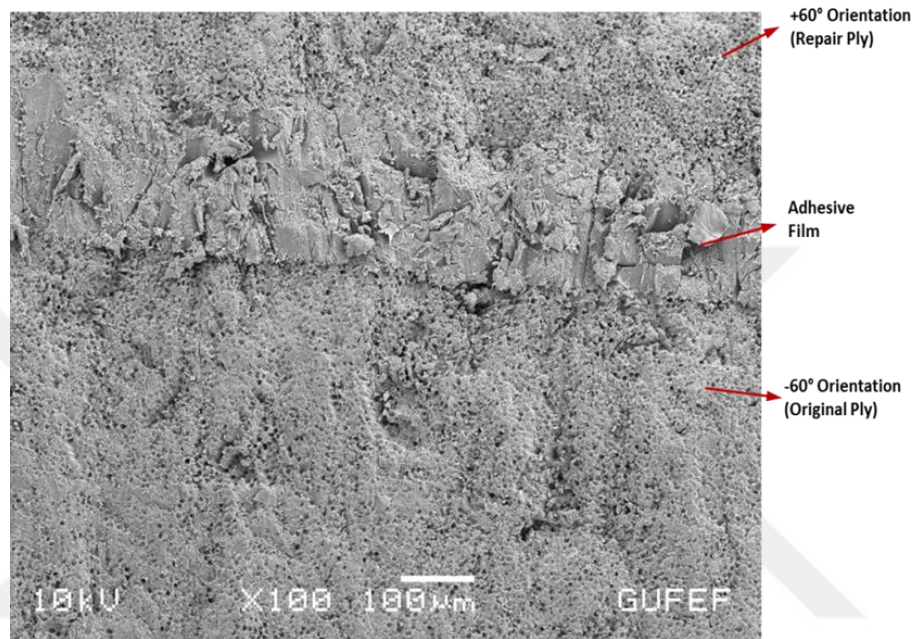
Figure 6.32: The SEM micrograph 4.1 for the 60° test specimens.

Different ply orientations were observed on Figure 6.32. and 6.33. And also we examined that the repair plies bonded perfectly to the original plies and there were no disbanding discrepancy.

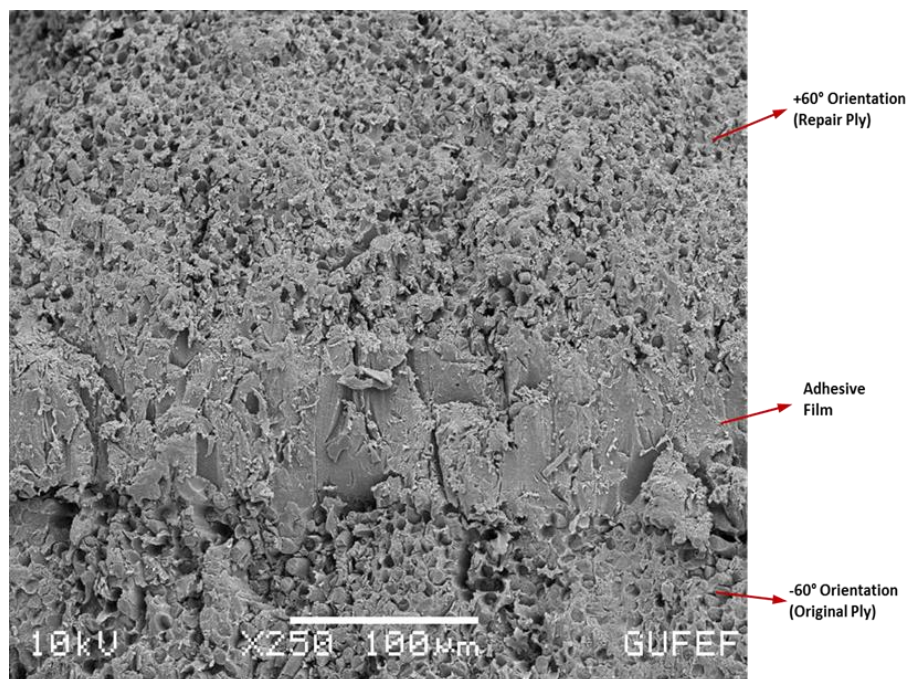
Figure 6.33: The SEM micrograph 4.2 for the 60° test specimens.

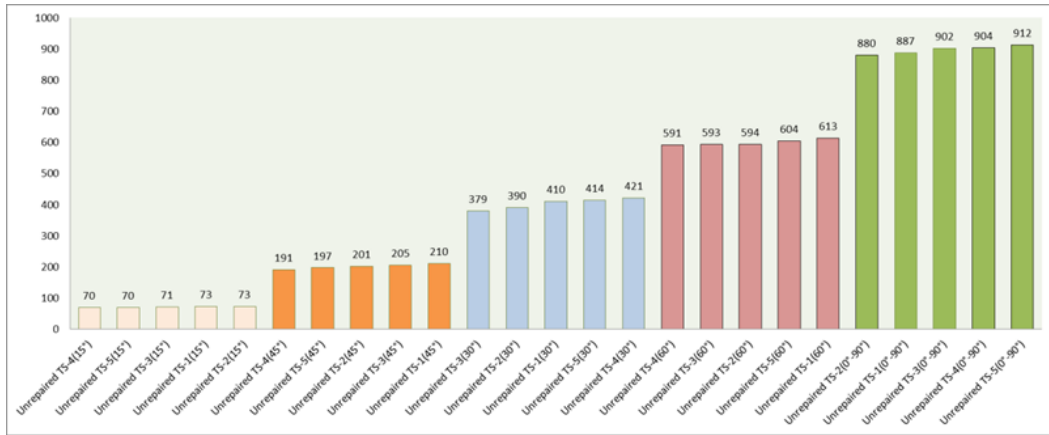
Figure 6.34: The maximum tensile stress resistances for all of the unrepaired test specimens compared in the same graph.

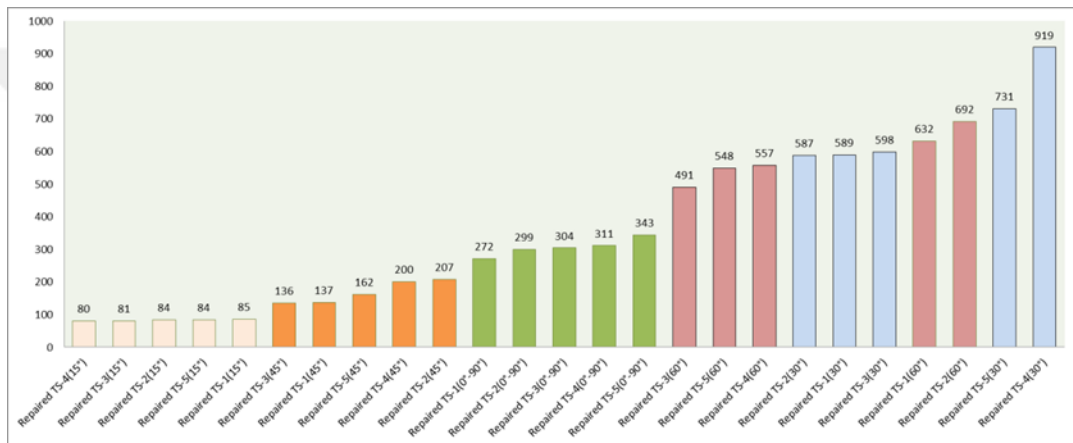
Figure 6.35: The maximum tensile stress resistances for all of the repaired test specimens compared in the same graph.

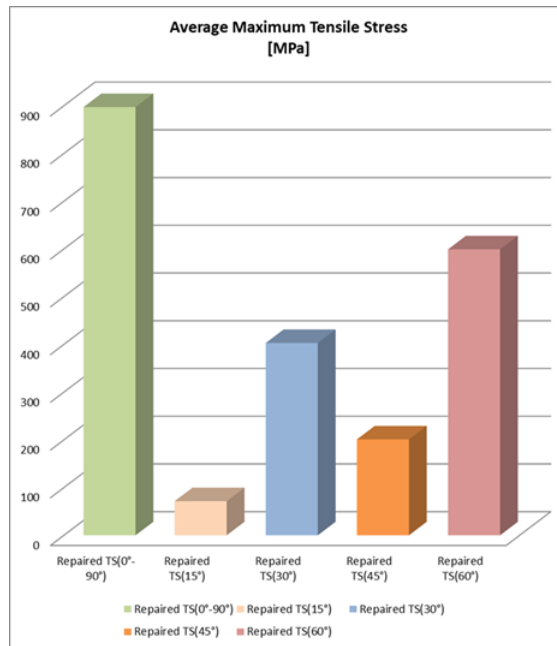
Figure 6.36: Average ultimate strength points of the unrepaired test specimens.

The tensile test was applied to examine the mechanical properties of the test specimens. The average results have been given in Figures 6.36., 6.37. and Table 7.1.

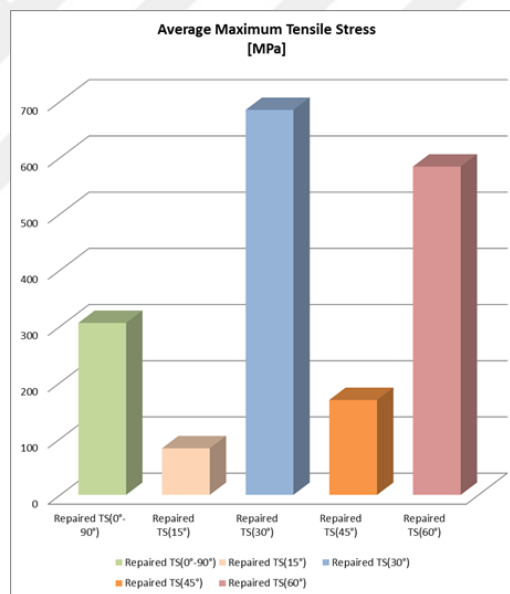
Figure 6.37: Average ultimate strength points of the repaired test specimens.

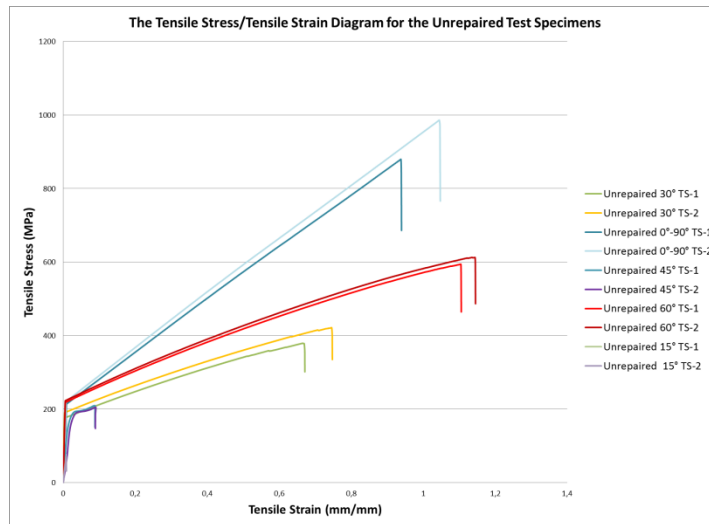
Figure 6.38: The tensile stress/tensile strain diagram for the unrepaired test specimens.

Two pieces from all of the lay-up orientations were chosen for being able to make a better comparison and analysis of the tensile stress/strain for the unrepaired test specimens in the same diagram. All of the relevant comments have been given in the conclusions.

Figures 6.38 and Figure 6.39 and Table 7.2 presents the yield point of repaired and unrepaired specimens. It was observed that yield strengths are relatively closer to each other for both type of specimen in contrast to some significant deviation in their post-elastic response such as average ultimate strength points.

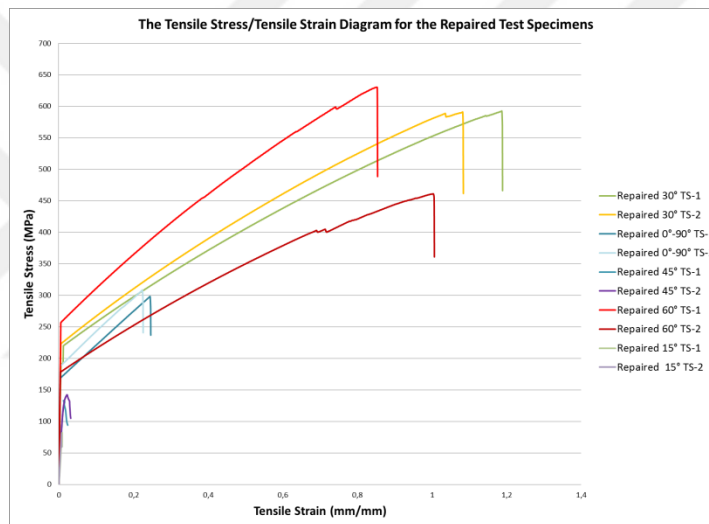
Figure 6.39: The tensile stress/tensile strain diagram for the repaired test specimens.
