**INVESTIGATION OF THE EFFECT OF
STRUCTURAL GRID DISCONTINUITY ON THE
EARTHQUAKE BEHAVIOR OF MIDRISE RC
MOMENT FRAMES**

**A Thesis Submitted to
the Graduate School of Engineering and Sciences of
İzmir Institute of Technology
in Partial Fulfillment of the Requirements for the Degree of**

in Civil Engineering

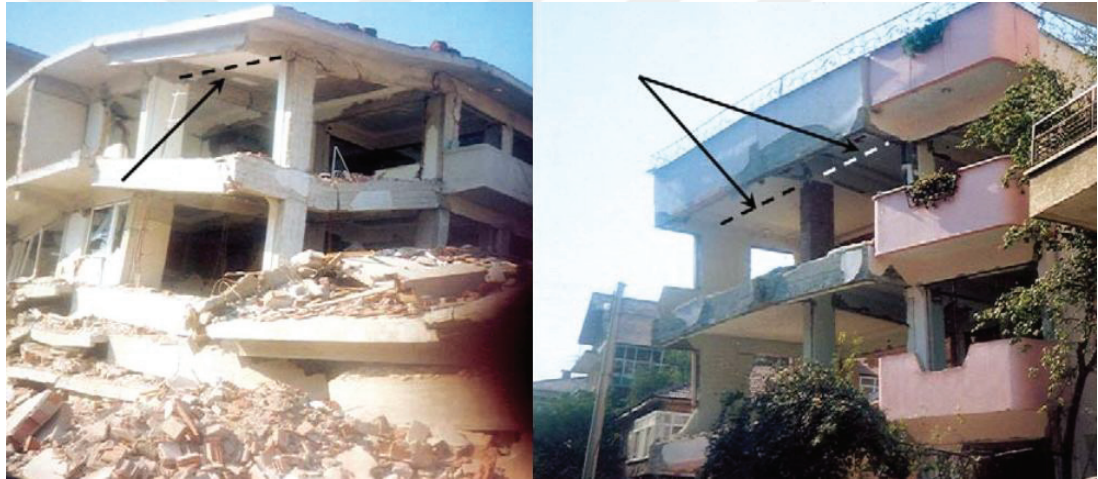
Figure 1.2. Damages related to frame discontinuity
(Source: Bal & Ozdemir, 2006)

Bal and Ozdemir (2006) investigated the behavior of reinforced concrete frames which have frame discontinuities along the perimeter frames. This perimeter frame discontinuity is caused by architectural concerns and constitutes slab bands instead of beams (Figure 1.1). Structural damages related to frame discontinuities are seen in Figure 1.2. For this study, 12 buildings which were designed in accordance with 1975 and 1997 Turkish Earthquake Regulation were chosen and seismic analyses were conducted for 5 different conditions. It is reported that nearly 40% reduction on ultimate strength of existing structures has been observed due to the perimeter frame discontinuity. The authors stated that beam discontinuity issue and column-slab connections control has to be considered in the earthquake specifications.

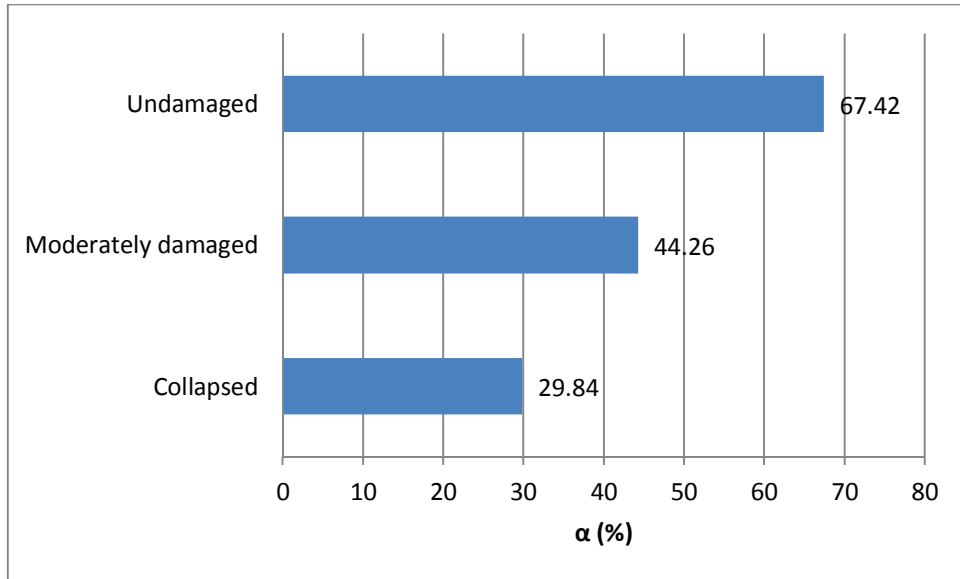
Figure 1.3. Damage states according to α values
(Source: Erkan, 2003)

Erkan (2003) carried out a statistical study in relation with earthquake damages in Düzce region and investigated the soil properties, damage states, soil-structure interaction and design parameters. The buildings examined were classified in terms of beam discontinuities and a discontinuity coefficient, α was determined as shown in Equation 1.1. The damage states according to average α values of the examined buildings are demonstrated in Figure 1.3 and the buildings having α value larger than 70% are in the undamaged condition as seen in the Figure.

$$\alpha = \frac{\text{The number of continuous beam frames}}{\text{The number of all frames}} \quad (\text{Eq 1.1})$$

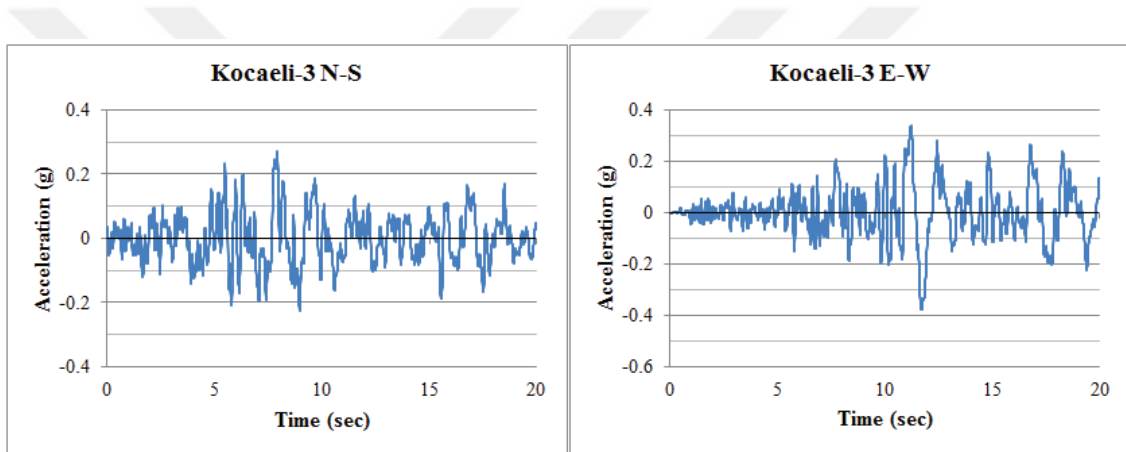
Figure 2.9. Kocaeli-3 ground motion pairs

A suite of eleven ground motion pairs was considered for the nonlinear time-history analysis. These ground motions are listed in Table 2.1. As it is seen from the Table 2.1, eleven ground motions from eight different earthquakes are chosen for the seismic analyses carried out in this study. The ground motions records waveforms are presented from Figure 2.4 to 2.14.

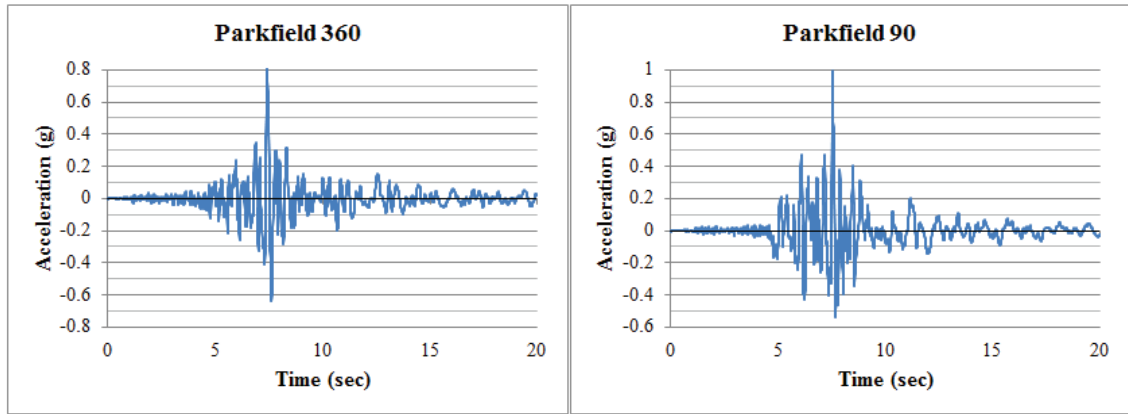
Figure 2.14. Parkfield ground motion pairs

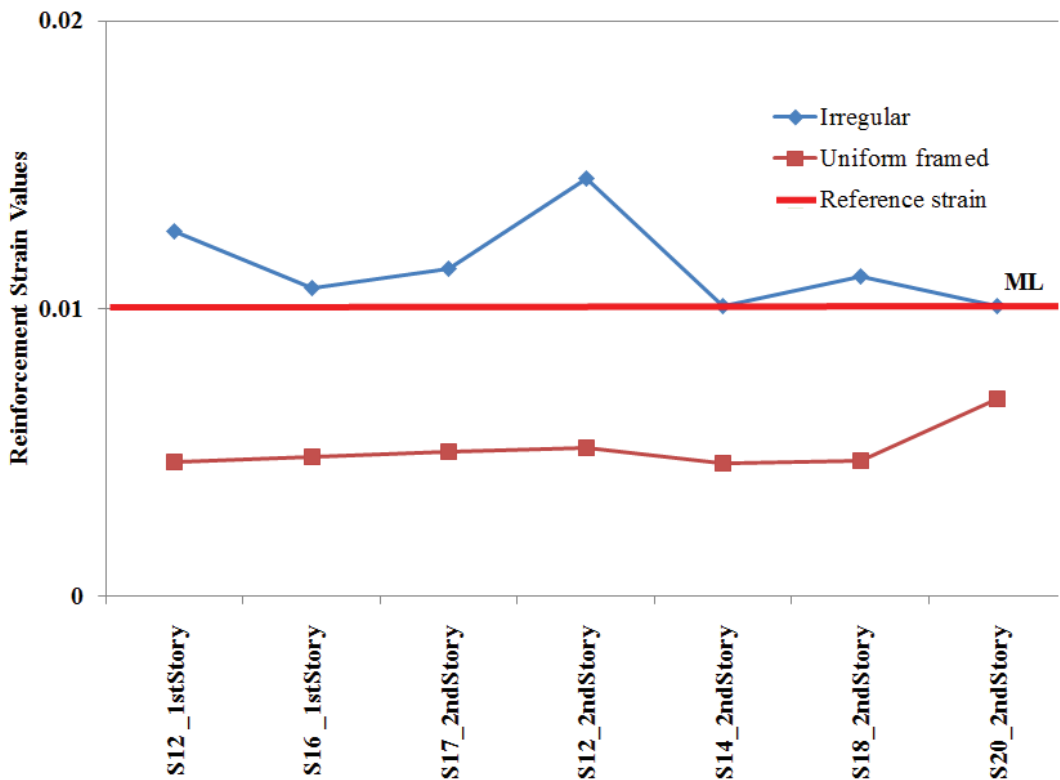
Figure 3.5. Comparison of Column Damage States

As mentioned previously the irregular structure has moderately damaged beams and columns while all members of the uniform framed structure are only in the light damage region. Two columns in the first story and 5 columns in the second story have moderate damages for the case study building 1 (irregular structure) according to the time history analysis made by using 11 earthquake sets. The severity of the column damages is determined by the strain values related to reinforcing steel as the analysis mentioned above. The Figure 3.5 demonstrates the comparison of column damage states between case study building 1 and case study building 2 (uniform framed structure). The comparison is done for the 7 columns which have moderate damages at the irregular frame. The limiting line (Minimum Damage Limit (ML) = 0.01) in Figure 3.5 shows the limit strain value in terms of reinforcing steel and the columns having larger strain values than 0.01 are in moderate damage region while having smaller than 0.01 are in light damage region. As it is seen in the Figure 3.5 the so-called columns for the uniform framed structure have strain values below the limiting line and therefore they are in light damage region.

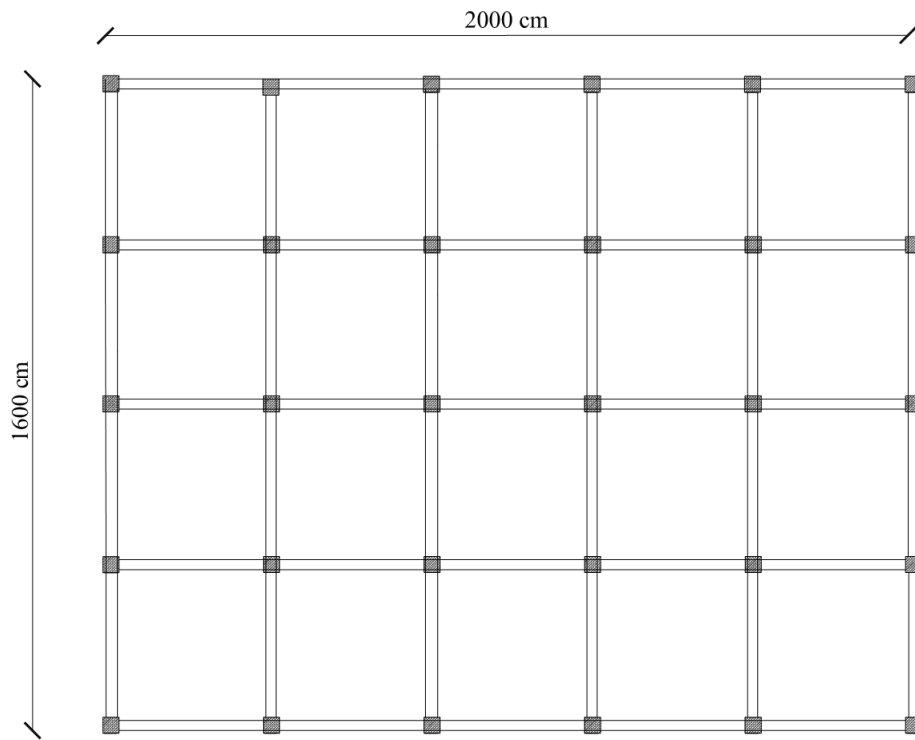
Figure 3.6. Floor plan of structure A ($T=0.49$ sec, $GDF=0$)

In order to demonstrate the effects of grid discontinuity on the building stiffness, 5 different structures are modeled and numerically investigated. The floor plans of the models related to this case study are shown in Figures 3.6, 3.7, 3.8, 3.9 and 3.10 and as it could be observed in the figures all models have same dimensions (16m x 20 m). The dimensions of beams (30x50 cm) and columns (40x40 cm) are selected the same for all models in order to investigate the effects of grid discontinuity only. These structures have various grid discontinuity factors (GDF) and they are listed in Table 3.11.

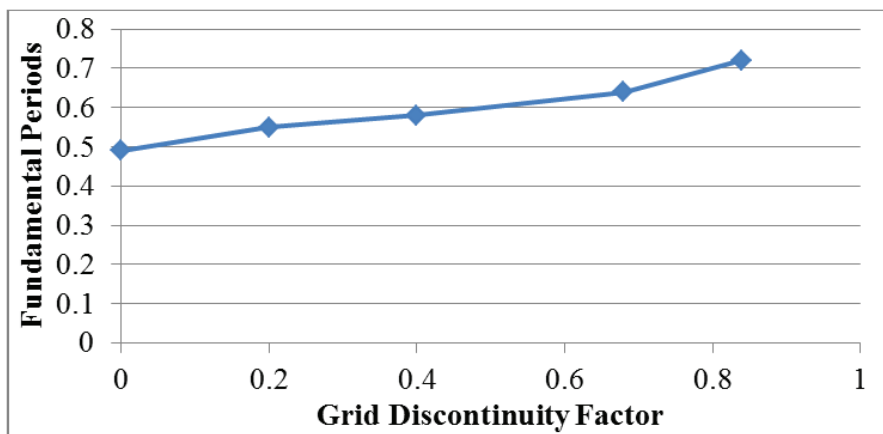
Figure 3.11. Fundamental period vs. grid discontinuity factor

The modal analysis of the investigated structures shows that there is a strong relation with the fundamental period of the structure and the grid discontinuity factor. It is observed that the period increases with the increase of the so-called factor. The relationship between grid discontinuity factor and the fundamental period is shown in graph in Figure 3.11. As it is seen in graph the grid discontinuity factor plays an important role regarding the stiffness characteristics of the buildings and leads to increase on the fundamental period of the structure.
