**THE EXAMINATION OF CONSTRUCTION  
TECHNIQUES OF MUĞLA HISTORIC HOUSES**

**in Architectural Restoration**

**Burcu IRGAT ERGİN**

**October 2008**

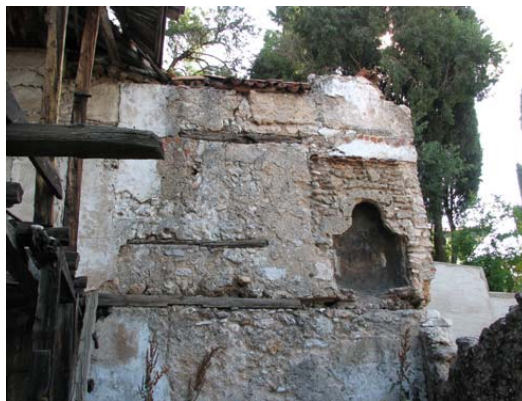
Belonging to the Ottoman Period, the houses with outer sofa are found in western parts of Anatolia (Tosun 1983). In this plan type, which was frequently found in Muğla houses, the house has two storeys and the sofa which faces to the courtyard is placed in front of the rooms that are lined up side by side. Providing the access from the ground floor, the staircase is located at any of the shorter sides of the sofa or between the rooms. In some examples, a certain portion of the other side of the sofa is occupied by the extension of the house, as an additional room (Ekinci 1985). The traces of a fireplace found on the extension of the side wall of a house on Şahidi Street, was an evidence of such a room which was once existed (Figure 4.1).

Figure 4.1. The traces on the wall of an additional room in the sofa (Şahidi St. No: 26).

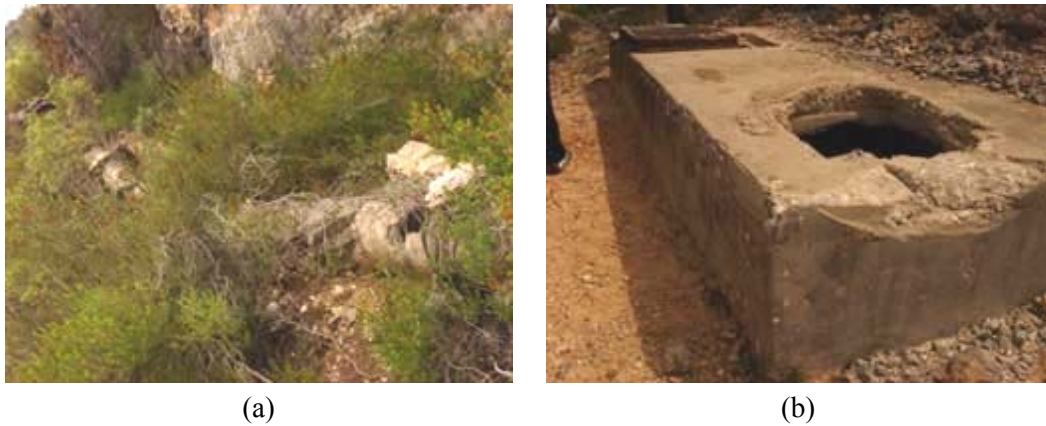
Muğla had a water supply network in the past (Aladağ 1991). In this system, water was provided from a spring and brought by means of baked clay pipes to a certain spots from where it is distributed to the ponds of the houses situated towards the upper parts of the site (Figure 4.2.a and Figure 4.2.b). Making use of the natural slope of the land, water was distributed to the ponds of the houses at lower parts.

Figure 4.2. a. Pipes of the water supply network, b. water distribution storage

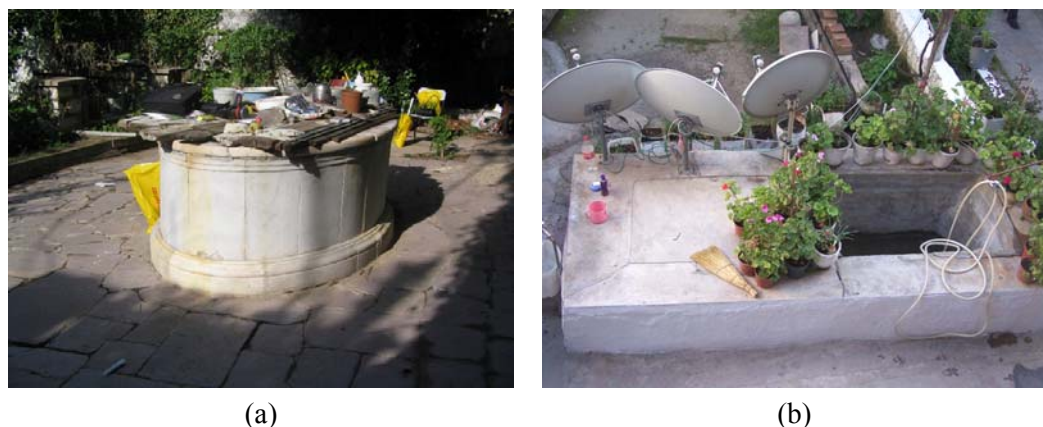
Although this network has been completely destroyed at present, some of the ponds in the gardens are still used. In addition to these ponds for ornamentation the ones converted from these ponds for leisure or watering flowers in the gardens are observed in some houses (Figure 4.3.a and Figure 4.3.b).

Figure 4.3. a. Pond for leisure (Arasta St. No: 9), b. Pond for watering purpose (Mustafa Muğlalı St. No: 37)

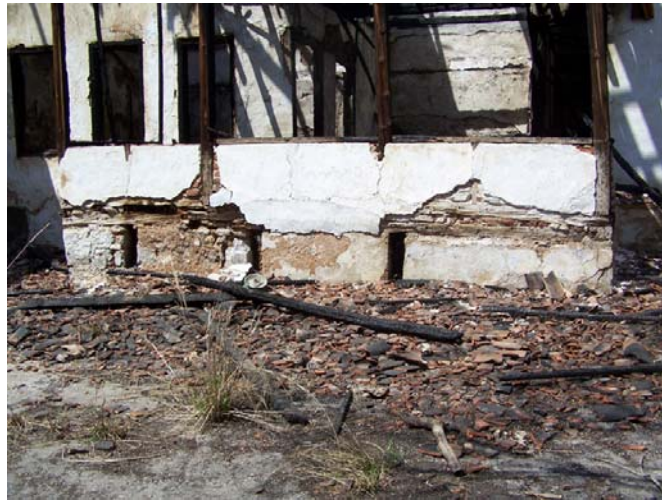
Generally, basement floor, 1-1.5m in height, is built to provide air circulation to prevent upper floors from dampness. Circulation is provided through the small holes on the basement façade walls (Figure 4.4). However, some of them may include spaces, slightly higher than those for air circulation, for storage purpose or a small kitchenette with a small fireplace (Tosun, 1983).

Figure 4.4. Small holes for air circulation on the basement façade wall (Şeyh Cami St. No: 32)

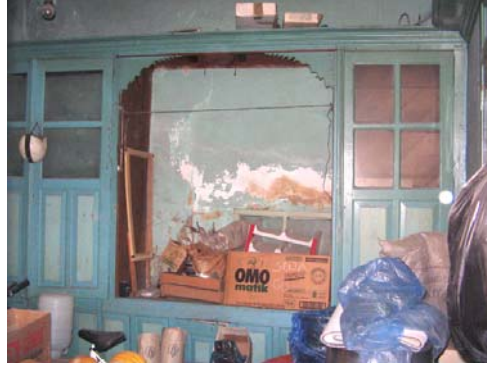
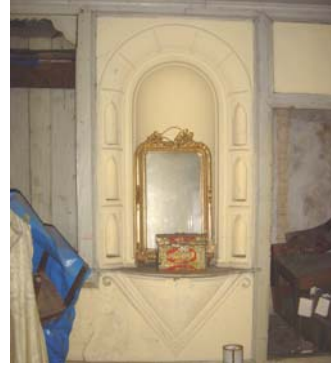
As in most of the traditional Turkish houses, the rooms of Muğla houses are arranged to meet most of the daily needs of a family life. Depending on the economic or social statute of the owners, square or rectangular, the dimensions vary greatly. However, due to the hot and humid conditions, the height of the rooms does not happen to be below 2.80 m., while it may extend till 3.5 m at the first floor. The height of the rooms of ground floor is 1.90 m. at minimum (Aladağ 1991). Each of the rooms of the first floor possesses fireplace, a large built-in closet, called '*yüklük*,' and a shelf, called '*elmalık*,' 18-20 cm in width encloses the room at the height of 2-2.10m (Ekinci 1985, Aladağ 1991). The closet generally contains an ablution space, called '*gusülhane*,' storage for beds '*döşeklik*,' and an alcove '*çiçeklik*.' It measures 50-60 cm in width and rises till the level of *elmalık*. Usually, *gusülhane* makes 15 cm protrusion from the closet. The floor of it is covered with zinc sheet and sloped outward to discharge wastewater (Ekinci 1985, Tosun 1983). *Döşeklik* part, below which is used as storage is placed 70-80 cm above the ground level (Figure 4.5.a). *Çiçeklik*, a semi-circled alcove like niche used as a place for flower arrangement or light, usually a candle, is located at the same level with *döşeklik* (Figure 4.5.b).

Figure 4.5. a. view from *döşeklik* and b. view from *çiçeklik* (Arasta St. No: 9)  
(Source: İYTE 2005)

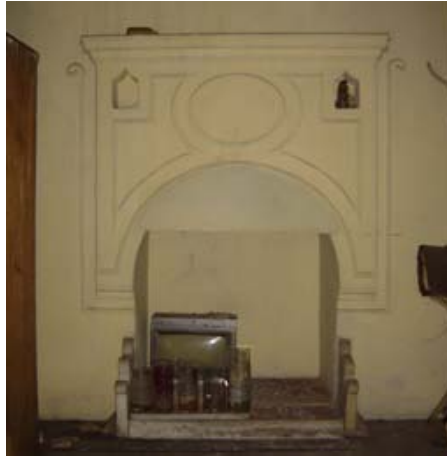
The fireplace which is usually located across the door measures 90-100cm in width and 50-60cm in depth (Figure 4.6). Fireplace is crowned with a projection which is called '*ocakbaşı*', 160-170 cm above the floor (Aladağ 1991, Ekinci 1985).

Figure 4.6. a. view from the ocak in Arasta St. No: 9, b. elevation, c. section and d. plan  
(Source: İYTE 2005)

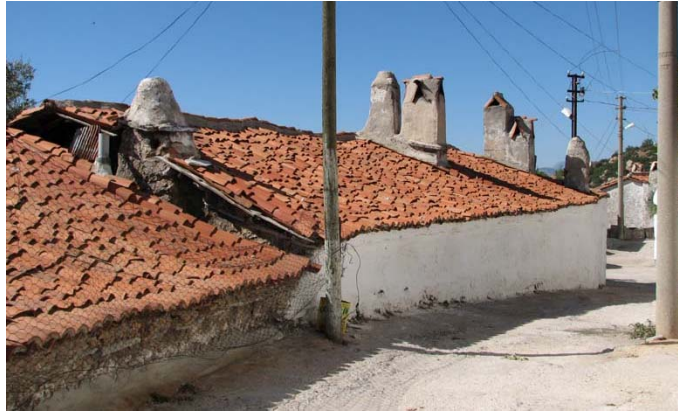
The northern façades, on the contrary of the southern, are embedded in the ground depending on the slope (Figure 4.7). Usually they do not have fenestration to outdoor. The other side adjacent to the neighbor house is also blind. The façade facing to the streets is enriched with the chimney which is collecting the flues of the fireplaces of the ground and first floor rooms. It protrudes 30-40 cm from the wall surface towards the street. The capping of the chimney which is found in numerous houses in Muğla is formed by means of specifically arranged Turkish roof tiles.

Figure 4.7. Northern façades of the houses embedded in the ground (Nalıncılar St. No: 6)

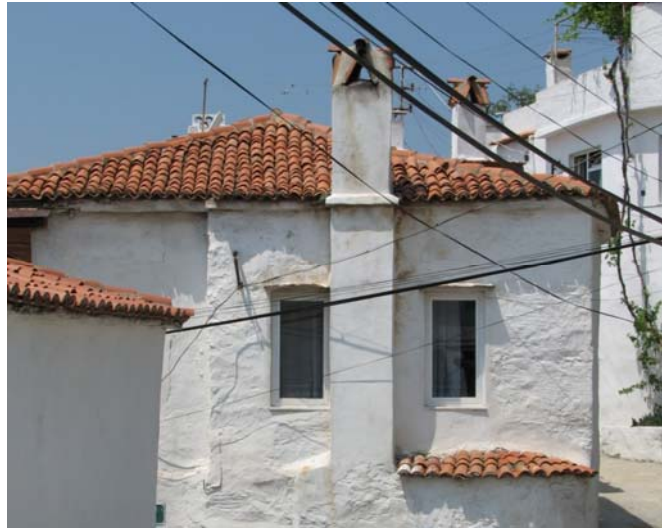
In some houses, two small windows, belonging to the rooms of the first floors, also take place on both sides of the chimney wall (Figure 4.8). The façades, facing to the street and neighbor houses are of rubble stone masonry without plastered but white-washed. Except the southern façade the band of eave formed of courses of slate stone, on which roof tiles rest on, encircles the façades. This kind of façade composition is seen most of the houses in Muğla. However, some different examples can also be found where the slope of the land ends. Although having the same plan type, as well as opening to the courtyard, in these houses it is seen that the rooms also open to the street

Figure 4.8. Street façade with chimney wall and small windows on its both sides (Şemsiana St. No: 16)

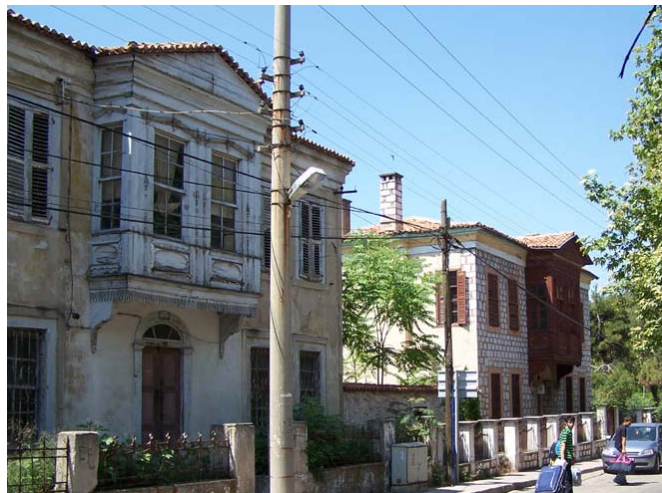
via *cumba*, and hence, the rear façade which had no opening in the other houses has changed. These houses were built in the 19<sup>th</sup> century. In such houses the front façade corresponds to the street façade. It is composed of an entrance door with a *cumba* above in the center, and the windows of the ground and first floors on both sides of this entrance axis (Figure 4.9). They give the impression that they are integrated with the street. The other façades may also have window openings.

Figure 4.9. Houses which is composed of an entrance door with a *cumba* above located in the central axis and the windows of the ground and first floors on both sides (Ragıp Bey St. No: 2 and 4)

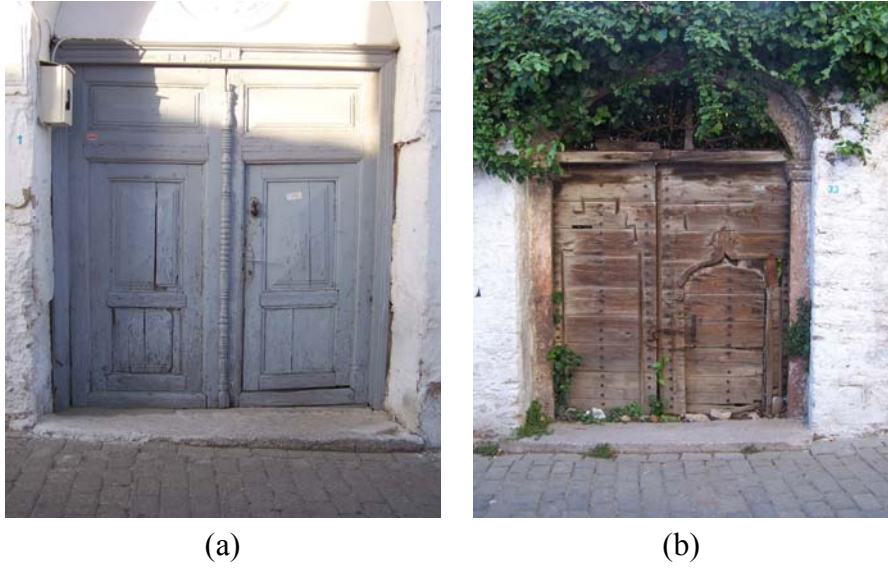
Figure 5.2. Examples of entrance gates with 'kuzuluk'. a. Prinççiler St. No: 1, b. Konakaltı St. No: 33

Together with the rear and side walls of the houses, courtyard walls define the boundaries of the plot with the minimum height of two meters but can be more depending on the width of the street, slope of the land and the household privacy to be visually protected. They house the entrance gate composed of two panes and a canopy above. One of the panes includes a smaller pane which is called ‘*kuzuluk*’ (Figure 5.1, Figure 5.2).

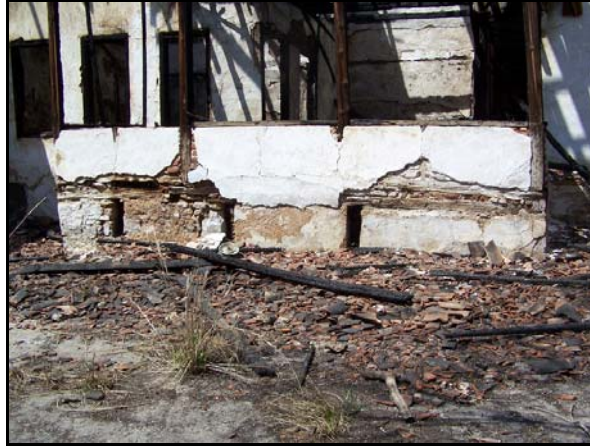
Figure 5.7. Holes left on the exterior façade of the basement for ventilation (Şeyh Cami St.No:32)

Unless specified, as that; footing and the portion of the wall from footing till the ground surface, such information should be taken with care not to confuse them with the properties of the basement walls. Because, in hot and humid environments, some of the basements may merely serve as ventilation galleries that are only accessed through manholes at the ground floor and they may be misleadingly interpreted as foundation walls (Figure 5.6.a and Figure 5.6.b). The ventilation is provided with the holes left on the exterior façade of the basement (Figure 5.7).

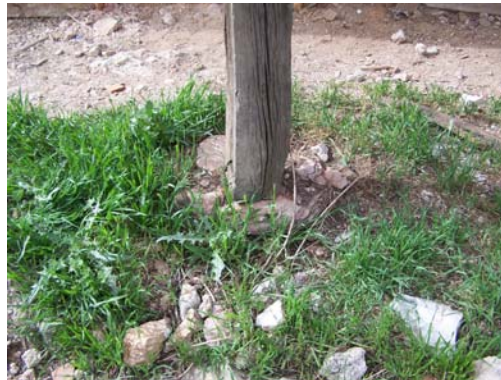
Figure 5.8. Timber post of the sofa placed on a single stone footing (Şahidi St. No: 26)

**Discontinuous foundation:** In this type, the foundation is composed of large sized blocks of stones placed under the free-standing timber posts (Figure 5.8).

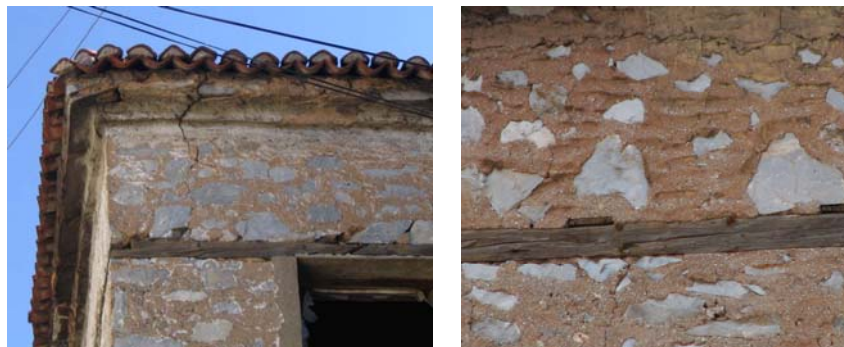
Figure 5.15. Rubble stone wall plastered with '*çivileme*' (Ulucami St. No: 24)

Inner surfaces of stone masonry walls are plastered. The outer surfaces are not plastered but white washed, in many cases annually. However, it is observed that the outer faces of the walls of some houses are plastered with a special technique, which is known as '*çivileme*' amongst the master masons of Muğla (Figure 5.15). In this technique, plaster is applied to the joints but extending over the stone surface to provide a further prevention against water penetration in addition to mortars in the joints (Aladağ 2007).

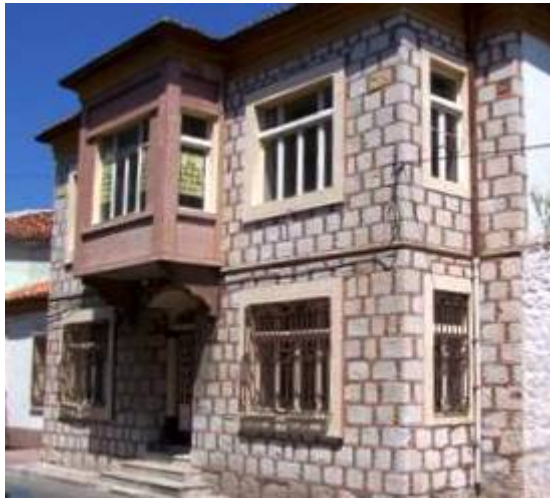
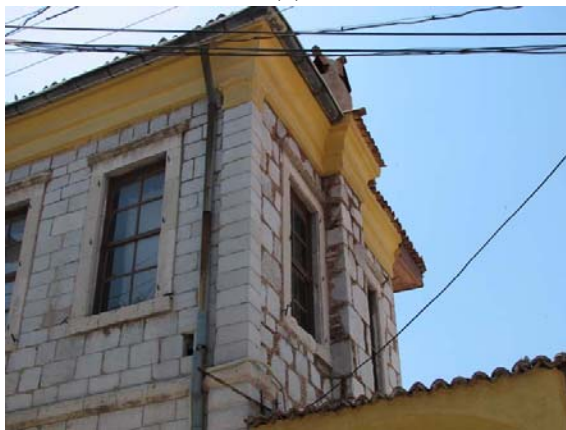
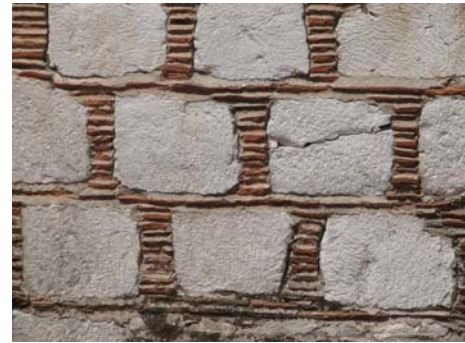
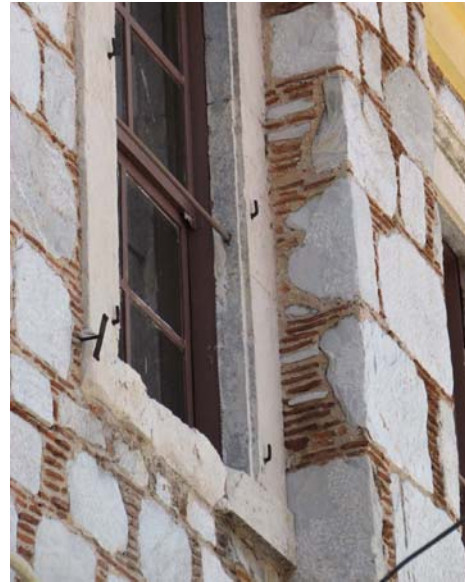
Figure 5.16. Examples from façades made of cut stone a. Ragıp Bey St. No: 7, b. Hekimbaşı St. No: 9, c. Roughly shaped rubble stone wall with roof tile pieces Hekimbaşı St. No: 9, d. Corner joint of cut stones and opening in cut stone wall Hekimbaşı St. No: 9

In the houses, built after the 19th century, the outer faces of the walls made of roughly shaped blocks of lime stone placed in horizontal courses with the pieces of roof tiles inserted between them are observed (Figure 5.16.a, Figure 5.16.b). They are said to be 45-50 cm in thickness (Sürer 1990). Vertical joints are wider (Figure 5.16.c). As seen in Figure 5.16.d, it can be estimated that they are composed of two leaves; the outer leaf is cut stone of which its backside is left rough and inner leaf is of rubble outer face of which is plastered, or as in many cases in the region and in Anatolia, of timber frame with infill (Güçhan 2007). The openings in these walls are framed with stone casings in all sides of the opening. Since could not be entered, information is not available about the cross-section as well as the inner surfaces of these walls.

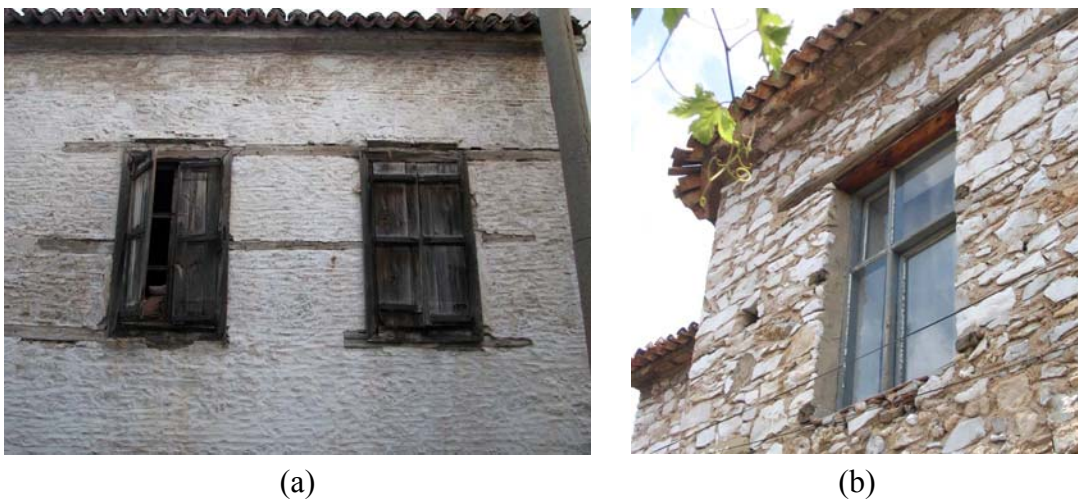
Figure 5.18. Wall plates placed at the mid of opening to fix jambs a. Yayla St. No: 13, b. Camcı St. 2nd dead end No: 36

The number of plates changes from three to five depending on wall thickness and cross-sections of plates. In some cases they are extended till the corner of the wall. The frames of the openings are fixed to the wall plates placed at the mid of the opening in its each side perpendicular or parallel to side of opening (Figure 5.18.a and Figure 5.18.b).

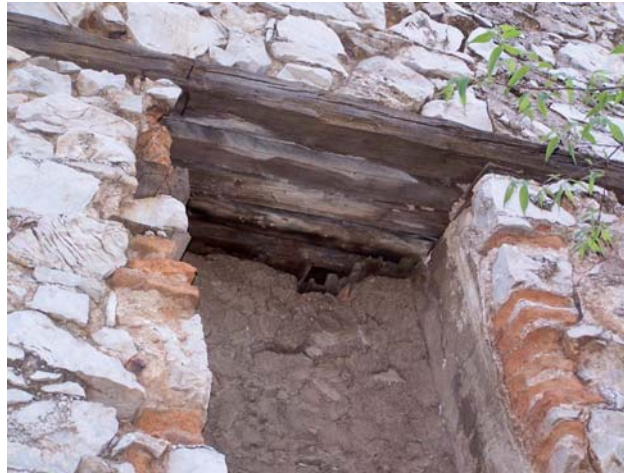
Figure 5.19. Opening of a built-in cupboard formed with wall plates (Konakaltı St. No: 5)

As in many houses in Anatolia, one of the outer walls from ground floor to roof level, relatively thicker than the other walls (~ 90cm) is assigned as a service wall also in some houses in Muğla. In this wall fireplace, built-in cupboards and niches are placed. Similarly to the openings in rubble stone wall, the built-in cupboards and niches are also formed by using wall plates as lintels (Figure 5.19).

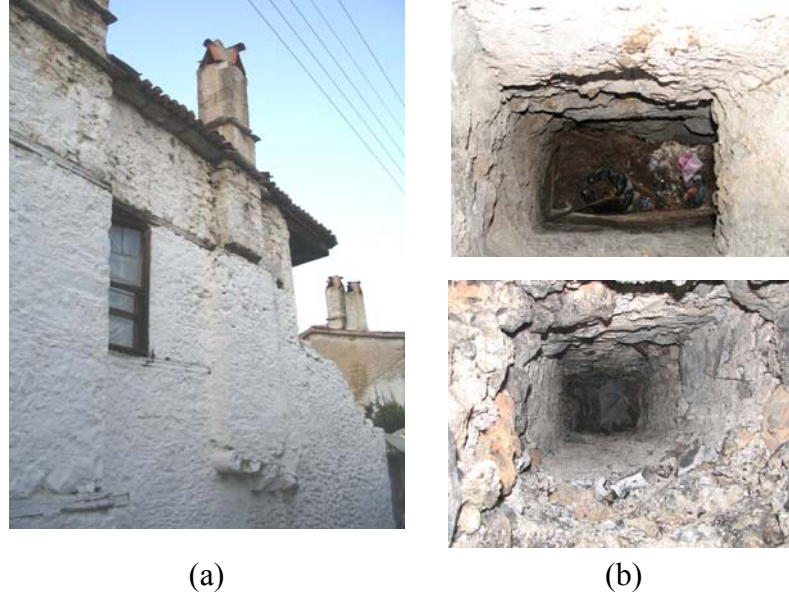
Figure 5.22. a. Protrusion of fireplace in first floor set on big stones placed in the wall (Yayla St. No: 18). Views from the inside of chimney (Şahidi St. No: 26). b. through fireplace, c. through upper part of chimney

Two fireplaces can be arranged in the same wall structure making a single protrusion raised from the ground to the level of the roof, or in separate protrusions on the same wall (Figure 5.21.a and Figure 5.21.b). In such a case, the back wall of the first floor fireplace is laid by deviating it on a wall plate set above the back wall of the fireplace on the ground floor (Figure 5.21.b). In case of the absence of a fireplace below, the exterior walls of the fireplace are laid on the big sized stone blocks set and

protruded from the wall (Figure 5.22.a). The width of the protruded wall is decreased to the thickness of the chimney wall below or above the level of the eave.

The flue of the chimney, which is also concealed in the same wall without protrusion measures 30/45cm and its inner surface is plastered to provide a better draught while preventing the leaks of smog through the joints of the rubble masonry (Figure 5.22.b). However, the outer surface of the walls of this chimney is also white washed without plaster like the other walls of the house.

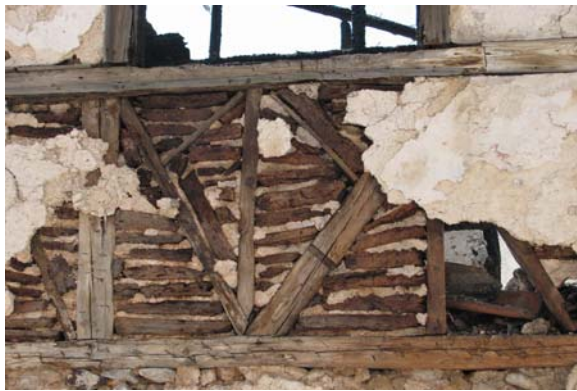
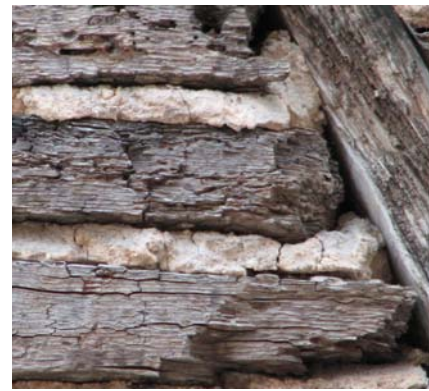
Figure 5.27. Timber-framed wall with wood-infill. a. partial elevation drawing, b. and c. views from the façade (Şeyh Cami St. No: 32)

The infill materials of these walls are mud, brick, stone, usually mixed with lime mortar, and wood. However, the rubble stone with mud mortar is common infill in Muğla houses owing to being easily obtainable in the region. Infill material of the house in Şeyh Cami St. No: 32 is wood pieces which was the only observed example in Muğla urban site during the survey. In this wall structure, wood pieces of 3-4cm in thickness, are placed parallel to wood beam, between frame components with mud mortar, but not nailed on to the frame members making the structure lightweight (Figure 5.27). If those pieces are nailed, the system is referred as *dizeme* technique applied in inner parts of Western Black Sea Region such as Bolu, Mudurnu and Göynük. *Hımiş* walls are plastered on both sides with lime plaster, sometimes including chopped straw (*kıtık*) and goat hair. The common problem for plastering these walls is the lack of adherence capability to wood elements. To solve this problem, the beams in floor level and posts in the corners are covered with wooden veneers (Figure 5.28.a and Figure 5.28.b) or the surface of the wood elements are notched or nails are partially inserted into the wooden member and slightly bended making an uneven surface to hold the plaster (Figure 5.29).

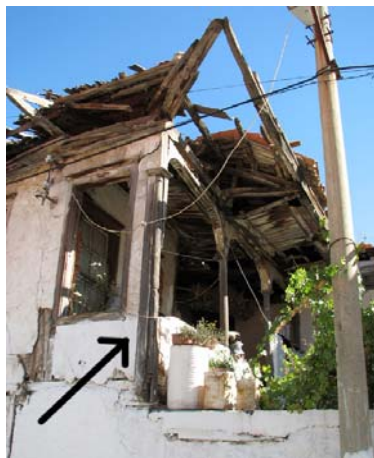
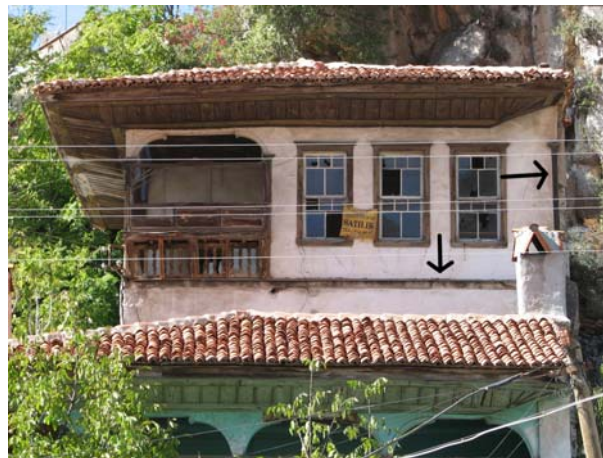
Figure 5.28. Covering wood elements in corners and floor levels with veneer; a. Saburhane St. No: 44, b. Bahçe St. No: 53

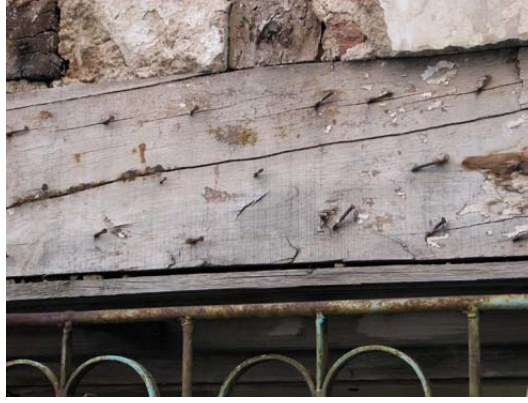
Figure 5.29. Using nails to hold plaster applied on wood elements (Şeyh Cami St. No: 32)

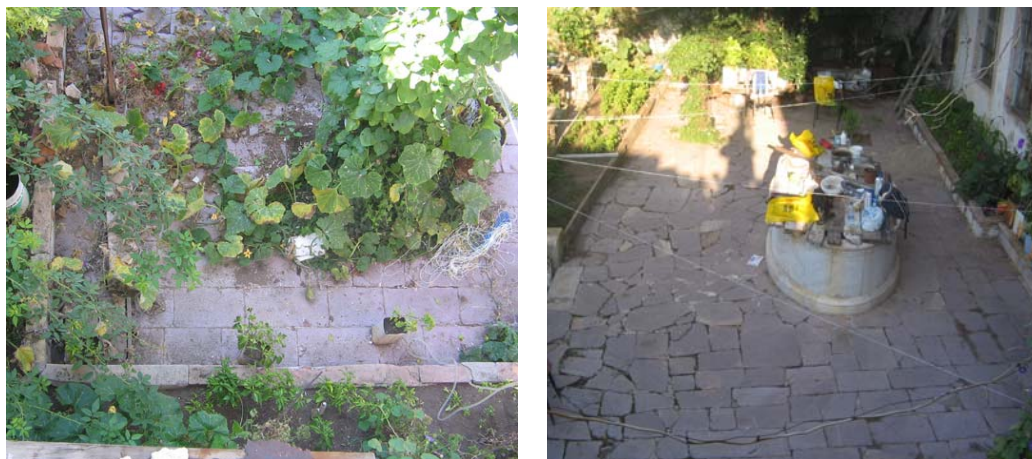
Figure 5.31. Views from a slate stone pavement of courtyard (Arasta St. No: 9)  
(Source: İYTE 2005)

The pavement of courtyard is usually formed of large sized plates of slate or cobble that are set on the leveled land. However, some houses in Saburhane district, the pavements may also be formed of pebbles that are embedded in the leveling mortar (Aladađ 1991). Since they are destroyed or changed largely with concrete, original floor structure of the courtyard could be observed only in one house during the survey (Figure 5.31).

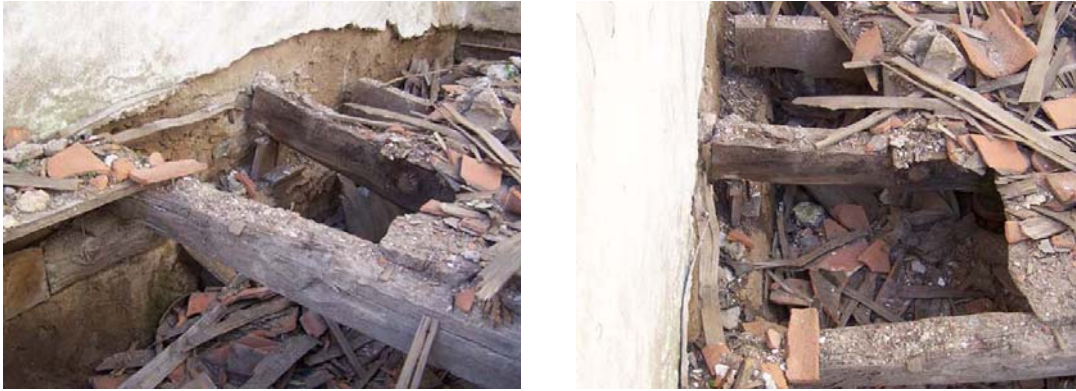
Figure 5.33. Views from ground floor covering the basement (Recai Güreli St. No: 12)

The ground floor of the earlier example of Muğla houses without basements were composed of slate or earth, often white clay, which are laid over bare earth. Owing to the progress in time, clay tile and wood are used. Common type of material is wood in most of the houses reached today (Küçükerman 1996). In a house, at Recai Güreli St. No: 12, which was recently demolished to be rebuilt, the system of the ground floor was comprised of planks nailed on the joints (with the intervals of 35-45 cm) rested upon the wall plates with different cross-sectional dimensions (12/15 cm) which were set on the protrusion of the basement wall. Other than being a basement, the space below the floor is very shallow, likely that it was functioning as the gallery for ventilation. The cross-sectional dimensions of the joist were 7/2, 7/9 or Ø12 cm and of the wall plates, which were used in pieces in varying lengths (Figure 5.32, Figure 5.33).

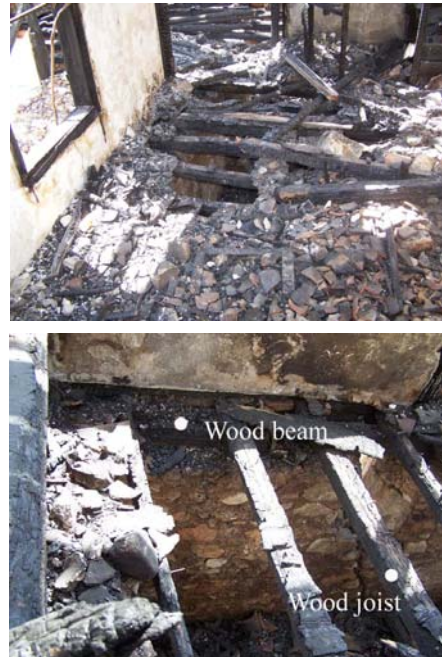
Figure 5.34. Connection detail of ground floor with *hımış* wall if there is a basement (Şeyh Cami St. No: 32)

In the second example at Şeyh Cami St. No: 32 and unfortunately burned during the survey time, the house had a similar space but it was higher (1.20 m) and was possibly used as the basement. The ground floor above this basement was formed in a way similar to the former example. Joists (approximately 8/8 cm), on which planks were nailed, with 30-45 cm intervals rest on the beams with the cross section of approximately 12/12 cm. Two beams were set on the wall where it extended upward in a different system, which was of wood frame with infill (Figure 5.34).

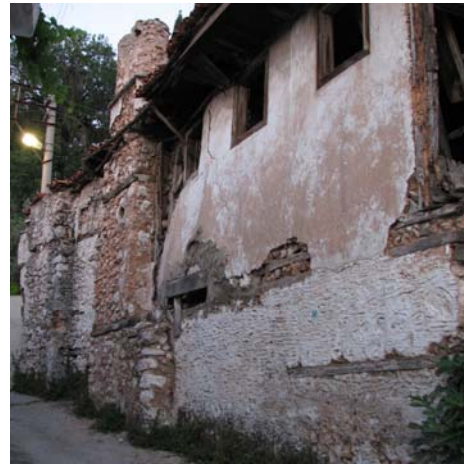
Figure 5.38 Connection detail of timber flooring with timber-framed wall in first floor. a. partial elevation, b. section, c. view from the façade (Şahidi St. No: 26)

Another solution is making a platform by decreasing wall thickness in upper floor. In this technique, the ground floor wall thickness reaches 90 cm because of placing fireplace inside the wall. Wood joists are placed on wood beams laid on this platform and the gaps between joists are filled with rubble pieces with mortar (Figure 5.37). In another example (Şahidi St. No: 19), wood joists are placed on wall plate in exterior surface of rubble stone wall and wooden beam of wall structure is laid above the wood joists (Figure 5.38).

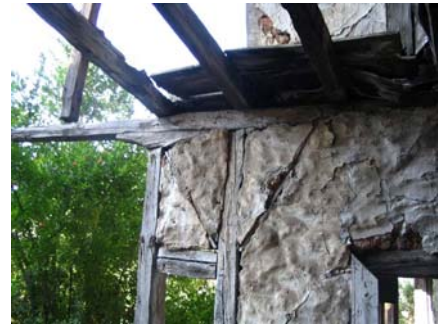
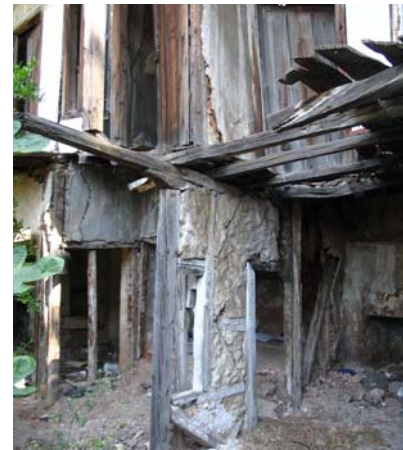
Figure 5.39. Connection detail of first floor wood joists with timber-framed wall (Şahidi St. No: 26) a. partial section, b. section A-A, c. views from the floor

If both of walls are made of timber-framed, generally, wood joists are placed on the wood beam which is supported by the posts and studs of the ground floor wall. Another beam is set on these joists. The posts and studs of first floor wall rest on this beam (Figure 5.39). In second solution, wood beam on which joist rested, is placed perpendicularly on the timber frame of the wall (Figure 5.40).

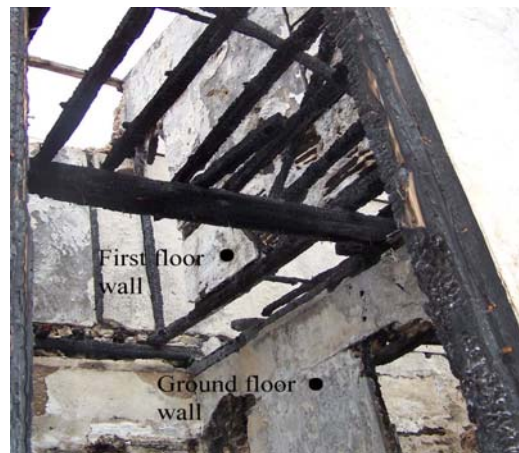
Figure 5.40. Connection detail of timber floor with timber-framed wall (Şeyh Cami St. No: 32)

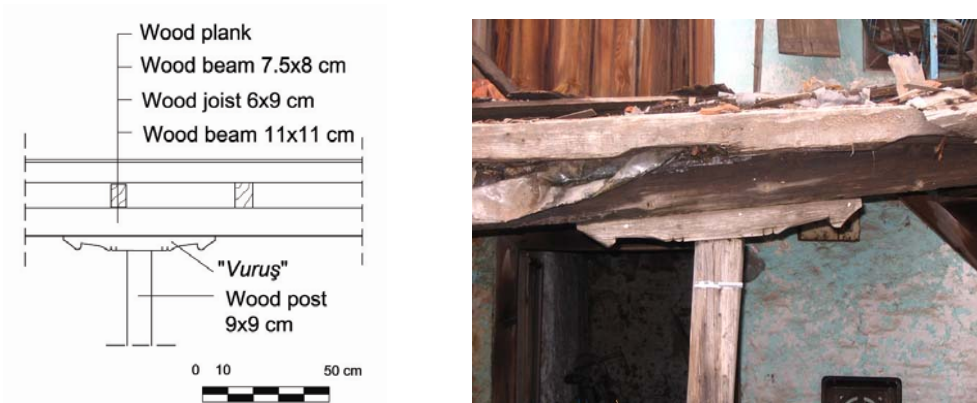
Figure 5.43. Detail of 'vuruş' (Camcı St. 2nd dead end No: 34)

These wood posts, with chamfered edges, are placed on stone blocks (slate stone) in the ground and finished at top ends with wood head, called ‘*vuruş*’, in order to diffuse the load (Figure 5.43).

The lengths of these heads vary between 60-80 cm length and they have triangular shape formed by chipping them towards the ends. Its later examples are volute shaped. The posts in the ground floor are tied with wood beam with variable cross-sections between 8/9, 12/12 cm. The floor of sofa is constituted with wood joists, 6/9, 8/9, 9/9 cm in cross-sections, placed on the wood beam at one or both of their edges, or to the wall plate of the rubble stone wall depending on the supporting structure in the ground floor (Figure 5.42). They are covered with wood planks of 2-3 cm in thickness. The posts of the first floor set either on wood joist or on a beam placed on wood joists. When second beam is used, the posts of two floors may not be placed on the same axes. Since they rest on the beam rested on the joists that are also placed on a beam, their axes may be deviated (Figure 5.44). The interval between the first floor posts enveloped with wooden railing called '*trabzan*', or a thin wall made of infilled timber-frame with lime plaster 90 cm height (Aladağ 1991, Tosun 1985, Ekinci 1985).

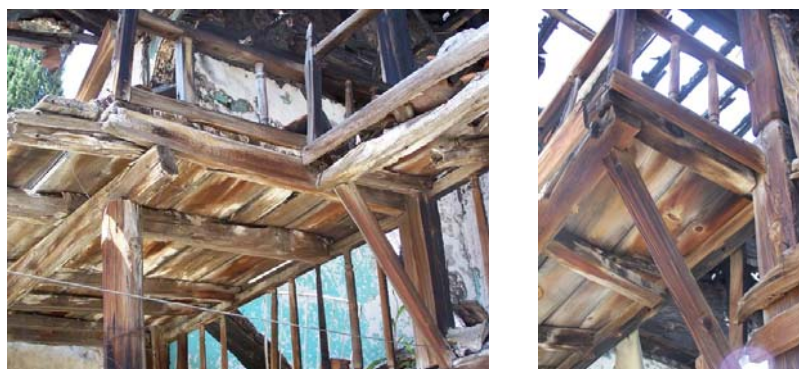
Figure 5.46. Views from *kerevet* (Cami St. No: 12)

In some houses there are elements, called ‘*kerevet*’, placed on one edge of the sofa, elevated around 50-70 cm from the sofa floor and extended 75-100 cm over the courtyard or street (Figure 5.46). It is supported either by posts or bracings connected the sofa beam on which railing of the sofa took place (Figure 5.47).

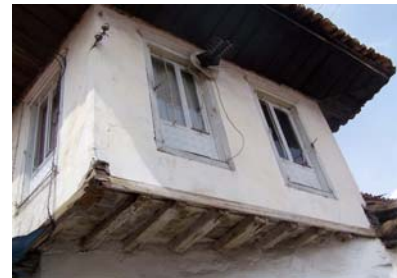
Figure 5.48. Projection for correcting distortions in first floor. a. Plan, b. section A-A, c. a view from projection (Sekibaşı St. No: 16)

The projection observed in Muğla houses are made for two different purposes. First one is applied to correct the distortions of ground floor layout which is shaped by the plot, in the first floor. In this type the projection, generally triangular in plan, formed by extending wood joists of first floor, supported by rubble stone wall of the ground floor and tying them with a wood beam at the end, the base of timber-framed wall of the projected part (Figure 5.48).

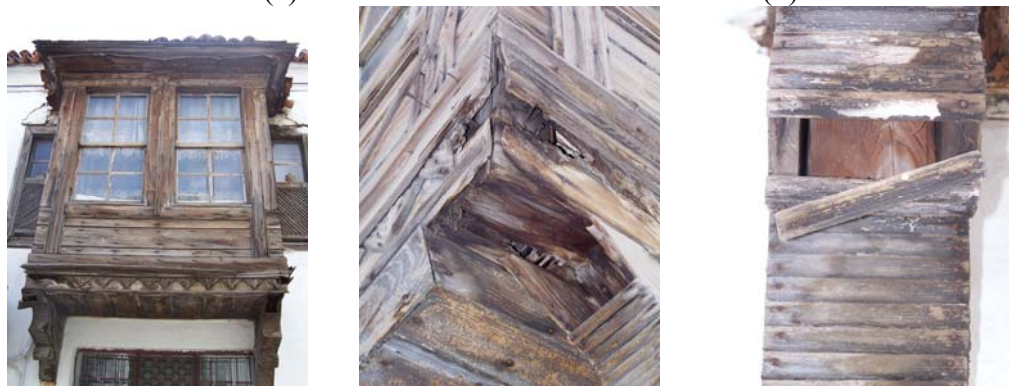
Figure 5.49. *Cumba* supported with bracings covered with wooden veneer. a. front and side elevation, b. section, c. views from *cumba* (Uçarçılar St. No: 6)

The second type projections are made for widening the street vista to be perceived from inside the house. These projections, seen especially in late houses and the ones situated in the lower part of the site where the land evened are the parts of a room or sofa and their widths change between 200-400cm depending on the widths of rooms and sofas. The construction principle of this type is similar to the first one. However, such type of projection or jetty, called '*cumba*', is supported by two or more bracings. The connections of the braces with wood joists are made in two different ways; placing the wood joists on bracings (Figure 5.49 and Figure 5.50) or on wood beam supported by bracings (Figure 5.51).

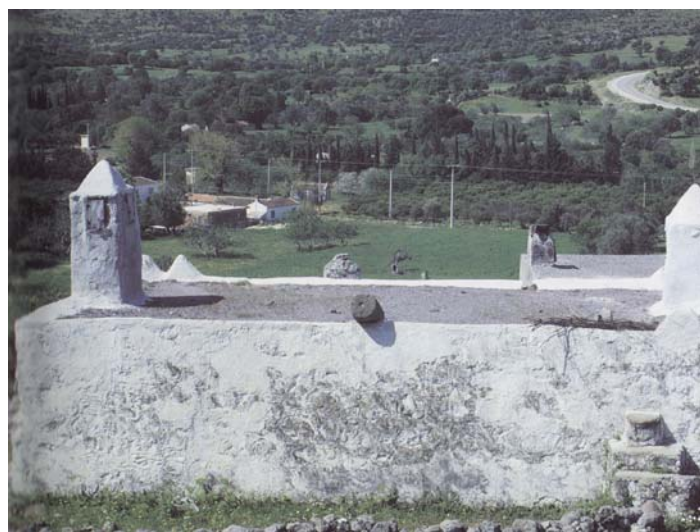
It is stated that roofs with earth cover had been used until the end of the 19<sup>th</sup> century. These roofs were covered clayey earth, called ‘*geren*’, and after every rain, the soil was pressed with cylindrical stone called ‘*yugu*’ (Aladağ 1991). The earthen roofs which do not exist in Muğla historic urban site today, however, they can still be found in close by surroundings of Muğla, especially in some of the coastal settlements (Figure 5.54).

Figure 5.54. Earthen roof in Bodrum – Muğla  
(Source: Aran 2000)

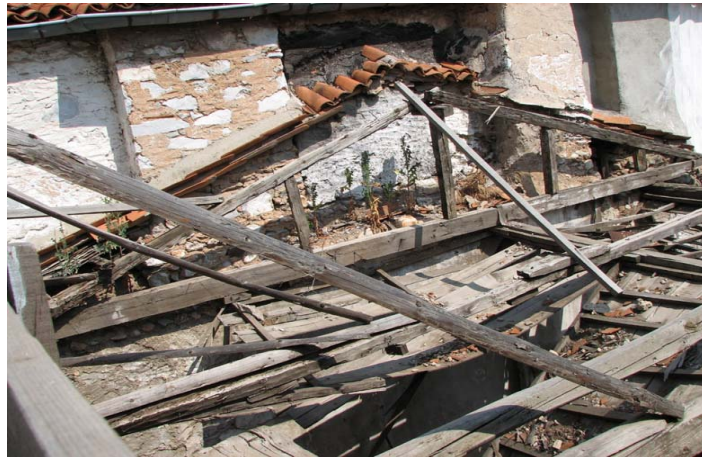
Figure 5.57. Slope of roof is formed with wood trusses, supported by post and studs, placed on ridge purlin and tie beam (next to Çeşme St. No: 2)

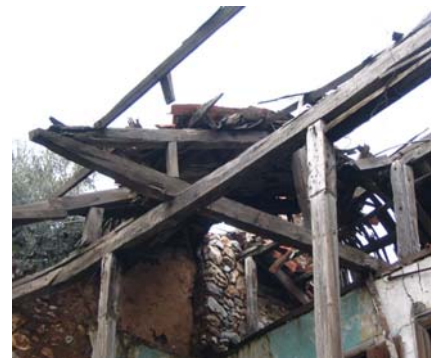
One edge of these beams is set on the wall plate in inner surface of rear wall of the house, while the other extended till the end of eaves and they are supported by front wall in first floor and posts of the sofa. On each tie beam, a post for supporting ridge purlin and studs, generally two on each side, all of which forming the wood trusses, are placed. Unlike to many other regions, there is no intermediate purlin on these studs. The slope of the roof is formed with the trusses, rested on the ridge purlin and directly on the tie beams (Figure 5.56, Figure 5.57). On the contrary to others, rafters; called '*soymok*' with cross-sections of 5/5 cm, in Muğla roofs are nailed perpendicular to the trusses with equal intervals. Then wood planks, called '*bedavra*' 130/10/0.3 cm in dimensions (Aladağ 1991), are nailed on rafters overlapping on each other. Turkish tiles, 15/12/30 cm in dimensions (Ekinci 1985) are laid over *bedavras* (Figure 5.58).

Figure 5.58. Pitched roof detail (Camcı St. 2nd dead end No: 34)

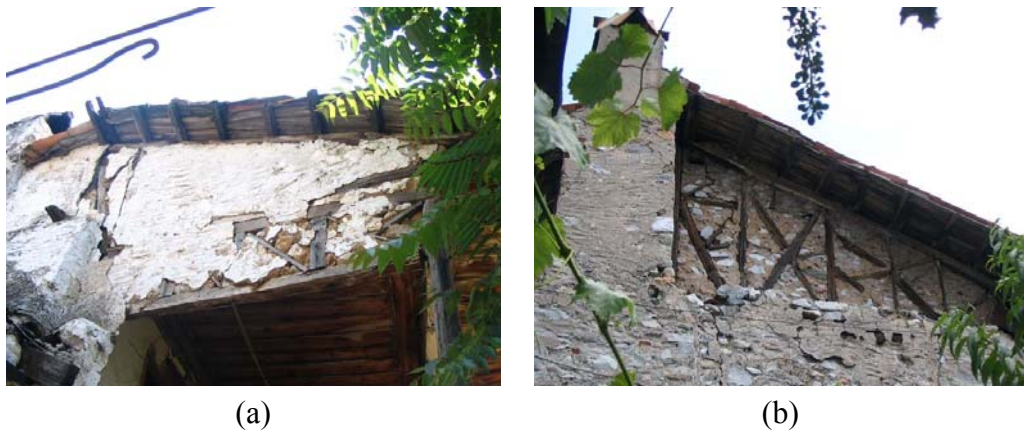
Figure 5.60. Timber-framed gable walls over short sides of sofa; a. Kahveoğlu St. No: 28, b. Süleymanbey St. No: 3

Gable walls, in the shorter sides of pitched roofs, can be considered as the extension of rubble stone outer walls. The ridge purlin is set into the gable wall at both ends. As well as those set in between, the wood trusses at the shorter sides of the building are placed at the gable walls (Figure 5.59). A certain part of the gable wall, corresponding to the side walls of the sofa may also be built of timber-framed with infill (Figure 5.60). In some houses, gable walls can be made of timber-framed with infill totally (Figure 5.61).

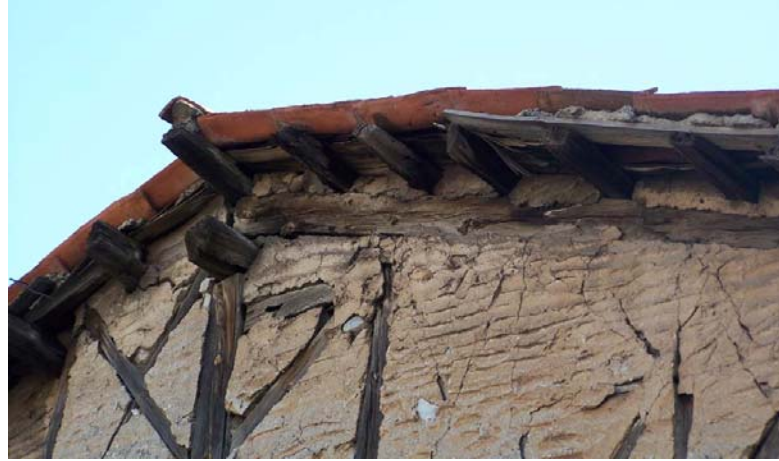
Figure 5.61. Gable wall made of timber-framed totally (Yayla St. No: 13)

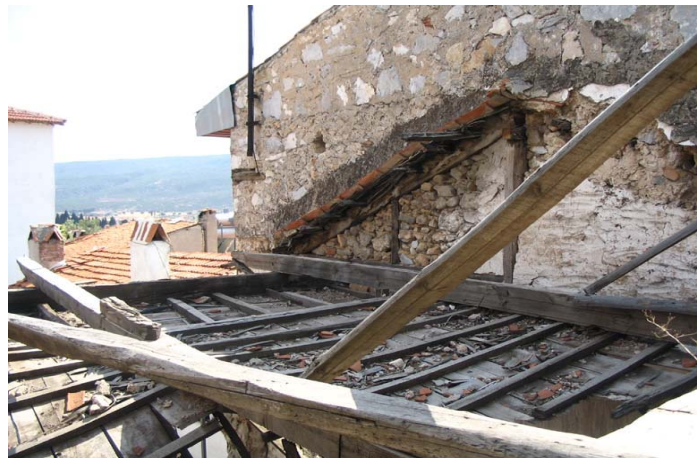
The roof is finished with wide eaves on the front façade facing to the courtyard and small eaves, called ‘*gumile*’, on other façades. The bottom of roof is covered with wood planks nailed on laths fixed under tie beams perpendicularly (Figure 5.62).

Figure 5.62. Wood plank covering at the bottom of roof which form the ceiling of the first floor (next to Çeşme St. No: 2)

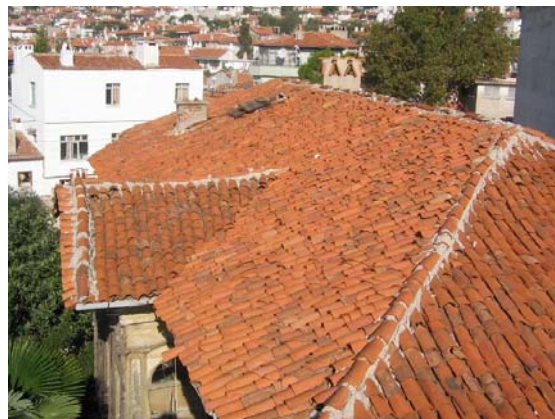
part of the roof. This small roof can be either hipped or pitched roof with a triangular pediment (Figure 5.64).

Figure 5.64. Intersection of pitched roof over the triangular pediment of *cumba* with the hipped roof (Arasta St. No: 9)

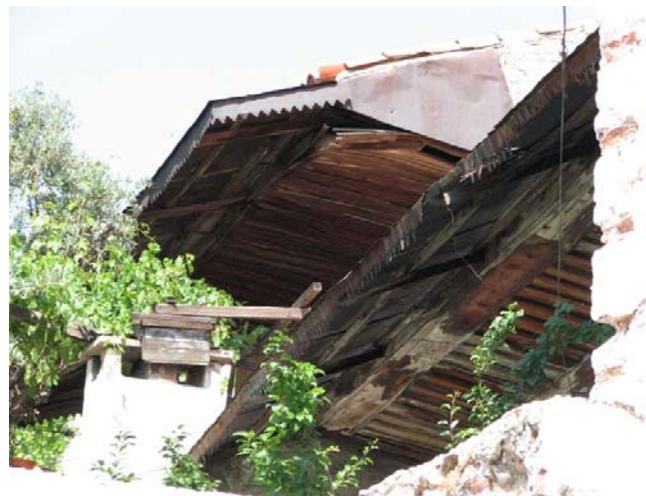
The eaves are usually decorated in varying forms with battens. Eaves fascia is 2.5 cm in thickness and 20 cm in width and made of wood in the shape of amulet rows. At the end of the eave, another eave, which is formed by covering with galvanized sheet over the wood rods that are nailed on the sides of trusses, is added in order to drain rain water away from the sofa. These eaves, called ‘tura’, are 80-100 cm in width (Aladağ 1991) (Figure 5.67).

Figure 5.67. Eaves made of galvanized sheets (Topaltı St. No:53).

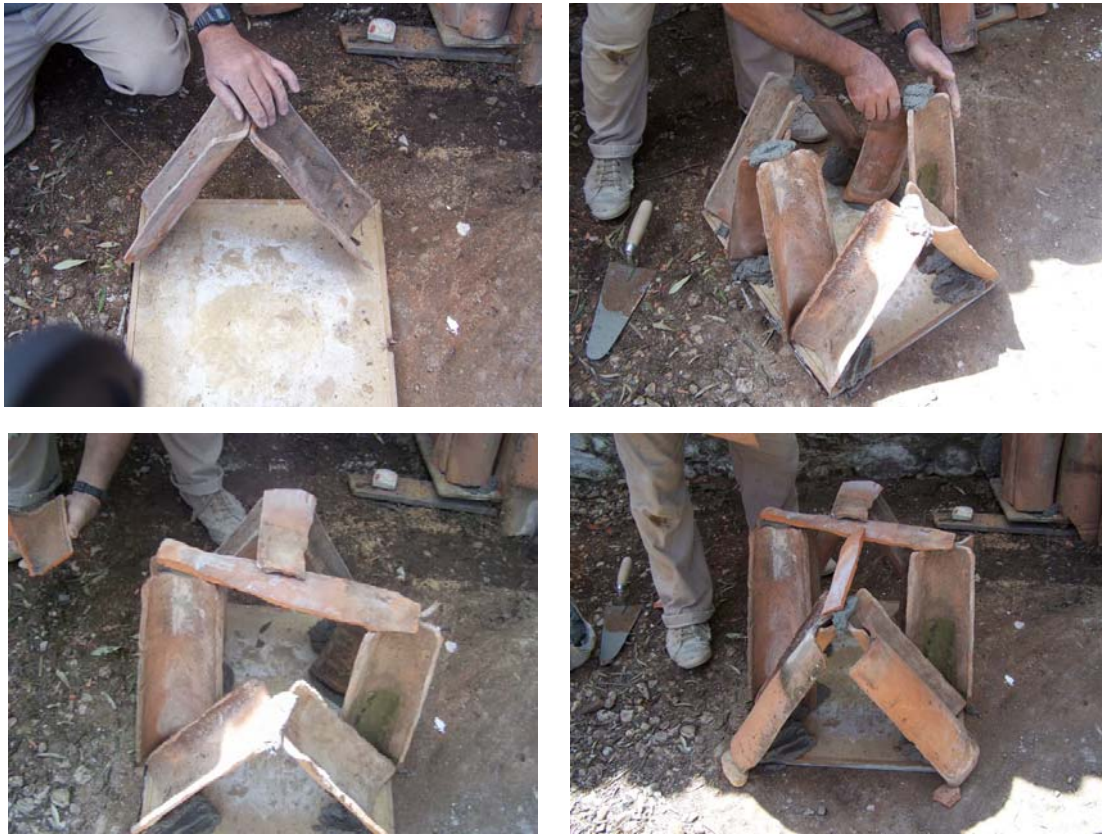
The most characteristic element of a Muğla house is its chimney with its cowl. It has a square plan and its cowl is obtained by a simple and quick arrangement of Turkish tiles abutting against each other as demonstrated by a master builder involved in the repair of old houses in Muğla (Ayhan 2008) (Figure 5.70).

Figure 5.70. The stages of the construction process of chimney cowl of Muğla houses  
(Source: Ayhan 2008)

He noted that it is good as protection against heavy rainfalls in the region and winds, blow from different directions. Turkish tiles are also used in chimney flashings. Aladağ states that these chimneys emerged at beginning of the 20<sup>th</sup> century, which was a period of transition from earthen roof to those covered with Turkish tiles (Aladağ 1991).

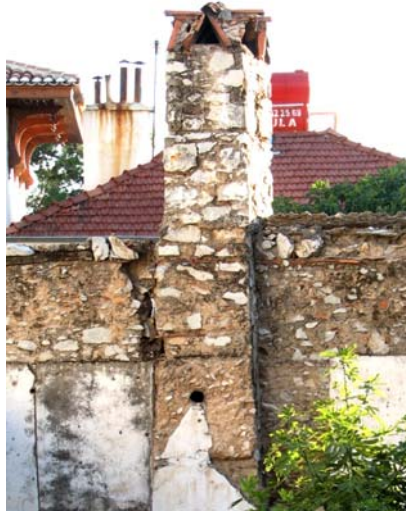
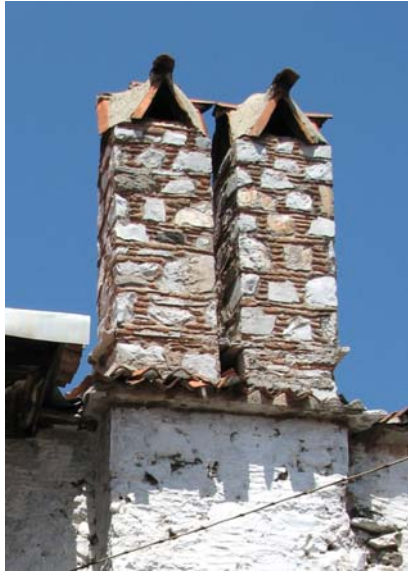
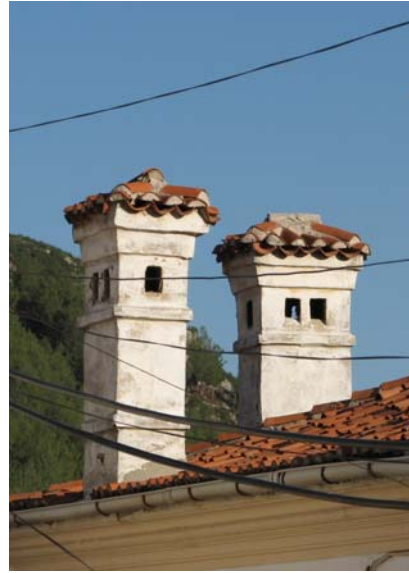
Giving most characteristic feature, became the symbol of traditional houses in historic urban part of Muğla, the chimneys are constructed in different compositions with square or circular cross sections (Figure 5.71).

Figure 5.71. Examples from different kinds of chimneys. a. İkizler St. between No: 12 – 14, b. Dibektaş St. No: 2, c. Havana St. No:33, d. Çınarlı St. No: 18

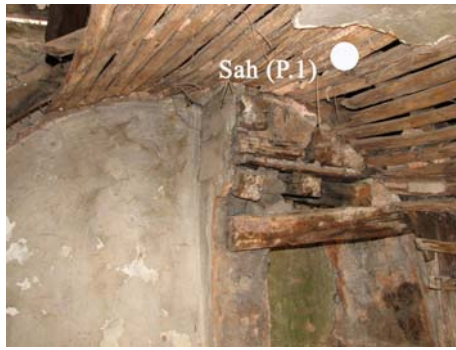
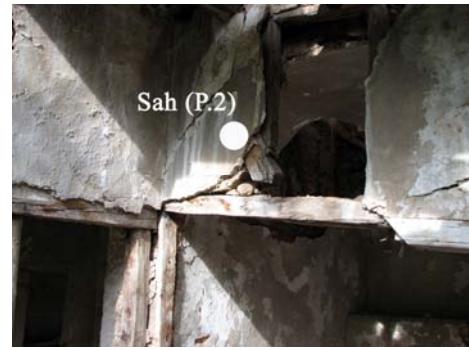
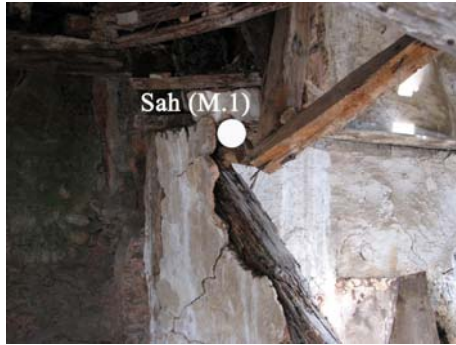
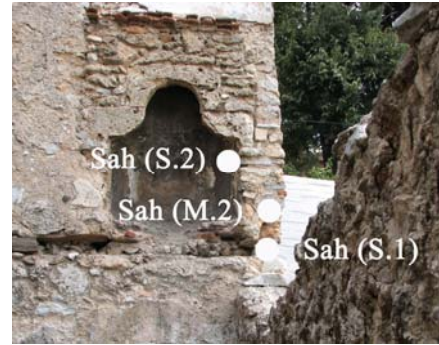
Figure 6.1 Samples from the house on Şahidi St. No: 26

The positions of the spots of sample-collection have also been indicated on the photographs according to the components of the houses individually or in pairs if they are located on the same street (Figure 6.1, Figure 6.2, Figure 6.3, Figure 6.4).
