**THE EXAMINATION OF CONSTRUCTION  
TECHNIQUES OF MUĞLA HISTORIC HOUSES**

**in Architectural Restoration**

**Burcu IRGAT ERGİN**

**October 2008**

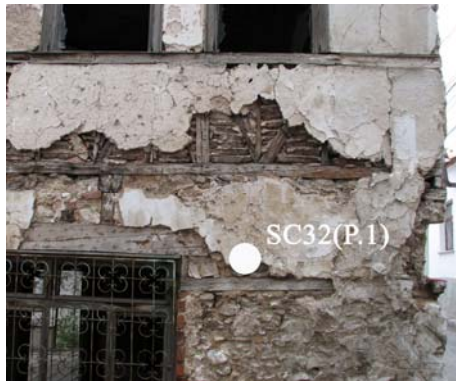
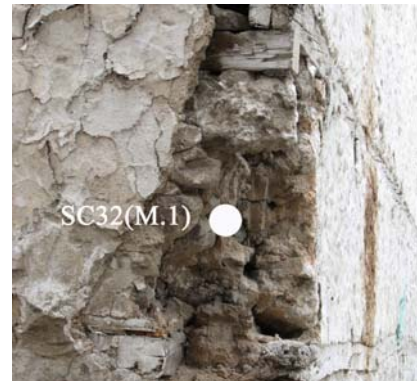
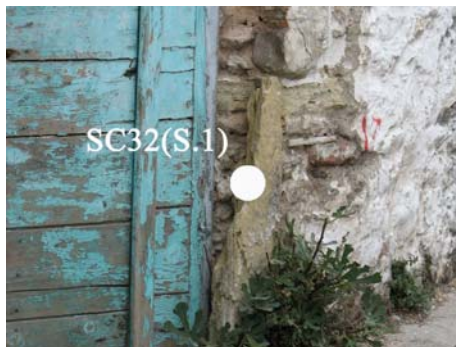
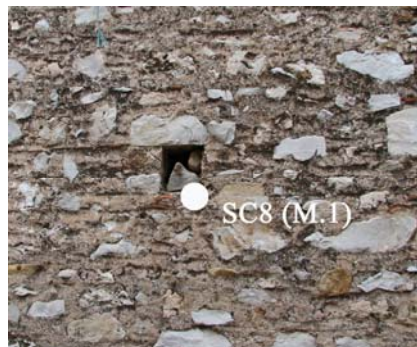
Figure 6.2 Samples from the houses on Şeyh Camii St. No: 32 and No: 8

The positions of the spots of sample-collection have also been indicated on the photographs according to the components of the houses individually or in pairs if they are located on the same street (Figure 6.1, Figure 6.2, Figure 6.3, Figure 6.4).

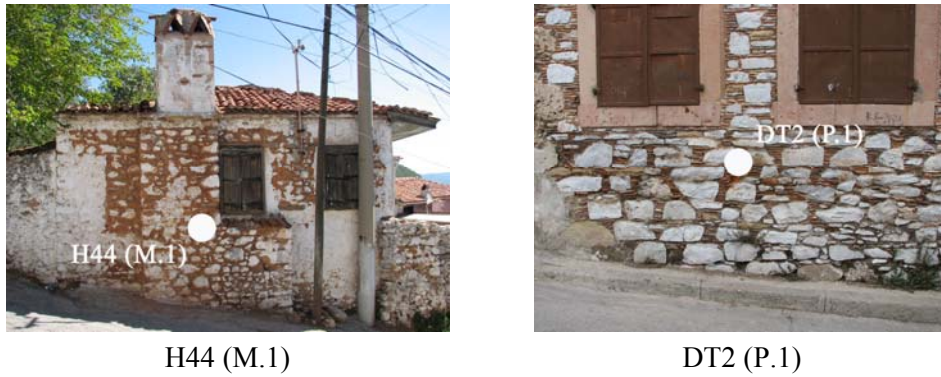
Figure 6.4 Samples from the house on Hisar St. No: 44 (H44 (M.1)) and Dibektaş St. No: 13 (DT2 (P.1))

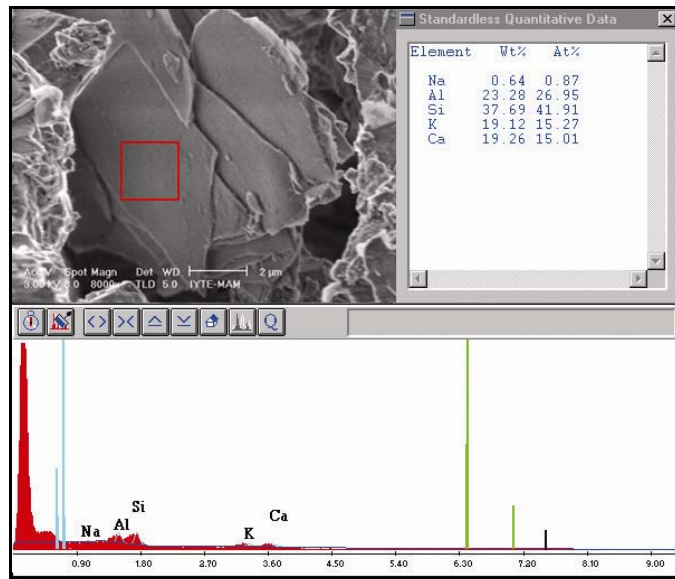
Figure 6.17 SEM image and EDX analysis of the sample SC32(S1)

XRD analyses were also performed on stone samples from, the frames of fireplaces Ik(S1), Sah(S2), the casing of gate SC32(S1), and Sah(S1) which is a sample of roughly cut lime stone most frequently used in the masonry walls of the houses and courtyard walls. According to these analyses, the sample of SC32-S1 which contains quartz and clay mineral illite with calcite is silt stone (Figure 6.16). The SEM image and EDX analysis show the clay mineral and its elemental composition of this sample (Figure 6.17).

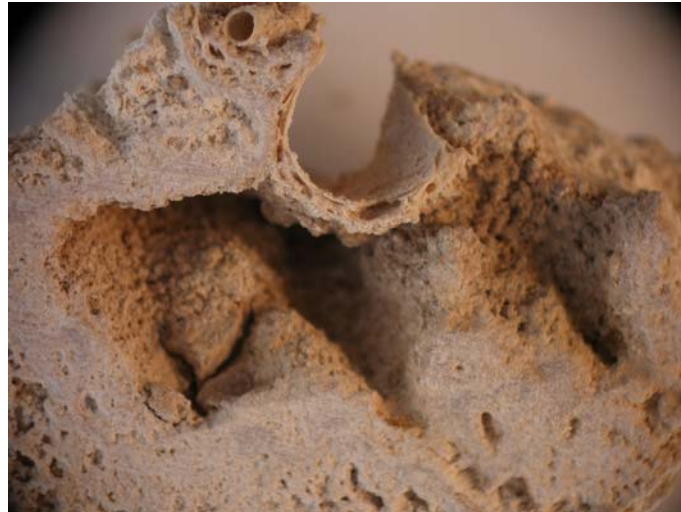
Figure 6.20 Stereo microscope image of the cross-section of sample Ik(S1)

The stone samples from fireplace frames should a very porous structure and defined as tufa likely formed around the roots of plants in marshy areas (Figure 6.20).
