DEVELOPING A PROACTIVE CONSERVATION APPROACH FOR AN
UNCOMFORTABLE INDUSTRIAL HERITAGE: ADANA SLAUGHTERHOUSE
(KANARA)

A THESIS SUBMITTED TO
THE GRADUATE SCHOOL OF NATURAL AND APPLIED SCIENCES
OF
MIDDLE EAST TECHNICAL UNIVERSITY

SEPTEMBER 2019

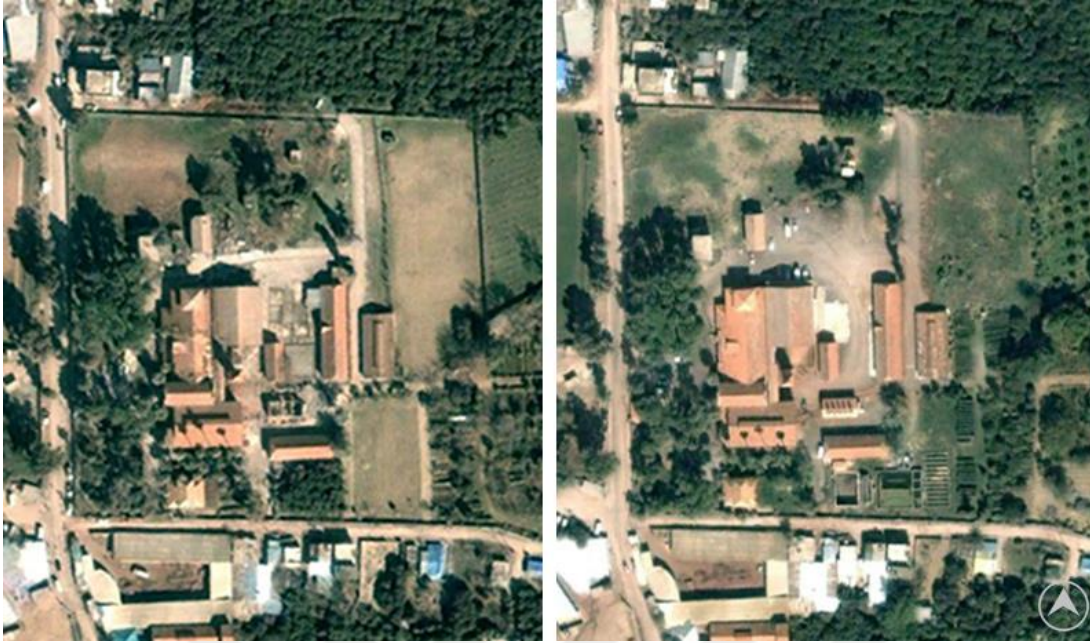
During the renovation in 2005, the damaged roofs were repaired, the door and window profiles were changed with PVC and the walls were painted. The roof of the dressing room building was entirely changed. A diner was built at the northern side and a control gate was built at the southern side of the main entrance. Wastewater treatment pools (*arıtma havuzları*) and a transformer were constructed on the southern side of the *paçahane* during these maintenances. Small buildings like water wells on the left side of the *bağirsakhane* and near the water tower, were removed.

Figure 3.83. In 2005 before the renovation (on the left) and after the renovation in 2006 (on the right)
(Source: Google Earth images)

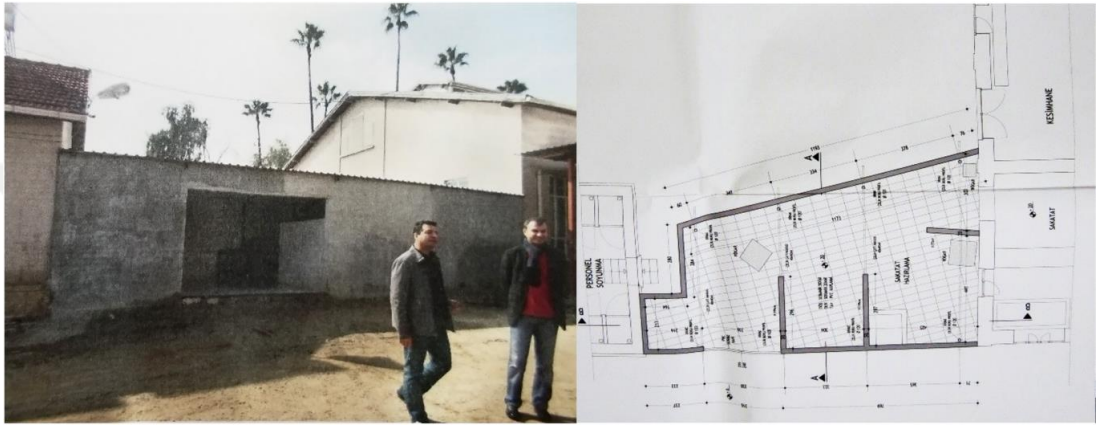
autoclaved aerated concrete covered with ceramic tiles. Because this mass was built in front of the slaughter hall's east façade, the original wall surface of the building was covered with ceramic tiles too. On the northern side of this structure, a passageway for the workers was built from plastic, semi-transparent material; to provide access from the dressing room to the slaughter hall in hygienic conditions.

Figure 3.92. Washing space addition (Source Adana Council for the Conservation of Cultural and Natural Property archive.)

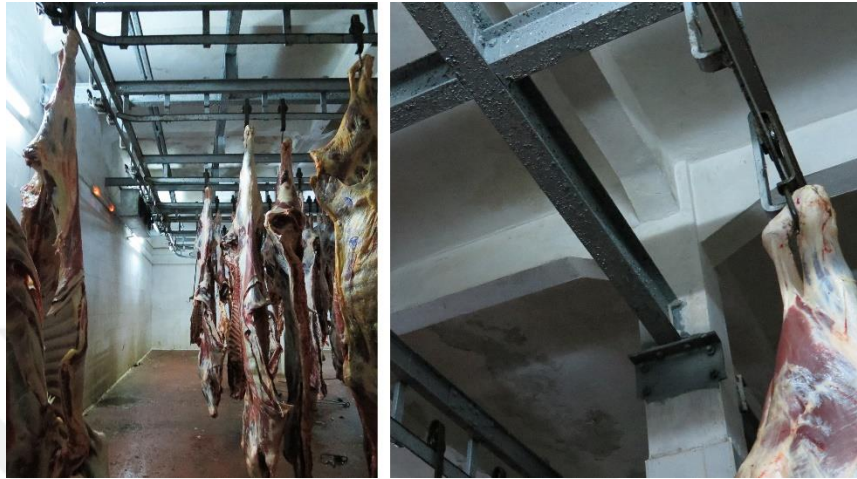
of the cold storage depots are covered with ceramic tiles, the floor is cast in place concrete and the ceiling plastered and painted.

Figure 3.112. Interior of the cold air depot and its column and beam system

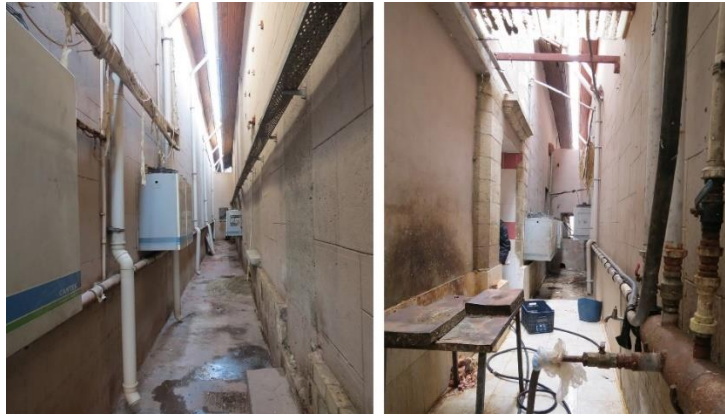
While having an architecturally featured front façade on the west, the slaughterhouse's east elevation was also designed with the same concept. However, the additional cold storage depots built in the 1960s created a visual barrier for that façade. According to the original plans, there were 8 windows and 5 doors belonged to different spaces on this façade. In the current situation, it is possible to identify those openings clearly even their function is lost. And because the additional building was built by leaving a space between, the original layouts are legible.

Figure 3.116. The space left between the slaughterhouse and cold storage depots

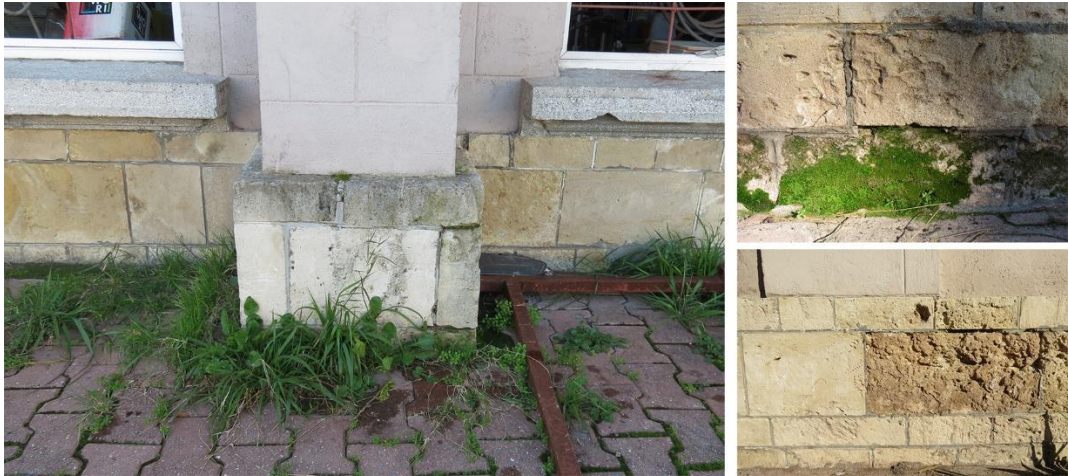
On the front façade, discoloration, deposits and biological formations emerged due to exposure to water. Especially on the stone surface, the blackening of the material occurred in time. The cut stones on the plinth level had encountered material loss and also some of them were repaired or replaced. On the roof elements, there were repairs with cement plaster. On the south façade, the repaired and replaced stone units can be identified as well as the material loss due to corrosion. There are several surface cracks on the plastered surfaces. The PVC drainage pipes and window shutters on the lantern got damaged in certain places. The same deteriorations are visible on the south façade while the east façade is encountering more problems because it is exposed to further damaging impacts. Addition of the masses, constant exposure to manure, blood and water create material loss and discoloration. Incompatible materials were used like ceramic cladding on the portion of the slaughter hall's east façade, inside the entrails preparation room. Because there is a narrow corridor formed between the slaughterhouse and cold storage depots, that portion of the east façade is used to put air condition units or other installations. Interior areas of the main pavilion faced the same problems; exposure to water and dirt, the use of incompatible materials and drainage problems.

Figure 3.117. New material use for the renovation of stone (on the left) microbiological growth and material loss (on the right)

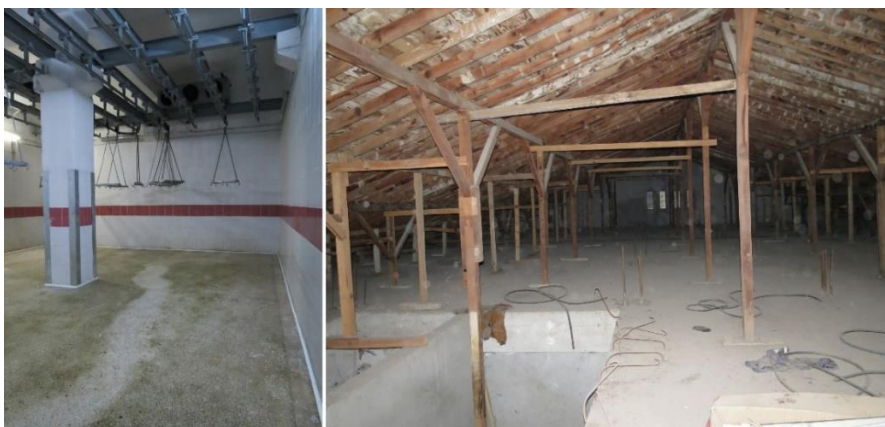
Figure 3.119. Interior of the depot (on left) timber frame structure observed in the attic (on right)

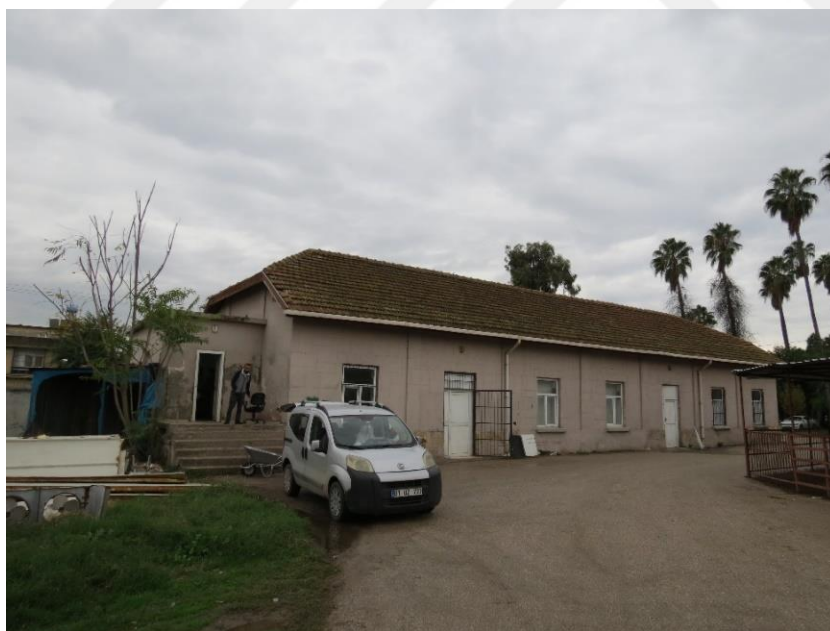
The stone veneer on the façades has a material loss, discoloration due to rising damp and surface cracks. The use of incompatible materials like PVC doors, windows, drainage pipes and suspended ceilings together with a mass addition are the factors that are harmful to the original character of the structure.

Figure 3.123. Exterior of the building

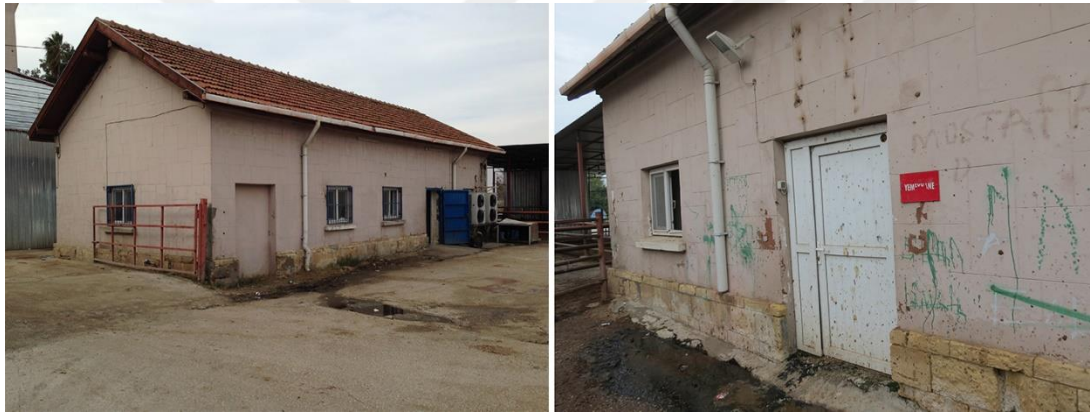
Figure 3.125. Exterior view (on left) deteriorations on the back façade of the building (on right)

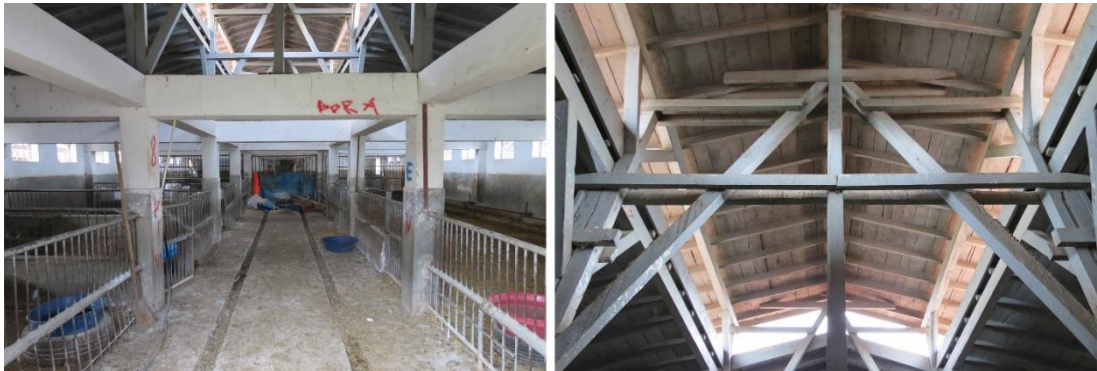
Figure 3.129. Interior view of the stable (on the left) and its timber roof structure (on the right)

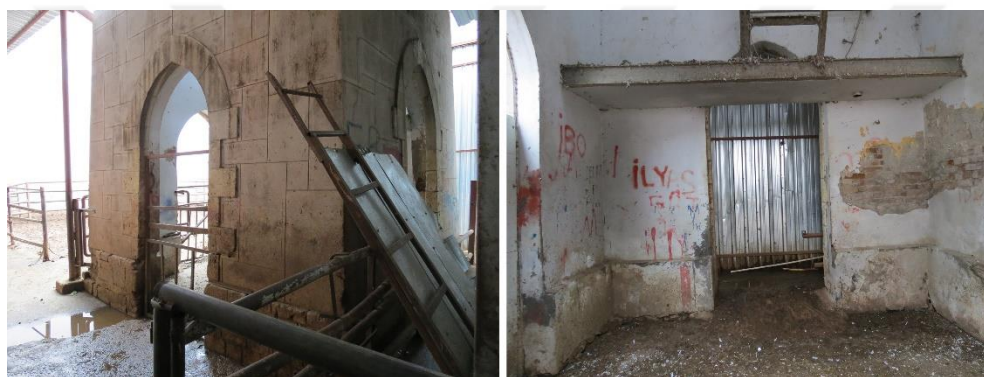
Figure 3.132. Exterior and interior damages of the water tower

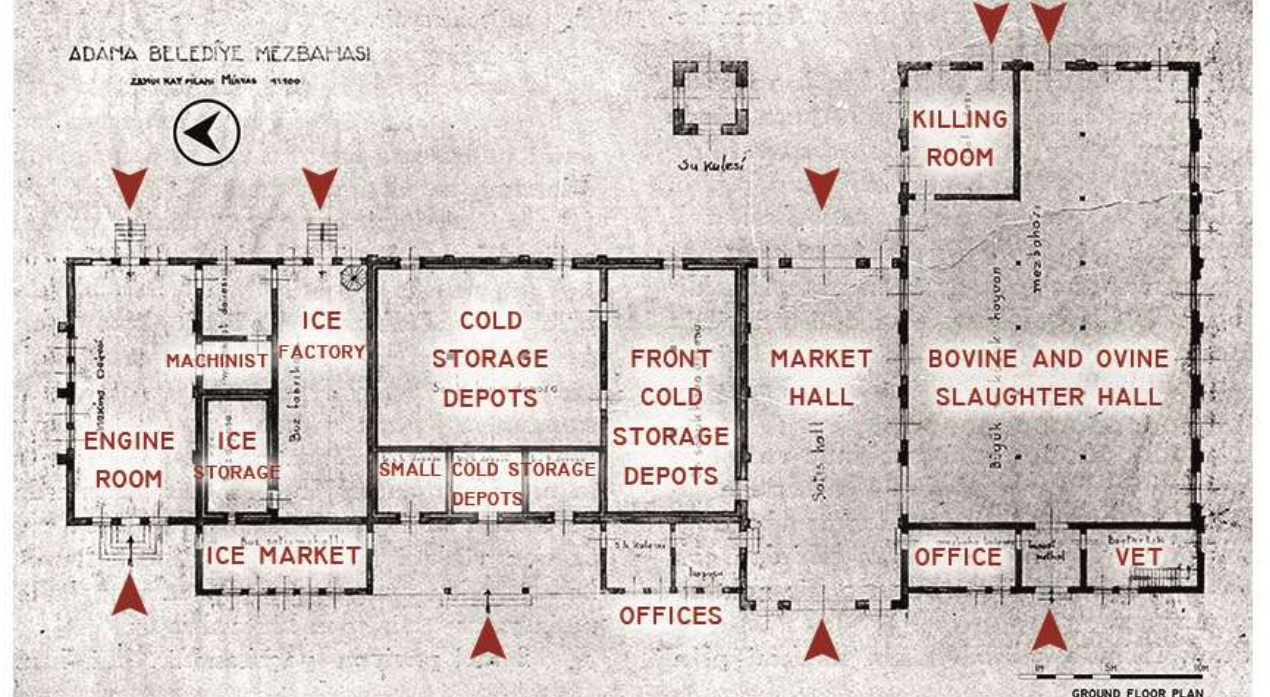
<p>ADANA BELEDİYE MEZBAHASI ZEMİN KAT PLANI MİTAS 1/500</p> <p>GROUND FLOOR PLAN</p>												
<p>BUILDING ID: SI - CI CONSTRUCTION DATE: 1932 - 196? ARCHITECT: SEMİH RUSTEM TEMEL - ? STRUCTURAL SYSTEM: CONCRETE FRAMED BRICK MASONRY ORIGINAL FUNCTION: SLAUGHTERHOUSE CURRENT FUNCTION: SLGH.-COLD STORAGE DEPOT NUMBER OF FLOORS: 1 AREA: 1560 M² (SLGH.) + 500 M² (COLD ST.) APPRX. BLD. HEIGHT: AVG. 10M USAGE: IN USE</p> <p>CONDITION OF CONSTRUCTION MATERIAL AND STRUCTURE</p> <table border="1"> <tr> <td>1</td> <td>DETERIORATION ON FINISHING MATERIALS, NO STRUCTURAL PROBLEMS</td> </tr> <tr> <td>2</td> <td>DETERIORATION ON MATERIALS, SLIGHT STRUCTURAL PROBLEMS</td> </tr> <tr> <td>3</td> <td>SEVERE DETERIORATION ON MATERIALS, DEEPER STRUCTURAL PROBLEMS</td> </tr> </table> <p>CHANGE:</p> <table border="1"> <tr> <td>1</td> <td>MINOR CHANGES THAT DO NOT AFFECT THE LEGIBILITY</td> </tr> <tr> <td>2</td> <td>PARTIAL CHANGES THAT AFFECT THE LEGIBILITY</td> </tr> <tr> <td>3</td> <td>MAJOR CHANGES IN PROPORTION/ORGANIZATION</td> </tr> </table>	1	DETERIORATION ON FINISHING MATERIALS, NO STRUCTURAL PROBLEMS	2	DETERIORATION ON MATERIALS, SLIGHT STRUCTURAL PROBLEMS	3	SEVERE DETERIORATION ON MATERIALS, DEEPER STRUCTURAL PROBLEMS	1	MINOR CHANGES THAT DO NOT AFFECT THE LEGIBILITY	2	PARTIAL CHANGES THAT AFFECT THE LEGIBILITY	3	MAJOR CHANGES IN PROPORTION/ORGANIZATION	<p>2013 DOCUMENTATION DRAWINGS</p>

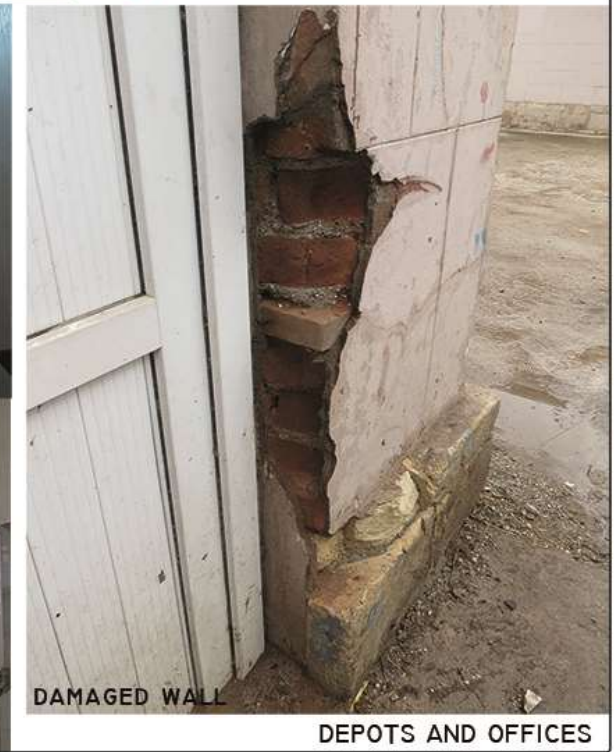
Z02

DAMAGED WALL
